Tech Notes

NUMBER 16

Repairing and Upgrading Multi-Light Wooden Mill Windows

SAWYER MILLS Dover, New Hampshire

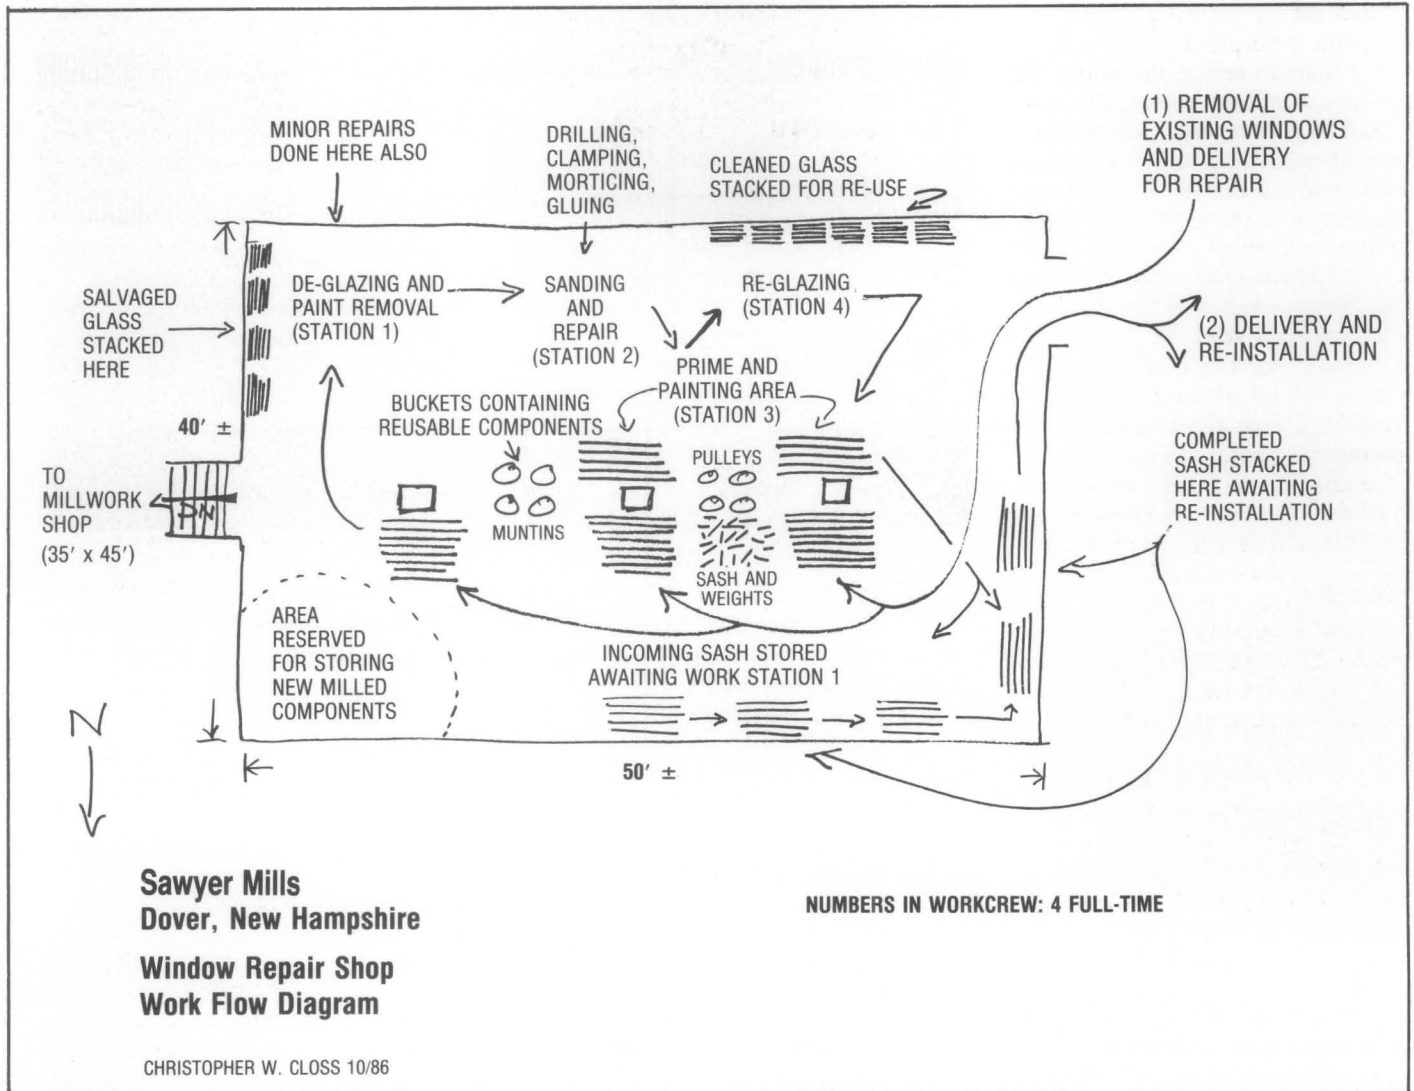
Figure 2. Drawing shows the plan of the window repair shop set up within Sawyer Mill during renovation work. The mobile mill-work site was located in a room immediately to the left of the repair shop. Drawing: Christopher Closs

labor force in a logical sequence (see figure 1). The decision was made to undertake the work on the site and to establish a mobile millwork shop adjacent to the window repair shop so that the former could continuously supply the latter (see figure 2). The shops had to be relocated only once during construction. A key factor making the on-site window repair approach feasible was that the millwork shop's variable workload from window repairs was supplemented by specialty orders from outside contracts, eliminating costly down-time.
