9 ROXBURY ROAD SCARSDALE, NEW YORK

Tech Notes

NUMBER 19

Repairing Steel Casement Windows

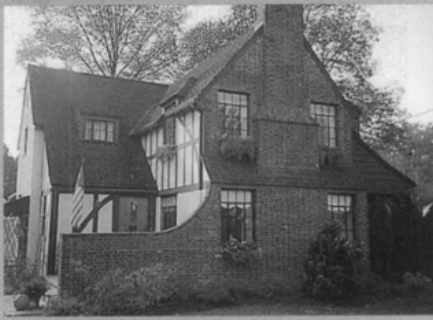
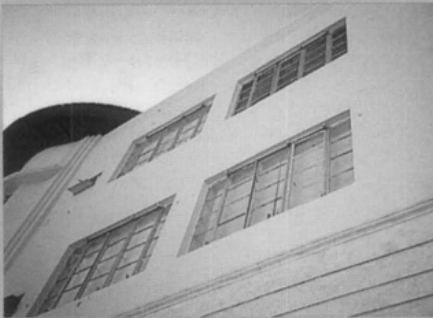
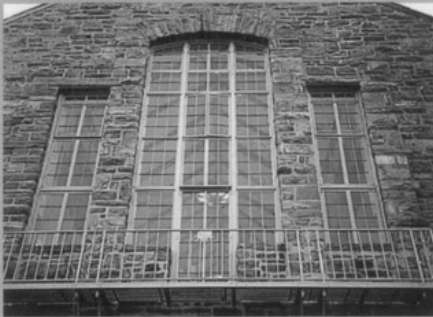
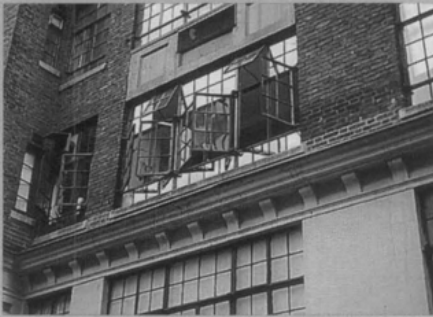
Inappropriate replacement windows dramatically affect the appearance of a historic home that once featured steel casement windows.
