Completion Report

Tusayan Museum, Grand Canyon N P

The project consisted of replacing or repairing all of the viga ends on the Tusayan Museum.

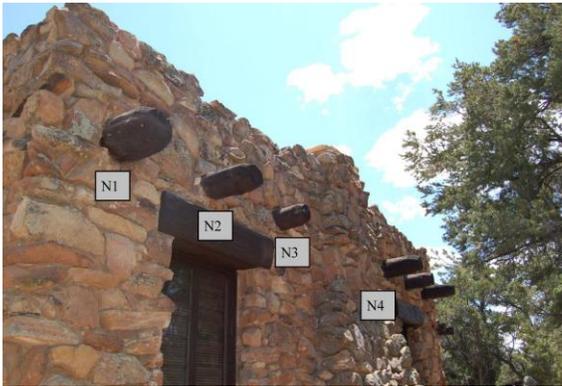
Vigas S3, S4 and S11 were approached in the same manner. For vigas S3 and S4, the remaining log was cut off flush with the outside of the building. The wood for all three vigas was then removed to a depth of around 6 inches inside the wall using large drill bits and an angle grinder with a special grinding wheel. Once the wood was removed, the end inside the wall was stabilized with an epoxe consolidant to protect the rest of the viga. Holes were drilled and Borate impel rods were installed at 11 and 2 o'clock one inch in from the outside surface of the log end. A hole was drilled and the impel rod inserted into the hole, which was then plugged. Finally, two pieces of fibertglass rebar were situated vertically two inches in from the top and bottom of the logs, drilled twelve inches into the remaining log and twelve inches into the viga end. The new viga ends were then epoxied in place. This technique of inserting Borate impel rods and fiberglass was used on all viga end replacements as a precautinary measure to protect the log

ends from moisture and as a means of attaching the new viga ends to the existing logs. All replacement ends were sized to the original for length and diameter.

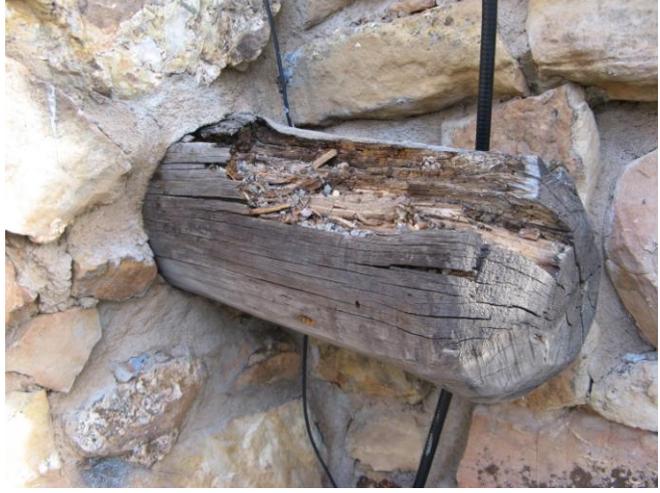
Viga ends prior to preservation
