THE CAPTAIN WILLIAM SMITH HOUSE

HISTORIC STRUCTURE REPORT

Minute Man National Historical Park
Lincoln, Massachusetts

December 2007

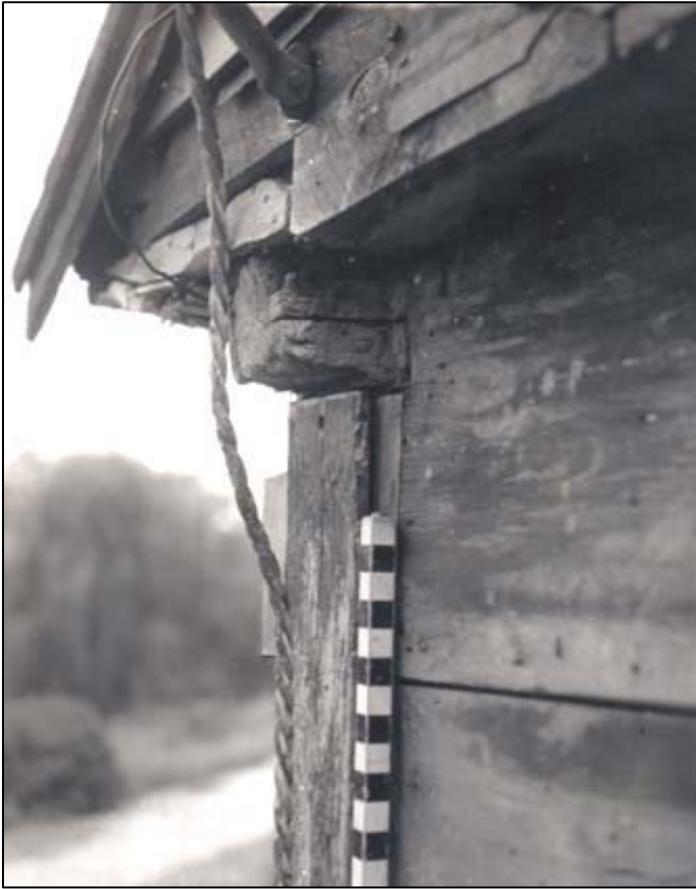
Figure 33. Main House:
South corner of east
gable end, showing
overhanging plate and
girt.

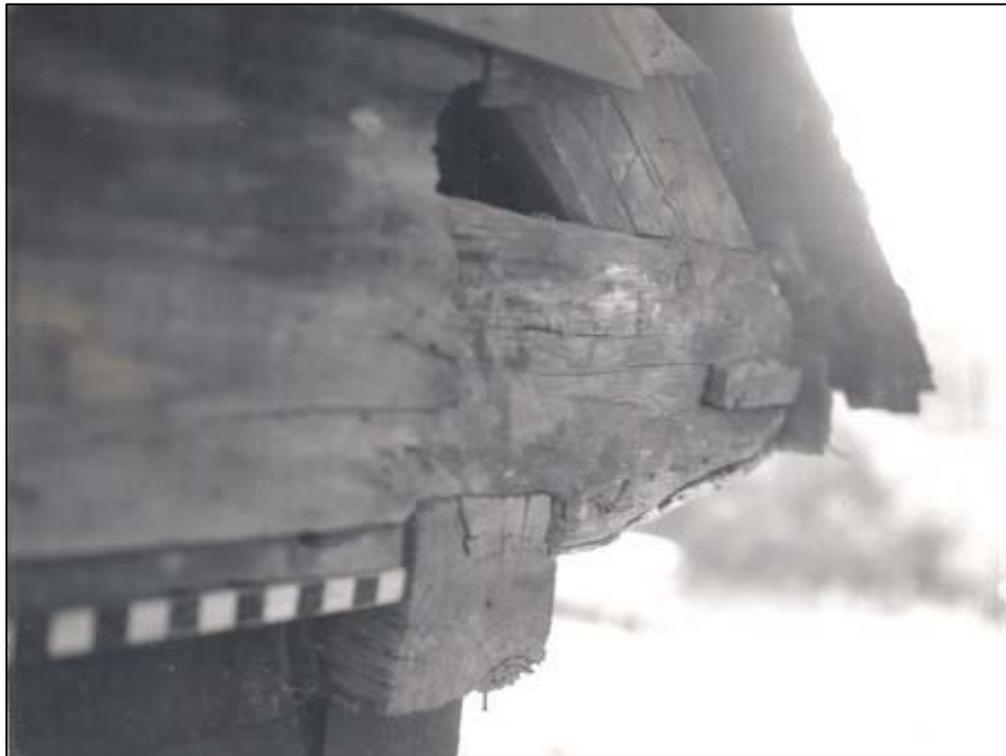
Figure 34. Main House: South corner of west gable end, showing overhanging plate and girt.

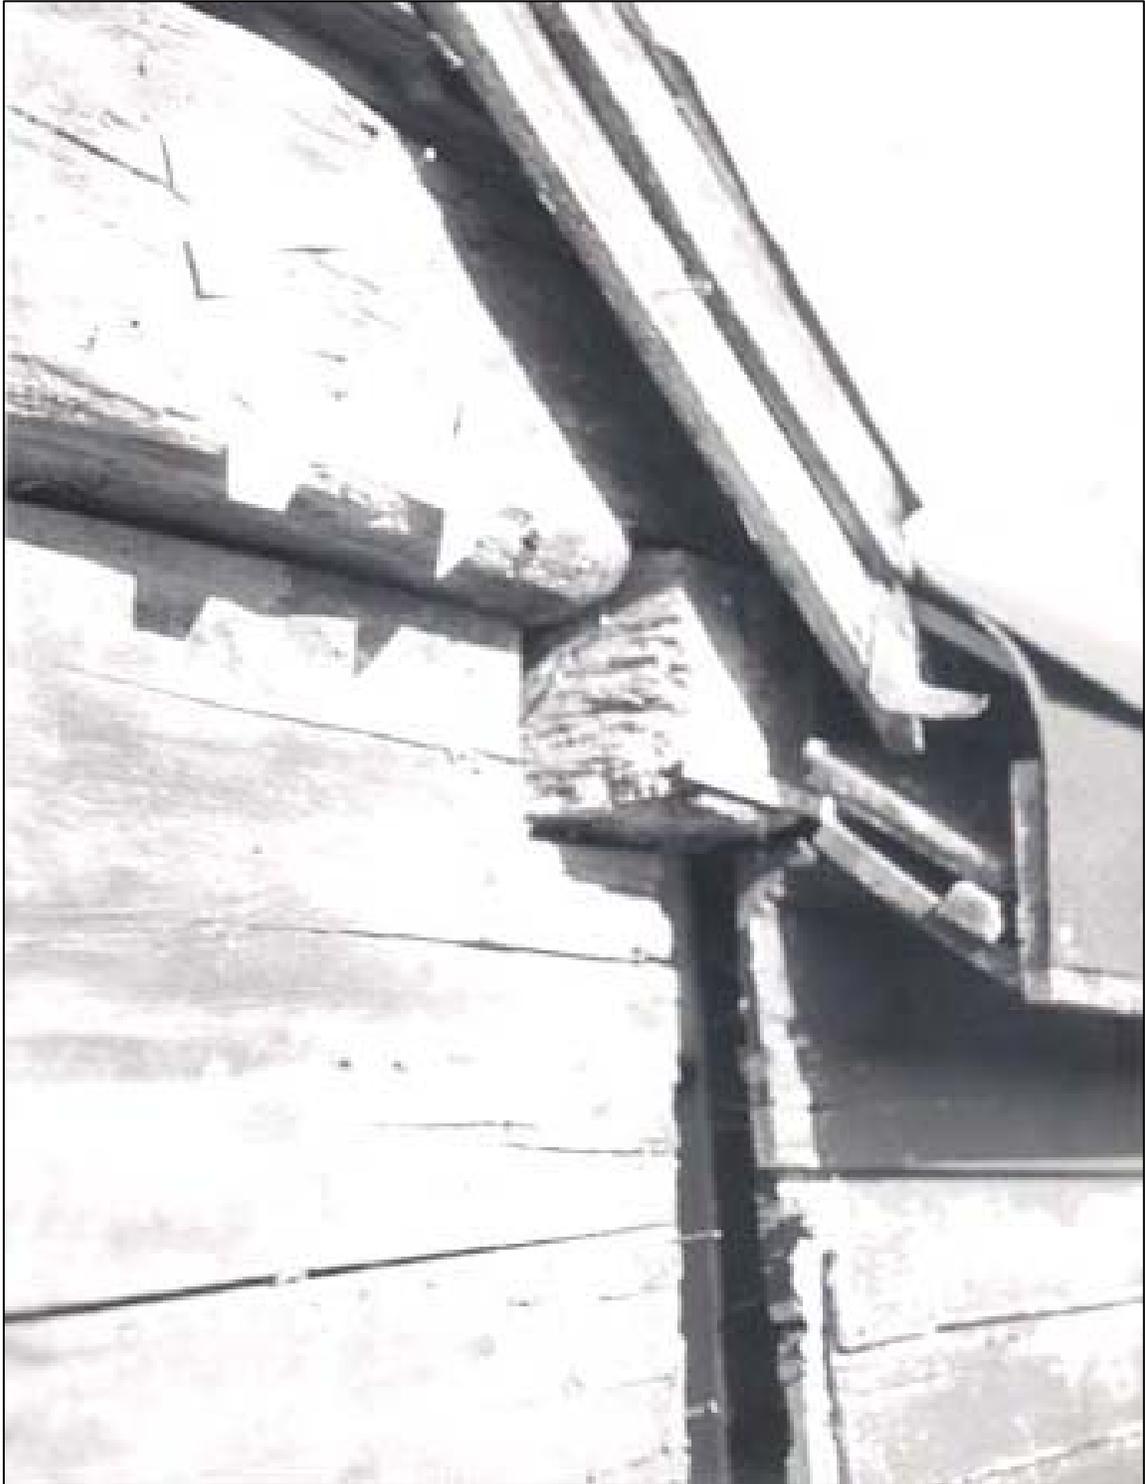
Figure 35. Main House: North corner of east gable end, showing end of north wall plate overridden by east overhanging girt; arrows point to pin connections of rafter and posts tenons.

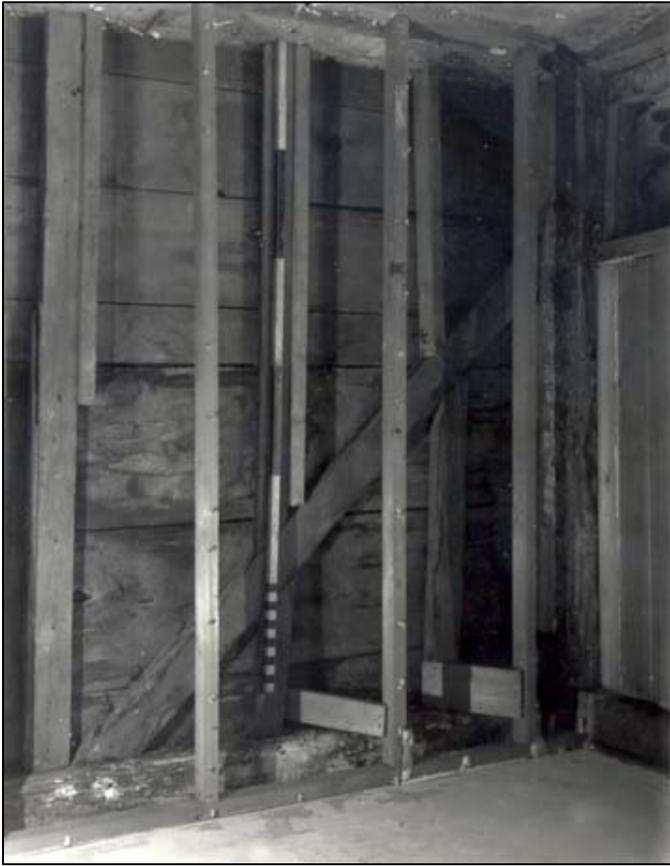
The original foundation sills, floor joists, principal posts, studs, corner braces, and plates were made from oak, as opposed to the girts, summer beams, and principal rafters, which were of pine (figs. 36- 41). The common rafters were mixed oak and pine. The large frame members were all hand- hewn and smoothed only on the surfaces that were exposed to the room interiors. Even so, there were exceptions to this rule; e.g., the posts and girts in the chambers were left in their roughed- out condition. The smaller- dimension pieces were mill- sawn, such

Figure 36. Main House:
East Parlor, north end of
east wall, showing
framing.

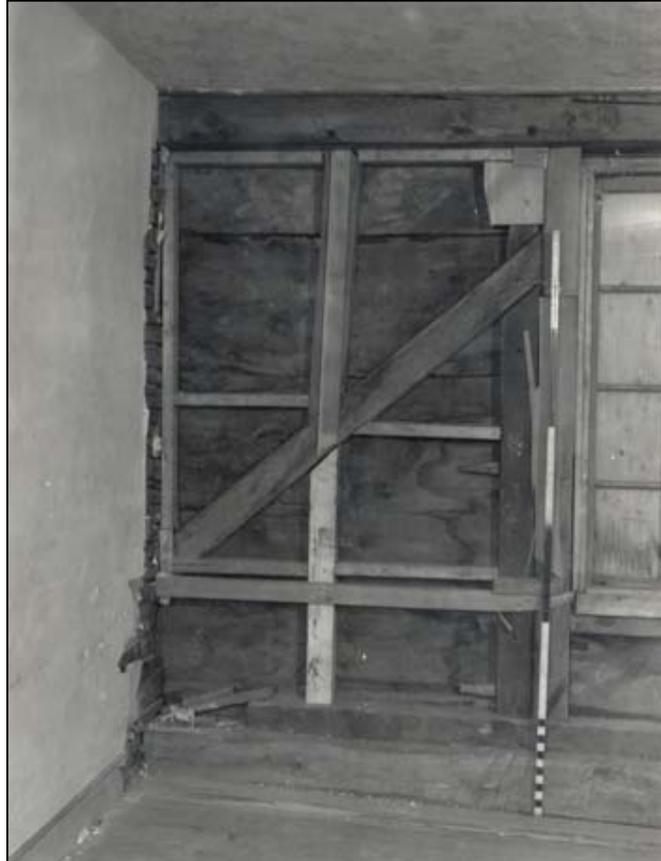
Figure 37. Main House:
East Parlor, south end of
east wall, showing framing.

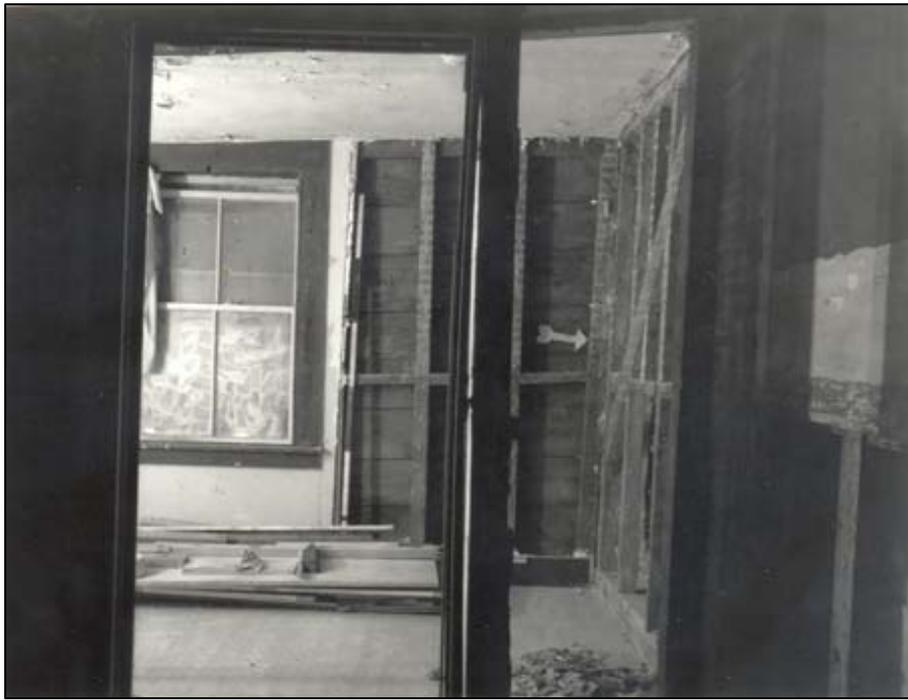
Figure 38. Ca.- 1900 Addition: Looking east from first- story center room along north (formerly exterior) wall of main house (at right), after wall covering was removed.

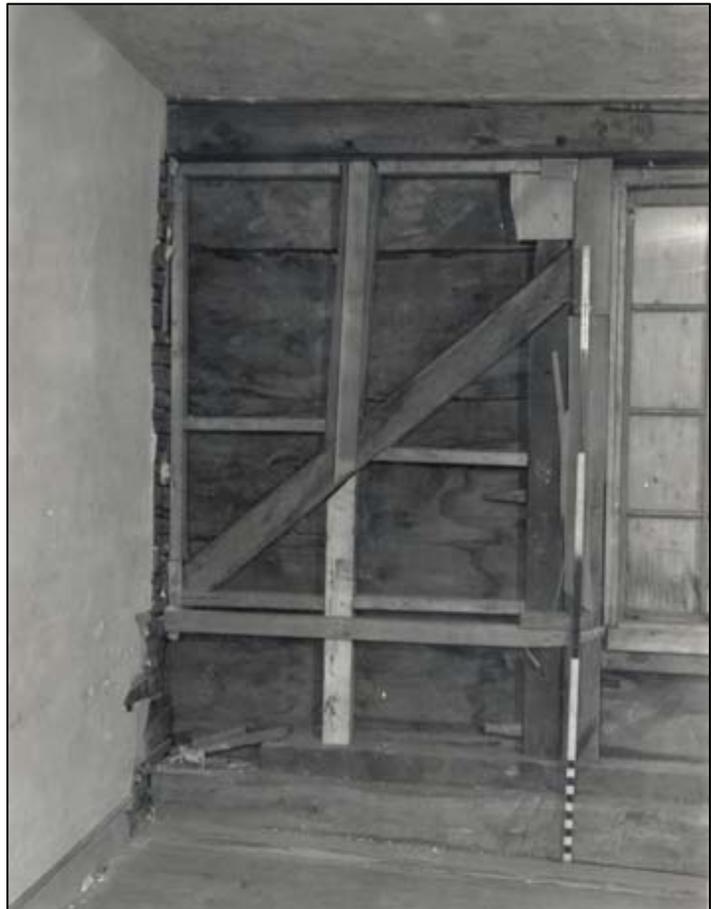
Figure 39. Ca.- 1900 Addition: First- story east room, looking south at exposed framing of north (formerly exterior) wall of main house, showing East Parlor lath split from original wall boards ca. 1810.

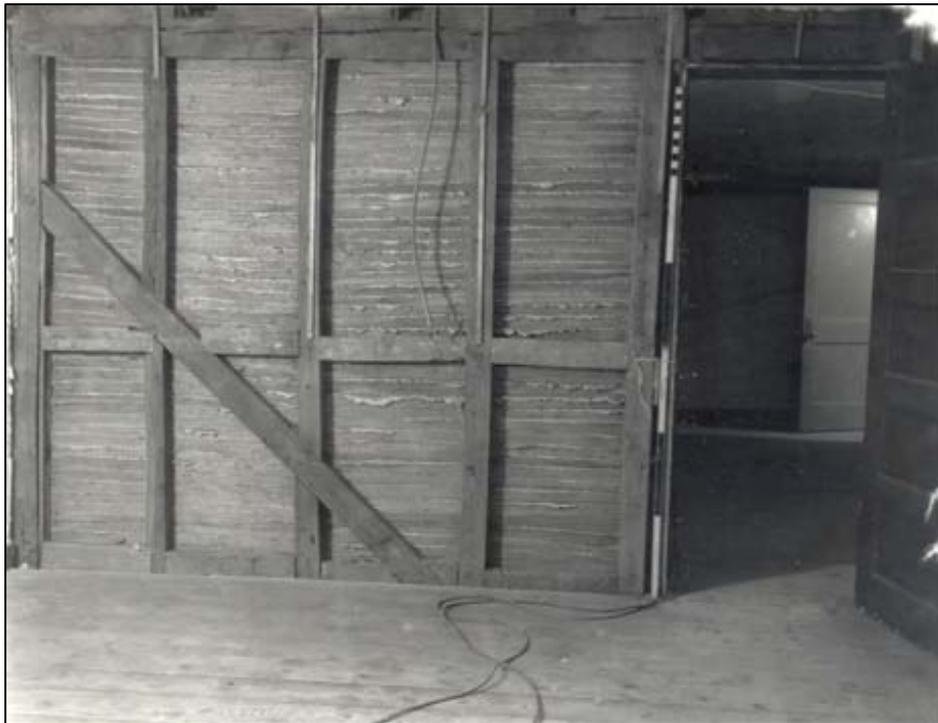
Figure 40. Ca.- 1900 Addition: Second- story east room, looking south at exposed framing of north (formerly exterior) wall of main house, showing oak framing members and East Chamber wall lath.

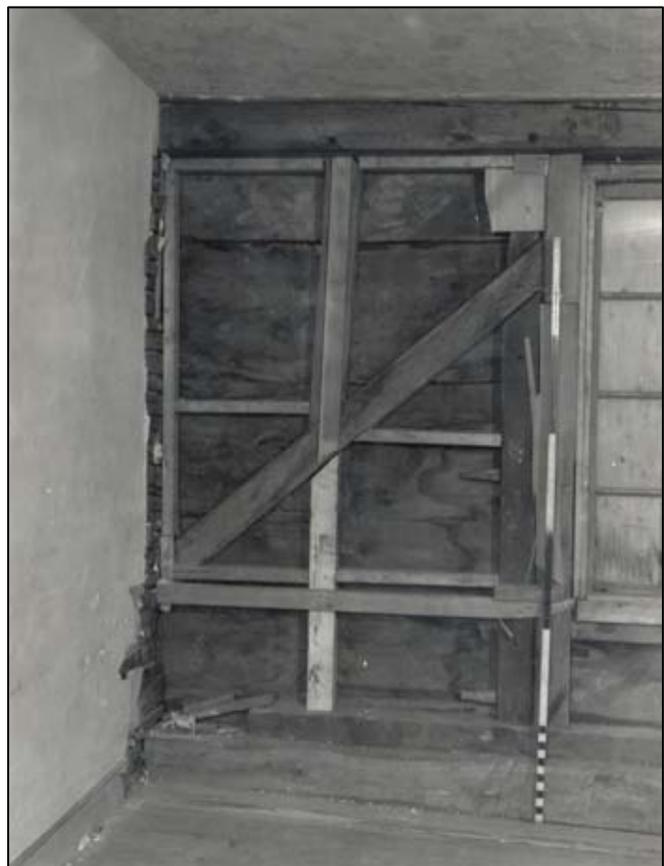
Figure 41. Ca.- 1900 Addition: Second- story west room, looking south at exposed framing of north (formerly exterior) wall of main house, showing oak framing members and West Chamber wall lath.

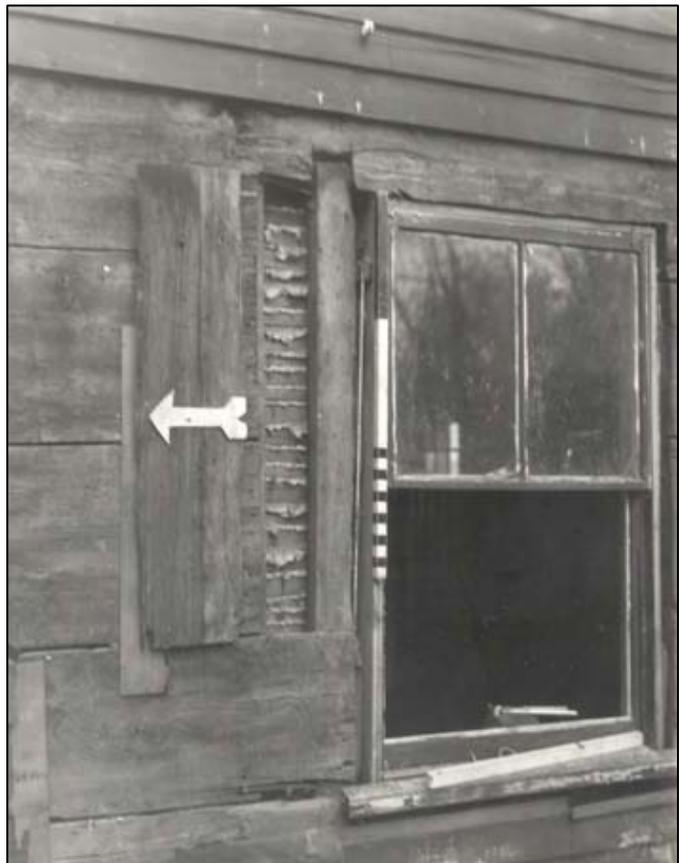
Figure 46. Main House:
West exterior wall, showing
West Parlor window; arrows
point to head and sill of ca.-
1692 window opening.

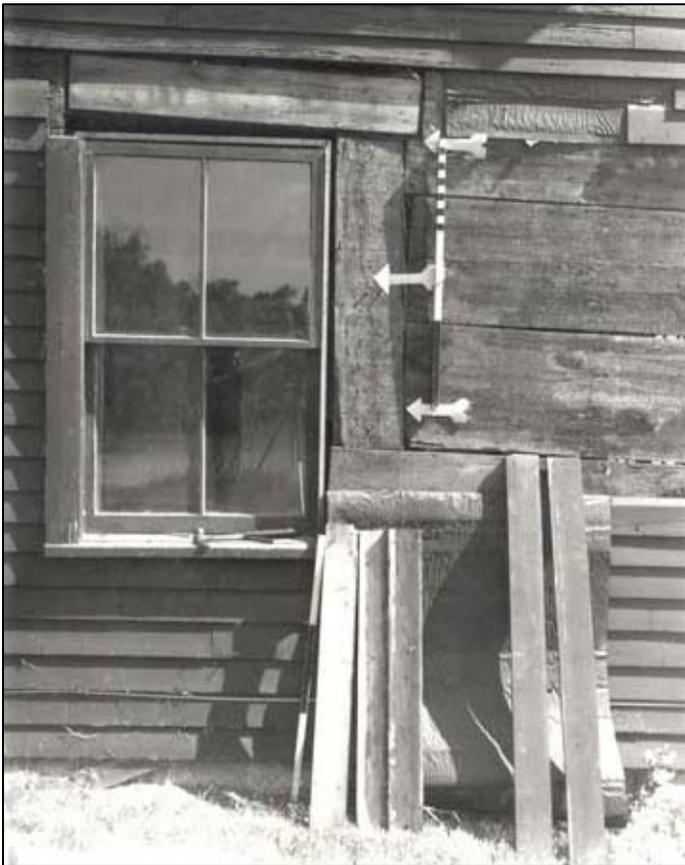
Figure 47. Main House:
West exterior wall, showing
West Parlor window; arrow,
which is attached to back
side of board reused to
narrow ca.- 1692 window
opening, points to molded
edge and red paint.

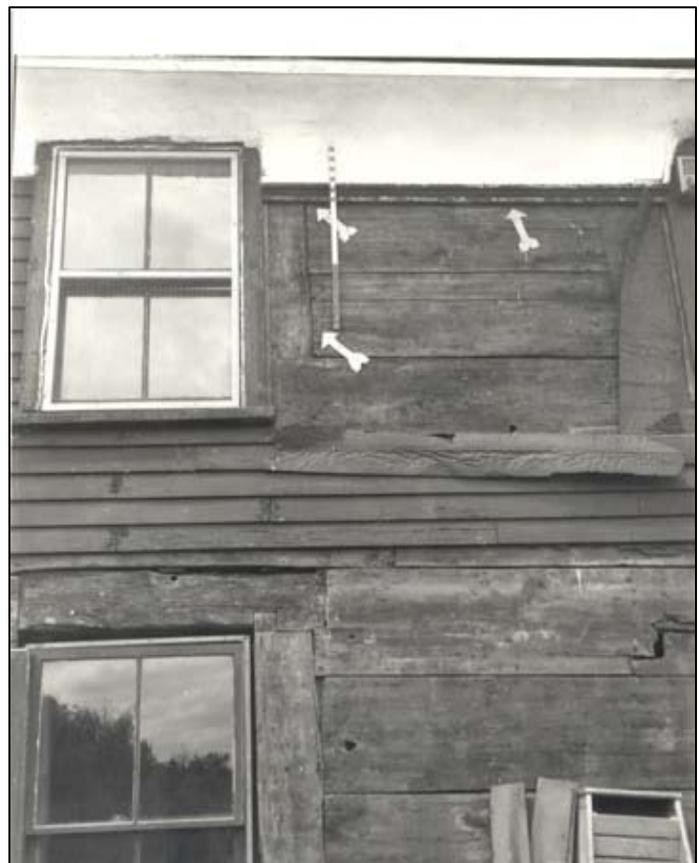
Figure 48. Main House:
South exterior wall,
showing East Parlor
window; arrows point to
head, sill locations of ca.-
1692 window opening.

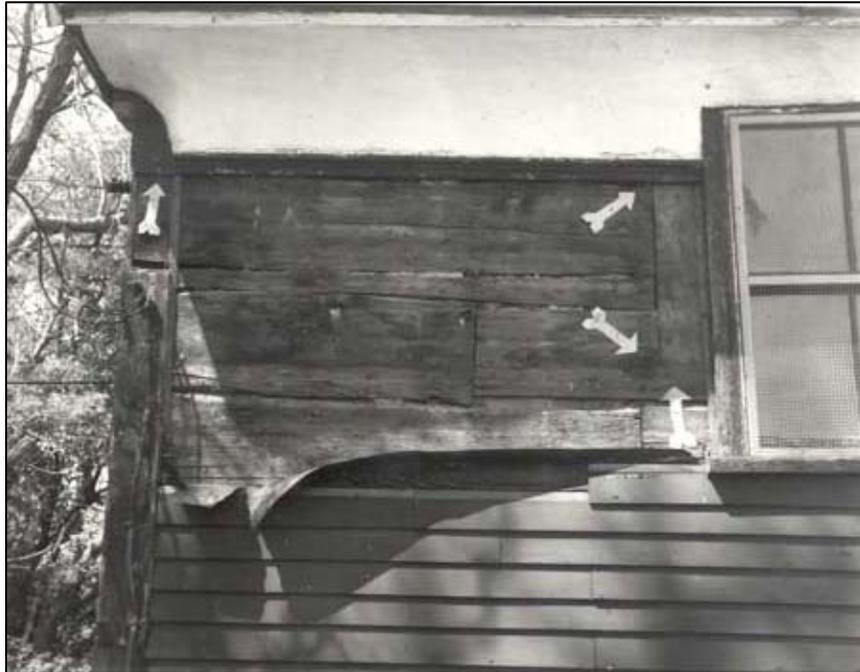
Figure 50. Main House: East exterior wall, showing East Chamber window; arrow points to outline of ca.- 1692 window sill, jamb.

The coved plaster cornice along the south wall was altered to cove also at its east and west ends (fig. 50); the remainder of the cornice was repaired with machine- cut lath and new plaster. A new shingled roof may have been installed.

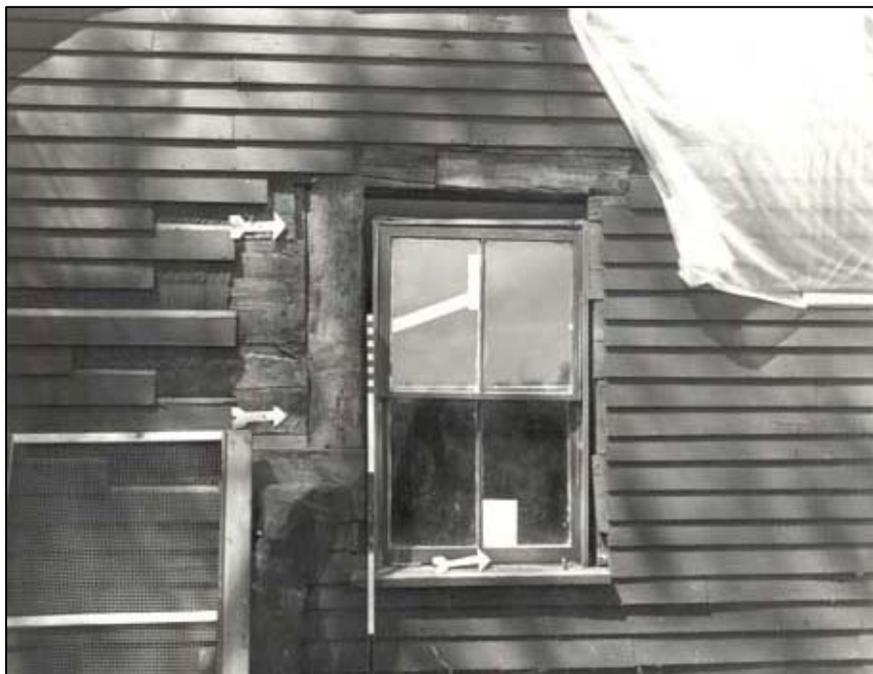
Figure 51. Main House: South exterior wall, west end, showing cove cornice and West Chamber window; left arrow points to former location of original bed molding; right arrows point to head, jamb, sill locations of ca.- 1692 window opening.

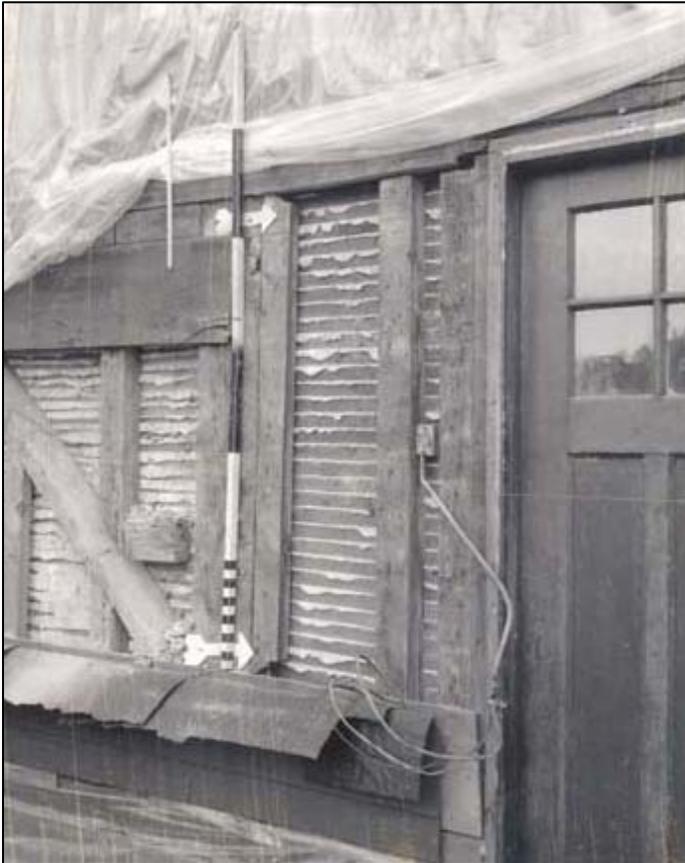
Figure 52. Main House: South exterior wall, showing West Parlor window; arrows point to head, sill locations of ca.- 1692 window opening.

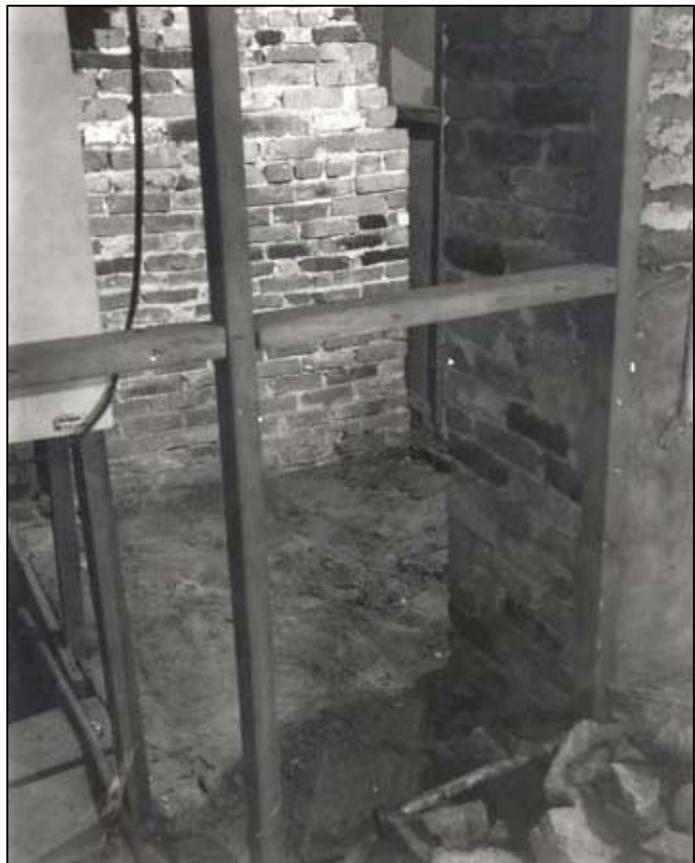
Figure 56. Main House: East Parlor, west wall after removal of ca.- 1956 paneling, showing space originally occupied by central chimney.

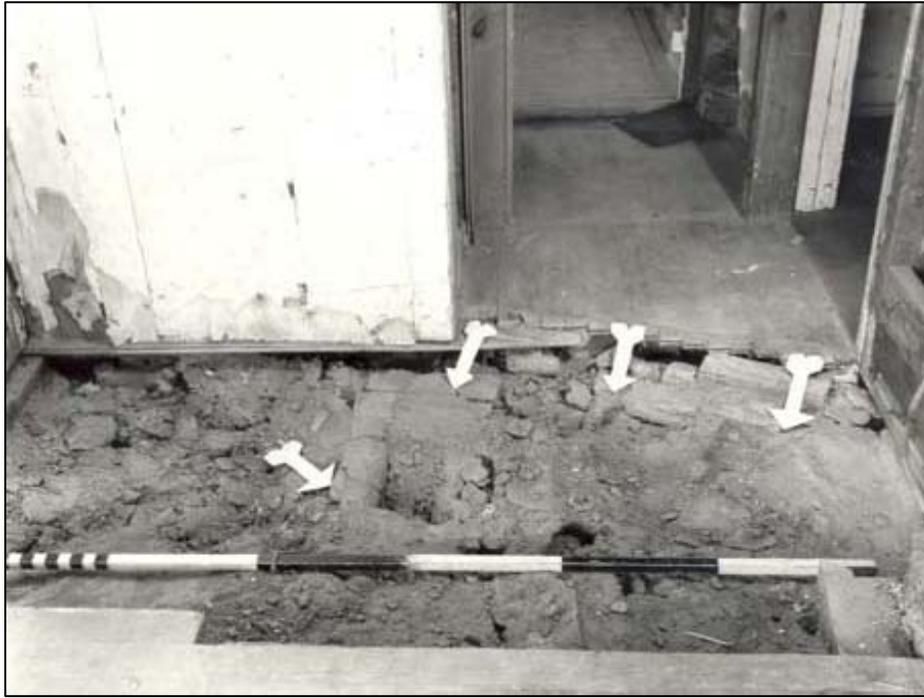
Figure 57. Main House: View of central chimney area, showing clay fill exposed when later concrete slab was removed; brick remains of ca.- 1692 and ca.- 1750 fireplaces lie beneath the fill.

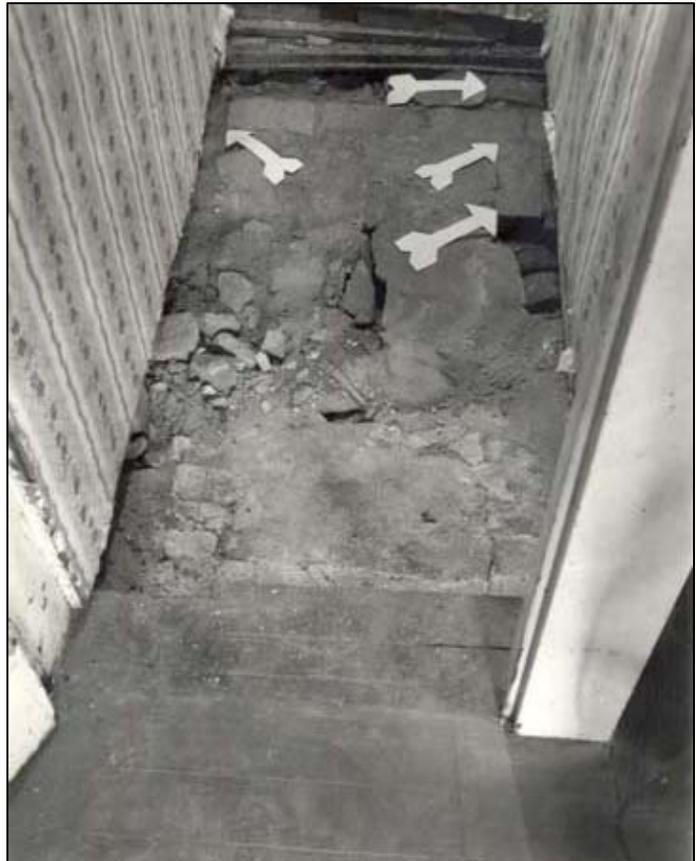
Figure 58. Main House: East Parlor, remains of north jamb of ca.- 1692 fireplace (left arrows), and of east side of ca.- 1750 fireplace in lean-to (right arrows).

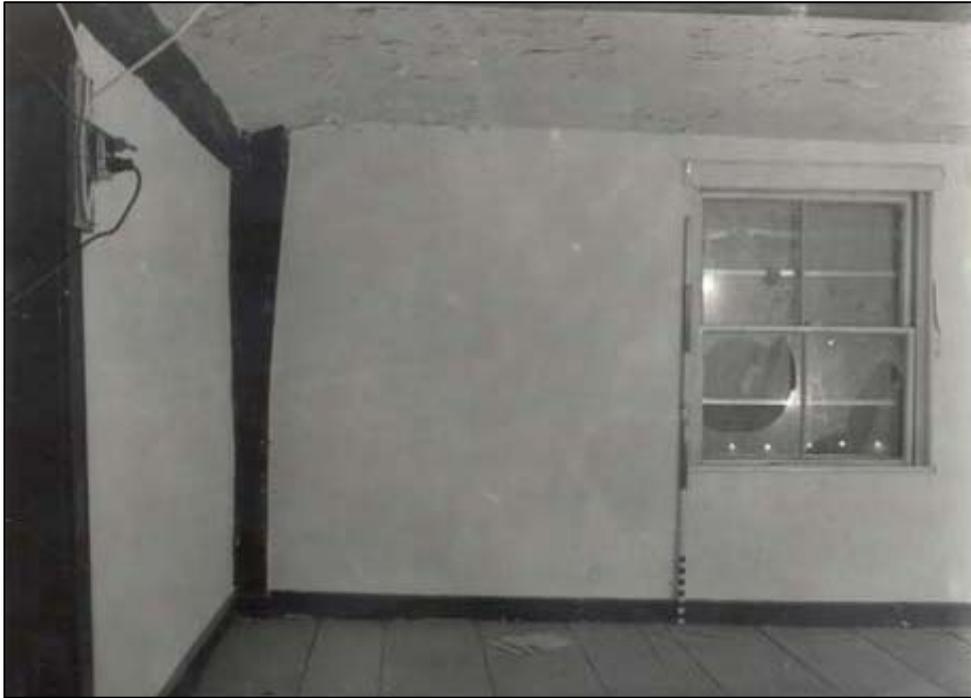
Figure 61. Main House: West Chamber, east wall, evidence of the ca.- 1692 hearth.

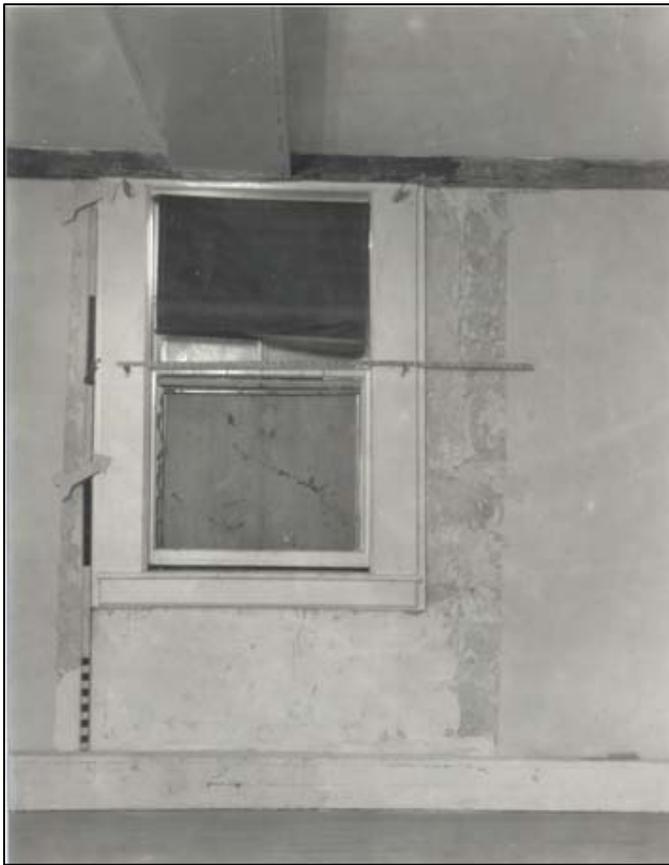
Figure 64. Main House: East Chamber, west wall, showing original wall boards being exposed as plasterboard is removed.

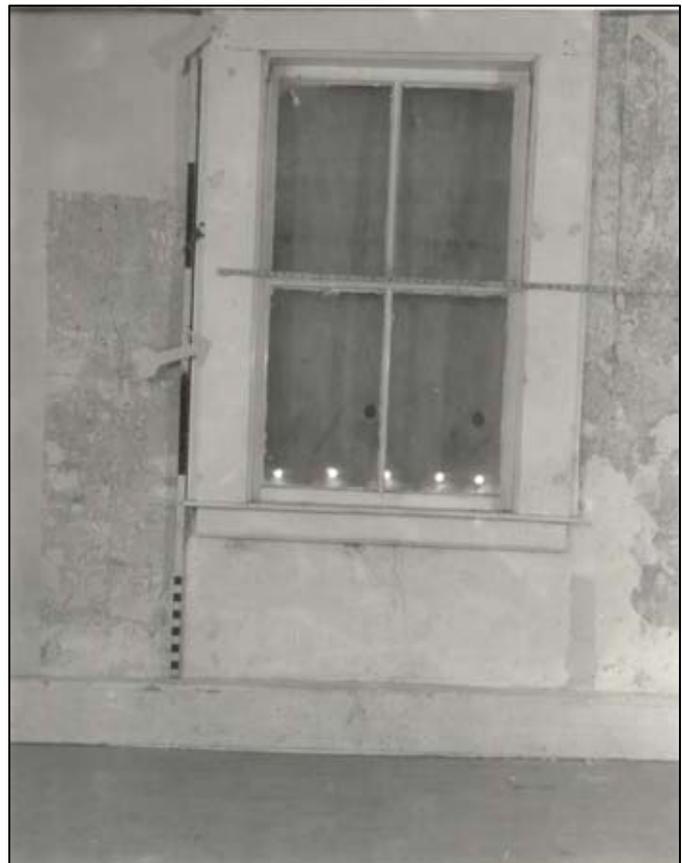
Figure 65. Main House:
West Parlor, west wall;
arrows indicate locations
of head, sill of ca.- 1692
window opening.

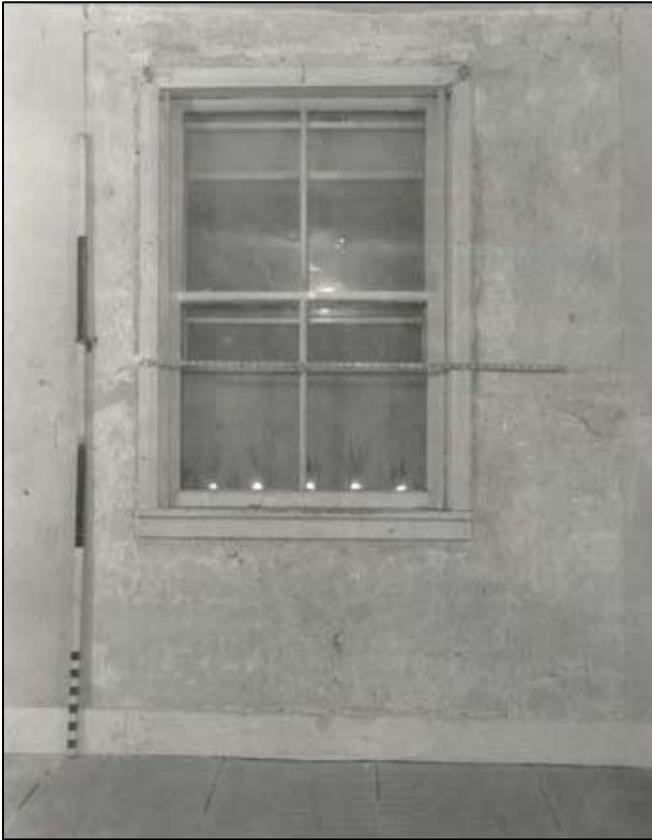
Figure 66. Main House:
West Parlor, south wall;
arrows indicate locations
of head, sill of ca.- 1692
window opening.

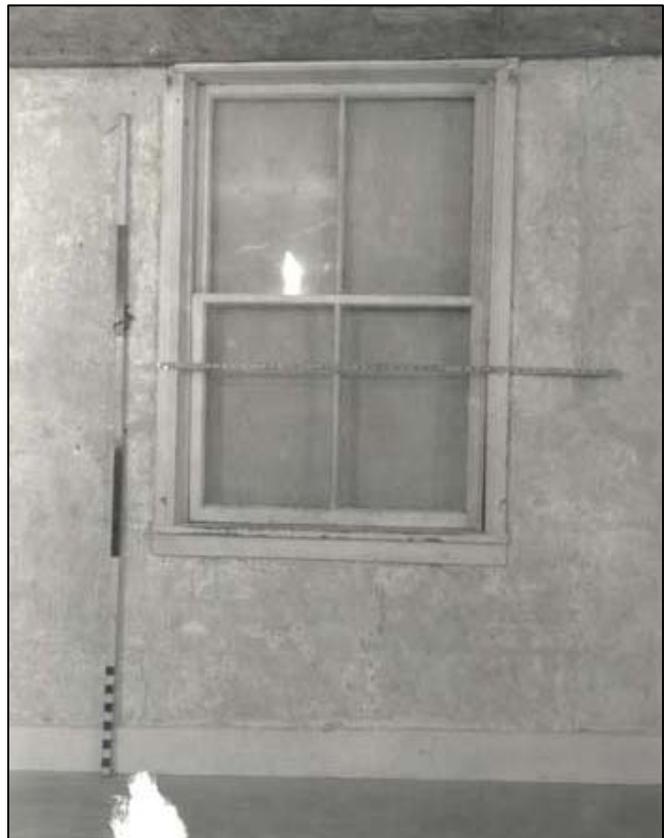
Figure 67. Main House:
West Chamber, west- wall
window, with wallpaper
peeled back to reveal
plaster patch from ca.-
1692 window opening.

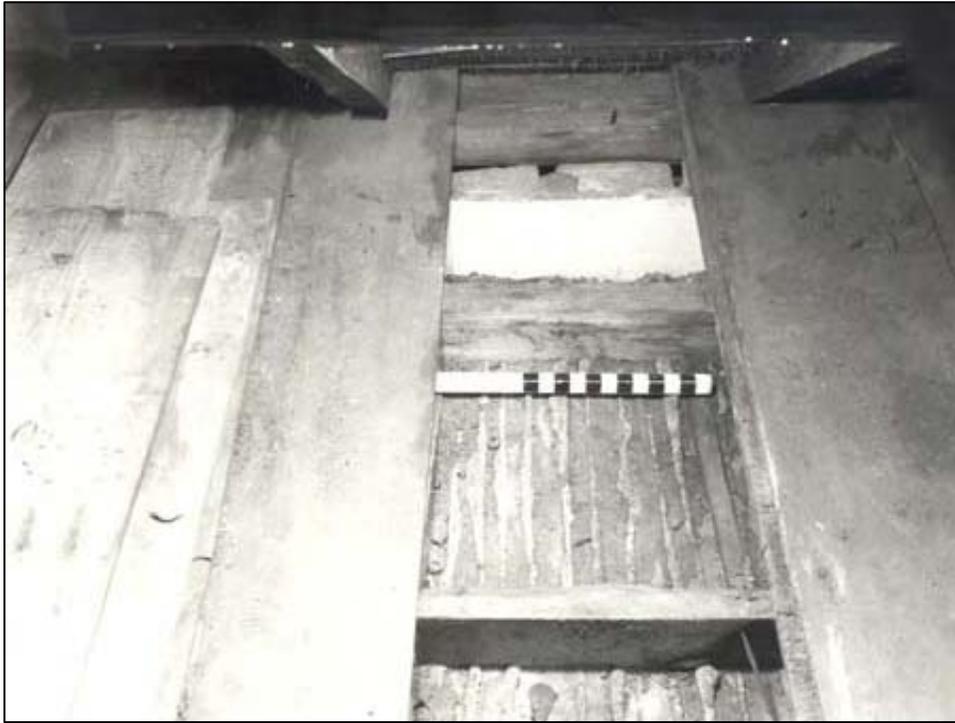
Figure 68. Main House:
West Chamber, south- wall
window, with plaster joint to
right indicating edge of ca.-
1692 window opening.

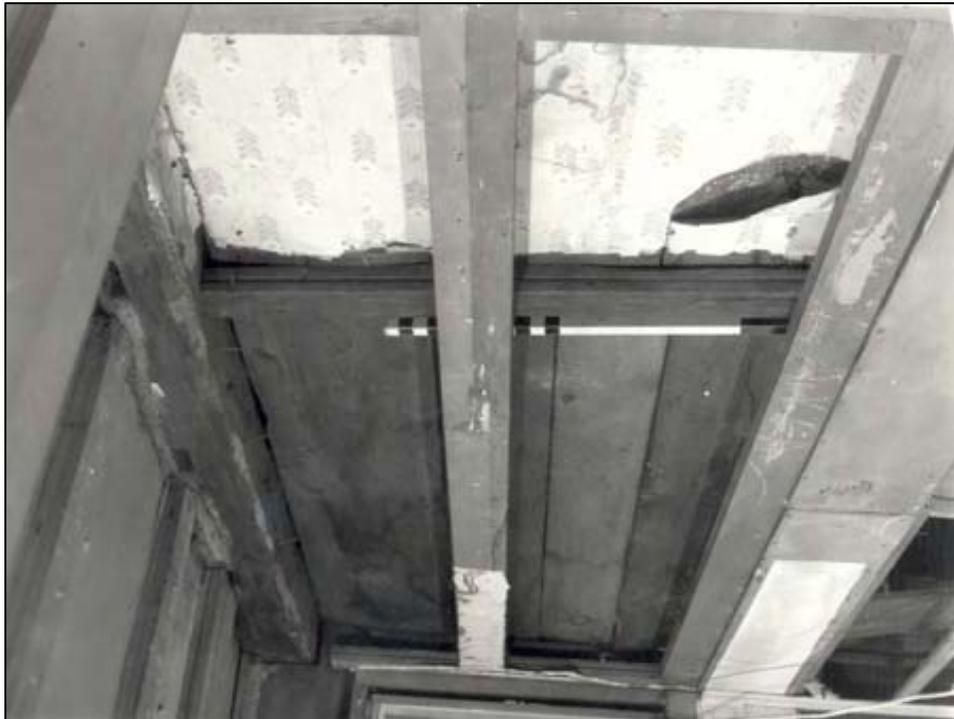
Figure 69. Main House: Attic, plaster over bricks between south plate and floorboards above West Chamber.

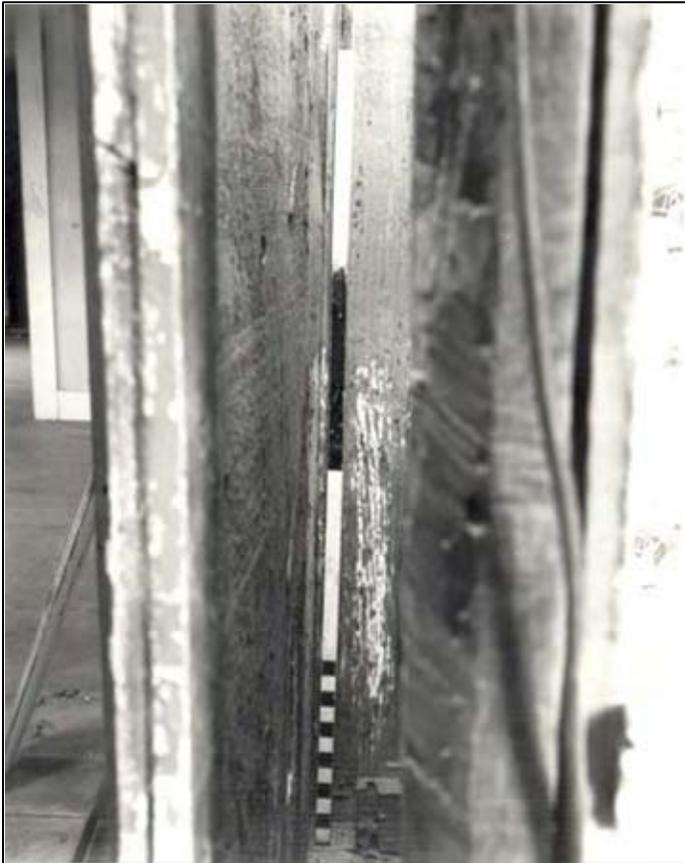
Figure 70. Main House: View of central chimney area, second story, looking east after removal of plasterboard walls and ceiling; scale stick rests on reused piece of ca.- 1692 handrail.

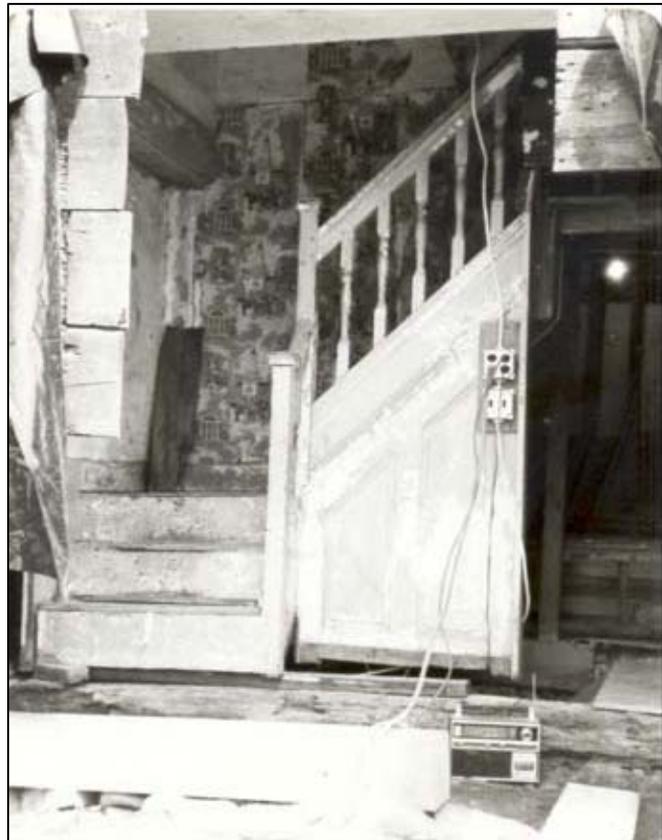
Figure 71. Main House: Front Hall, looking northwest into West Chamber, showing cut- out for first step of original attic stairway (removed ca. 1750).

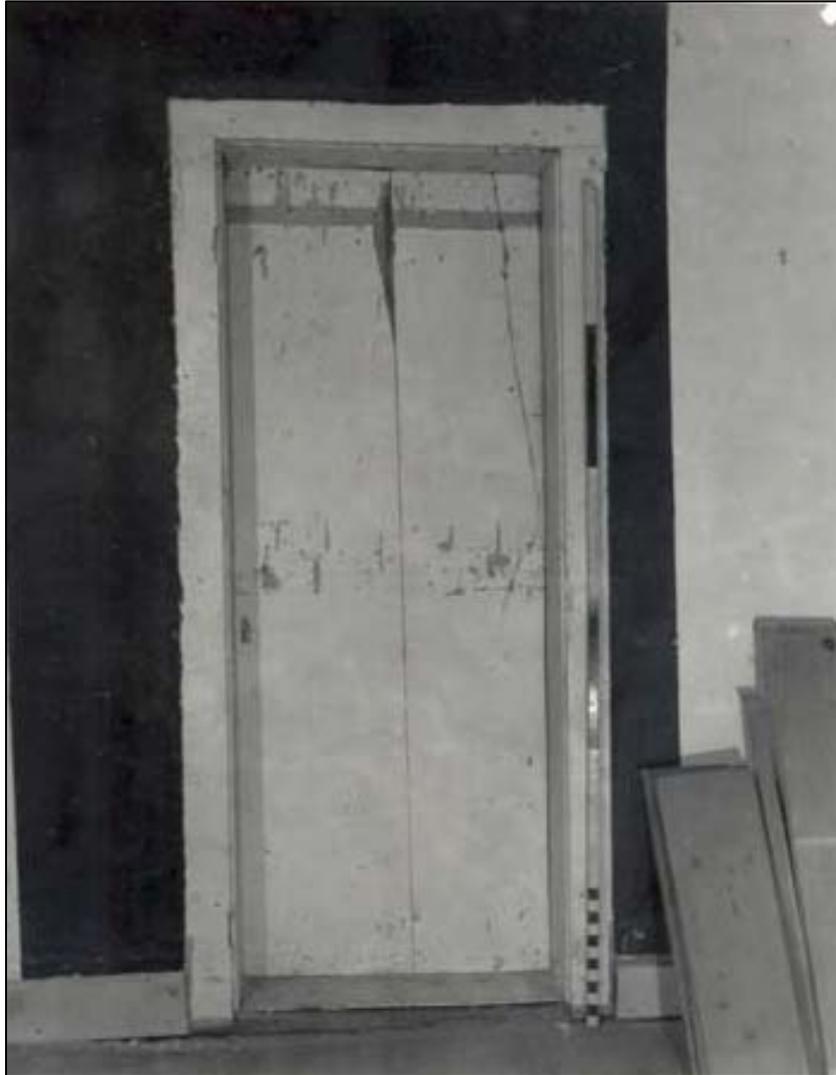
Significant changes also were made to the interior of the house. The ca.- 1692 front stairway was rebuilt into its present configuration (fig. 74- 75). It included an open balustrade and paneling below.¹¹² Figure 76 shows the back side of a section of the ca.- 1750 paneling; it was later hinged to serve as the present- day door to the cellar.

Figure 76. Main House:
Rear side of present- day
cellar door.

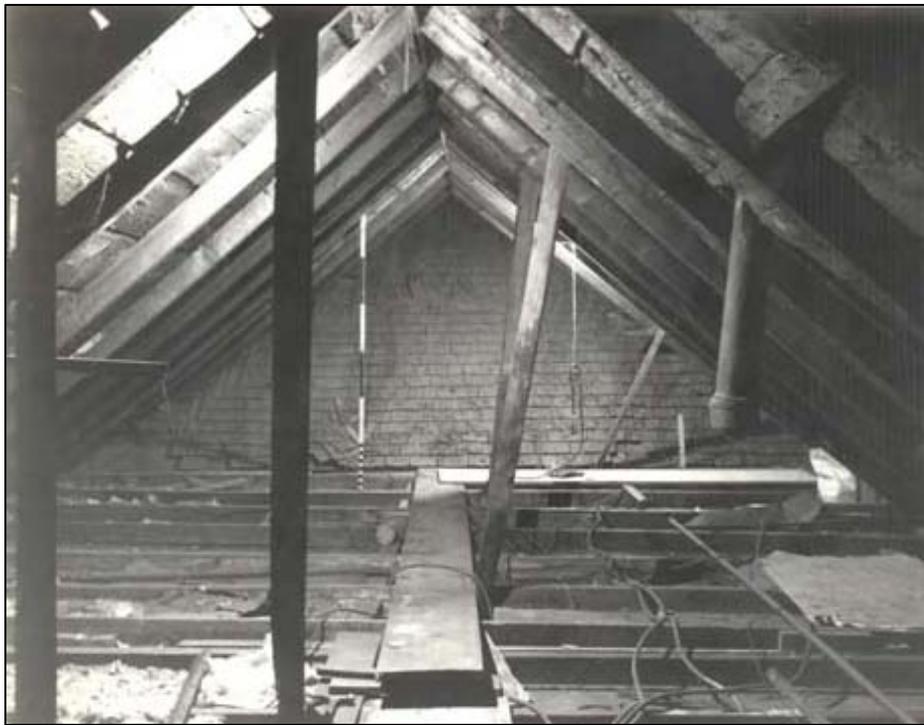
The roof covering from ca. 1692 until ca. 1935 would have been wood shingles. Wood shingles dating back to ca. 1890 still remain on the north side of the ca.- 1692 roof, and can be seen from the attic spaces of the ca.- 1900 addition (fig. 92).

Figure 92. Ca.- 1900 Addition: Attic, looking south at roof of ca.- 1692 house.

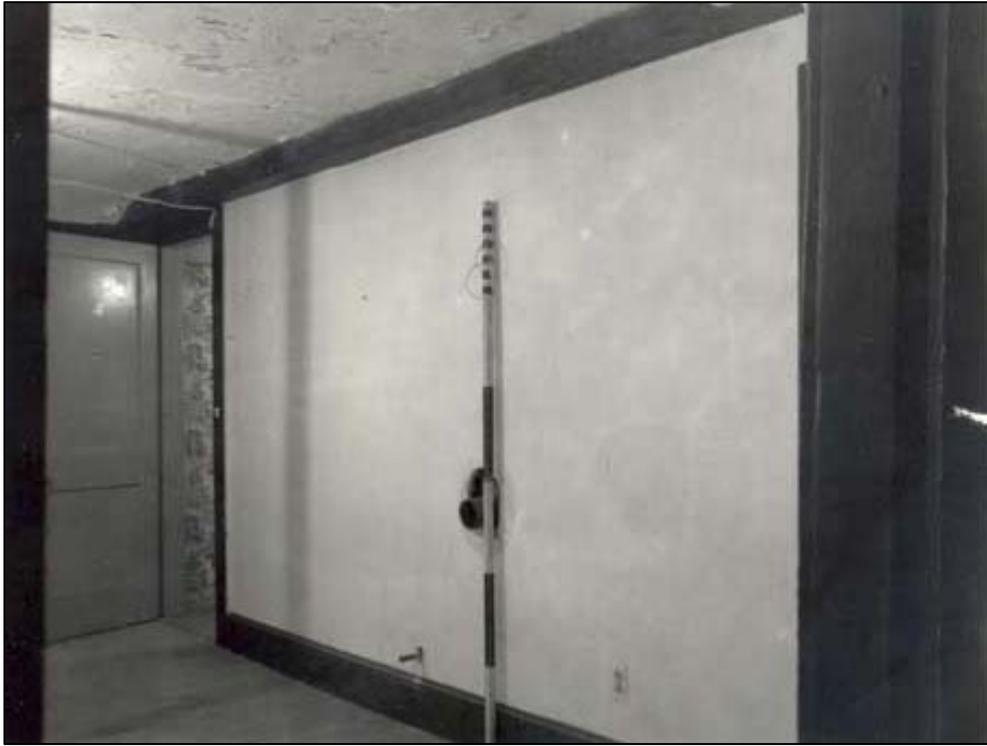
The north, east, and south walls of the East Chamber are lath and plastered and presently covered with wallpaper painted yellow. The west wall is covered with plasterboard, also wallpapered and painted yellow. Near the center of the west wall, 24 inches above the floor, is a metal vent pipe and collar measuring 4 inches in diameter and painted black (fig. 102). Below, at baseboard level, is a half- inch gas- supply pipe projecting through the wall.

Figure 102. Main House: East Chamber, west wall prior to architectural investigation.
