THE CAPTAIN WILLIAM SMITH HOUSE

HISTORIC STRUCTURE REPORT

Minute Man National Historical Park
Lincoln, Massachusetts

December 2007

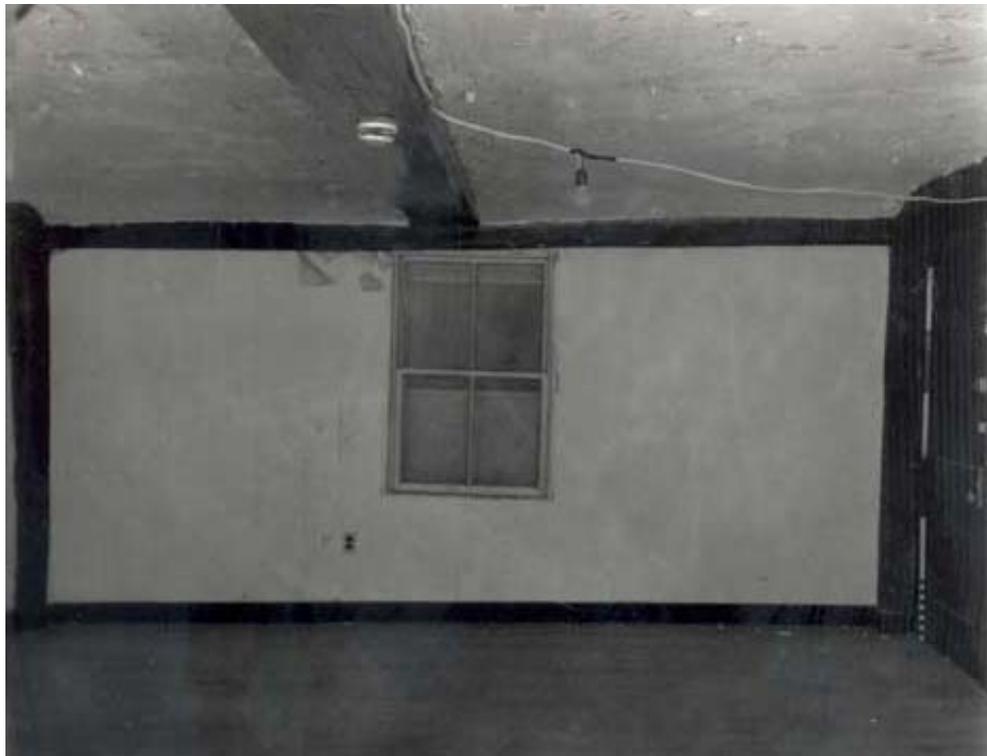
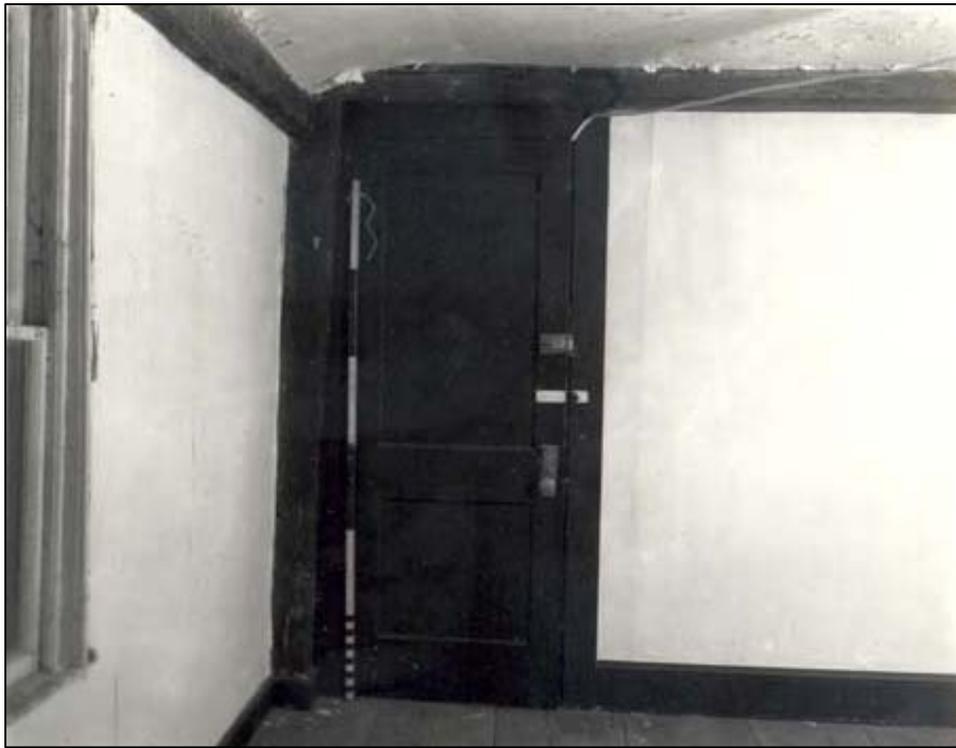
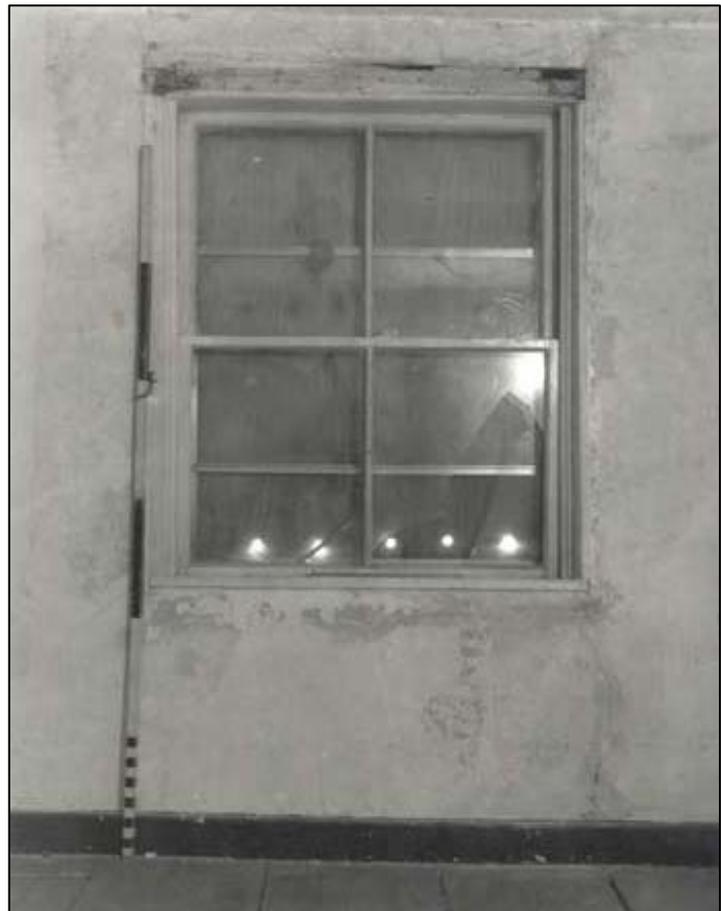
Figures 102- 105 depict the East Chamber prior to the architectural investigation. The visible elements date to several periods in time. The oldest exposed features of the room are the west chimney girt; the north and south plates; the summer beam; the four corner posts; the majority of the floorboards; and probably the lath and plaster ceiling and walls. These features appear to be original to the building, and may date back to ca. 1692.

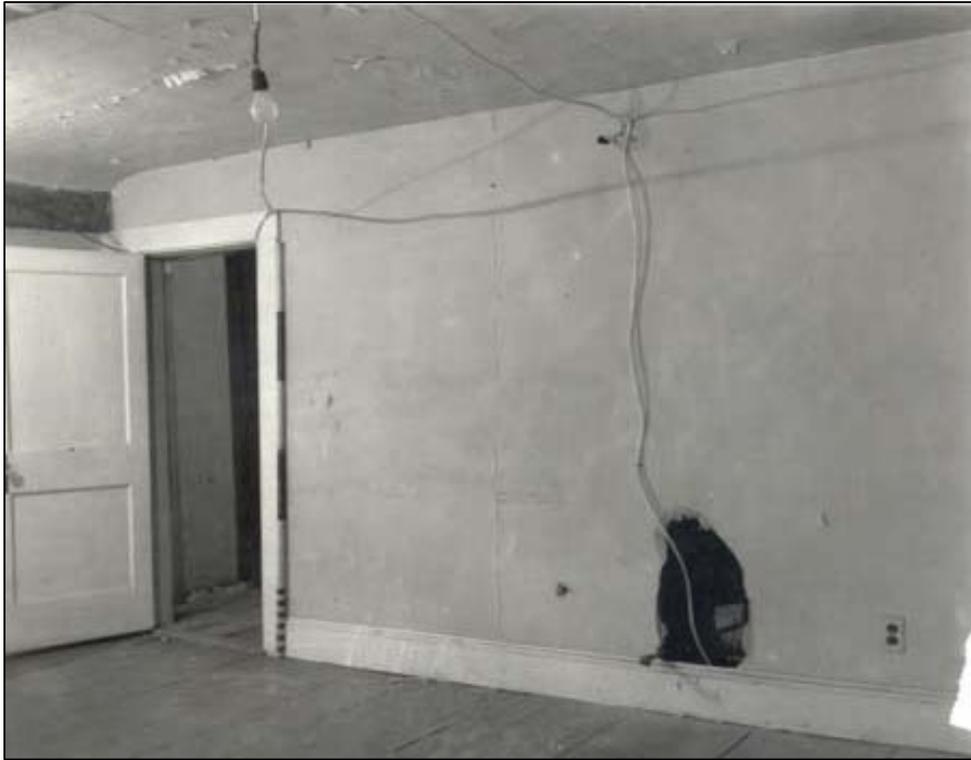
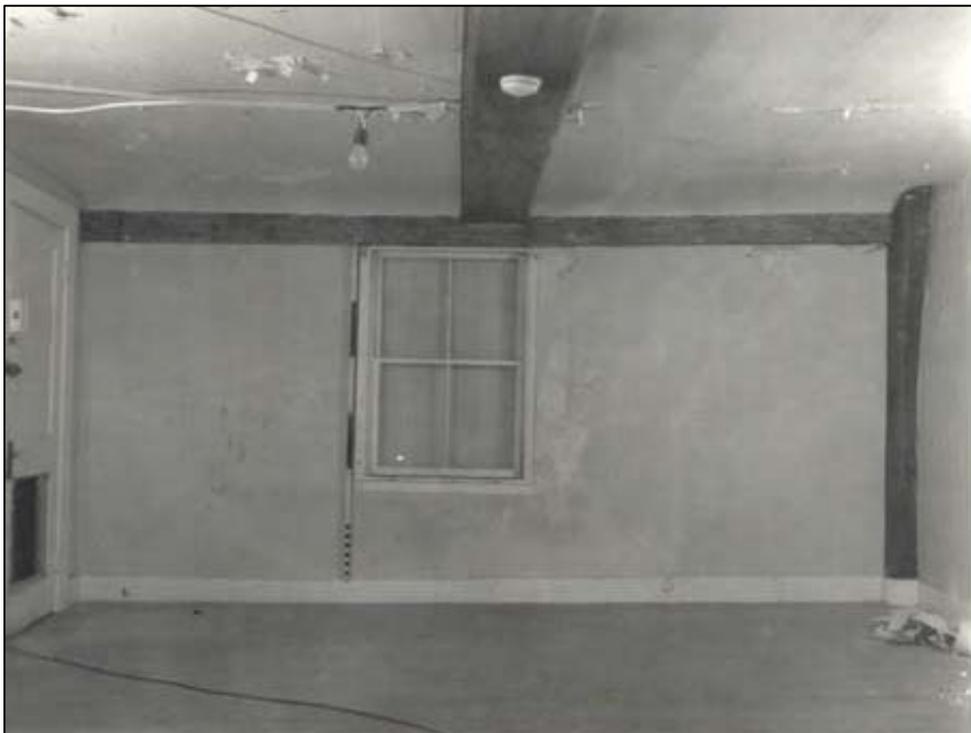
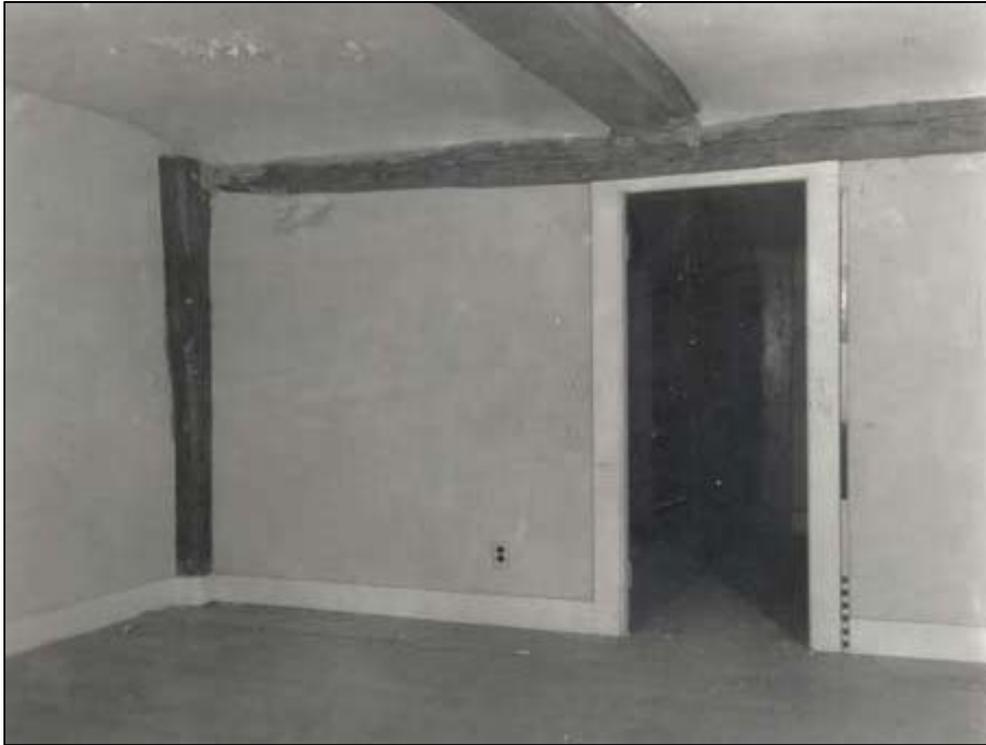
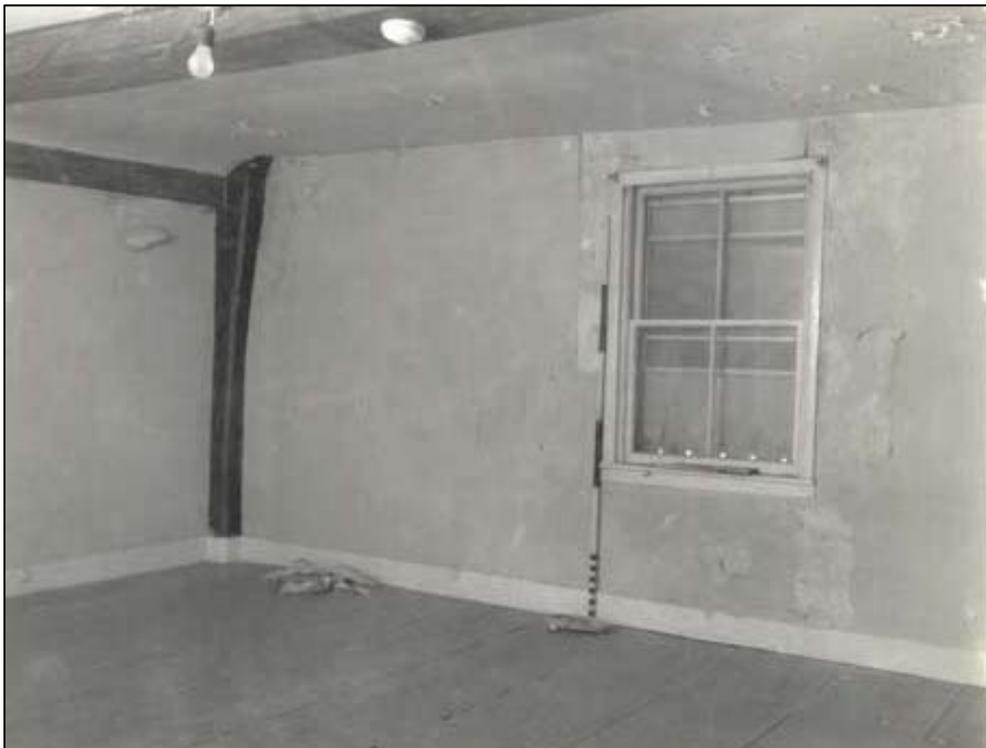
Figures 106- 109 depict the West Chamber prior to the architectural investigation. Like the East Chamber, it contains features representing several building periods in time. The oldest visible parts of the room are the north and south plates, the summer beam, the west corner posts, the floorboards, and possibly the plaster ceiling. The north, south, and west plaster walls could also be original to ca. 1692.

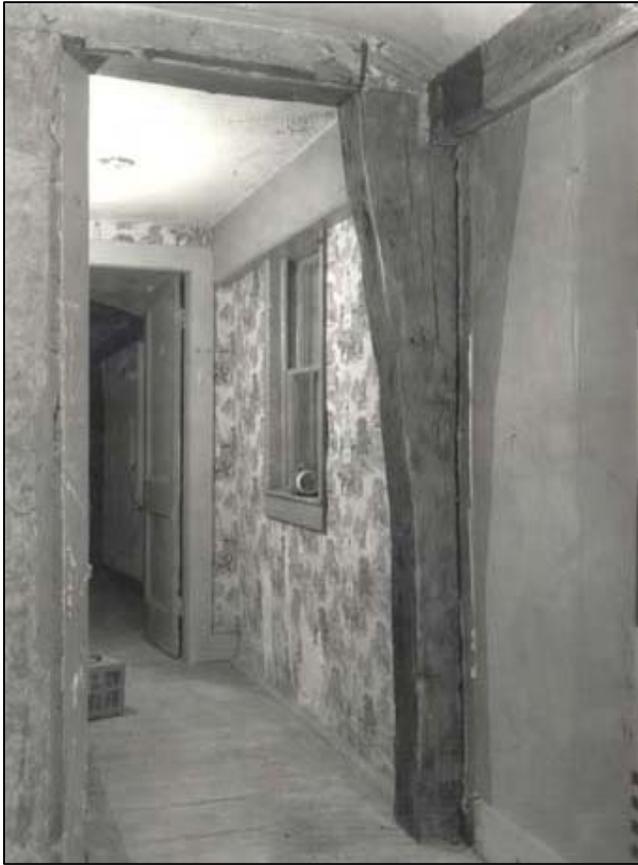
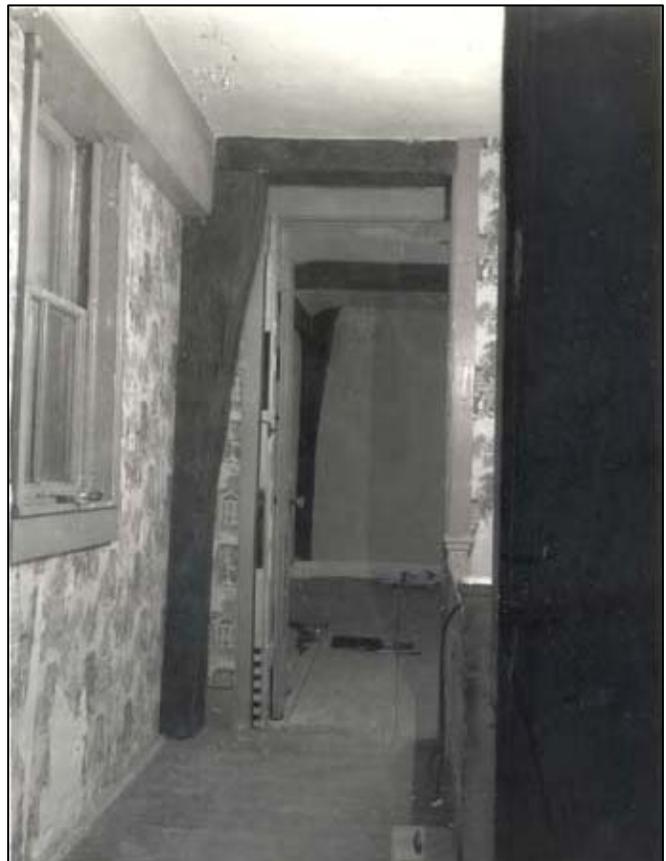
Figures 110- 111 depict the front hall. It occupies an area within the chimney bay roughly equal to the entry hall in the first story. Running along the south wall of the house, it measures 3 feet wide and connects the two chambers in the second story. It has a single- thickness floor covered

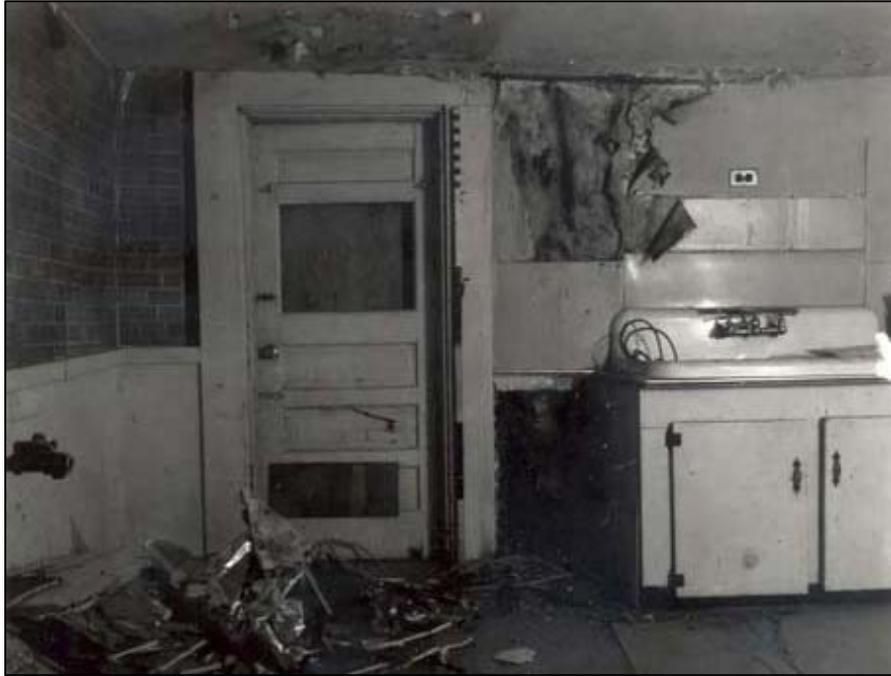
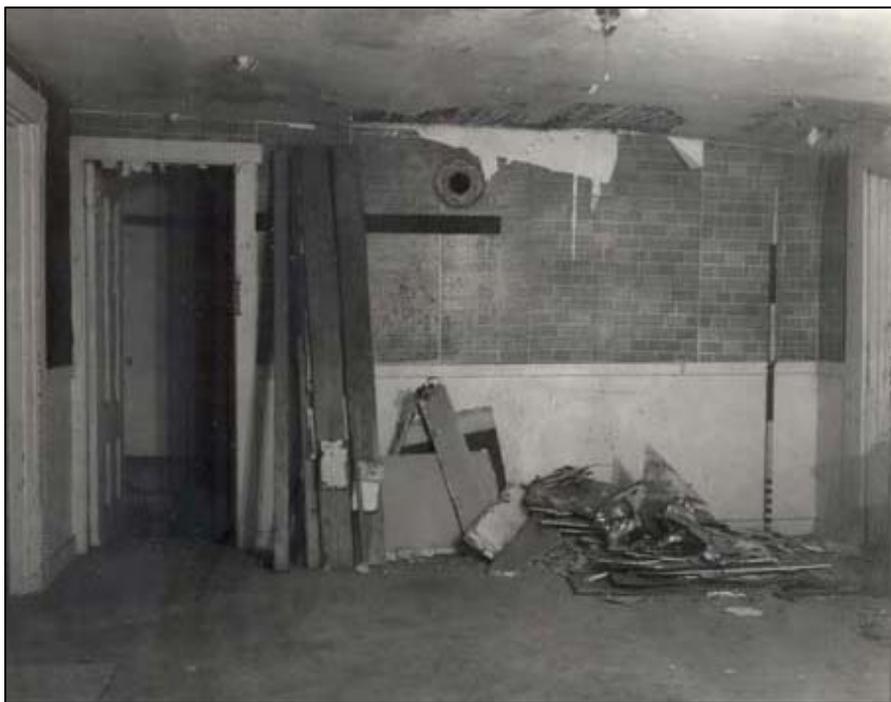
Figures 112- 113 depict this room prior to the architectural investigation. It was originally (ca. 1900) a kitchen for one of the two residential units in the house at that time. The center room may have initially included the small room to its east, but the physical evidence indicates that the current division occurred at an early date. When the house became a four- unit apartment building ca. 1956, the room became the kitchen of the first- story east apartment. The room currently measures 12 feet 10 inches by 15 feet 2 ½ inches. The ceiling height varies from 7 feet 0 inches along the south wall to 6 feet 6 inches along the north wall.

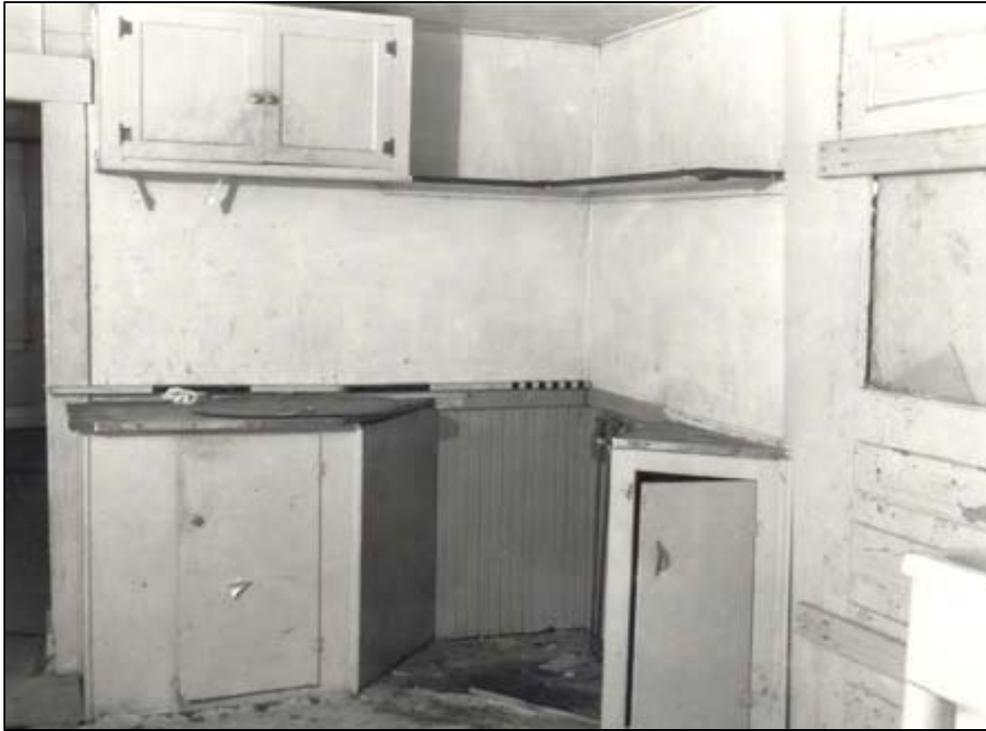
Figure 114 depicts this room prior to the architectural investigation. This room was originally (ca. 1900) a sitting room for Mrs. Butcher. A short hallway in the northeast corner connected the room to the adjacent kitchen. When the house was divided into four apartments ca. 1956, the room became the kitchen for the first-story west apartment. The northeast hall was converted into a modern bathroom (see fig. 95).

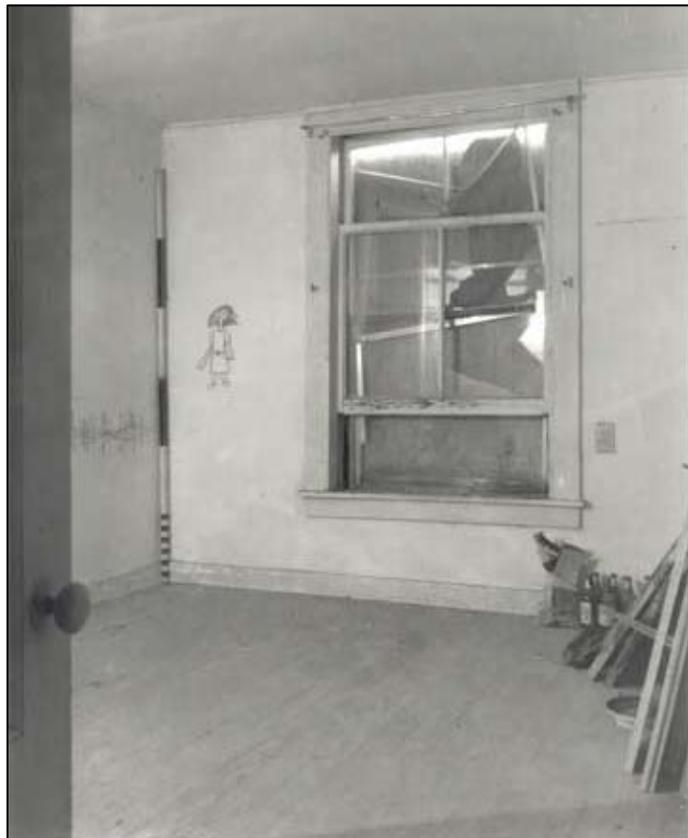
Figure 115 depicts this room prior to the architectural investigation. It also was most recently part of the first- story east apartment. Originally it measured 8 feet 10 ½ inches by 12 feet 4 inches, but its south wall was moved 1 foot 6 inches northward to provide additional space for the adjacent bathroom. The ceiling height measures 6 feet 9 inches (+/- ½ inch). A closet along the south wall measures 2 feet deep by 4 feet 5 inches long. The walls and ceilings of the room are covered with plasterboard; the ceiling is painted, but the walls have wallpaper that is painted over.

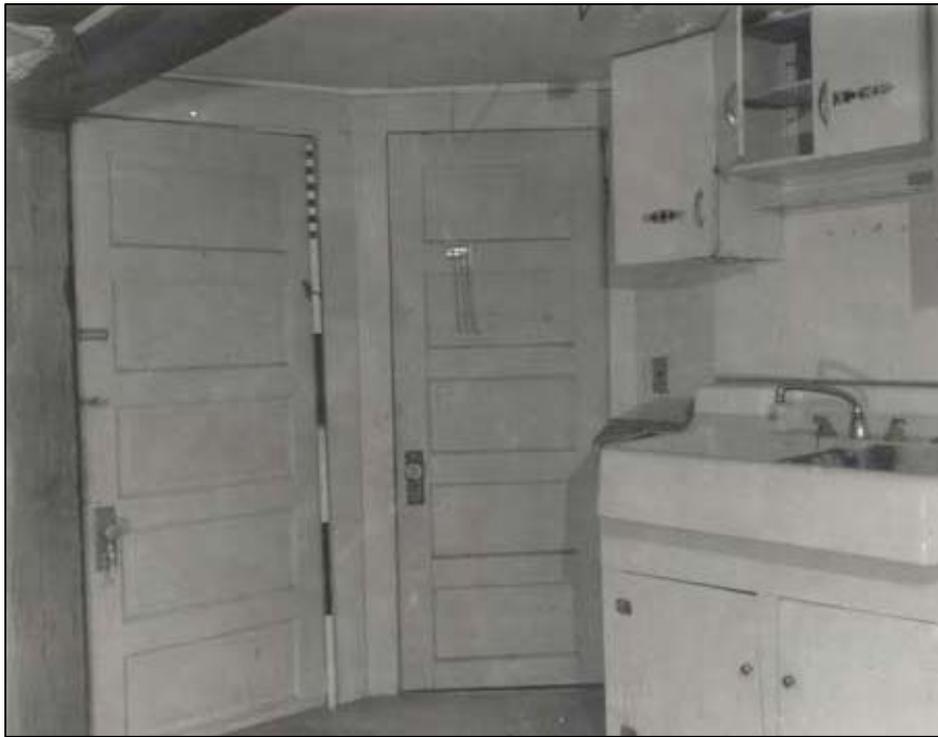
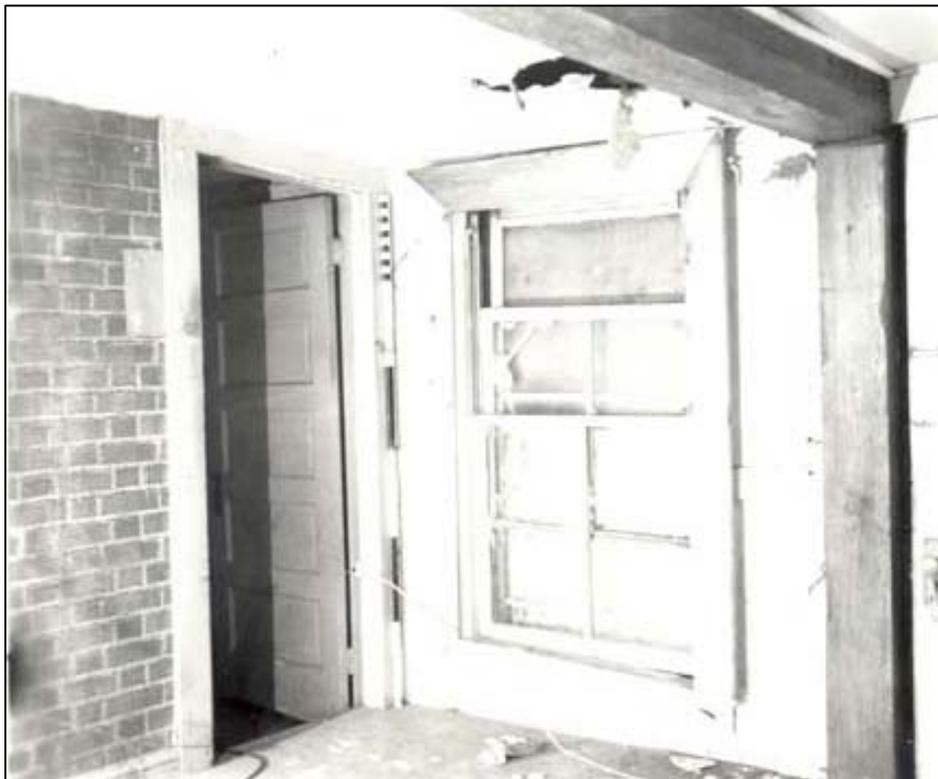
Figures 116- 117 depict the center room prior to the architectural investigation. It was created ca. 1900 as the kitchen for the second of the two residential units in the house at that time. Ca. 1956 the room was remodeled to serve as the kitchen for the second- story west apartment. This remodeling included the creation of a doorway in the north wall, leading to a hallway along the west side of the ell. From this hallway, residents of the second- story west apartment could access the enclosed north porch built ca. 1956. There is a bathroom off the northeast corner of the room, partitioned out of space in the ell.
