# BUILDING 24

## HISTORIC STRUCTURES REPORT

*Charlestown Navy Yard • Boston National Historical Park*

PREPARED BY GOODY, CLANCY & ASSOCIATES

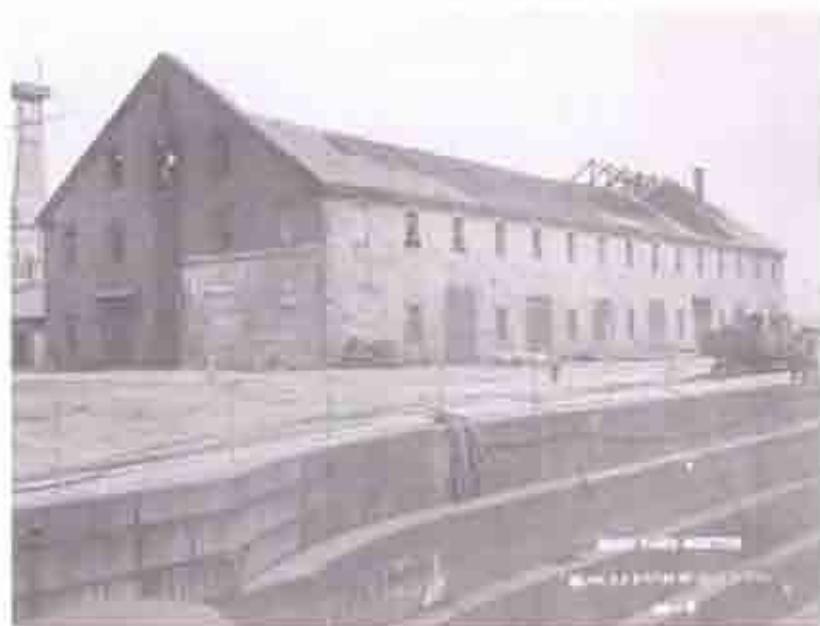
In September 1910, there was a fire in the building. The majority of the damage appears, from 1913 photographs, to be to the roof (B9). The building was then being used as the Construction and Repair offices and rigging loft and was abandoned after the fire.

(B9) "NAVY YARD BOSTON BLDG 24 FROM W JULY 2 1913 24-B" Looking southeast. Shows the building after the 1910 fire and before the demolition of the roof and interior framing for reconstruction.

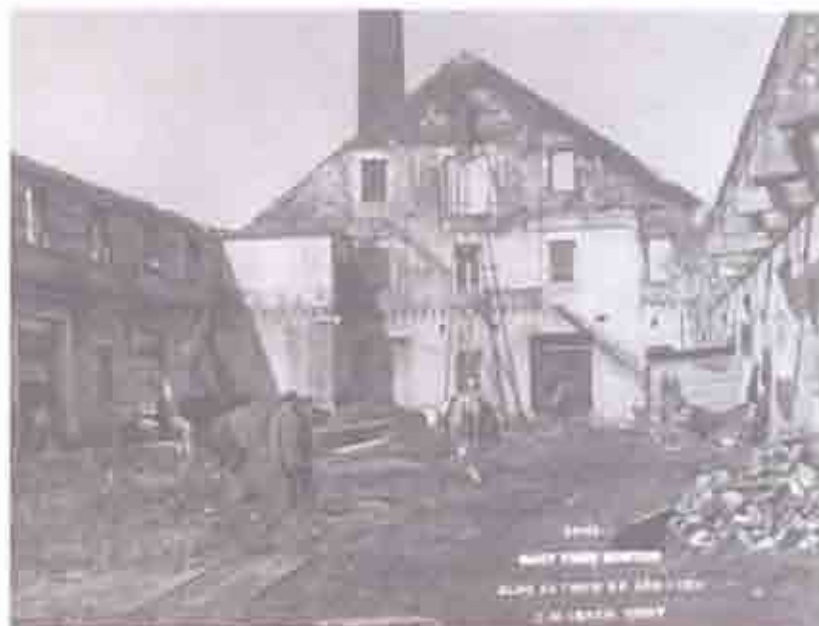
(B18) "24-17 NAVY YARD BOSTON BLDG 24 FROM SE APR 1 1914 C M LEACH CONT". Interior after the 1910 fire, looking north in a photo from 1913.

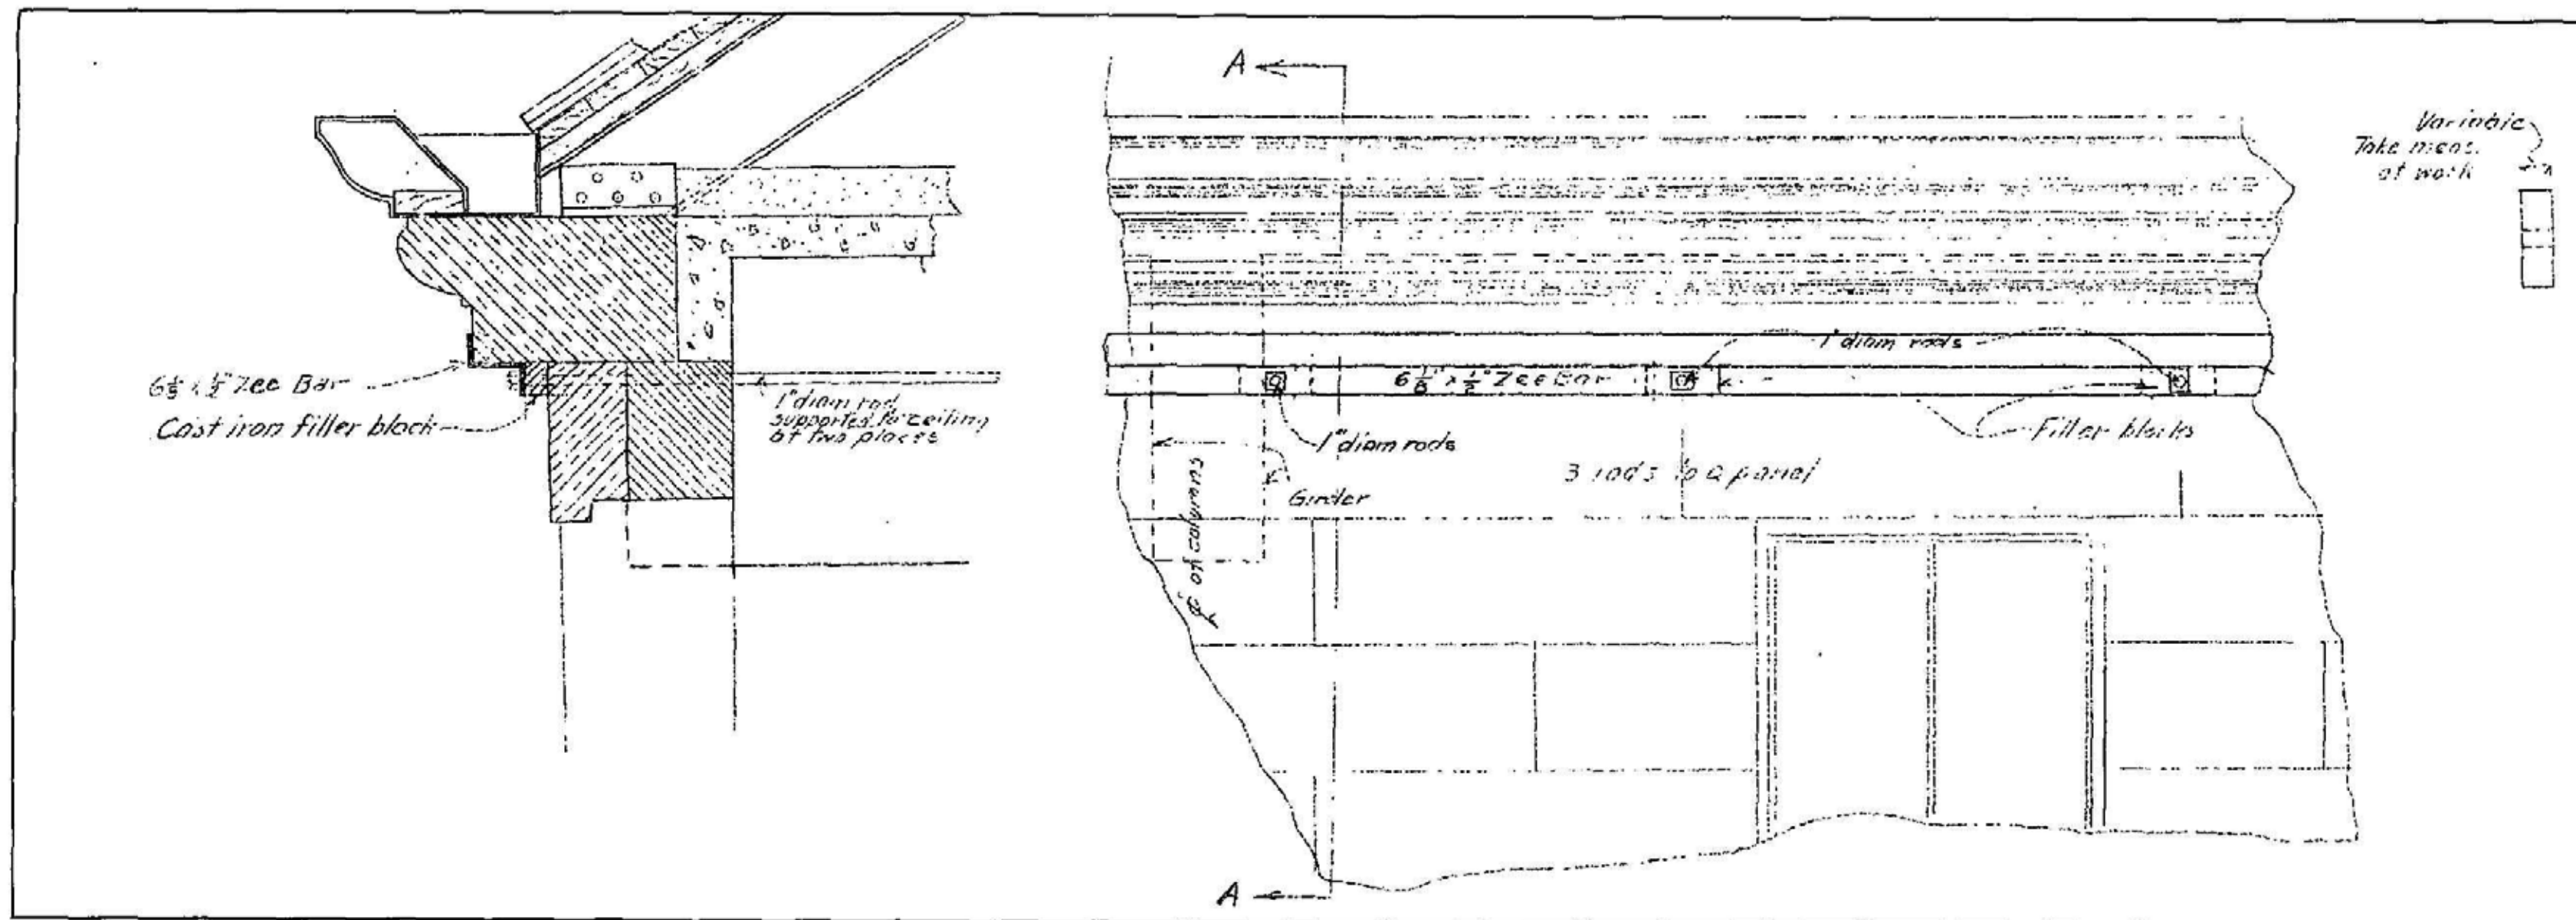
(C11) Drawing 24-53 showing detail section and elevation with Z-shaped channel and tie-rod system installed in 1922.

In 1919 is found the first written record of structural problems with the building. Drawing 24-48 "Plan Showing Elevations at Bottom of Girders Supporting 3rd Story Floor Beams, Taken Jan. 25, 1919." A note on the drawing states "Crack at back of stone cornice extends between Cols 1-14 on east side and between Cols 5-14 on west side. The crack is 1/2" to 2-1/2" in width, 1/6" deep." The crack noted can still be seen along the third floor eaves. The concrete slab is cracked along the rafter line.

Drawing 24-53 "Plan Showing Method of Repairs at Copping of Building", dated March 22, 1922, shows an elevation and section of a Z-shaped

channel and tie-rod system that was installed through the cornice (C11). Presumably, this system was installed to counter the perceived spreading of the walls as noted above. See the Existing Conditions Section of this report for the structural analysis of this problem.

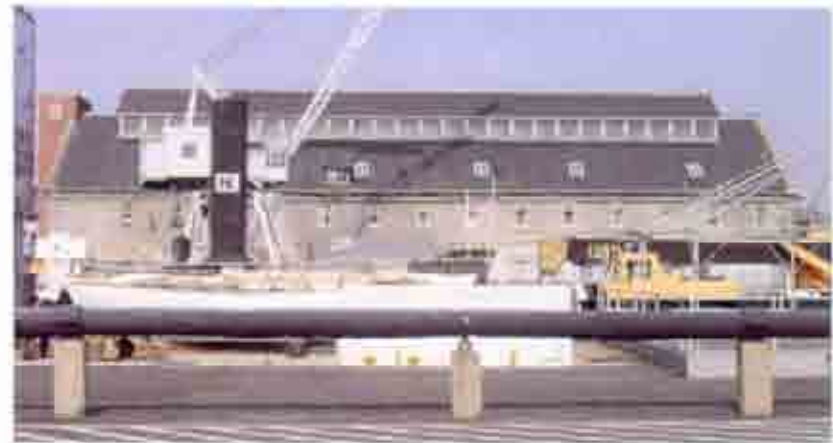
Fig. 1 West Elevation. Due to obstructions at ground level, a full view of the entire facade is not possible.

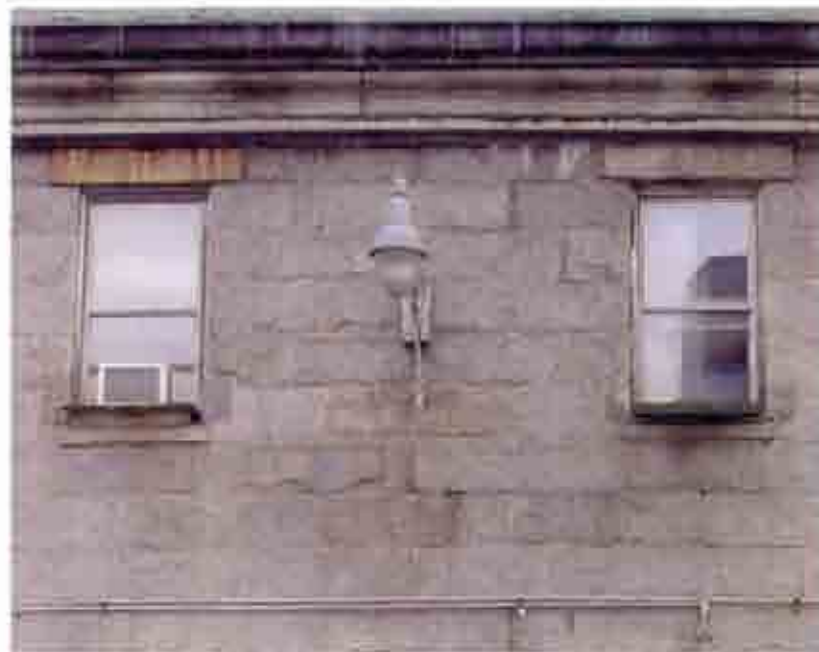
Fig. 6 Notches on either side of these windows just above the sills were infilled with granite after removal of blueprint-drying racks.

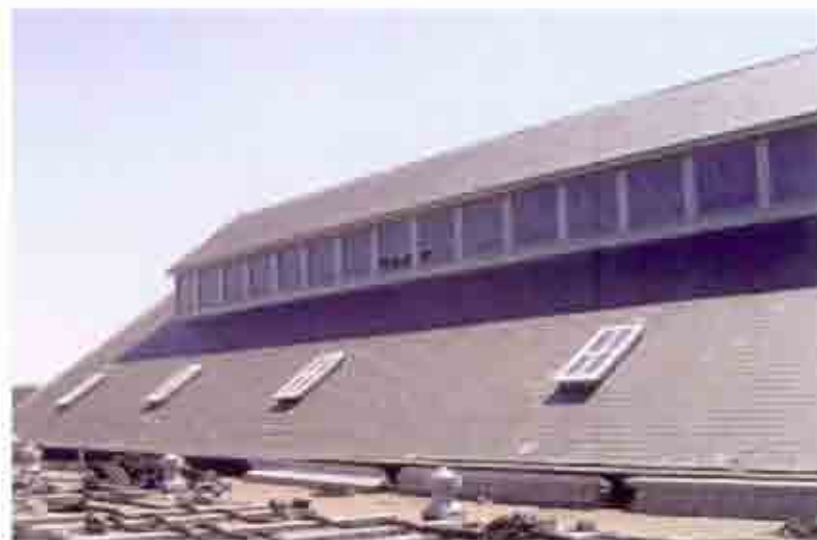
**Fig. 11** The slate roof, installed in 1913-14, has been on the building longer than the original gable roof.

**(a) Slate.** The slate is relatively intact in locations where it is not surrounding the numerous penetrations or terminations through the roof. Where the slate intersects the gutters, monitor or skylights, there has been extensive remedial work to stop leaking. The slate in these areas has been covered with bituminous material and repairs have resulted in a high percentage of broken slate. Due to the numerous penetrations through the roof, there are few areas of undisturbed slate tiles. Slate typically has a life expectancy of 75-100 years if properly installed and maintained. Assuming that the slate was installed in 1913, it is 90 years old

and reaching the end of its expected life span. If extensive work is performed on the roof, the cost to salvage and work around the existing slate may not be justifiable (Fig. 11).

*(a) Slate.* The slate is relatively intact in locations where it has not been disturbed for repairs. Installing new gutters and flashing around skylights and the monitor would require the removal of approximately 2' of slate surrounding the replaced element. With this disruption, there would be few areas on the roof that remain undisturbed. The slate on the roof is almost 90 years old and it is not advisable to salvage the slate for reuse. Replacement of the slate with new slate to match the original in color, texture and size is recommended.

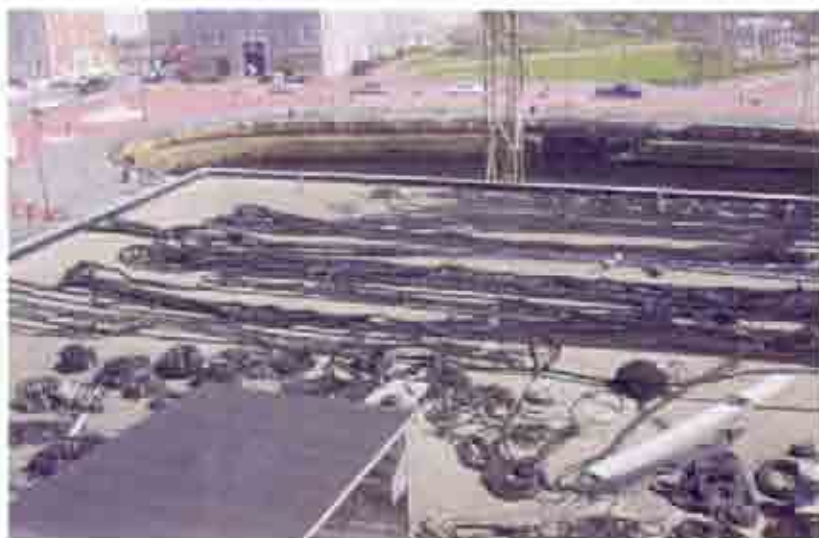
Fig. 21 Flat roof North end of roof

The built-up roof on the addition may be the original 1943 roof. It is in poor condition and has been leaking over many years (Figs. 21 & 22). Repairs are made as needed to stop leaks. The roof is currently used to store rope and other materials, making a thorough review of conditions difficult. The NPS must determine if this use will continue after re-roofing the addition. The type of roofing specified will be determined based on the intended future use.

The flat roof requires replacement as soon as possible. If the roof is no longer used to store coils of rope, a single ply membrane should be installed. All of the flashings must be replaced, with particular emphasis on the flashing details where the addition meets the original building.

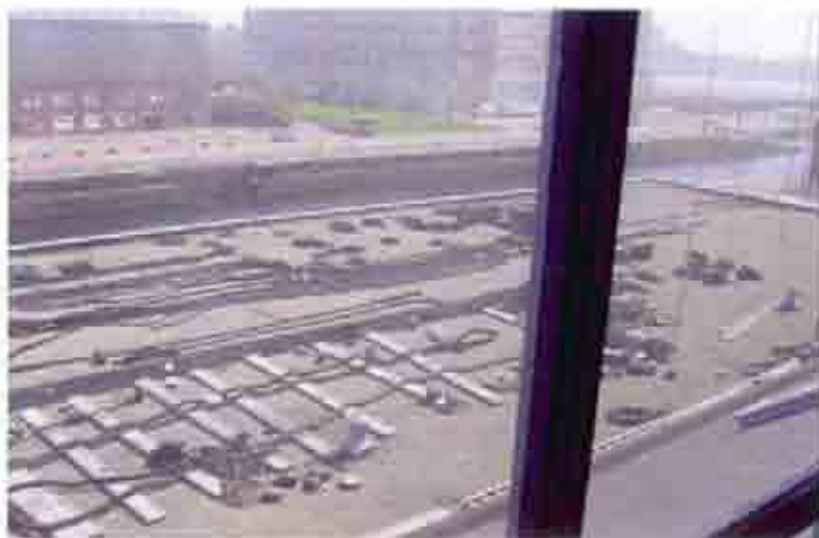
Fig. 22 Flat roof South end of roof

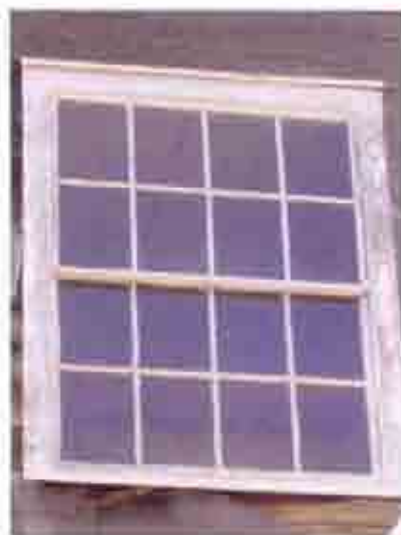
The current windows were fabricated and installed in 1991 (Fig. 23). The Section 106 review of the proposal states that the windows much match the original in detail. The current windows replicate the 8-over-8 sash configuration of the original 1943 windows.

**Fig. 23** Typical window on the 1943 East Extension

The windows in the extension are wood with true divided lites, 8/8 sash with ropes (or chains) and pulleys for operation. Many of the ropes are broken or missing. The size of the sash makes opening the windows without the weights difficult. The windows are generally in fair condition, with gaps around the perimeter allowing air infiltration.

The quality of the windows is too poor to warrant restoration of the windows. Minor repairs, including trim installation and caulking, would result in a reduction in the air infiltration, and replacement of broken cords would allow for easier operation of the windows. The windows should be replaced within the next 10 years.

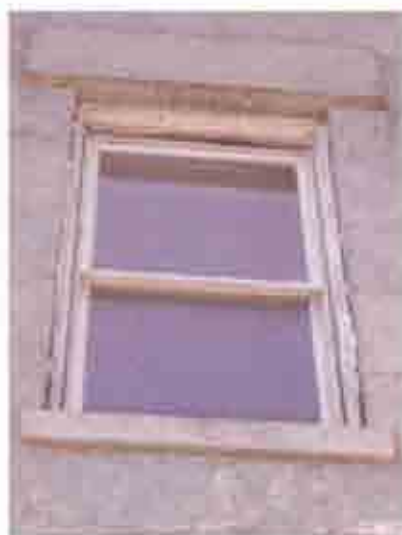
**Fig. 24** Typical window on the 1847/1913 Building

The main building windows were originally 12/12 sash. Some of the sash were replaced pre-1913 with 2/2 sash at offices. In 1913 the sash were replaced with 1/1 wood sash. The current windows and frames were installed in 1989–1990 and are 1/1 wood sash with vinyl jamb liners (Fig. 24). The windows are inexpensive, prefabricated units that were not custom made for the openings. There are a few windows on the building that were not replaced in 1989–90. The elevator shaft windows were installed in 1943.

The windows in the main building are poor quality, they fit loosely in the openings, causing the sash to rack and twist. Most of them are difficult to reach, making their operation even more difficult. Many of the windows do not have interior trim, increasing the probability of air infiltration. The exterior wood trim varies around the building.

These windows are not significant. When the windows are replaced they should be replaced with 1/1 sash to replicate the appearance of the 1913 rebuild. There are window drawings from the 1913 rebuild that show the sash details.

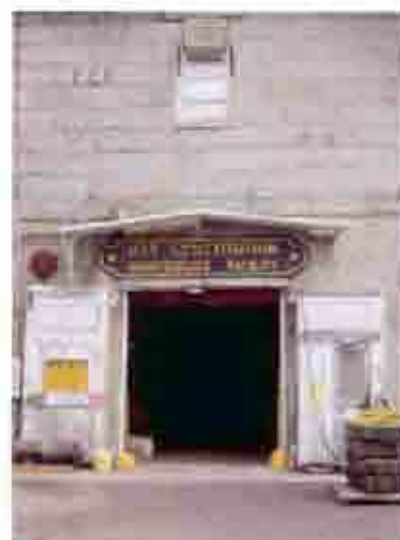
Fig. 25 The main service door, with roll-down door inside.

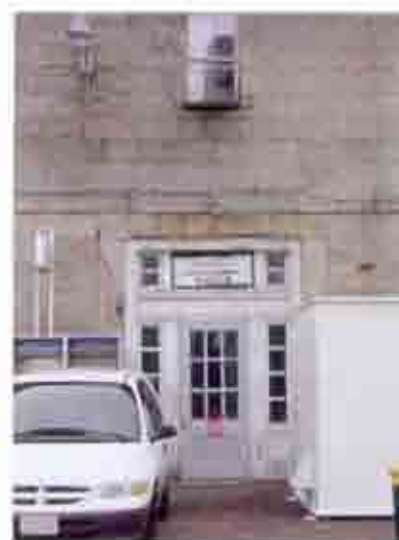
Fig. 26 The northernmost door on the west side was replaced in the 1990s.

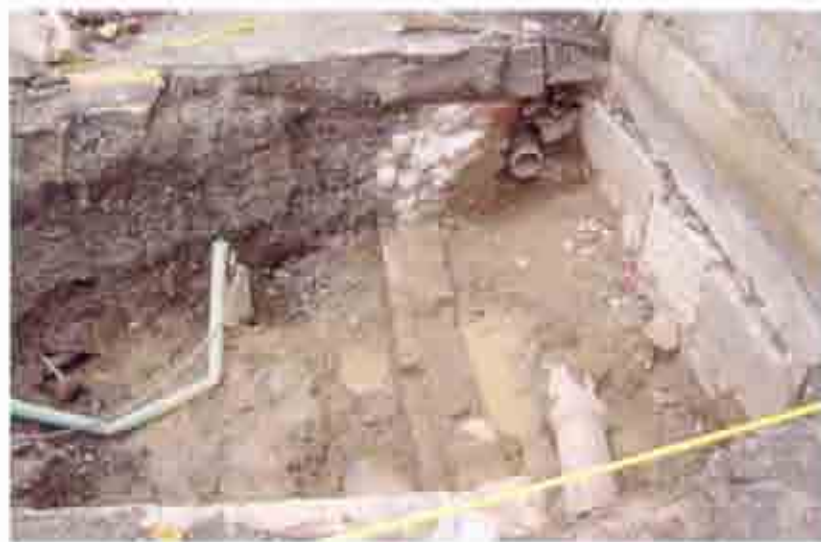
At a depth of approximately three feet from the surface, a brick wall was uncovered that prevented further excavation. The NPS Archaeologist was called to determine the significance of the structure. During research for this report, an 1873 drawing (C3) was found showing a scale platform in this location. This brick wall may have been associated with this structure (Fig. 36).

**Fig. 36** During test pit excavation on Aug. 18, 2002, a brick wall was found at a depth of three feet, preventing further digging.
