# DRY DOCK 1

## HISTORIC STRUCTURE REPORT

*Charlestown Navy Yard • Boston National Historical Park*

PREPARED BY MCGINLEY KALSOW & ASSOCIATES

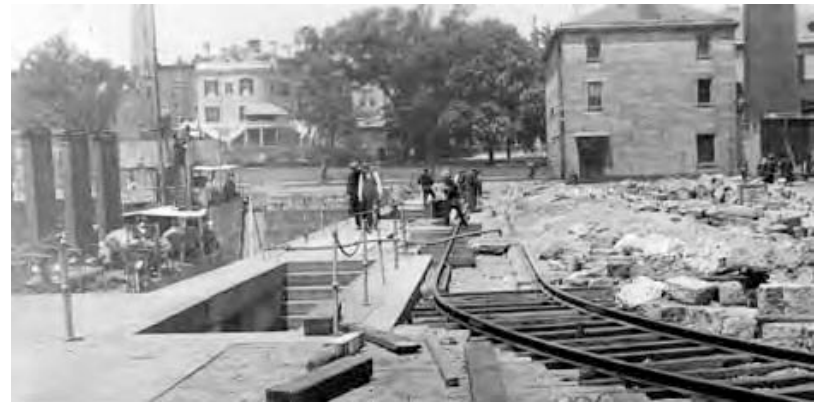
**(B6)** Detail from historic photograph from 1913, showing the opening at the coping level to Stair 5, on the east side of the dock.

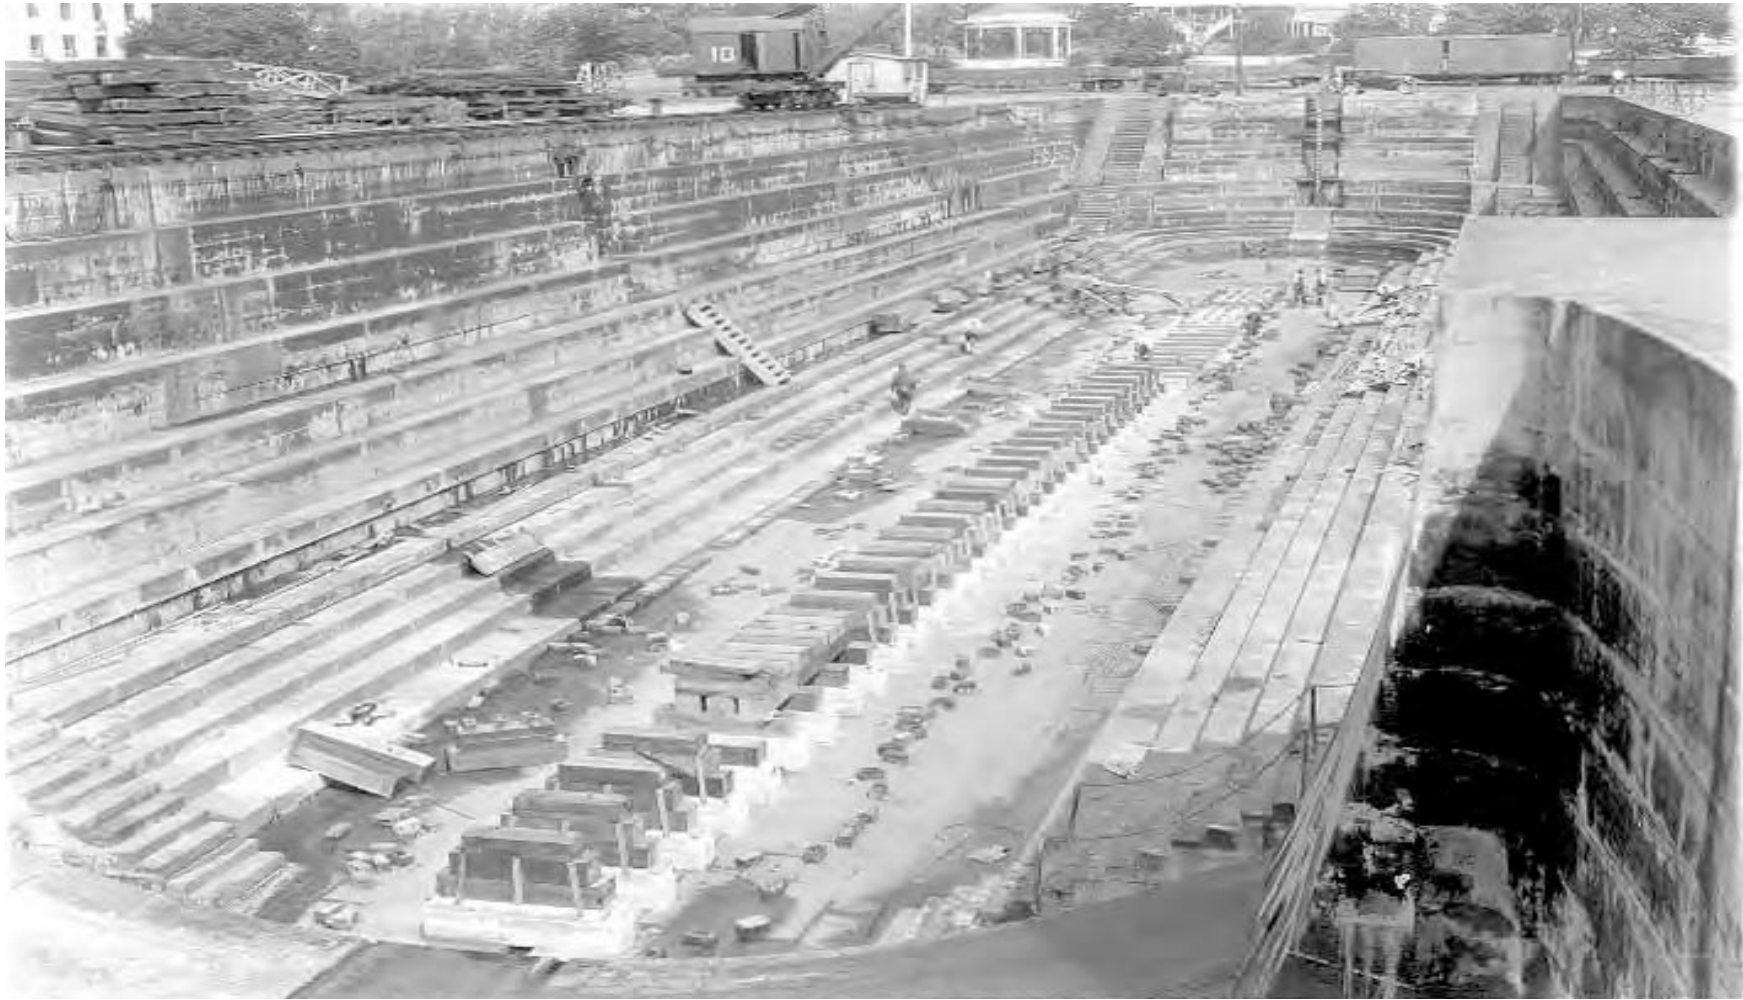
**(B10)** View of Dry Dock I, from 1930, looking northwest, toward the head of dock, with the turning basin in the foreground. Note that at the middle of the dock, on the west side, a wooden stairway was located above the lower altars and provided access to the dock's floor.

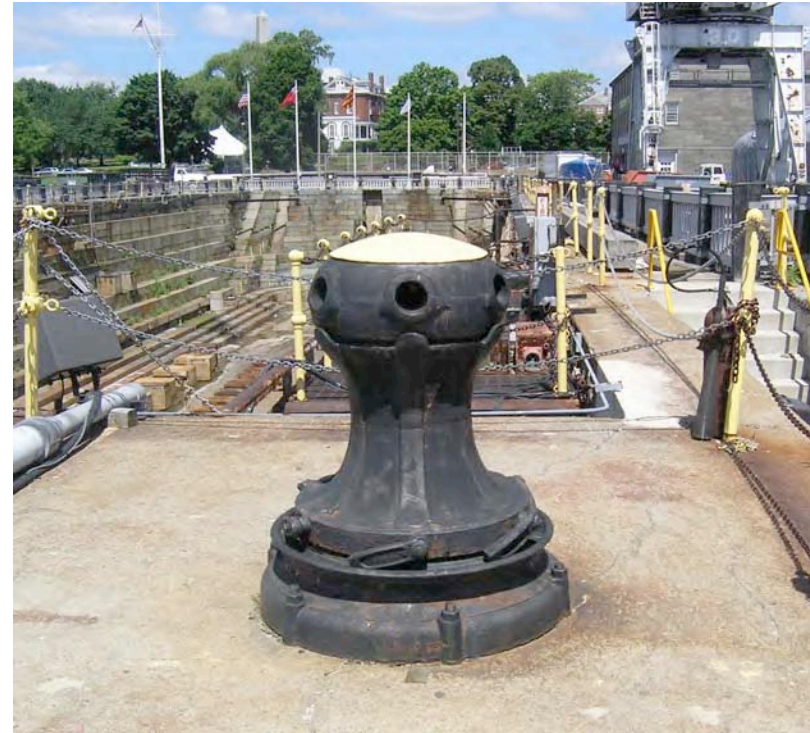
**Fig. 1** View of hand-powered capstan on the east side of the dock at the seaward end. This is one of two surviving *in-situ* hand-powered capstans.

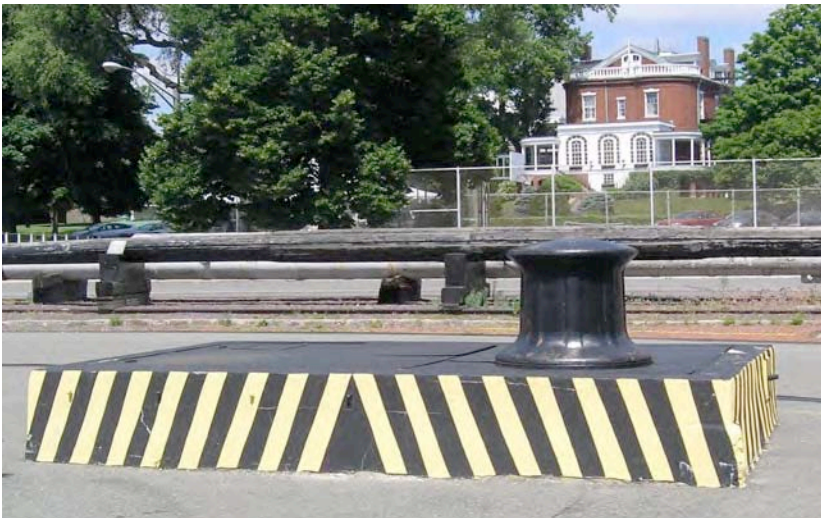
**Fig. 2** View of Capstan 2 at the head of dock. This is one of three electric-powered capstans dating from 1942.

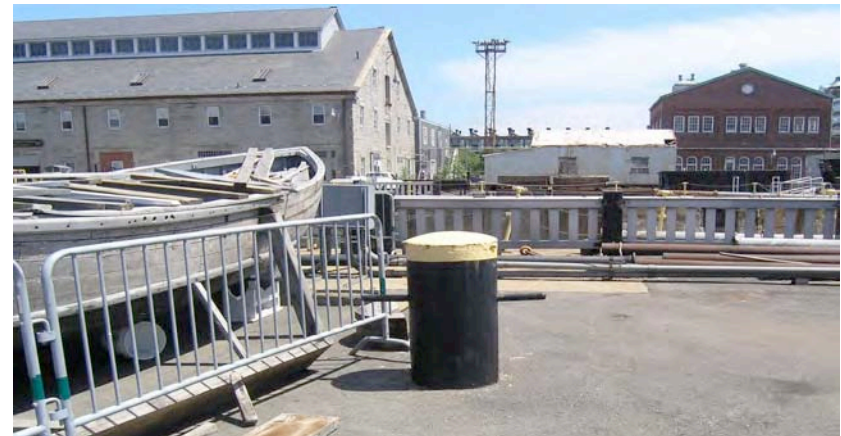
**Fig. 3** View of Bollard near the seaward end.

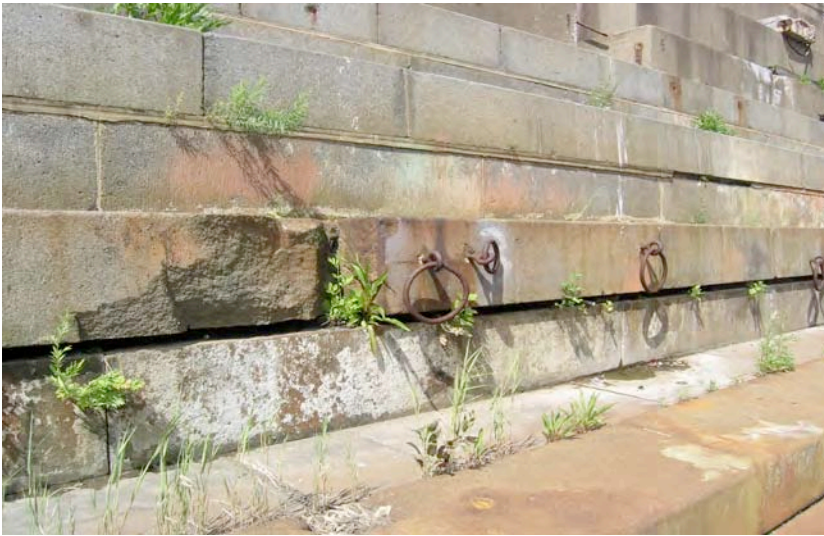
**Fig. 4** Detail of iron rings along west wall of dry dock

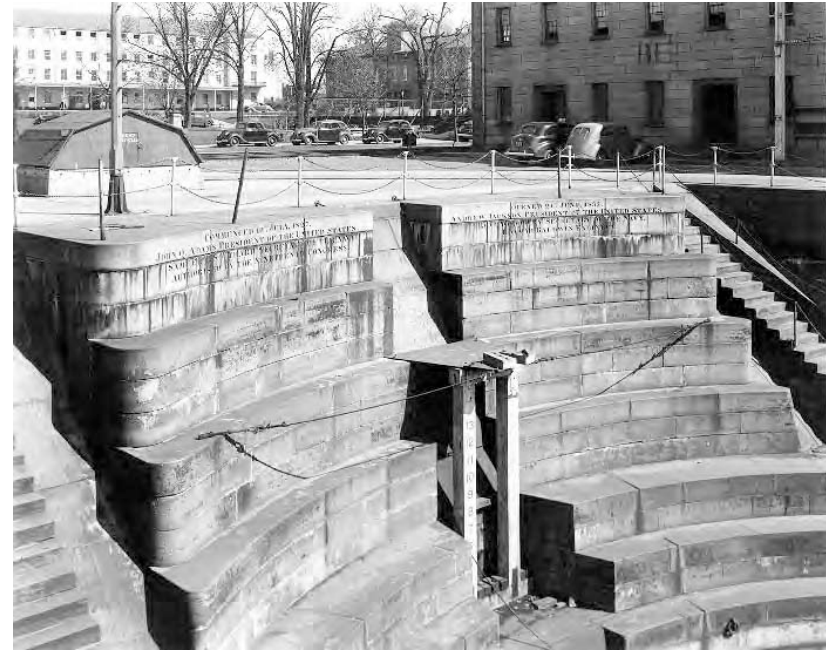
**(B11)** Photograph taken in 1939, showing the upper altars at the head of the dock. The original inscription was carved into the granite blocks of the uppermost altars. All of these stones were removed and reassembled as part of the inland extension, completed in 1860. The gambrel-roof structure just beyond the lightpole was the shed that covered Capstan 2.

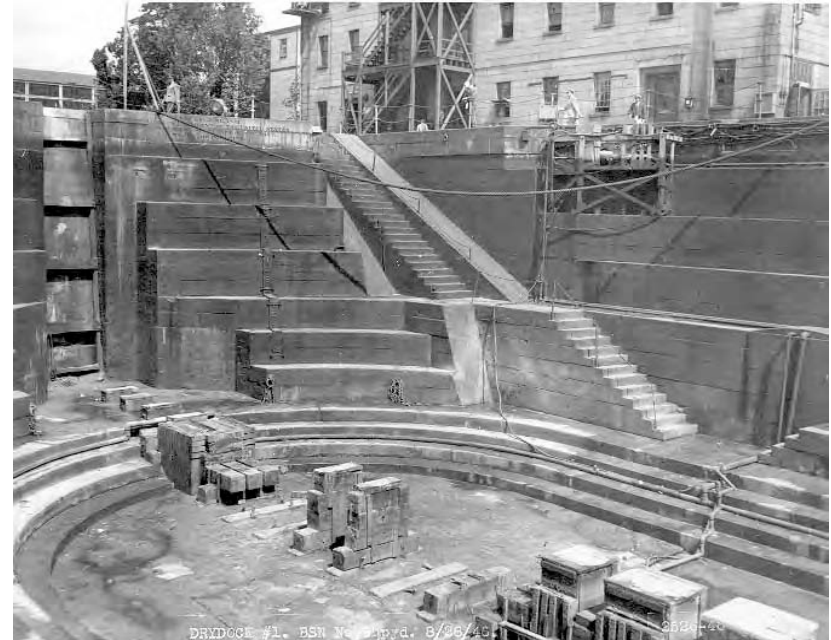
**(B13)** View in 1946 showing the opening where the center slide formerly stood and the cuts made to the altars on either side of the slide. At the center slide, the spaces between the remaining granite blocks (which formed the backing) were later infilled with brick and the blocks, except for the lower one, were covered with concrete.

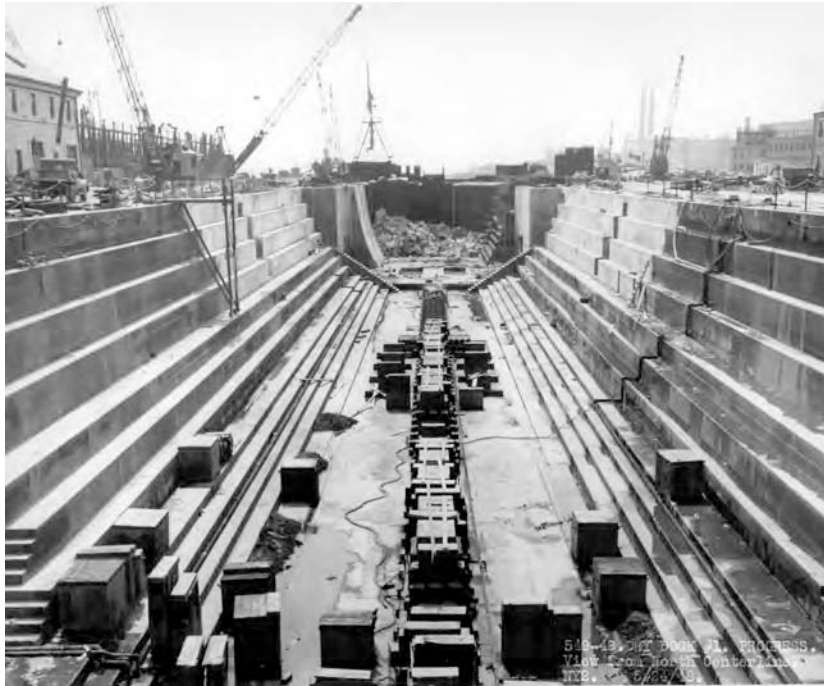
**(B22)** View in 1948 of seaward extension, looking south. Note that the new concrete altars conformed to the dimensions of the original granite altars.

This replacement encompassed the upper four altars below the coping level and extended nearly half of the dock’s length. Below Altar No. 4 grouting was pumped under pressure to consolidate the rubble masonry. Additional work included the partial removal of the granite miter sill of the floor and its replacement with a 6-inch concrete floor liner. The dimensions of the new concrete altars were identical to those of the original granite altars (see **B22**).

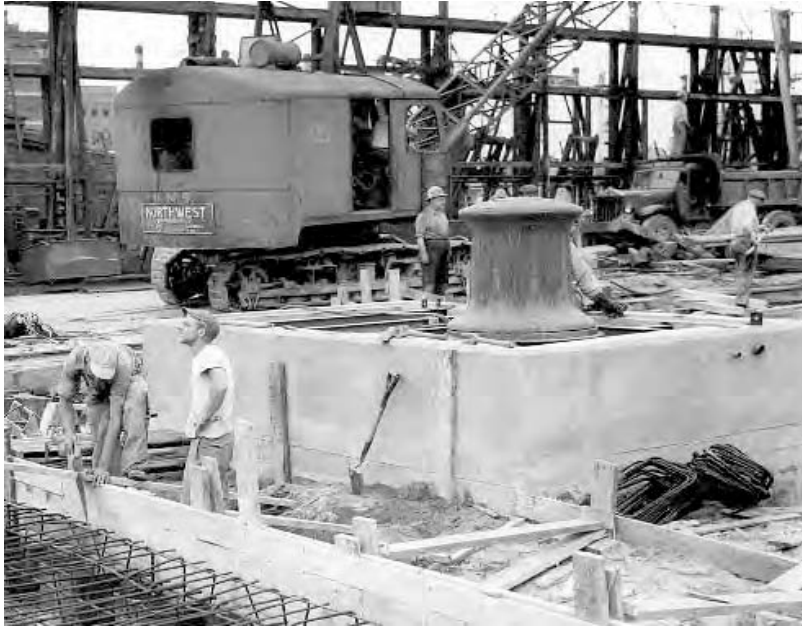
**(B24)** Photograph taken in July 1948, showing relocated Capstan 3, including the capstan barrel, which rests on top of the newly constructed capstan pit.

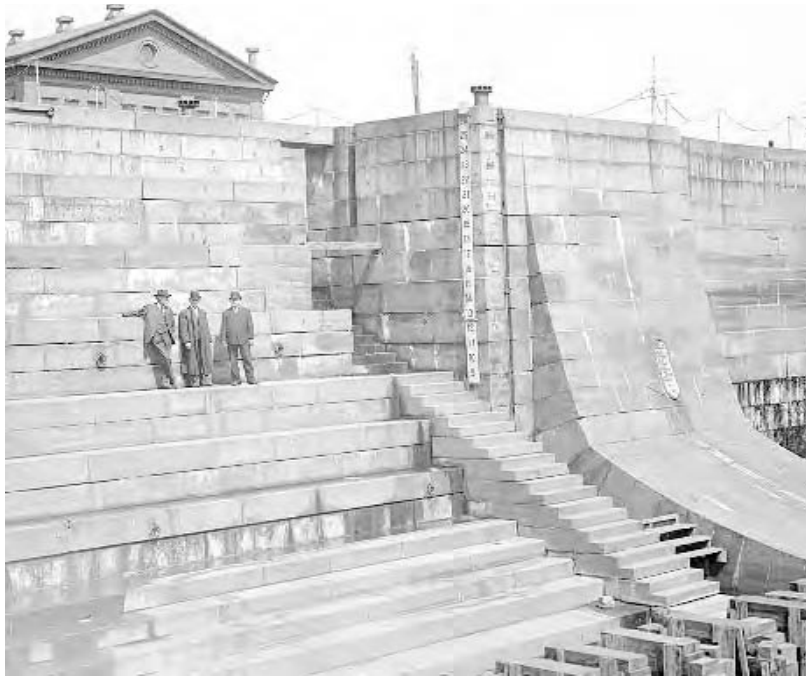
**(B7)** View of one of the draft gauges of Dry Dock 1 in the late-19th century. This gauge was adjacent to the original seaward stairs (Stair 1) on the east side of the dock.

extension. All of the gauges are in deteriorated condition with many faded or missing numbers.

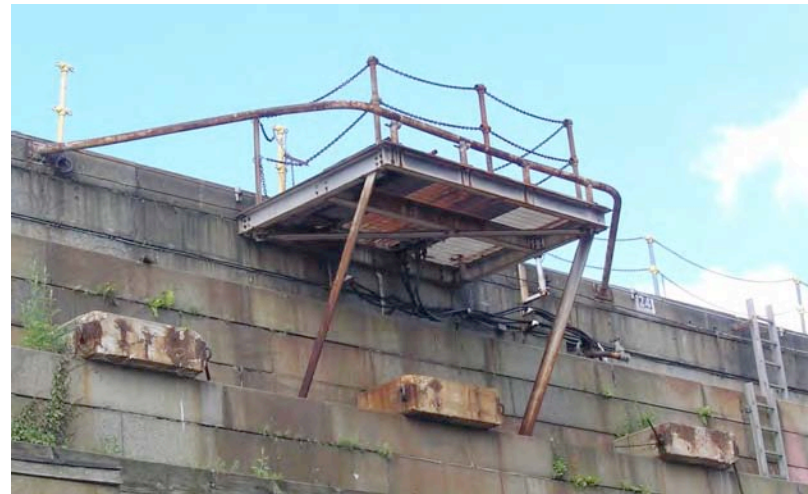
**Fig. 5** View of steel platform on west side of the dry dock.

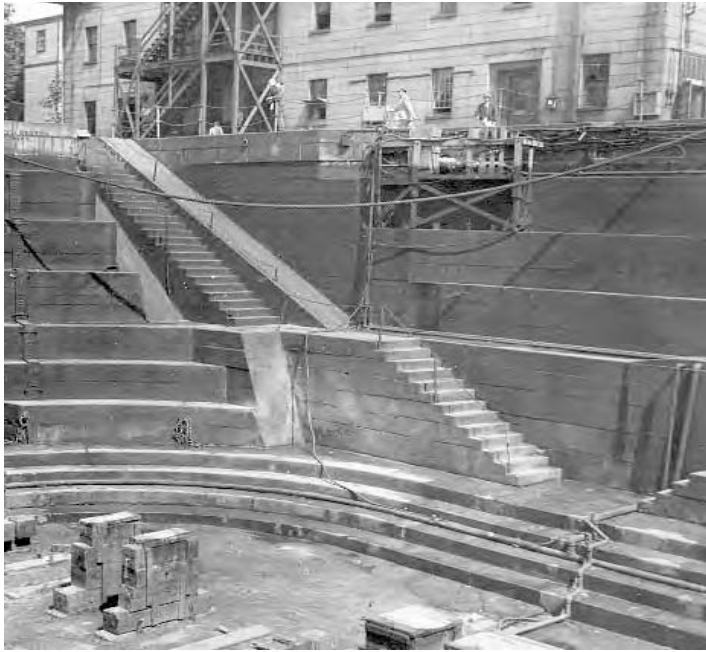
**(B13)** Detail from a photograph taken in August 1946, showing granite stairs (Stair 4) on the east side of the head of the dock. Located above the stairs is a wooden platform, replaced in the 1950s with a steel platform. Note the absence of fixed utility lines that were installed a few years later along with the steel platforms.

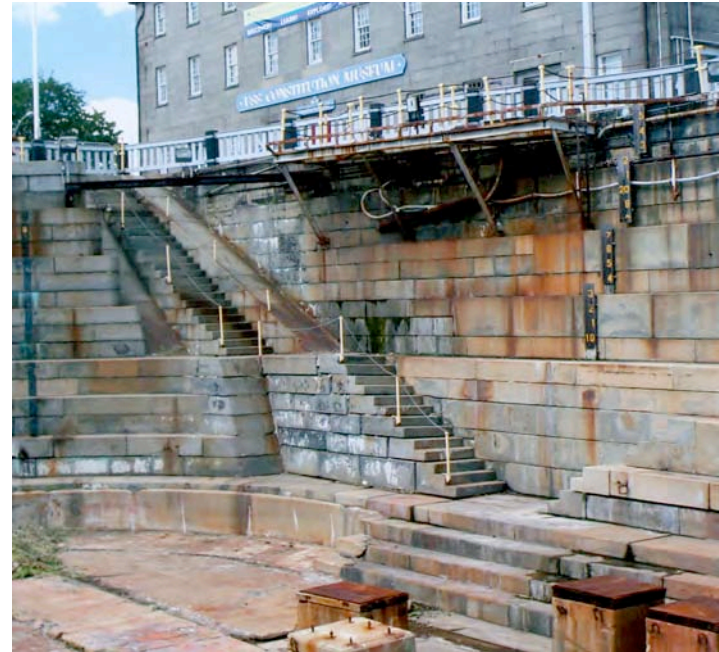
**Fig. 6** A nearly identical view of the stairs and platform on the east side at the head of the dock. Note the addition of steel brackets, supporting electrical cable lines, and utilities that run along the east side of the dock.

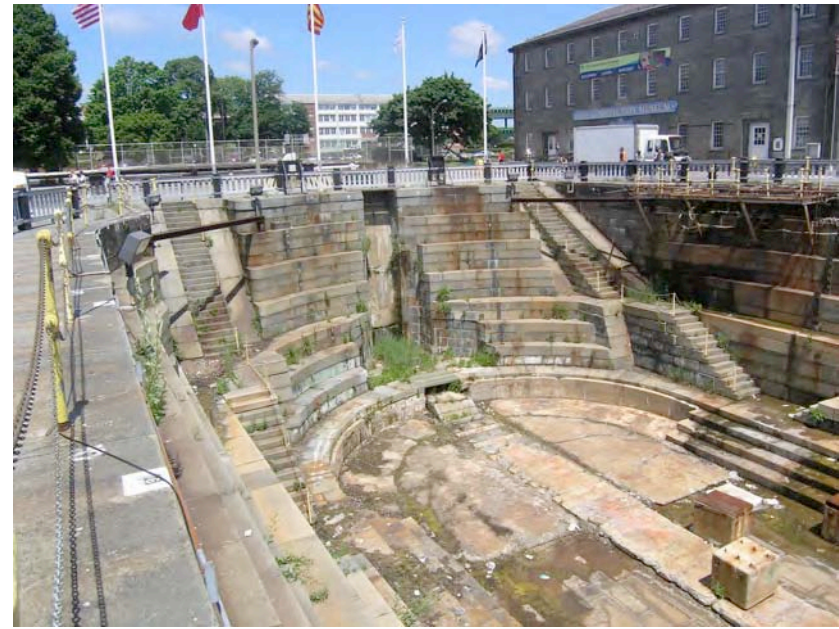
At the head of dock, a reinforced concrete slab, measuring 36 feet in length and extending the full width of the dock floor, overlays the granite floor. A series of concrete blocks, which are the remains of a keelson, extend along the centerline of the dock a distance of approximately 60 feet (see below, “Keelson and Plinth”). About half these blocks rest on top of the concrete slab, the other half rest on the granite floor. The

**Fig. 7** View of floor at head of dock, showing the concrete slab and concrete ties that extend along the centerline of the dock.

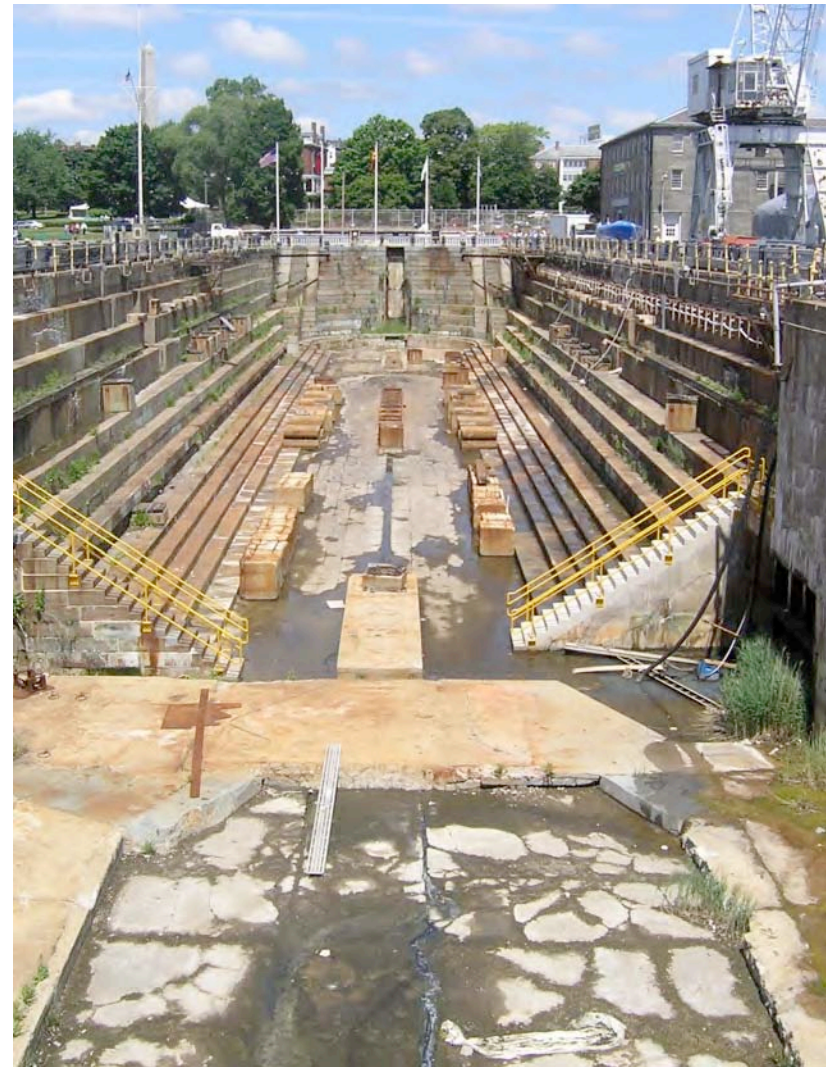
concrete floor of the 1947-1948 seaward extension is in fair condition except in the propeller pit area where it is severely cracked in random patterns and joints are in poor condition.

In the 1950s and 1960s various changes were carried out to the floor, including the cutting of sections of the concrete slab, to enlarge the propeller pit (**Fig. 8**), and the installation of a reinforced-concrete plinth to increase the clearances for servicing vessels with sonar domes (see section below, “Keelson and Plinth”).

**Fig. 8** Detail of propeller pit and cuts made in the granite stone at the seaward end of the dock

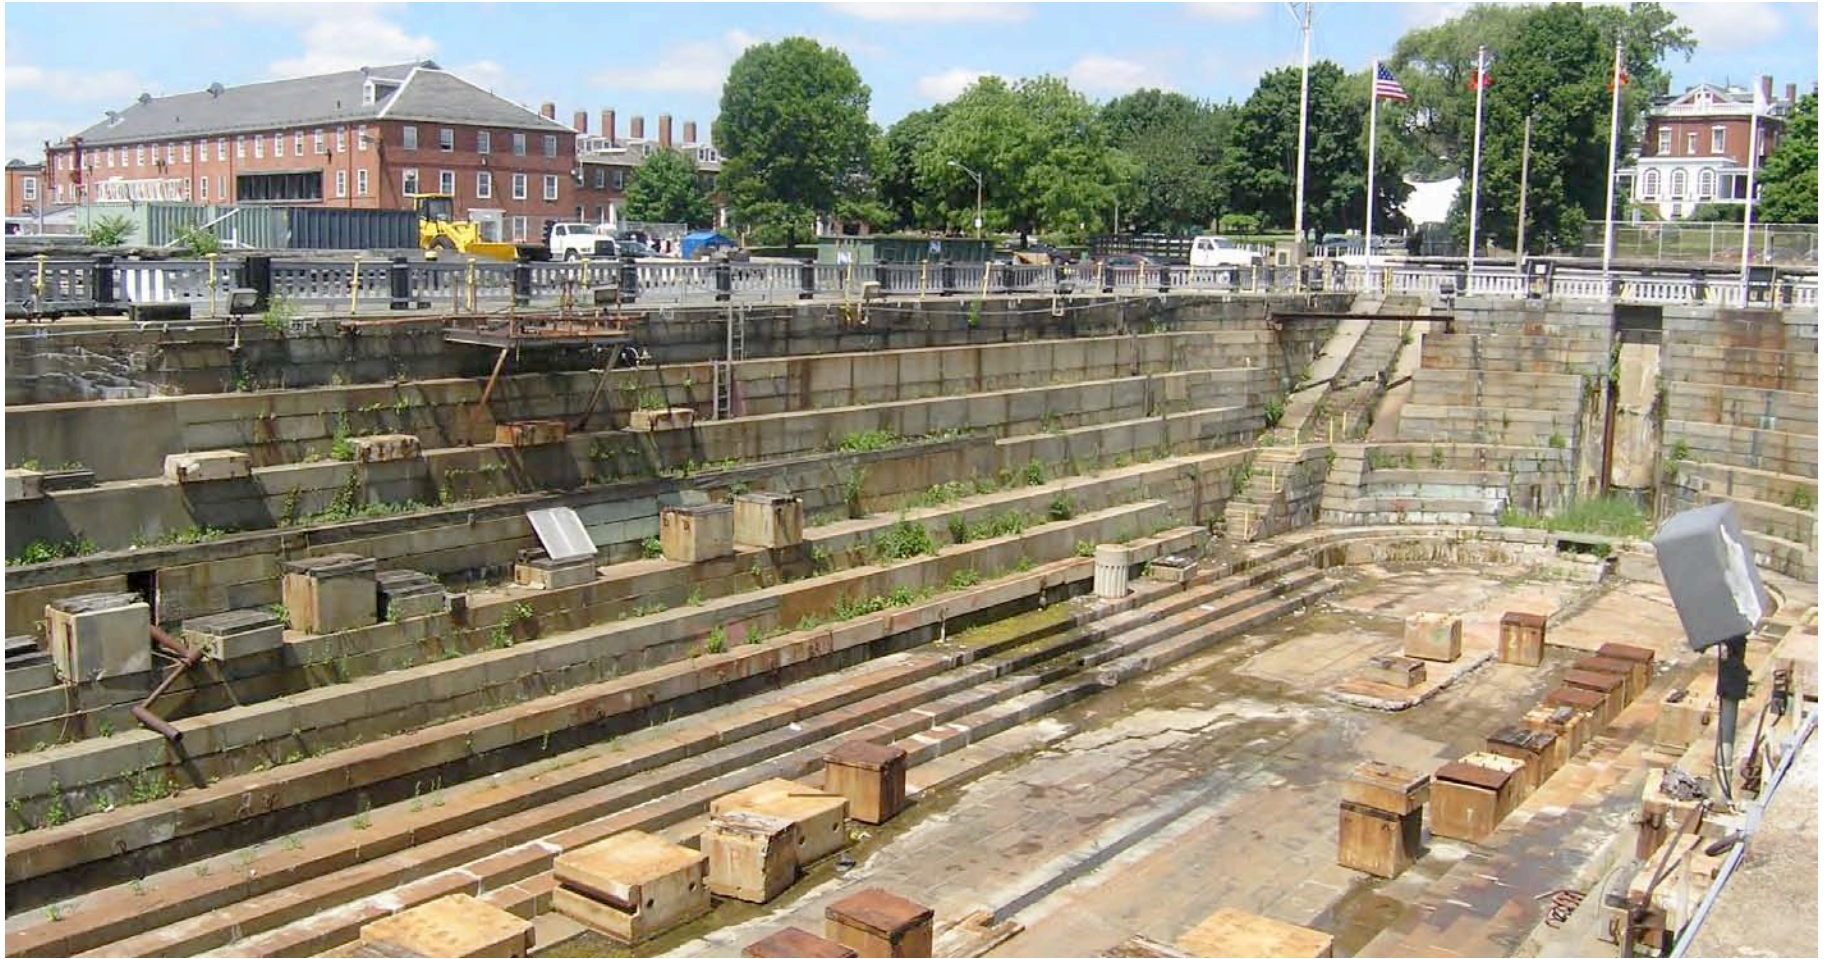
The infill for the new 65-foot section of the chamber was constructed with Cape Ann granite with blocks almost twice the height of the original blocks. The original and mid-19th century sections are distinctive, clearly identifiable features of the dock (**Fig. 9**).

The granite blocks that comprise the altars and step-backs are in excellent condition except for a few blocks that have chipped edges or cracks where holes have been drilled for iron or steel appurtenances that have rusted and jacked. The blocks are generally level and straight except in areas of the two granite stairs at the head of dock where there has been some movement of blocks at the lower level.

**Fig. 9** View looking northwest toward the head of dock. Along the west side of the chamber, from left to right, may be seen the three major construction periods of Dry Dock I. At left are the concrete altars from 1947-1948; adjoining these concrete altars are the original altars of Quincy granite; the large blocks to the right are composed of Cape Ann granite, used to construct the altars as part of the inland extension completed in 1860.

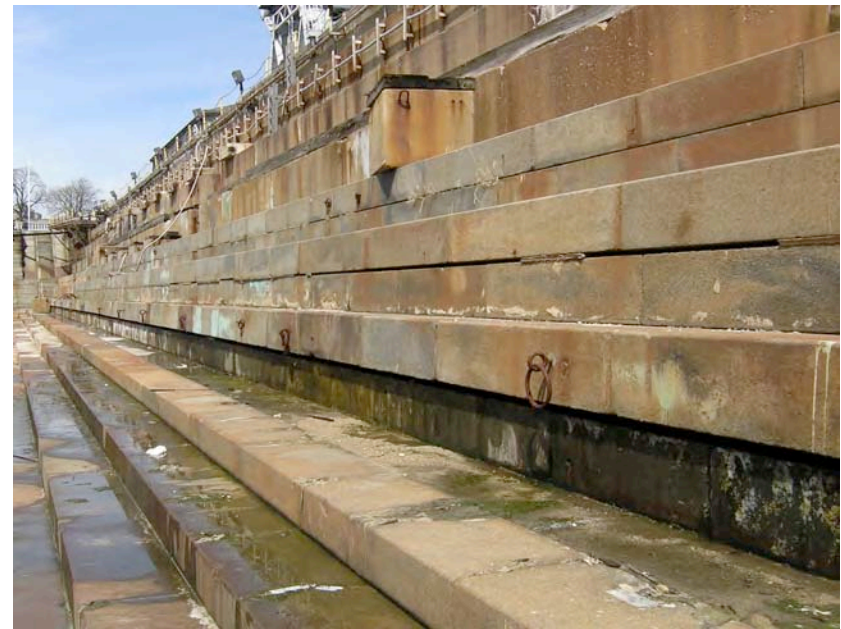
There is little evidence of wall movement or depression. An inspection performed in 1947 revealed that some of the granite blocks of the side walls had bulged inward as much as 4 inches. The upper four altars of about half of the length of dock's side walls were removed and replaced with concrete replicating the original form. Much of this concrete work is in fair to good condition, although there is some cracking and spalling, most notably on the east side of the chamber near the seaward extension.

**Fig. 12** View looking north showing the east side of the chamber. The lower altars and stairs of granite were retained, while the upper altars were replaced with reinforced concrete nearly half the length of the dock.

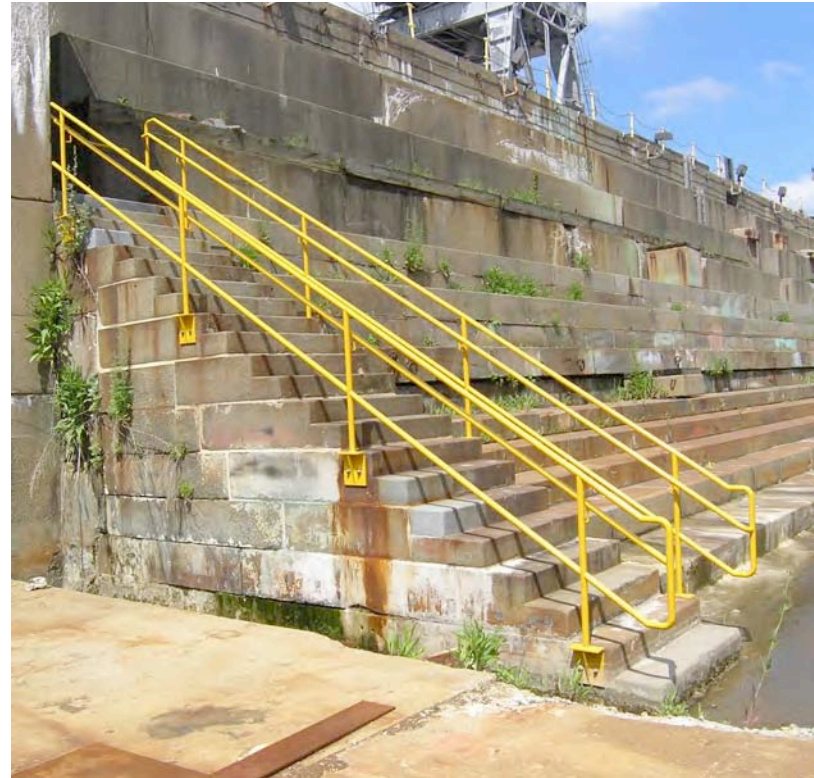
**Fig. 14** Lower flight of Stair 2, on west side near the seaward extension. This original section of stair was preserved as part of the 2004 repairs of Dry Dock 1.

By 2000, the concrete of Stairs 1 and 2 was seriously deteriorated and four years later these two stairways were rehabilitated to provide OSHA compliant and safe access to all levels of the dock. This work included replacement of all deteriorated concrete steps. The lower flight of Stair 2 was retained with the stonework reset and repaired, and all mortar joints cleaned and repointed. New railings and security gates were installed for Stairs 1 and 2.

A number of the surviving granite stairs have steel post and chain railings, which are in very poor condition and do not meet OSHA standards. Granite blocks that have moved need to be reset to uniform treads and risers, all joints require re-grouting and repointing, and railings need to be code compliant.

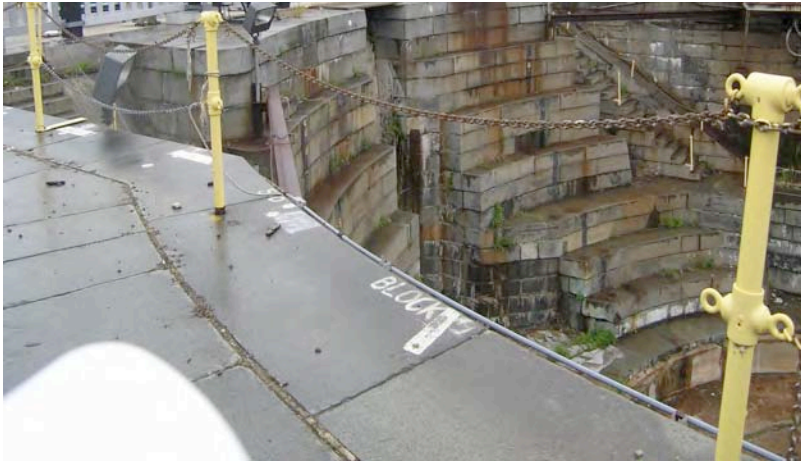
On the west side the original granite coping is generally in good condition (see **Fig. 18**) and, with the exception of some

**Fig. 18** Detail of coping on the west side near the head of the dock, where the original granite remains in place.

coping has been patched more extensively with concrete or asphalt. Similarly the granite coping at the middle sections of the dock on the east and west sides is largely intact with some concrete patching. The concrete slab that was poured at the coping level as part of the seaward extension is in fair condition.

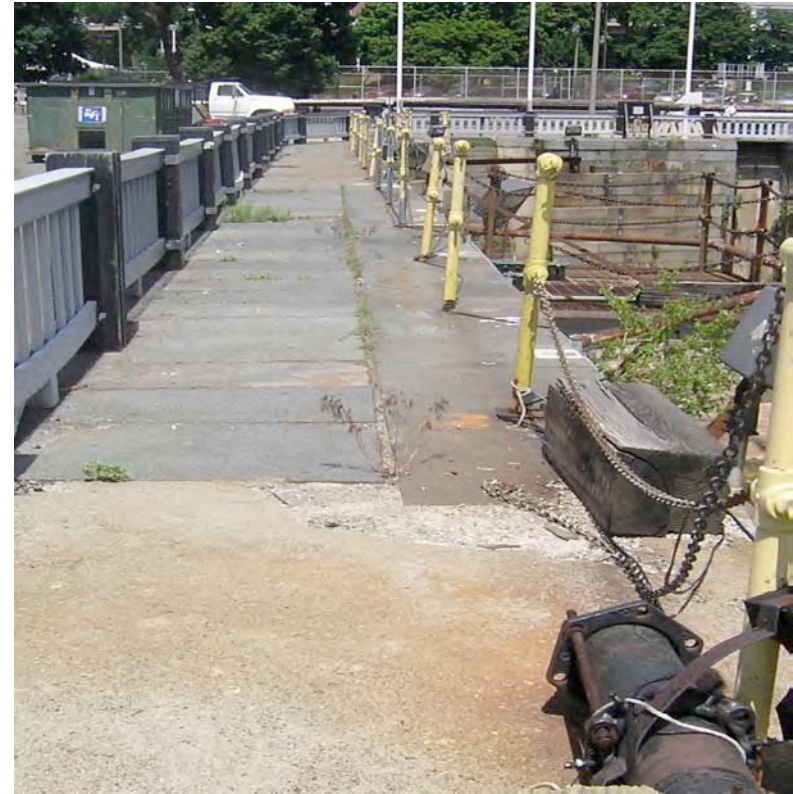
The coping includes the original 1832-1833 granite coping at the head of the dock, the 1856-1860 granite coping of the inland extension, and the concrete slab installed around the perimeter of the southern one-third of the dock as part of the 1947-1948 seaward extension (see **Fig. 19**).

Some granite was probably removed during construction of the seaward extension and replaced with concrete. In general, there are numerous utility, grates and steel platform components including many rusted pieces that surround the granite coping and concrete slab around the perimeter of the dock.

**Fig. 19** View looking north, along west side of dock showing the coping from three different time periods. In the foreground is concrete slab (late 1940s); abutting the concrete is granite (from the late 1850s); and beyond, around the head of the dock, is the original granite coping.

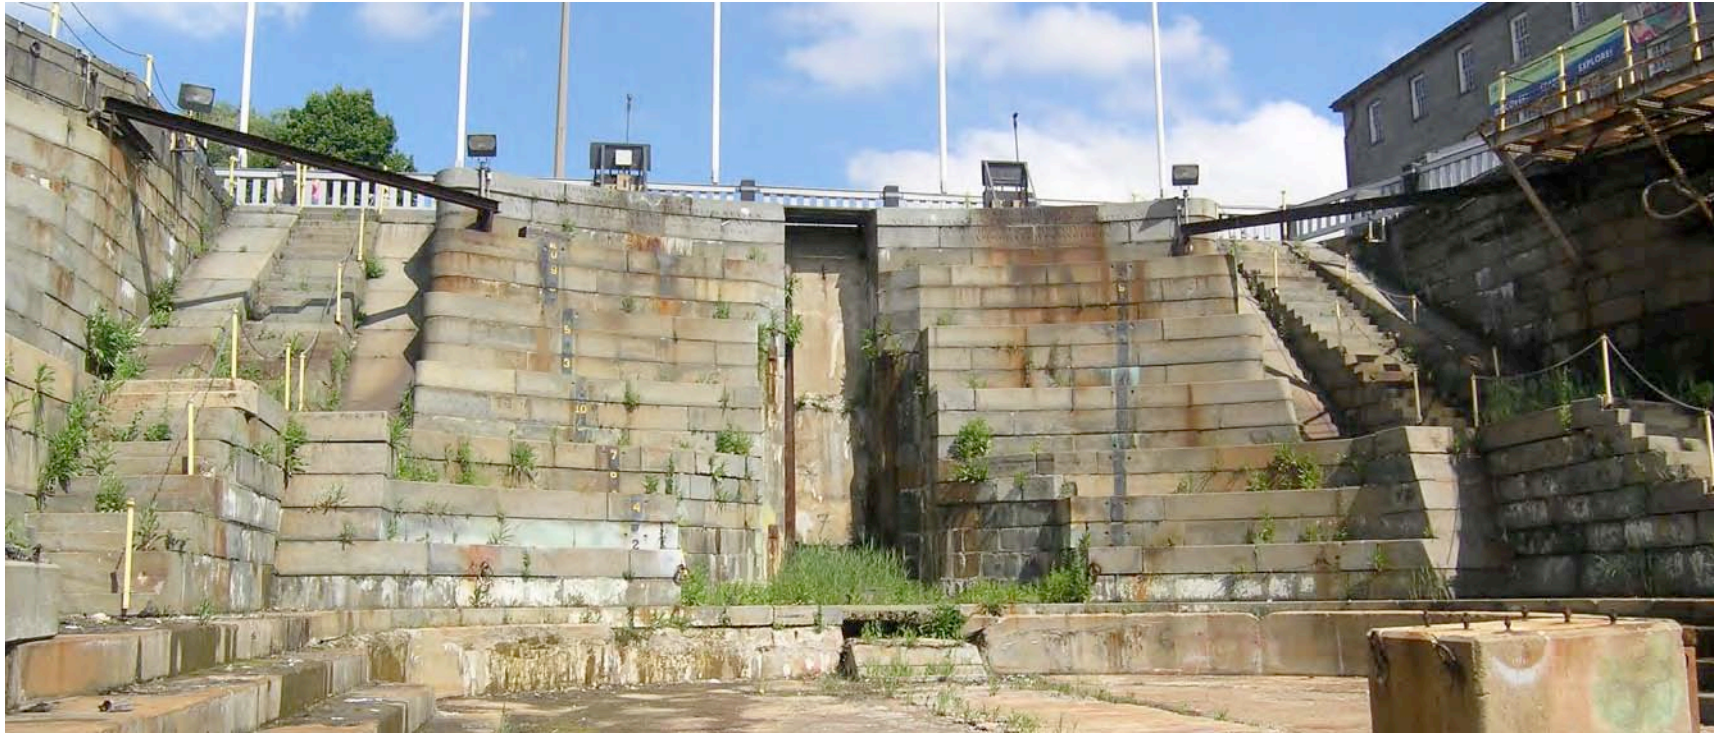
**Fig. 20** View of head of dock showing alterations to center slide and lower stairs to the dry dock floor.

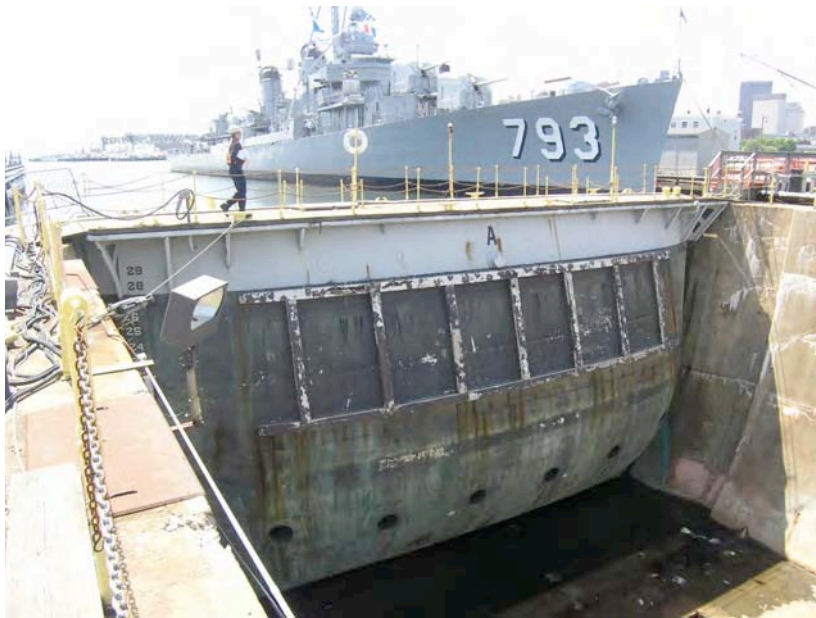
The caisson is currently flooded and seated with the “A” dryside facing the chamber and the “B” wet side facing the harbor. It has been in this position since 1996 when SS *Nobska* was drydocked. The main level (machining deck) was in fairly good condition and very little active corrosion was found on the gate’s interior.

**Fig. 22** View of the steel caisson, looking south.

Some rust was evident in isolated locations at floor-to-wall connections but overall the paint coating was clean. The heaviest corrosion was isolated in the southwest corner of the machinery deck where leakage through some rivet holes collected on the floor. Lower levels of the gate were not inspected since it was flooded. The seals (seat) of the caisson appear to be largely watertight; however, when the caisson is overhauled the structural elements that constitute the seat, as well as the gaskets that prevent leakage, should be thoroughly inspected and repaired as required.

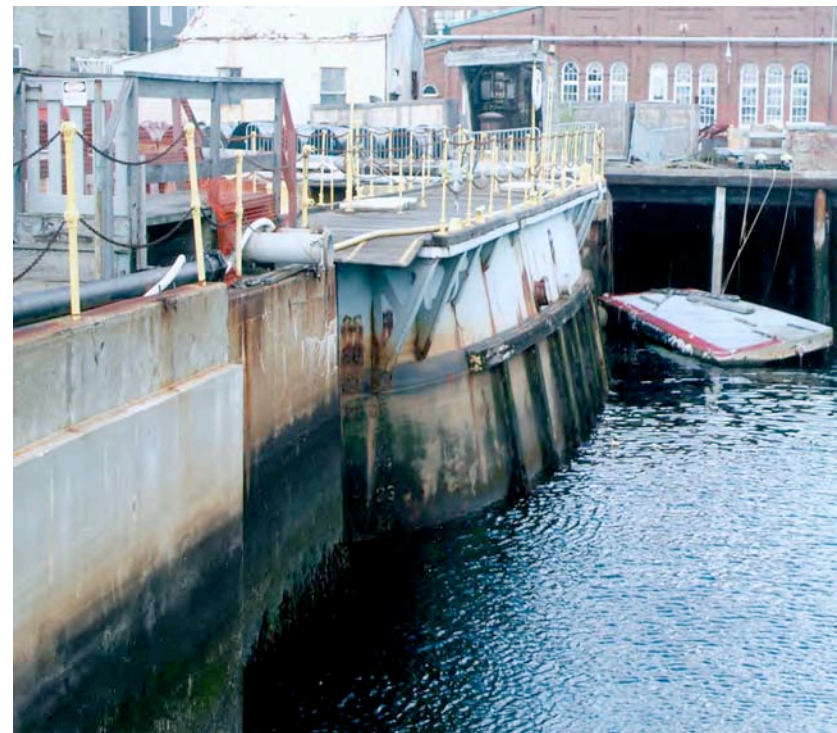
No cracks were evident in the steel from a visual inspection of the dry, inside of the gate. Ultrasonic thickness measurements

**Fig. 23** View of the steel caisson on the seaward side.

were taken of the hull plating and compared with the original thicknesses which revealed that several areas of both sides have a greater than 25% reduction. In general, the entire lower half of the wet side exhibits corrosion beyond the 25% threshold, which is the limiting criterion for dry dock certification by the U.S. Navy.<sup>86</sup> All sections of steel plating that are less than 75% thickness will require replacement or double plating. Mechanical equipment (including pumps and

valves), electrical equipment, seals, and wood decking should be repaired or replaced as necessary and the installation of a cathodic protection system is recommended.

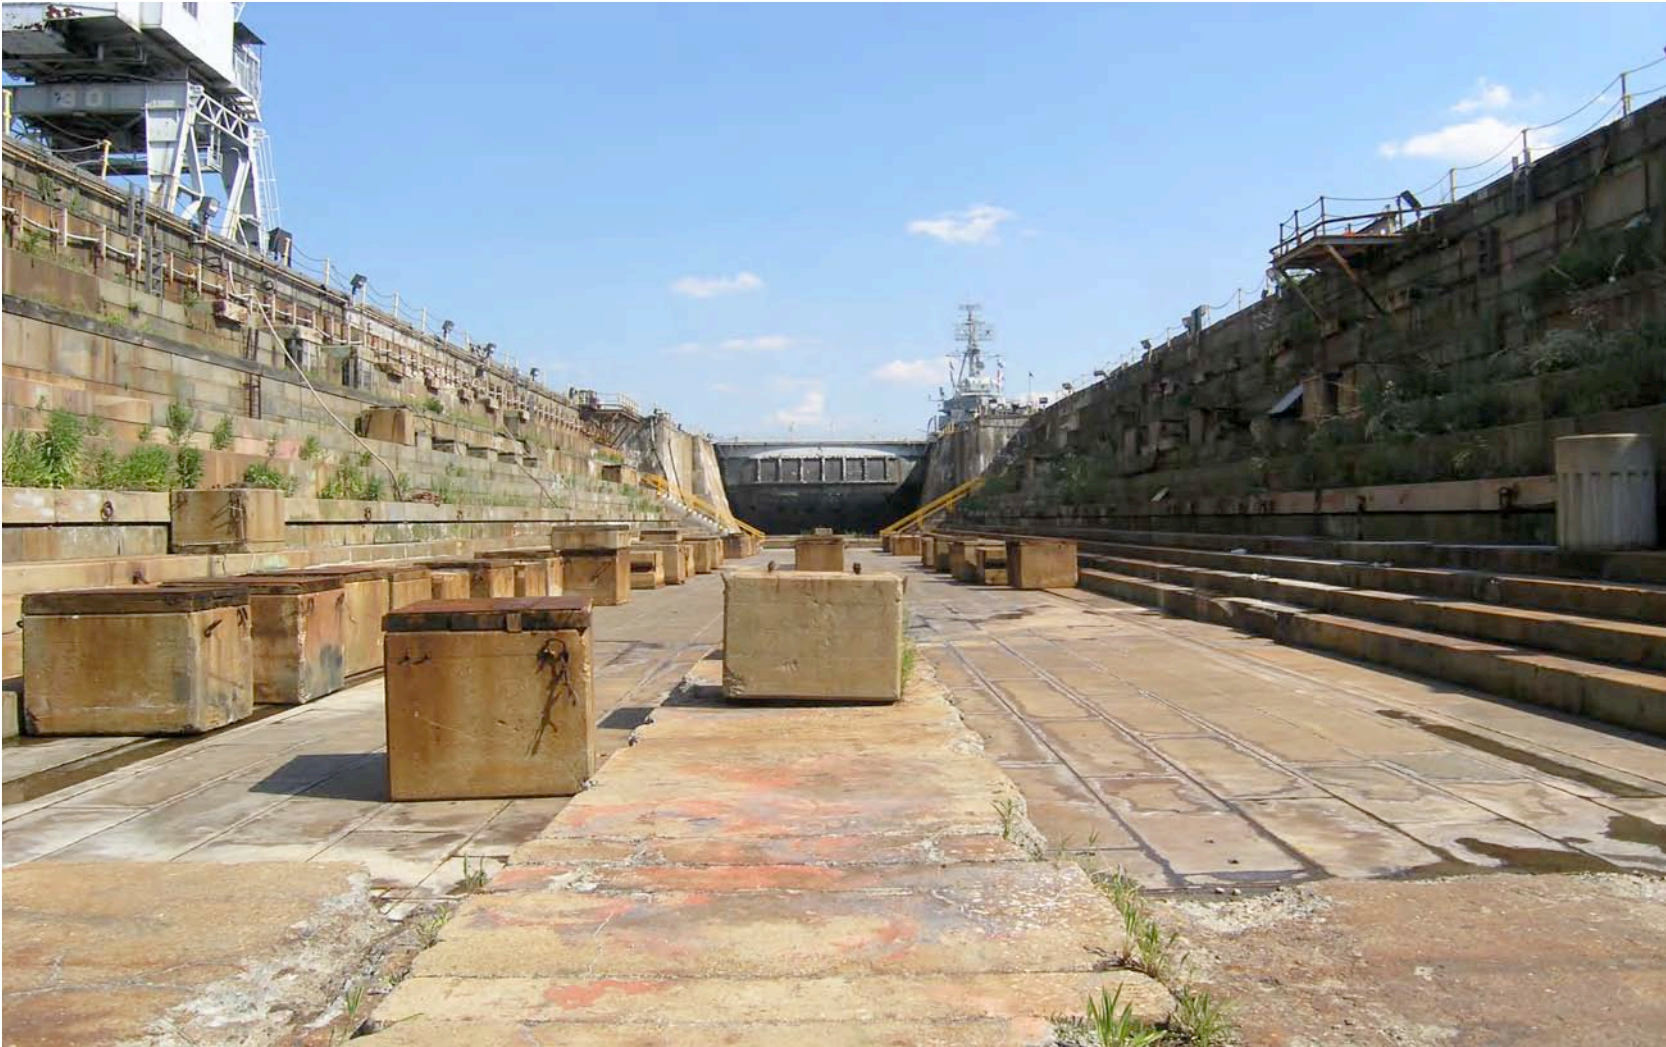
**Fig. 24** Granite floor and keel blocks, looking south toward the steel caisson.

Although the concrete of most of the keel blocks is in good condition, about 15 blocks exhibit cracking and spalling of concrete. Most of the steel U-bolts, which are embedded in the concrete and permit the moving of the blocks, are missing or severely corroded. This deteriorated condition of these U-bolts substantially limits the use of the keel blocks. Moreover, a number of the keel blocks contain rotten timber blocking attached with steel tie downs.

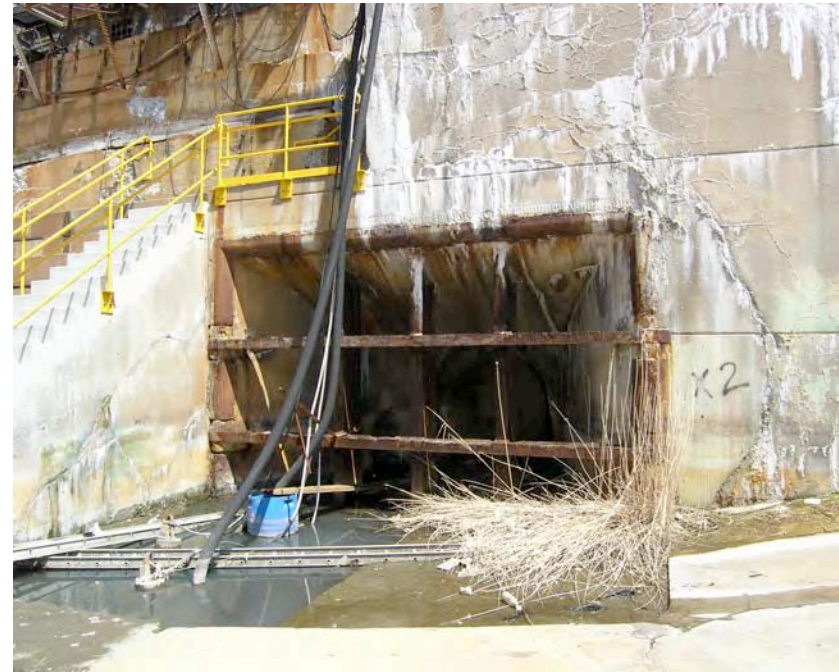
This large intake culvert represents the Navy’s last major construction effort of Dry Dock 1. Completed in 1960, it eliminated the older dewatering system of floor drains and smaller outlets in the chamber’s walls. As seen in **Fig. 27** the culvert contains a steel frame at its intake.

A number of years ago the tunnel into which the culvert connects was sealed off and the dewatering is now accomplished with six (Barnes Manufacturing Company) diesel-powered pumps mounted on timber skids. Suction hoses extend from the coping level down into the dock’s chamber and the pumps discharge through two steel pipes located on

**Fig. 27** Detail of tunnel intake and steel frame across its entrance.

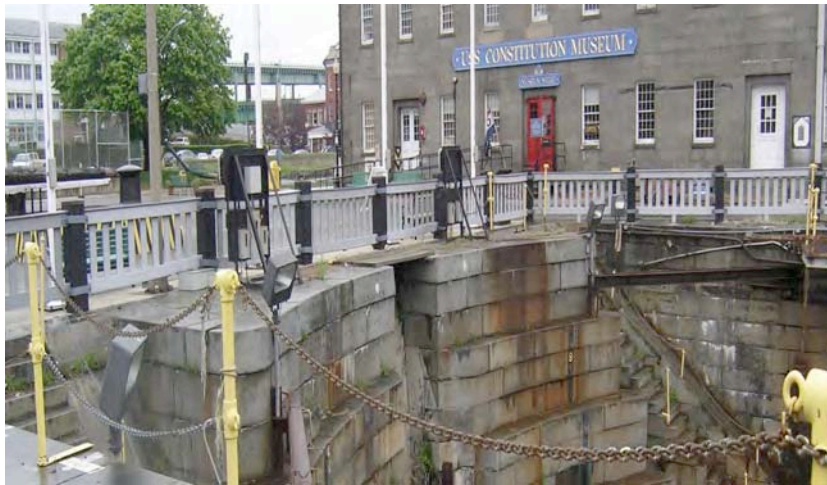
A steel stanchion and chain fence, which dates from World War II, is located along the edge of the coping to protect workers from falling into the dry dock. This fence is in fair to poor condition with missing sections. Beyond the stanchion and chain fence is a public safety fence/guardrail comprised of wood posts and a composite railing, which extends around the dock's perimeter.

**Fig. 28** View of safety fencing, with wood posts and composite railing, at head of dock, looking northeast. In the foreground is the older stanchion and chain fence, with the stanchions painted yellow.

This new safety fence/guardrail is made of a composite plastic material (from recycled materials) and attached to wooden posts with metal brackets. Although in fair condition, the composite railings are beginning to sag from their own weight and the long-term durability of this fence/guardrail is questionable.

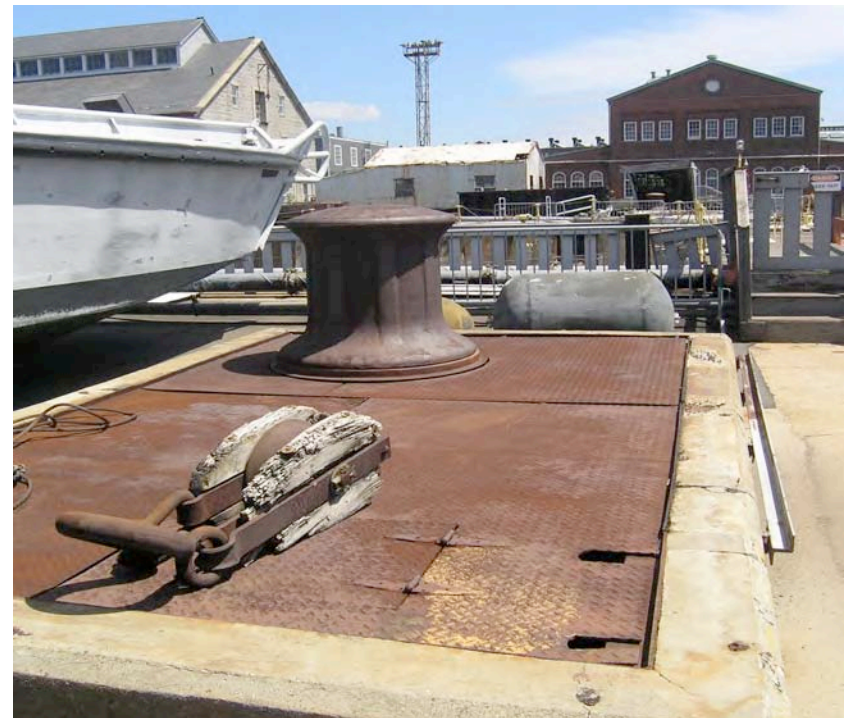
**Fig. 29** One of three electric-powered capstans; this one is on the on west side of the dock at the seaward end.

As part of the 1947-1948 seaward extension, two of the electric-powered capstans (No. 1 and No. 3) were relocated to the south. These two capstans are severely corroded and in need of repair. The steel plates that span the reinforced concrete capstan pits are severely deteriorated and in need of replacement. The concrete pits, however, are in good condition.
