# DRY DOCK 1

## HISTORIC STRUCTURE REPORT

*Charlestown Navy Yard • Boston National Historical Park*

PREPARED BY MCGINLEY KALSOW & ASSOCIATES

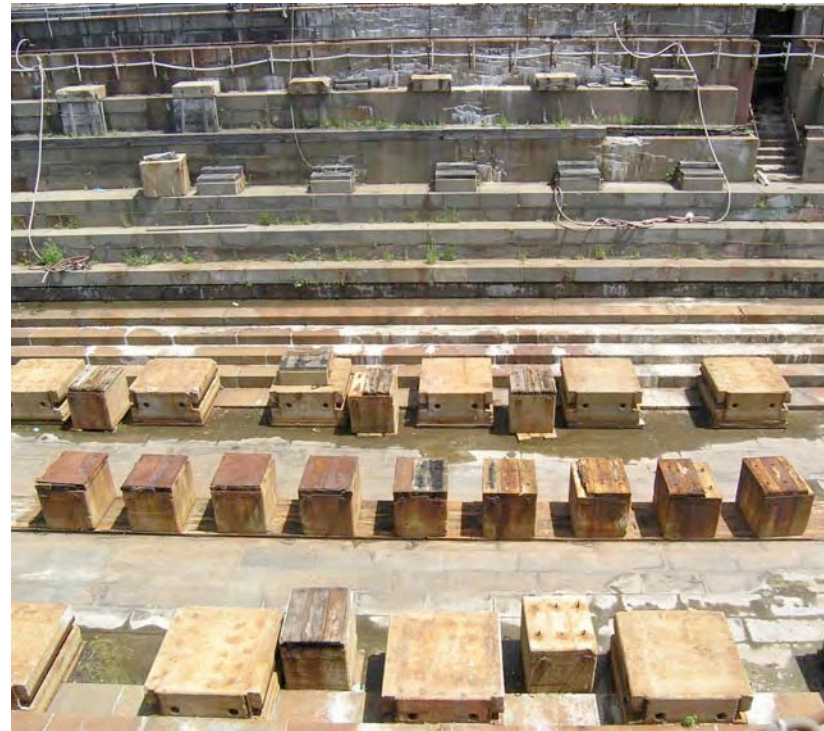
Although the concrete of most of the keel blocks is in good condition, about 15 blocks exhibit cracking and spalling of concrete. Most of the steel U-bolts, which are embedded in the concrete and permit the moving of the blocks, are missing or severely corroded. This deteriorated condition of these U-bolts substantially limits the use of the keel blocks. Moreover, a number of the keel blocks contain rotten timber blocking attached with steel tie downs.

**Fig. 31** View of concrete keel blocks showing the three different types of blocks.

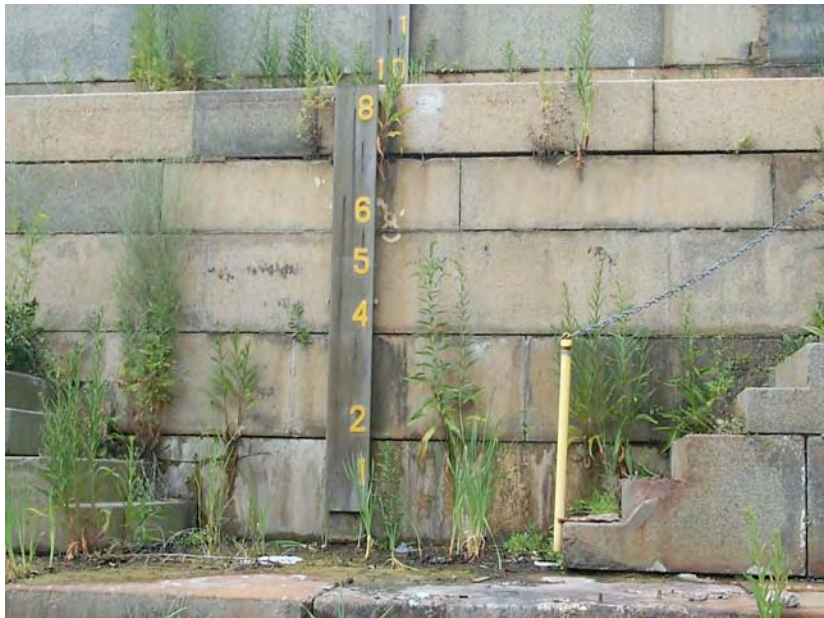
**Fig. 32** Detail of draft gauge [file Dry Dock 8/10/05; #6612]

extension. All of the gauges are in deteriorated condition with many faded or missing numbers.

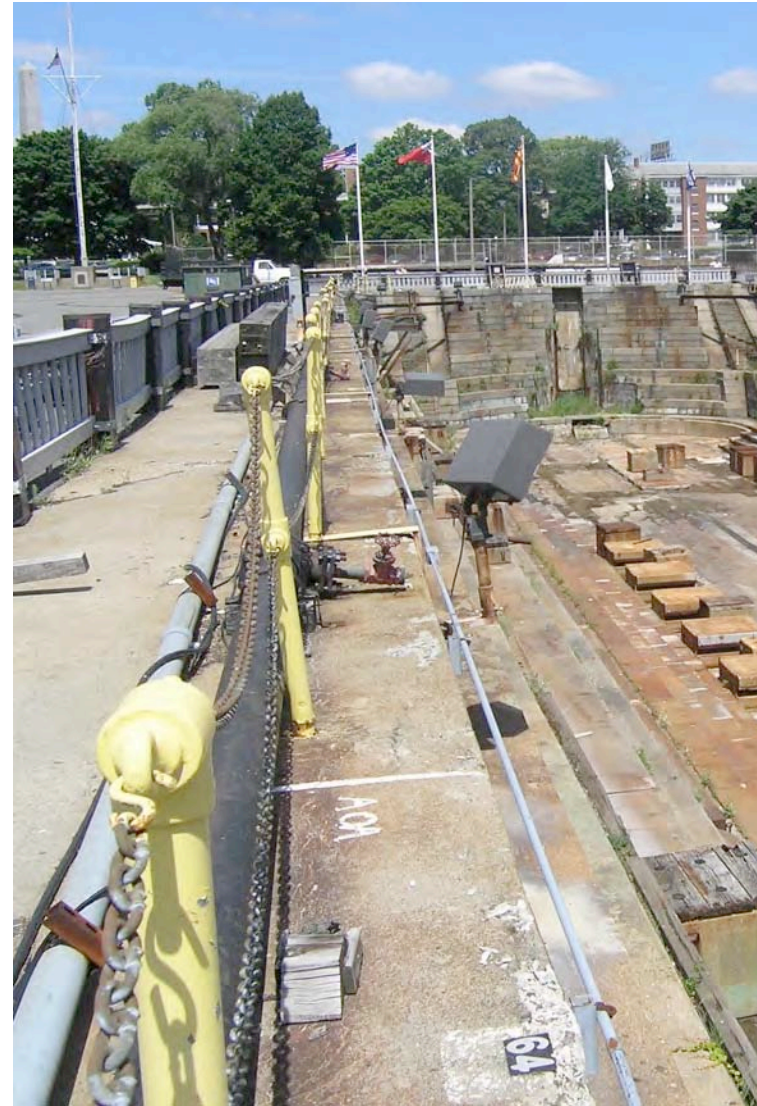
Most of the older utility lines are located along the east side of the dock at or near the coping level. A series of steel brackets, numbering approximately 65 and attached to the uppermost altar, extend along the east side of the chamber. These appear to have carried electrical cables and about a half dozen of these brackets are severely rusted.

**Fig. 34** View of pipes, electric cable, and floodlights along the west side of the dock.
