Cape Hatteras National Seashore
Bodie Island Light Station
Double Keepers Quarters
Historic Structure Report

Joseph K. Oppermann - Architect, P.A.

2009
Historic Structure Report
Bodie Island Light Station
Double Keepers Quarters
Historic Structure Report

Building Investigation/
Building Condition Assessment

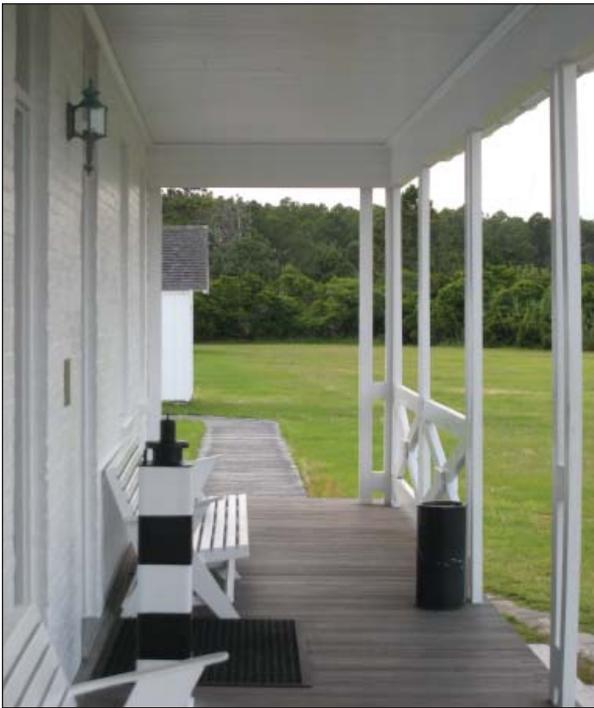
Figure 19, Looking north from East Porch.

The seven pairs of coupled posts and four sets of X-braced railings per porch are an unusual feature first documented in 1893 photographs. These configurations are probably original features given the early documentation of their existence, even though the 1872 plans call for ten solitary posts.

According to photographs, the paired posts and X-braced porch railings continued until 1954 when they were replaced by single posts without porch railings similar to the 1872 plans. The single posts were replaced with paired posts and X-braced rails which were in place in 1990. However, because insect damage was so severe, George Perrot, who

supervised the NPS repair effort in 1990-92, reports that all posts and rails had to be replaced. The posts measure 2" by 4". The top rail measures 1" by 5", the bottom rail 1" by 6", and the cross rail 1" by 4".

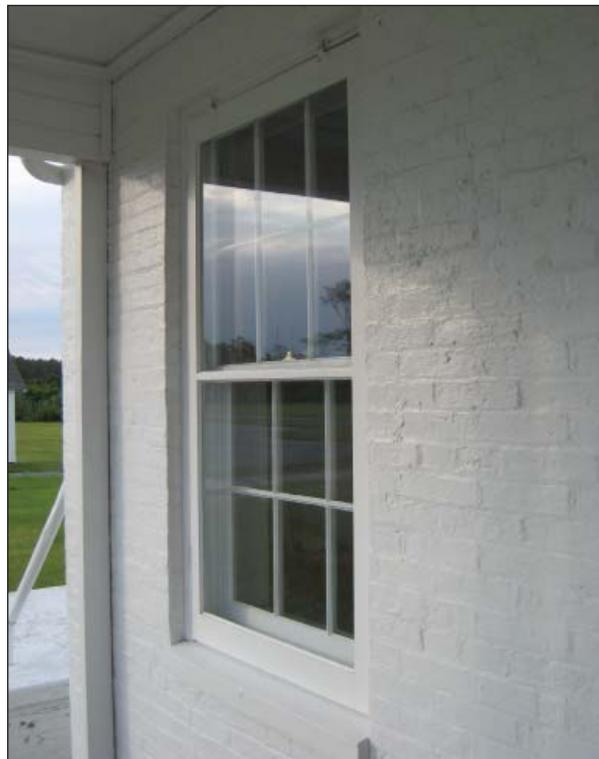
Figure 25, Typical first-floor window.

The windows appear along the east and west walls, the long elevations of the Quarters. At both the first and second levels, the window units are the original, wood, double-hung sash, in a six-over-six light design. At first floor, the window units measure 2'-8" wide by 5'-2" tall. At second floor, the window units are 2'-8" wide by 4'-10" tall.

Each window opening has an exterior sash window consisting of a wood sash of full-opening dimensions with thermal glass. Two metal receivers at the top rail of each sash attach to matching hooks on the window header. The thermal windows were added during the 1990-92 repair campaign.

Also at each window are scars at the jambs from butt hinges for shutters. Shutters are shown on the building in a 1933 photograph. No evidence was observed of other shutter hardware such as plate or driven pintles, other jamb hinges, hooks, holdbacks or latches.

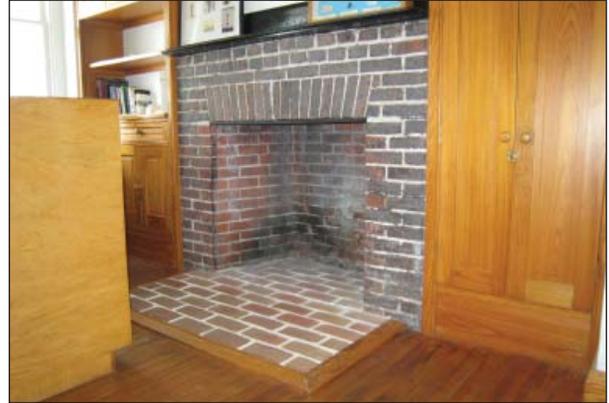
Figure 42, Fireplace of Room 101.

On the north wall is the exposed-brick fireplace for the original Kitchen. The early if not original firebox is intact. The opening measures 3'-3" across at the front face and 1'-1" deep, the beveled cheek walls forming a 2'-4" wide back wall. Many of the brick along the back of the firebox have heat fractures and spalled exposed surfaces. A metal strap supports the flat arch of the hearth. In 1990-92 a

new brick hearth measuring 4'-3" wide and 2'-1" deep was laid. Also during those repairs, a Dutchman repair was made to the front of the mantel shelf. In 1954, the front of the shelf was hacked off to enclose the fireplace with a stud wall.

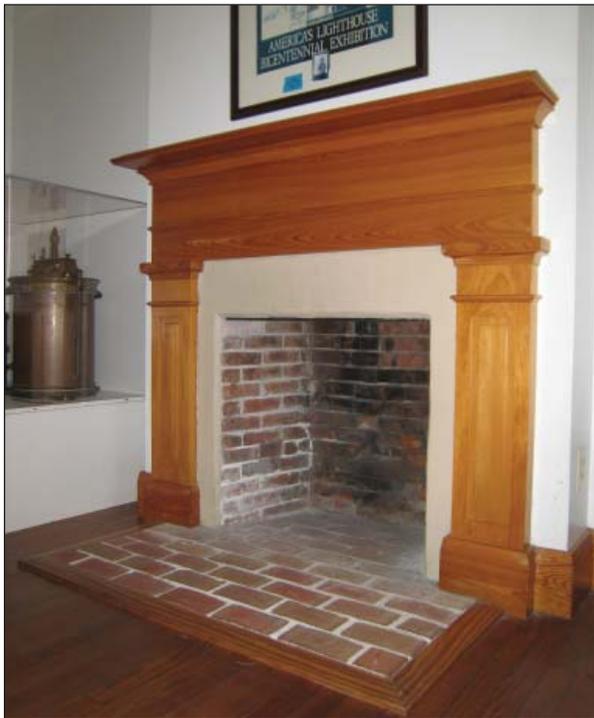
Figure 62, Fireplace and 1992 replacement mantel of Room 110.

beveled cheek walls forming a 2'-1" wide back wall. Some of the brick along the back of the firebox have heat fractures and spalled exposed surfaces. In 1990-92 it was reconstructed using the fireplace mantelpieces at the St. Augustine, FL, Lighthouse Keepers' Quarters as a model in combination with features and details found in this building and the nearby Oil House. Also in 1990-92, a new brick hearth measuring 4'-1" wide and 2'-1" deep was laid.

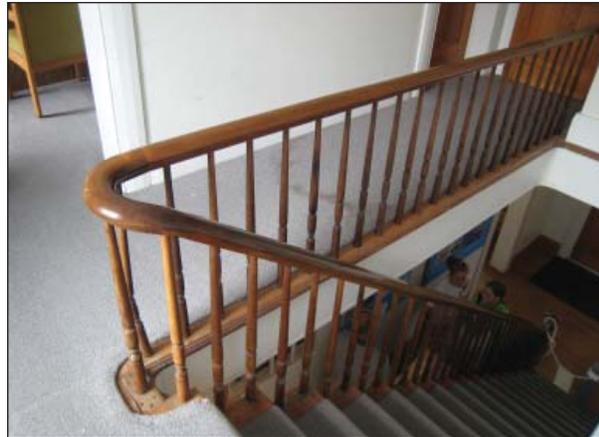
Figure 67, Staircase at second level.

The original 1872 staircase is partially intact at this level. A large section of the original handrail and

balusters were apparently lost when part of the hall was made a storage area post-1954 and pre-1989. The storage room was removed and the missing staircase elements reproduced for reconstruction of the hall during the 1990-92 campaign.

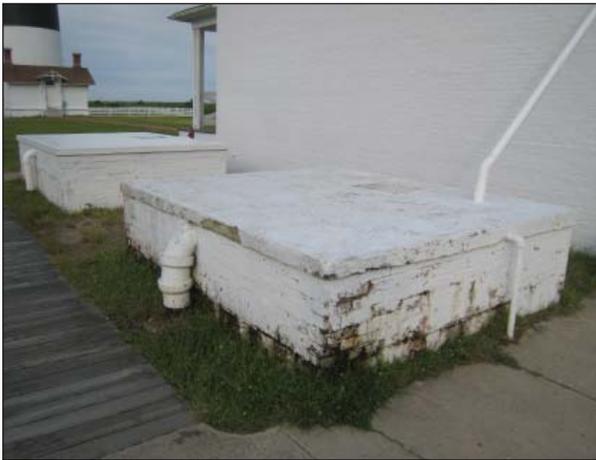
Figure 76, North side cisterns.

There are three cisterns, two on the north side of the house and one on the south. The design characteristics of all three are similar. Above grade, the brickwork for each cistern stands about 2'-3" tall with a 4 inch concrete slab as cap. Below grade, according to Perrot, the brickwork extends down an equal distance before reaching accumulated silt. Though visually obscured, it is assumed that the base is also of the same masonry construction.

The above-grade portion is rectilinear in plan for each cistern. The easternmost of the north cisterns measures 8'-2½" by 11'-3½"; the westernmost measures 8'-1½" by 9'-6". The cistern on the southeast corner of the Quarters measures 8'-2" by 9'-7". Cisterns of same approximate size at the northwest and southeast corners appear on the 1893 survey, suggesting these two are early if not original. The northeast cistern is documented as being constructed in 1900.

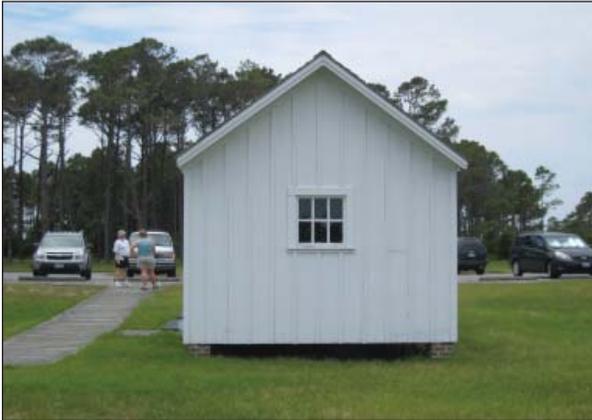
Figure 79, East elevation, 1920 Storage Shed.

The building is wood framed, covered on the exterior by what appears to be the original board-and-batten siding. The plank boards measure 1'-0" by ⅞". The square-edge battens measure 1" by 2".

In the 1990-92 repair campaign, the building was raised to a height of about 2'-0" above grade and placed on eight new brick piers each measuring 1'-0" by 1'-0".
