CAPE LOOKOUT NATIONAL SEASHORE
Cape Lookout Village
FISHING COTTAGE #2
**HISTORIC STRUCTURE
REPORT**

**Historical Architecture, Cultural Resources Division
Southeastern Regional Office
National Park Service**

2004
Historic Structure Report
Fishing Cottage #2
Cape Lookout National Seashore
Cape Lookout Village
LCS#: 091833

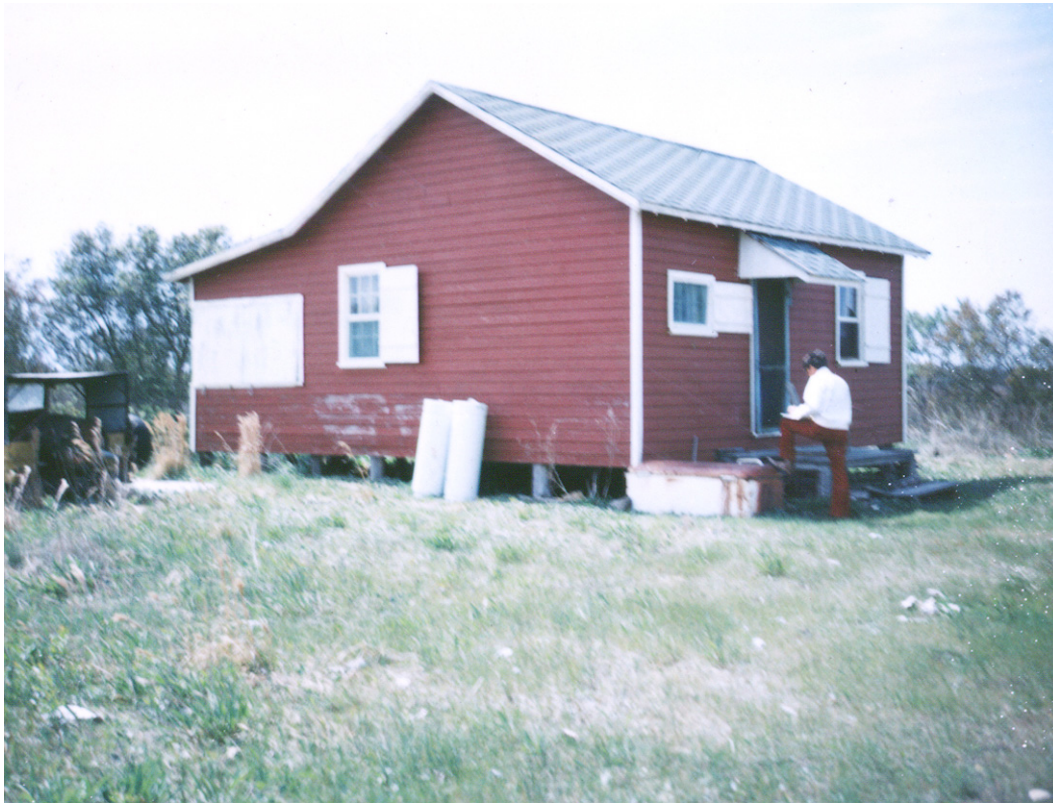
This building has undergone very few alterations since it was originally constructed, and nearly all of these appear to have occurred in the last twenty- five years. At some point, perhaps because of the growth of trees and shrubs on that side of the house in recent years, the steps to the porch were removed and the porch now functions as a utilitarian back porch to the house. At the southeast end of the porch, the wall has been altered and a ramp constructed so that all- terrain vehicles and other equipment can be stored on the porch. The house may have originally been painted red, its color in 1976, but has been painted white in recent years. The asphalt- composition roof covering has also been changed from bright blue shingles, which may have been original, to the present white roll- type roofing.

Figure 11 View west of house in 1976. (CALO Land files)

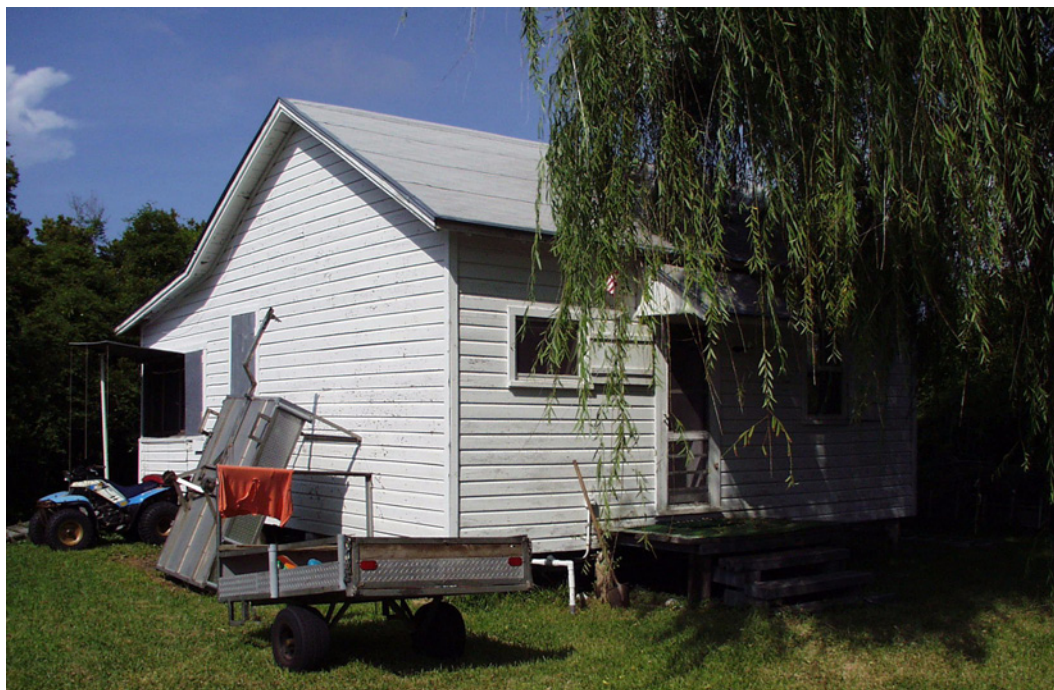
Built about 1950, Fishing Cottage #2 is a small, wood- framed, end- gabled structure located a few hundred yards northeast of the Coast Guard Station. The house is wood- framed with an end- ga- bled roof and a shed- roofed porch, continuing a vernacular tradi- tion embodied in the Gaskill- Guthrie House, the Bryant House, and others of the older “fish houses” in the village. The porch door is now closed and inaccessible, and the main entrance to the house is at the small, sheltered stoop on the opposite side of the house. The footprint of the building, including the porch, mea- sures about 22’- 4” by 26’- 2” and contains about 380 square feet of interior floor space plus about 165 square feet on the porch. Un- like most of the other private residences in the village, this house, though simple and utilitarian, is a sturdy, well- constructed build- ing. Materials are generally uniform and of standard dimensions typical of the mid- twentieth century. In general, it is in very good condition, although threatened by termite activity and a failing roof covering.

Figure 12 View west. (NPS-SERO-CRS, 2002)

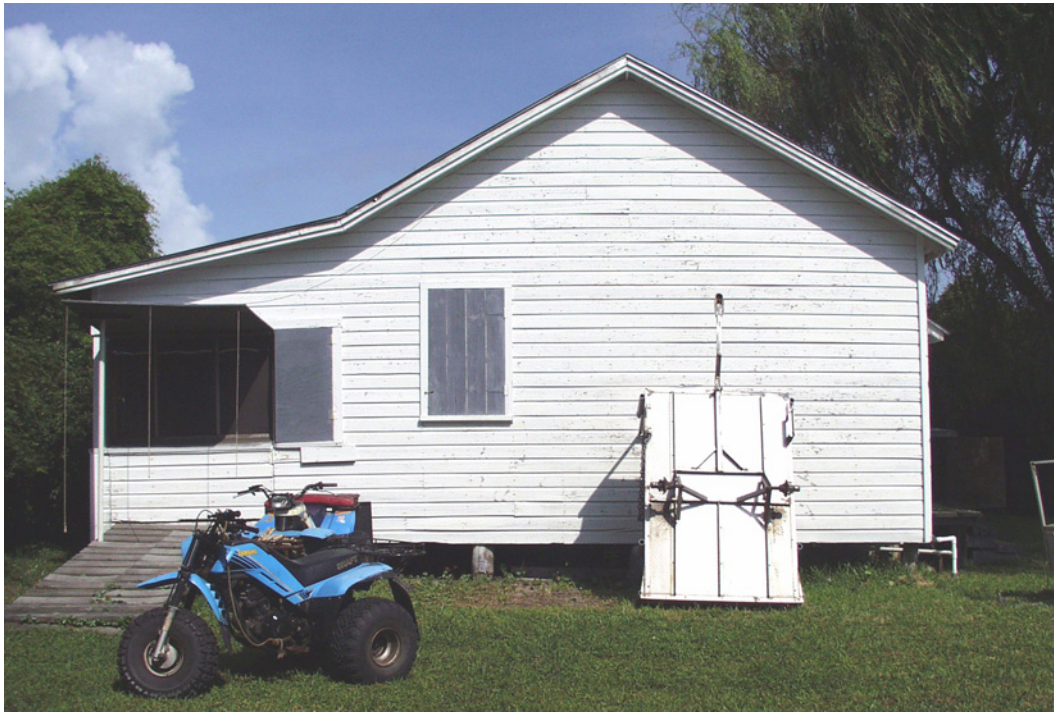
Figure 13 View northwest.
(NPS-SERO-CR, 2002)

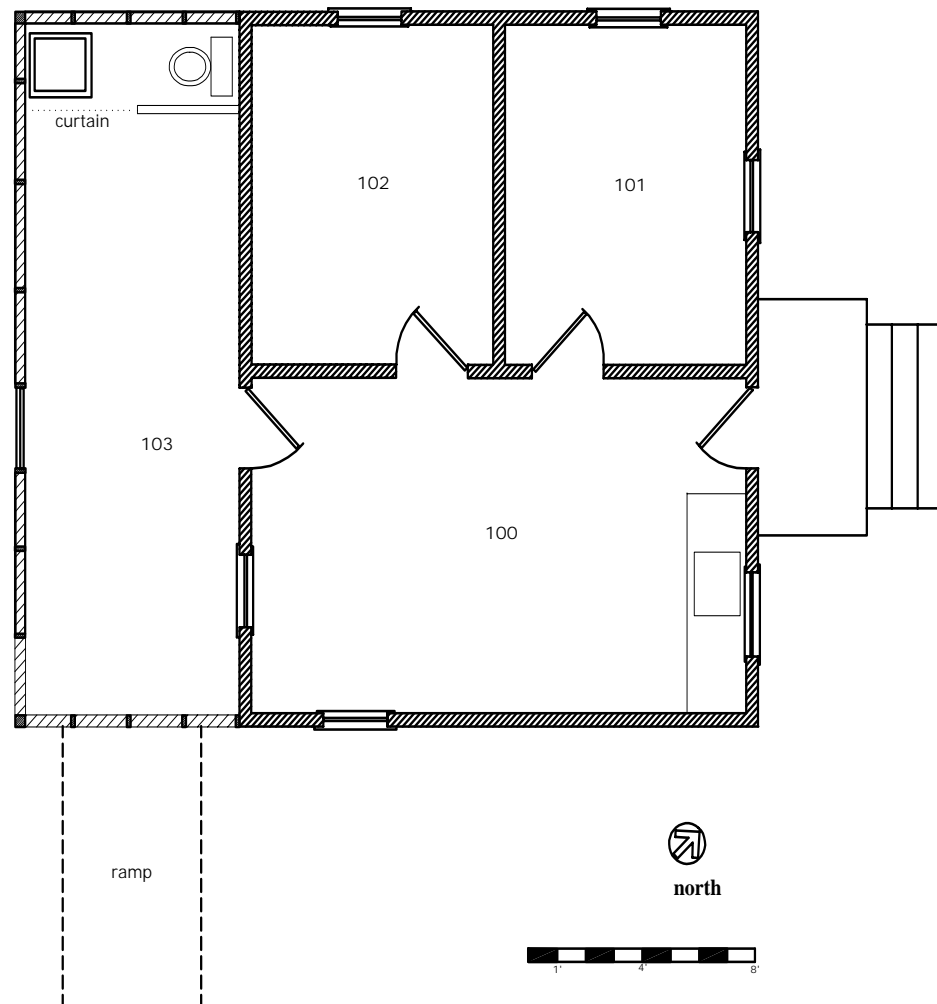
Figure 20 Plan of existing house. (NPS-SERO-CRS, 2002)

The northwest end of the porch has been partially enclosed in recent years to allow installation of a shower and toilet. At the southeast end, the knee wall has been cut and hinged to swing open and part of the wall above the screening has been removed to increase vertical clearance. These alterations are associated with the ramp that allows small vehicles to be stored on the porch.

- Reconstruct missing portions of southeast porch wall
- Remove plywood shutter at southeast end and replicate board- and- batten shutters to match original shutters elsewhere on the building
