Cape Lookout Village Lewis-Davis House Historic Structure Report

HISTORIC STRUCTURE REPORT

**Historical Architecture, Cultural Resources Division
Southeast Regional Office
National Park Service**

2004

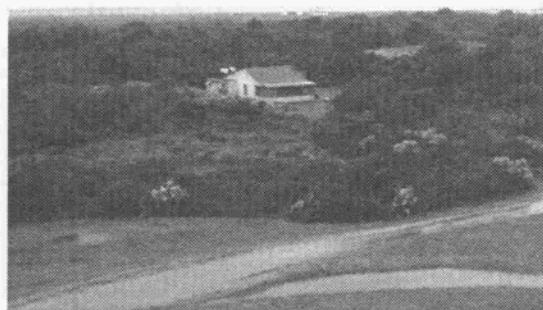
As elsewhere at Cape Lookout, there have been dramatic changes to the landscape in the last quarter of the twentieth century, particularly in the stands of trees and shrubs that now surround the site. A road that historically allowed pedestrian and vehicular traffic to bypass the Coast Guard Station runs on the south side of the house but is now little more than a foot-path.

Figure 19 View to northwest of Lewis-Davis house from lookout at Coast Guard Station (NPS-SERO-CR, 2002)

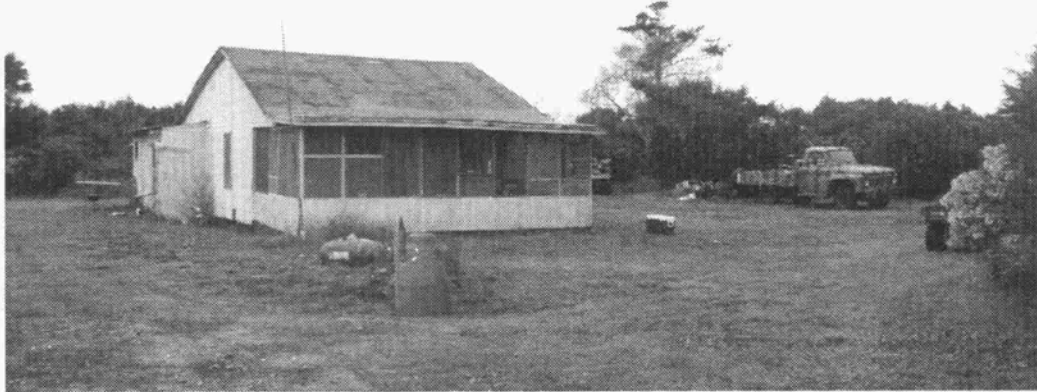
Figure 20 View to north of Carrie Davis House. (NPS-SERO-CR, 2002)

The structure has suffered major damage from termites and a leaking roof. Floors are collapsing in Rooms 101, 104 and 105, and there appears to have been major damage to the sills throughout the house. The roof, too, is in extremely poor condition, with large areas of rotten and termite-ridden rafters and decking. Although most of the historic finishes remain in place, the house as a whole is in very poor condition.

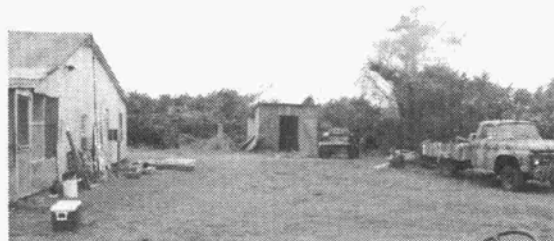
Figure 21 View to northwest, showing metal storage building in rear yard. (NPS-SERO-CR, 2002)

Like the Gaskill- Guthrie House, the house was built on a lot 50' by 220' that combined two of the original lots laid out by the Cape Lookout Development Company in 1915. In the rear yard is a modern metal storage building, 12'-3" by 15'-3". Partially-burned piles of refuse litter the grounds.

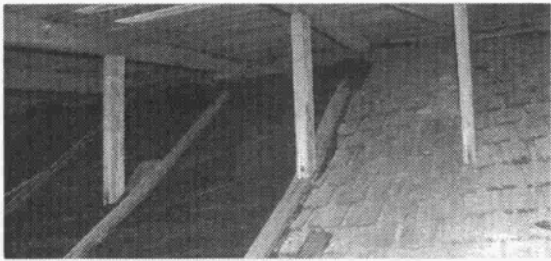
Figure 27 View of wood shingle roof on original structure encompassing Rooms 100 and 101. (NPS-SERO-CR, 2002)

The present roof also has a solid deck, mostly 1" by 6", except on the modern additions where plywood is used. The present roof covering is modern, asphalt, "hurricane" shingles that have been heavily patched with tar or other coatings. The roof covering is leaking badly, especially at the rear of Room 104 and near the center of the house.

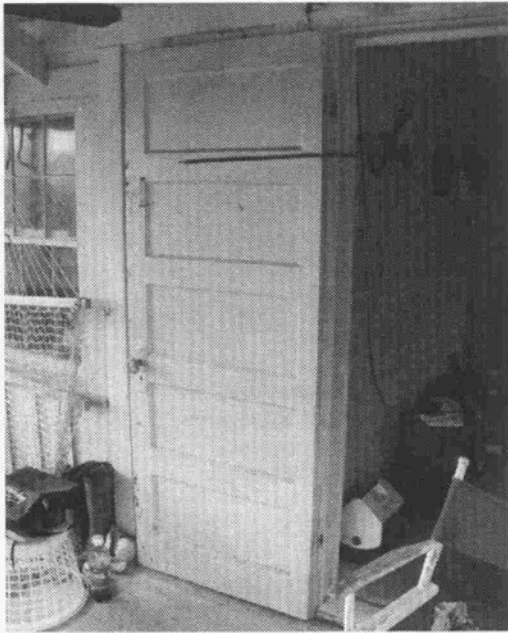
Figure 30 View of front door D-1. (NPS-SERO-CR, 2002)

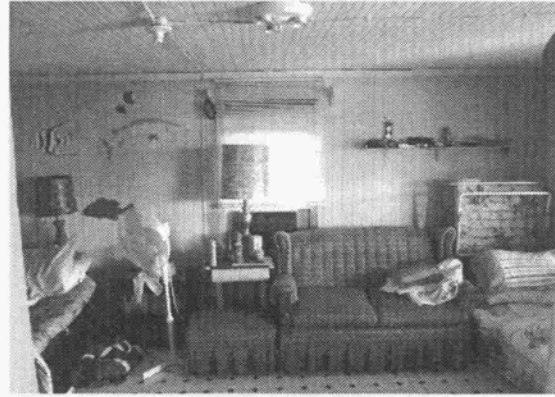
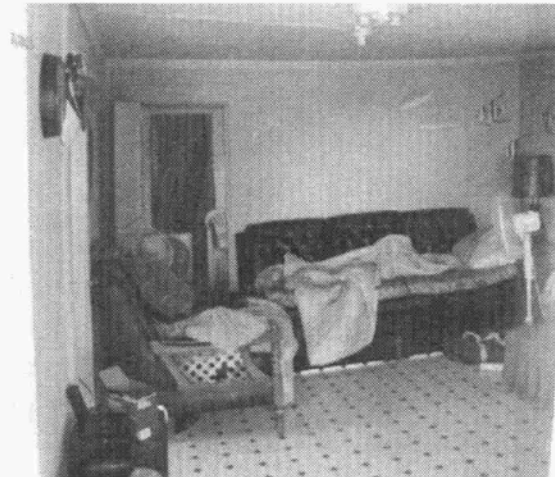
The front door opens into this room, which is about 11' by 15'-3". Most of its historic features remain intact and in good condition.

Figure 32 View to northeast in Room 100. (NPS-SERO-CR, 2002)

Figure 33 View to northwest in Room 100. (NPS-SERO-CR, 2002)

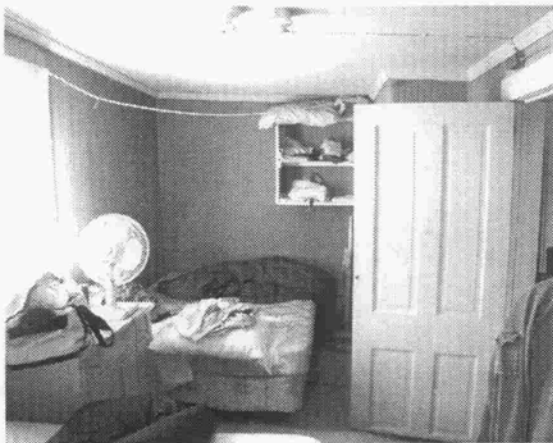
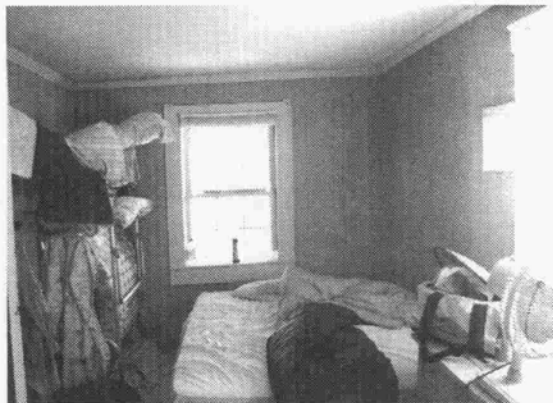
Figure 34 View to west in Room 101. (NPS-SERO-CR, 2002)

Figure 35 View to southeast in Room 101. (NPS-SERO-CR, 2002)

The floor is in dangerous condition and appears to be collapsing due to major deterioration of floor joists and/or piers under this part of the house.

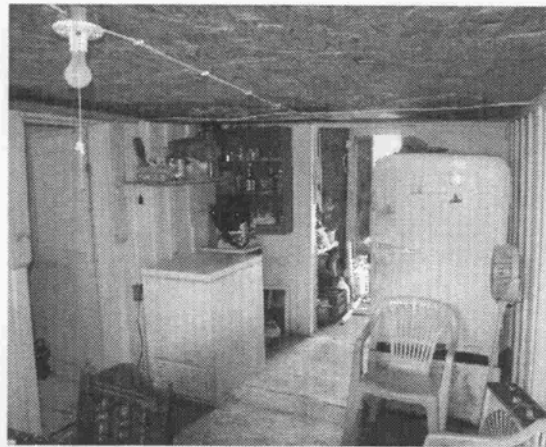
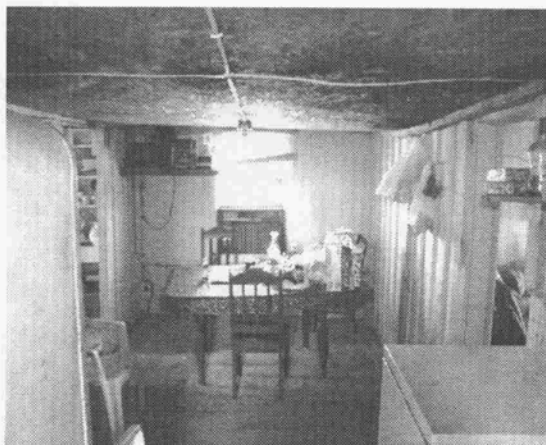
This room measures 8'-2" by about 15'. All of the rooms in the house except Room 101 open to this room. Major damage is ongoing where the roof is leaking along the wall adjoining Room 100.

Ceiling: The ceiling is set at about 7' and covered by sheets of wafer board. Original tongue- and-groove boards, 3-1/2" wide, probably V-joint, remain in place beneath the wafer board, but many are probably damaged or deteriorating due to water penetration. The ceiling has been braced along the middle of the

Figure 36 View to south in Room 102. (NPS-SERO-CR, 2002)

Figure 37 View to northeast in Room 102. (NPS-SERO-CR, 2002)

the east wall because water-damaged joists are collapsing in that area.

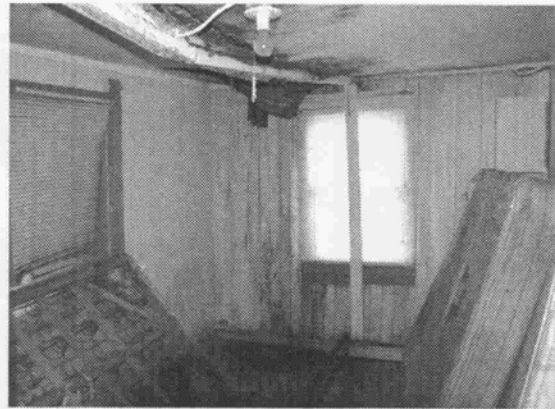
Ceilings: Like the walls, the ceilings appear to be very loosely framed, using widely-spaced 2" by 4" joists or, in some cases, 2" by 6" laid flat. The ceiling above Room 104 has been heavily damaged by water penetration and termites.

Measuring 8'-4" by 11'-6", this room is in extremely poor condition.

Floors: The floor is carpeted over plywood, although there appears to be an underlying layer of historic tongue- and- groove material. Water penetration and termites have destroyed the connection between the joists and the rear sill, allowing the entire floor to collapse at that end of the room.

Ceiling: The ceiling, like the floor, is on the verge of total collapse due to severe termite and water damage. It was originally finished with double- V- joint, tongue- and- groove boards, 3-1/2" wide.

Figure 40 View to west in Room 104. (NPS-SERO-CR, 2002)

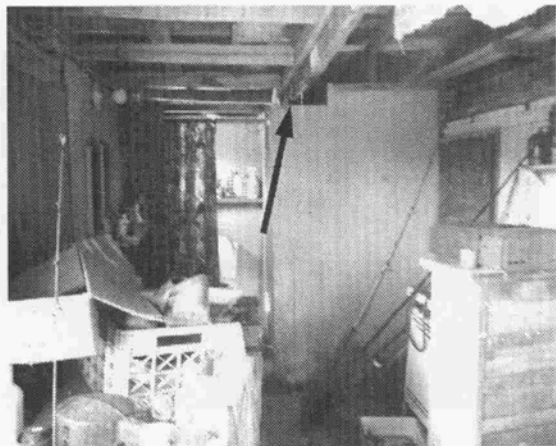
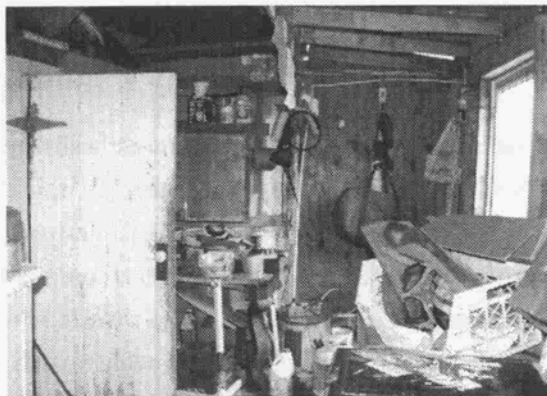
Figure 42 View northwest in Room 105. Arrow marks header at outside of historic porch. (NPS-SERO-CR, 2002)

Figure 43 View to southeast in Room 105. (NPS-SERO-CR, 2002)

Floor: The floor is modern plywood and is suffering from severe water damage near the entrance to the bathroom area.
