Cane River Creole National Historical Park
Oakland Plantation
The Cottage
Historic Structure Report

Historic Structure Report

Cottage

Cane River Creole National Historical Park

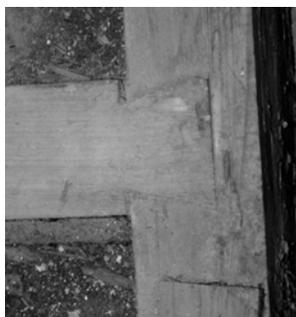
The structural system is wood frame on masonry piers, the remaining early brick masonry piers, and recent- vintage pyramidal precast concrete piers. The characteristics of the structural system, materials, framing and connections, are distinctly different in each identified addition or modification.

The likely oldest identified part of the house is timber frame using hand-hewn structural members and

pegged mortise- and- tenon and dovetail joints. This structural assembly appears to coincide with the areas of *bousillage* found in the walls of the older part of the building. The floor plans produced by Hartrampf, Inc. and the Office of Jack Pyburn, Architect for the Conditions Assessment Report for this structure indicate sizes of structural members in the floor, ceiling and roof systems. The members in the walls were not exposed during the investigation for this report.

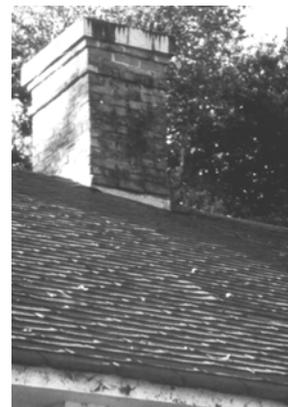
Evidence in the attic indicates that the building at one time had a hipp roof, probably covered with wood shingles. The wood nailing strips to support wood roofing remain under the existing plywood decking. In the 19th century, the roof configuration was changed to a gable end roof covered first in wood shingles, then with corrugated metal over the older, south part of the house. A V- groove (12" on center) galvanized metal roof probably

was original to the north addition. Asphalt shingles were installed as a part of the 1957 renovations. The existing roof was installed more recently. The existing roofing tabs have an exposure of approximately 7" with an approximately 12" wide tab.

The slope on the largest portion of the roof is 7 1/2" per foot on the front and the rear. The existing 7 1/2"/foot pitch appears to be the earlier pitch of the front and back slope of the Creole cottage. A change in the roof slope to 5"/foot occurs at the rear southwest bedroom (106). The south bathroom (108) addition has a shed- type roof sloping down to the south at a pitch of 5- 3/8" per foot.

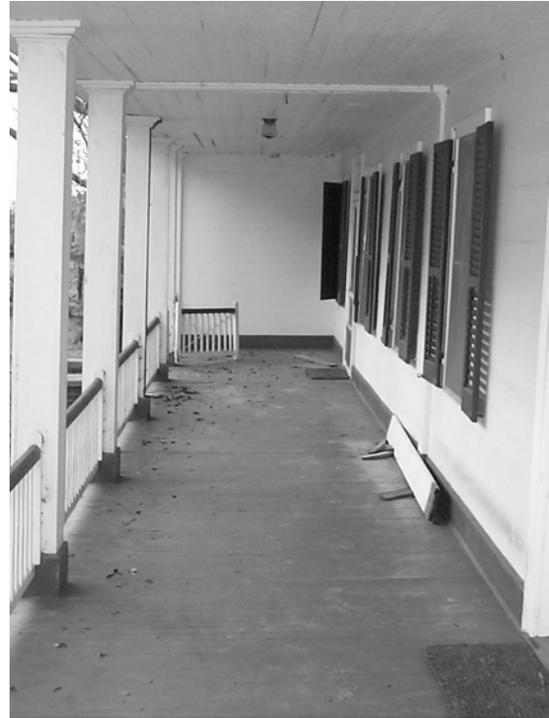
The current front gallery consists of two parts: the earliest section and an addition on the north; the division is noted by the occurrence of a ceiling beam dividing the two sections and a change in the size of the ceiling boards. Additionally, the earlier section of the porch is framed on 6" x 8" beams and 3" x 8" joists. The addition is framed on 6" x 6" beams and 3" x 8" joists.

The gallery is supported by seven 8" x 9" columns with two- part molding trim at the top, creating capitals, and simple 1x plinth trim at the bottom. Investigation reveals earlier columns encased within these square columns on the main section of the gallery. The original columns are of sawn wood with chamfered edges and a square base. Notches in these earlier columns indicate the previous existence of two horizontal rails, presumably wood, that probably comprised the front porch railing.

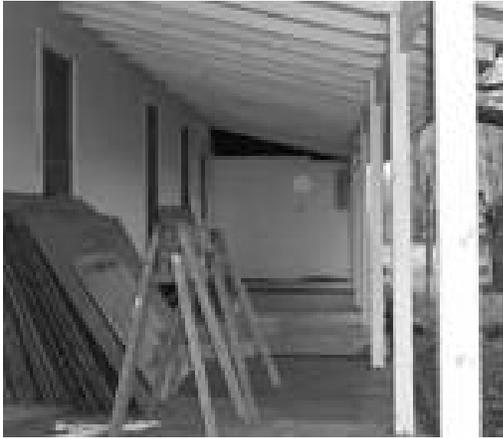
Oral history places the construction of the rear gallery as part of the 1957 renovation. The gallery is framed on 4" x 4" beams and a mix of joists measurements: 2" x 4", 3" x 4", 4" x 4", 2" x 5", 5" x 4", 4" x 5". The variety of sizes of framing material suggest that the gallery was constructed of at least some material salvaged from elsewhere rather than

new, standard- dimensioned wood. The gallery roof is supported by six 3" x 4" posts. The ceiling of the gallery is the exposed underside of the butt jointed roof decking above. The flooring is tongue- and- groove planks measuring 4 1/4". The National Park Service repaired the gallery floor and ceiling framing and roof in 1999/2000.

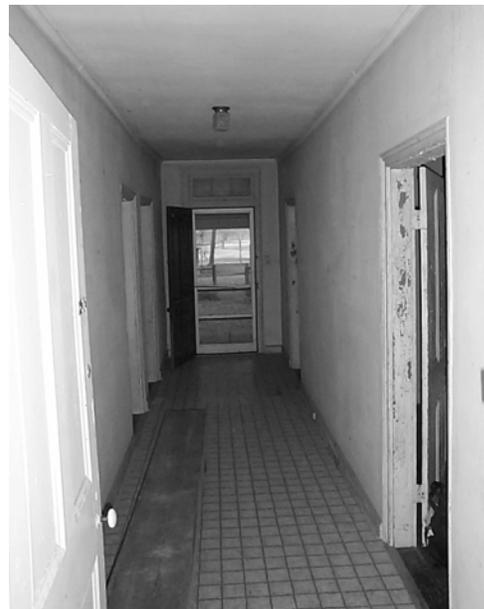
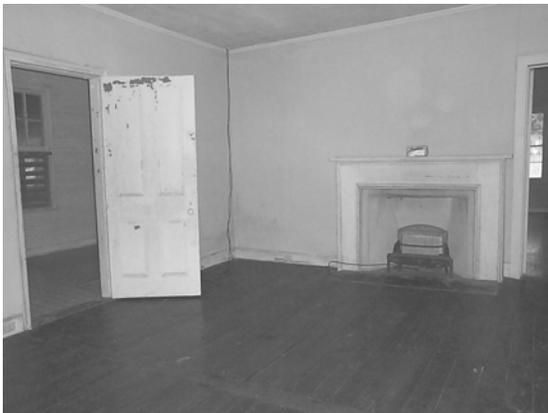
Hall (101)

Floors: The hall flooring consists of creamed colored and square patterned sheet vinyl, likely installed in 1954. This flooring is laid over a plywood or particleboard sub-floor. Examination of the hall flooring from under the house indicates that plank flooring remains at the lowest strata of flooring in the hall. The interior threshold conditions reveal the relationship of the plywood layer in relation to the earlier and, possibly, original layer of flooring.

Walls: Testing confirms that both hallway walls are of *bousillage* construction. Walls are finished with gypsum wallboard (1957 vintage) that has been painted off-white. In this room, the gypsum wall board is attached to an earlier wood plank wallboard. The characteristics of the underlying wood wallboard are not known as it was not exposed and invasion into the wall assembly was limited to a 1" coring in a few selected areas. The wood siding was approximately 3/4" in thickness. Two of the doors entering into the bedrooms (106), (109) are the same in size and style. The opening into the kitchen is the same dimension as the two bedroom door openings. The openings for the front, rear, and into the living room (102) possess similar characteristics. (See Finish Schedule).

Ceiling: The ceiling is 9'-2" high and is finished with gypsum wallboard painted white over an earlier wood ceiling above. From observations in the attic, the earlier ceiling finish was 11"-12" wide boards running in a north-south direction, the short dimension of the hall.

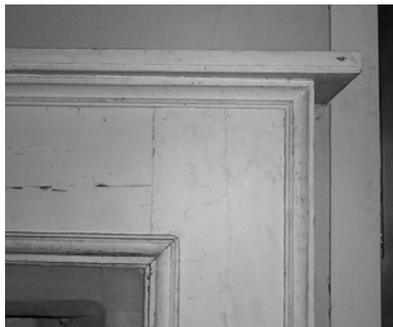
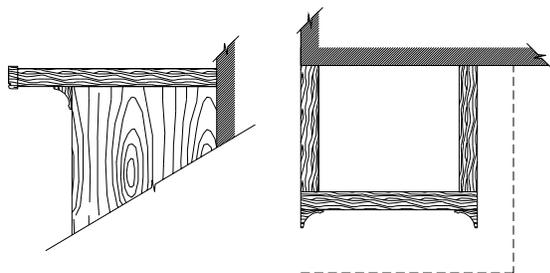
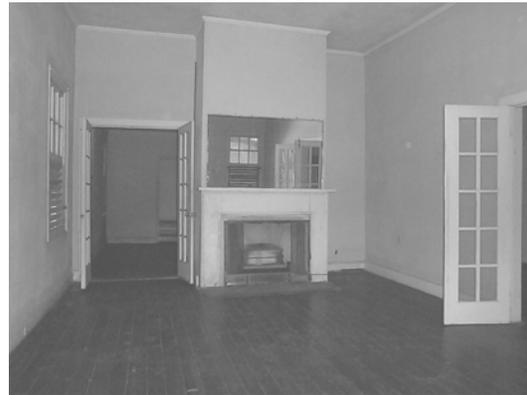
Photo detail, section through living room mantel, and plan view at surround

flooring running in a north/south direction, 4" to 5 1/2" wide with a reddish stain finish similar to that found in room 102. The flooring is in good condition.

Walls: The walls have been covered with 1/2" gypsum wallboard. The walls in this room are painted a light green. The ceiling measures 10' - 10" in height. The west wall of this room, common with Room 104, was added in the 1957 phase of improvements. It appears to be a conventional wood- frame construction in a modern stick- built manner. This room has two interior door openings consisting of a pair of French doors leading into the living room (102) and another to the dining room (104) and one four- paneled exterior door (D4) connecting the room to the front gallery. Two window openings are located on the north side of the room and two flanking the exterior door on the east side. All windows but one have temporary louvered ventilation installed by the NPS.

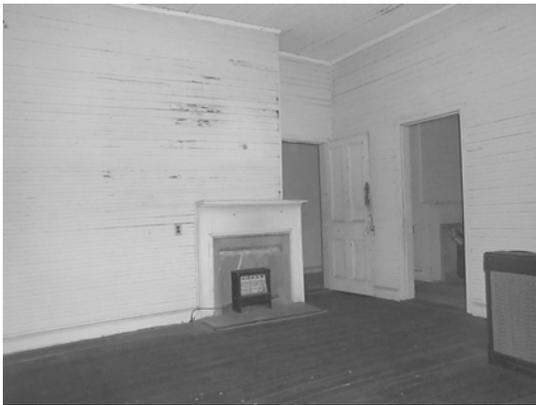
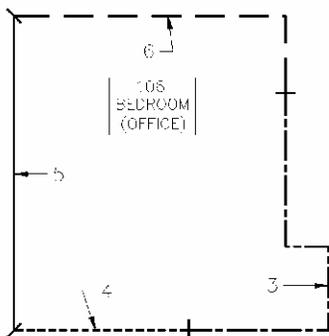
Floors: The floorboards are wood and measure 3- 3/8" wide installed in east/west direction. The floorboards are rough in condition and unfinished. It is understood that this room was carpeted when the National Park Service acquired the property. Doris Brett Vincent stated that the rooms of the house were not carpeted when she was living there (pre- 1960).¹⁸²

Walls: The walls are 3" tongue- and- groove bead board paneling painted white and running in a north- south direction. The bead board in this room is common to the rooms on the south end of the building and varies by 1/4" from that found in the kitchen. There are three door openings in the room: one leading

pair of 6/6 double- hung windows. A "ghost" of a window can be discerned on the south wall, now paneled in bead board to match the rest of the room. This may indicate that the bead board was installed before the bathroom was built.

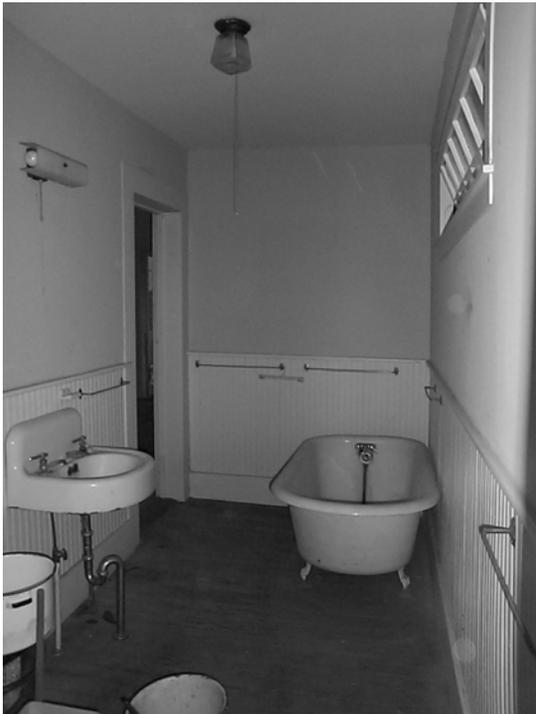
plumbing fixtures include a white, floor- mounted tank type toilet, a wall- mounted, enameled cast- iron lavatory, and a white enameled cast- iron tub with claw feet. There is also a gas space heater located in this room.

Restroom (Room 108): It is strongly recommended that the bathroom be retained in its historic character and used as a unisex toilet for staff. It will be difficult to keep the toilet and sink functional while retaining the historic character of this room and also have the restroom be ADA accessible. Therefore, an alternative approach to accessible restrooms for handicapped staff and visitors must be considered if the preservation and use functions conflict with the ADA requirements. However, if the National Park Service determines that it absolutely must make the space ADA accessible, see the Ultimate Treatment section for recommendations.

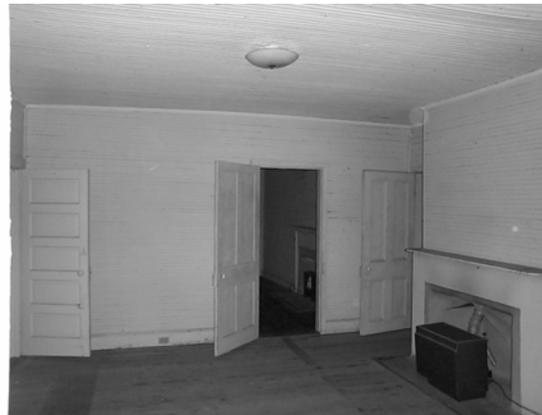
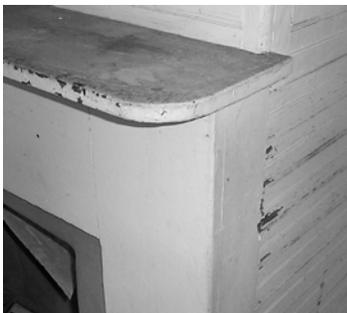
Bedroom (109)

s different from other rooms in the cottage. While the entire floor consists of unfinished worn floorboards, there is an unusual arrangement of the floorboards. On the north side of the room, north of an east- west line 5'-9" from the north wall are 6" +- floorboards running north/south. In an area around the fireplace and still north of the east west line 5'-9" off of the north wall, floorboards measuring between 11" and 13½" wide are installed in front of the hearth. Approximately centered on door D12 and running from the threshold of that door eastward is a single floorboard measuring 4½"x 3'-3" wide set in the otherwise north- south running flooring. In the same east- west alignment as the oddly oriented floorboard at door D12 but on the east side of the room is another board 4½"x 5' from the east wall. South of the above-defined east west line 5'-9" from the north wall are floorboards of 4"+_ and running north/south. Currently, no explanation has been found for the piecemeal arrangement of these floorboards. However, it is possible that the floor around the fireplace was damaged, either from fire or wear, and replaced.
