HISTORIC STRUCTURE REPORT

Wright Hall

Carillon Historical Park

March 30, 2006
Final Submission

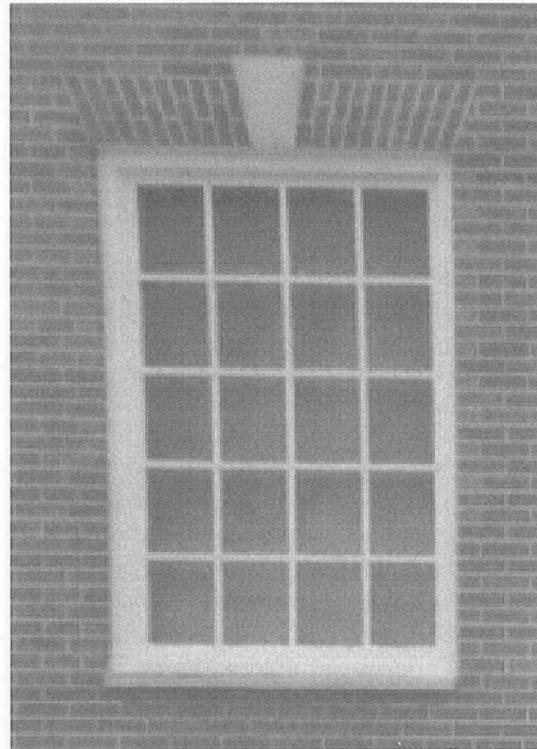
Figure 26: Window arch, typical

wood-framed transom. The entire door unit is capped by a wood trim pediment flashed at the top with copper, regleted into the face brick. Each window has a flat arch with a limestone key (figure 26). The fifth window on the elevation is a round steel window centered in the wood pediment over the main entry.

Each window on the flat walls has a brick flat arch and limestone key, and matches the north elevation windows in type and style. The keys on this elevation show more weathering and wear than those at the north elevation.

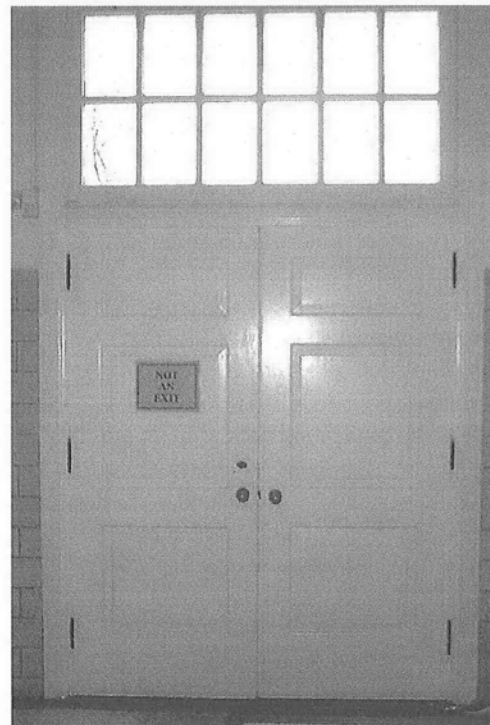
Figure 31: Interior of entry door.

Doors: The main entry doors are solid wood rail and stile doors with three raised panels set into each (figure 31). The wood casing and trim appear to be in good condition with minor water damage at the lower left corner of the frame. The wood panels are in good condition. The handset, escutcheon plate and hinges appear to be original to the door. The thumb turnlock appears to have been modified, as there is some

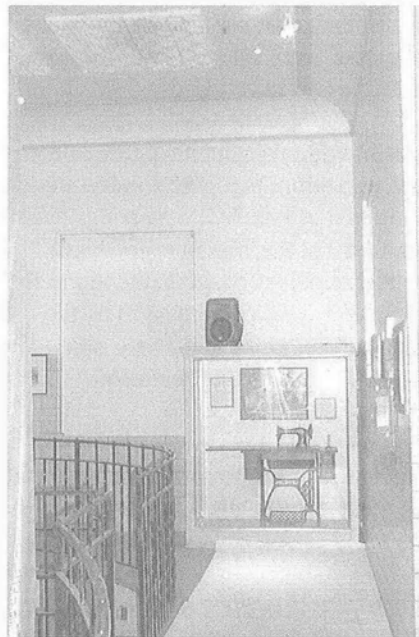
Figure 33: East interior elevation.

Doors: The new passage opening is a hollow metal frame with a wood trim profile different than the trim profiles utilized in the building. There is the appearance of a transom panel above the door that indicates the original height of the window. This opening is not trimmed out and is painted to match the wall color.

Plaster: The flat plaster appears to be in good condition without cracking. All surfaces have a painted finish. The finishes on the plaster are further outlined in the decorative finish analysis section. The plaster wall has some penetrations from the wood mounting rail.

The recommendation is to maintain the east and west wing openings as doors and to modify the trim. In doing so, the trim should be simplified so that it is flat with a radius profile. The faux transom also should be trimmed out and the new opening replicated.

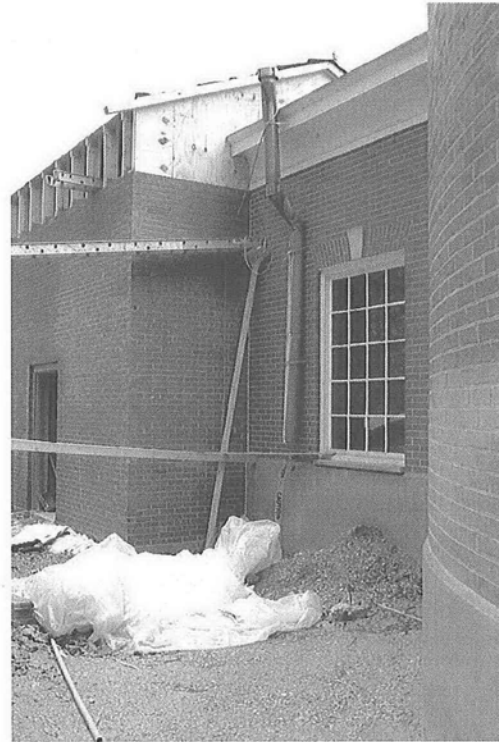
Figure 34: Connector building

General description: The west interior elevation includes the new entry to the corridor connecting to the new wing (figure 34). The brick and plaster are the same height and edge detail as the north elevation. The exposed tile requires some minor pointing under the windows. The display cases in the corners of the wall are immovable and the tile was not surveyed behind them.

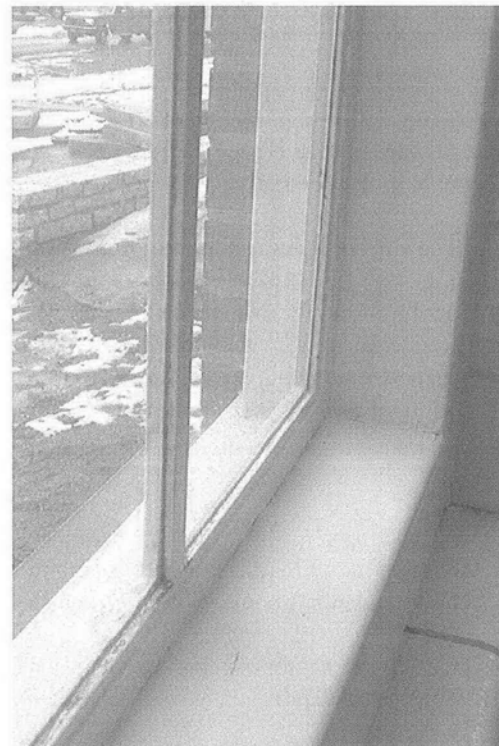
Figure 35: Steel window.

Windows: The two steel windows north of the new entrance are in good condition (figure 35). The condition of the windows is consistent with the north elevation, in terms of heat loss and deterioration of painted surfaces.

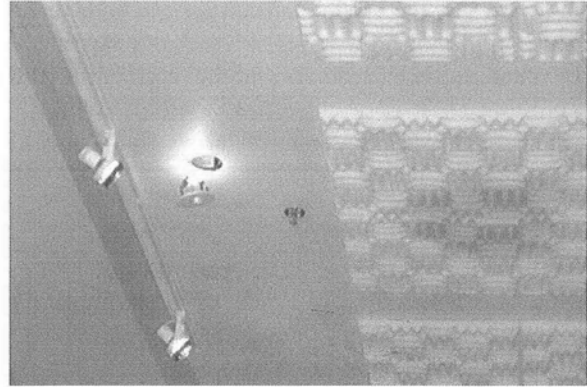
Figure 37: Ceiling and track lighting

Lighting: The current lighting is not original to the main space as seen from historic photographs (figure 22). The openings from the original ceiling fixtures remain and are evident from dust collection in the acoustical panels mounted over the openings. The current lighting of the hall central space, apsidal end and portico is covered in detail in the lighting analysis later in this section (figure 37).

The existing structure has been modified with the removal of the original lights and the insertion of acoustic pads. The current lighting system, which is a few years in age, consists of Halo (or equal) MR16 downlights and PAR30S trackheads (also Halo or equal). The trackheads are fitted with black egg crate louvers. (Refer to figure 37).

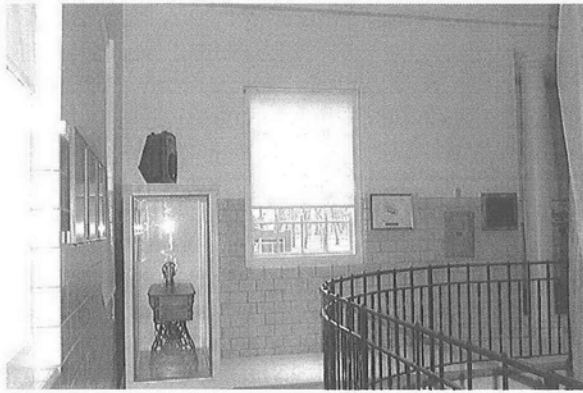
Figure 38: Interior corner showing railing

Railing: Visitors are protected from the three-foot drop to the lower floor where the Wright Flyer III is located by a transparent but strong railing. It is likely that the simple details and use of strong materials was intentional to allow optimal viewing of the Wright Flyer III without visual competition (figure 38). The railing is grounded in the terrazzo floor. There is some minor cracking at these locations.

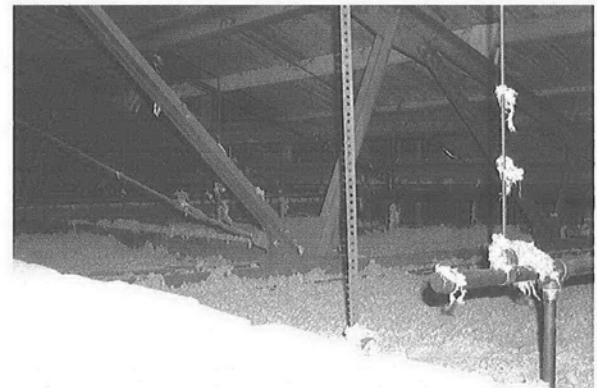
Figure 39: Attic

It appears that the attic was built as indicated in the drawings. The primary modification is the introduction of a blown cellulose insulation material (figure 39). The space is not heated and a draft is noticeable. An improvised drainage system made of a garden hose and visqueen can be seen under the cupola. It does not appear that much water drains through this system.

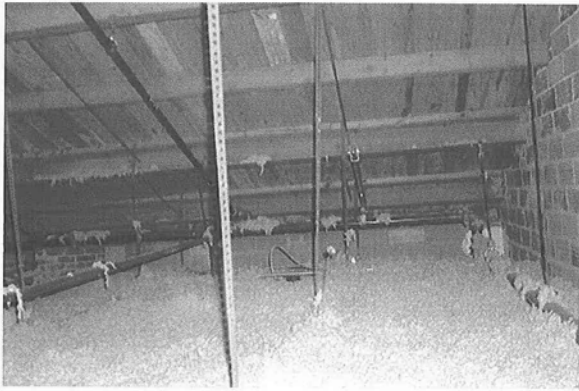
Figure 40: Wooden substructure in attic

Roof: The wood substructure and the wood and steel framing are all clearly visible and appear to be in generally good condition (figure 40). The only location where previous water infiltration is evident is at the framing between the flat and pitched roofs at the rear of the building. This is consistent with information obtained from photographs and the plaster condition below.

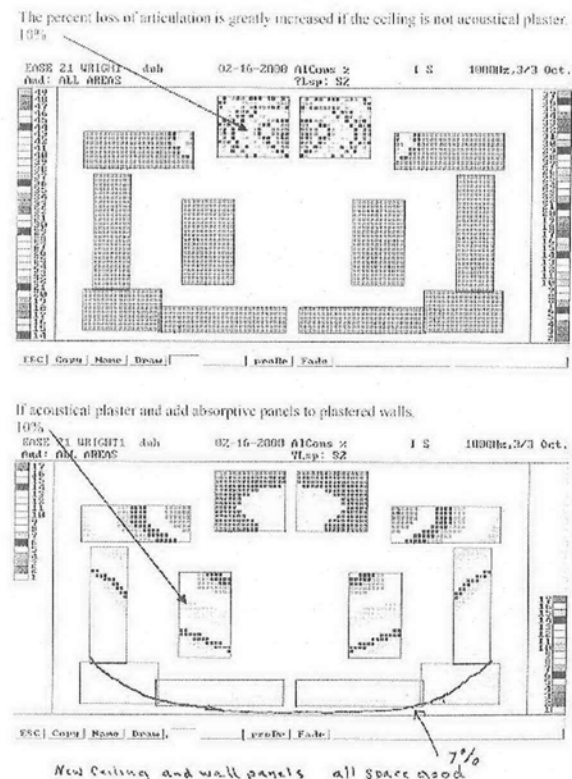
Figure 41: Acoustical reverberation information.

be controlled. Most acoustical plasters of this period were made of lime plaster mixed with a high percentage of asbestos fibers, the same fibers as were used for thermal insulation (although asbestos was not found in the Wright Hall ceiling). Originally, the ceiling in Wright Hall would have had a reverberation time of about 1.5 to 2 seconds, and one could communicate with an elevated voice level across the 30 feet of the flyer display (figure 41).

absorbed. The effect would have been very noticeable, the reverberation time at mid frequencies may have been as high as 5 seconds and speech intelligibility could have been reduced by 25 to 30%. At some time within the last ten years, a plastic foam Somex was applied to the ceiling surface to restore the middle and high frequency sound absorption that had been lost over the years by the repainting of the ceiling. The reverberation time in the hall at this time is about the same as it was in the newly opened hall in 1950. However, a new heating system has added a high level of noise at about 51 dBA to the hall and non-amplified speech is non-intelligible at a distance greater than 15 feet.

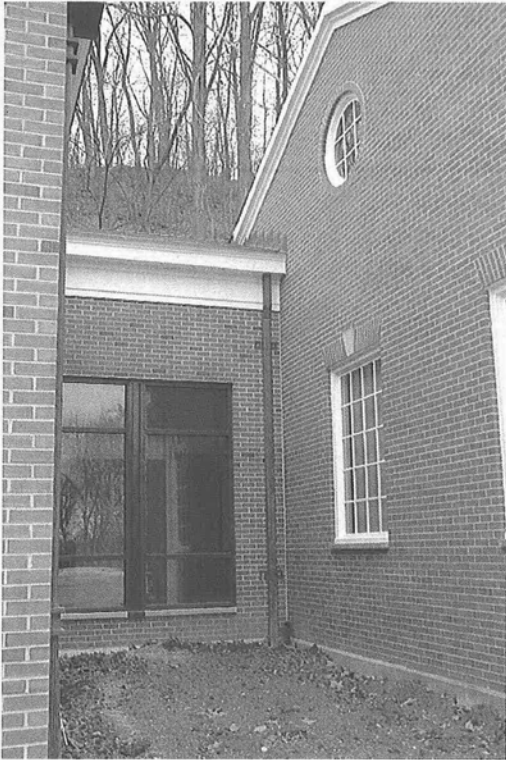
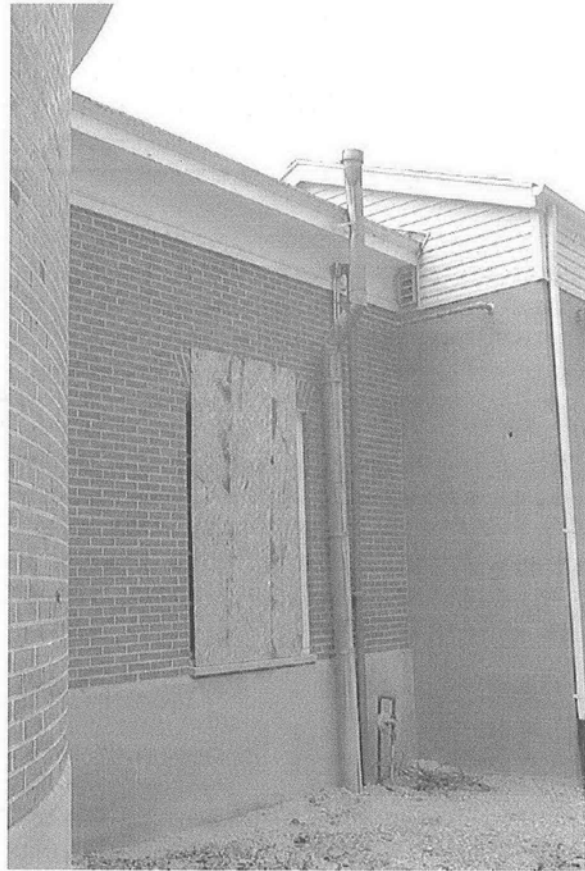
Figure 42: Connector Building

The connectors from the wing additions do and will continue to house the new mechanical units for Wright Hall. In general, there is good separation between the structures to prevent transference of vibration. (figures 42 and 43). The only exception to this is the block wall that separates the mechanical area from the corridor. The wall directly abuts the exterior brick of the Hall. The passage to the new

Figure 43: Connector Building

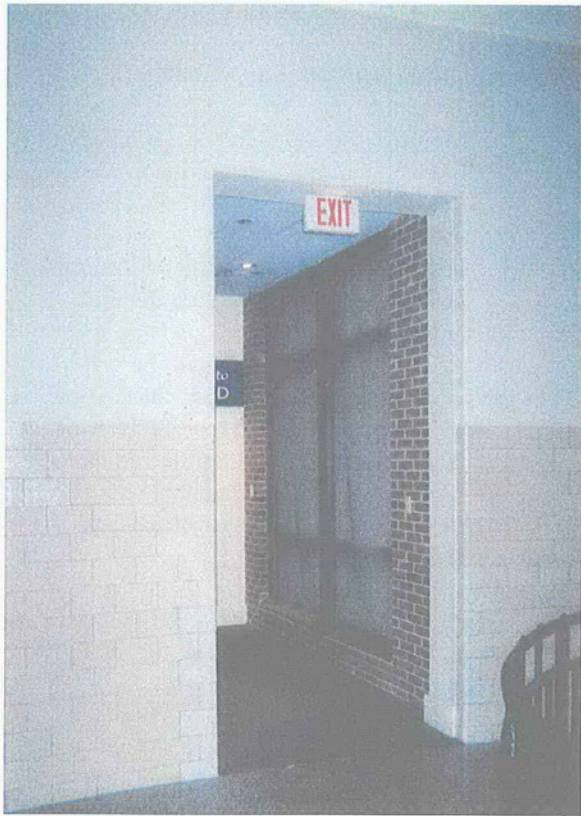
Figure 48: Actual opening installation (QE|A 2005)

Post-construction inspection revealed that treatment alternative 2 was implemented very successfully (figure 48)

The recommendation is to maintain the east and west wing openings as doors and to modify the trim. In doing so, the trim should be simplified so that it is flat with a radius profile. The faux transom also should be trimmed out and the new opening replicated (figure 47).

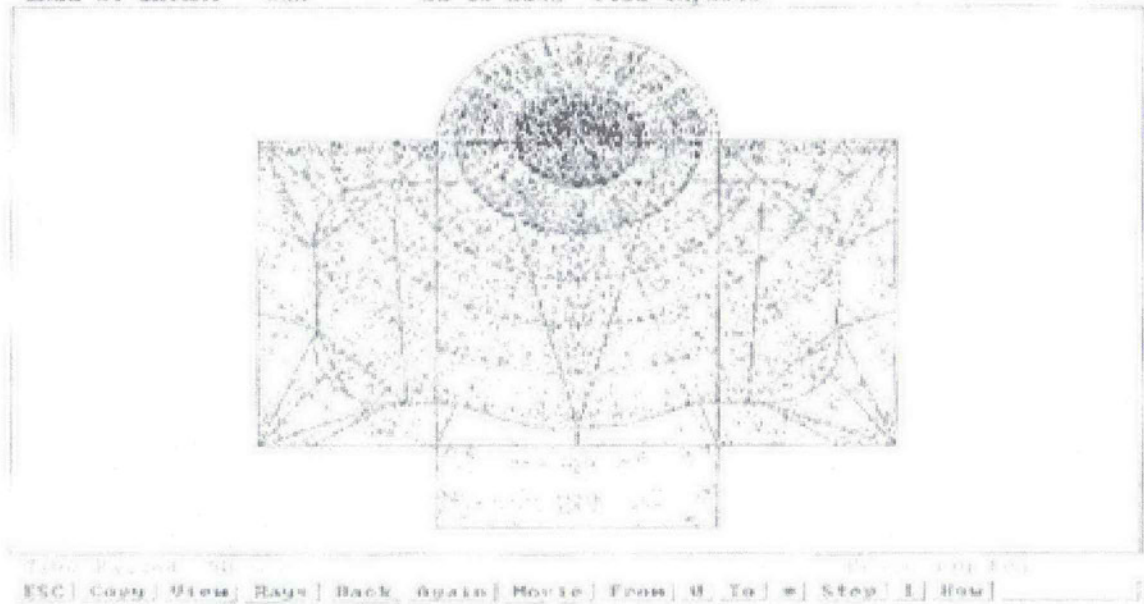
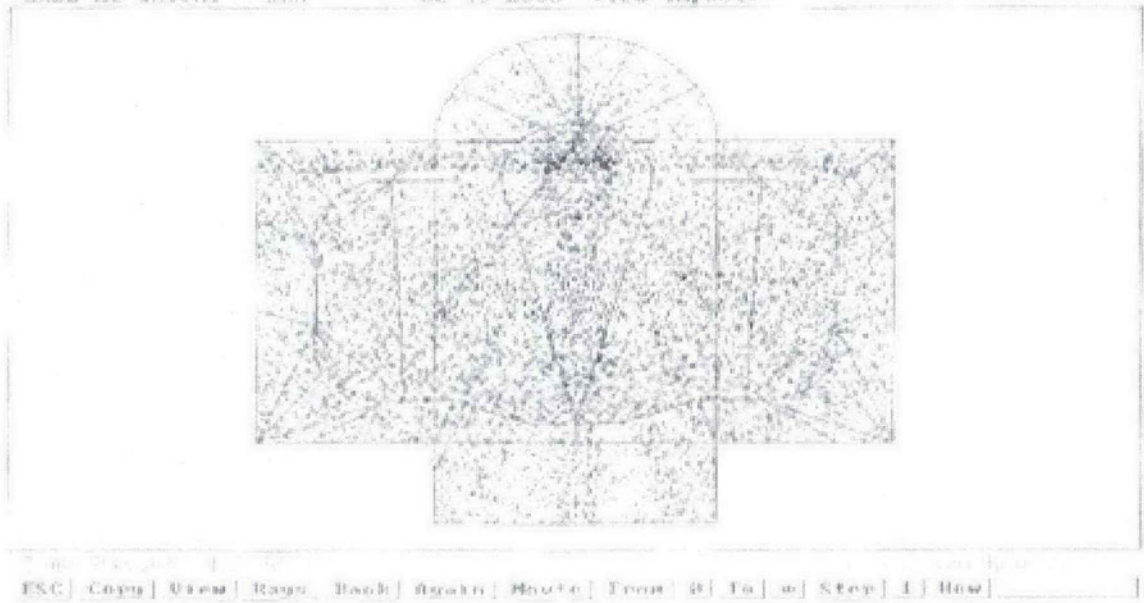
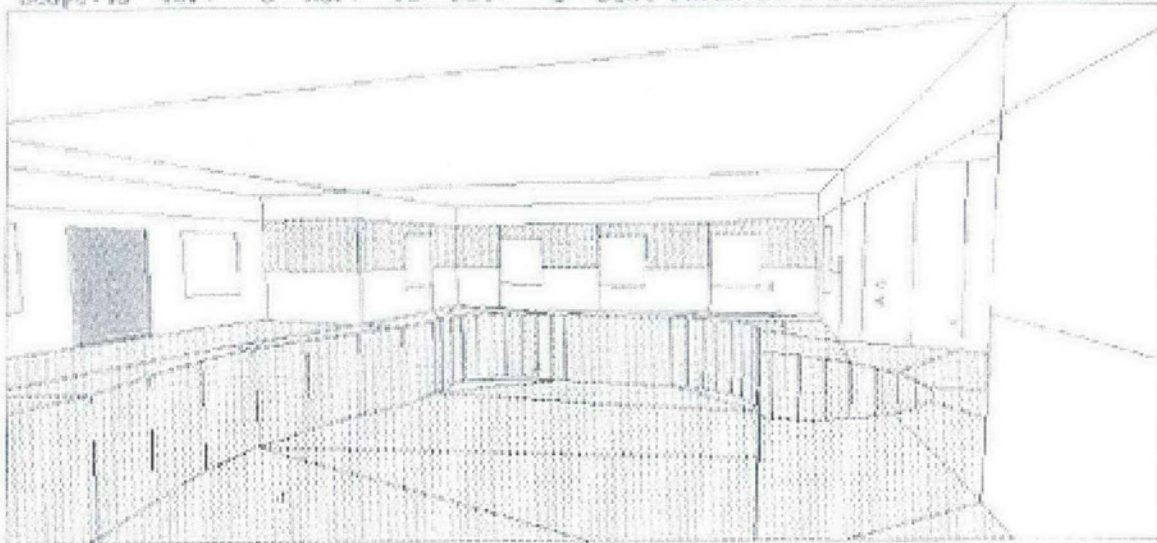
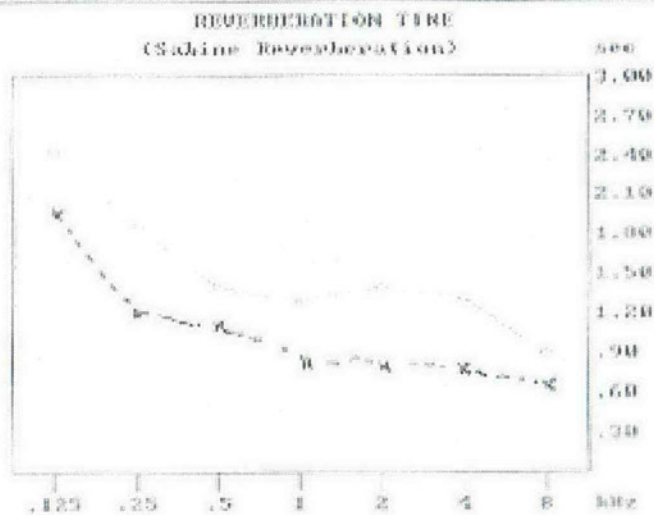
Figure 49: Acoustical Review of direct and reflected speech. (Geiger & Hamme, 2000)

First 50 milliseconds of speech from speaker (Direct sound and early reflections)
EASE 21 WRIGHT.dvb 02-16-2000 View Impacts

Diffused reflected speech after 50 milliseconds (no good for high articulation)
EASE 21 WRIGHT.dvb 02-16-2000 View Impacts

The acoustic recommendations are made primarily with regard to improved voice acuity in the existing line space comprised of hard surfaces. This would require the addition of treatment to the walls and ceiling. The existing ceiling panels in the plenum space can be used. Wall detailing is also critical in terms of acoustic concerns. The material type, edge detail and configuration need to be sympathetic to the existing window details. These solutions respect the significance of the monolithic appearance of the wall plane. A scheduling of the wall treatments is recommended.

Modified hall with wall panels. (596 sq.ft. of 2"-thick glassfiber wall panels)

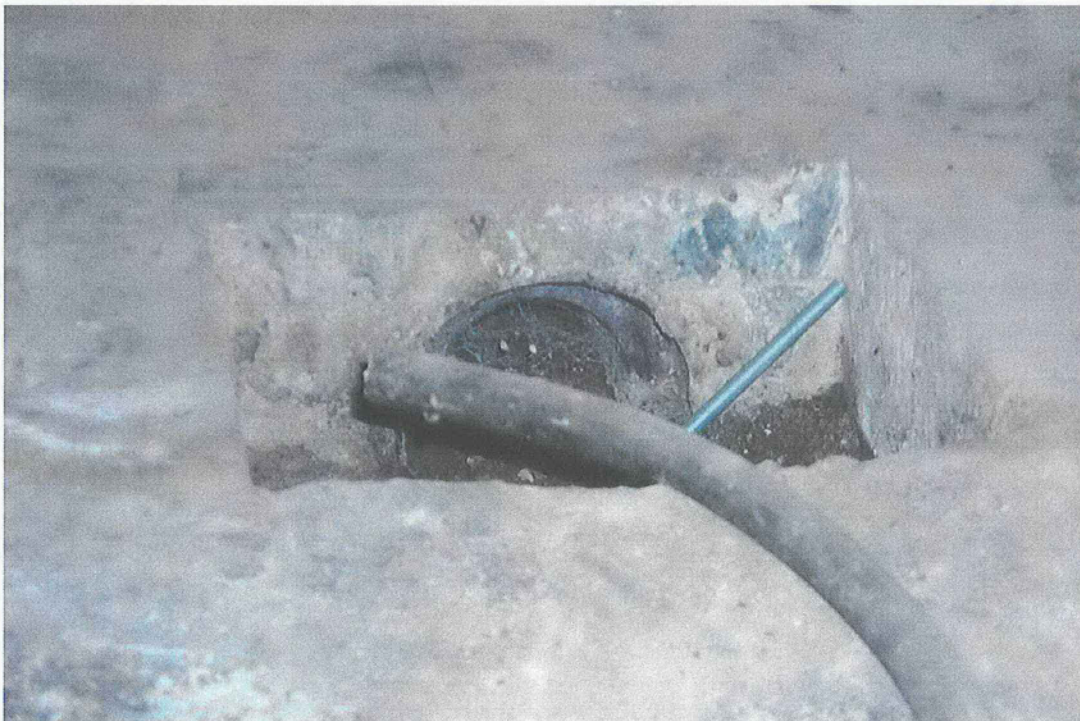
Wright Hall south plenum, drain (QE\A 2000)

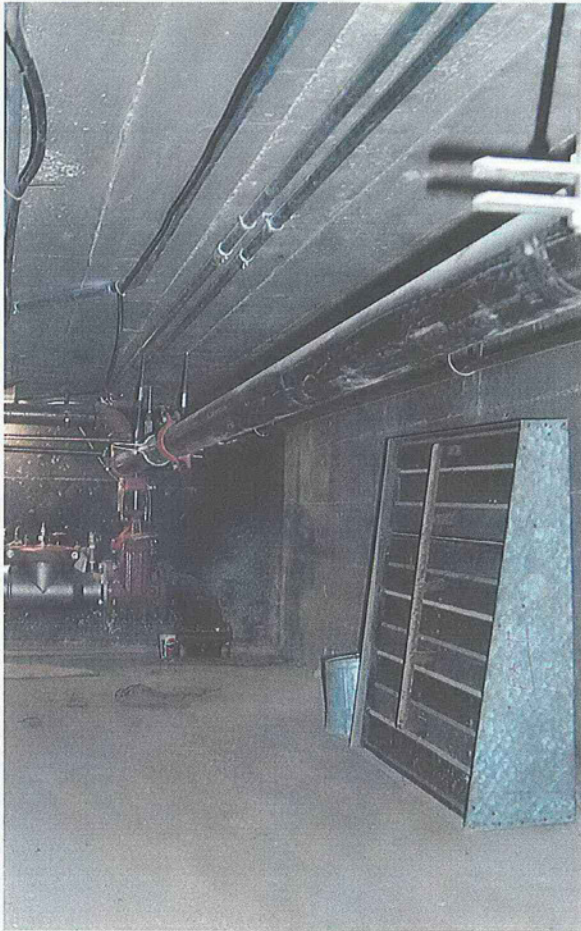
Wright Hall east plenum, thru-wall crack (QE\A 2000)

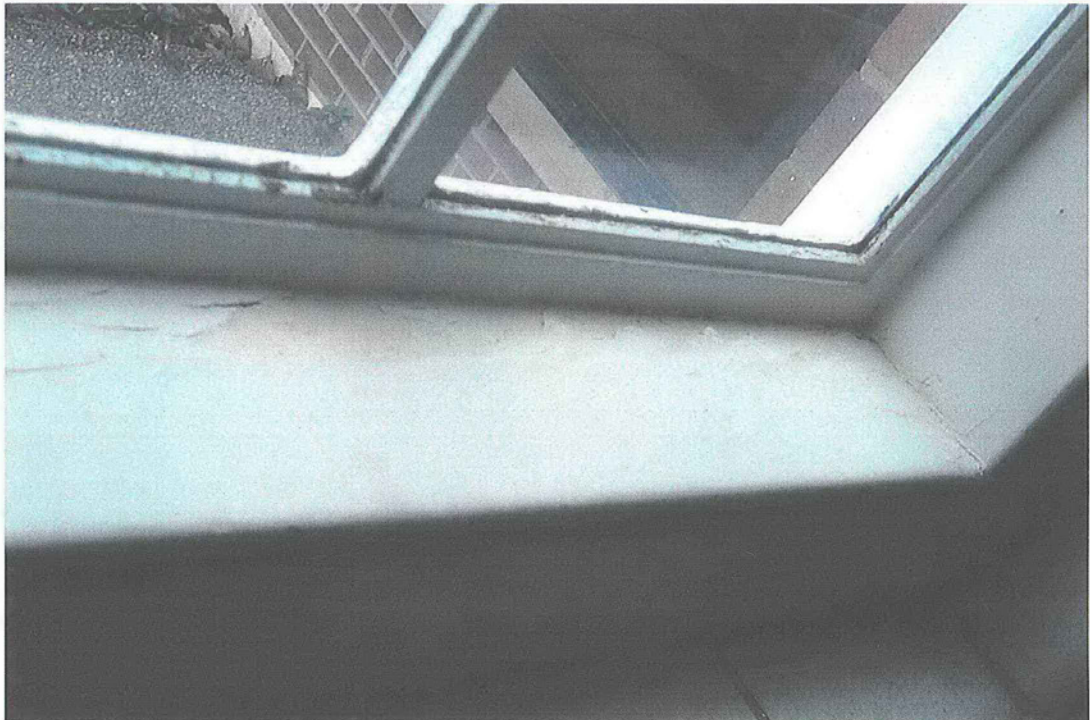
Wright Hall interior, typical window condition (QE\A 2000)

- As the tinted ultra-violet film on the windows wears out and needs to be replaced, the previous recommendations for the installation of interior storm windows with UV panels should be implemented.
