HISTORIC STRUCTURE REPORT

FORT POINT LIGHT

└ FORT POINT NATIONAL HISTORIC SITE

May, 1972

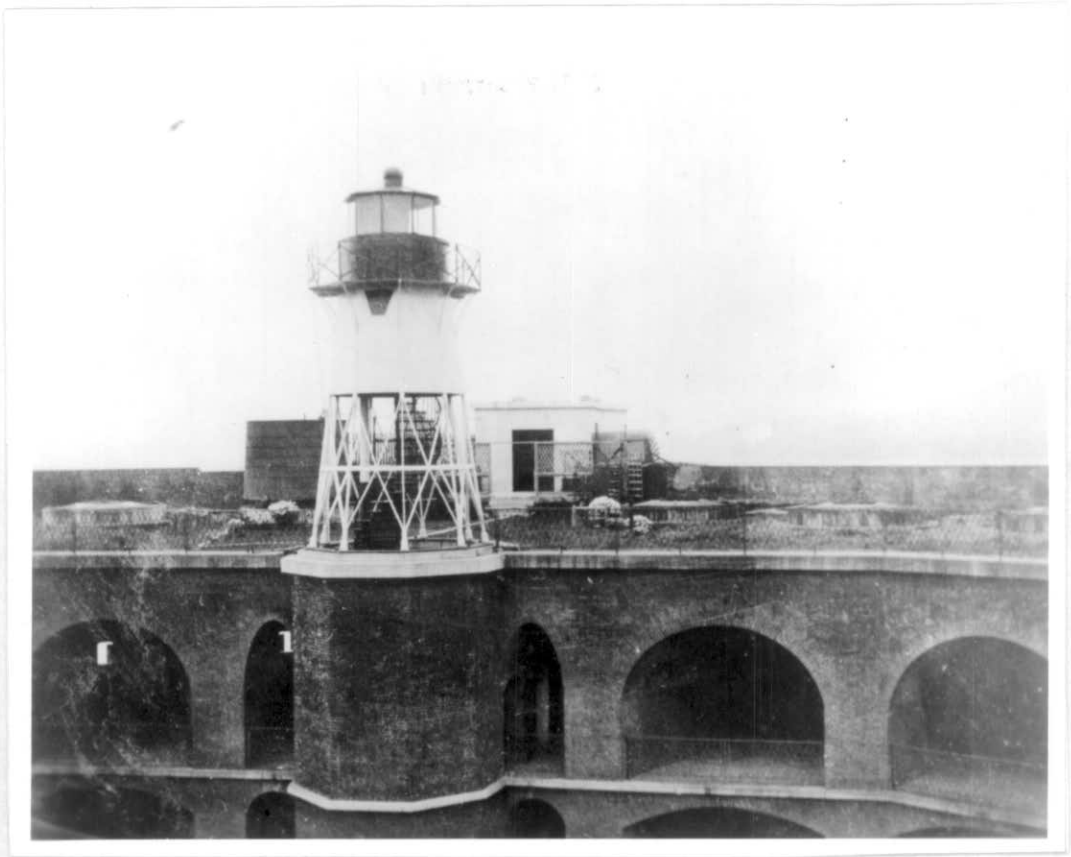
ILLUSTRATION NO. 2

View of Fort Point Light during historic period. Note the painting scheme, the light shield on the landward side of the lantern, and the dome over the roof vent. Also, note the large pipe extending from level "B" through level "A", and other structures over the westerly bastion.

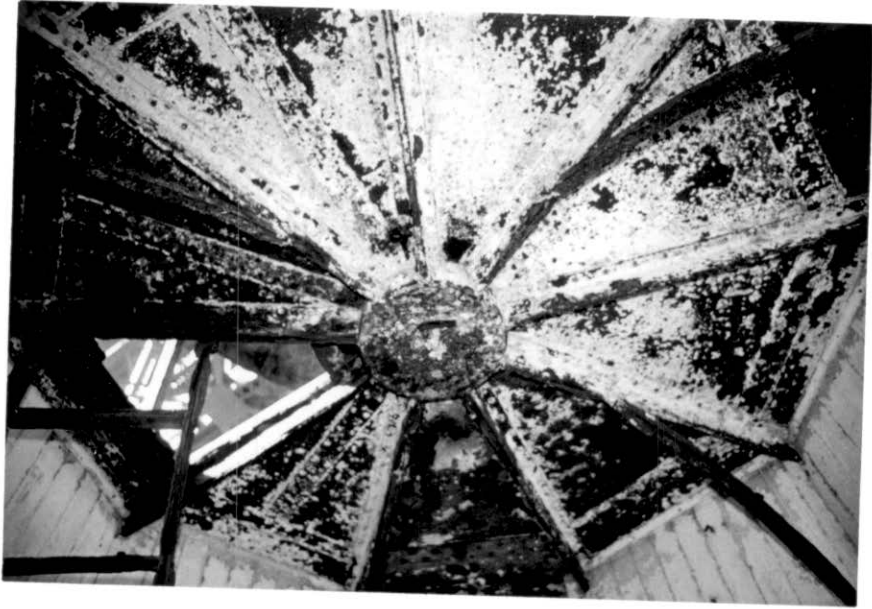
ILLUSTRATION NO. 10

Detail of windows and interior T&G wall lining at level "B".
Note iron knee bracing.

14. Repair interior T&G wall lining and decking and construct new hinged trap door at level "B".
15. Repair T&G decking at level "C".
16. Enclosed spaces shall be made weather-tight.

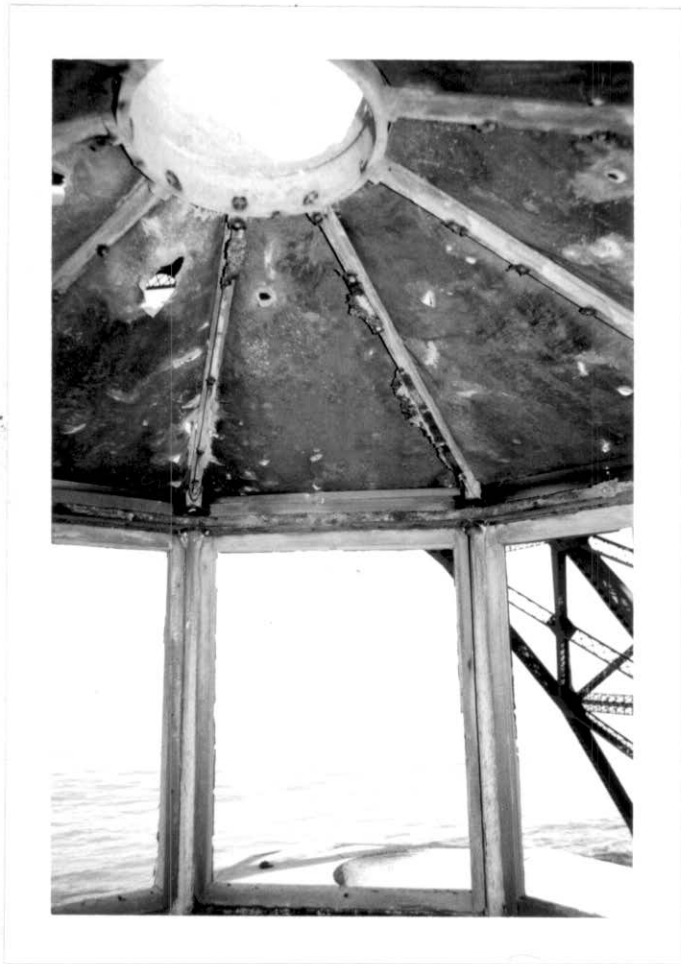
ILLUSTRATION NO. 12

Detail of framing and assemblage of access door at parapet, level "C".
