National Park Service
U.S. Department of the Interior

Fort Point National Historic Site
Golden Gate National Recreation Area

Abbreviated Fort Point Historic Structure Report

September 2006

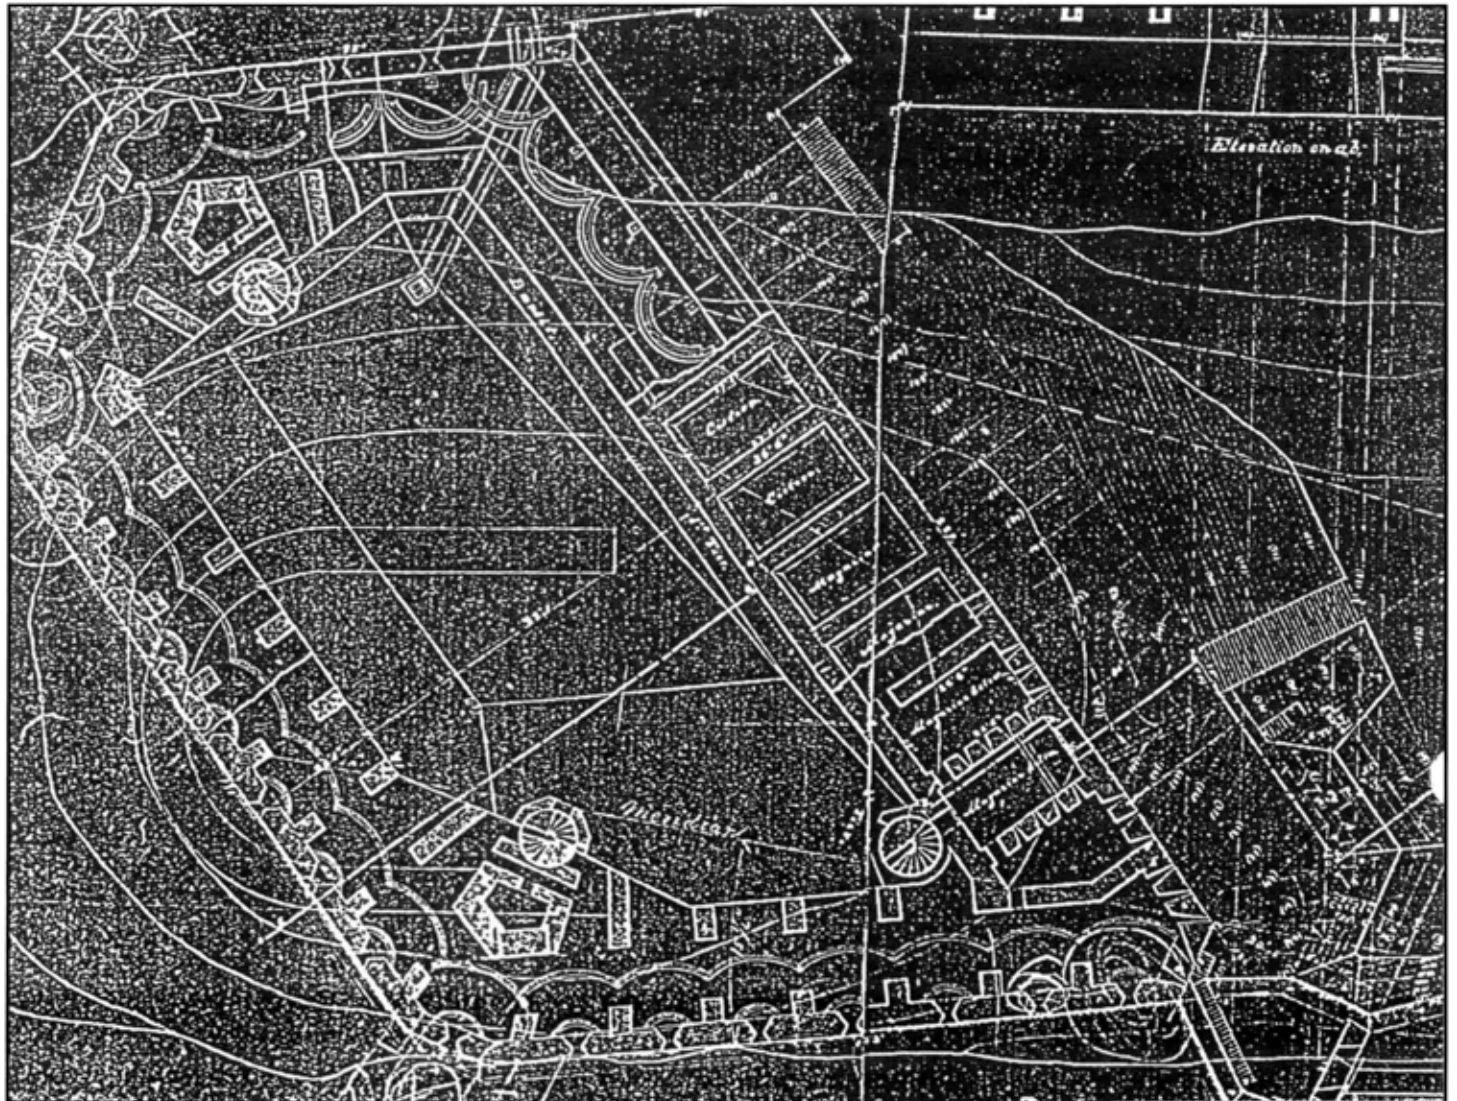
Figure 2. Drawing: Composite Floor Plan, drawn by Danville Leadbetter, c. 1853, with Project Engineer Barnard's Bastion additions sketched in. Credit: Fort Point NHS Collection, Golden Gate National Recreation Area.

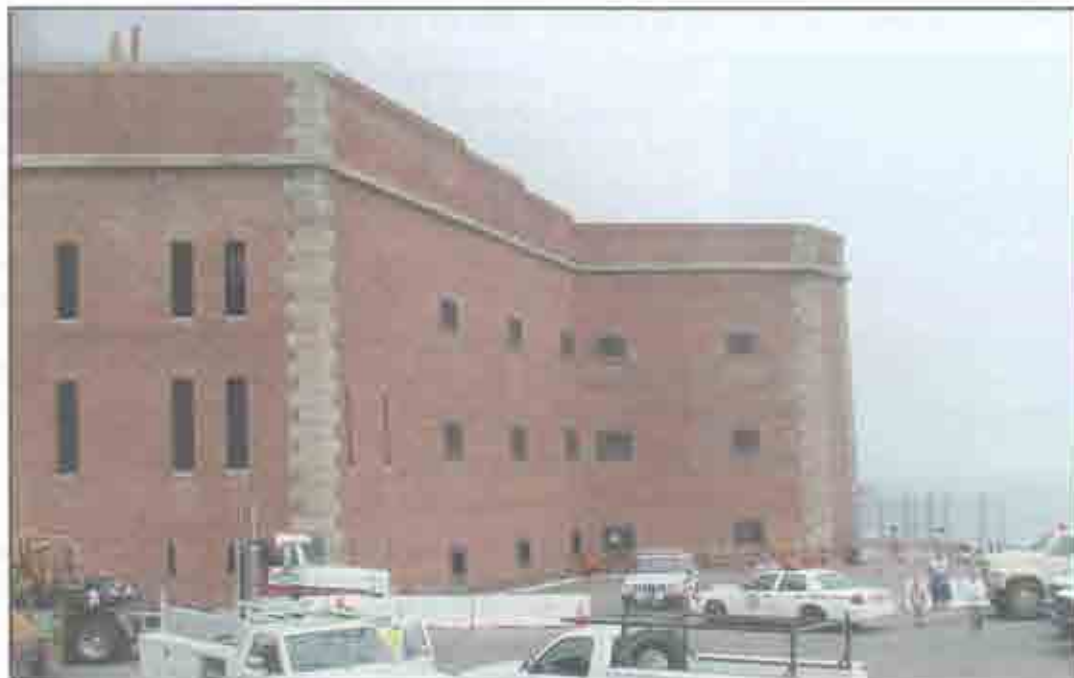
Lateral displacement is evident in the south flank parapet. (Jane Lehman, 2005)

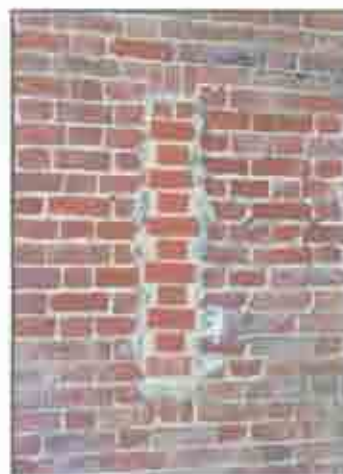
Former rifle slit on south flank filled in with brick. (Jane Lehman, 2005)

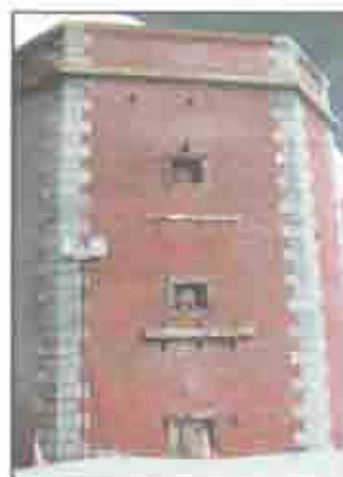
The west face of the west bastion has the remains of a fog bell and other structures that were attached to the sides of the fort. (Jane Lehman, 2005)

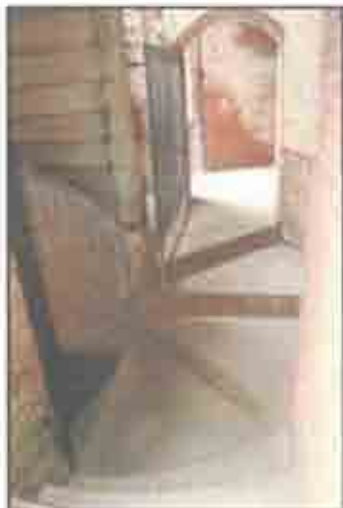
Each landing in the circular staircase is composed of slightly different shaped pieces of granite depending on the floor-to-floor heights. (John Martini, 2005)

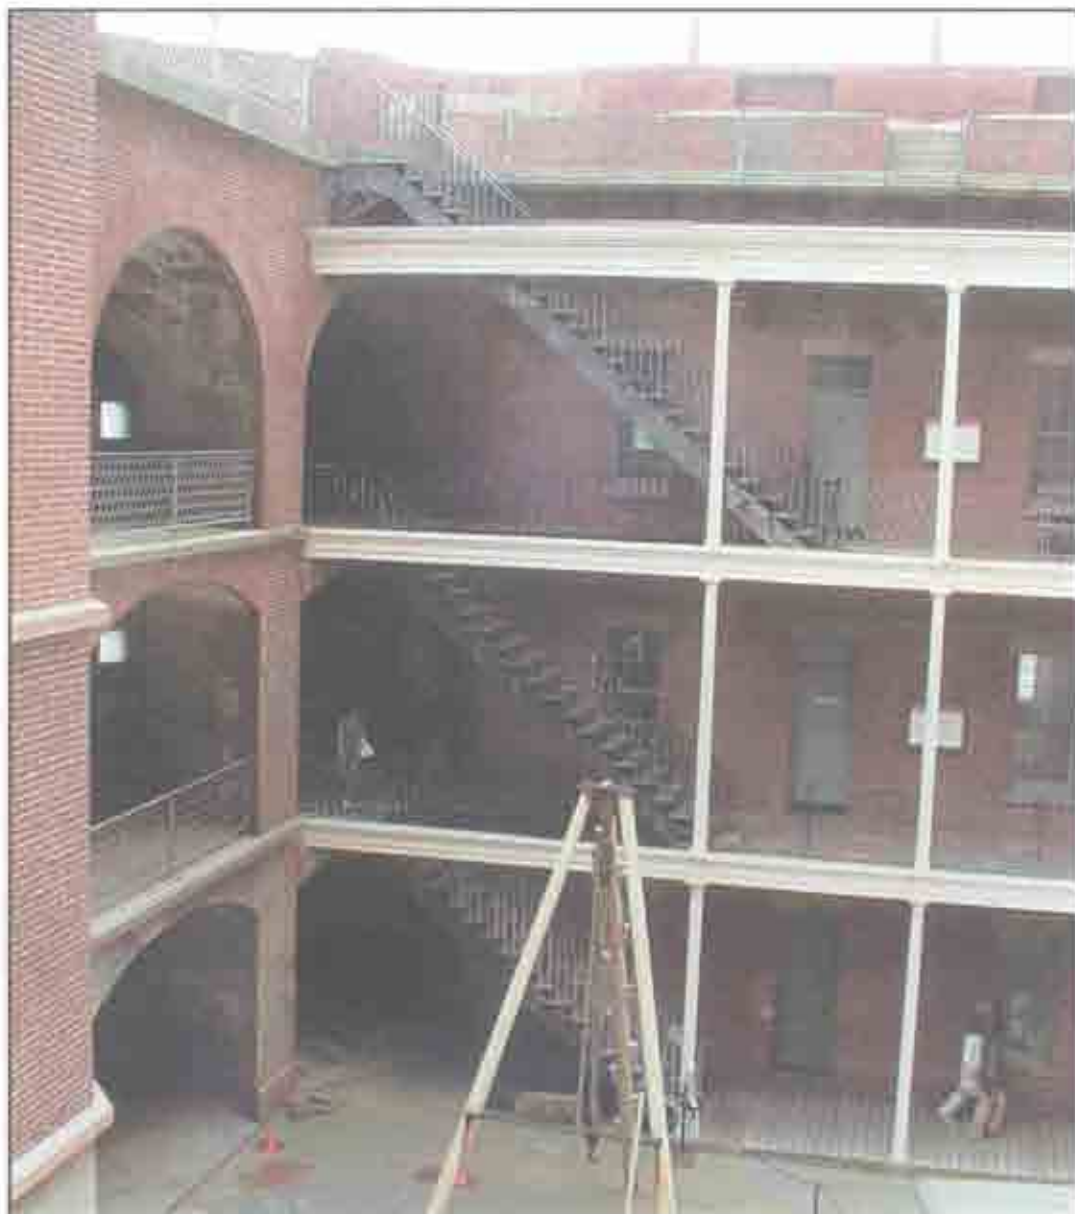
The cast iron staircase at the east end of the gallery is the only straight-run staircase in the fort. (Jane Lehman, 2005)

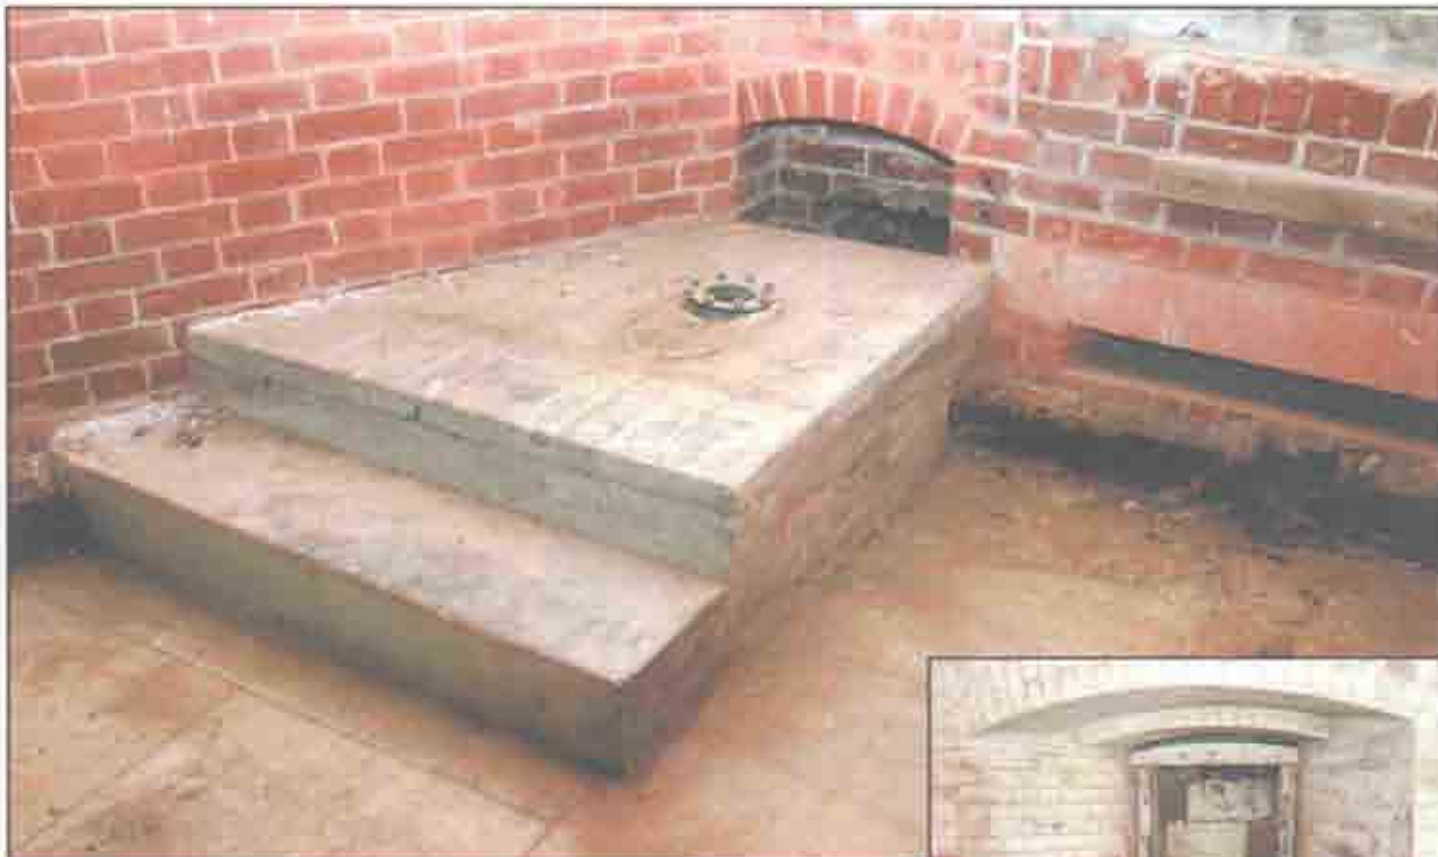
These concrete platforms for plumbing fixtures remain from the 1914 attempted remodel of the fort into a disciplinary barracks. (John Martini, 2005)

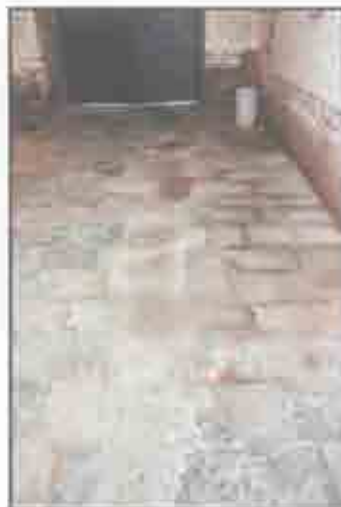
The original granite floors remain in good condition although a large concrete patch exists where a previous water line was installed. (John Martini, 2005)

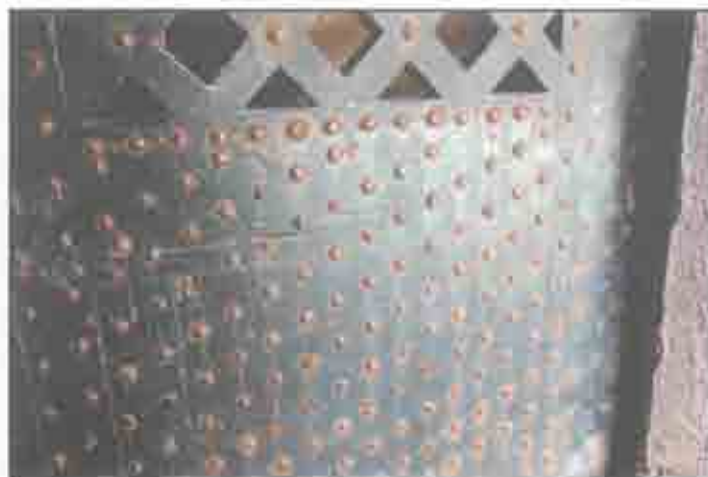
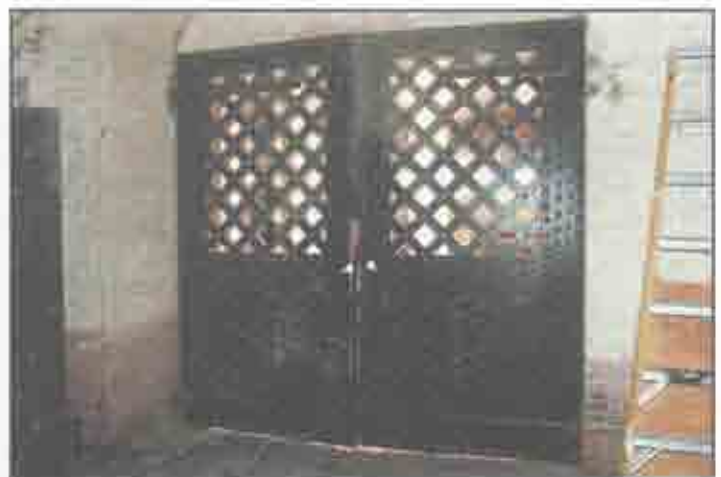
The rivets on the original wood doors rust quickly in the marine environment. (John Martini, 2005)

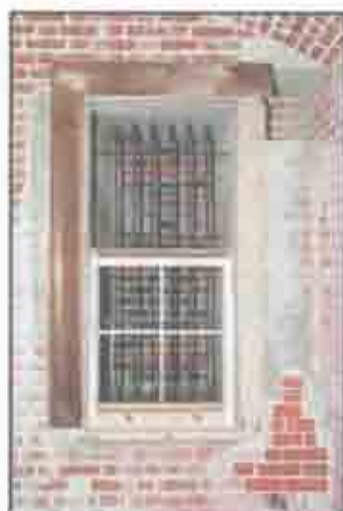
Rifle slit openings were enlarged and then bricked up leaving various building components. (John Martini, 2005)

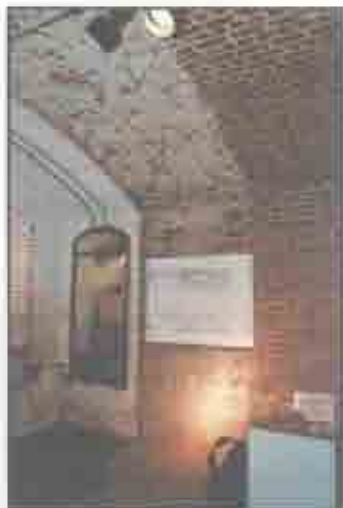
Walls were removed in the magazines during the conversion of the fort to a disciplinary barracks in 1914. Half of the 4-foot thick brick and rubble wall remains at right, while only the outline of a wall remains above. (John Martini, 2005)

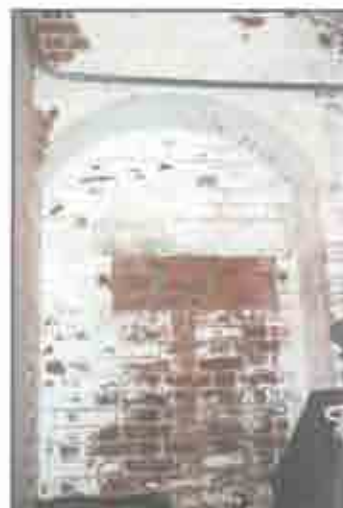
The rifle slit in the corridor of the jail area has been infilled with brick. (John Martini, 2005)

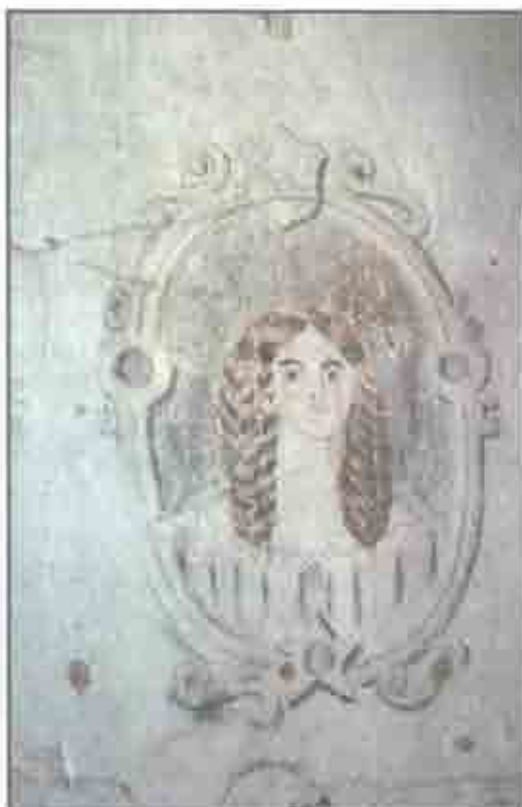
In the north jail cell, there is a drawing on the wall that was done by a prisoner in the 1860s. It is fair condition now, but should be preserved. The drawing depicts an oval portrait hung on a nail of a young woman with Victorian dress.

The drawing on the wall of one of the jail cells was done by a long ago prisoner. (John Martini, 2005)

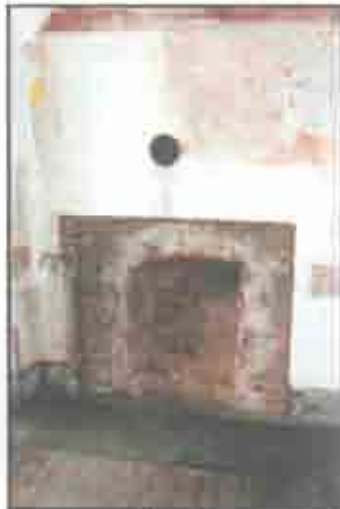
It is apparent from the remnants in this non-commissioned officer's room that the fireplaces were not part of the fort's original construction. (John Martini, 2005)

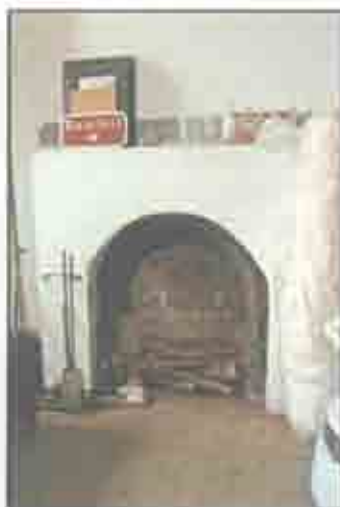
One of the older style fireplaces in non-commissioned officer's quarters E. (John Martini, 2005)

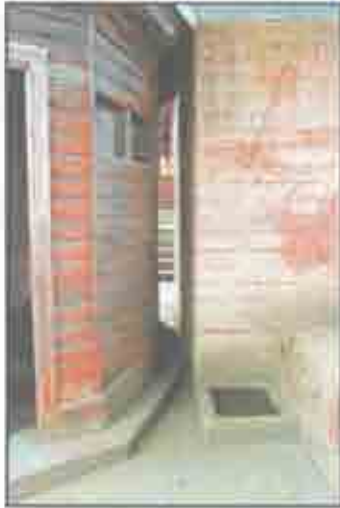
The remnants of the WWII searchlight housing are adjacent to the penthouse for stair #1. (John Martini, 2005)

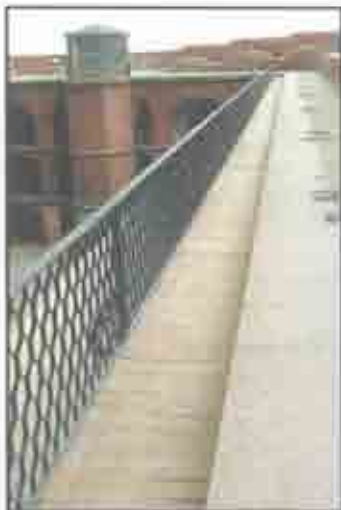
This 3-foot wide walkway and railing above the gallery on the southwest gorge elevation was replaced in a 1973 project. Beyond is the penthouse over stair #3. (John Martini, 2005)

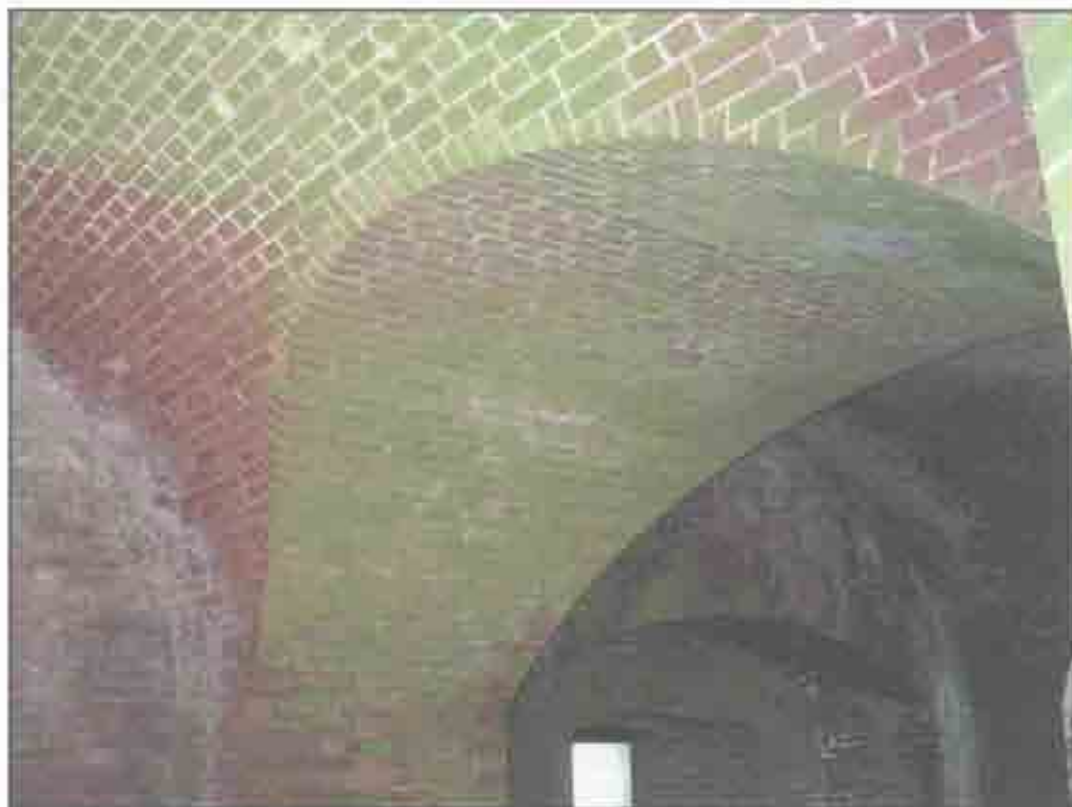
Condition Photo 2:
Intersecting Arch of Casements
98 and 99; Biological growth and
efflorescence settle on masonry
surfaces. (Courtesy of ARG, 2003)

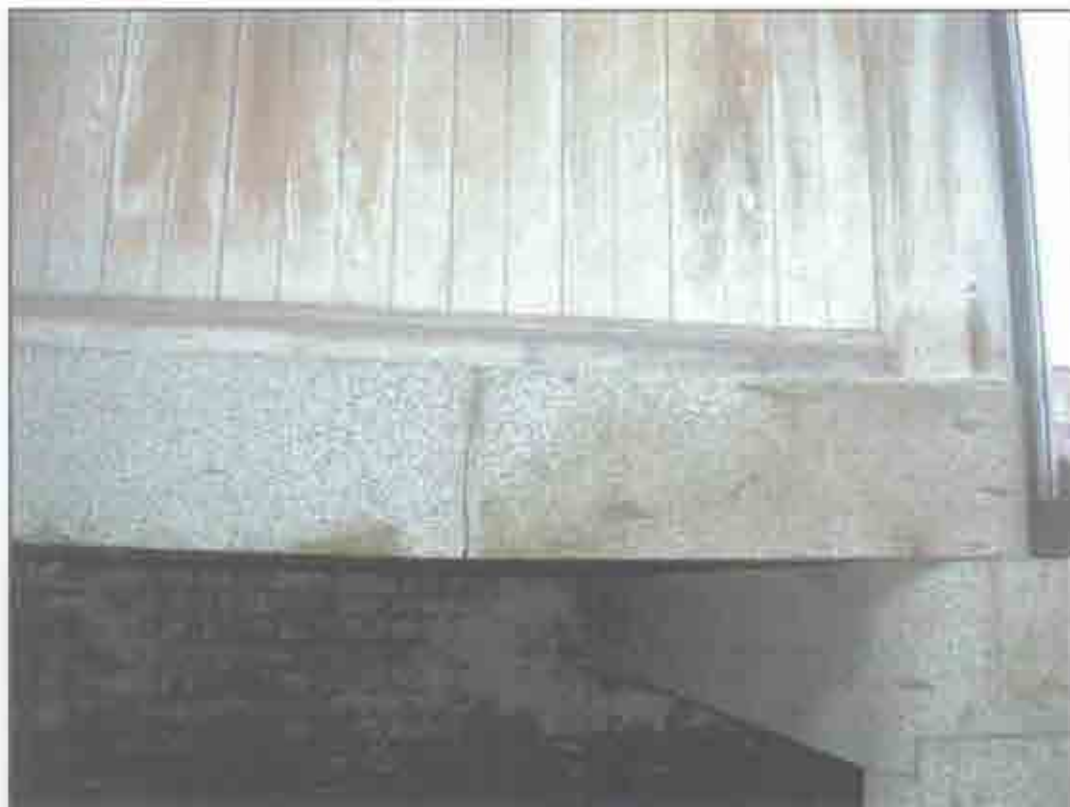
Condition Photo 6:
Top Landing at Barbetta Tier; Crack
in granite. (Courtesy of ARG, 2003)

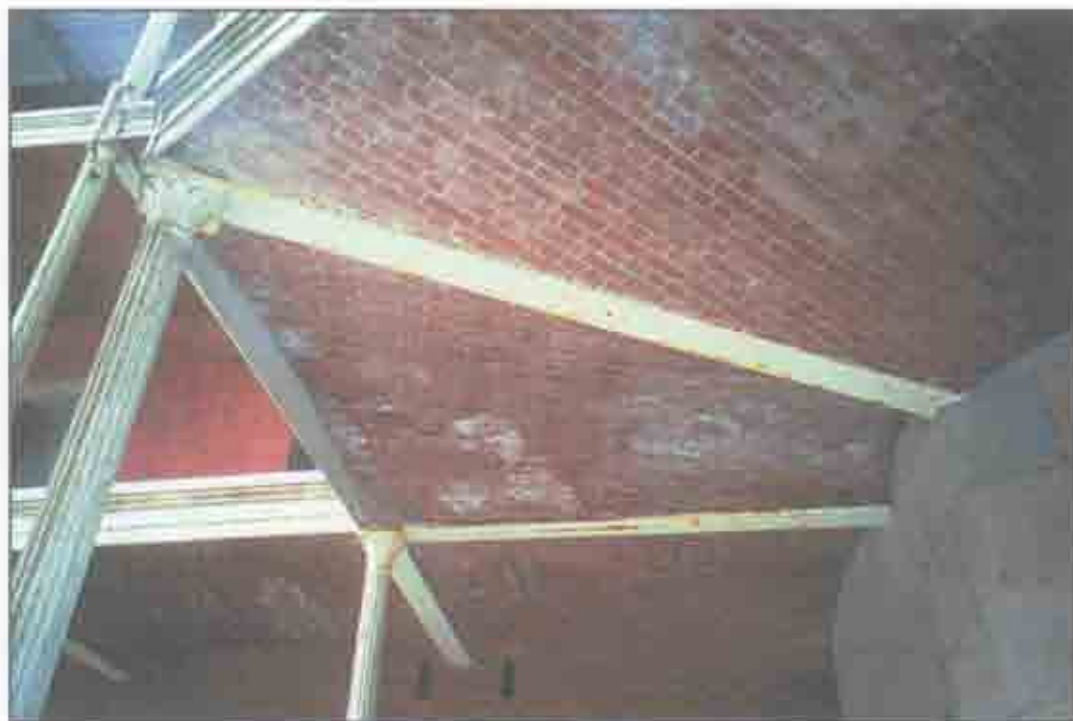
Condition Photo 9:
Southeast Courtyard—Underside
of Walkway at Tier One; Metal
corrosion and staining of the granite
walls. The brick facing is spalling.
Efflorescence occurs on the brick and
granite masonry.
(Courtesy of ARG, 2003)

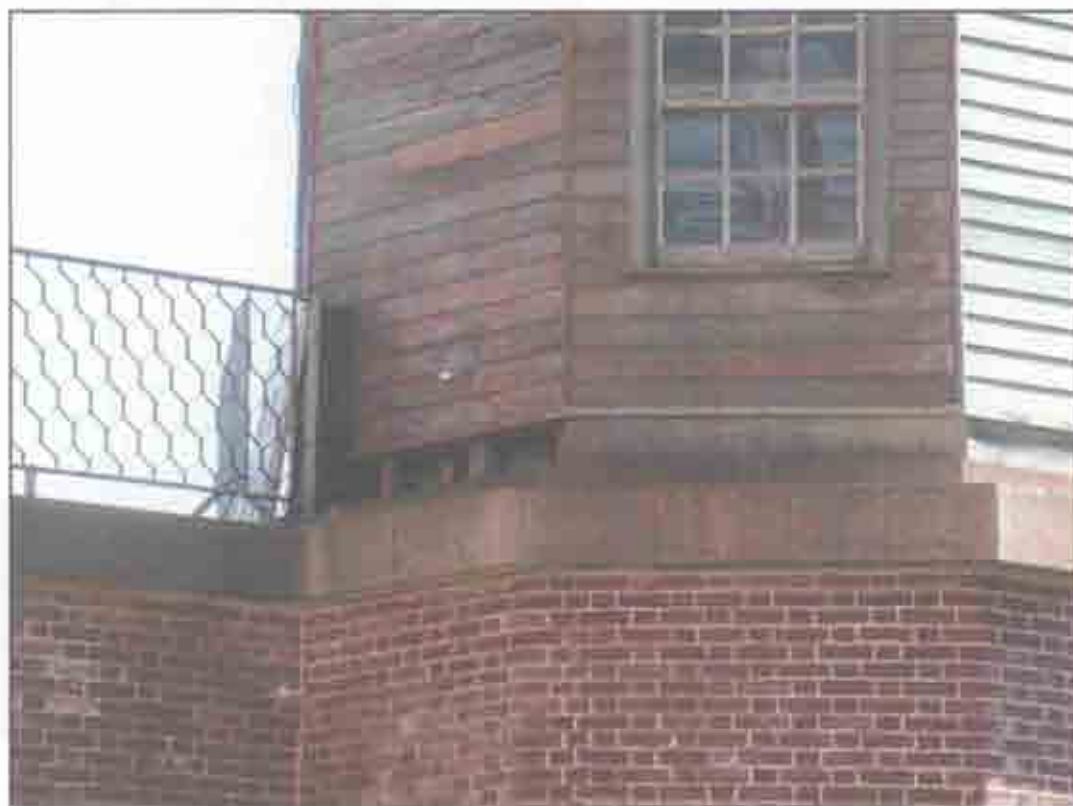
Condition Photo 13:
Stair 3; Missing siding exposes the
structural framing. (Courtesy of ARG,
2003)

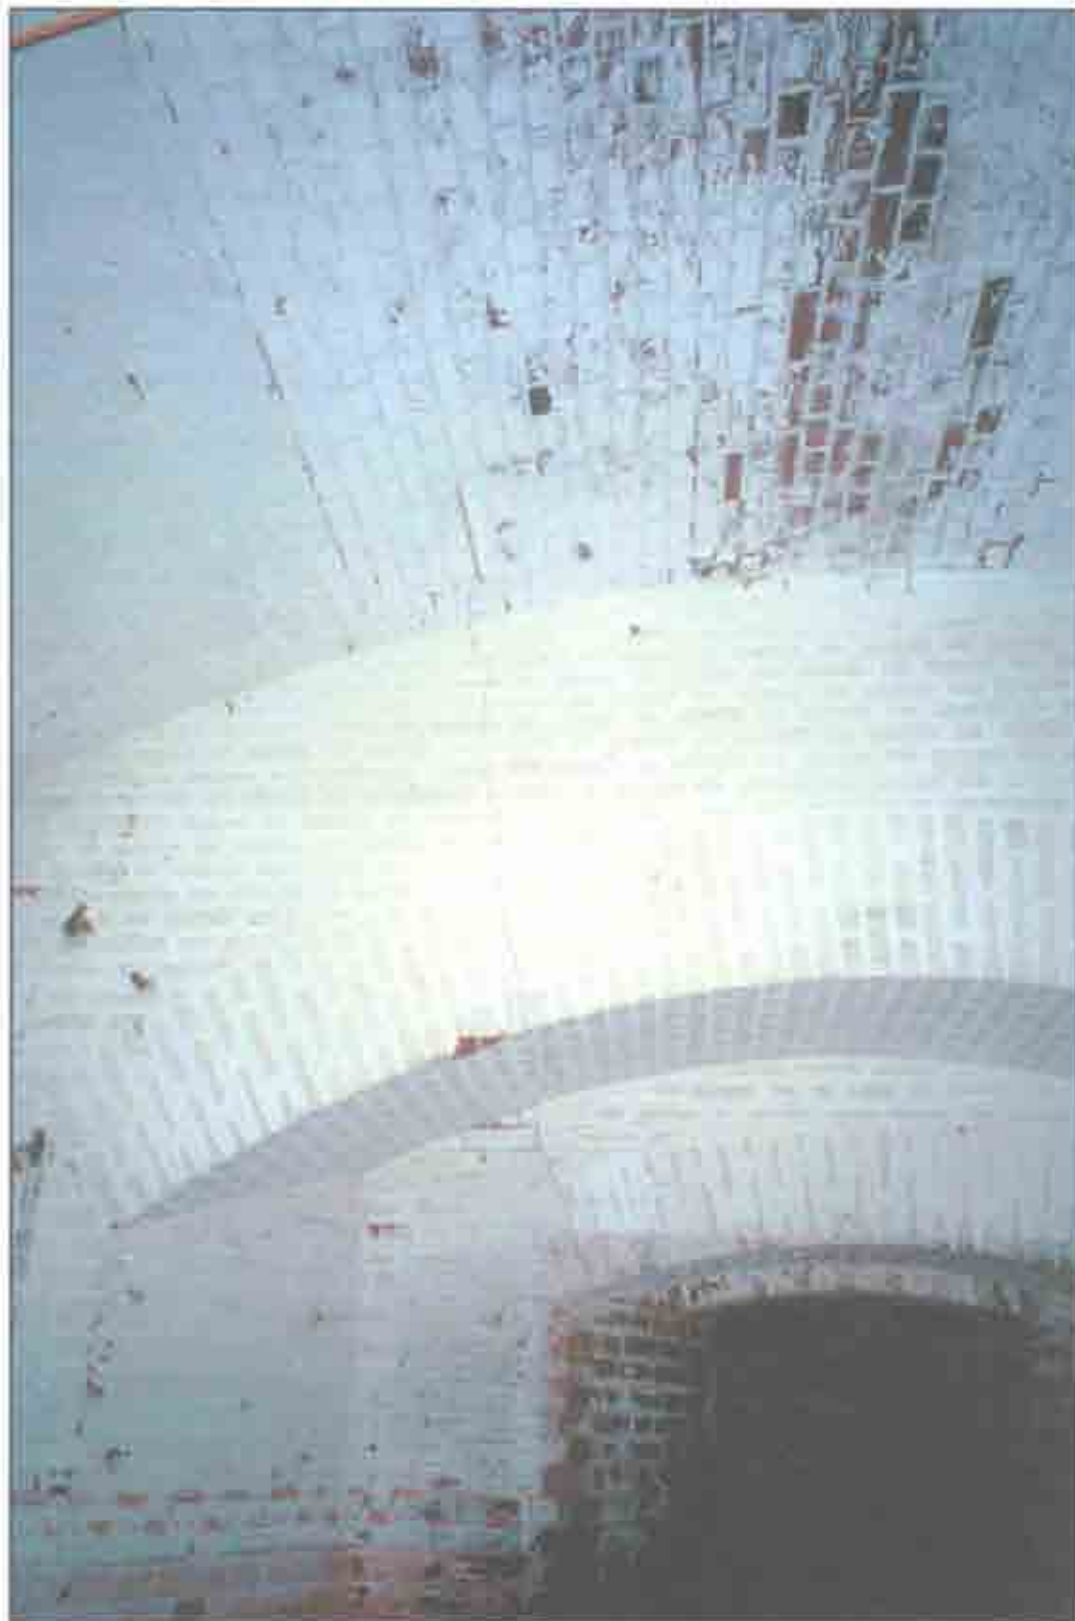
Condition Photo 15:
Casemate 19; Cracks in brick masonry
and joints have failed. The heavily
flaking paint is typical in casemats.
(Courtesy of ARG, 2003)

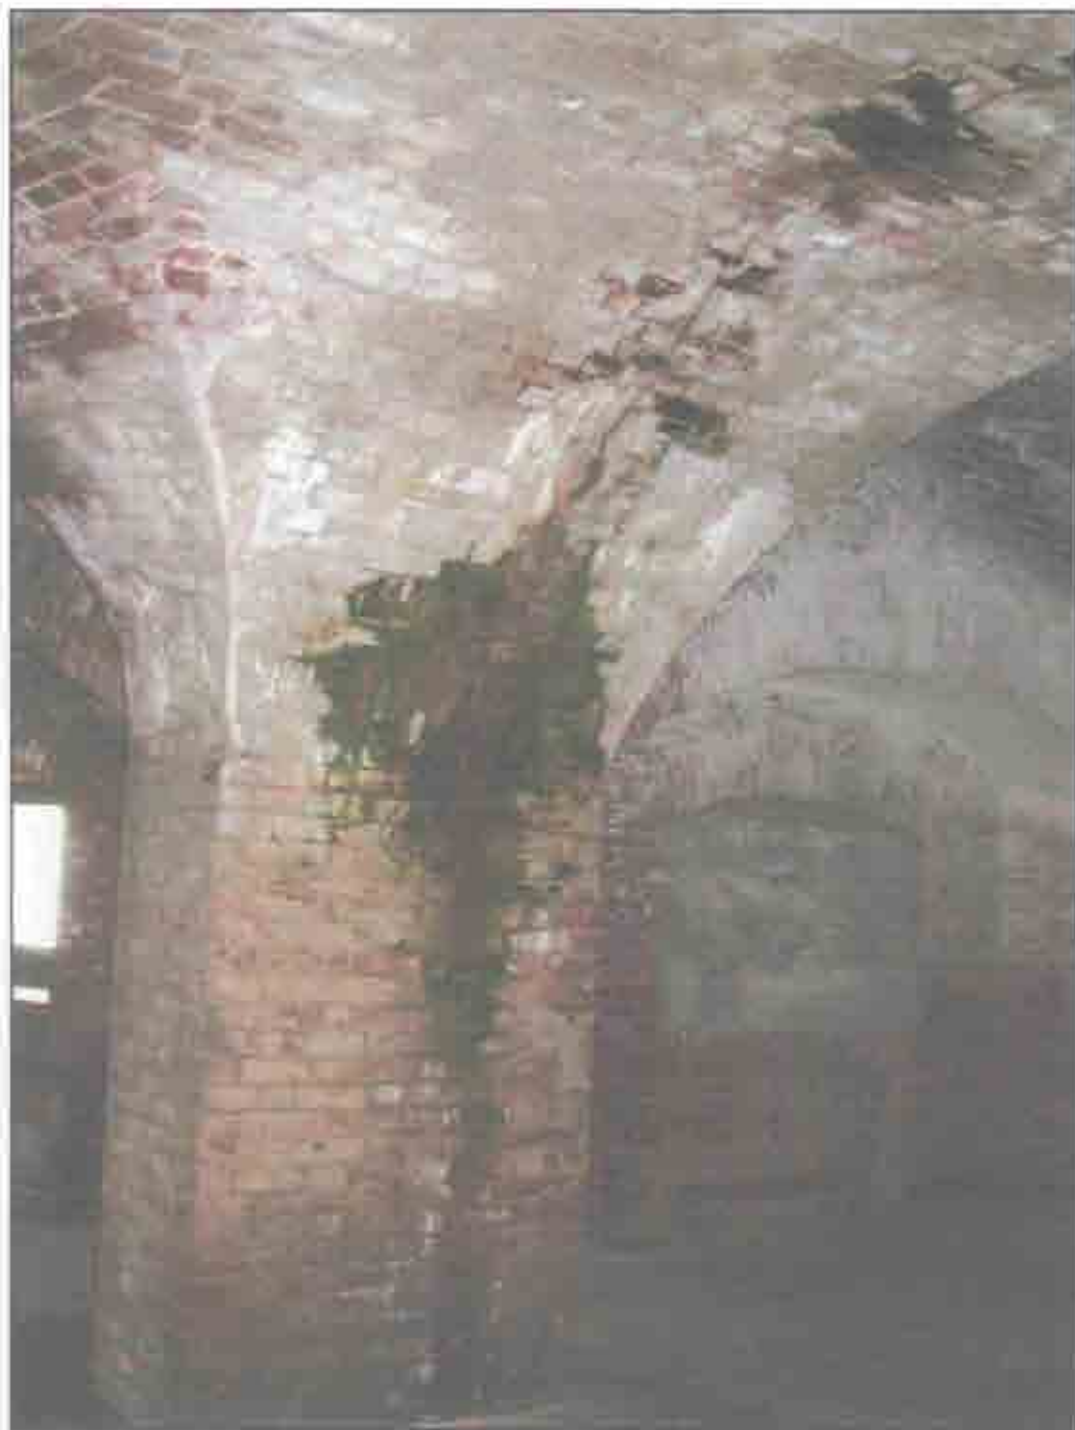
Condition Photo 17:
Casemate 68A- Third Tier; Crack
spanning the arch of a casemate,
typical at the intersection of the east
bastion and arch of the adjacent
walkway. Extensive water damage,
biological growth and efflorescence
of masonry. (Courtesy of ARG, 2003)

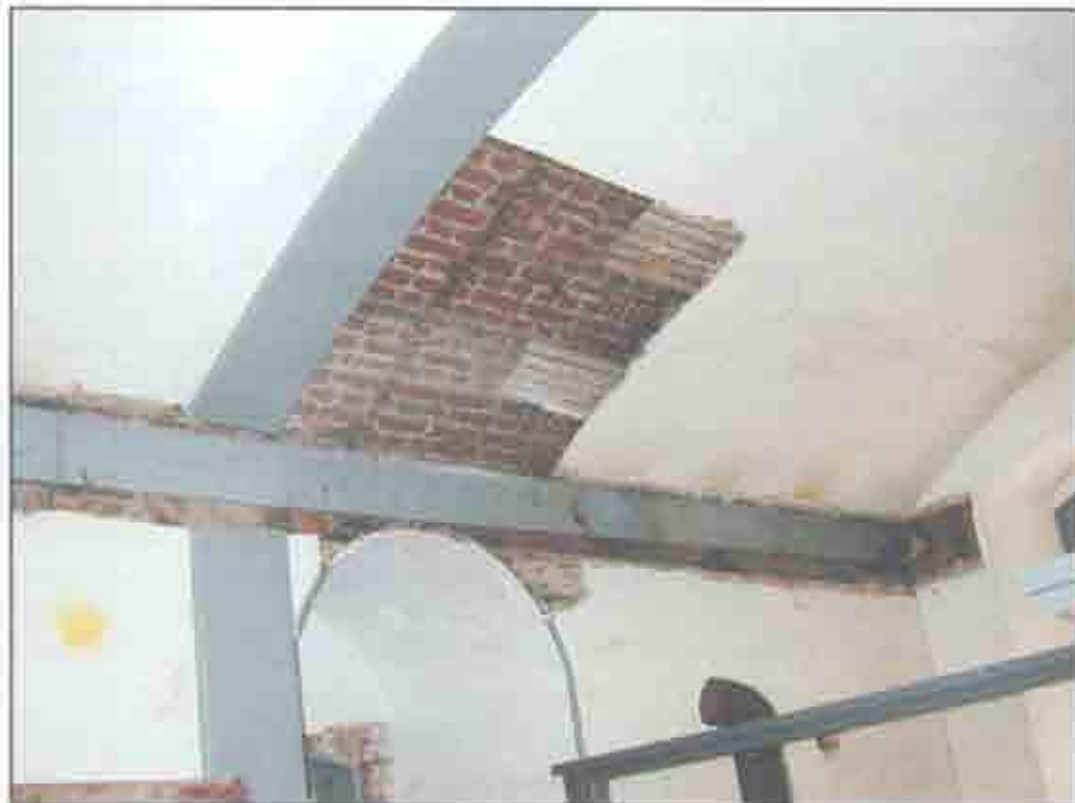
Condition Photo 20:
Photo shows interior plaster
patching at 2nd tier.
(Courtesy of ARG, 2003)

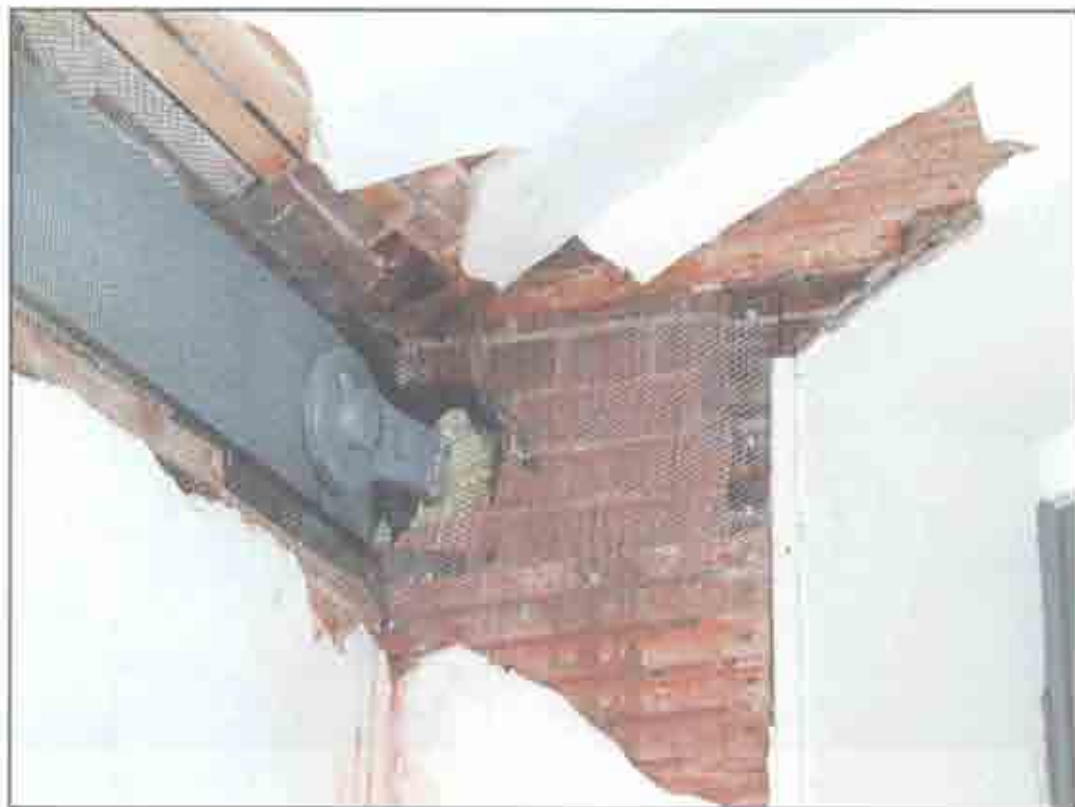
Condition Photo 21:
Detail of brick lath, wire mesh, and
plaster layers. (Courtesy of ARG,
2003)

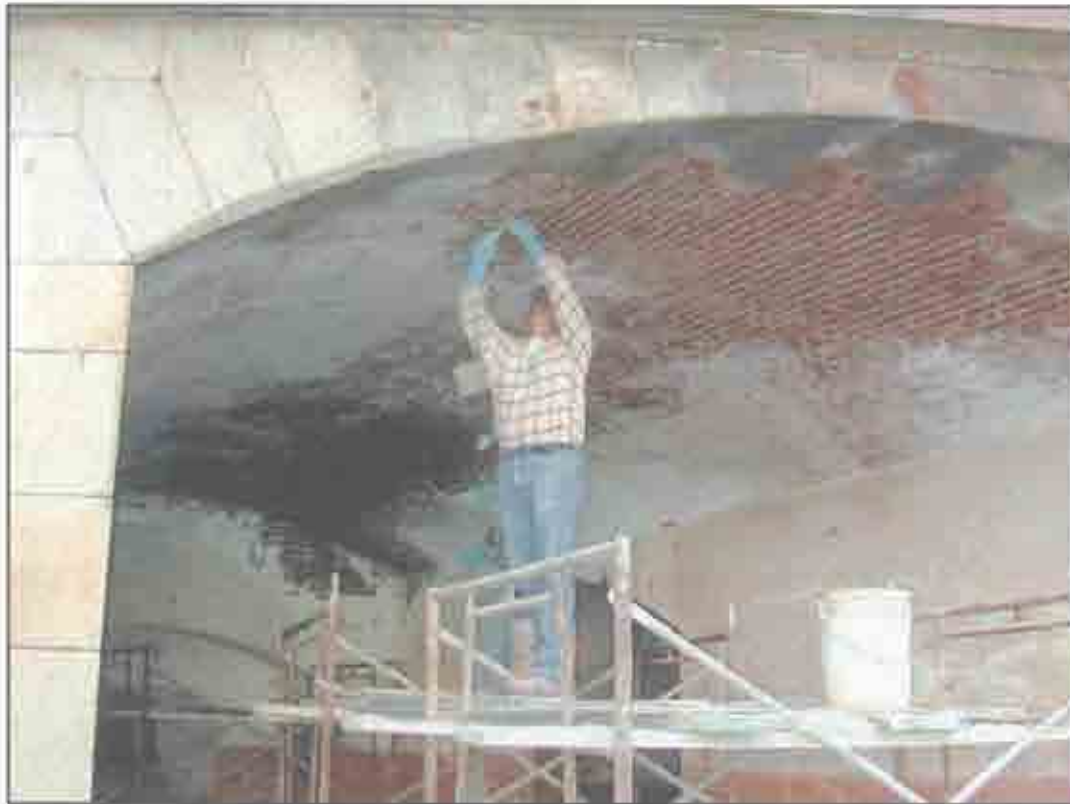
Condition Photo 22:
Masonry repointing project at 1st
tier. (Courtesy of ARG, 2003)
