**Fort Pulaski National Monument  
Quarantine Attendants' Quarters**

**Historic  
Structure  
Report**

March 2004

2004  
Historic Structure Report  
Quarantine Attendants' Residence  
Fort Pulaski National Monument  
Savannah, GA  
LCS#: 12172

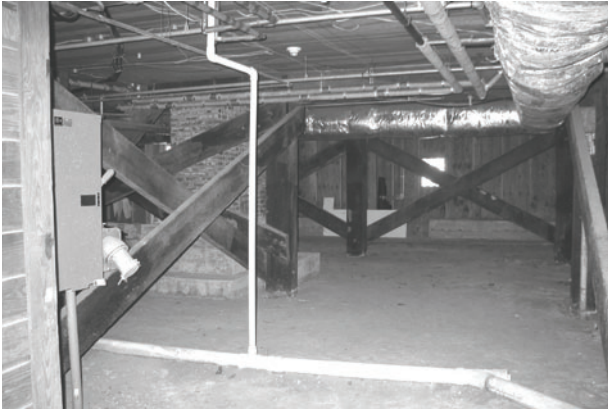
FIGURE 24. View west under north porch, showing typical piles and cross-bracing. (NPS-SERO-CR, 2003)

There is no evidence that the piles and beams forming the foundation have ever been replaced, although there is at least one brace west of the chimney base which was probably added during World War II. Piles and beams are in relatively good condition. There has been some oxidation of the iron straps and bolts, and termite damage is visible on the pile at the southeast corner of the house and in isolated areas elsewhere.

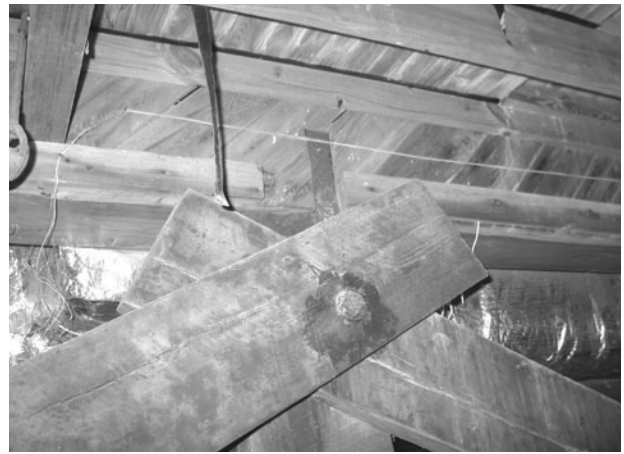
FIGURE 25. View of typical pile-beam-crossbrace

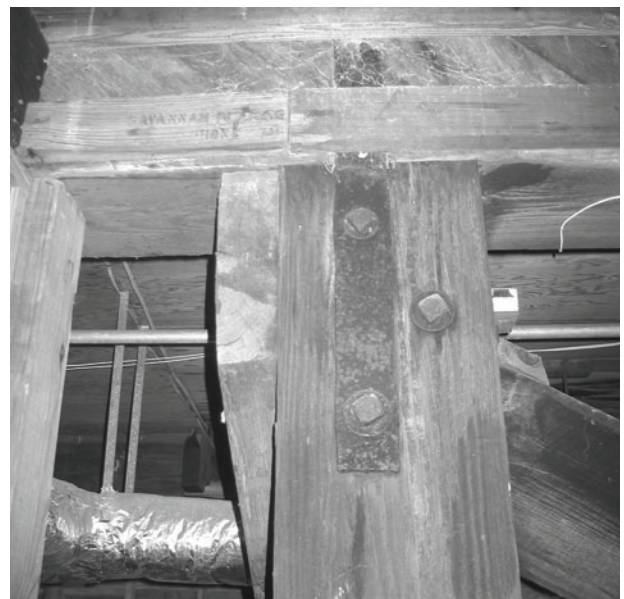
FIGURE 26. View of typical iron strap that secures house framing to pilings. (NPS-SERO-CR, 2003)

probably made with wire nails. Although none of the wall framing could be examined, the building appears to have been built with a conventional wood frame resting atop the wooden piles and beams that form its foundation. The building's frame appears to be in generally good condition, and although there is no visible evidence that framing is overloaded or inadequate, hidden termite damage and rusting fasteners may have reduced the building's capacity to withstand storm damage.

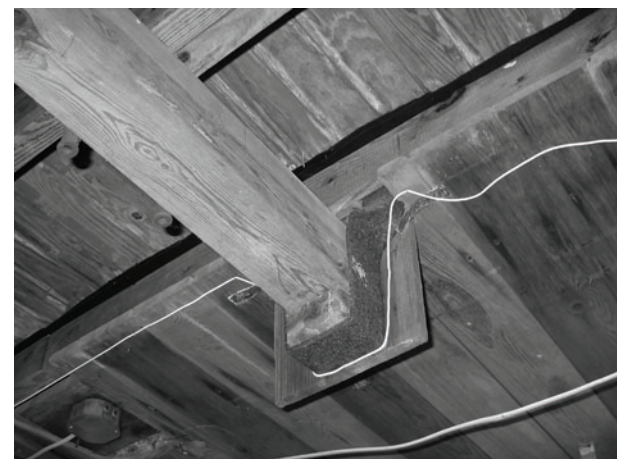
FIGURE 27. View of typical cast-iron U-shaped bracket used to hang beams for porch floor joists. (NPS-SERO0CR, 2003)

**Porches.** The porch floors are framed by joists set between beams that run perpendicular to the outside walls of the house. On the north, east, and now-enclosed west porches, these beams were hung from U-shaped, cast-iron brackets that are probably bolted to the sills. Only one of the original beams has not been replaced by modern material of slightly smaller dimension; it is located under Room 107, which was created by enclosing part of the west porch prior to World War II. On the south porch, which was added after original construction and then completely rebuilt in 1942, the iron brackets are not present.

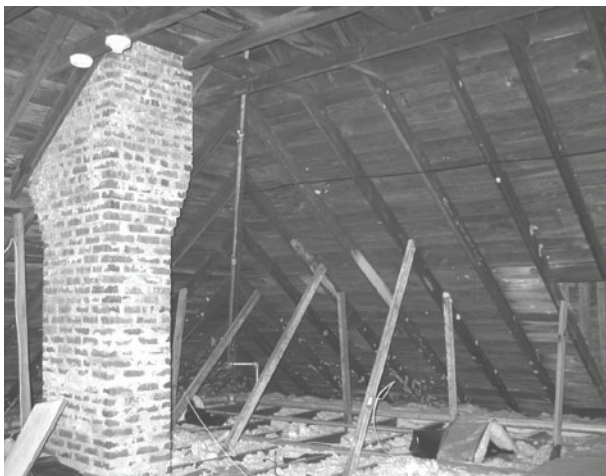
The chimney is corbeled out above the attic floor to a wider stack that runs through the roof. The reason for this corbeling is not clear, unless it was simply to create a larger, more visually appealing, chimney stack above the roof line. The top of the chimney

FIGURE 28. View northeast of chimney stack as it rises through the attic. (NPS-SERO-CR, 2003)

was originally finished with a stone or concrete slab raised above the flue opening, but it was damaged by a lightning strike in the 1970s and the chimney was rebuilt to its current configuration by the park's maintenance crew.

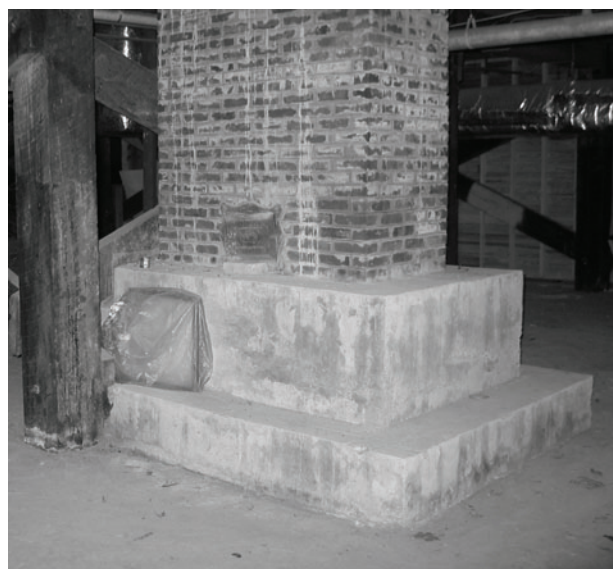
The existing chimney and fireplace were constructed by the Navy in 1942 and are in good condition. The foundation of the chimney is formed by a two-tier, concrete base poured in forms constructed with 6"-wide boards. The bottom tier of the base measures about 6'-6" by 9' and rises about 14" before stepping in to the second tier, which is about 4'-6" by 7'. It rises about 24" to the bottom of the brick chimney base, which itself is about 2'-6" by 5' in plan. Brick are standard, hard-fired, red brick set with a hard, grey, Portland mortar. There was apparently no cleaning of the masonry after construction, leading to its present stained appearance. A cast-iron door for an ash dump is located at the base of the brick shaft. Hinges in the frame are broken and the door is detached. All elements are rusting.

FIGURE 29. View southwest of chimney breast. (NPS-SERO-CR, 2003)

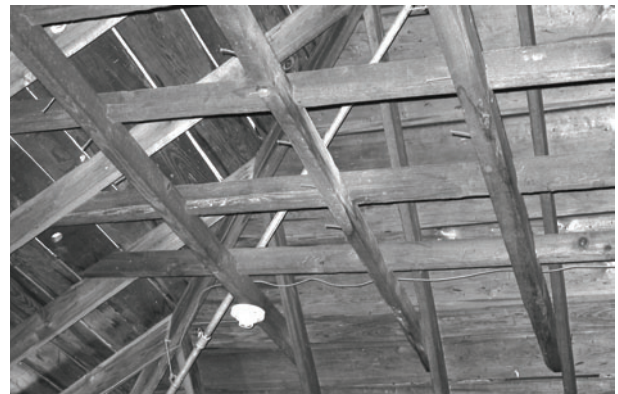
FIGURE 32. View northwest in attic showing cross-braced collar beams on main roof. (NPS-SERO-CR, 2003)

centers with 1" by 6" (nominal dimension) ridge-boards. The rafters are braced and cross-braced by two sets of collar beams (2" by 4", nominal dimension), with the set running east and west notched and set over the other set which runs north and south. Knee braces, 2" by 4" (nominal dimension), have been installed on all sides of the attic, probably after the house was constructed.

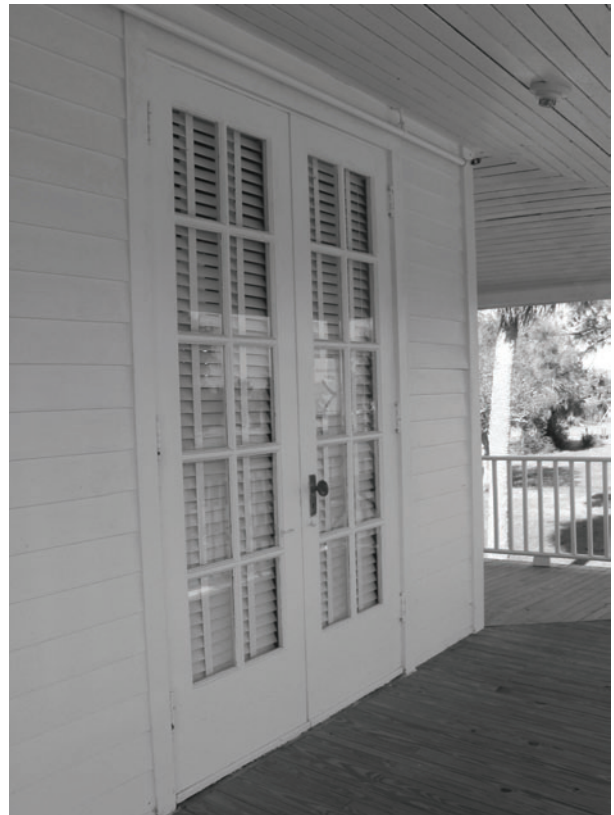
Pairs of double French doors are located on the north, east, and south sides of the house. All are about 5'-0" by 8'-0" with ten lights in each door. Doors are hung with 4", brass, butt hinges with movable, ball-end pins, and the entry door in each set is fitted with a mortise lock with oval brass knobs and a rectangular, brass, escutcheon plate. Sliding, brass, barrel bolts, originally fastened the other leaf of each pair of doors. Some of these have been recently replaced with cast-aluminum bolts, and most of those that remain have been painted.

FIGURE 38. View of typical double French doors, these located on the east side of Room 101. (NPS-SERO-CR, 2003)

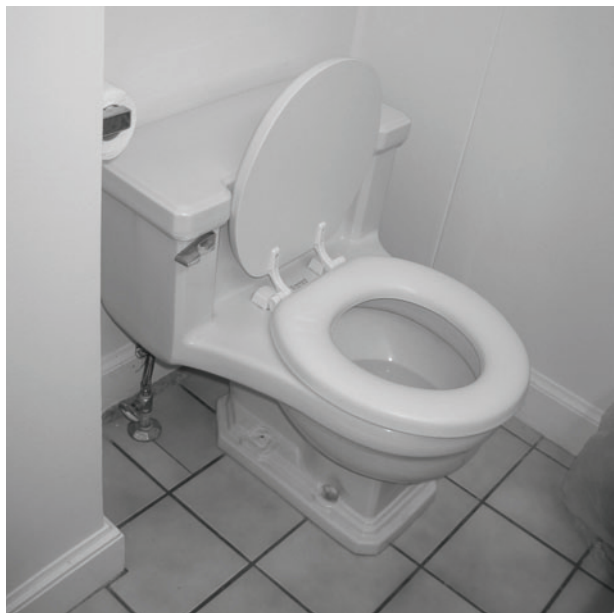
FIGURE 56. View of historic toilet in bathroom 104. (NPS-SERO-CR, 2003)

**Fixtures.** The historic lavatory was replaced, perhaps as early as the 1960s. At present a wooden cabinet with formica countertop spans the north side of the room. The toilet, a "Standard One-Piece," is dated October 3, 1941, and was installed during the remodeling in 1942. A similar toilet was present in Room 102 until replaced in 2002.

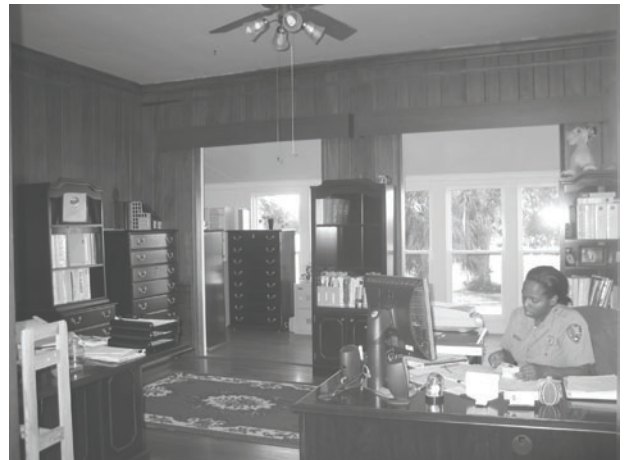
FIGURE 69. View southwest in Room 109. (NPS-SERO-CR, 2003)

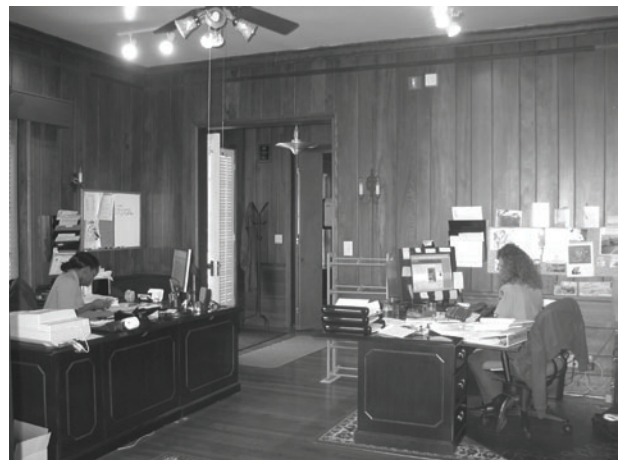
FIGURE 70. View northeast in Room 109. (NPS-SERO-CR, 2003)

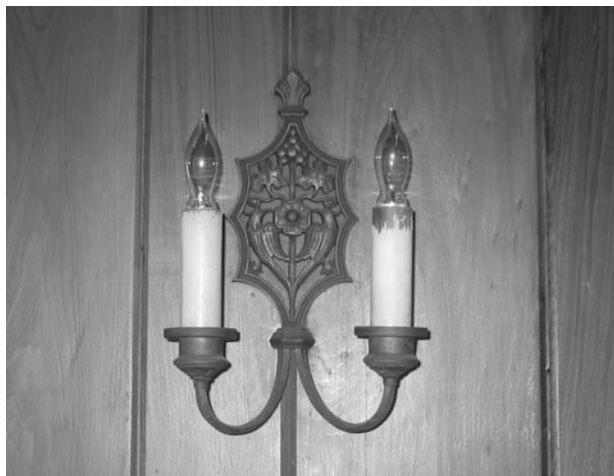
FIGURE 71. View of wall sconce, c. 1942, located in Room 109. (NPS-SERO-CR, 2003)

**Electrical.** The building's electrical system was rehabilitated in 1995, and presumably is in good condition, although loose wires and coverless junction boxes were noted in the attic. Only three light fixtures remain from the historic period, the overhead light in Room 100 and the two wall sconces in Room 109. The fixture in Room 100 is operative; the sconces are not.

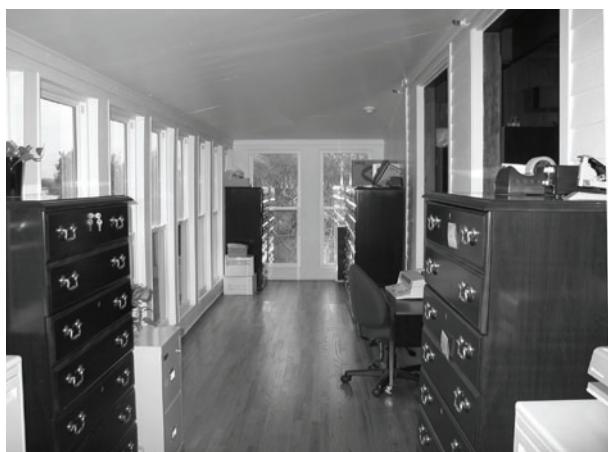
FIGURE 72. View north in Room 110. (NPS-SERO-CR, 2003)

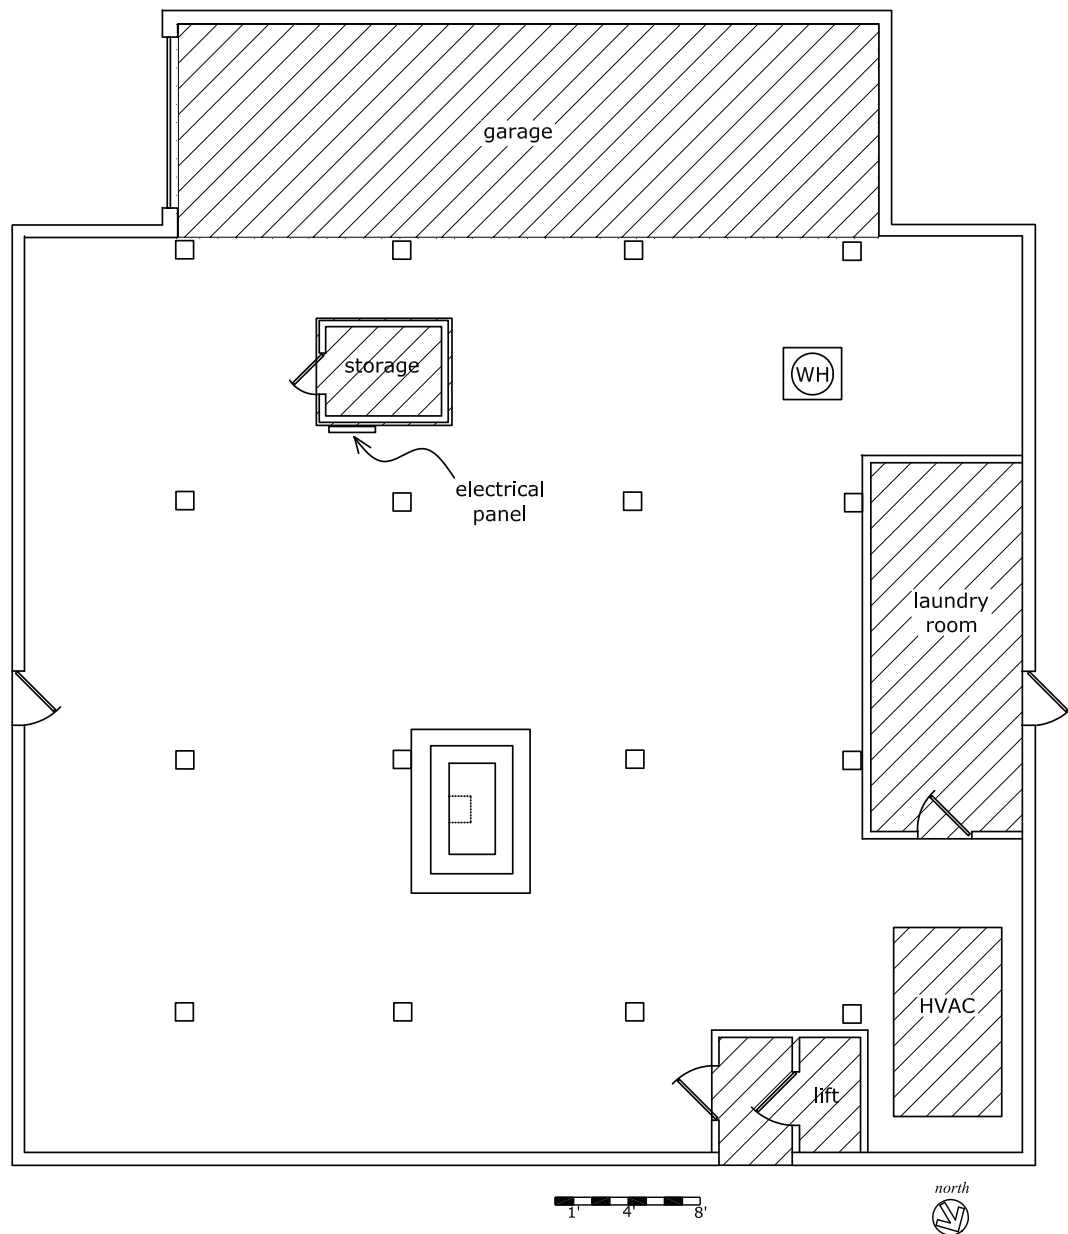
FIGURE 74. Plan of existing basement. Concrete slab-on-grade is indicated by hatching; remainder of floor is dirt. (T. Jones, NPS-SERO-CR, 2003)

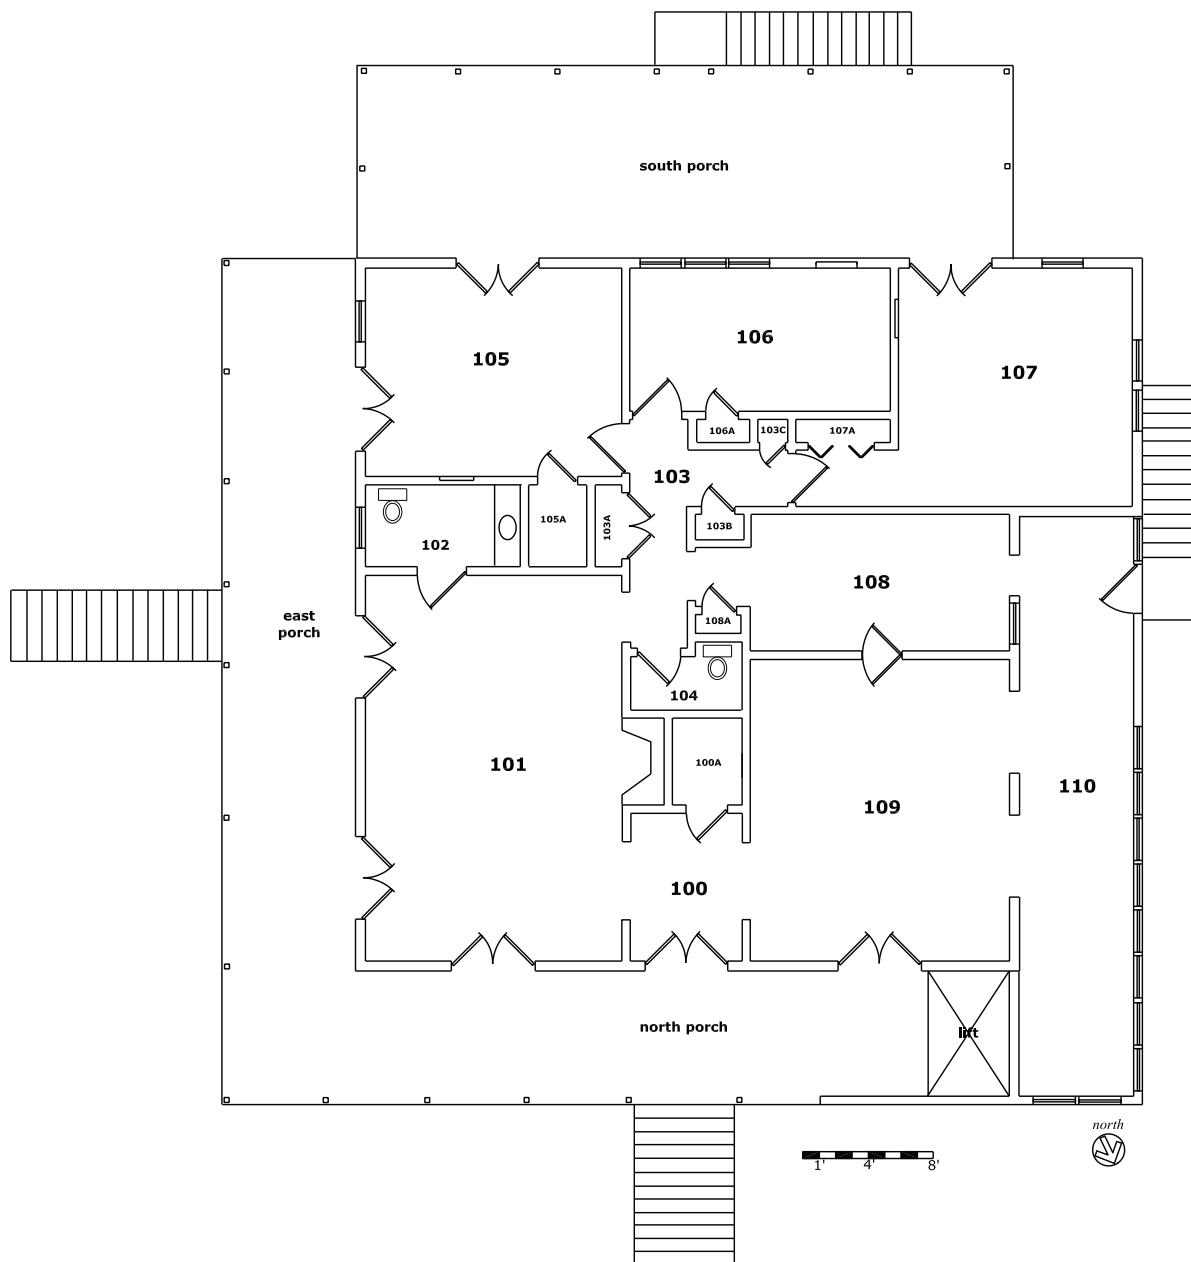
FIGURE 75. Plan of existing first floor. (T. Jones, NPS-SERO-CR, 2003)
