Historic Structures Report:

Lee's Ferry and Lonely Dell Ranch

Glen Canyon National Recreation Area,
Arizona

**AA Project No. 1084
September 2000**

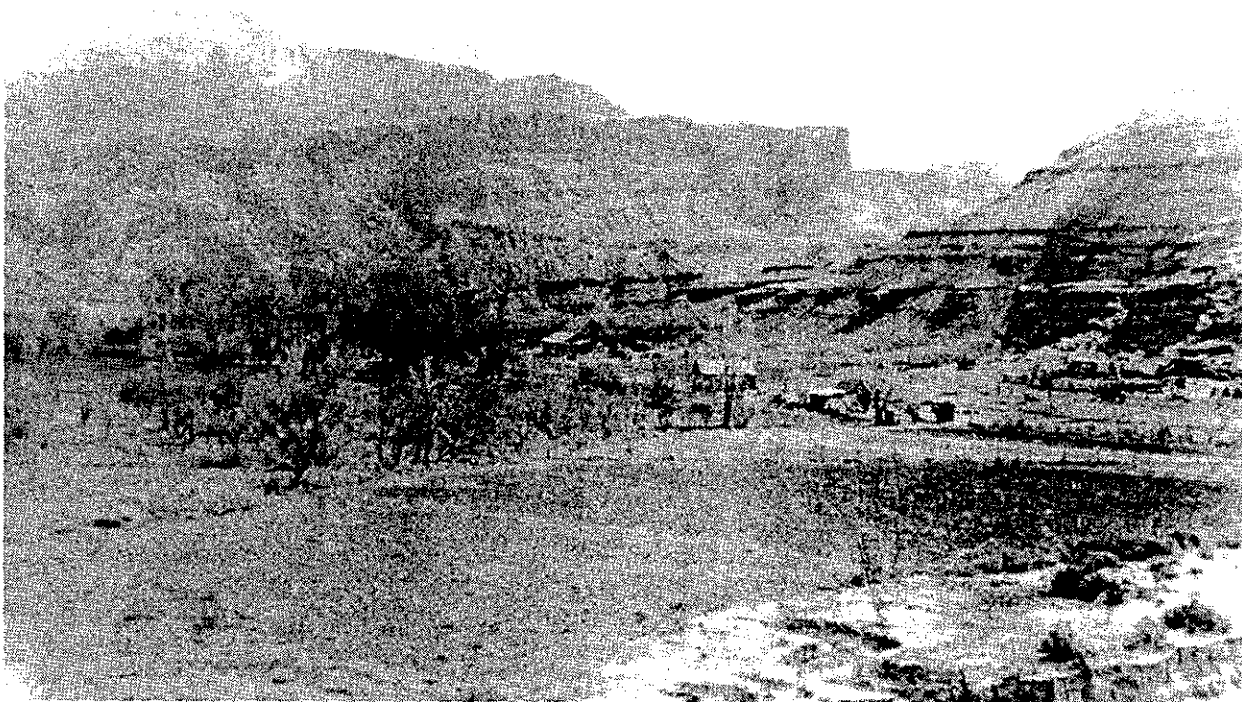
Photograph 10: Lonely Dell Ranch c. 1931

Work done by Weaver at this time included installation of ceiling joists and a paperboard ceiling, rehabilitation of doors and windows, and whitewashing of the walls. It appears that Weaver also removed the north wall of the room addition to form an entry porch for the east door [Photograph 10]. The full nature of the door and window alterations at this time is not known. The north door and screen door were replaced. The ceiling installation involved mortising the ceiling joists into the log wall at either end. Interestingly, the perimeter 2 x 4 ceiling ledger is nailed to the outer wall with cut nails, and fragments of old newspaper were found behind it. The newspaper's type style and subject matter imply publication prior to 1935, but no definitively dated scraps were found. The newspaper and the cut nails would tend to indicate that the loft is 19th century construction. Perhaps this portion of the ceiling framing predates Weaver. Roof materials shown in historic photographs show a smooth, light colored material, which is assumed to be rolled composition roofing.

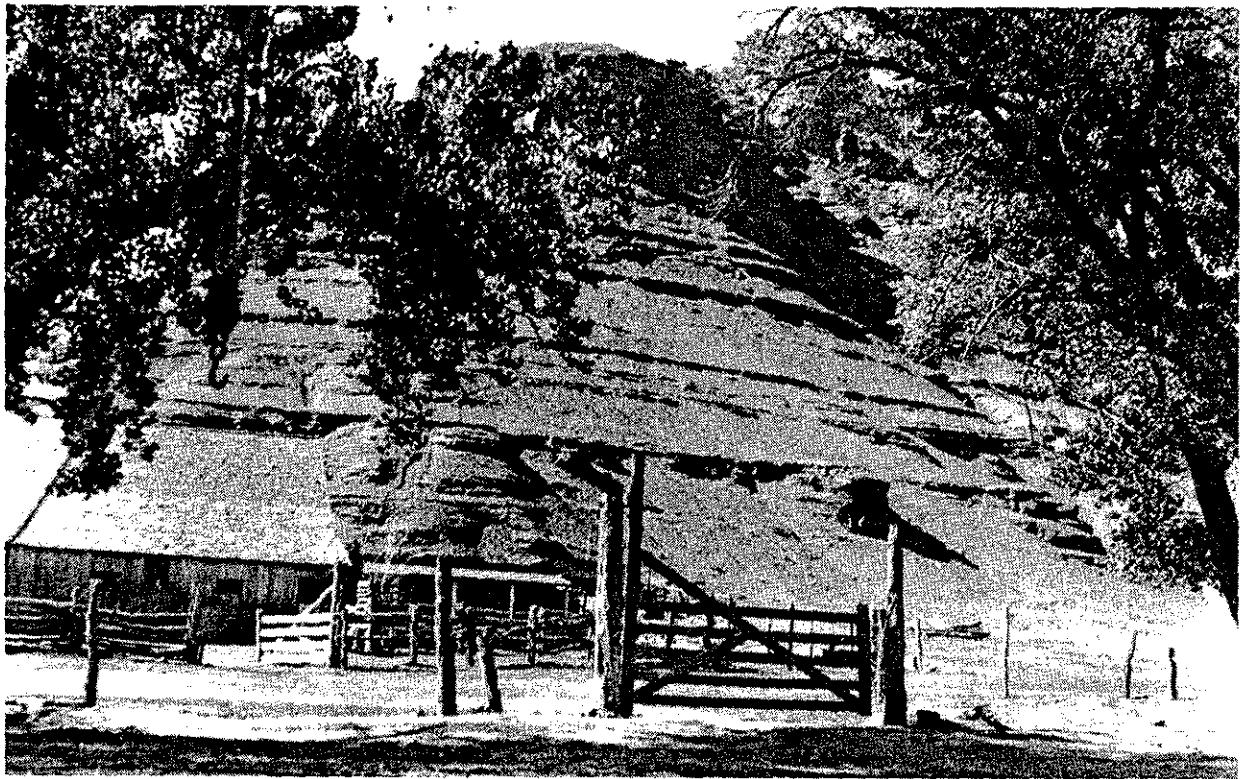
Photograph 11: Lonely Dell Ranch, Barn c. 1936

Alterations during the early part of this period (1940-56) included complete removal of the eastern room/porch addition [Photographs 11 and 12]. It is also likely

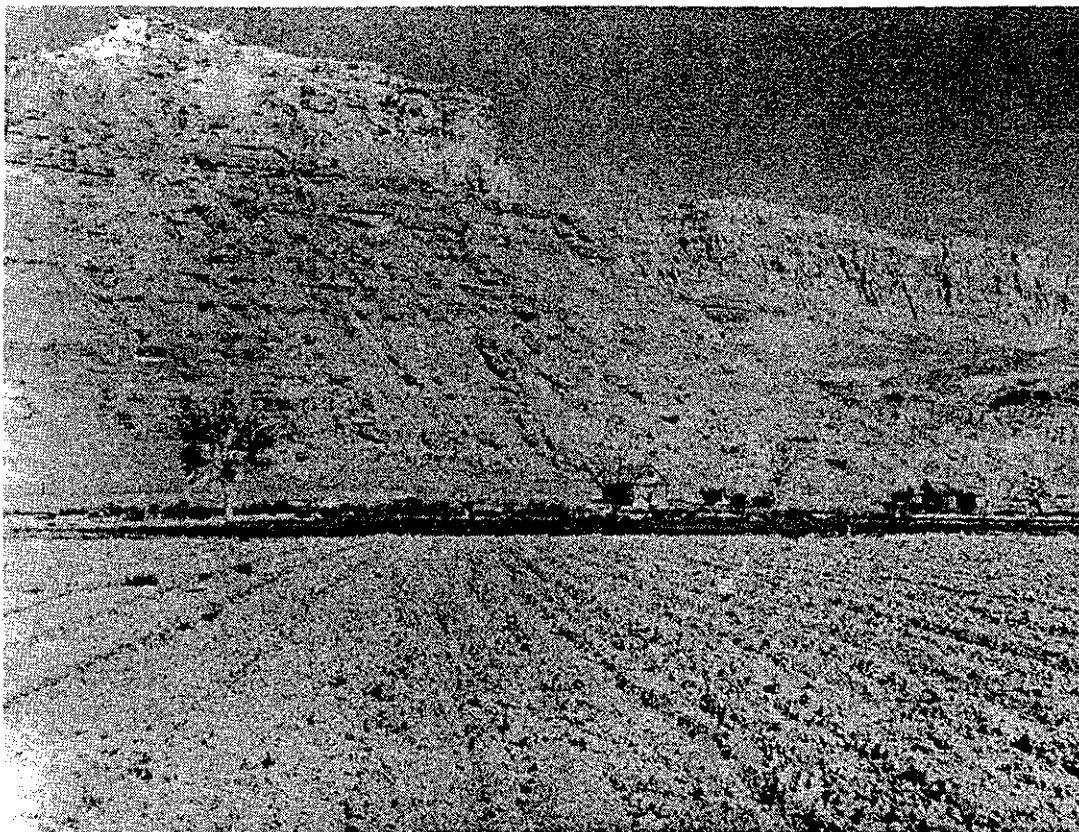
Photograph 13: Lonely Dell Ranch, Jerry Johnson Cabin c. 1936
Cline Library – NAU, P.T. Reilly Collection

Later in this period (1956-64), a new porch was constructed, substantially as seen today except that the posts were originally knee-braced. The trim around the south window was added, and the building (which had lost the Weaver-era whitewashing) was left natural wood except for white trim [Photograph 13].

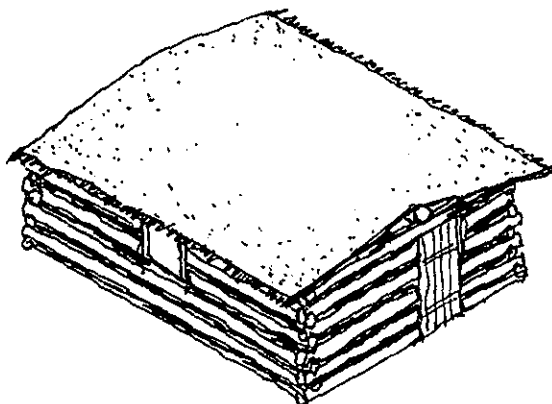
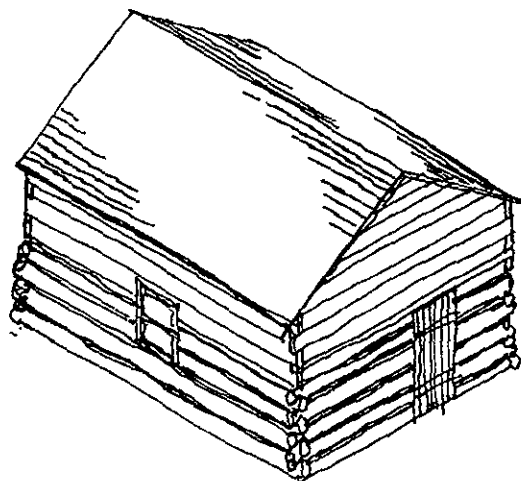
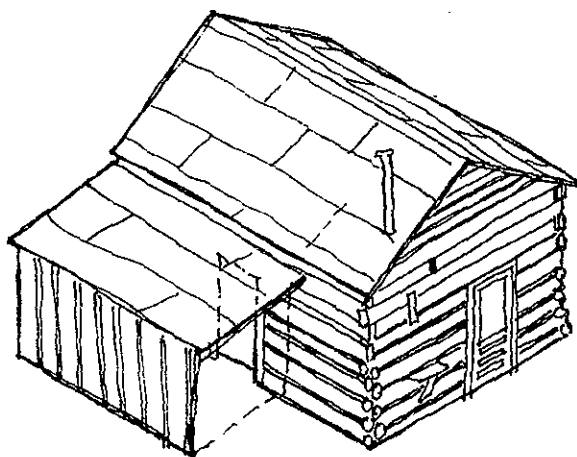
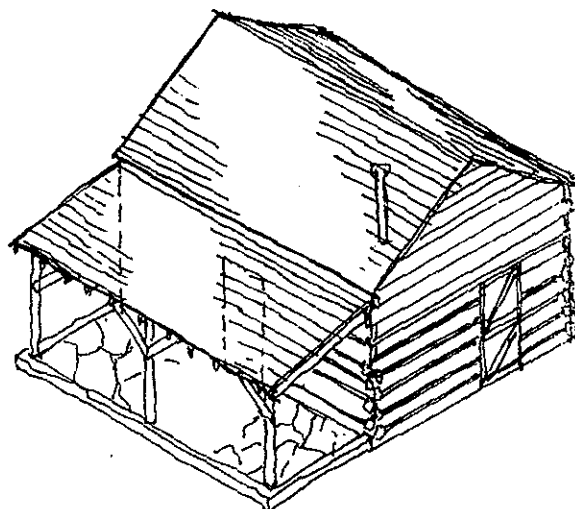
Figure 7: Evolution of Samantha Johnson Cabin

Short log walls, timber and dirt roof, simple doors and windows

Upper walls added, roof added, doors/windows extended, floor installed

(Room addition to side prior to Weaver c. 1930)
Doors and windows rehabilitated, interior rehabilitated (ceiling installed), whitewashed

East porch addition, interior ceiling converted to loft, exterior wood trim alterations

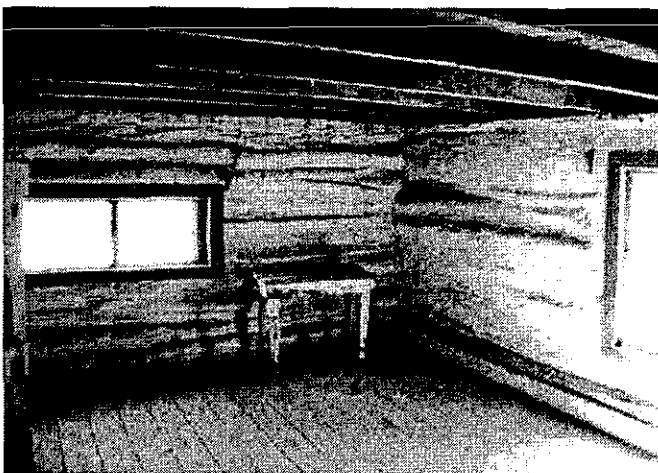
Photograph 33: Interior

A ladder built of rough poles and sticks provides access from the first floor up into the loft. Several rungs have been broken.

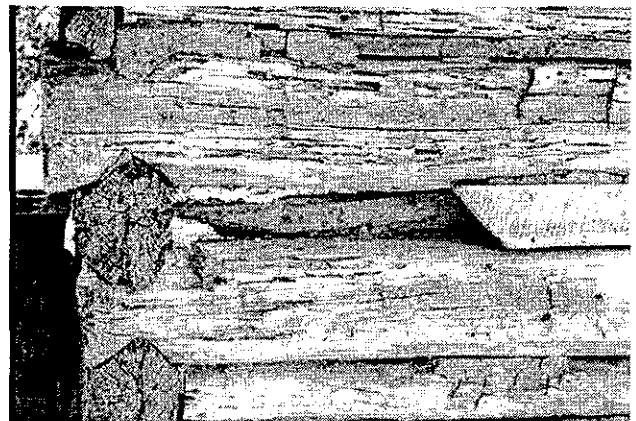
Photograph 34: Detail of chinking

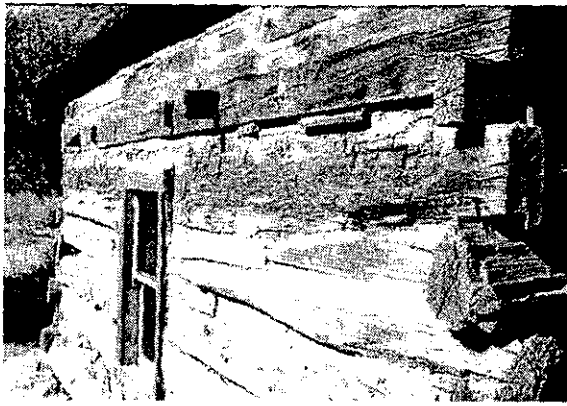
Photograph 35: Salvaged logs at west side

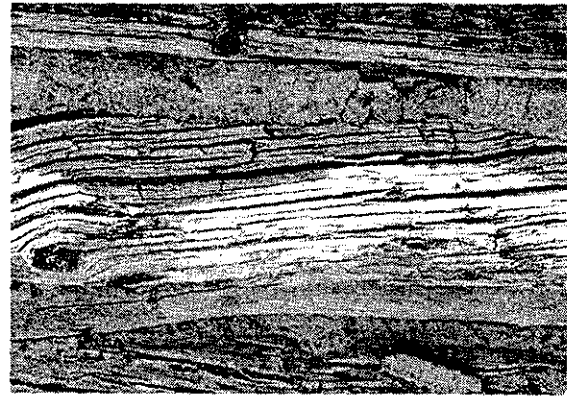
Photograph 36: Detail of log weathering

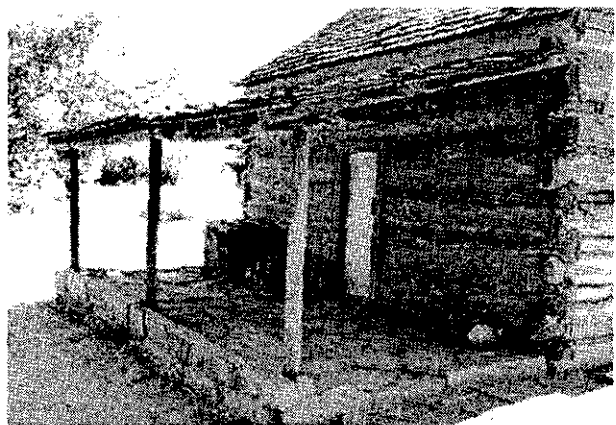
Photograph 40: Late porch addition

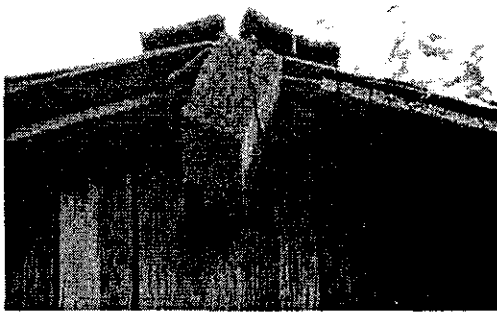
Photograph 50: Detail of twisted ridge beam

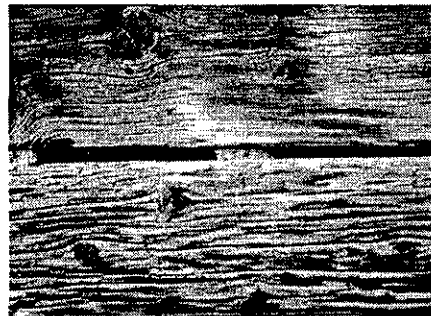
Photograph 51: Detail of log weathering and eroded chinking

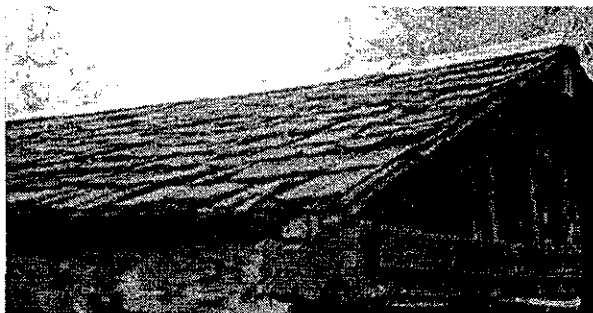
Photograph 52: View of roof condition

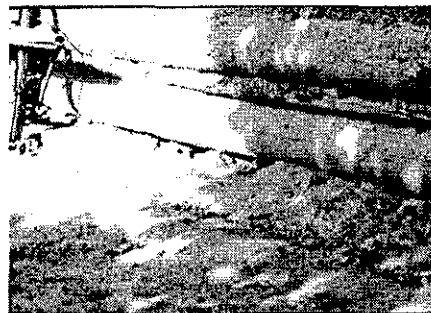
Photograph 53: Condition of wall base

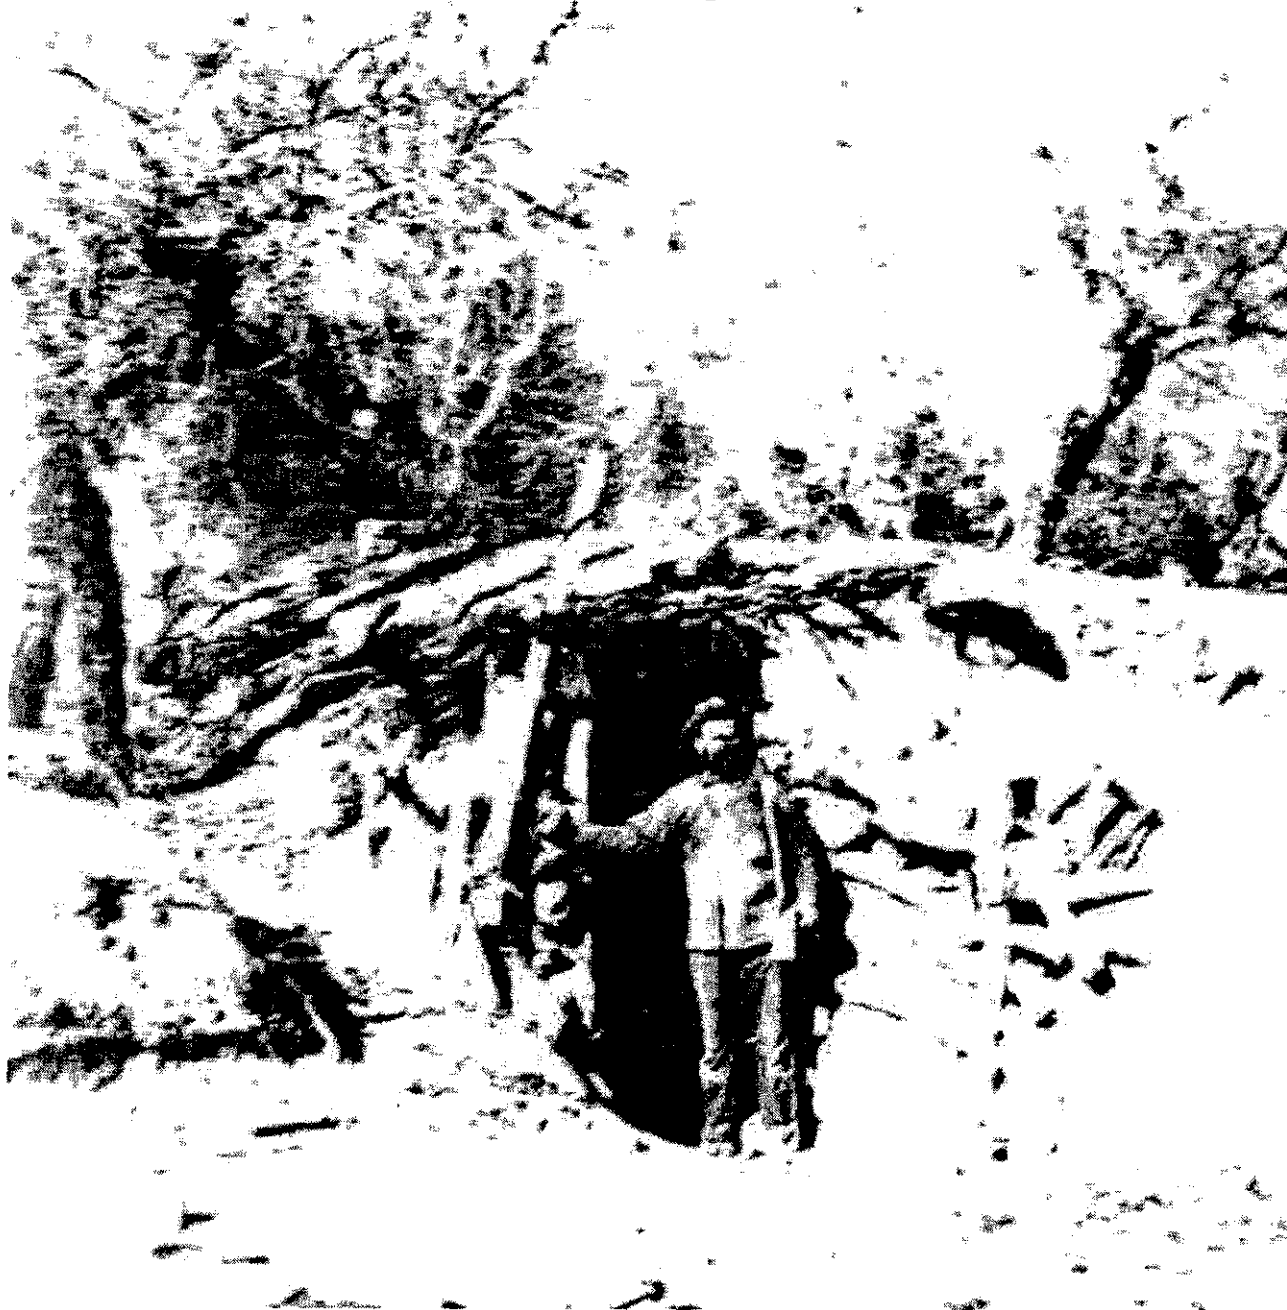
The Stanton Photo [Photograph 62] depicts a much ruder structure than is present today. Although the quality of the photograph is poor, it does not appear that a stone "façade" wall was present in 1898. This feature may have been added at a later unknown date.

Photograph 62: Lonely Dell Dugout, c. 1898.

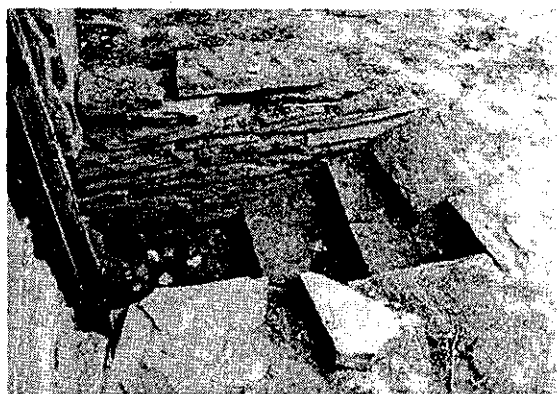
A series of sandstone steps extends from the south side of the building about five feet. Descending into the Dugout, its sides are stone retaining walls. Of the four stone treads, the top one has failed, with the soil under it beginning to slip down into the excavation. The second tread is also beginning to fail. The other two treads have only some edge damage from the years of use.

Photograph 68: Detail of entry steps.

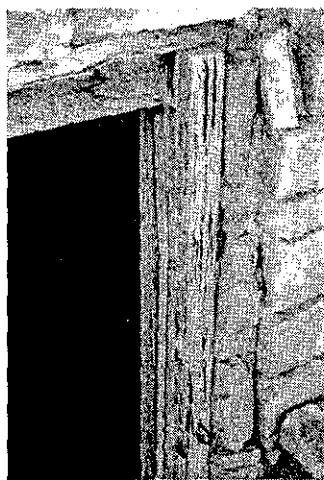
Photograph 71: Detail of damaged door frame.

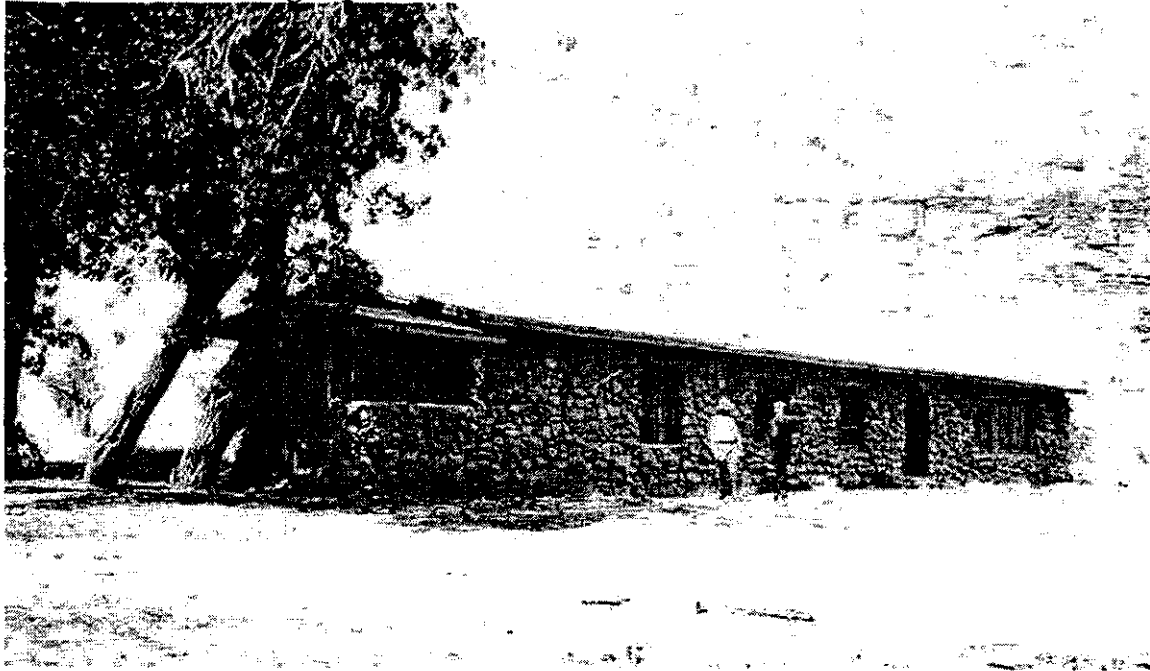
Photograph 77: Weaver Ranch House, 1936

A photograph taken in 1936 shows the completed first phase of the Weaver Ranch House (Photograph 77). The roofing material visible in this photograph is a rolled composition type roof. Restoration would require removal of the steel roof installed in 1982 and re-installation of a composition roof with a mineral surface cap sheet. For maintenance purposes, the roofing system installed could be a modified bitumen type, which would last longer and stay more flexible than conventional built-up roofing, while retaining the same appearance.

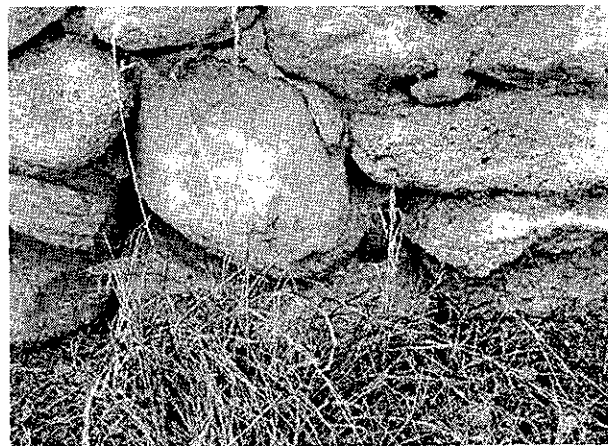
Photograph 91: Detail of joints in stone masonry.

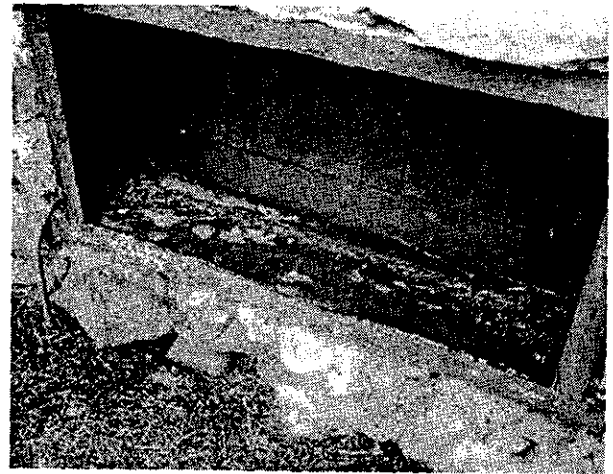
Photograph 94: Pass door for logs by fireplace.

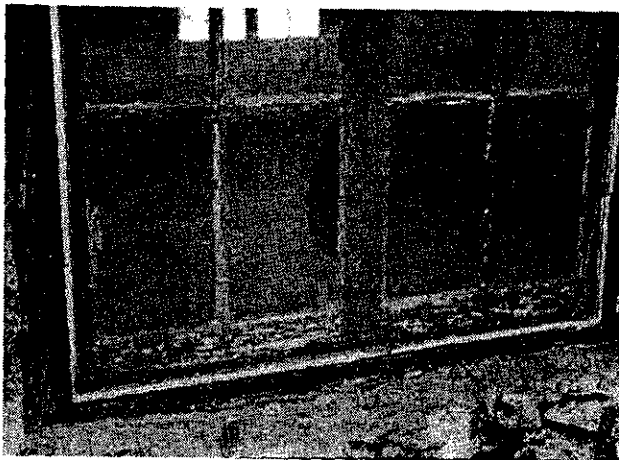
Photograph 95: Weathering of wood windows.

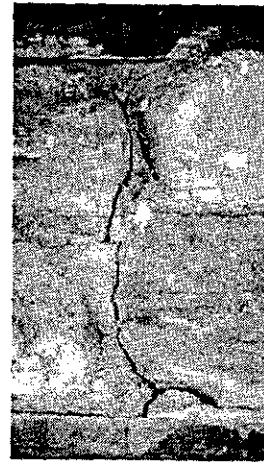
Photograph 96: Typical cracking above door and window openings.

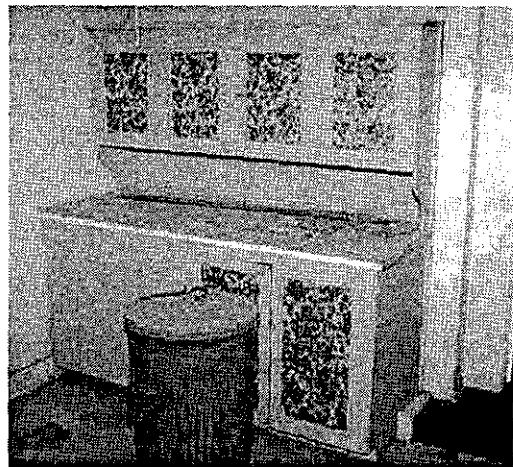
Wooden casework found in the Kitchen also appears to be an original or early feature (Photograph 100, Photograph 102). The cabinets are of painted wood. Contact paper has been applied to the panels, and hardboard paneling was applied over the earlier galvanized steel countertops. Original hardware, including hinges and bin pulls, remains. A work counter has been built around the center post, of wood framing with a shiplap board top later covered in hardboard. A porcelain enamel steel cabinet, matching the drain board, also is found in the Kitchen. The top of the cabinet has had contact paper applied over it. At the 1937 addition, all original interior trim has been replaced with varnished fir boards and varnished finger-jointed door frames.

Photograph 102: Original cabinet in kitchen.

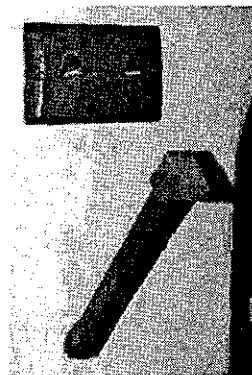
Photograph 104: Missing lamp support.

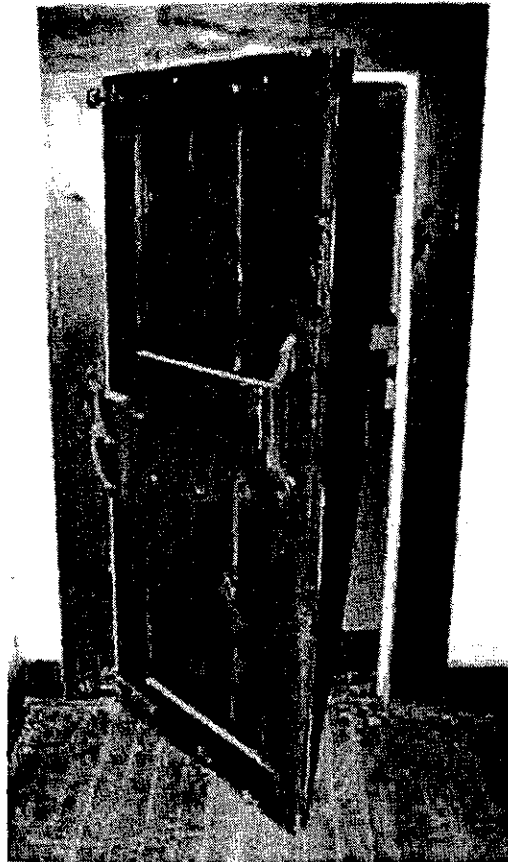
Interior doors vary in design. The door between the Kitchen and the Dining Room is site-built of shiplap wood boards on horizontal rails; hardware is ornamental, including forged iron hinges, a spring closer, a wooden pull handle, and a brass push plate (Photograph 107). The kitchen side of the door is painted while the Dining Room side is stained dark brown. The door is in fair condition, having sagged, and drags on the floor wearing on both the door and the floor. The door from the Kitchen to the side storage room is also field-built of wood planks over a stile and rail back up. It carries original strap hinges and most of a surface latch. This door has been sagging for a very long time, evidenced by the many layers of paint, which have now locked it into a drooping position. The door drags on the floor when more than 45 degrees open. The surface latch is no longer

Photograph 107: Dining Room/Kitchen door.

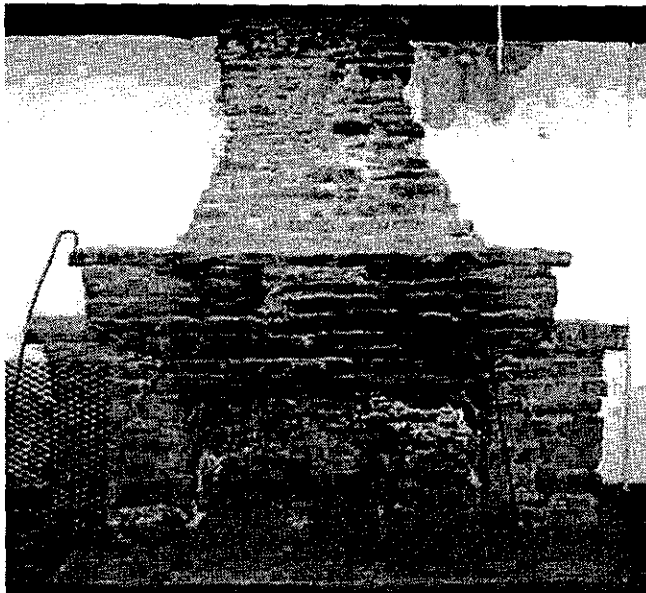
The fireplace in the Living Room is built of rustic ashlar sandstone (Photograph 108). The hearth is covered with sandstone flags. The fireplace opening is quite large. The flue is unlined sandstone and has no damper, although it appears to have a large free area and smoke shelf. The firebox itself has a sandstone lining, which is quite deteriorated in the rear. Some damage has been done to the exposed stonework at the chimney by a (now repaired) roof leak, but the damage is confined to the area above the mantle. With the exception of the mortar erosion from the leak, the fireplace is visually in excellent condition. The unlined nature of the fireplace design probably makes it dangerous to use due to the possibility of flue gasses and/or fire escaping from the chimney.

Photograph 108: Elevation of fireplace.

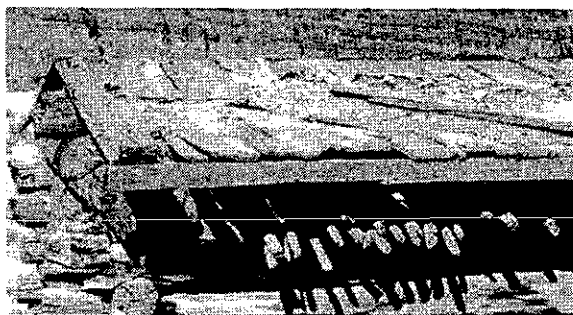
The entire roof structure appears to be non-original and has two layers. The lower layer consists of a central ridge pole, 12 inches in diameter, which spans from one end to the other supporting smaller two inch to three inch diameter latilla poles spanning from the center to each side wall and extending out at the eave about one foot. The ends of the latillas look freshly cut and the majority of bark is still in place on these poles, implying that they are relatively new. Still, above this primitive-looking roof structure is a secondary covering consisting of 1 x 12 boards supported on five continuous 4 x 6 members resting on the latillas cross-wise. The top surface of the boards appears to have been covered in rolled roofing covered in dirt. Little is left but scraps of the roofing and the color is not apparent. Most of the dirt and the rolled roofing is gone today, leaving the board sheathing exposed (Photograph 120). The sheathing is warped, cupped, checked, etc. from exposure to rain and snow and is generally beyond repair or reuse.

Photograph 120: Detail of roof condition.

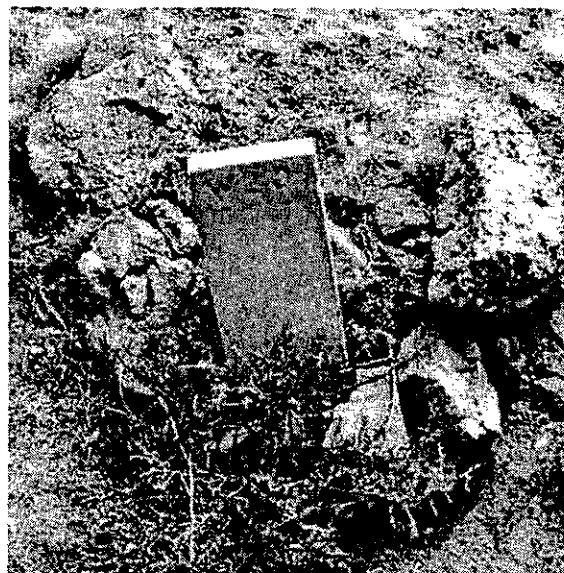
Photograph 127: Winifred Johnson site

The Winifred Johnson marker is of marble. Marble is also commonly used for monuments because of its longevity and ability to resist weathering. This marker is in good condition but could be lost if not mounted to the site (Photograph 149).

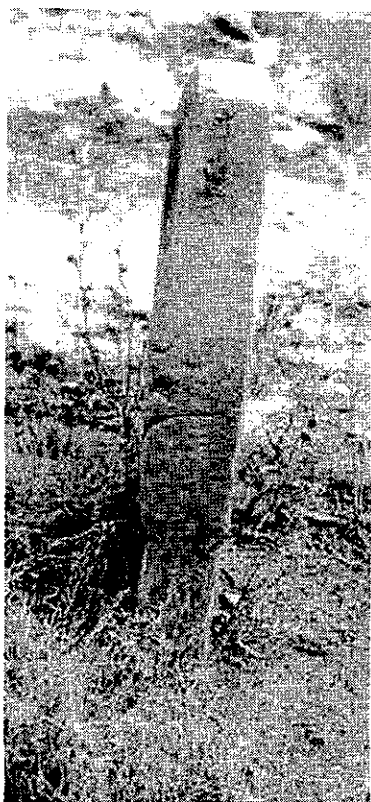
The majority of markers are of native sandstone. Sandstone is relatively soft and porous and thus is subject to weathering. It is also formed in layers, which may delaminate if moisture is allowed to penetrate the edges of the layers (Photograph 148). The Brinkerhoff stone is an example of surface weathering (Photograph 146, Photograph 147). The top part of the stone is in good condition, with a legible inscription. The lower part of the stone has been subject to direct rain and back-splash, as well as rising damp and snow. This has caused a loss of thickness of about half near the base. Many other sandstone markers either had no inscription or it has worn off. They occur in various states of decomposition, from relatively intact stones to ones suffering delamination, to those lying on the ground unanchored.

Photograph 146: Erosion of sandstone

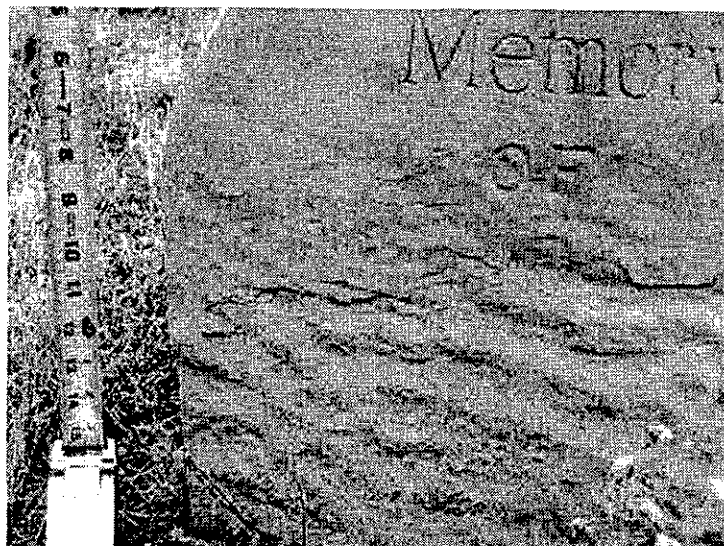
Photograph 147: Erosion of sandstone

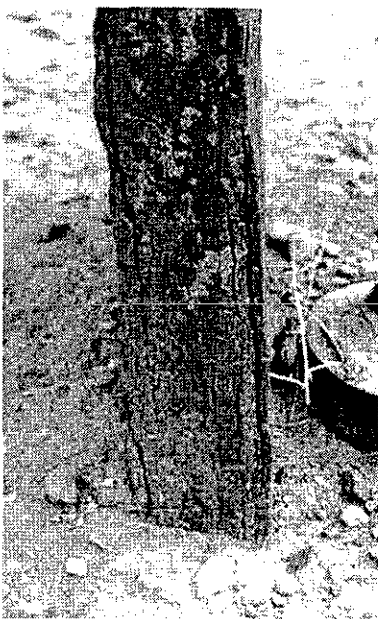
Photograph 148: Sandstone delamination

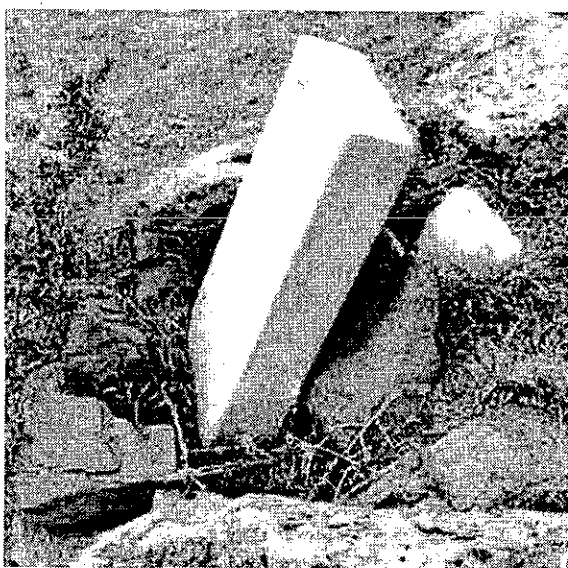
Photograph 149: Headstone not attached to ground

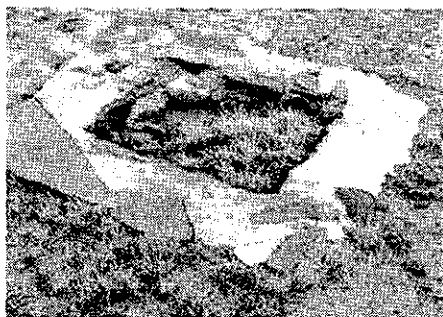
The main visual feature of the irrigation system is the ditch that conveyed water from the Paria River to the fields. The intact portion of the ditch runs from just north of the Cemetery to the southern end of the south field, a total distance of about two thousand feet. The ditch is shaped like a wide "V" in cross section, about three feet in width at the top with a flat bottom. It is lined with sandstone flags, about 1-1/2" thick, most of which are set in portland cement mortar (Photograph 155). Today most of the ditch is filled with silt from floods and/or from cross-drainages. Gates are located at intervals along the ditch, and served to channel water to each field, as it was needed. The gates in place today are constructed of wood 2 x 4s and 1x boards (Photograph 154). Catch basins are located at points where an abrupt change of direction is needed. These features are constructed of sandstone blocks set in portland cement mortar (Photograph 153).

Photograph 153: Stone catch basin at north end

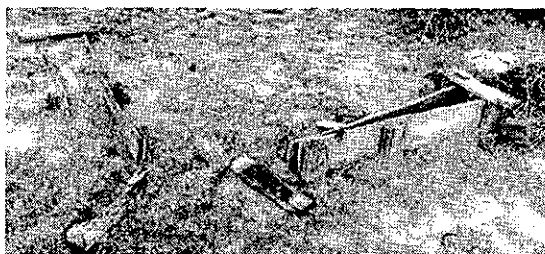
The upper portions of the remaining ditch are about half filled with silt. Most head gates in these areas are collapsing from the weight of retained soil, are silted in, or are deteriorating from rot and/or insect damage. These gates will probably be lost in the near future if not stabilized. In general, the irrigation ditch is suffering deterioration from several causes. Some areas are damaged from ground movement. Tamarisk trees are growing along much of the ditch alignment, damaging or displacing stones with their expanding trunks and root systems. Just to the south of Jackson's Cabin, a small wash crosses the ditch from west to east. This was previously accommodated by channeling the wash into a corrugated steel pipe that crossed the ditch (Photograph 158). Due to lack of maintenance, the wash bypassed the pipe and flooded the ditch with sediment (Photograph 157). The ditch has been completely covered over at the crossing point, and the silt depth tapers off gradually in both directions.

Photograph 154: Typical wooden head gates

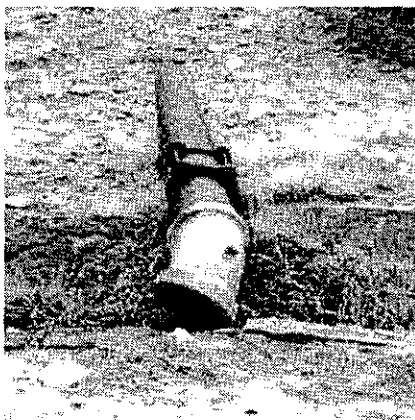
Photograph 156: Modern fill pipe no longer used

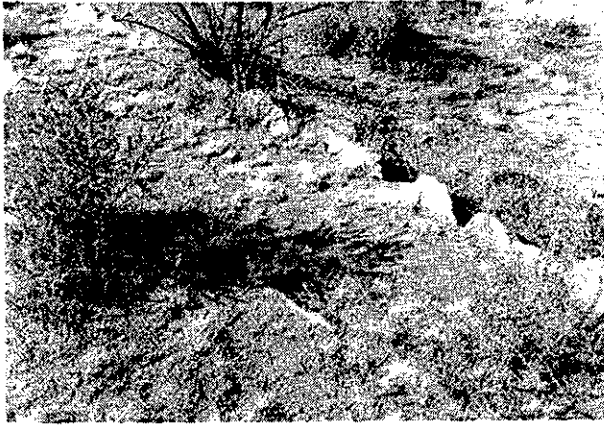
The center segment of the ditch system is in a fair state of repair, having been kept in use in recent years. This area starts just north of the Ranch House compound, where the ditch is fed from a pipe leading from storage ponds above on the hillside. The ditch continues south, splitting near Emma's Cabin to supply the lawn area south of the Weaver Ranch House. The main trunk of the ditch passes west of Emma's Cabin, continuing to the south fields. At the south field, the ditch is once again silted in from cross drainage. Most of this silt appears to come from runoff from the access road that parallels the ditch. Some lengths of the ditch are completely covered with silt. The ditch re-

Photograph 157: The ditch is silted-in in several places.

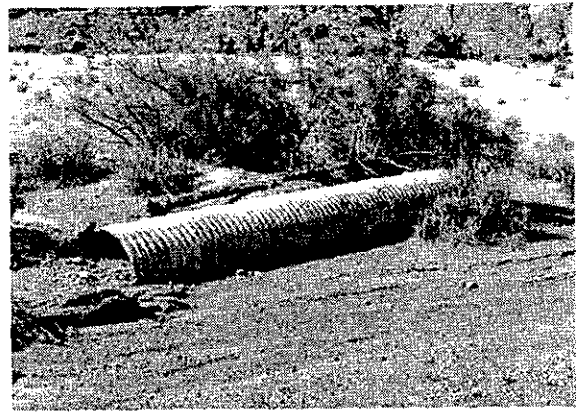
Photograph 158: Culvert formerly used to conduct cross-drainage over the ditch

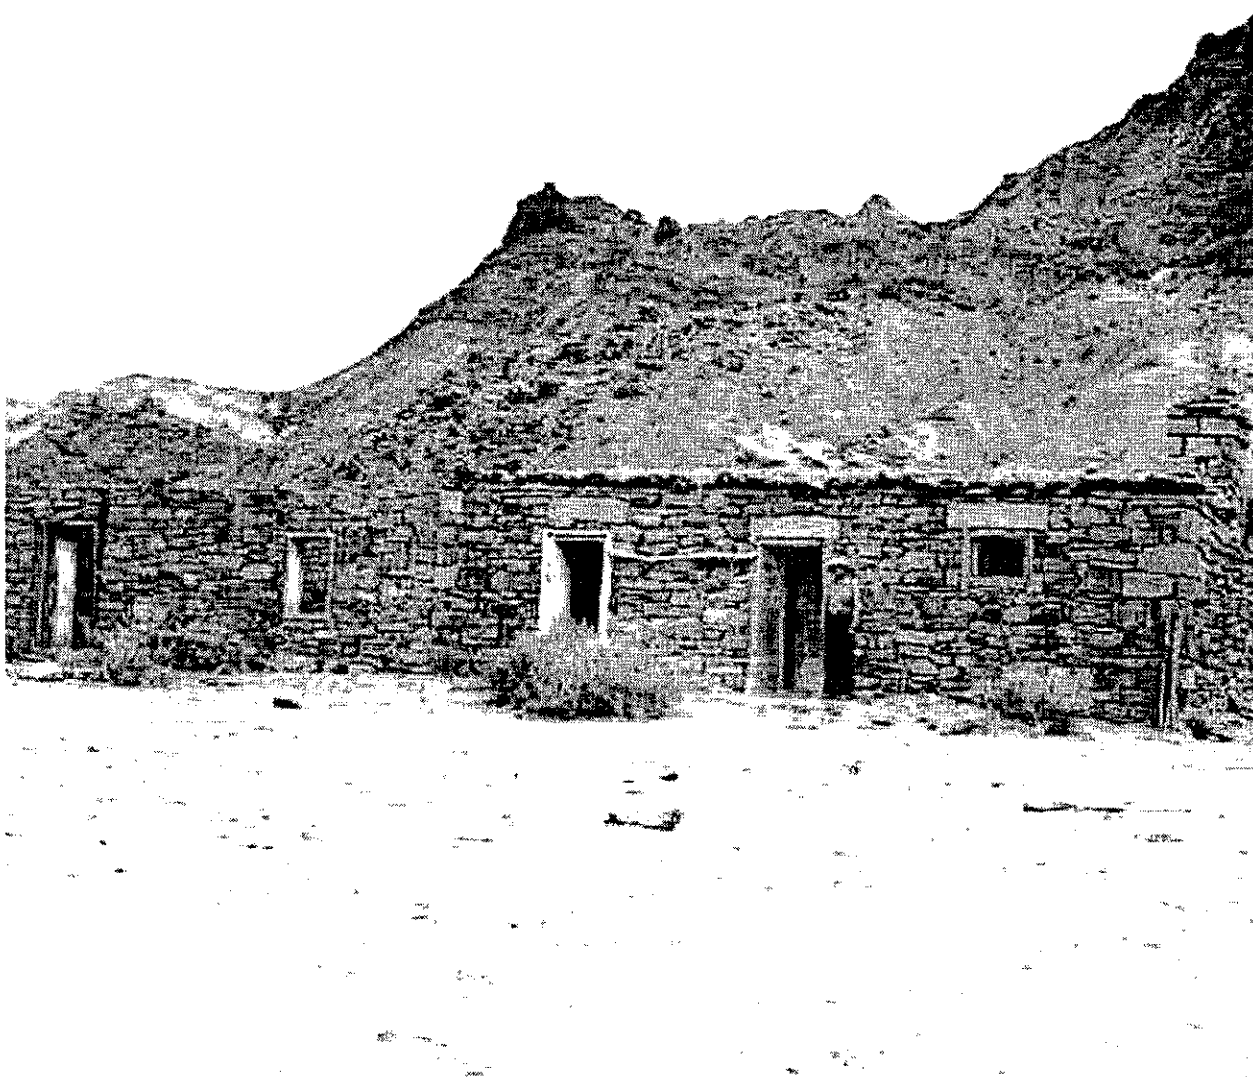
Photograph 180: Lee's Ferry Fort with a partially demolished Spencer addition c. 1948.

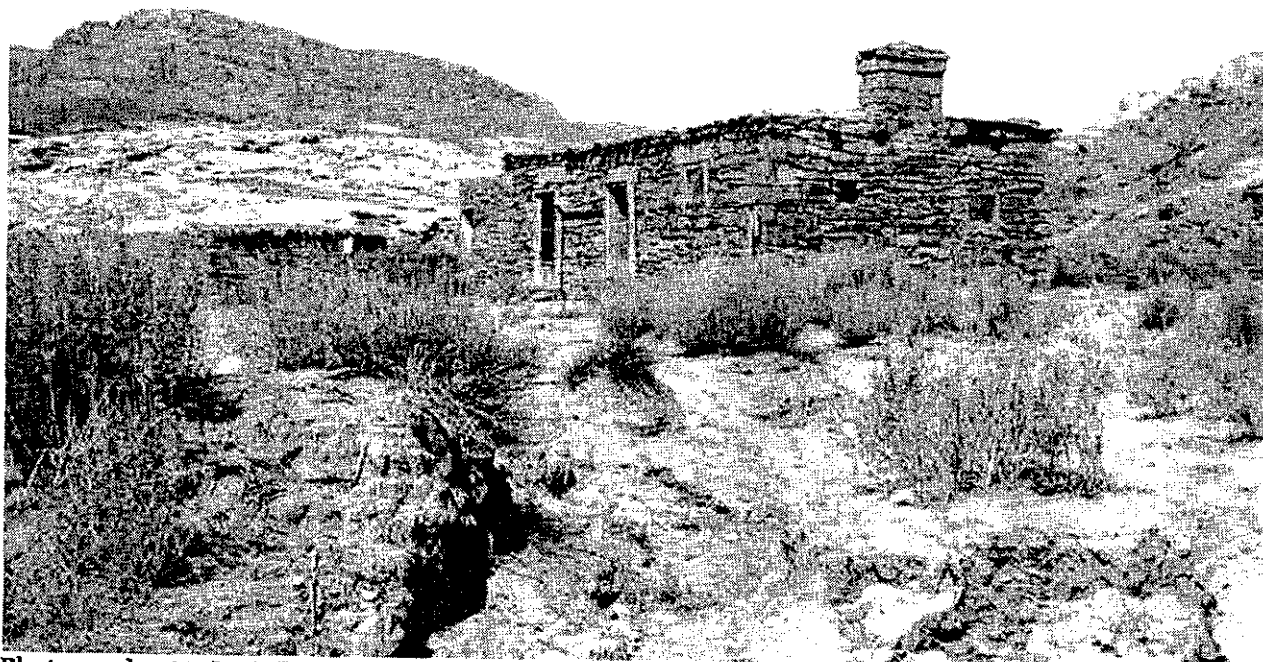
Photograph 181: Lee's Ferry Fort after abandonment c. 1959. Note Spencer addition with roof removed but otherwise intact.
University of Utah, Crampton Collection

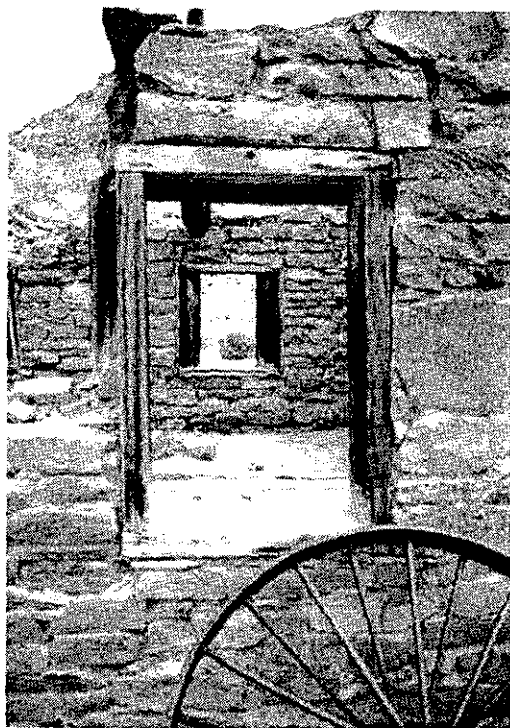
Photograph 187: Spencer Addition window frame supporting stones

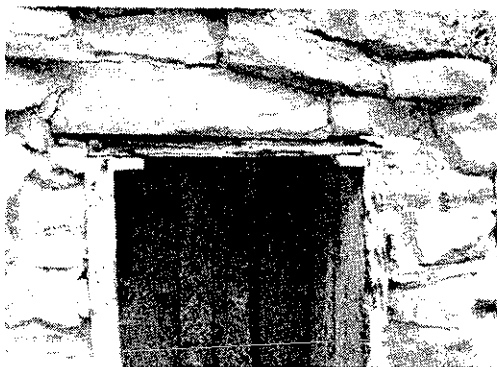
above. There is no door, but the opening is protected by vertical iron pipes set in a 3 x 12 frame in order to allow public viewing while providing security. There is no screening or other feature that will keep out bats, which apparently inhabit the building (see following discussion regarding roof structure). One additional door was cut into the north side of the building, directly adjacent to the Root Cellar location. The door is narrow and short, and is presently boarded up with 1" thick dimensional lumber. The frame is of 2 x 12 construction. The lintel is warped and sagging, and much of its face shows significant termite damage. There is some loosening of stones above the lintel (Photograph 189).

Photograph 189: Lintel at rear door.

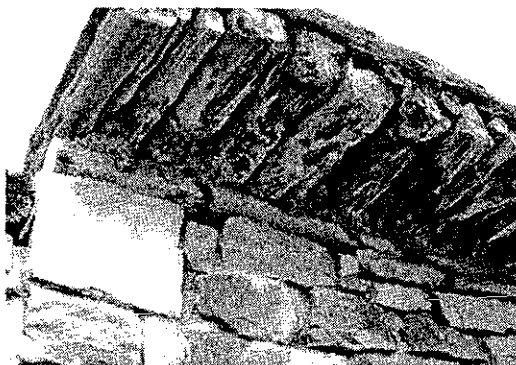
Photograph 190: Condition at reconstructed eaves.

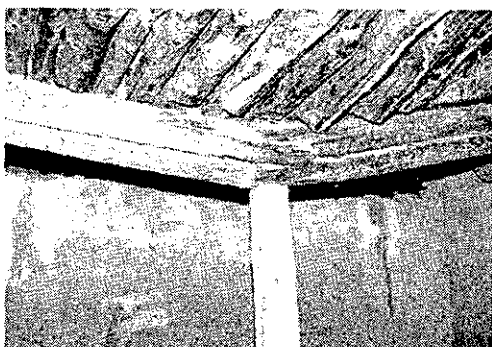
The roof structure of the original part of the fort consists of five large poles running lengthwise (east-west) at the west room and six logs running the same direction at the east room, avoiding the centered fireplace at the east end. Two of the beams rest atop the north and south walls; an interior bearing wall supports the other beams at the center of the building. Tapered pole latillas, tapering from about four inches to about eight inches in diameter, span between the major poles in alternating directions (Photograph 190). While the major poles are weathered gray and may be original, the thinner secondary poles appear to be new except for the center bay of the east room. The space between the smaller poles at the eaves is chinked with mud. Much of this chinking has fallen out, allowing bats to enter and live inside. The result of this bat infestation is a continuing deposition of guano, primarily on wall surfaces and on the floors. One of the major log beams has failed in the west room and is now supported at the point of failure by a 4 x 4 post (Photograph 198). The resulting low spot in the roof has caused a severe and worsening moisture problem by retaining ponding water, which eventually leaks through the roof assembly into the interior of the building (Photograph 191). This condition will also lead to progressive failure of this entire area of roof structure.

Photograph 191: Collapsing roof structure supported on shoring.

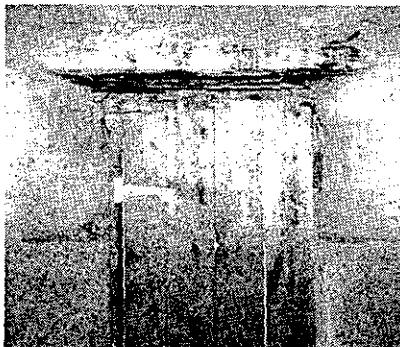
There are two door openings at the south side of the original fort. Large lintel stones span each opening. The west opening appears to have originally been a gun-port window similar to the remaining loopholes (Photograph 192). The present door assembly includes 1 x 16 jambs supporting a lintel of two 2 x 8s. The space above is filled with an additional 12" of stone masonry supported on the wood lintel, which is now sagging substantially. The sill is composed of three 2 x 8s, side by side. At the interior, the jambs of the top two feet of the opening are splayed, reflecting its original function as a loophole. The door within the opening is built up of four planks on a "Z" frame. The east door consists of a modern sheet of plywood within a frame of 1x wood boards. The frame is boxed out such that it projects forward about 6" from the face of the stone wall (Photograph 188). While the plywood is obviously a temporary feature, the frame was probably modified by Spencer in order to accommodate a new door and an outward swinging screen door. Today this frame is in deteriorating condition due to insect and water damage. A wood plank door is stored inside the building (Photograph 196); early hardware is in evidence, consistent with dating this door to 1910-1920, e.g. the Spencer period. At the west wall of the original fort, a door was cut into the masonry in order to gain access to the Spencer addition. A composite wood lintel composed of a 2 inch thick and a 1 inch thick piece of lumber nailed together supports this opening. This lintel is sagging, although there is little damage as of yet to the stone masonry

Photograph 192: Interior of door converted from old loop-hole

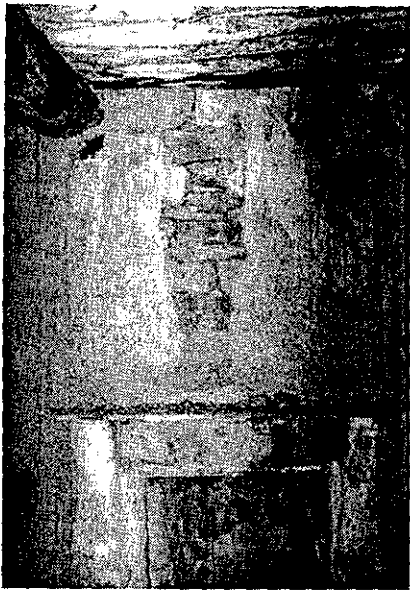
Photograph 193: Wall erosion above fireplace

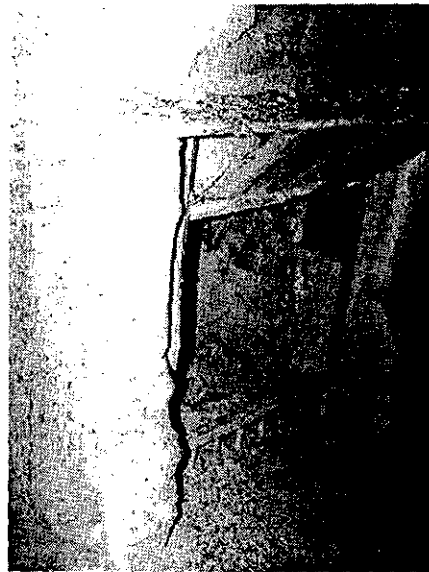
The fireplace is of unlined stone masonry. A metal mantel assembly has been constructed over the fireplace opening out of sheet metal and angle iron (Photograph 194).

Photograph 194: Fireplace and metal shelf.

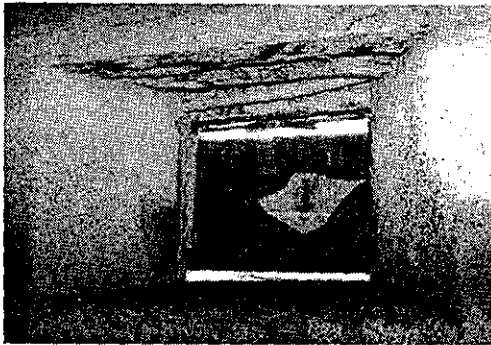
Four loophole windows are provided in the main room of the fort. These were enlarged to full windows in 1899, and then restored by NPS back to loop holes in 1976-7 (Photograph 195). There are no frames or enclosures of any kind at these features. Bats evidently gain access through them. The Spencer addition has a number of remains of original wood windows in place in the ruined walls. One of the windows is warping, its lintel supporting a remaining roof beam.

Photograph 195: Interior of typical loop-hole window.

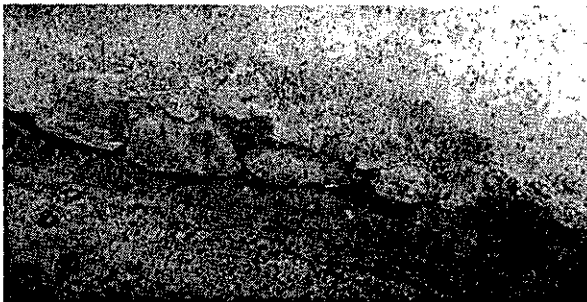
Photograph 197: Erosion at base of interior side of wall.

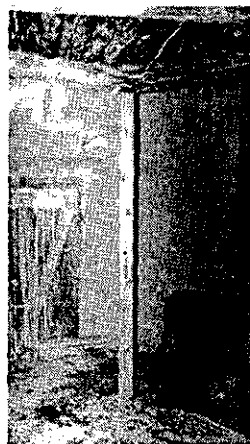
Photograph 198: Structural shoring in the west room.

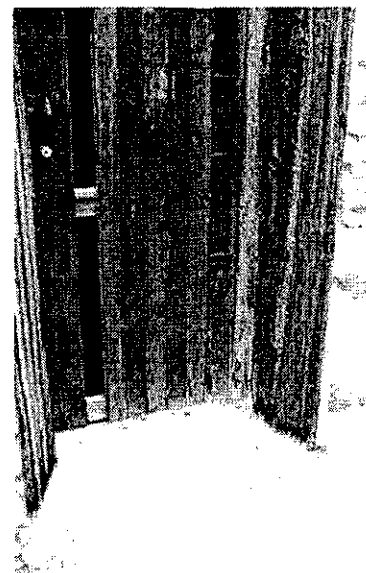
The door frame is built up of finished lumber and is splayed outward at the jambs. The lintel consists of a 2" thick board with a 1" thick board nailed to the bottom. The entire door frame and lintel is set in portland cement mortar. The lintel has not sagged and there is no damage of the stonework above the lintel. There is a wooden sill at the base of the door opening, which is quite worn (Photograph 212). The splayed jambs are severely weathered as well, although damage appears to be limited to the surface. All wooden elements of the frame were painted white at one time, but almost all of this paint has weathered off. The door of the building is built up of 3/4" x 3-1/4" wide T&G boards nailed to horizontal 2 x 4 rails. One board is missing. This door appears in the 1969 HABS drawings.

Photograph 212: Entry door.
