Historic Structures Report:

Lee's Ferry and Lonely Dell Ranch

Glen Canyon National Recreation Area,
Arizona

**AA Project No. 1084
September 2000**

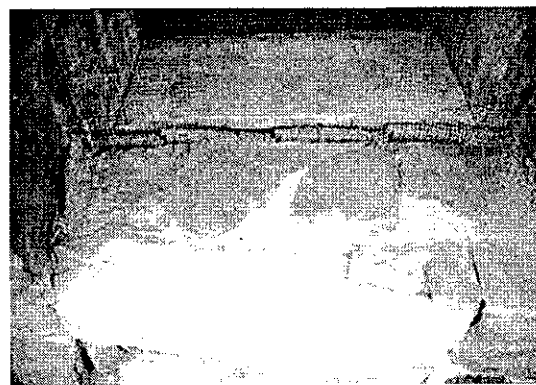
Photograph 214: Sill at north window.

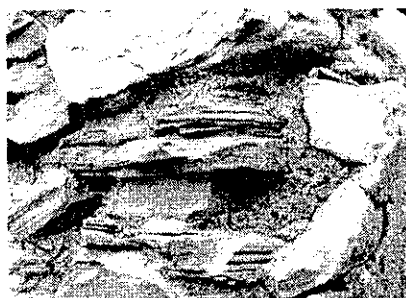
Walls are of red sandstone, 1'-6" thick and about four feet high. Stonework and masonry appear substantially the same as the 1969 HABS drawings. portland cement mortar pointing is in evidence throughout the structure (Photograph 223). The portland cement does not appear to be very deep, but rather was applied as a coating of sorts over the earlier mud mortar. As of yet, there is little evidence that the portland cement has resulted in any damage to the sandstone.

Photograph 223: Detail of
masonry joints.

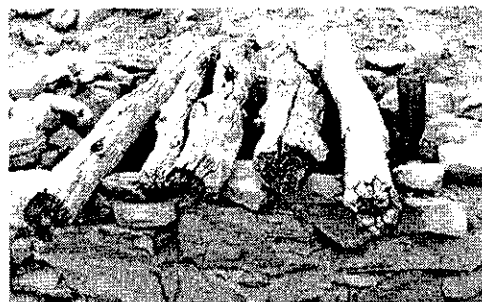
The roof structure as it appears in early photographs and in the 1969 drawings consisted of five logs or poles. Two poles were placed horizontally atop the side walls. Two other poles spanned between them. The last pole ran down the center ridge of the roof, supported by the intermediate poles. This basic structure was then covered with latillas and earth fill. Today it appears that the five same poles remain, but all five are simply running from side to side (parallel) and there are no signs of the latillas or the dirt roof (Photograph 224).

Photograph 224: Roof timbers.

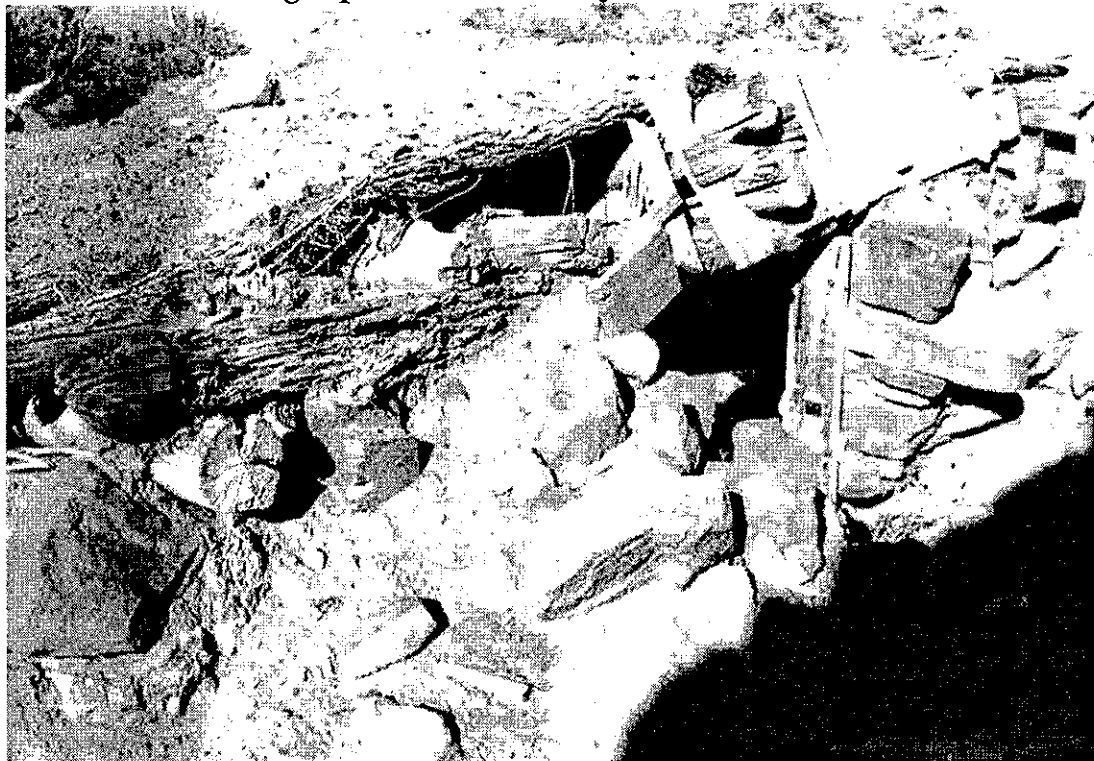
The root cellar was in a ruined condition when the Park Service took over the property (Photograph 225, Photograph 226). It was stabilized along with the Fort in 1967.

Photograph 225: Root Cellar entry prior to collapse, c. 1959.

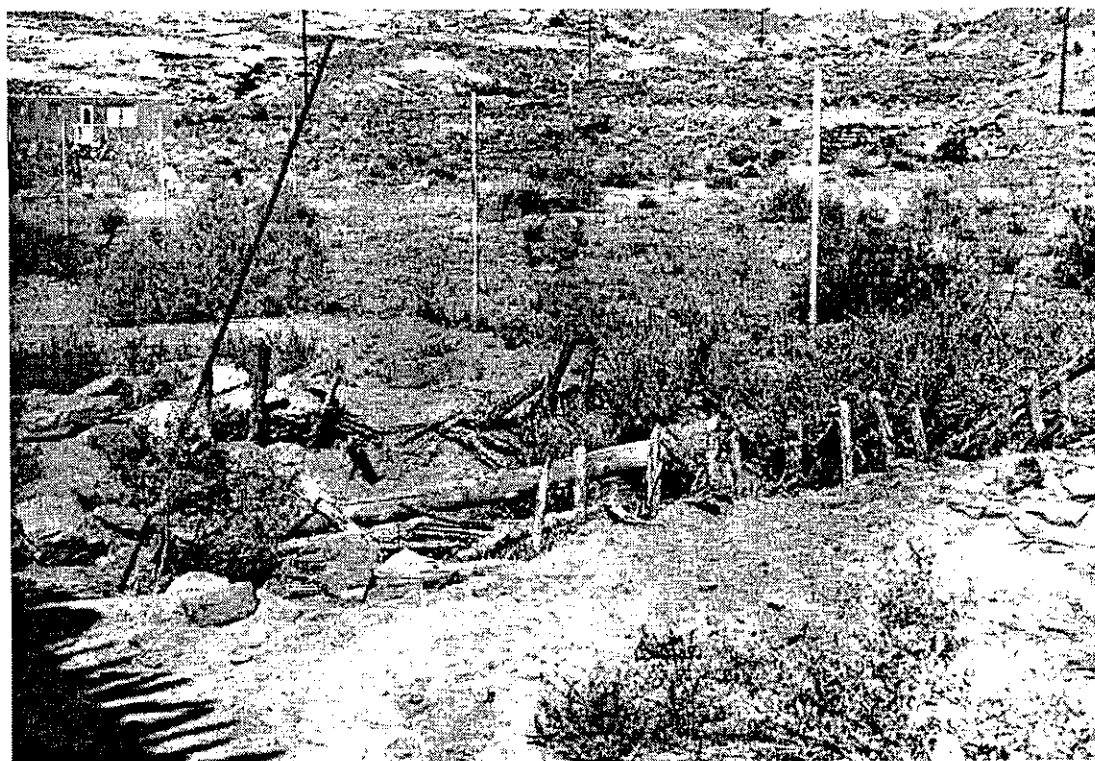
Photograph 226: Root Cellar c. 1976.

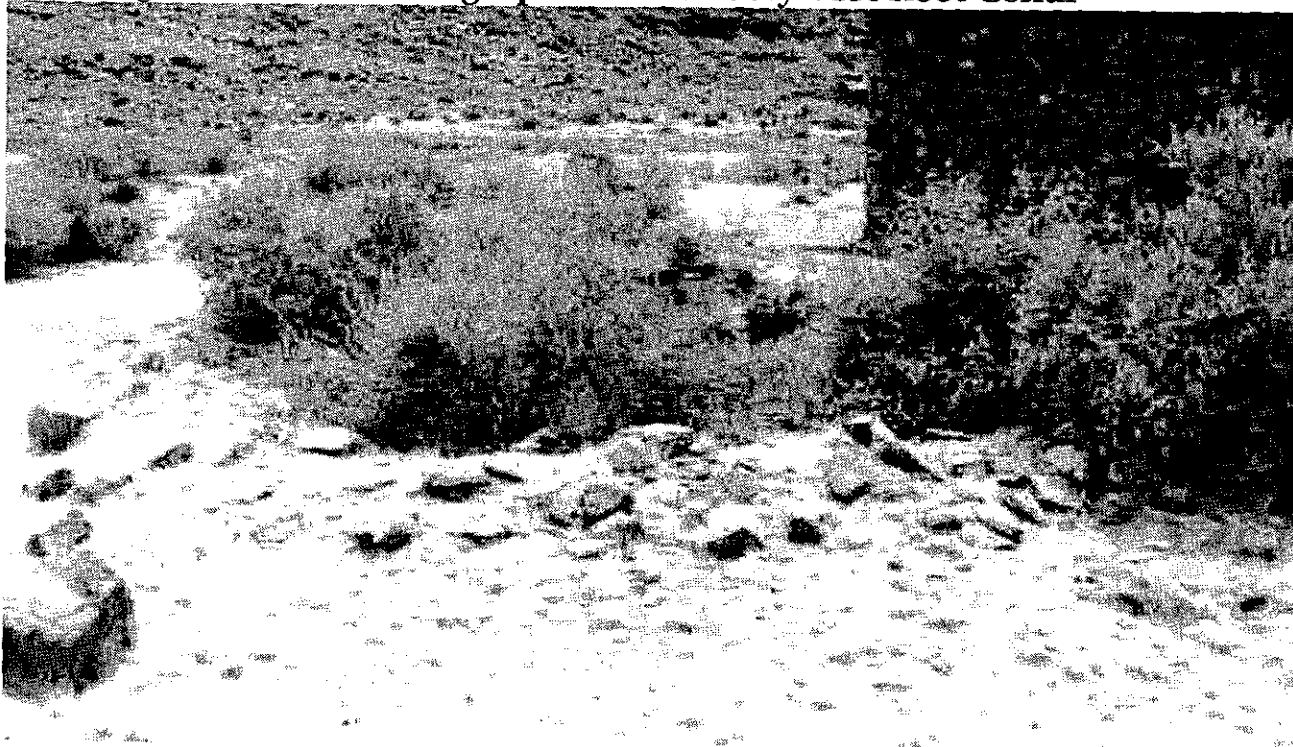
All that remains of this structure is a shallow pit bordered irregularly by stones, and overgrown with brush (Photograph 227, Photograph 228).

The Root Cellar site is heavily obscured by vegetative growth. This growth also may deteriorate sub-surface features through root action.

Photograph 227: Root Cellar site, looking southeast.

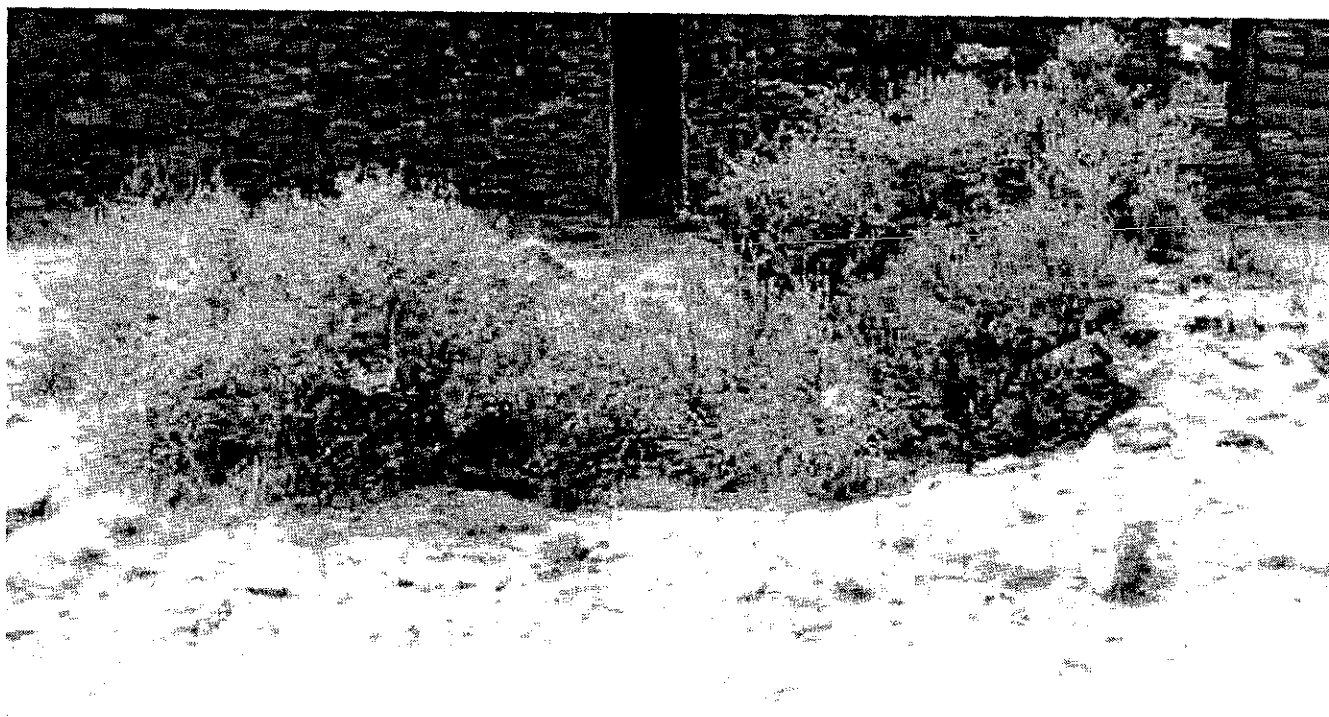
Photograph 228: Root Cellar site looking south.

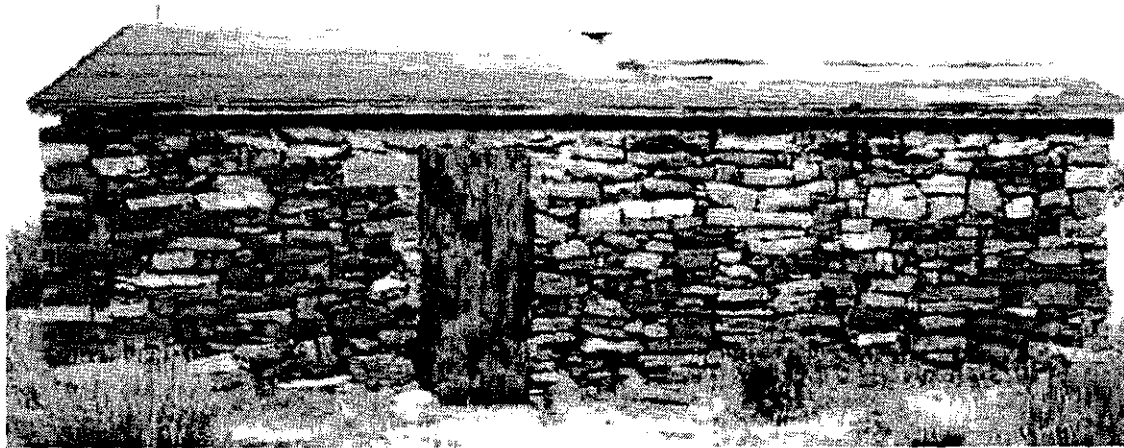
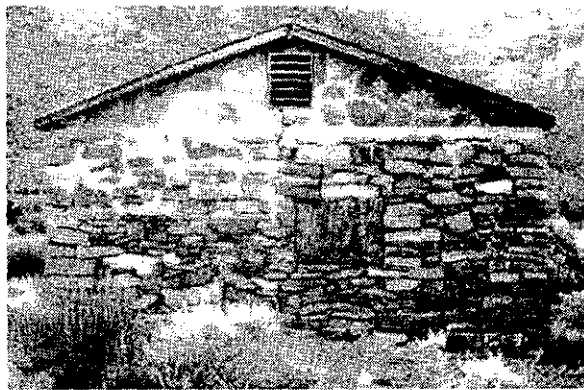
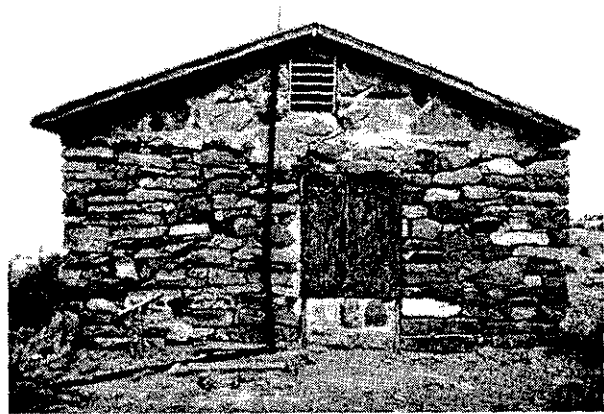
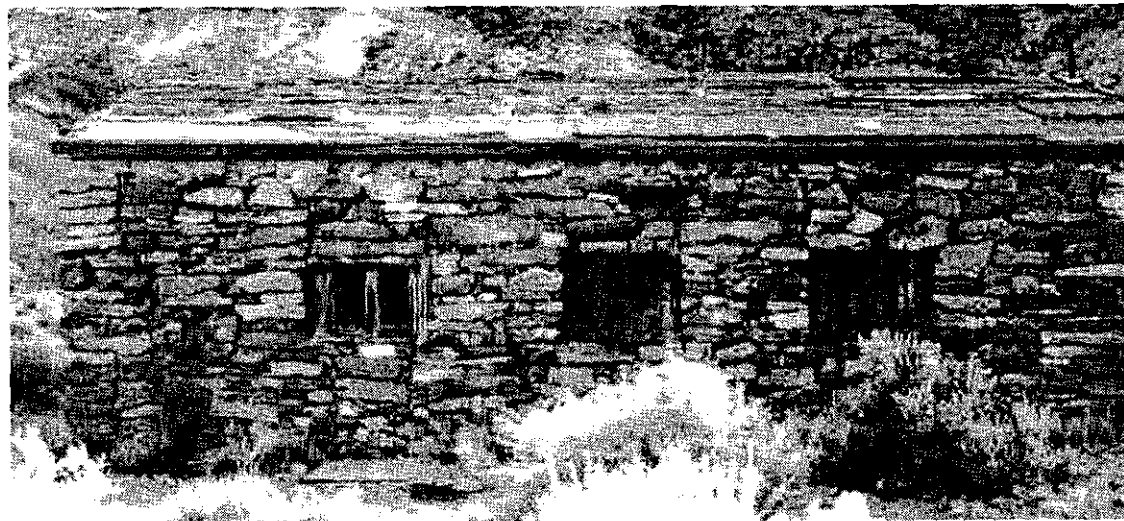
The Spencer Building is a single story stone building with a rectangular plan measuring 18 feet by 30 feet (Photograph 230 through Photograph 233). The roof structure forms a gable on the sides, and is framed of conventional dimensional lumber. The entry door faces north. Five windows are placed on the other three facades. The interior has a concrete slab floor and exposed stone walls. A wood framed partition faced in paperboard encloses a restroom. The ceiling most recently was paperboard over the wood ceiling joists, but most of this has fallen, exposing the roof framing.

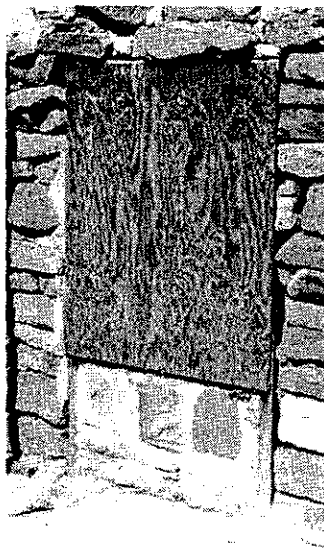
The stonework around the entry door perimeter has all been set in portland cement mortar, a result of alteration by USGS. Likewise, the east window was a door opening prior to rehabilitation (Photograph 235). This window opening was not provided with a formal lintel, but the wall above was simply supported on the wood window frame. This has resulted in a severe crack in the wall that extends all the way up to the roof line (Photograph 234). A similar crack also occurs at the west wall, beginning at the ground, passing through the window opening, and extending to the roof line (Photograph 238). This crack has been repointed numerous times in the past but recurs. Examination of the interior side of this crack reveals a severe structural separation of about ½". A portion of the north wall stonework adjacent to the entry door, an area of about two square feet, has collapsed outward because of mortar joint erosion (Photograph 236). Several stones are also missing from the east gable end wall above the attic vent. Wood lintels over all windows and doors are generally severely deteriorated from water and insect damage. They are sagging due to the weight of 2 to 2-1/2 feet of stone masonry above them.

Photograph 235: East window opening.

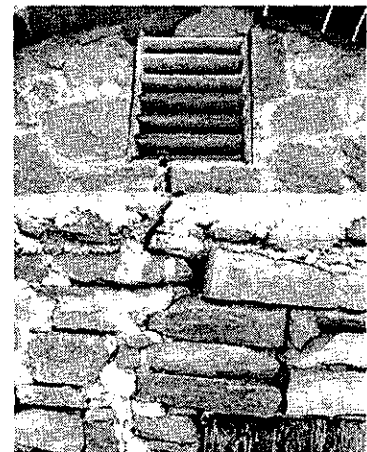
Louvered attic vents at each gable are fabricated of 1 x 8 lumber with insect screen (Photograph 234, Photograph 238). The jamb pieces of the western attic vent are spreading apart, probably due to the widening of the wall crack that passes through the attic vent opening.

Photograph 238: Crack through west vent.

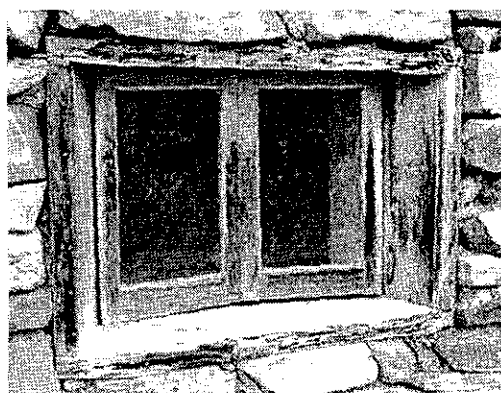
Windows are paired single-light casements (Photograph 239, Photograph 244). There are five window openings. The frame of each window supports the stone masonry above, and is in poor condition, sagging under the weight. Most of the windows are boarded up. All appear to be in a weathered condition, with deteriorated paint, sash, and glazing putty, particularly on the lower parts of the windows.

Photograph 239: Typical window.

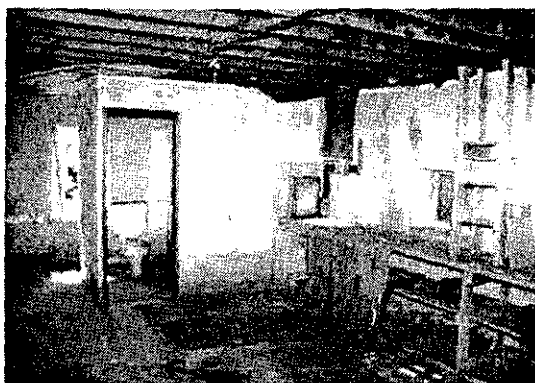
The interior, originally a single space, has had one corner partitioned off for a bathroom (Photograph 241). A work bench or countertop which also carries a sink has been added along the south wall (Photograph 242). In general, the interior is severely deteriorated due to roof leaks.

Photograph 241: Overview of interior, looking southeast.

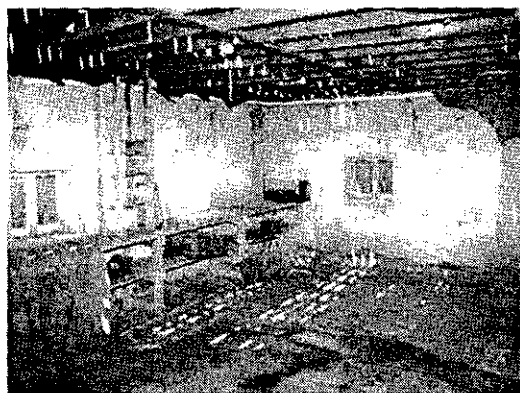
Photograph 242: Overview of interior, looking southwest.

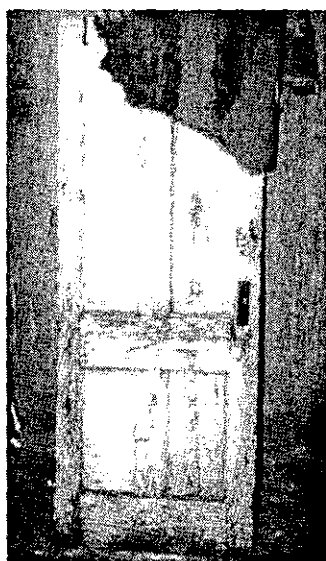
Photograph 243: Entry door stored inside.

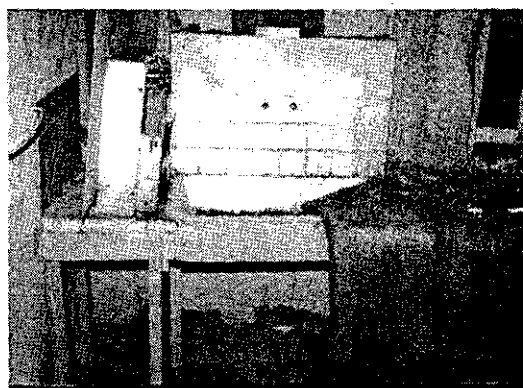
Photograph 245: Work sink in bench.

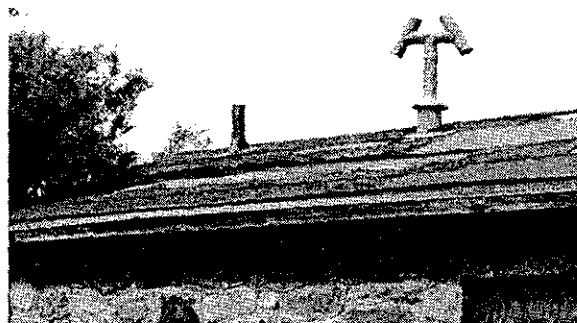
admitting rainwater into the building (Photograph 253).

Photograph 253: Roof condition.

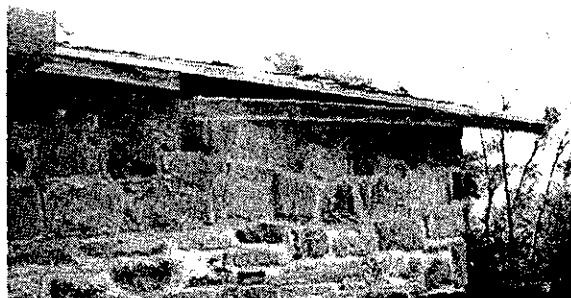
At the eaves, the underside of the rafters and sheathing is left exposed, the ends being trimmed with a 1 x 4 fascia board. 1" thick blocking is notched and fitted between the joists at the top plate of the wall. There are some remnants of white paint to be found under the eave, but there is virtually no paint left on the fascias. The fascia on the west side of the building is separating from the rafters and will probably soon be lost (Photograph 254). It is evident that several pieces of roof sheathing have been replaced with new wood painted brown, probably in the 1984 restoration program. The remaining paint finish has traces of brown paint over the earlier white, probably indicating a late change made by NPS.

Photograph 254: Deteriorating fascia at west eave.

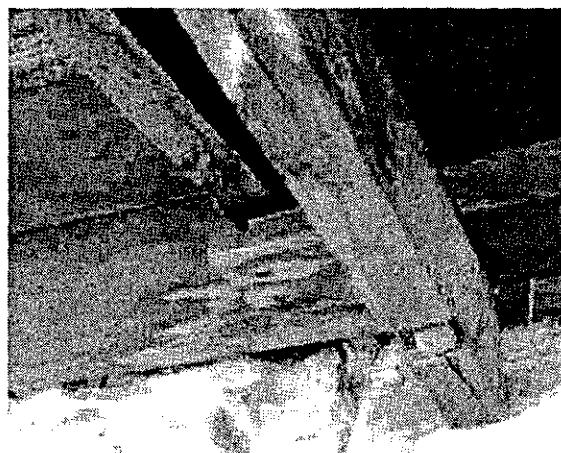
A small, shed-roofed entry porch roof protects the door on the west side. The structural connection of this porch to the rest of the building is tenuous. Each porch roof joist is connected to the bottom of a 2 x 4 wood plate using lag screws; this plate is then nailed up to the underside of several roof joists (Photograph 255). This places these nails in tension. The porch roof is supported on a pair of 2 x 4 posts, connected securely to the concrete porch slab with steel angle clips and lag screws. The paint finish on the posts has failed.

Photograph 255: Porch roof attachment to eave.

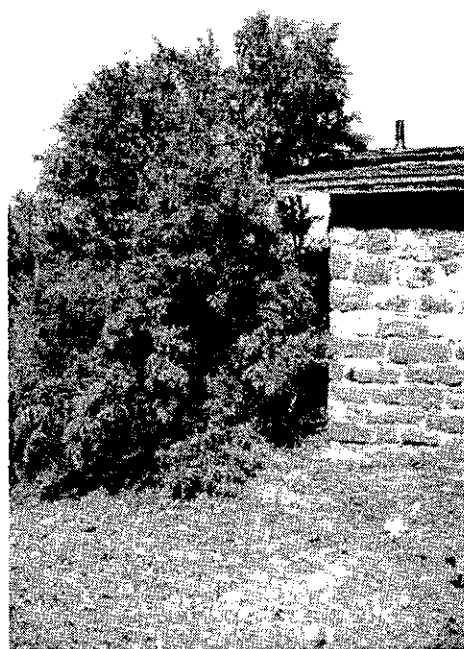
A tamarisk tree grows adjacent to the building on the south side (Photograph 256). The tree is in contact with the walls and eave of the building and has the potential to cause physical damage. Periodic reports by NPS staff have repeatedly identified this tree and recommended that it be trimmed back.

Photograph 256: Tamarisk tree at south side.

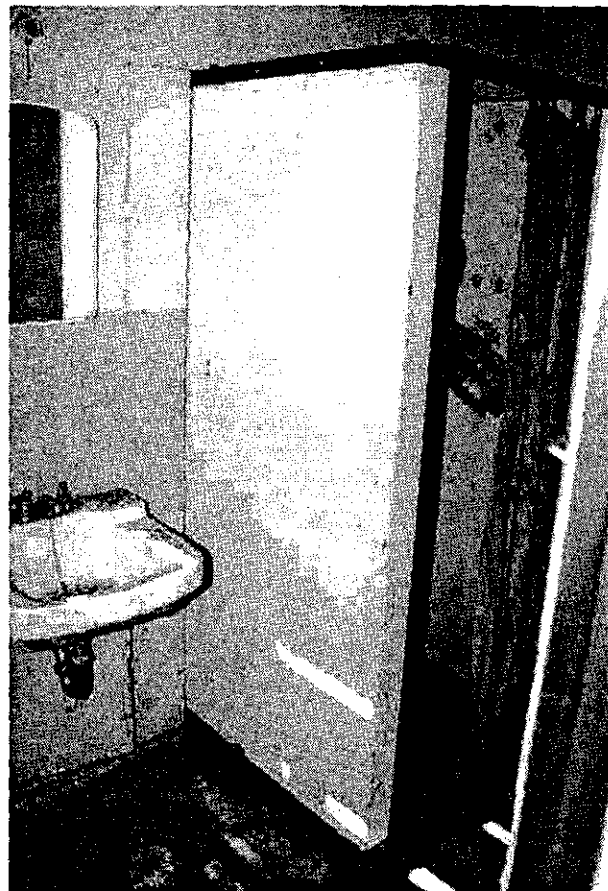
Plumbing fixtures appear original (Photograph 259). The shower is a

prefabricated enameled steel unit, in poor condition. The top rail is rusted and the unit is very dirty. The wall-hung lavatory is intact, but dirty. An intact medicine cabinet is provided above the lavatory. The water closet, also intact but dirty, has a cracked seat.

Photograph 259: Restroom plumbing fixtures.

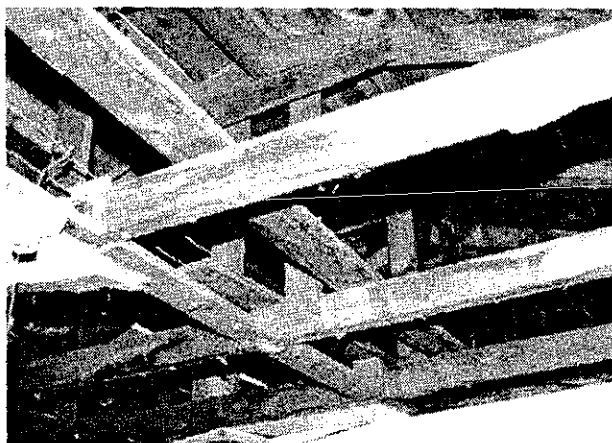
The roof is conventionally framed using finished dimensional lumber (Photograph 260). 2 x 4 rafters meet at a ridge beam and are tied together using 1x6 collar ties. Ceiling joists are independent from the rafters and are also 2 x 4 framing. 1 x 12 board sheathing spans between rafters. The roof structure is in good condition with the exception of the roof sheathing, much of which is water damaged. Several pieces of sheathing are new wood replacements dating to recent repair efforts.

Photograph 260: Roof and ceiling framing.

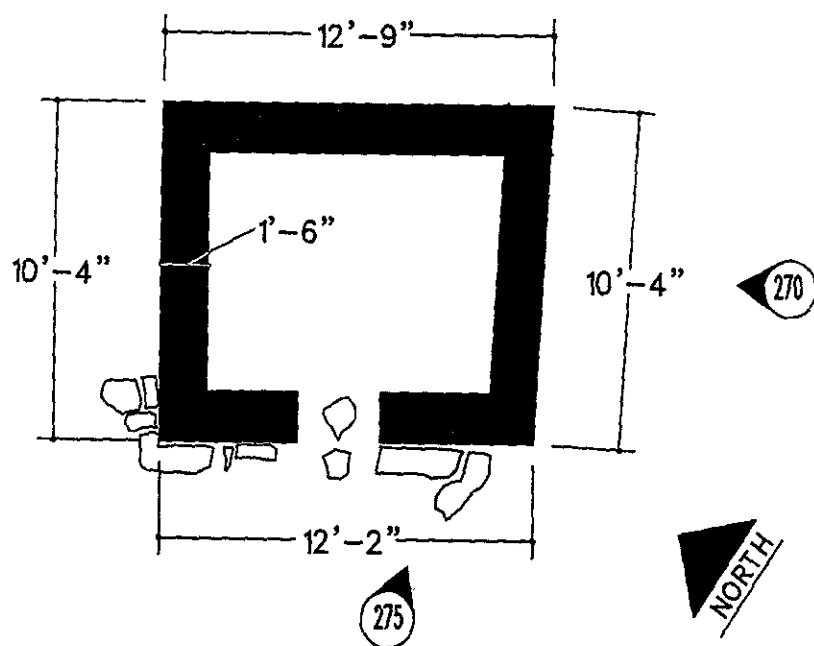
Figure 83: Upper Ferry Structure #1 (Louse House)

This is a rectangular structure consisting of four-foot high sandstone walls laid in mud mortar (Figure 83, Photograph 270). A door opening is found on the south side, facing the river. This structure was substantially stabilized in 1986. Previous documentation indicates that the east wall of the structure had partly collapsed by 1986 and that the structure was stabilized in this condition. However, the damage to this wall visible today indicates that the wall collapse is progressing (Photograph 275). Because the top course of stones was left off this area, rainwater could continue to saturate the interior of the wall and erode the adobe mortar. There has been some additional mortar deterioration, mostly limited to the top courses of stone masonry.

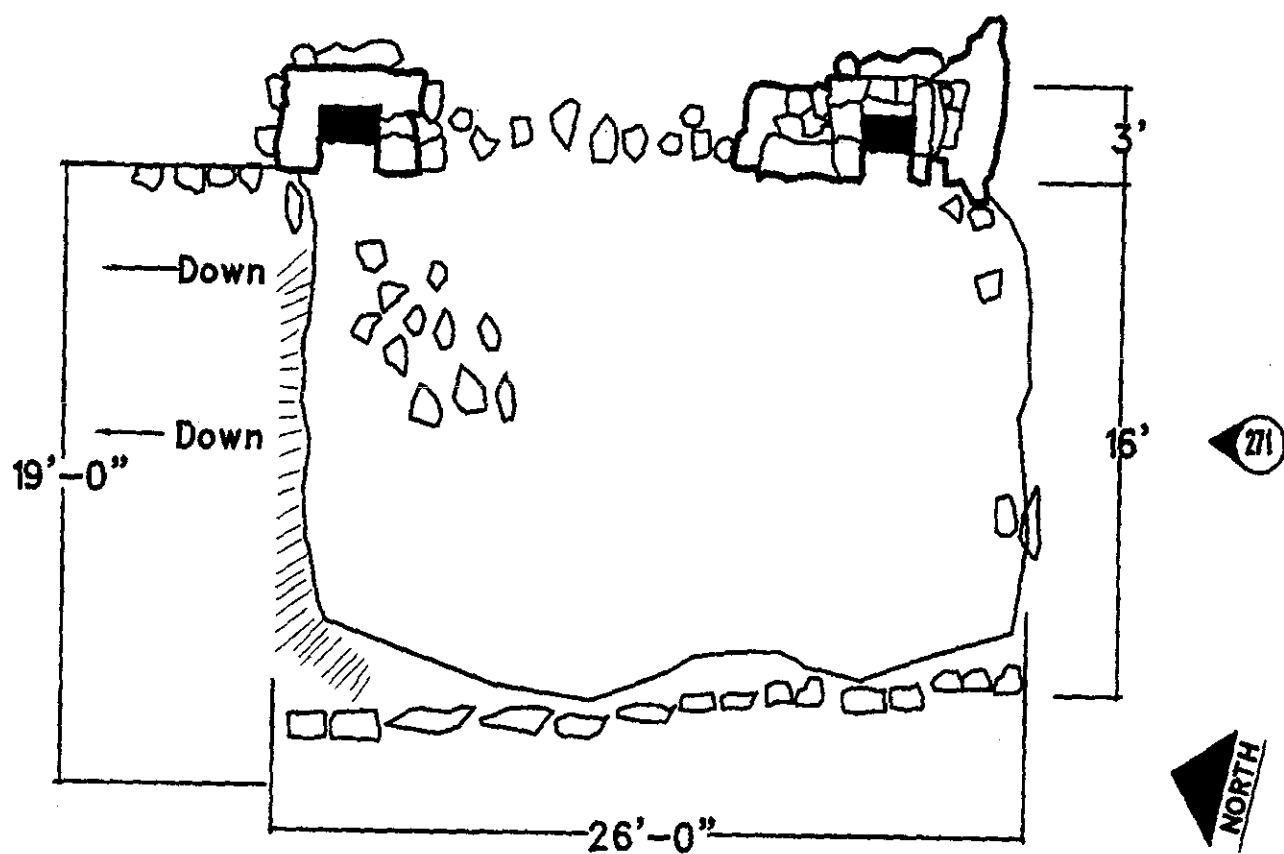
Figure 84: Upper Structure #2 (Frank Johnson Cabin)

This structure has significant above-ground features on the northeast side of the site (away from the river) (Figure 84, Photograph 271). Features include a pair of fireplaces and remnants of stone walls. The rest of the site is limited to foundation stones and rock rubble. This structure, too, was significantly stabilized in 1986. There appears to be little or no change since that stabilization effort was completed. Like Structure #1, there has been some erosion of mud mortar due to rainwater.

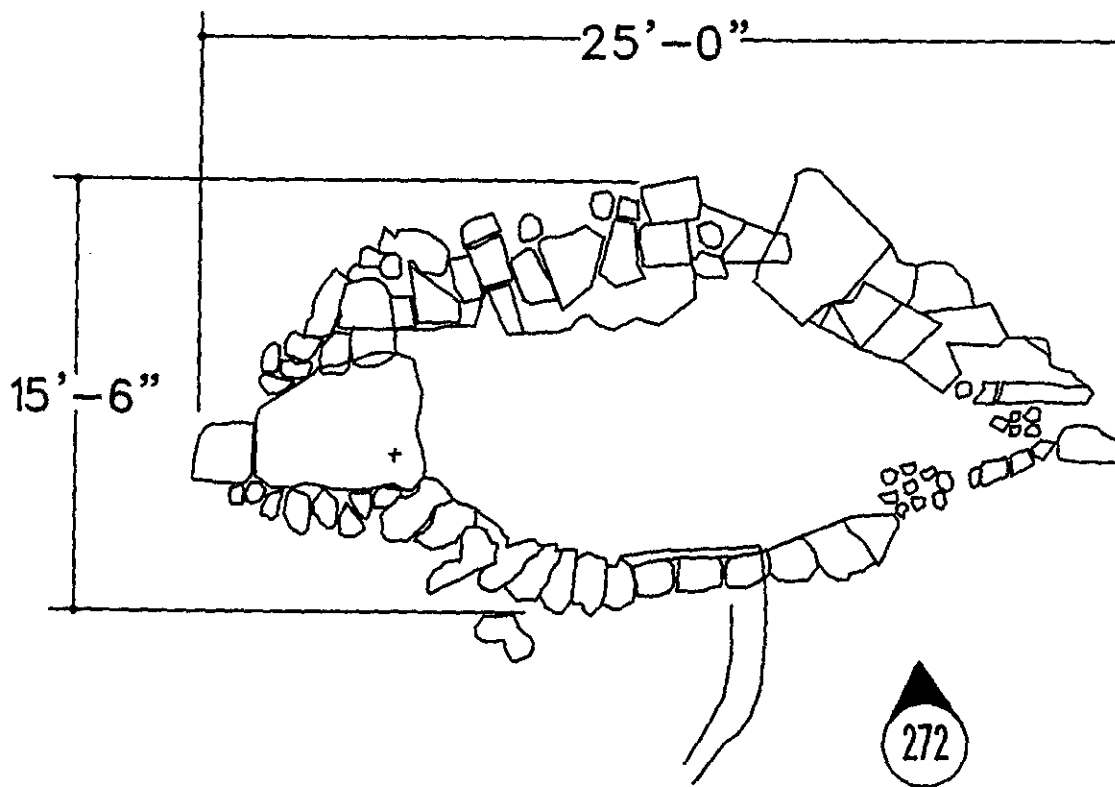
Figure 85: Upper Ferry Structure #3 (Small Corral)

This is an irregular structure of dry-laid stone masonry (Figure 85, Photograph 272). The irregular shape of the stone walls takes advantage of pre-existing stone monoliths to form some parts of the corral. There has been no discernable change to this structure following stabilization and documentation in 1986.

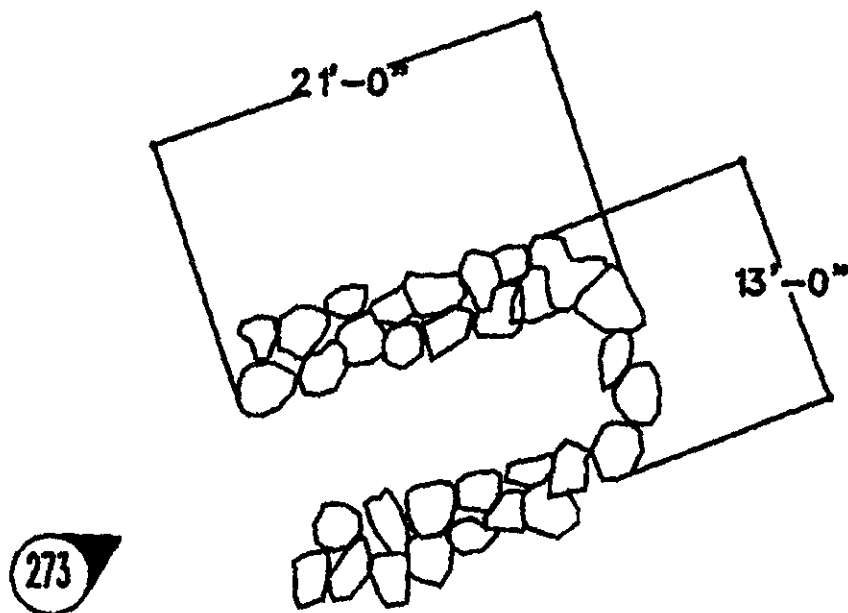
Figure 86: Upper Ferry Structure #5 (Dugout)

This structure is substantially unchanged from when stabilization was completed (Figure 86, Photograph 273). It appears stable at this time. Future impacts to be consider include potential erosion from water streaming down the hill, and damage from hikers traveling along the trail which leads through the structure.

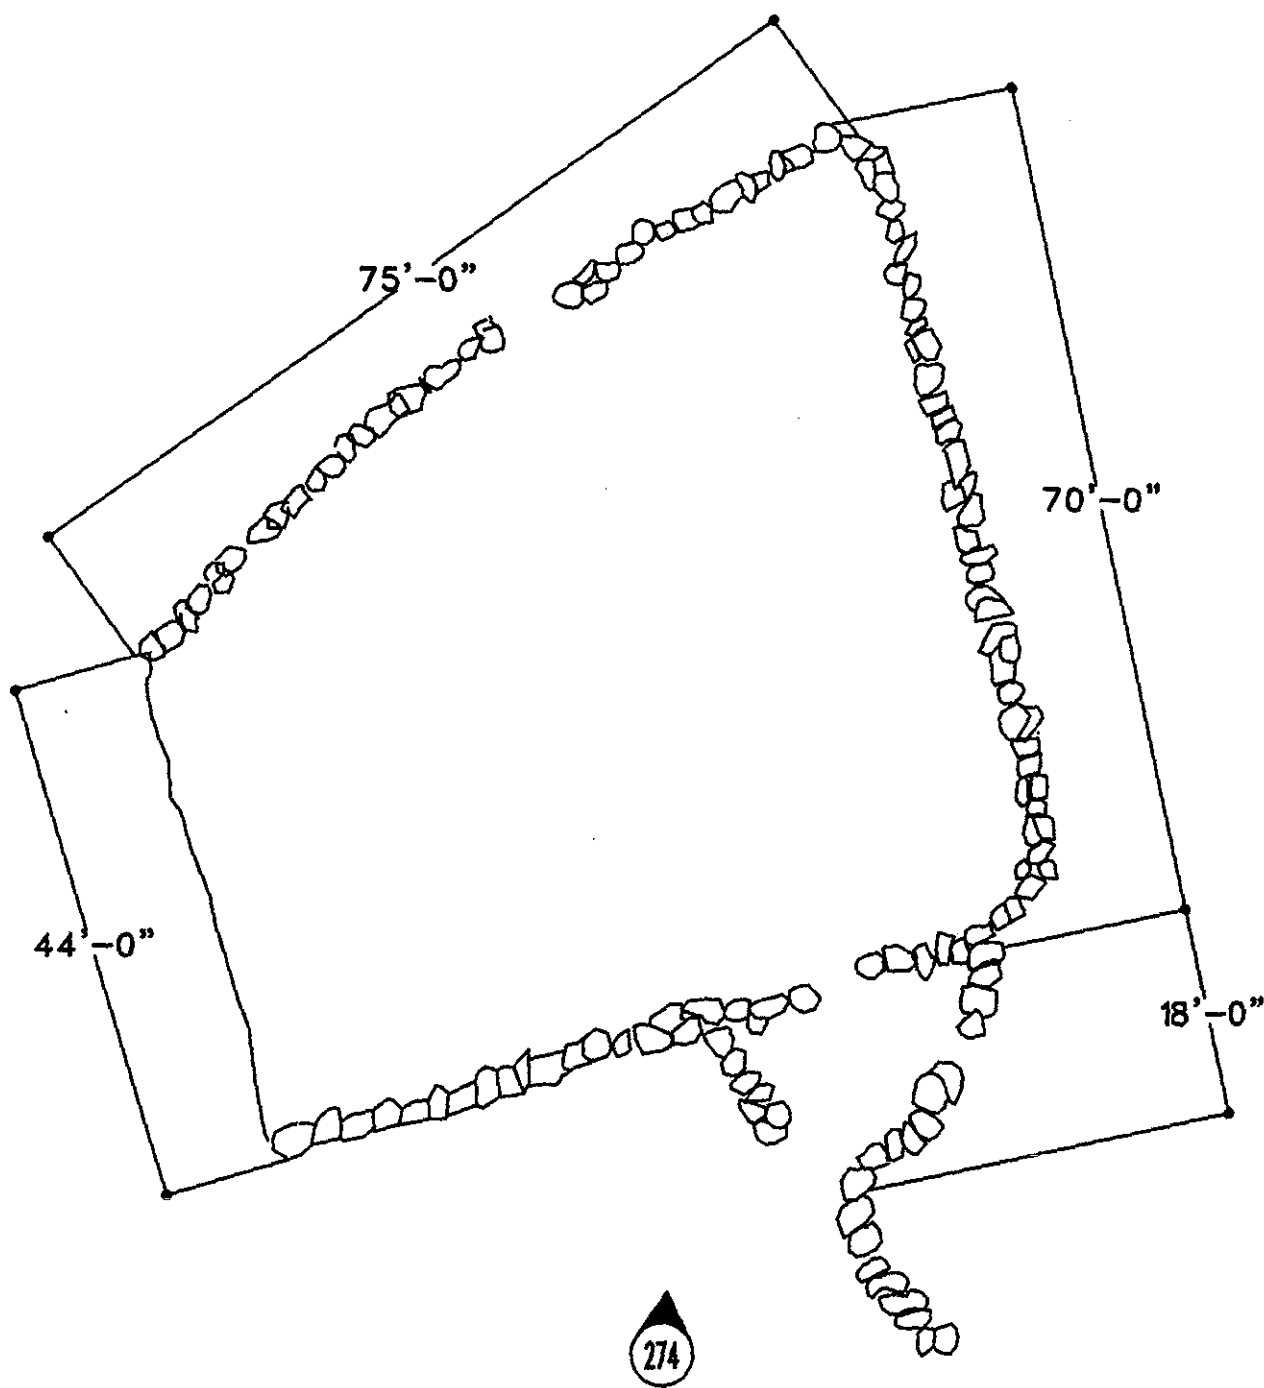
Figure 87: Upper Ferry Structure #4 (Large Corral)

Pre-existing stone monoliths were integrated into dry-laid field stone walls to enclose as much area as possible (Figure 87, Photograph 274). The structure is largely unchanged since the 1986 stabilization and documentation. Some erosion of the hill at the upper end (northeast) of the corral has occurred, due to natural drainage from the hillside above. A channel has been cut along the northeast border of the corral, running northwest and west to the river. Some continuing damage also occurs from hikers, since the main foot trail upriver from this point passes through the center of the corral.

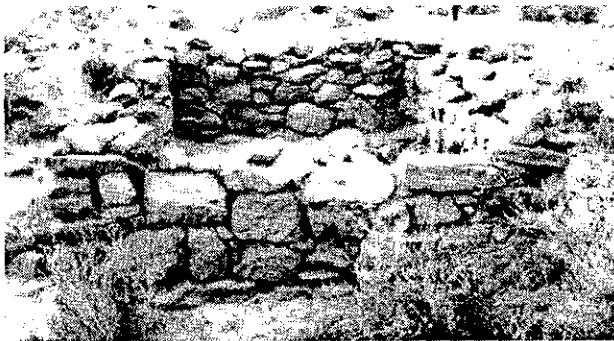
Photograph 270: Structure #1, the "Louse House".

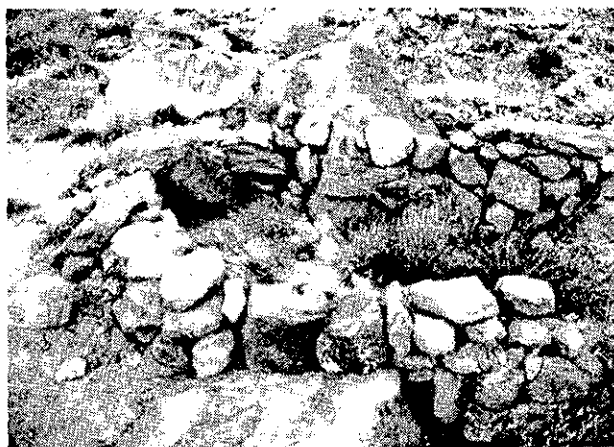
Photograph 271: Structure #2, the remains of the Frank Johnson Cabin.

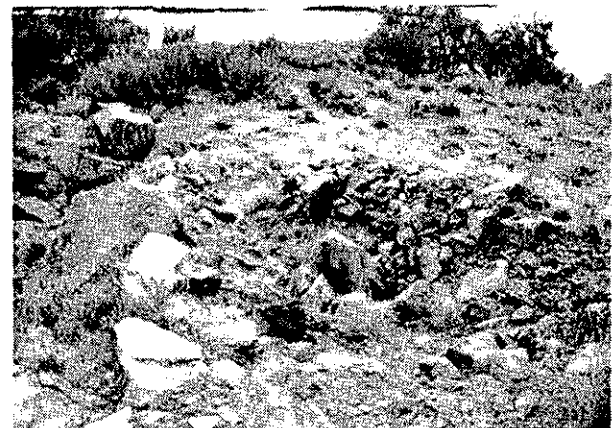
Photograph 272: Structure #3, the Small Corral.

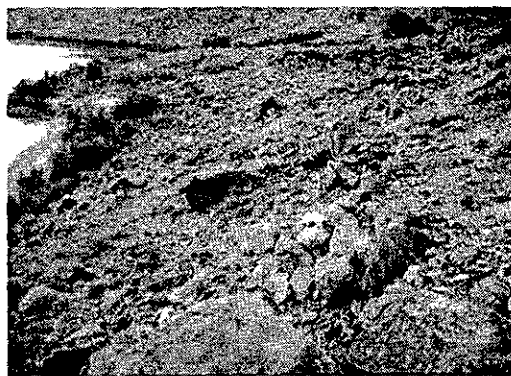
Photograph 273: Structure #5.

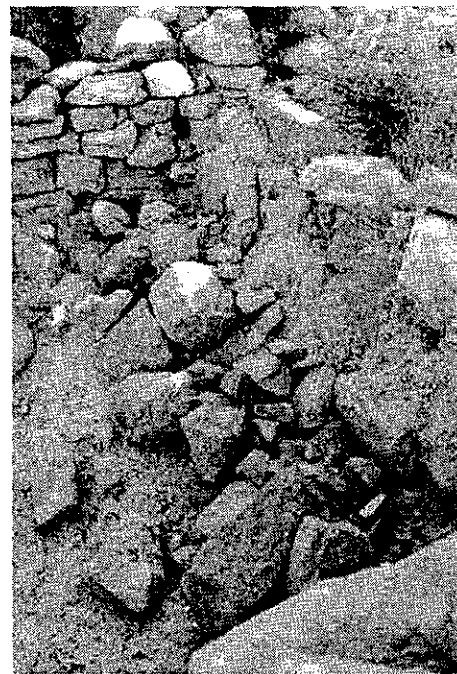
Photograph 274: Structure #4, the Large Corral.
