## Alcatraz Barracks Building 64

Abbreviated Historic Structure Report

September 2003

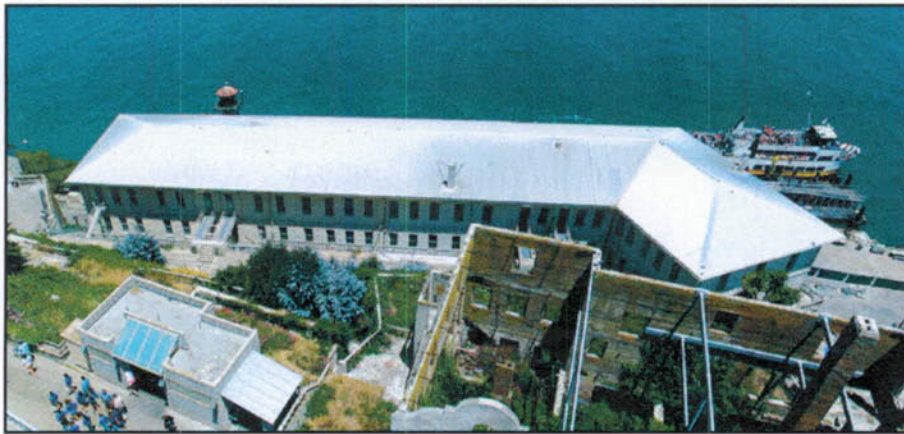
Above: View of Building 64 roof from Lighthouse, 2003. PARC, Golden Gate National Recreation Area.

The current roof configuration is a simple hipped roof with 16-gauge corrugated aluminum roofing panels 4' wide by 11' long metal. There are copper U-section gutters around the entire roof with 4 inch copper leaders at regular intervals. There is a ridge bar permanently mounted on the roof where safety lines can be clipped during roof work. The majority of the metal roof in the 'dogleg' portion blew off in a windstorm on November 8, 2002 and was repaired in February of 2003. The November storm also damaged several framing members, requiring their removal and replacement. The gutters and downspouts appear to be in good condition, but tend to collect a considerable amount of debris due to the presence of nesting gulls.

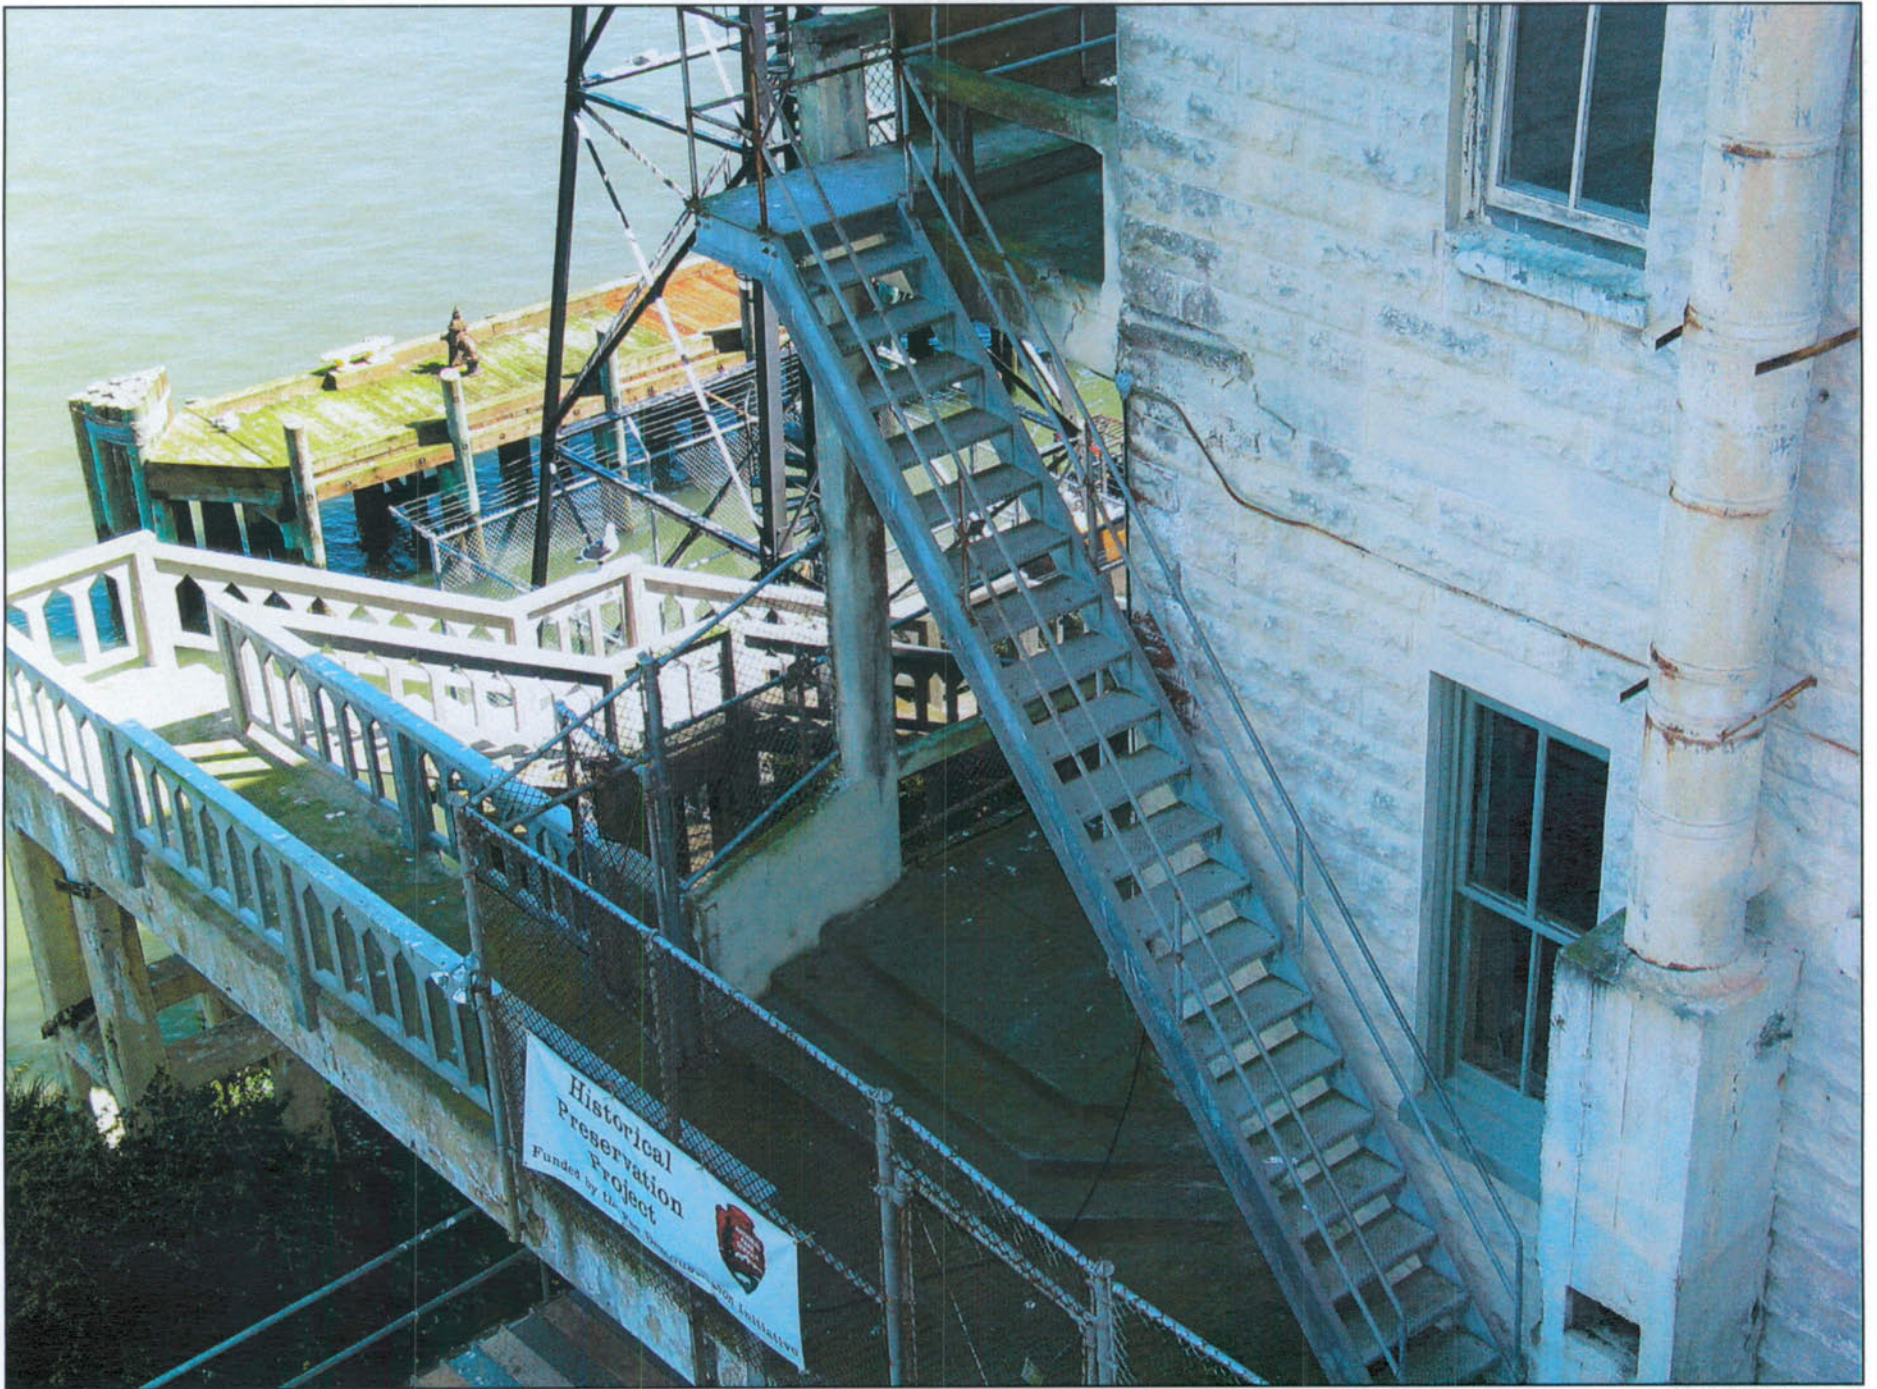
Opposite page: View of metal stair and concrete stair, north side, 2003. Photo Credit: John Martini.

There is an abundance of different stair types at Building 64. Granite and brick stairways are built into the wall at China Alley at the west. These are the oldest stairways associated with the building and are in good condition. There is a flight of cast iron stairs that date from the same Military Barracks period that provided access from the Parade Ground to the third floor. This stair was likely relocated from the Citadel when the main Cell House was constructed. Several years ago the stairs collapsed onto a second floor wood frame addition and were never repaired. The cast iron treads and risers are broken in several places and have extensively rusted, but they appear to be salvageable. Salvaging this stair is desirable, as it is one of four remaining sets of cast iron stairs on the island.

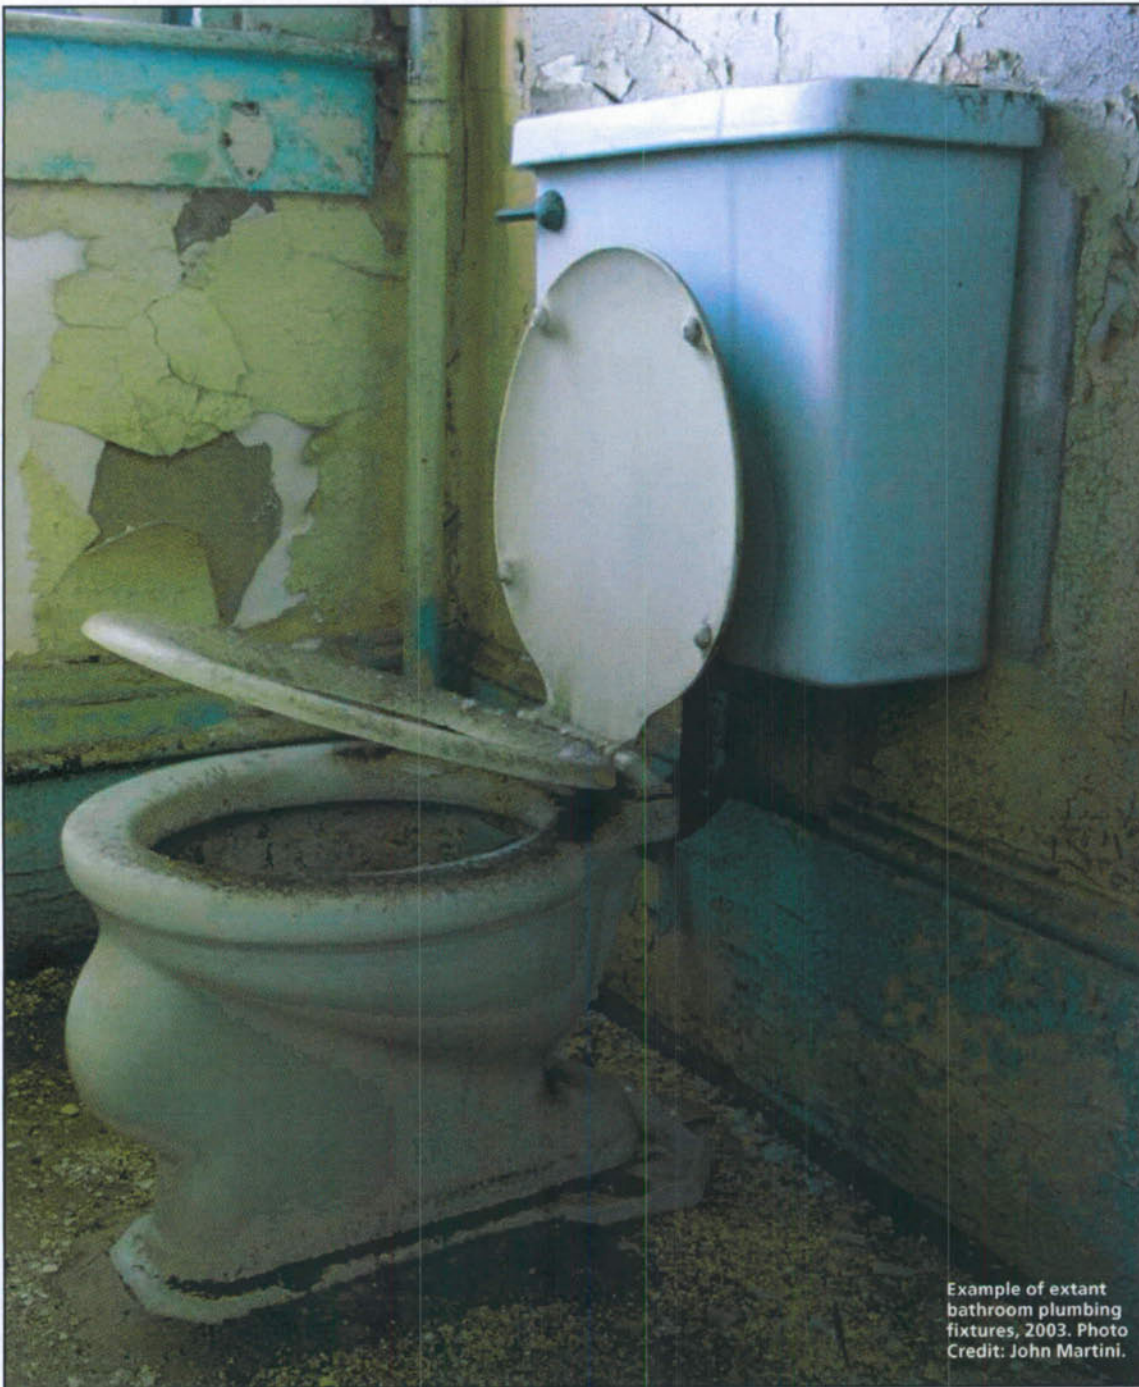
Example of extant bathroom plumbing fixtures, 2003. Photo Credit: John Martini.

floor-mounted bowls with wall-mounted tanks. The majority of the tanks are broken off the walls and the bowls are clogged with debris. In almost all cases, the wall-mounted sinks are broken off the walls.

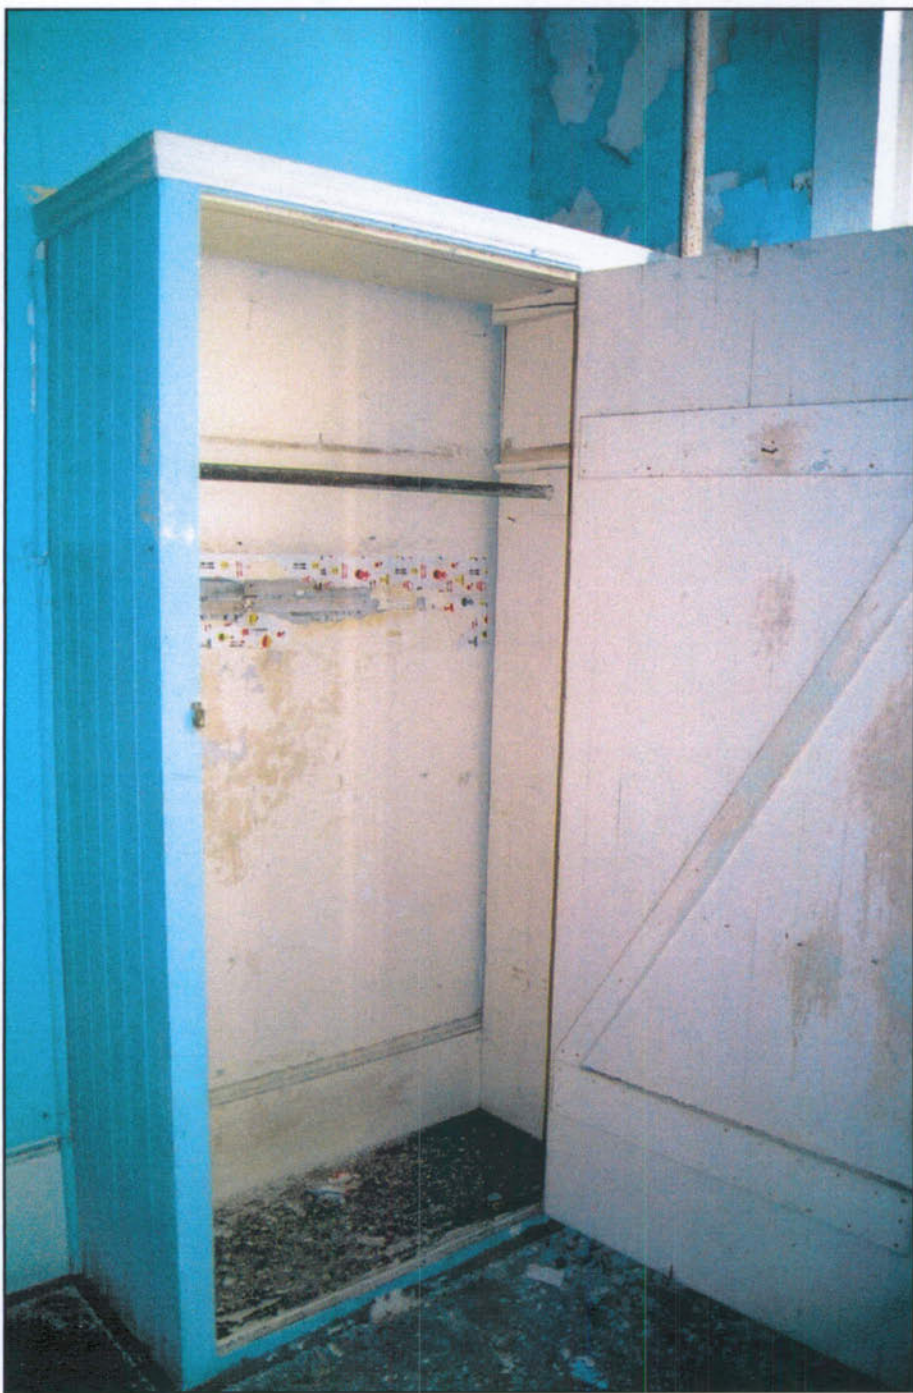
Left to right: Army-era locker converted to closet, 2003. Photo Credit: John Martini.

Typical built-in kitchen cabinetry, 2003. Photo Credit: Jason Hagin.
