113/D-555
Grand Canyon

North Rim Entrance Station

Historic Structure Report

North Rim Entrance Station
Historic Structure Report

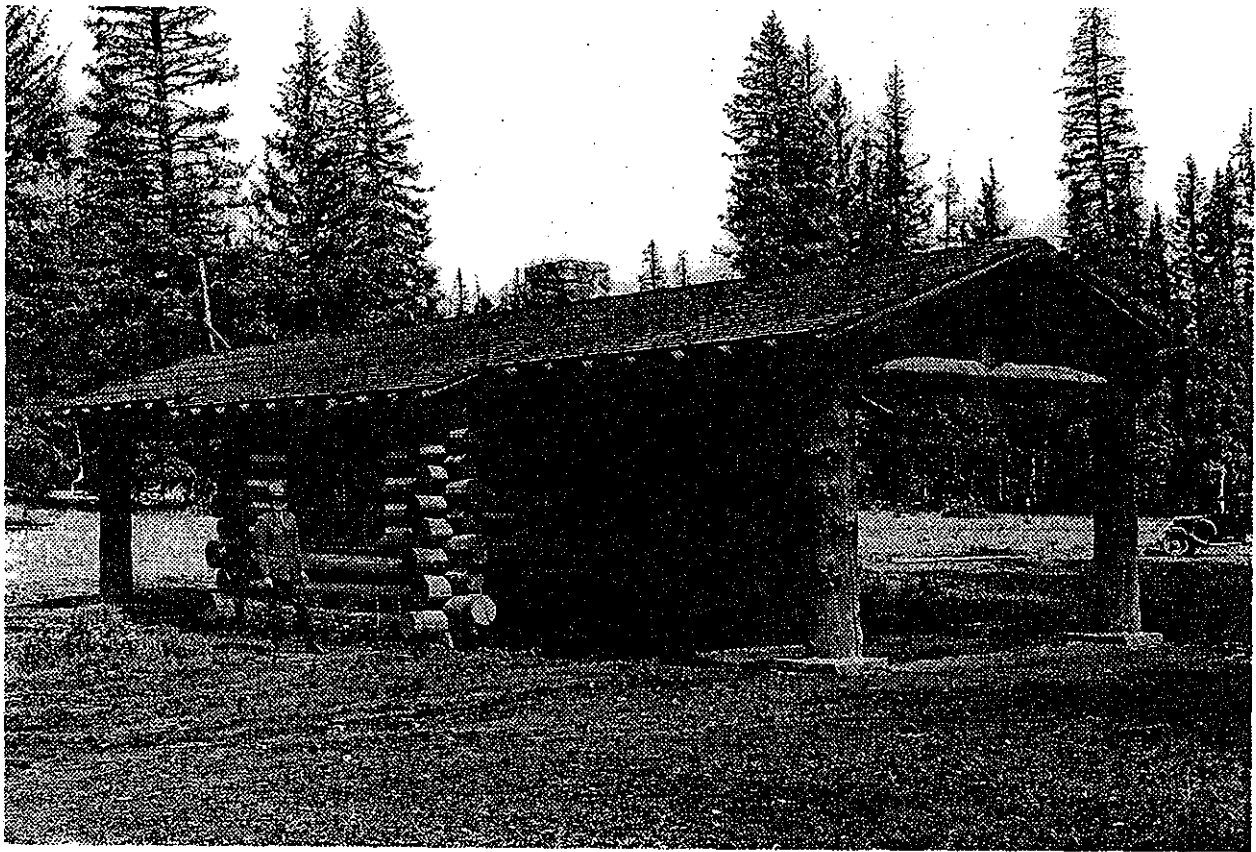
Figure 1. The image illustrates the north elevation of the North Rim Entrance Station. Note the masonry chimney, the height of the exposed native stone masonry base and the doubling of every sixth roof shingle course as a decorative element. Photo is dated 1929. GCNPA Number 3884.

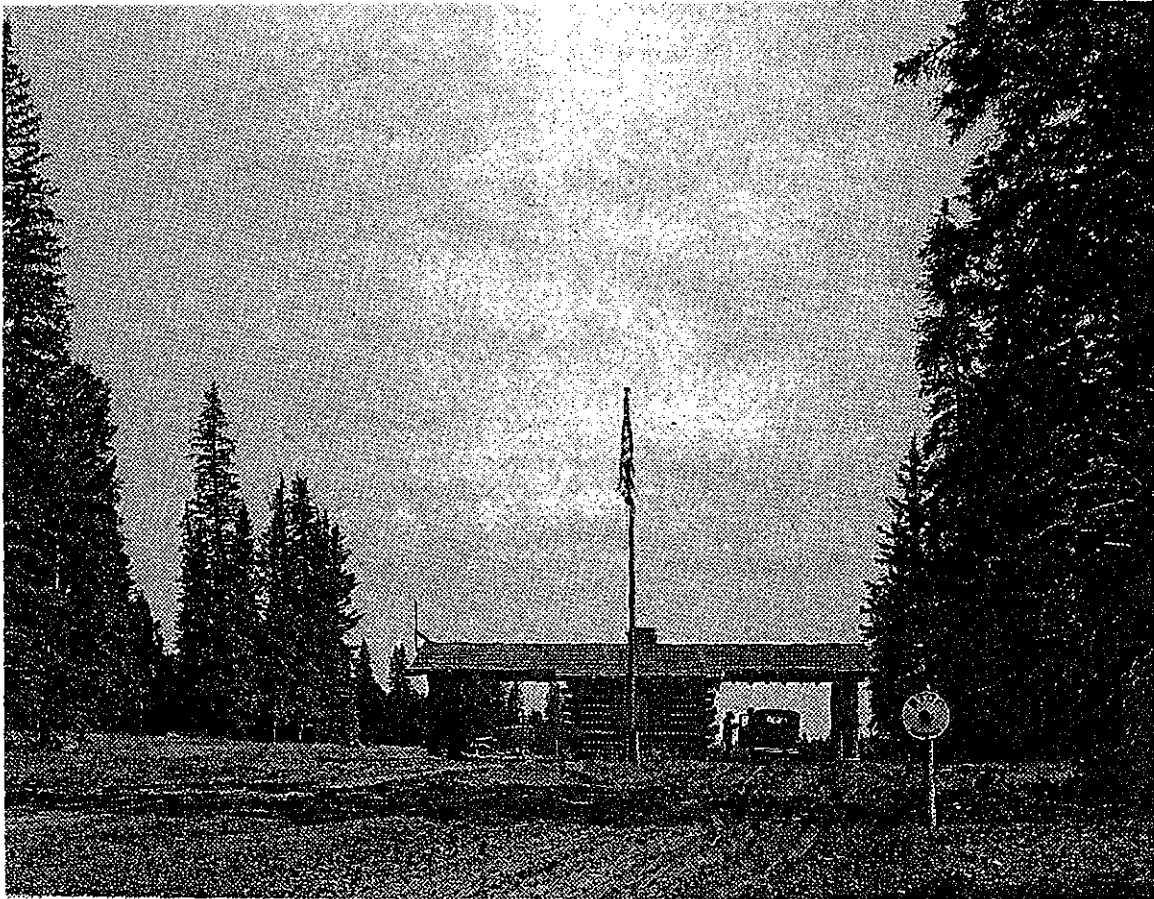
Figure 3. This early image of the North Rim Entrance Station illustrates how the building and canopies functioned at the time of construction. Though the canopies are no longer extant, the way that the ranger approaches arriving vehicles, by stepping into the roadway, is unchanged. Photo is dated 1930. GCNPA Number 9937.

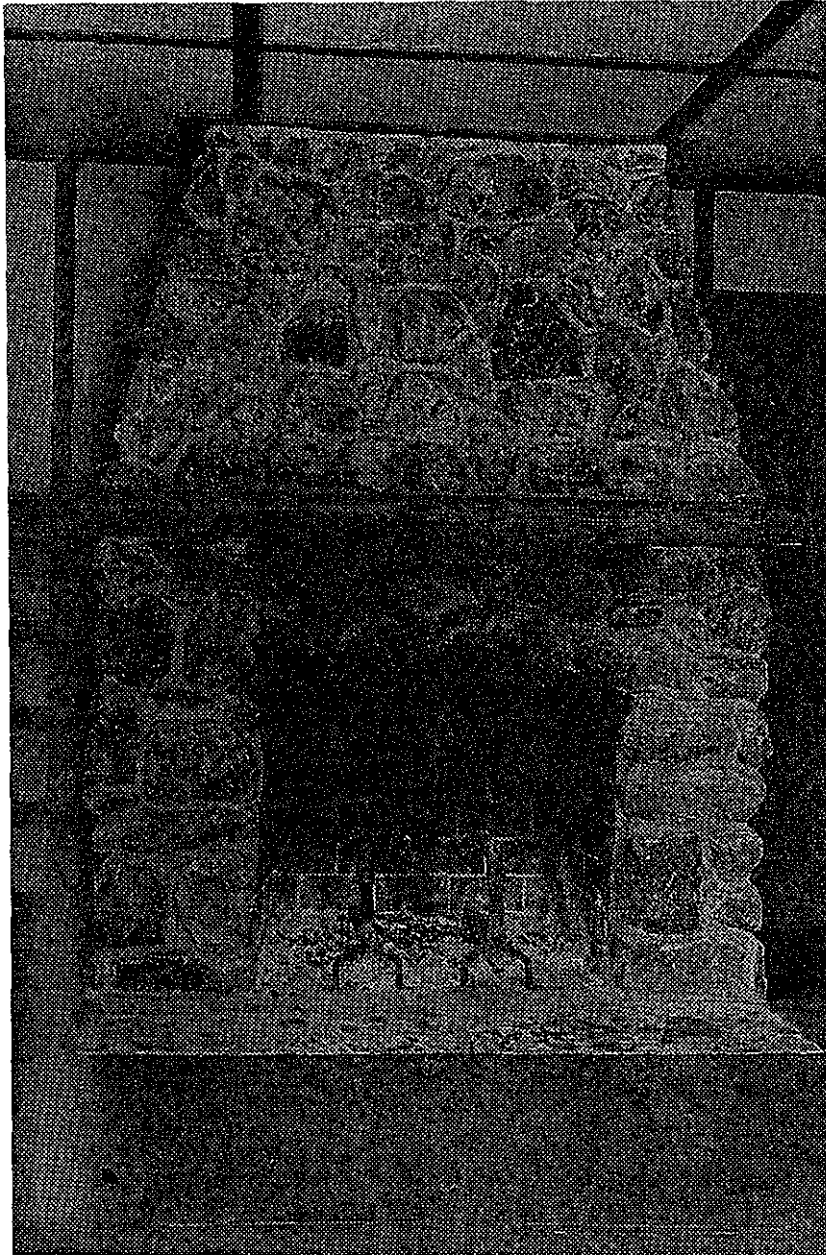
A key feature is the wood-burning stove located in the center of the room. It replaced a rustic stone fireplace, of rough hewn masonry, that stood in the same position. (See Appendix E, Figure 15 and Appendix F, Figure 10.) The stove sits on a 4 inch concrete base.

Figure 15. The image illustrates the original fireplace on the interior of the North Rim Entrance Station. The original interior finishes appear to be celotex panels with varnished or dark painted battens. The stone fireplace was removed during the rehabilitation campaign of 1954-55. Other works at that time included the removal of the interior partition wall, masonry chimney, and wood floor. The works significantly altered the character of the building's interior. Photo is undated. GCNPA Number 8048.

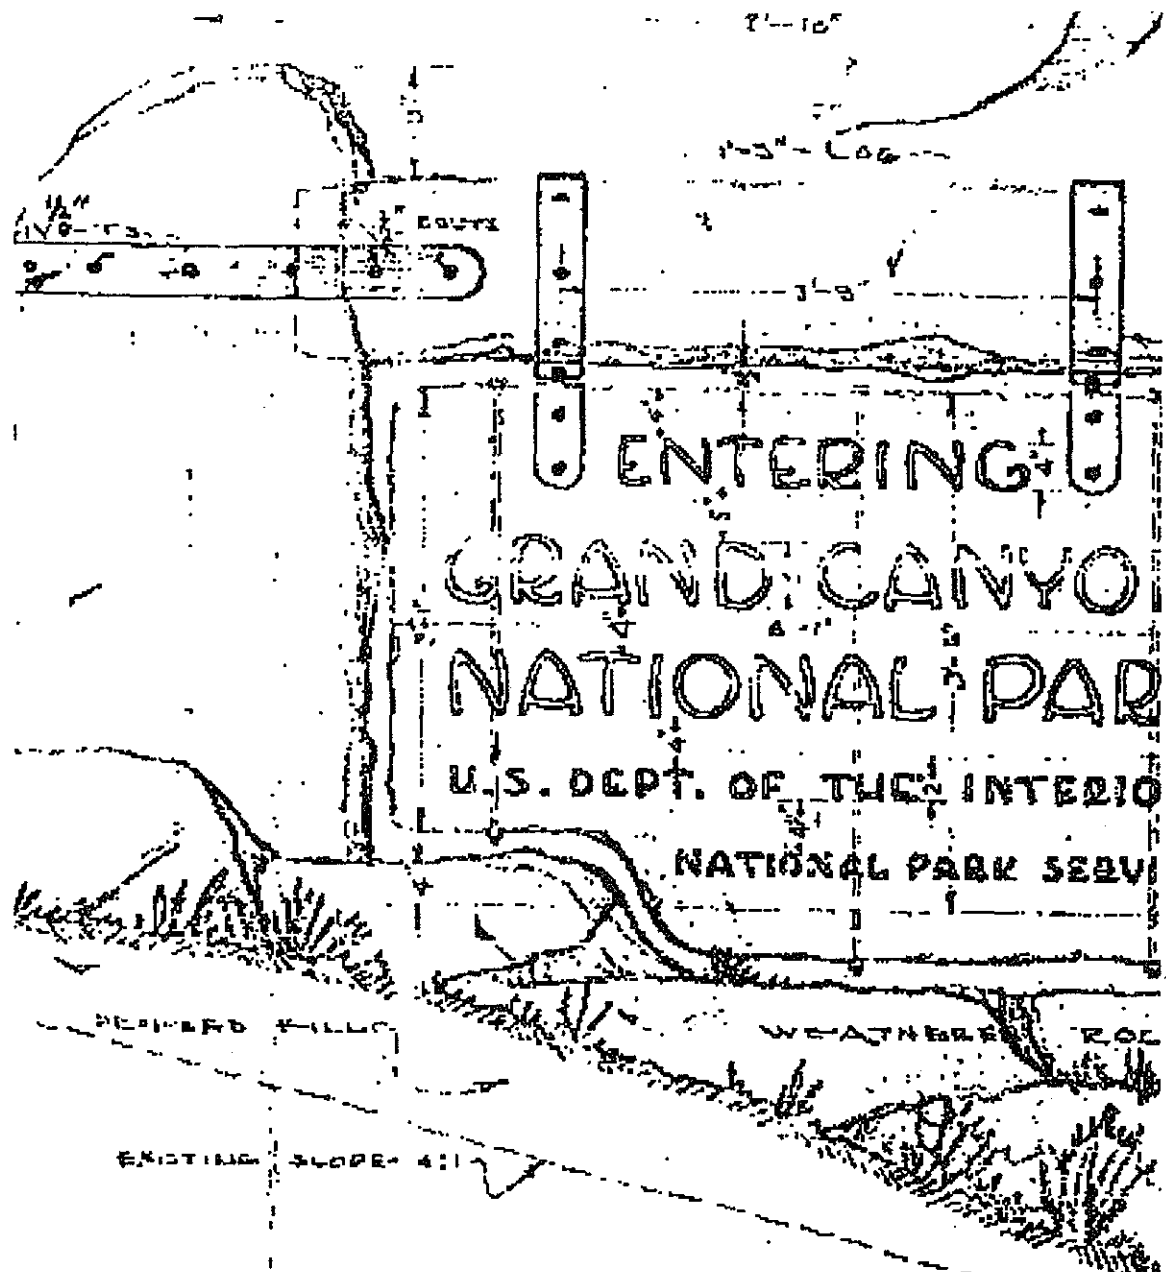
Designed and installed in 1939, the original sign introducing the Grand Canyon National Park is extant but has been recently altered. The sign sits at the actual boundary of the park, a short distance to the north of the checking station. The original 1939 panel has been retained and reused; it now hangs from a new horizontal beam resting on massive peeled whole log posts and is held with heavy metal straps with oversized rivets. The panel is painted brown (though was probably stained natural wood originally) with white painted lettering, and a scalloped edge around the perimeter. The lower left corner of the panel is cut back, contoured to follow the line of the masonry base below which, though extant, is partially obscured by the grade. Altered in the 1990s, the new design retains the original carved hanging sign but clunky new posts and unsympathetic landscaping make it less successful than the original. (See Appendix E, Figure 16.)

Figure 16. The image is a drawing of the North Rim Entrance sign, 1938. Note that the panel is cut back at the lower left hand corner to follow the contour of the rocks and landscaping. The hanging sign has been refurbished and reused but the landscaping no longer retains the original configuration.

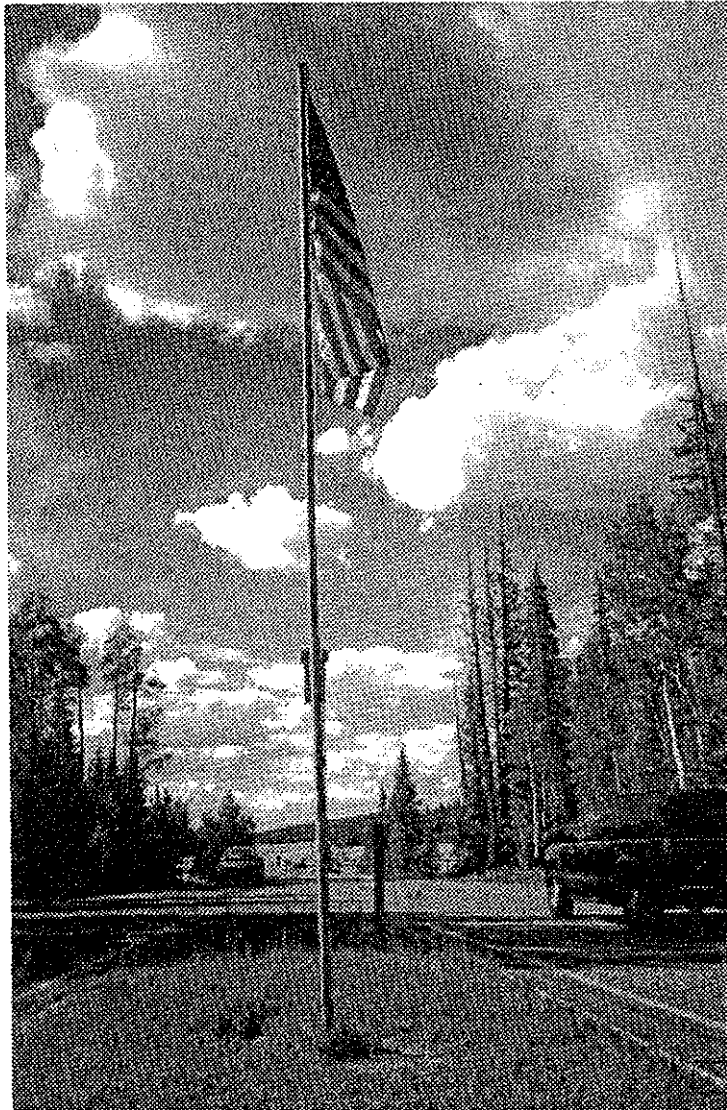
Figure 2. The image illustrates the prominent flagpole that stands in front of the North Rim Entrance Station. A key component of Park Service gateway design, the flagpole was meant to act as a heraldic element signaling the entrance of the park, and, in the view of Stephen T. Mather, inspire nationalistic pride. ARG Photo dated June, 2000.

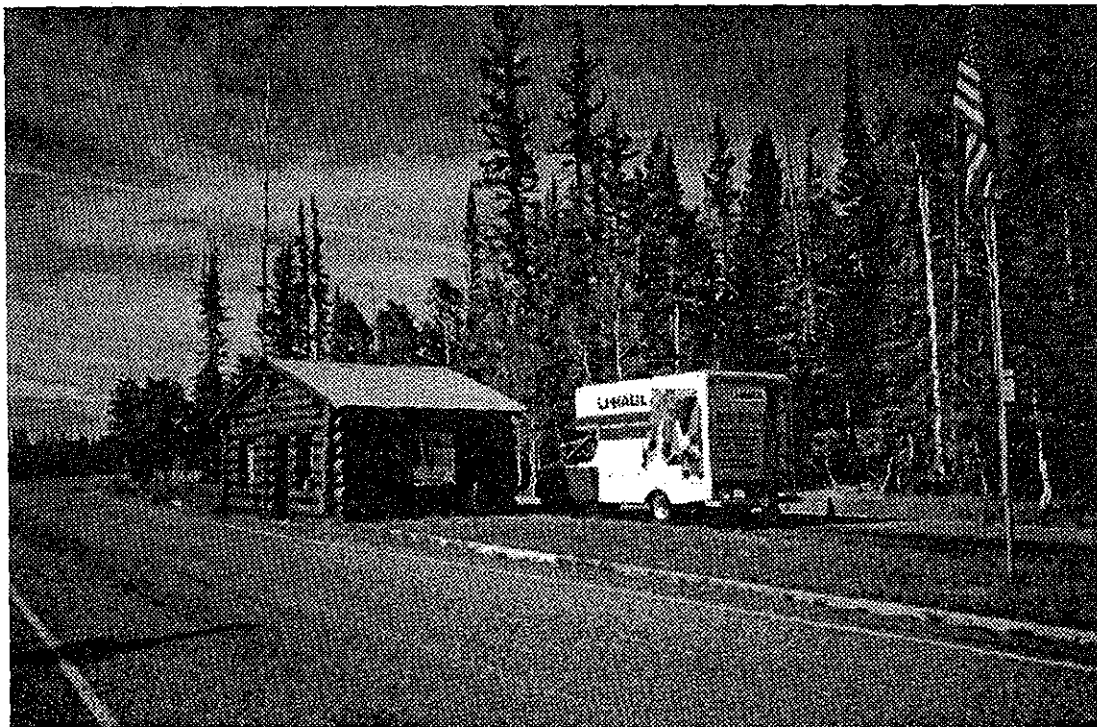
Figure 4. The image illustrates the relationship between the North Rim Entrance Station and the type of larger vehicles that could not access the North Rim when the canopies were extant. Removal of the canopies allowed passage into the park of the recreational vehicles and trucks which gained popularity in the decades after WWII. The exact date of the removal of the canopies is unknown, but probably dates to the late 1950s or 60s. ARG Photo dated June, 2000.

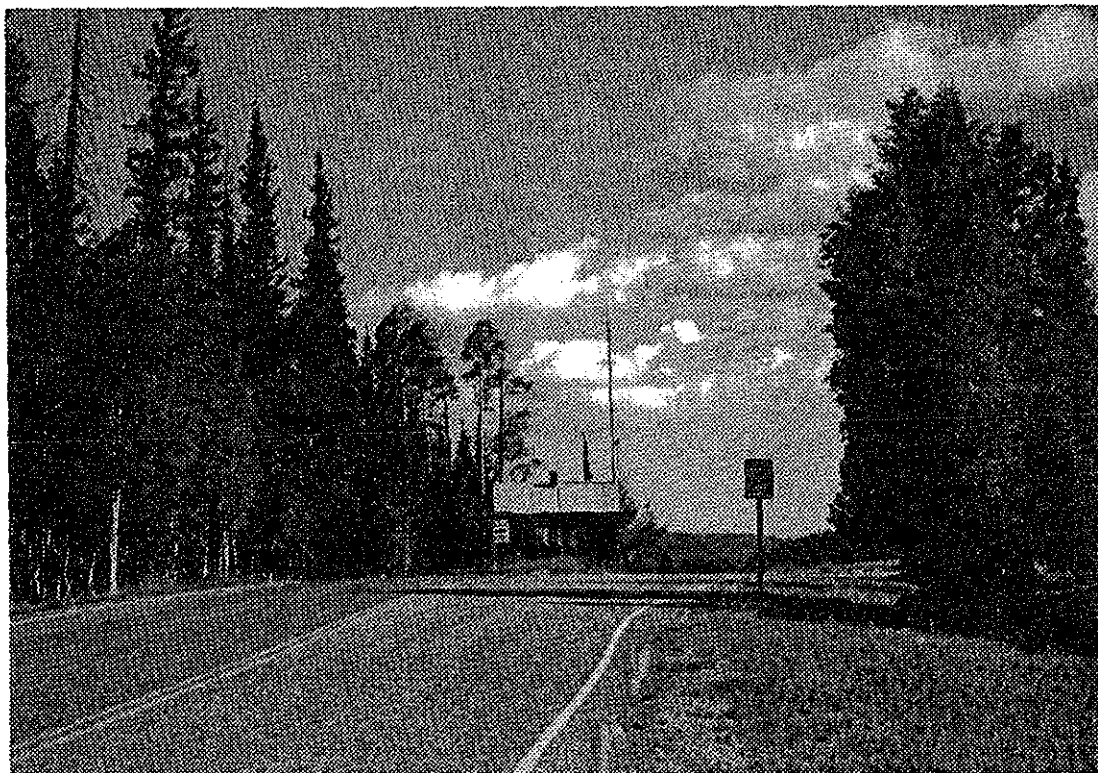
The North Rim Entrance Station sits just inside the Grand Canyon National Park boundary on the North Entrance Road thirteen miles north of the edge of the North Rim, Bright Angel Point and the Grand Canyon Lodge. The building is sited intentionally atop the slight, wooded saddle separating Demotte Park from Little Park. The approach road from Jacob Lake to the entrance station and on to the North Rim covers long, undulating stretches and steep slopes with corresponding grades and curves over 40 miles. Several miles north of the entrance station, the road opens to a wide grassy meadow with a thick forest of trees along both edges. As the traveler crosses the meadow nearing the park, the length of road dips and rises, revealing the distant entrance station to the viewer in stages. Approaching the park boundary, the trees again close in upon the station to create a narrow portal to the park. Traffic is funneled through the entrance passage toward the south to another wide meadow, almost a mirror image of the meadow to the north. The building's elevated position on the crown of a knoll provides commanding views north and south across both meadows, allowing the ranger to see oncoming traffic. (See Appendix F, Figures 5 and 6.) From a distance the building's transparency is apparent as it is possible to see blue sky beckoning through the station's windows on the north and south sides. The transparency lends an interesting detail, but is not an original feature as the old stone fireplace stood in the center of the structure, blocking the view through the building. (See Appendix F, Figure 7.)

Figure 7. The image illustrates the south approach to the site. ARG Photo dated June, 2000.

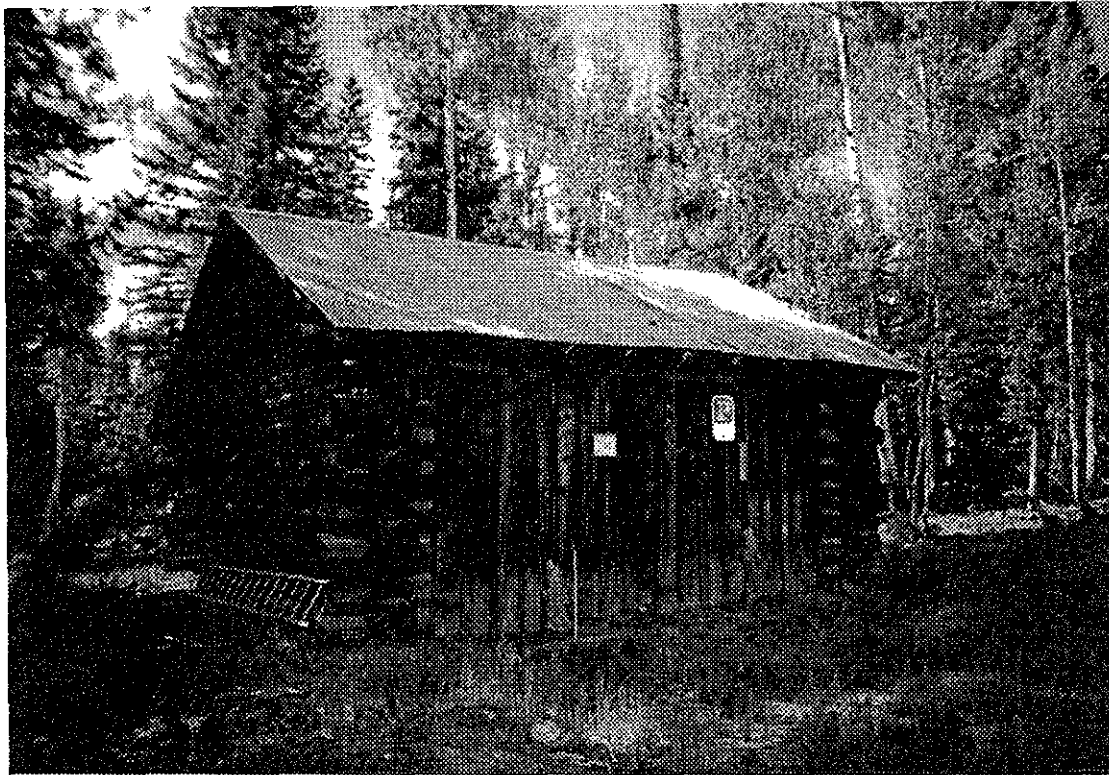
Figure 16. The structure in this image is Building 122A, a garage ancillary to the employee residence near the park entrance. This underutilized structure is located approximately 400 feet from the North Rim Entrance Station. Though in need of rehabilitation and waterproofing, the shed could provide additional storage space for the entrance station. See the Treatment and Use Section of the HSR for further discussion of this structure. ARG Photo dated June, 2000.

Another option for providing additional storage space for the entrance station is to move excess materials off site and out of the building. Building 122A, a garage ancillary to the employee residence (Building 122) is located approximately 440 feet to the east of the entrance station. While the building appears to be used by the employees who reside nearby, it does seem somewhat underutilized. Though in need of rehabilitation and water-proofing, the building could provide additional storage space for printed materials, pallets, etc. (See Appendix F, Figure 16).
