Grand Canyon Railroad Depot

Historic Structure Report

prepared for the
National Park Service

prepared by
Chamberlin Architects, PC
Grand Junction/Lakewood, Colorado

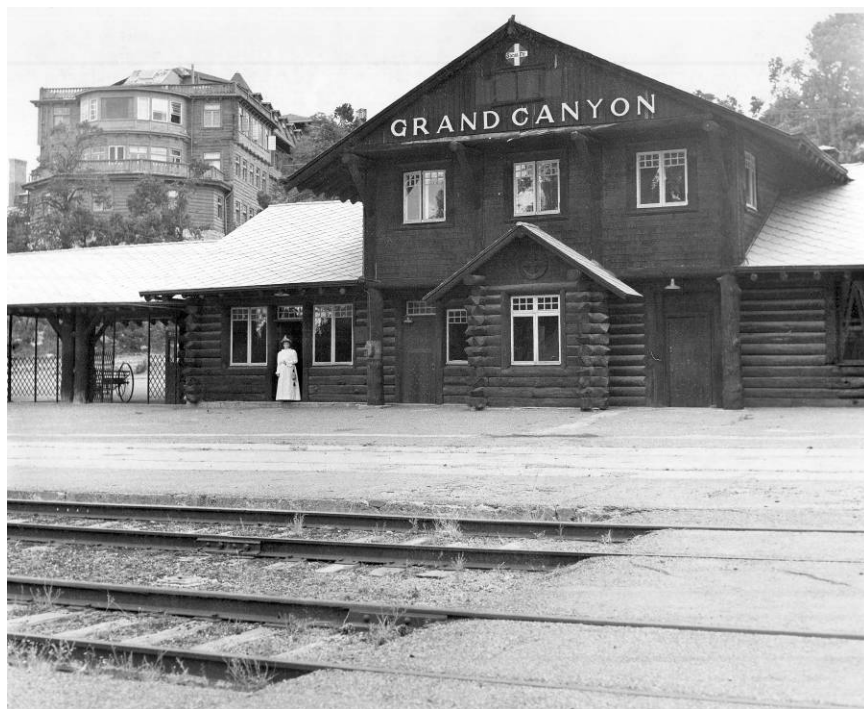
H-40 Train in Depot yard. Note activity in front of Depot appears to be laying or removing asphalt. Date August 1964. Photograph by N. Fox. NPS Catalog # GRCA 41395

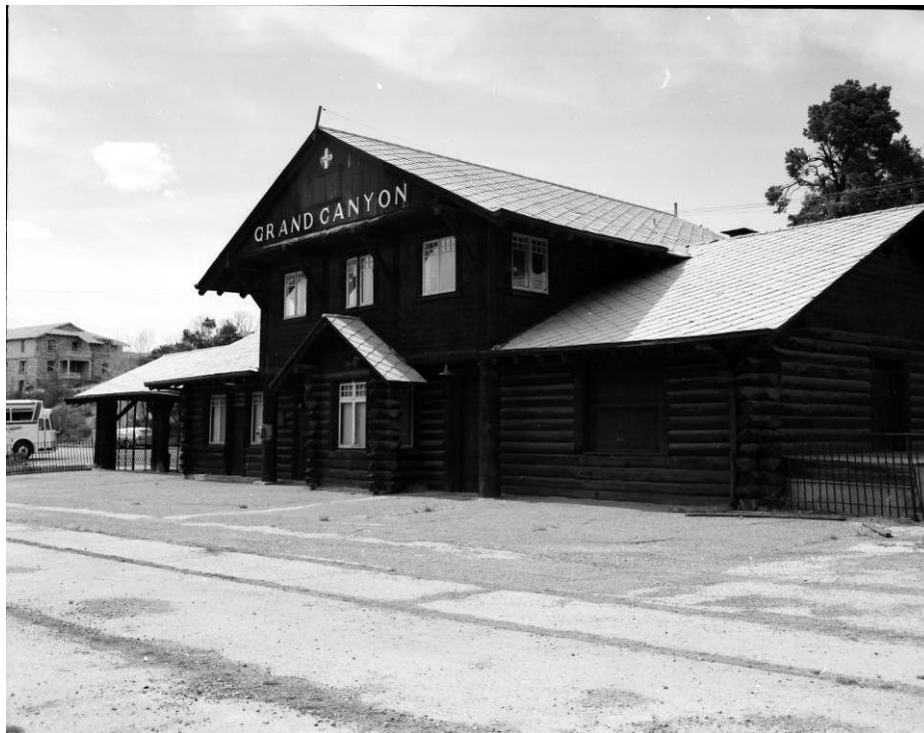
H-55 Santa Fe Railroad Depot, southern exposure. Note apparent deterioration of wood members of upper gable. Date 1976. NPS photo. NPS Catalog # GRCA 10736

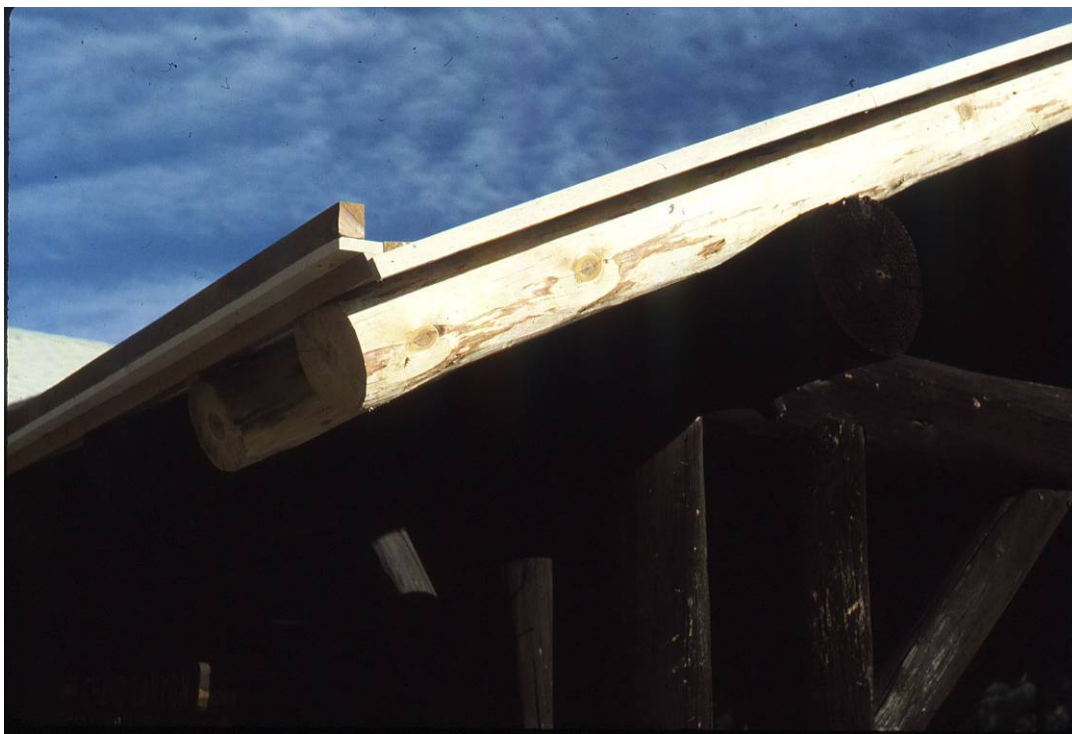
H-74 Grand Canyon Depot, west end and covered waiting area during repair of roof damage. Date late summer-fall 1984. Scanned from building files.

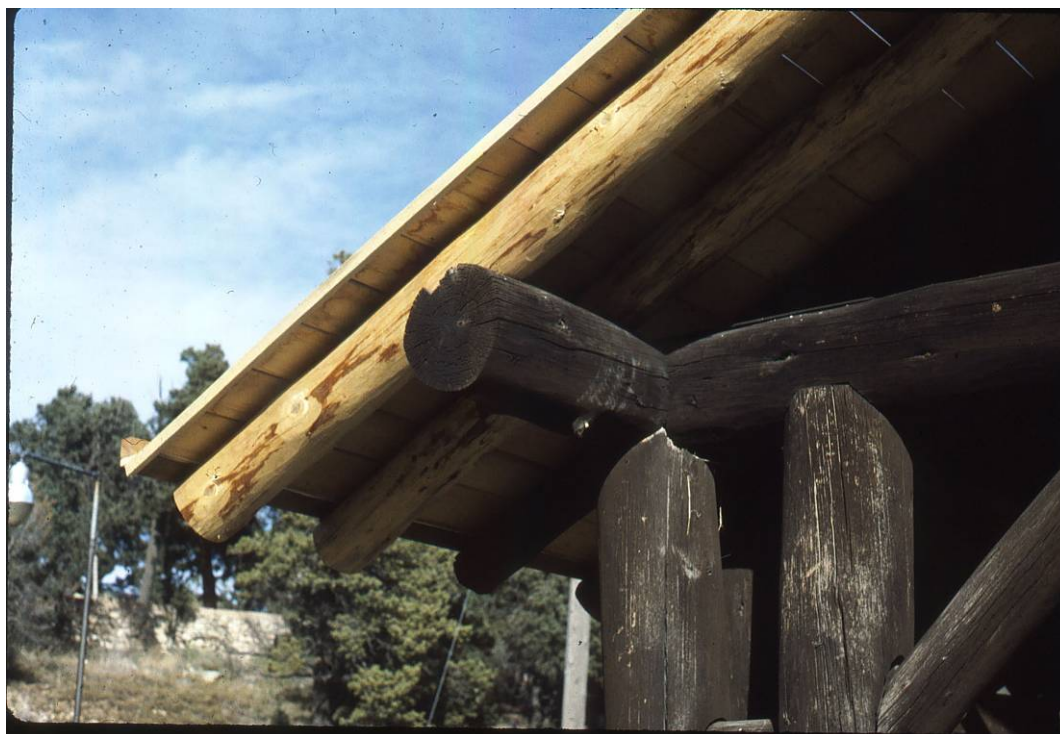
H-75 Grand Canyon Depot, west end and covered waiting area during repair of roof damage.
Close up of eave. Date late summer-fall 1984. Scanned from building files.

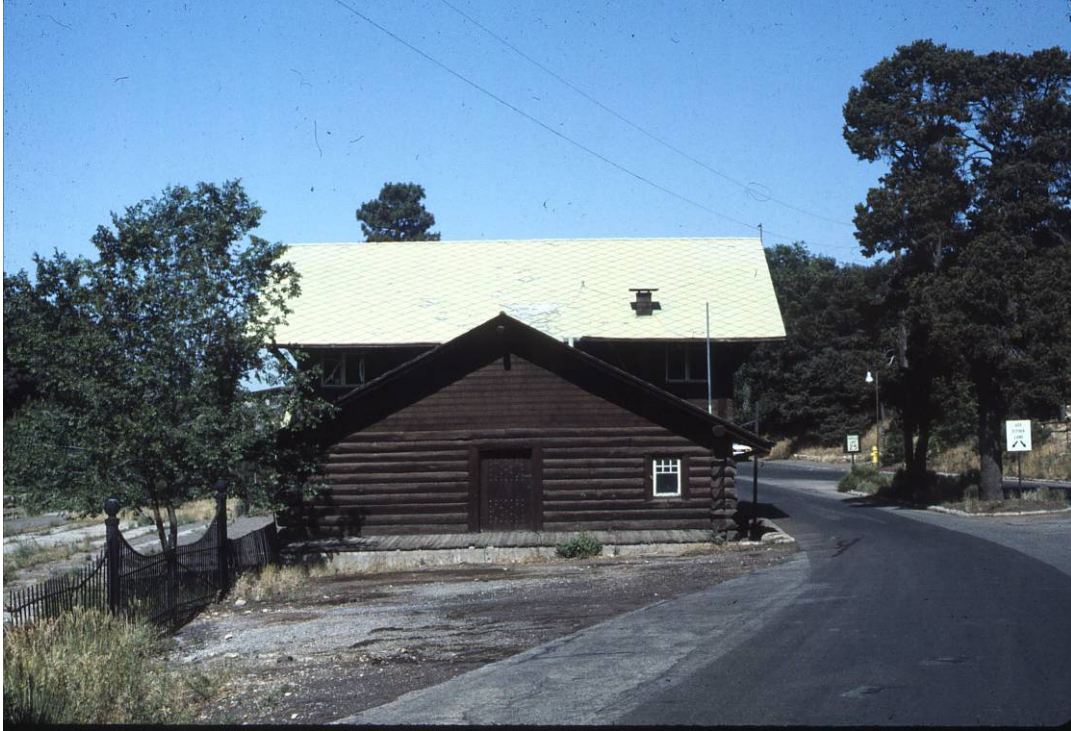
H-76 Grand Canyon Depot, west end and covered waiting area during repair of roof damage.
Close up of eave. Date late summer-fall 1984. Scanned from building files.

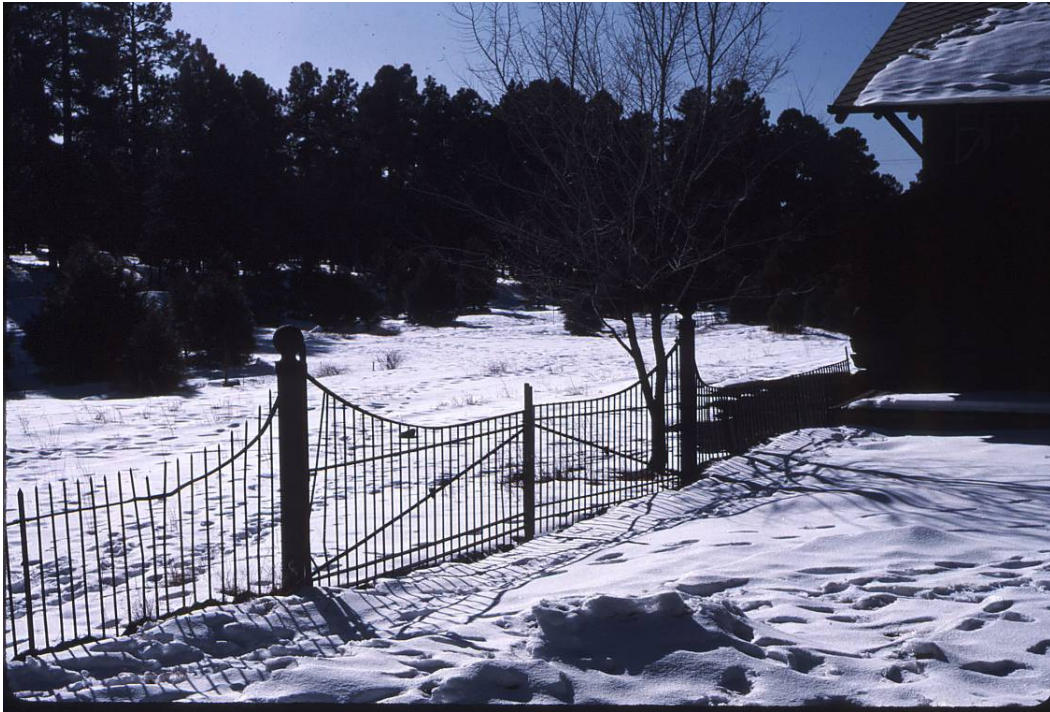
H-81 Grand Canyon Depot close up of log repair on south side brackets. Date 1984-1986.
Scanned from building files.

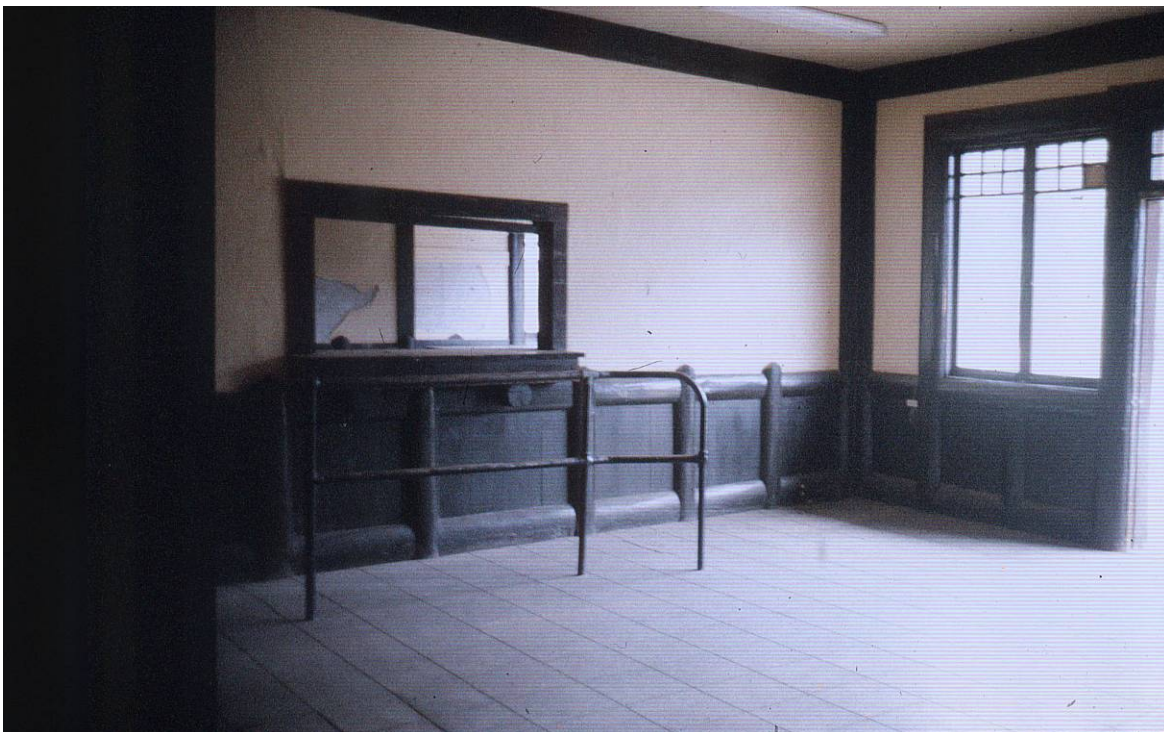
H-84 Grand Canyon Depot Waiting Room looking southeast. Note that the ceiling light fixture is missing. Compare to photograph H-136. Date 1984-1986. Scanned from building files.

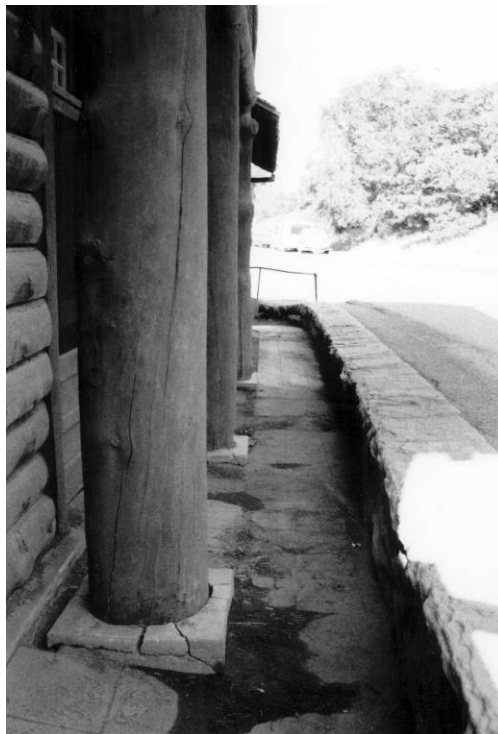
H-92 Grand Canyon Depot north side. Note cracked concrete column bases. Date assumed to be July 31, 1986. NPS photos. Scanned from building files.

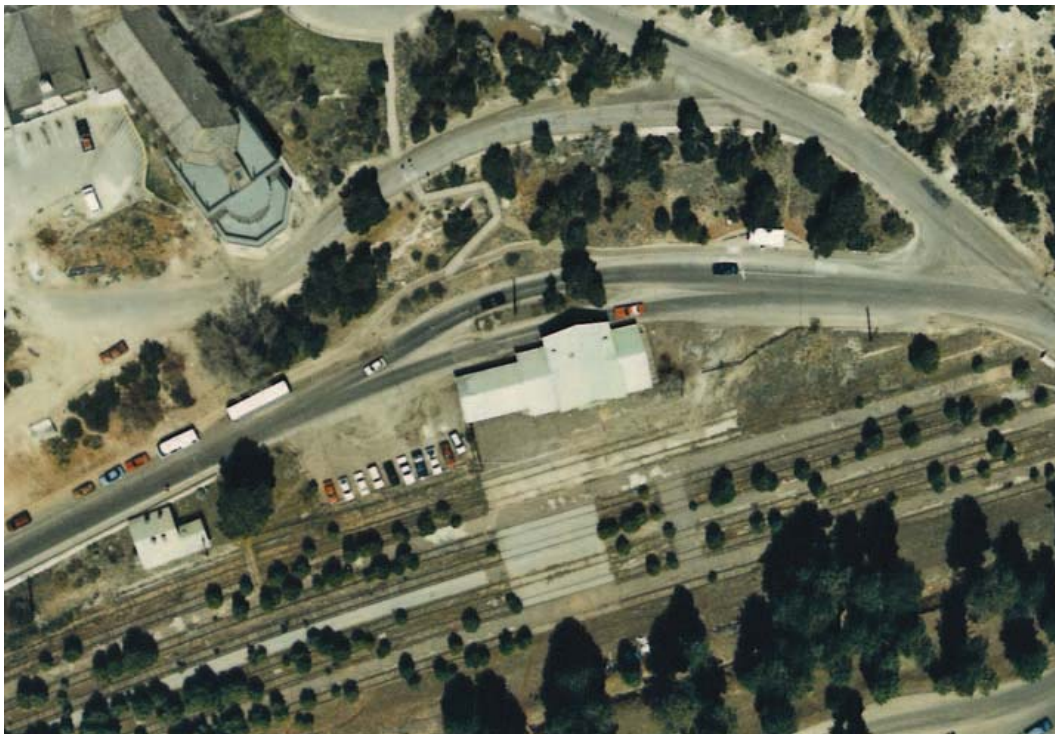
H-98 Close up of aerial photograph. Note cement asbestos shingles still in place. Date 1986.
NPS Document 113-FL21

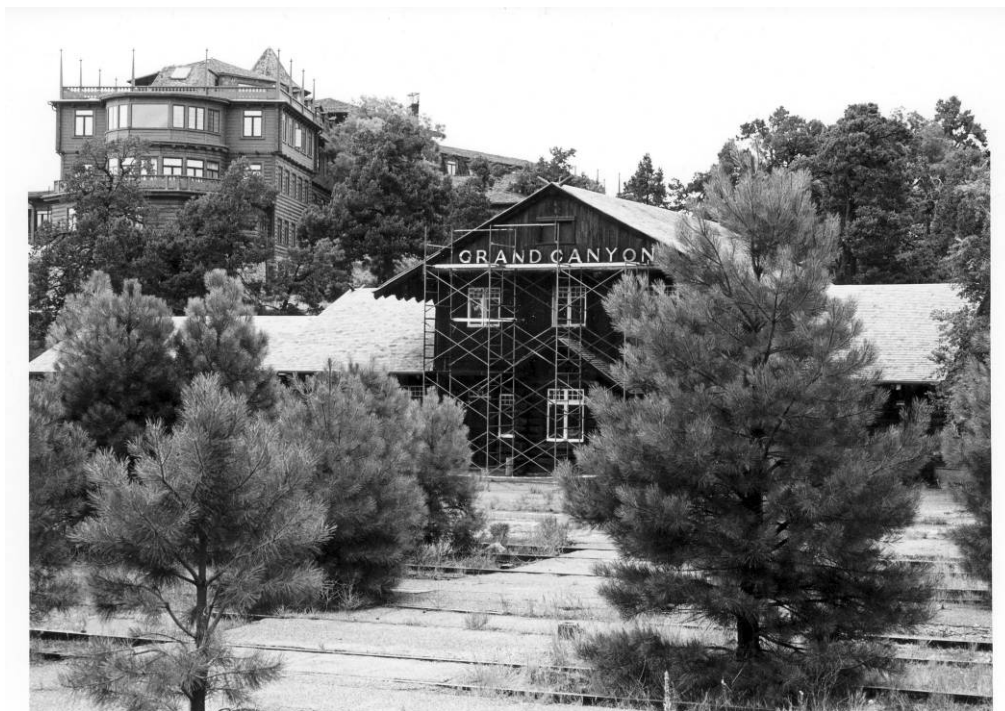
H-99 Santa Fe Railroad Depot with scaffolding – during historic renovation. Note that cement asbestos shingles have been replaced with wood. Date 1987. NPS photo. NPS Image # 16442

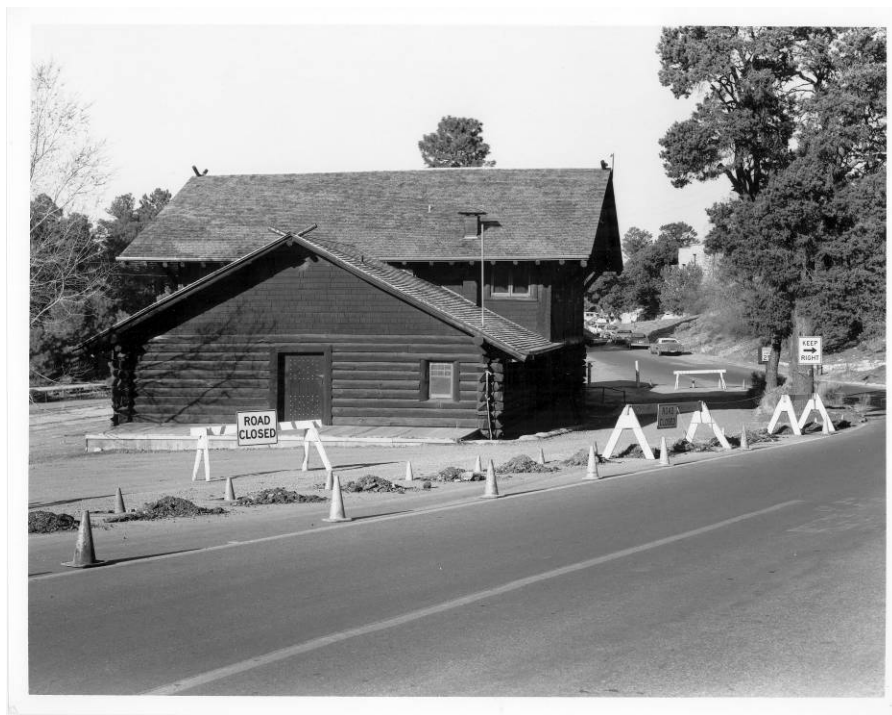
H-101 Grand Canyon Train Depot. East end. Note construction of guard rail in front. Also note that the iron fence on the south side is missing. Date March 23, 1988. NPS photo. NPS Image # 15911

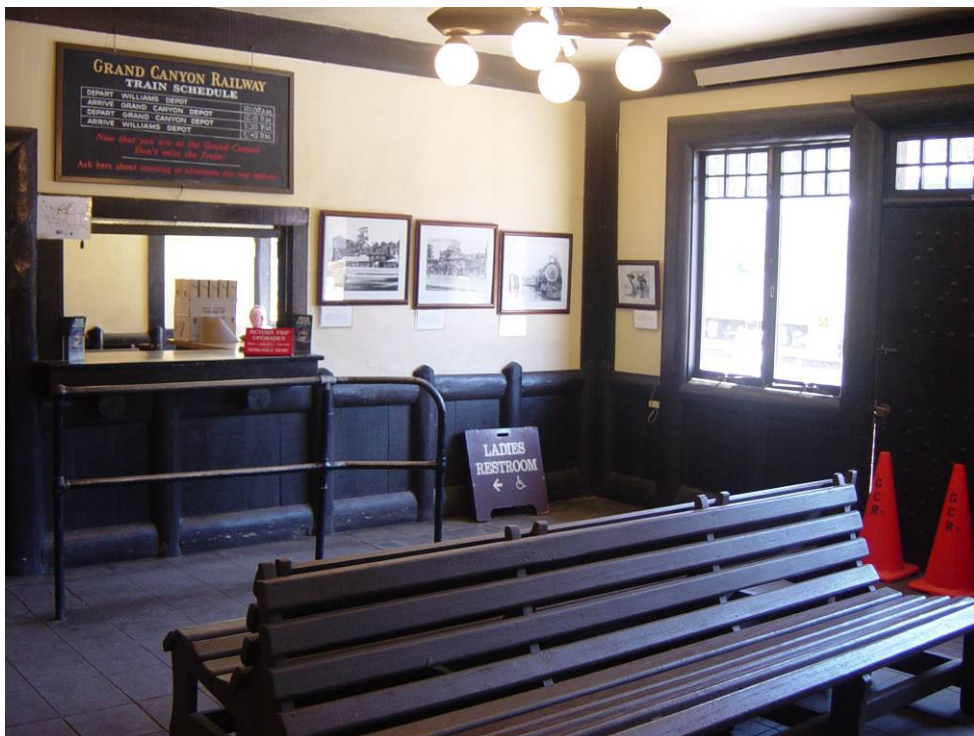
H-136 Grand Canyon Depot Waiting Room looking south east. Note ceiling light fixture. Compare to photograph H-84. Date September 23, 2002. Scanned from building files.

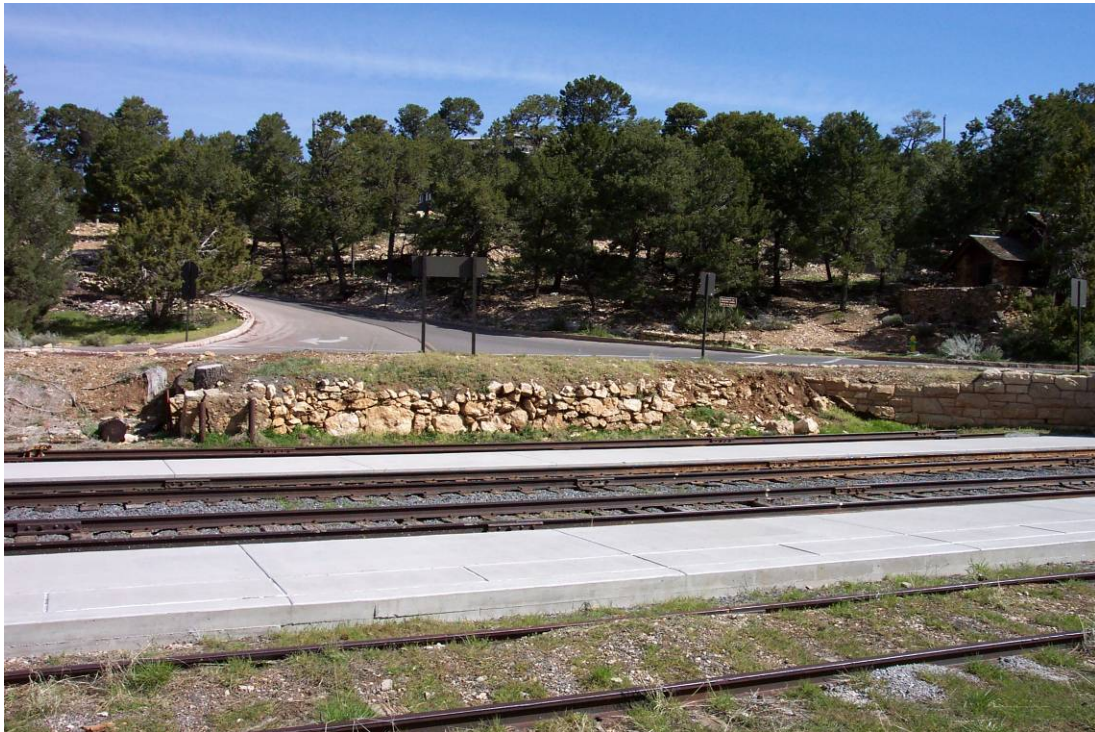
H-155 Rubble wall east of the Grand Canyon Depot prior to reconstruction. Date 2005. From building files. Photo by Craig Struble.

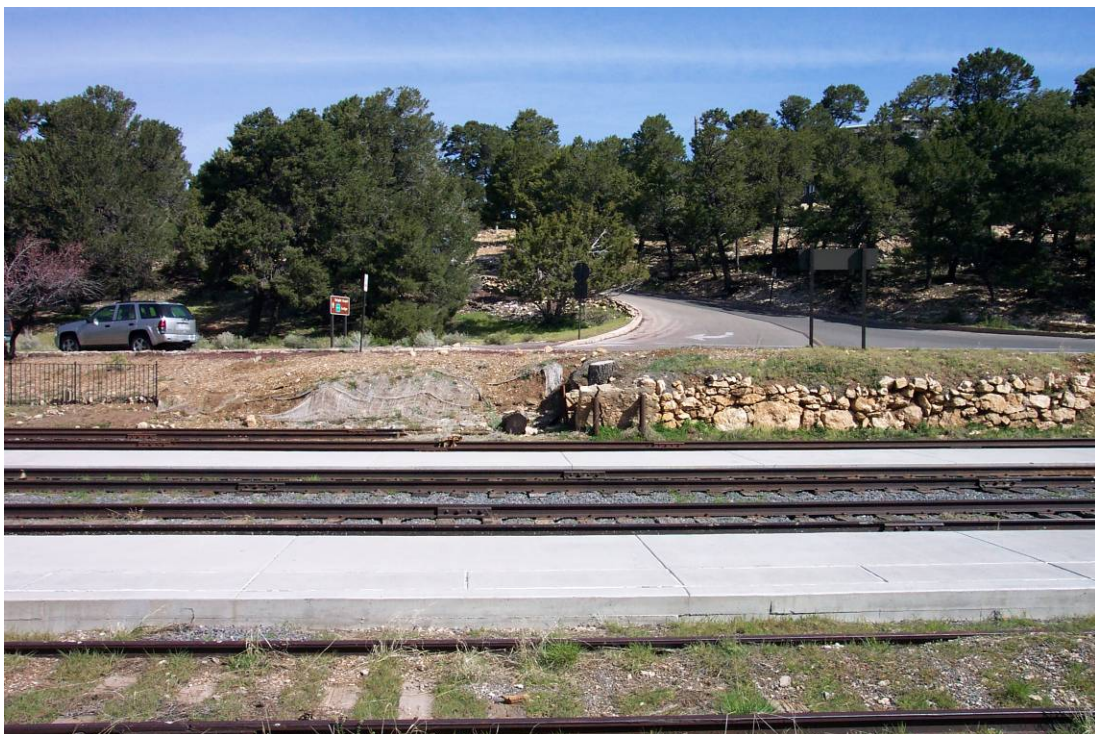
H-156 Rubble wall east of the Grand Canyon Depot prior to reconstruction. Date 2005. From building files. Photo by Craig Struble.

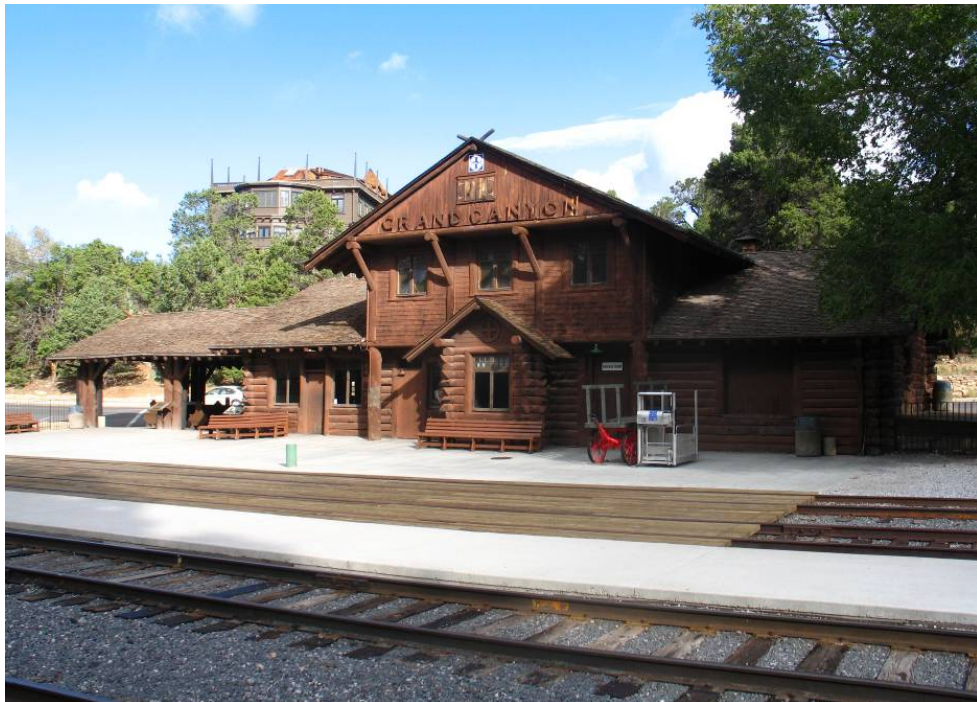
E-1 View from southeast with El Tovar visible beyond on the left. Note that the sash color of the existing windows is much lighter than historic photographs taken after about 1940. See photographs H-29 and succeeding photos. October 3, 2007. Photograph by Martin/Martin.

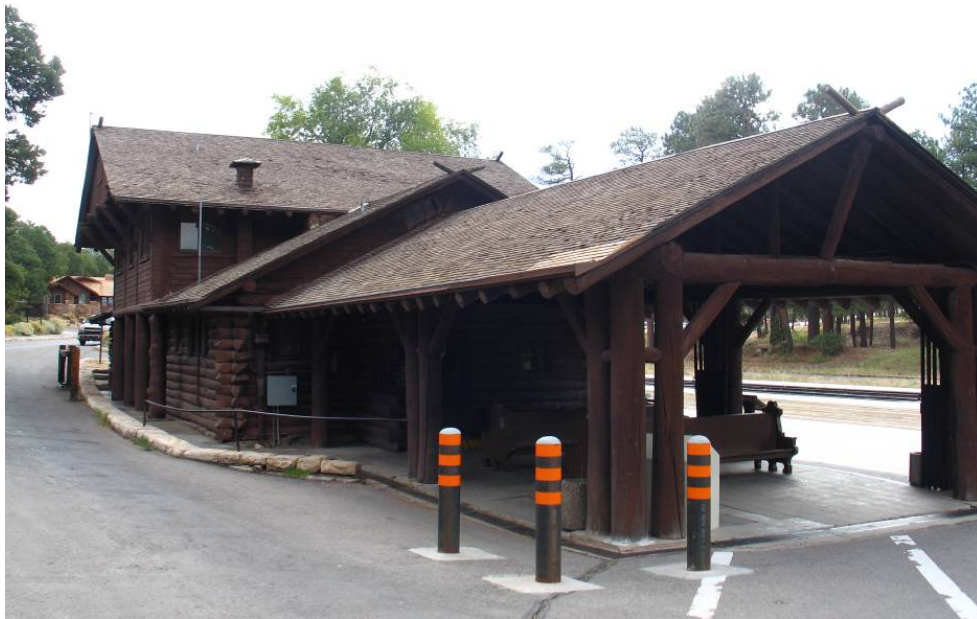
E-4 View from northwest. Note repair to eave. October 3, 2007. Photograph by Martin/Martin.

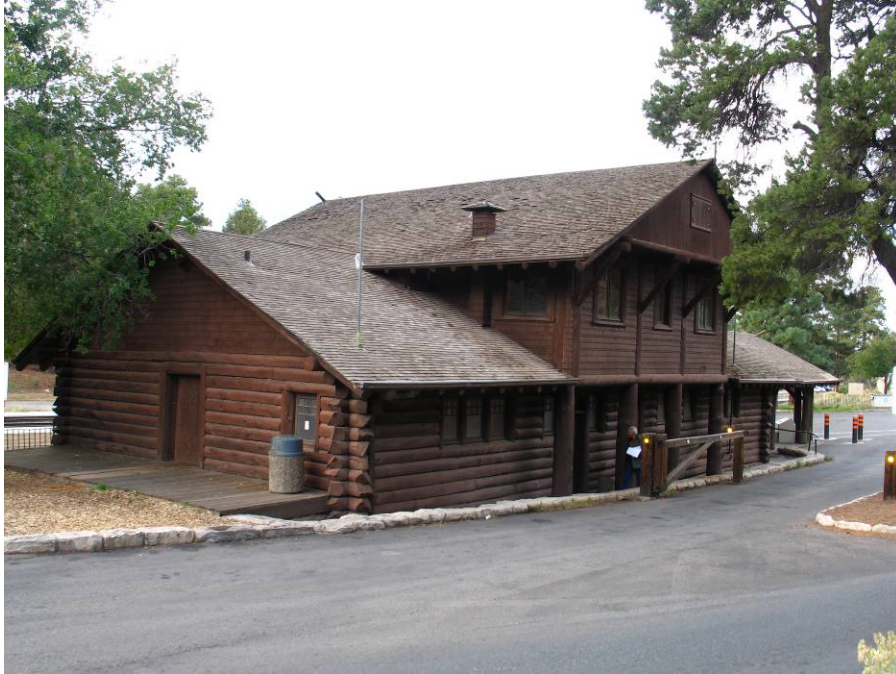
E-5 View from northeast. Note that the barge rafter extensions are missing from the east gable. October 3, 2007. Photograph by Martin/Martin.

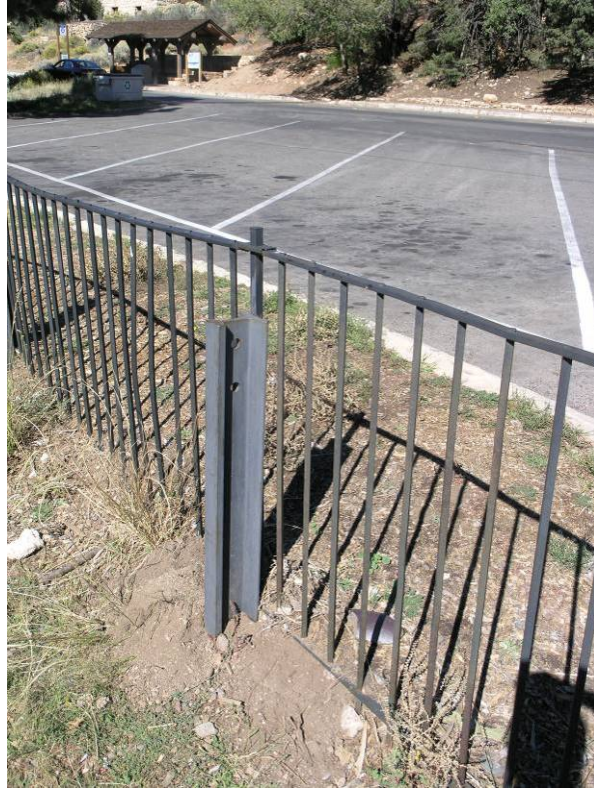
E-7 Metal fence along south side of parking area. Note steel rail for support and buried bottom rail. October 3, 2007. Photograph by Chamberlin Architects.

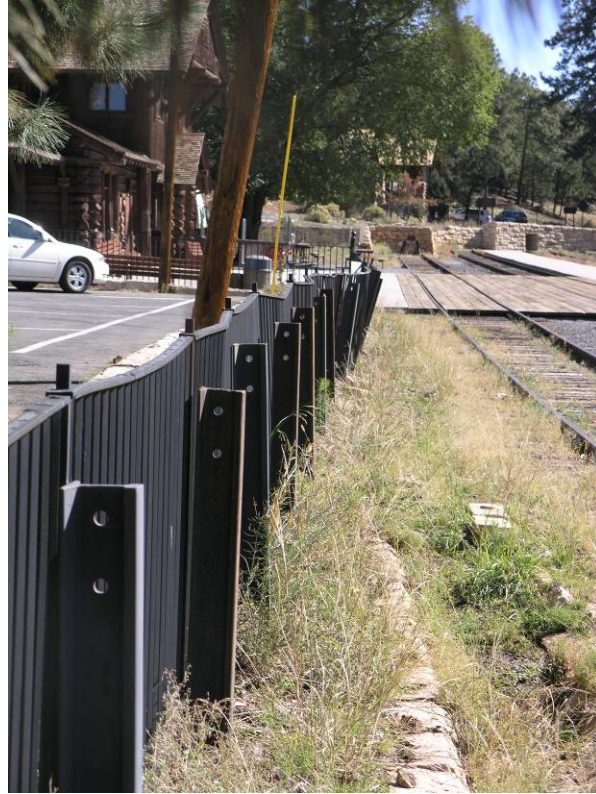
E-9 View of metal fence looking east. Note partially buried stone curb on the right side. October 3, 2007. Photograph by Chamberlin Architects.

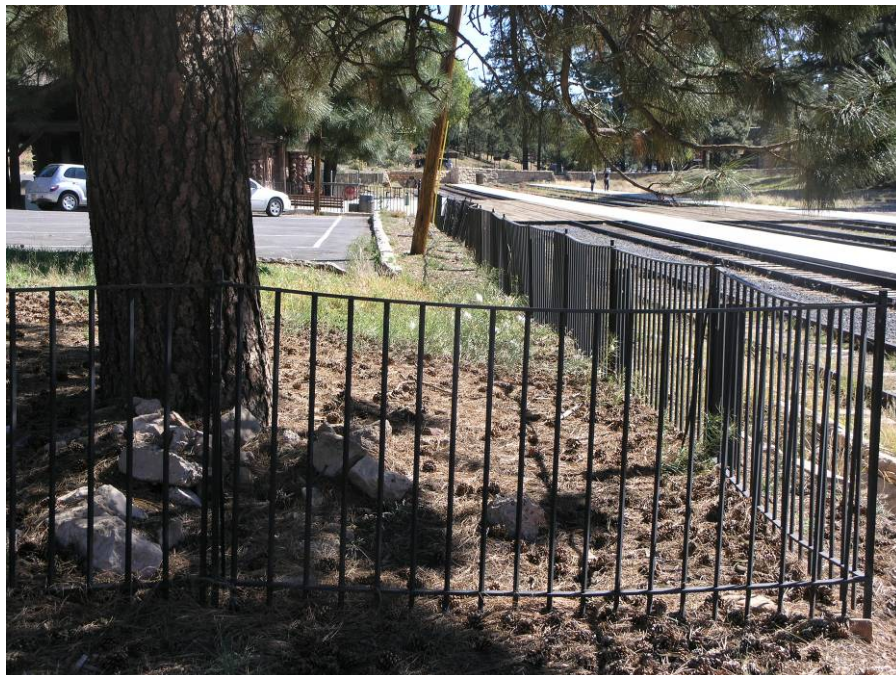
E-10 Metal fence, southwest corner of parking area. Note sag in rails. October 3, 2007. Photograph by Chamberlin Architects.

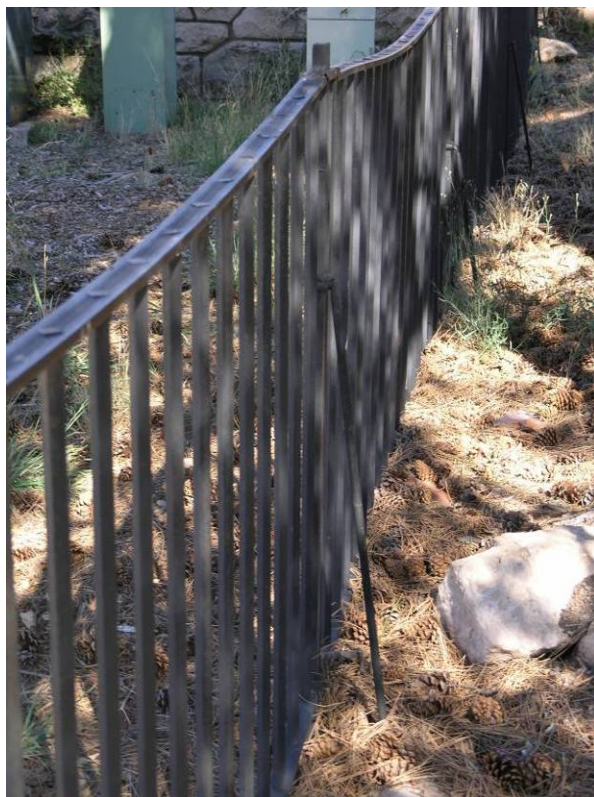
E-11 Metal fence, west end of parking area. Note original bracing still in place. October 3, 2007. Photograph by Chamberlin Architects.

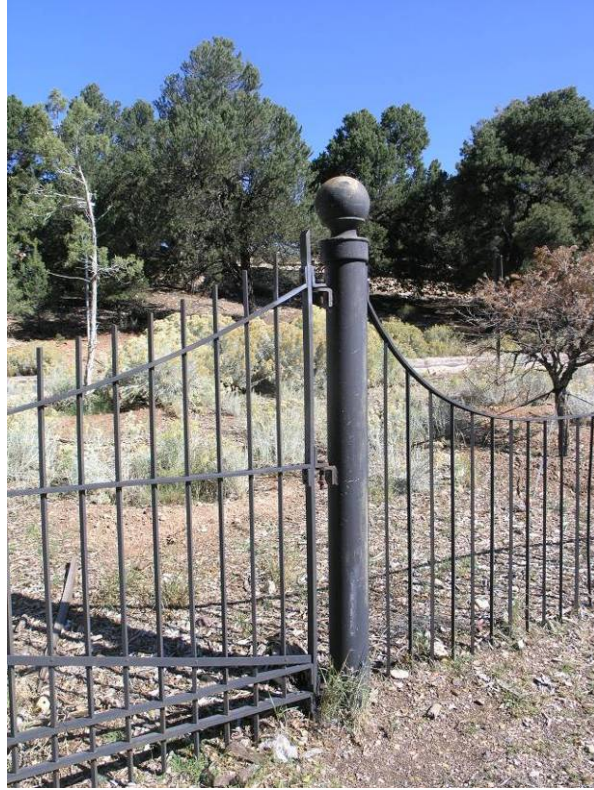
E-12 Gate on east side of Depot. October 3, 2007. Photograph by Chamberlin Architects.

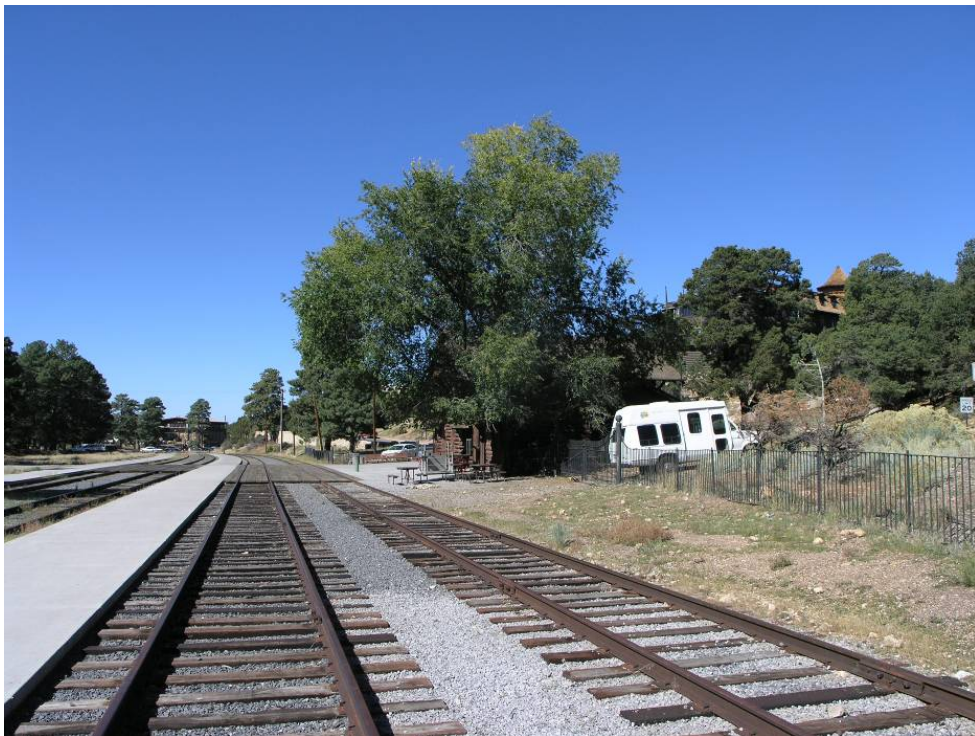
E-15 View of rubble wall looking east. October 3, 2007. Photograph by Chamberlin Architects.

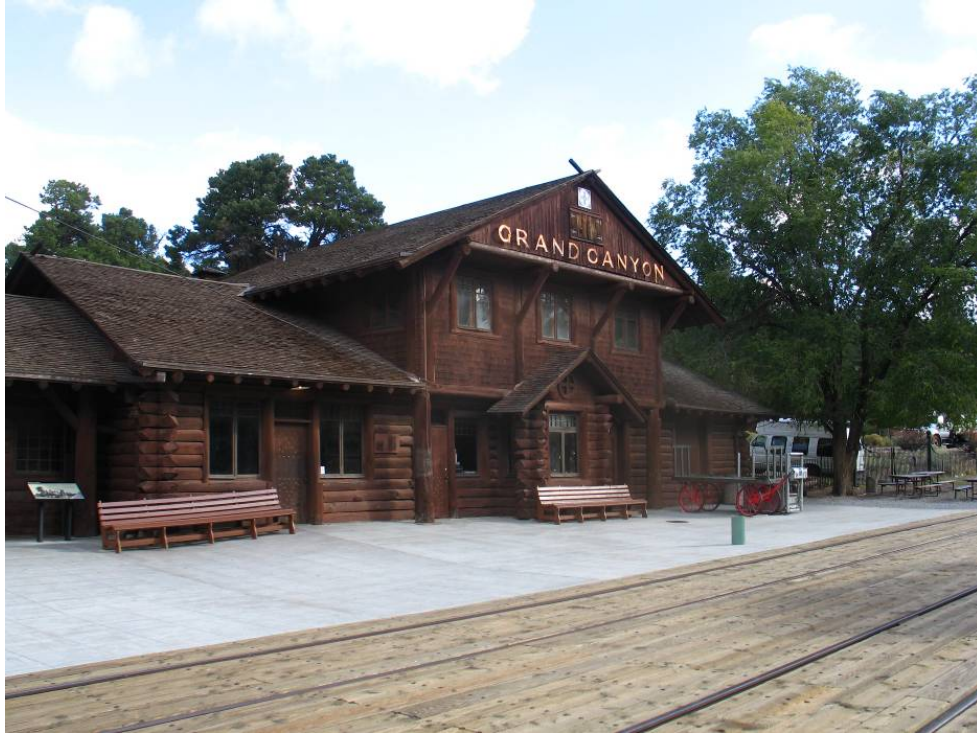
E-16 View looking west of railyard in front of the Depot. October 3, 2007. Photograph by Chamberlin Architects.

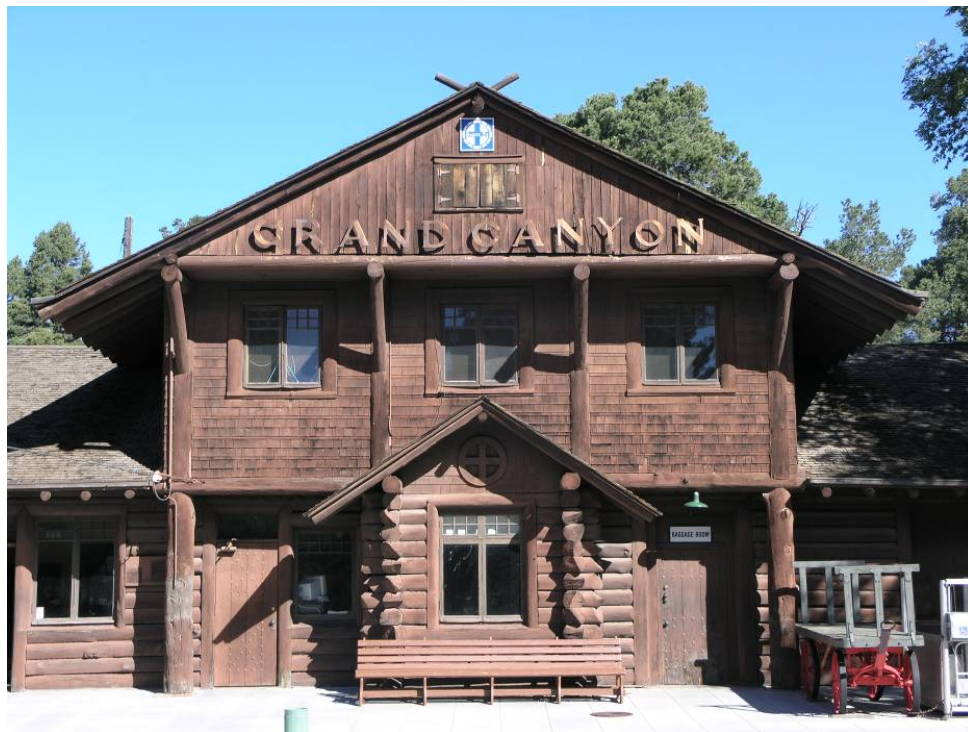
E-17 South elevation and view of platform. October 3, 2007. Photograph by Martin/Martin.

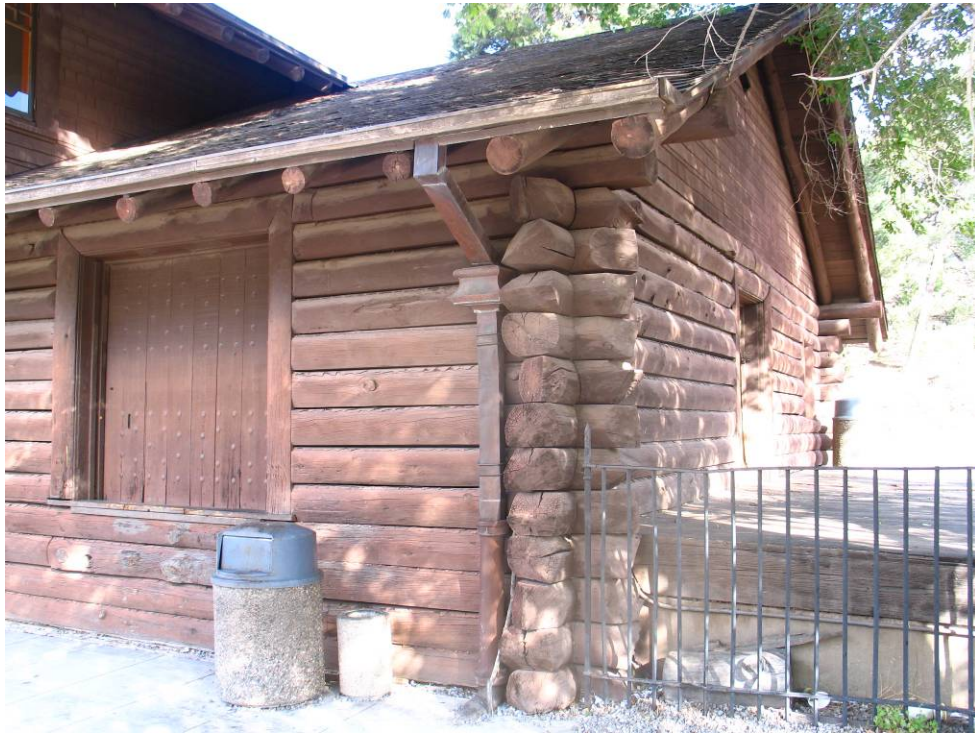
E-18 Center of South elevation. October 3, 2007. Photograph by Chamberlin Architects.

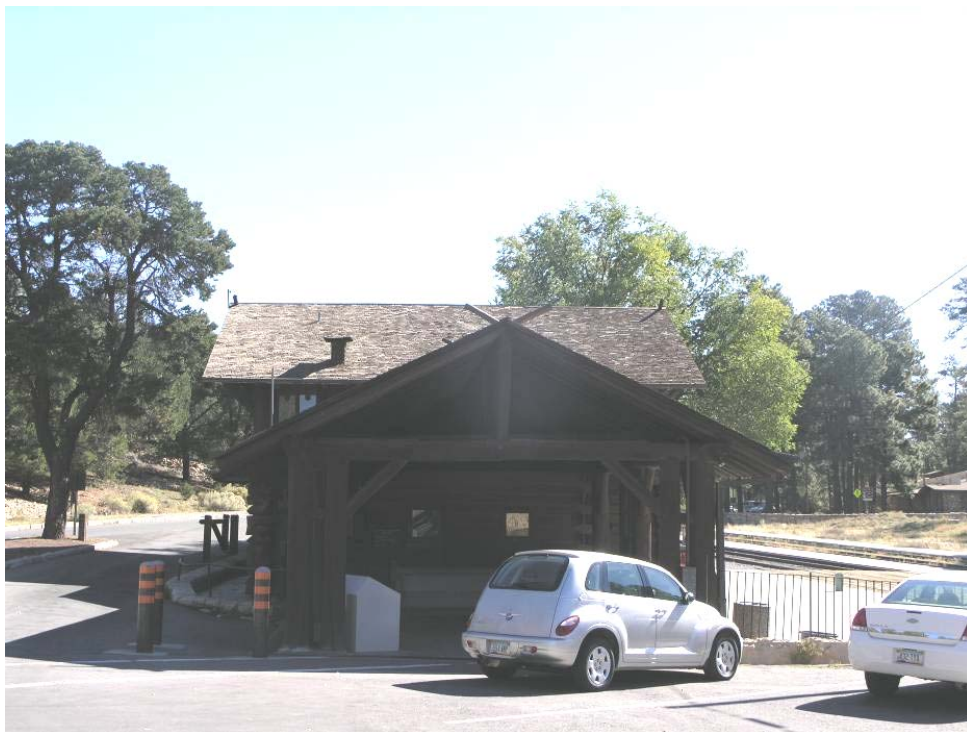
E-19 South elevation, east end. Door 104B to the left. October 3, 2007. Photograph by Chamberlin Architects.

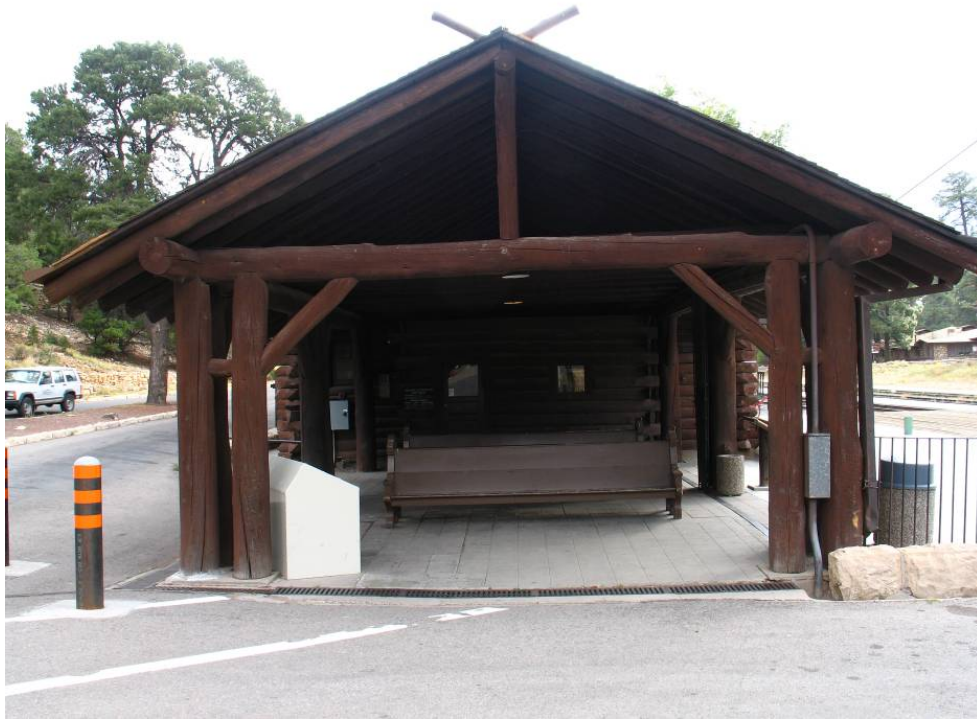
E-20 West side of building. October 3, 2007. Photograph by Chamberlin Architects.

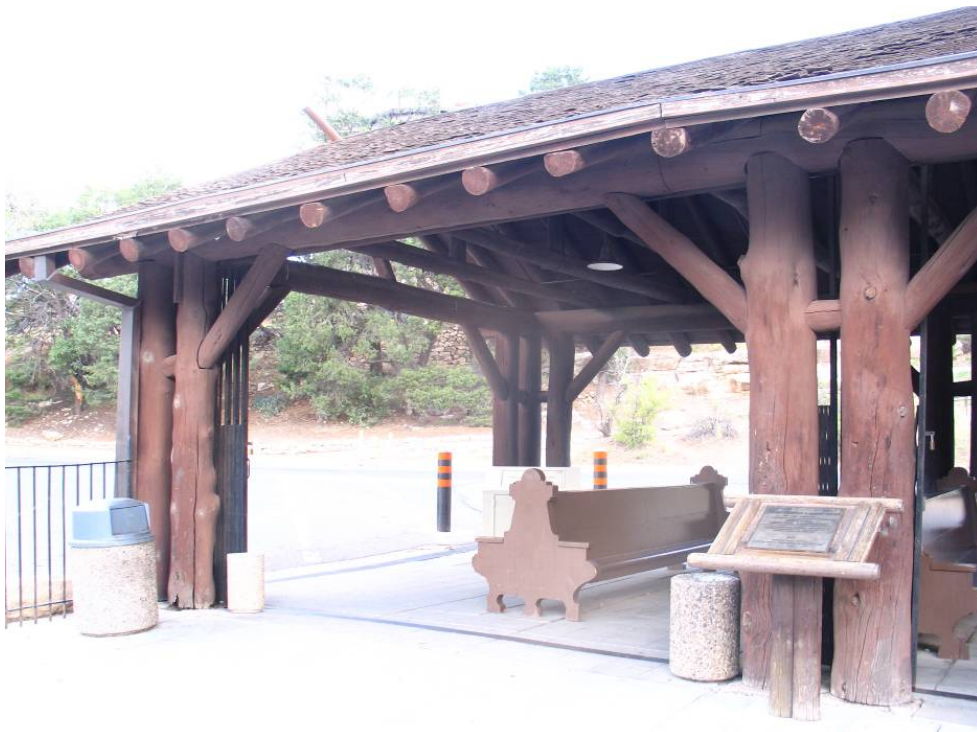
E-21 West elevation of covered waiting area. October 3, 2007. Photograph by Martin/Martin.

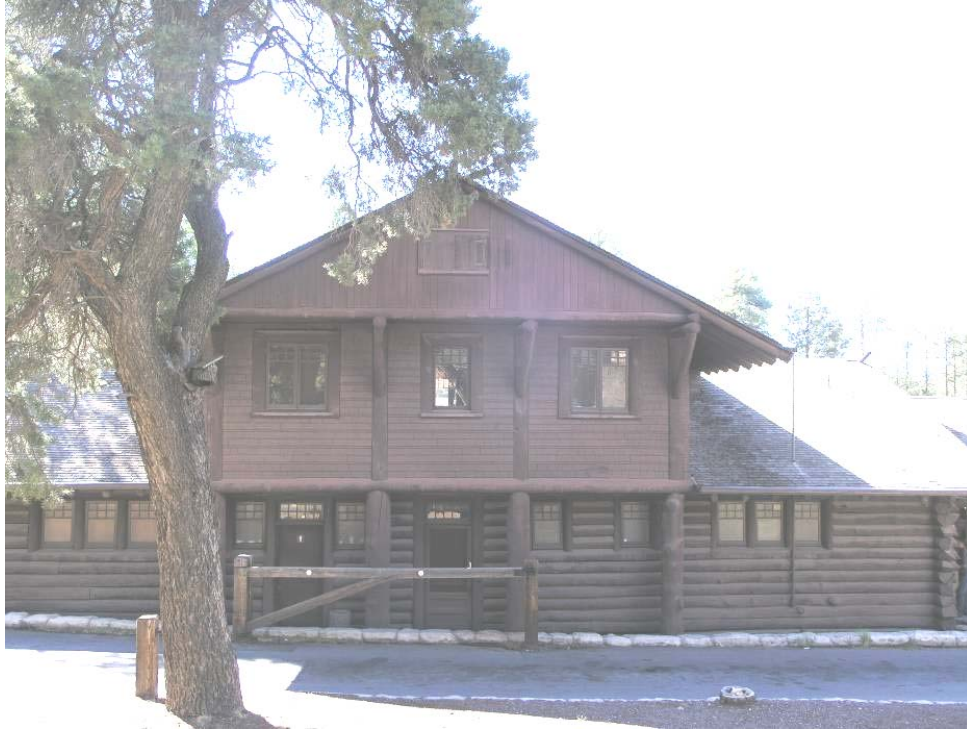
E-22 South side of covered waiting area. Note variation in gutter. October 3, 2007.
Photograph by Martin/Martin.

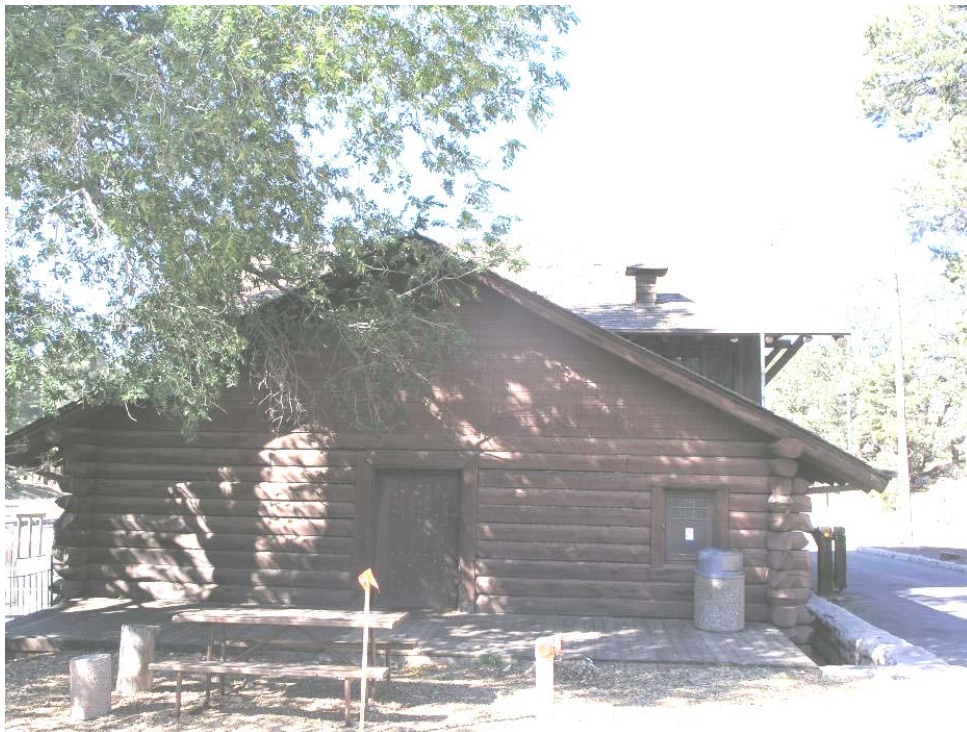
E-23 Center of north elevation. October 3, 2007. Photograph by Chamberlin Architects.

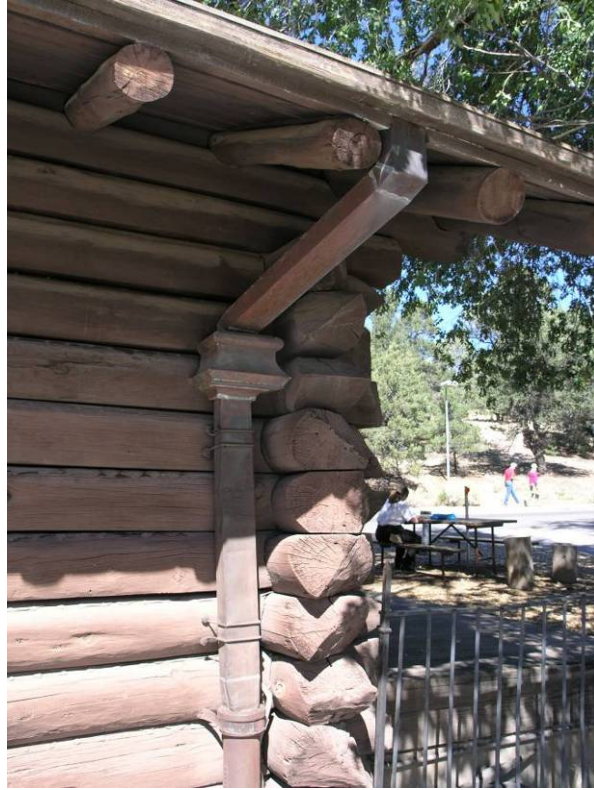
E-24 East side of building. October 3, 2007. Photograph by Chamberlin Architects.

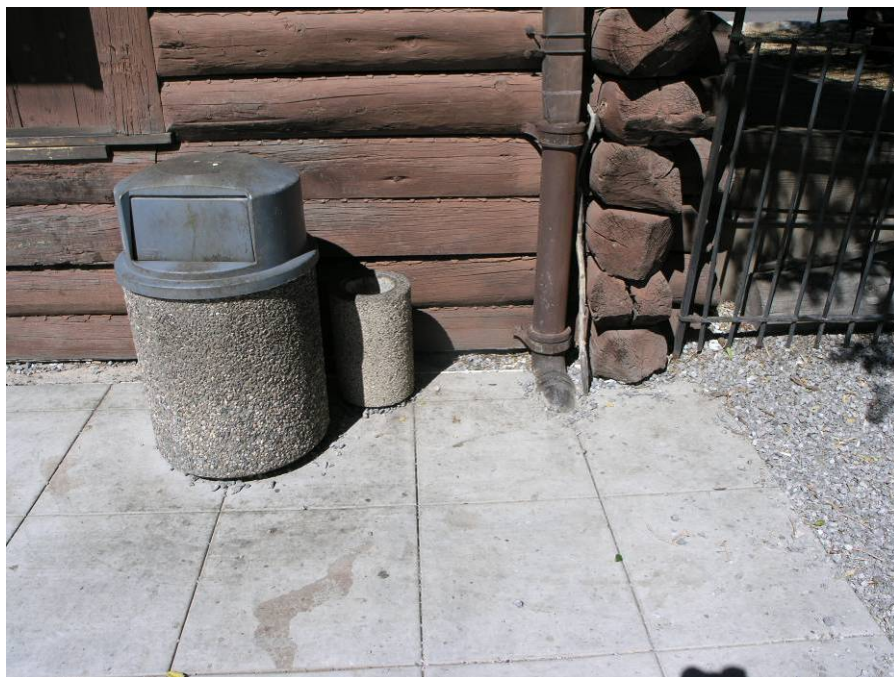
E-25 South façade, southeast corner. Note reconstructed copper downspouts. October 3, 2007.
 Photograph by Chamberlin Architects.
