Grand Canyon Railroad Depot

Historic Structure Report

prepared for the
National Park Service

prepared by
Chamberlin Architects, PC
Grand Junction/Lakewood, Colorado

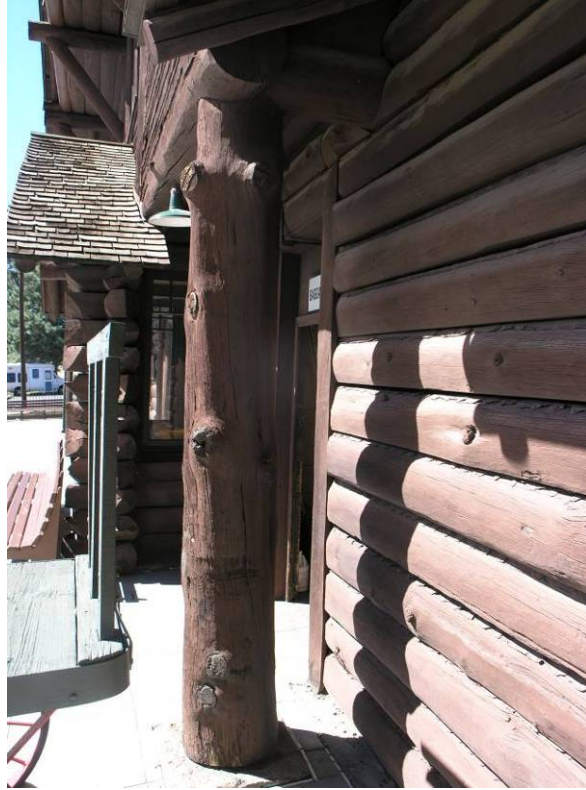
E-26 South façade, southeast corner, below photo above. October 3, 2007. Photograph by
 Chamberlin Architects.

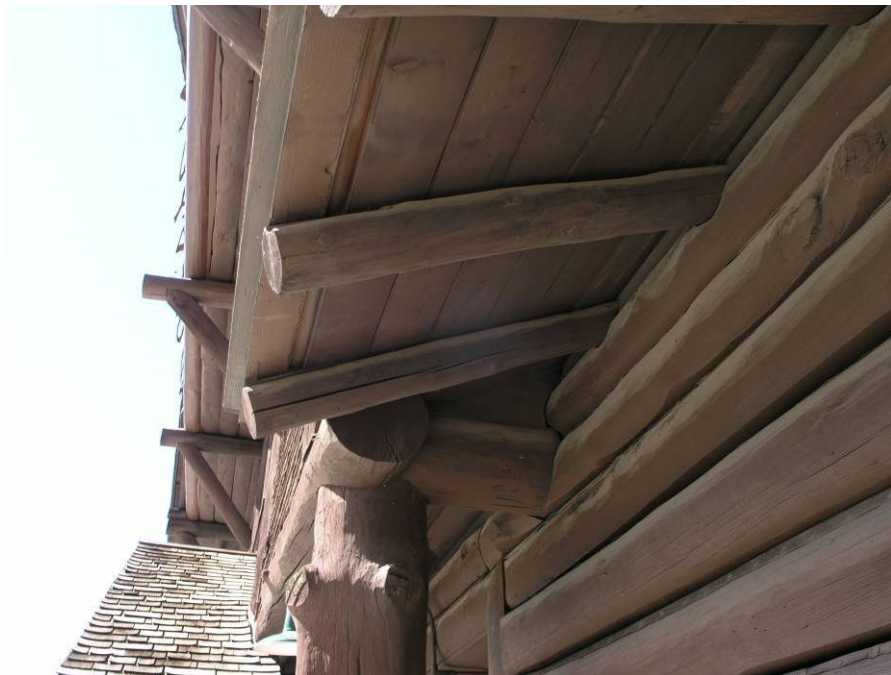
E-27 South façade, looking from east to west. October 3, 2007. Photograph by Chamberlin Architects.

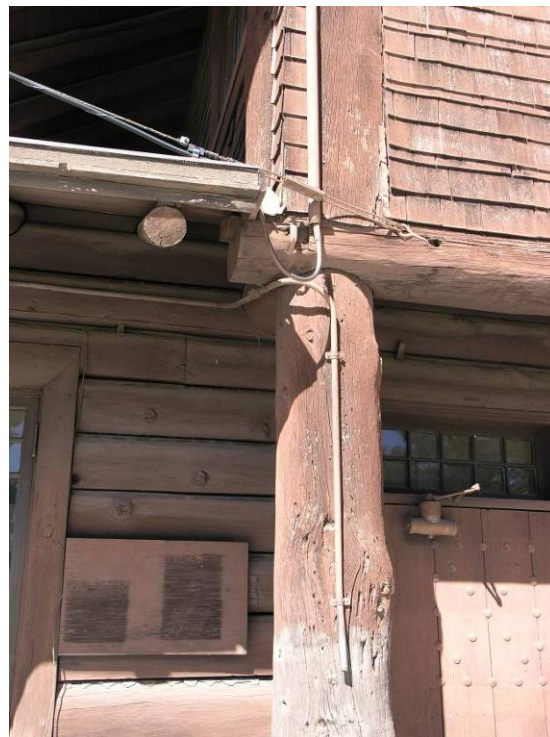
E-33 South façade. Doors 101A to the right and 102A to left. Windows 118 and 117. Note telephone cable coming into column. October 3, 2007. Photograph by Chamberlin Architects.

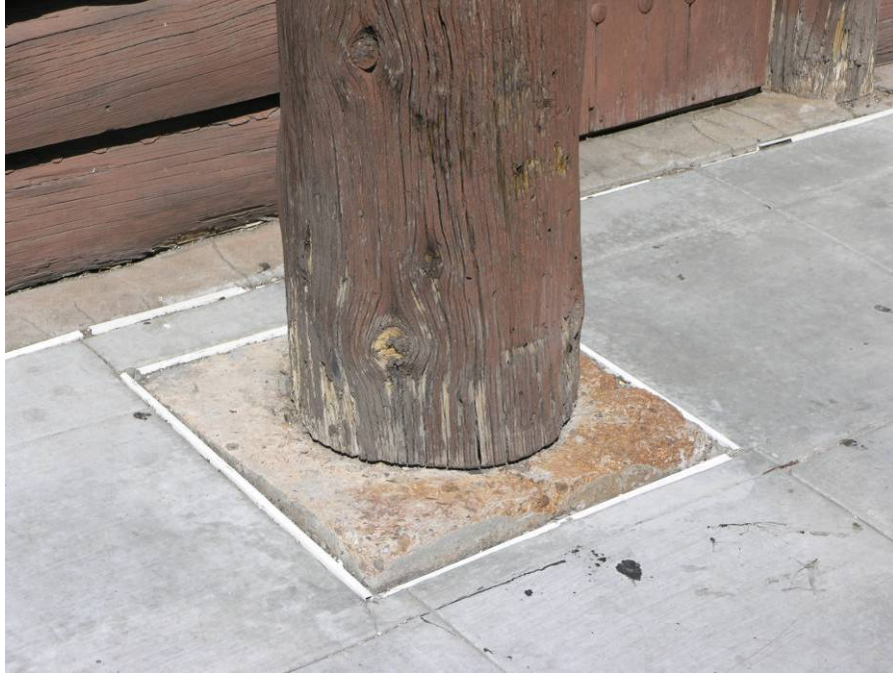
E-34 South façade. Door 102A to right. Note telephone cable and conduit attached to log column. These should be removed if possible. Also note discoloration of column. October 3, 2007. Photograph by Chamberlin Architects.

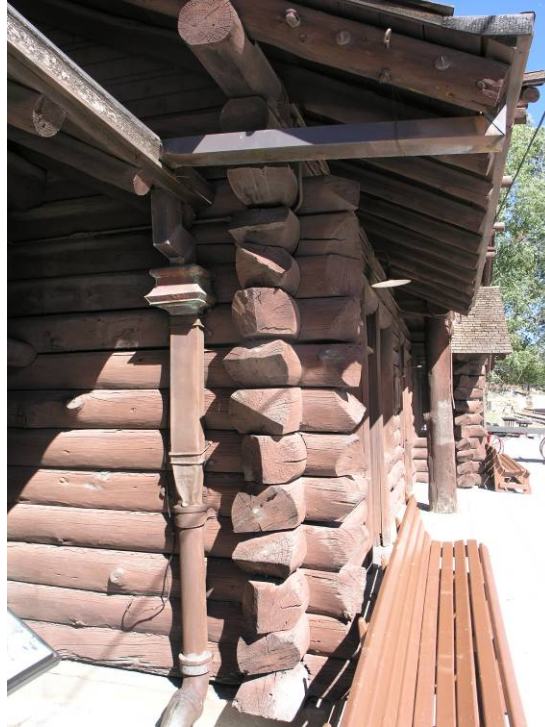
E-36 South façade, southwest corner of building, covered waiting area beyond. Window 118 to right. October 3, 2007. Photograph by Chamberlin Architects.

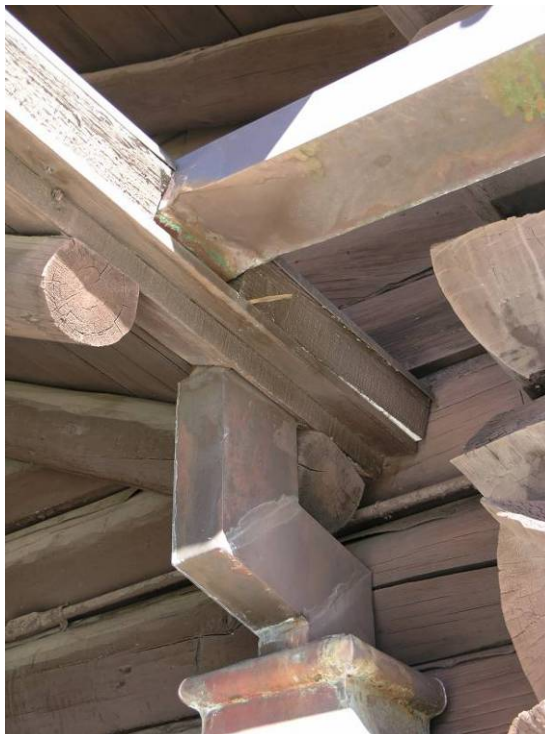
E-37 South west corner. Note that leader is disconnected from gutter on the right. October 3, 2007. Photograph by Chamberlin Architects.

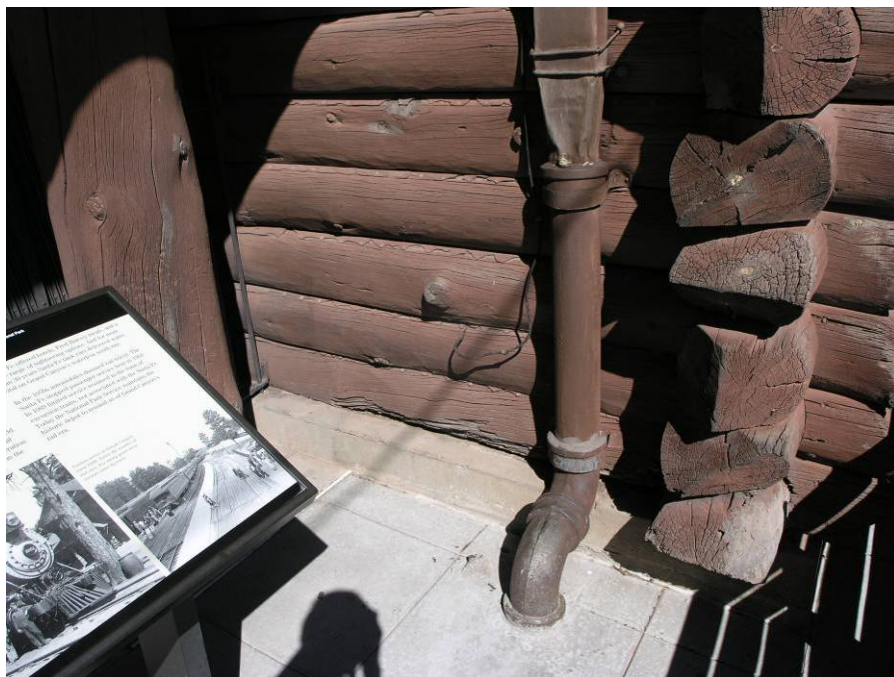
E-38 Same location as above, downspout/gutter detail. October 3, 2007. Photograph by Chamberlin Architects.

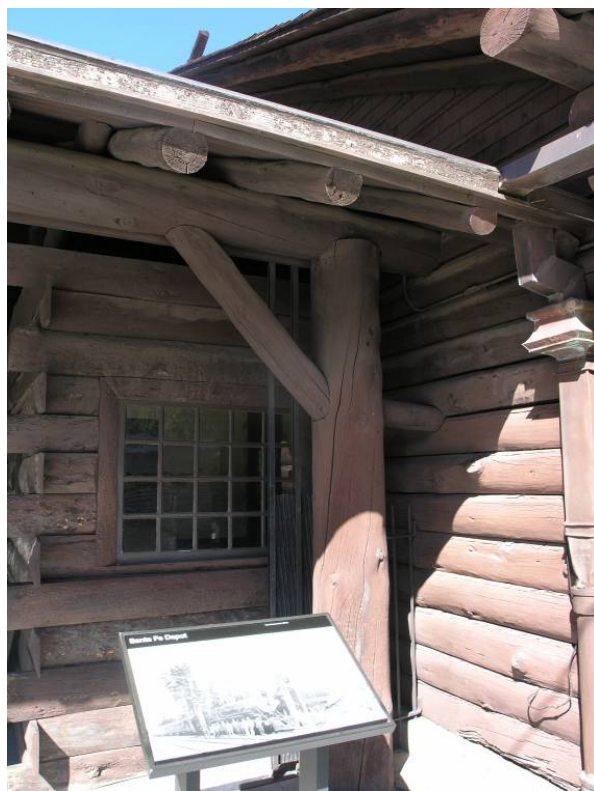
E-39 Southwest corner, base of downspout, covered terrace gate on the left, and Vestibule wall on left beyond gate. October 3, 2007. Photograph by Chamberlin Architects.

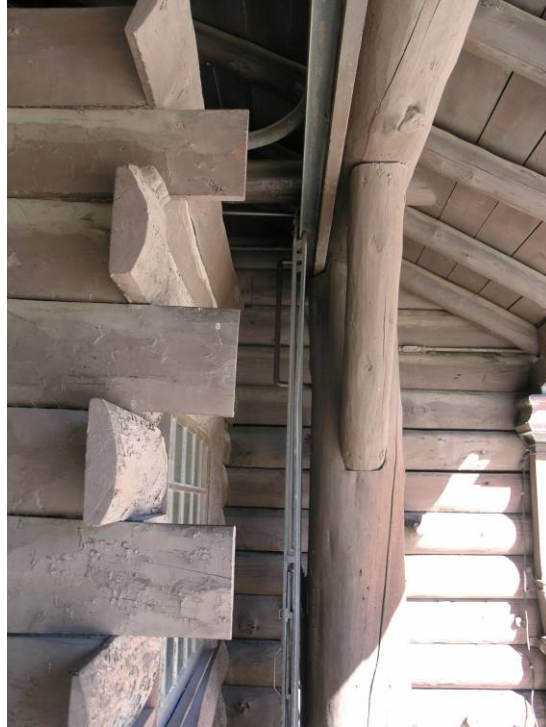
E-40 From the south looking northeast. Window 119. Collapsible gate is visible behind the column. October 3, 2007. Photograph by Chamberlin Architects.

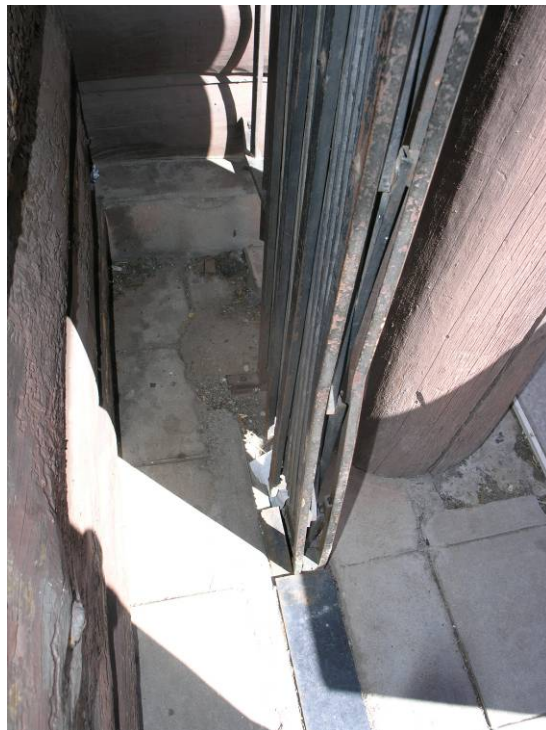
E-41 West façade, south side. Note collapsible gate and track. October 3, 2007. Photograph by Chamberlin Architects.

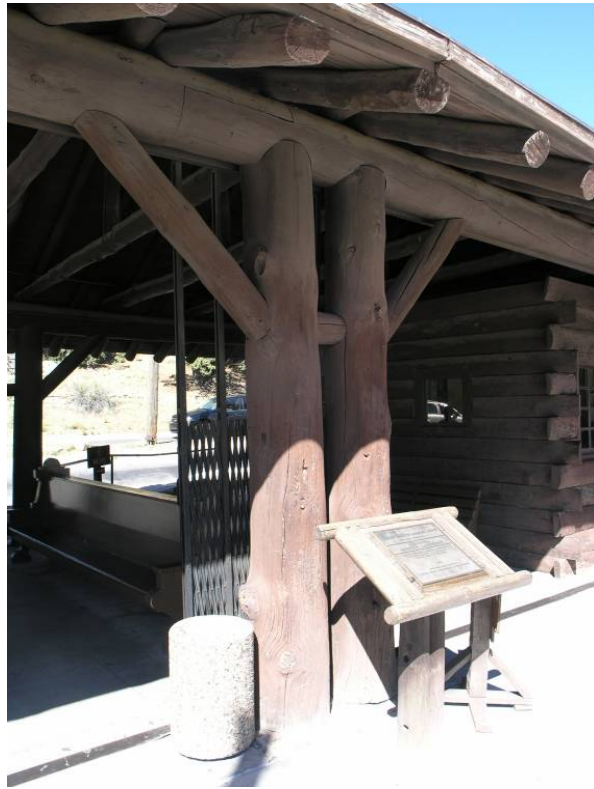
E-42 West façade, south side. East end of collapsible gate. Note base track is covered. October 3, 2007. Photograph by Chamberlin Architects.

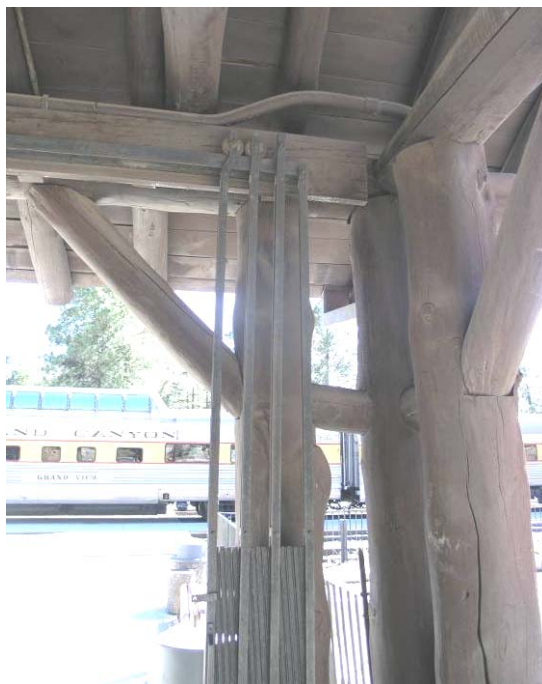
E-44 South side of covered waiting area looking south. Note collapsible gate and track. October 3, 2007. Photograph by Chamberlin Architects.

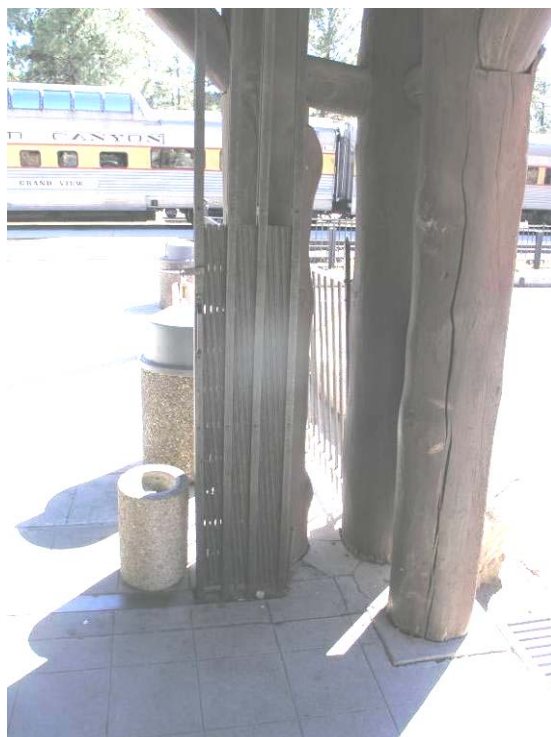
E-45 Southwest corner of covered waiting area. Note differential settlement of columns evident by the slope of the log spacer. October 3, 2007. Photograph by Chamberlin Architects.

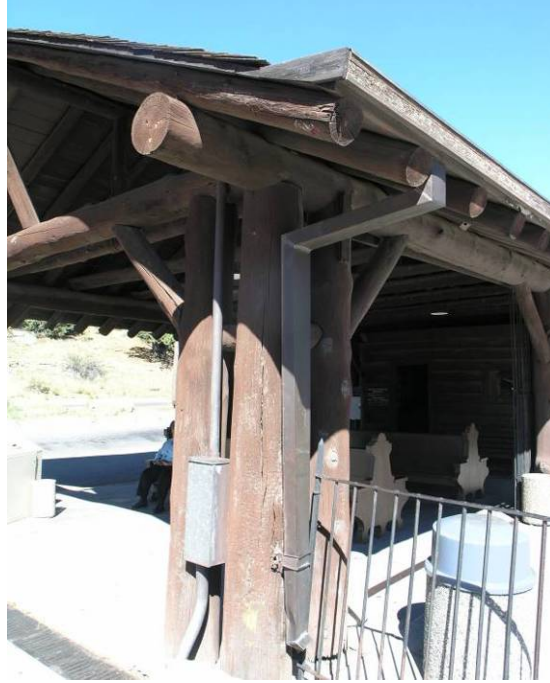
E-46 Base of columns southwest corner of covered waiting area. October 3, 2007. Photograph by Chamberlin Architects.

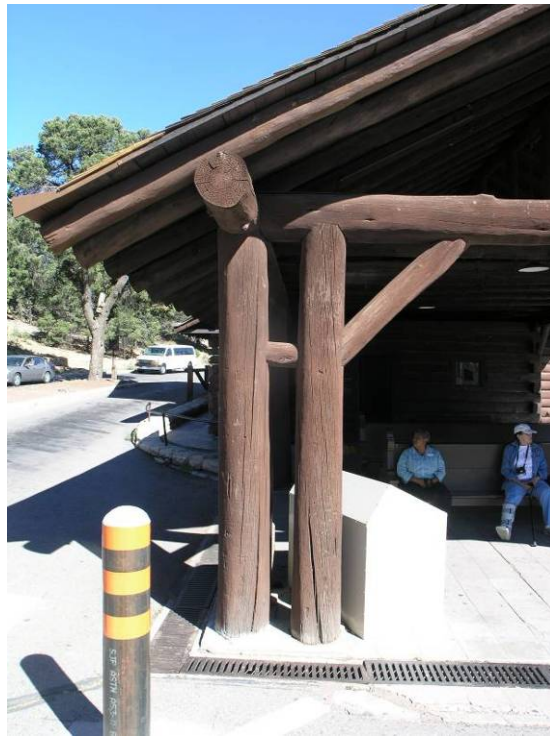
E-47 Southwest corner of covered waiting area looking northeast. Roof drain leader, added in 1986, is not historic. Note wrought iron fence to the right. October 3, 2007. Photograph by Chamberlin Architects.

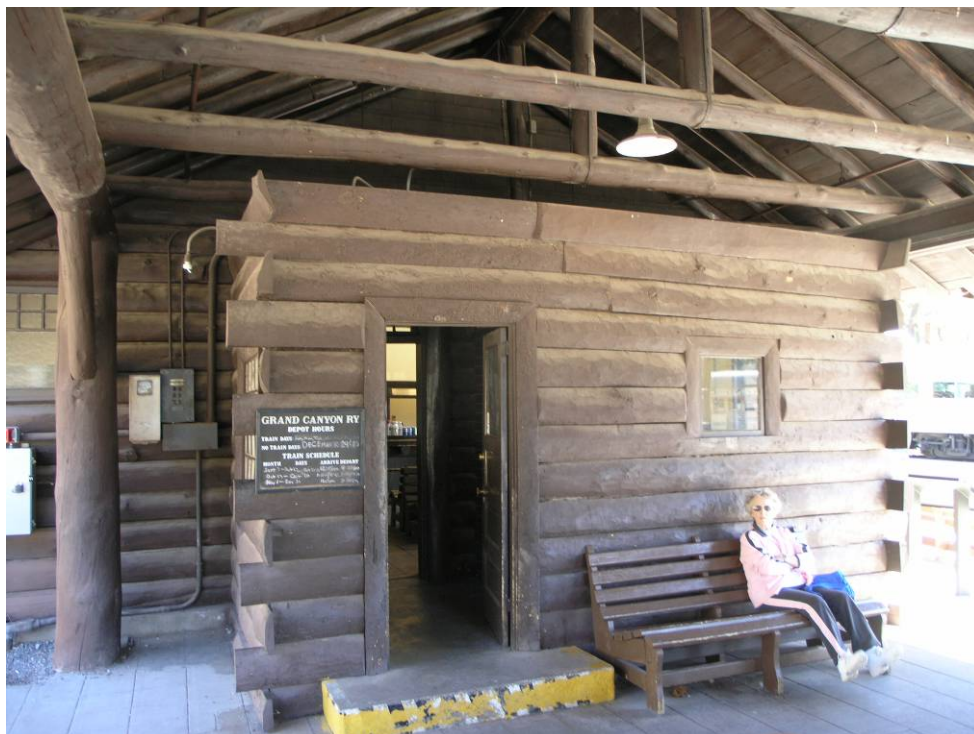
E-48 Northwest corner of covered waiting area, looking east. Note cracks in log columns. October 3, 2007. Photograph by Chamberlin Architects.

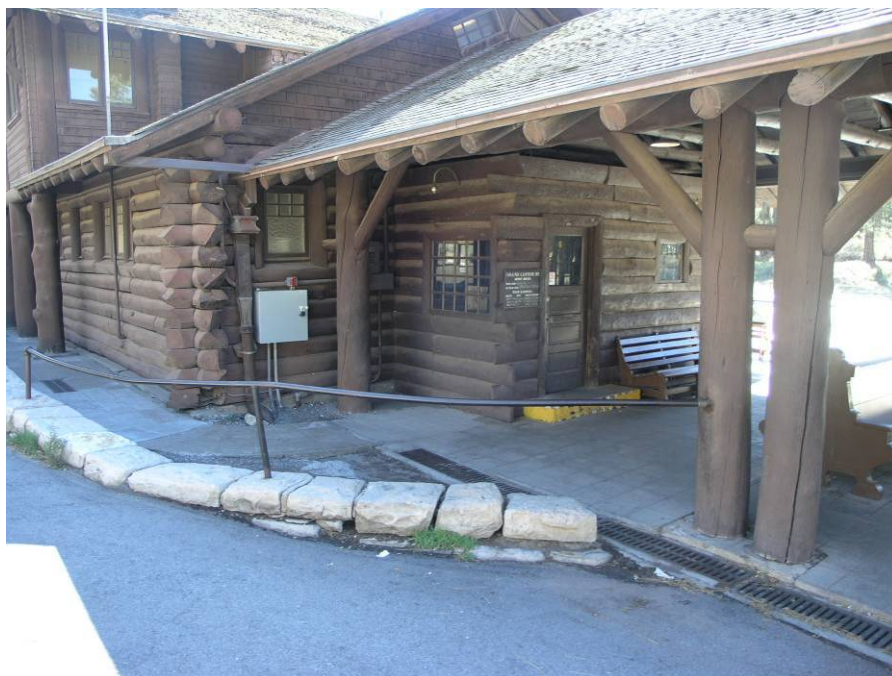
E-49 West elevation of vestibule. Door 111 and Window 120. October 3, 2007. Photograph by Chamberlin Architects.

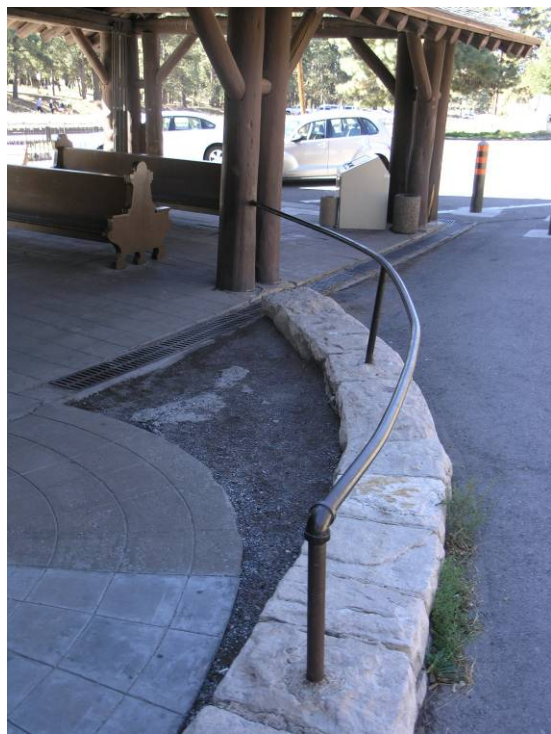
E-51 Base of column on east side of covered waiting area. Note handrail attached to column, installed sometime after 1935. October 3, 2007. Photograph by Chamberlin Architects.

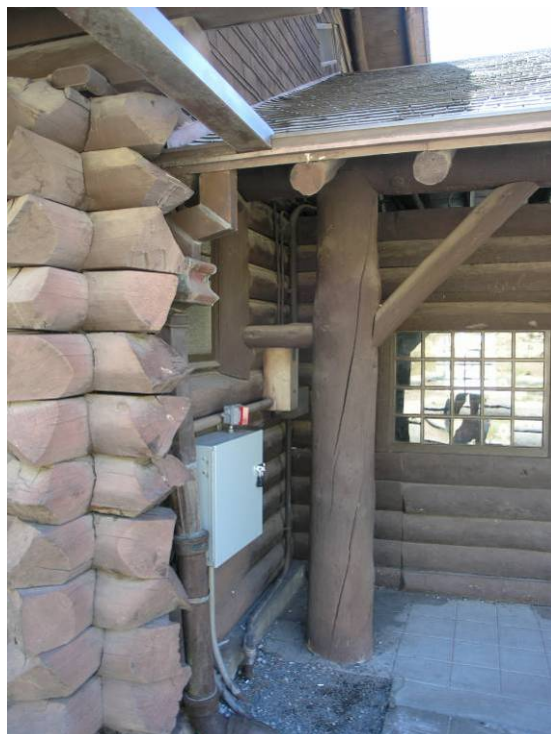
E-53 Northwest corner of building. Window 121 on right. October 3, 2007. Photograph by Chamberlin Architects.

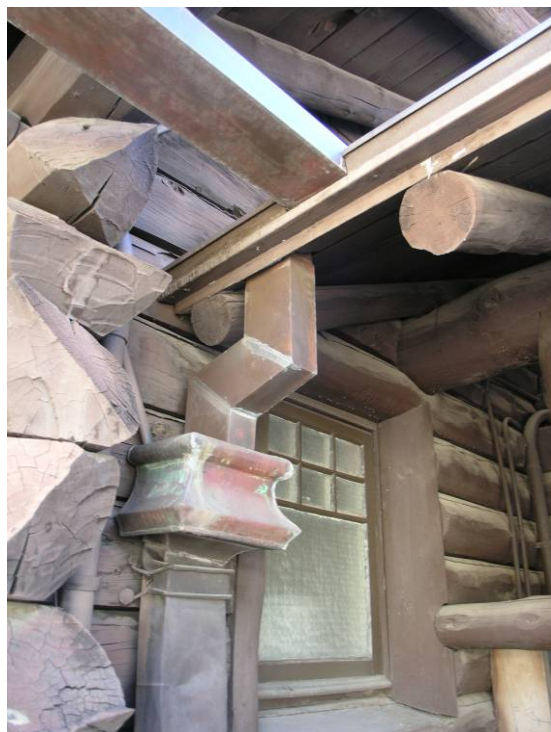
E-54 Northeast corner of building. Window 101. October 3, 2007. Photograph by Chamberlin Architects.

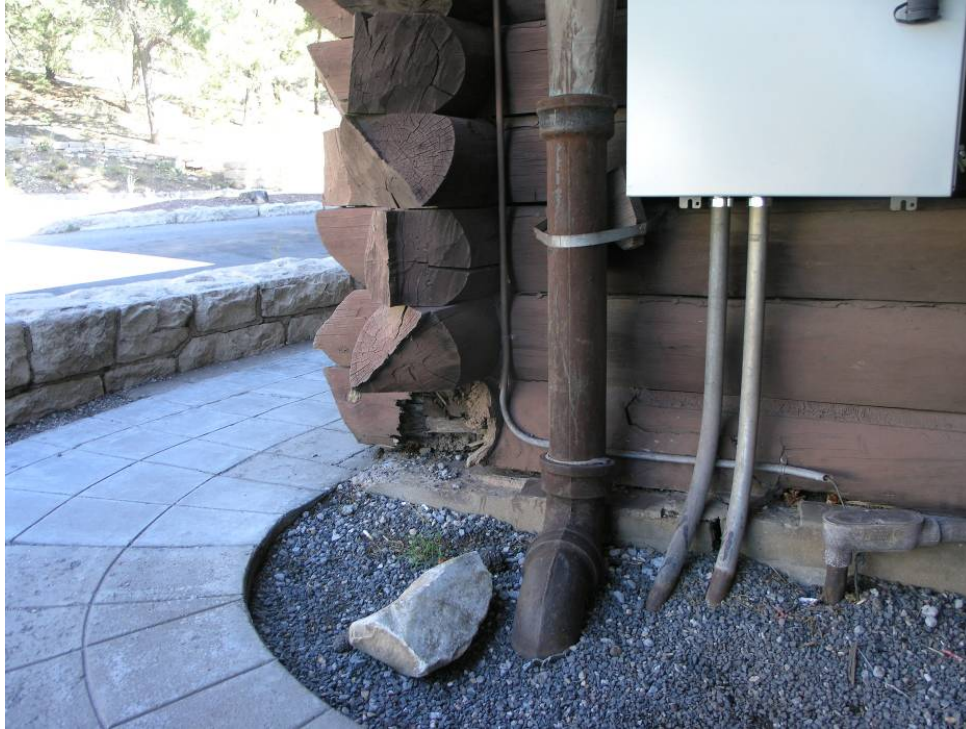
E-55 Northeast corner of building, base of downspout. October 3, 2007. Photograph by Chamberlin Architects.

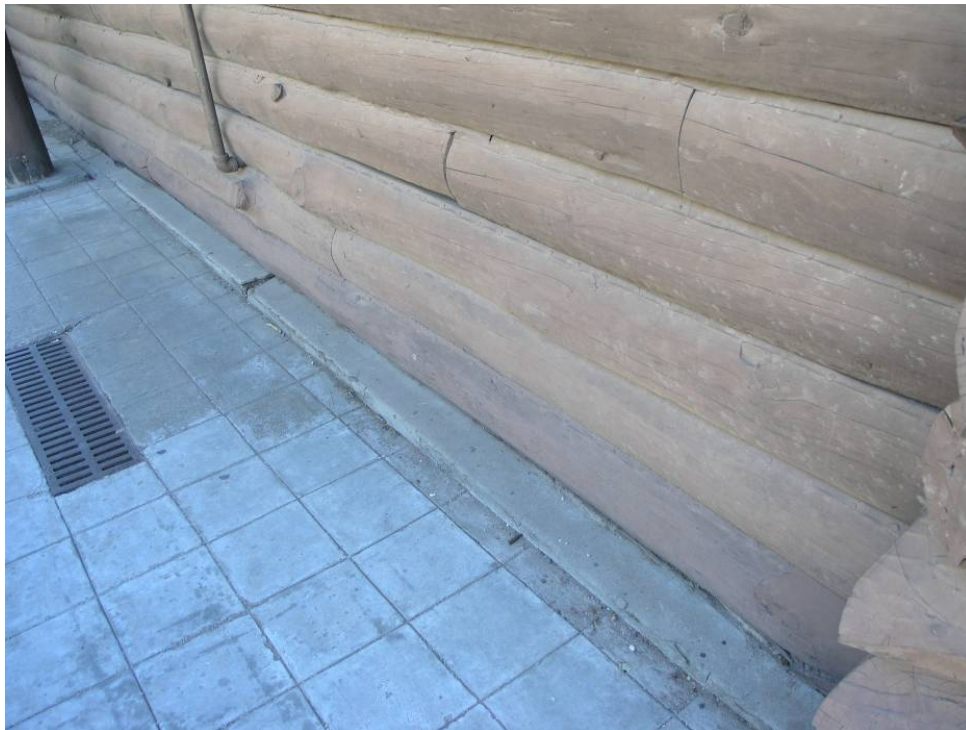
E-56 North façade, northwest corner to right. October 3, 2007. Photograph by Chamberlin Architects.

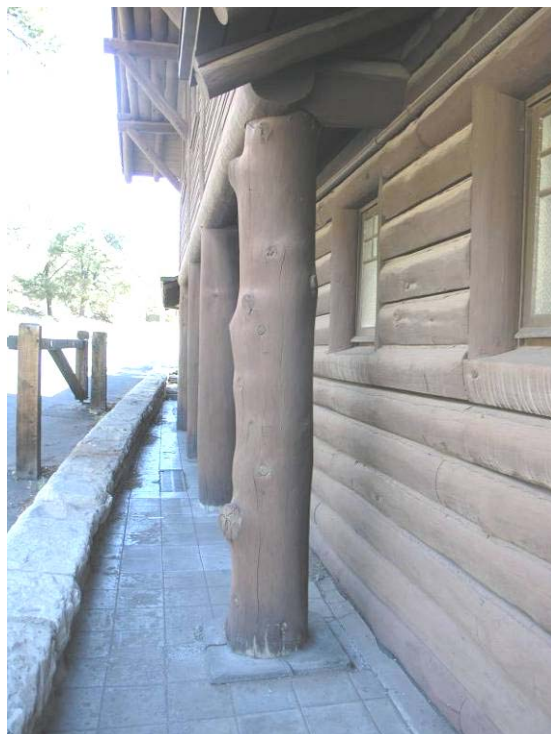
E-57 North façade, looking east. Note deterioration at column bases. Also note the gaps between some of the wall logs. October 3, 2007. Photograph by Chamberlin Architects.

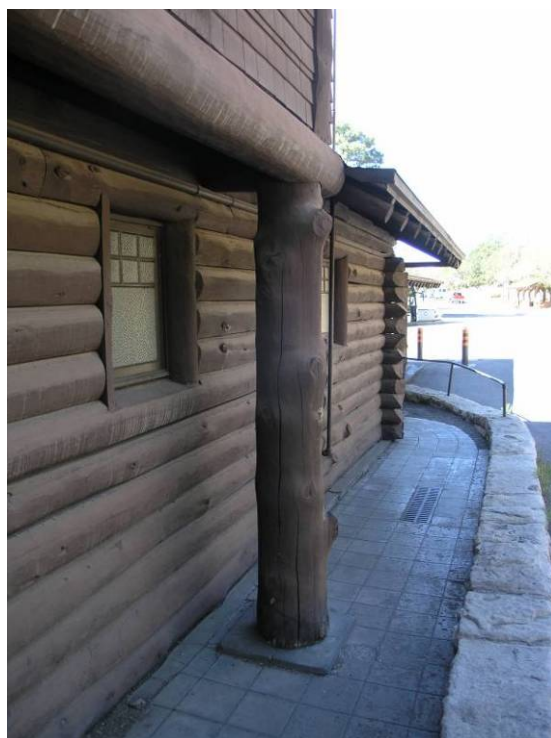
E-58 North façade, looking west. October 3, 2007. Photograph by Chamberlin Architects.

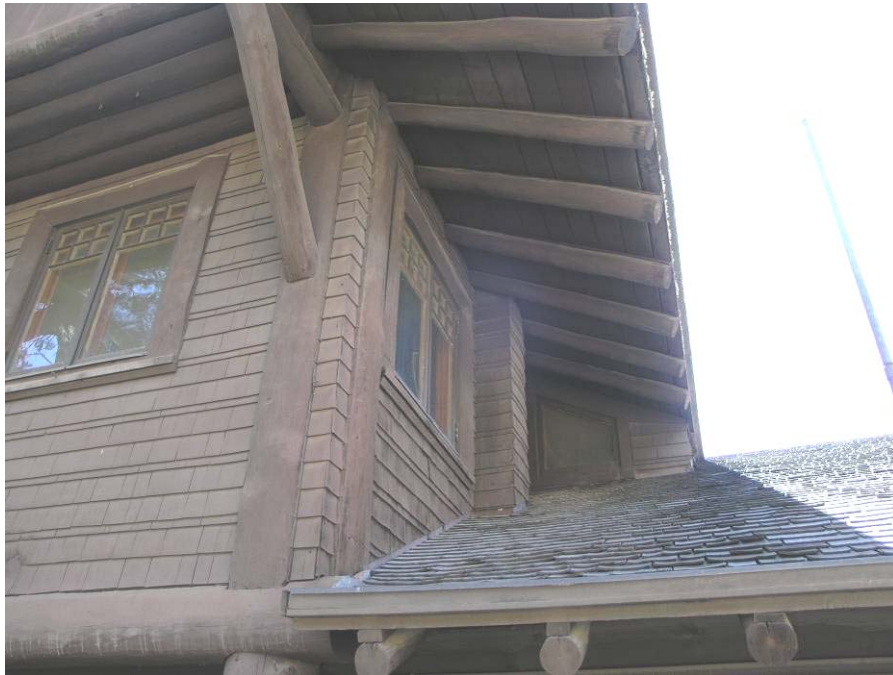
E-59 North façade, looking at second floor northwest corner. Windows 202 and 201. Window 214 is visible under the eave to the right. October 3, 2007. Photograph by Chamberlin Architects.

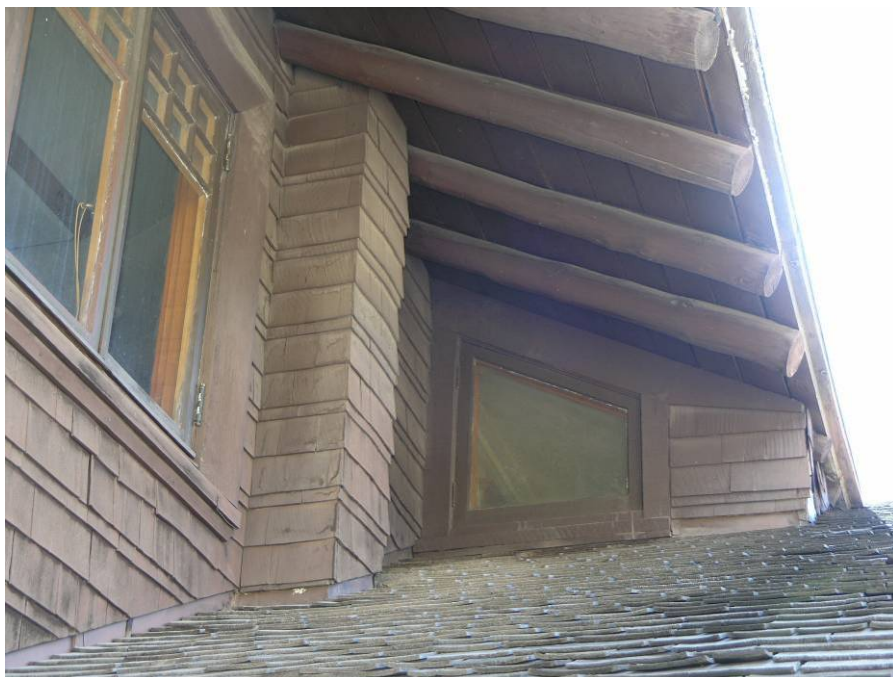
E-60 Looking southeast at second floor west wall. Windows 201 and 214. October 3, 2007. Photograph by Chamberlin Architects.

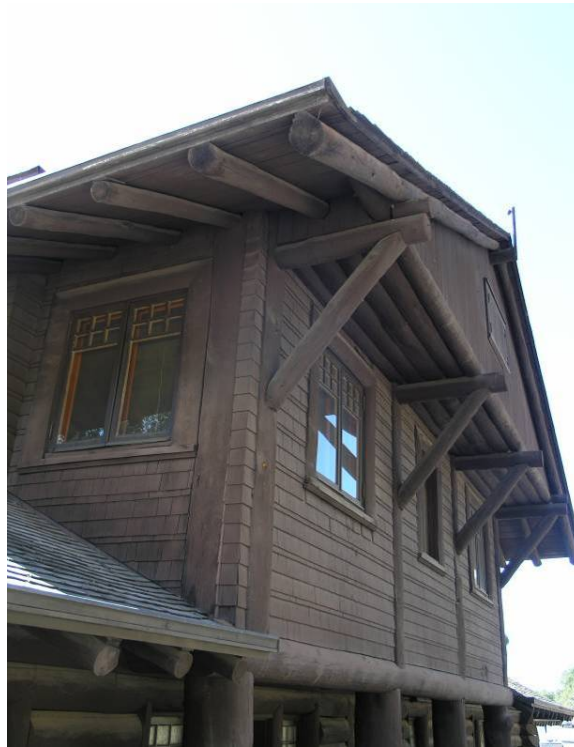
E-61 North façade, looking southwest. Window 205 is to the upper left. Note the wood piece nailed to the gable peak. This should be removed. October 3, 2007. Photograph by Chamberlin Architects.

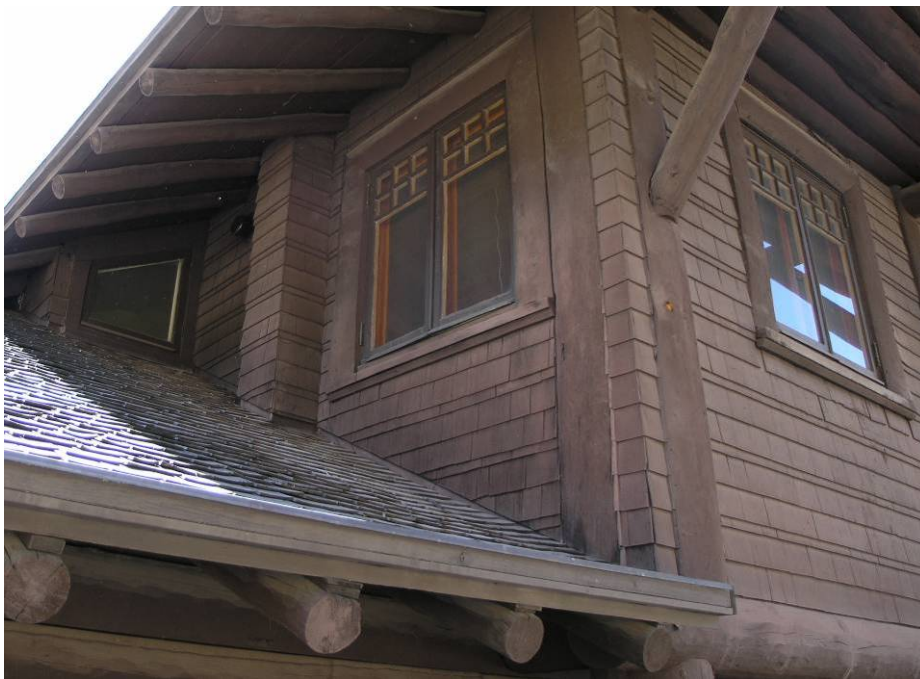
E-62 Northeast corner of second floor. Windows 206 to far left, 205 and 204. October 3, 2007. Photograph by Chamberlin Architects.

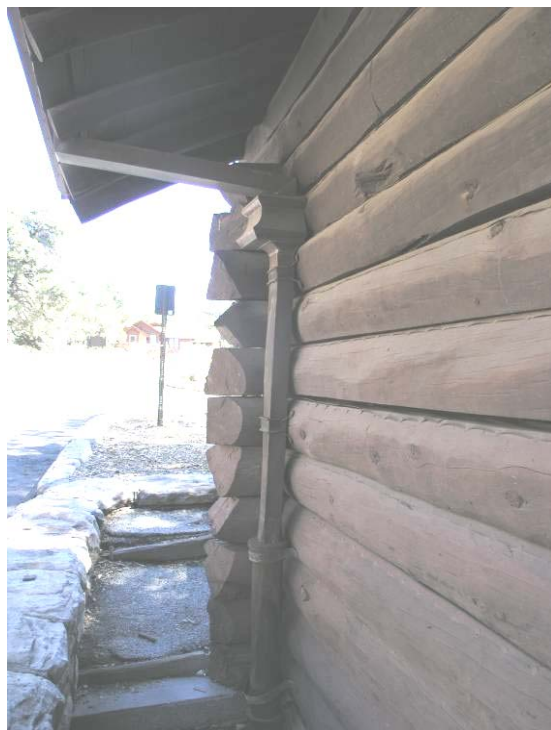
E-63 North façade, looking at northeast corner of building. Note the large gapes between some of the logs. October 3, 2007. Photograph by Chamberlin Architects.

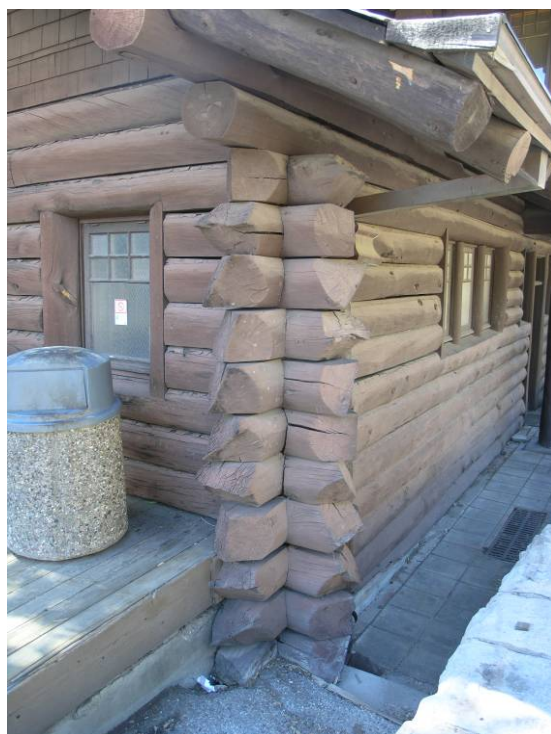
E-64 Northeast corner of building. Window 112 on left. October 3, 2007. Photograph by Chamberlin Architects.

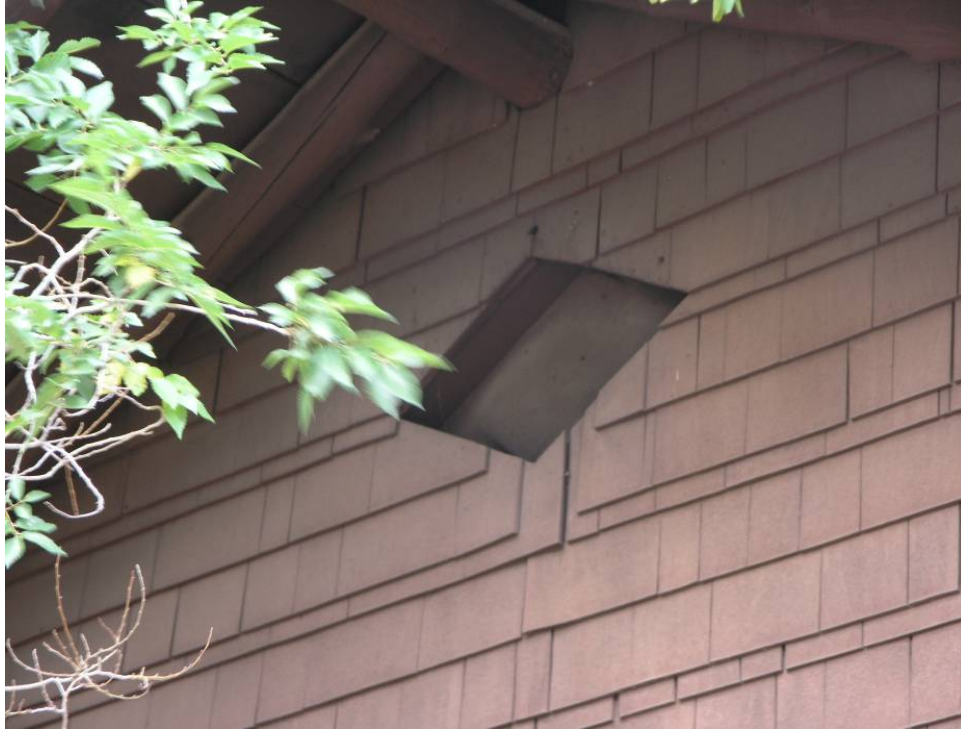
E-65 East façade, gable vent. Note that the vent has been closed off. A suitable screen and louver should be installed. October 3, 2007. Photograph by Chamberlin Architects.

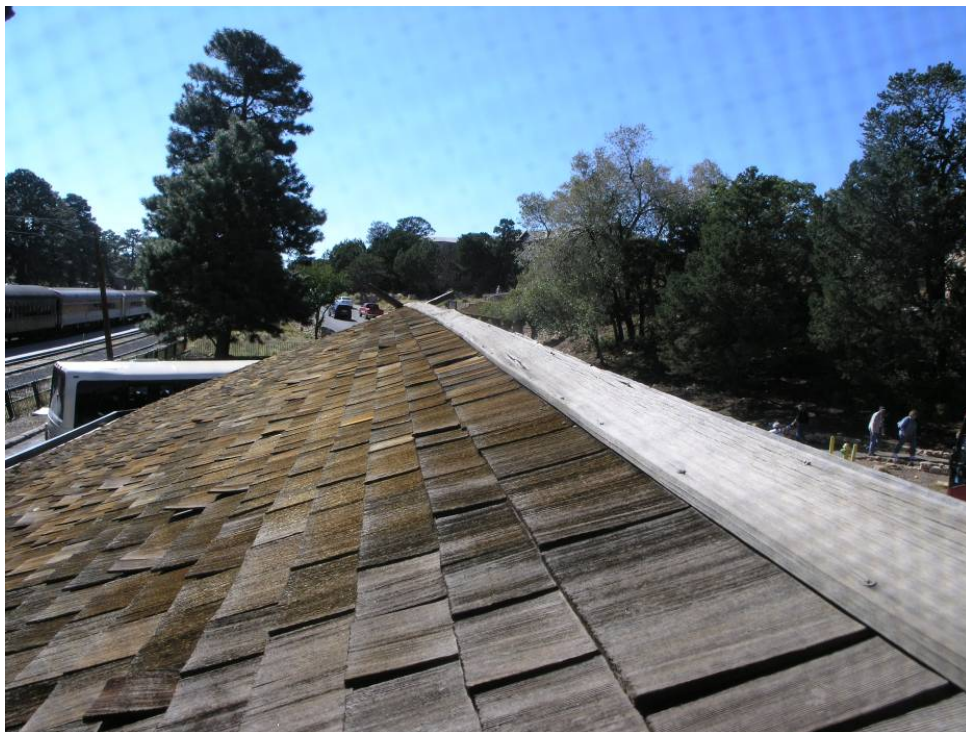
E-66 South facing roof over covered waiting area, looking west, taken from West Bedroom. October 3, 2007. Photograph by Chamberlin Architects.

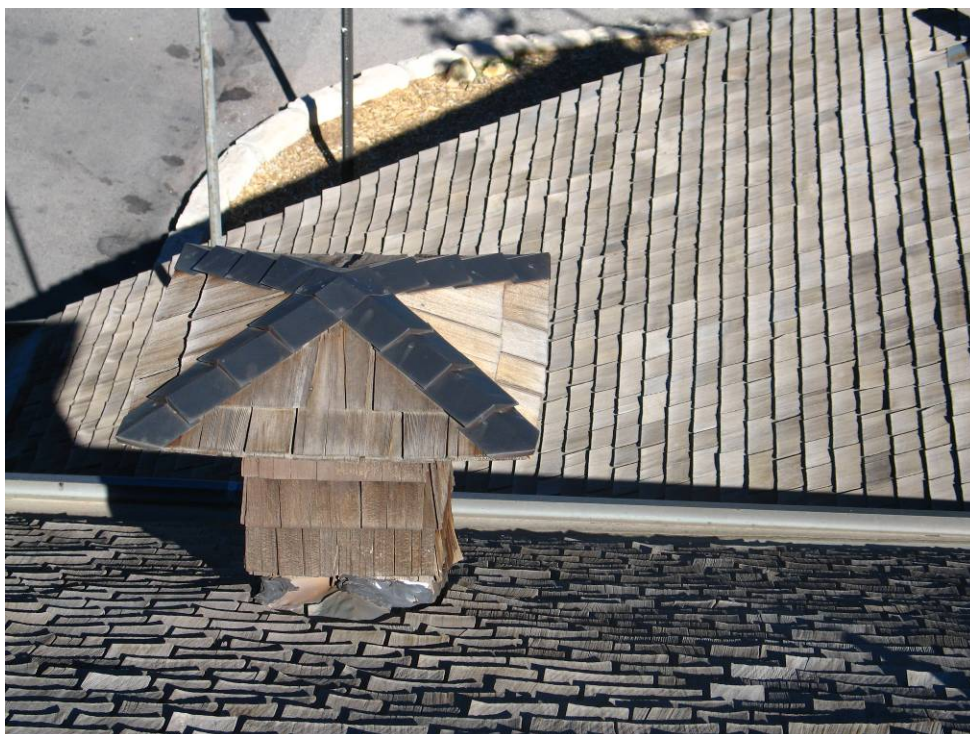
E-82 Top view of restroom vent. October 3, 2007. Photograph by Martin/Martin.

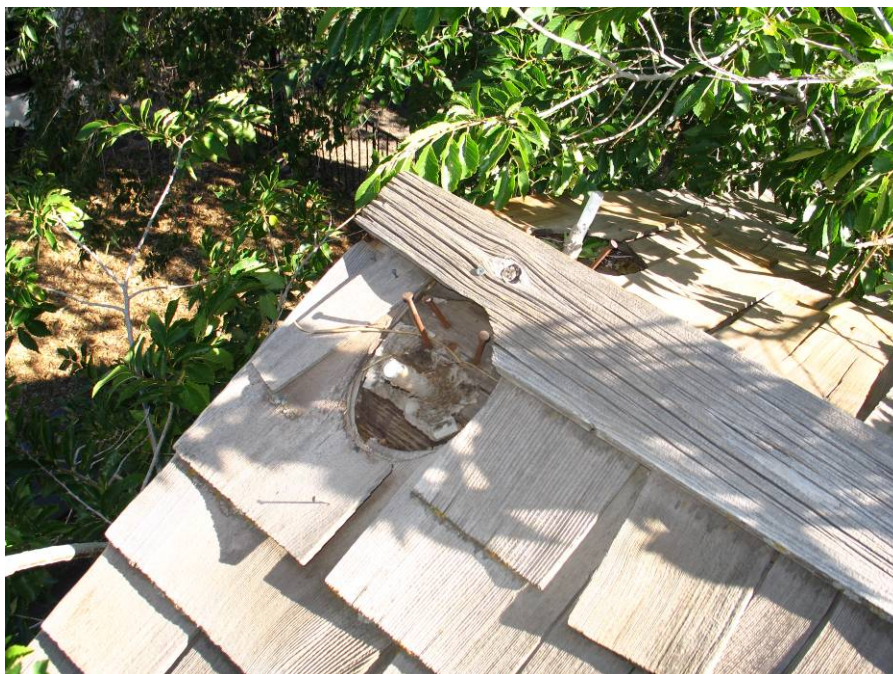
E-85 Evidence of missing barge rafter extensions at east roof. October 3, 2007. Photograph by Martin/Martin.

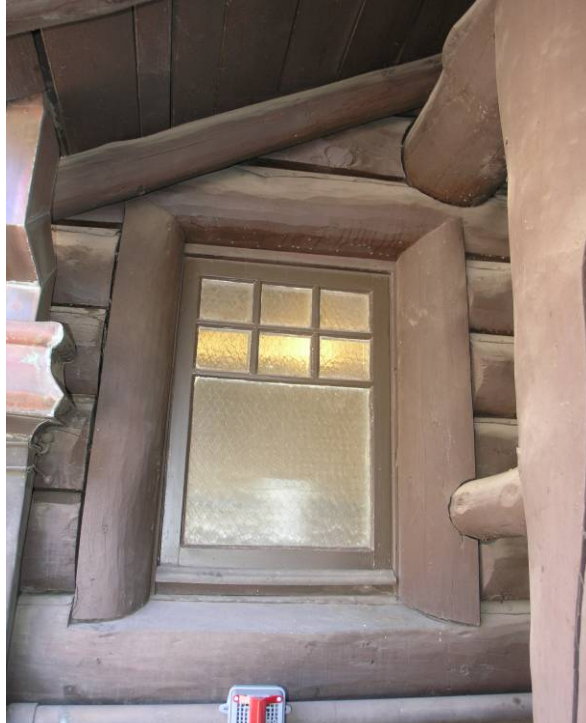
E-89 Window 101. Note that the sash color of the existing windows is much lighter than historic photographs taken after about 1940. See photographs H-29 and succeeding photos. October 3, 2007. Photograph by Chamberlin Architects.

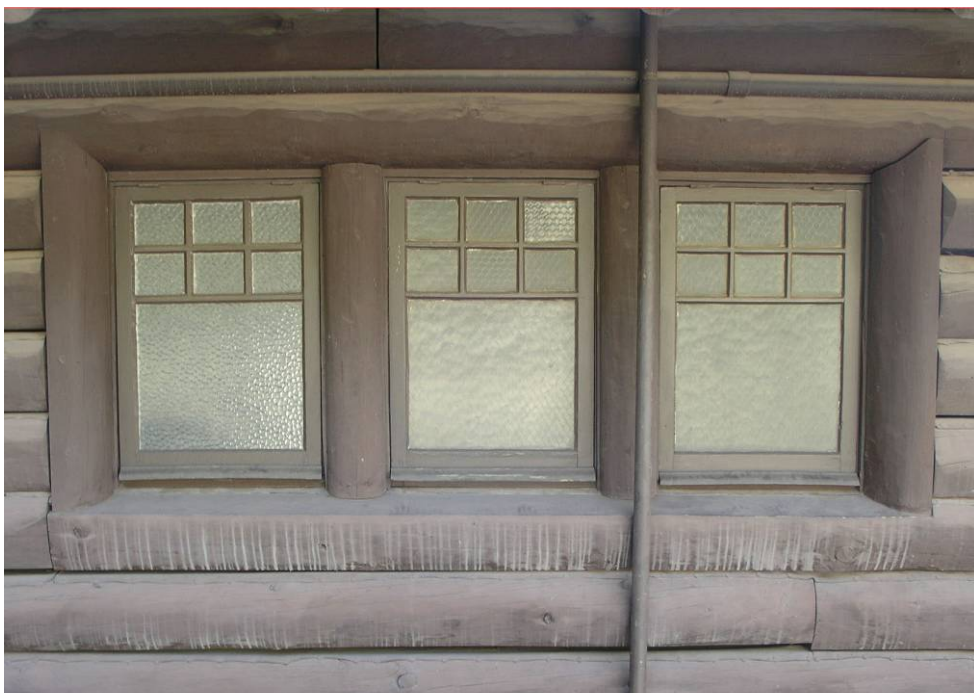
E-90 Windows 104, 103 & 102. Note the different type of glass in 104. October 3, 2007. Photograph by Chamberlin Architects.

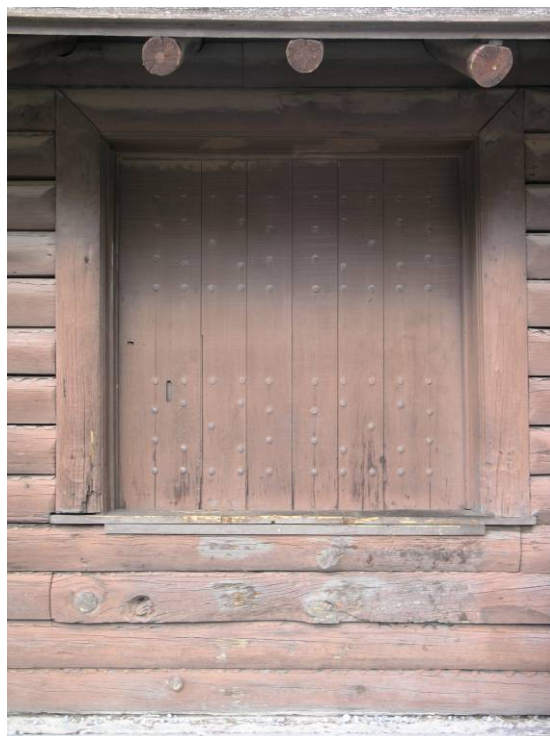
E-102 Door 104B. Note wear of logs below the door. Protection should be provided. October 3, 2007. Photograph by Chamberlin Architects.

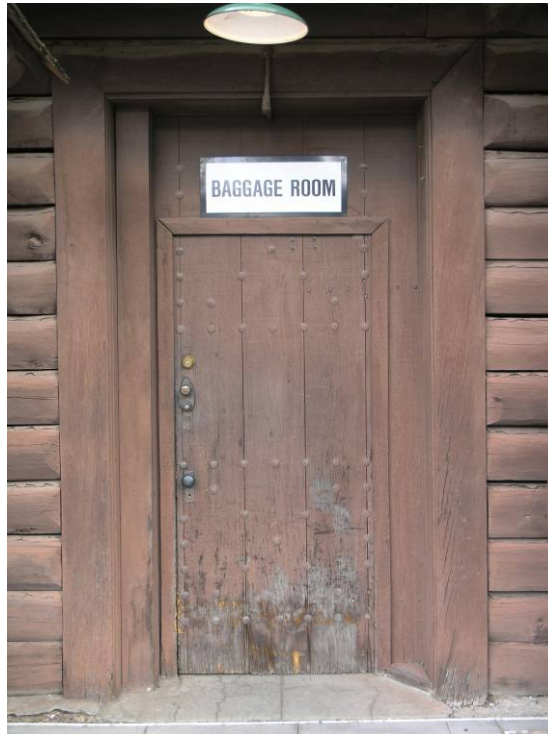
E-103 Door 103A. Note traffic wear on door. October 3, 2007. Photograph by Chamberlin Architects.

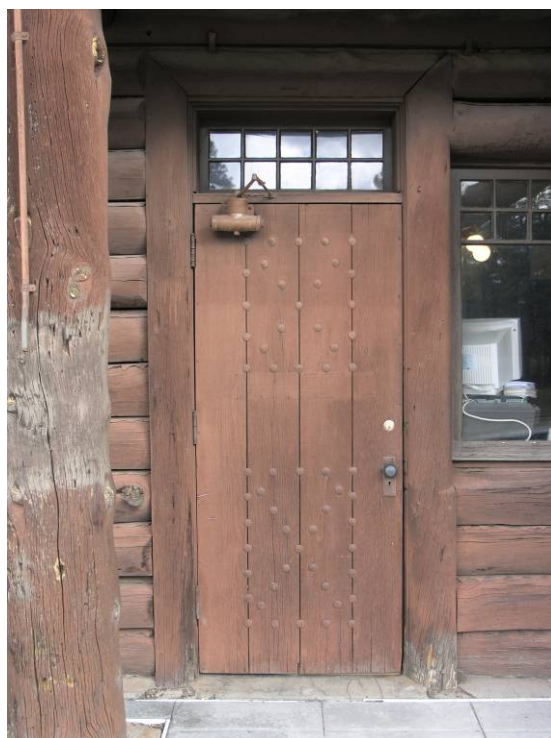
E-108 Door 102A. Note deterioration at base of casing. October 3, 2007. Photograph by Chamberlin Architects.

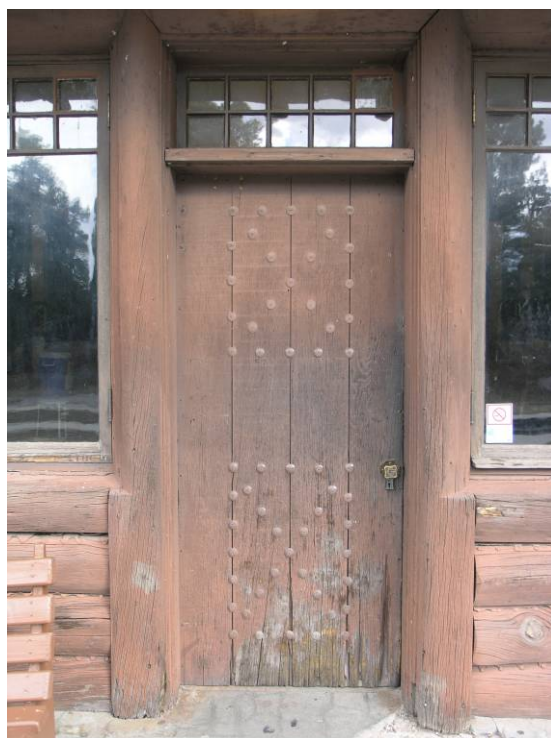
E-110 Door 101A. Note deterioration of door. October 3, 2007. Photograph by Chamberlin Architects.

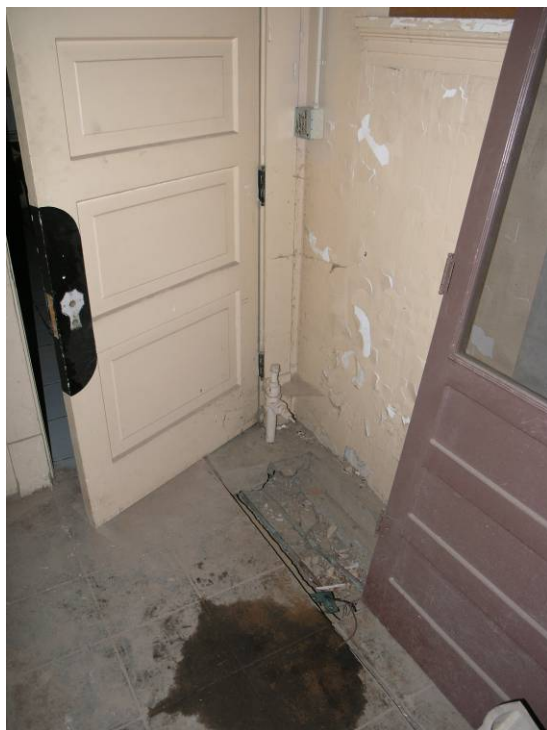
I-37 Men's Restroom East 105, northwest corner. Door 105. Note floor access for steam pipes. October 3, 2007. Photograph by Chamberlin Architects.

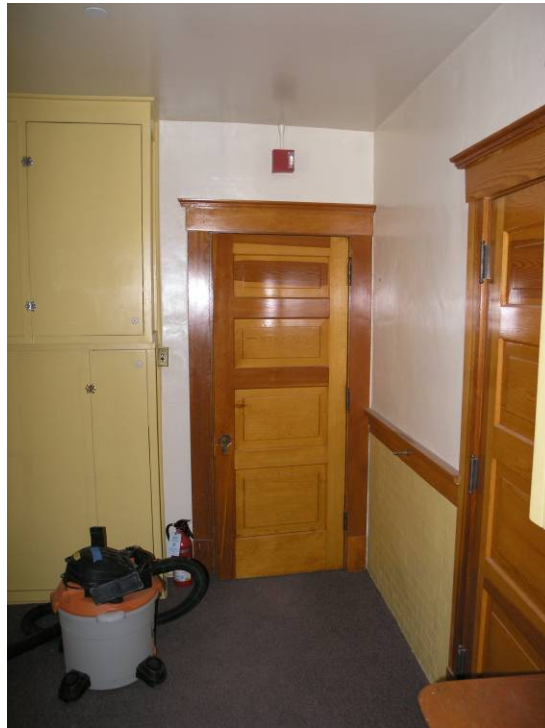
I-68 2nd Floor Hall 205 Closet, looking out into Hall 205. Note the change in floor level and material. Floor material in closet is possibly the original pine. May 2, 2008. Photograph by Chamberlin Architects.

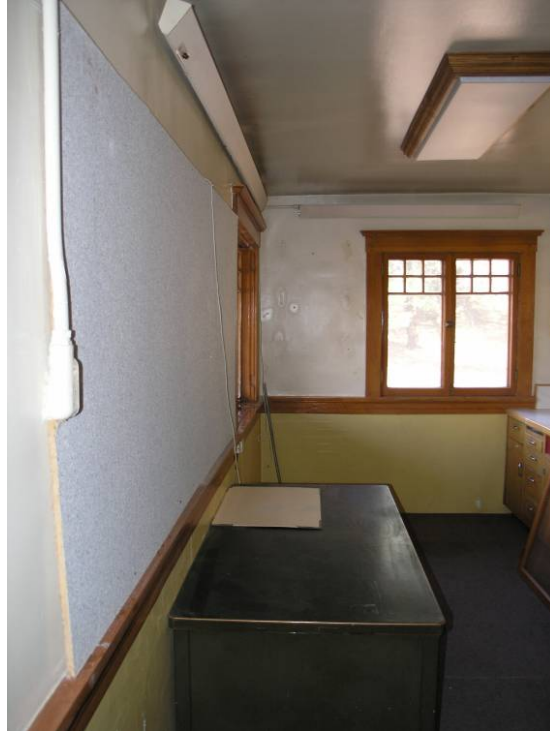
I-70 Kitchen 206, south wall, southwest corner. Door 206B. Note electric cove heater. October 3, 2007. Photograph by Chamberlin Architects.
