Grand Canyon Railroad Depot

Historic Structure Report

prepared for the
National Park Service

prepared by
Chamberlin Architects, PC
Grand Junction/Lakewood, Colorado

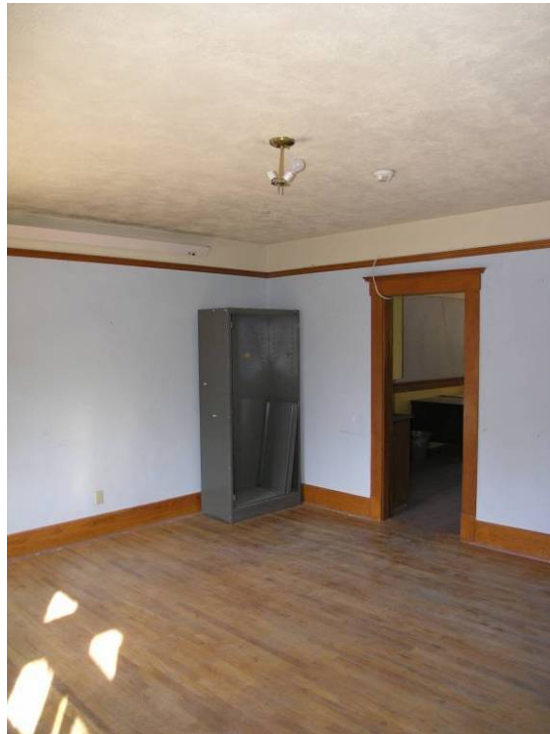
I-80 Living Room 201, southwest corner. Windows 210 and 211. Note electric cove heaters. October 3, 2007. Photograph by Chamberlin Architects.

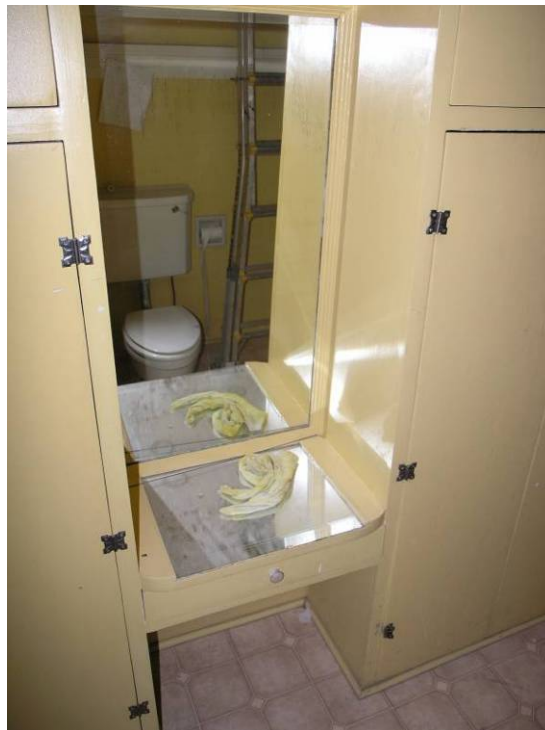
I-99 Bathroom 203, southeast corner. Note trim wrap around onto south wall. May 2, 2008.
 Photograph by Chamberlin Architects.

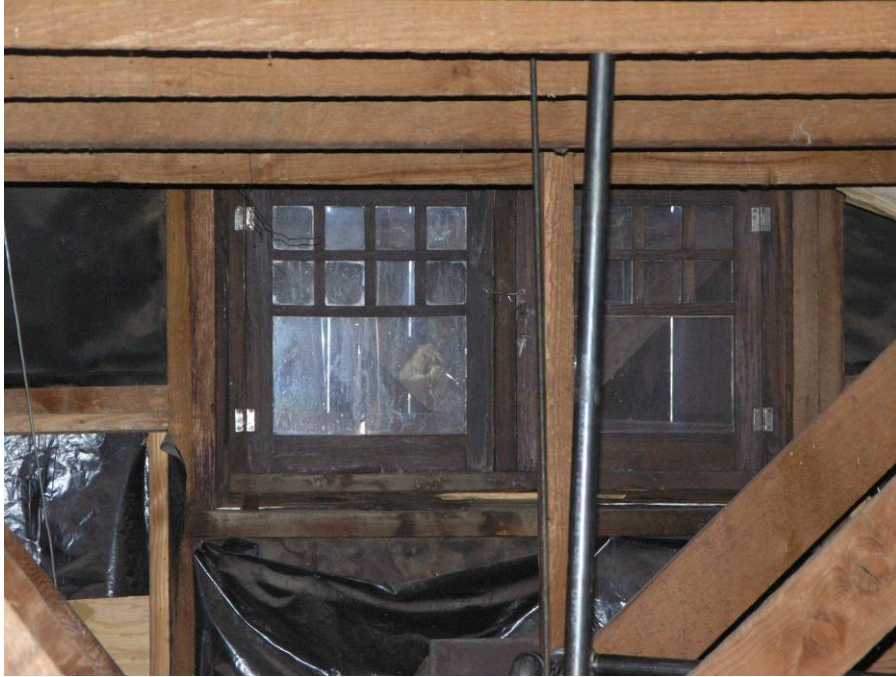
I-108 Attic space looking southwest. Note leak in fire sprinkler line. October 3, 2007. Photograph by Chamberlin Architects.

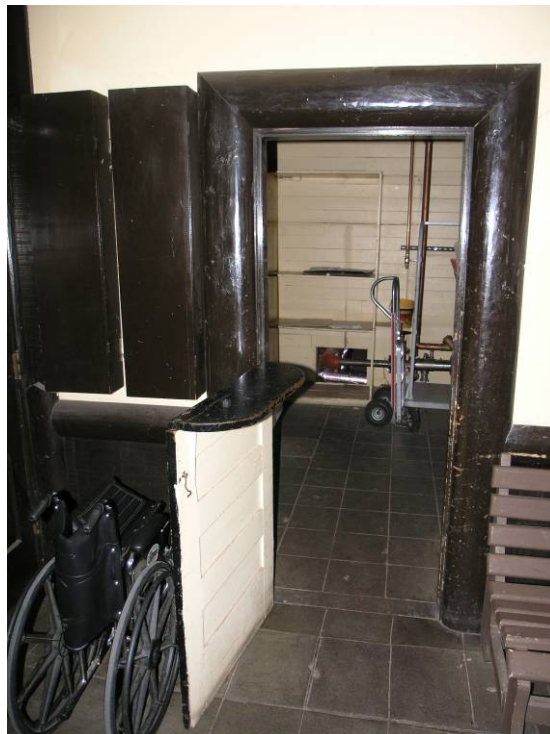
I-121 Door 107B (left) and partial door 102E. Note wood cabinets mounted on wall between the doors. Conflict with Door 107B. October 3, 2007. Photograph by Chamberlin Architects.

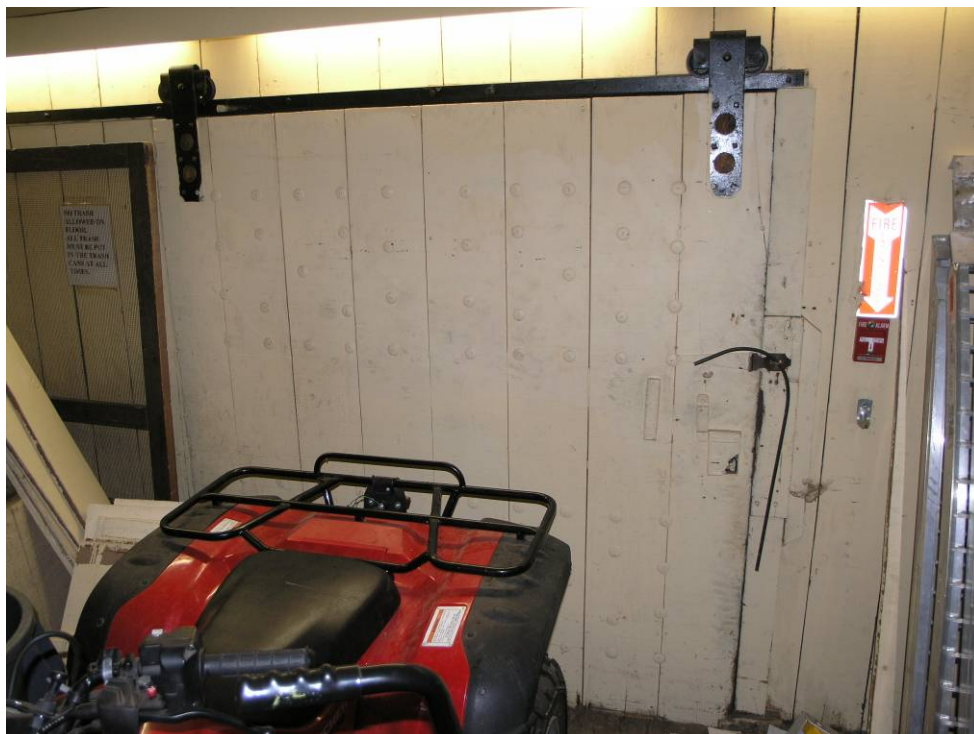
E-101 Door 104A. Note deterioration at base of casing. October 3, 2007. Photograph by Chamberlin Architects.

I-126 Door 104A. Note decorative cabinet door to the left. October 3, 2007. Photograph by Chamberlin Architects.

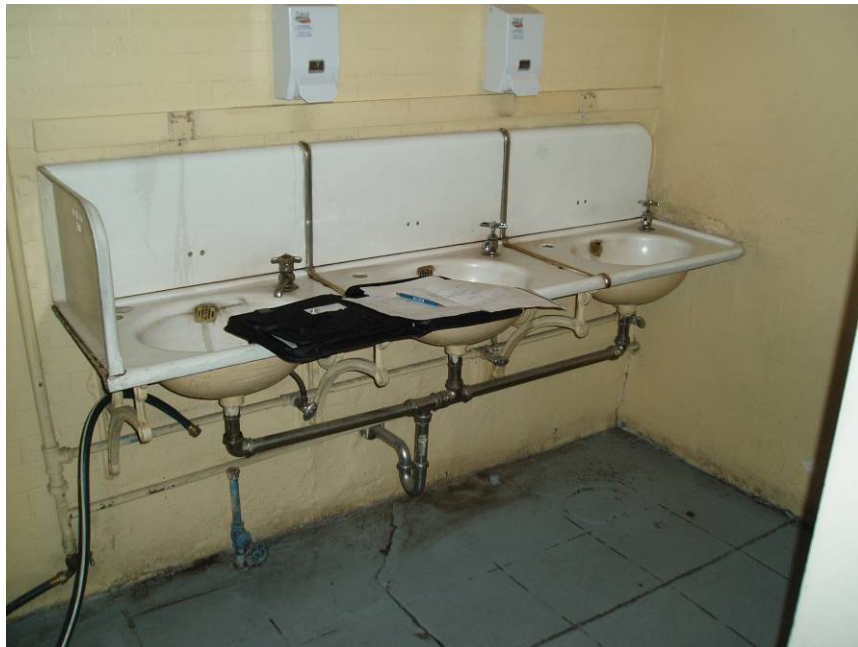
M-1: Women's Restroom 110 Lavatories. Photograph by MKK.

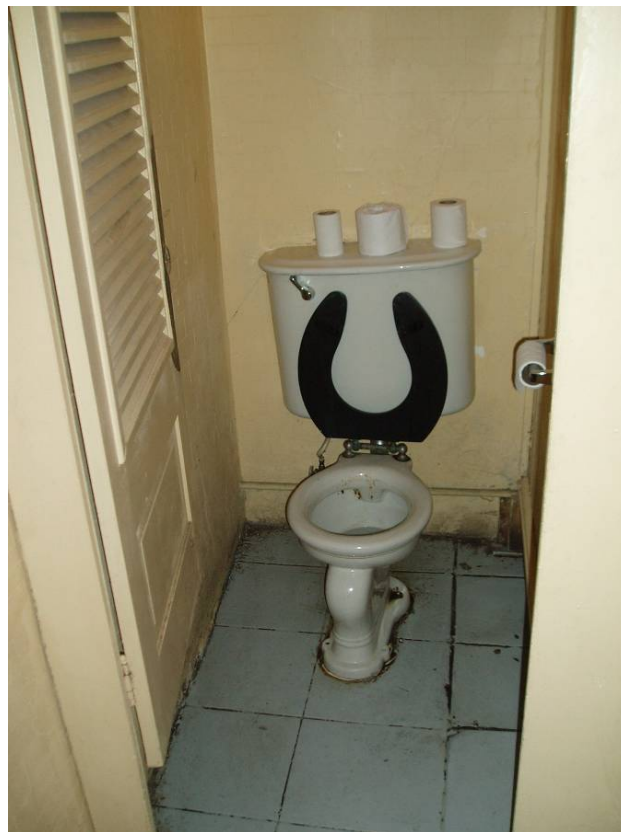
M-2: Mens's Restroom 106 Water Closet. Compare to fixture in Women's Restroom [Photograph M-13] Photograph by MKK.

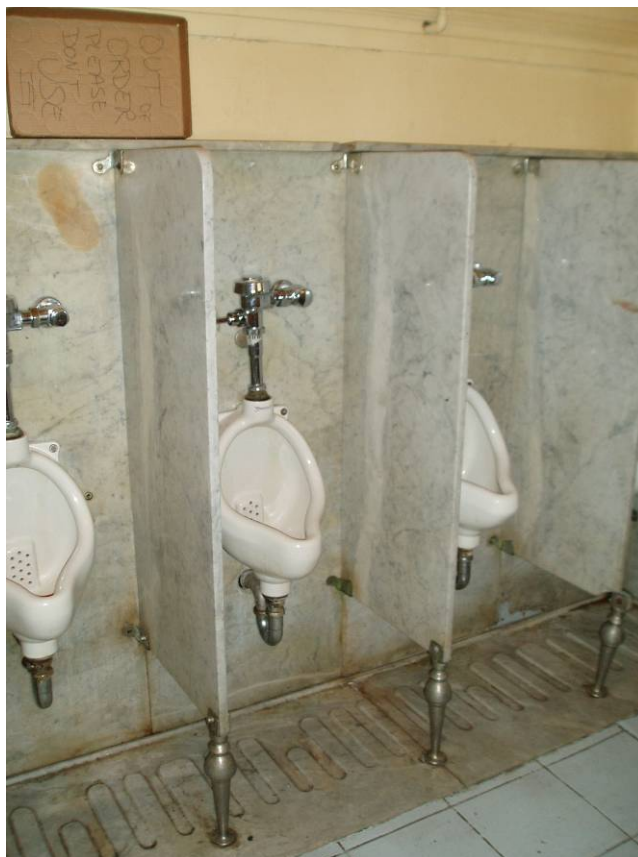
M-3: Men's Restroom 106 Urinals. Note marble floor, wainscot and partitions. Photograph by MKK.

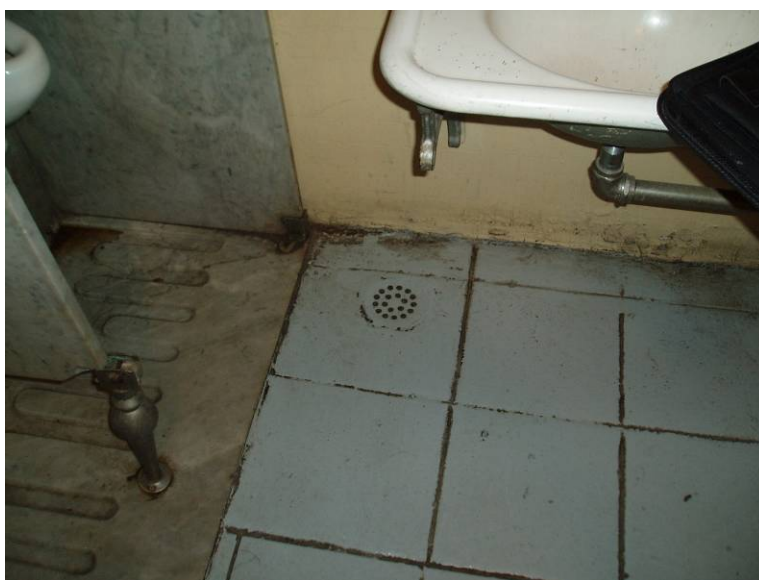
M-4: Men's Restroom 106 Floor Drain. Photograph by MKK.

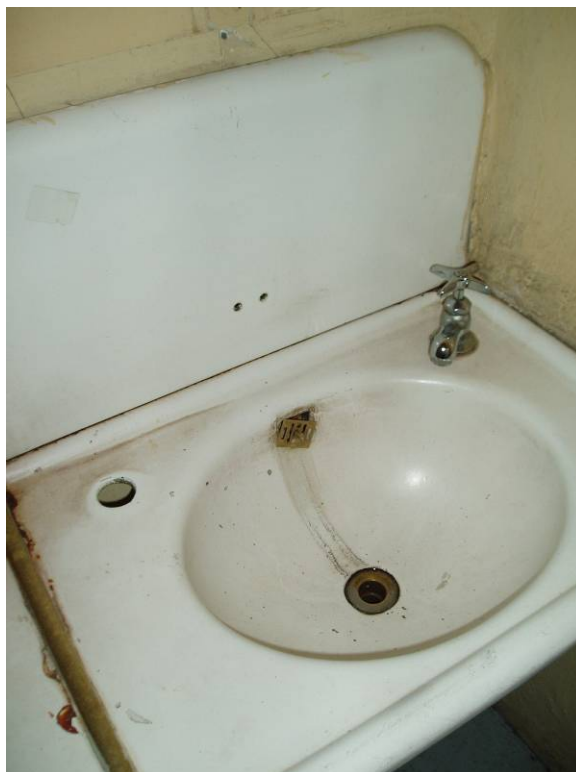
M-5: Women's Restroom 110 Lavatory Bowl and Trim. Note staining of bowl. Photograph by MKK.

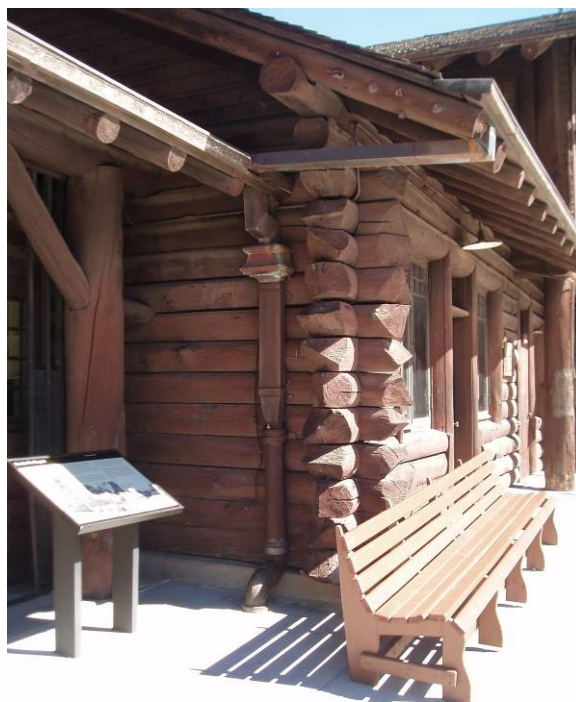
M-6: Copper Downspouts. Photograph by Chamberlin Architects.

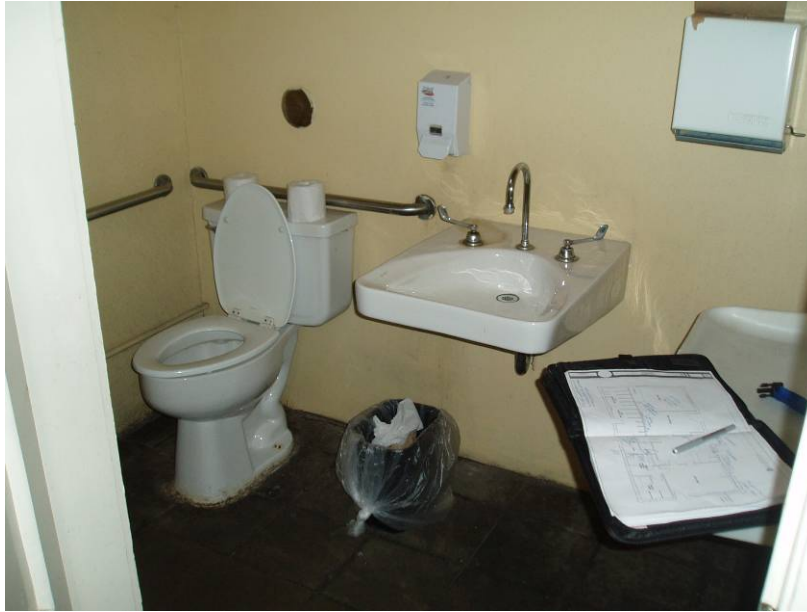
M-7: ADA Family Restroom. Photograph by MKK.

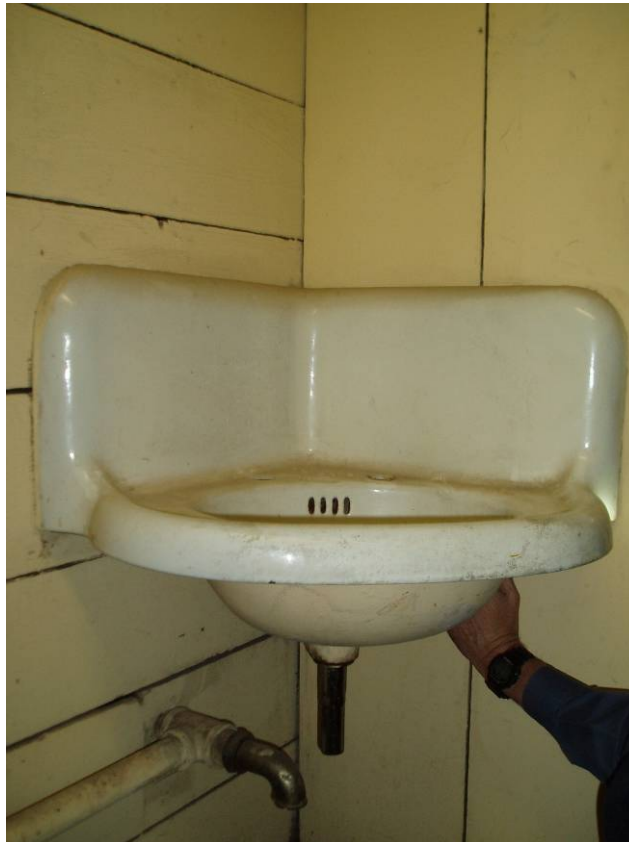
M-8: Freight Room Service Sink. Photograph by MKK.

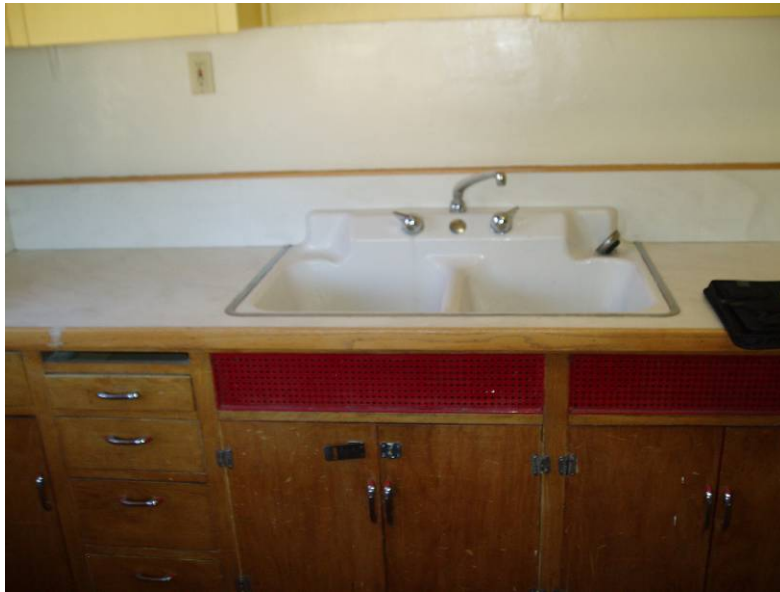
M-9: Kitchen Sink. Photograph by MKK.

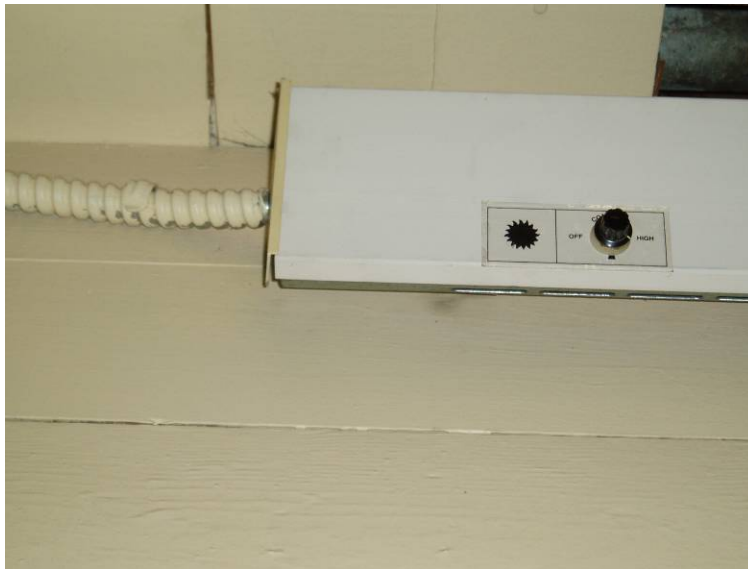
M-10: Cove Heater Unit-Mounted Thermostat. Photograph by MKK.

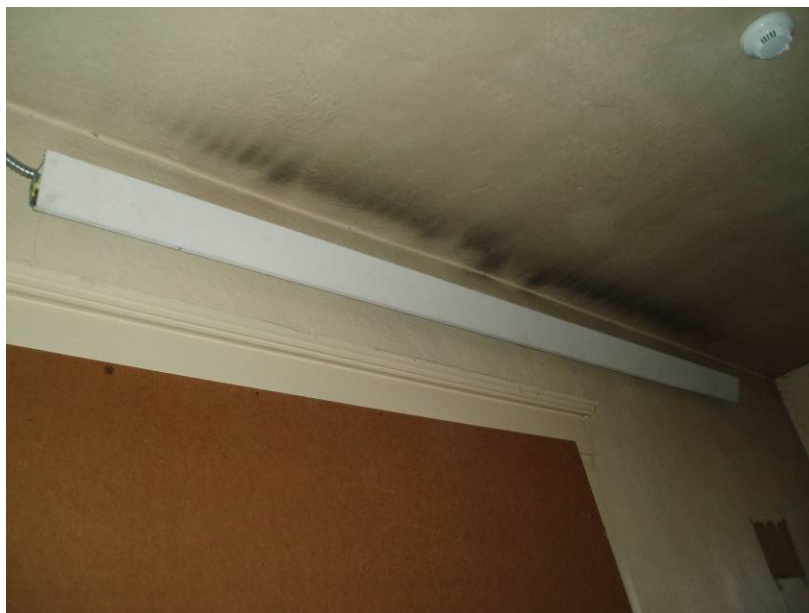
M-11: Cove Heater Discoloration. Photograph by MKK.

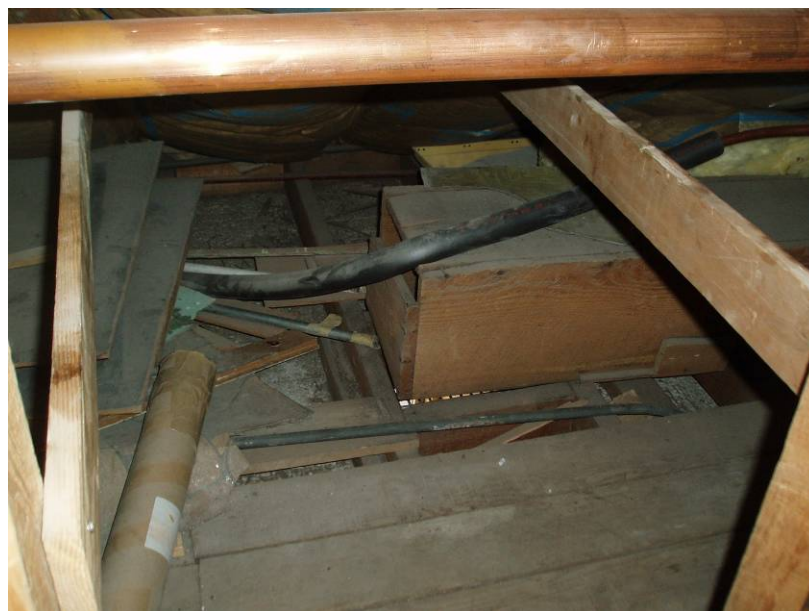
M-12: Wood Ventilation Duct. Photograph by MKK.

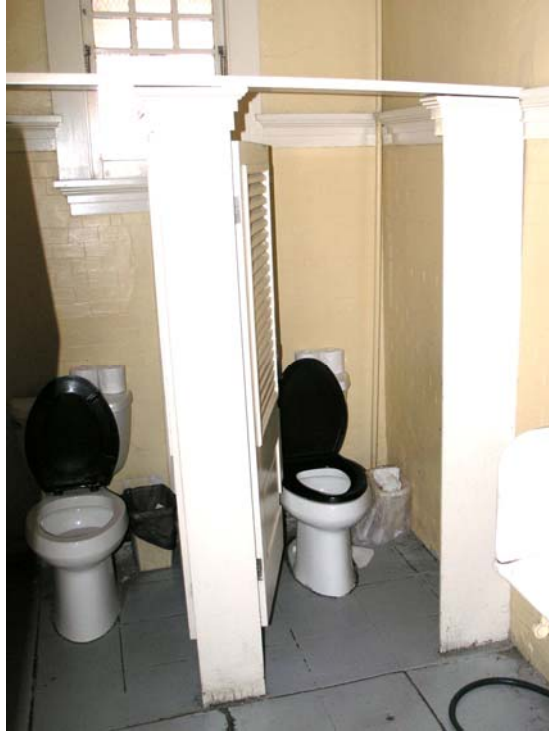
M-13: Womens's Restroom 110 Water Closet. Note that the women's fixtures appear to be more modern compared to men's [Photograph M-2. Photograph by Chamberlin Architects.

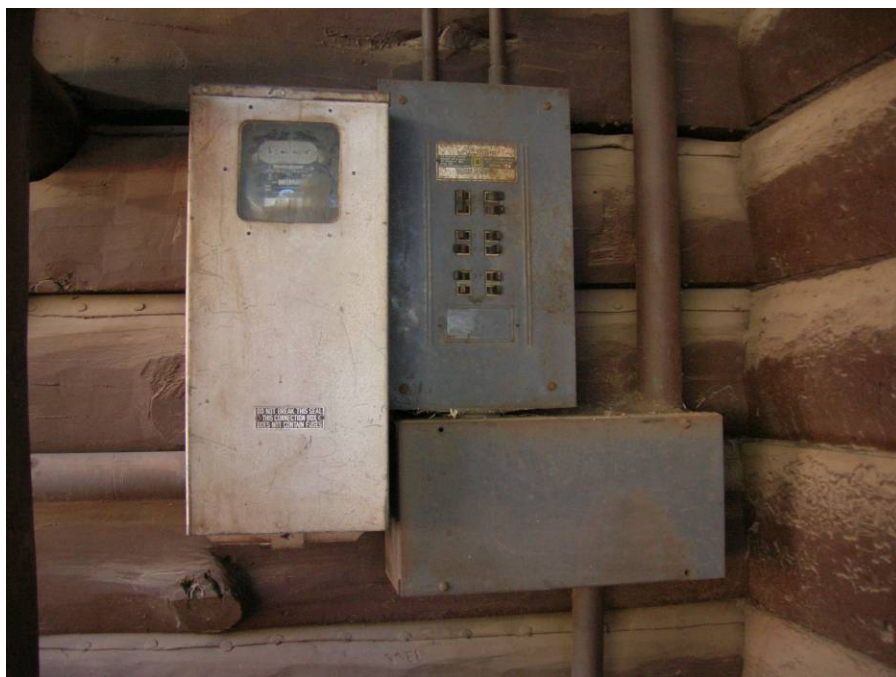
EL-1: Main Electrical Service. Photograph by MKK.

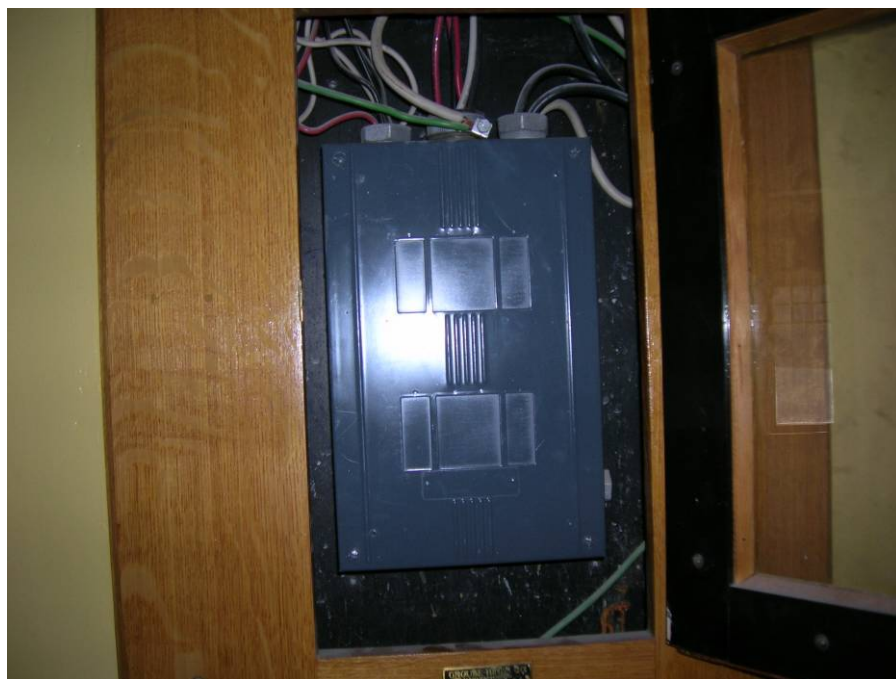
EL-2: Panel "B" in existing fuse box location. Photograph by MKK.

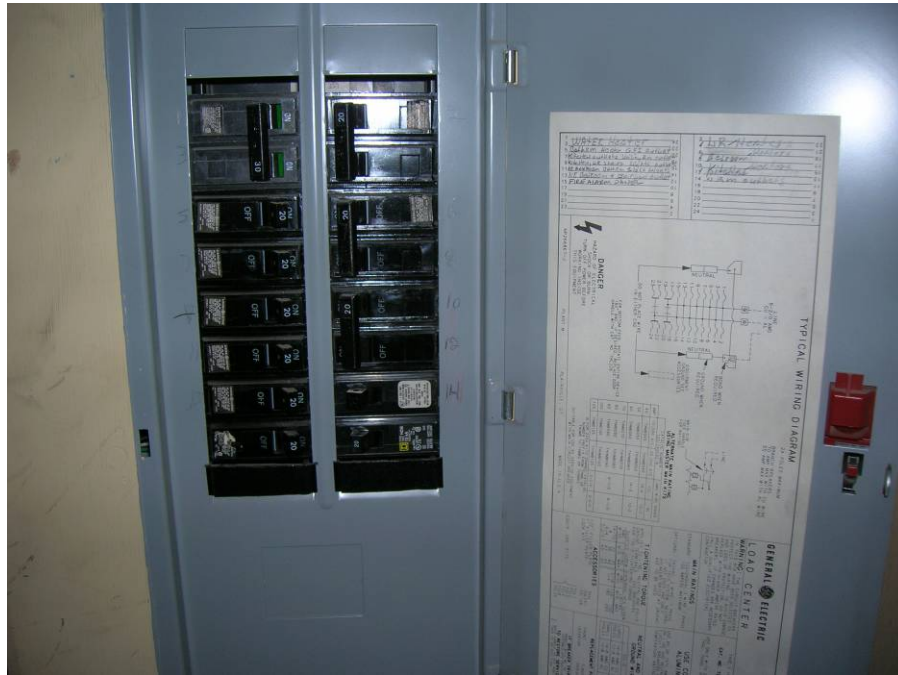
EL-3: Panel “C” in stair landing. Photograph by MKK.

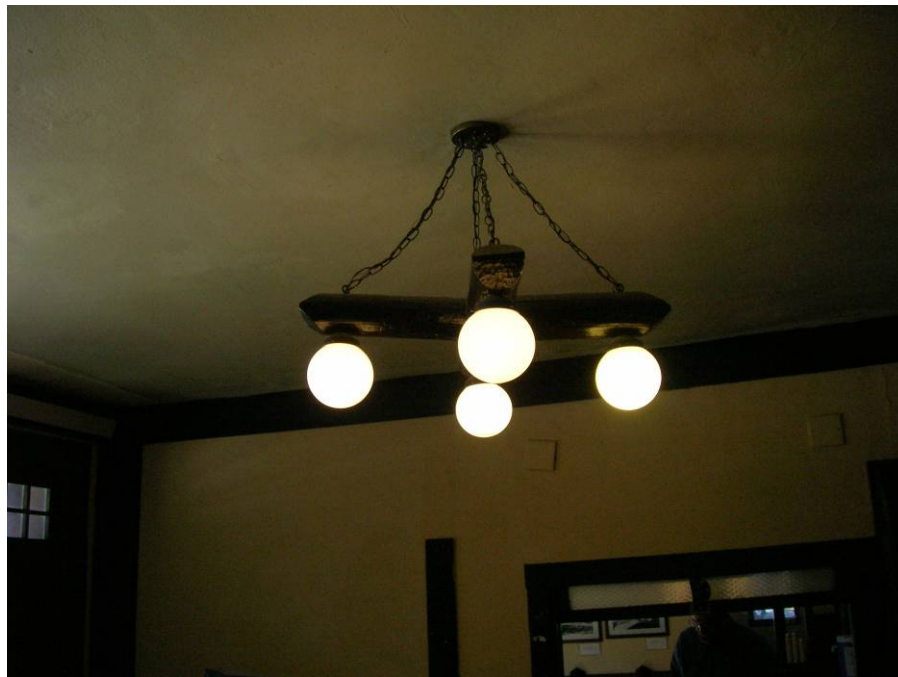
EL-4: Replica Chandelier in Waiting Room. Photograph by MKK.

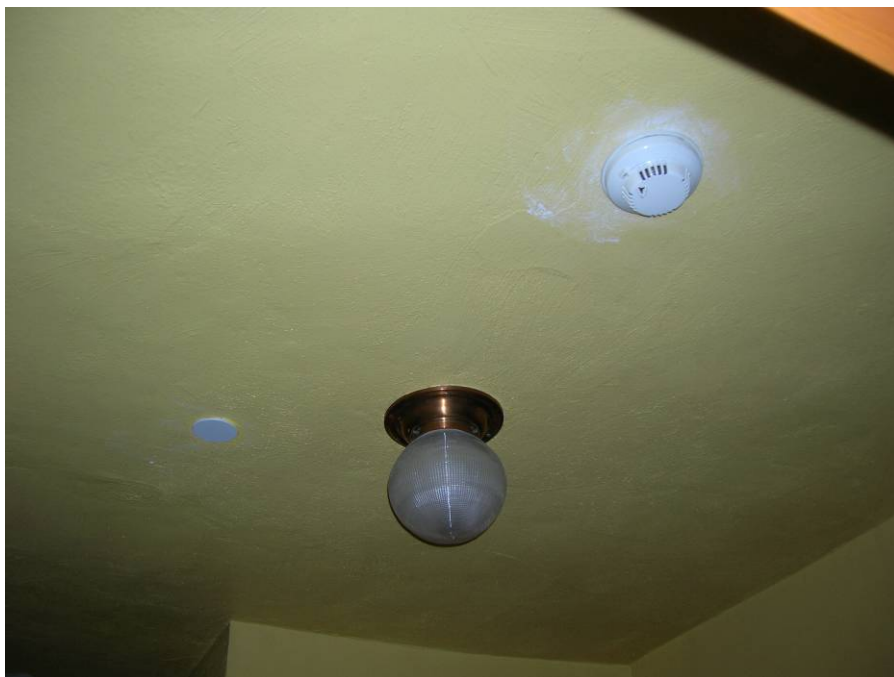
EL-5: One-Lamp Luminaire. Photograph by MKK.

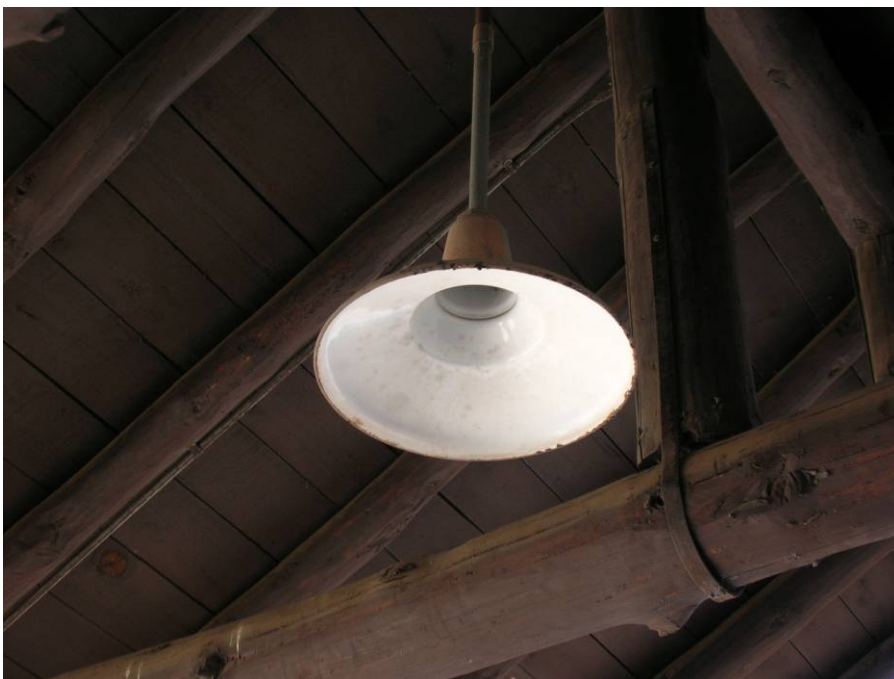
EL-6: Luminaire in covered exterior waiting area. Photograph by MKK.

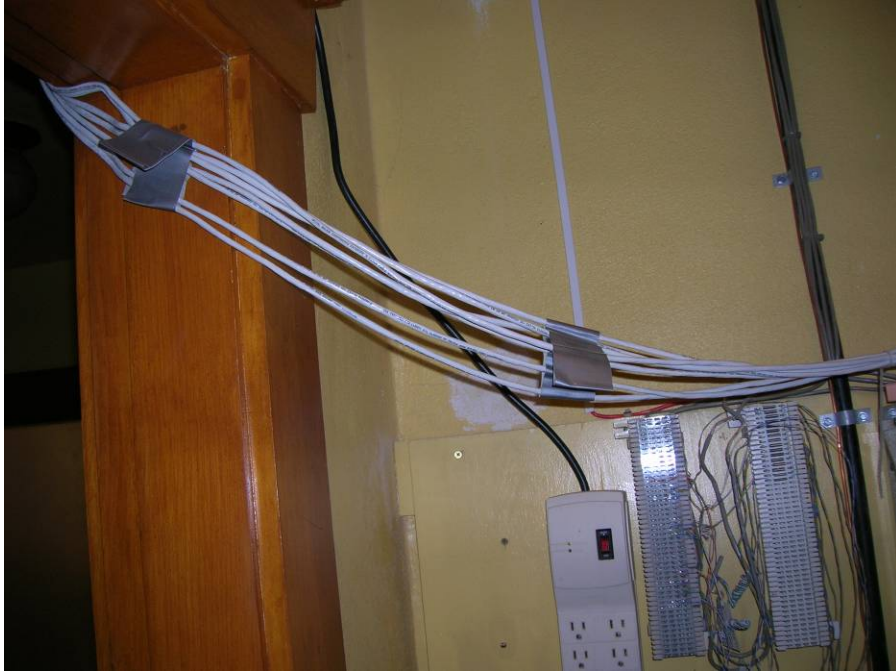
EL-7: Telecommunication cabling leaving closet. Photograph by MKK.

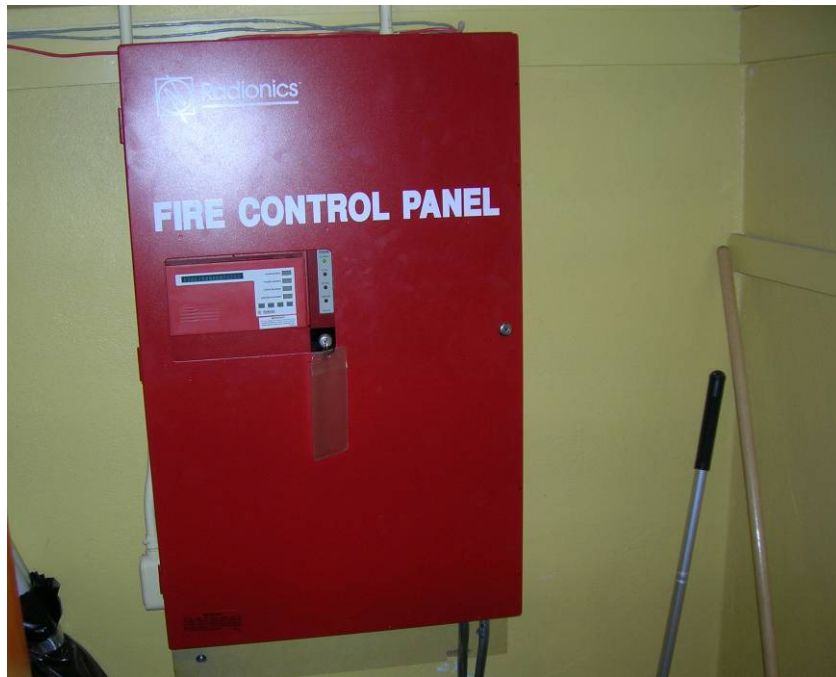
EL-8: Existing fire alarm control panel. Photograph by MKK.

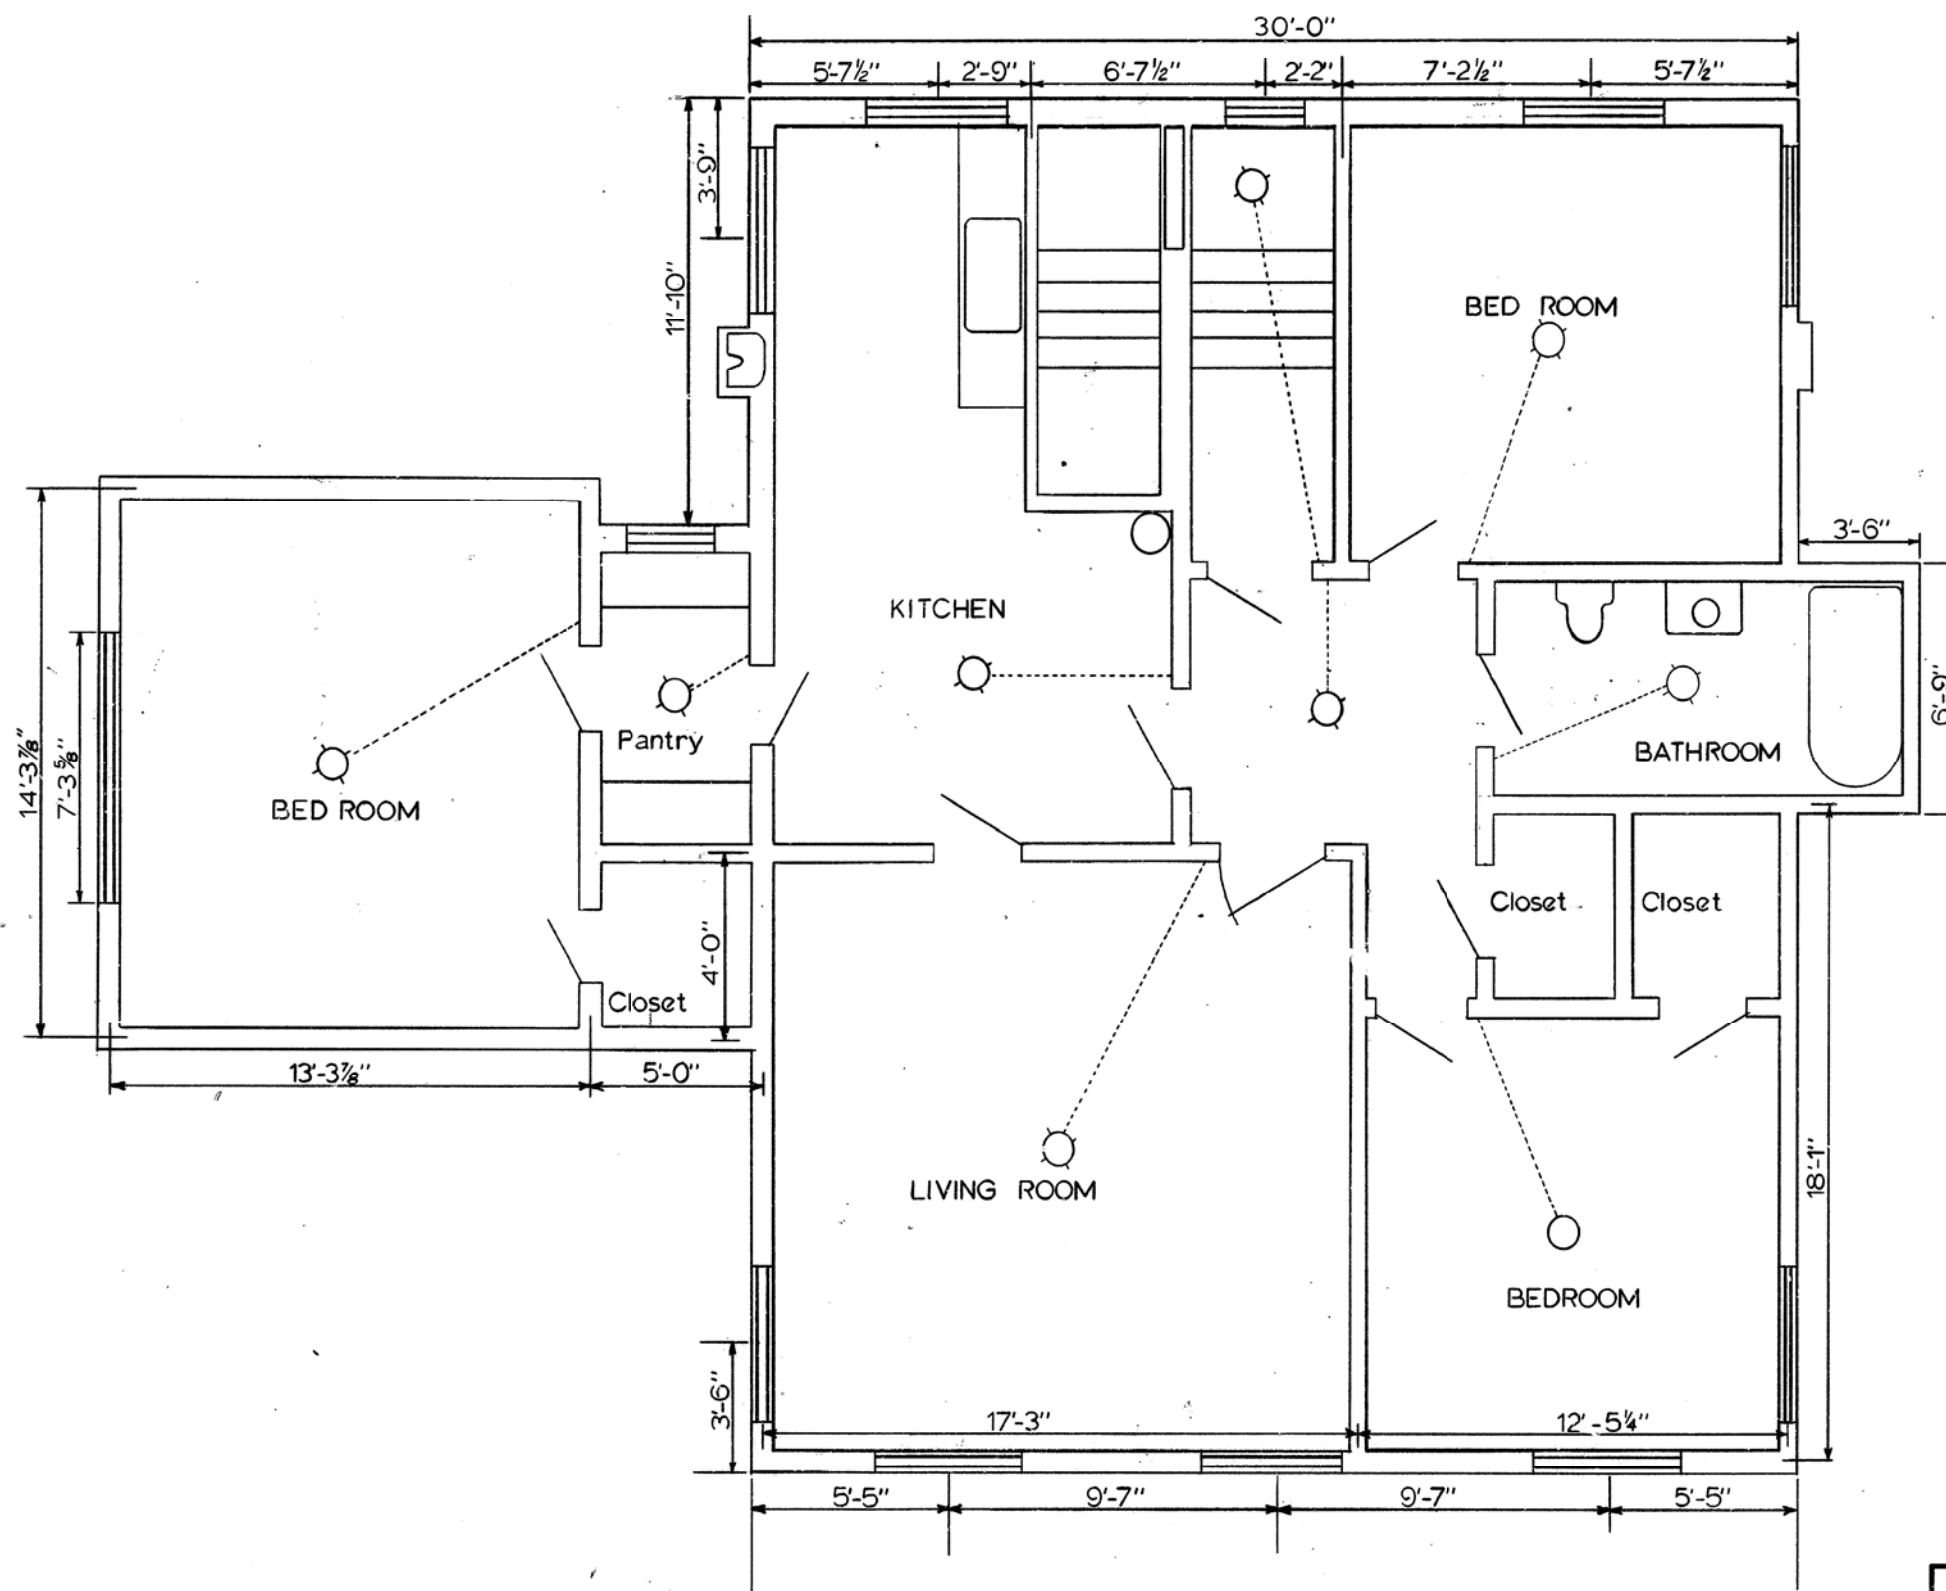
This drawing copied from a drawing by the Santa Fe Railroad dated April 30, 1919. Since that time several changes have been made that have not been recorded. This drawing does not reflect those changes.

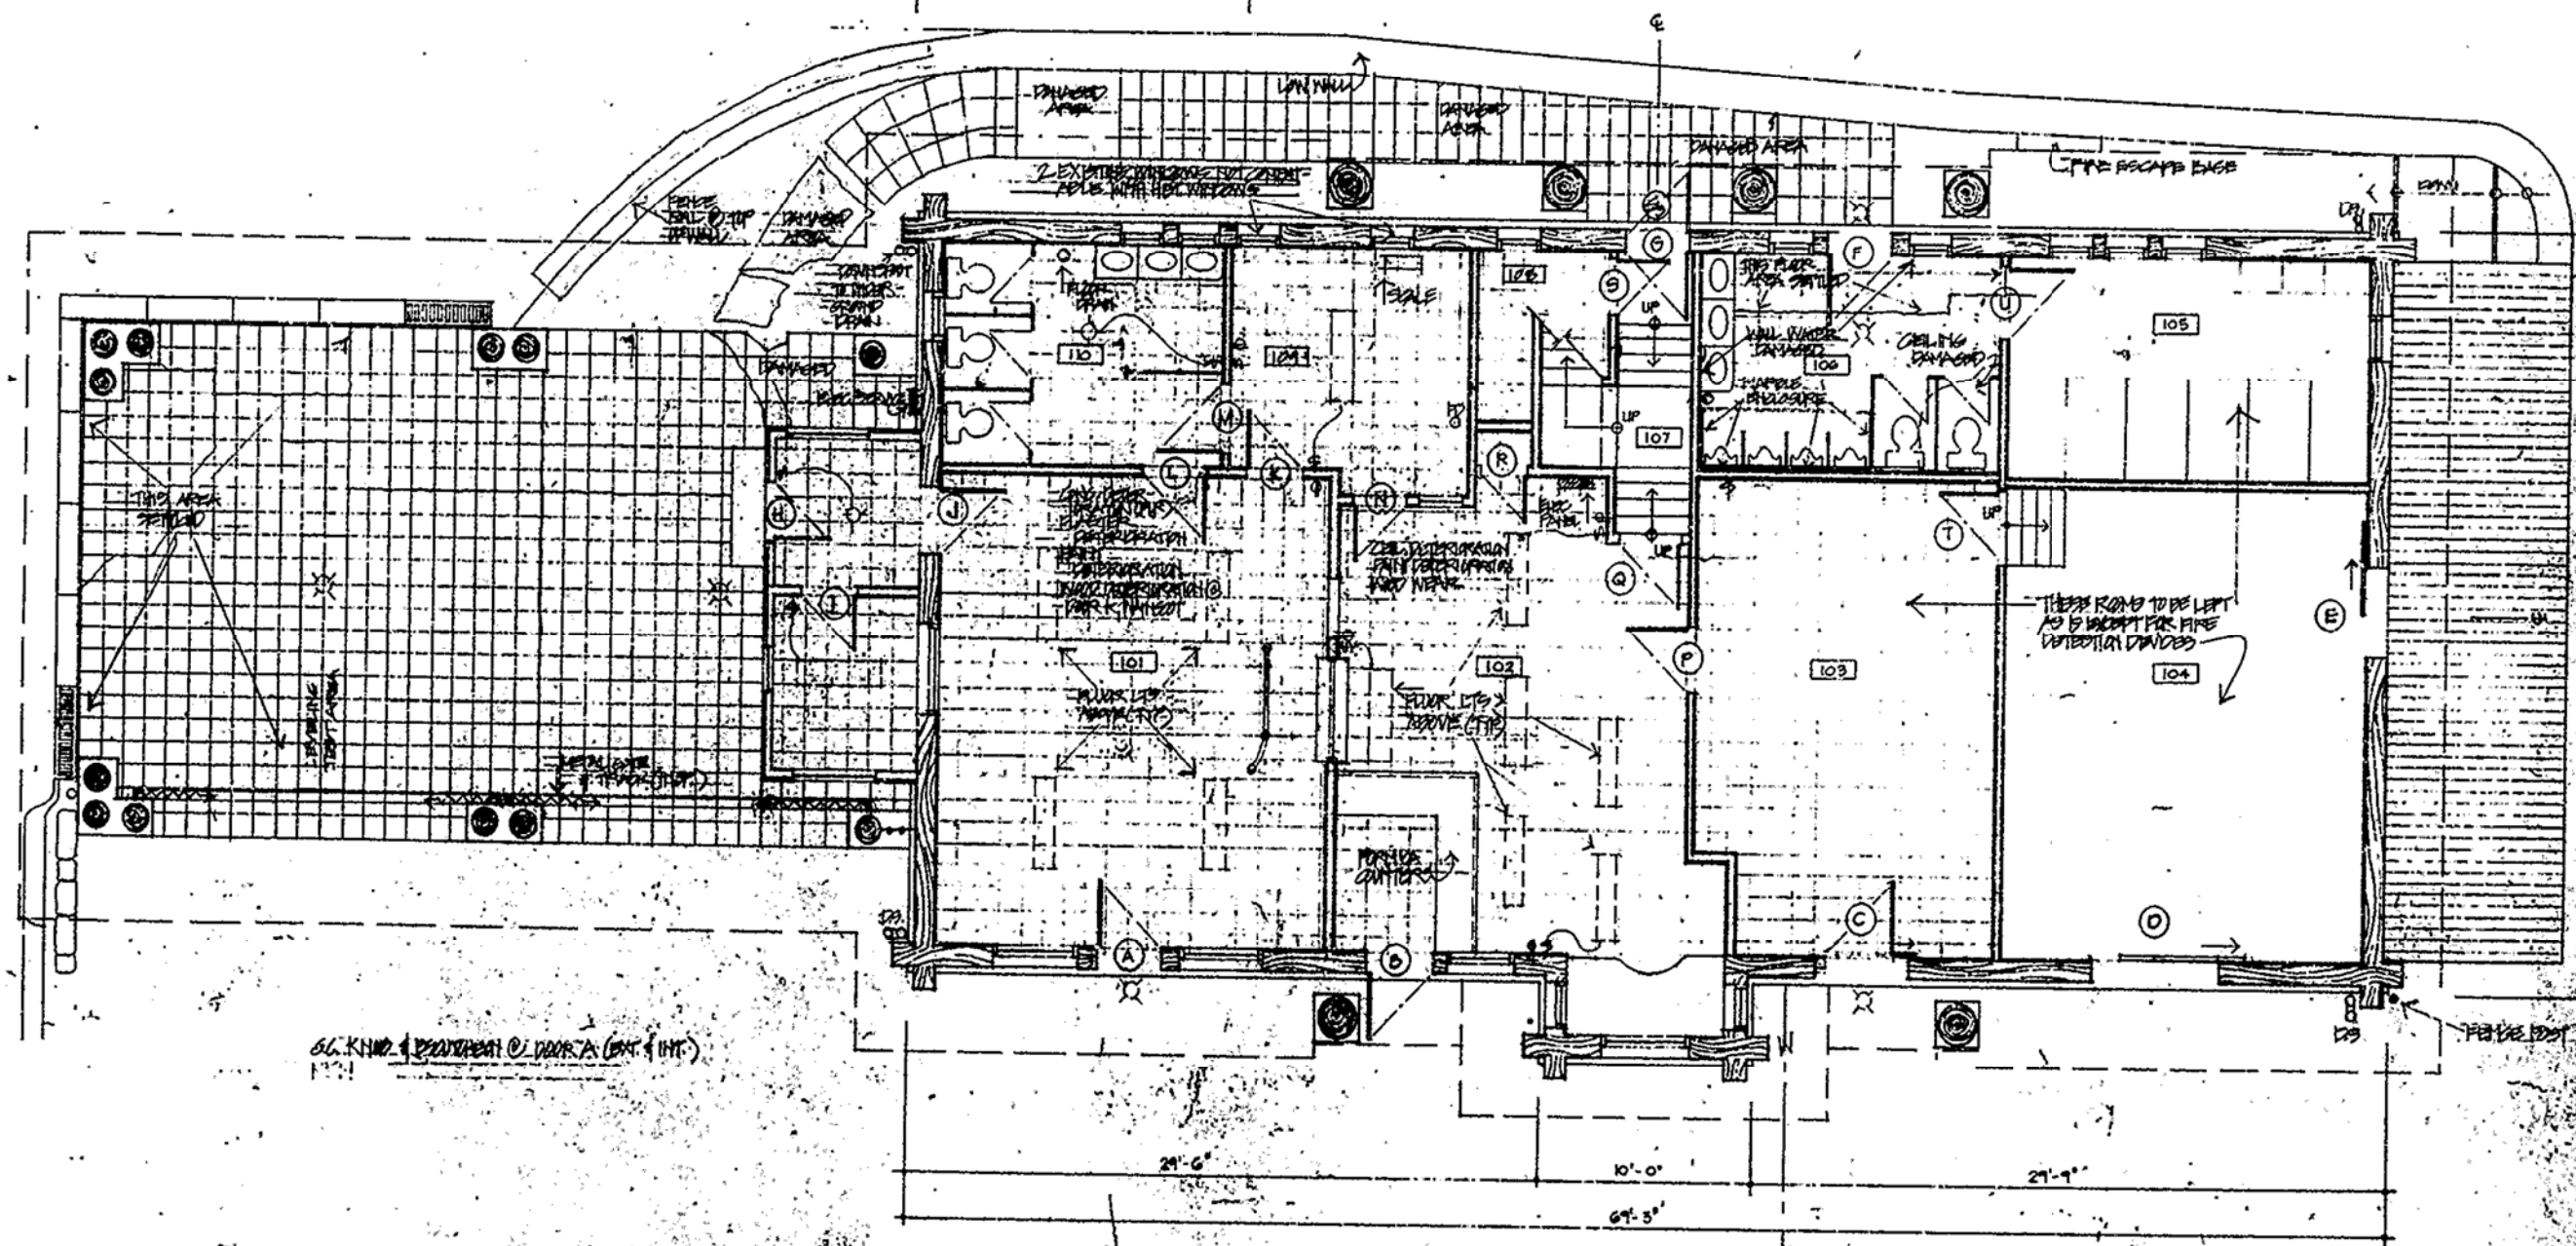
EXISTING CONDITIONS FLOOR PLAN

NOTE: NORTHALL HAS DIFFERENTIAL SETTLEMENT PROBLEMS. TO BE DEALT WITH IN ANOTHER PHASE

NOTE: SETTLEMENT REMAINS ARE NOT PART OF THIS PHASE I WORK. CONDITIONS ARE TO BE MONITORED FOR ONE (1) YEAR.

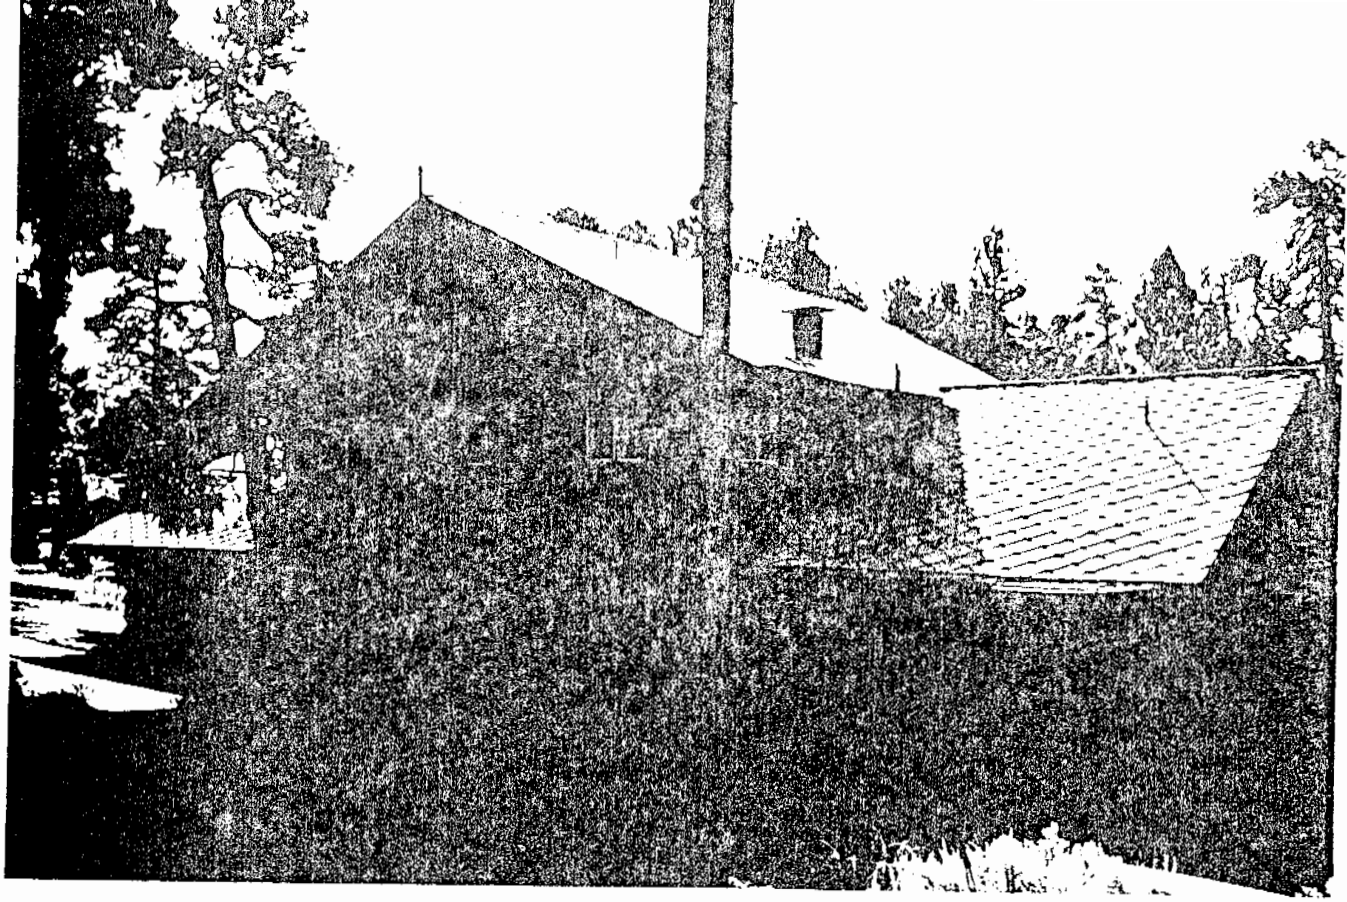
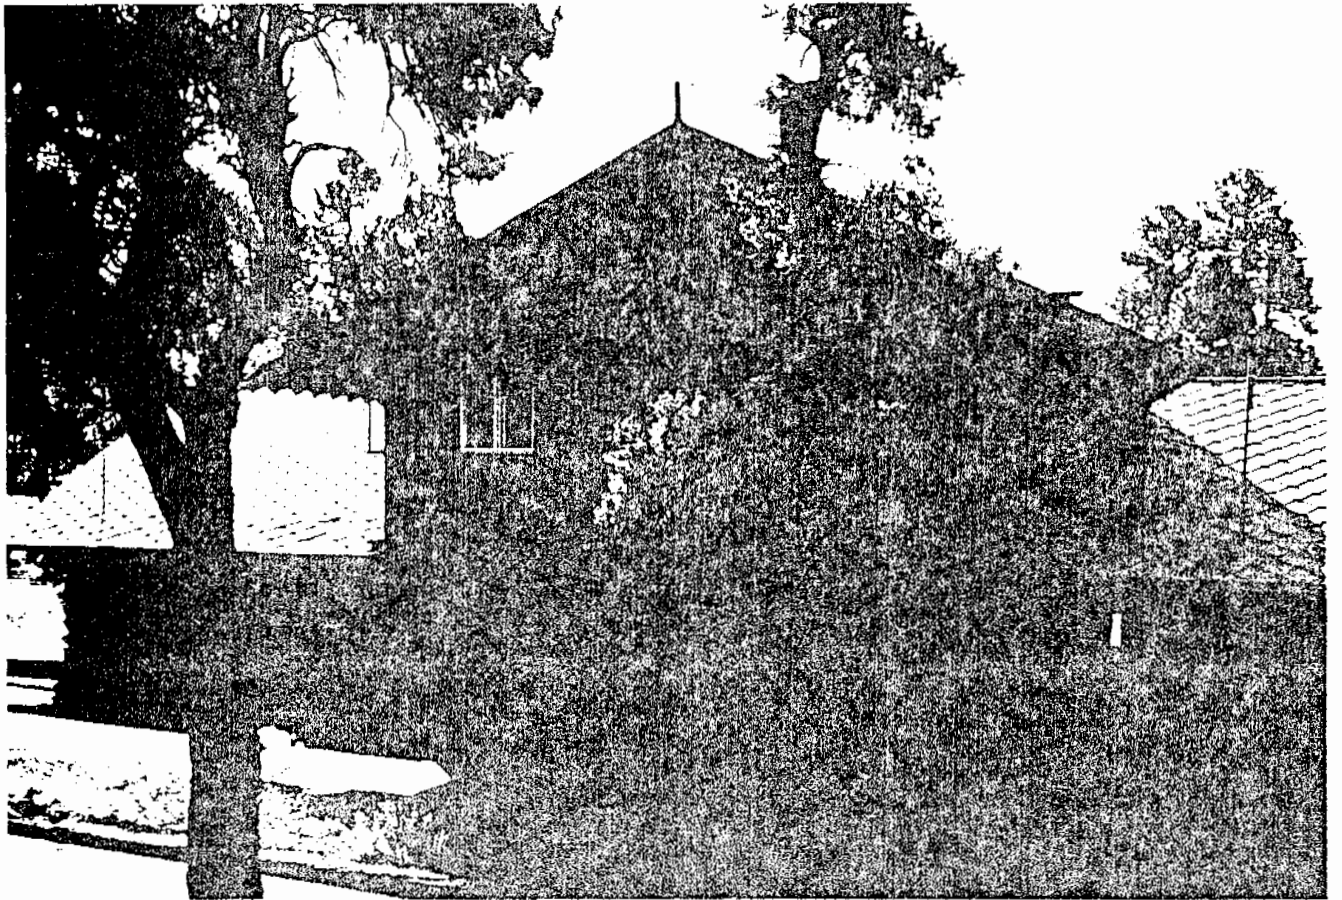
Southeast corner of Grand Canyon Depot and
iron yard fence
