Grand Canyon Railroad Depot

Historic Structure Report

prepared for the
National Park Service

prepared by
Chamberlin Architects, PC
Grand Junction/Lakewood, Colorado

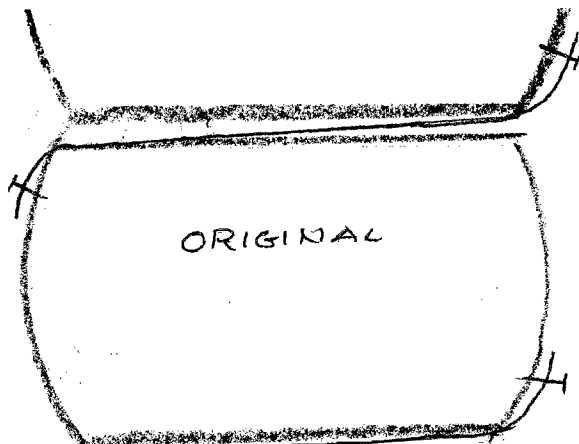
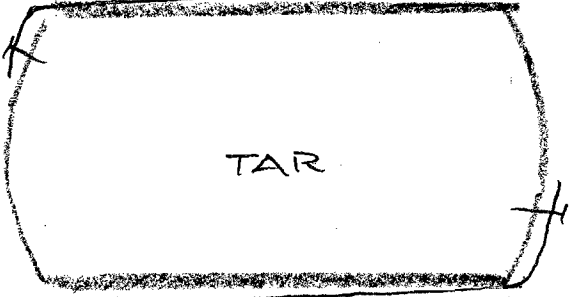
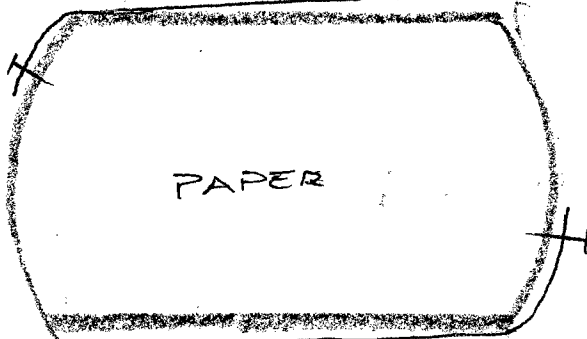
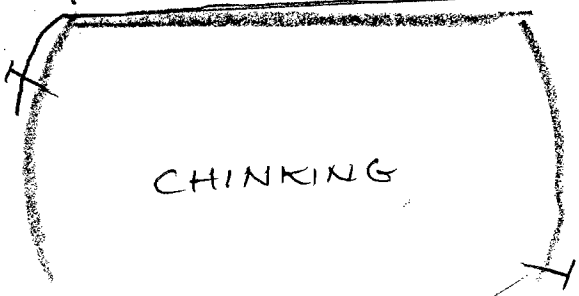
A proposal to cover the original felt with new entails pulling the exterior nails , trimming off wrinkled original paper , and forcing the covering into and back against what should be healthy and resilient tar paper secured to the backside of the log above thus pinching the new to fasten the inside . The exposed portion would be sized , oiled , and fastened with the original nails . Opportunity exists to coat the recesses with oil but added insulation or other attempts to improve upon a good thing should be avoided to allow this process to reoccur in 2079 .

ORIGINAL

TAR

PAPER

CHINKING

1"
SEMI
SQUARE
HEAD
ROOFING
NAIL

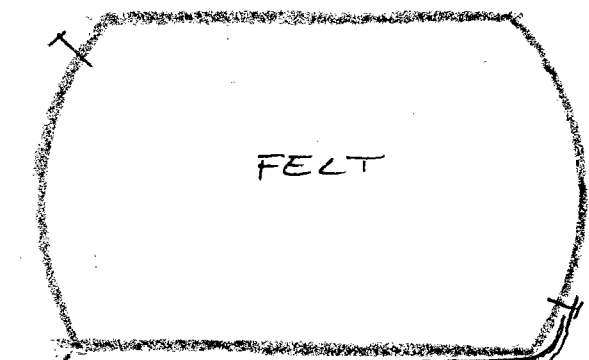
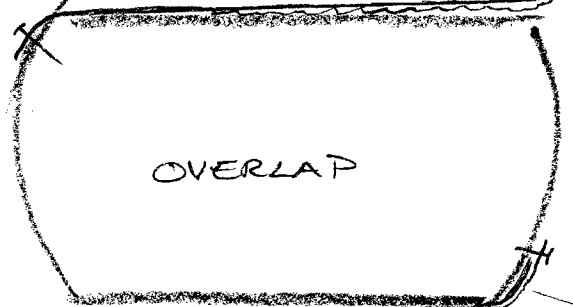
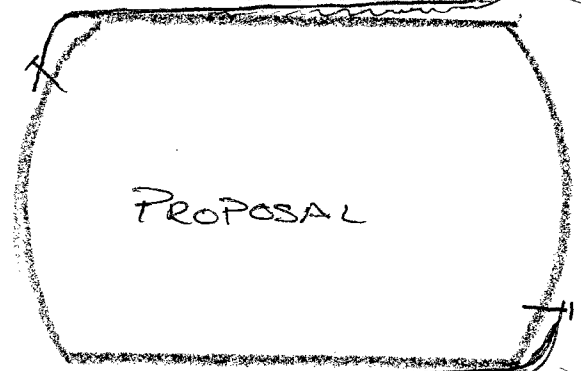
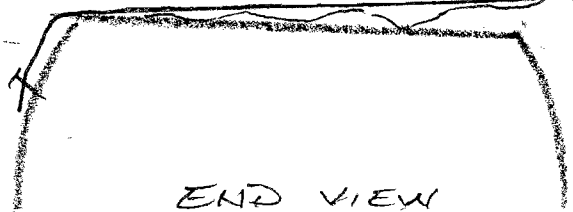
A unique design characteristic of this ancient structure is the chinking between the logs . Customary chinking of mud , clay , or mortar acts as elemental insulation against wind , weather , dirt , and insects only until the freezing and thawing cracks it to allow it to fall out as the building shifts and settles . This problem is solved on this redwood structure by wrapping heavy tar paper from the outside of the lower , under and secured to the log atop it . The drawing is not accurate in detail , but serves to illustrate .

Eighty years have radiated much sun to the surface of this old structure and did bake the exposed felt to a brittle thin crust . Most of the South and East side has deteriorated to leave only a semi-square roofing nail with a ring of brittle material under it as the rotting felt pulled away into the shady gap between the logs .

While no damage is apparent as a result of this decomposition , the nails are now rusting unprotected allowing moisture to channel down into the interior of the timber . Even redwood decomposes a little and there exists now the opportunity to salvage a majority of the original antique roofing nails before climate swings and rust drop them onto the railyard as souvenirs .

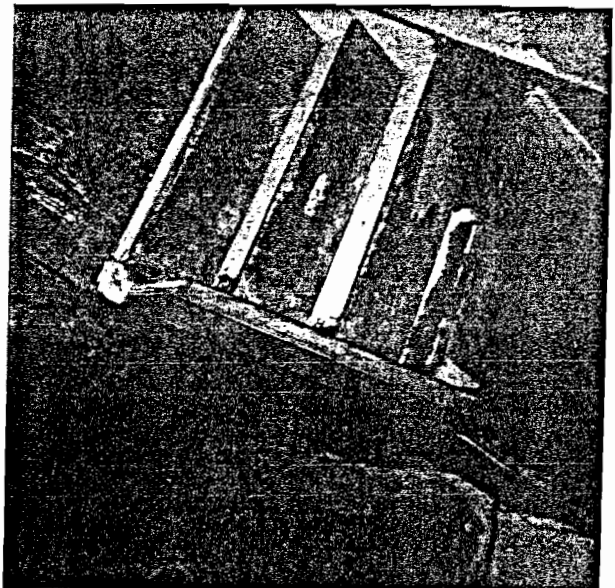
Original trough saved as attached
was marked & shadowed for rungs

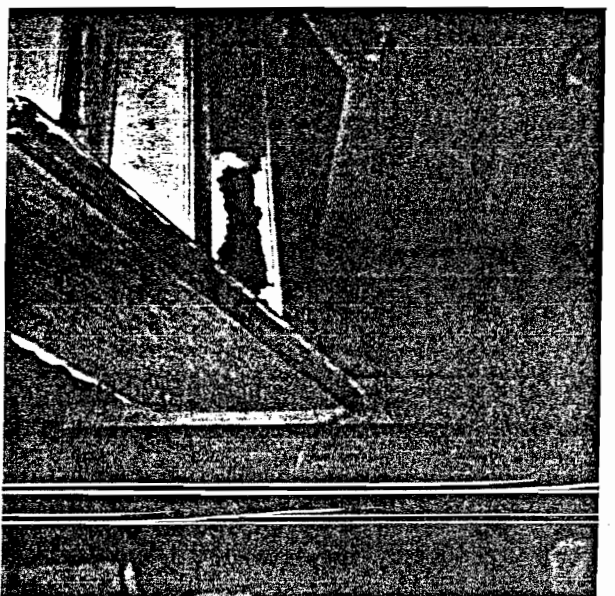
pre-repair condition of fabric
Riser facing trim split from tilt

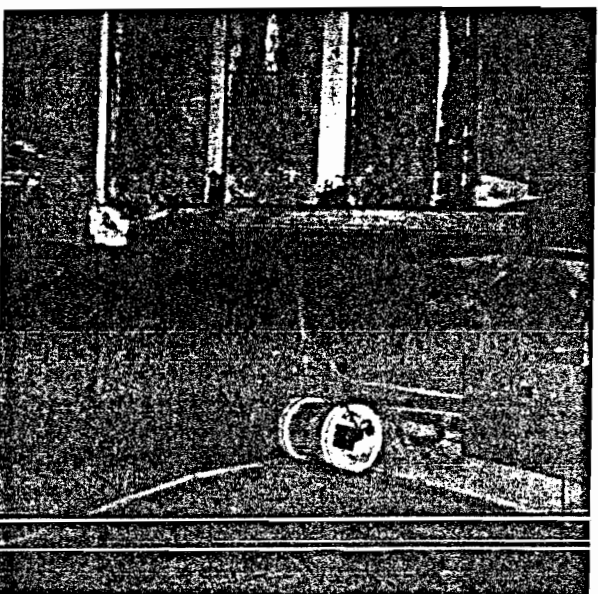
Down from window
shadows & nail holes in rough

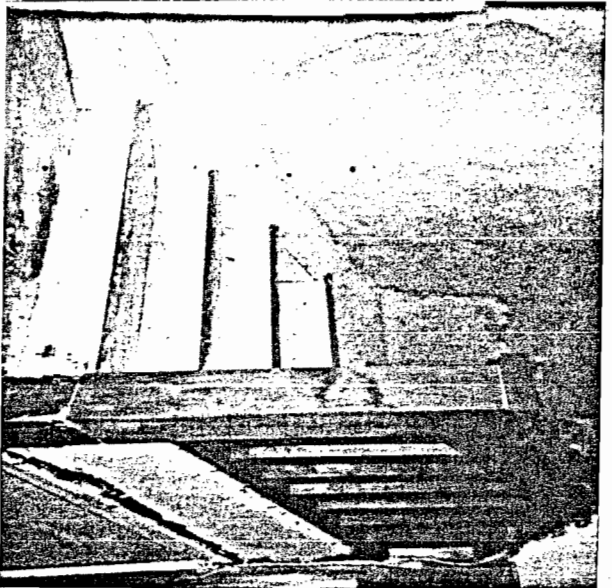
Bottom bannister reconstructed
to save all remaining historic fabric

The lower and center bannister railings were reconstructed to most closely approximate the original that was cut out to allow a piano to be moved upstairs sometime in the early forties. Evidence of the original configuration was found ; in the attic above Freight room , inside the remnants of the original posts , and the existing original portion remaining at the second floor level entry . Much re-alignment , fortification , and resurrection of the existing riser covering was required to approximate the original position of these features . The North footing of the Depot has settled , causing the internal casements and load bearing features to tilt out of plumb & twist out from square . The gaps were forcibly decreased , and the inclinations brought closer to perpendicular , but exact positioning to original is not known and was not attempted as not to further stress the ailing aged timbers .

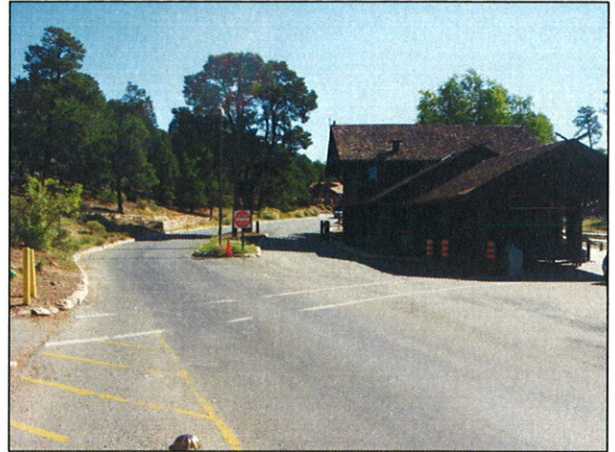
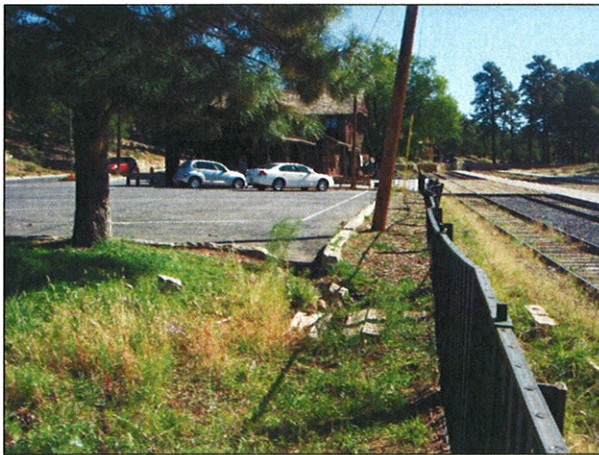
Adjacent to the north side of the structure is a short stone retaining wall coming up to an asphalt roadway (see photo, right). Traffic on this road is west bound only. There is a median in the road previously serving to separate east and west bound traffic. The south lane is now primarily used as bus parking. Additionally, there are designated spaces for bus parking to the west of the structure. At one point during our site review, all spaces were full and three busses were parked in the south lane. To the north is a steep embankment up to additional points of visitor interest. A serpentine pedestrian walkway and a concrete paved roadway to the east provide access.

South of the depot lay the railroad tracks. These are active serving visitors to the Grand Canyon. (See photo, center).

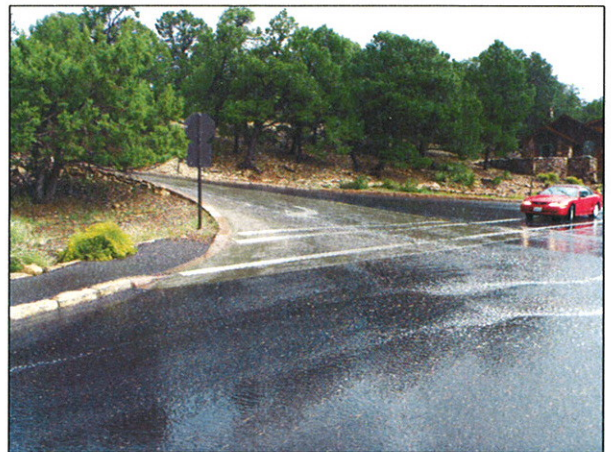
concentrates flows (see photo, bottom) bringing them to an inlet and trench grate located east and slightly north of the structure. There is also evidence that some of this flow is lost at the intersection of the access road and service road. A swale has developed at this location and sediment has been deposited at the bottom of the embankment. This sediment can be seen in the photo (top right) just right of the existing speed limit sign. For the purpose of developing design

recommendations we have delineated Basin A without consideration of the service road intersection. Our recommendations include providing a pan at this location to eliminate the loss of flow at this location. Basin A is 3.9 acres, sloping southwest toward the structure at an average of 8.71%. This produces a 5-year flow of 4.08 cfs and a 100-year flow of 15.01 cfs. This is based on rainfall information for Grand Canyon, Arizona, obtained from the NOAA website. A copy of this can be found in the appendix. In review of the existing drainage inlets located near design point 1, this inlet has a capacity of approximately 6.2 cfs.

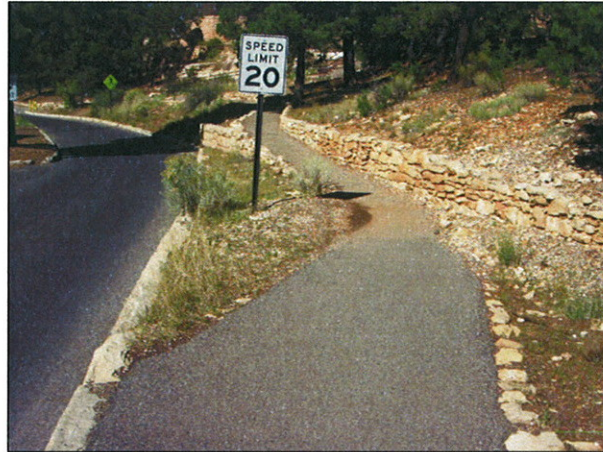
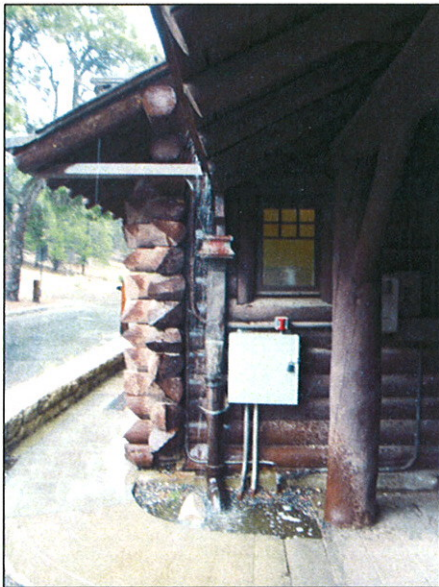
Downspouts are taken underground into the same drainage system. There are low areas around the building that do not drain. It also appears that the roof gutters need maintenance (see photo, above). Basin B also includes drainage from the road. This drains to the wall shown in the above photo. There are low spots along the wall where water may pond before evaporating or infiltrating into the joint between the wall and the asphalt. Basin B drains west along the building wrapping around the concrete seating area through a long trench grate before outletting into a concrete swale, under the fence to the railroad tracks (see photo, right).

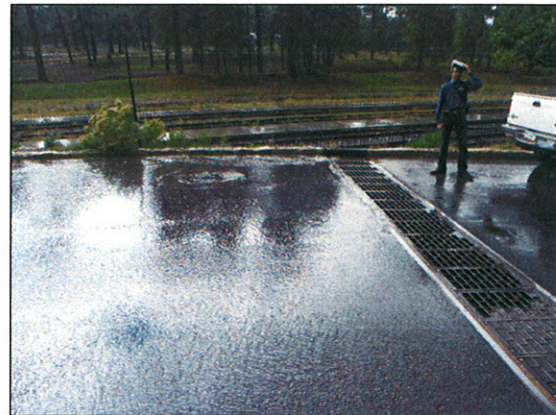
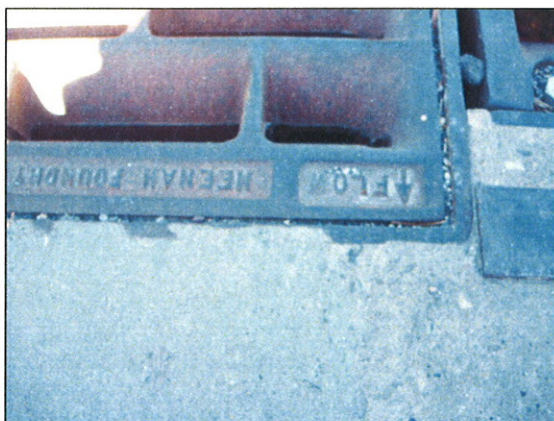
located northeast of the site (see photo, above). This will increase the capacity of the inlet to capture approximately 80-100% of the 5-year flow. Additionally, it was observed that the grate on the existing inlet has been installed backwards. This type of grate is directional. See the flow arrow provided on the grate in the photo. This should point west. Turning the grate will increase the capacity of the inlet.

Control of drainage immediately surrounding the building (basin B flows) is a priority. These are the flows that most frequently stress the structure and, therefore, cause the most damage over time. The structure will also benefit from eliminating the high flows draining west along the north side of the site. Based on the calculations included in the appendix of this drainage study, we recommend that one to two additional inlets be constructed just west of the existing inlet

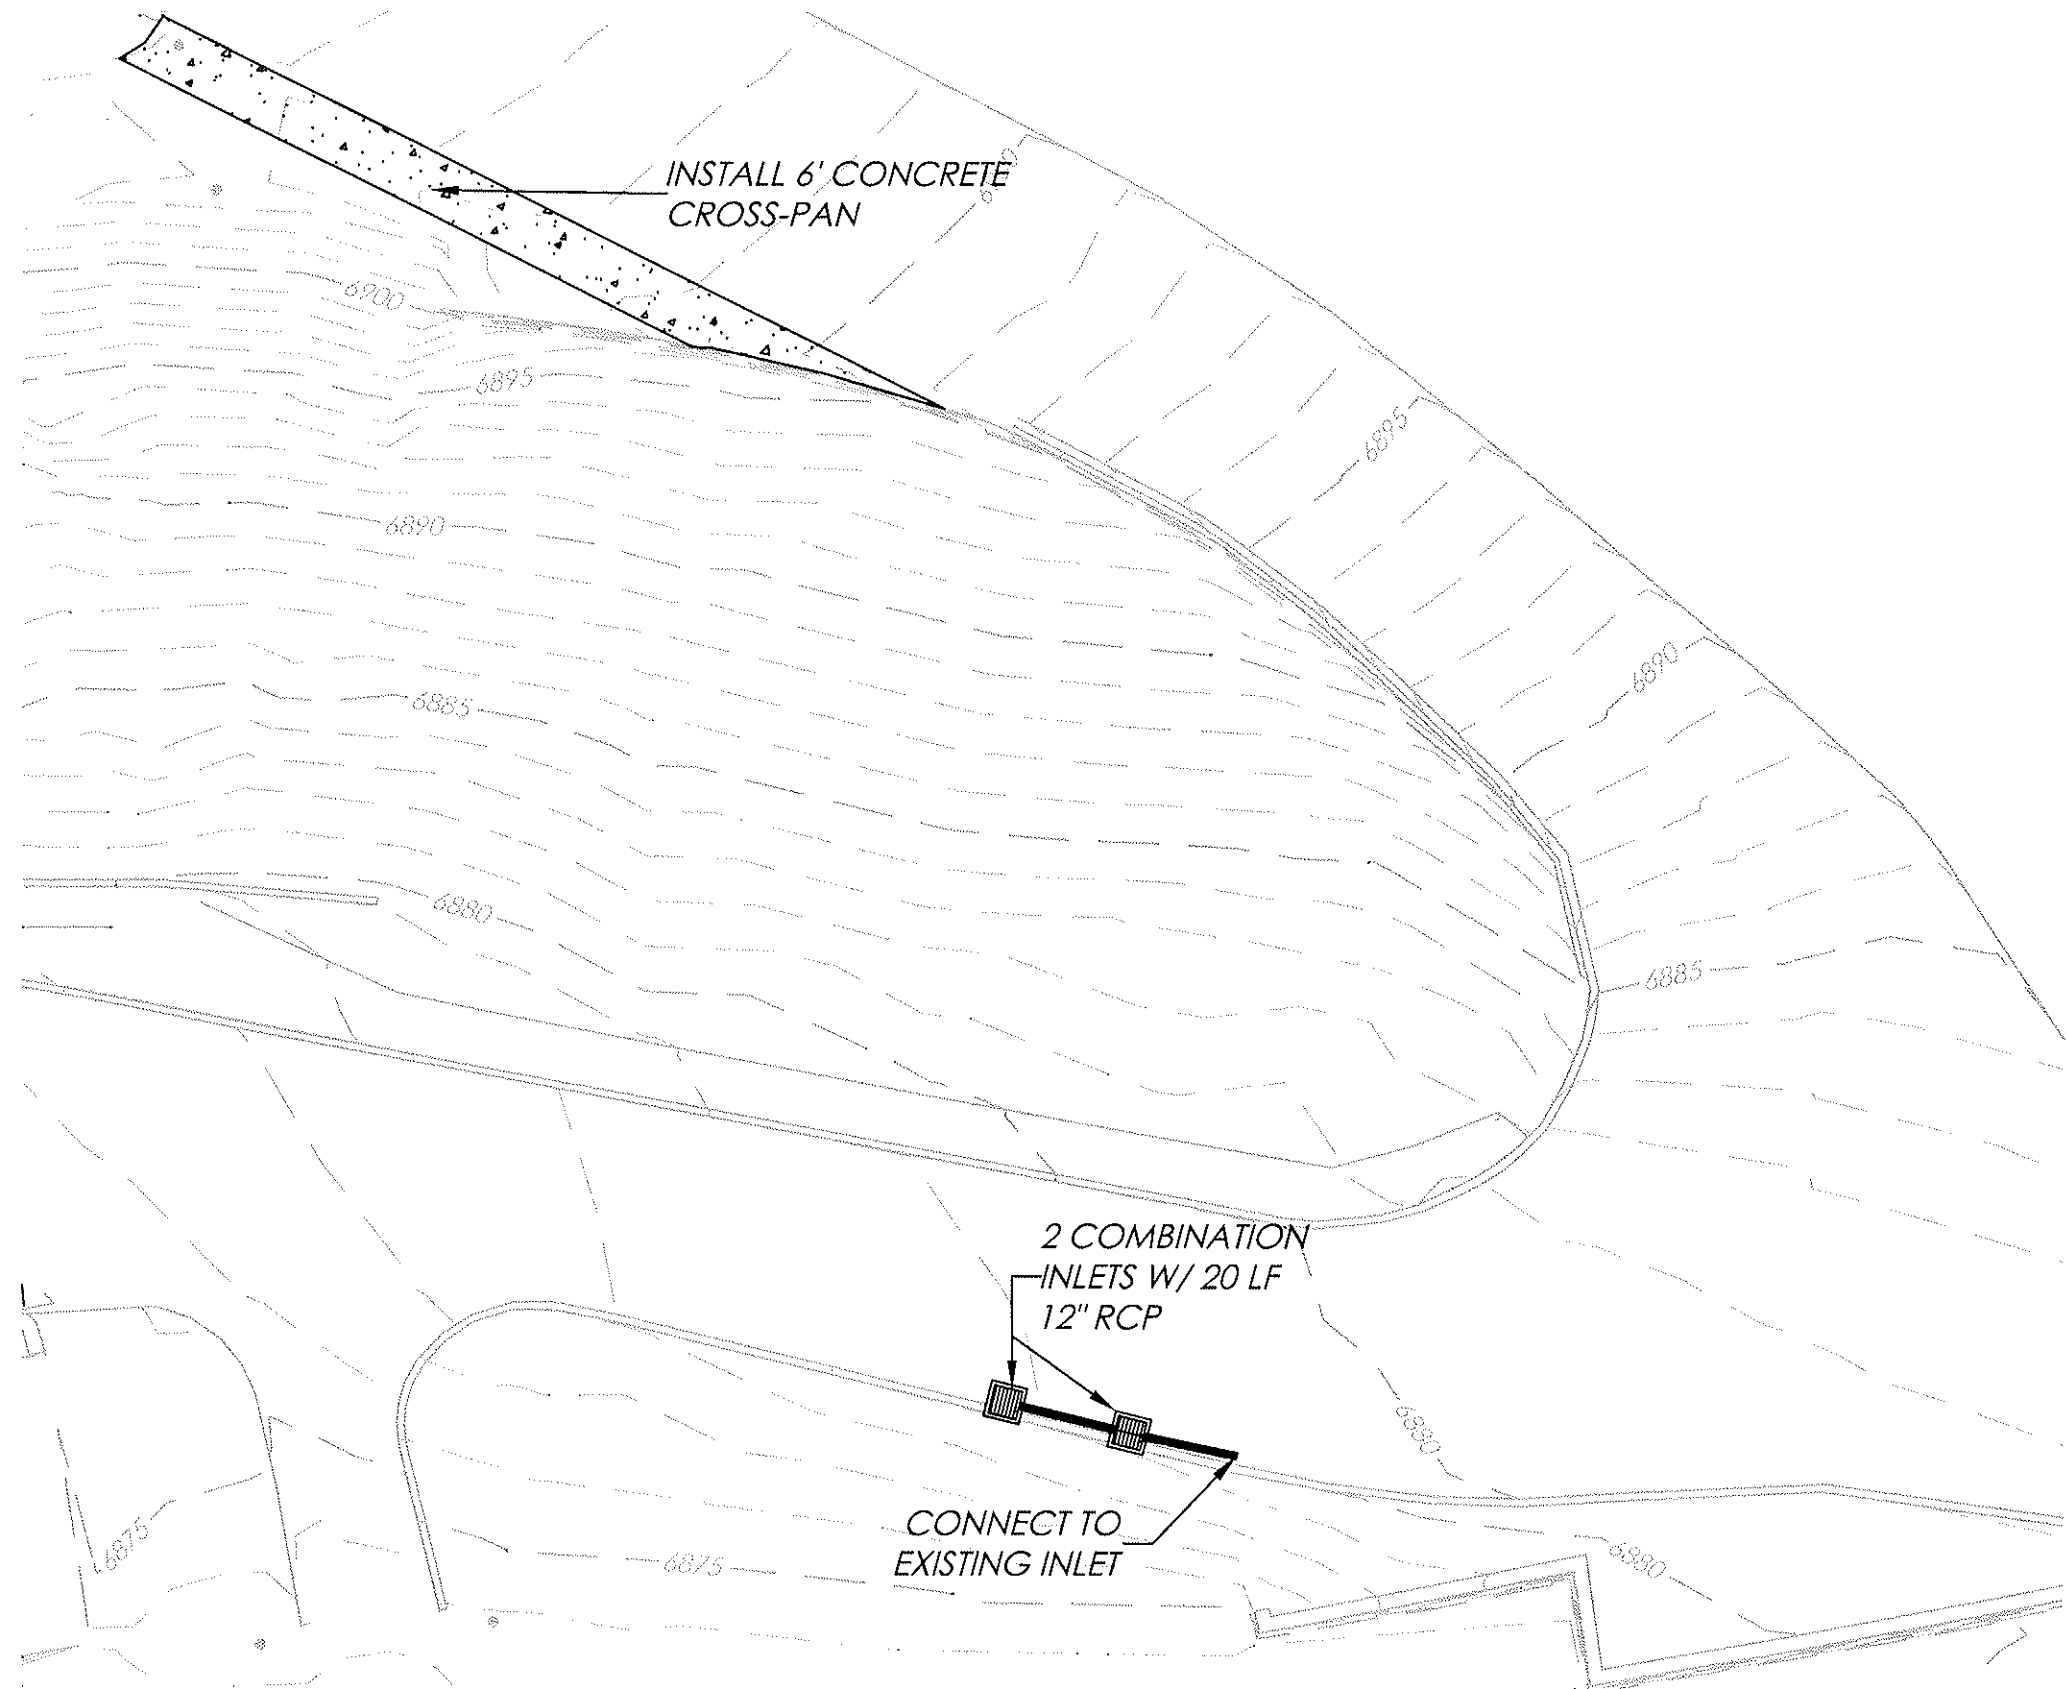
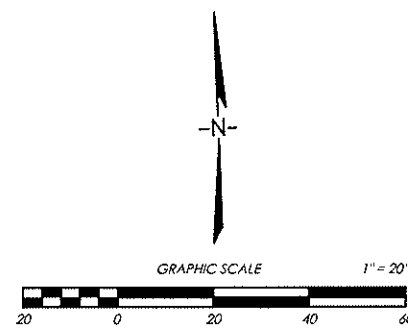
DESIGNED: HKP	SUB SHEET NO.	TITLE OF SHEET GRAND CANYON DEPOT DRAINAGE REMEDIATION ALTERNATIVE 3 HISTORIC STRUCTURE REPORT GRAND CANYON NATIONAL PARK	DRAWING NO. 1 2 PMS/PKG NO.
TECH. REVIEW:			SHEET 5 of 6
DATE:

Improper slope away from the Depot is the major drainage issue with this site, compounded with insufficient piping capacity. These recommendations will address both conveyance capacities and grading issues. In order to correct deficient grading, all slopes away from the building shall be 2% or greater. The structural engineer has also recommended that where impervious surfaces are adjacent to the building, a slope of ten percent for five to ten feet away from the building shall be provided. In order to correct deficient conveyance capacities, additional pipes and inlets are necessary. As a result, this report recommends the construction of Alternative 1 or Alternative 3, because both provide high flow capacity and have long term maintenance advantages. Should the park select Alternative 3, bus parking should be considered. Although alternative 3 is more expensive, it also includes an option for landscaping, which would increase the aesthetic qualities surrounding the Depot. Alternative 3 also includes the removal of the wall adjacent to the north side of the building, which would improve accessibility.
