South Rim Ranger Operations Building  
Historic Structure Report

Grand Canyon National Park, Arizona

## I. EXECUTIVE SUMMARY

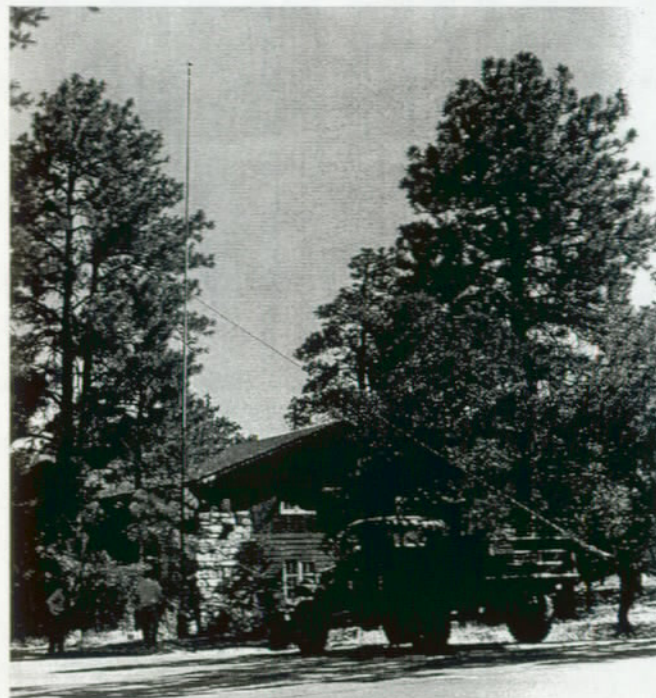
GCNPA Photograph Number 2310.

Figure 16: Erecting flagpole after repairs, June 1952.

Flagpole re-installed (non-compliant) in a location different from the historic.
- 2000 Boiler flue replaced. This new flue was not replaced per park compliance requirements and is placed directly in front of, and blocks the view from, a second story window.

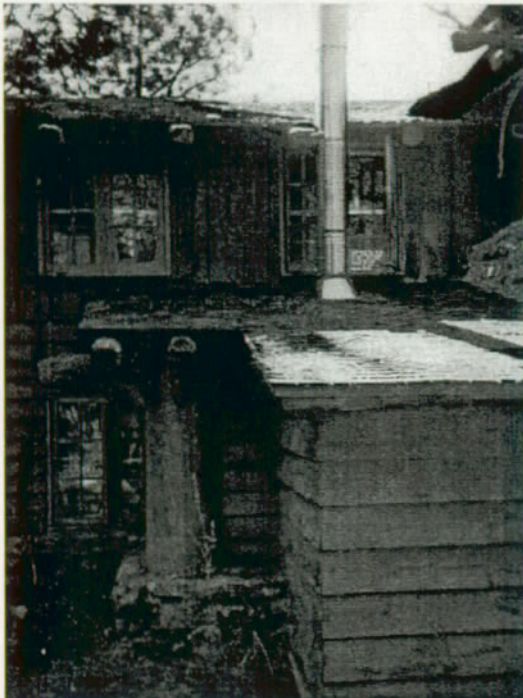
Photo ARG.

While the exterior has been altered, these changes, such as the installation of the metal awning, have been generally sympathetic. The exceptions are the recently installed flue at the rear (**Figure 18**), the vault added to east side of building, the removal of the exterior door at the east elevation, the electrical service at the south elevation, the replacement front door, and the reconfiguration of the south facade by eliminating a first floor window and inserting a door. The interior design has been compromised by the addition of interior walls, removal of historic finishes, relocation of doors, and the addition of an office into the lobby space. While some materials, such as the log rafter ends and decorative log work, have been

Figure 18: Flue at east elevation, added Spring, 2000.

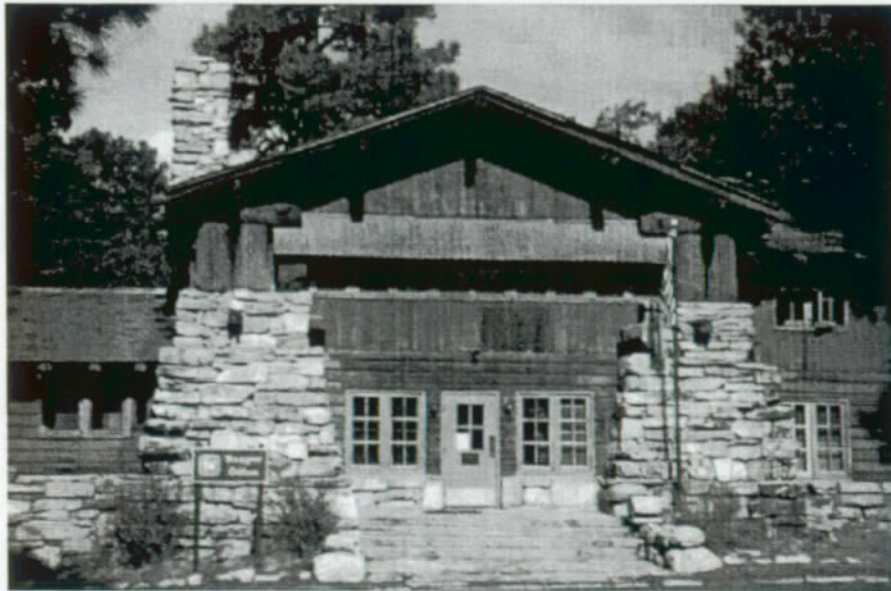
Figure 20: Principal facade, May, 2000. Dark patch above the main door and window on right indicates the previous position of non-historic building sign.

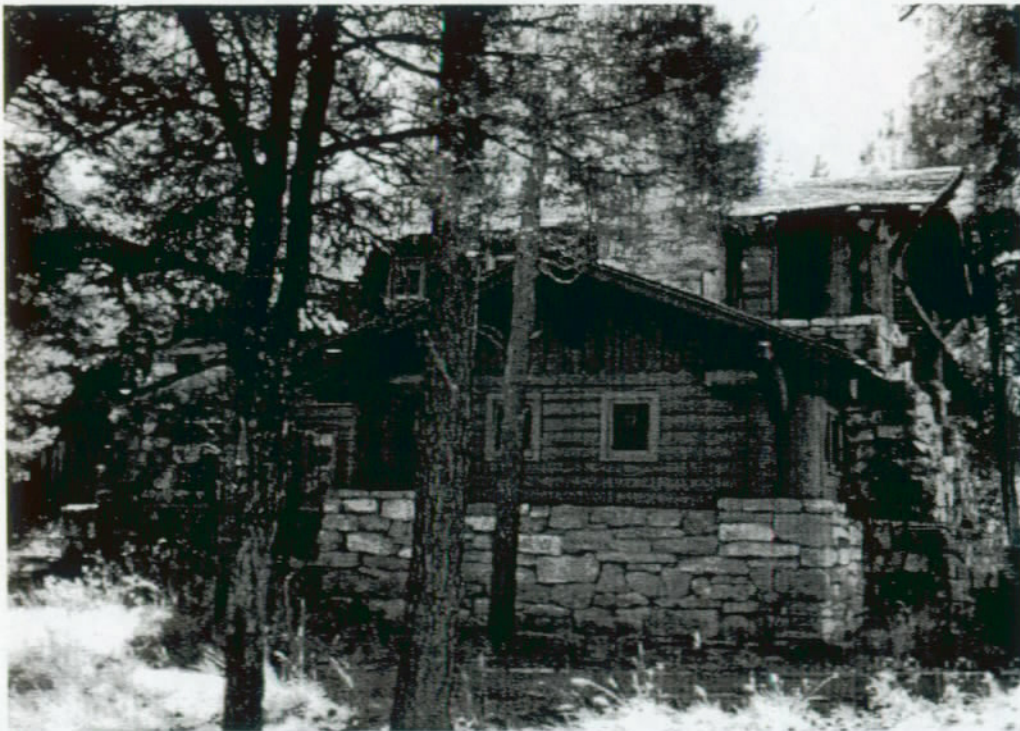
Figure 22: North elevation.

General exterior conditions are the same as at the west elevation. Deviation from the standard conditions at this elevation include new hardware at the three second-story windows. The western window at room 104 is damaged and needs to be reattached to the frame. Additionally, the western-most crawl space (vault), at the time of our site May 2000 site visit, contained approximately two feet of standing water.

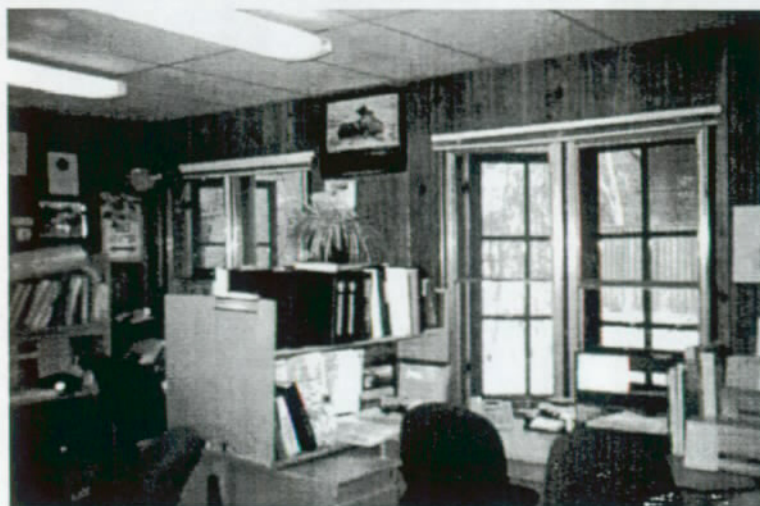
Figure 25: Typical first floor office interior.

The first floor spaces are in fair to good condition. The boiler pipes broke in 1976 and all of the interior finishes (celotex and batten), except in the toilet rooms and lobby, were replaced. The newer finishes in the structure are in good condition though not appropriate for the historic character of the structure.

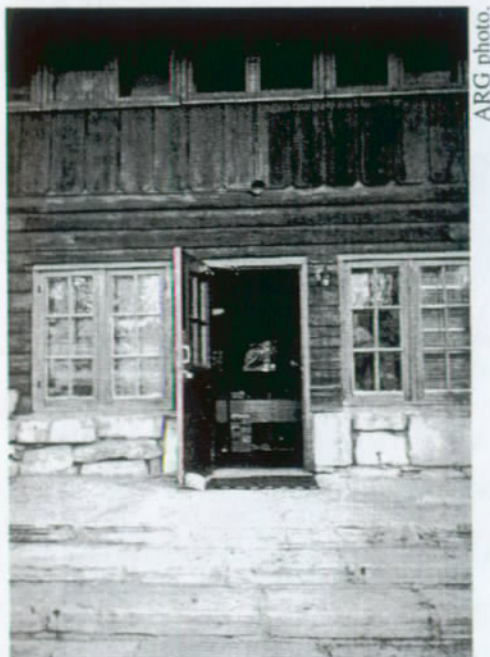
Figure 26: Principal entrance, 10 July 2000.

primary lobby space is in keeping with the building's design. It would be awkward to insert desks and workspaces into this area, which should continue to serve a public function. The re-instatement of public access to the lobby does, however, raise issues for handicapped accessibility, as this primary entrance is accessed by exterior stairs. This issue is discussed in the "requirements for treatment" section of this document.

Public access further compounds the issue of security. Park security experts recommend the addition of security cameras and keyless entry systems at both exterior doors. Given the configuration of the lobby and stairway, it would be difficult to block public access to the second floor from the lobby. It may be possible to establish a completely secured area in the south wing of the building by adding doors to the south hallways at both the first and second floors.

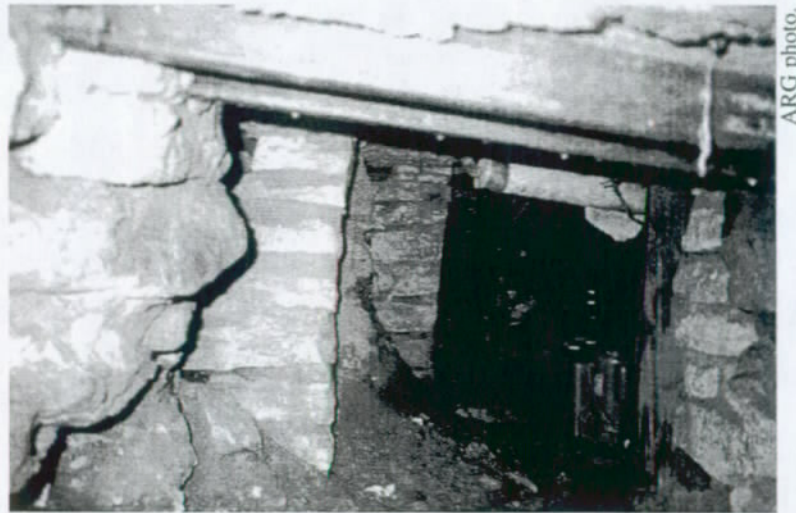
Lastly, the utility tunnels underneath the north end of the building are subject to seeping groundwater. (Figure 29) At times, water in the tunnels has risen to a depth of 24 inches. A drain should be installed at the low end of the tunnels to allow the water that enters between the surrounding rock strata and top soil to drain back out to the surrounding soil.

Figure 29: Utility tunnel. Standing ground water was measured to a depth of 24" in May, 2000.

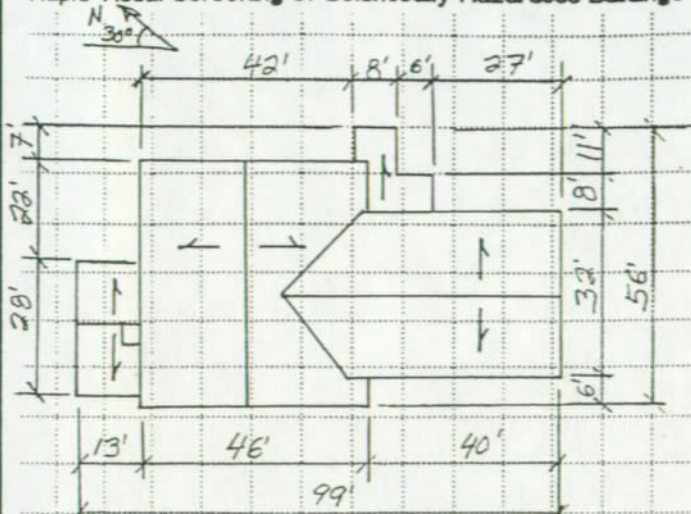
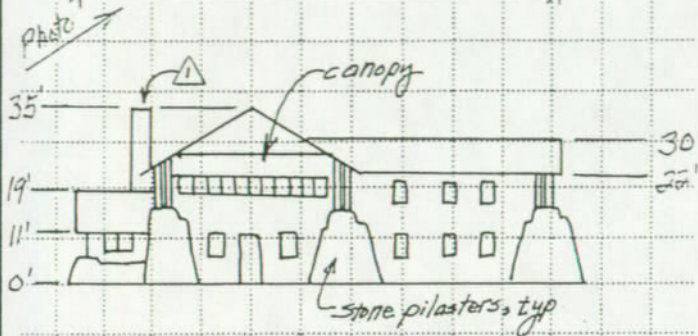
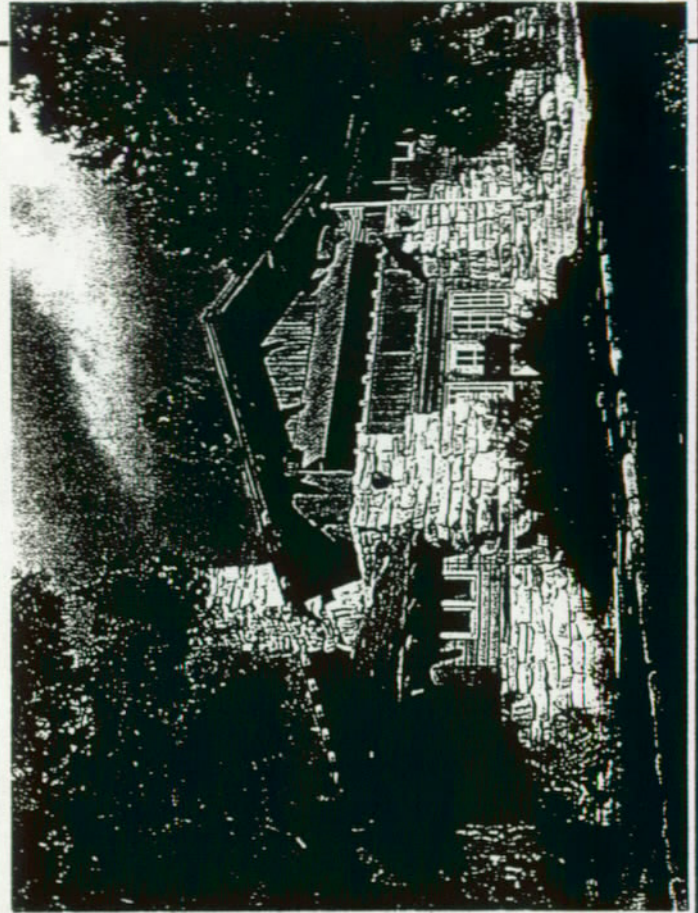
COMMENTS  $\Delta$  Unreinforced stone chimney may fall & damage roof below during earthquake
