**HERBERT HOOVER**  
11 CORE AREA BUILDINGS

NATIONAL HISTORIC SITE / IOWA

HISTORIC STRUCTURE REPORT  
ELEVEN CORE AREA BUILDINGS  
HERBERT HOOVER NATIONAL HISTORIC SITE  
WEST BRANCH, CEDAR COUNTY, IOWA

Volume 1: Administrative and Architectural Data

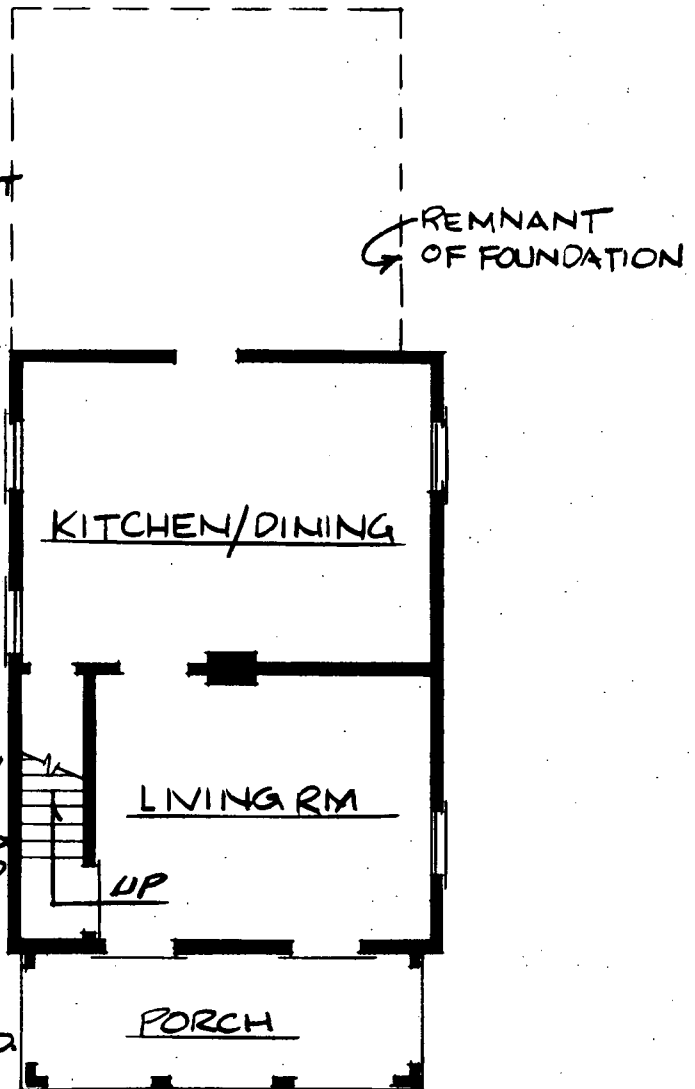
FIRST FLOOR PLAN

THE FOUNDATION WHICH EXISTED BEFORE THE 1978 STABILIZATION BY THE NATIONAL PARK SERVICE, INDICATED THAT THIS EAST ADDITION WAS ORIGINALLY 16' X 14 FT (SHOWN DASHED)

IN 1885 SMITH SOLD THE PROPERTY TO ELISHA HAINES WHO AT ONCE STARTED TO MAKE IMPROVEMENTS. THE WEST BRANCH LOCAL RECORD OF JUNE 25, 1885 SAID THE ENTIRE STRUCTURE WAS BEING RE-MODELED. ITS POSSIBLE THAT THIS COULD HAVE INCLUDED THE SOUTH BAY & ENLARGING EAST ADD. THE DIFFERENCE IN DETAILING BETWEEN THE NORTH & SOUTH BAYS WOULD INDICATE THAT THE NORTH BAY WAS BUILT LATER.

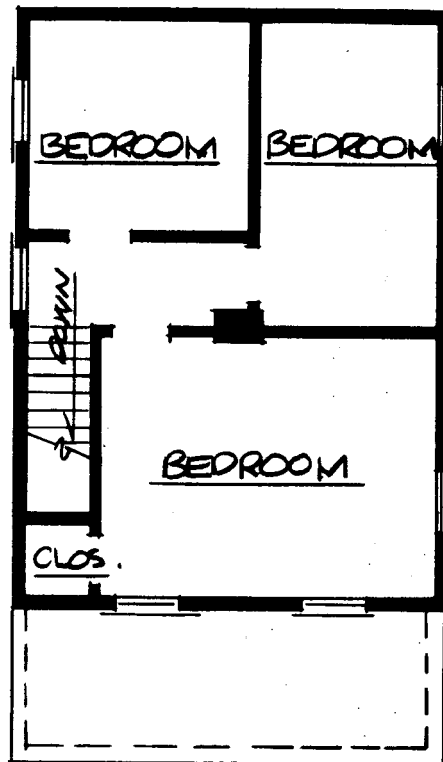
SECOND FLOOR PLAN

PHYSICAL EVIDENCE INDICATES  
THAT ORIGINALLY THE EXTERIOR  
WALLS OF THE SECOND FLOOR (INTERIOR)  
WERE FINISHED WITH ROUGH SAWN  
1x12 BOARDS LAID HORIZONTALLY.  
WITHIN A FEW YEARS, WOOD  
LATH & PLASTER WERE ADDED

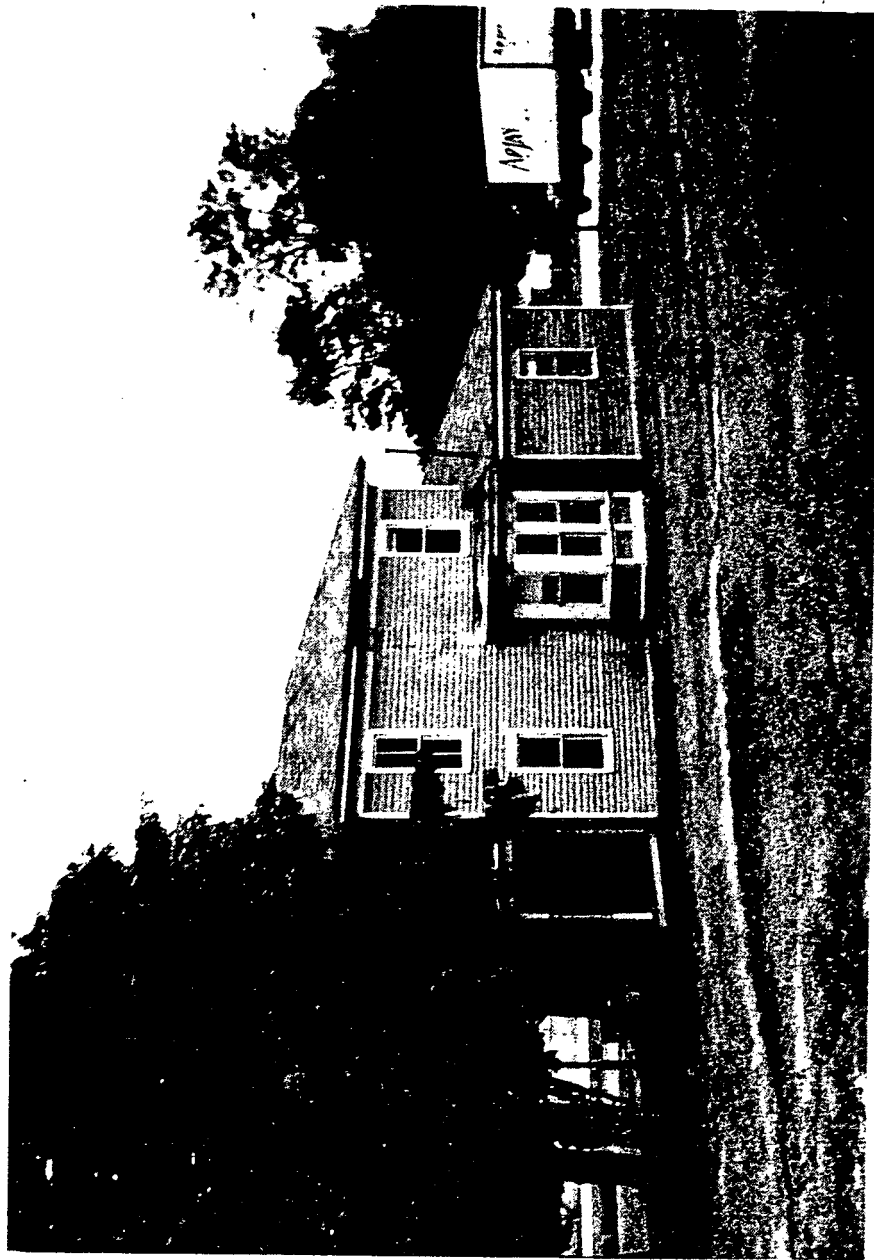
HS-2:2, P. T. SMITH HOUSE, 1978. Existing view looking southwest after stabilization. The original negative is at the Hoover Presidential Library, West Branch, Iowa.

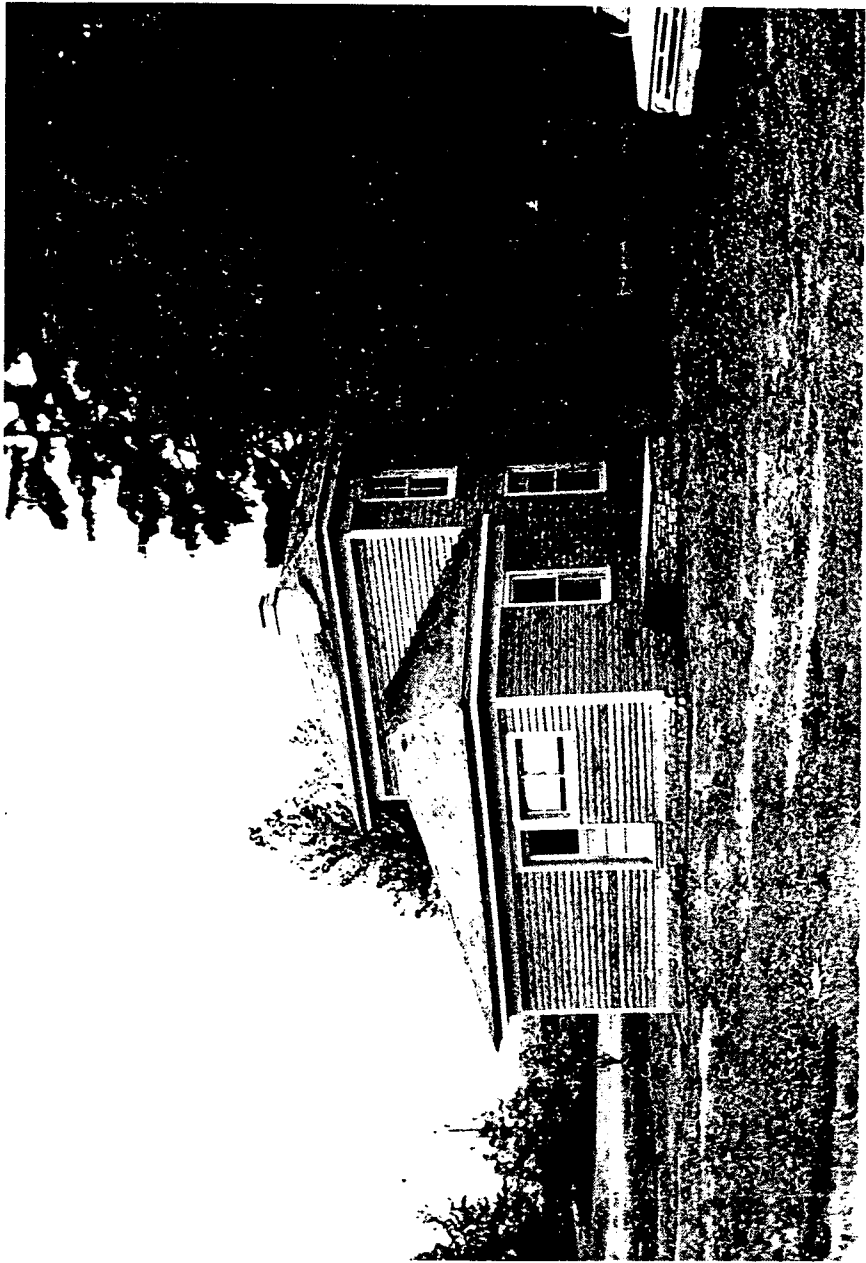
HS-2:3, P. T. SMITH HOUSE, 1977. View looking north prior to stabilization and removal of chimney. The original negative is at the Denver Service Center, National Park Service.

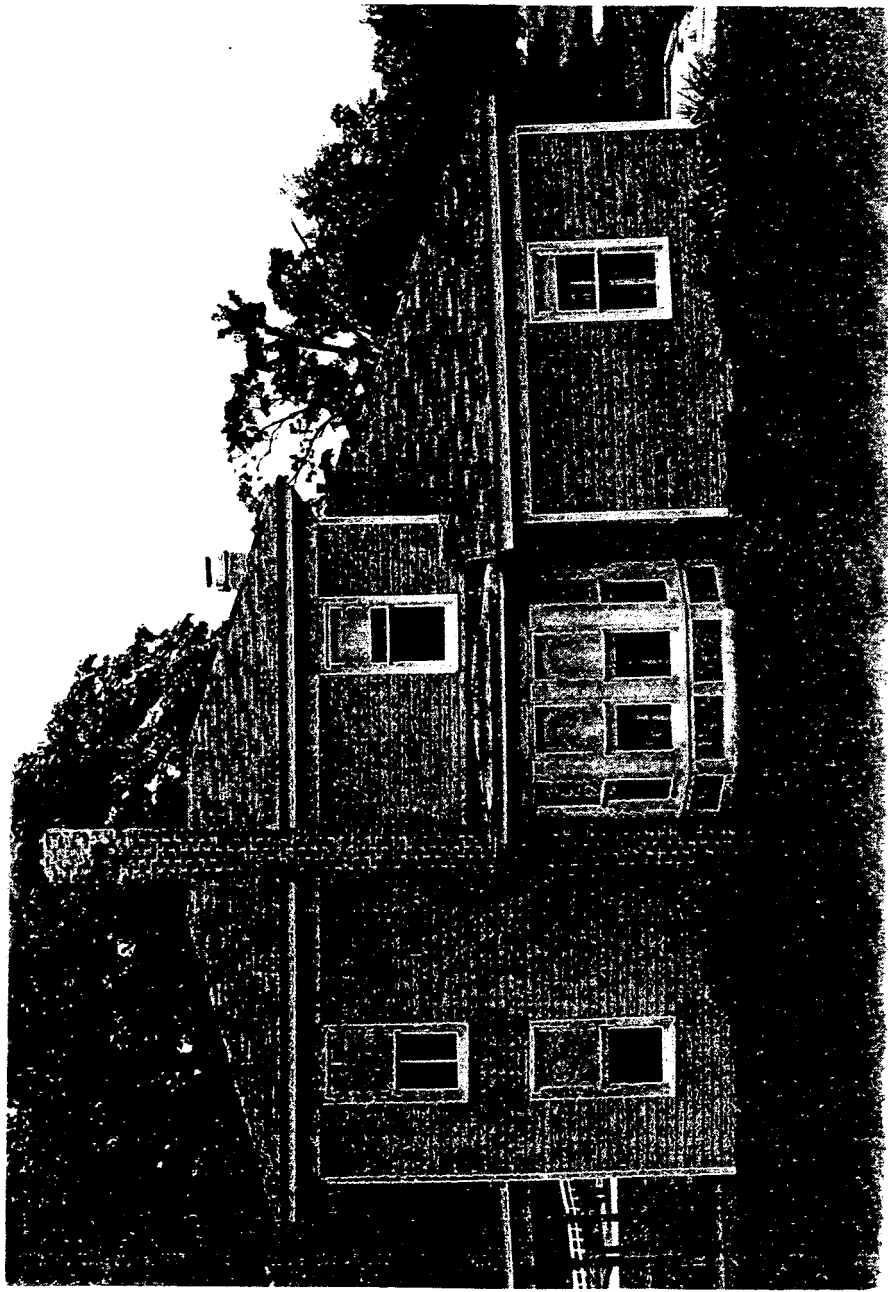
HS-2:4, P. T. SMITH HOUSE, 1977. View looking southwest prior to stabilization. The original negative is at the Denver Service Center, National Park Service.

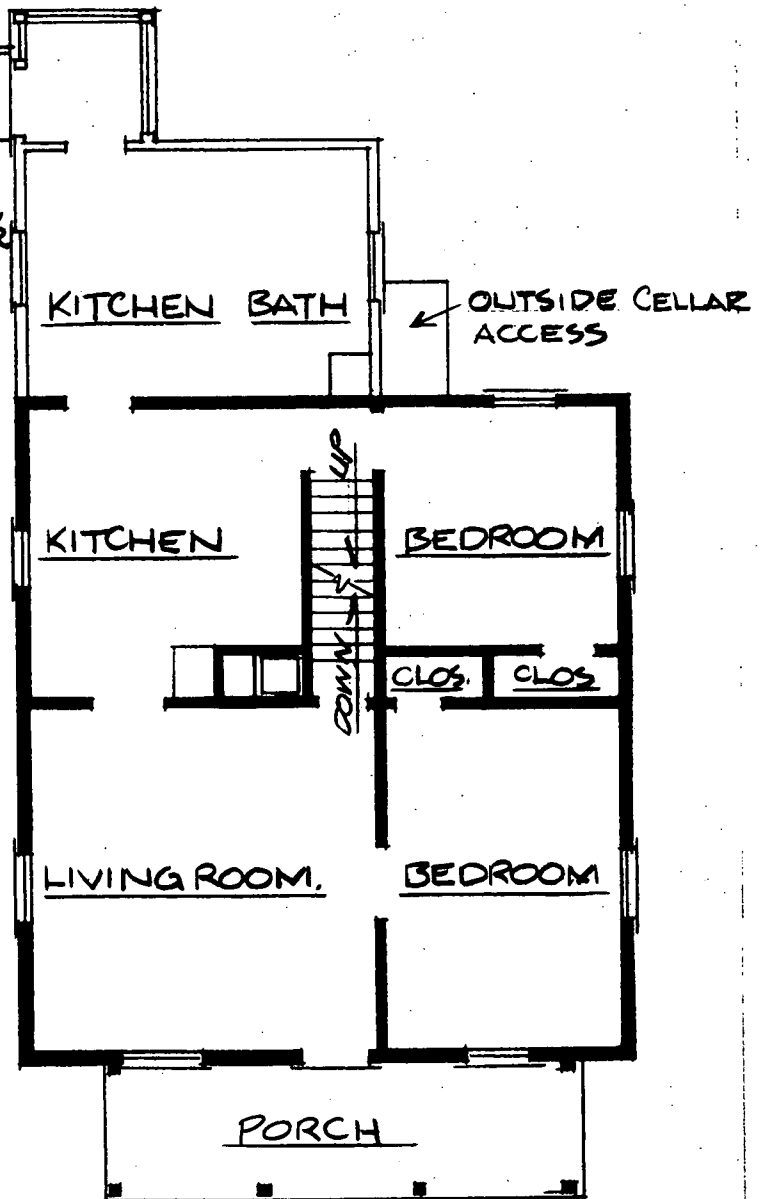
FIRST FLOOR PLAN

THE HANNAH VARNEY HOUSE WAS BUILT IN 1899 & CONTAINED FOUR ROOMS. IT WAS DESCRIBED AS HAVING A FRONT & REAR PORCH WITH A SMALL BASEMENT, ABOUT 1/4 OF THE FIRST FLOOR, UNDER THE SOUTHEAST CORNER. THIS HAS BEEN VERIFIED BY EXAMINATION OF THE EXIST. FLOOR SYSTEM. THE EXACT PLAN OF THE REAR PORCH, AT THE PRESENT TIME, IS UNKNOWN.

THE BLUNTS ACQUIRED THE PROPERTY IN 1916 AND AFTER MOVING IN, ADDED A LEAN-TO ADDITION WHICH CONTAINED A KITCHEN, BATH, AND A SMALL PORCH ON THE NORTHEAST CORNER. THE EXACT DIMENSIONS OF THIS ADDITION WERE LOST WHEN THE HOUSE WAS MOVED IN 1967.

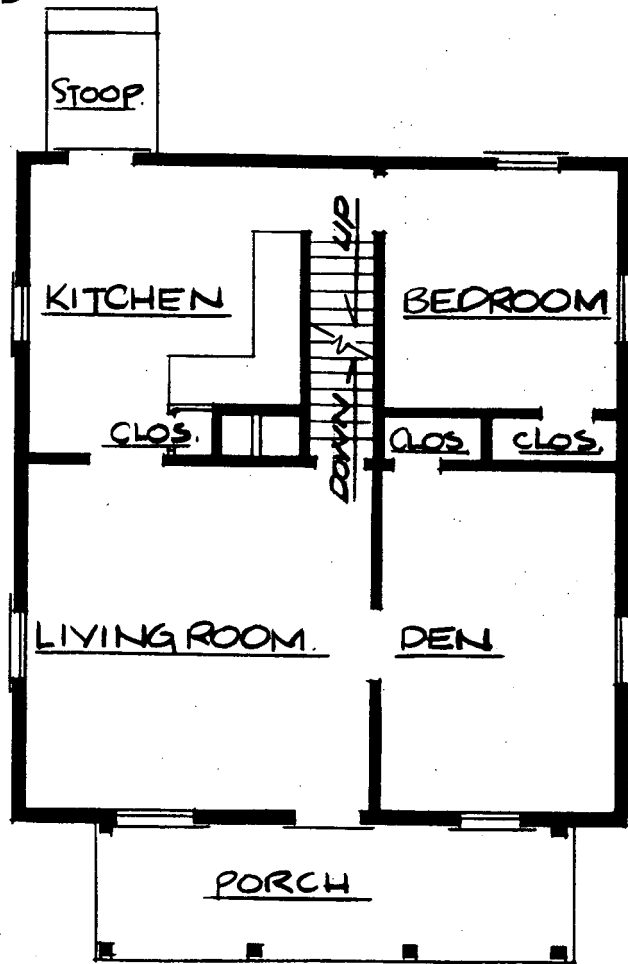
FIRST FLOOR PLAN

THE HANNAH VARNEY HOUSE WAS ORIGINALLY LOCATED APPROXIMATELY WHERE THE ENTRANCE TO THE HERBERT HOOVER PRESIDENTIAL LIBRARY IS. THE HOUSE WAS MOVED IN 1967 BY THE NATIONAL PARK SERVICE AND SET ON A NEW FOUNDATION WITH A FULL BASEMENT. THE REAR, LEAN-TO WAS ELIMINATED AT THIS TIME AND A NEW WOOD STOOP BUILT FOR THE REAR DOOR. THE INSIDE OF THE HOUSE WAS UPDATED TO SERVE AS OFFICES. THE HOUSE HAS SUBSEQUENTLY BEEN ALTERED TO SERVE AS A RESIDENCE.

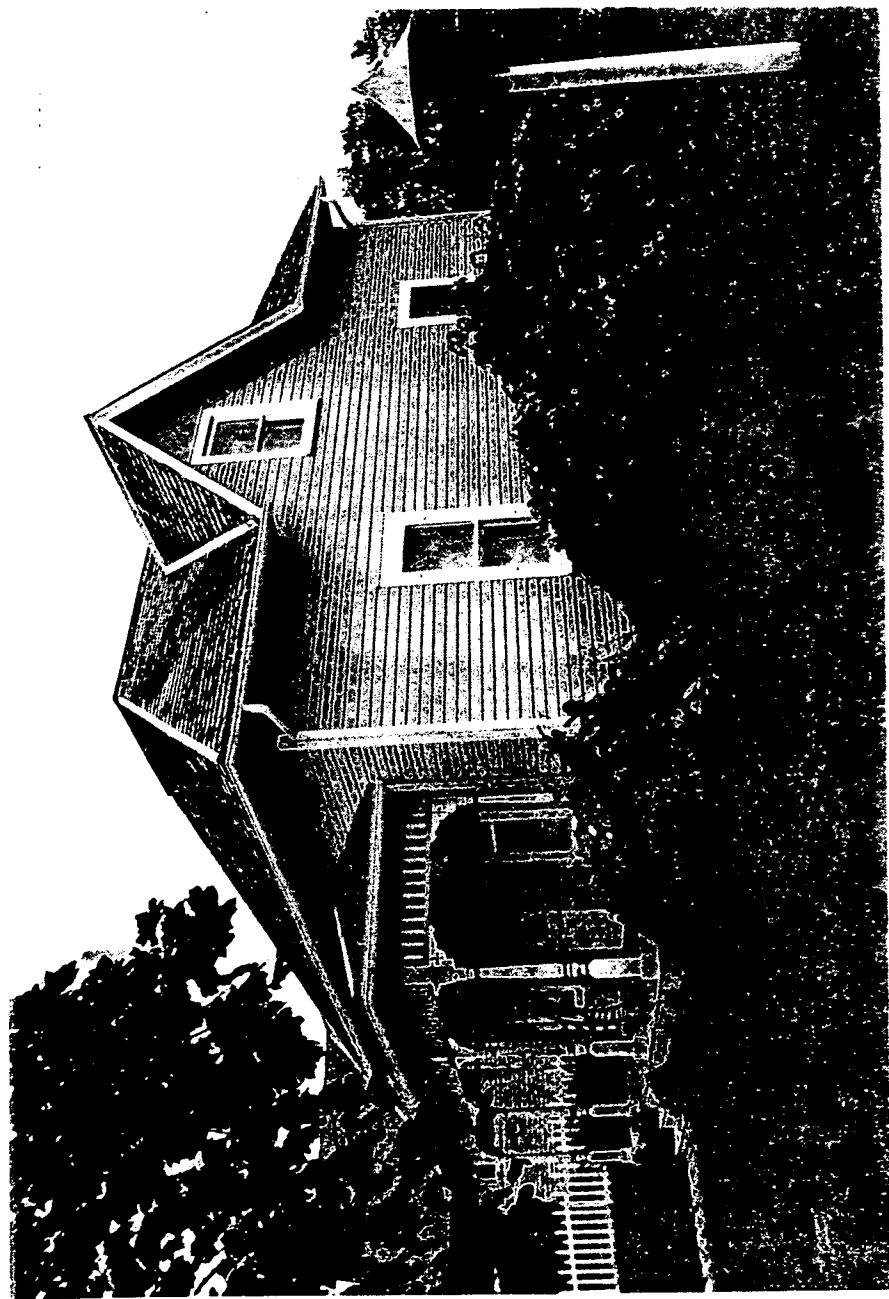
HS-4:1, HANNAH VARNEY HOUSE, 1977. Existing view looking northeast. The original negative is at the Denver Service Center, National Park Service.

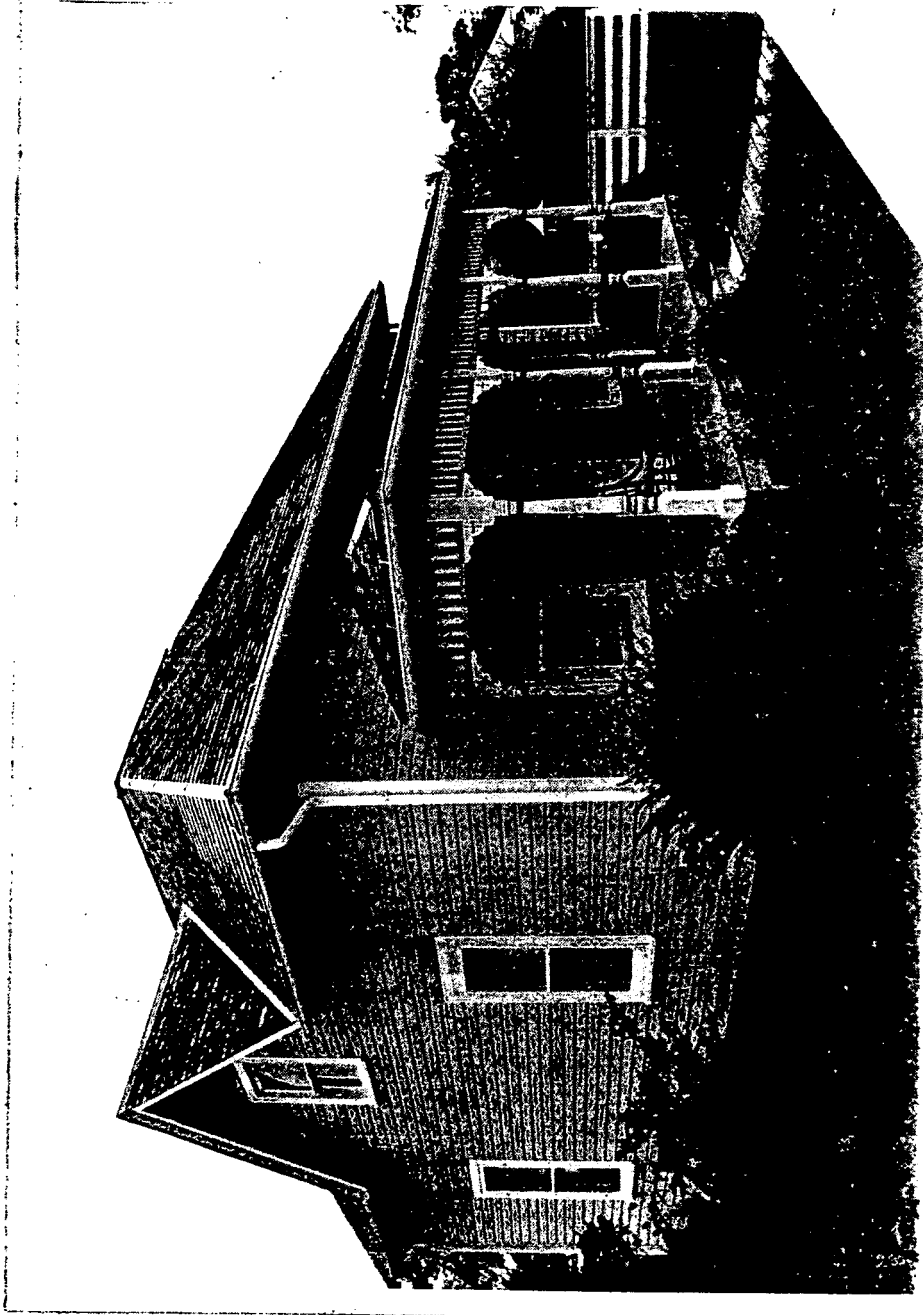
HS-4:2, HANNAH VARNEY HOUSE, 1977. Existing view looking southeast. The original negative is at the Denver Service Center, National Park Service.

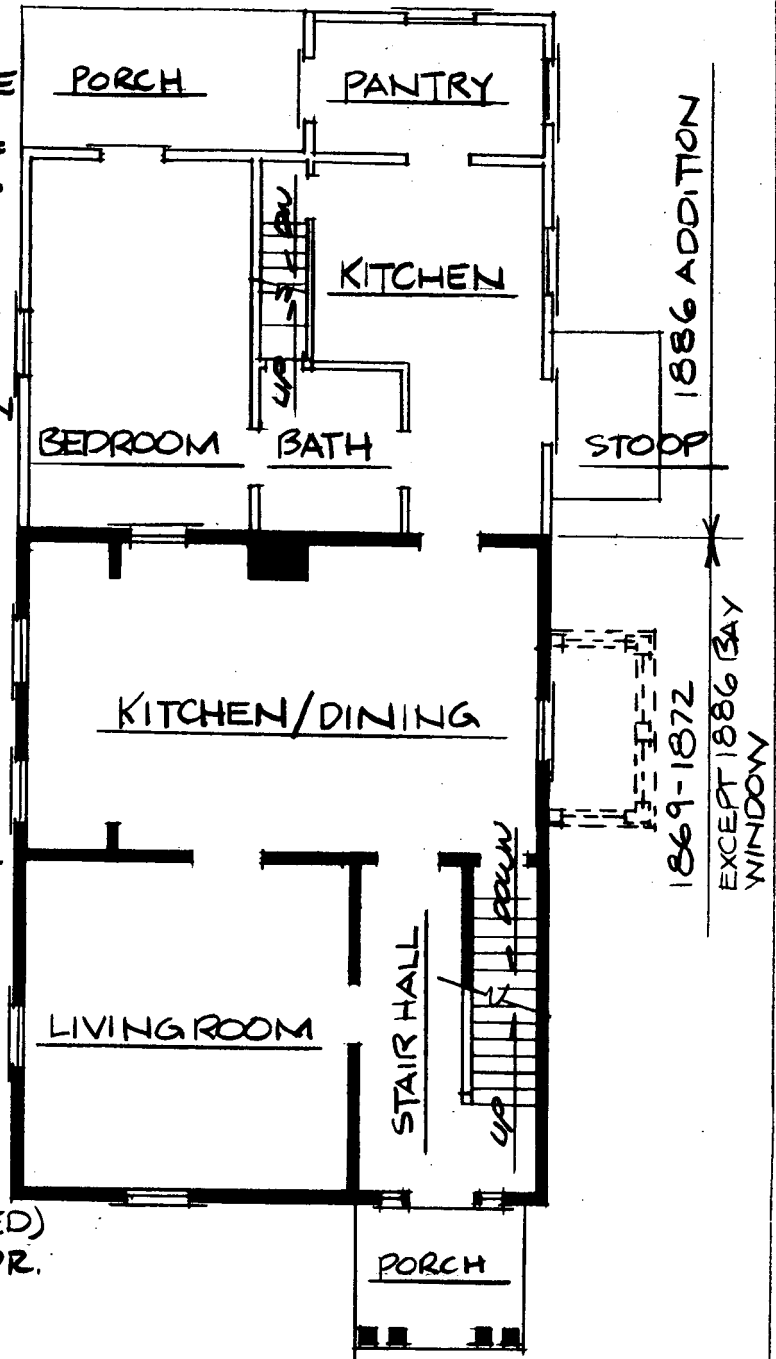
FIRST FLOOR PLAN

THE ORIGINAL PARTITIONS WERE LOCATED BY FIELD EXAMINATION.

THE BAY WINDOW (SHOWN DASHED) WAS PROBABLY ADDED BY DR. LEECH IN 1886.

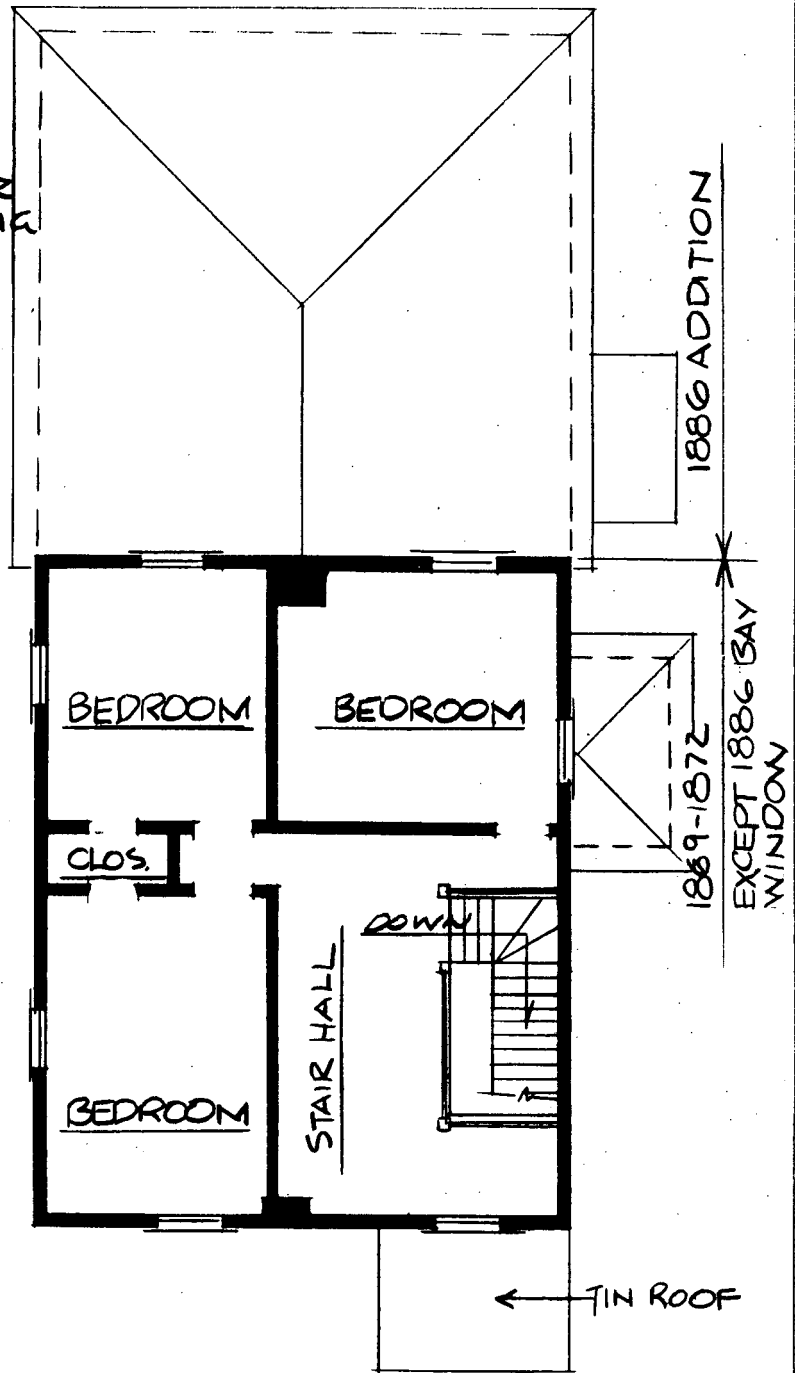
SECOND FLOOR PLAN

THE LOCATION OF THE SECOND FLOOR PARTITIONS & DOORS WAS DERIVED FROM EXTENSIVE FIELD EXAMINATION. THE STAIR OPENING THRU THE FLOOR IS EVIDENT IN THE FLRNG. THE STAIR & THE DESIGN OF THE RAIL AROUND IT IS CONJECTURE.

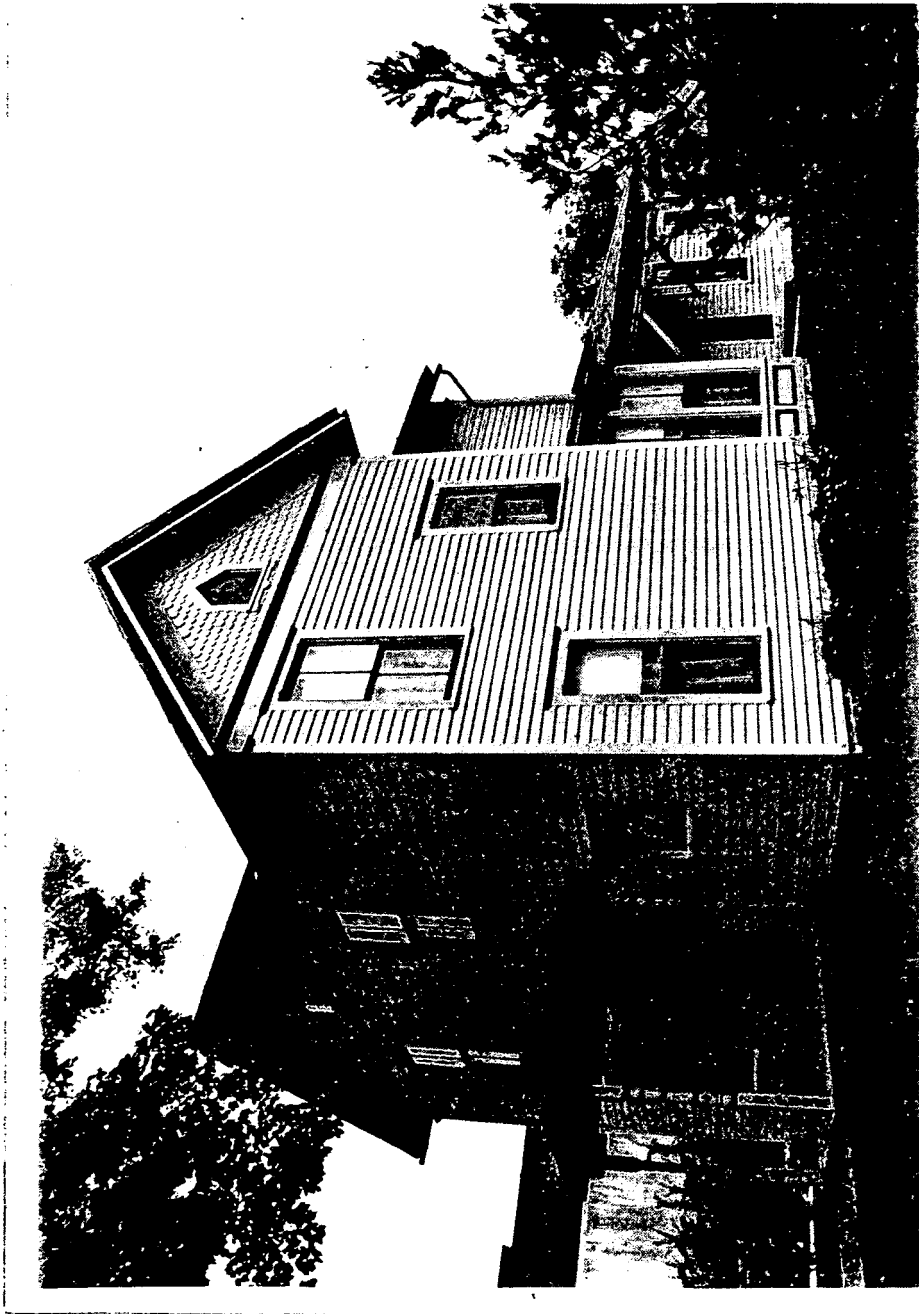
The structure is currently unoccupied and, except for the stabilized/reconstructed foundation walls, is in deteriorated condition. Plan HS-6:P3 (volume 2, appendix F) and photographs HS-6:1 and 2 show existing conditions after the 1974 National Park Service stabilization work.

HS-6:2, LABAN MILES HOUSE, 1977. Existing view looking southwest. The original negative is at te Denver Service Center, National Park Service.

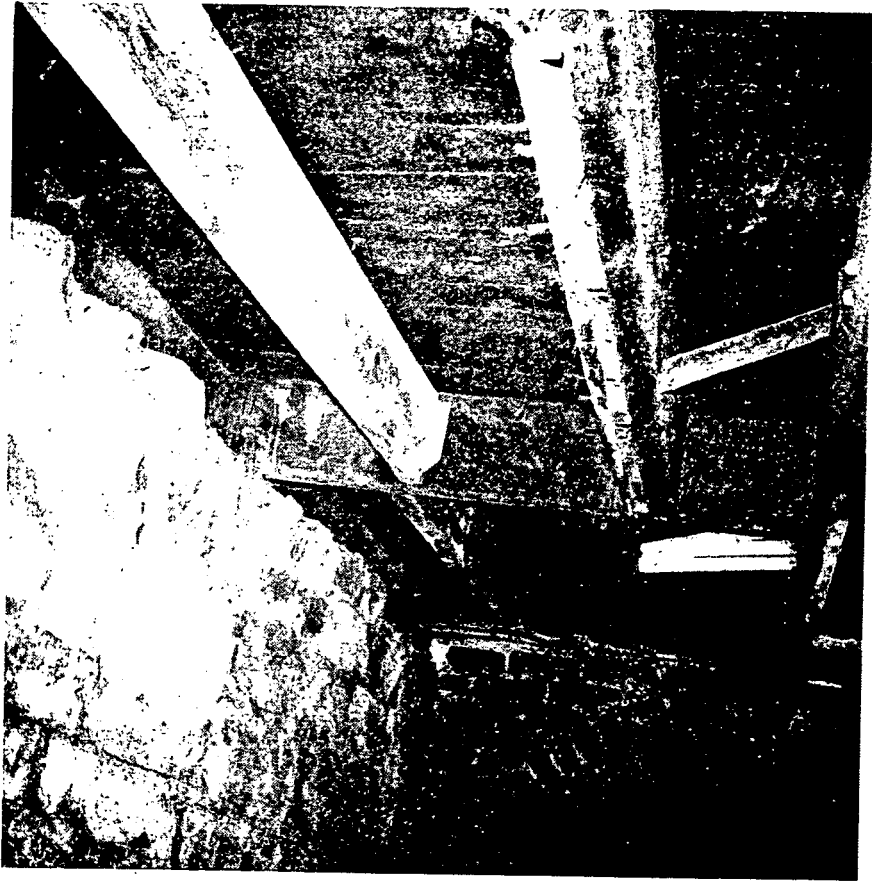
The location of the original stair to the basement (pre-1901) is evident in the first-floor framing at the southwest corner of the basement (see photograph HS-6:8). Photograph HS-6:9 shows the original (pre-1901) location of the stair in the basement. Note the brick arch on top of the original stone foundation, which was built to support the earth above.

HS-6:9, LABAN MILES HOUSE, 1978. This photograph shows the "tunnel" at the southwest corner of the house where the original basement stair was located before the house was moved east. The brick arch was built to carry the earth above. The original photograph and negative are at Wagner. Marquart. Wetherell. Ericsson. Architects, Des Moines, Iowa.

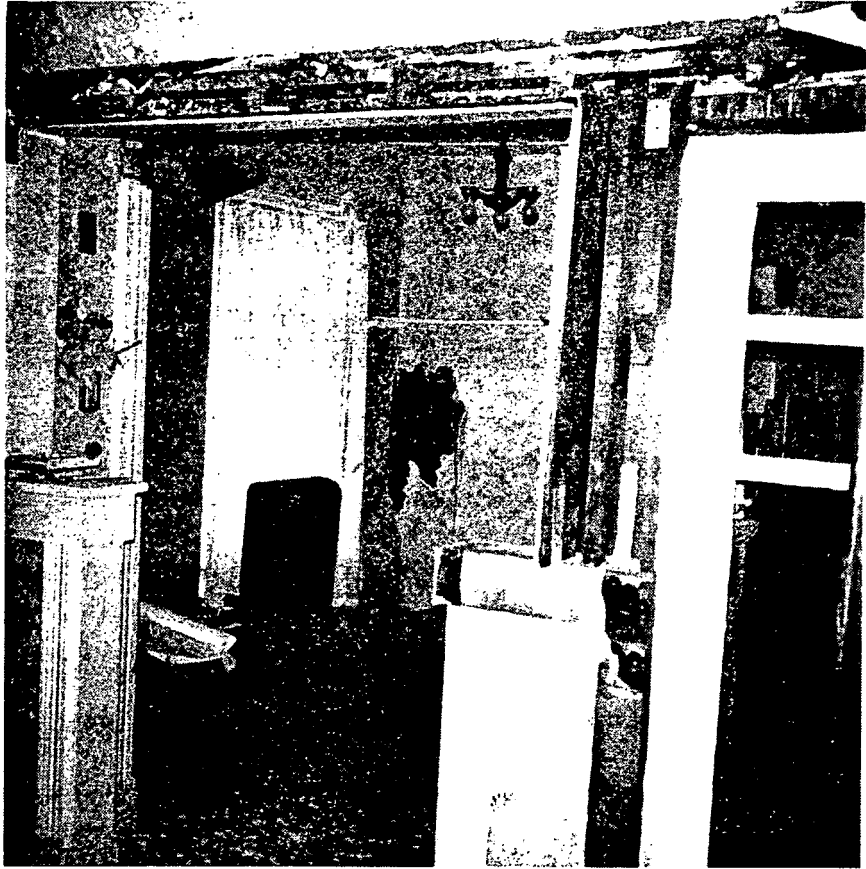
HS-6:10, LABAN MILES HOUSE, 1978. View, looking northeast on the first floor, shows the general condition of the house. Note where the trim stops on the jamb at the left of the photograph. This locates the height of the original opening in the dining room nook. The original photograph and negative are at Wagner. Marquart. Wetherell. Ericsson. Architects, Des Moines, Iowa.

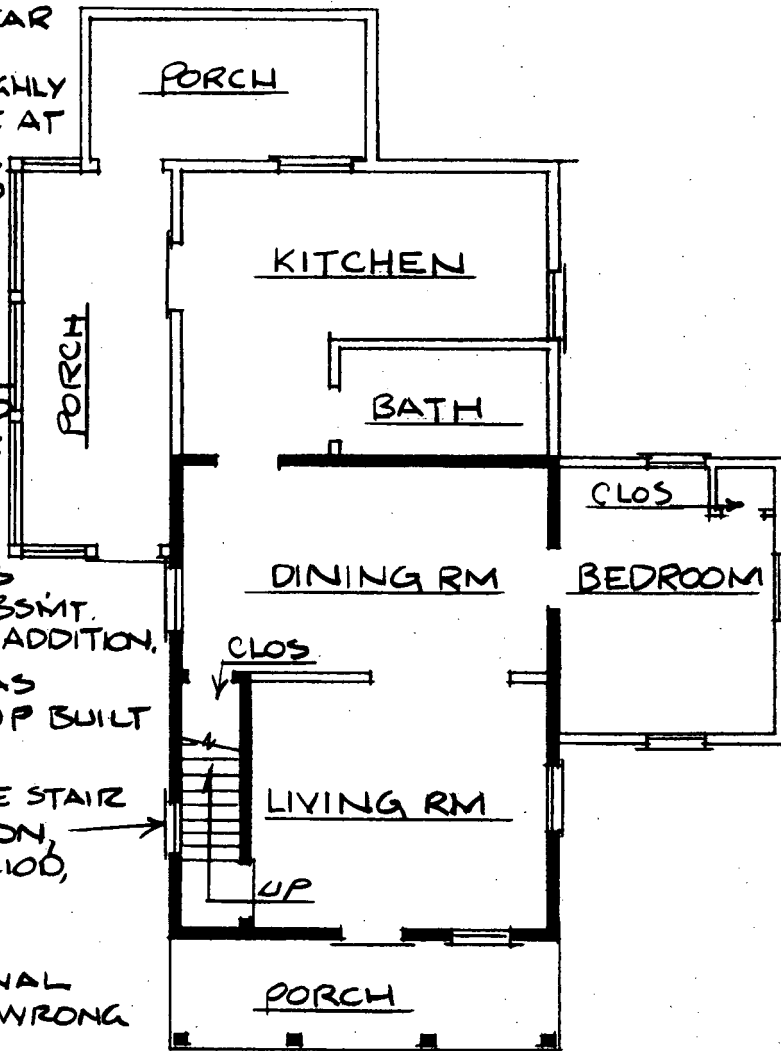
FIRST FLOOR PLAN

IN 1976-77 THE NATIONAL PARK SERVICE INSTIGATED SOME REPAIRS UNDER THE EMERGENCY STABILIZATION PROGRAM WHICH INCLUDED:

- 1) THE WEST PORCH WAS DEMOLISHED & A NEW BSMT. BUILT UNDER THE WEST ADDITION.
- 2) THE SOUTH PORCH WAS DEMOLISHED & A STOOP BUILT IN ITS PLACE.
- 3) TWO WINDOWS, BY THE STAIR ON THE SOUTH ELEVATION, WHICH WERE LATE PERIOD, WERE CLOSED IN.
- 4) A NEW CHIMNEY WAS CONSTRUCTED IN ORIGINAL LOCATION (ALTHOUGH WRONG SIZE)

THE HOUSE AFTER STABILIZATION IS THE SAME AS THE 1898 PLAN W/ THE EXCEPTION OF THE REAR STOOP.

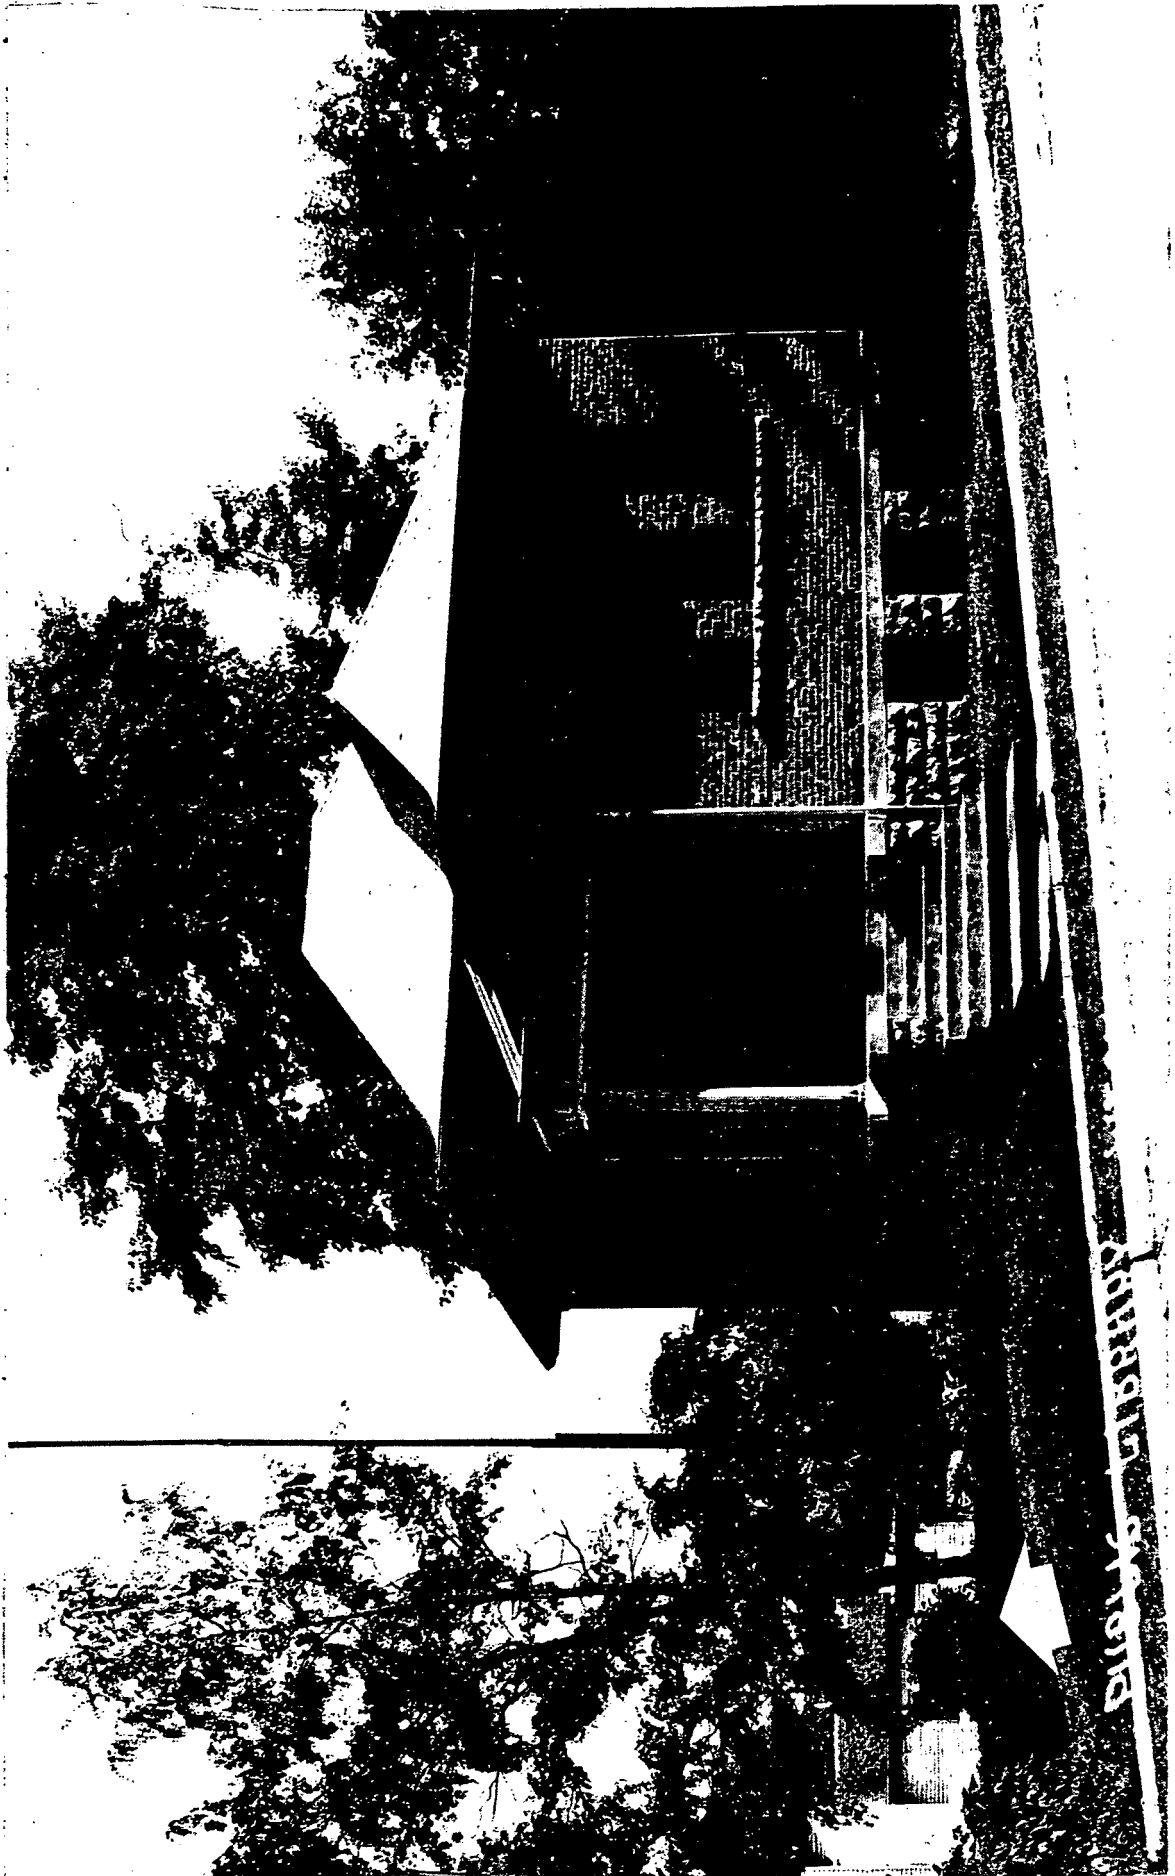
HS-9:10, JAMES STAPLES HOUSE, ca. 1920. View looking south at the public library. This is a portion of the original photograph which shows that the rear portion of the Staples house has remained unchanged for the last 48 years. Also visible is the chimney, which does not center on the ridge; the ridge appears to be metal. The original photograph is with G. Speight, West Branch, Iowa. A copy of the negative is at the Hoover Presidential Library, West Branch, Iowa.

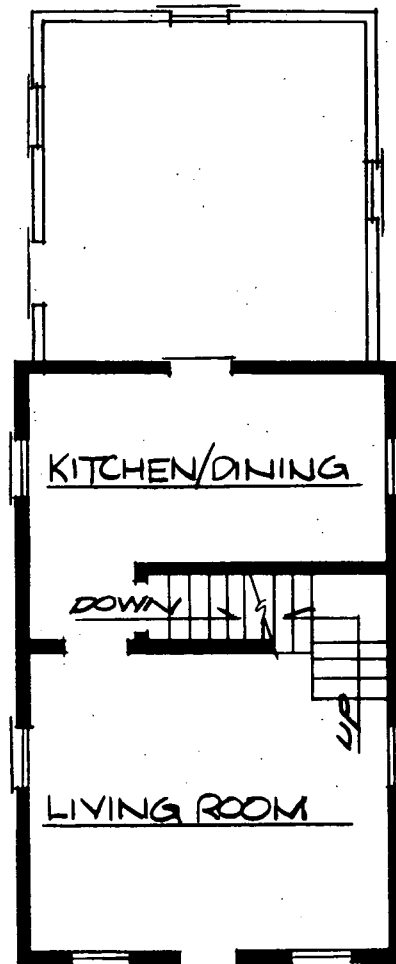
FIRST FLOOR PLAN

IT IS FELT THAT THE WEST WING, SHOWN HERE, IS NOT ORIGINAL, SINCE FIELD EXAMINATION OF THE JAMES STAPLES HOUSE, WHICH WAS BUILT ABOUT THE SAME TIME AND BY POSSIBLY THE SAME CARPENTER, INDICATED THAT THE WEST KITCHEN WING WAS NOT ORIGINAL. THE 1872 ATLAS OF CEDAR COUNTY TENDS TO VERIFY THIS, AS IT INDICATES A HOUSE OF ABOUT THE SIZE OF THE TWO-STORY PORTION.

THERE IS SOME DOUBT AS TO WHETHER THE STAIRS SHOWN HERE ARE IN THE CORRECT LOCATION. IN ALL OF THE OTHER HOUSES IN THE PARK, OF THE SAME VINTAGE & OF COMPARABLE SIZE, THE STAIR IS LOCATED TO THE SIDE OF THE HOUSE, ALLOWING THE CHIMNEY IN THE MIDDLE TO SERVE BOTH ROOMS.

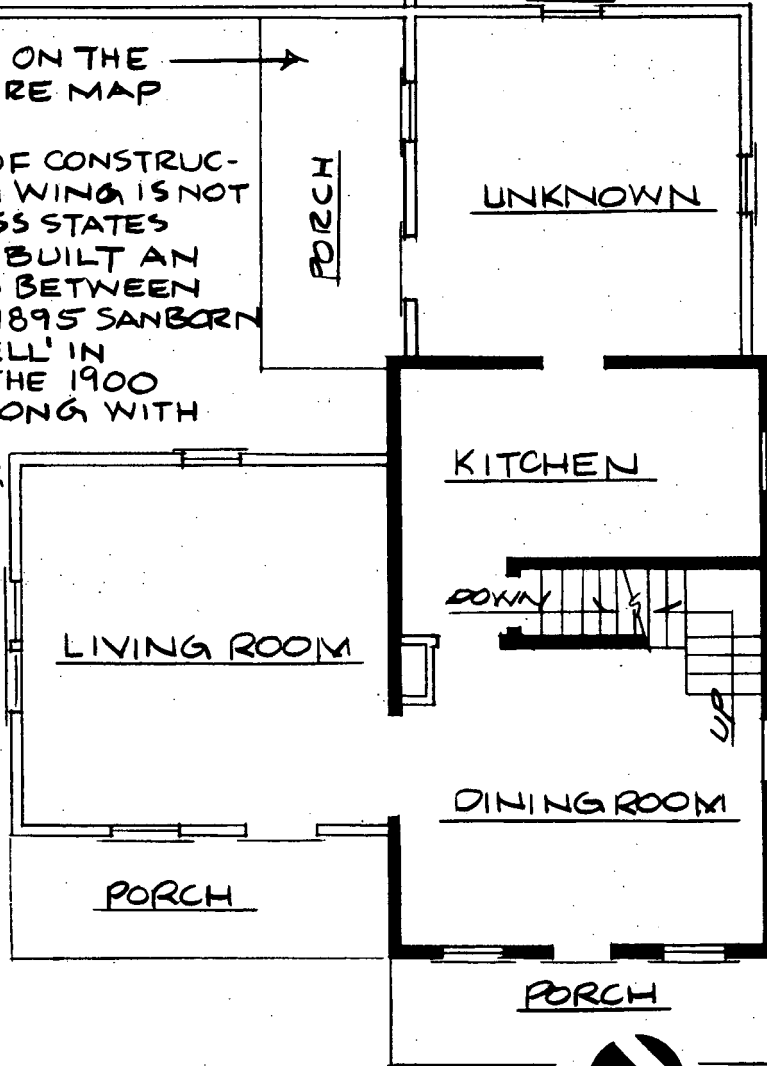
FIRST FLOOR PLAN

THE 1895 & 1900 SANBORN FIRE MAPS SHOW A 22 FT x 10 FT. ADDITION TOUCHING AT THE SOUTHWEST CORNER OF THE HOUSE ALTHOUGH ITS PURPOSE IS UNKNOWN.

THIS PORCH SHOWS ON THE 1895 SANBORN FIRE MAP

THE EXACT DATE OF CONSTRUCTION OF THE SOUTH WING IS NOT KNOWN. ED BEARSS STATES THAT VAN BUTLER BUILT AN 'ELL' AND PORCHES BETWEEN 1903 & 1909. THE 1895 SANBORN MAP SHOWS THE 'ELL' IN EXISTENCE AND THE 1900 SANBORN MAP ALONG WITH A PHOTOGRAPH OF VAN BUTLER'S GAR FRIENDS, DATED 1912, SHOW THE PORCHES.

THE 1895 & 1900 SANBORN MAPS ALSO NOTE THAT ALL ROOFS ARE WOOD SHINGLE.

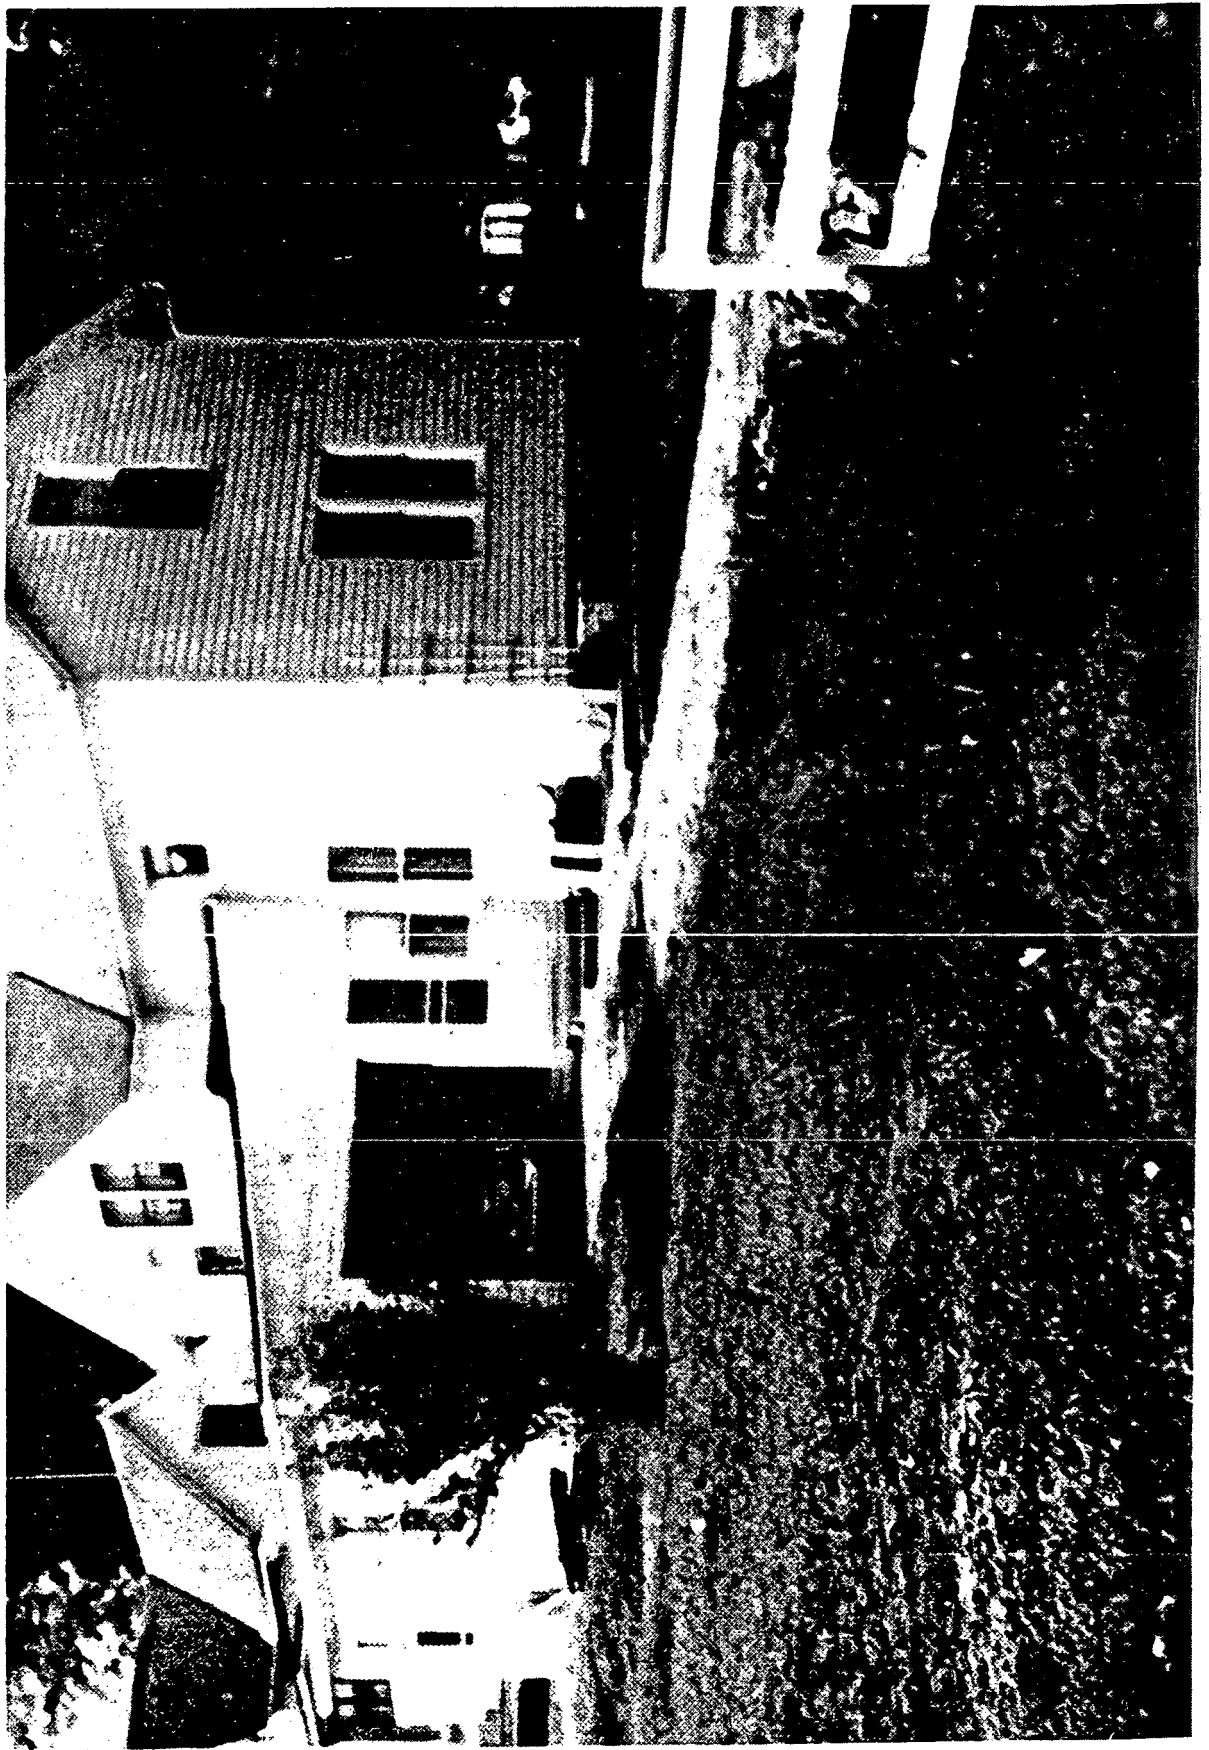
Historic photograph HS-10:8, ca. 1950 looking northeast, shows that the windows in the south ell have not yet been altered. A comparison of this photograph with aerial photograph 3 shows that the second-floor west windows of the original north wing have been altered.

HS-10:8, E.S. HAYHURST HOUSE, ca. 1950. View looking northeast. The windows shown on the south and west elevations of the south two-story wing appear to be original. The windows in the west elevation gable of the original wing appear to be altered (see aerial photograph 3). A copy of the photograph is at Herbert Hoover National Historic Site, West Branch, Iowa (reference N. 9-18).

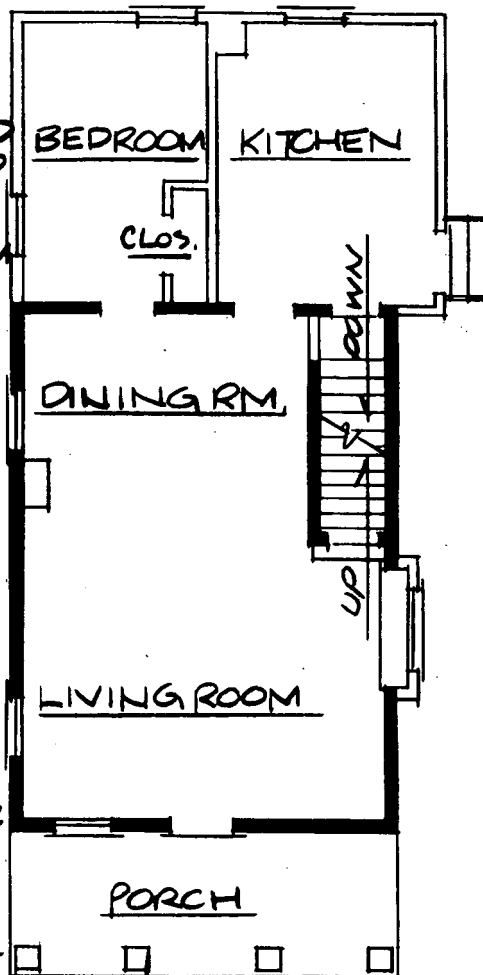
FIRST FLOOR PLAN

THE SANBORN FIREMAPS FOR 1895 THRU 1912 SHOW A NARROW FRONT PORCH AND THE REAR ADDITION TO BE ABOUT 16FT X 12FT. SOMETIME AFTER 1909, POSSIBLY 1914, A.C. HUNTER CHANGED THE FRONT PORCH FROM WOOD TO CONCRETE BLOCK. HUNTER REBUILT THE PORCH AGAIN IN 1920 USING THE SAME MATERIAL.

THE SANBORN MAP OF 1927 SHOWS THE EAST ADDITION AS BEING 18FT. N. & S., INSTEAD OF 16FT. IT'S POSSIBLE THAT 1914 WAS THE DATE THAT THE EAST ADDITION WAS ENLARGED.

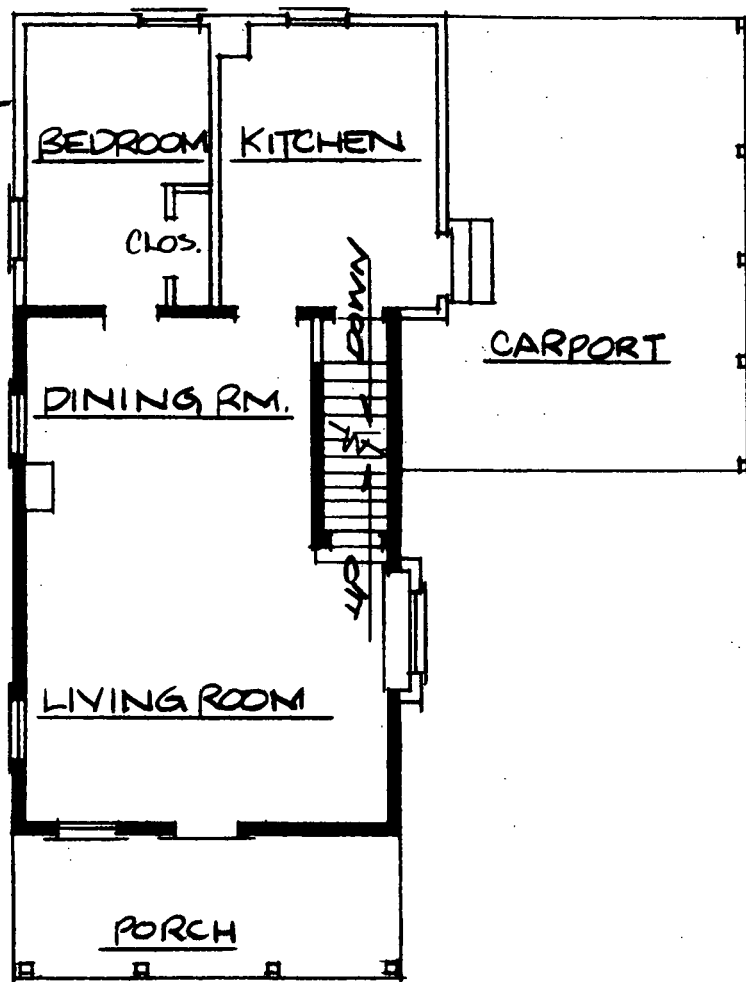
FIRST FLOOR PLAN

THE CARPORT ROOF &  
POSTS WERE REMOVED  
IN 1977 BY THE NATIONAL  
PARK SERVICE.
