**HERBERT HOOVER**  
11 CORE AREA BUILDINGS

NATIONAL HISTORIC SITE / IOWA

HISTORIC STRUCTURE REPORT  
ELEVEN CORE AREA BUILDINGS  
HERBERT HOOVER NATIONAL HISTORIC SITE  
WEST BRANCH, CEDAR COUNTY, IOWA

Volume 1: Administrative and Architectural Data

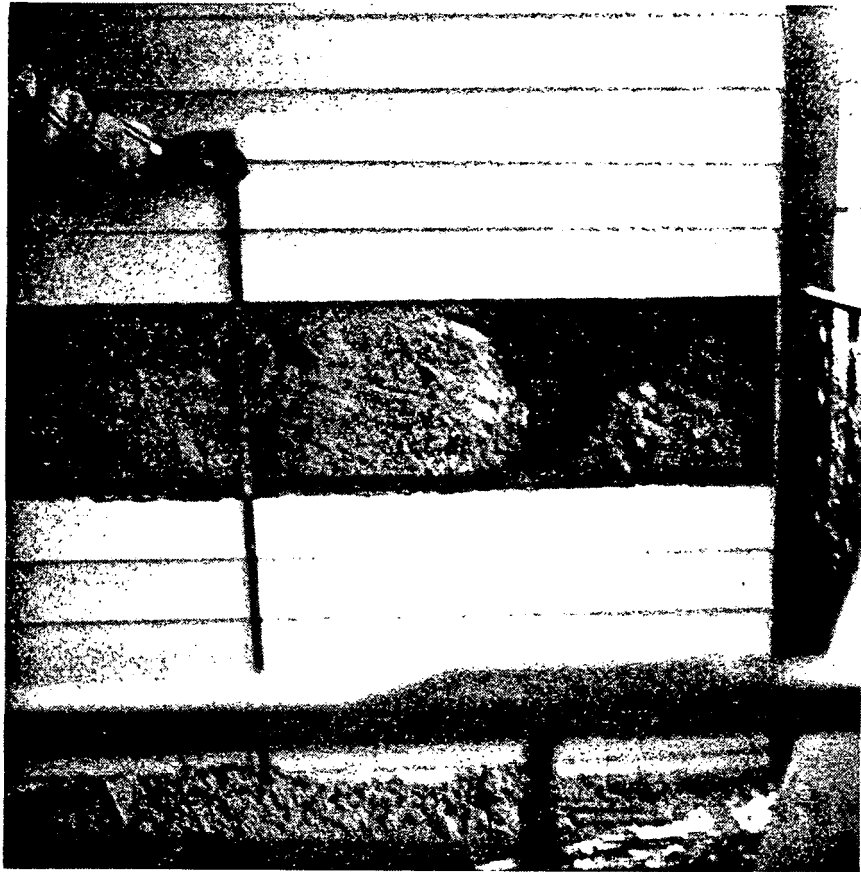
HS-18:4, DAVID MACKEY HOUSE, 1978. View looking east; the west elevation of the house shows a portion of the framing for the original west window. Note that there is no sheathing on this house. The original photograph and negative are at Wagner. Marquart. Wetherell. Ericsson. Architects, Des Moines, Iowa.

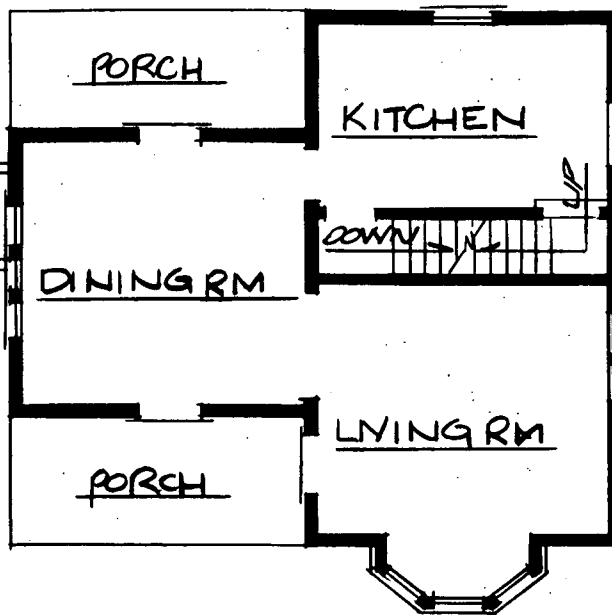
FIRST FLOOR PLAN

IN 1891 THE WRIGHTS MADE IMPROVEMENTS TO THEIR PROPERTY AND IN 1894 SPENT 500<sup>00</sup> MORE ON IMPROVEMENTS. ITS POSSIBLE THAT PART OF THIS WAS USED FOR ENLARGING THE REAR PORCH.

THE ORIGINAL BAY WAS OCTAGONAL SHAPED, AS SHOWN ON 1895 SANBORN MAP. BY THE TIME OF THE 1900 SANBORN THE BAY HAD CHANGED TO HEXAGONAL SHAPE. THE WRIGHTS HAD A FIRE IN 1901 WHICH NECESSITATED REBUILDING SOME OF THE BAY.

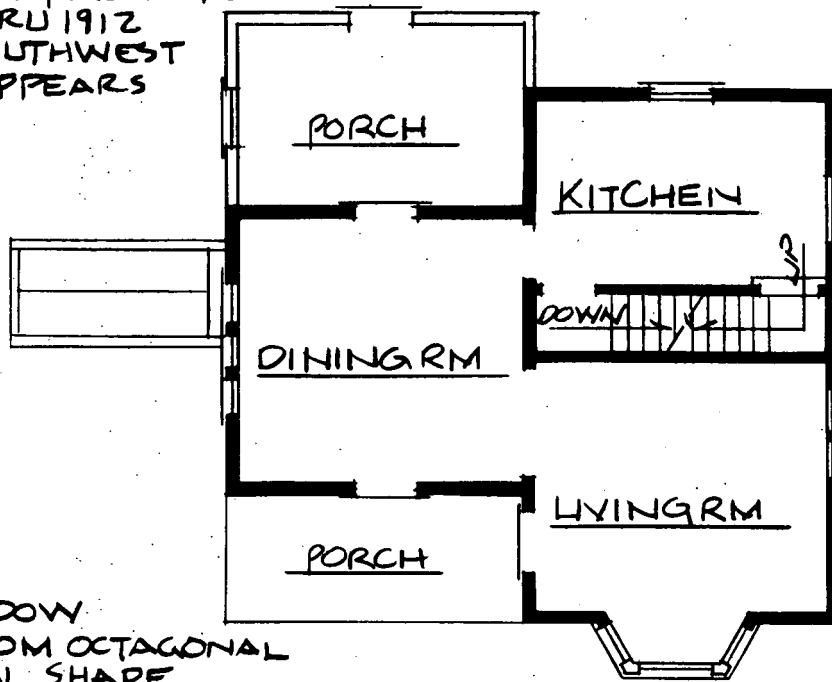
FIRST FLOOR PLAN

THE SANBORN FIRE MAPS  
FOR 1895 THRU 1912  
SHOW THE SOUTHWEST  
PORCH AS APPEARS  
HERE.

THE BAY WINDOW  
CHANGED FROM OCTAGONAL  
TO HEXIGONAL SHAPE  
BETWEEN 1895 & 1900.

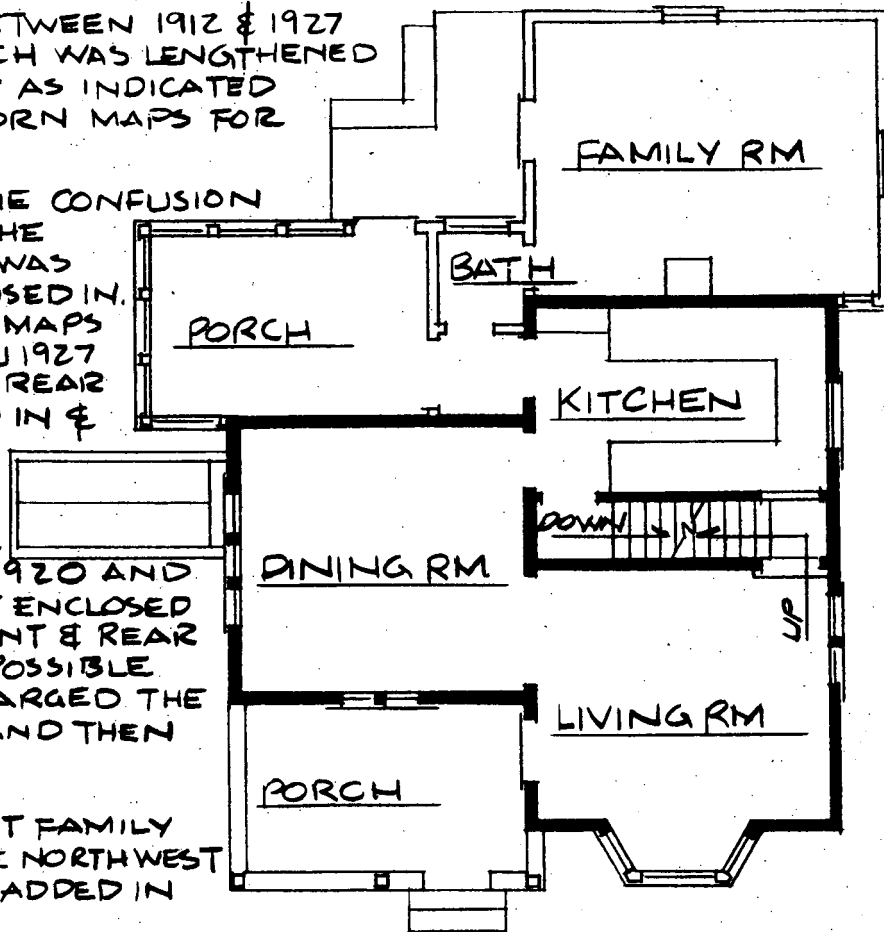
FIRST FLOOR PLAN

BERT PENNOG  
ACQUIRED THE  
PROPERTY IN 1920 AND  
SAID THAT HE ENCLOSED  
BOTH THE FRONT & REAR  
PORCHES. ITS POSSIBLE  
THAT HE ENLARGED THE  
REAR PORCH AND THEN  
ENCLOSED IT.

THE 15FT x 12FT FAMILY  
ROOM, ON THE NORTHWEST  
CORNER, WAS ADDED IN  
CIRCA 1951.
