INDEPENDENCE  
DESHLER-MORRIS HOUSE

NATIONAL HISTORICAL PARK / PENNSYLVANIA

HISTORIC STRUCTURE REPORT  
ARCHITECTURAL DATA SECTION

DESHLER-MORRIS HOUSE  
INDEPENDENCE NATIONAL HISTORICAL PARK  
GERMANTOWN, PENNSYLVANIA

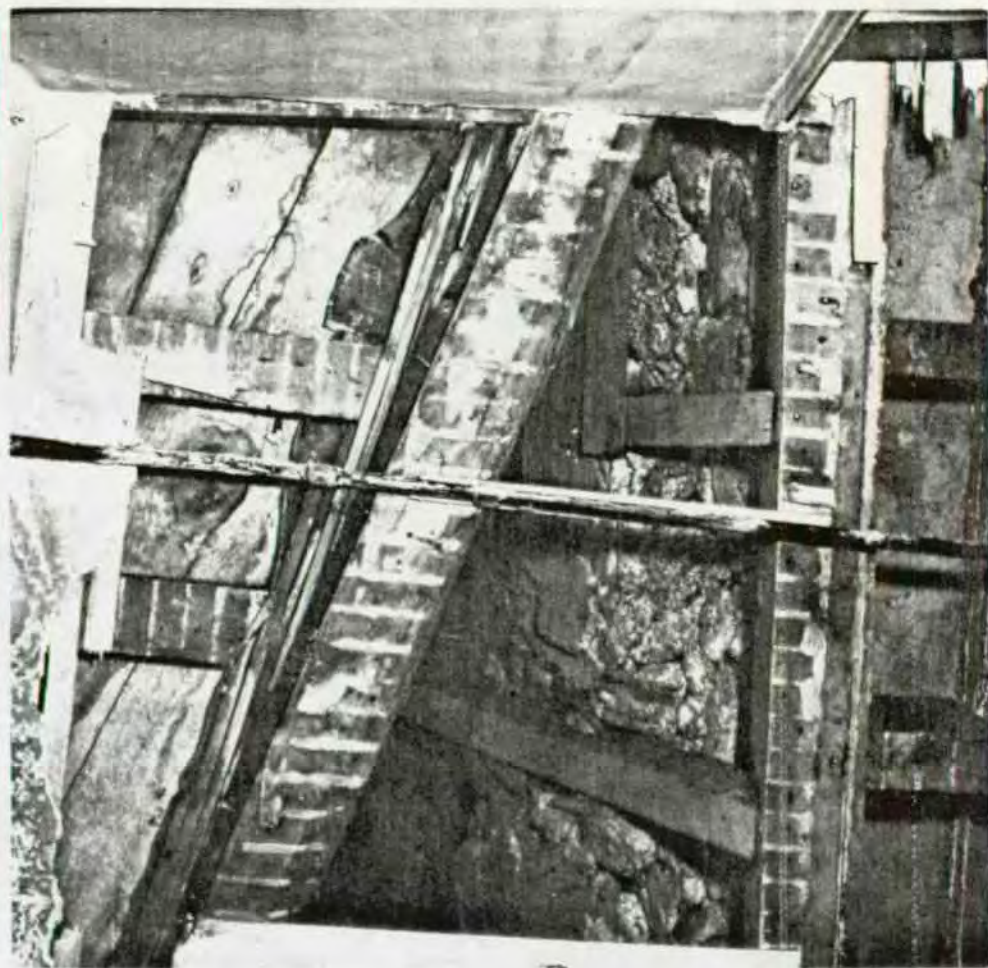
ILLUSTRATION 11 - PHOTOGRAPHED BY NPS.

1750s Section

Looking East, 19th century roof shingles on boards covered by verticle studs for 1909 window. Note 1772 ceiling rafters below 1750 roof rafter.

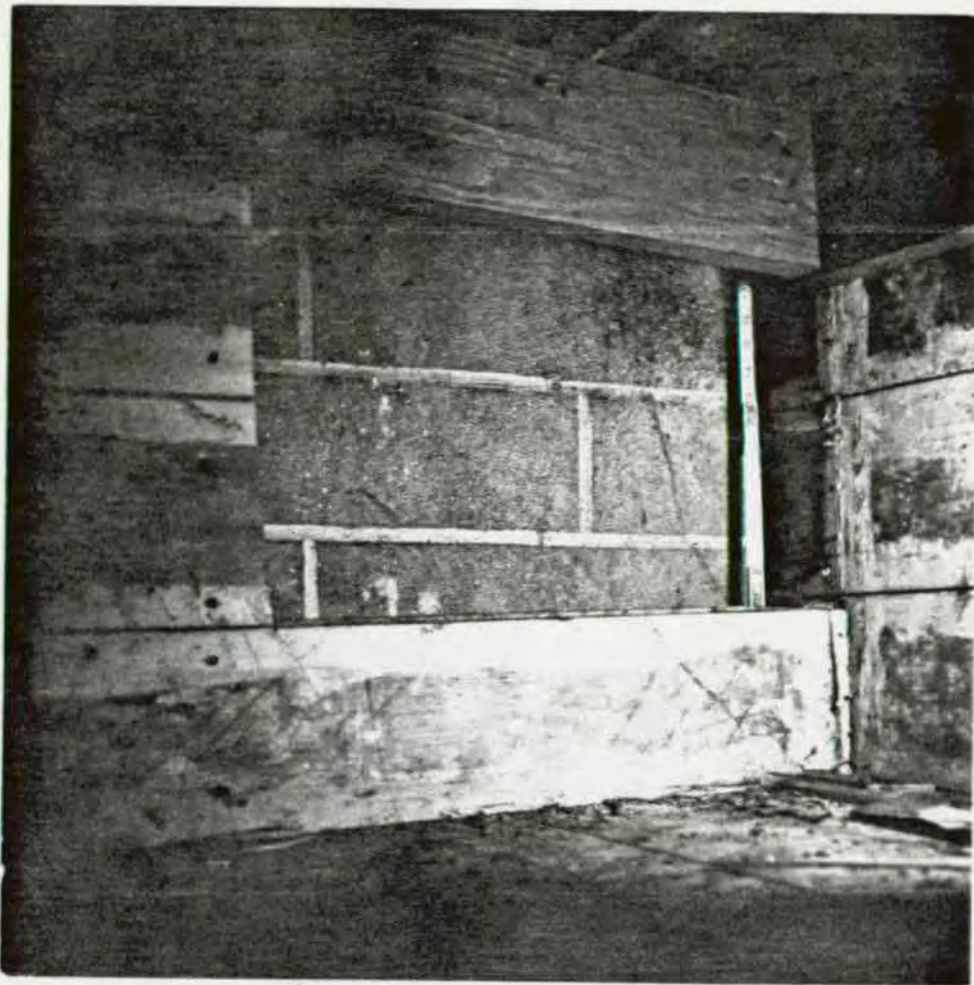
ILLUSTRATION 12 - PHOTOGRAPHED BY NPS.

1750s Section

Exterior west wall as seen from Room 307 (reservoir over 1850s section) looking east.  
Original 1750s stucco with scoring that was protected by 1850s construction.

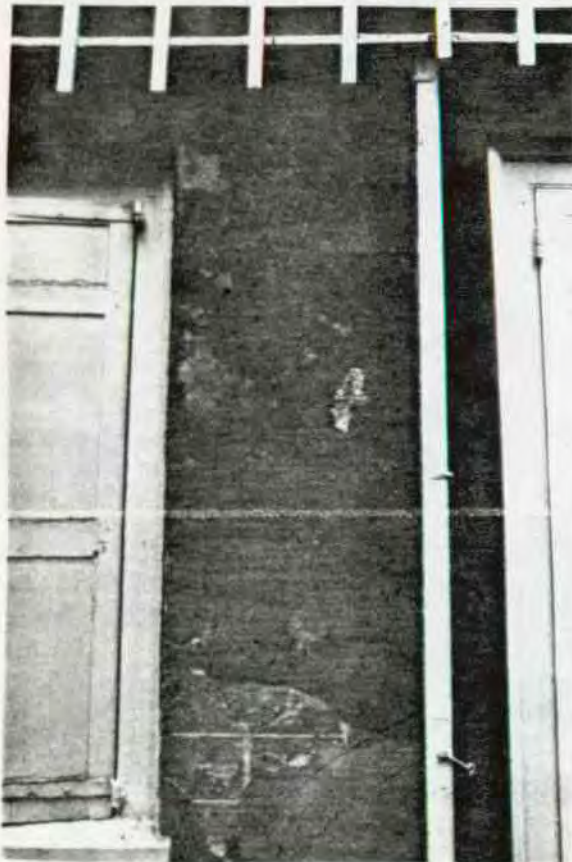
ILLUSTRATION 13 - PHOTOGRAPHED BY NPS.

1750s Section

Exterior South wall looking north.  
Note original stucco with coursing  
and various covering layers.

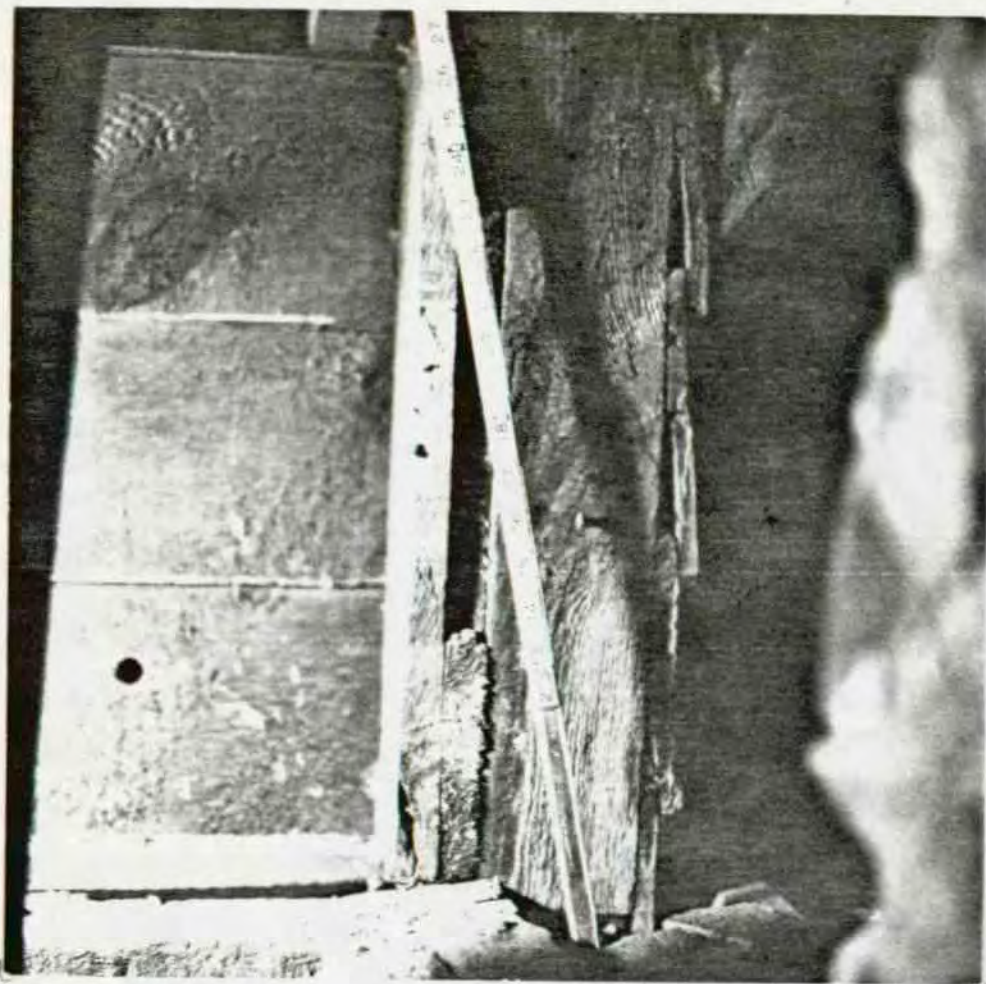
ILLUSTRATION 14 - PHOTOGRAPHED BY NPS  
1850s Section  
Original clapboards on west wall of 1850s section. Visible  
from attic space of 1909 addition, looking south.

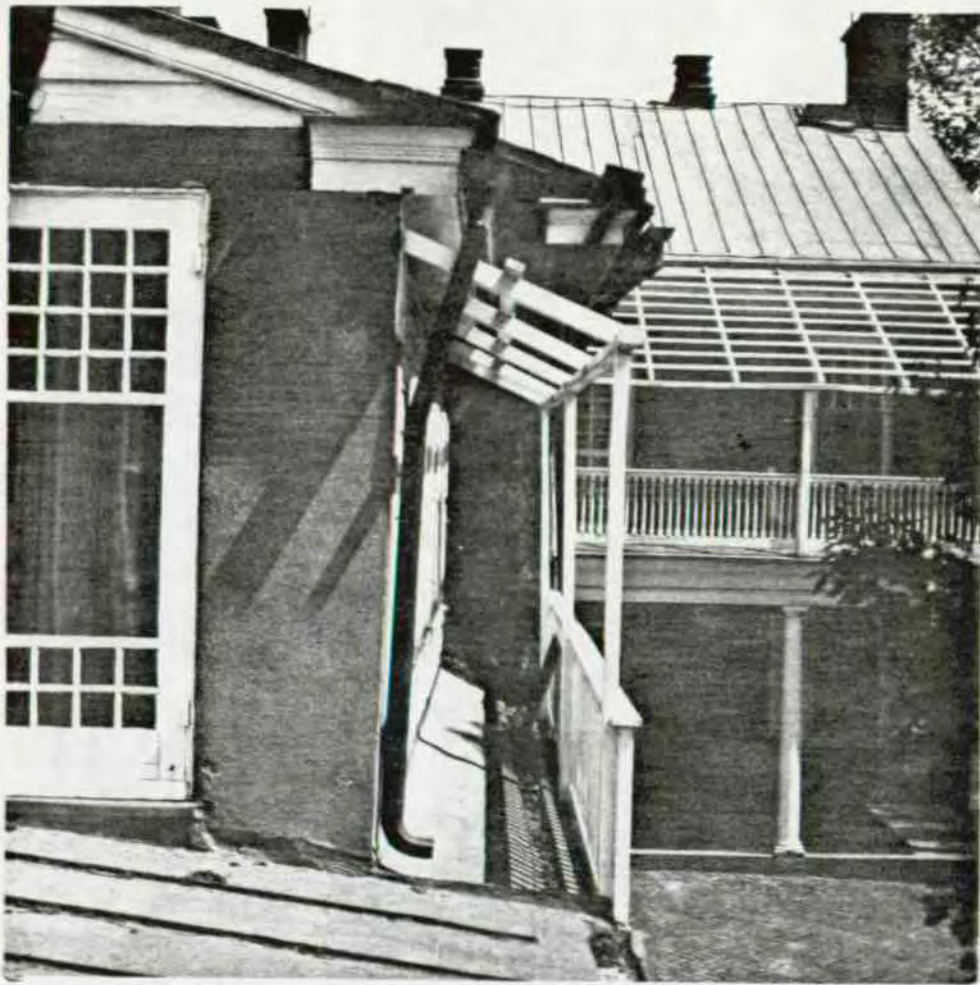
ILLUSTRATION 15 - PHOTOGRAPHED BY NPS.  
1850s Section  
Original roof cornice - imitation of 1750s roof cornice in  
background. Note clapboards above the second floor on the  
west elevation, looking east.

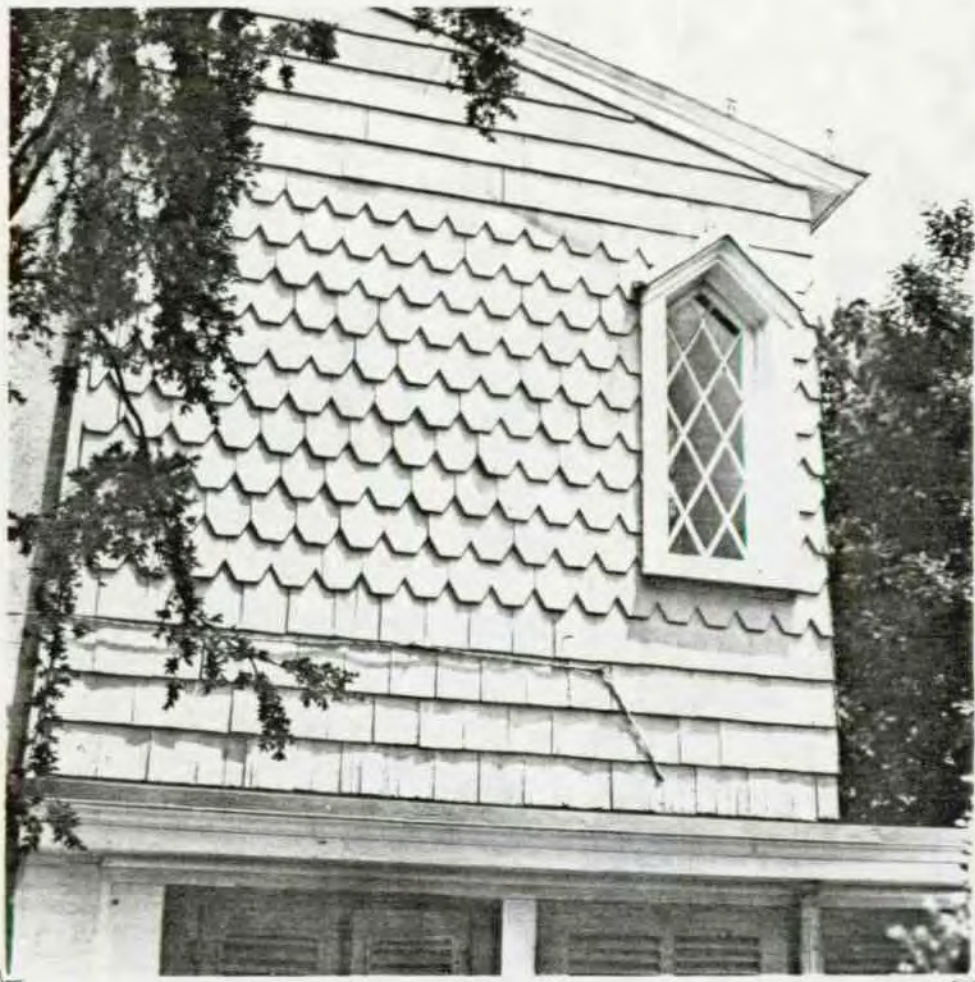
ILLUSTRATION 16 - PHOTOGRAPHED BY NPS.  
1880s Section  
West wall, looking east. Note the unusual shingle pattern  
on the second floor.

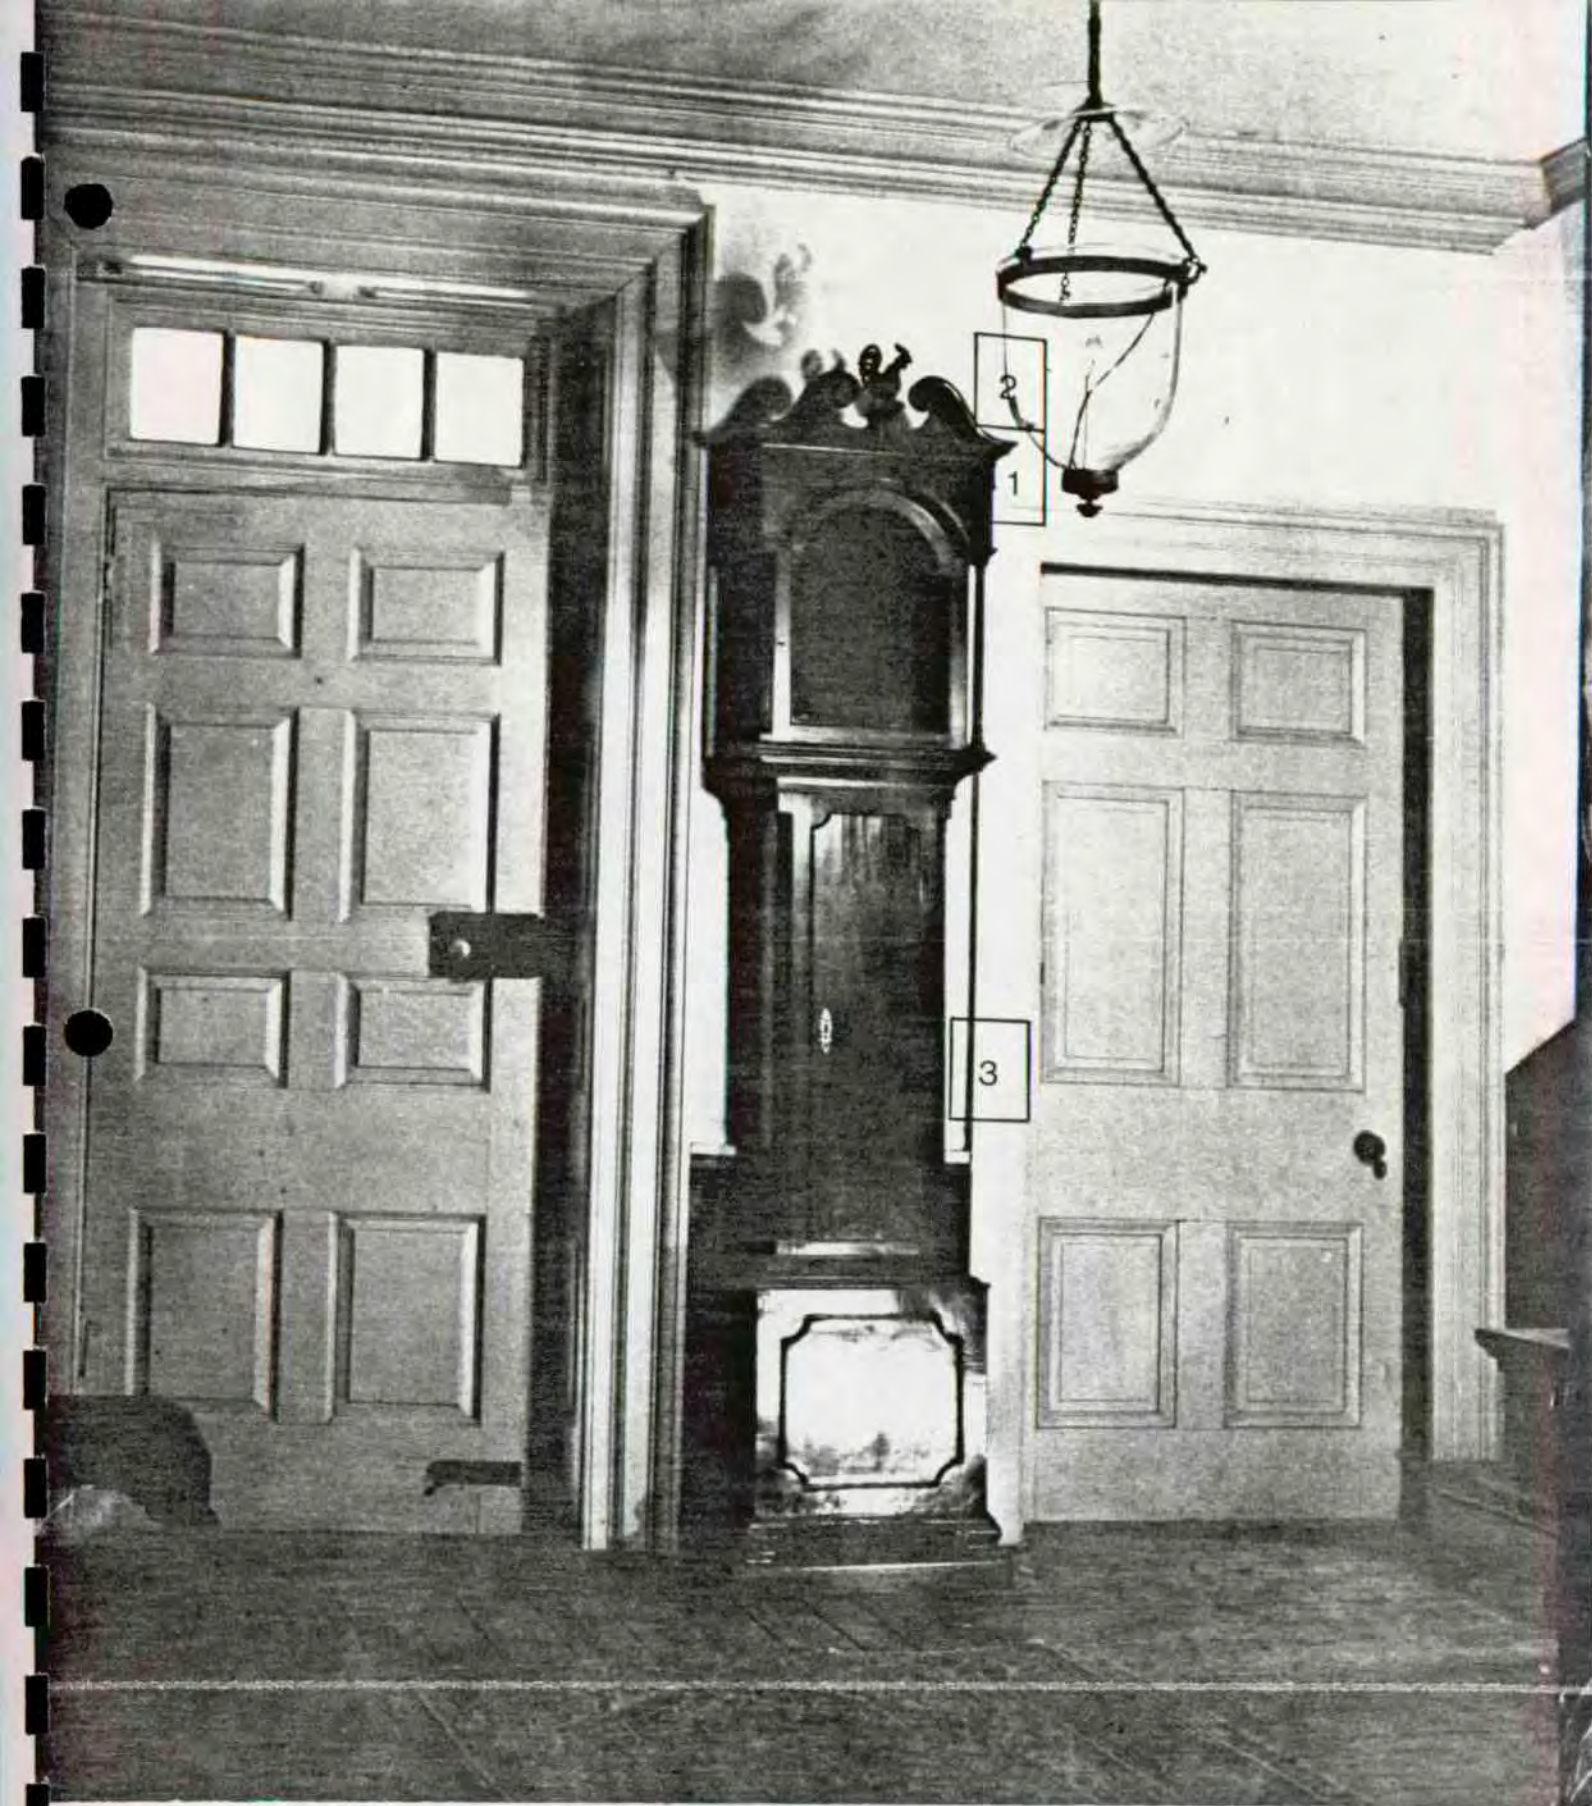
ILLUSTRATION 20 - PHOTOGRAPHED BY JAMES DILLON AND COMPANY.  
1750s Section

Doorway from Room 109 to Porch 108. Note hinge shadows on the right and left of this doorway framing. Note also cut transom at left. Looking south.

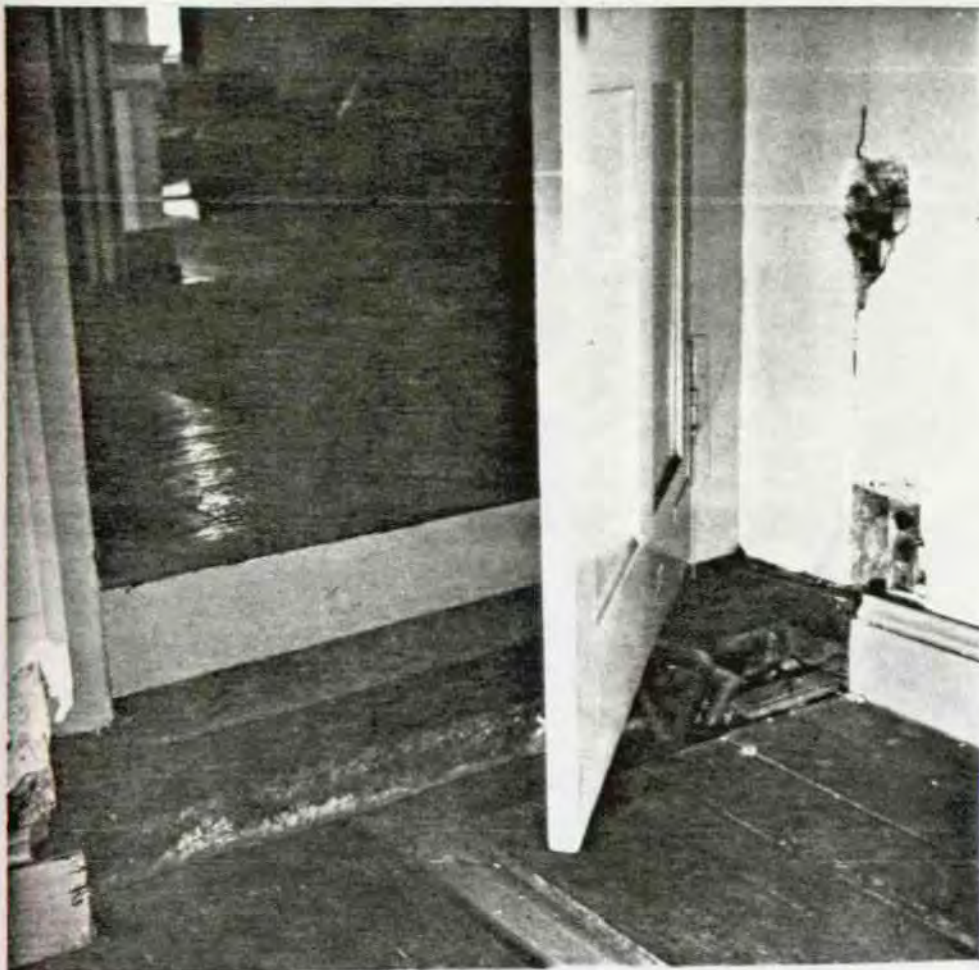
Doorway between Room 206 and 207, looking north. Original north jamb was buried (note hand-wrought nails) along with splayed stucco jamb (note white coring lines).

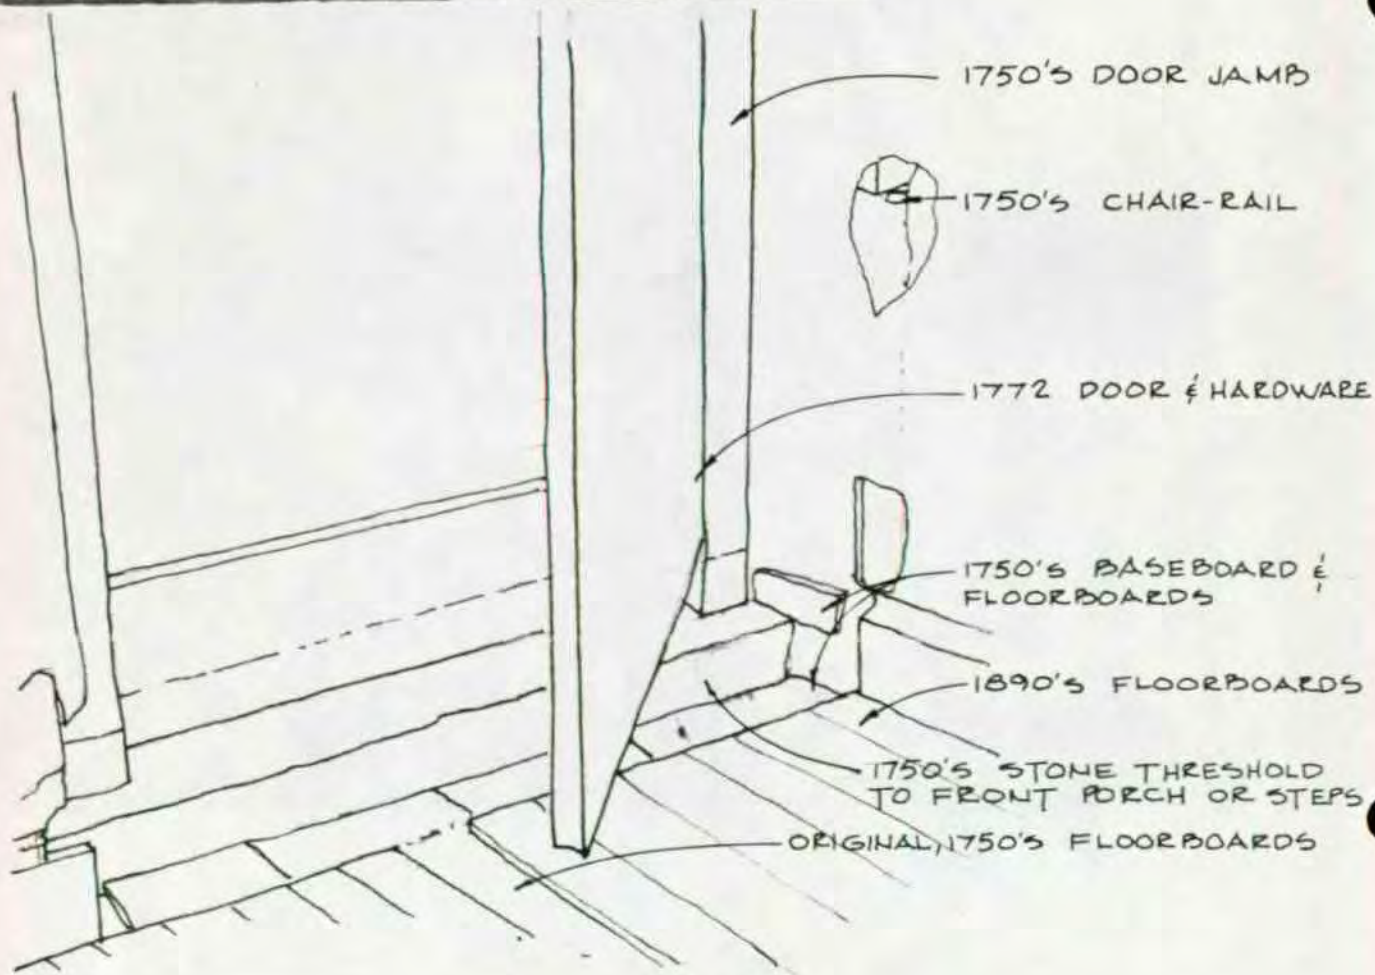
ILLUSTRATION 32  
 Photographed by NPS  
 1750s Section -  
 Room 207. Doorway  
 between Rooms 206 and  
 207 looking east.  
 Original stone threshold.

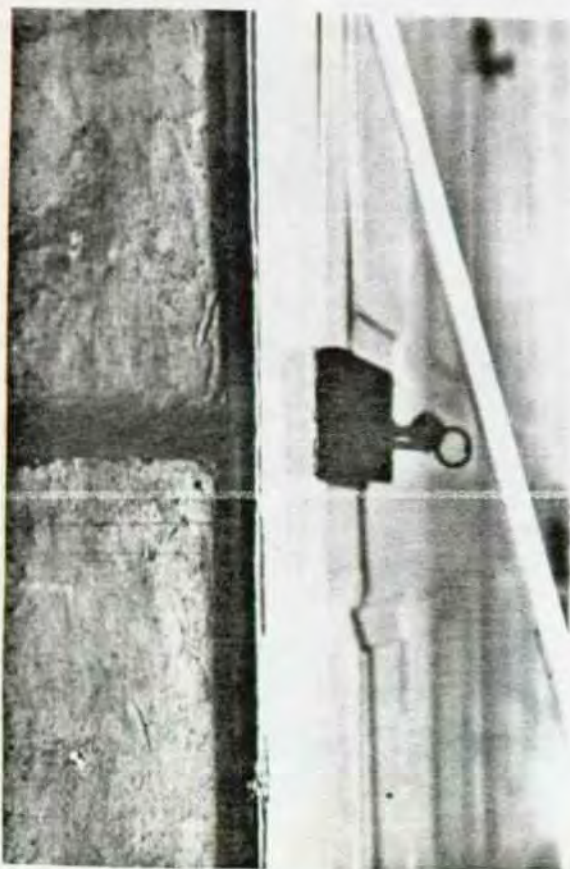
ILLUSTRATION 34  
Photographed by NPS.  
1750s Section  
Room 207. 1884 cabinet and original stair paneling looking northeast.

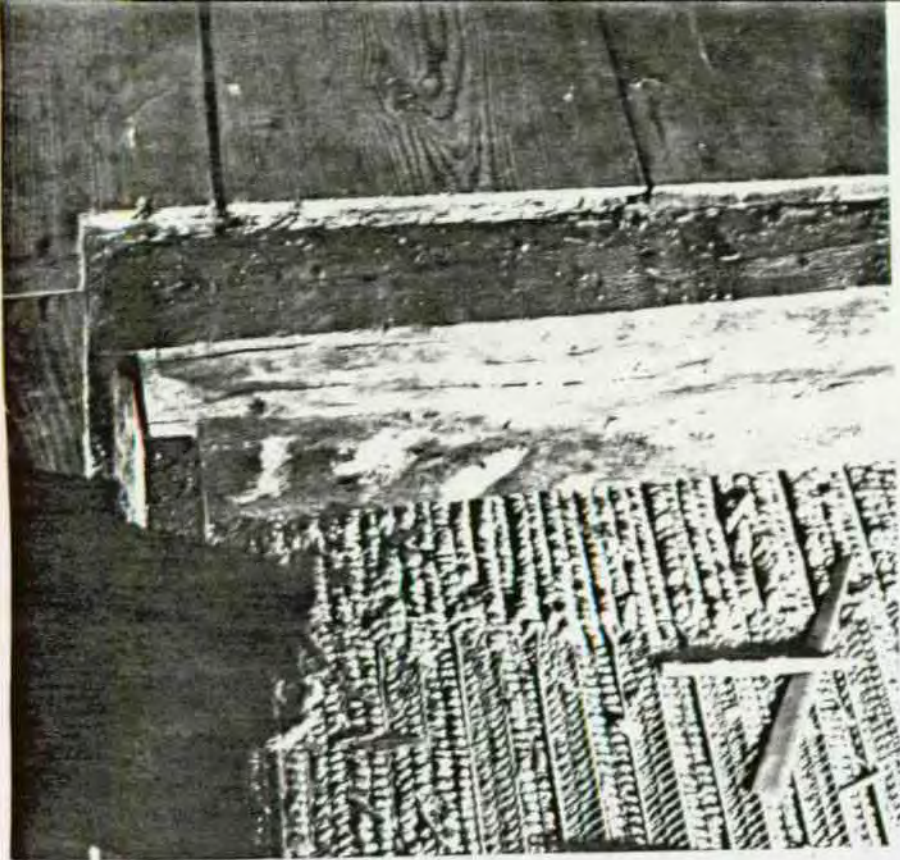
ILLUSTRATION 35  
Photographed by NPS.  
1750s Section  
Room 207, looking east. Edge of  
shelf mark after removal of 1884  
cabinet. Note mortise slots for  
closet rail.

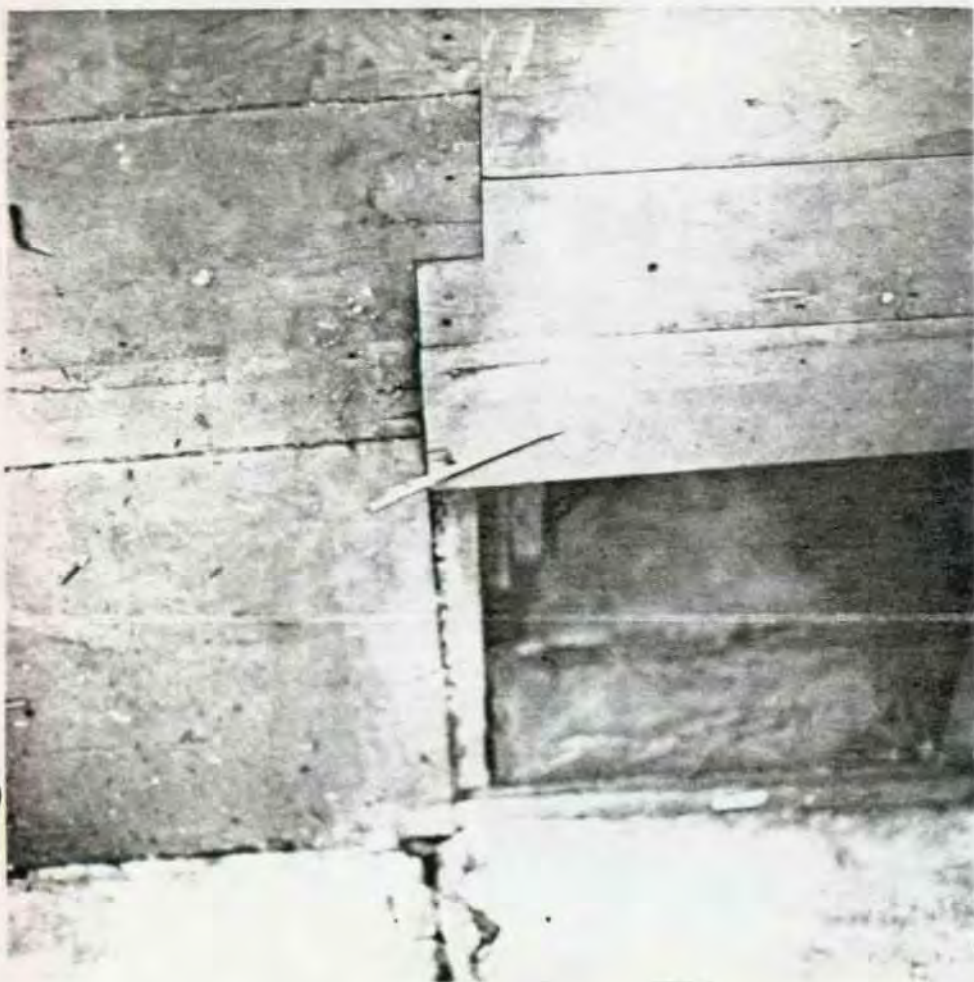
ILLUSTRATION 36

1750s Section

Room 208 looking east. Hearth joist with mortar stains from supporting arch.

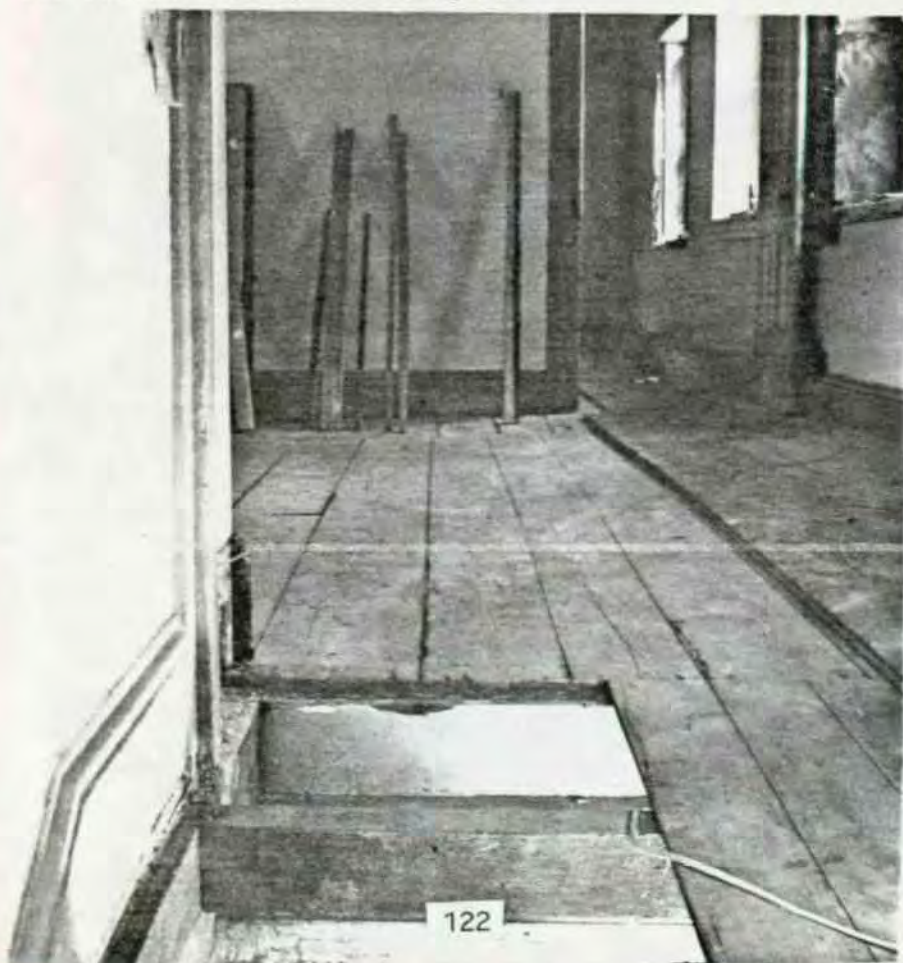
ILLUSTRATION 38  
Photographed by NPS.  
1750s Section  
Doorway between Room 208 and 209. Bottom step end profile.  
See sketch overlay for analysis.

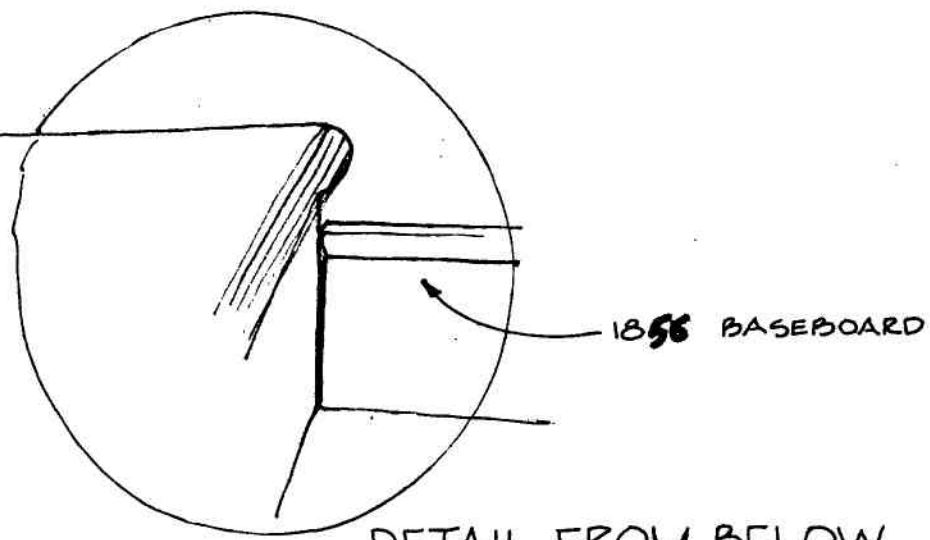
ILLUSTRATION 39  
Photographed by NPS.  
1750s Section  
Doorway between  
Rooms 208 and 209.  
Changes in flooring  
and steps. See  
sketch overlay for  
explanation.

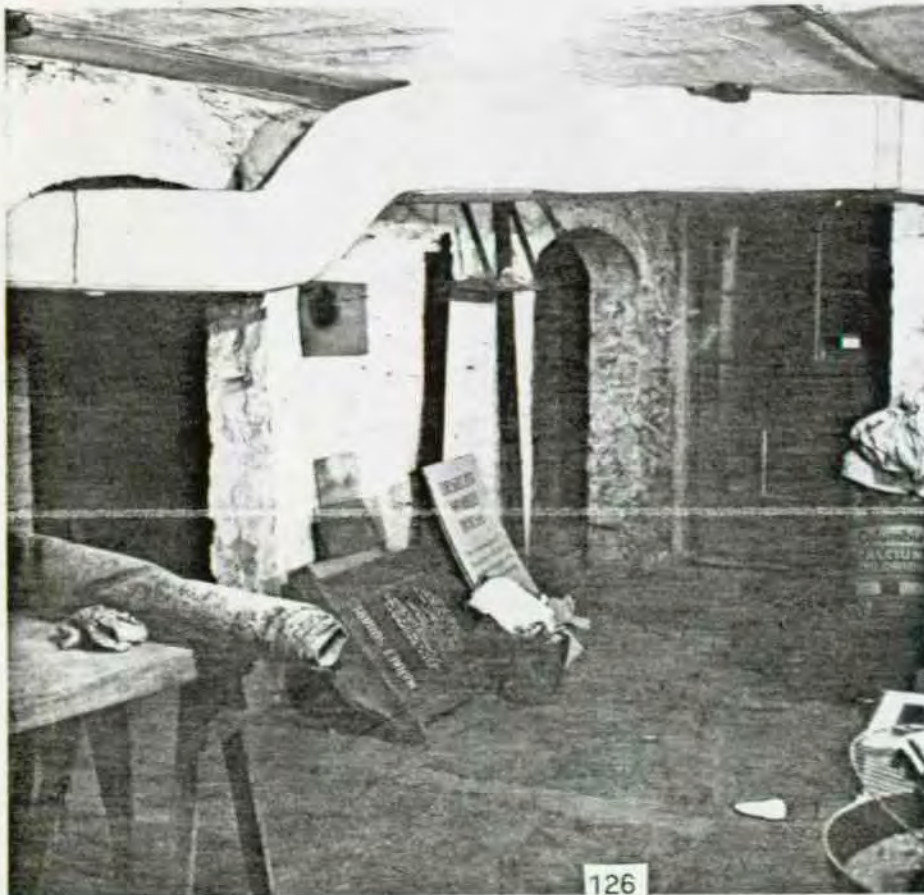
ILLUSTRATION 43  
Photographed by NPS.  
1772 Section  
Cellar-Room 02. Brick pier (1884) with wedges to support joists.

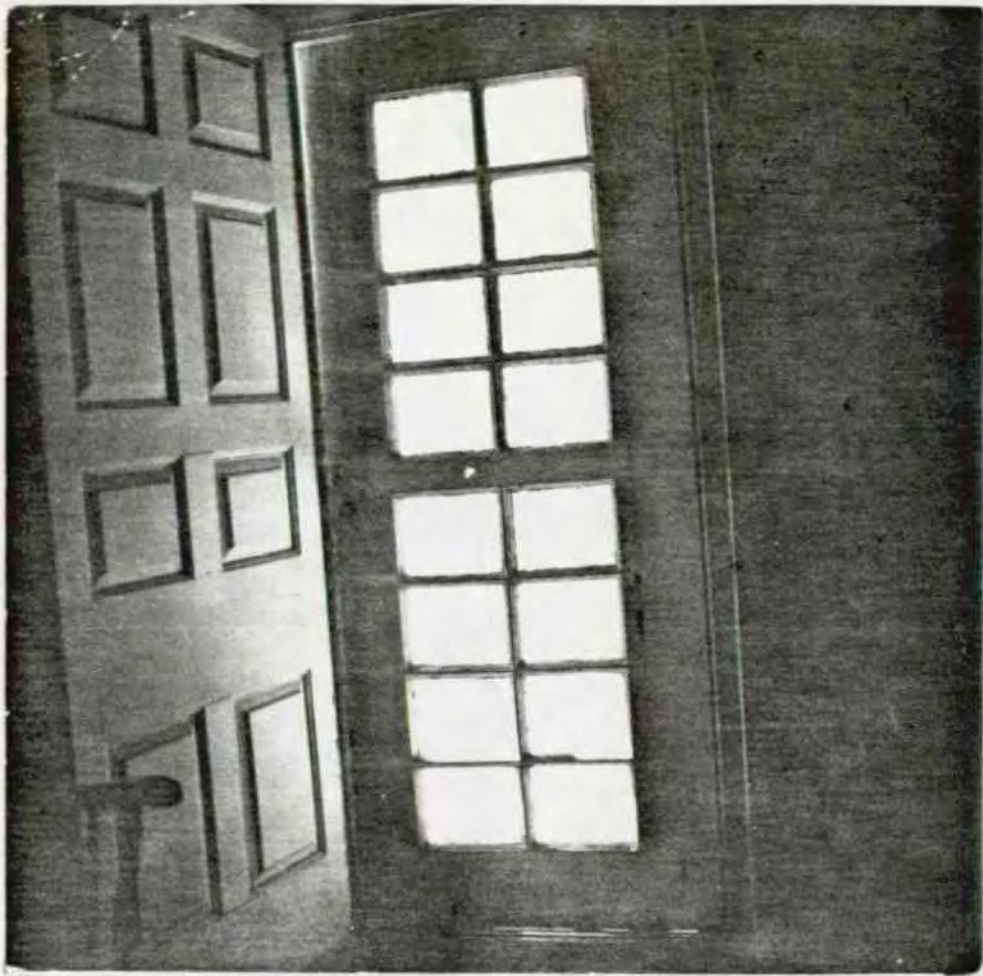
ILLUSTRATION 59

Doorway to porch from Room 206, looking west. Note glazed door consists of two original window sash from the 1750s section turned on their sides.

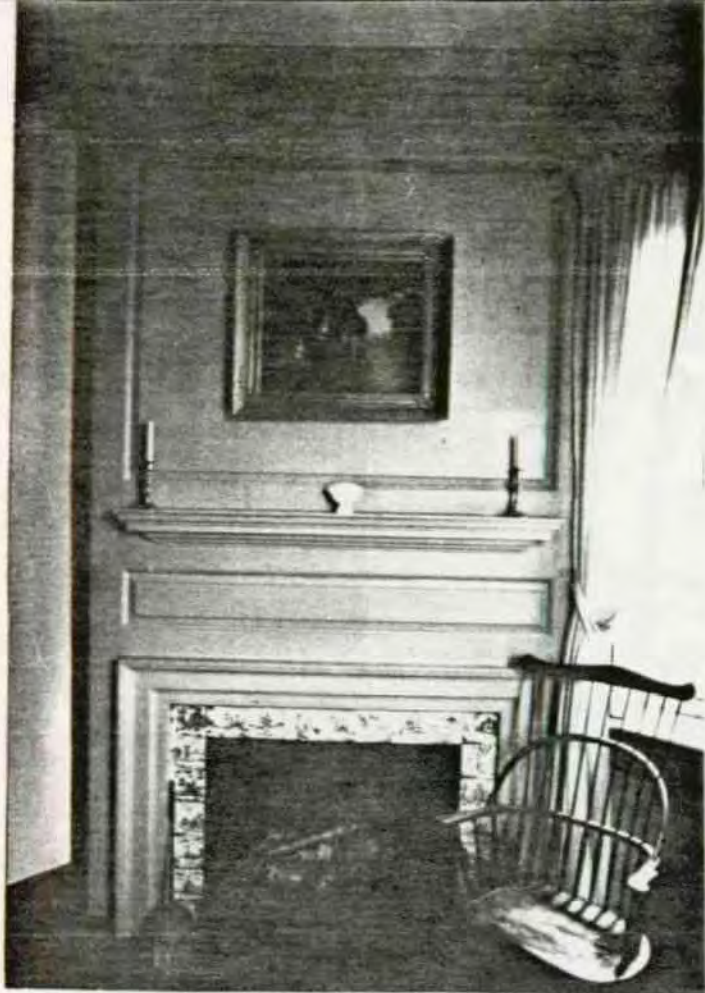
ILLUSTRATION 60  
Photographed by NPS.  
1772 Section  
Room 205, south wall.

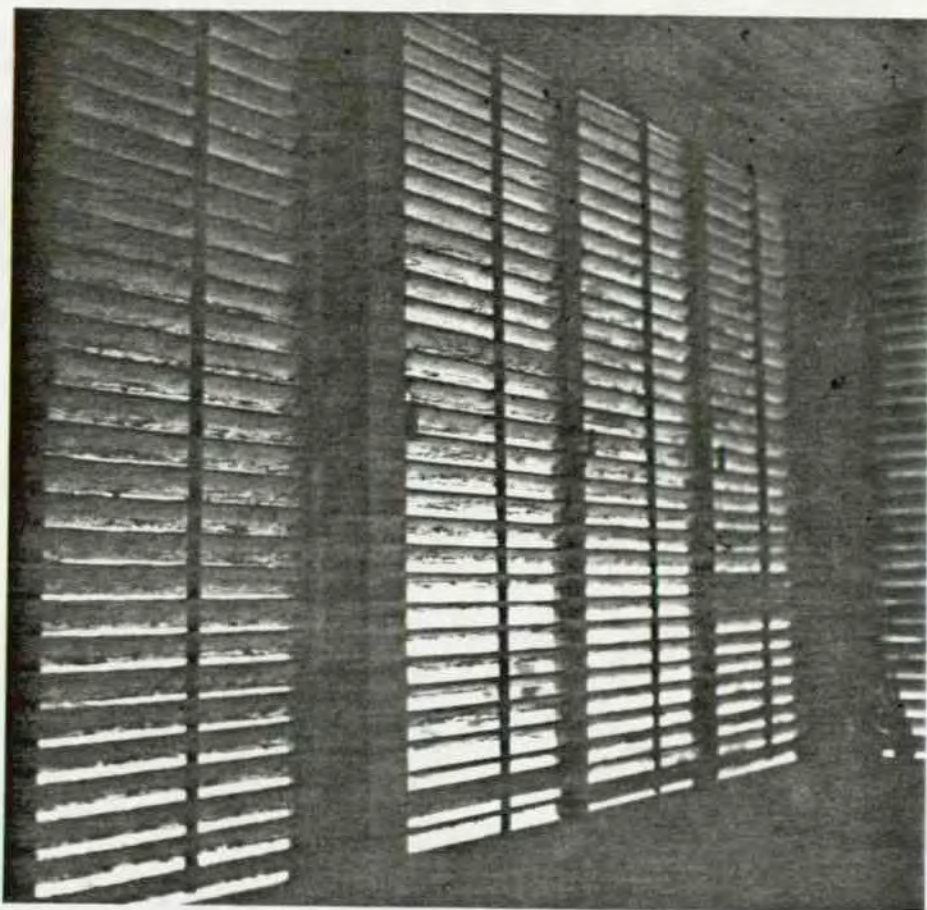
ILLUSTRATION 62  
1880 Section  
Room 115, louvered shutters, looking southwest.

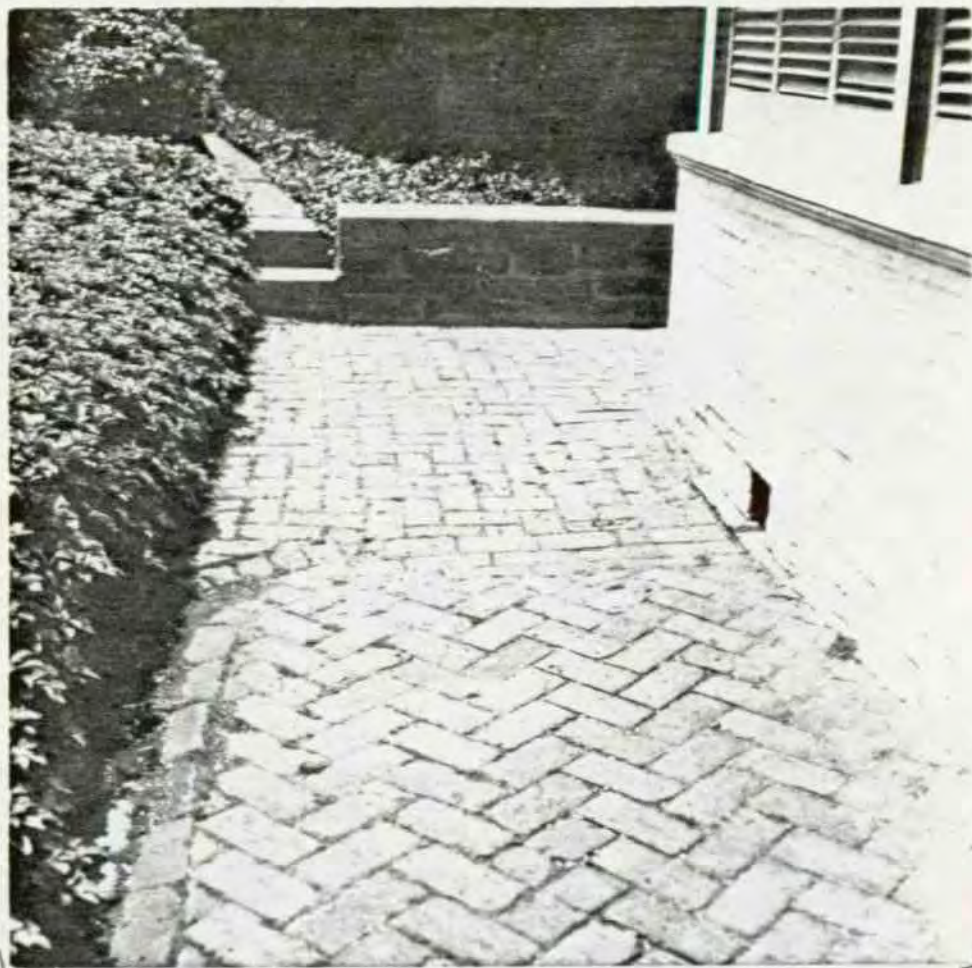
ILLUSTRATION 63  
1880 Section  
Brick paving outside Room 115, looking west. Note opening  
through wall for hydrant.
