HISTORIC STRUCTURE REPORT
THE SOUTH FORK DAM
HISTORICAL DATA
JOHNSTOWN FLOOD NATIONAL MEMORIAL
PENNSYLVANIA
PACKAGE NO. 124

Harlan D. Unrau

DENVER SERVICE CENTER
BRANCH OF HISTORIC PRESERVATION
MID-ATLANTIC/NORTH ATLANTIC TEAM
NATIONAL PARK SERVICE
UNITED STATES DEPARTMENT OF THE INTERIOR
DENVER, COLORADO

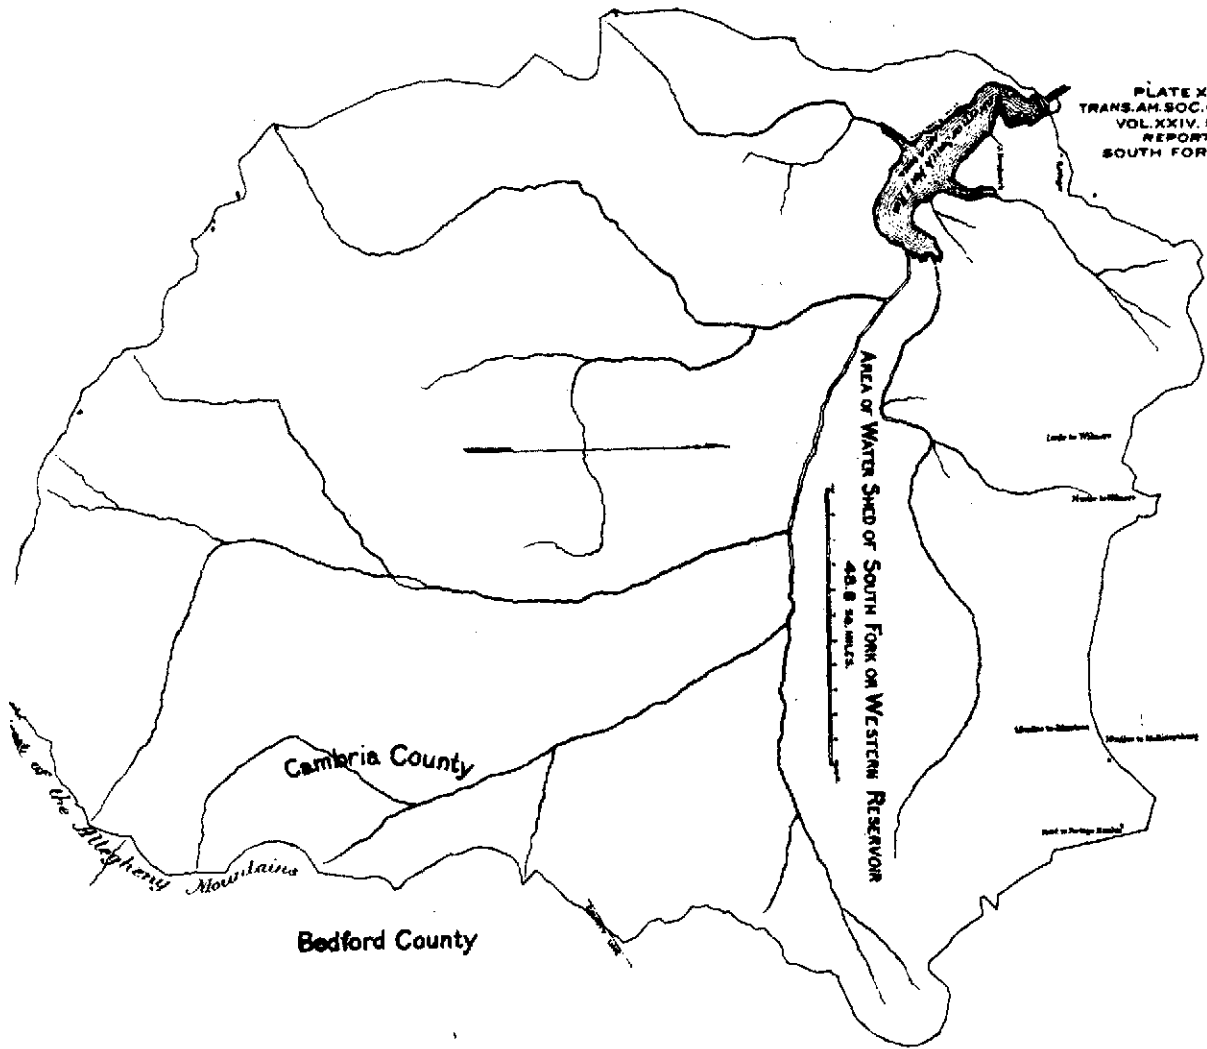
PLATE XLVII
TRANS. AM. SOC. CIV. ENGRS.
VOL. XXIV, NO. 477
REPORT ON
SOUTH FORK DAM.

131. "The Drainage Area of the South Fork Basin," Engineering News and American Railway Journal, XXII (September 14, 1889), 241. A copy of the map prepared by Lee, which appears as Plate XLVII in "Report of the Committee on the Cause of the Failure of the South Fork Dam," may be seen on the following page. Lee found that 16 inches of water were running over the dam when it broke and that the slope on the inner face of the dam was 2.75 to 1 in some places. "Editorials and Editorial Notes," Engineering News and American Railway Journal, XXI (June 22, 1889), 575.

Finally on January 15, 1890, the four-man inspection committee of the American Society of Civil Engineers released its report on the causes of the failure of the South Fork Dam. According to the report, the engineers concluded that the "failure was due to the flow of water over the top of the earthen embankment, caused by the insufficiency of the wasteway to discharge the flood water." The breach in the dam was "about 420 feet wide at the top and 50 to 200 feet wide at bottom." The amount of earth and stone that had been washed out of the breast amounted to some 90,000 cubic yards. "All the material put in in 1880 and 1881, to repair the breach of 1862" had been washed out "together with part of the old embankment made in 1851 and 1852." Some parts
