HISTORIC STRUCTURE REPORTS
FOR TEN BUILDINGS

ADMINISTRATIVE, PHYSICAL HISTORY AND ANALYSIS SECTIONS
KLONDIKE GOLD RUSH NATIONAL HISTORICAL PARK
SKAGWAY, ALASKA

Prepared by
Catherine H. Blee, Archeologist,
Robert L. Spude, Historian
and
Paul C. Cloyd, E.I.T. Historical Architect

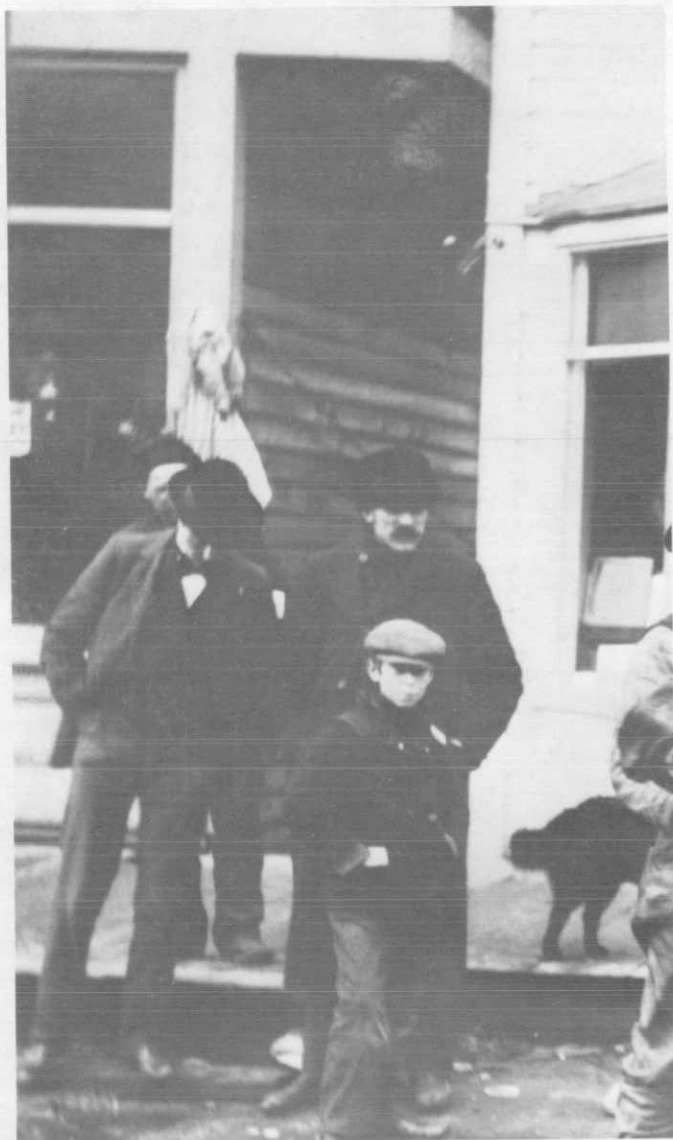
Photograph 3. Detail from March 22, 1900 photograph. Original northeast corner of building. No evidence is visible of stairway at this side, although the opening may have led to a stairway further to the west.

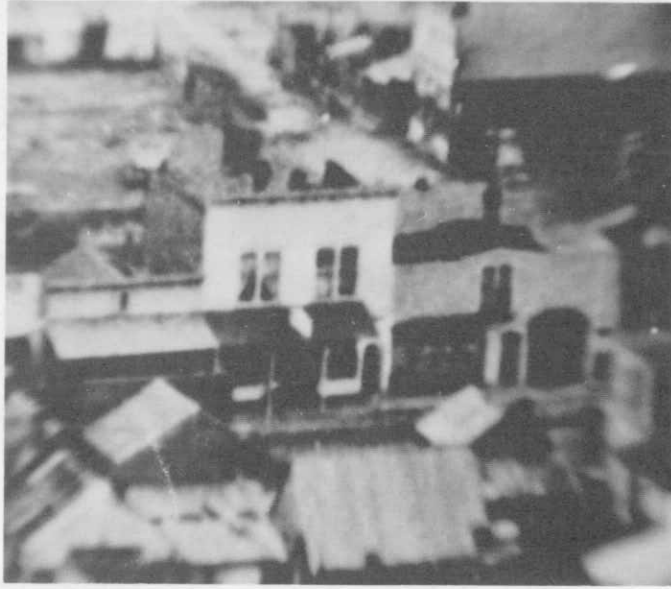
Photograph 4. Detail from a ca. 1903 photograph. Note addition of wooden porch and doorway at northeast corner.

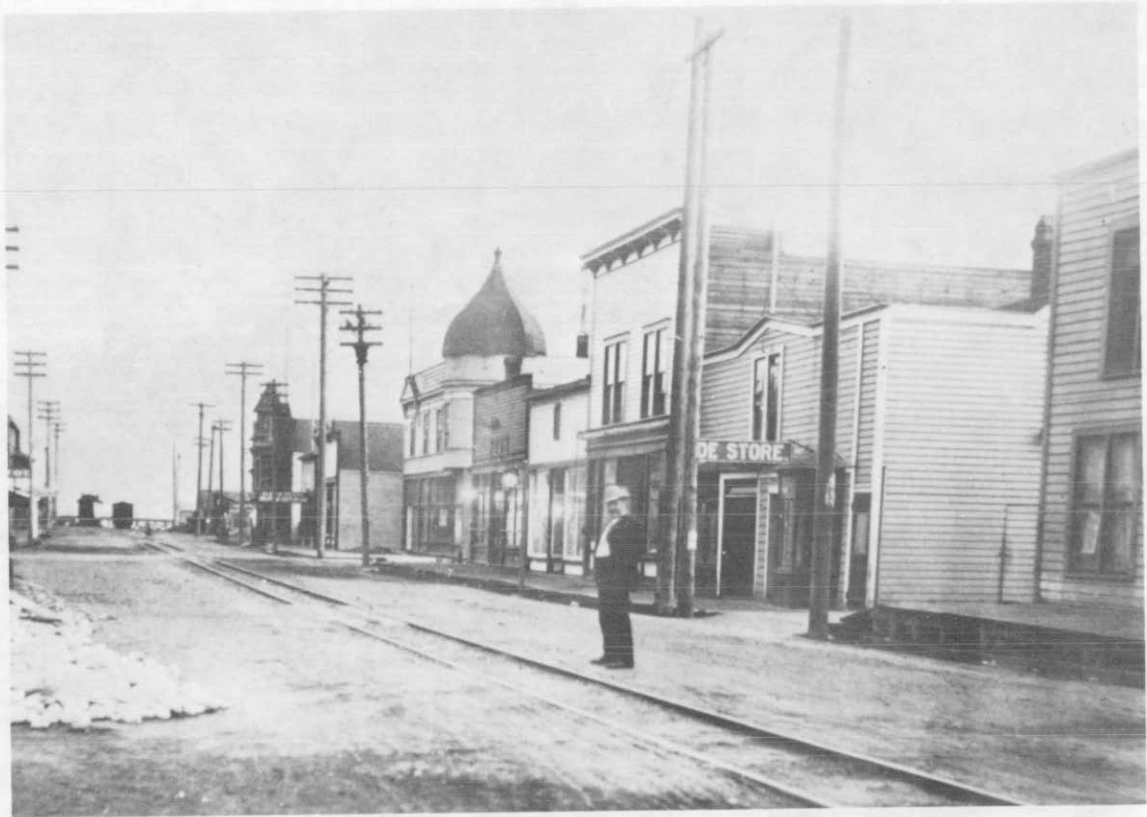
Photograph 6. From a ca. 1908 photograph. Note ramping of grade and boardwalk. North elevation of building was unpainted. Yukon Archives, Barley Collection.

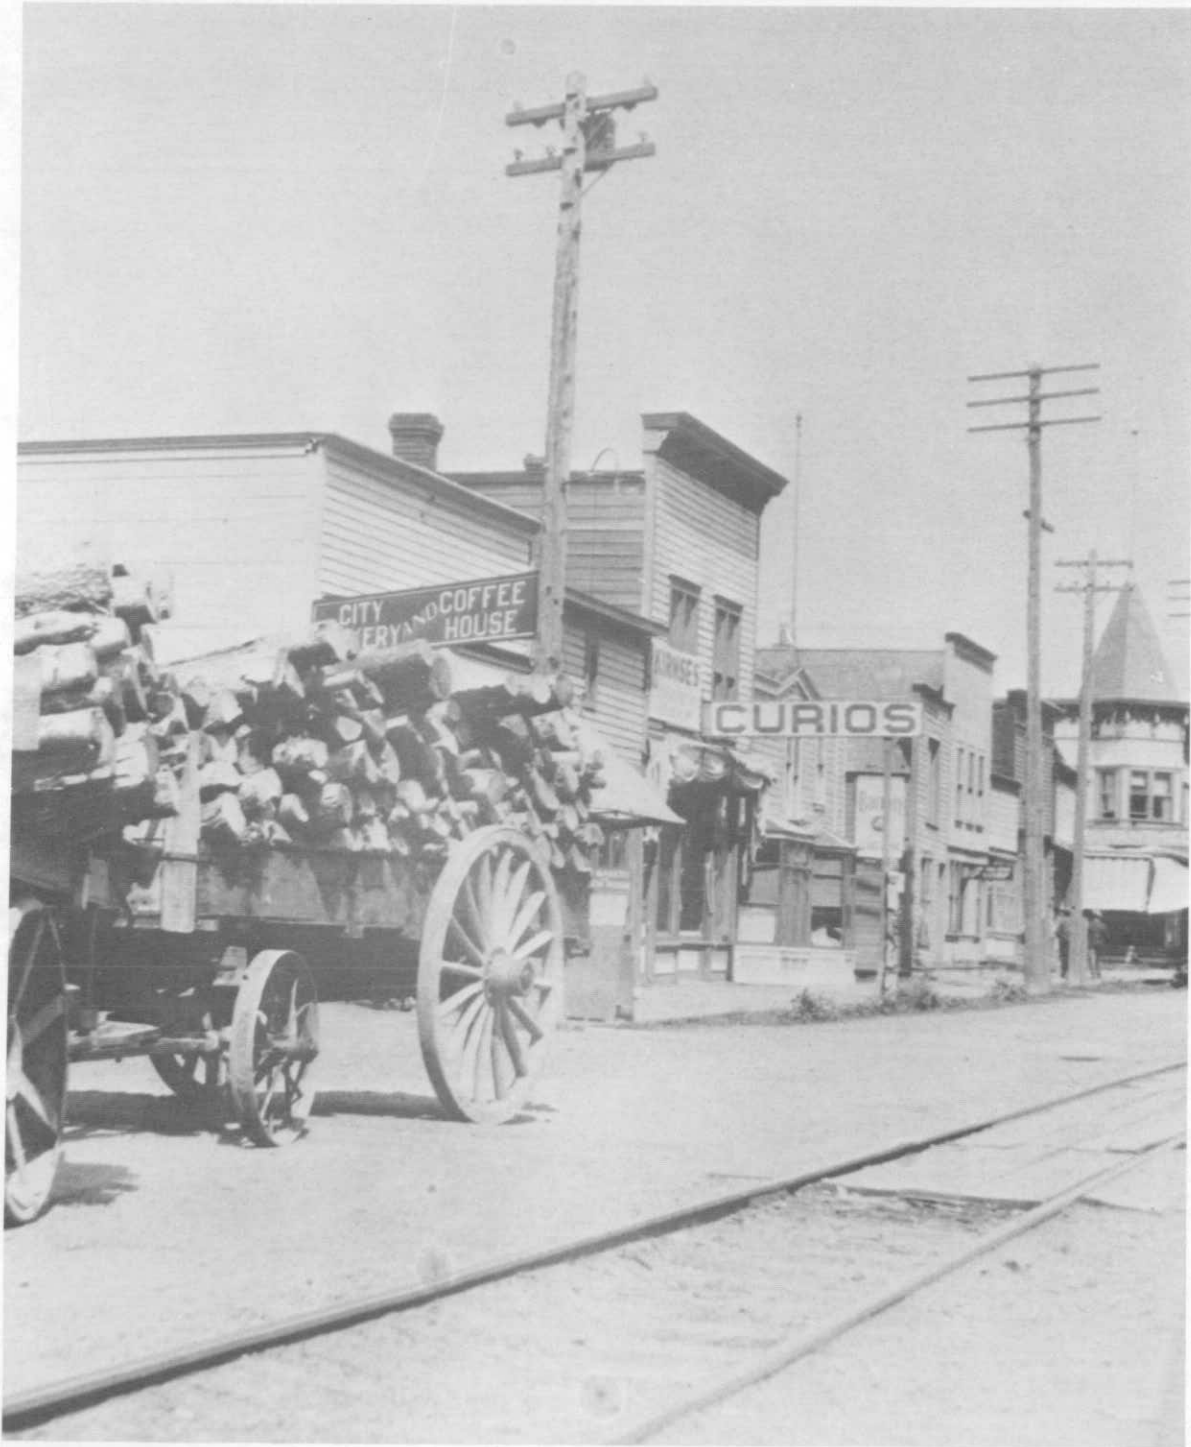
Photograph 7. From a ca. 1915-20 photograph. South elevation of building was also unpainted. Alaska Historical Library, Juneau.

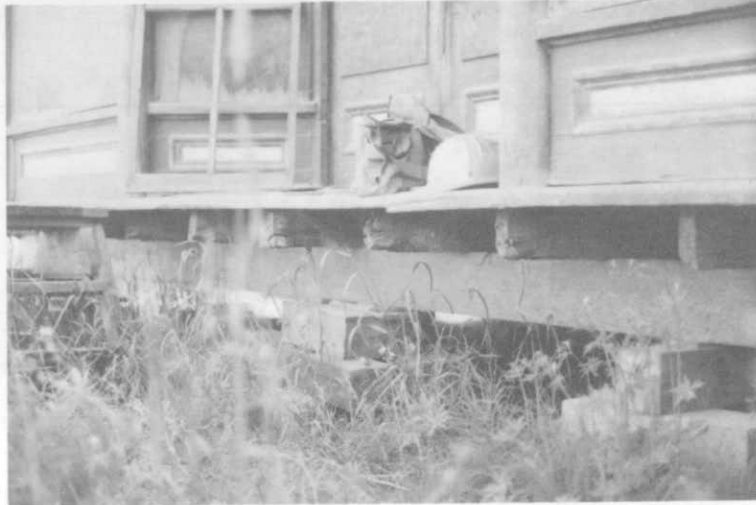
Photograph 24. Cribbing and floor framing detail.

1898 false front addition

1901-02 false front addition

Original false front

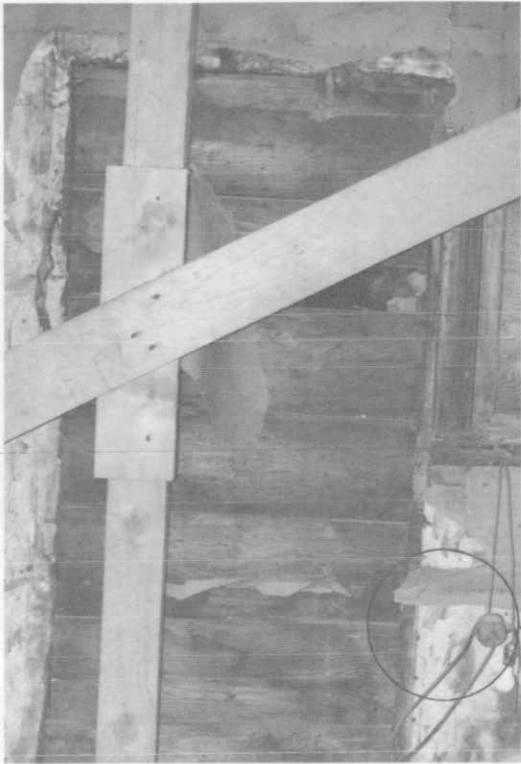
Photograph 12. South door
(originally west) infill.

Detail indicates opening existed prior to installation of fabric, wallpaper backing and first layer of wallpaper

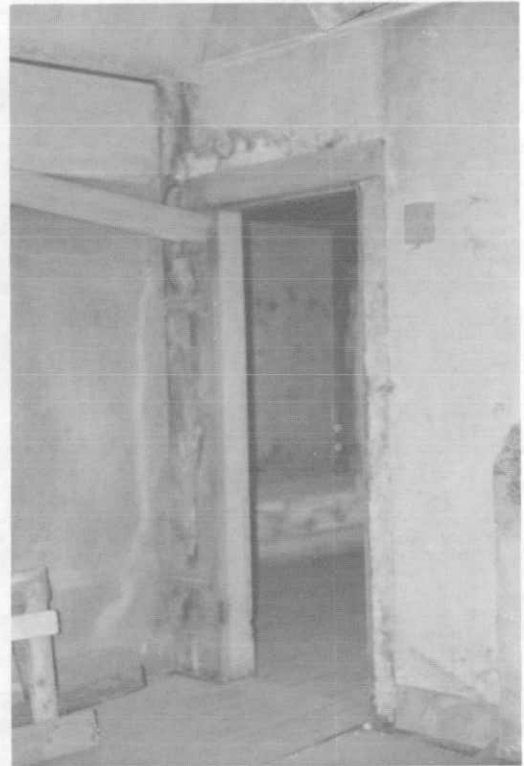
Photograph 17. Northeast corner, room 2.

Remove wallpaper

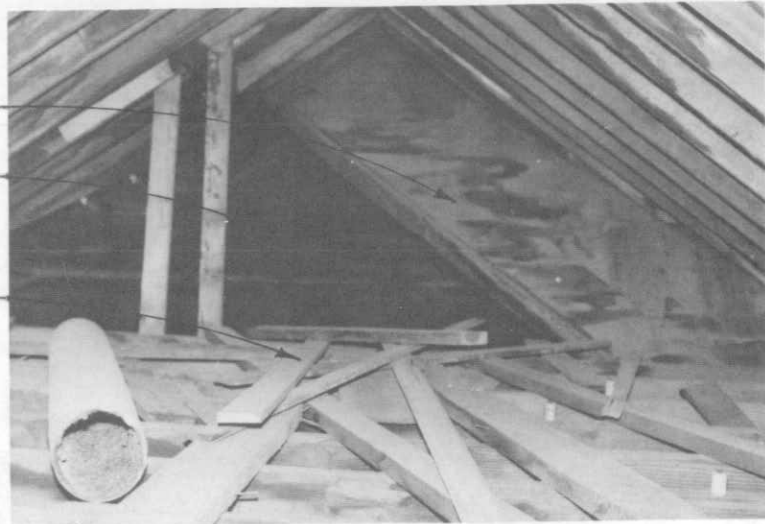
Photograph 22. Northwest corner, room 2.

Original roof
Original gable location
(see photograph 2)
Remove excess lumber

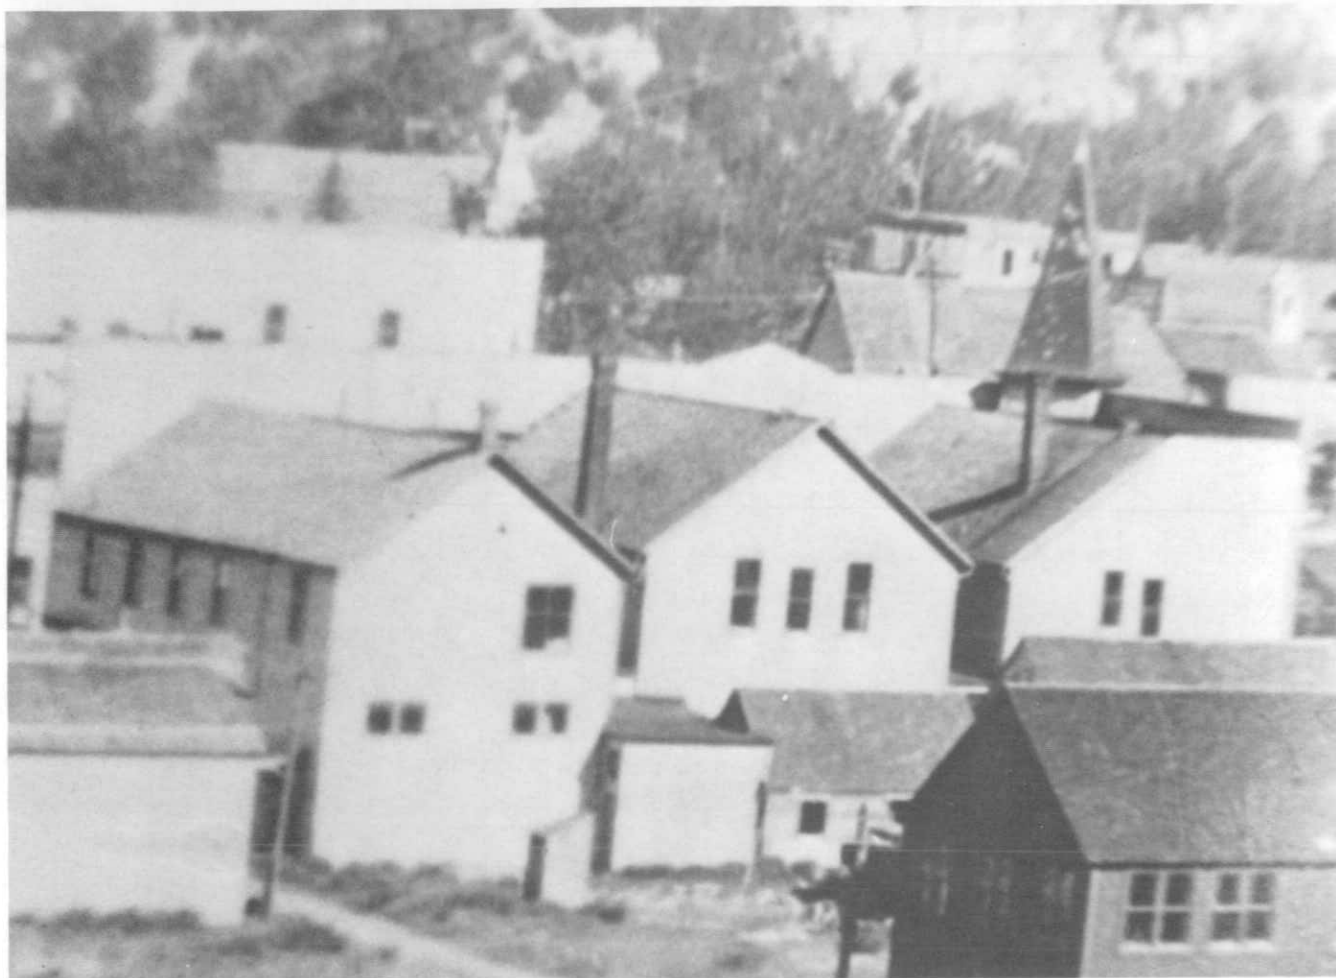
Photograph 7. Detail from a ca. 1916 photograph. Note modification of east first floor windows and addition of second floor window.

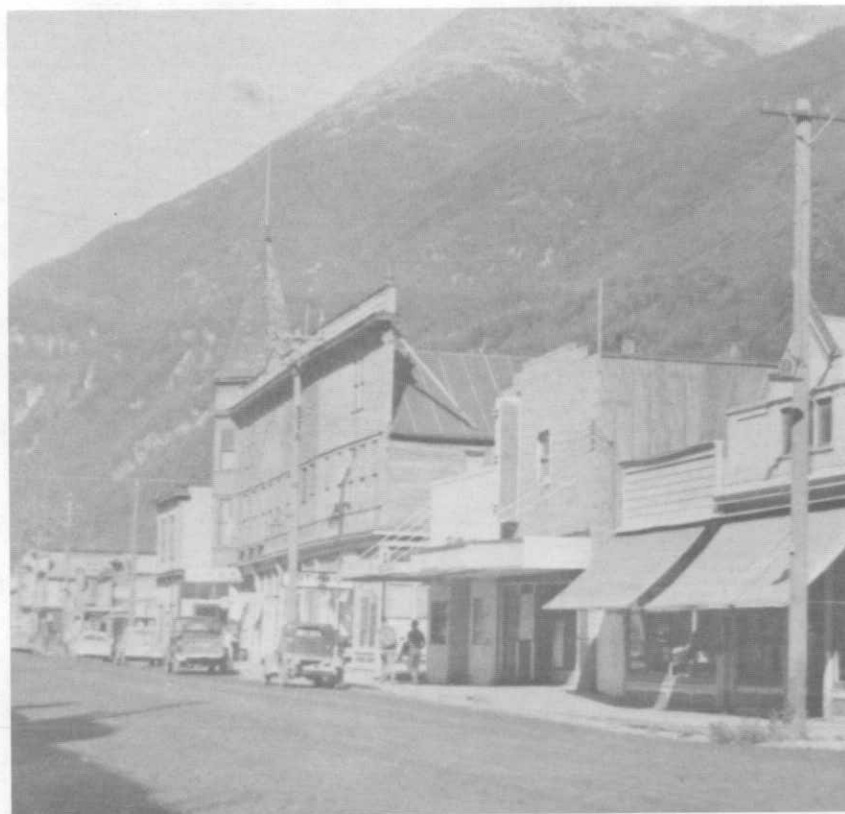
Photograph 11. From a ca. 1950 photograph.
Note roll roofing. Dedman's Photo, Skagway.

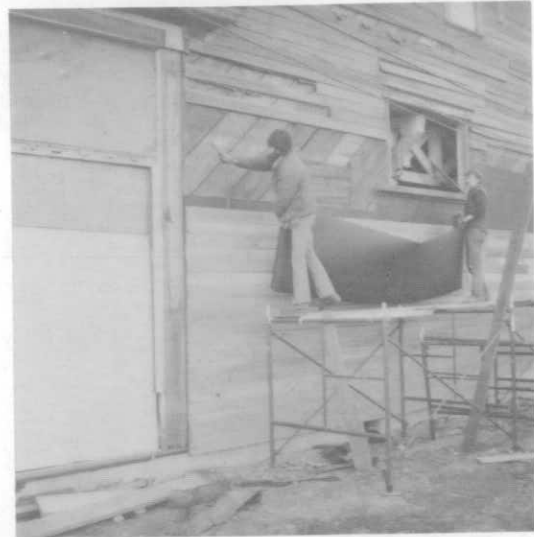
Photograph 21. April 1980. Note
typical 1 x 12 diagonal sheathing
with horizontal boards at historic
window location.

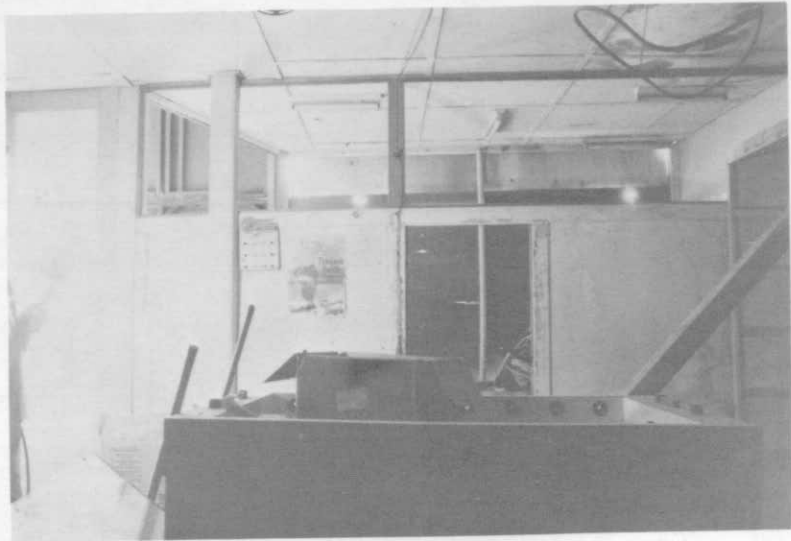
Photograph 26. 1978. As found conditions.

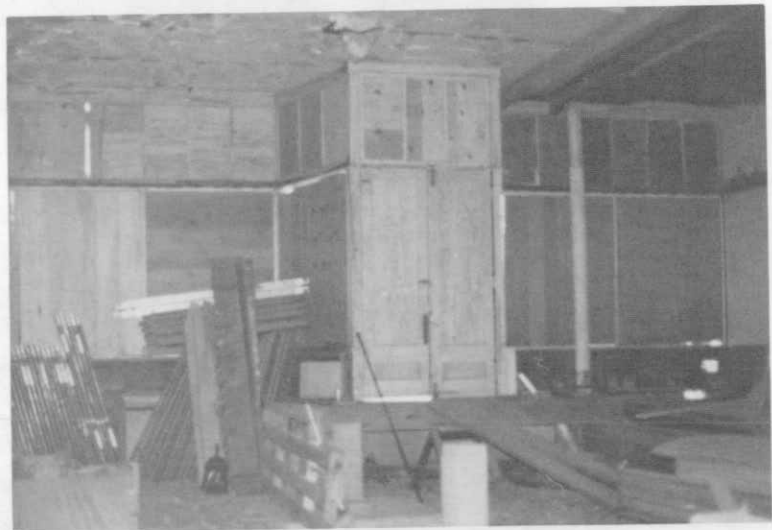
Photograph 28. 1981. After floor removal.

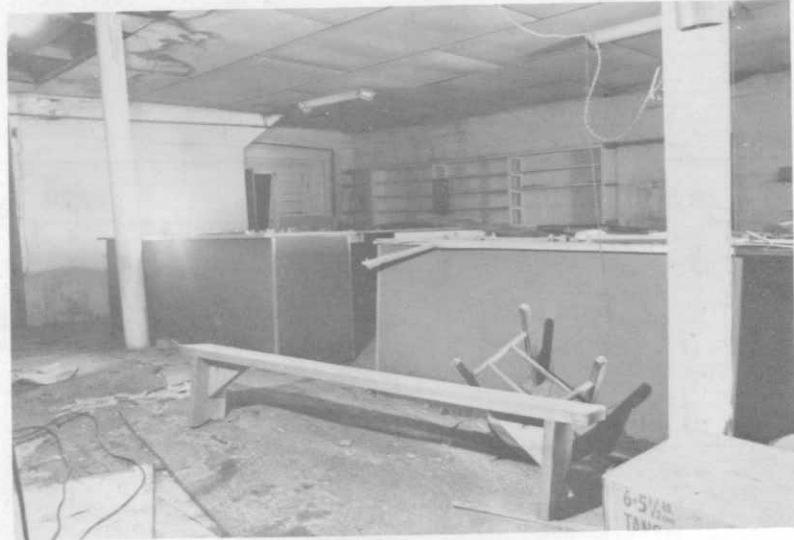
Photograph 32. 1978. As found conditions.

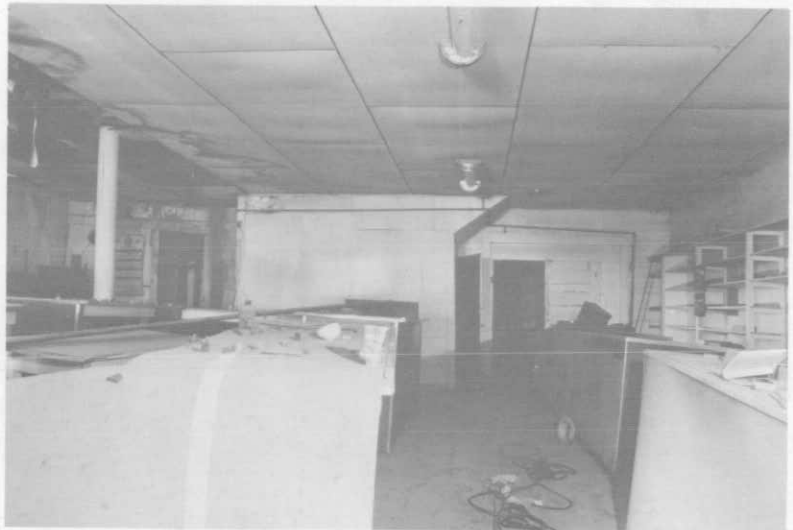
Photograph 35. East wall, as found conditions, 1978.

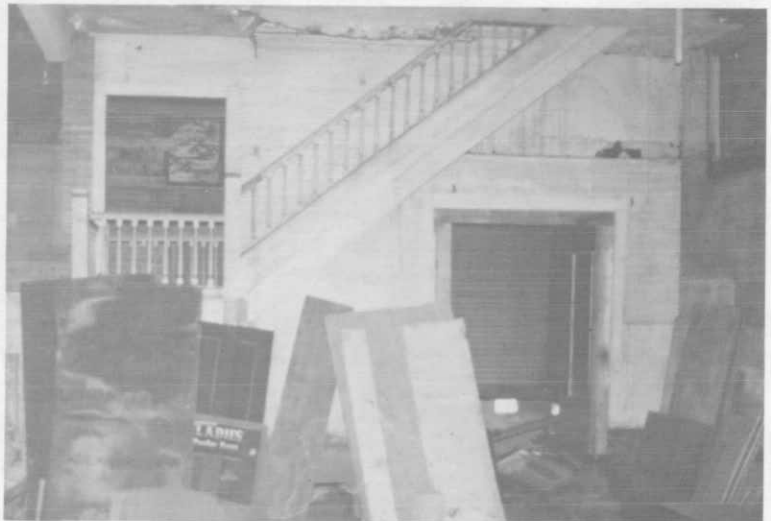
Photograph 37. 1981. East wall. Floor removed,
foundation in place.

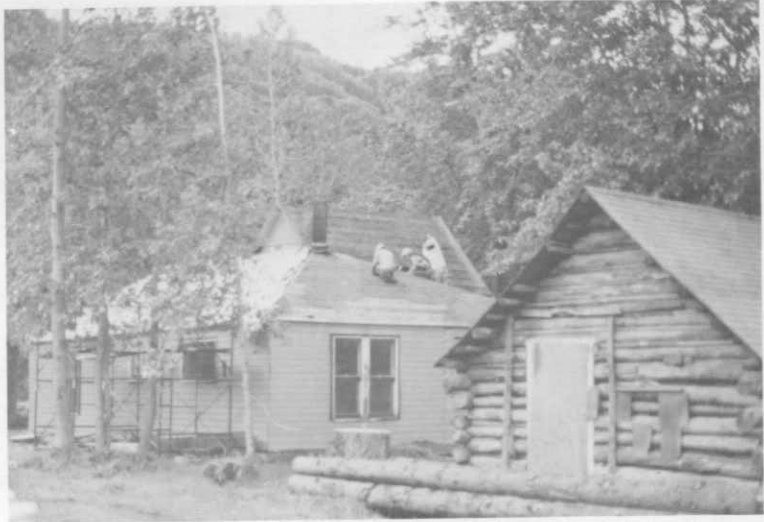
Photograph 27. View from northwest. July, 1981.
New shingle roof installation in progress.

Removal of all as-found roofing materials occurred in the summer of 1981 and were replaced with plastic coated steel foil and fire retardant treated shingles (see photographs 26 and 27). Rebuild chimneys with reinforced masonry using 1:4:8 (Portland cement:lime: sand) mortar. Install 1 by 3-inch wood ridge capping.

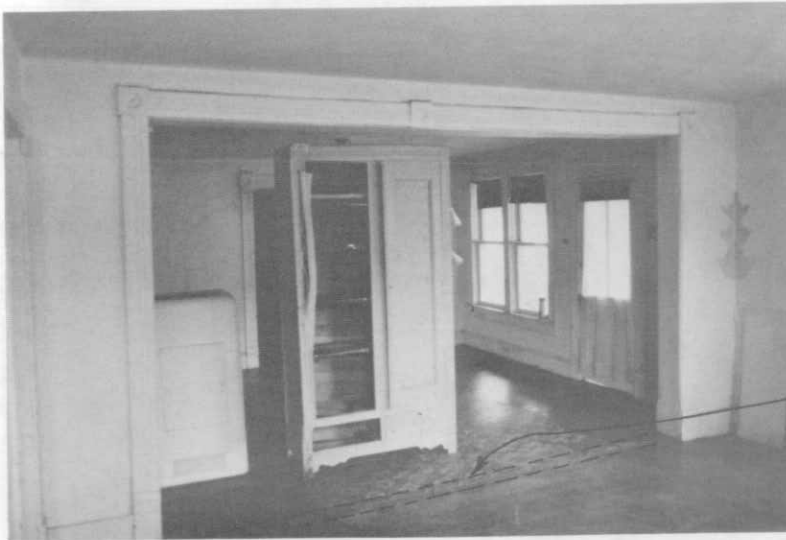
Photograph 33. East wall of parlor.
N.P.S. photograph by R. Copeland, Oct. 1979.

Fabric finishes removed
spring 1980.

Historic wall location. See
photographs 11 and 13.

Former wall location.
See photograph 11.

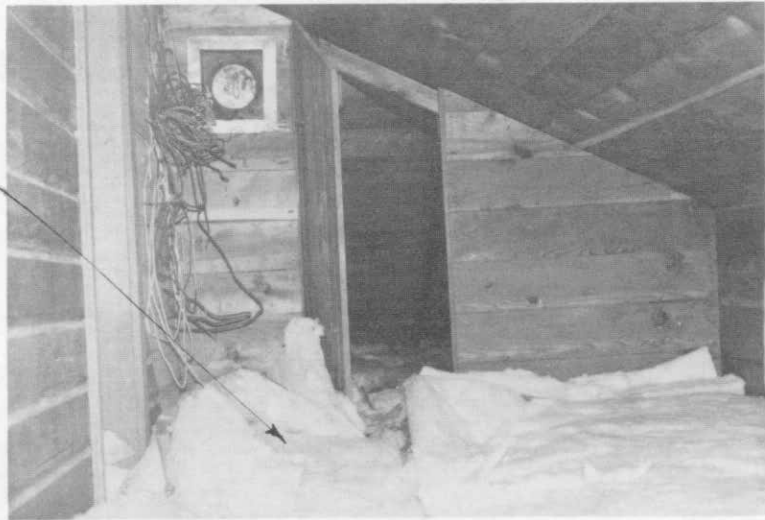
Photograph 57. Attic hall, west end.

Original roof now
enclosed by 1901
addition

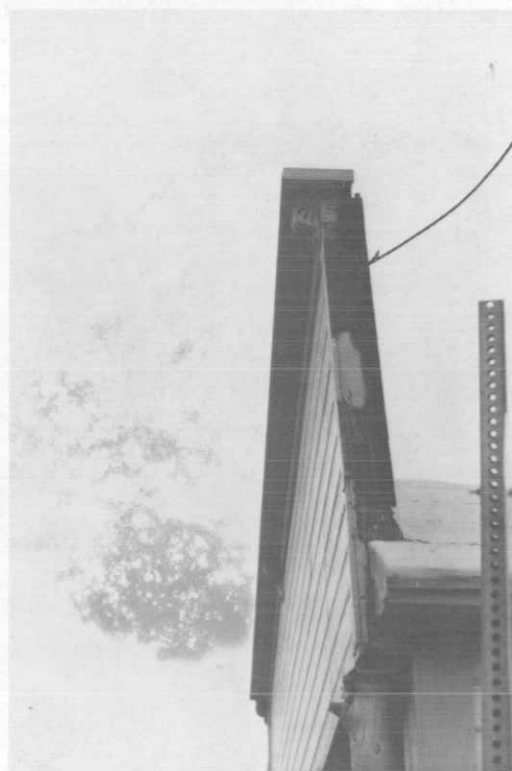
Photograph 24. False front detail.

Retain corrugated
metal siding

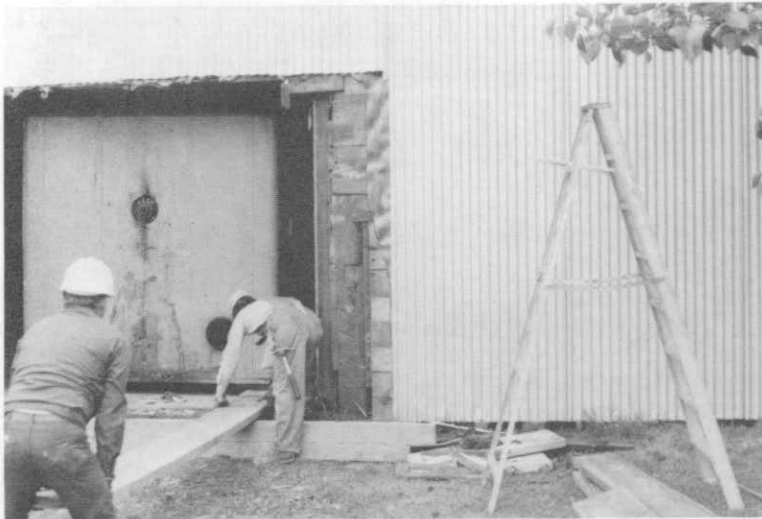
Photograph 27. South elevation during removal
of bakery oven. Note haphazard construction of
wall sheathing.

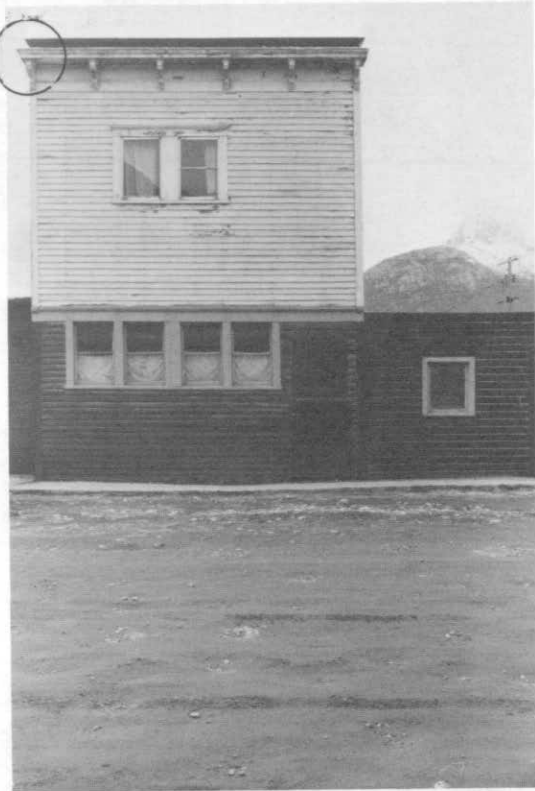
Photograph 32. Ca. 1905 and 1943
additions. North elevation. N.P.S.
photograph by T. Busch, Oct. 1977.

Remove existing roofing,
install shingle roof

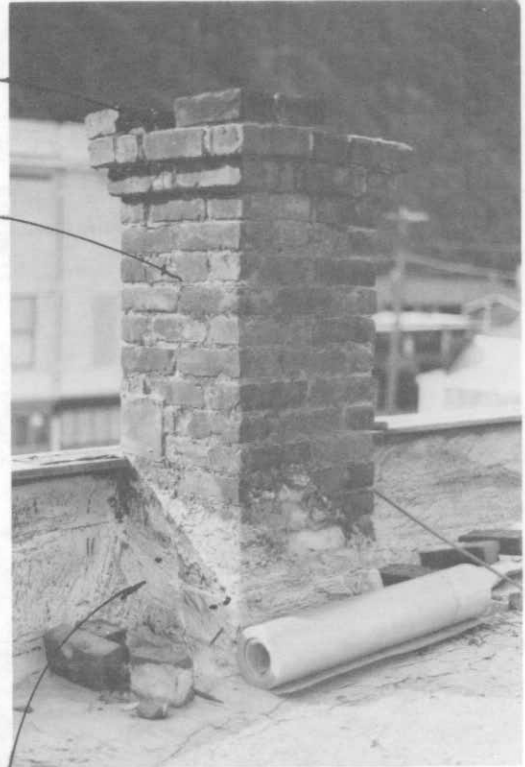
Photograph 37. Chimney detail,
second story roof, ca. 1905 addition.

Restore detailing

Repoint masonry

Install mechanical exhaust
within restored chimney

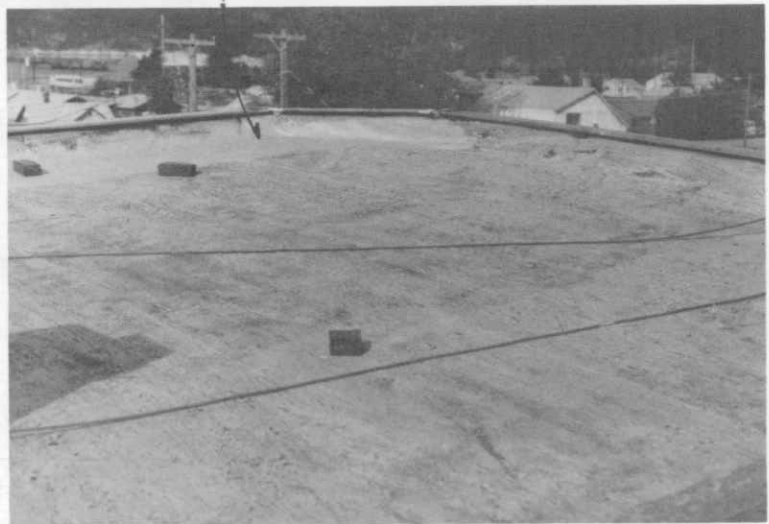
Photograph 39. Second story roof, ca. 1905
addition. View toward southwest.

Install proper flashing

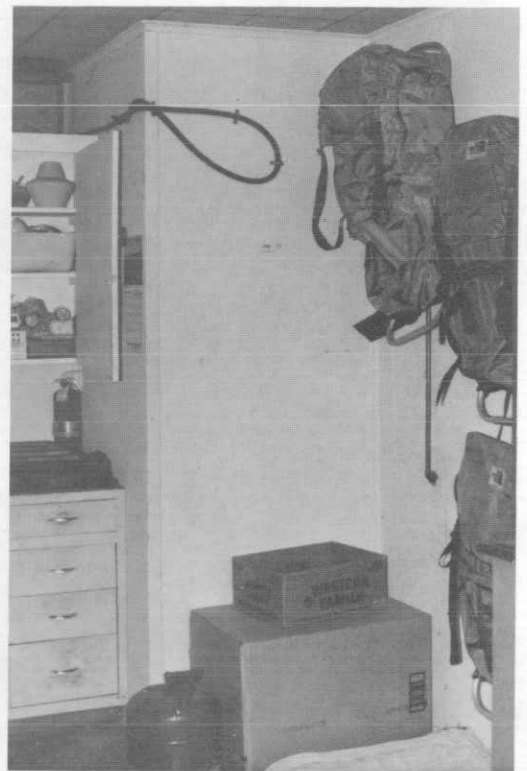
Photograph 54. Room 104, southwest corner.

Remove plumbing and interior finishes

Remove door frame

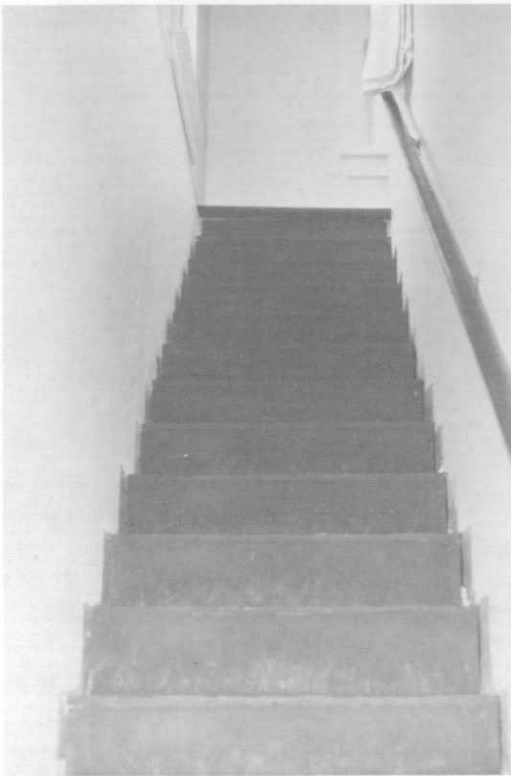
Photograph 22. North stairs.
Remove and relocate.

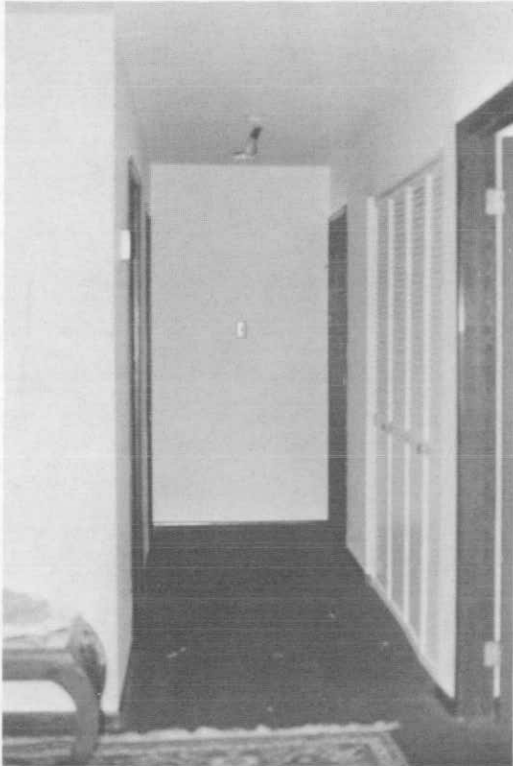
Photograph 27. Southwest corner.

Locate new stairway entry here
