HISTORIC STRUCTURE REPORT

CHARLES E. ARNOLD HOUSE (HS-20)

Lincoln Home National Historic Site
Springfield, Illinois

August, 1994

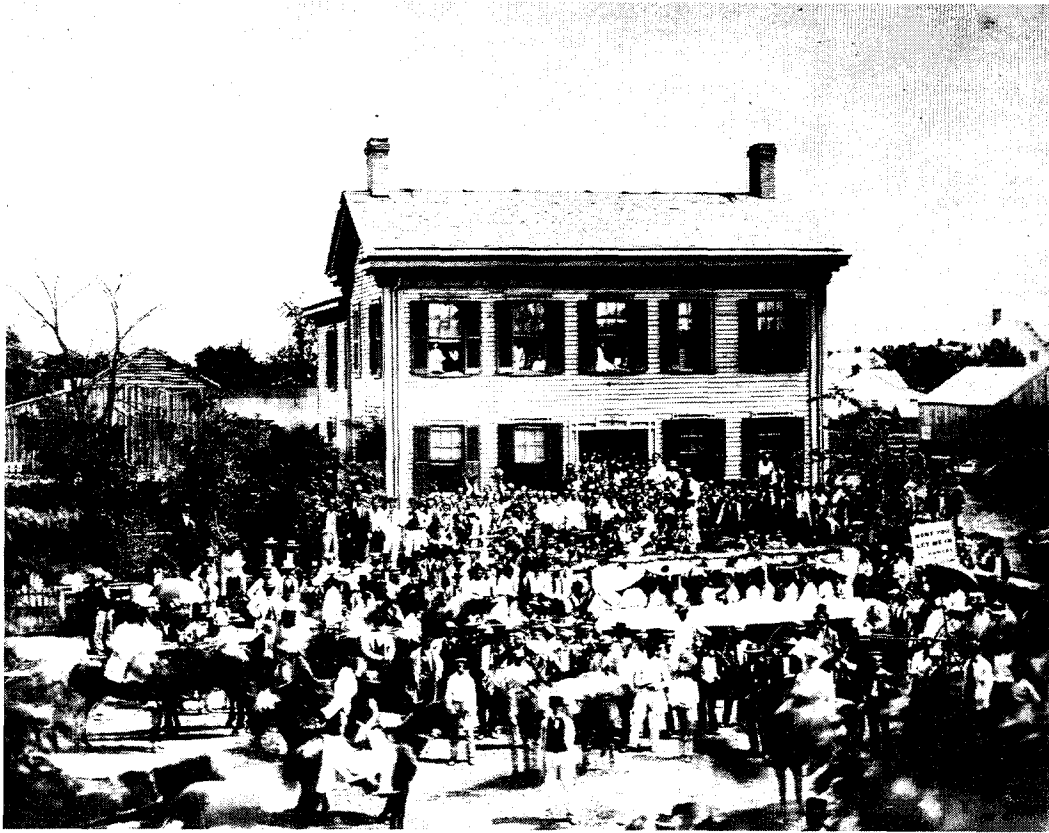
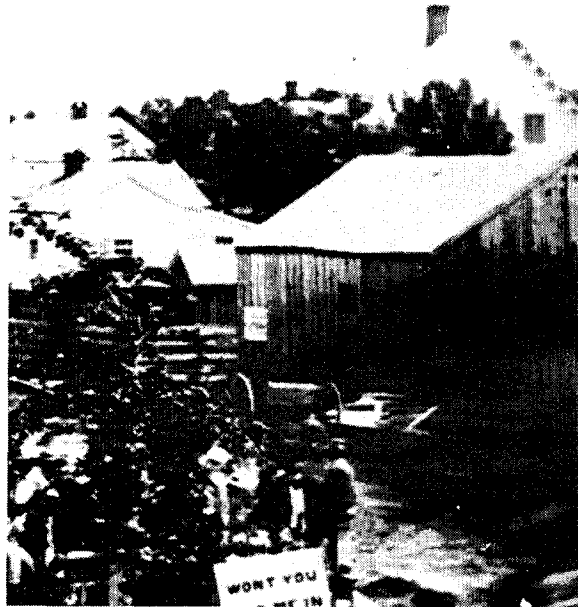
FIGURE 2.12: AUGUST 8, 1860 PHOTOGRAPH (FROM THE WEST/NORTHWEST)

In this photograph of a Republican rally at Lincoln's Home celebrating his presidential nomination, the Arnold House barn is seen at the far right-hand side of the photograph. At the bottom is an enlarged portion of this photo at the barn. Note the vertical batten and board siding, the pitched roof, and four-pane window on the north face.

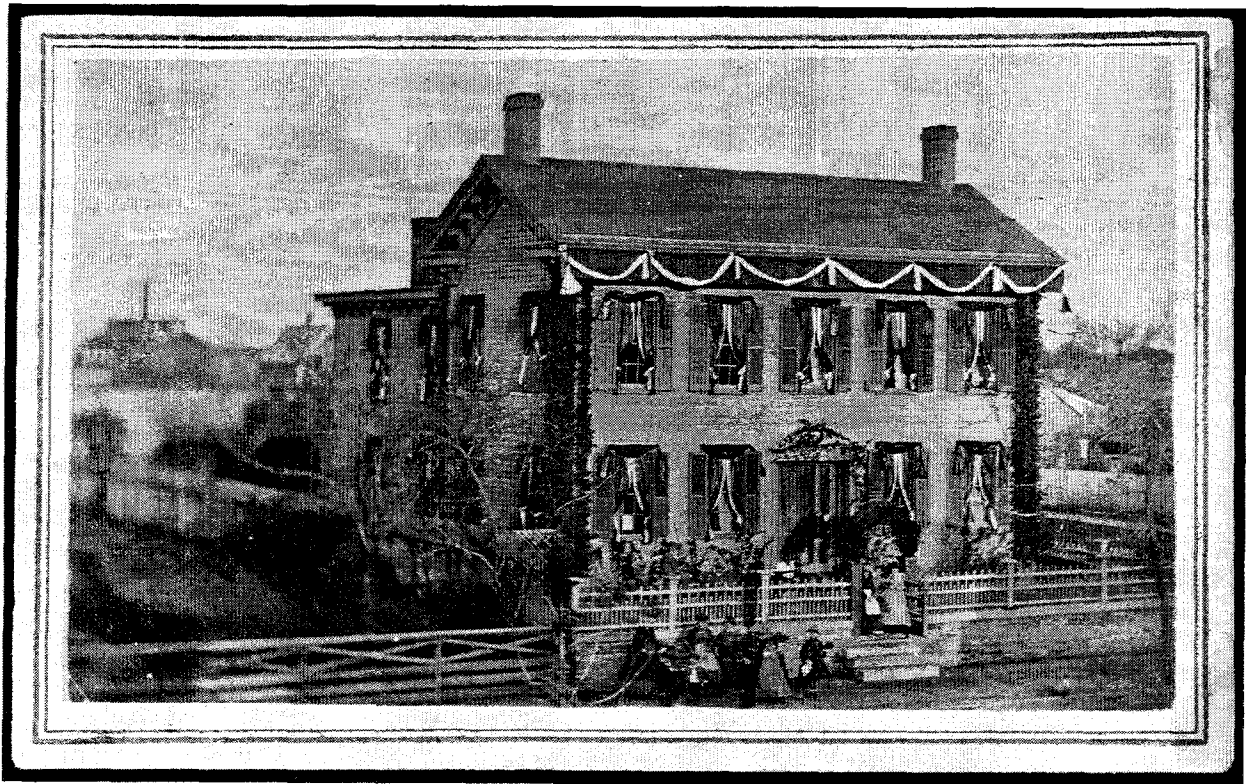
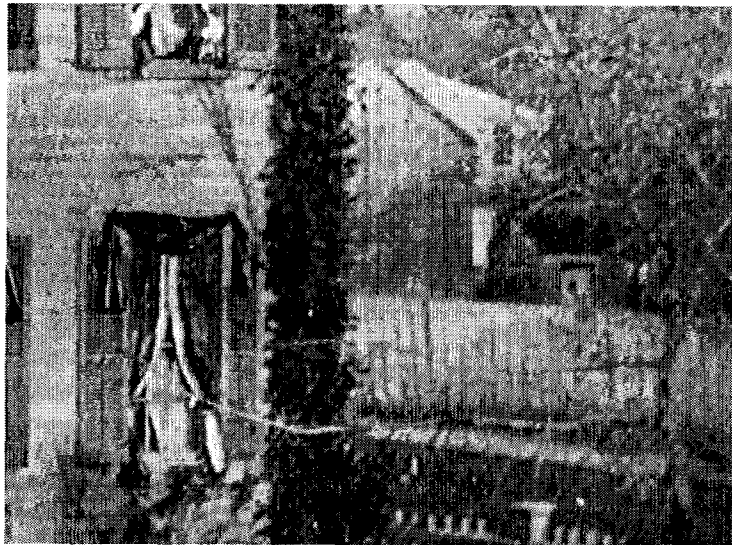
FIGURE 2.13: APRIL 1865 PHOTOGRAPH (FROM THE NORTHWEST)

This photograph shows the Lincoln Home draped in memorial bunting. The Arnold House east yard is seen at the right hand side of the photograph. Note the partial view of the west elevation of the Arnold House barn, the white vertical board fence, and the small building (probably the privy) near the southwest corner of the barn. At the bottom is an enlarged portion of this photo of the barn and privy.

Only one photograph provides any visual evidence of the privies associated with the Arnold House. The privy seen is a small, slightly rectangular structure with a gable roof. There is a small door centered on the west elevation, with a small window-like opening. The privy sets off of the southwest corner of the barn and the gable ends face north and south (see Figure 2.3).

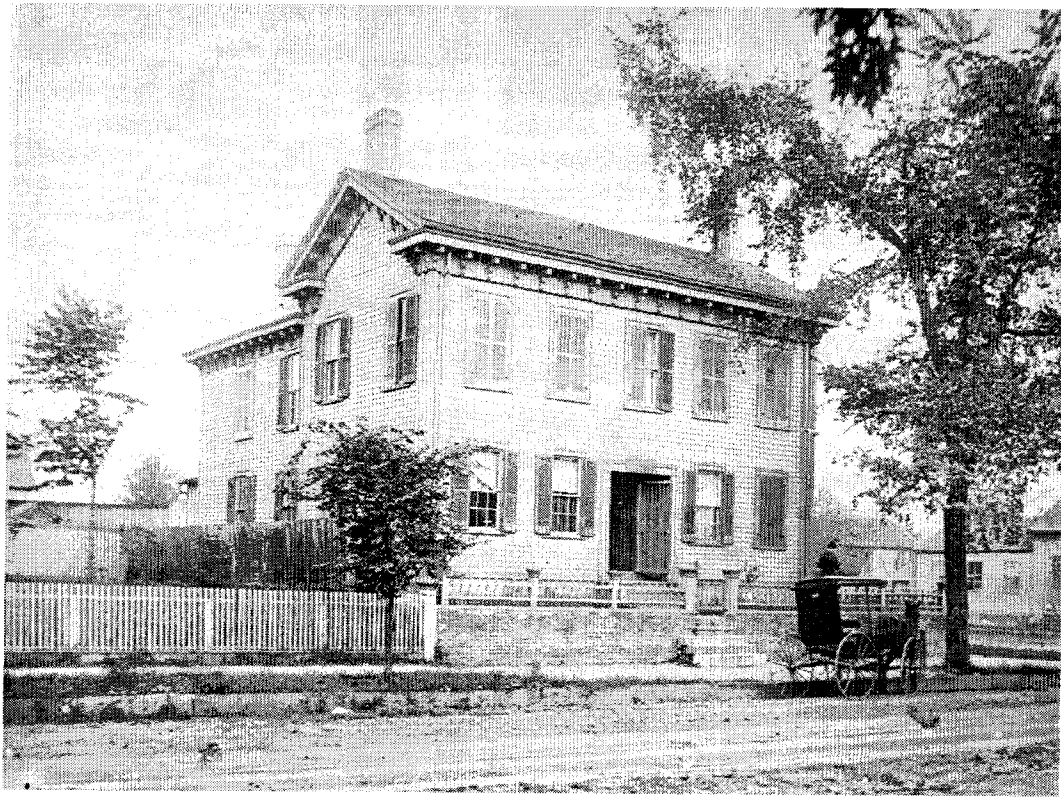
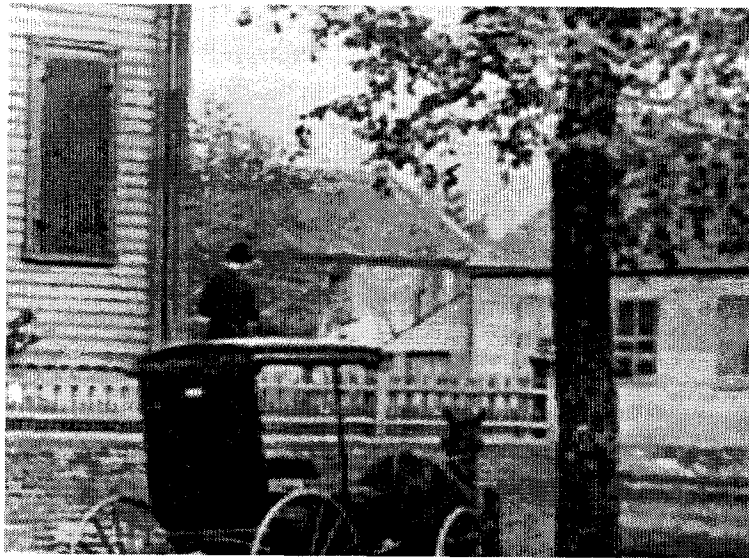
FIGURE 2.14: Circa 1885 PHOTOGRAPH (FROM THE NORTHWEST)
A large portion of the north elevation of the Arnold House is seen at the right-hand side of this Lincoln Home photograph. At the bottom is an enlarged portion of this photo of the Arnold House. Note the two different roof lines with similar pitches, the fenestration configuration (with the shutters closed), the four steps leading to the shuttered door, and attached shed at the east end of the house.

Figures 2.14 through 2.17 indicate the location of the north door at the 1840 cottage. This door is located approximately 2'-10" from the east end of this portion of the house, and is approximately 2'-10" ± wide by 7'-0" ± tall. Field investigations did not yield any physical evidence of the door location. The character of the door itself is not clearly seen in any of the historic photographs; however, there is some vague indication of panels near the bottom of the door. A small white speck at the east side of the door seen in Figures 2.16 and 2.17 appears to be a white porcelain door knob. The door is also shown to have a two-leaf shutter. Each shutter leaf appears to have two intermediate rails dividing it into three panels of louvers.

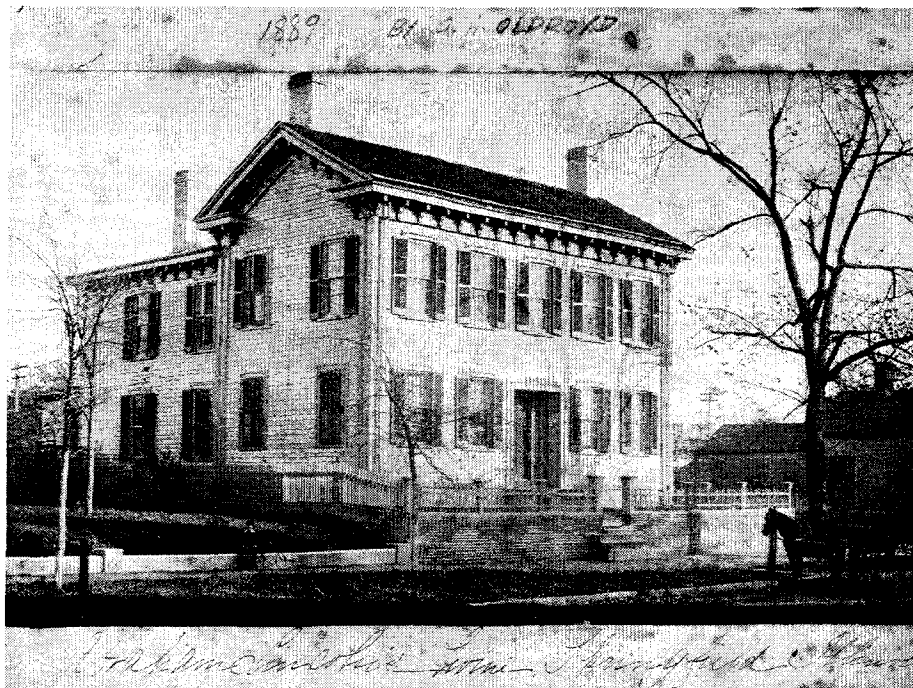
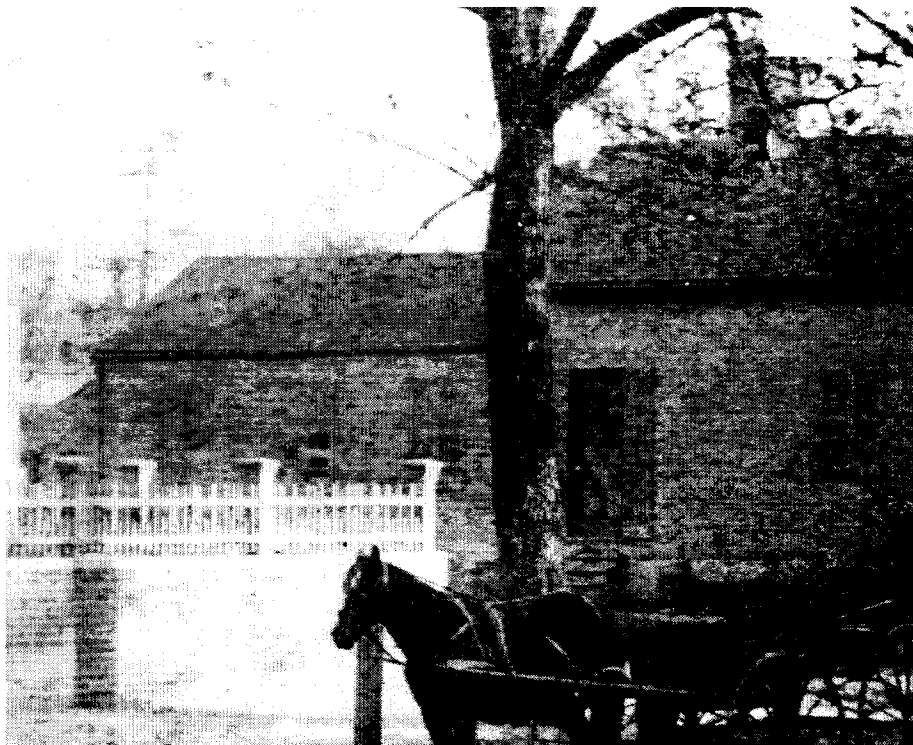
FIGURE 2.16: Circa 1889 PHOTOGRAPH (FROM THE NORTHWEST)

This photograph shows most of the east addition and a large portion of the story-and-a-half portion of the Arnold house. A profile at the chimney profile above the roof is evident but not clearly seen in this view. At the bottom is an enlarged portion of this photograph of the Arnold House.

Historic photographs, maintenance documentation, and the physical conditions of the roof of the 1840 cottage indicate that this was always a gable-ended roof, originally finished with wood shingles. The original shingles were 7¼" and wider, 16" in length, and laid-up with a 5" exposure to the weather.¹⁵ The original sycamore roof rafters and original wide sheathing boards still remain in place (see Figure 3.30). The use of sycamore for structural framing is apparently unique in the park and probably fairly uncommon in the city. Nineteenth-century photographs indicate a wood-shingled gable roof over the east addition, with a shed-roofed structure backed up to this addition (the attached shed). The roof material at the attached shed is not known, but was probably wood shingles. Figures 2.14 and 2.16 provide evidence of the early roof drainage system of the house. The gutter seen at the north eave of the 1840 cottage empties into another gutter at the eave of the lower, one-story, east addition roof. These finally drain out through a downspout at the northeast corner seen here. These gutters appear to be hung on the eaves with metal straps (see Figure 2.16). It seems likely then that the gutters and downspouts were also metal.

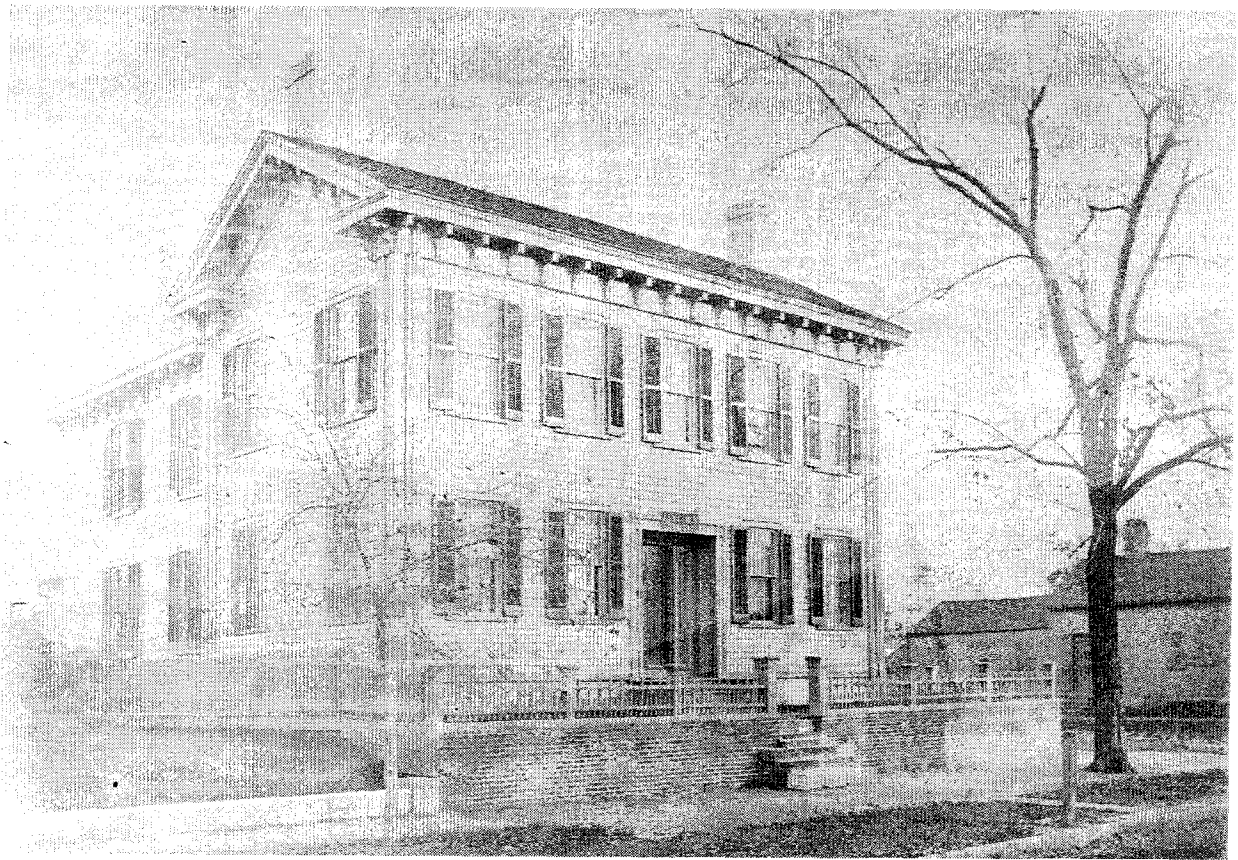
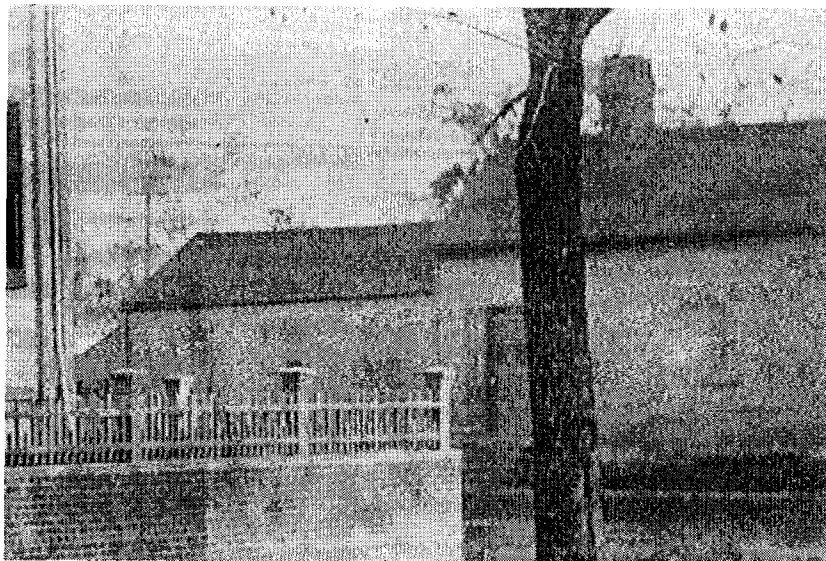
FIGURE 2.17: Circa 1888-1895 PHOTOGRAPH (FROM THE NORTHWEST)
This photograph shows most of the north elevation of the Arnold House prior to its relocation on the site. At the bottom is an enlarged portion of this photograph of the Arnold House. Note the open leaf of the door shutter and the white porcelain door knob.

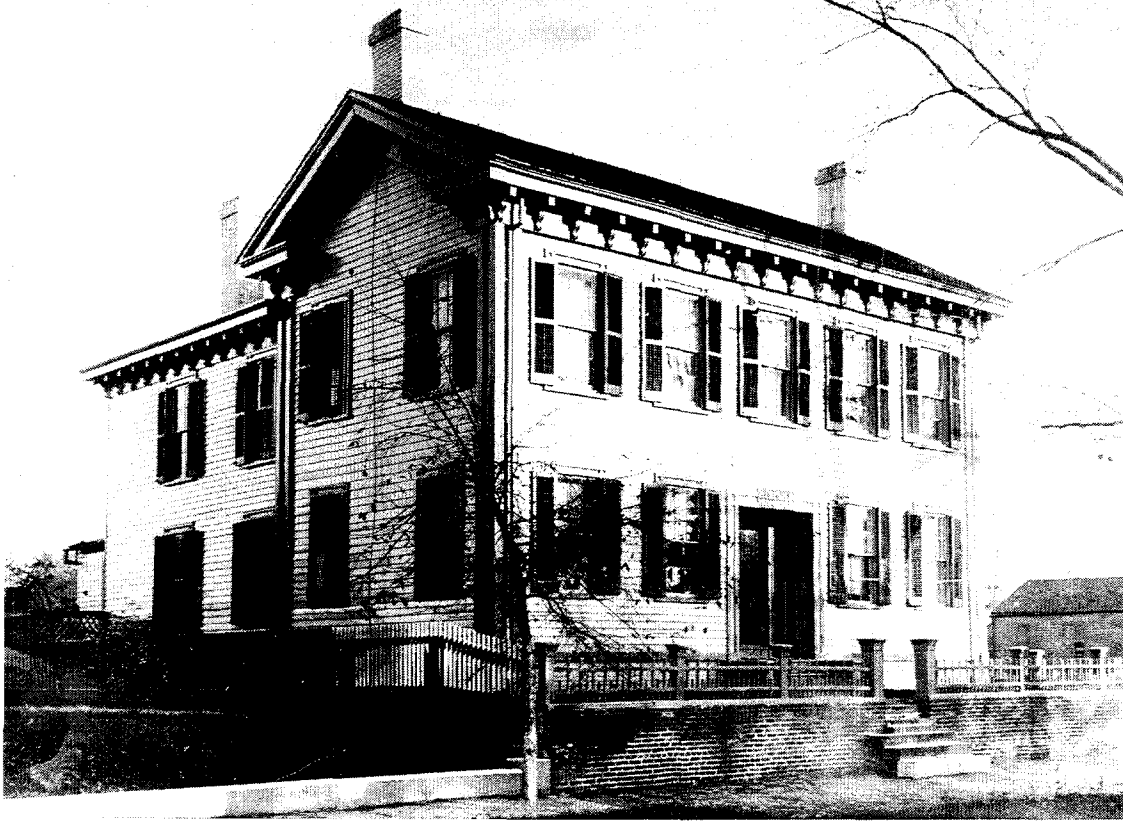
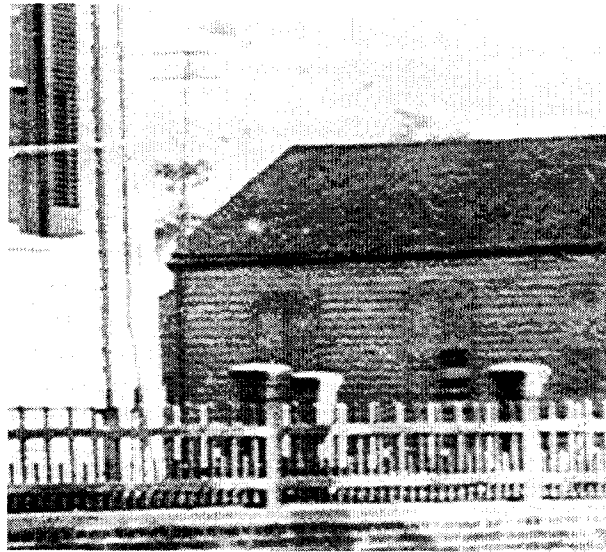
FIGURE 2.18: UNDATED PHOTOGRAPH (FROM THE NORTHWEST)
This photograph shows most of the early east addition to the Arnold House.

Nineteenth-century photographs provide evidence of the earliest envelope of the one-story east addition; however, what can be seen in the photographs is very limited. There are apparently three siding boards above the head trim of the windows. Several boards can be counted in Figure 2.18, but the lack of clarity in the photograph does not allow this siding to be compared with any building feature.

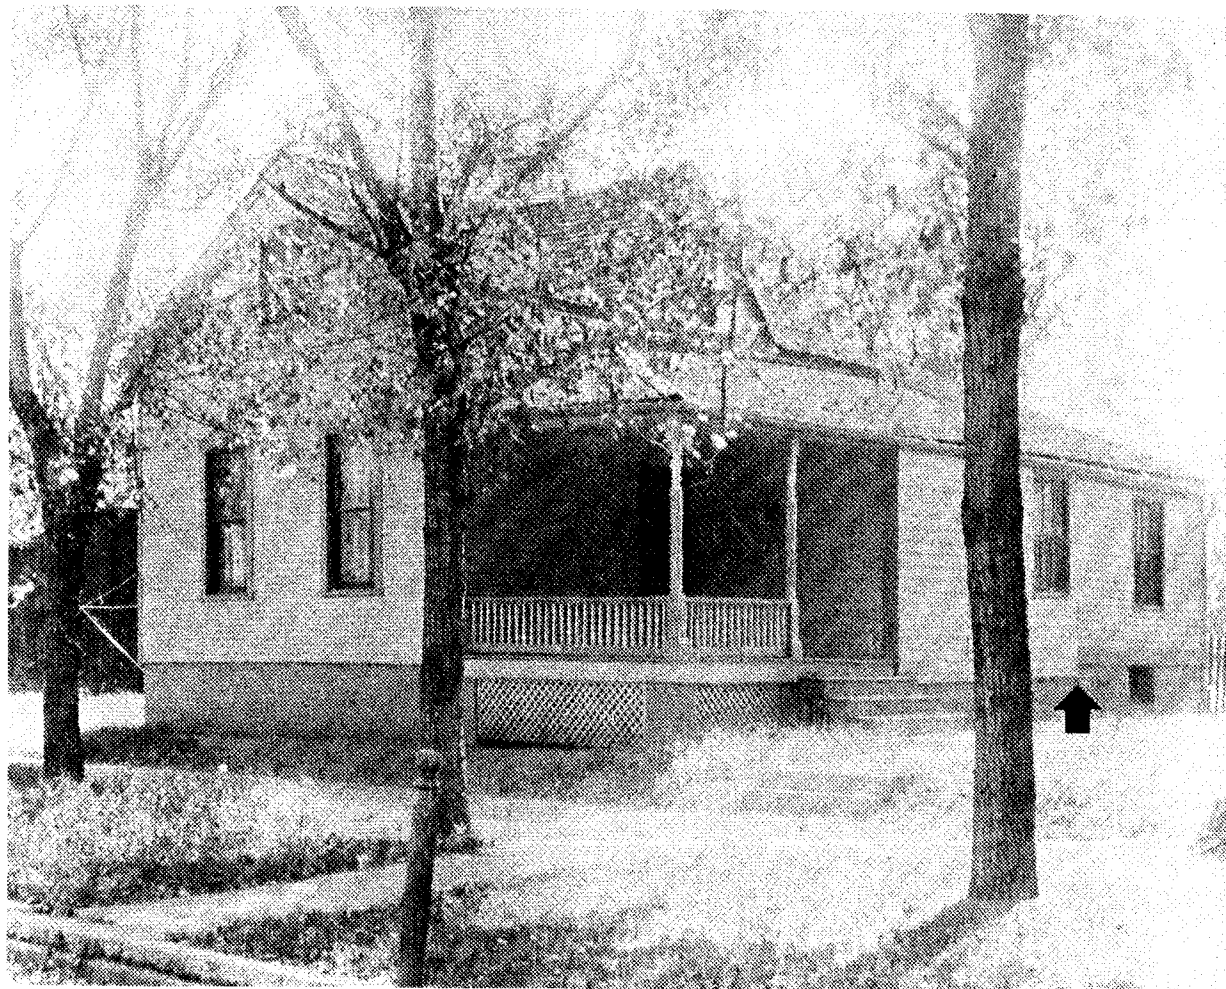
FIGURE 2.21: 1916 PHOTOGRAPH (FROM THE NORTHWEST)

This photograph of the Arnold House shows the house after it was relocated toward the rear of the lot. The house, relocated in 1900, was turned ninety degrees so that what is the north elevation in this view was the west elevation previously. The limits of the house seen here to the change in the siding height (see arrow) at the west elevation, represent the portions of the house that was relocated intact. The remaining portions seen in this photo were constructed using salvaged lumber. This salvaged lumber may have been from the additions to the original house at the previous location. Note added dormer and dormer windows.

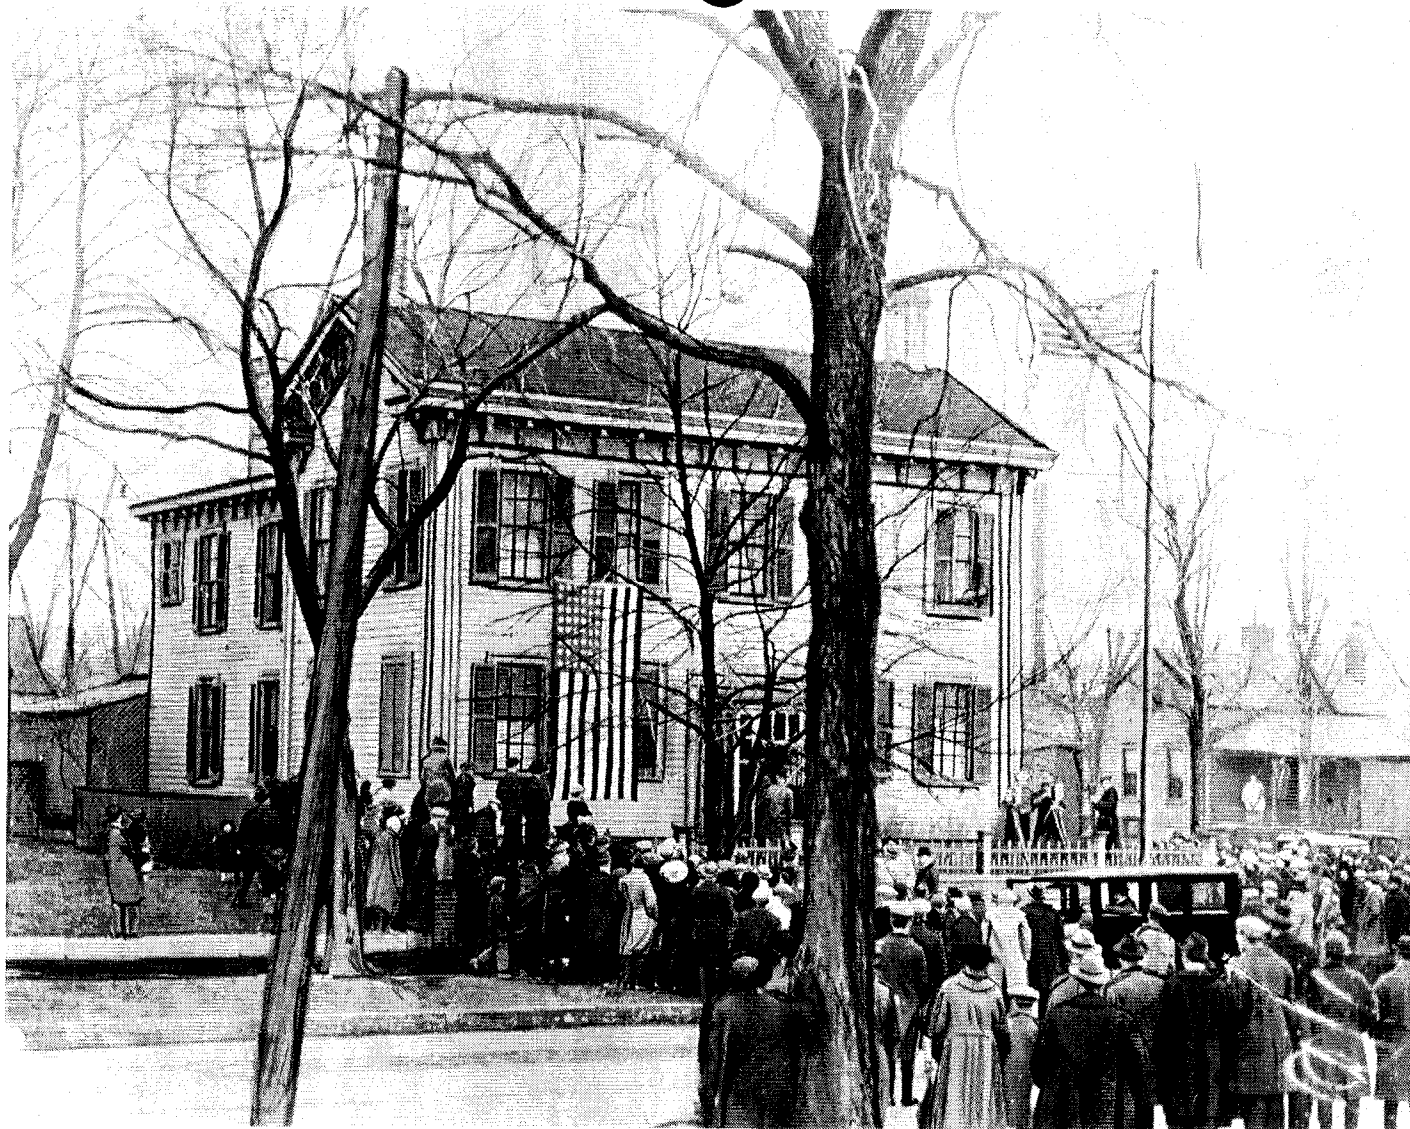
The second photograph (Figure 2.22), taken from further away and dating to circa 1920, shows a wider, albeit similar, view of the house. In this photograph the chimney stack is seen but no detail is discernable. A chimney stack not previously seen is also evident; however, it is not clear if this is part of the Arnold House or a neighboring house.⁸⁹ Also in this photograph, some character of the roof at the south addition to the house is seen. It, too, was built using salvaged lumber.

FIGURE 2.22: Circa 1920 PHOTOGRAPH (FROM THE NORTHWEST)
The Arnold House is seen at the right-hand side of the photograph.

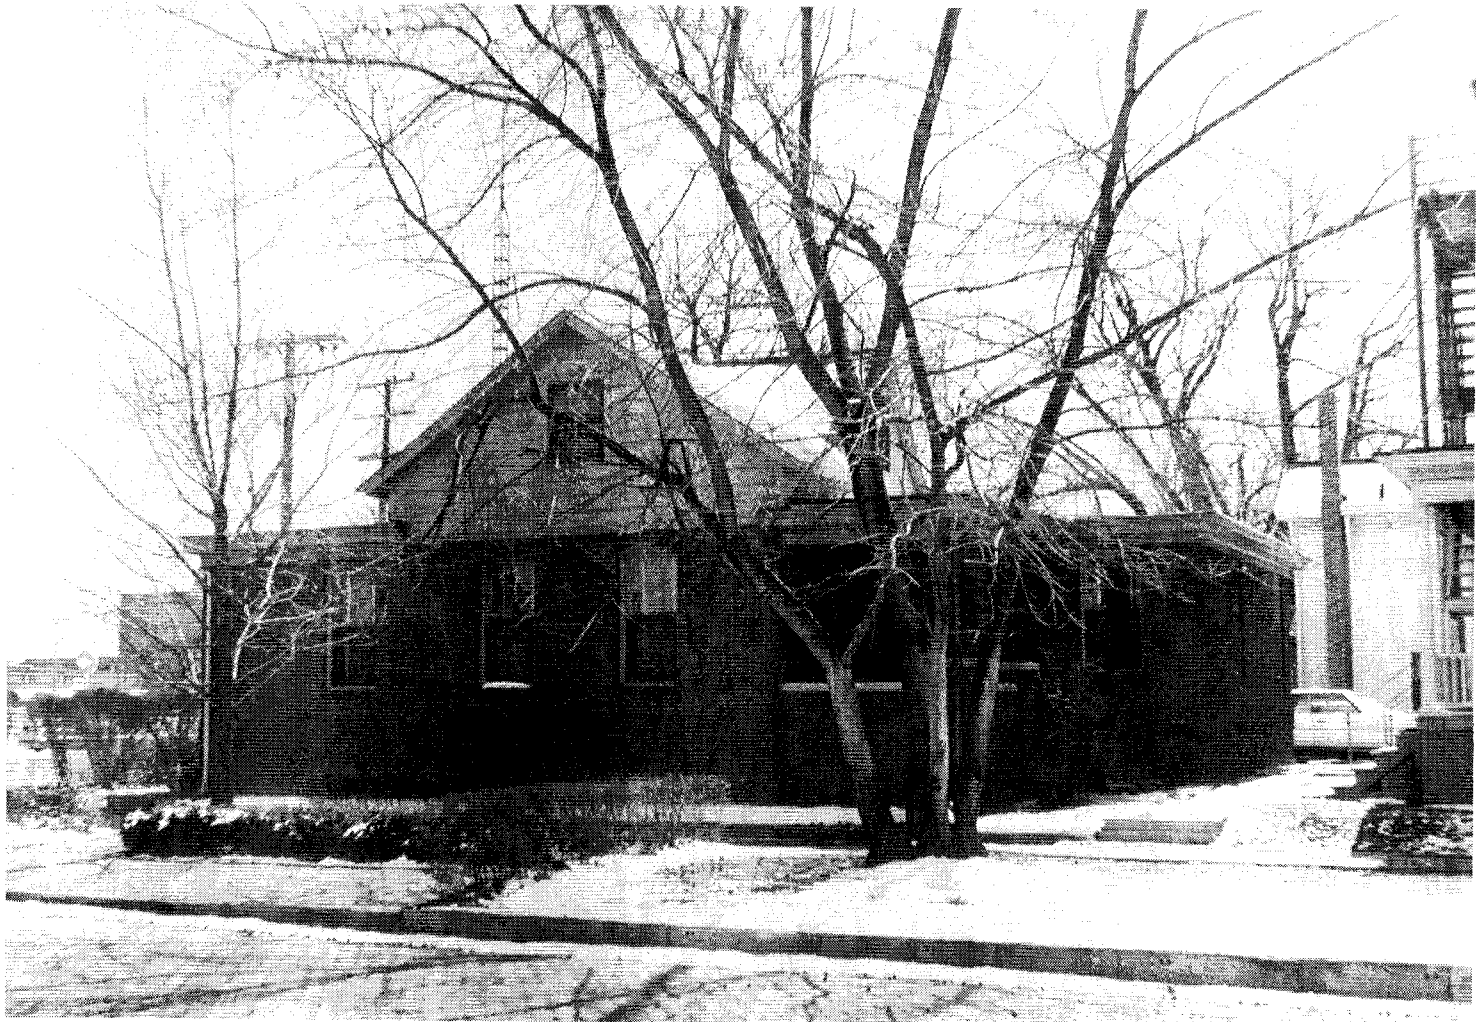
FIGURE 2.23 EARLY 1970's PHOTOGRAPH (FROM THE NORTH)
This photograph of the Arnold House was taken after the Lincoln Home National Historic Site was authorized. Note the close proximity of the Rebecca Cook House at 500 South Eighth Street.

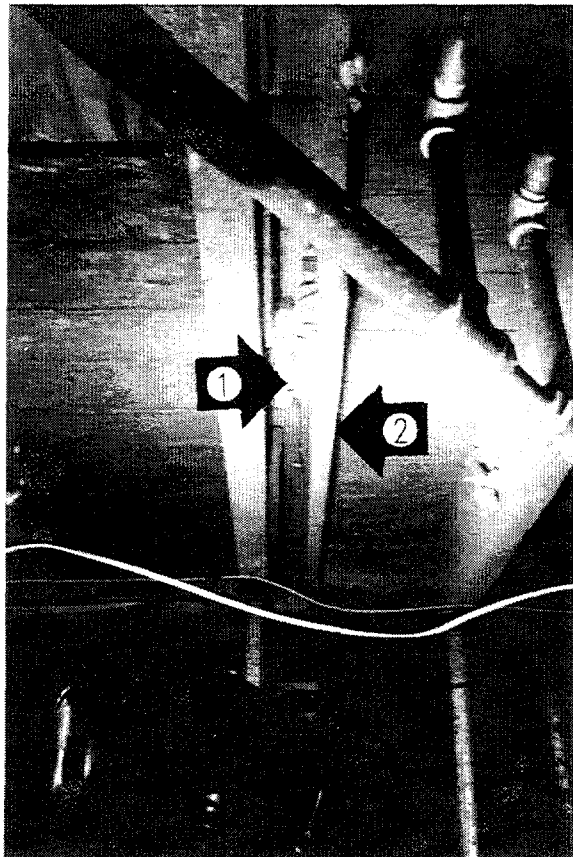
FIGURE 3.12: FRAMING AT NON-EXTANT INTERIOR WALL

There is little apparent evidence of the early floor plan of the house; however, it is probable that the plan was very simple, much as the house itself was. Remnants of an early wall, and patches or changes in the plaster finishes, suggest that there was originally a wall running across the house between the two intermediate posts in the sidewalls of the 1840 cottage. All of these pieces of evidence align with one another, and there is even a corresponding break in the subfloor at the first floor which can be viewed from the basement (see Figure 3.12). This wall was located approximately 15'-4" from the finish face of the

present north wall. Remnants of this same wall at the second floor (see Figure 3.26) indicate that this original wall was balloon-framed from the first floor joists to the rafters and collar ties at the roof. Portion of this wall remain today as part of the end-wall of the stair adjacent to the upper landing and the final two steps to the second floor (see Figure 3.23). During the nineteenth century and into the early twentieth century, this wall would have framed into the sides of the chimney.

Photo at the first floor framing and subfloor at the non-extant historic wall. Note the break in the floor (1) and the 1"x nailer board at the ends of the floor boards (2).

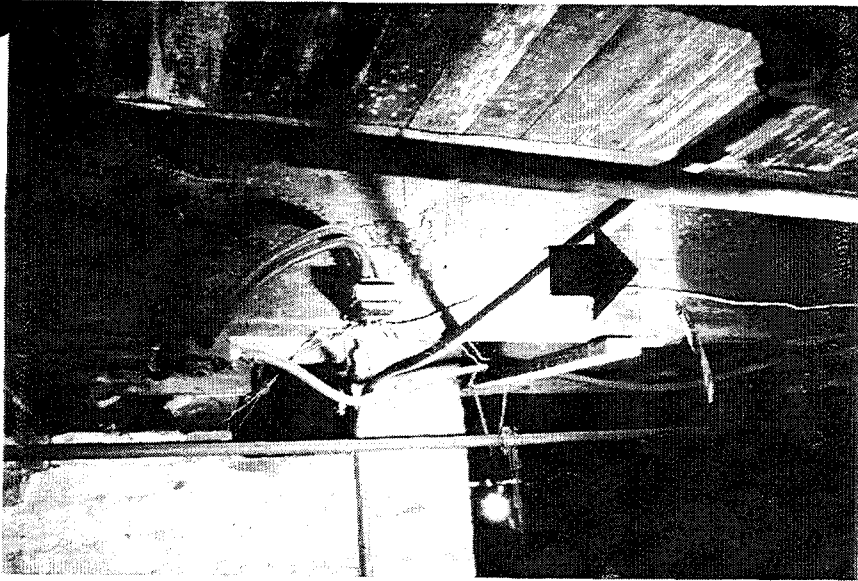
FIGURE 3.13: CHARRED FRAMING

Note the former joist location visible on the bottom and side of this charred joist.

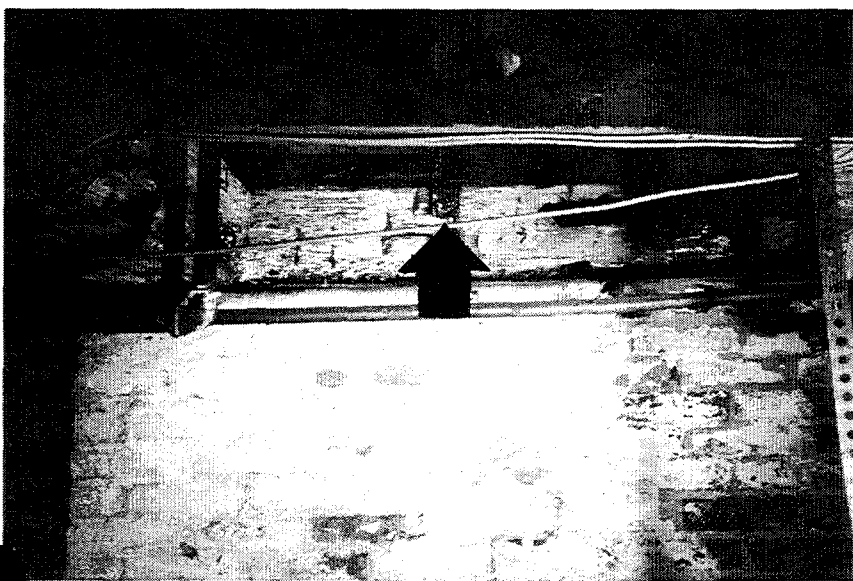
FIGURE 3.14: ALTERED FRAMING

There is evidence of a basement access stair after the house was relocated in 1900. A paint outline on the west wall of Room 002 (see Figure 3.11) indicates a steep stair to the basement. Although it is not entirely clear, this stair probably had ten treads and eleven risers. The shadow outline in the paint on the basement wall indicates risers and treads about 8" each. To install this stair, a floor opening had to be framed in, which required that three floor joists be severed and the ends removed. Pockets in the sill beam indicate that the joists at this framed opening originally continued to the sill beam at the wall adjacent to the stair (see Figure 3.14). It is not known if this location for an interior basement access pre-dates 1900.

View of sill beam at the interior basement stair opening. Note the severed joist tenon remaining in the sill beam mortise.

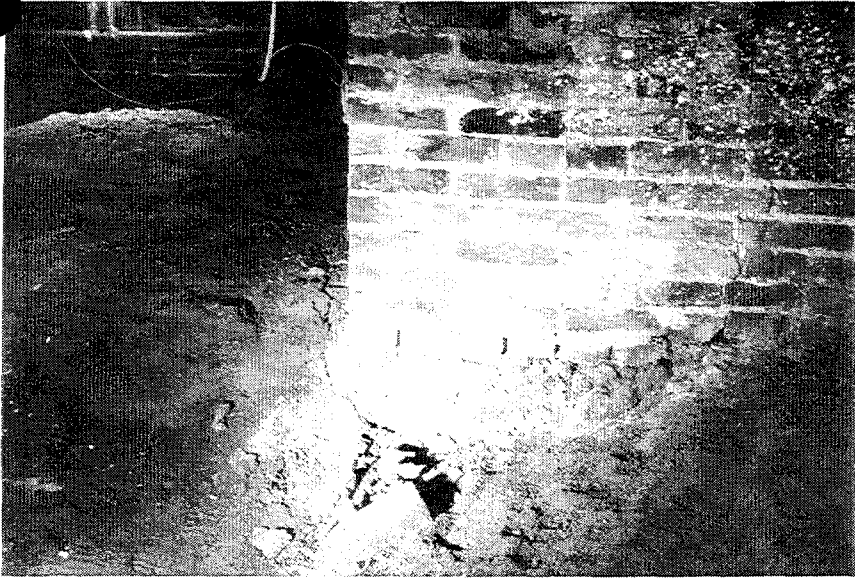
FIGURE 3.15: FOUNDATION WALL

View of brick foundation wall at the exposed base.

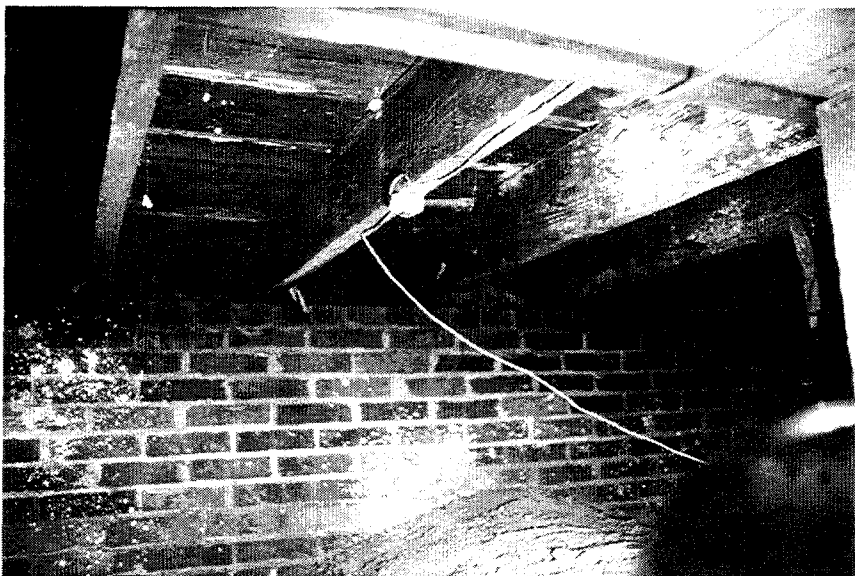
FIGURE 3.16: FLOOR FRAMING

First floor framing at Crawlspace 004A.

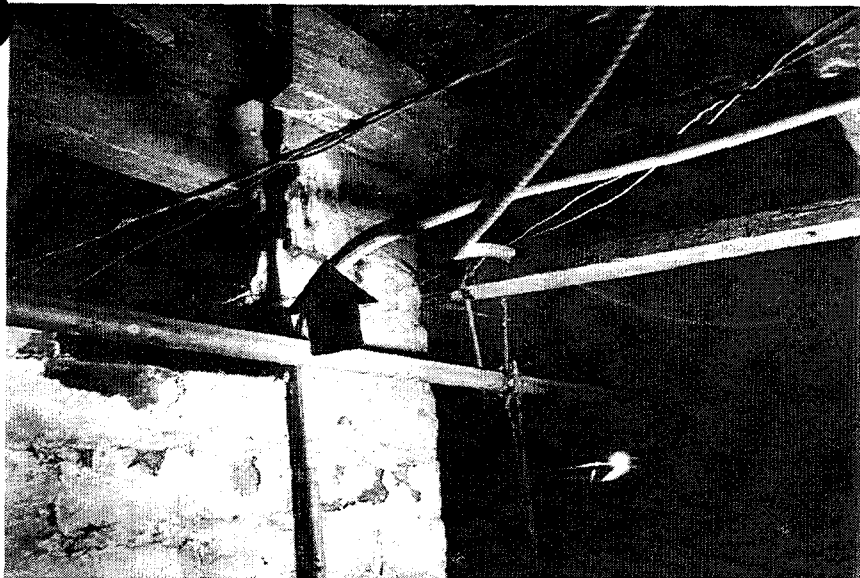
FIGURE 3.17: ORIGINAL CORNER BOARD

Remnants of an original corner board.

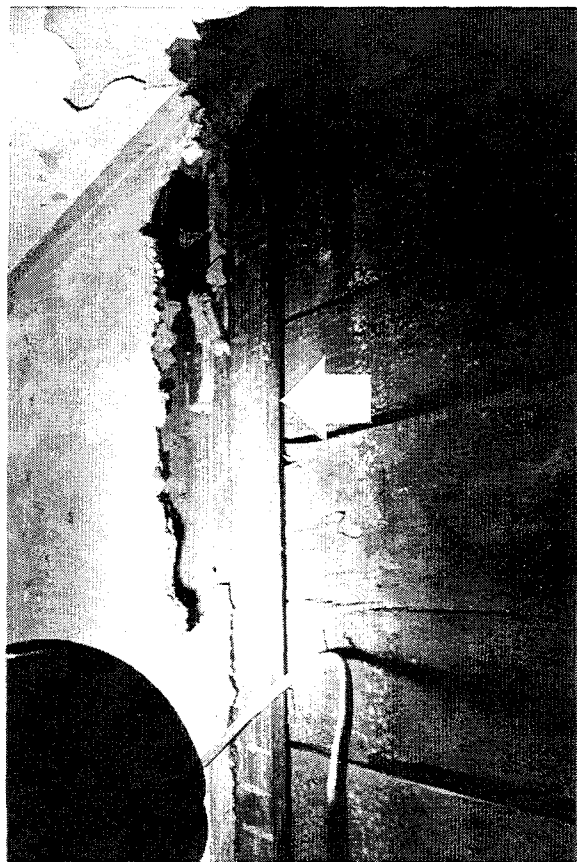
FIGURE 3.18: ORIGINAL CORNER BOARD

Original corner board and wide board sheathing behind later wall finishes. Note the faint historic clapboard siding marks on the board.

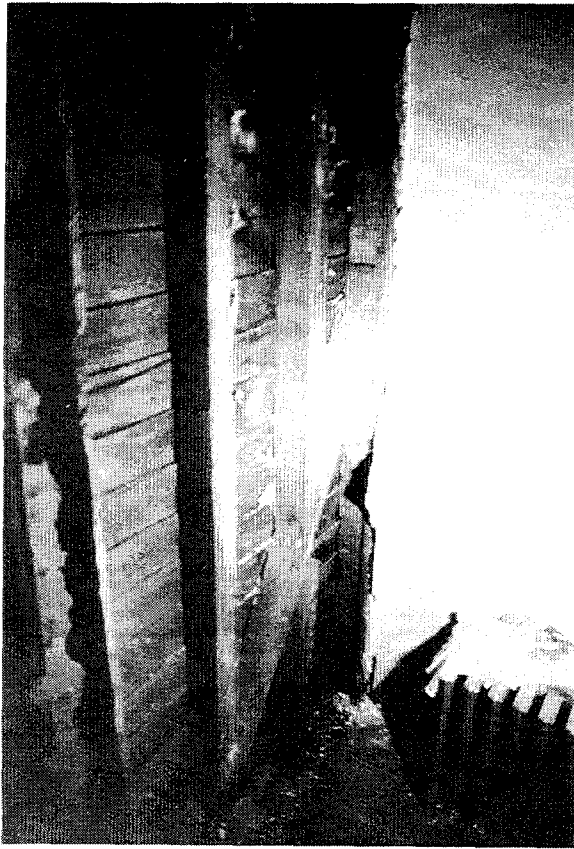
FIGURE 3.19: CORNER BRACING

Diagonal corner bracing at the present northwest (original southwest) exterior corner of the 1840 cottage.

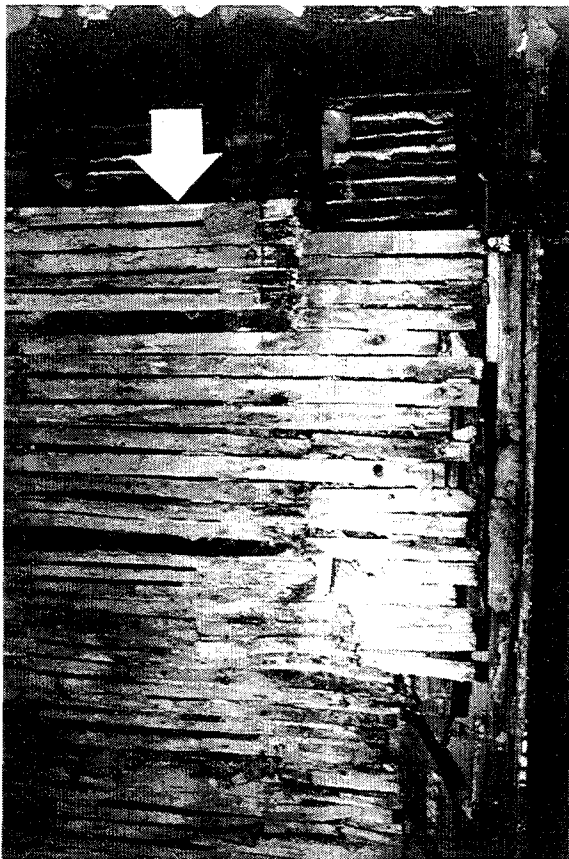
FIGURE 3.20: HAND-SPLIT LATH

Pre-1850 lath at the intermediate post at the east wall of Room 104A.

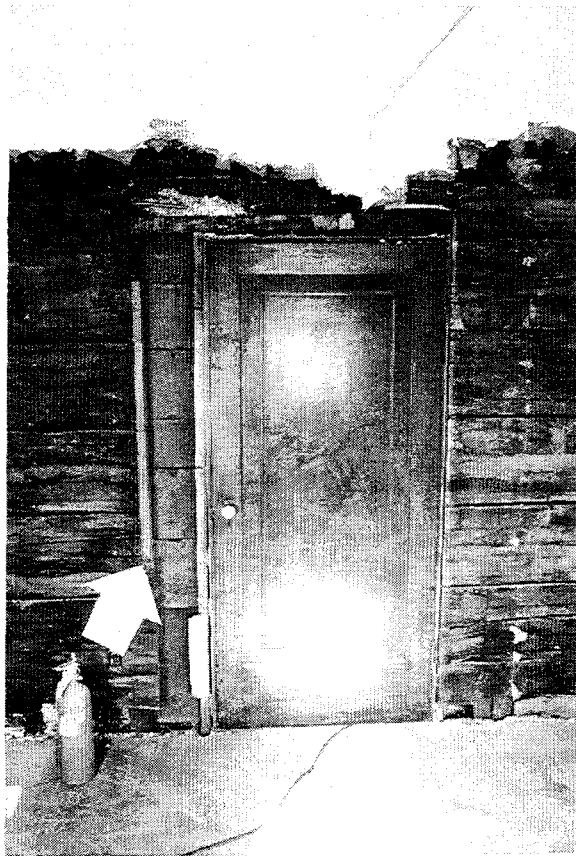
FIGURE 3.21: ORIGINAL WINDOW LOCATION

Door 108E is placed in a former window location. Note the short sheathing board return at the lower left corner of the opening.

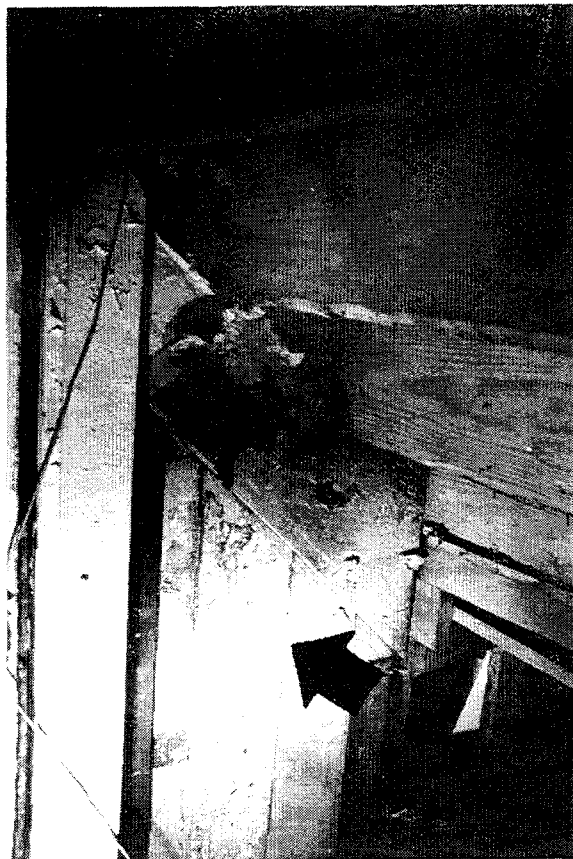
FIGURE 3.22: ORIGINAL STAIR STRINGER

Portions of the existing stair framing dates to the earliest stair construction. Two $\frac{3}{4}$ " x 12" stringers remaining from the original stair construction have been exposed at the sloped ceiling above the water closet in Room 101E (see Figure 3.22). These stringers are in good condition; however, the stair's original structural configuration has been altered, probably as part of the circa 1940's renovations. A small remnant of the original stringer at the end of the present west stringer suggests the beginning of framing for a winder. The current east stringer frames into a $2\frac{3}{4}$ " x $4\frac{1}{2}$ " post under the landing while the current west stringer frames onto the side of $1\frac{3}{4}$ " x $3\frac{1}{2}$ " post and is apparently nailed to the wall. The contemporary treads and risers (probably dating to the circa 1940 renovations) installed at the original stringers, as well as the landing and two final steps to the second floor from the upper landing, maintain their original tread size and slightly-varying riser heights. The treads are $9" \pm$; however, the risers vary from $8\frac{1}{4}"$ to $8\frac{1}{2}"$ below the upper landing and $8"$ to $7"$ at the final steps to the second floor. There is a contemporary low guard rail at this second floor stairwell opening.

Note the vertical board wall finish at the wall adjacent to the stud.

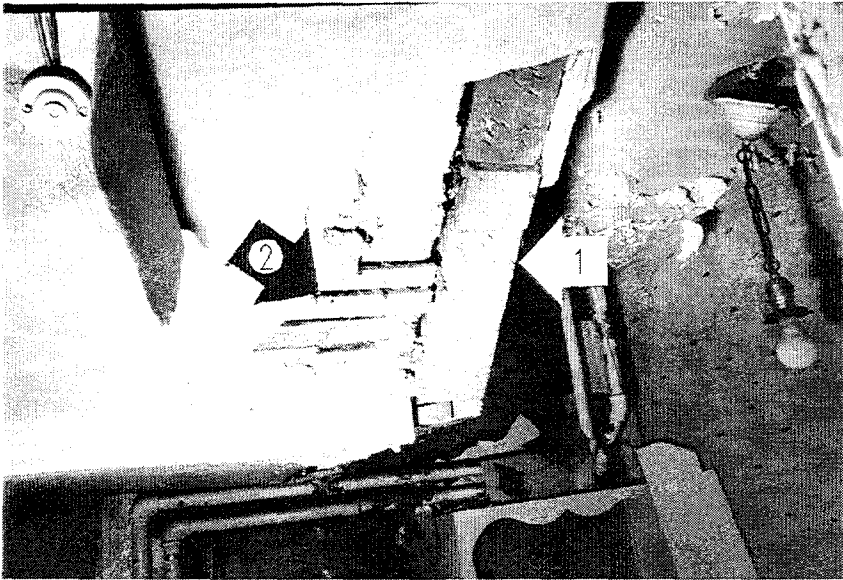
FIGURE 3.23: HAND-SPLIT LATH AT THE STAIR SOFFIT

As previously stated, some areas of early plaster over hand-split lath remain at the stair soffit (see Figure 3.23). This lime-based, hair-reinforced plaster pre-dates the 1850's. The yellowish color of the sand in the plaster also indicates a pre-1870's date.²⁴ This makes the plaster found at the landing soffit among the oldest plaster remaining in the house. This plaster is in good condition with the exception of a few areas where it has loosened from the lath. Paint

Remnants of the removed original interior wall at first floor (1) are seen in this photograph. Note the hand-split hickory lath on the stair soffit (2).

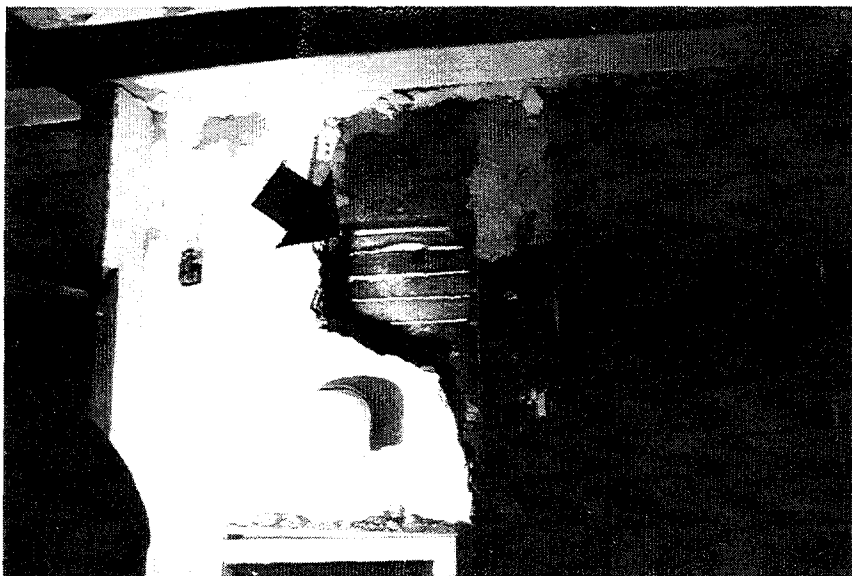
FIGURE 3.24: CUT-OUT IN THE SHEATHING

There is also evidence suggesting that a free-standing cast iron heating stove once stood in the east one-story addition to the original 1840 cottage. A 10" diameter, rough-cut hole in the wall sheathing, found behind the plaster in Room 106A at what is now the south wall (the east wall prior to 1900) of the 1840 cottage, was probably the passage for a heating stove smoke pipe (see Figure 3.24). This pipe would have probably vented through the brick chimney.

Opening cut in sheathing for the flue pipe passage.

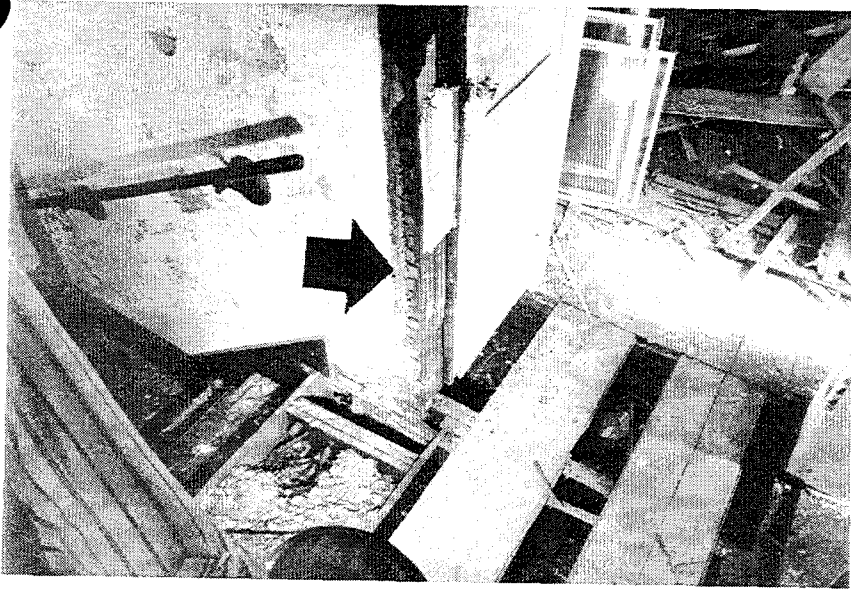
FIGURE 3.25: NON-EXTANT HISTORIC WALL

At a circa 1840 wall on the second floor, near the top of the stair, there is a line in the early plaster indicating the former edge of a door casing (see Figure 3.25). Further, there are two almost-parallel cracks, approximately 5" apart, at the ceiling running in the same direction as, and in the same plane as, the early wall. These plaster cracks are apparently at the edges of a plaster patch. The opposite end of this apparent door opening has been lost to later renovation work. The clearly vertical line of the early plaster, coupled with the patch in the ceiling,

Remnants of non-extant original interior wall are seen at second floor. Note the hand-split hickory lath and line of an apparent non-extant door trim.
