HISTORIC STRUCTURE REPORT

CHARLES E. ARNOLD HOUSE (HS-20)

Lincoln Home National Historic Site
Springfield, Illinois

August, 1994

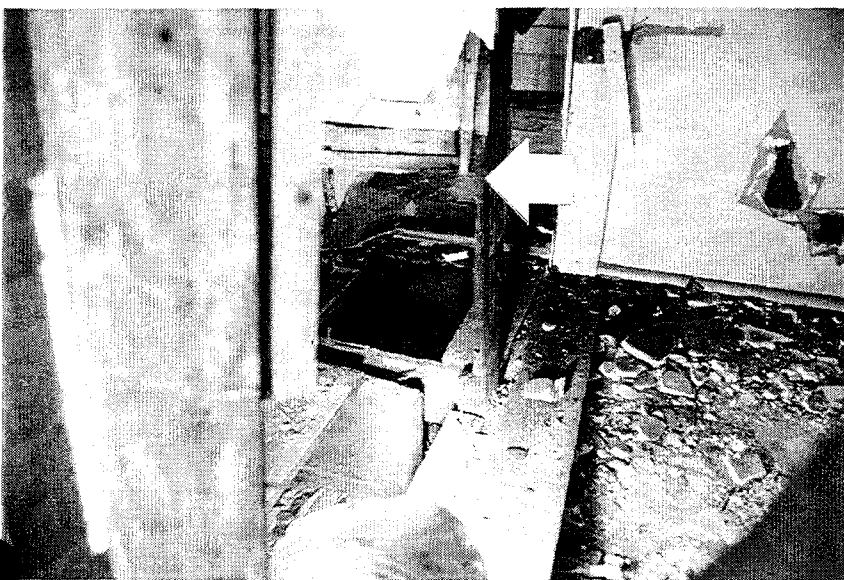
FIGURE 3.26: NON-EXTANT HISTORIC WALL

present north wall. Remnants of this same wall at the second floor (see Figure 3.26) indicate that this original wall was balloon-framed from the first floor joists to the rafters and collar ties at the roof. Portion of this wall remain today as part of the end-wall of the stair adjacent to the upper landing and the final two steps to the second floor (see Figure 3.23). During the nineteenth century and into the early twentieth century, this wall would have framed into the sides of the chimney.

Remnants of non-extant original interior wall at second floor. Note the notch in the bottom of the stud.

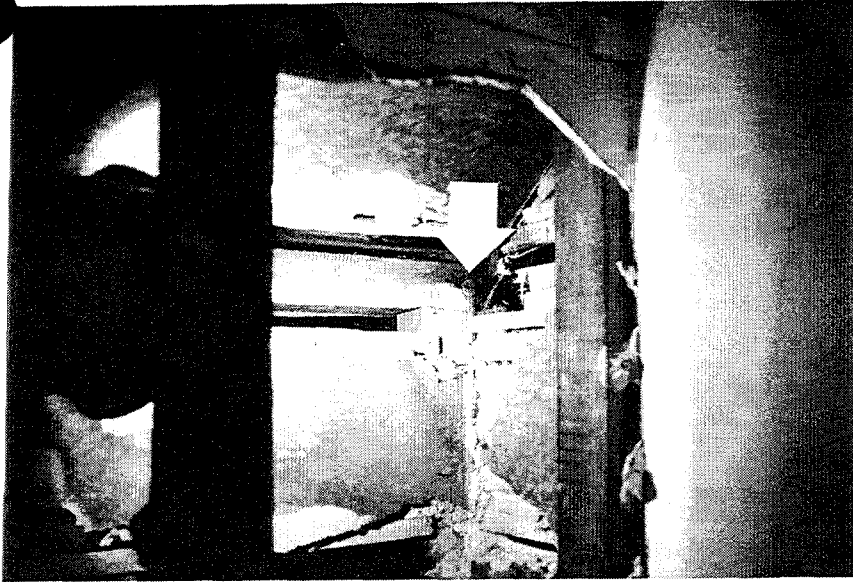
FIGURE 3.27: ORIGINAL TOP PLATE

Exterior sidewall at the top plate. Note the treenail fastening at the top plate and corner post.

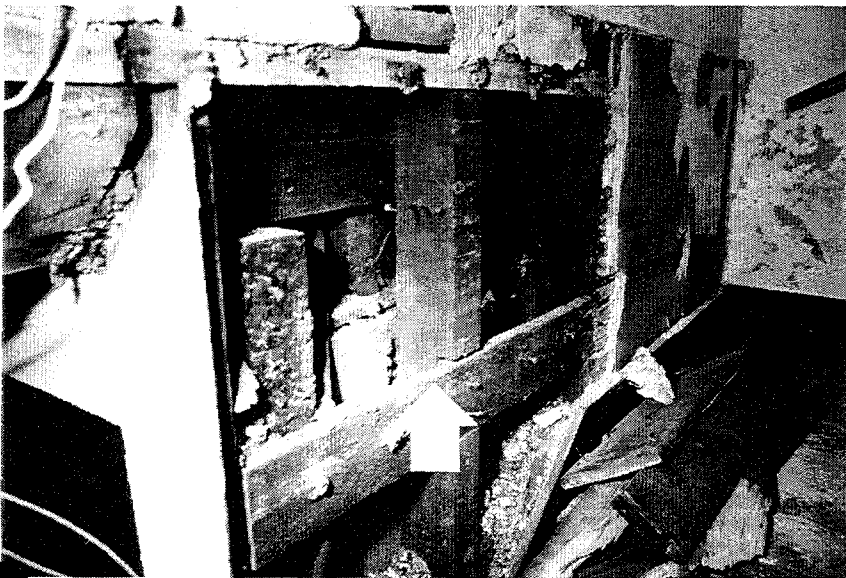
FIGURE 3.28: LEDGER BOARD AT STAIR

The history of the interior stairs of the Arnold House can only be understood from the physical conditions investigations. The earliest stair in the Arnold House was probably a ladder, rather than a stair. Slight indentations forming joists saddles in the ledger board at two of the studs adjacent to the existing stair opening suggests that the floor joists continued across the stairwell at one time (see Figure 3.28). This indicates the second floor was accessible only by a ladder, probably located in the area of the existing upper landing. It is not clear how

Ledger board at the exterior sidewall adjacent to Stair S1. Note the joist saddles on the ledger adjacent to the studs.

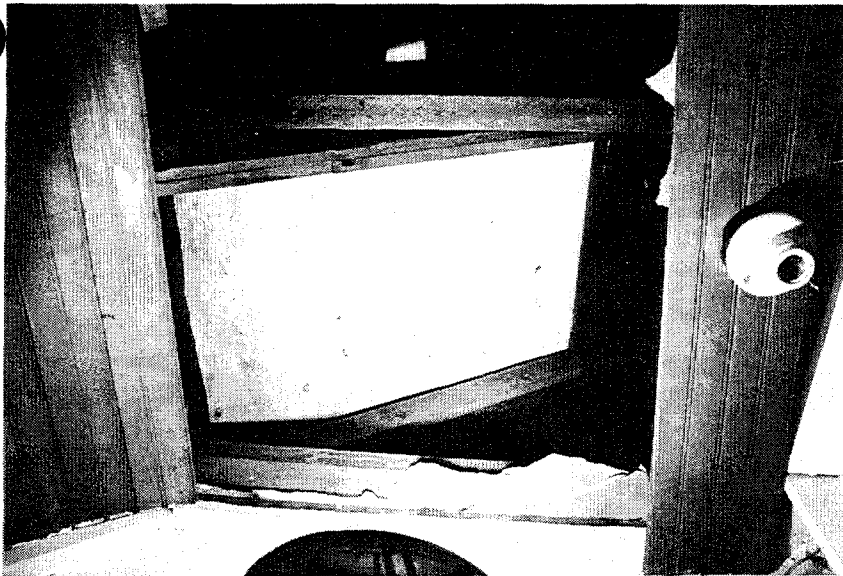
FIGURE 3.29: ROOF FRAMING AT NON-EXTANT CHIMNEY

The framed opening at the roof (see Figure 3.29), when considered with the east limits of the chimney opening at the second floor framing, indicates that the maximum size of the chimney stack through the roof would have been 2'-0" (at the present east and west) x 1'-4" (at the present north and south).

View of the framing closure at the non-extant chimney.

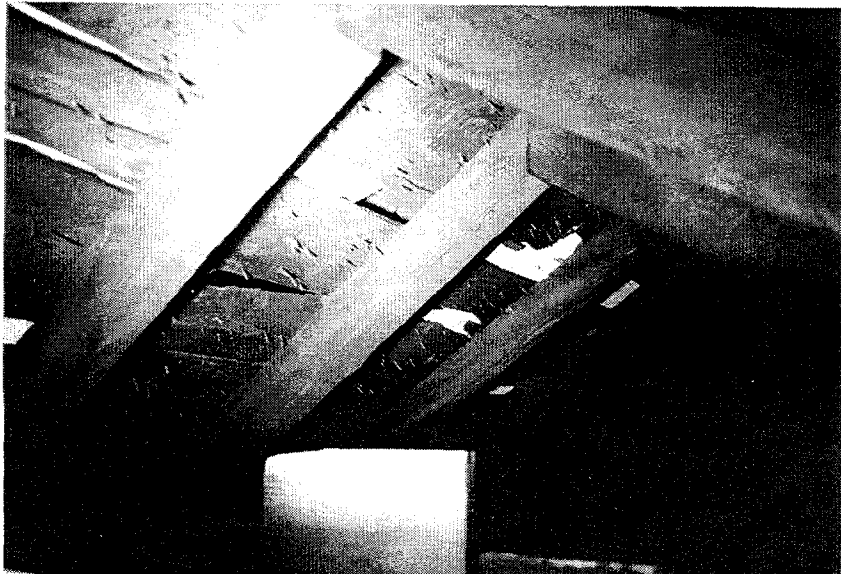
FIGURE 3.30: ROOF FRAMING

View of the roof rafters and original roof sheathing.

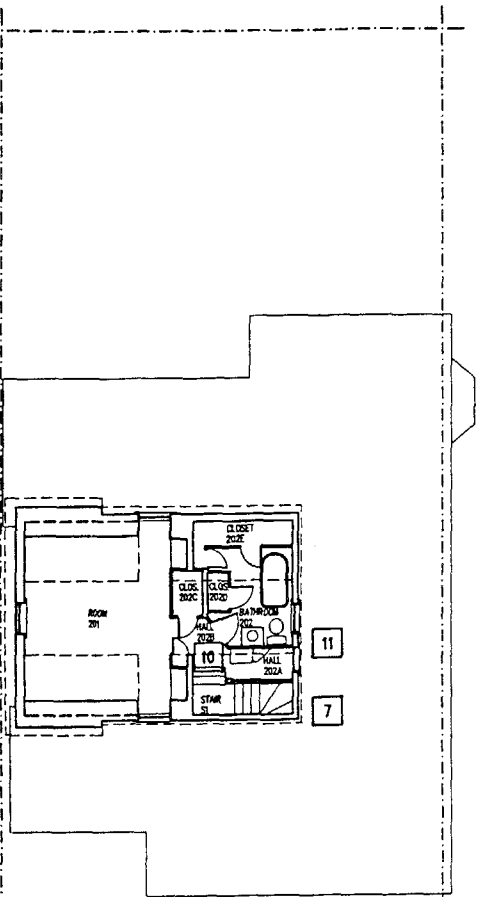
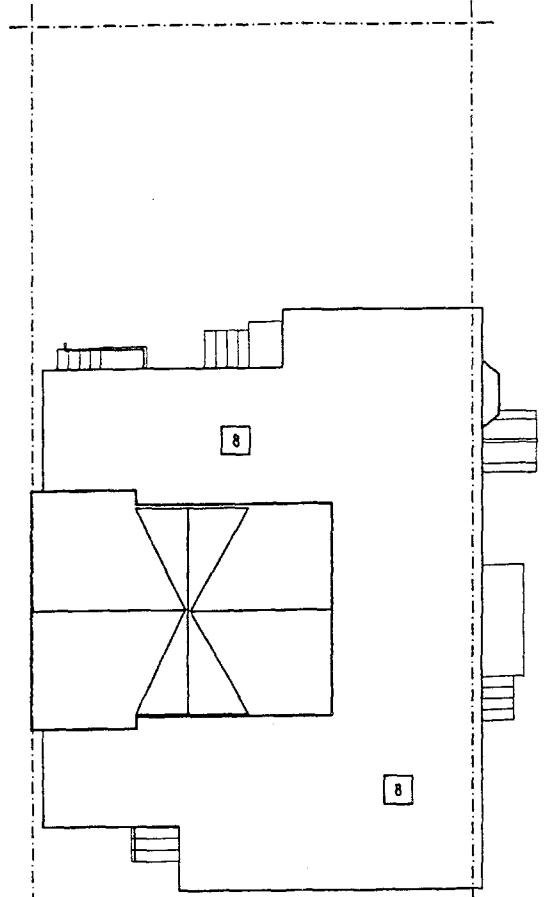
- 1 THIS FIREPLACE AND CHIMNEY STACK WAS DEMOLISHED TO THE FOUNDATION AND THE HEARTHINGS WERE REMOVED.
- 2 INTERIOR BASEMENT ACCESS REMOVED.
- 3 CHIMNEY FLUE AND BASEMENT WALL DEMOLISHED TO FLOOR.
