HISTORIC STRUCTURE REPORT

JULIA SPRIGG HOUSE (HS-11)

Lincoln Home National Historic Site
Springfield, Illinois

May 1995

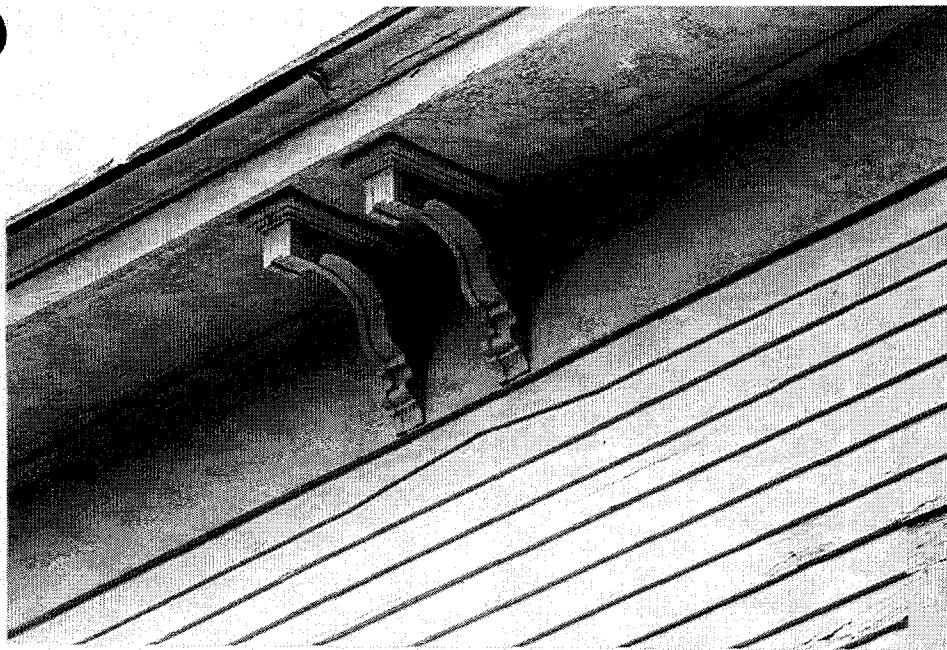
**FIGURE 3.5 TOP
CLAPBOARD AT
SOUTH WALL
1874/1879 ADDITION**

Although no original interior window trim casing has been found, paint marks at the windows in the intermediate attic suggests that this casing was approximately 5" wide. These paint marks do not indicate any kind of profile at the head casing trim. Additionally, an angled profile cut into the bottom one-third of the clapboard directly beneath the south elevation frieze board, probably follows the profile of the exterior head trim at the 1874/1879 second floor window, which would have been located at this elevation (see Figure 3.5). It is probable that all the 1874/1879 windows and doors had a similar head profile.

This angle cut profile most likely was cut to match the head trim profile at an 1874/1879 window in this location.

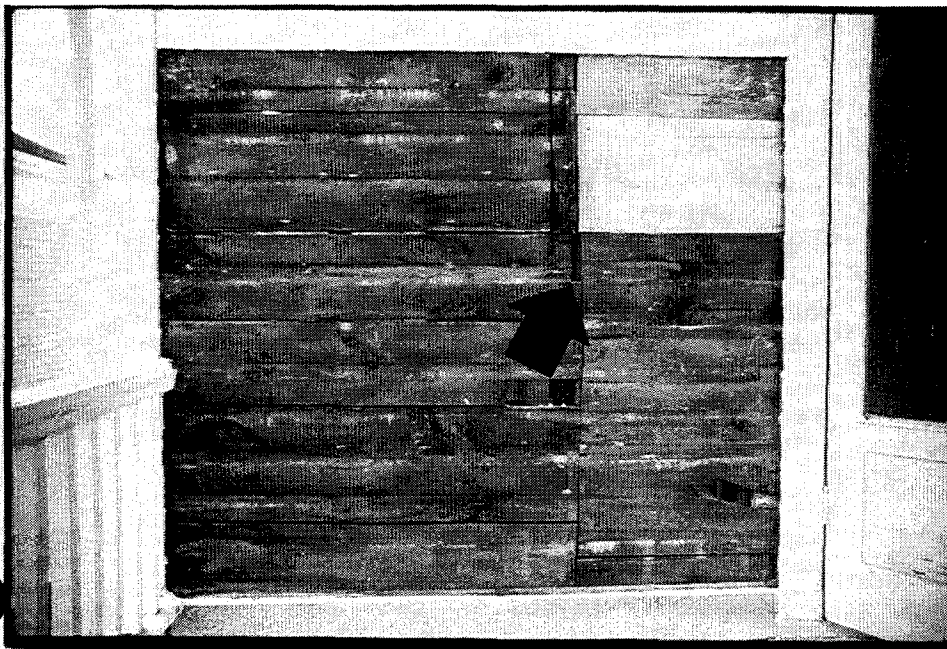
**FIGURE 3.6 SECOND
FLOOR SHEATHING**

Only minimal evidence of the second floor window sill rough openings has been found. An opening in the sheathing at the south window indicates a sill rough opening 2'-9½" ± above the existing finish floor. An apparent cut in the sheathing at the southern-most window on the east wall indicates a sill rough opening 3'-3" ± above the existing finish floor (see Figures 3.6 and 3.7). No clear evidence has been found to suggest a sill rough opening at the windows in the west wall. However, it can be certain that the sills would have been clear of the roof line of the 1851 cottage. It should be noted that the heights of the head and sill rough openings from the original floor level would be 2'-0" ± less than those listed above.

This is a view of the sheathing at the south end of the east wall on the second floor of the 1874/1879 addition. Note the slight cut in the sheathing apparently indicating a window location.

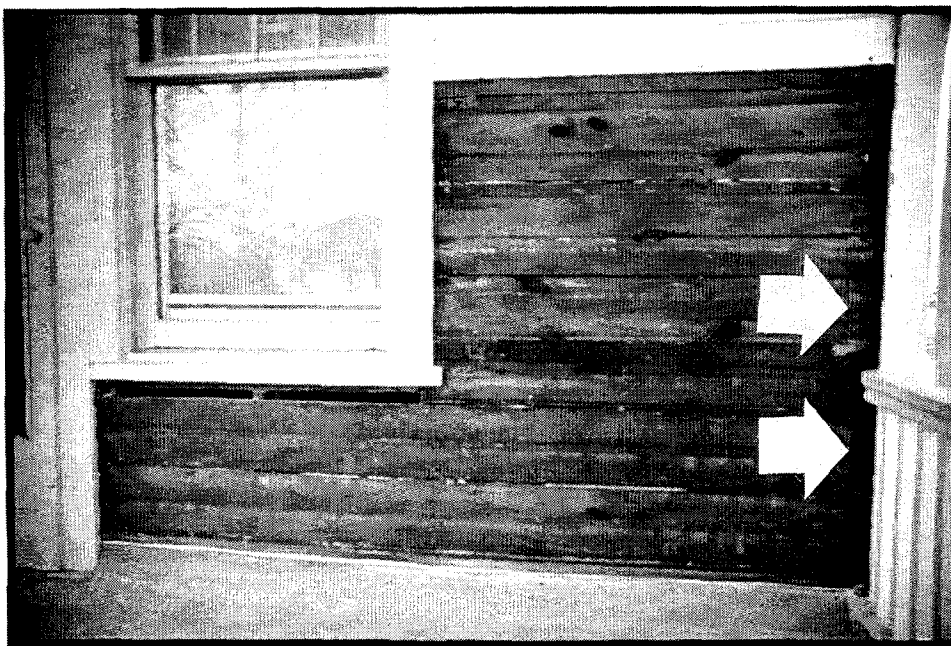
FIGURE 3.8 SECOND FLOOR SHEATHING

The north, east, and south walls of the 1874/1879 addition are sheathed with a 1" x wide board sheathing (see Figure 3.8), varying in width from 8" to 12½". Where removals allowed for examination, this sheathing appeared to be in good condition. No sheathing was found at the west elevation. It may be that no sheathing ever existed at this surface; rather, the interior side of the studs (see Figure 3.63) was sheathed, or perhaps the sheathing was removed as part of the 1922/1924 renovations. No conclusive evidence has been found to confirm either possibility.

A view of the sheathing at the north end of the east wall at the second floor of the 1874/1879 addition. Note the opening in the sheathing for the window. Also note the two areas of sheathing cut outs (one is infilled) near the corner board and handrail.

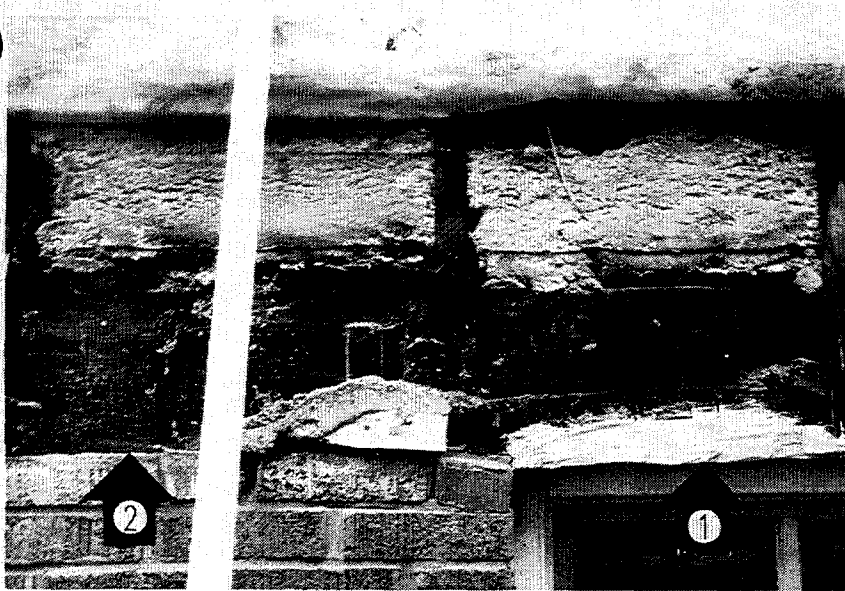
FIGURE 3.9 SILL BEAM AT THE SOUTHWEST PORCH

View of sill beam (1) and box sill (2) junction in the south wall of the 1851 cottage. This junction is near the limits of the southwest porch.

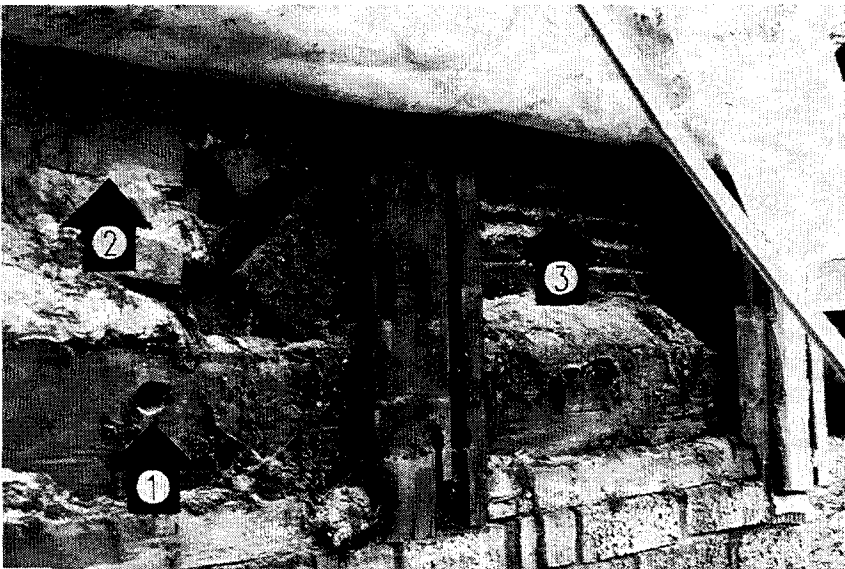
FIGURE 3.10 NORTHWEST CORNER OF THE 1851 COTTAGE

A view of the diagonal bracing at the northwest corner (north wall). Note the treenail location (now only a hole) (1), the brick nogging (2), and hand hewn lath to the right side of the photograph (3).

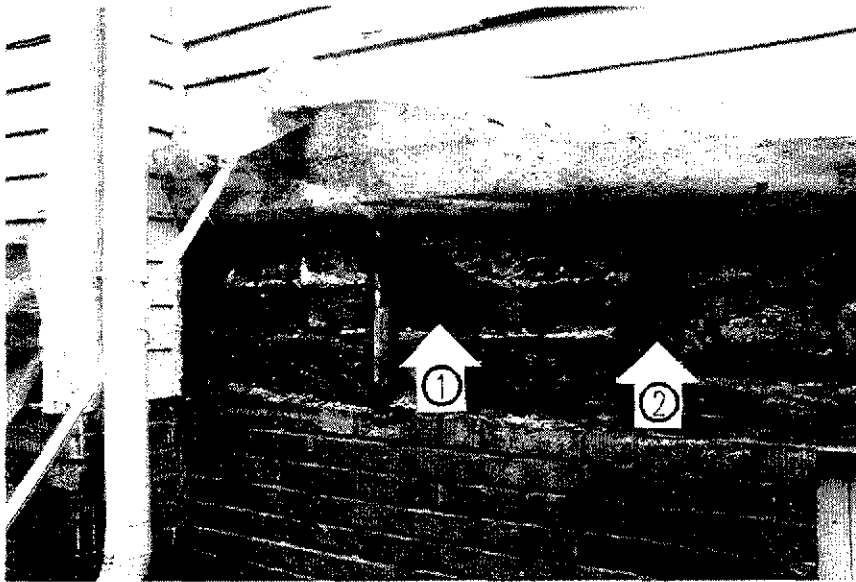
FIGURE 3.11 NORTH-EAST CORNER OF THE 1851 COTTAGE

A view of diagonal bracing (1) at the northeast corner (north wall) of the 1851 cottage. Note the furring strips on the face of the studs (2). These studs were furred-out to allow alignment with the sheathing at the second floor.

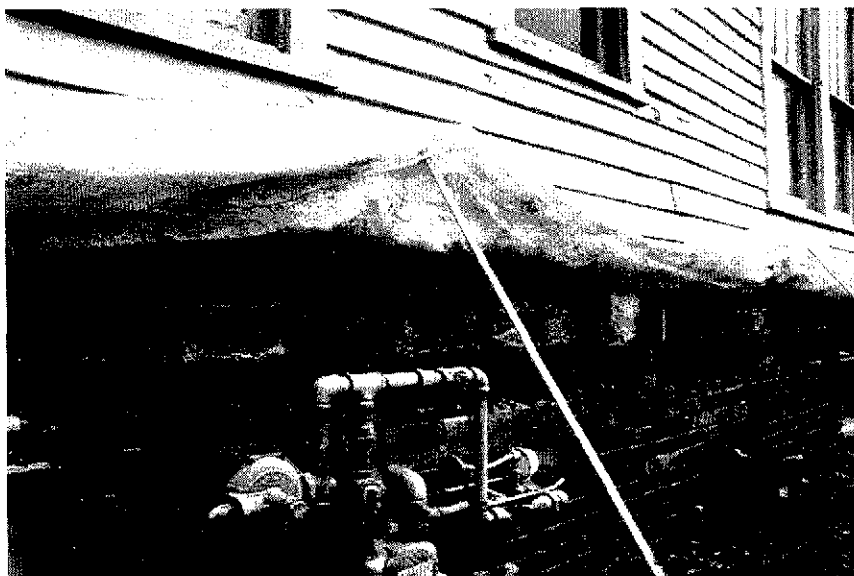
FIGURE 3.12 VIEW OF THE NORTH WALL OF THE 1851 COTTAGE

A view of the north wall showing studs, stud furring, and brick nogging.

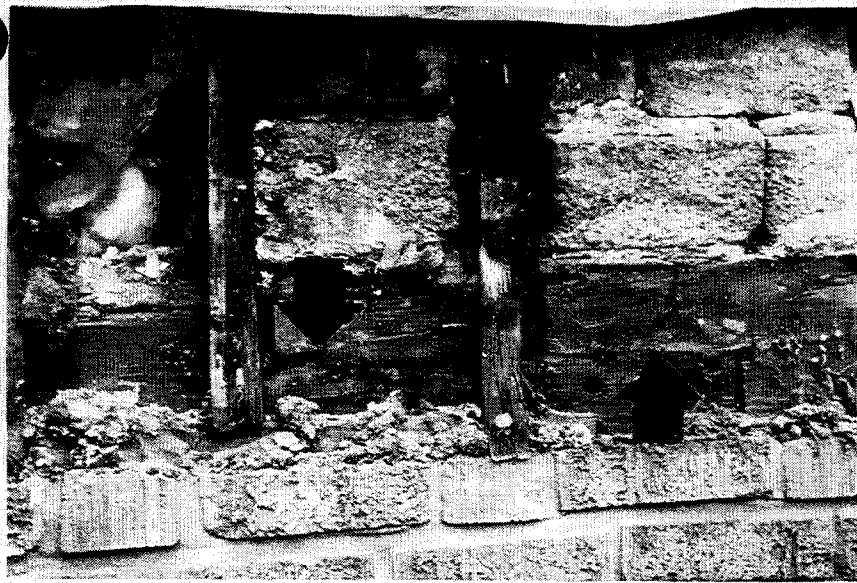
FIGURE 3.13 SHOULDER LAP AT THE 1851 COTTAGE SILL BEAM

This is a view of the shoulder lap at the north sill beam at the west ell.

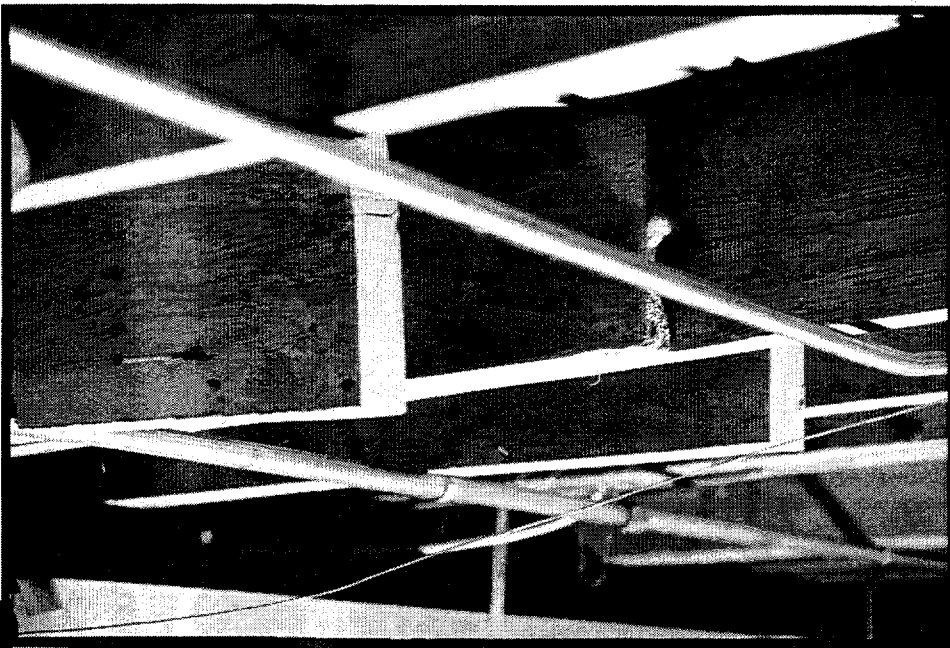
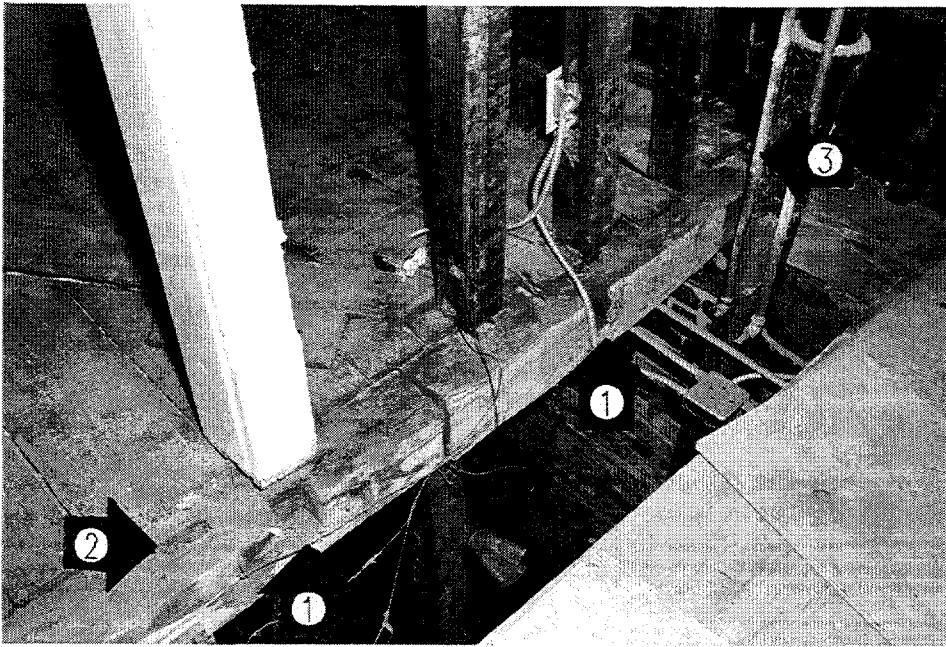
FIGURE 3.19 JOIST POCKETS AT THE SOUTHWEST PORCH

beam. Approximately 12'-9" east of the west foundation wall, there is a 5½" (wide) x 5⅞" (tall) beam which is dovetailed into the perimeter sill beam (see Figure 3.19). This beam lies at the eastern limits of the original porch. This beam, dovetailed into the perimeter sill beams, is severed into two sections near the south foundation wall. The construction techniques used and this beam's similarity to the east-west traveling beams at the mid-span indicate that this beam was installed as part of the original cottage construction. The fact that it is in two sections may only be a condition of available lumber lengths. Originally, this beam most certainly rested on a foundation wall. Today, the severed ends are supported at their break by a single 4x4 nominal twentieth-century post. The original joists west of this beam span from the north sill beam over the center sill beam and cantilever. The cantilevered ends of these joists (see Figure 3.18) lie at the northern limits of the original southwest porch and indicate the possible location of an original sill beam set on top of a non-extant foundation wall. Twentieth-century nominal framing has been installed in the area of this porch. Approximately 3'-0" of the south sill beam and a 2" x 8" box sill, aligned with the exterior face of the adjacent sill beam (see Figure 3.9), represents the south limits of this early porch. Joist pockets in the east beam (see Figure 3.19) and the west sill beam indicate that longitudinal joists spanned this area at one time carrying the porch floor loads. There is an additional pair of pockets notched into the south sill beam. For an additional discussion of this porch, see PORCHES in this Division.

This wood sill beam, severed into two pieces, is located at the east limits of the southwest porch of the 1851 cottage. Note the joist pockets in the beam (1). At one time the porch floor joists framed into these pockets. Also note the mortise for a stud tenon (2) and the dovetailed joint (3) where this sill beam intersects the perimeter sill beam.

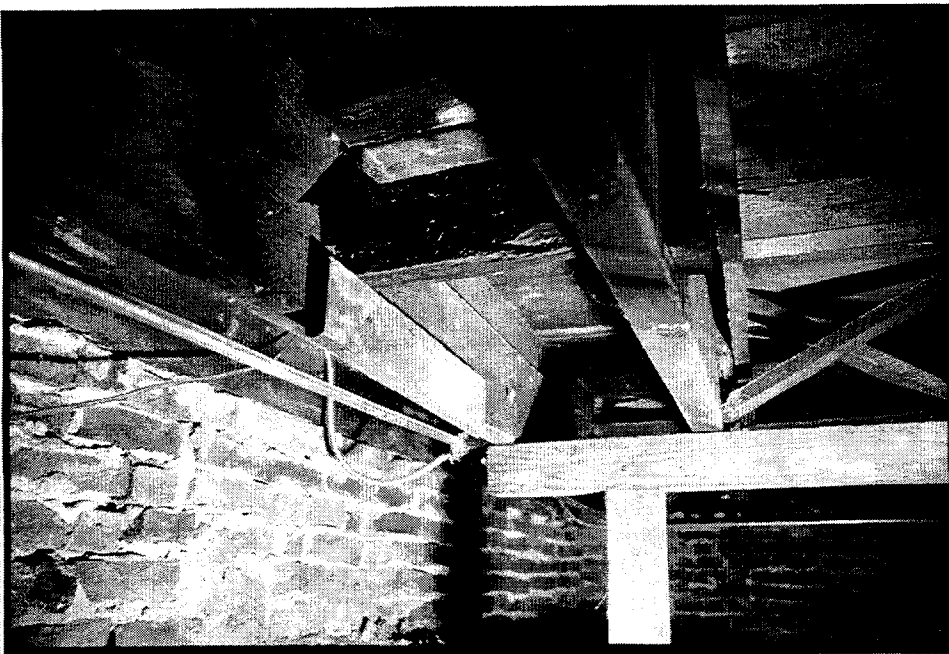
FIGURE 3.25 LOCA-
TION OF THE CHIM-
NEY STACK AND
HEARTH

These notches in the first floor joists of the 1874/1879 addition are near the north wall in Crawl Space 001 and indicate the limits of the hearth at the non-extant fireplace and, probably, the east and west limits of the fireplace itself.

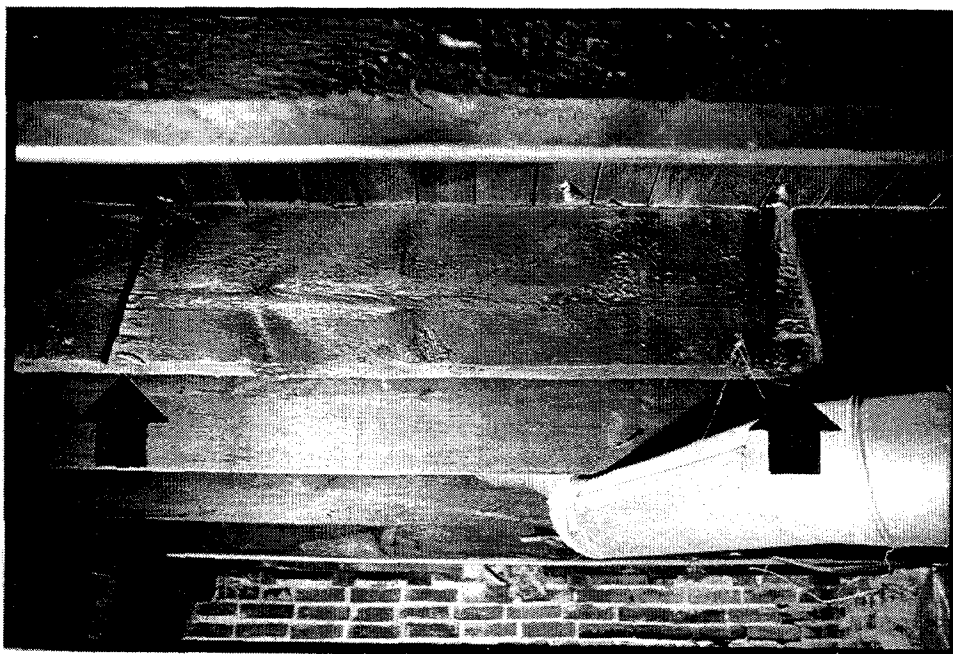
FIGURE 3.26 INDICA-
TION OF THE
1874/1879 ADDITION
STAIR

This is a view of the newel post indications at the joist in Crawl Space 001.

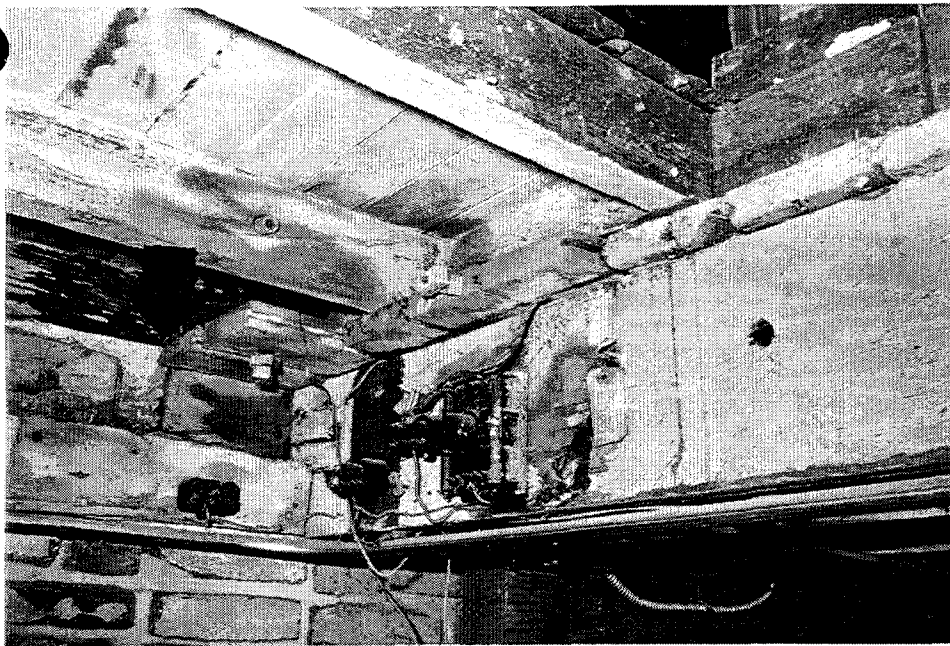
FIGURE 3.27 CELLAR ACCESS EVIDENCE

While there is no documentation of an original stair to the basement (or cellar), physical evidence suggests that there may have always been a stair to the basement (see Figure 3.27). The stair opening would have been no wider than 2'-0" ± and would have been framed by the west sill beam and the adjacent floor joist (now-severed) within the limits of the present floor opening at the northwest corner of the house. The floor opening was likely always 7'-6" ± long (its present length) since there is no evidence to indicate that the floor boards were ever nailed into the west sill beam north of this point. However, it is possible that these holes are filled with paint and not visible. Additionally, some of the floor boards end at the location of the former joist.

This cut in the subfloor at this sill beam notch represents the probable width of an interior cellar access.

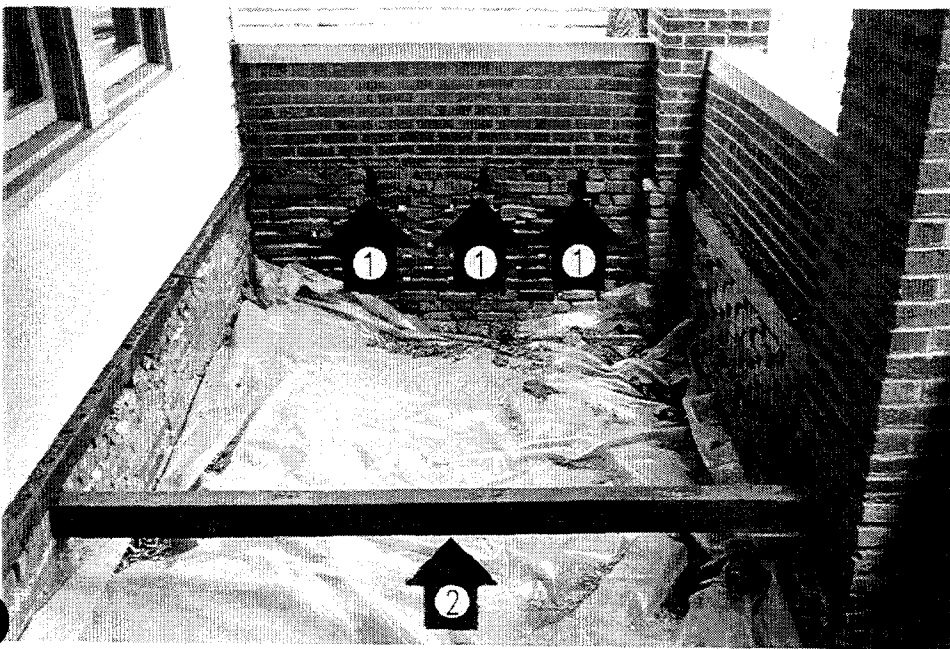
FIGURE 3.28 EAST PORCH FRAMING

Nominal 2x6 framing rested in these notches (1) at the brick wall. Wood beams (2) are located at the intermediate brick piers.

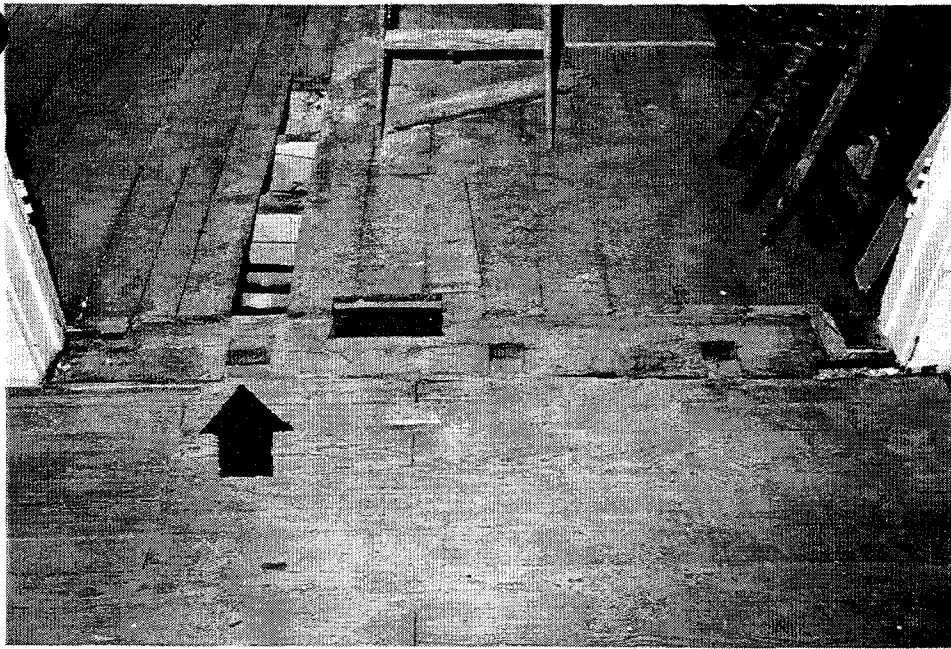
FIGURE 3.29 TOP OF SILL BEAM AT EAST WALL OF 1851 COTTAGE

This sill beam indicates the mortise locations for tenoned wall framing including studs and an intermediate post. The intermediate post location (see arrow) sets at the east end of an interior wall.

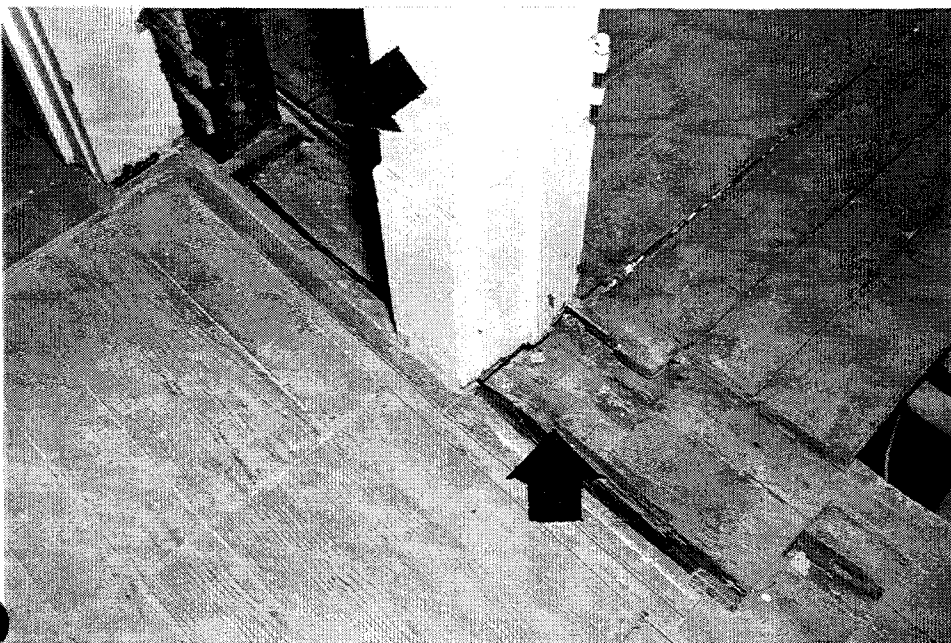
FIGURE 3.30 TOP OF SILL BEAM AT EAST WALL OF 1851 COTTAGE

This sill beam indicates the notched location for the door sill at the east (front) door to the cottage.

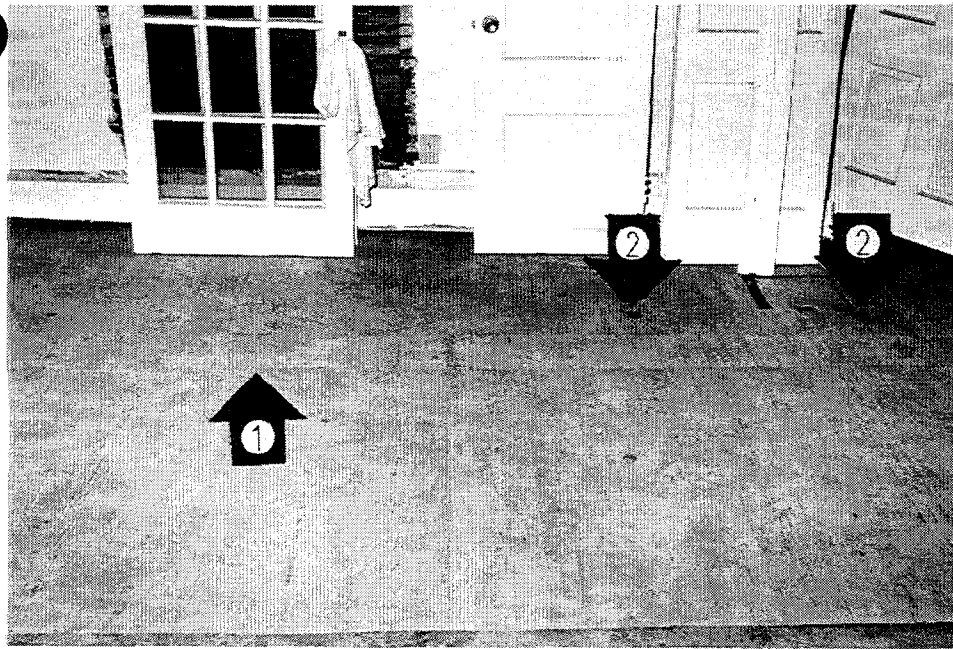
FIGURE 3.31 GHOST-ED WALL LOCATION AT FLOOR OF ROOM 101

This wall location—with a door at its east end (1)—travels directly in front of the location of nineteenth-century stair newel posts locations (2).

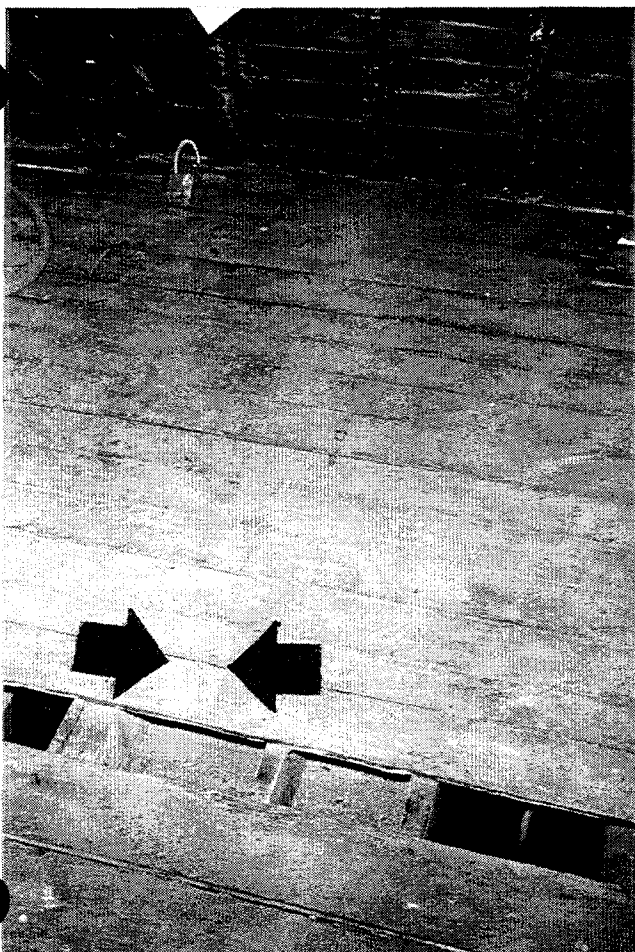
FIGURE 3.32 GHOST-ED WALL LOCATION AT FLOOR OF ROOM 103

This faint mark (see arrow) at the subfloor indicates the wall which set at the west limit of the entry vestibule of the 1851 cottage.

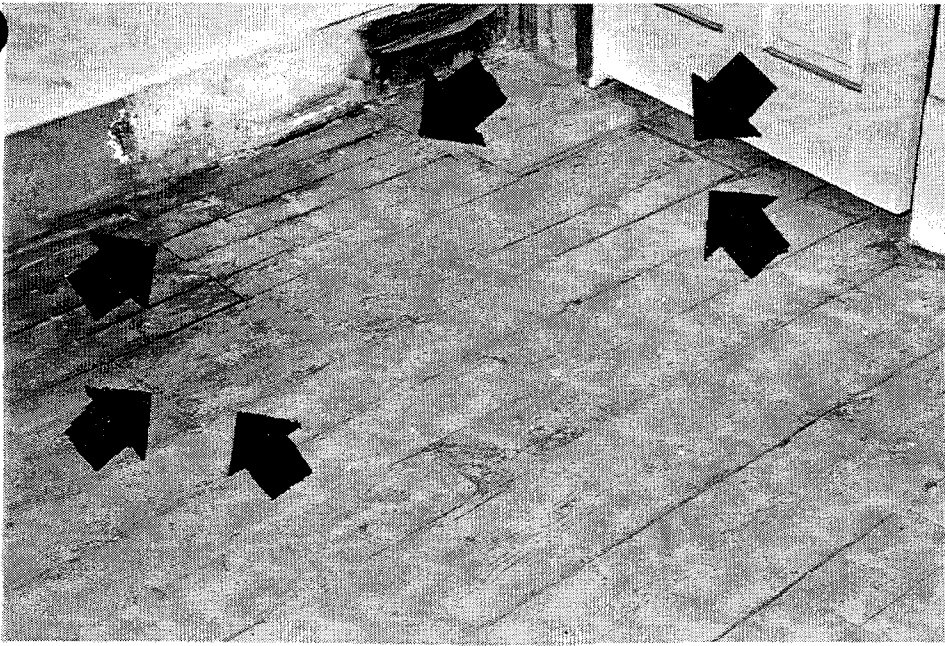
FIGURE 3.33 SUB-FLOOR AT ROOM 104

These infill boards at the subfloor indicates the location of the passage of a chimney flue. The location of these boards aligns with the largest framed opening seen in Figure 3.34.

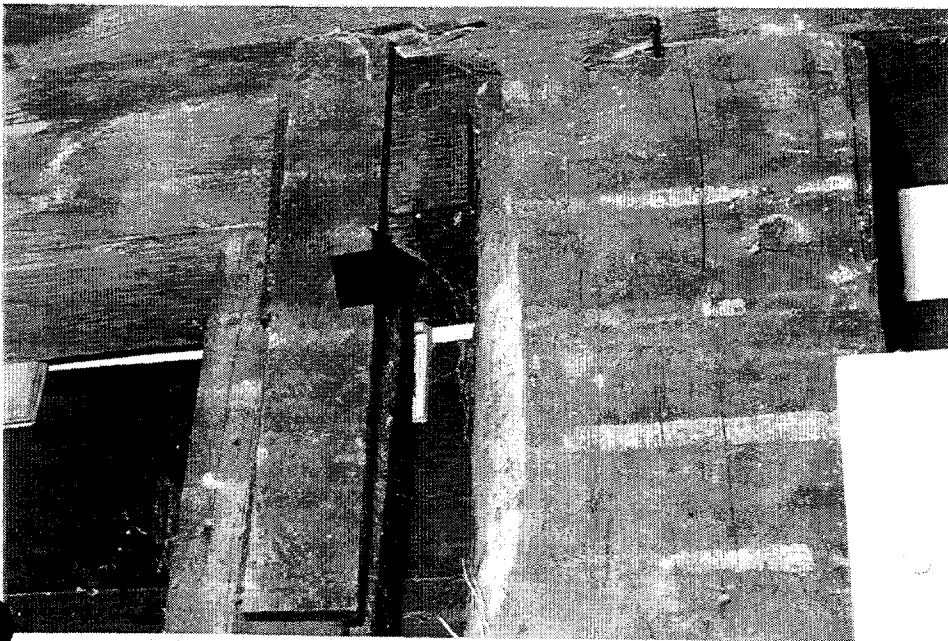
**FIGURE 3.42 WEST
PORCH BEAM OF
SOUTHWEST PORCH**

This view shows the framing condition of the west beam of the southwest porch at the west wall corner post. Note the paint line at what would have been a cornerboard (see arrow).

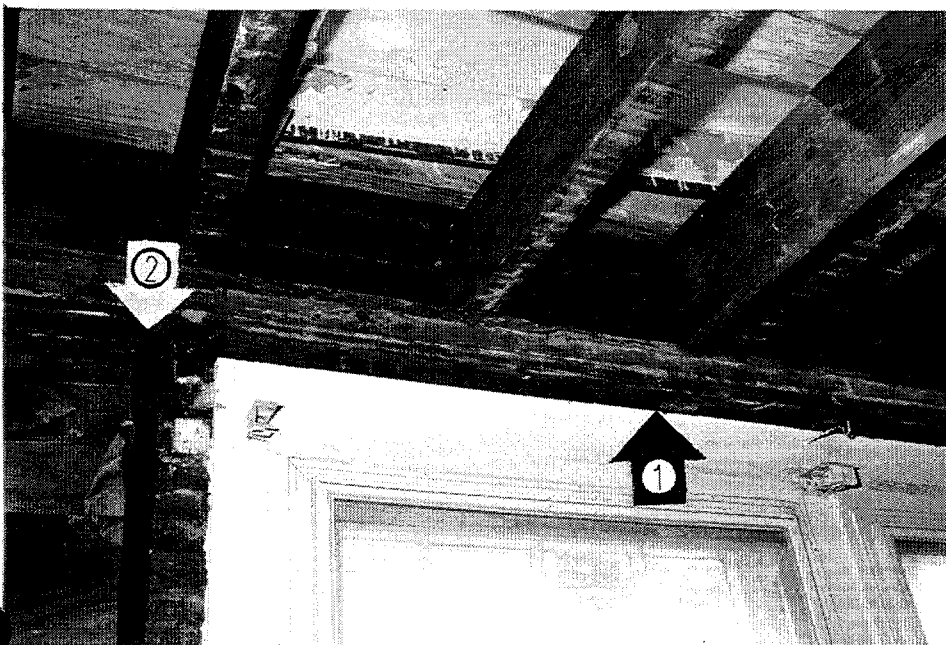
FIGURE 3.44 UNDER-SIDE OF SOUTH BEAM OF SOUTHWEST PORCH

This unpainted area (1) is most likely indicates the 1851 single intermediate post location at this porch. This mortise (2) and a similar one 5'-9" ± to the south probably represents the location of a second set of intermediate porch posts.

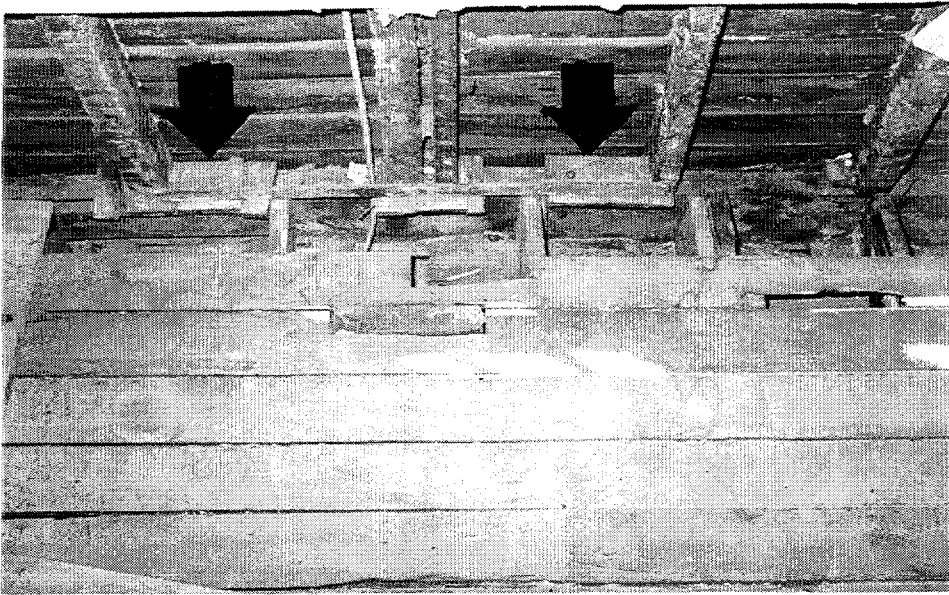
**FIGURE 3.45 SOUTH-
WEST PORCH FLOOR
BOARDS**

These remnant floor board ends remain at the location of the non-existent southwest porch.

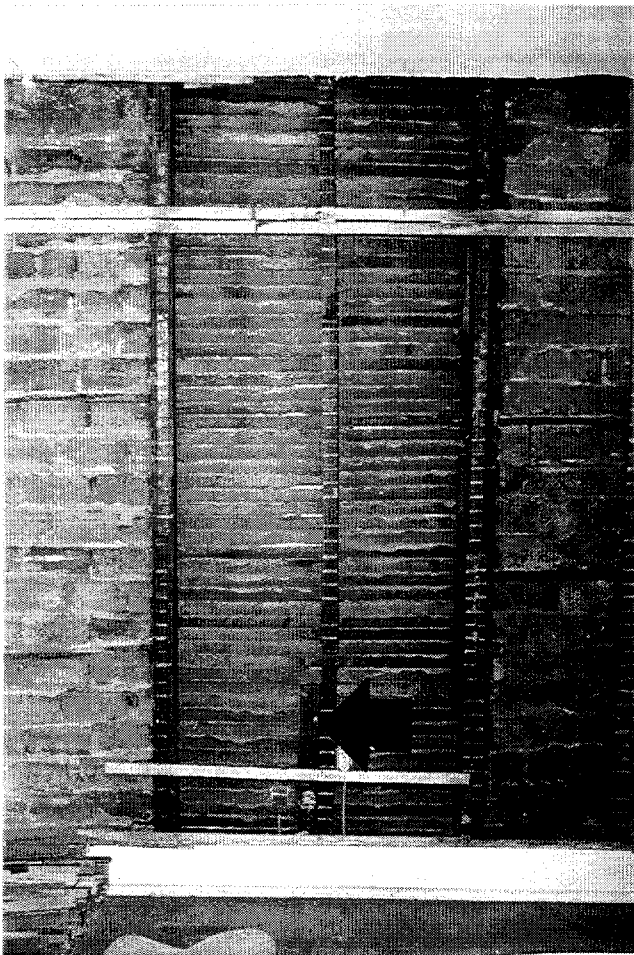
**FIGURE 3.46 1851
COTTAGE WINDOW
ROUGH OPENING**

This rough opening provided information which helped to size the window openings. Note the 1851 stud cripple (see arrow) which would have supported the sill framing of the window. Also note the brick nogging at either side of the rough opening.

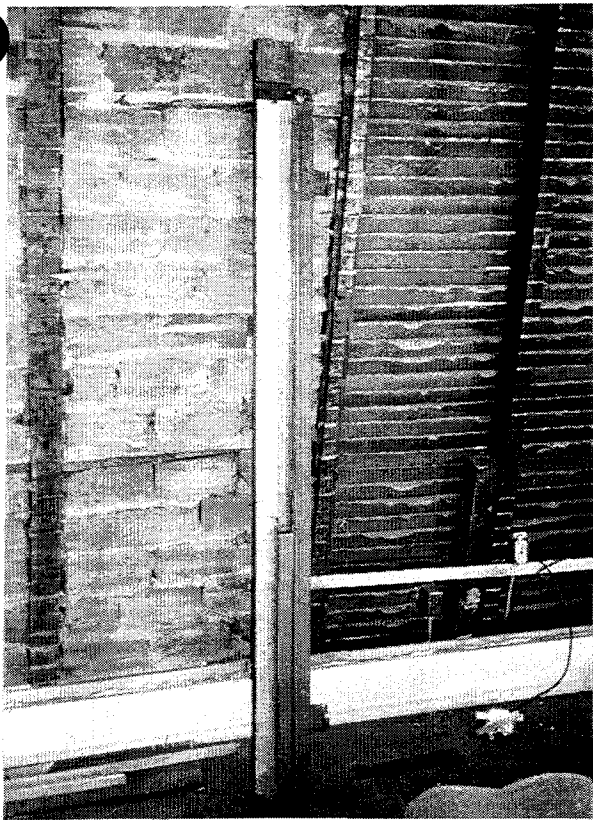
FIGURE 3.47 1851
COTTAGE WINDOW
JAMB DISCOVERED
IN WALL CAVITY

This jamb, discovered during field investigations, provided information concerning not only the 1851 cottage windows and shutters, but also the painted interior and exterior finishes of the cottage.

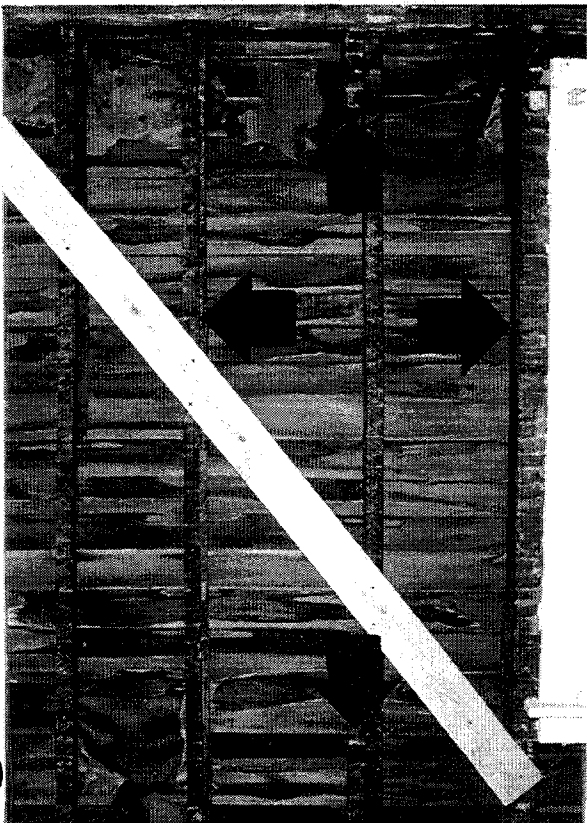
FIGURE 3.48 1874/1879
WINDOW LOCATION
AT SOUTH WALL OF
ROOM 107

This rough opening was most likely the location of a window salvaged from the north wall of the 1851 cottage southwest porch.

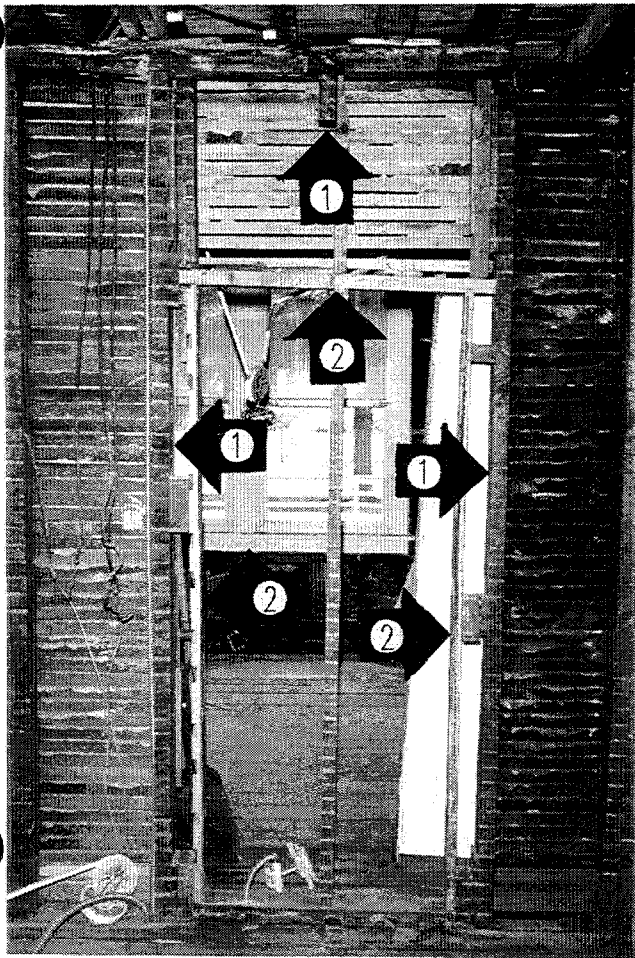
**FIGURE 3.49 DOOR
ROUGH OPENING**

Investigative removals at the wall between Rooms 103 and 104 revealed two remanent pieces of a stair stringer used to frame a twentieth-century door rough opening inside an 1874/1879 door rough opening (see Figure 3.49). These 1¼" thick stringer remnants are rabbeted out; one indicating the 90 degree intersection of the tread and riser and the other indicating the nosing. It is believed that this stringer may have been part of the stair installed as part of the 1874/1879 additions. During later renovations, these remnants were used with other scrap lumber to infill walls. Both stringer remnants appear to be cut from the same piece, and when analyzed together provide evidence of an 8½" riser height and 8½" tread depth with a ¾" nosing. If these remnants are, in fact, from the 1874/1879 addition, then the total stair length would have been 11'-4" ±.

This rough opening, framed-in as part of the 1874/1879 construction episode, was the opening between Rooms 103 and 104. (See arrows #1 for limits of rough opening.) As part of the 1922/24 construction opening, this rough opening was infilled for a smaller door. (See arrow #2 for limits of rough opening.) The jamb framing for the later door opening was framed with salvaged stair stringers, probably from the 1874/1879 addition.

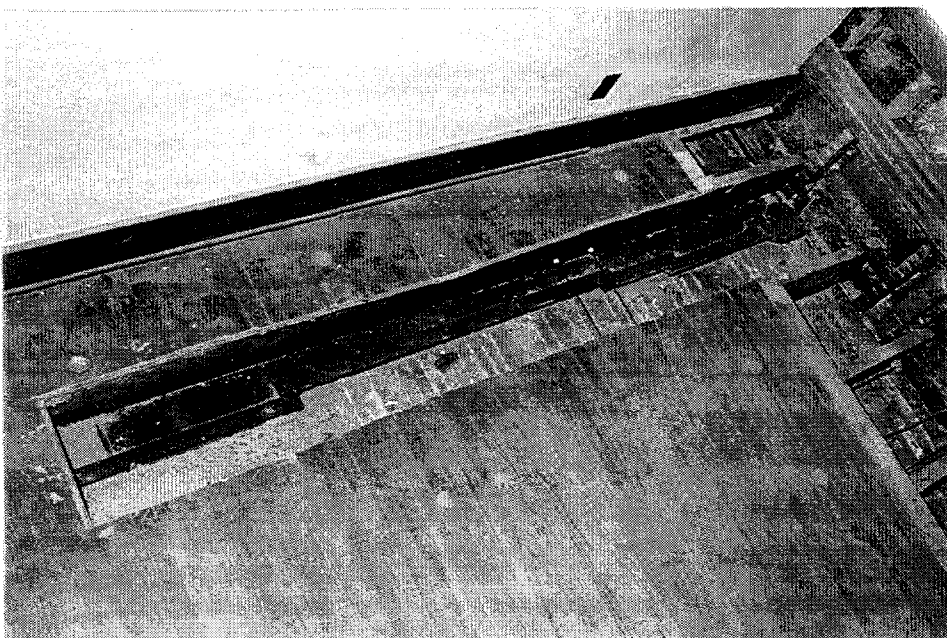
**FIGURE 3.50 DOOR
JAMB TRIM**

This ornate trim board was discovered in a floor joist cavity at Room 201. This trim is believed to be from the front (east) door of the 1874/1879 addition.

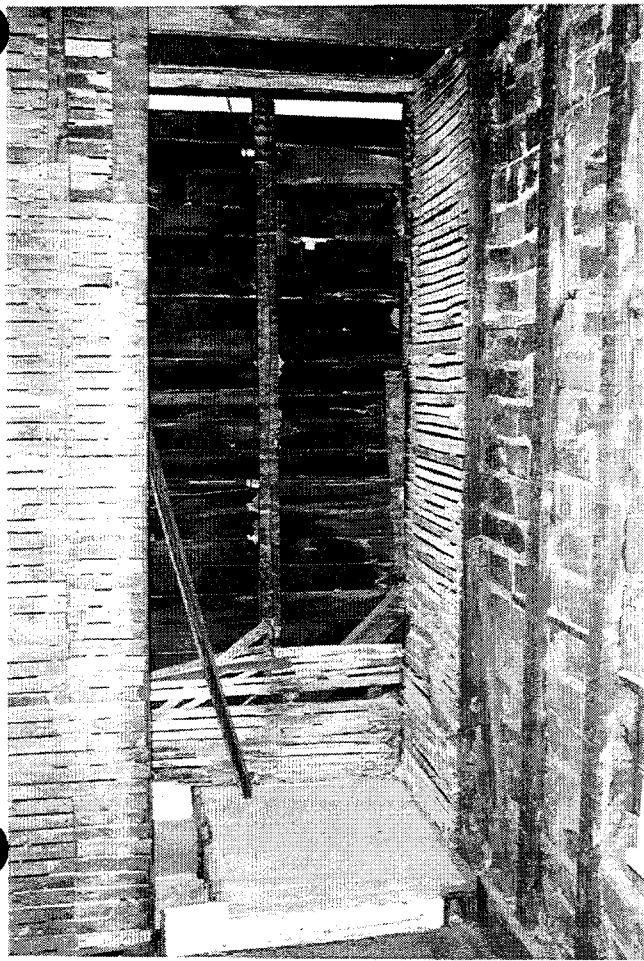
FIGURE 3.51 HAND-SPLIT LATH

During the selective removal process, a small area of hand-split lath was discovered on the north and west walls at the northwest corner of the 1851 cottage (see Figure 3.51). The handsplit lath at the west wall only extended to 1'-8"± above the floor and the plaster over this lath had a distinctive yellowish tint, indicative of nineteenth-century plaster. The hand-split lath at the north wall extended the full height of the wall. Analysis of the plaster spread over this lath (Sample P1, see Appendix B) determined that its composition was very similar to that of the mortar from the nogging in the wall, suggesting a similar age.³⁴

This hand-split lath, discovered in Room 108, is a remnant of the 1851 cottage lath. Similar remnant lath was found above the top plate of the 1874/1879 walls between Rooms 103 and 104, and Rooms 107 and 108.

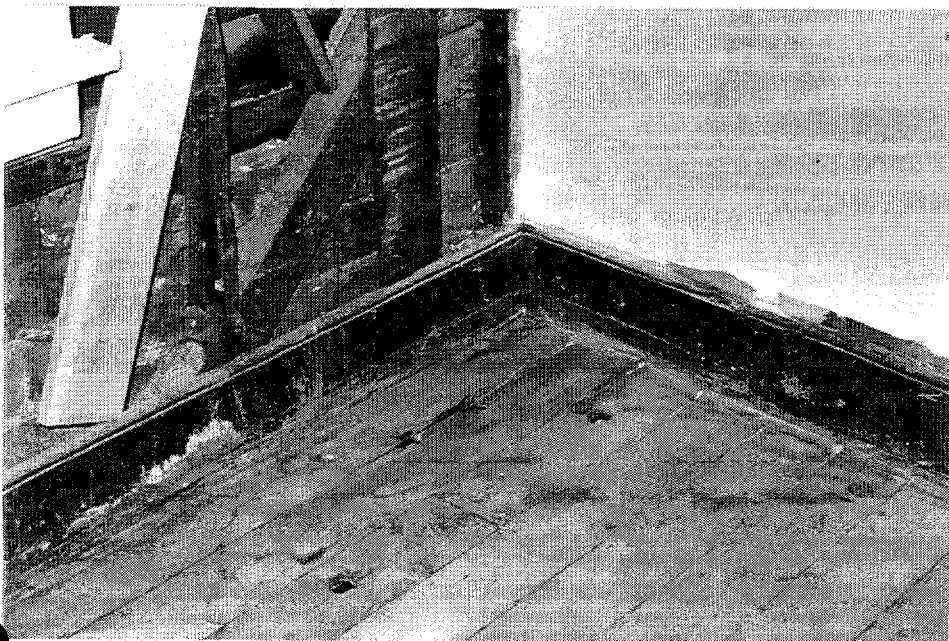
FIGURE 3.52 WOOD BASE

Removals of the existing baseboards at the north, east, and south walls of Room 104 and part of the south wall of Room 105 revealed nineteenth-century baseboards behind (see Figure 3.52). These baseboards are believed to be from the 1851 cottage. The baseboards at the south wall of both rooms were probably relocated when this wall was constructed as part of the 1874/1879 construction episode. These baseboards are simple 1" ± x 6½" boards with a quirk bead cut at the top. These baseboards are installed over the lath and were themselves the plaster ground. Paint analysis of this feature revealed a gray (Munsell N 5.75/) base layer with a white (Munsell 5Y 9/1) layer over that, with a present finish of a dark brown varnish.⁴⁷ The top two layers are the same layers found at other features, including the porch beam and the remnant siding board (see EXTERIOR FINISHES in this Division).

This simple wood base with a quirk bead at its top is probably the original baseboard in the large east room (most likely a parlor) of the 1851 cottage.

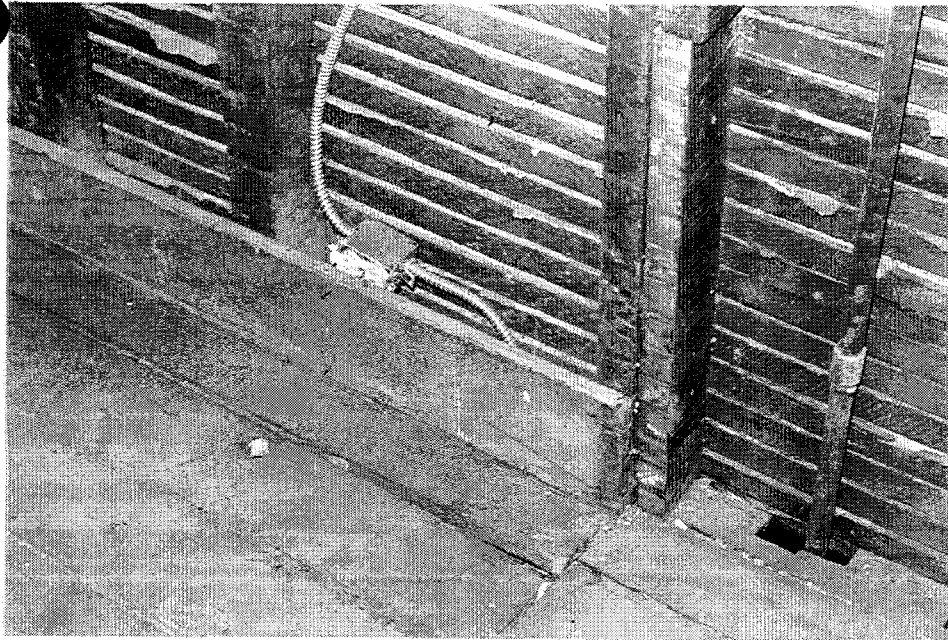
**FIGURE 3.53 WOOD
BASE**

Removal of the existing baseboards at the north and south wall of Room 108 revealed a nineteenth-century baseboard behind (see Figure 3.53). These

This plain wood base is probably the original baseboard in the large west room (most likely a kitchen) of the 1851 cottage.

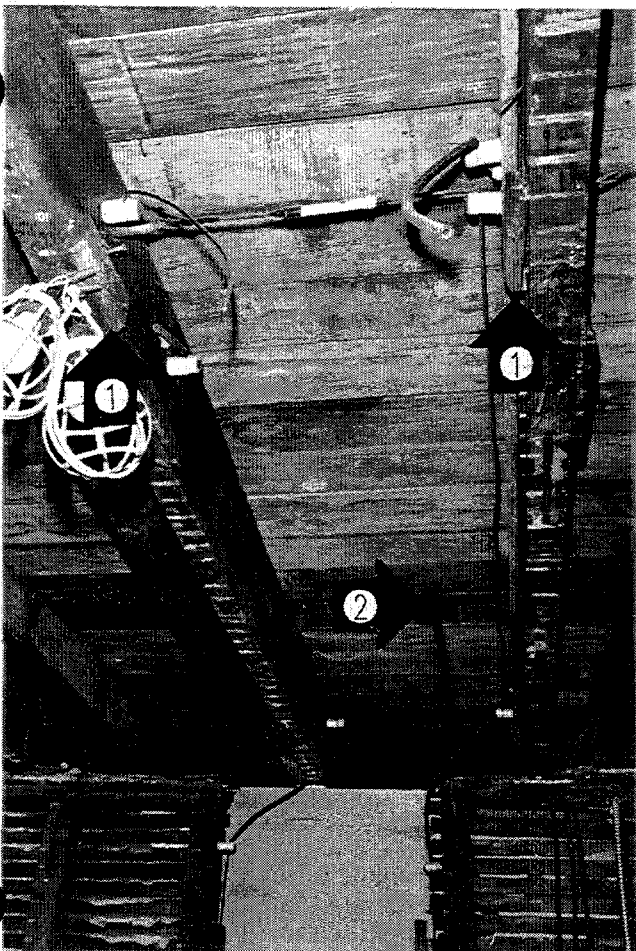
**FIGURE 3.54 GAS
LAMP LOCATION**

These framing features (1) were likely installed to support a hanging gaslight fixture, probably installed during the Hof-ferkamp ownership. A "T" fitting at the gas piping (2) would have allowed a line to service a fixture in this location, centered in Room 103.

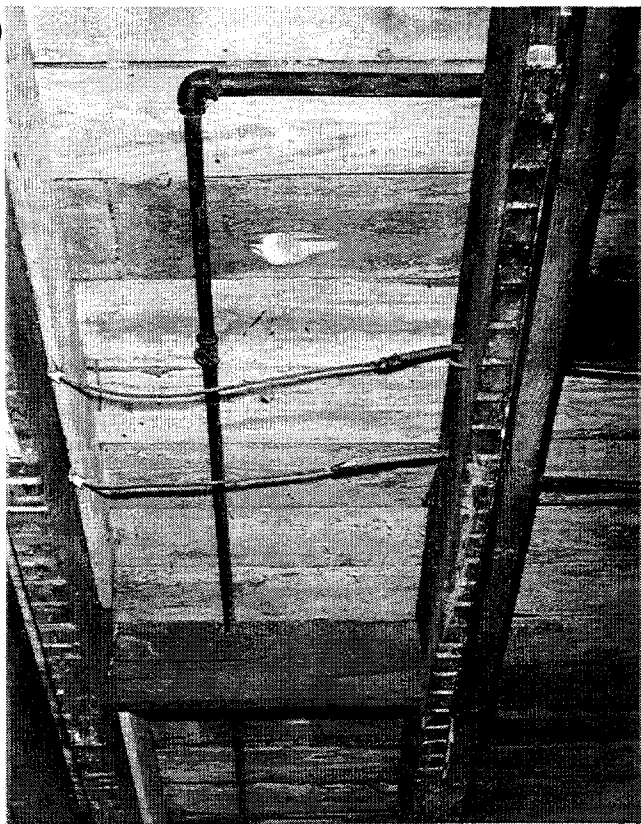
**FIGURE 3.55 GAS
LAMP LOCATION**

In the ceilings of rooms 103 and 104, there are 1" and $\frac{3}{4}$ " gas light piping.⁵⁰ This piping is cast iron and has one down-turned "T" connection (see Figure 3.55) indicating the location of a lamp fixture in Room 104. This fixture was located approximately 5'-6" off the south wall and 8'-0" off the east wall. A second fixture location in Room 103 was located approximately 6'-4" off the south wall and 8'-0" off the east wall (see Figure 3.54). Evidence of gas lamp locations—and the existence of piping for gas lamps—was also discovered in Room 107 and 108; however, this evidence was not as compelling. Notches in the top of the ceiling framing of Room 108 which align with the pipe discovered in adjacent Room 104, suggest the pipe continued into this room. The fixture would most certainly have been centered in the room. The pipe likely elbowed into Room 107. A single wood bracket feature—a remnant of what was certainly a pair—similar to that found at Room 103, indicate the location of a lamp approximately 8'-6" from the west wall and aligned with the fixture location in Room 103.

This downward facing "T" fitting at the gas piping indicates the probable location of a gaslight fixture, centered in Room 104.
