HISTORIC STRUCTURE REPORT

JULIA SPRIGG HOUSE (HS-11)

Lincoln Home National Historic Site
Springfield, Illinois

May 1995

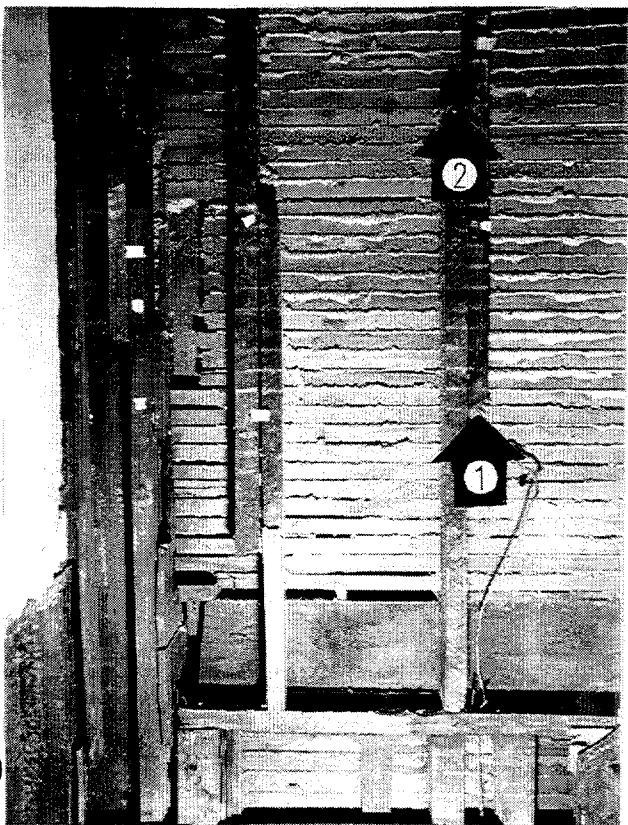
**FIGURE 3.56 INDICA-
TION OF THE 1851
COTTAGE ROOF
SLOPE**

ered-off. Apparently, salvaged studs (bearing to the sill plate) were scabbed to several of the remaining angled-bottom studs. This salvaged stud framing includes the ends of some of the original studs which were cut out when the headers were installed (see Figure 3.56).

These angled bottom studs (1) in the west wall of the 1874/1879 addition indicate the roof slope of the cottage prior to 1922/1924. Note the angled tops of some of the scabbed-on studs (2). These are the salvaged ends of other 1874/1879 wall studs from this wall which have been severed.

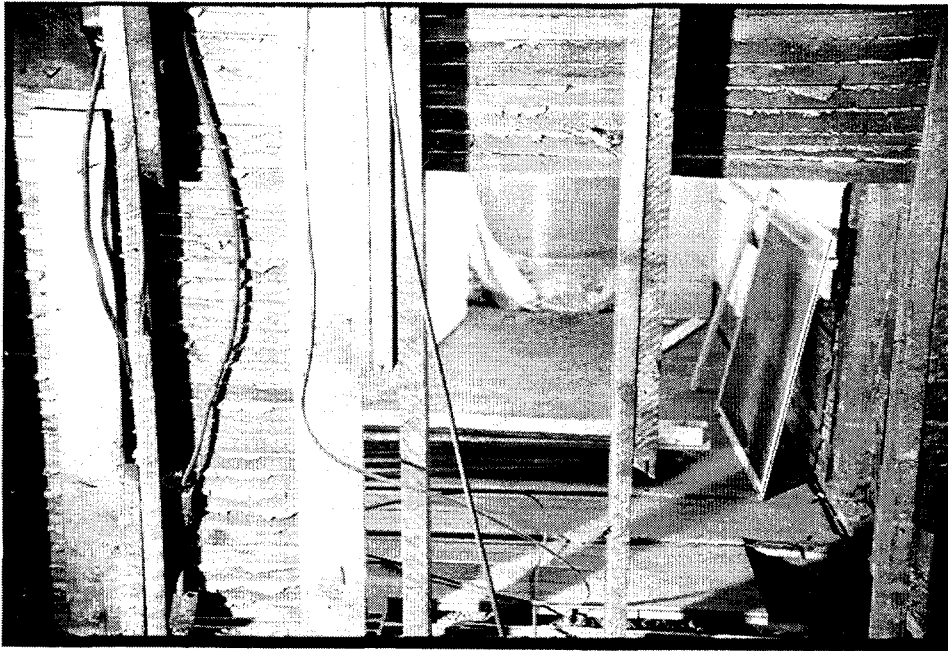
FIGURE 3.57 INDICATION OF THE 1851 COTTAGE ROOF SLOPE

These angled studs in the west wall of the 1874/1879 addition indicate the roof slope of the 1851 cottage. This evidence, coupled with other similar evidence, suggests that the roof peak was $11\frac{1}{2}'' \pm$ to the south of center.

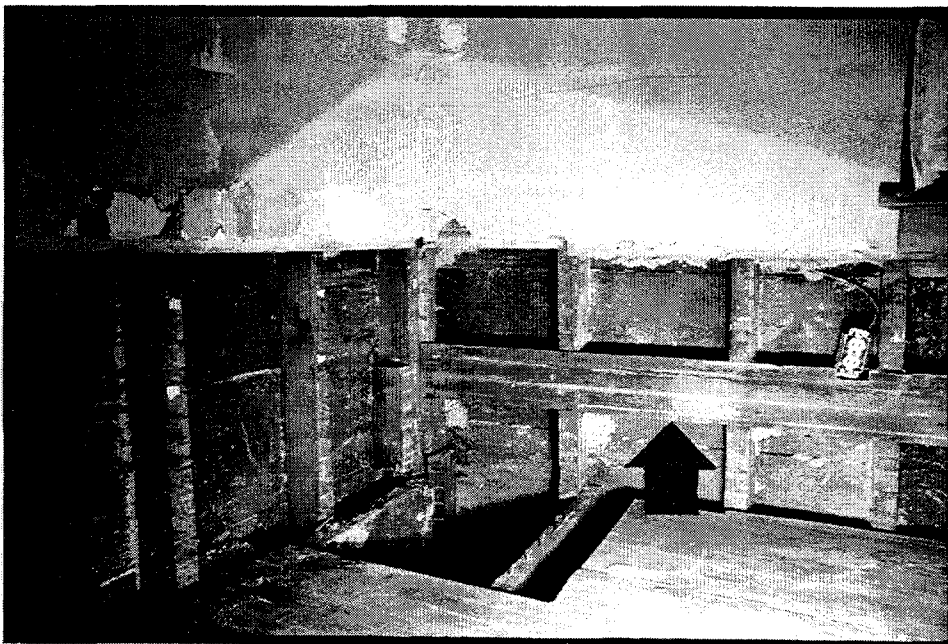
FIGURE 3.58 LEDGER BOARD AT THE 1874/1879 ADDITION

This is the 1874/1879 ledger board at the east wall of Room 202. From 1874/1879 until 1922/1924, the existing floor joists rested atop this ledger.

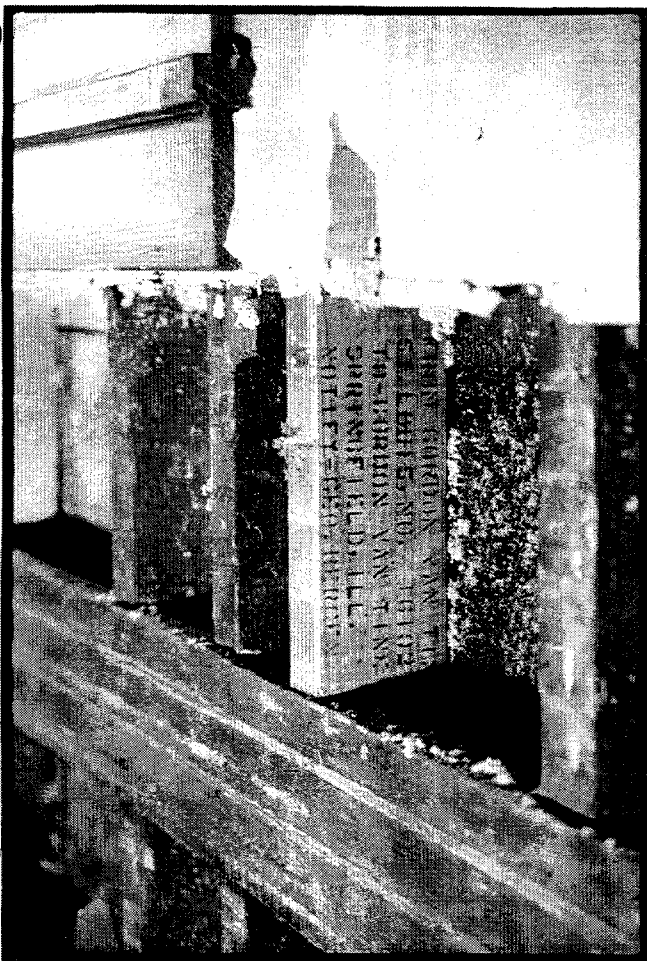
FIGURE 3.59 MARKINGS ON THE STUD FRAMING BELOW WINDOW 201B

This mark reads:

"From Gordon Van Tine
St. Louis, MO. 1G192
To - Gordon Van Tine
Springfield, ILL.
Notify - Geo. Bergen"
This stud probably dates
to 1924 during the renovations
begun by Carl
Mund, but completed by
George Bergen.

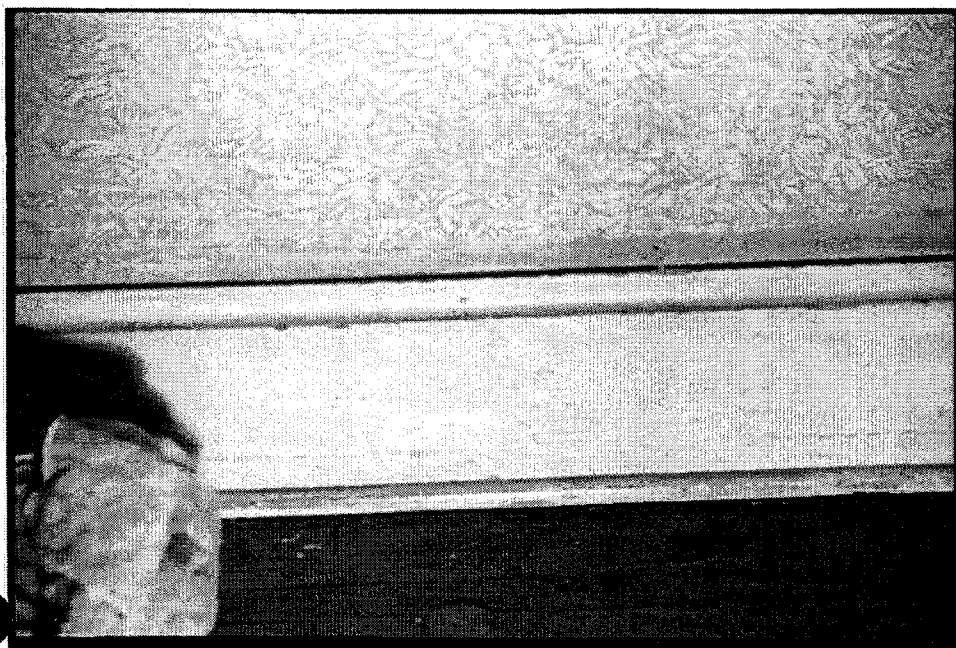
FIGURE 3.60 BASE TRIM AT CLOSET 204A

Paint analysis indicates
that this base was proba-
bly wood grained. This
base is obviously sal-
vaged, perhaps from
elsewhere in this house
during the 1922/1924
renovations. A similar
base exists in Closet
101A.

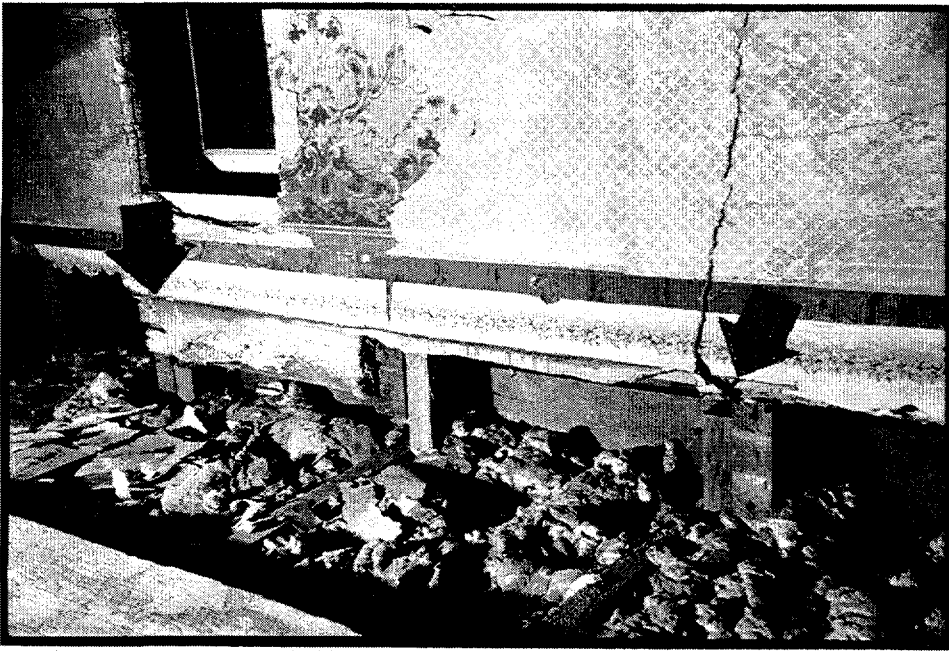
FIGURE 3.61 EVIDENCE OF WINDOW LOCATION IN THE 1874/1879 ADDITION

This evidence indicates the 1874/1879 window head at the northernmost window location on the east wall in the intermediate attic space (above Room 202). Also note the wallpaper layers which pre-date 1922/1924.

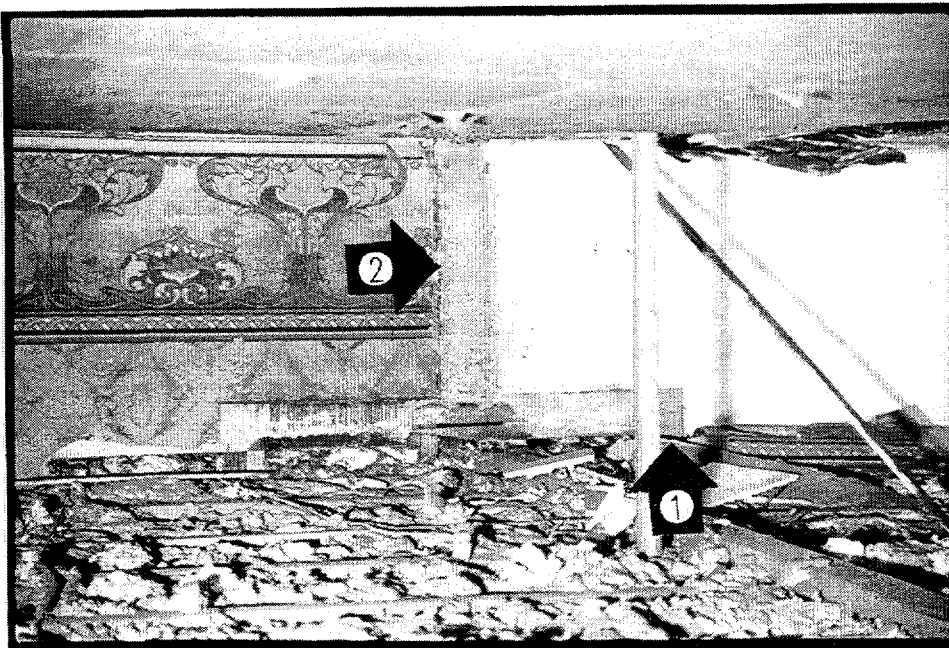
FIGURE 3.62 EVIDENCE OF WINDOW LOCATION IN THE 1874/1879 ADDITION

In this view is seen an 1874/1879 window head (1) at the south wall in the intermediate attic space (above Stair S1). Note the wall indications (2) above the window head trim limits.

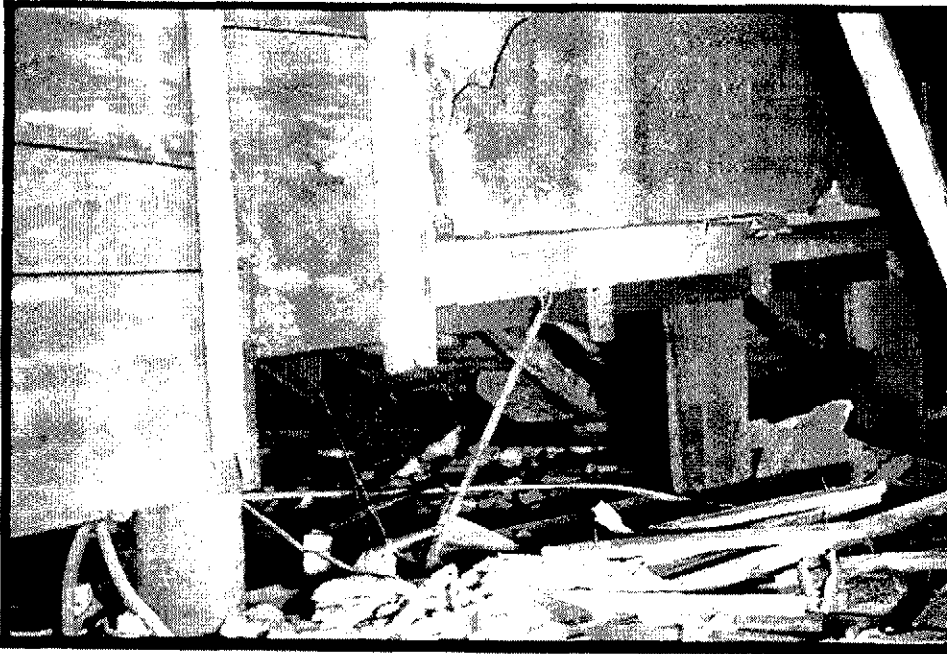
FIGURE 3.63 EVIDENCE OF WINDOW LOCATION IN THE 1874/1879 ADDITION

This evidence indicates the 1874/1879 window head at the northernmost window location on the west wall in the intermediate attic (above Room 202).

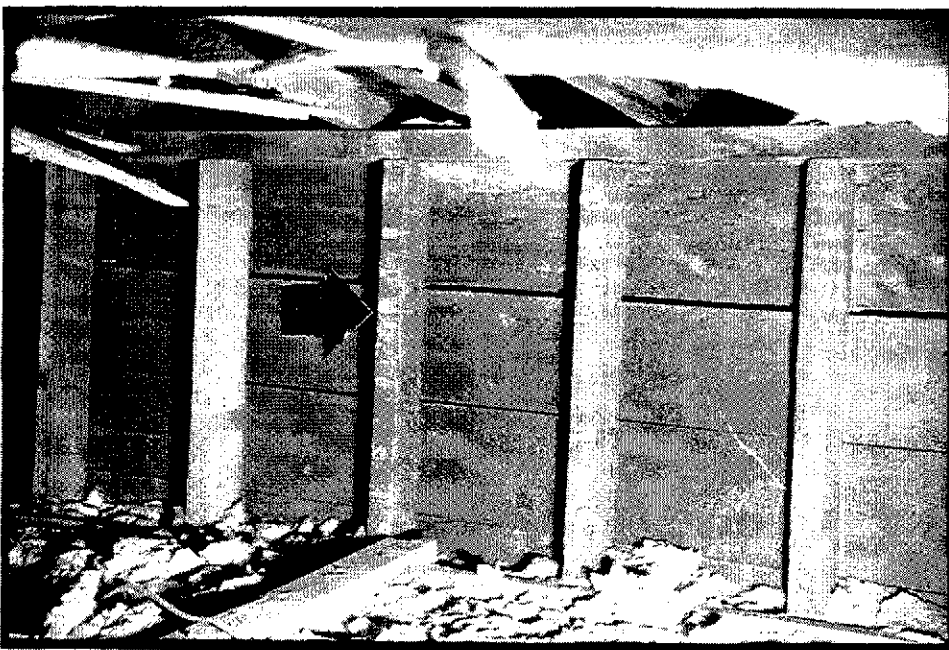
FIGURE 3.64 EVIDENCE OF CHIMNEY STACK LOCATION IN THE 1874/1879 ADDITION

Attic A202 (see Figure 3.64) suggesting the passage of the chimney stack through this space. Finally, there is an inconspicuously infilled opening in the roof sheathing, which indicates the location of the chimney stack's passage through the roof (see Figure 3.71).

These water marks on studs indicating the fireplace chimney location on the north wall in the intermediate attic (above Room 202).

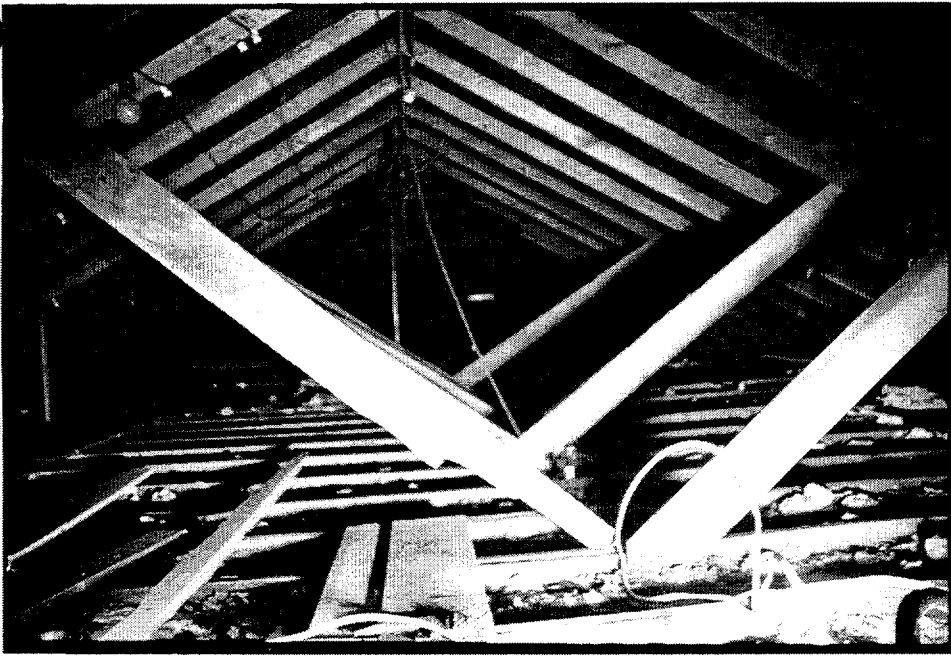
**FIGURE 3.65 FRAM-
ING AT WEST WING
ATTIC**

This is a view of the west attic looking west. The brace framing was added by the National Park Service.

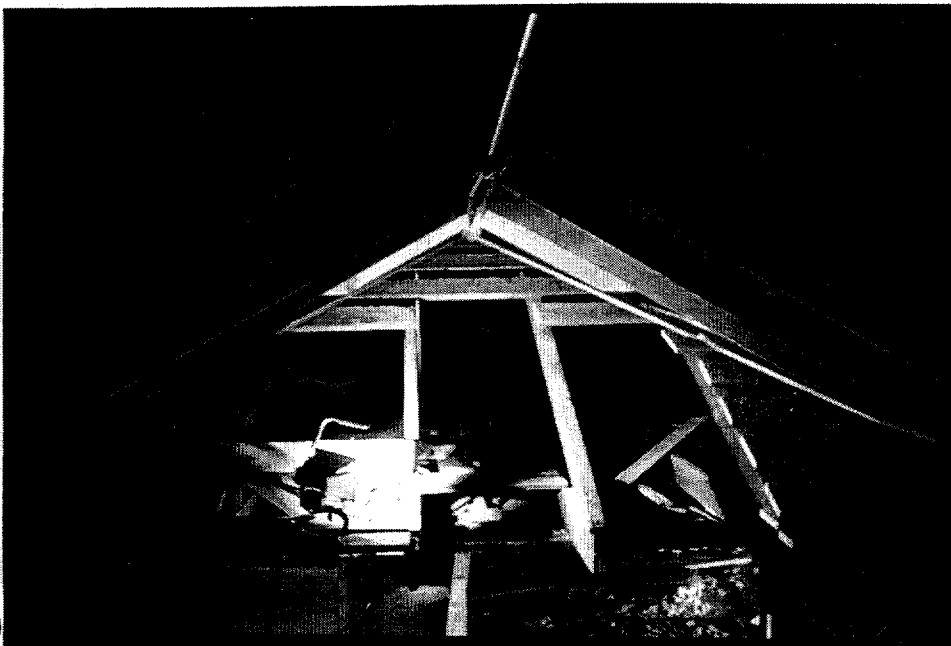
**FIGURE 3.66 FRAM-
ING AT THE ROOF
INTERSECTION**

This is a view of the west attic looking east toward the intersection of the two roof structures.

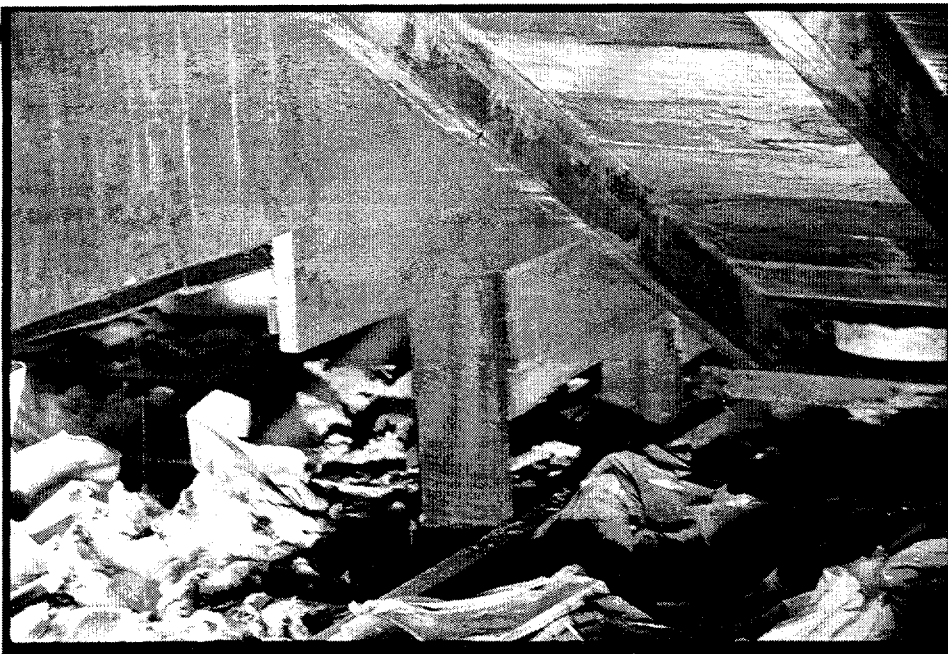
FIGURE 3.67 1874/1879
CORNICE BOARD
AND CLAPBOARD
SIDING

A view of the cornice board and clapboard siding remnants in the west attic.

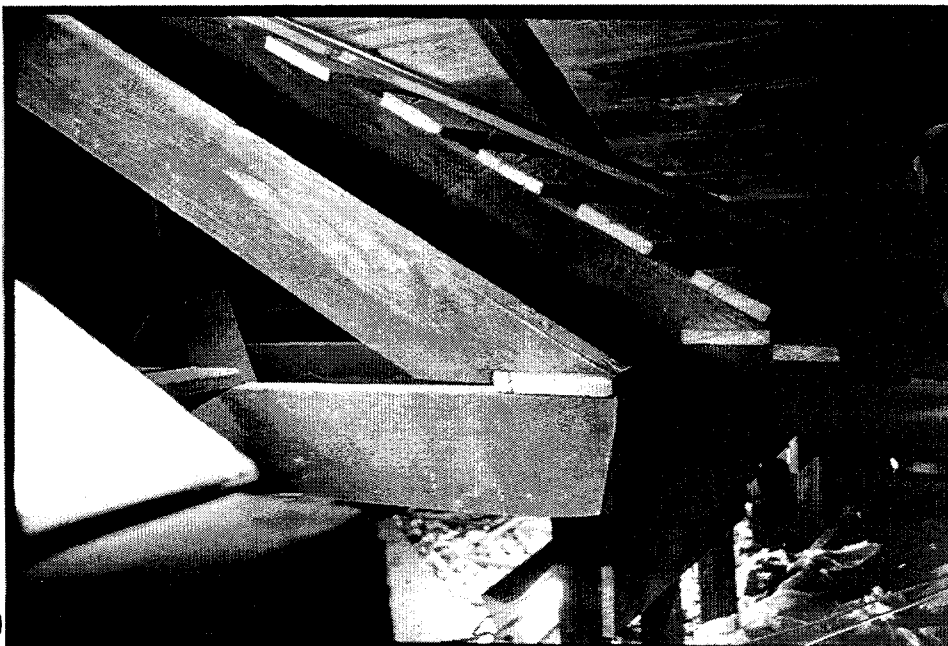
FIGURE 3.68 RAFTER
AT JOIST END FRAM-
ING

This is a view of the roof rafter bearing condition at the joists of the 1874/1879 addition.

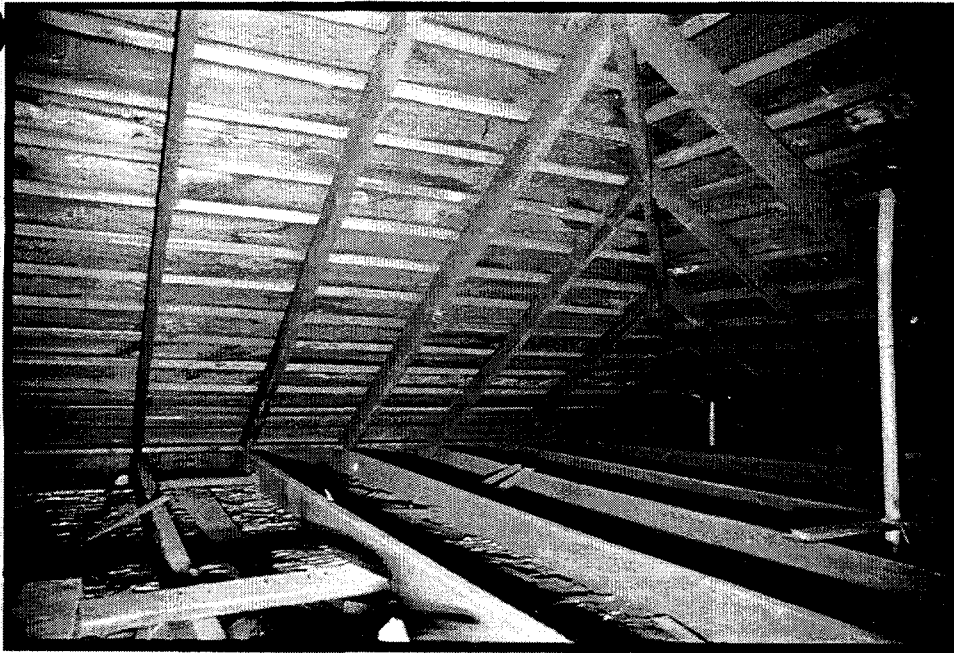
FIGURE 3.69 ROOF FRAMING AT THE 1874/1879 ADDITION

This is a view of the attic looking southeast.

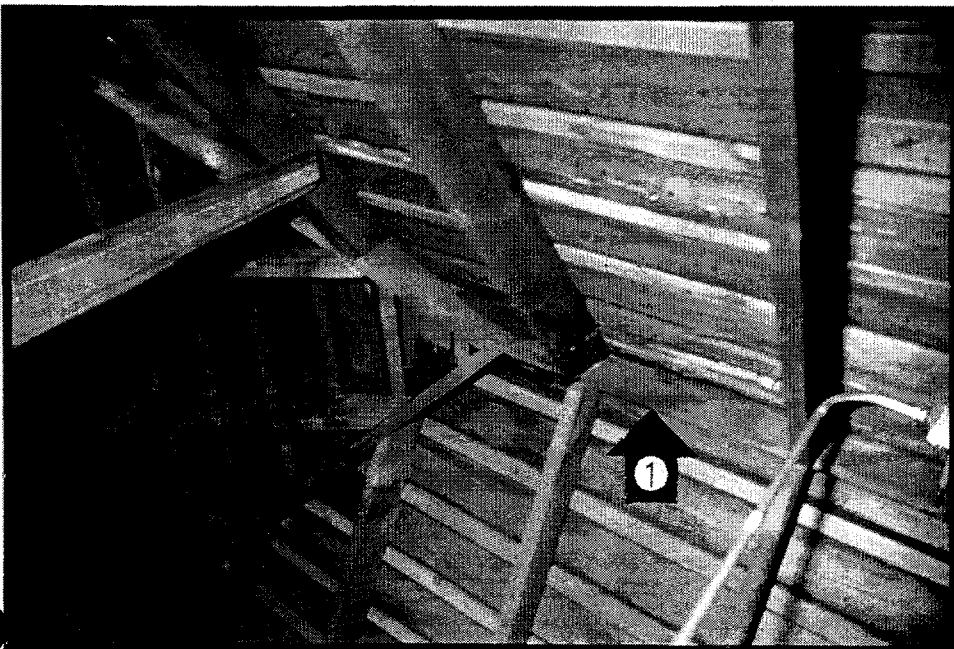
FIGURE 3.70 ROOF FRAMING AT THE 1874/1879 ADDITION

This is a view of the junction of the rafters to the ridge board (1).

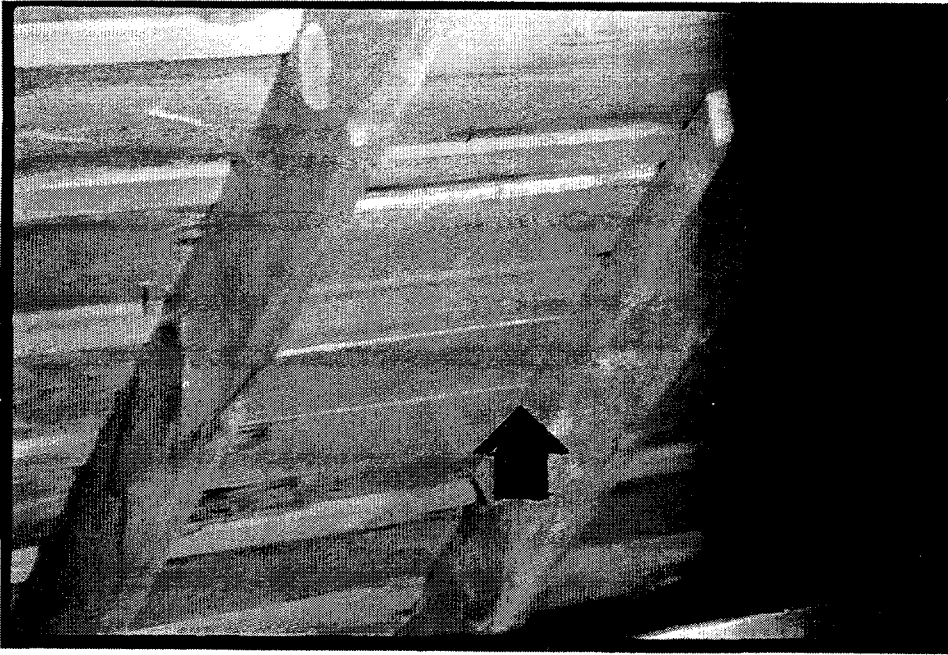
FIGURE 3.71 EVIDENCE OF CHIMNEY STACK LOCATION IN THE 1874/1879 ADDITION

This is a view of the opening in roof sheathing at the 1874/1879 chimney location.

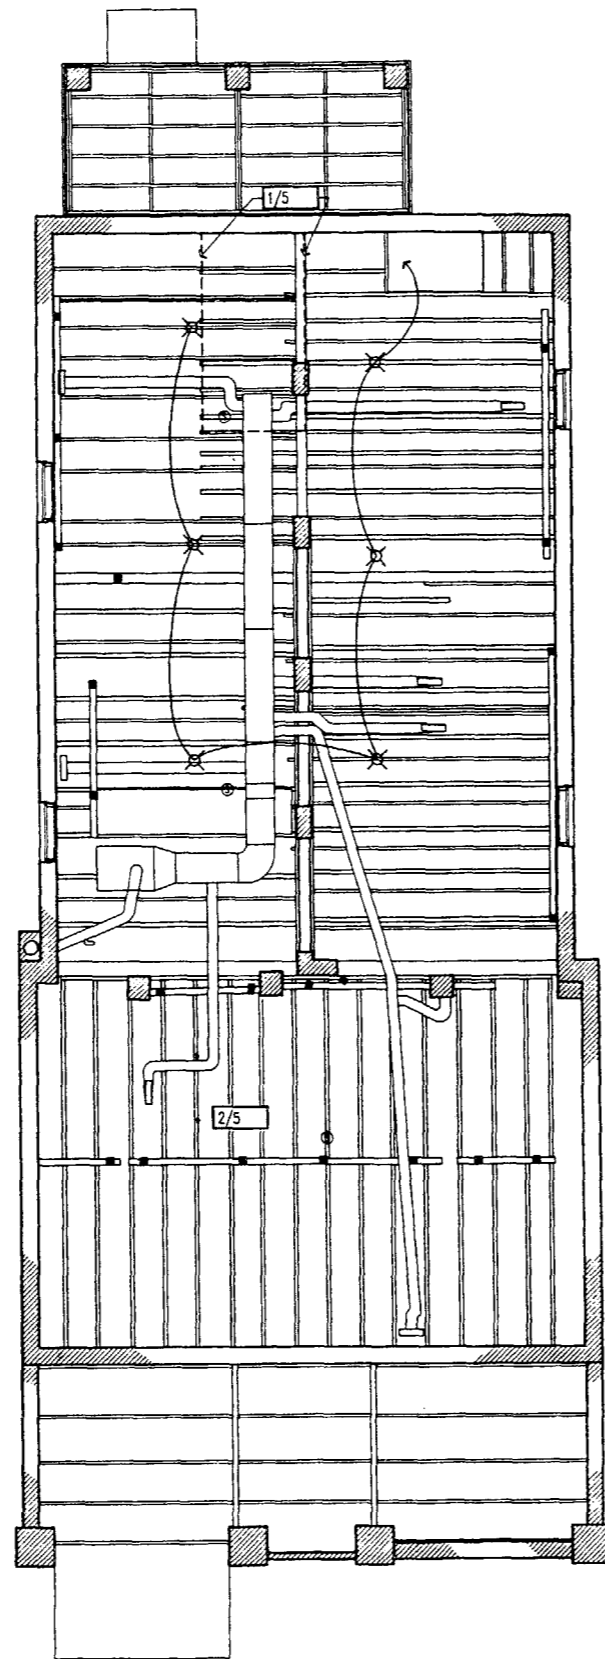
1. LIMITS OF UNPAINTED SURFACES AT CEILING
2. EVIDENCE OF NEWEL POST AT ORIGINAL STAIR LOCATION FOR 1874/1879 HOFFERKAMP ADDITION.

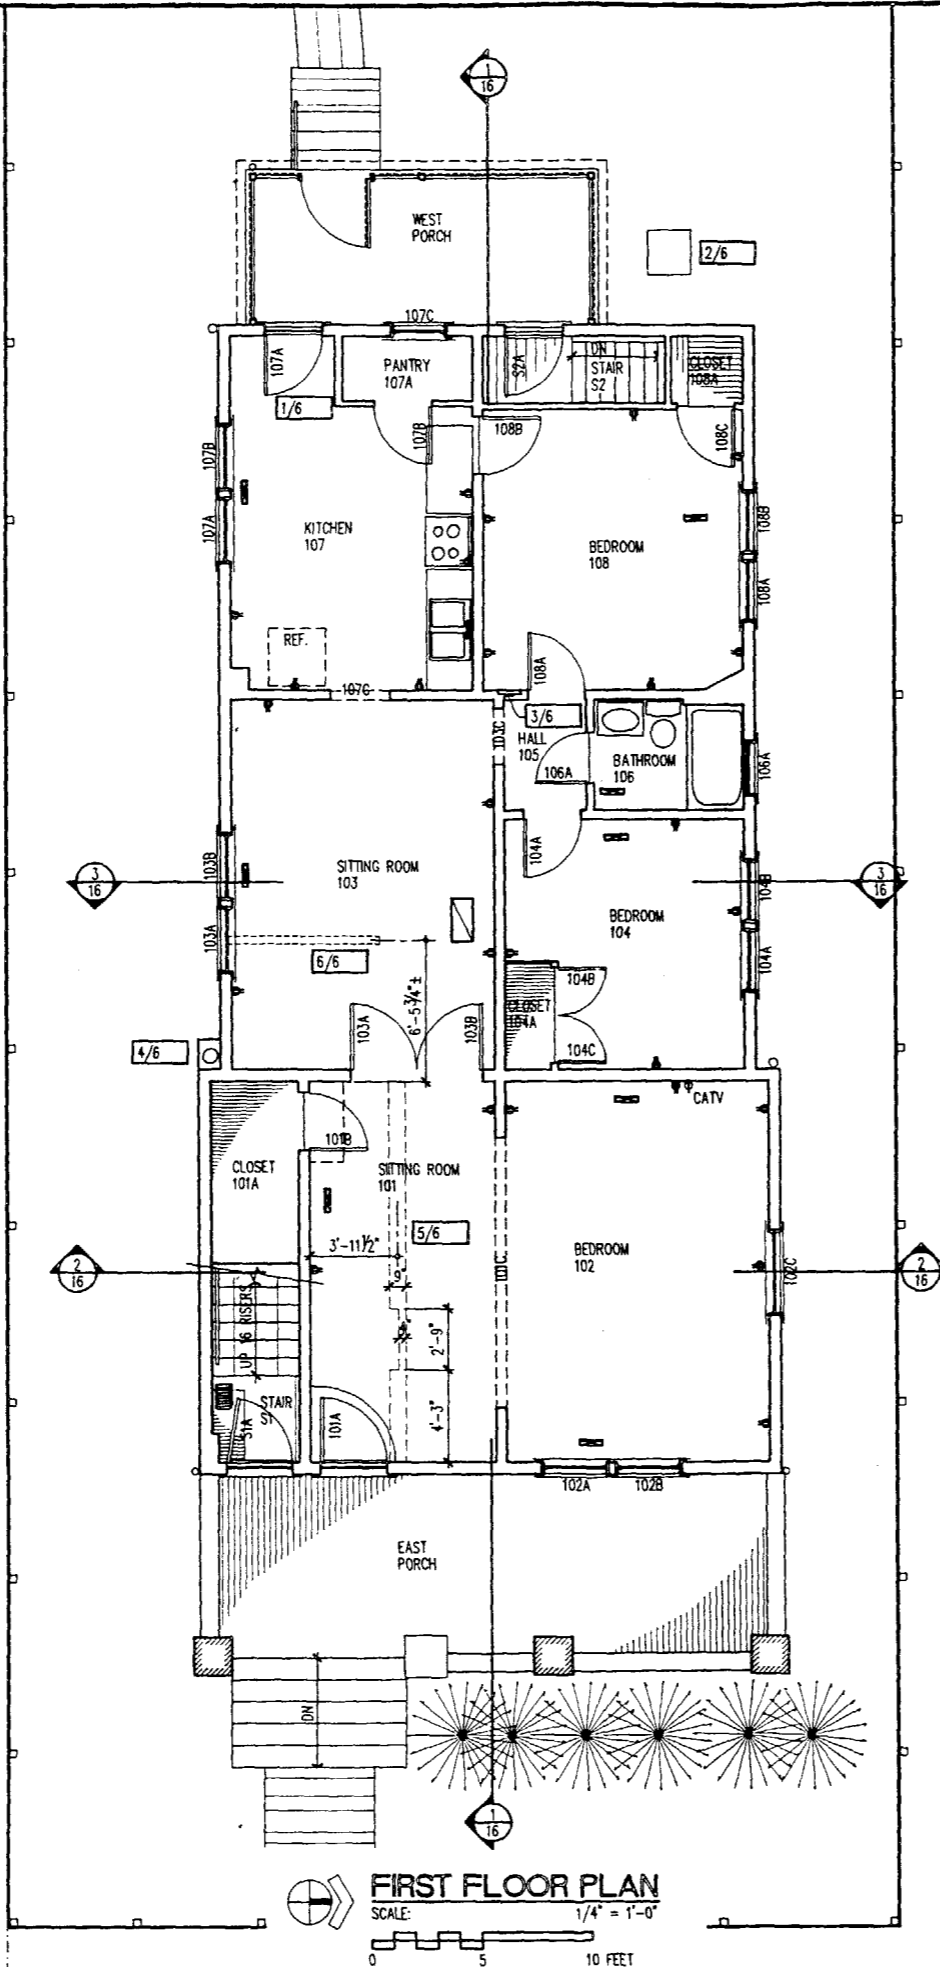
FIRST FLOOR PLAN
 SCALE: 1/4" = 1'-0"
 0 5 10 FEET

1. FIRE ANNUNCIATOR PAD
2. AIR CONDITIONER CONDENSER UNIT
3. ELECTRIC CIRCUIT BREAKER BOX
4. SMOKEPIPE FOR FURNACE AND WATER HEATER
5. INDICATION AT PRESENT SUBFLOOR (GHOSTED OUTLINE) OF INTERIOR PARTITION WALL.
6. INDICATION AT PRESENT SUBFLOOR (CUT NAIL MARKS AND FAINT GHOSTED OUTLINE) OF ORIGINAL INTERIOR PARTITION WALL AT 1851 COTTAGE.

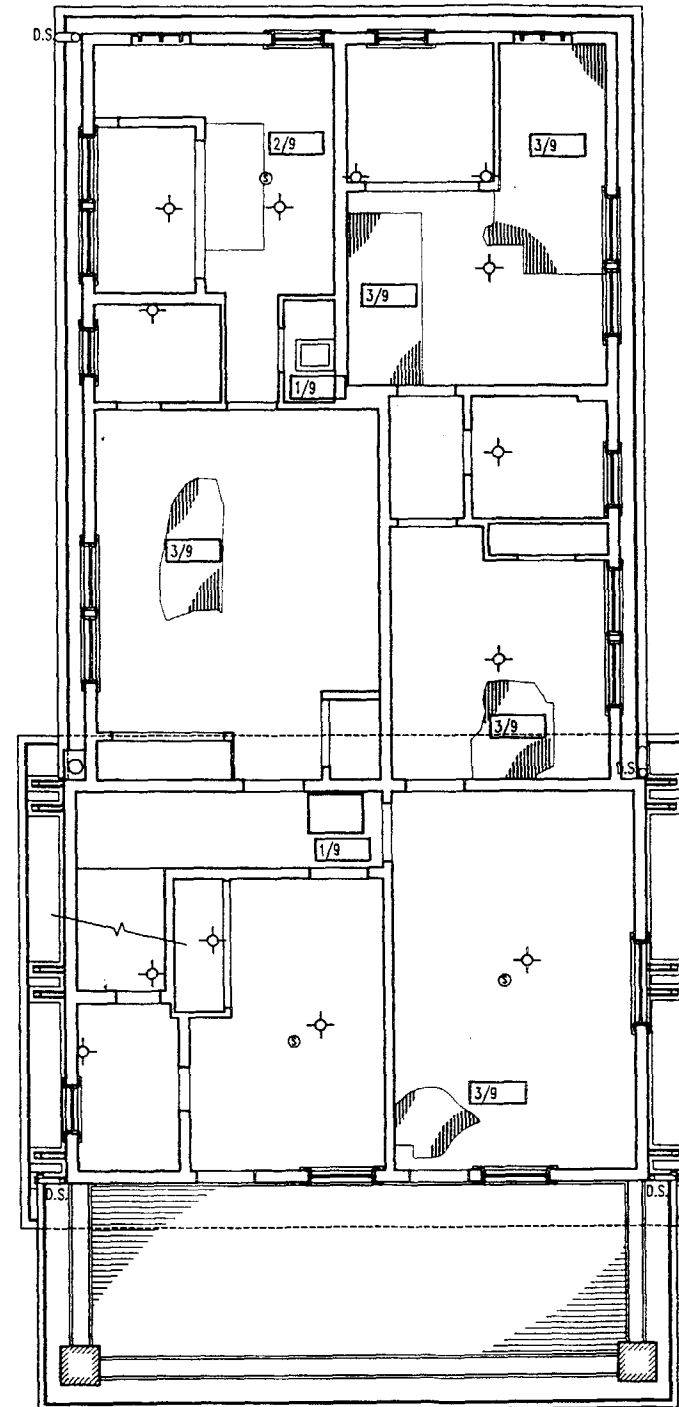
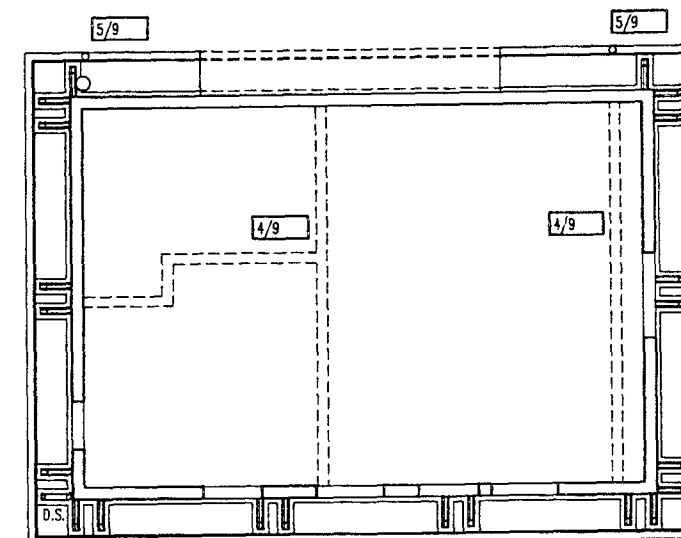
SECOND FLOOR REFLECTED CEILING PLAN
 SCALE: 1/4" = 1'-0"
 0 5 10 FEET

1. ATTIC ACCESS HATCH
2. PLYWOOD PANEL SECURED TO CEILING
3. AREA OF EXPOSED WOOD LATH
4. 1874/1879 WALL INDICATIONS AT ORIGINAL CEILING OF THE HOFFERKAMP ADDITION.
5. DOWNSPOUT DROP

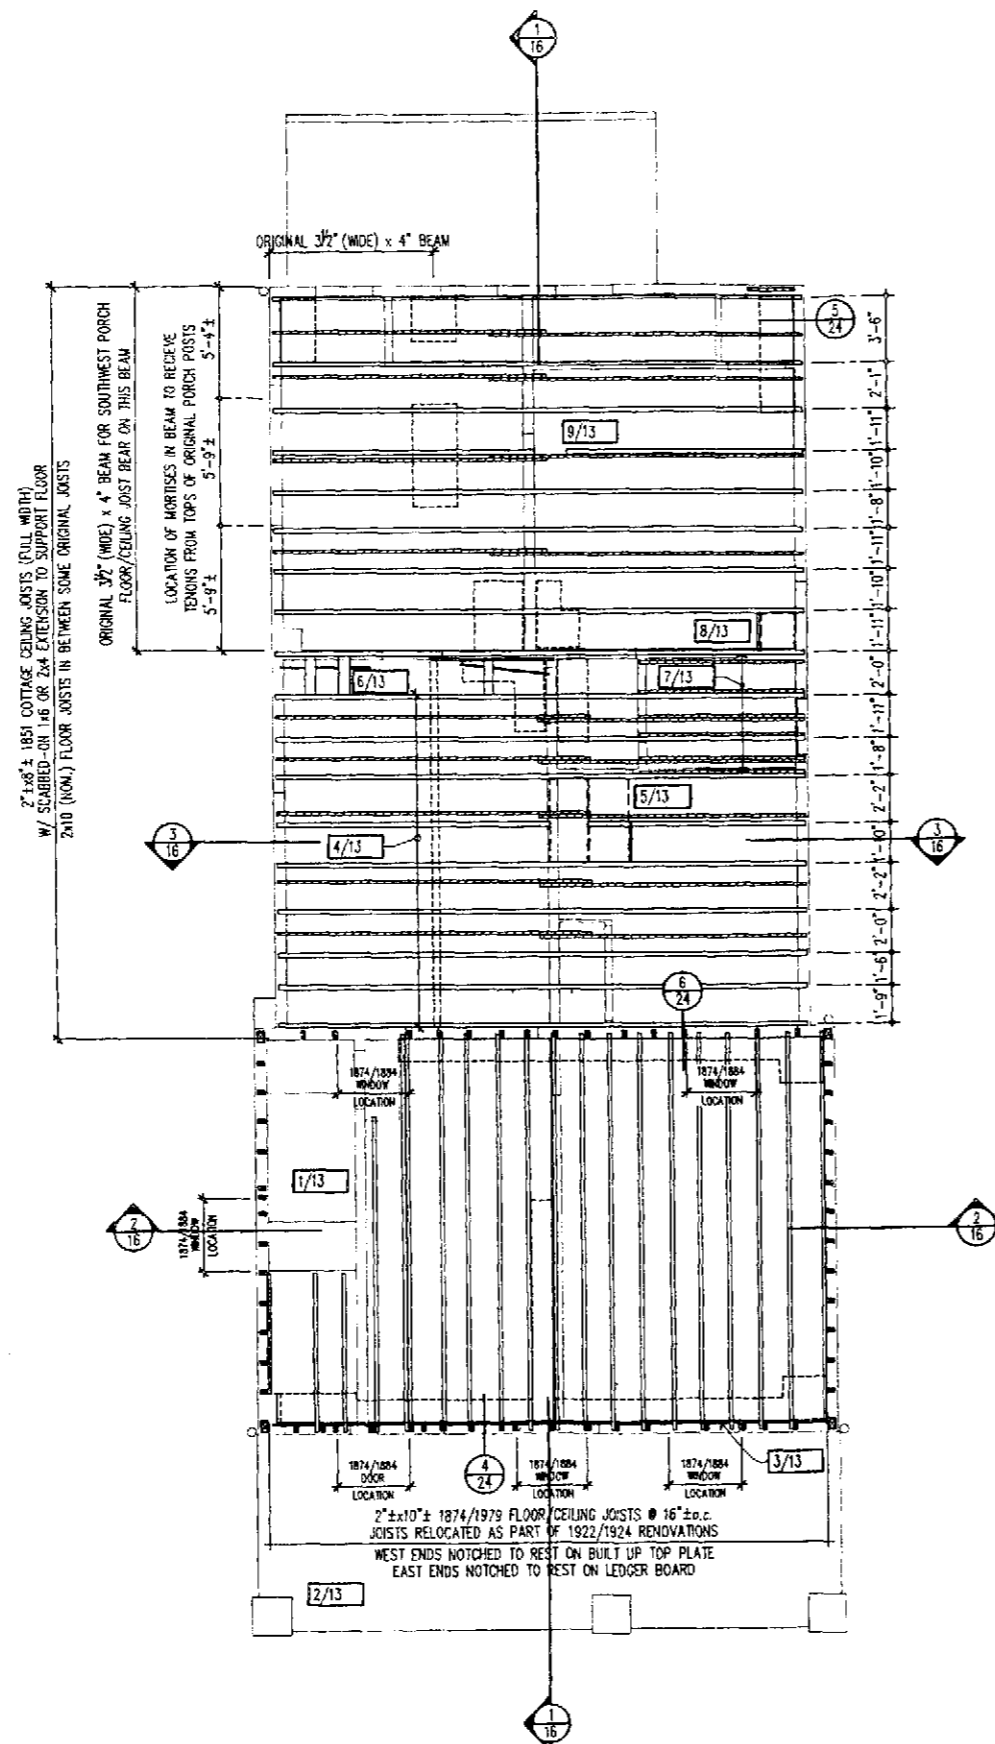
SECOND FLOOR FRAMING PLAN
 SCALE: 1/4" = 1'-0"
 0 5 10 FEET

1. FRAMING CONDITIONS AT STAIR UNKNOWN
2. FRAMING AT EAST PORCH UNKNOWN
3. 7/8" x 3 7/8" LEDGER (CIRCA 1922)
4. 8" WIDE, 1" DEEP NOTCHES IN THE BOTTOMS OF THE 1851 COTTAGE CEILING JOISTS IN THIS AREA, INDICATE THE LOCATION OF AN ORIGINAL PARTITION WALL.

8. THESE DASHED LINES REPRESENT THE LIMITS OF REPLACEMENT SECOND FLOOR SUBFLOOR BOARDS. THIS AREA MAY HAVE BEEN THE LOCATION OF CHASE FOR THE 1922/1924 STACKED DUPLEX.

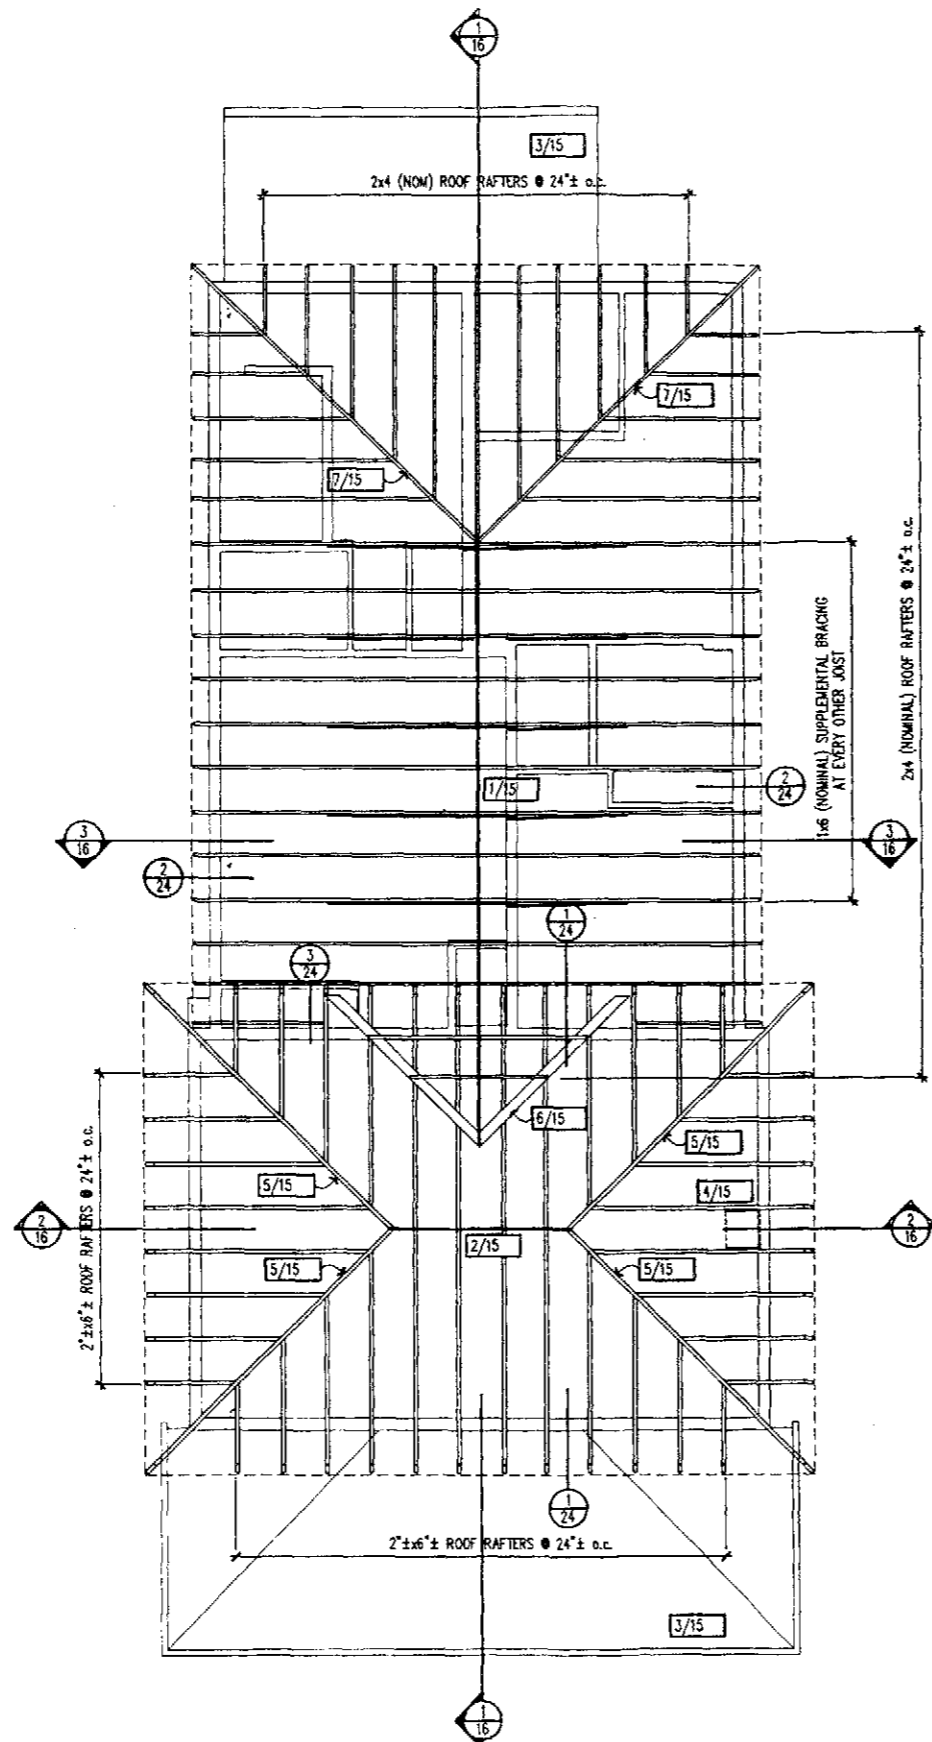
ROOF FRAMING PLAN
 SCALE: 1/4" = 1'-0"
 0 5 10 FEET

- NOTES**
- 3/4" x 5" RIDGE BOARD
 - 1" x 5-1/4" RIDGE BOARD
 - ROOF RAFTERS AT EAST & WEST PORCH ATTIC UNKNOWN
 - LIMITS OF INFILL SHEATHING AND ASSOCIATED 1x FRAMING AT EARLY CHIMNEY PASSAGES.
 - 2"x6"± JACK RAFTERS
 - 1"x BEARING PLATE AT ENDS OF WEST ROOF RAFTERS ON TOP OF EAST ROOF SHEATHING.
 - 2x4 (NOM) JACK RAFTERS

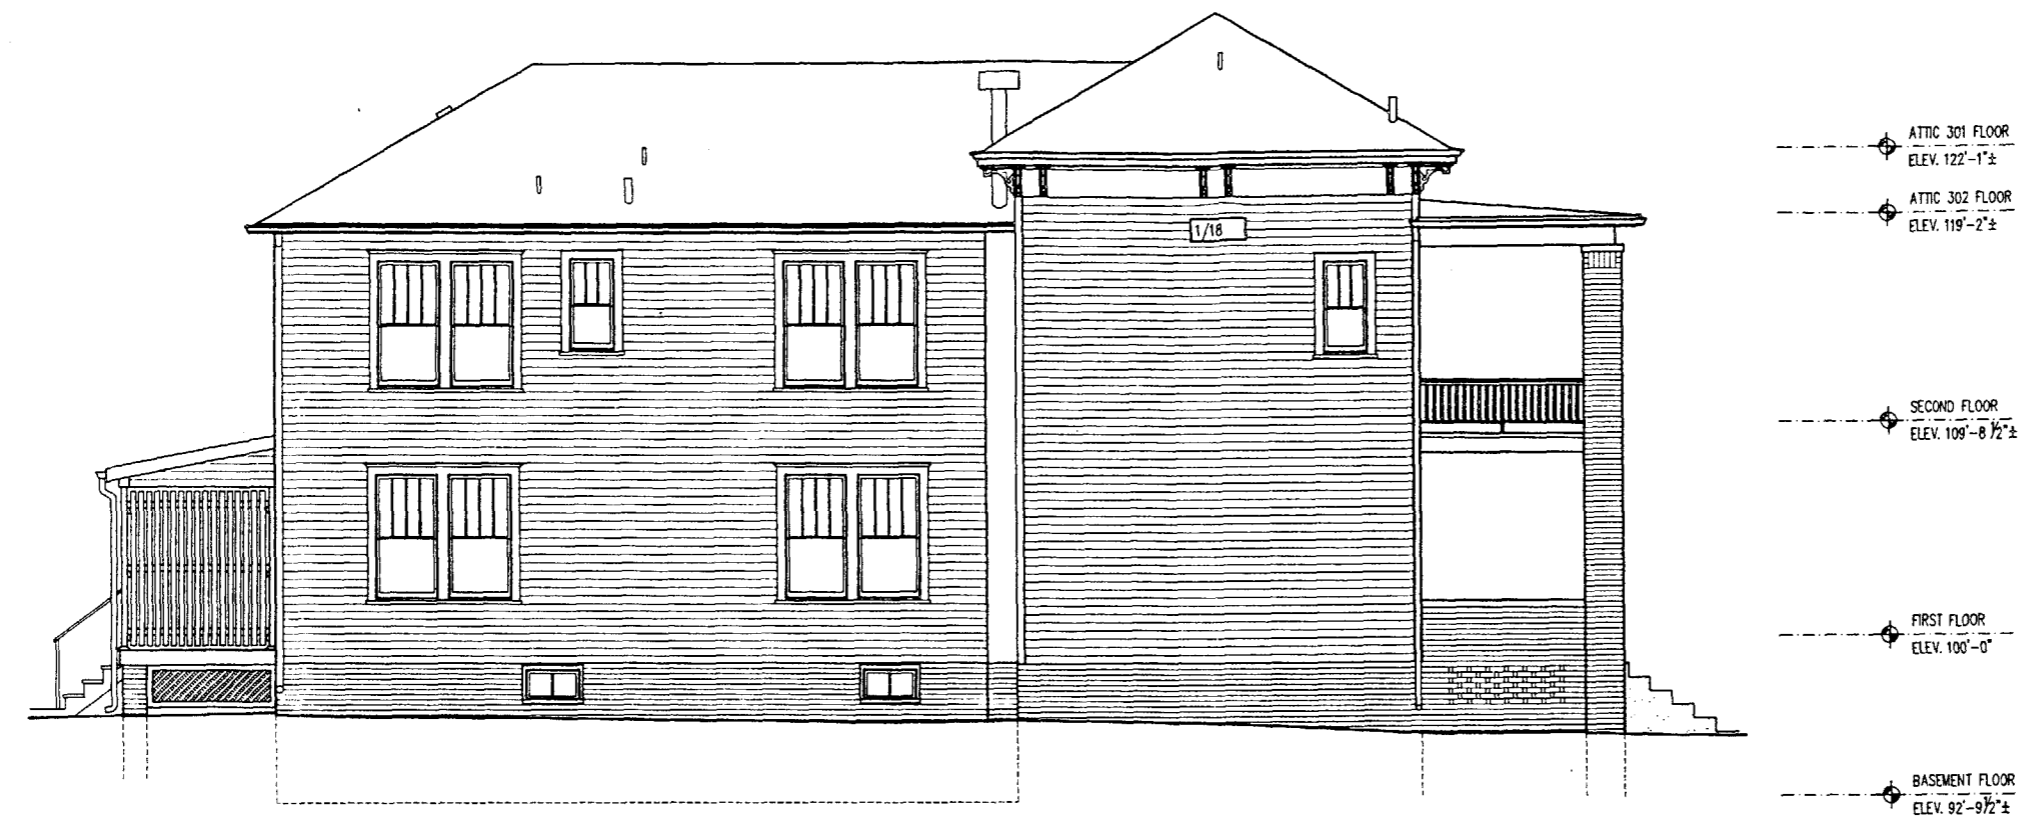
SOUTH ELEVATION
SCALE: 1/4" = 1'-0"
0 5 10 FEET

1. THIS ANGLED PROFILE, CUT IN THE BOTTOM OF THIS CLAPBOARD, IS AT THE FORMER LOCATION OF A WINDOW DATING TO THE HOFFERKAMP ADDITION (1874/1879). THIS PROFILE PROBABLY FOLLOWS THAT OF THE HEAD TRIM AT THE WINDOWS (AND DOOR) OF THE HOFFERKAMP ADDITION.

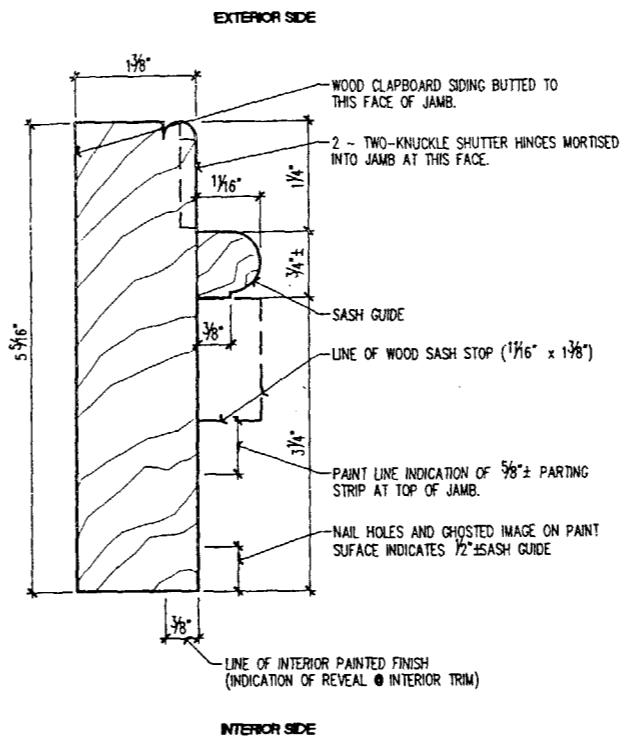
1851 COTTAGE WINDOW JAMB & HARDWARE
 DISCOVERED IN EAST WALL CAVITY AT ORIGINAL NORTHERN-MOST WINDOW LOCATION

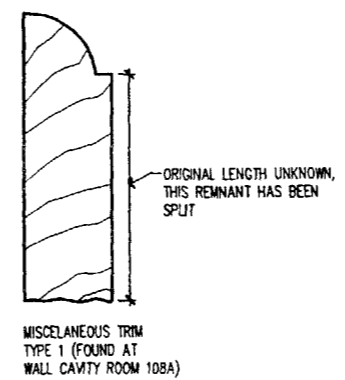
MISCELLANEOUS TRIM TYPE 1 (FOUND AT WALL CAVITY ROOM 108A)

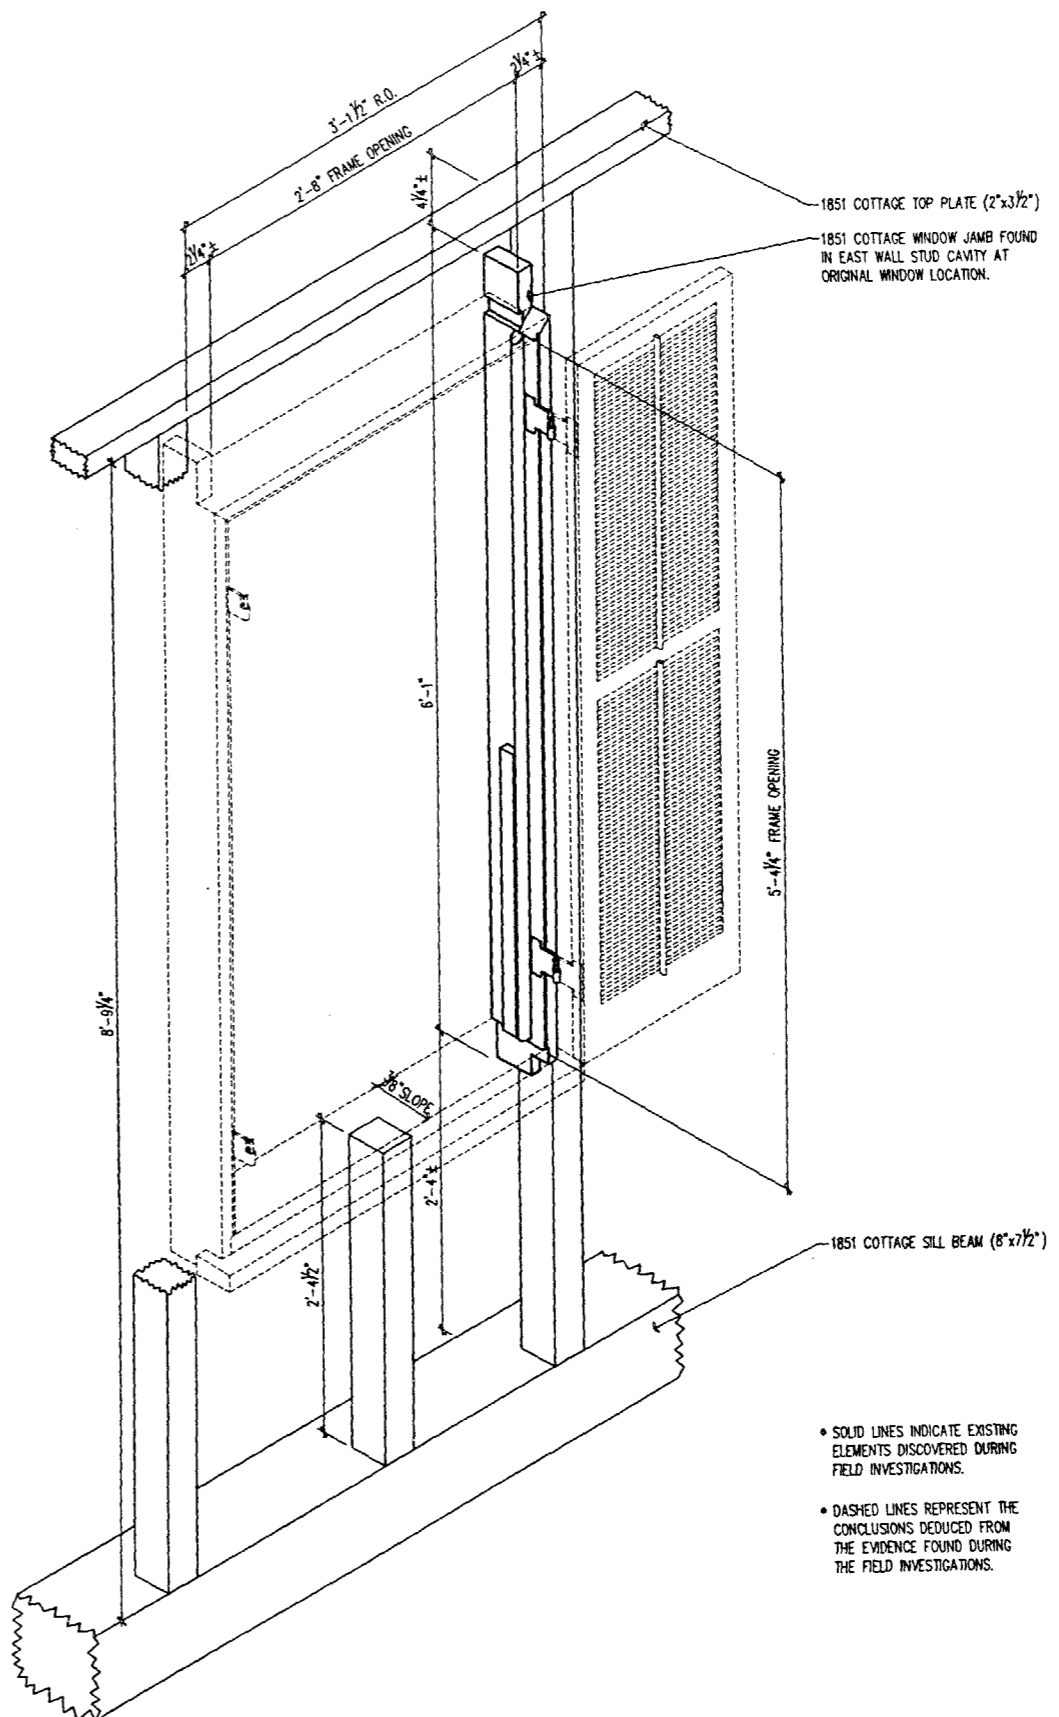
1851 COTTAGE TOP PLATE (2"x3 1/2")
1851 COTTAGE WINDOW JAMB FOUND IN EAST WALL STUD CAVITY AT ORIGINAL WINDOW LOCATION.
