HISTORIC STRUCTURE REPORT

JULIA SPRIGG HOUSE (HS-11)

Lincoln Home National Historic Site
Springfield, Illinois

May 1995

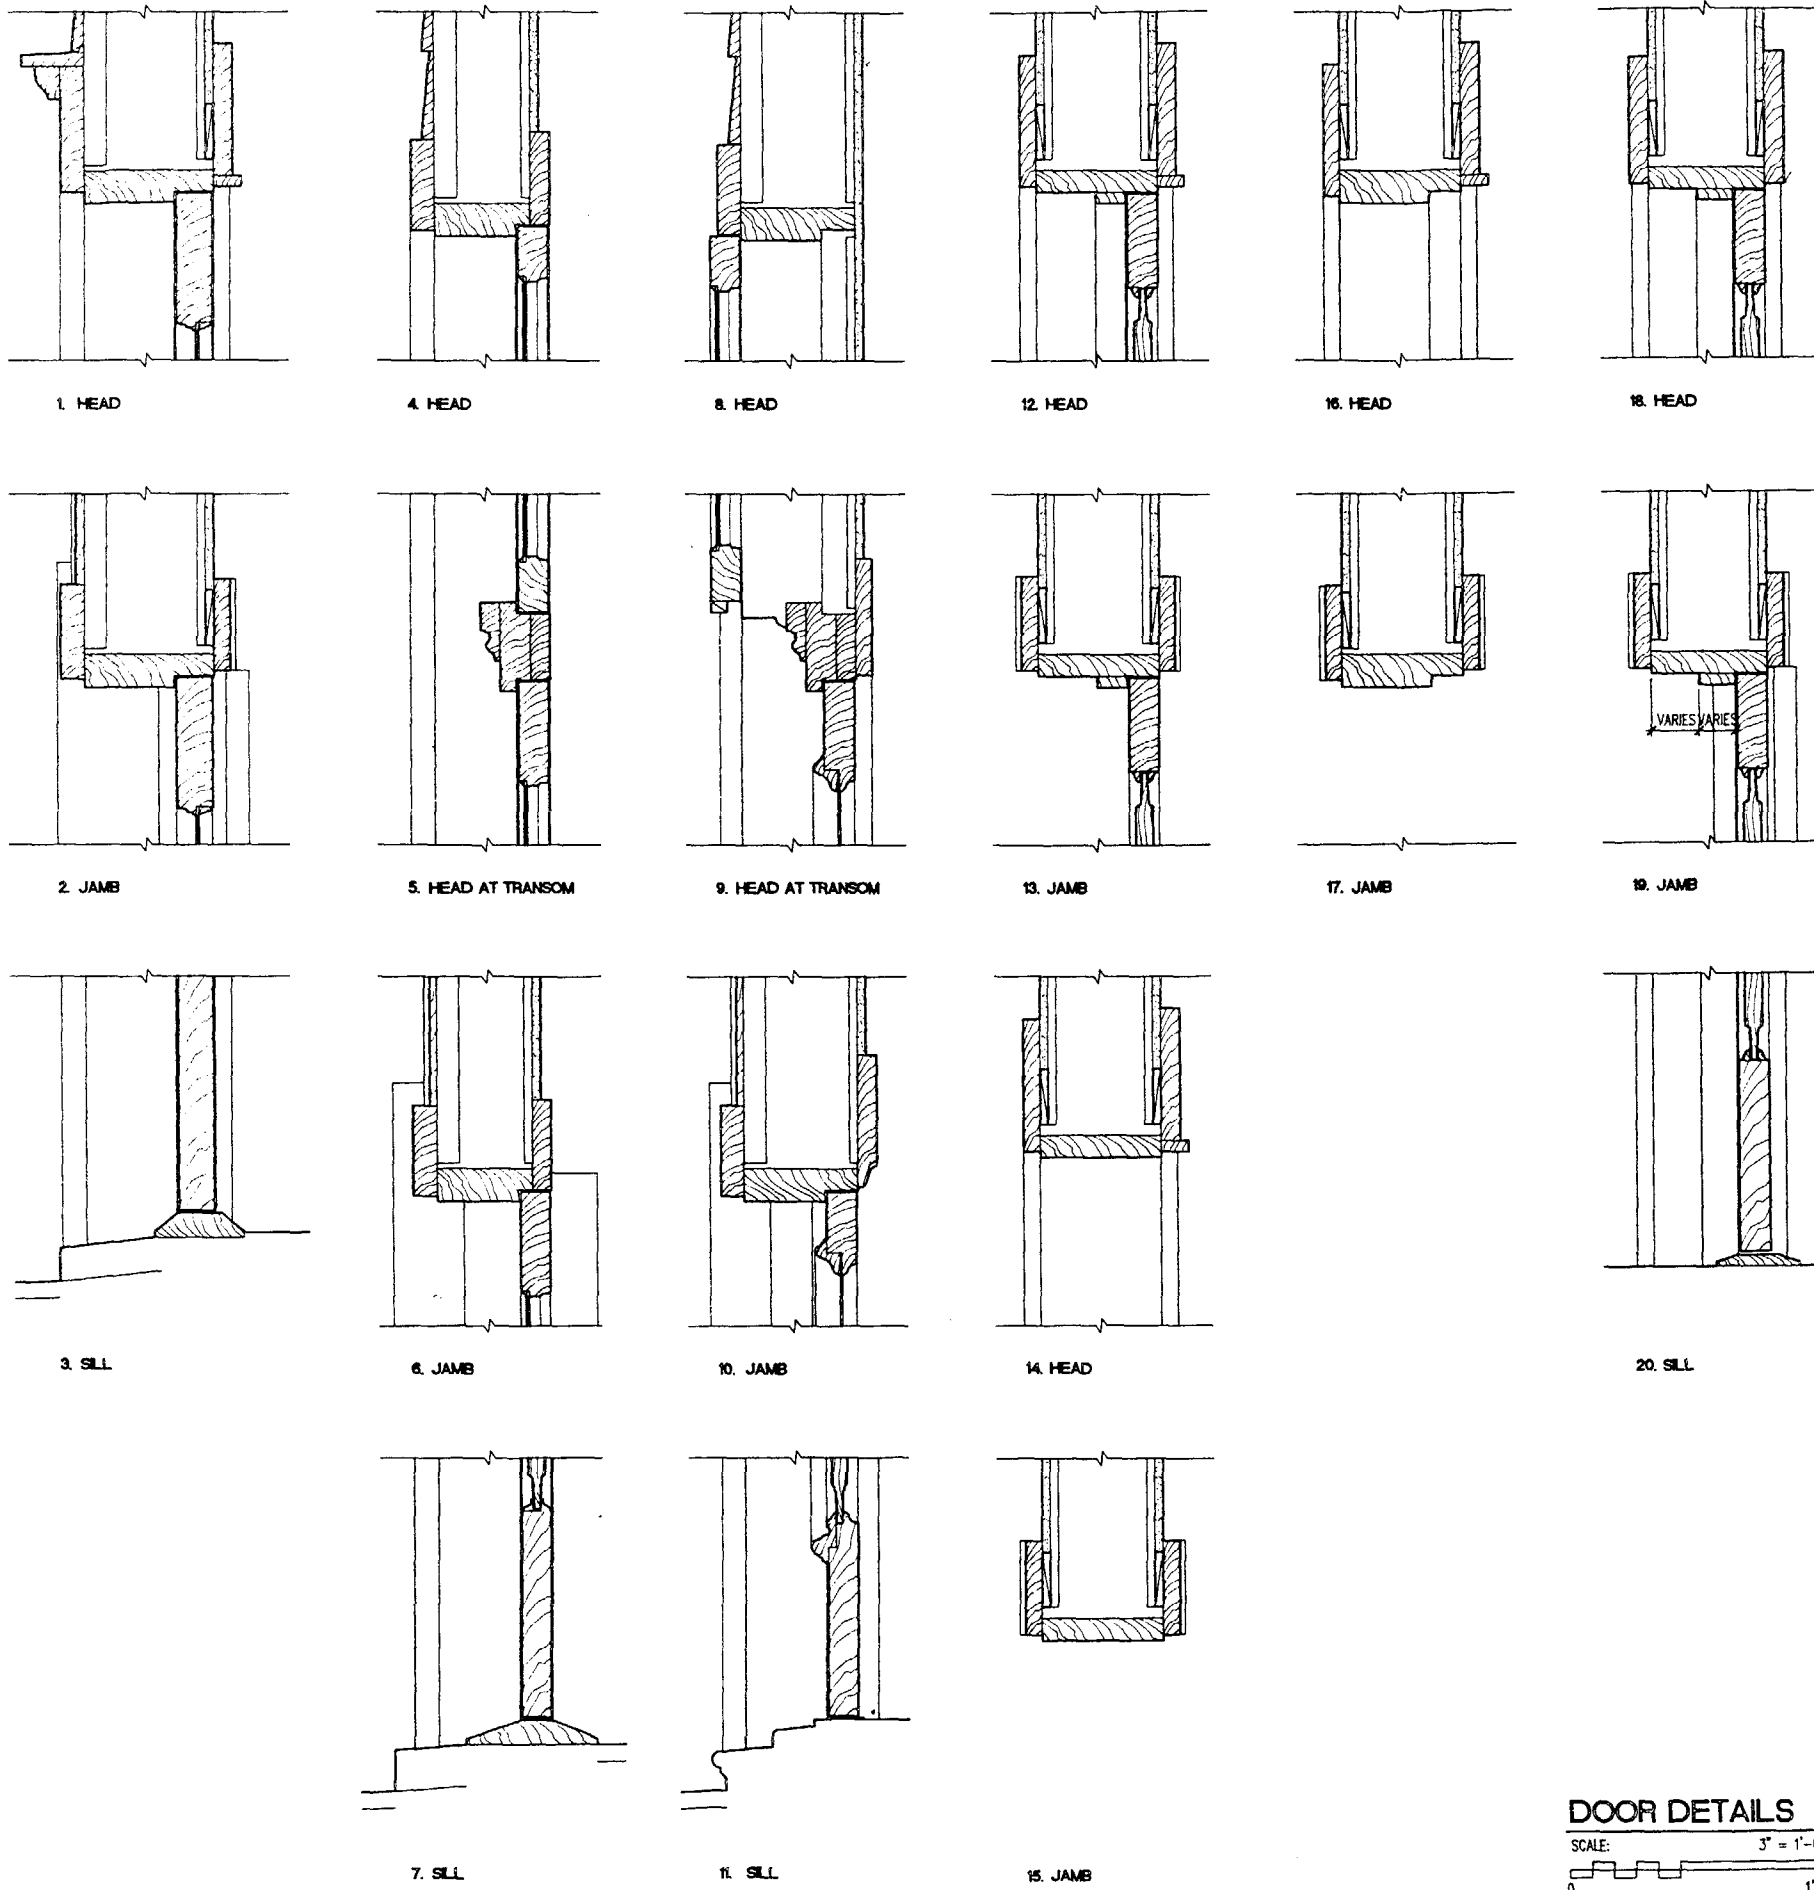
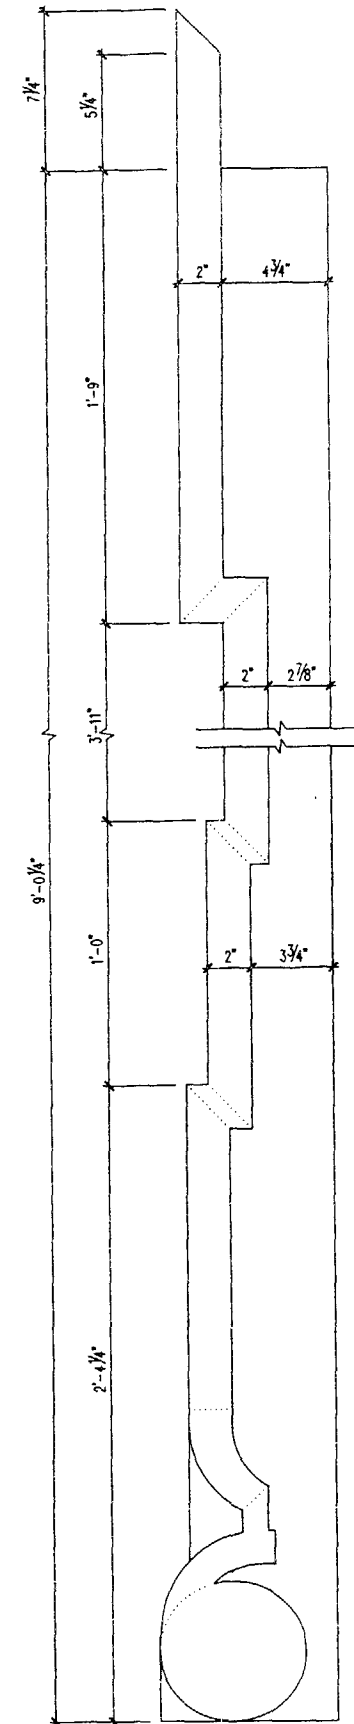
LOOSE 1874/1879 DOOR JAMB TRIM DISCOVERED IN FLOOR JOIST VOID • ROOM 201

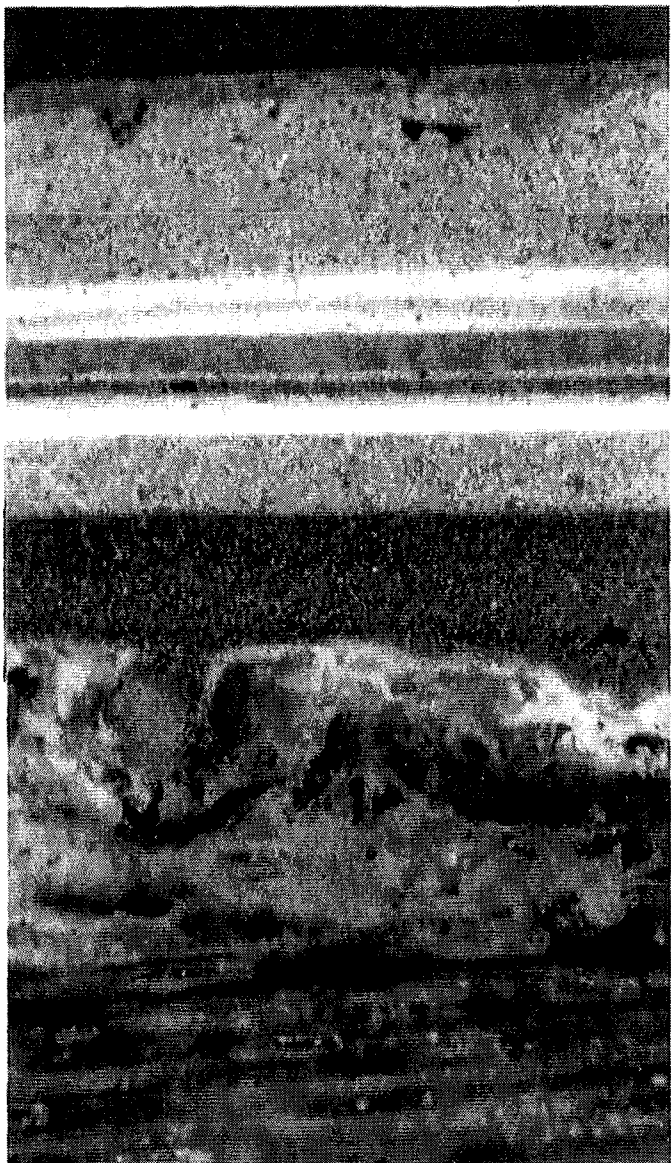
Building: J. Sprigg House
Room/Elevation: South Wall, Exterior
Feature: Porch Beam Casing

- 12.
- 11.
- 10.
- 9.
- 8.
- 7.
6. Grey
5. Yellow **
4. Yellow **
3. Yellow **
2. White
1. (unclear)
- Substrate: Wood

** These probably correspond with layers 6-8 in sample #1.

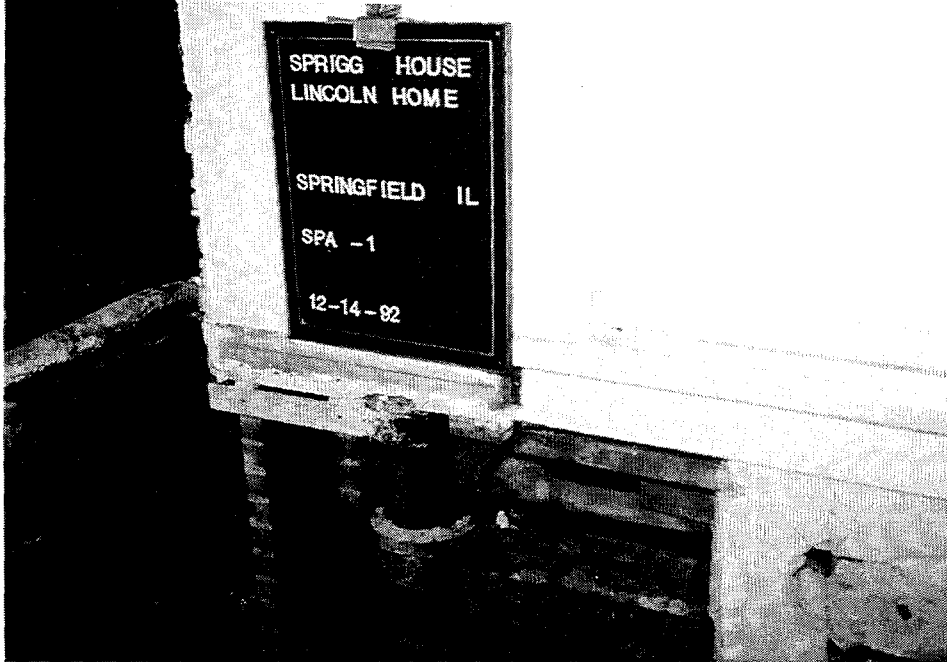
Photo SPA-1
1922 Plaster
Bathroom 201A-Wall

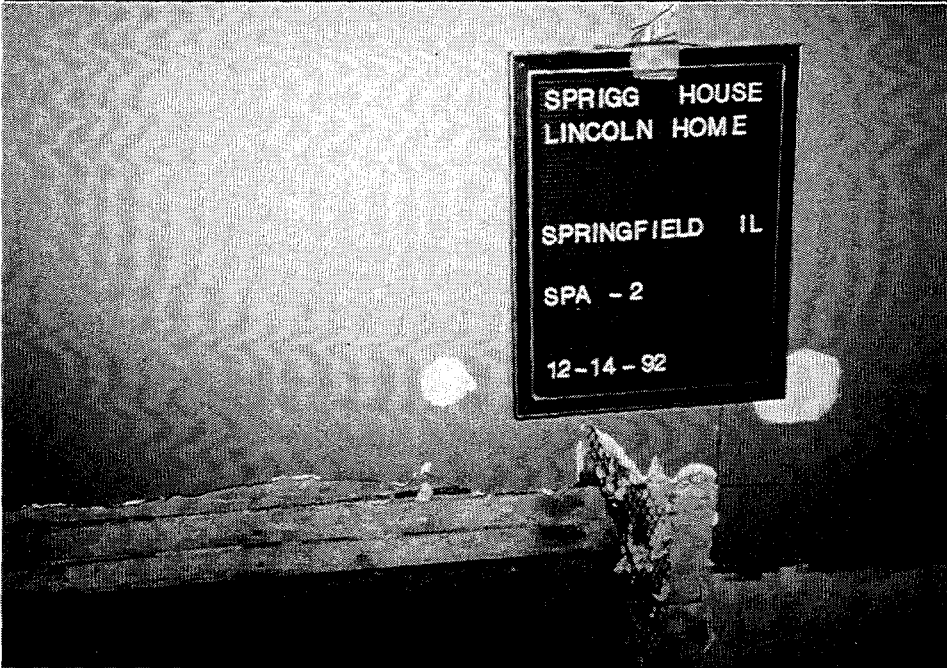
Photo SPA-2
1922 Plaster
Room 208-Wall

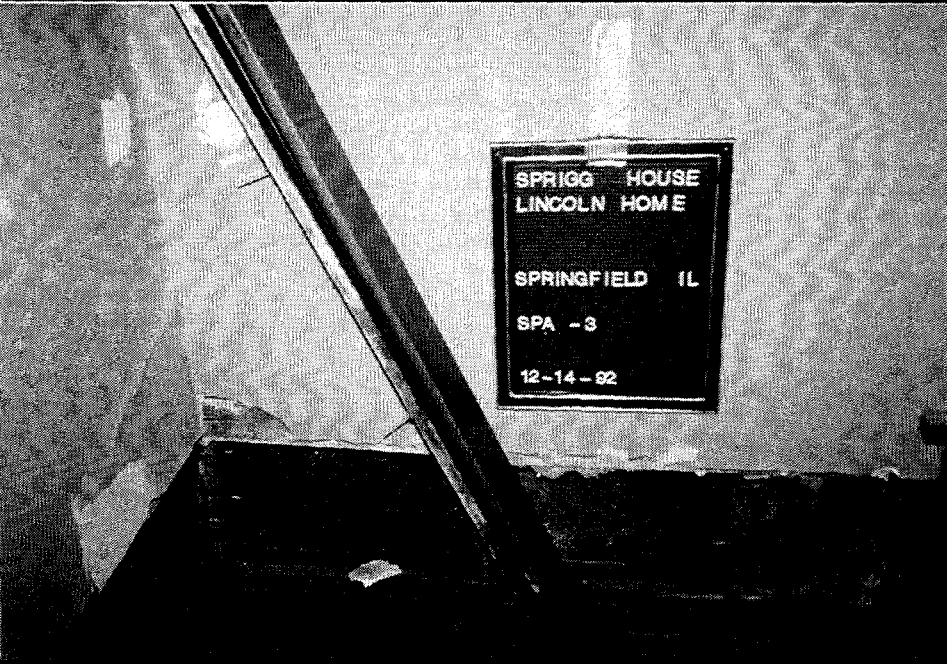
Photo SPA-3
1922 Plaster
Room 202-Wall

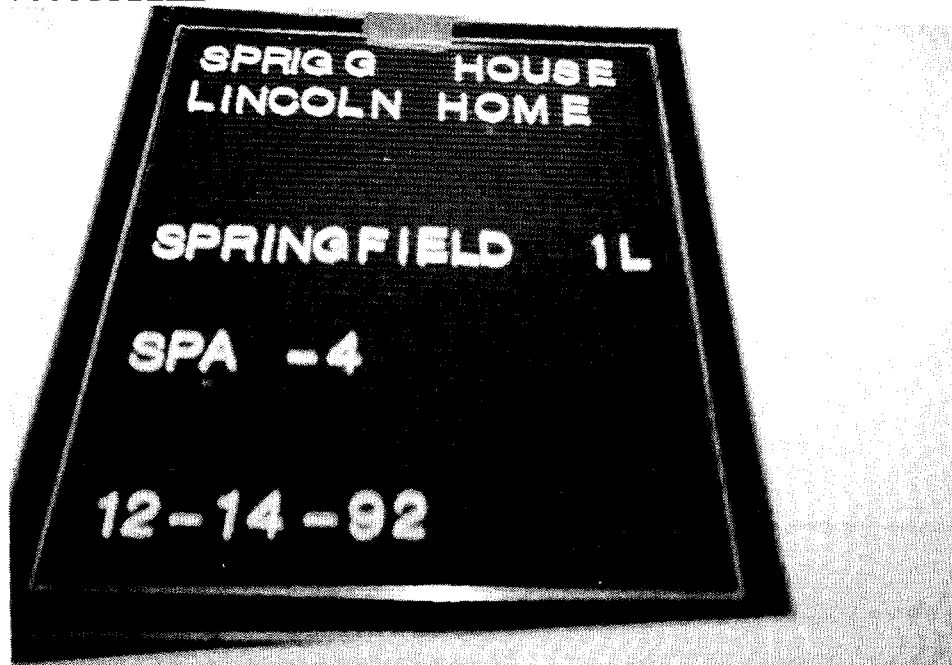
Photo SPA-4
1922 Plaster
Bathroom 206-Ceiling

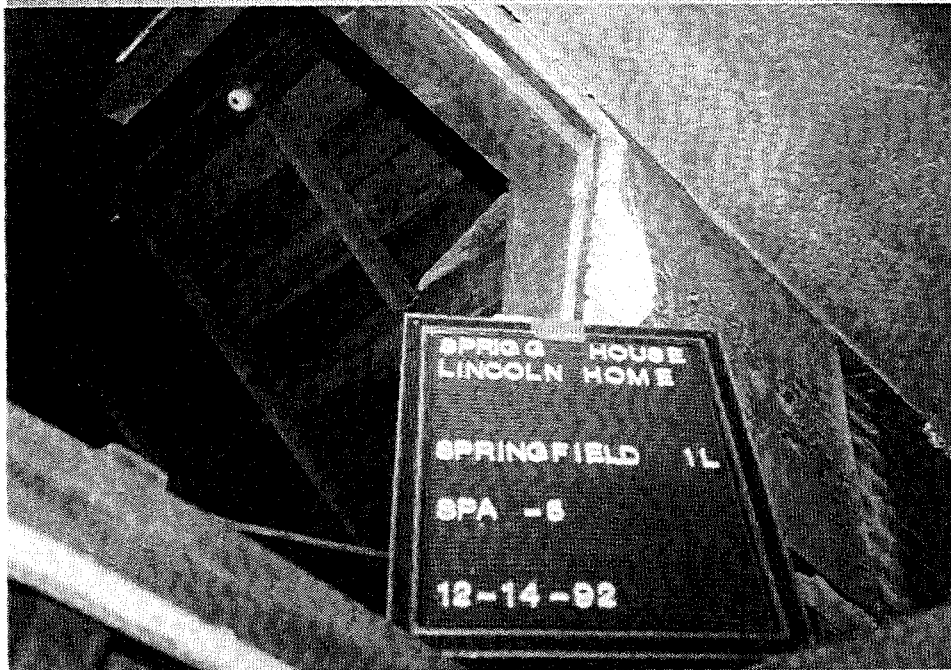
Photo SPA-5
1922 Plaster
Hall 201D-Ceiling

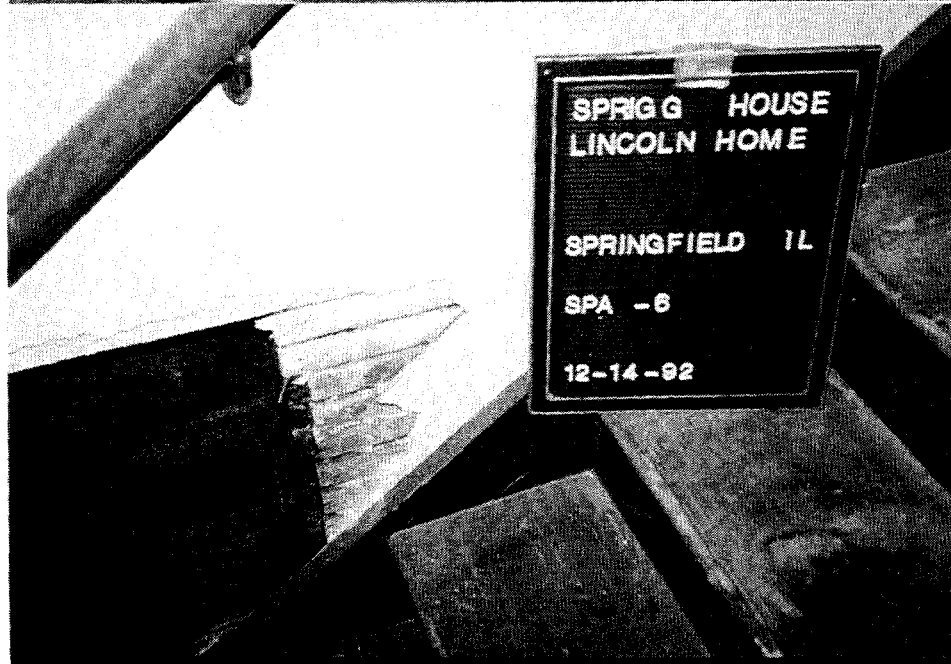
Photo SPA-6
1922 Plaster
Stair S1-Wall

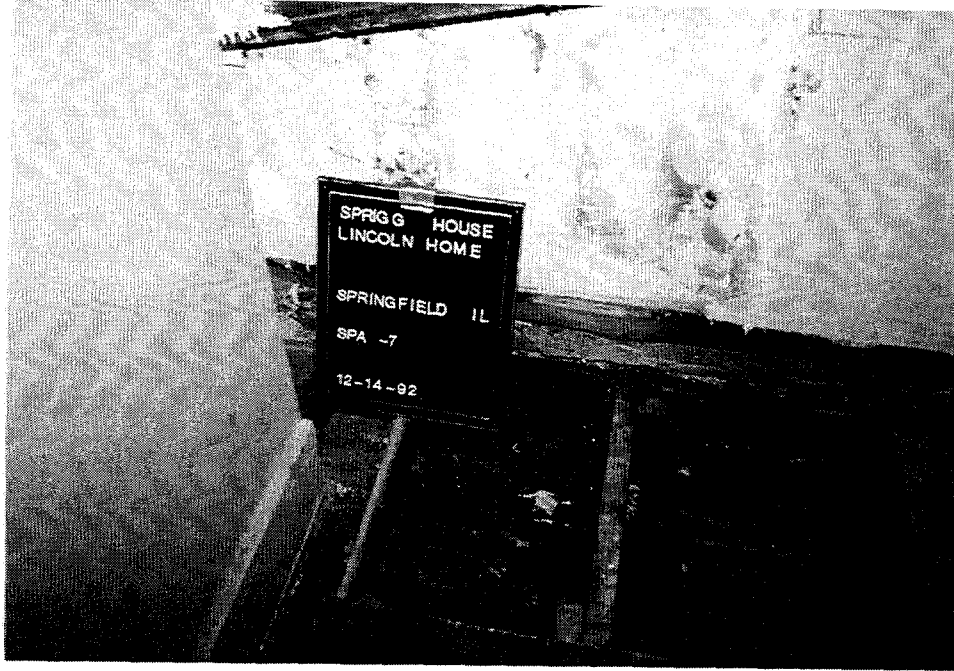
Photo SPA-7
1922 Plaster
Room 207-Wall

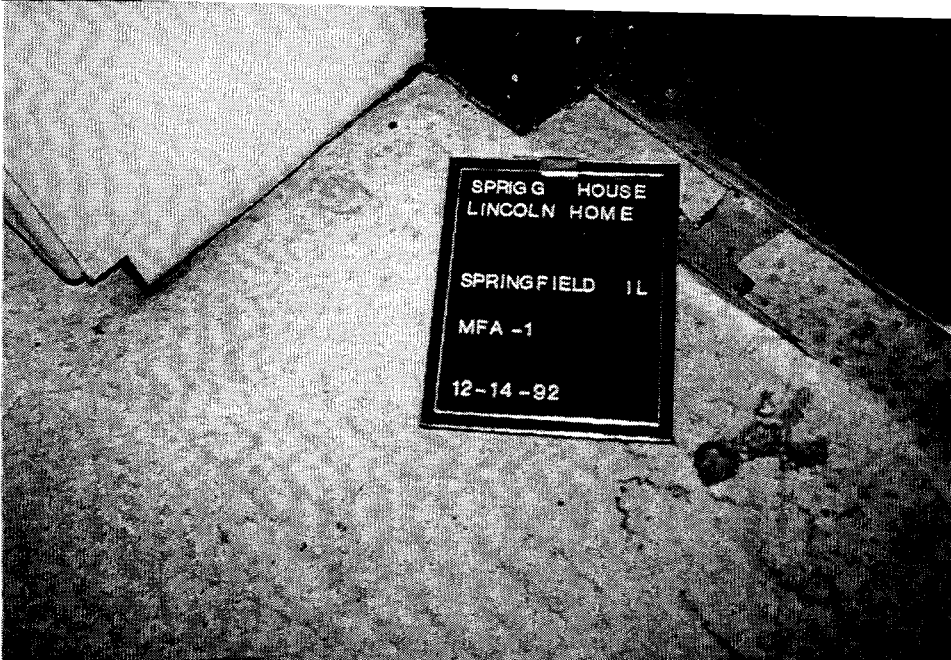
Photo MFA-1
Sheet Flooring-Linoleum
Room 208

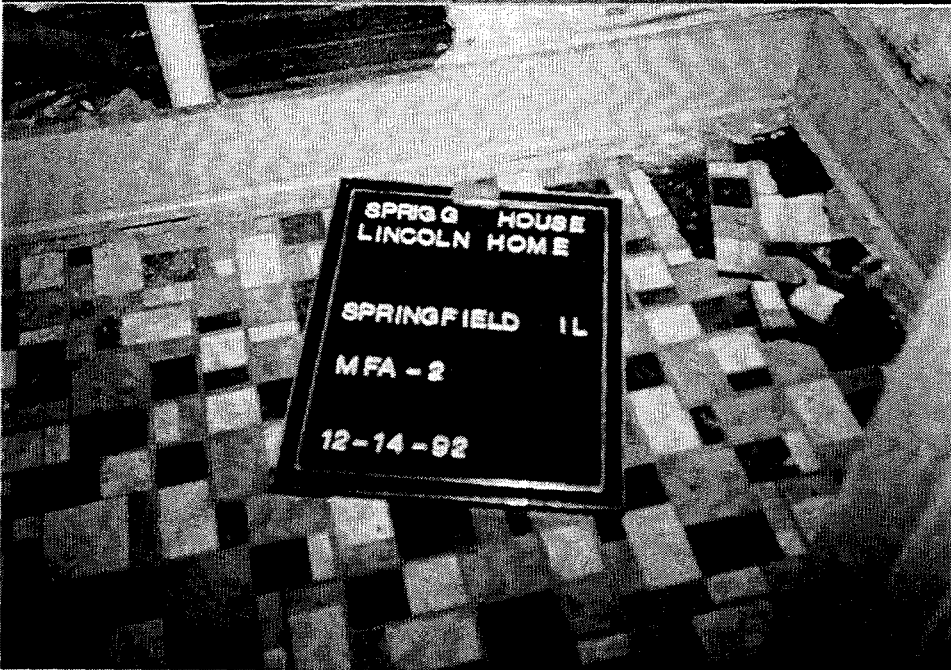
Photo MFA-2
Sheet Flooring-Linoleum
Closet 207B

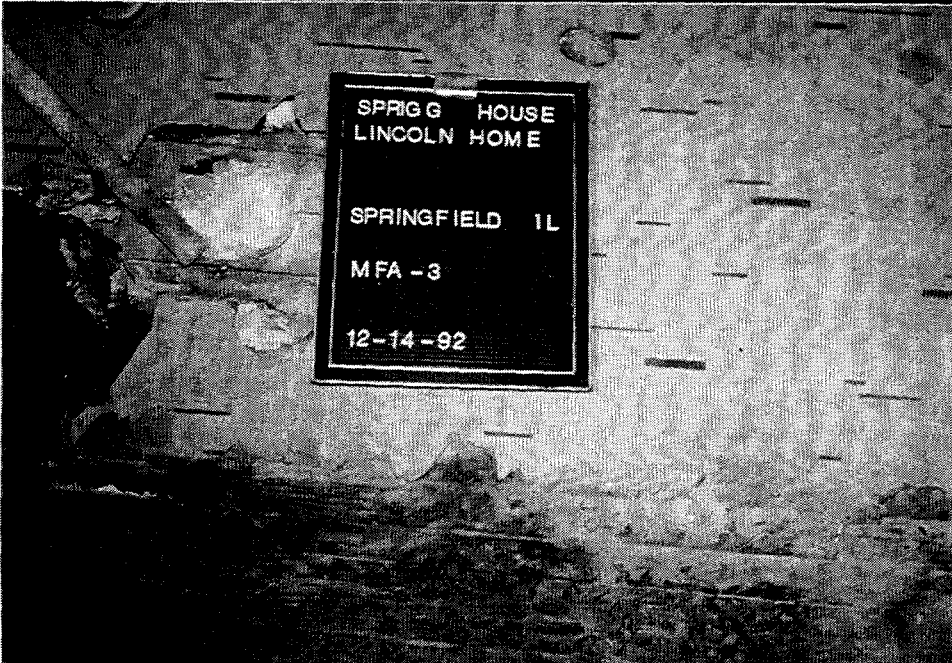
Photo MFA-3
Sheet Flooring-Linoleum
Bathroom 201A

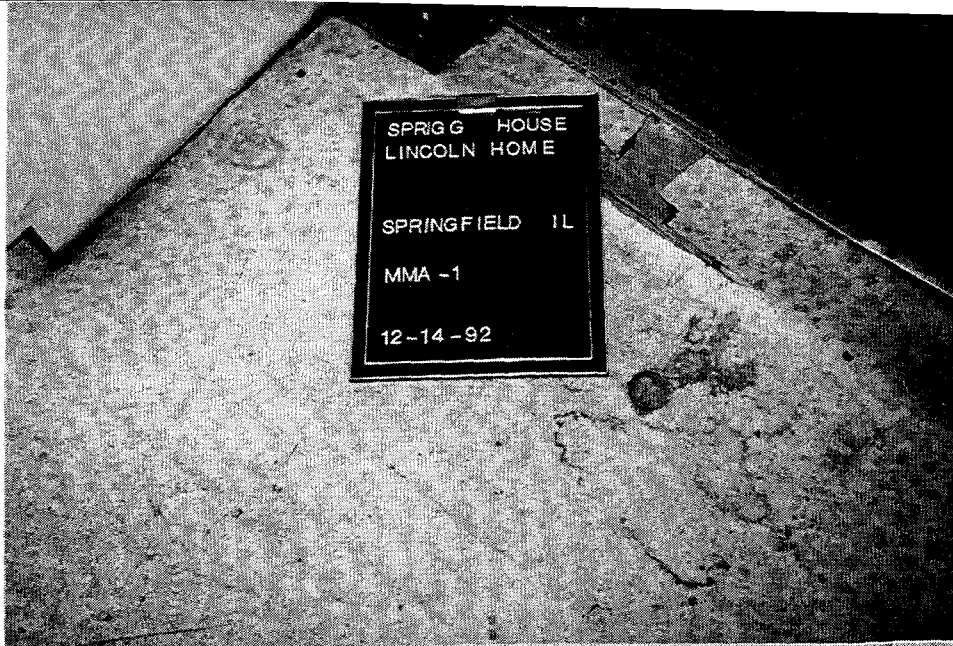
Photo MMA-1
Mastic Under Sheet
Flooring Room 208

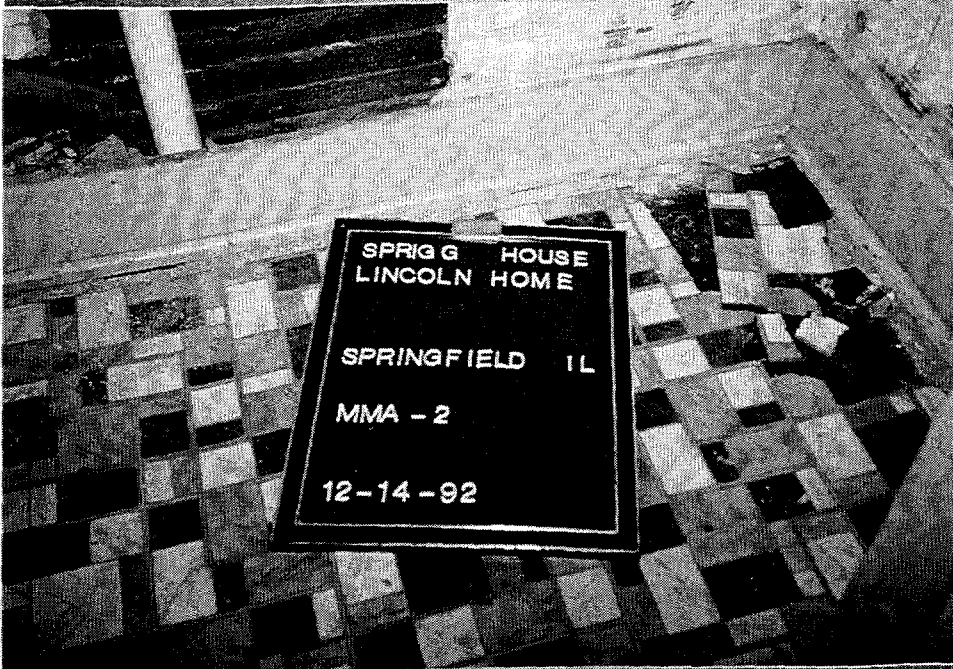
Photo MMA-2
Mastic Under Sheet
Flooring Closet 207B

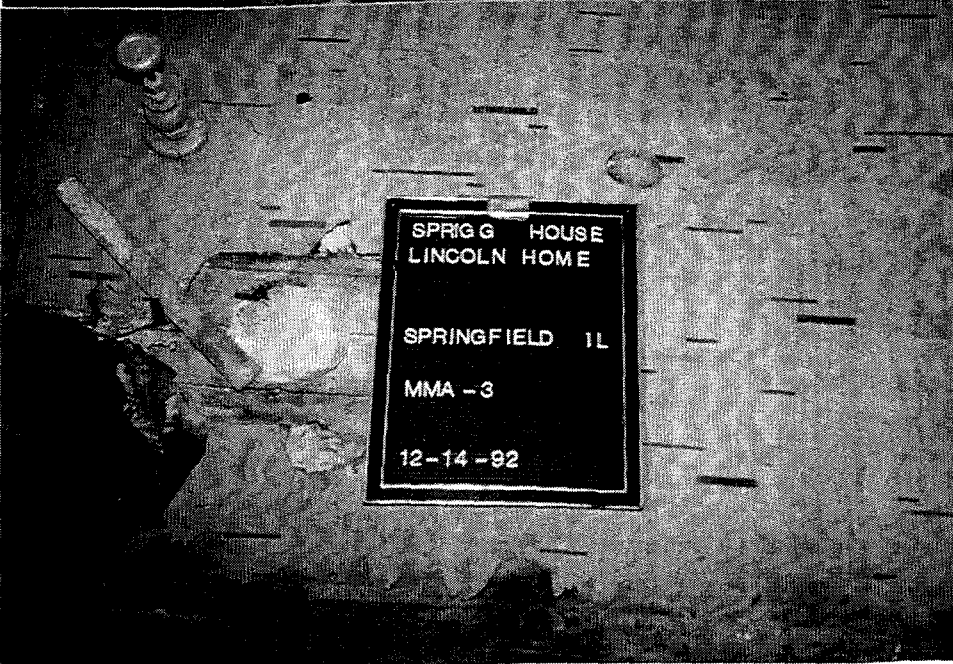
Photo MMA-3
Mastic Under Sheet
Flooring Bathroom 201A

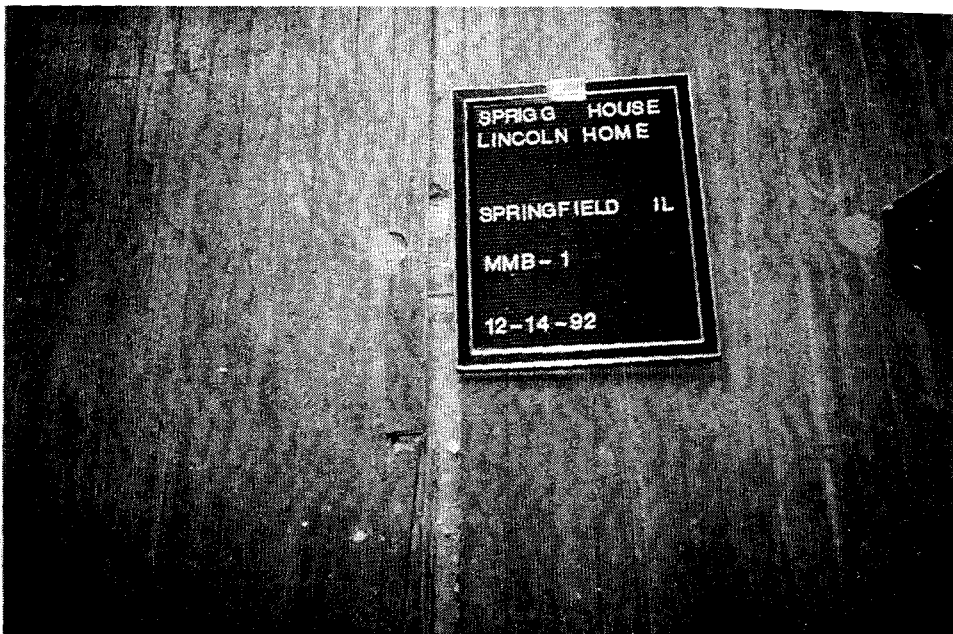
Photo MMB-1
Felt Paper Under Wood
Floor Room 204

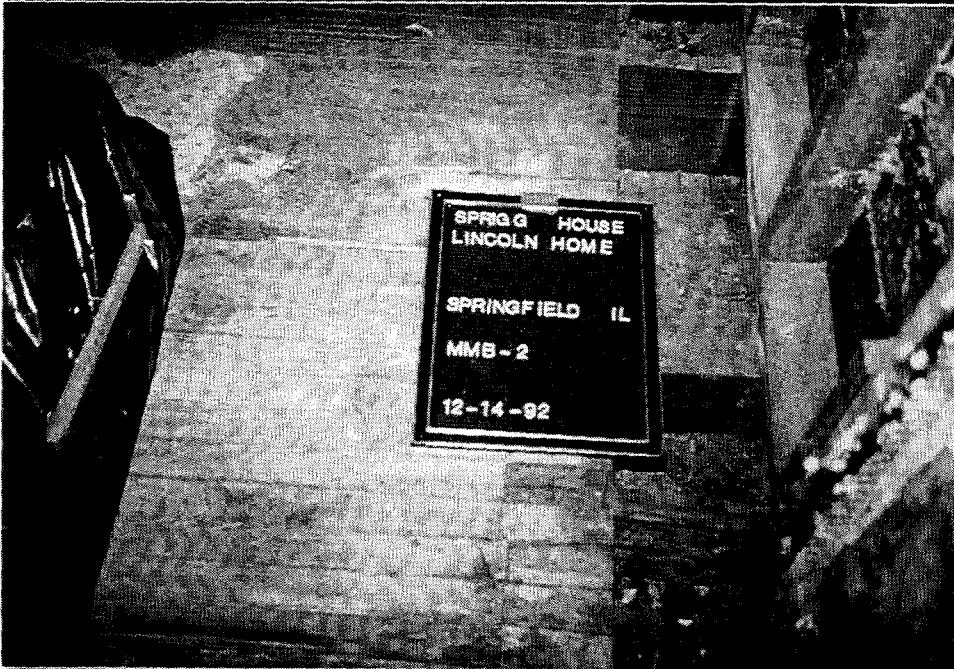
Photo MMB-2
Felt Paper Under Wood
Floor Room 208

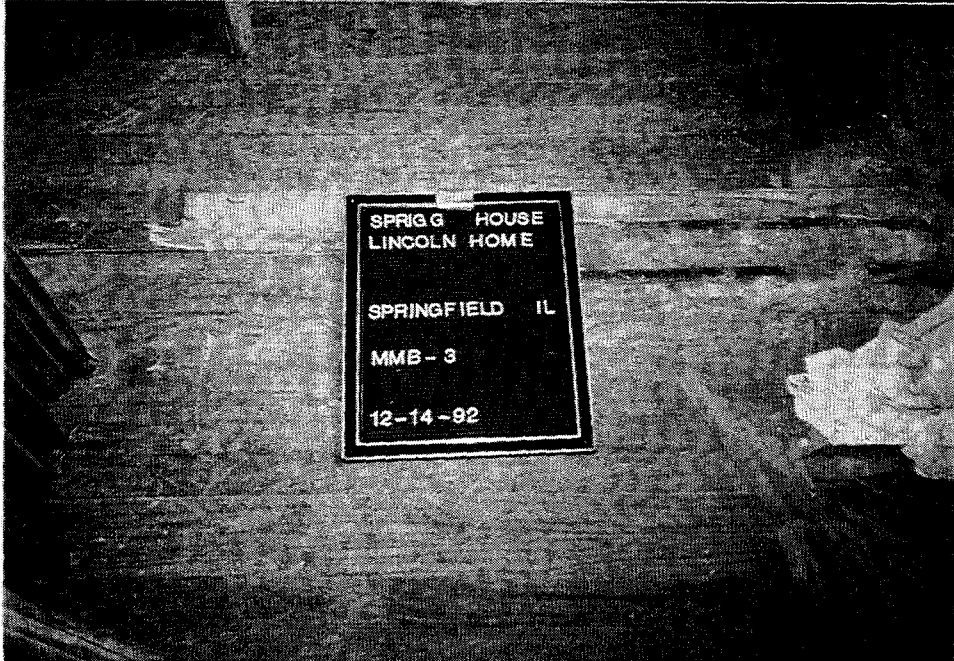
Photo MMB-3
Felt Paper Under Wood
Floor Room 202

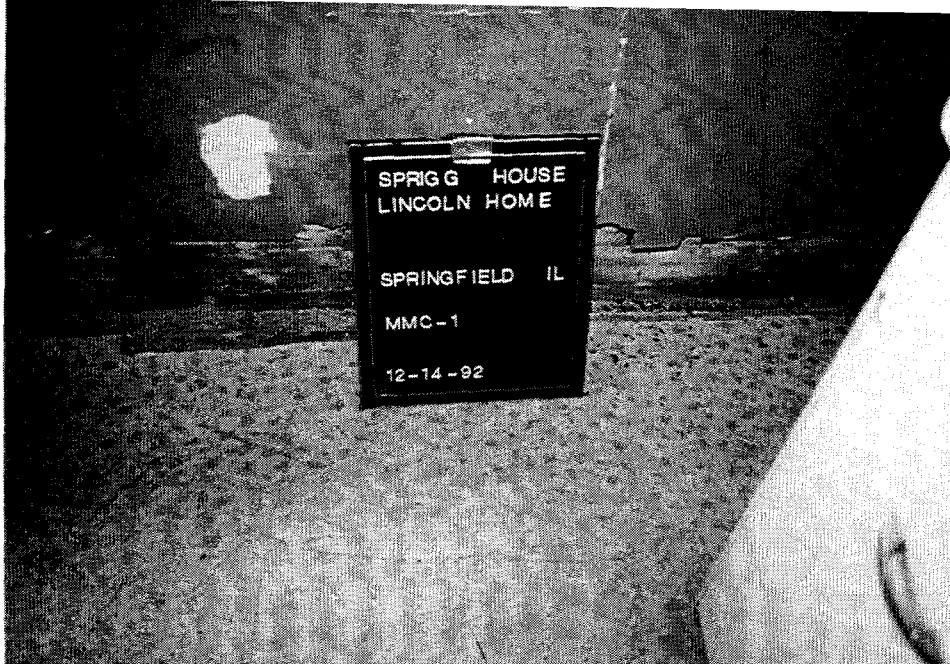
Photo MMC-1
Fibrous Wall Board
Room 208

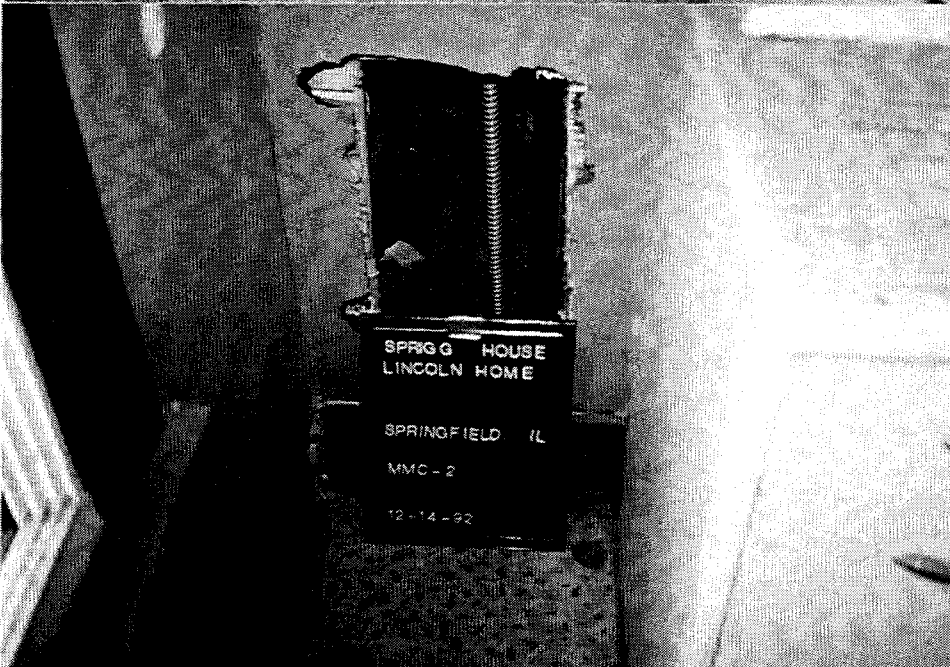
Photo MMC-2
Fibrous Wall Board
Room 208

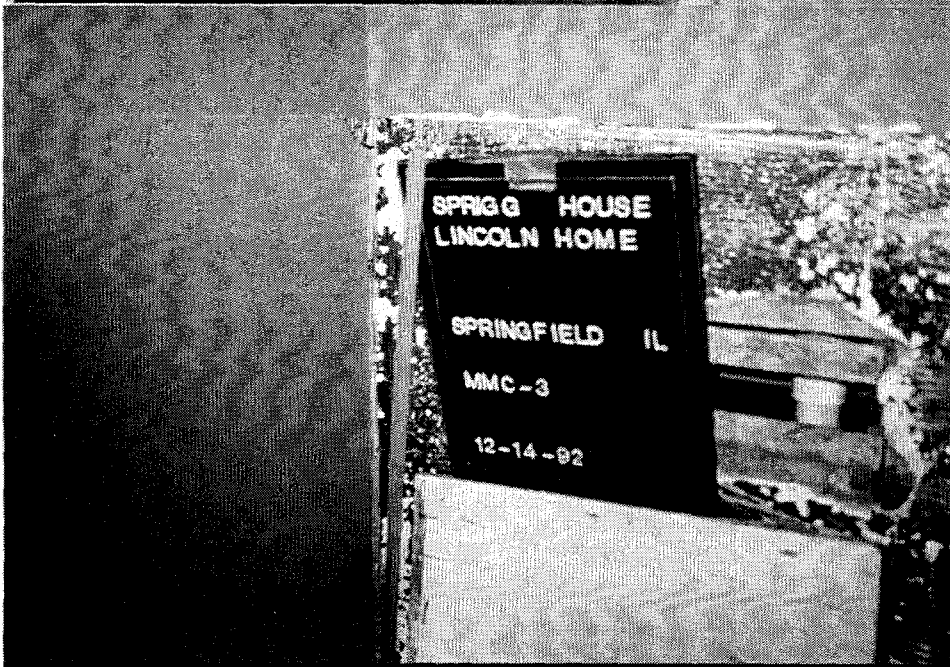
Photo MMC-3
Fibrous Wall Board
Room 208

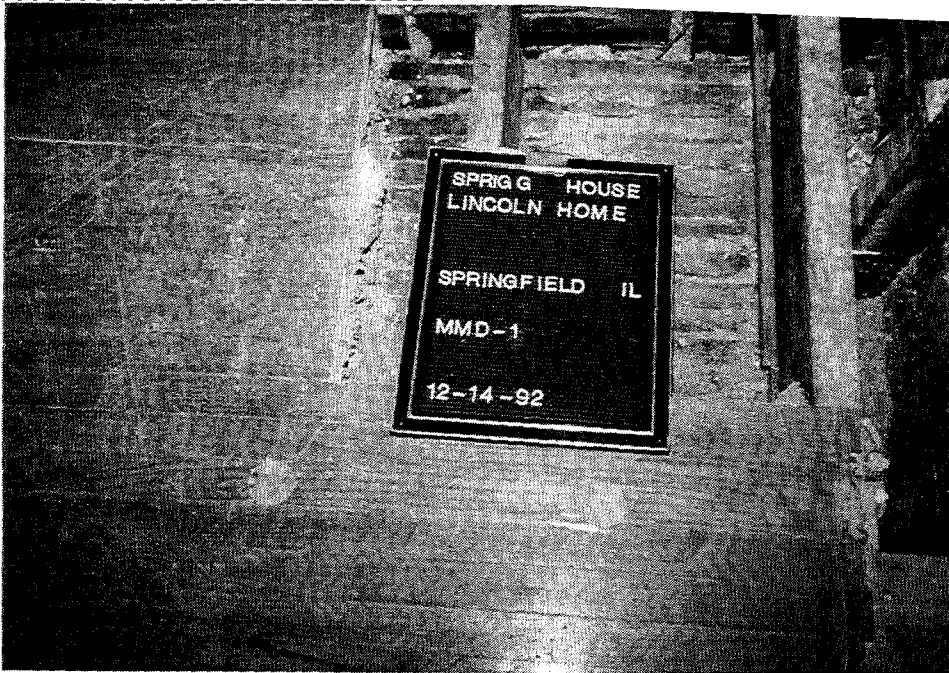
Photo MMD-1
Blown-in Insulation
Room 202

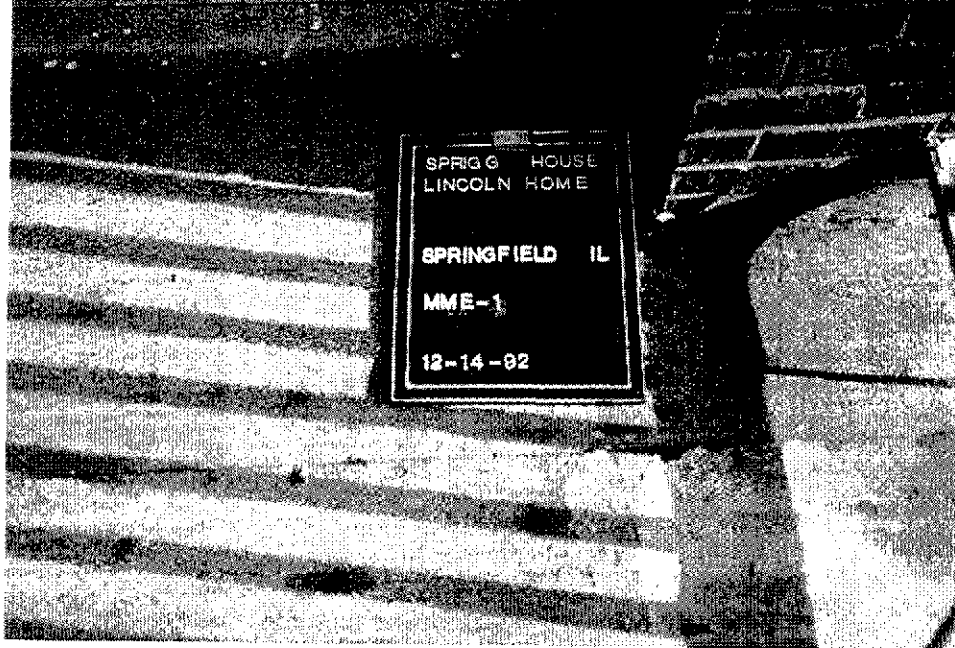
Photo MME-1
Roofing
Second Floor Balcony

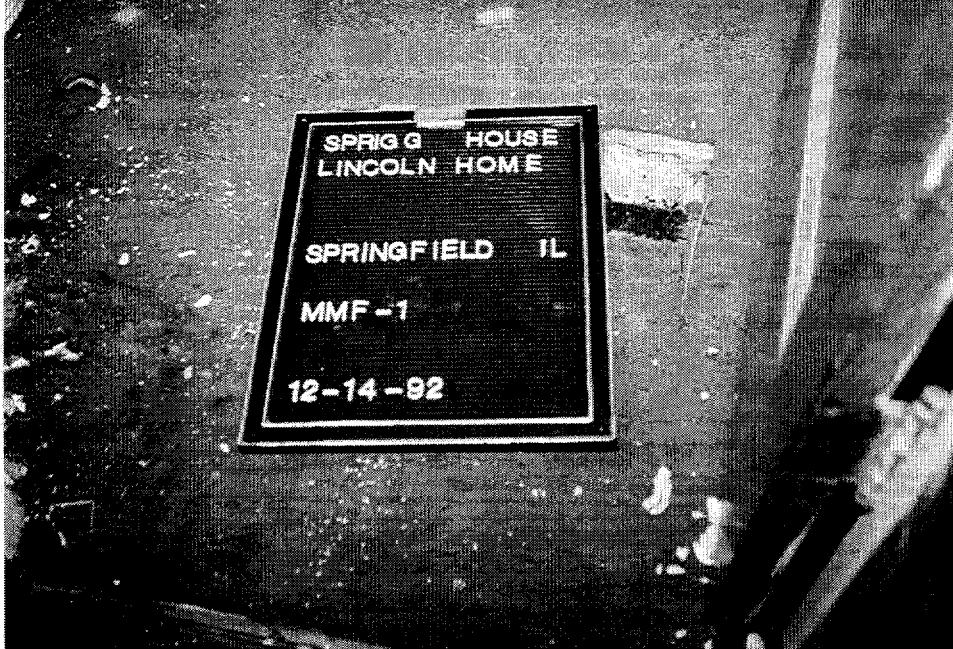
Photo MMF-1
Mastic Under Carpet
Room 207D

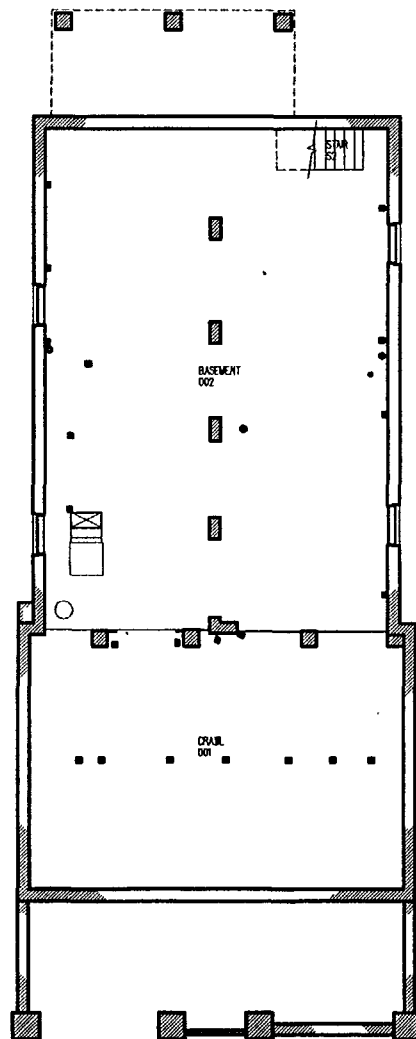
NO SUSPECT MATERIAL ON THIS FLOOR
