LINCOLN HOME  
INTERIOR AND EXTERIOR RESTORATION  
LINCOLN HOME NATIONAL HISTORIC SITE  
HISTORIC STRUCTURE REPORT  
ARCHITECTURAL DATA SECTION - VOLUME II

Architectural Data Section - Volume II of II

Lot 8 - Block 10  
Lincoln Home National Historic Site  
Springfield, Illinois

20 February 1984

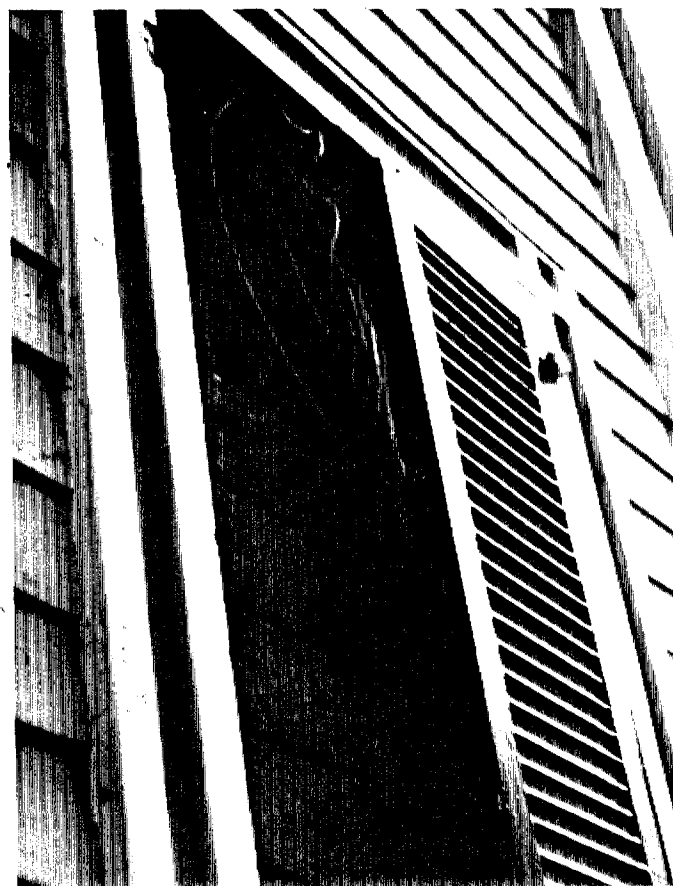
Photo showing closed-in window (boarded) by Mr. Lincoln when he added top part to house, north side of bottom floor.

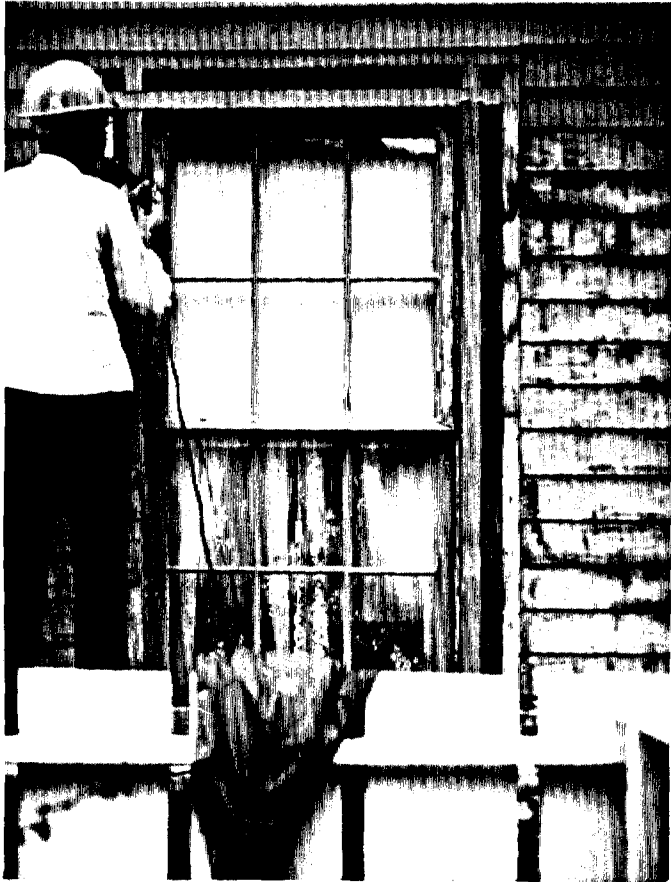
Photo showing removing old paint down to bare wood with electric heater. First floor, north side.

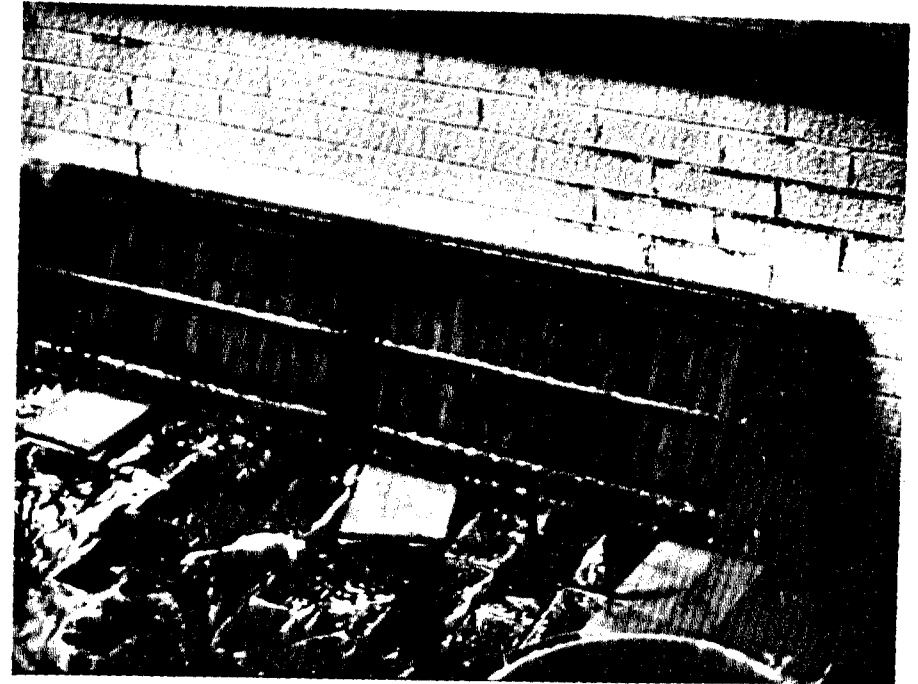
Photo showing paint removed from shutter. This was removed with caustic Soda-Flake - 76%  $\text{NA}_2\text{O}$ .

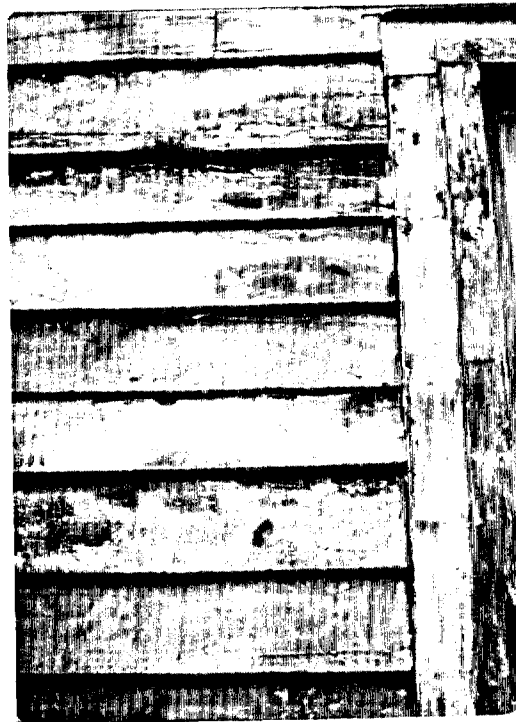
Photo showing some of the deterioration on siding and trim, east (back) first floor.

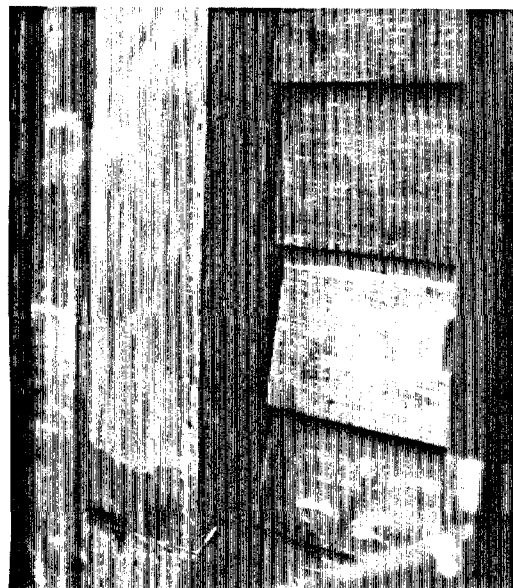
Photo showing large space in between board siding and trim at corner, front (west). Arrow showing this.

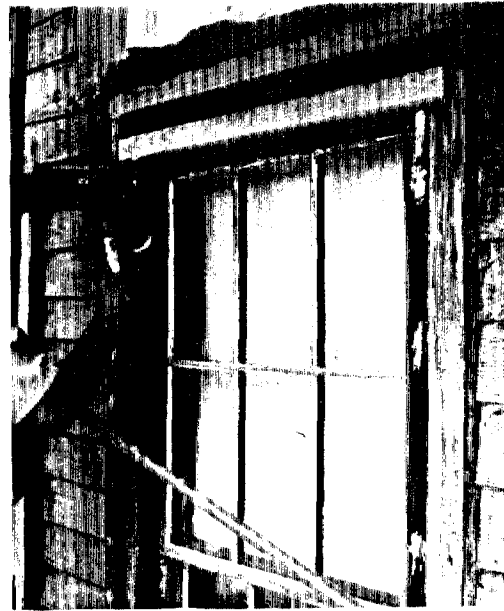
Photo showing replacement of deteriorated wood materials on window trim. New looking wood is the replacement in front, west.

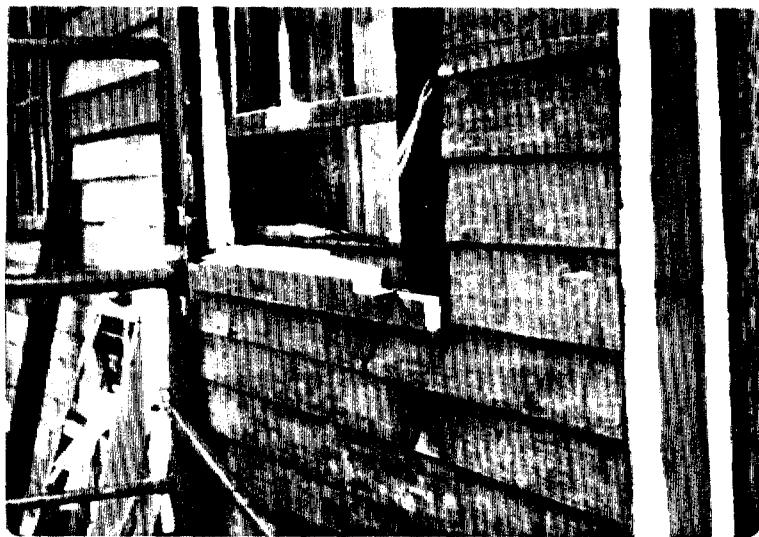
Photo showing deteriorated areas removed from sill.

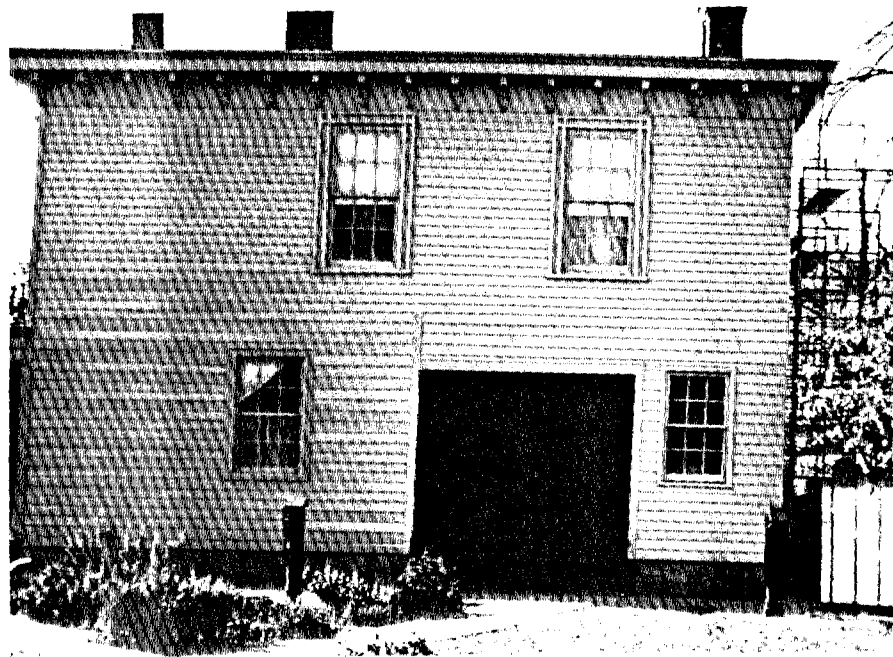
Photo showing back side (east) with primer and one top coat of paint applied.

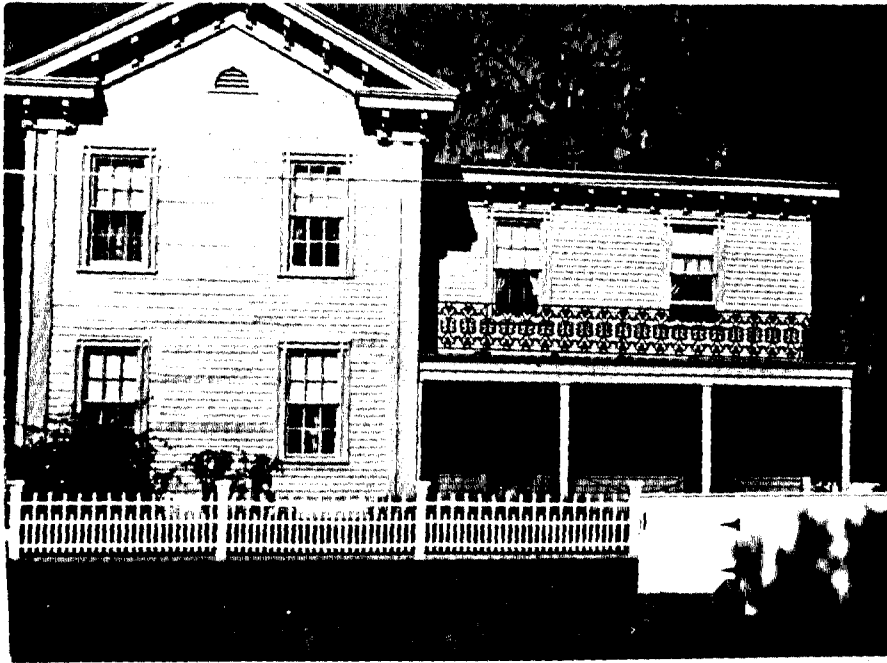
Photo showing first coat exterior wood paint,  
south side.

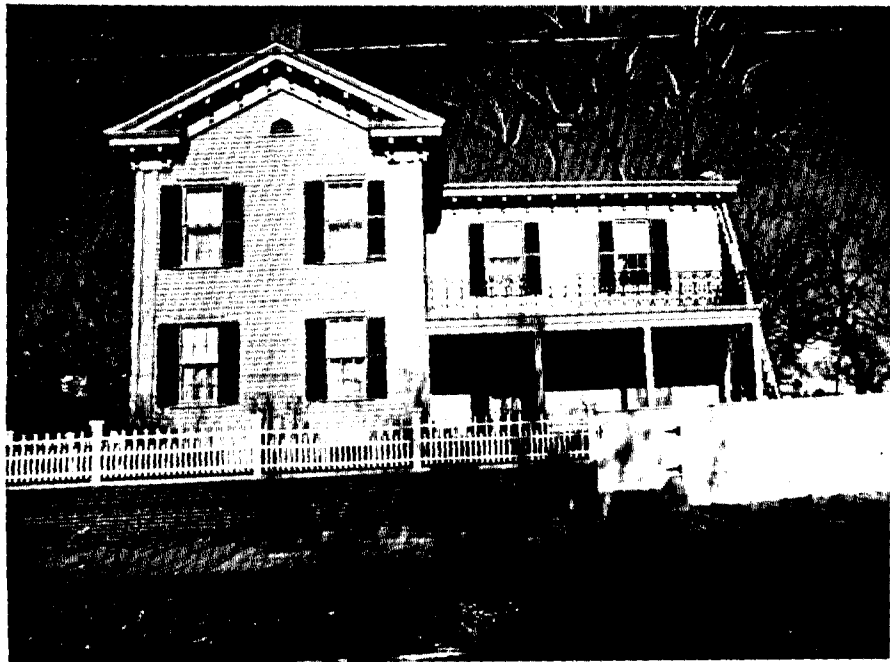
Photo showing completed paint job on south side of home.

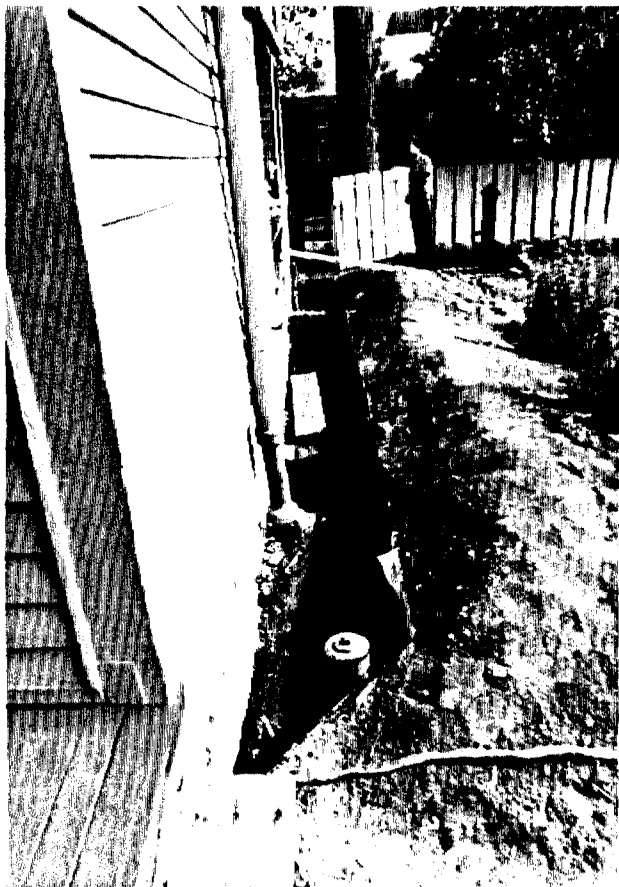
Photo showing soil excavated so old deteriorated mortar could be removed and new mortar replaced. Back side, east.
