HISTORIC STRUCTURES REPORT
ARCHITECTURAL DATA, PART I

REHABILITATION AND RESTORATION
OF THE
DOGAN HOUSE

MANASSAS NATIONAL BATTLEFIELD PARK
Virginia

April 1960

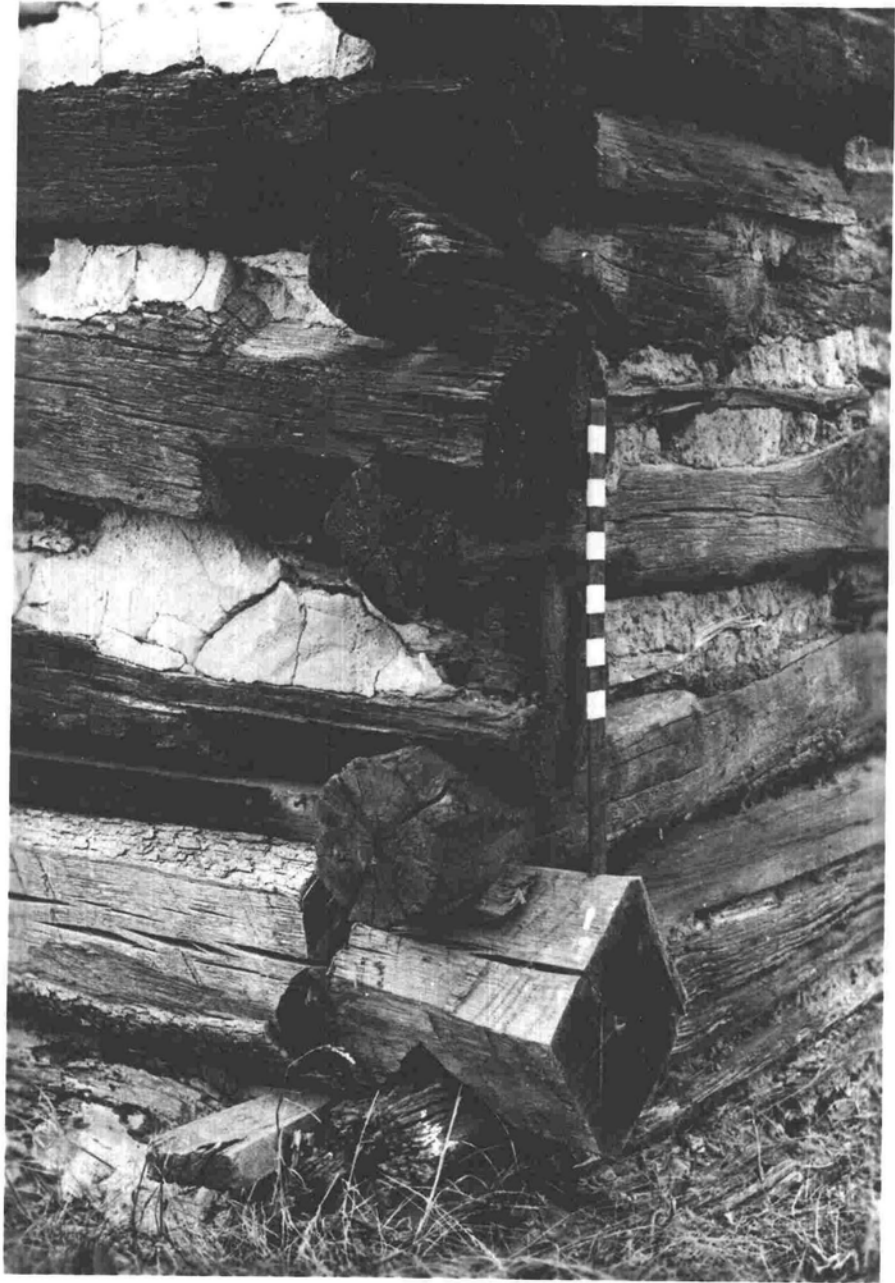
ILLUSTRATION NO. 21 LOG CORNER

This photograph shows a more detailed view
of the serious deterioration occurring in the lower
logs. Log to the lower left is a 1950's replacement.

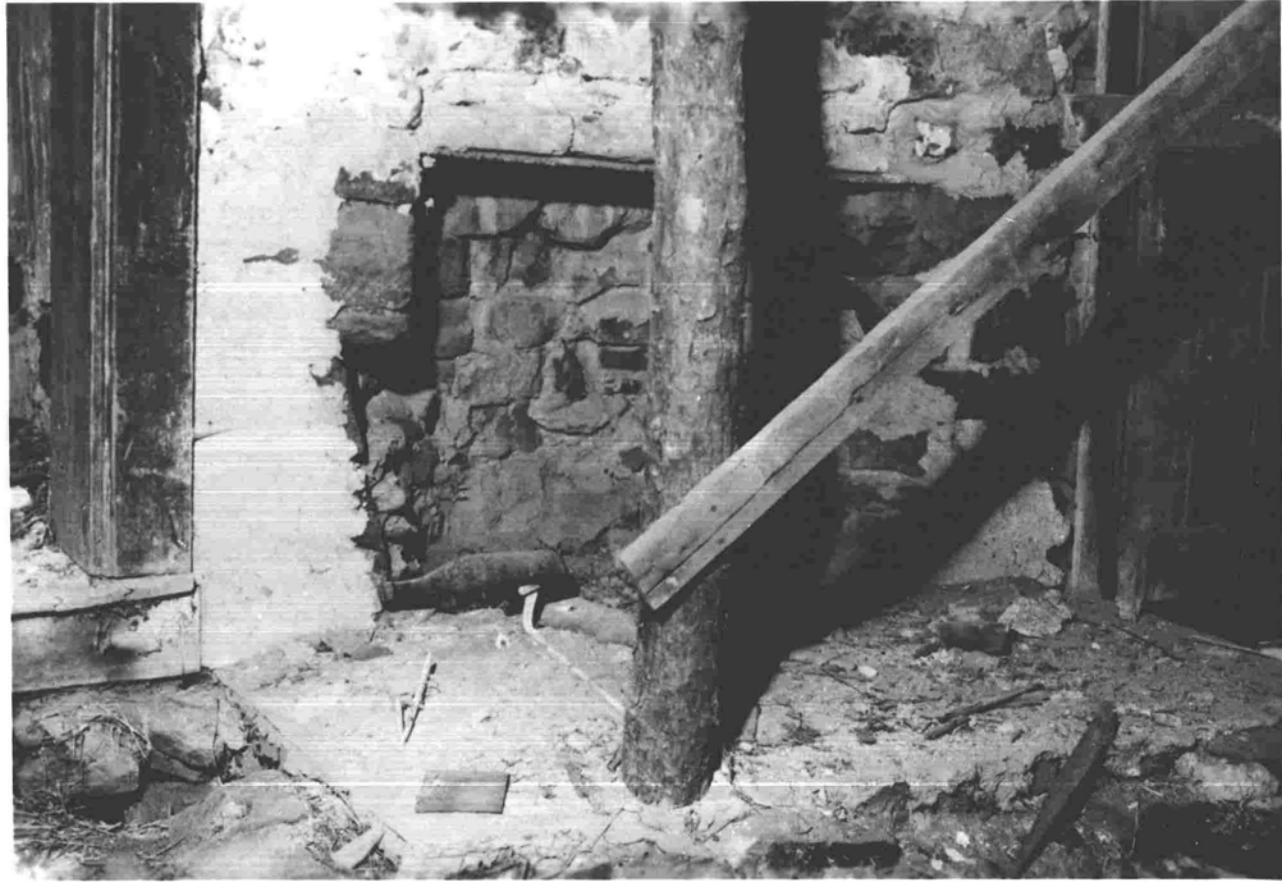
ILLUSTRATION NO. 30 PANTRY DOOR

Low narrow board and batten door, 2'-5½" X
4'-10½", used for access into pantry (4' X 4') located
east of chimney on the 1st floor of the log portion of
the Dogen House. Notice method of chinking logs with
mortar and then applying whitewash over entire wall surface.

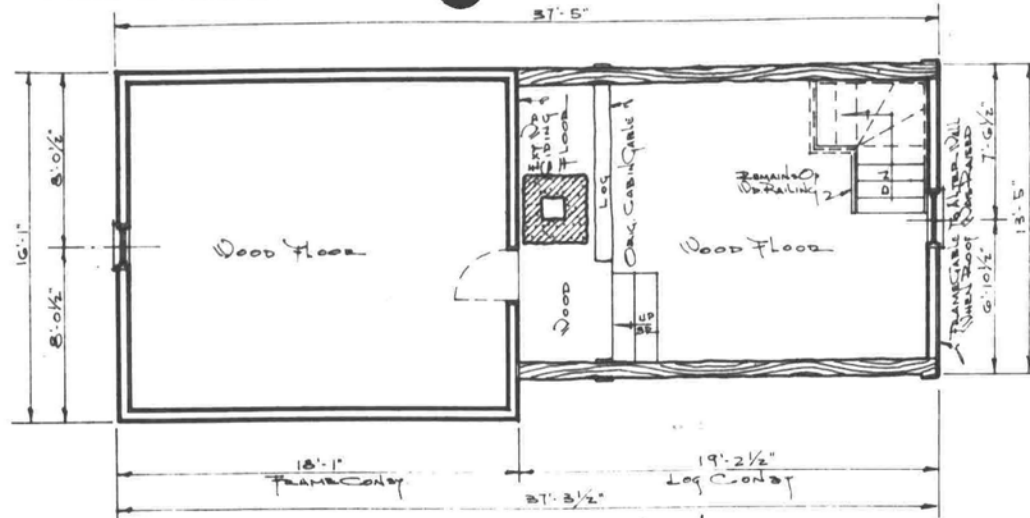
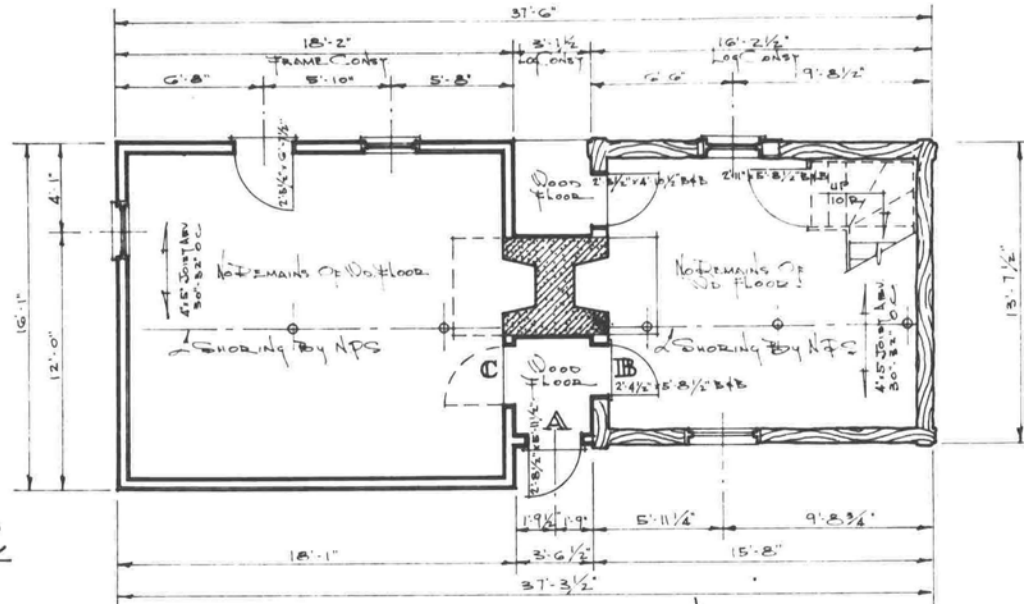
First and second floor plans of W. H. Dpgan
House showing existing conditions as found in 1959 by
summer measuring team for HABS.

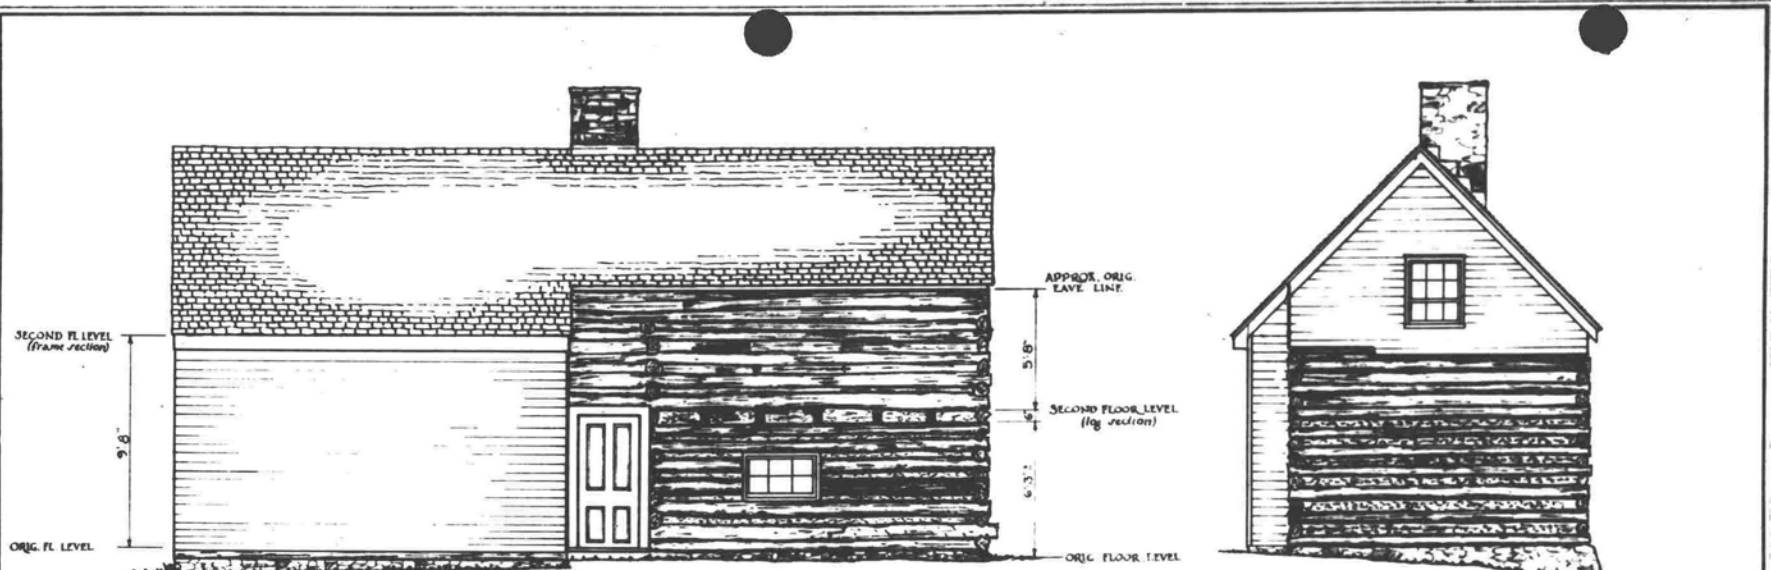
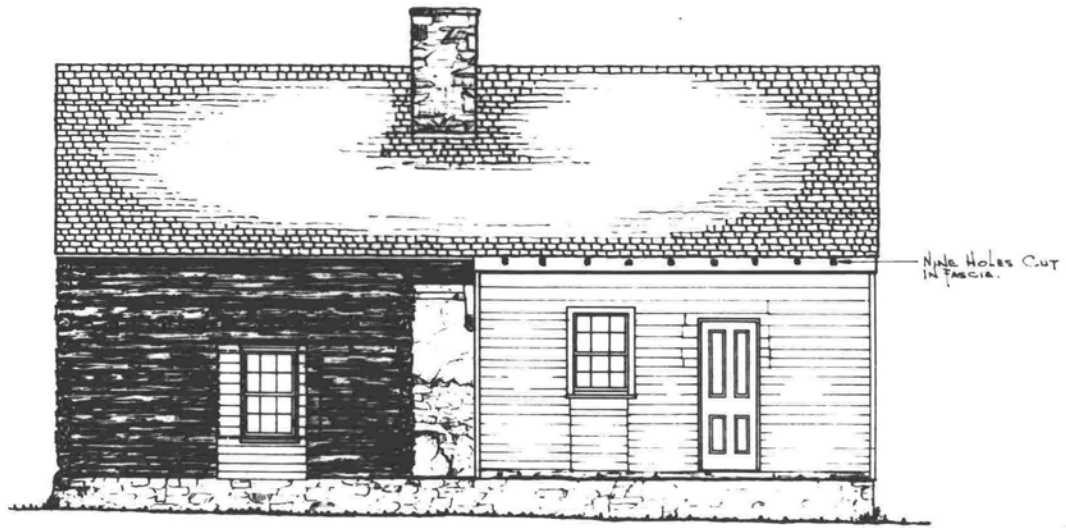
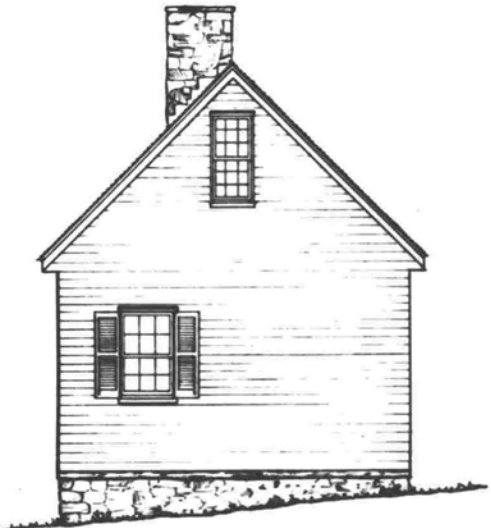
Sheet three shows the four exterior elevations
of the Dagan House containing certain conjectural attempts
at restoration where evidence suggested such changes.

N.B. - CERTAIN CONJECTURAL RESTORATIONS HAVE BEEN MADE IN DRAWING THESE ELEVATIONS WHERE EVIDENCE SUGGESTS THEM - NAMELY IN CORRECTING THE SKEWNESS IN THE WALLS AND ROOF, IN DRAWING THE WEST DOOR, IN INDICATING THE PRESENT SINGLE PILED SASH WINDOWS AS DOUBLE HUNG, AND IN INDICATING SHUTTERS WHERE HINGLES SUGGEST THEM. WHERE EVIDENCE IS LACKING CONCERNING THE ORIGINAL APPEARANCE OF SOME FEATURES, SUCH AS THE WINDOW-DOOR, ARRANGEMENT OF THE EAST ELEVATION, IT IS DRAWN AS FOUND. THE LOGS ABOVE THE SECOND FLOOR LINE ON THE WEST ELEVATION ARE OF A DIFFERENT CHARACTER FROM THOSE BELOW, AND ARE CHINKED WITH SMALLER LOGS RATHER THAN WITH MORTAR AS BELOW. SIDING WITH A 1/2" DEAD, 4R. TO 6R. TO WEATHER, IS ON THE EAST, NORTH AND SOUTH SIDES OF THE FRAME SECTION, AND AROUND THE EAST WINDOW OF THE LOG SECTION. PLAIN SIDING IS ON THE WEST SIDE OF THE FRAME SECTION, AND ON THE SOUTH GABLE OF THE LOG SECTION.
