HISTORIC STRUCTURES REPORT
ARCHITECTURAL DATA, PART II

REHABILITATION AND RESTORATION
OF THE
DOGAN HOUSE

MANASSAS NATIONAL BATTLEFIELD PARK
Virginia

August 1960

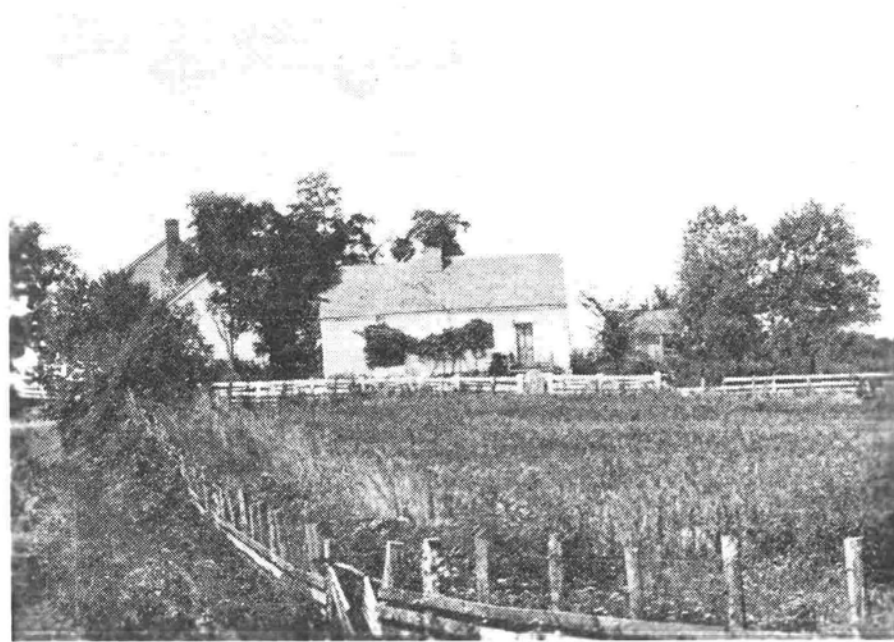
ILLUSTRATION NO. 4.

A part log and frame house very similar to the present Dogan House. In this instance, the log portion was added to the frame structure, unlike the Dogan House where the frame building was moved over and attached to the log cabin. Interior details of both structures are very similar. This building is located about 1/2 mile from Centreville, Va. on Route 28.

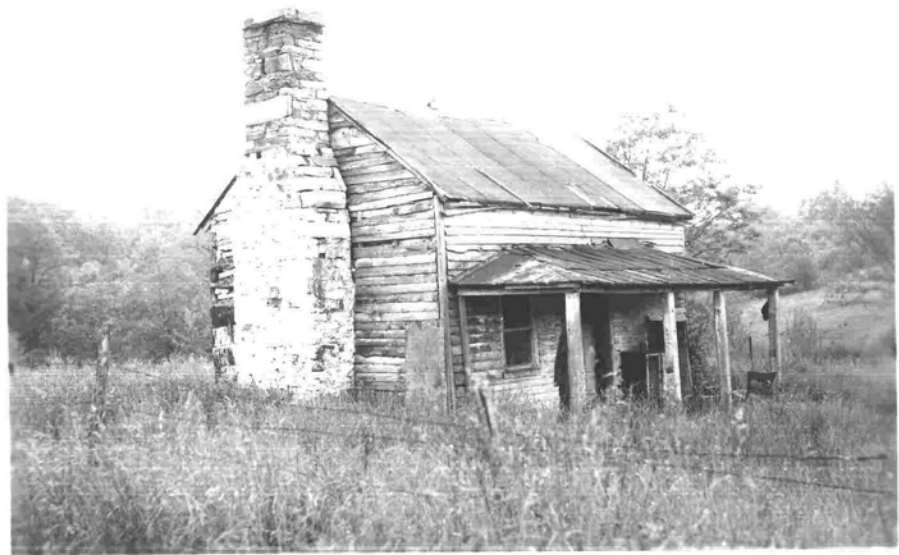
ILLUSTRATION NO. 10

Illustration No. 10 shows a portion of "Fleetwood" ca. 1822, located about 10 miles south of the Dogan House. The frame portion of "Fleetwood" more than any other pre-Civil War building left standing in the Manassas area comes closer to matching construction details as found in the frame addition of the Dogan House. Of particular interest is the beaded weatherboarding, the beaded corner boards, beaded and tapered verge boards, beaded fascia boards, beaded window and door casings with a moulded backband, and the use of varied sized window sash. The building is of particular value in showing how weatherboarding was cut and applied. This is well illustrated in the photograph. Here again is shown the application of whitewash over both masonry and wood surfaces.

A good example of a pre-Civil War frame building standing with minor changes since its construction. Many of the details are similar to the frame addition of the Logan House. Notice window and door trim with backband. Design of the three panel door for the Logan House was taken from this building. Notice whitewash over weatherboards and chimney stack. Stone House built in 1822, and is located 3.7 miles from Bristol, Virginia, on Route 611.

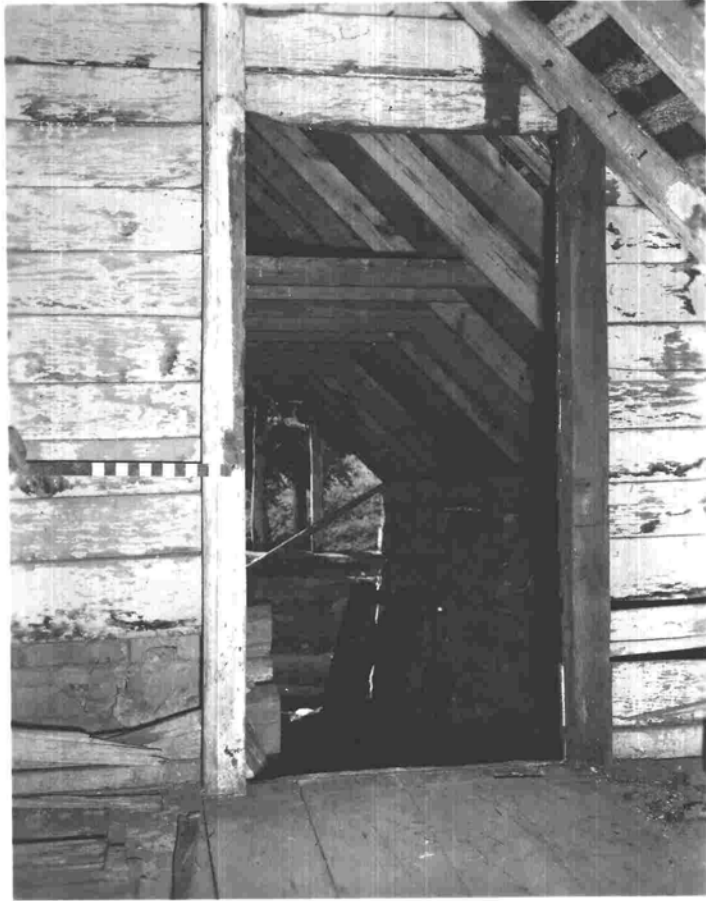
This view shows the changes that occurred in 1881 to the south wall, second floor of the frame addition. A four light window was removed and a doorway cut through for access into the log cabin. Outline of the original window sill and trim can be seen on the stud to the left. To the right, the outline of the stud can be seen on the weatherboarding above and from the original mortice and tenon joint at floor level.
