Historic Structures Report

DOGAN HOUSE

Manassas National Battlefield Park

Prepared by
Orville W. Carroll
June 1962

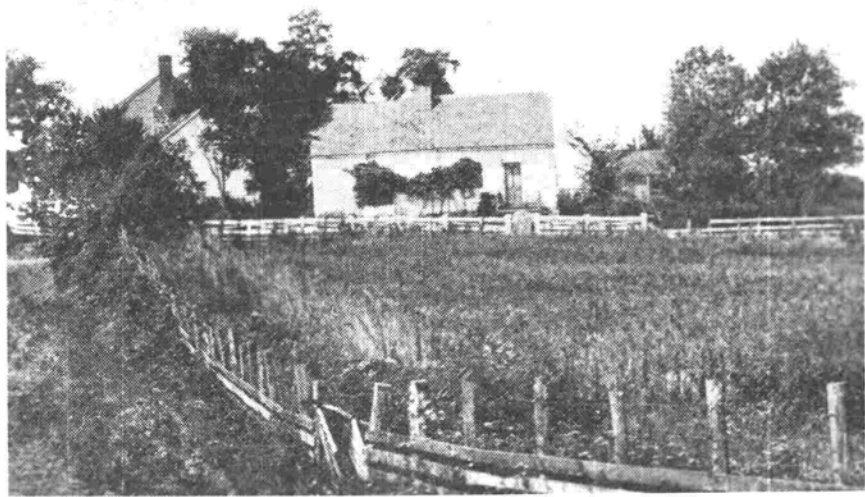
ILLUSTRATION NO. 2

The Groveton crossroads as it appeared in 1907, 42 years after the end of the Civil War. This view shows the condition of the Dogan House after the 1882 remodeling but before the lowering of the Warrenton Turnpike and the Groveton-Budley Road.

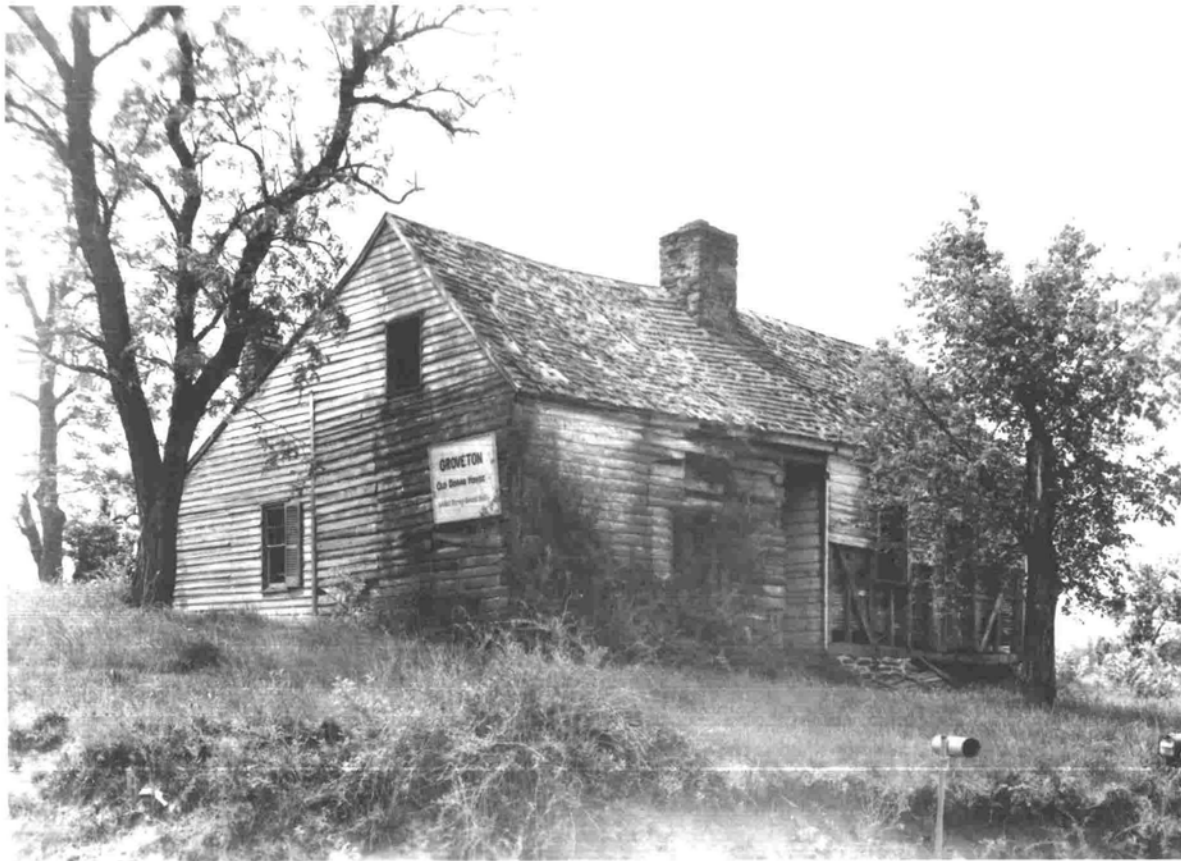
ILLUSTRATION NO. 4

By the mid-1930's the Dogan House had reached a rapid stage of deterioration. The old house went through a series of various uses such as carpenter shop, chicken house and tenant house. At one time, the Dogan's had planned to convert the house into a "tea-room."

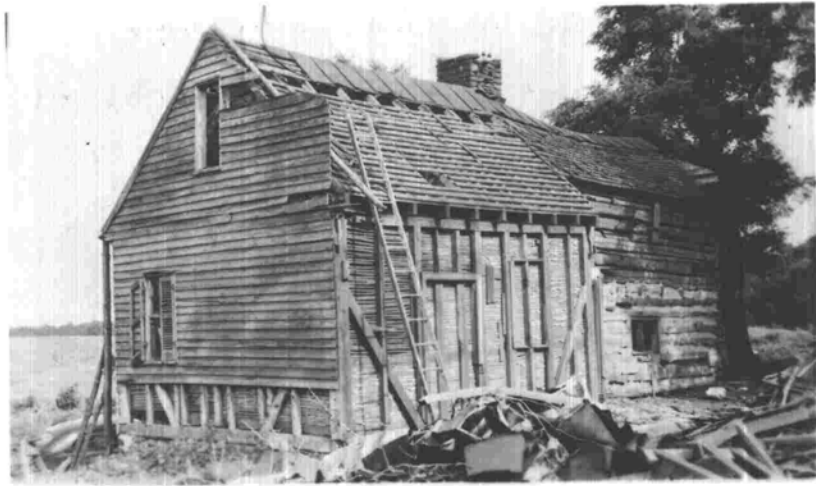
ILLUSTRATION NO. 5

In 1947, the Prince William County Chamber of Commerce purchased the Dogan House and 4914 square feet of land from W. H. Dogan. In 1948, the PWCCC supervised the stabilization of the house by Raymond Cross, carpenter. During this time, the west addition was removed as shown by this photograph. The house was officially deeded to the NPS in 1949.

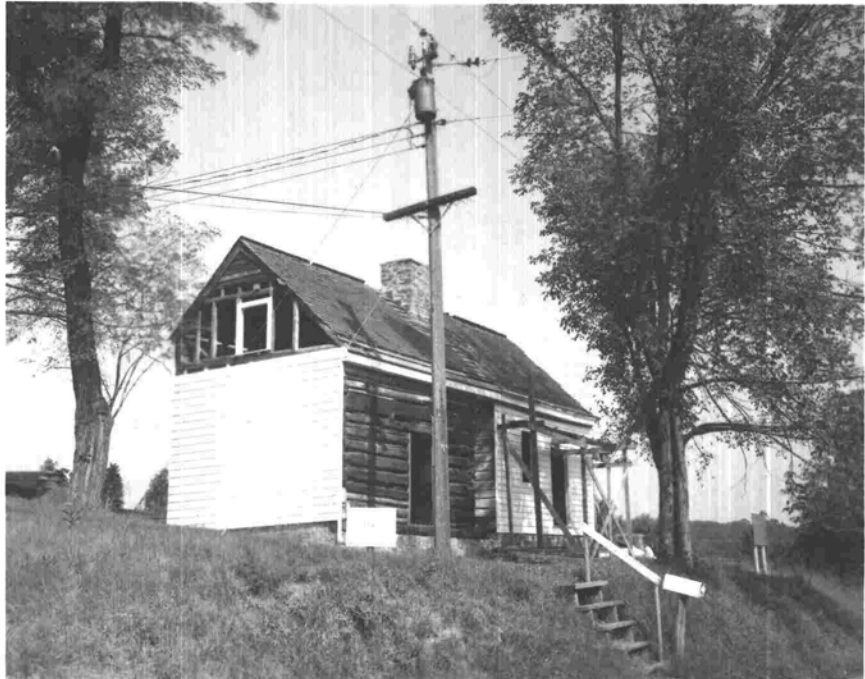
ILLUSTRATION NO. 16

The historic scene of the Dogan House has now almost become obscure by the introduction of utility poles, steps, mailboxes, the lowering of the adjacent roadbeds and the establishment of a cemetery to the west. The Dogan House is all that remains of the old Groveton Village.

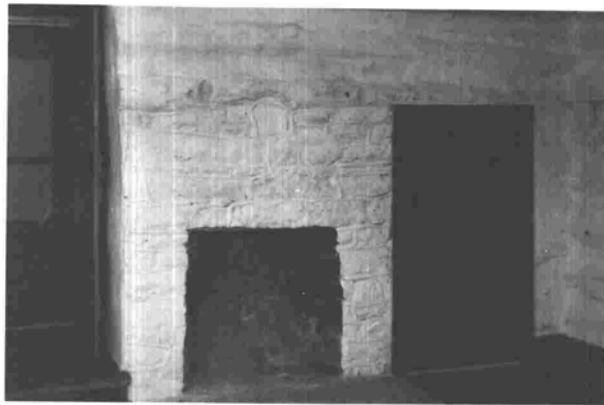
ILLUSTRATION NO. 29

An interior view of the log cabin looking north on the 1st floor. The door trim, baseboard and wooden shelf is original to the house. The pantry door was reconstructed.

The steps between the log cabin and the frame addition on the 2nd floor, added in 1881, were removed and the openings replaced to their earlier appearance. (See Illustration No. 29).

The door opening cut between the log cabin and the frame addition on the 2nd floor in 1881 was restored to its earlier condition with a four light window. (See Illustration No. 29).
