historic structure report
architectural data section
volume 1
june 1985

MARTIN VAN BUREN

HISTORIC STRUCTURE REPORT

LINDENWALD

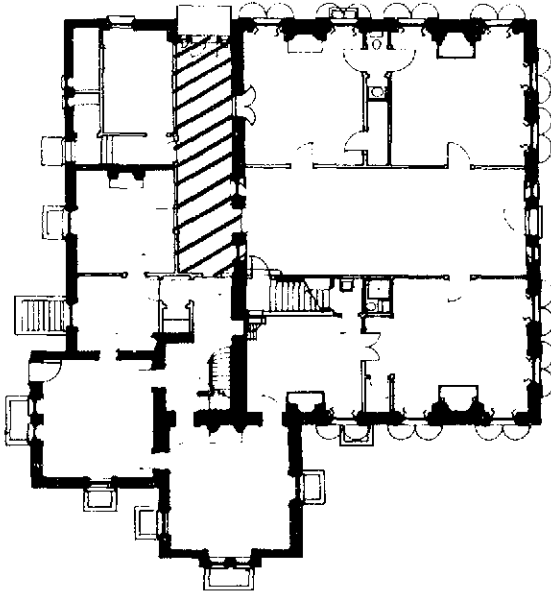
q. Room 119 - Hall

Room 119 is an entrance hall approximately 33' in length along the northern portion of the west wall of the 1797 house. This hall was added as part of the 1849 work. Entry from the exterior is through a double-door opening in the north wall (D109). Access from this hall is provided by two doors in the west wall--one to room 120, a hall (D114), one to room 118, nursery (D115)--and by a former exterior door opening in the east wall (D108) leading into the central hall, room 105.

Change in the original appearance of this room has occurred as a result of deterioration of the terneplate roof and gutter drainage system. Plaster patches, probably dating within the last 20 years, may be seen on the west wall over door 114, on the north end of the ceiling, and on the east wall. Entire sheets of gypsum board replaced original plaster on the skylight walls. Ceiling patches fell during 1978 roof repairs. Removal of a gypsum board infill on the east wall in 1979 exposed a brick-filled ca. 1797 opening with a flat lintel and the pre-1849 paint finishes on the original exterior brick wall. The brick and mortar infill has been dated to the 1849 construction period, details of which include a continuous baseboard along this wall. The ca. 1797 painted brick surface was scored to receive plaster, but the 1849 brick masonry was able to receive the plaster finish directly.

The preservation and restoration work recommended for room 119 includes the following items:

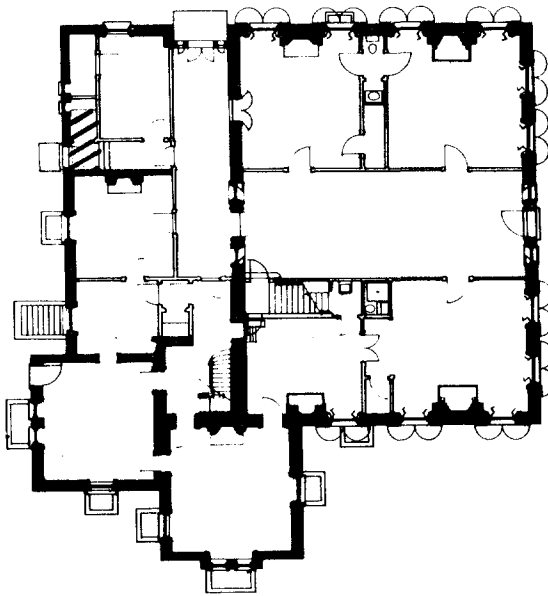
s. Room 121 - Privy

This privy has remained in its original form since ca. 1849 (see IP041). It has a wood-encased seat above a stone-lined privy well. The built-in seat is composed of one horizontal, recessed panel with molding on the vertical front and four similar panels with the cyma recta molding on the top or horizontal surface. One larger panel on the top is butt-hinged for the seat opening.

Remove a board with hooks on the east wall, if it is found to be nonhistoric.

Replace the door (111).

Restore the painted wood surfaces to a cream color (Munsell 2.5Y 9/2 Benjamin Moore GB-30).

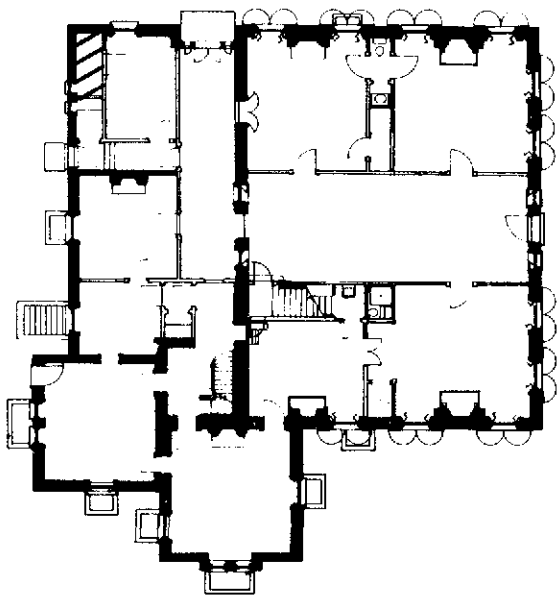
t. Room 122 - Storage

This closet occupies the northwest corner of the ca. 1849 addition. It is entered from a small bedroom, room 123 (D110).

There does not appear to be a built-in or attached system for hanging clothes or for storage except for one shelf at the north end. Neither the shelf nor several ledger strips appear to be original.

Remove molded ledger strips secured to the north and west walls for further investigation; replace these ledger strips with strips matching those on the east wall.

Remove the metal patch along the west wall; assess and repair any deterioration to which it may be related.

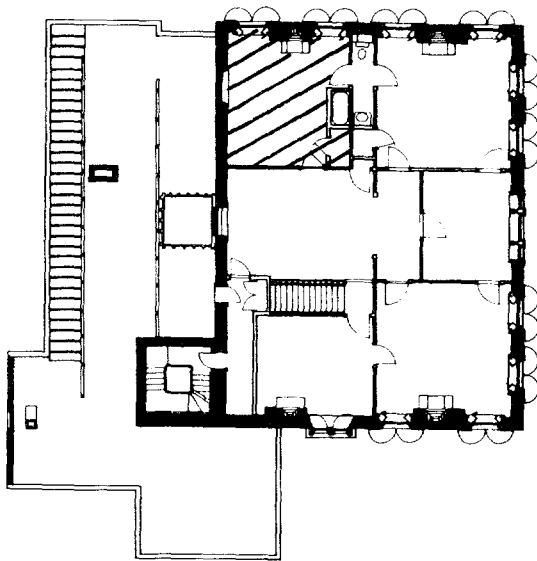
a. Room 201 - Guest Chamber

This second-floor bedroom is in the northwest corner of the ca. 1797 house. Access is from the central hall, room 206 (D209). A door opening in the north end of the east wall (D207), leads to a closet, room 203, and also permits passage through to the northeast bedroom, room 205. There are two windows (210 and 211) flanking a chimney breast in the north wall and a cabinet in the west wall location of a ca. 1797 window opening (W212).

The earliest change that has been noted in room 201 was the removal of all chair rails. The evidence consists of horizontal plaster infill at an approximate height of 35". This change occurred in all major rooms of the ca. 1797 house and has been associated with ca. 1840 work of Martin Van Buren. The case supporting this date and the association with Van Buren is well documented in rooms 101, 105, and 109 (see section IV.B.2).

Repair and stabilize the plaster wall and ceiling in areas where the ca. 1960 lowered ceiling intervened and above window 212 where roof deterioration caused water leakage.

Replace missing butt hinge parts, and hang window 212 doors.

Remove the 20th century sash locks, and replace them with reproductions.

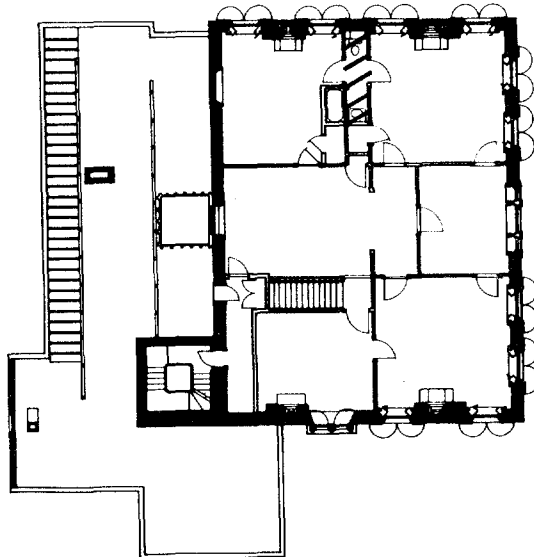
b. Rooms 202/203/204 - Closet/Bathroom/Closet

Room 202 was a closet built in the southeast corner of room 201 by Campbell, ca. 1960. This enclosure was removed by the park maintenance staff in 1978.

Rooms 203 and 204 are secondary spaces between the major north bedrooms, rooms 201 and 205. Room 203 (north of room 204) was enlarged to receive a bathtub by relocating a portion of the west wall farther west. This ca. 1960 work included the closet construction that created room 202. Plumbing for the toilet and sink fixtures in room 203 has been attributed to the DeProse family through oral history and the 1938 DeProse drawings.

Replace the floorboards.

Replace several baseboards.

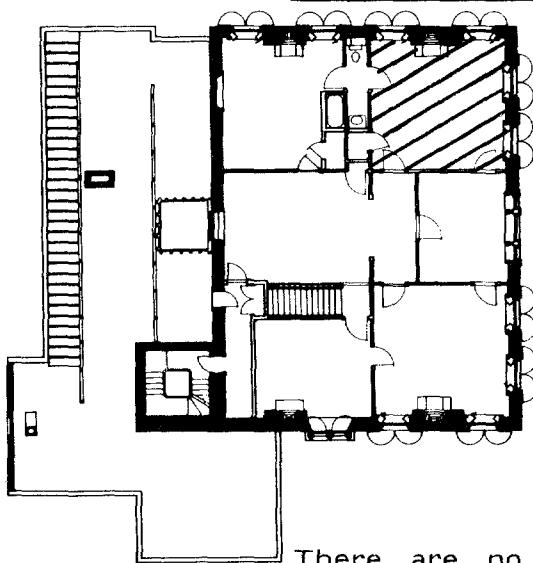
c. Room 205 - Guest Chamber

This second-floor bedroom is in the northeast corner of the ca. 1797 house. Primary access is from room 207 (D204), and another door opening in the south wall (D203) allows passage from room 208. Two door openings in the west wall (D205, 206) provide access to closet space. The opening at the north, into room 203, also permits passage into room 201. There are two windows in the east wall (W206, 207) and two windows in the north wall (W208, 209) flanking a chimney breast.

Make miscellaneous plaster repairs and stabilize, particularly at the south end ceiling along the east wall where the ca. 1960 lowered ceiling contacted the walls; fill the small south wall opening.

Repair (and replace) the nonhistoric masonry work at the rear wall of the firebox, and mortar fill between the stone lintel veneer and brick.

Remove the 20th century sash locks and replace with ca. 1840 reproductions; replace the window 207 stop; replace the HL hinges on windows 206 and 209.

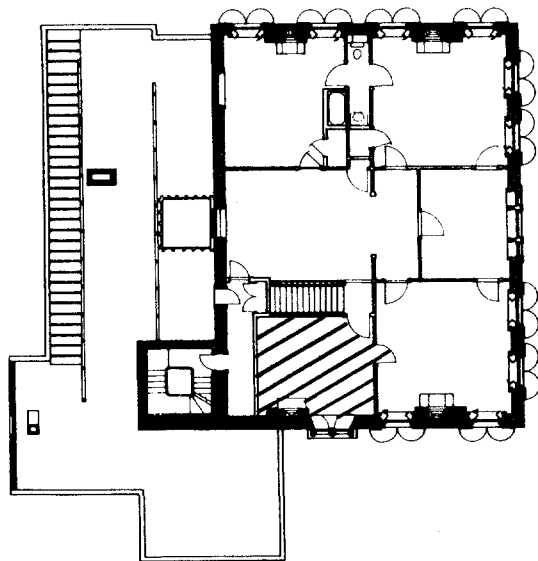
e. Room 210 - Chamber

This second-floor bedroom is in the southwest corner of the ca. 1797 house. Access is from a door opening in the north wall from the central hall (D215, see IP052). There is a door opening (D216) in the east wall leading into room 209, the southeast bedroom. The bay window in the south wall has two round-headed windows (W215, 216, see IP053). A chimney breast is also located in the south wall.

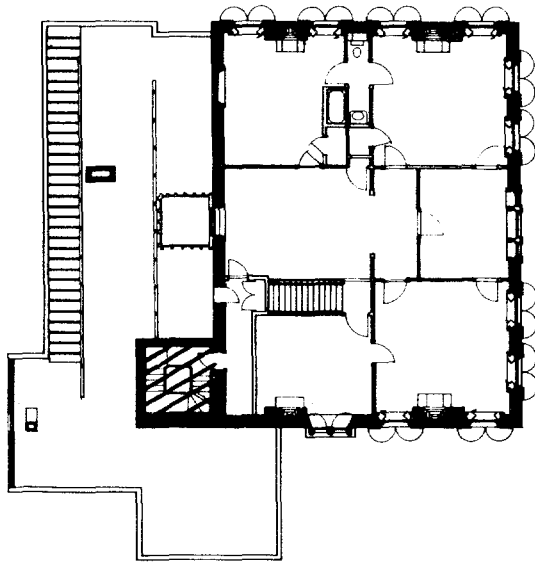
g. Room 212 - Tower Stair

This room is the second floor level of the 1849 tower. The first floor of this stairhall is described as room 113.

The stair begins at the north end of the west wall in room 113 and makes continuous quarter-turns in a series of five risers with landings and winders up to the level of room 308. The entire construction is a cantilevered support system with various sizes and configurations of wood joists pocketed into the exterior brick walls (this construction is partially exposed in the third-floor area where plaster has been removed; see IP068). There are individual arched

Restore the treads and risers to a light brown color (Munsell 10YR 6/2, Benjamin Moore ET-45).

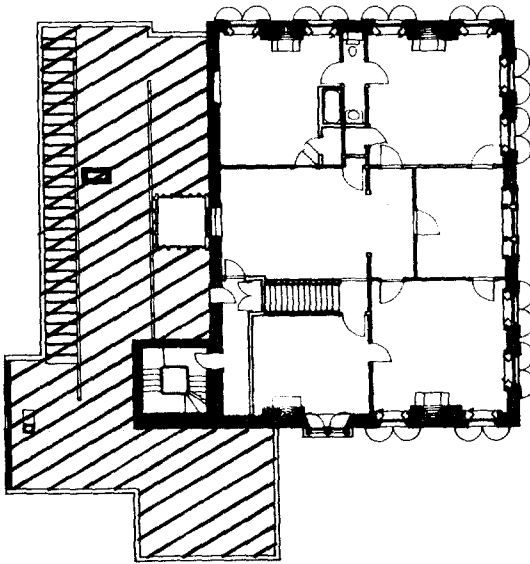
h. Room 213 - 1850 Attic

Room 213 is the entire attic space above the one-story addition except the tower stair and skylight. This space extends along the entire west wall of the 1797 house, wraps around the tower at the south end, and extends around a small portion of the south wall of the 1797 house. Access to room 213 is from room 211 through door 212, and up one 12-3/4" step.

All areas are unfinished open rafters, two parallel roof trusses, and steel jack posts at the north end. All areas have wood flooring except immediately west of the west truss where the floor joists are exposed and filled with

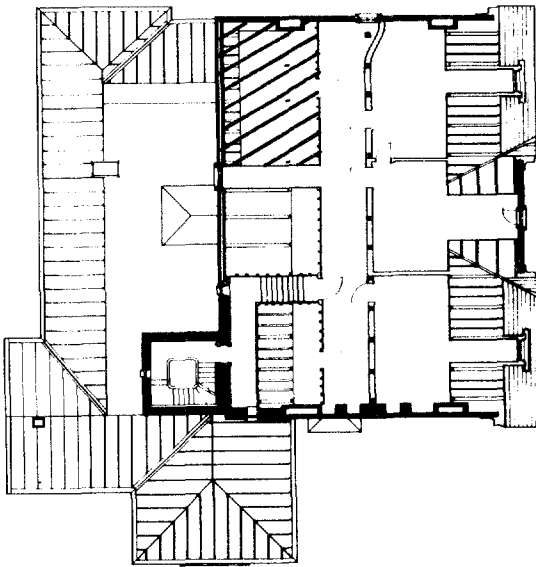
b. Room 301 - Attic

Room 301 is in the northwest corner of the third floor (attic) of the 1797 portion of the house (see IP059). It is a rectangular space approximately 14' by 21'. Since it has no windows and the walls and ceiling are not finished, it is assumed to have been used for storage only.

The east and south walls are constructed of wood studs, most of which are reused lengths of architrave and cornice moldings. There is no finish on the room 301 side of these studs, but the back side of the circular-sawn wood lath and plaster that forms the finish of room 302 is exposed between the studs.

Lay fiberglass batt insulation, 10" to 12" thick.

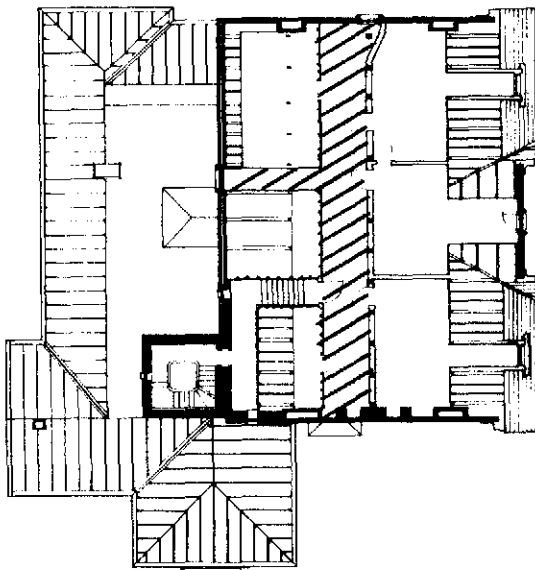
c. Room 302 - Hall

Room 302 is the T-shaped central hall of the third floor. The crossbar portion of the "T" is 6' 10" by 55' 4" oriented in a north-south direction, just west of the center of the building (see IP060). The stem of the "T" is 3' 1" by 12' 10" and extends in a westerly direction to window 307 in the west gable.

The walls are whitewashed two-coat plaster on circular-sawn wood lath except for the north end wall, which is three-coat plaster on brick, and the south end wall, which is two-coat plaster on brick. The baseboards are simple, planed 5-1/4" by 1" boards that were used as the

Lay fiberglass batt insulation, 10" to 12" thick, on the floor.

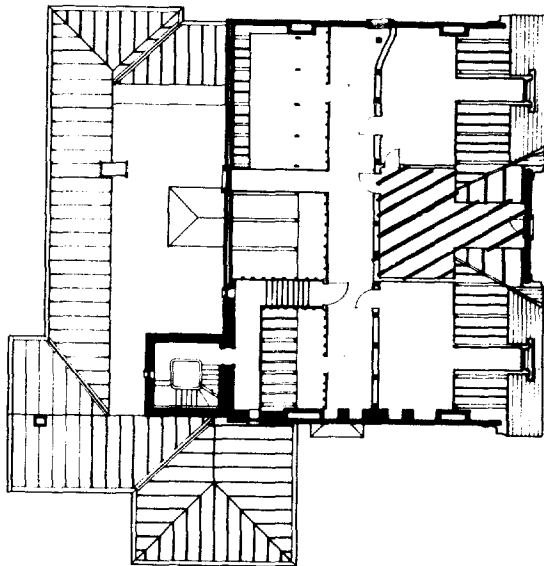
e. Room 304 - Servant's Chamber

Room 304 is the central attic room on the east side of the house. It consists of a main rectangle 11'11" by 15'11" with a rectangular space 7'6" by 10'0" adjoining it to the east (located under the gable; see IP063). This room was probably used as a servants' bedroom during the historic period.

Walls, floor, and ceiling are identical to those in room 303 with the following exceptions: In the north wall of the gable extension, a hole was cut to allow access to the former roof surface now covered by the ca. 1850 gable roof. In the south portion of the east wall, a hole was cut for

Lay fiberglass batt insulation, 10" to 12" thick, on the floor.

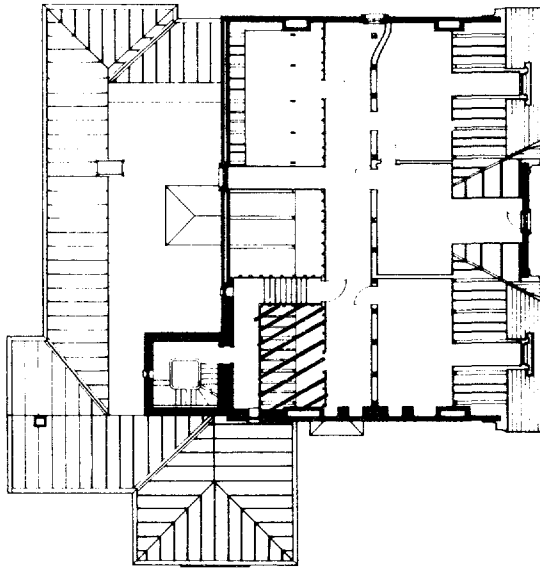
g. Room 306 - Attic

Room 306 is at the south end on the west side of room 302. It is 9'5" by 14'8". It was probably used for storage during the historic period.

The west, north, and east walls are exposed studs and the backside of circular-sawn wood lath and plaster. The east wall is 6'3" high, the west wall 2'9" high. The west wall transfers the load from roof rafters and floor joists down to the second-floor joists. Originally these loads were carried by the masonry west wall, but the ca. 1850 creation of room 307 required cutting the rafters and joists. The south wall is brick, the ca.

Lay fiberglass batt insulation, 10" to 12" thick.

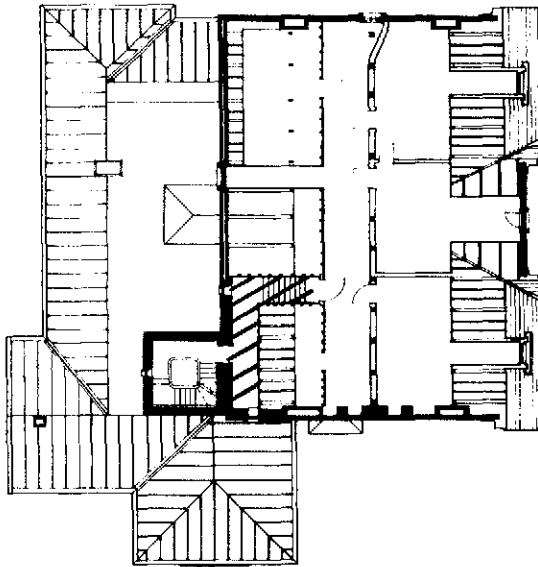
h. Room 307 - Hall

Room 307 is in the southwest corner of the third floor. It is L-shaped, with one leg 3'9" by 19'0" adjacent to the west exterior wall of the 1797 portion of the house (see IP064) and the other 3'7" by 9'1" projecting eastward from its north end (see IP065). This latter leg contains nine risers that connect the main area of the third floor with the lower level of the passageway and the adjacent landing to the tower stair (room 308). This room was created in the course of the ca. 1850 construction to provide access to the third floor from the new tower stair, thus allowing the earlier stair in the room 203 area to be removed. Its configuration

was dictated by the ca. 1797 roof construction, which limited the height of the ceiling of the western, passageway part, and the ceiling over the stairs.

Install a transparent barrier (of acrylic sheet) at the third-floor level to reduce heat loss through the tower, while maintaining visual continuity for visitors observing the tower stair from the first floor.

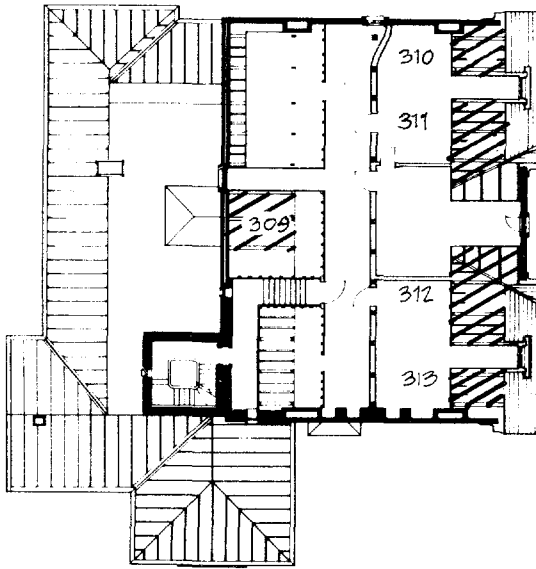
j. Rooms 309/310/311/312/313 - Attic

These rooms are not really rooms at all inasmuch as they were not intended for regular access. In fact, access was not possible until access holes (generally 1'6" by 2'0") were cut in the lath and plaster walls of the adjoining rooms.

The walls of these rooms were the unfinished back side of the lath and plaster walls of the adjoining rooms, except for the north wall of room 310 and the south wall of room 313, which were the exposed brick of the north and south gables, respectively (see IP066).
