MINUTE MAN NATIONAL HISTORICAL PARK
JOHN NELSON HOUSE & BARN

HISTORIC STRUCTURE ASSESSMENT REPORT

NOVEMBER 2008

PREPARED BY:
JOHN MILNER ARCHITECTS, INC.
CHADDS FORD, PA

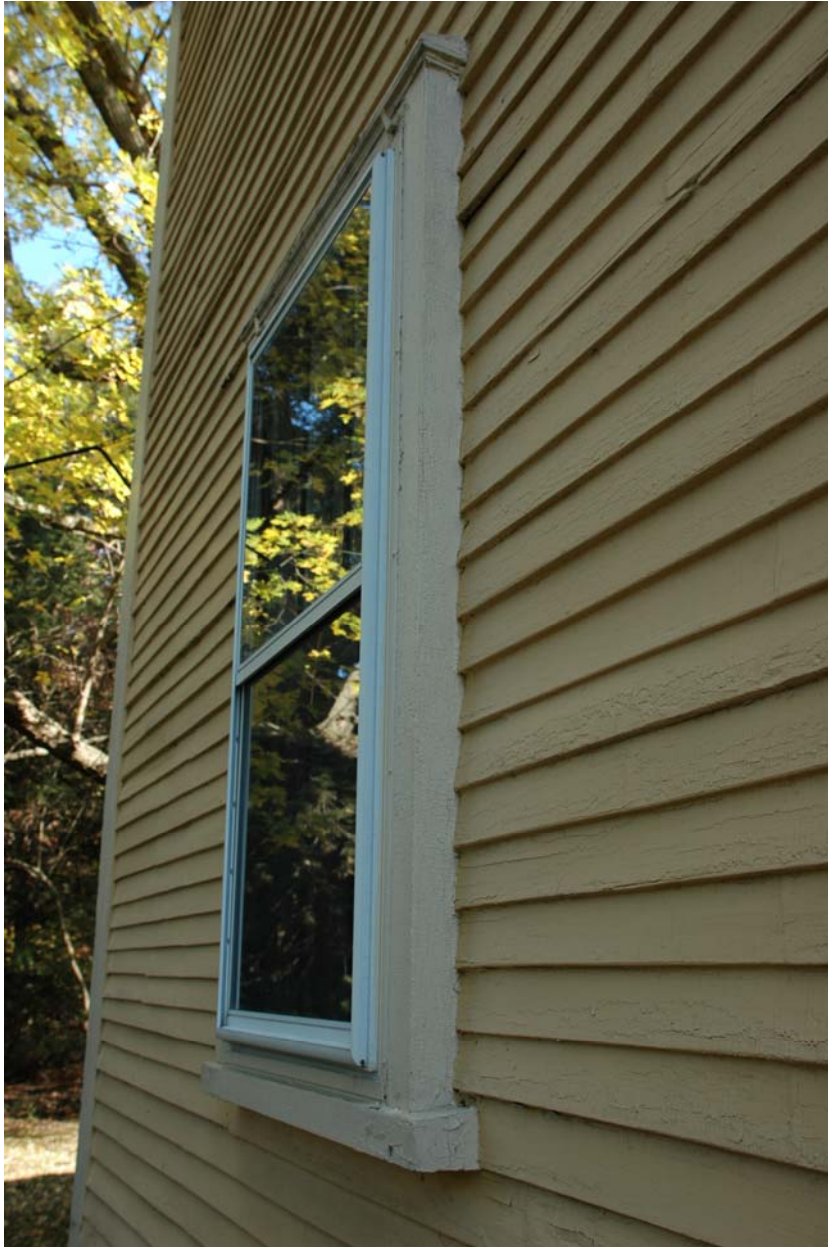
Figure SE-16. Window Type w-A: 6-over-6 double hung window with flat board trim and cornice. An aluminum triple-track storm window is attached to the wood frame. This window type is found at the south, west and north elevations of the northwest wing. On the south elevation Type w-A is found at #101, 102, 201, 202, & 203.

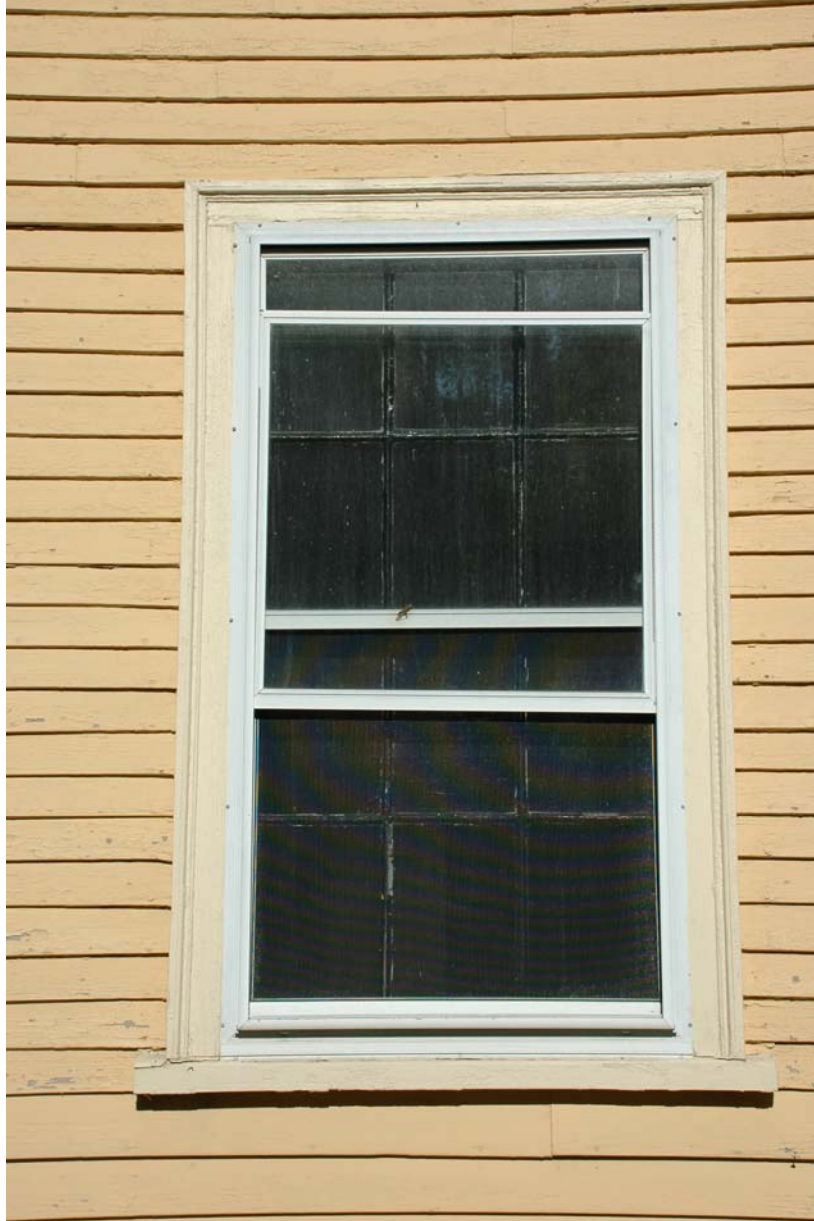
Figure SE-17. Window Type w-B: 6-over-6 double hung window with profile backband trim, found only at the main block. An aluminum triple-track storm window is attached to the wood frame. On the south elevation Type w-B is found at #105, 106, 107, 108, 206, 207, 208, 209, & 210.

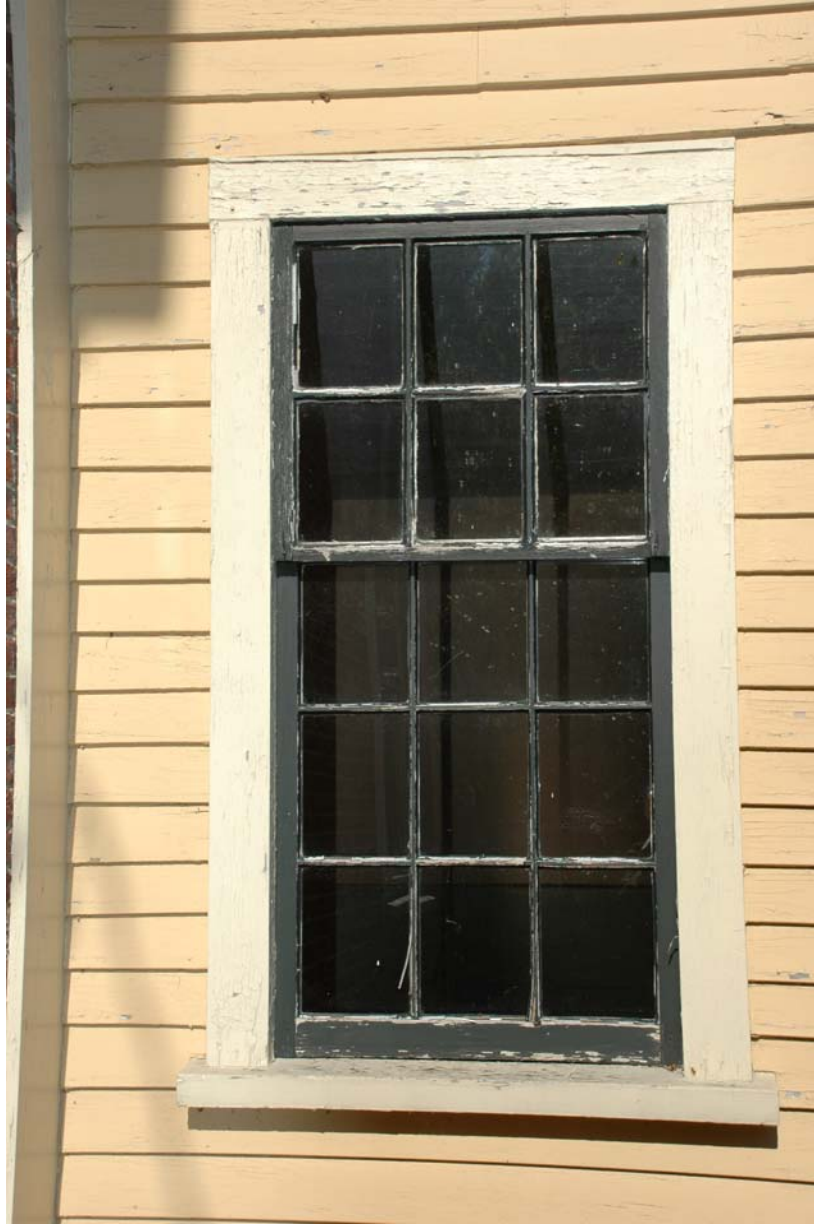
Figure SE-18. Window Type w-C: 6-over-9 single hung with flat board trim. On the south elevation Type w-C is found at Window #110.

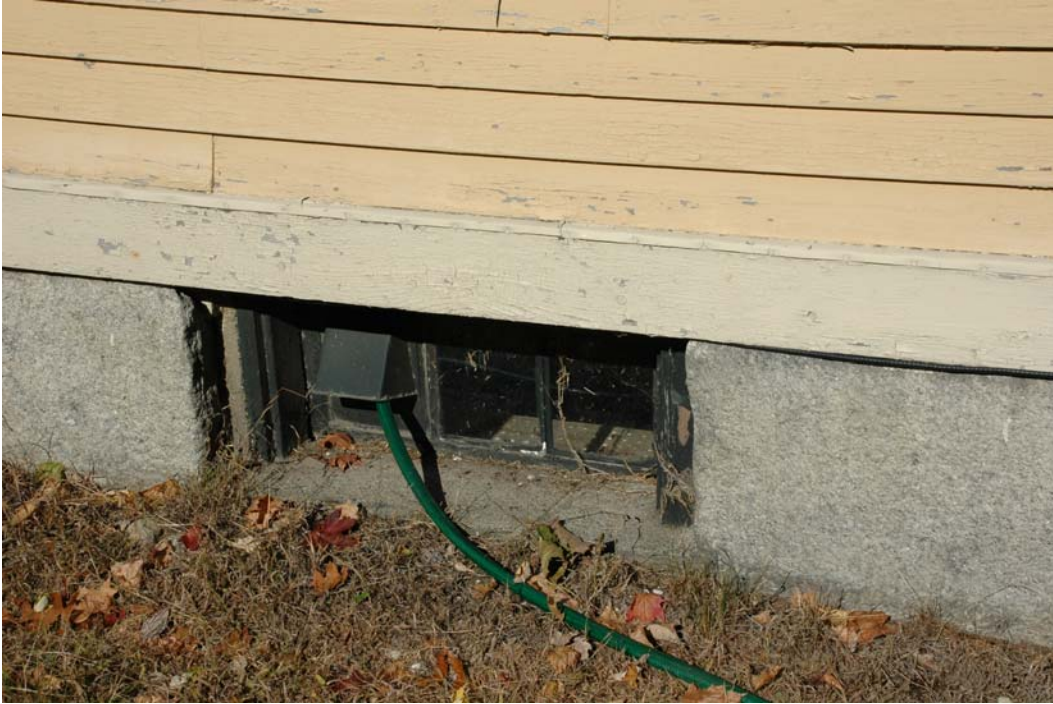
Figure SE-19. Window Type w-H: 3-light fixed basement window. On the south elevation this window is found at locations #001 and 002.

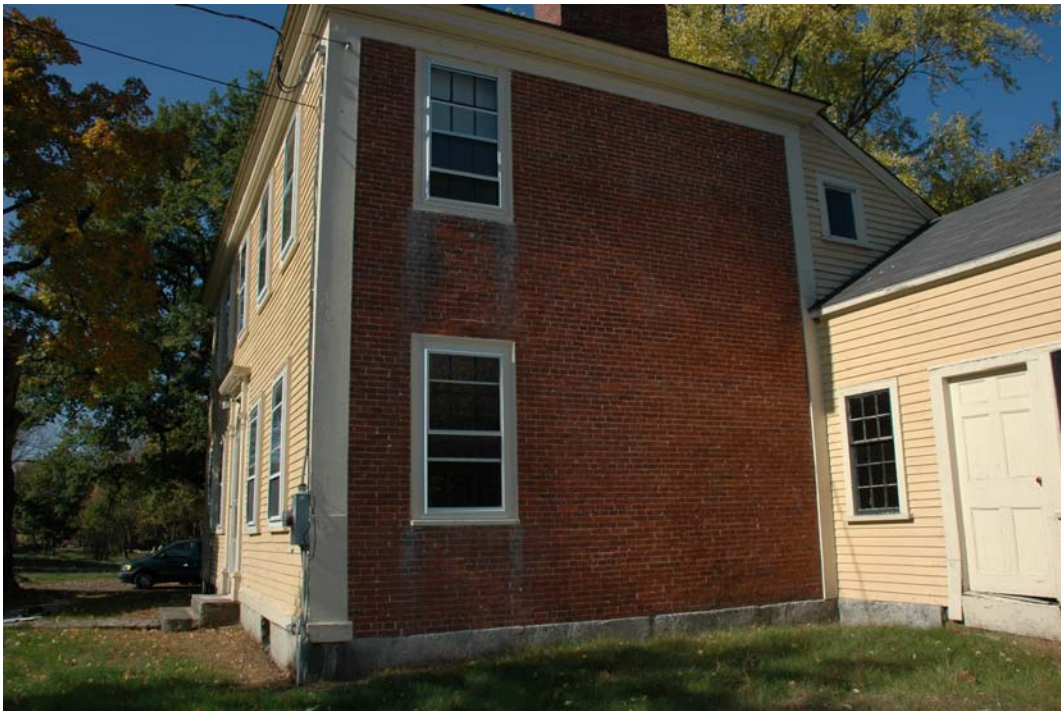
Figure EE-2. East Elevation of main block.

- The east elevation of the main block is comprised of brick laid in common bond [fig. EE-2]. The brick surface is stained in the areas directly below the window sills and along the base above the stone foundation. It appears as if the brick surface had been painted for a time and then later removed, as evidenced by small areas of paint remaining in brick and mortar crevices.
- The brick pointing mortar appears to be original, however further investigation is required to determine its age and composition. In the section of wall between the first and second floor windows (#109 and #211) there is water damage that has resulted in areas of deteriorated and missing mortar.
- There are large open joints between the brick wall and the wood window frames, which allow water to infiltrate the wall.

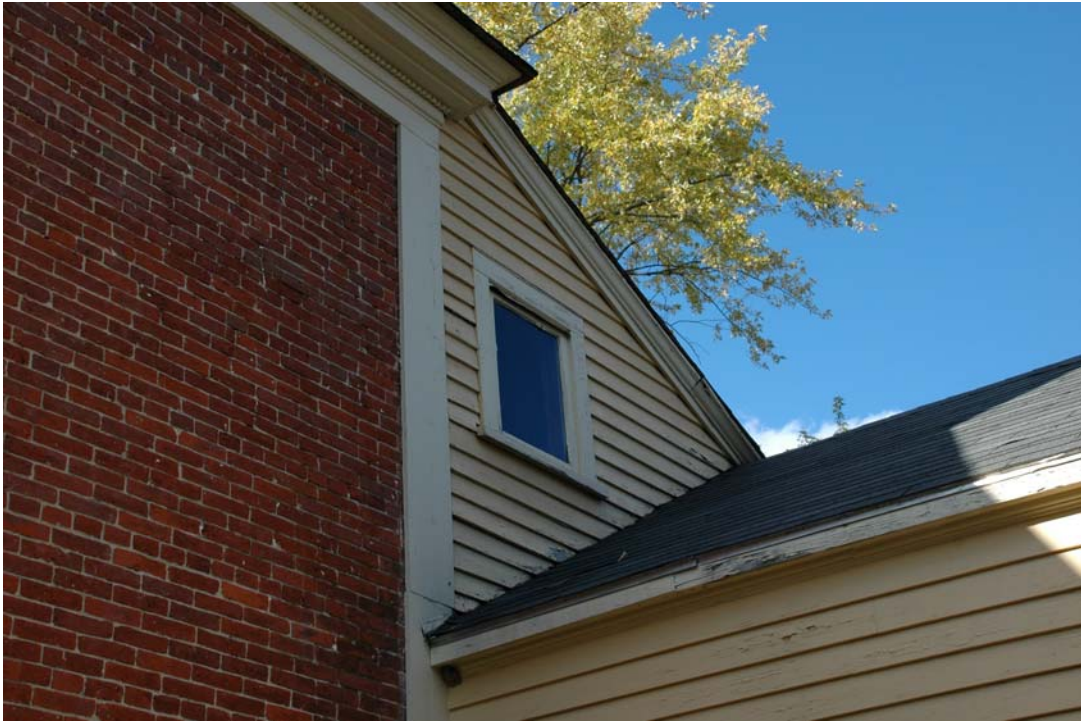
Figure EE-5. East elevation of main block and rear addition. Window #212, Type w-E. The original sash was a 3-light casement as documented in HABS photographs.

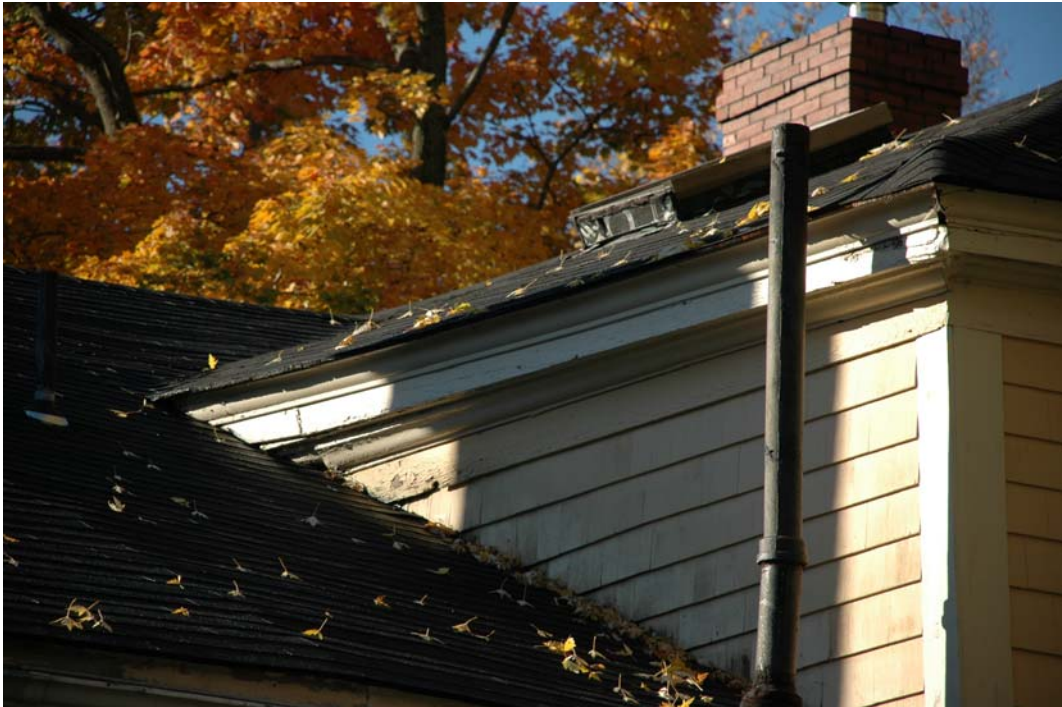
- The portion of the 2-story northwest wing that is exposed to the east elevation is clad with painted wood shingle siding. Shingles are deteriorated along the roof line of the 1-1/2 story northeast wing. The paint is cracked and peeling [fig. EE-7].

Figure EE-7. The exposed portion of the northwest wing at the east elevation. The skylight (window # 218) can be seen above the roof eave, below the chimney.

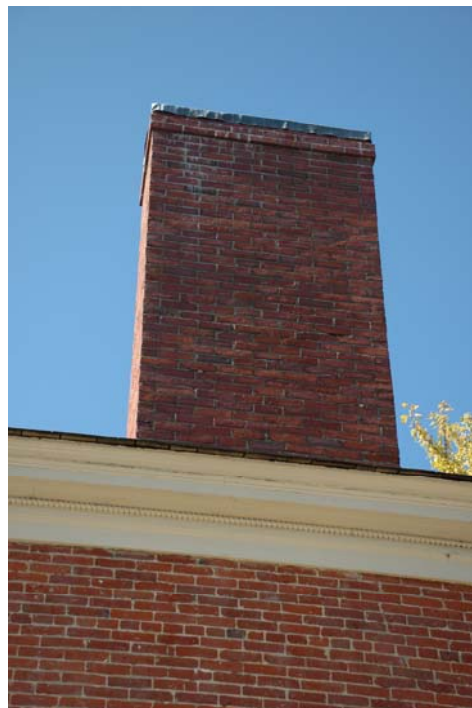
Figure EE-8. East main block chimney.

- There is one brick chimney on the east elevation, centered on the main block brick end wall [fig. EE-8].
- This chimney most likely contains three separate flues: one for the large fireplace and bake oven in Room 108, one for the fireplace in Room 103, and one for the fireplace in Room 204. The Room 108 fireplace and bake oven flue was reworked and incorporated into this chimney when the main block was constructed, as noted in the mason's bill of work to Josiah Nelson, Jr. in 1808.
- The brick and mortar appear to be in good condition.
- The chimney is capped with sheet lead.

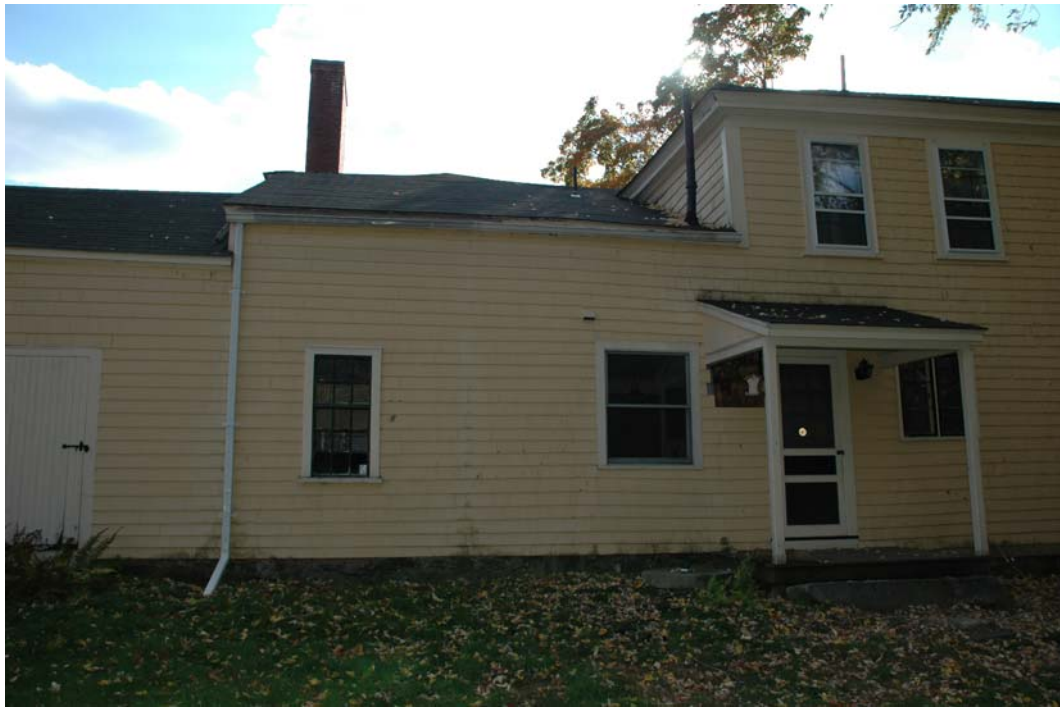
Figure NE-3. North Elevation of original 18th-century block. This section is the only location that has a gutter and downspout.

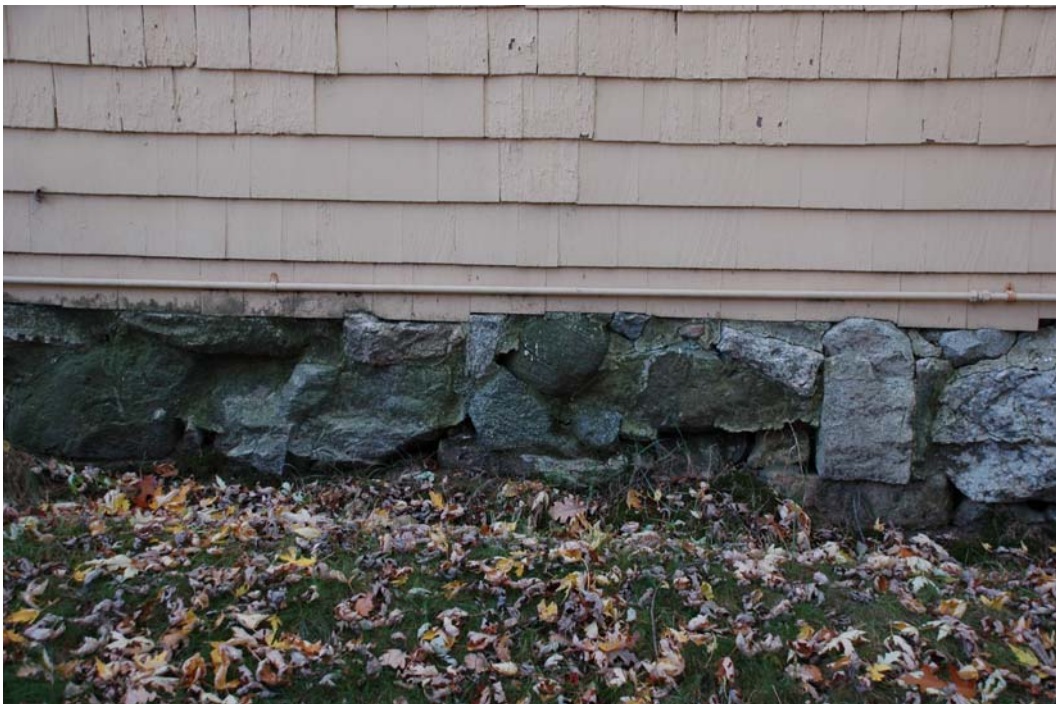
Figure NE-5. Random rubble stone foundation wall and painted shingle siding at north elevation.

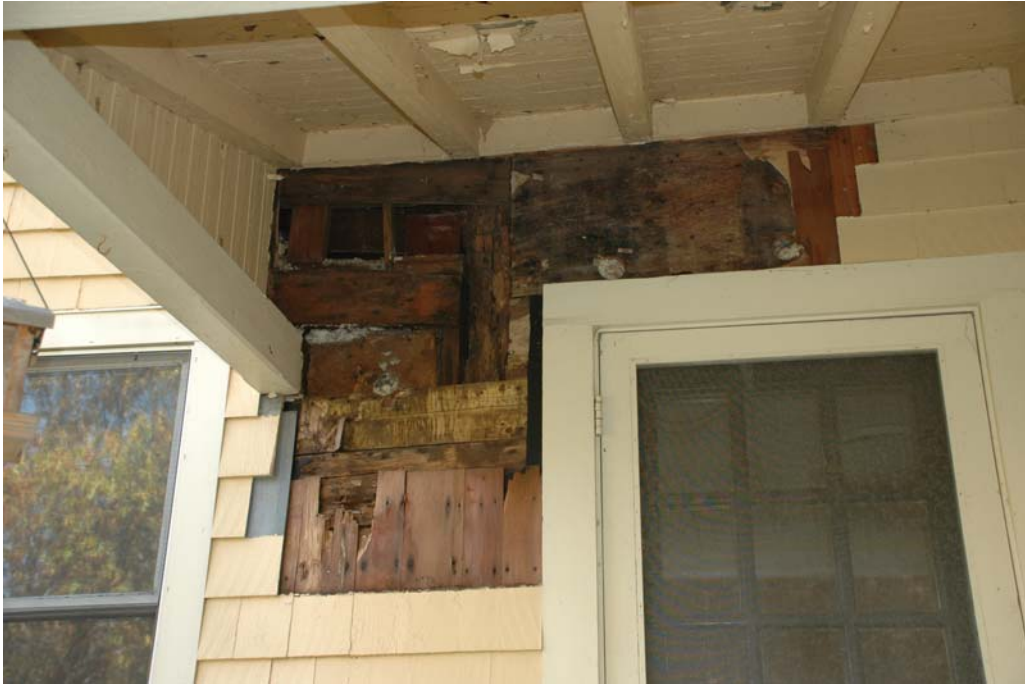
Figure NE-8. Wall under rear porch where shingles and sheathing were removed to expose deteriorated framing behind.

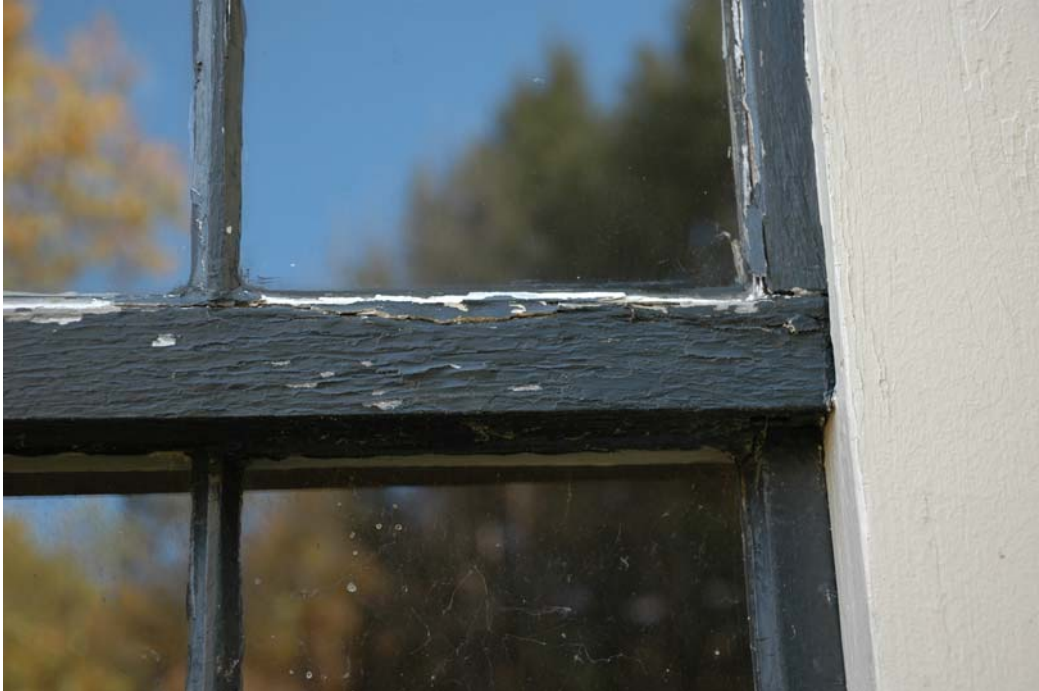
Figure NE-14. Detail of deteriorated wood sash at Window #112.

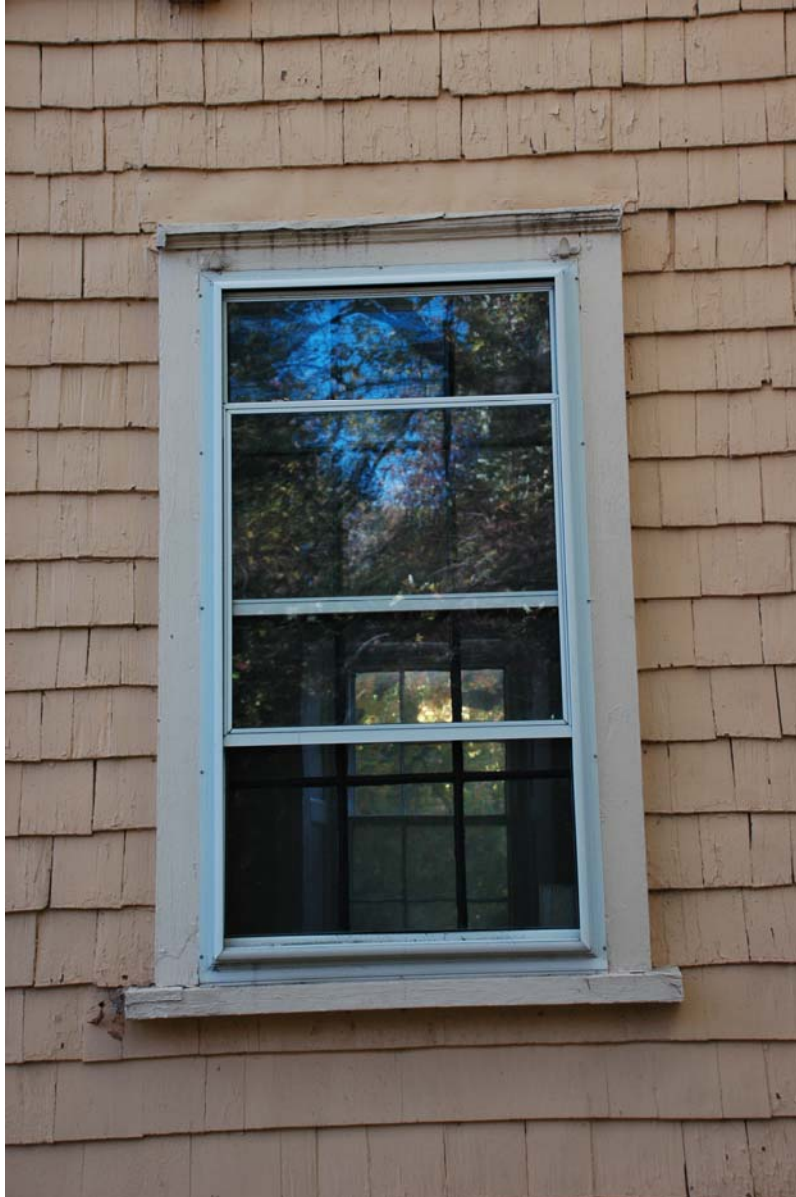
Figure NE-17. Window #115, Type w-A. Lower left portions of frame and sill are rotted and flashed with metal.

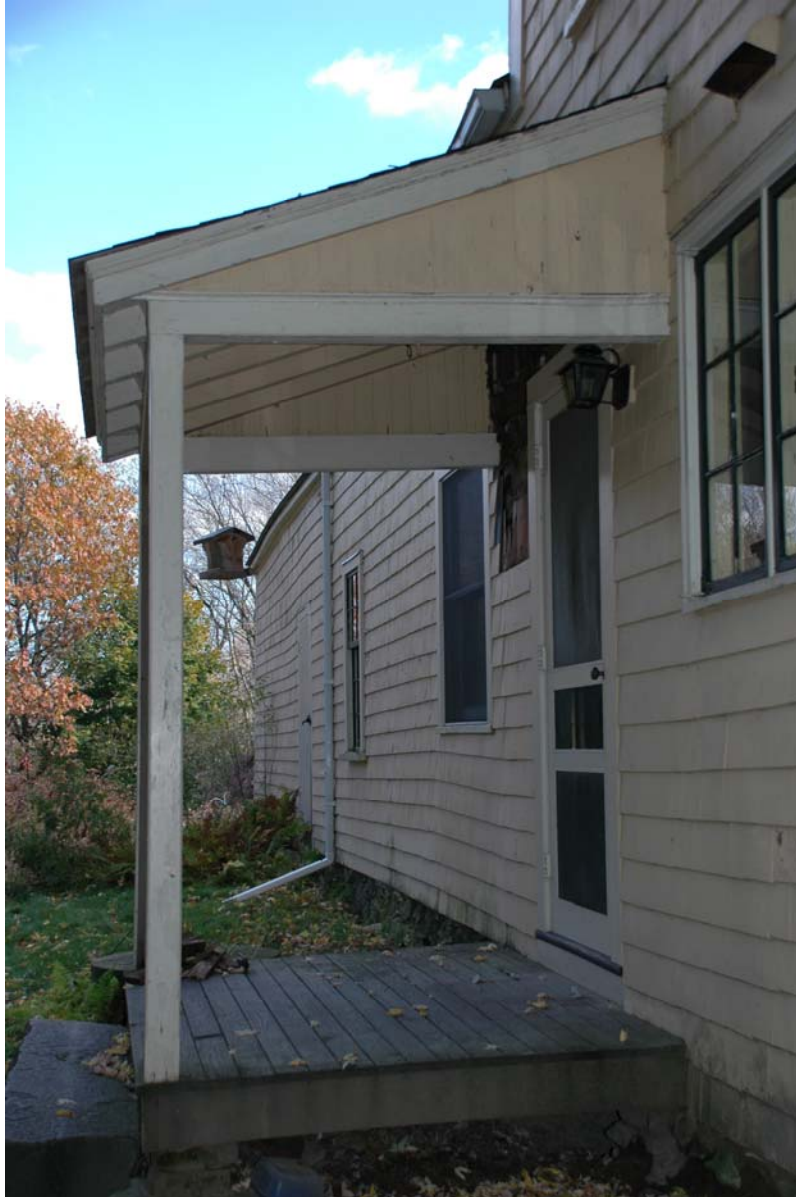
Figure NE-18. Side view of rear porch, looking east.

- The wood cornice at the northwest wing is a profile crown molding and profile bed molding. A large percentage of the north elevation cornice is rotted and paint is worn. The northwest corner of the cornice is rotted and covered with sheet metal.
- There is a covered rear porch at the center of the north elevation and Door 1/107. The porch deck is comprised of 5/4 x 4" boards and 3-3/4" square posts supporting a simple shed roof. The porch roof is comprised of asphalt shingles over wood shingles [fig. NE-18].

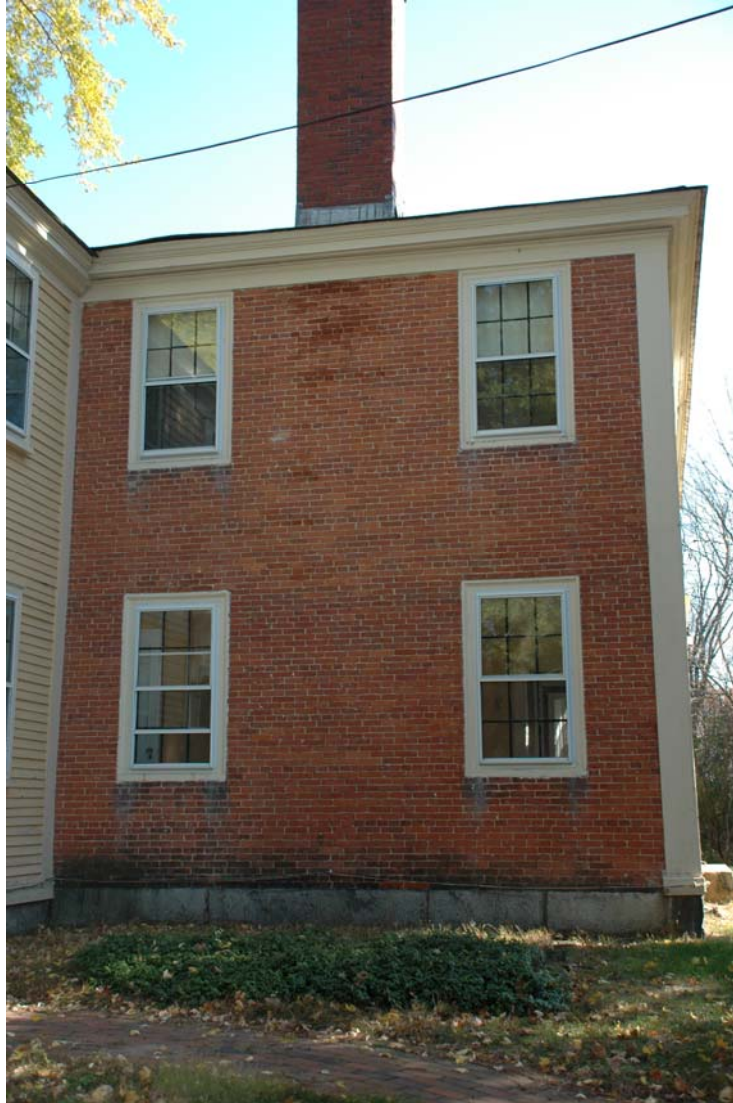
Figure WE-3. West Elevation of the main block with windows#103, 104, 204, & 205 all Type w-B.

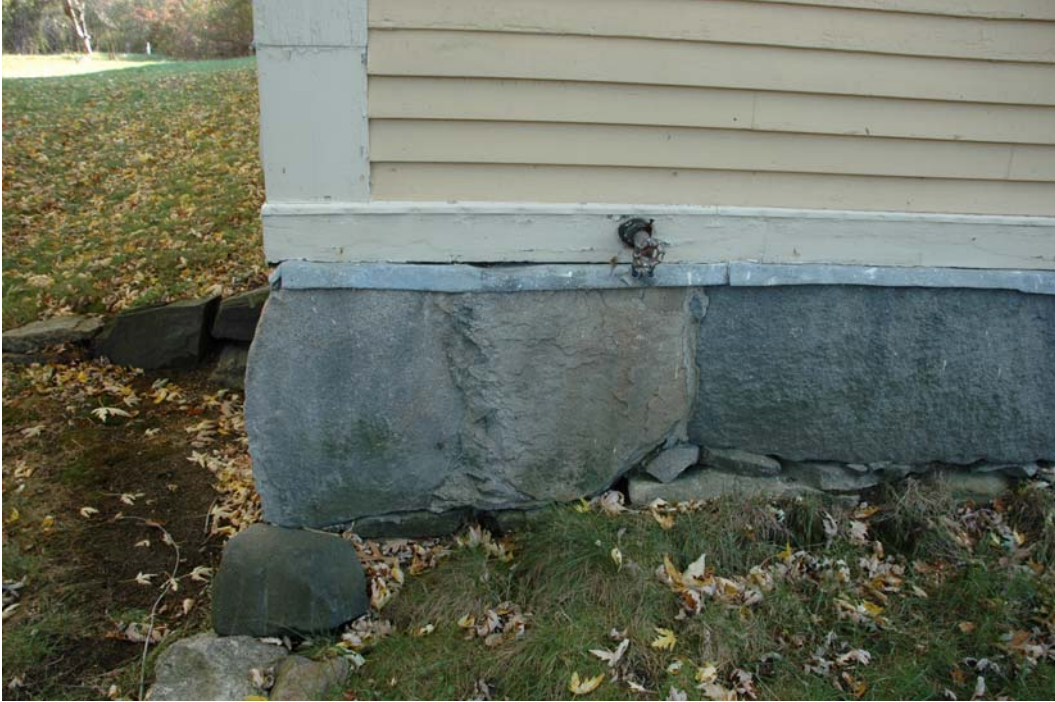
Figure WE-4. Foundation wall at west elevation of northwest wing.

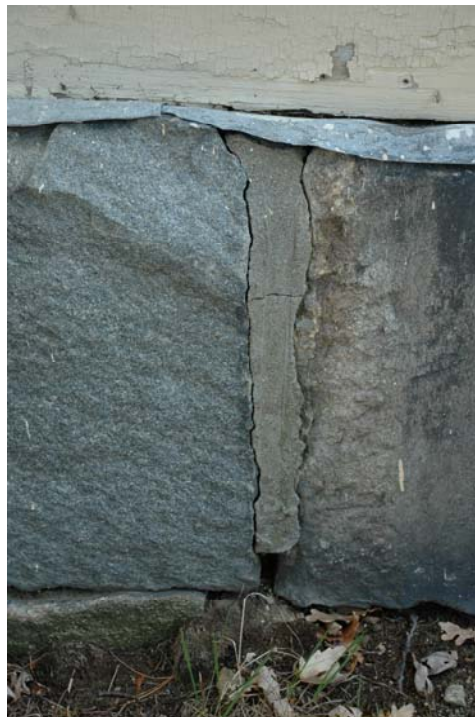
Figure WE-5. Detail of west elevation foundation wall showing condition of shrunken and cracked mortar.

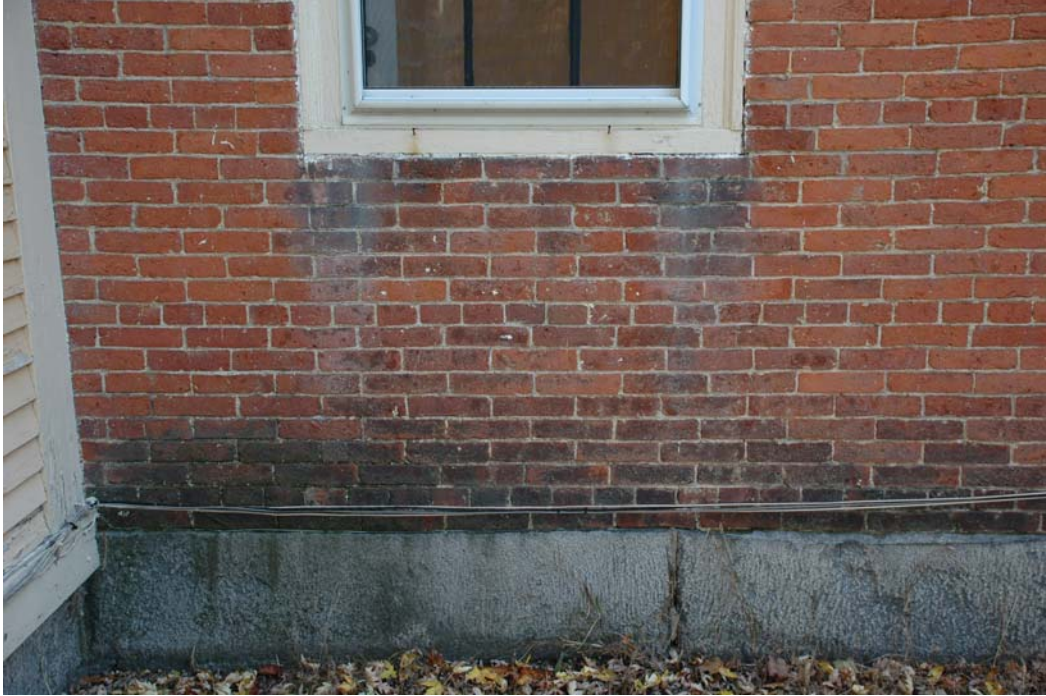
Figure WE-6. Granite slab foundation and brick wall at west elevation of main block. Brick wall and stone foundation wall exhibit significant water staining.

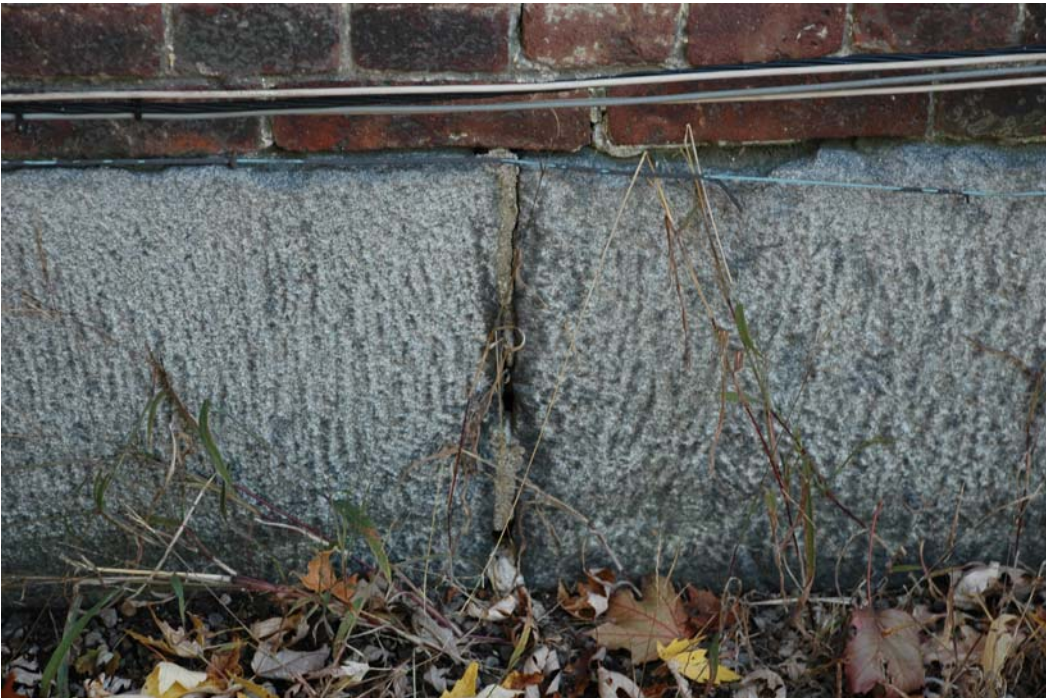
Figure WE-7. Detail of foundation wall at west elevation of main block, showing condition of shrunken and missing mortar.

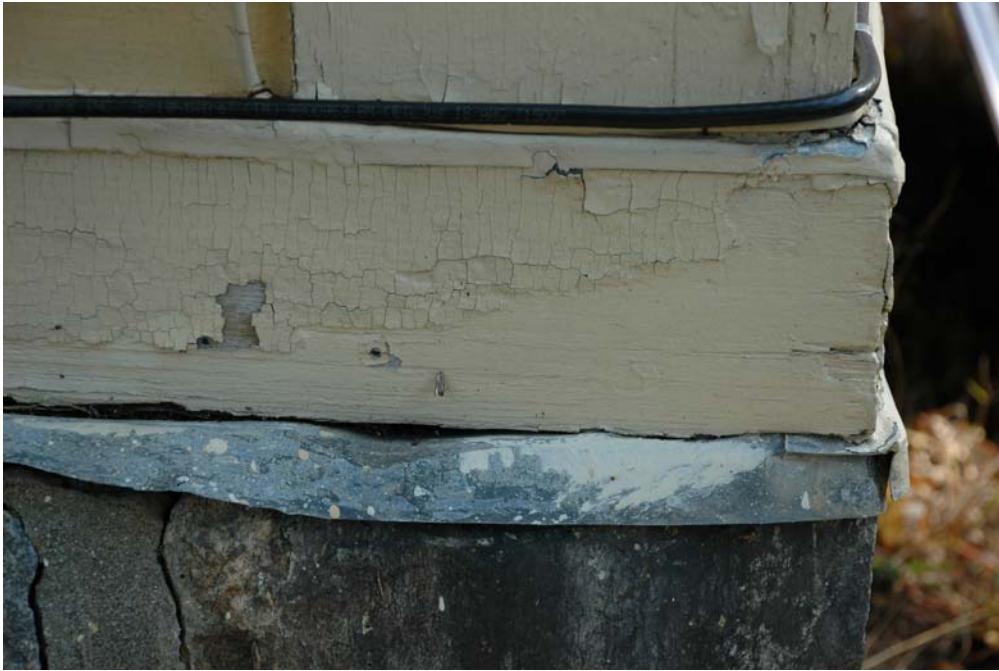
Figure WE-8. Corner board and apron at the west elevation of the northwest wing, exhibiting cracked and peeling paint.

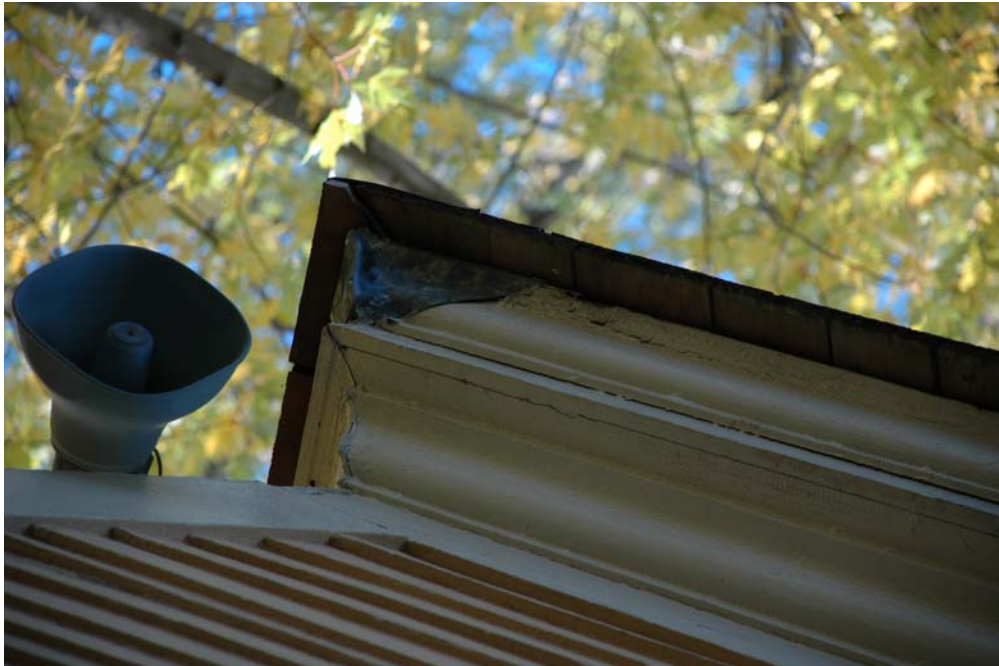
Figure WE-9. Roof cornice at west elevation, with deteriorated crown molding covered with metal. An alarm speaker is attached to the adjacent wall.

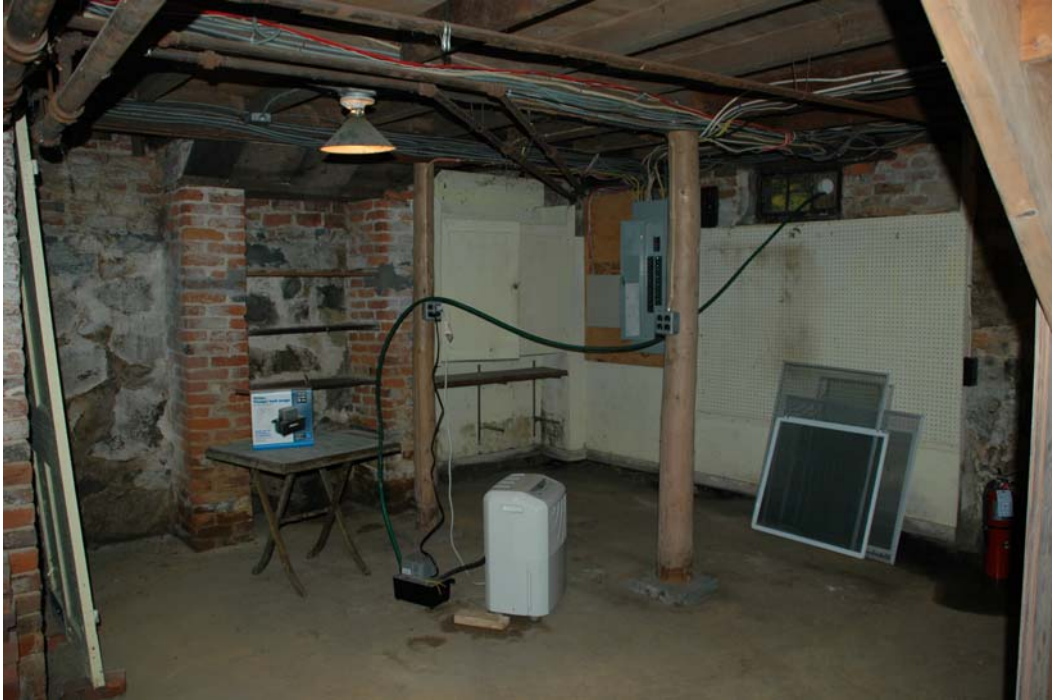
Figure 002-1. East and south walls at Room 002, with the brick fireplace support on the east wall and Window #002 on the south wall.

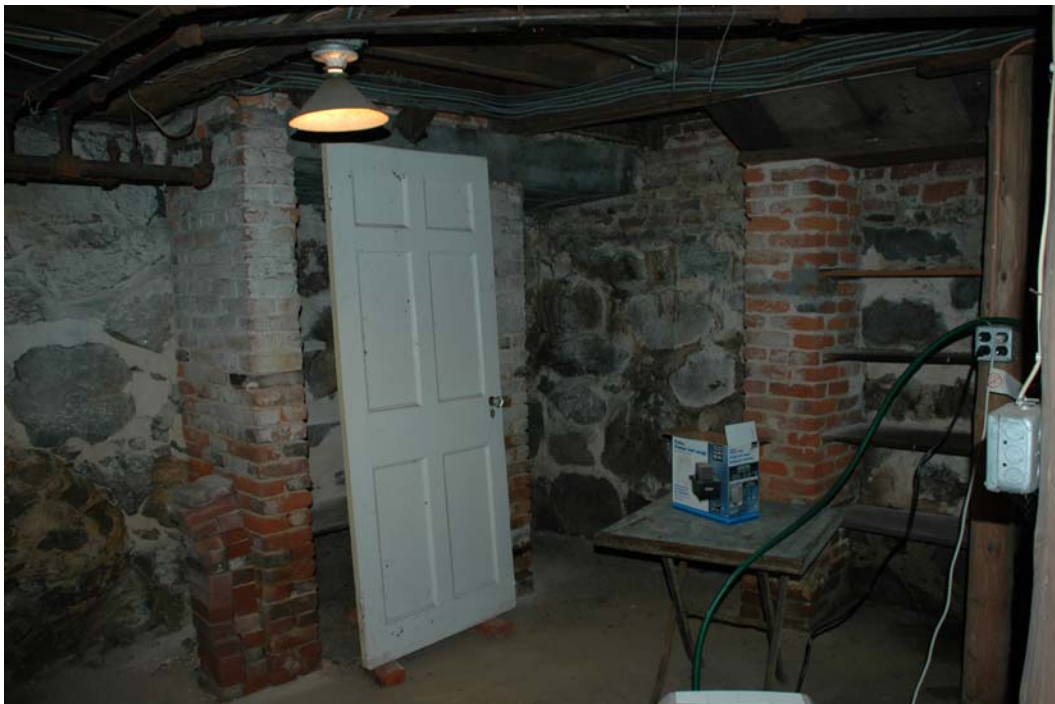
- The north wall is exposed random rubble stone to grade level, with brick above grade. There are two brick piers on the northeast section of the wall that support the large cooking fireplace and bake oven above. Most likely, this is the existing fireplace foundation that was underpinned during the main block construction, as listed in the 1808 bill to Josiah Nelson, Jr. from Jacob Robinson. The wood fireplace lintel was later reinforced with concrete.

Figure 002-2. North and east walls of Room 002, with the brick supports under the Room 108 fireplace that were underpinned and reworked when the main block was constructed.

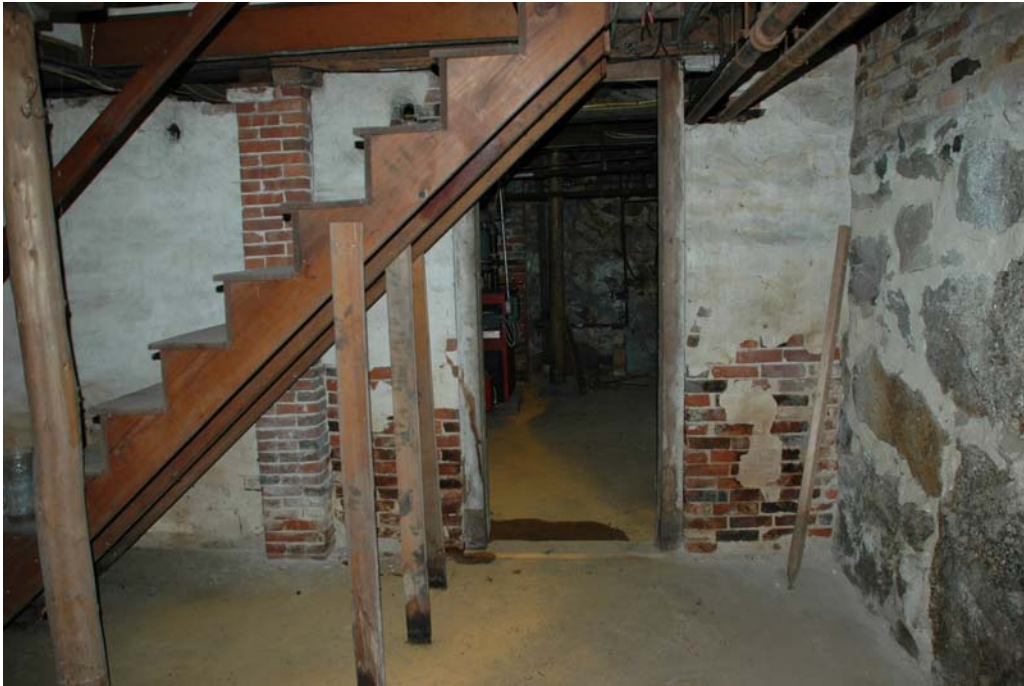
- The east wall is a painted brick wall that separates the east and west sections of the main block basement. The wall is not bearing, however there is a bearing brick pier centered in the wall. There are openings and penetrations in the brick wall and the paint has peeled off in many areas. A wood staircase runs along the west wall and lands in Room 107.

Figure 002-3. West wall of Room 002, looking toward basement stair and to Room 001.

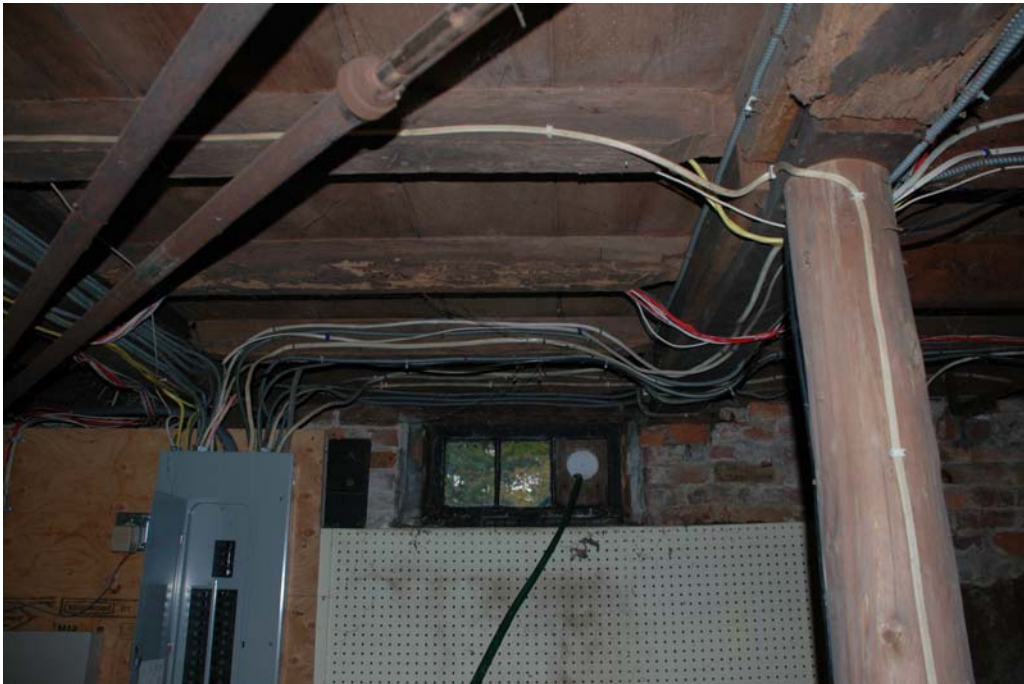
Figure 002-4. South wall of Room 002, with Window #002. The beam on the right is severely deteriorated.

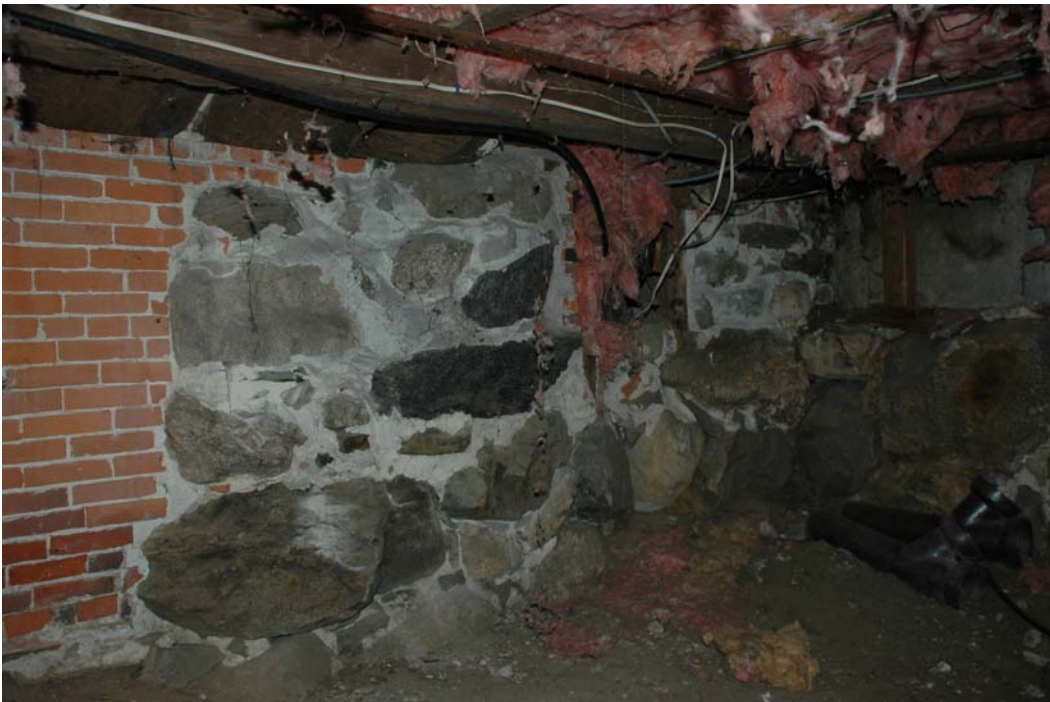
- The east wall is exposed random rubble stone with brick at the northernmost section. The brick supports what appears to originally have been a bake oven in Room 106. There is an ash cleanout in the brick [fig. 003-3]. The center section of the east foundation wall, which is the support for the back-to-back fireplaces and hearths above in Rooms 104 and 106, is rubble stone. The south section of the east wall is also stone and contains an opening to the crawl space under the unexcavated section of the northwest wing [fig. 003-2].

- The east wall would have been the exposed exterior west foundation wall of the northwest wing prior to the construction of the second phase. It appears that the east wall masonry has a clearly defined southwest corner. The south wall appears to have been added since the second phase masonry is not keyed in. It is not possible to observe the joint between the first and second phases of the northwest wing on the exterior south elevation because the stone slab steps to Door 1/105 are situated in front of this area.

Figure 003-2. Room 003, east wall. This may have been the exterior foundation wall prior to the construction of the northwest wing second phase. The wall appears to have been significantly reworked at some point, with the brick infill at the fireplace and bake oven foundations.

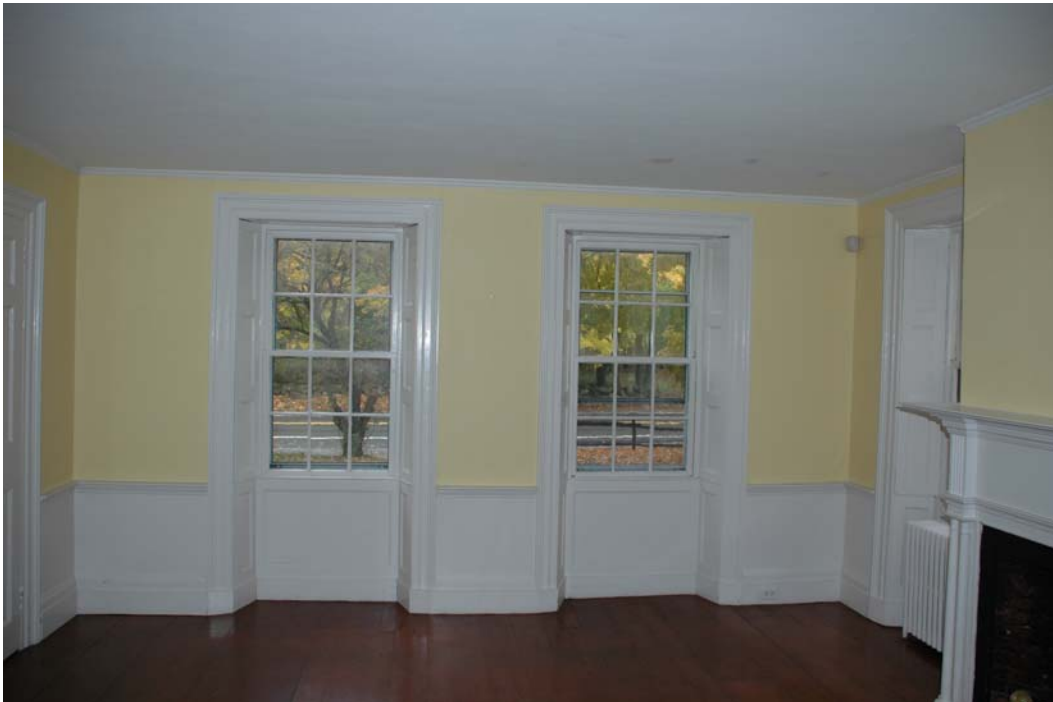
- **Windows 103, 104, 105 & 106:** 6/6 double hung, $\frac{3}{4}$ " muntin wood sash. The windows have splayed paneled jambs from the floor to the window head and paneled interior shutters. There is paneled wood wainscot in place of a typical interior sill and 3-piece casing that sits on plinth blocks. The shutters are painted shut and the sash and muntins have thick layers of paint [fig. 102-1].

Figure 102-1. South elevation of Room 102, showing the splayed and paneled window jambs with recessed sills.
