MINUTE MAN NATIONAL HISTORICAL PARK
JOHN NELSON HOUSE & BARN

HISTORIC STRUCTURE ASSESSMENT REPORT

NOVEMBER 2008

PREPARED BY:
JOHN MILNER ARCHITECTS, INC.
CHADDS FORD, PA

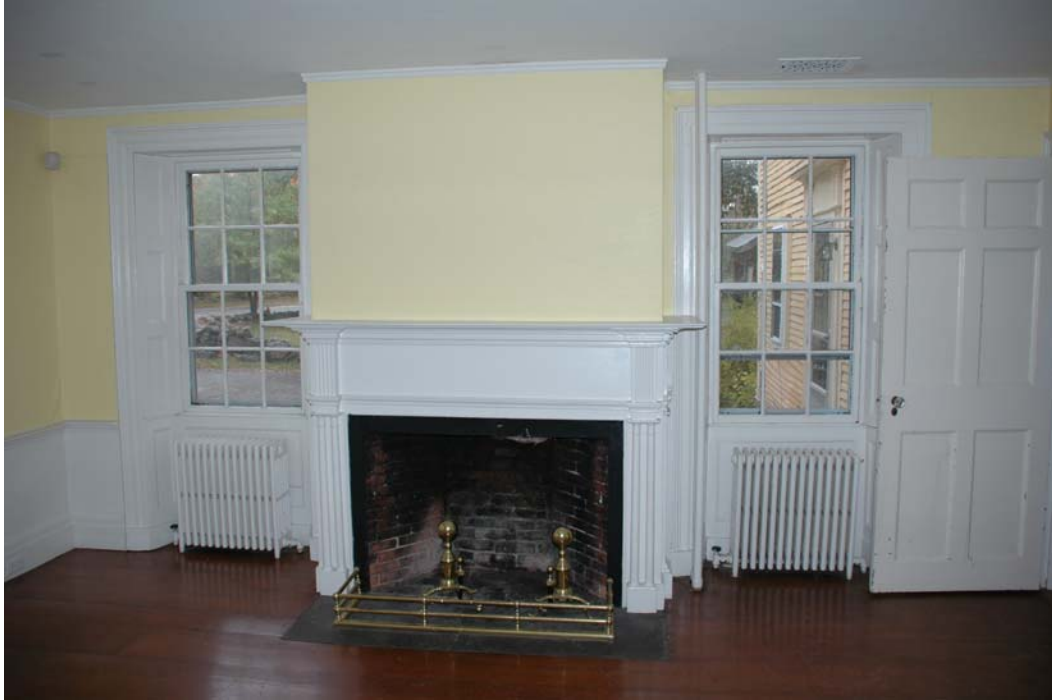
- The fireplace is original to the circa 1808 main block. The firebox is brick with a painted plaster face.
- The decorative painted wood mantel appears to be original to the room.
- The stone hearth is cracked and the firebox pointing mortar is chipped and failing.

Figure 102-2. West elevation of Room 102, decorative fireplace mantel.

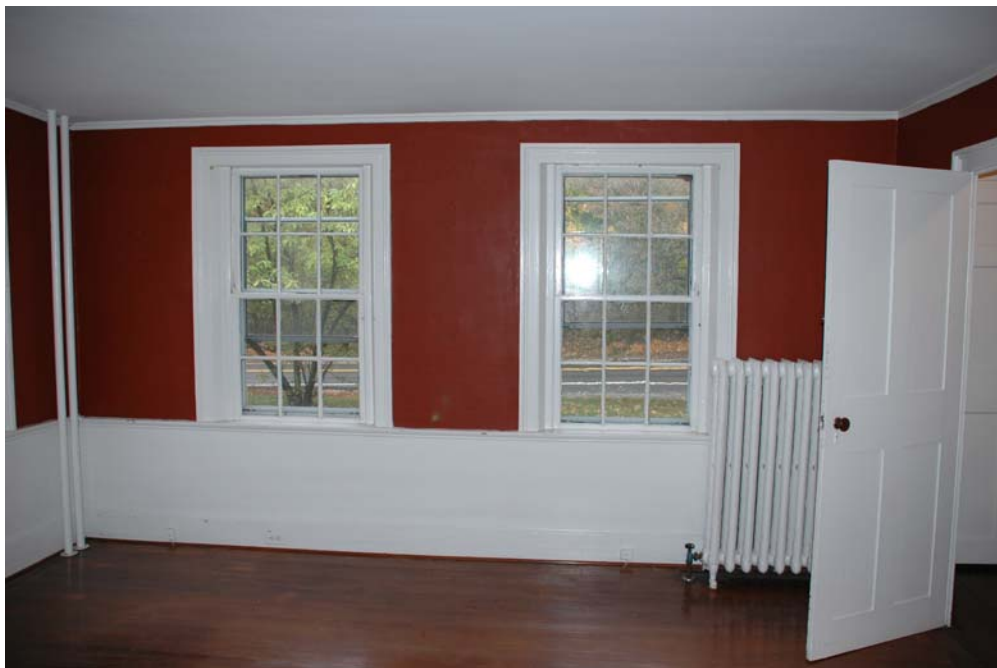
- **Windows 107 & 108:** 6/6 double hung with $\frac{3}{4}$ " muntin wood sash and shallow splayed jambs. Both windows, bottom sash are rotted and poorly repaired. Window 107 glass lights are cracked.
- **Window 109:** 6/6 double hung with $\frac{3}{4}$ " muntin wood sash and deep splayed jambs.

Figure 103-1. South elevation of Room 103 with Windows 108 and 107.

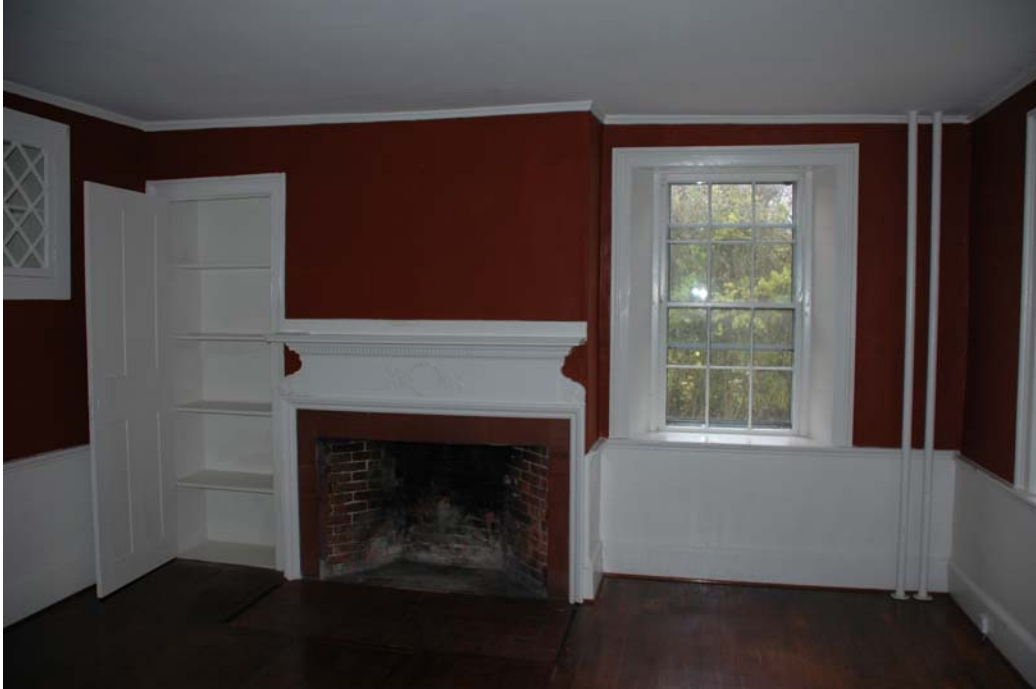
- The fireplace location and size appear to be original to the circa 1808 main block.
- The firebox is brick with a square tile surround and hearth. The tile is 4-1/2" square, machine-made and stamped with "A.E. Tile Co.", a company based in Zanesville, Ohio that operated from 1876-1930's.
- The square tile hearth is recessed $\frac{1}{2}$ " below the finish floor level, appearing to be flush with the original floor level.
- The decorative painted wood mantel appears to be a manufactured mantel dating from the late 19th or early 20th century. Most likely the mantel, tile hearth and firebox surround were installed to replace an earlier mantel. Additionally, the south side of the fireplace masonry mass appears to have been increased in width by 1-1/4" to accommodate the width of the current mantel, with a vertical joint visible in the face of the plaster.

Figure 103-2. North elevation of Room 102 with fireplace and Door 3/103 leading to a wall cabinet.

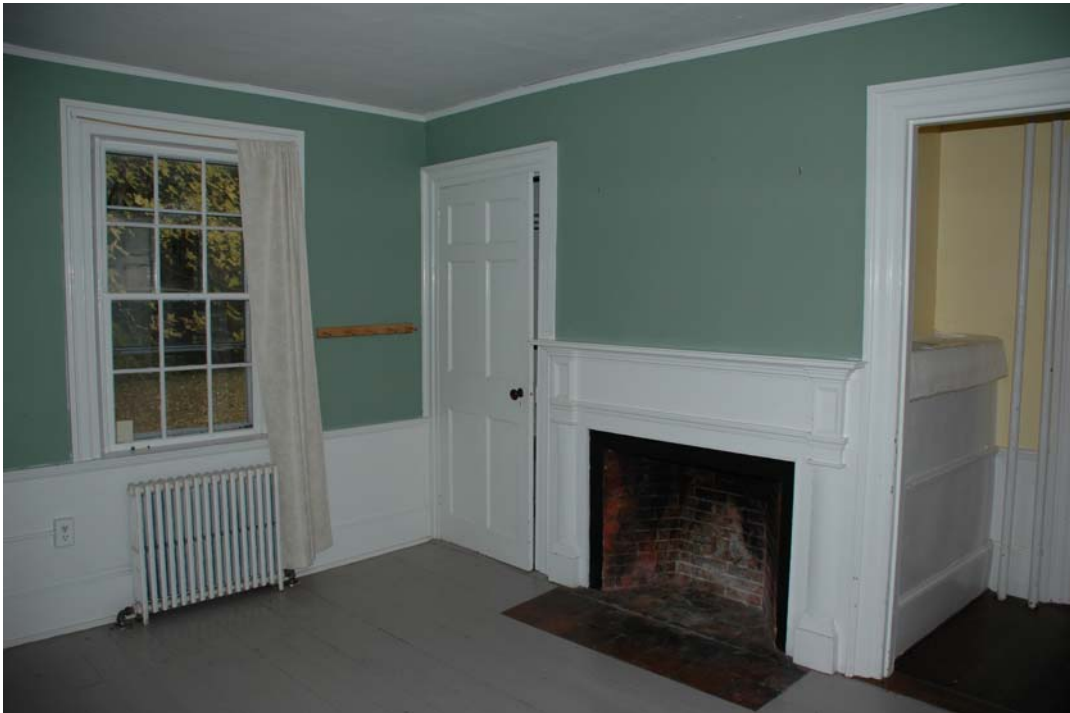
- **Door 2/104:** [fig. 104-1] Type d-B. Located on the east wall, this door leads to a closet with a hanging rod. The base of the closet is built up with the masonry remains of the original bake oven from Room 106, currently removed. The remains of shallow shelves are found behind the right door jamb, which were present when the bake oven was in use. The shelves were since cut off and the closet enlarged in depth using space originally part of the removed bake oven [fig. 104-5]. The door panels are recessed flat on both faces, with panel profile moldings on the Room 104 face. The door hardware consists of brown porcelain door knobs, with the closet interior knob broken off.

Figure 104-1. North and east elevations of Room 104. Doors 2/104 and 1/104 are on the east wall, with the fireplace centered between. Door 2/104 leads to a closet and Door 1/104 leads to Room 105.

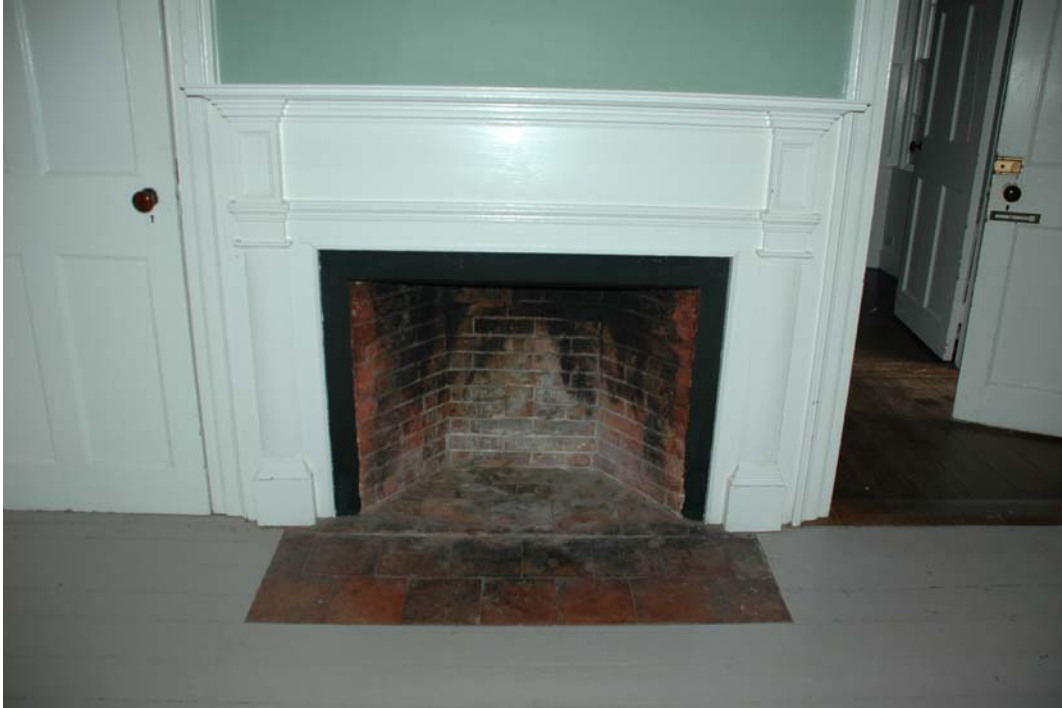
- The brick fireplace appears to be original to this room, which was most likely constructed as an addition to the northwest wing. The firebox is brick with a painted plaster face.
- The square brick hearth appears to be original.
- The brick firebox is stained and brick surface is damaged.
- The decorative painted wood mantel is possibly original to the room, but further investigation is required to determine its age. The mantel is centered on the firebox and hearth.

Figure 104-4. Room 104, detail of fireplace.

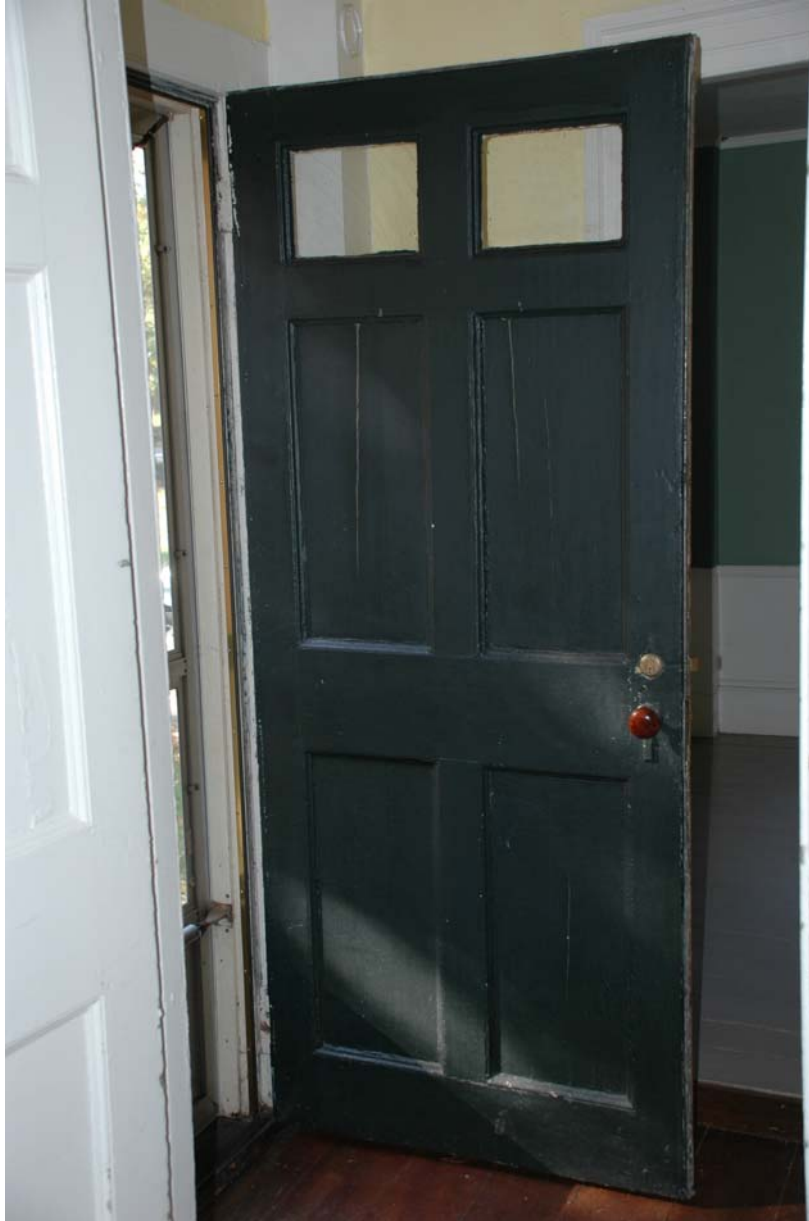
- **Door 1/105:** [fig. 105-1] Type d-A. Located on the south wall, this door leads to the exterior. 6-panel painted wood door leaf with top 2 panels consisting of glass. The hardware consists of brown porcelain knobs, cylinder rim lock and metal interlocking threshold. The original covered escutcheon for the exterior key is painted shut and the interior escutcheon is missing.

Figure 105-1. Room 105, looking west. Door 1/105 is open to the exterior face.

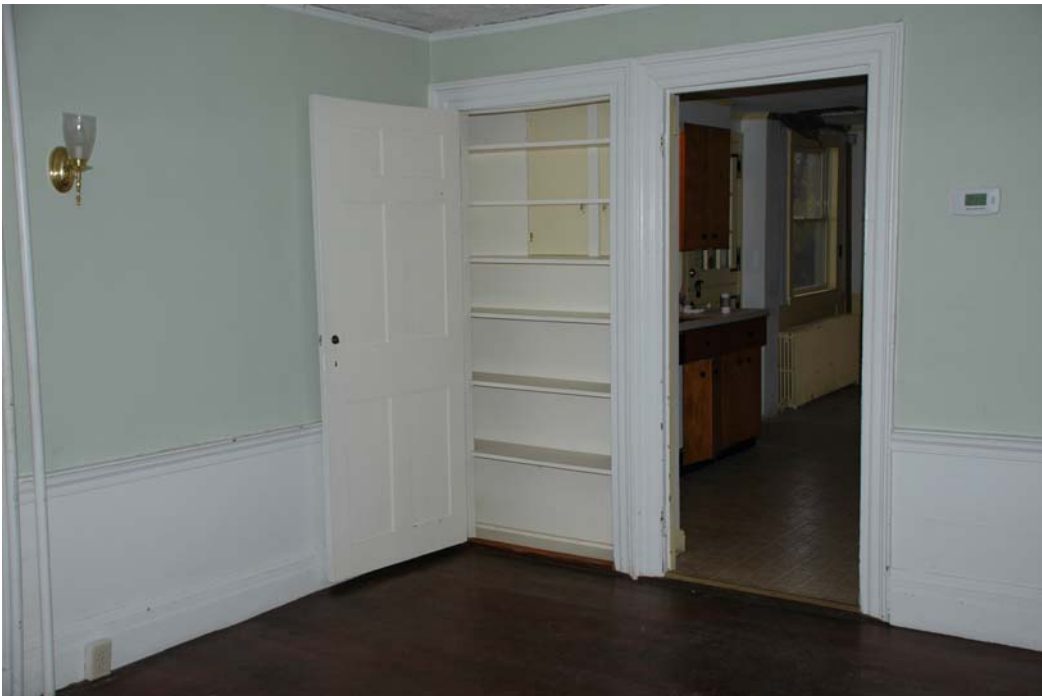
Figure 106-4. North and east elevations of Room 106. Door 3/106 is on the left and Door 4/106 is on the right. Door 4/106 leads to Room 107 and is missing a door leaf (the pintel hinges and latch receiver are still intact).

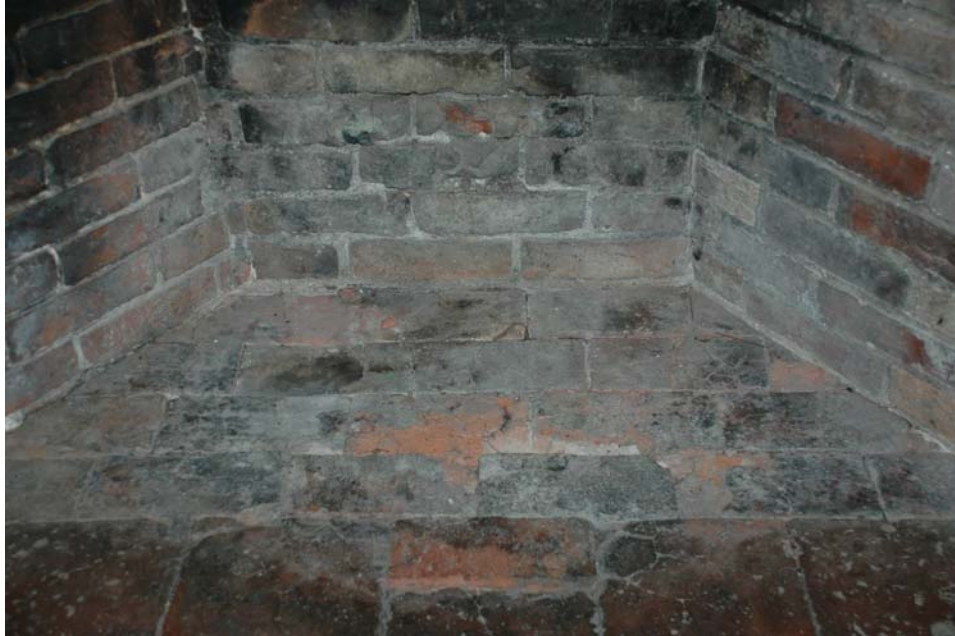
Figure 106-7. Room 106, detail of firebox condition with damaged and stained surface, typical of fireplaces throughout the house.

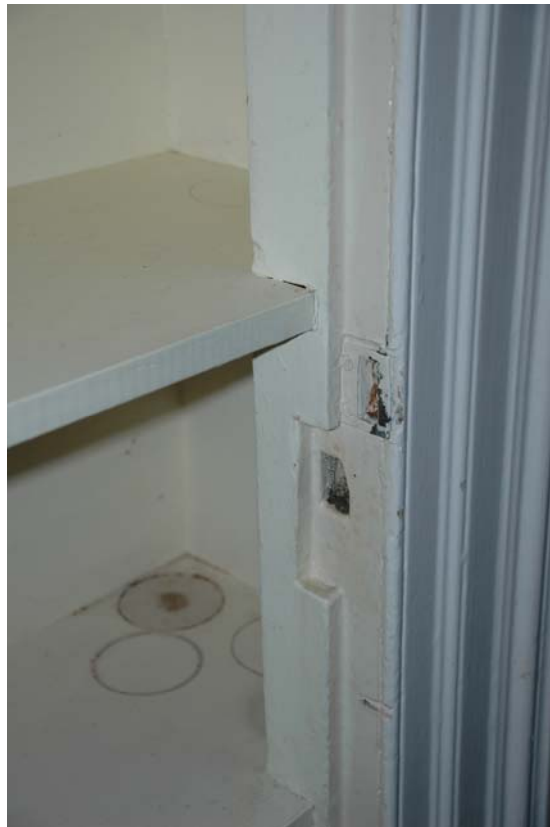
Figure 106-8. Room 106, detail of right jamb at Door 3/106 showing indentation in door stop for the original box rim lock.

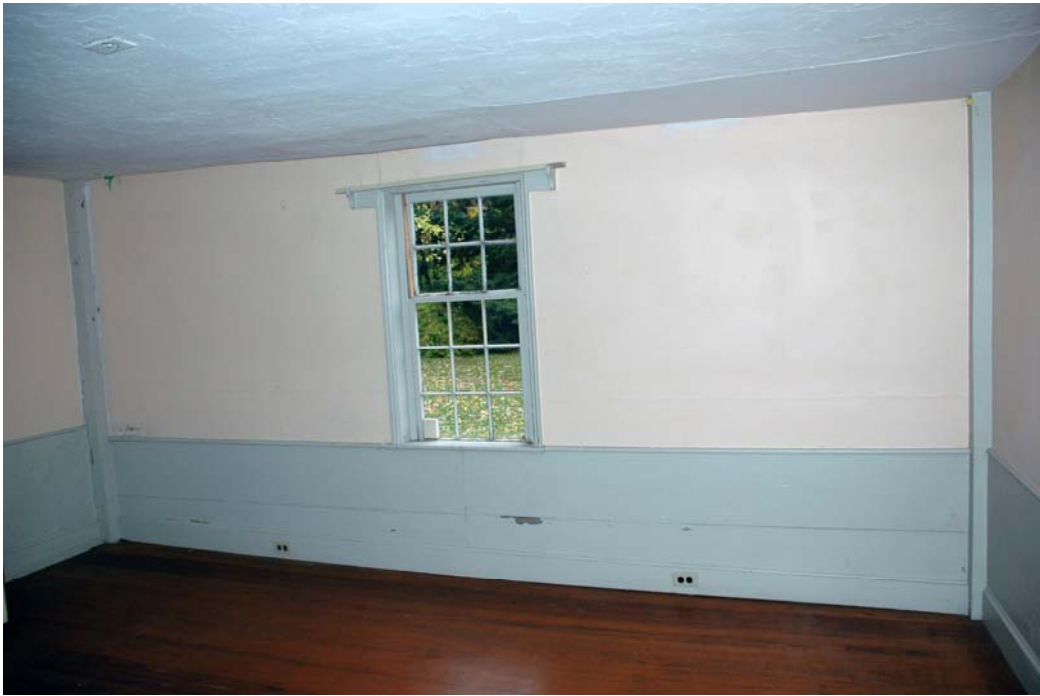
- North Wall: The plaster surface is cracked above Window 112 and the paint is peeling and chipping [fig. 108-4]. There is a vertical scar in the plaster, east of the window, which appears to correspond with the possible partition and enclosed stair mentioned in the discussion of the East wall.

Figure 108-4. North elevation of Room 108 with Window 112.

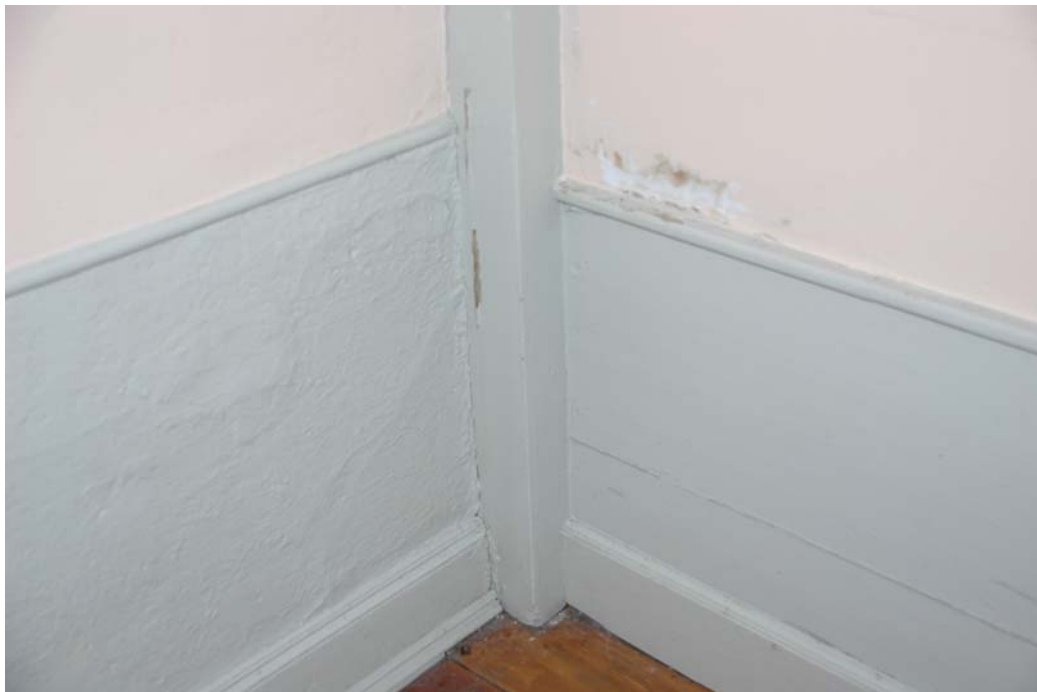
- wall, and so the chair rails do not align at the northwest corner of the room [fig. 108-5]. There is an applied profile shoe molding along the baseboard north of Door 1/108, possibly to conceal a gap between the sagging floor and the baseboard.
- South Wall: [fig. 108-6] The large brick cooking fireplace and bake oven are found on the South wall. The plaster surface exhibits cracking above the fireplace.
 - Electrical outlets are installed in the wainscot on the east wall and in the baseboard on the north wall.
 - The west side of the fireplace mass contains a high cupboard with shelves and sliding wood board doors, accessible from the east side.
 - Exposed painted corner posts project out from the northwest, northeast and southeast corners of the room.

Figure 108-5. Room 108, detail of northwest corner with exposed corner post. The west wall (on the left) is plaster below the chair rail while the north wall (on the right) is horizontal board wainscot. The chair rails do not align and the west wall has a different baseboard and an added shoe molding.

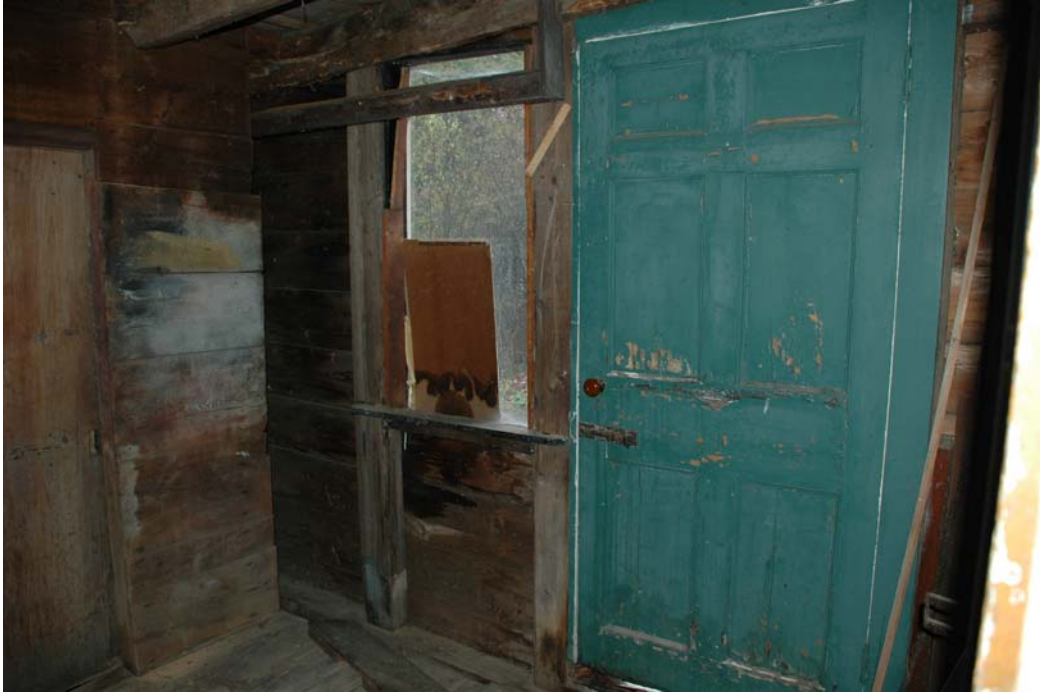
- **Door 1/109:** [*fig. 109-2*] Type d-A. Located on the south wall, this door leads to the exterior. Door frame is integral with the frame and sill of Window 111. 6-panel painted wood door leaf. The paint is peeling and the door surface is worn. The hardware consists of brown porcelain door knobs and a metal slide bolt.
- **Door 2/109:** [*fig. 109-4*] Type d-E. Located on the north wall, this door leads to the exterior. Board-and-batten painted wood door leaf. The bottom of the door is rotted and a reinforcing board has been applied to the interior surface. The hardware consists of a reproduction thumb latch (matches Door 2/108) and a hook-and-eye latch.
- **Door 2/110:** [*fig. 109-3*] Type d-E. Located on the east wall, this door leads to the carriage house. Comprised of two unfinished wide boards, the door slides on head-mounted hardware.

- **Window 111:** [*fig. 109-2*] The sash is missing and the opening is infilled with a single piece of Plexiglas. The sash opening size is similar to Window 110. The frame and sill are integral with the frame of Door 1/109.

Figure 109-2. Room 109, south elevation with Door 1/109 and Window 111 (sash missing).

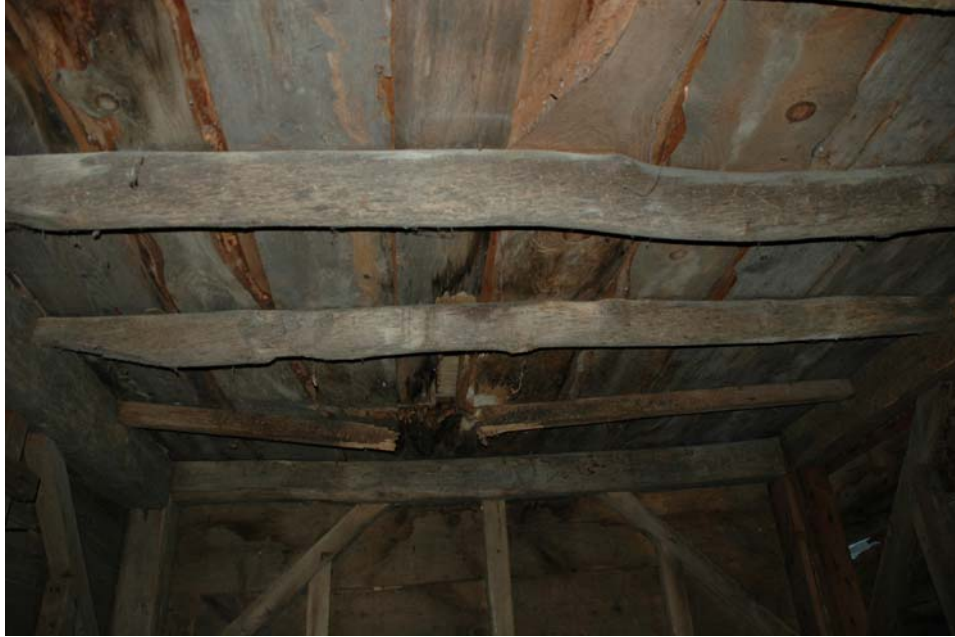
Figure 110-2. Ceiling view of Room 110, including damaged joist in background.

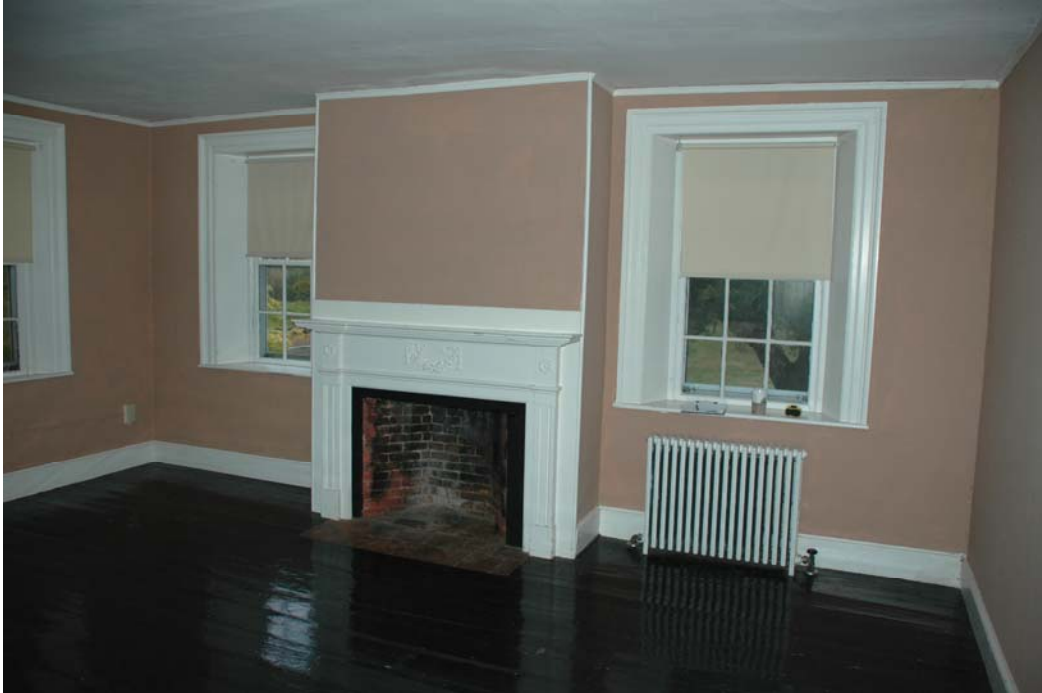
- The firebox is brick with a painted plaster face and the hearth is square brick. The firebox and hearth appear to be original to the circa 1808 main block. The firebox is stained and the brick surface is damaged.
- The decorative painted wood mantel is not centered on the firebox and the fireplace is not centered on the masonry mass that projects into the room. It is possible that the mantel is original, dating from the early 19th-century construction date of the main block, based upon similar stylistic features found in typical mantel designs from the Federal time period. Further investigation is needed to determine the age of the fireplace mantel.

Figure 202-2. West elevation of Room 202 with Windows 205 & 204.

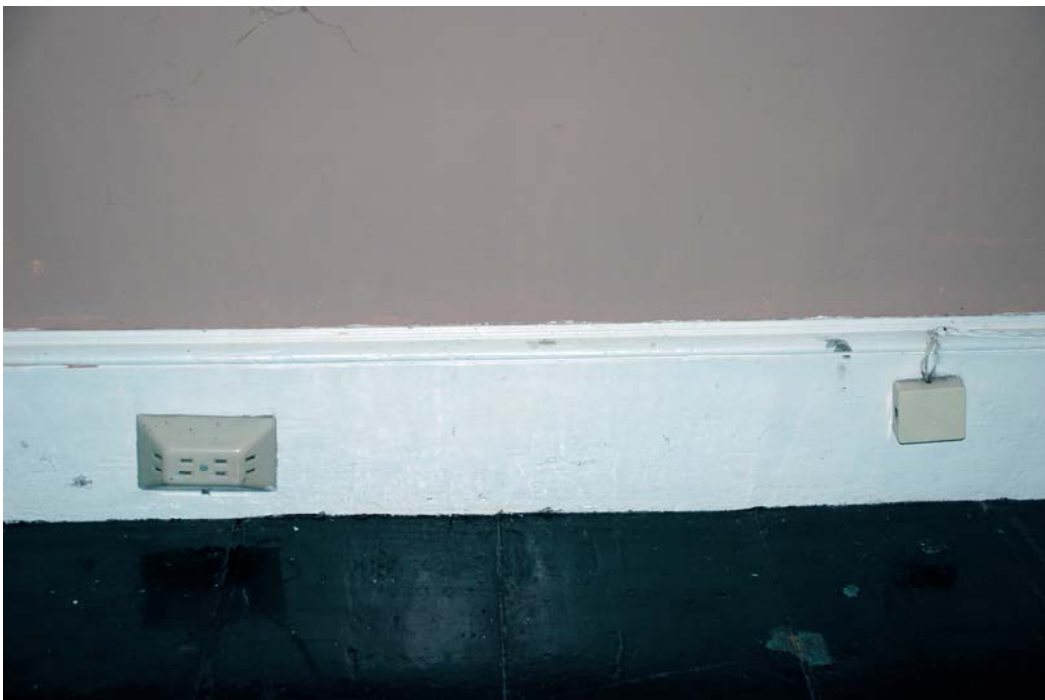
- The walls are painted plaster. The north and south walls have a few cracks.
- The painted wood baseboard has a cap profile.
- The casing profiles in Room 202 appear to match the profiles of Room 201.
- Electrical outlets and conduit run along the surface of the south and east walls [fig. 202-7].

Figure 202-7. Room 202, detail of baseboard with surface mounted outlets and wires.

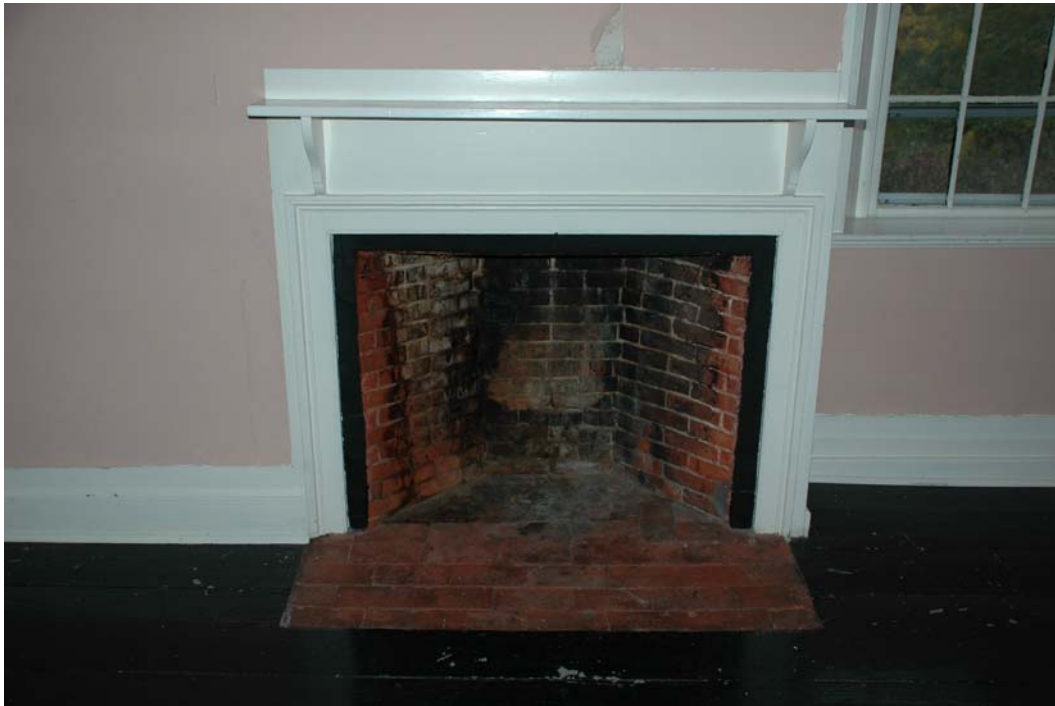
- The firebox is brick with a painted plaster face and the hearth is brick. The firebox and hearth appear to be original to the circa 1808 main block. The firebox is stained and the brick surface is damaged.
- There is a decorative painted wood surround with a simple bolection molding and mantel shelf with brackets. The backband profile of the bolection appears to be the same as the window casing backband profile. Further investigation is needed in order to determine the age of the fireplace surround.

Figure 204-4. Room 204, fireplace and hearth.

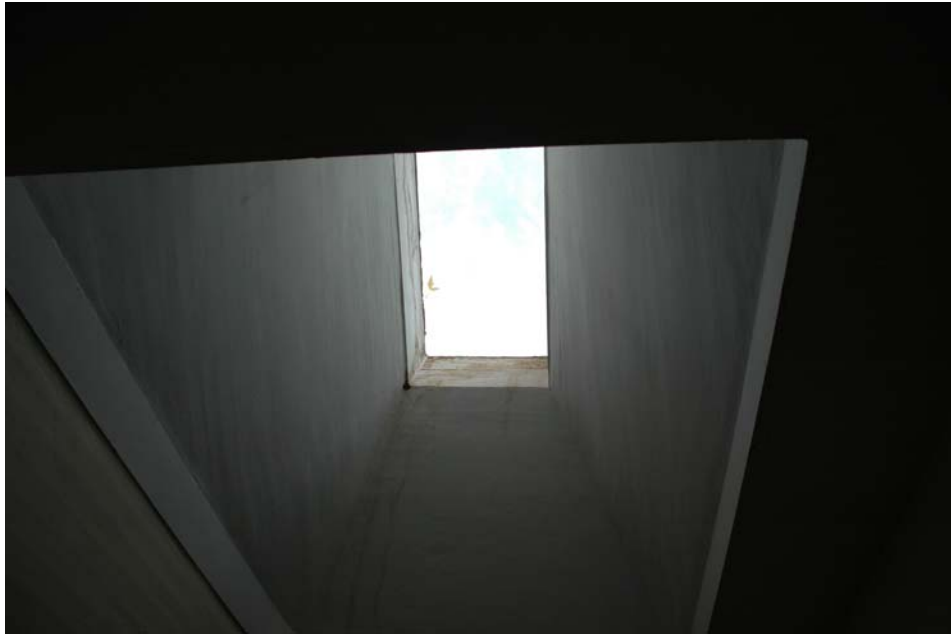
- The ceiling is painted plaster.
- There is an access panel to the attic (2'-0" x 2'-0") in the west end of the room.
- There is a fixed skylight in the center of the ceiling [fig. 205-4].
- A pendant light fixture and smoke detector are installed in the ceiling.

Figure 205-4. Skylight in Room 205.

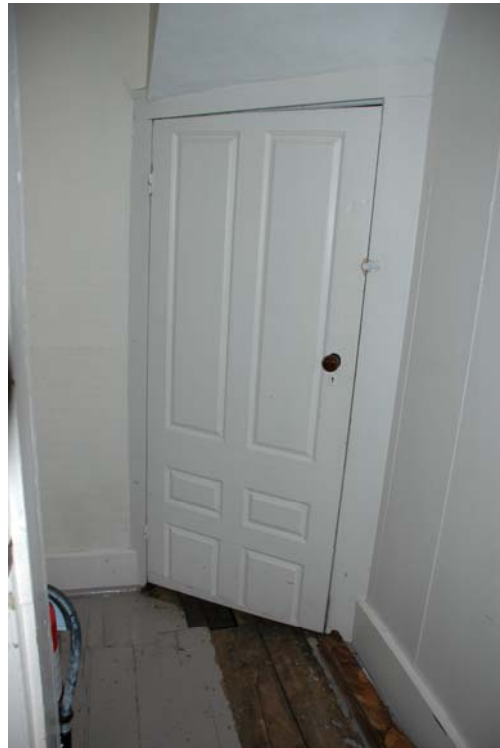
- **Door 1/201:** Located on the south wall, this cased opening leads to Room 201. The door leaf is missing. There is a latch receiver for a thumb latch remaining on the jamb.
- **Door 1/205:** [fig. 205-5] Type d-F, modified. Located on a 45 degree angle at the intersection of the north and east walls, this door leads to the attic space above the kitchen and the original 18th century structure. 6-panel painted wood door leaf, which has been modified to accommodate the floor sag. The hardware consists of brown porcelain door knobs.
- **Door 1/206:** [fig. 205-3] Type d-G. Located on the north wall, this door leads to Room 206. 4-panel painted wood door leaf. The door panels are recessed flat on both faces, with profile panel moldings. The hardware consists of brown porcelain door knobs.

Figure 205-5. North and east elevations of Room 205 with Door 1/205 that leads to the attic, Room 209. The door leaf has been modified to accommodate the sloping floor.

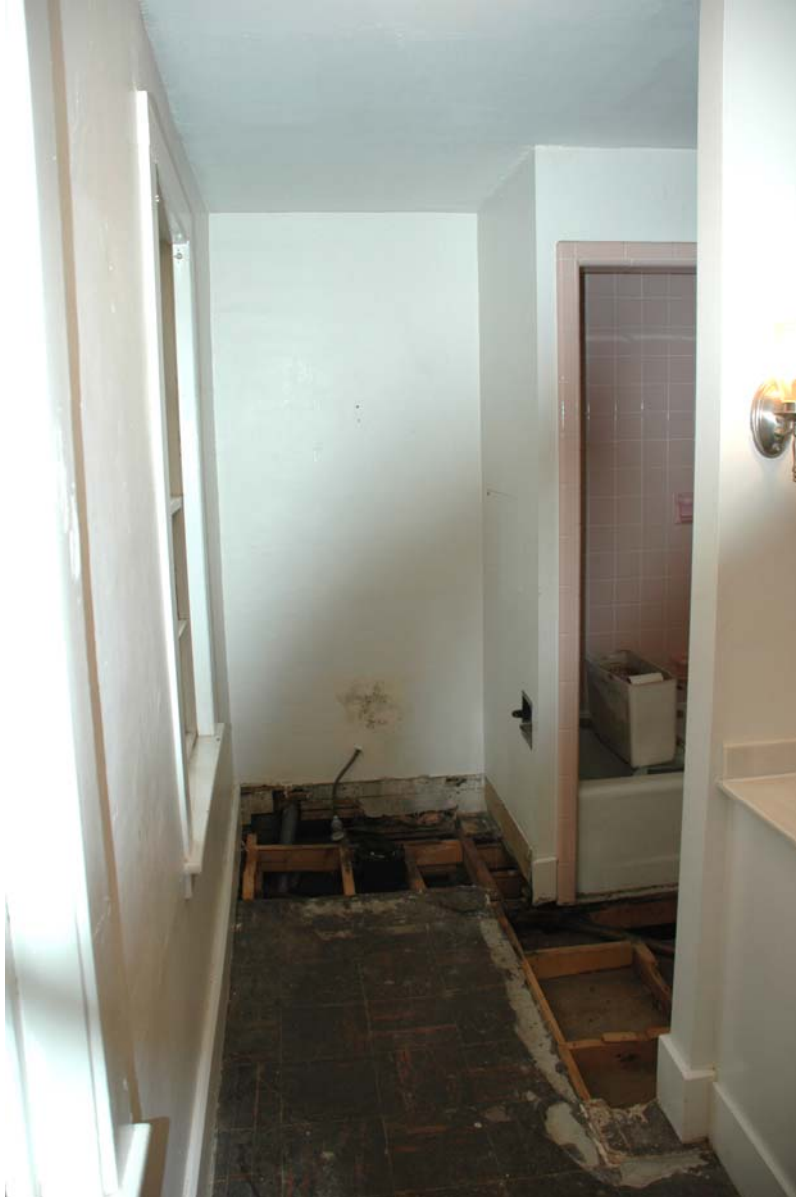
- Asbestos composite tile (9" square) on plywood subfloor, on the original wood floor boards (8-1/2" - 10") that are continuous north-to-south from Room 205. The original floor structure sagged significantly from structural failure and sleepers were installed to level the floor for the tile installation.
- The tile and subfloor had been previously removed from around the toilet and bath area, exposing the sleepers and original wood floor boards [fig. 206-2 & 3].

Figure 206-2. Room 206, looking east. A portion of the floor and subfloor was previously removed. Sleepers were installed to correct the sagging floor prior to the installation of the partition wall on the right, the bathtub and surround, and the tile floor.

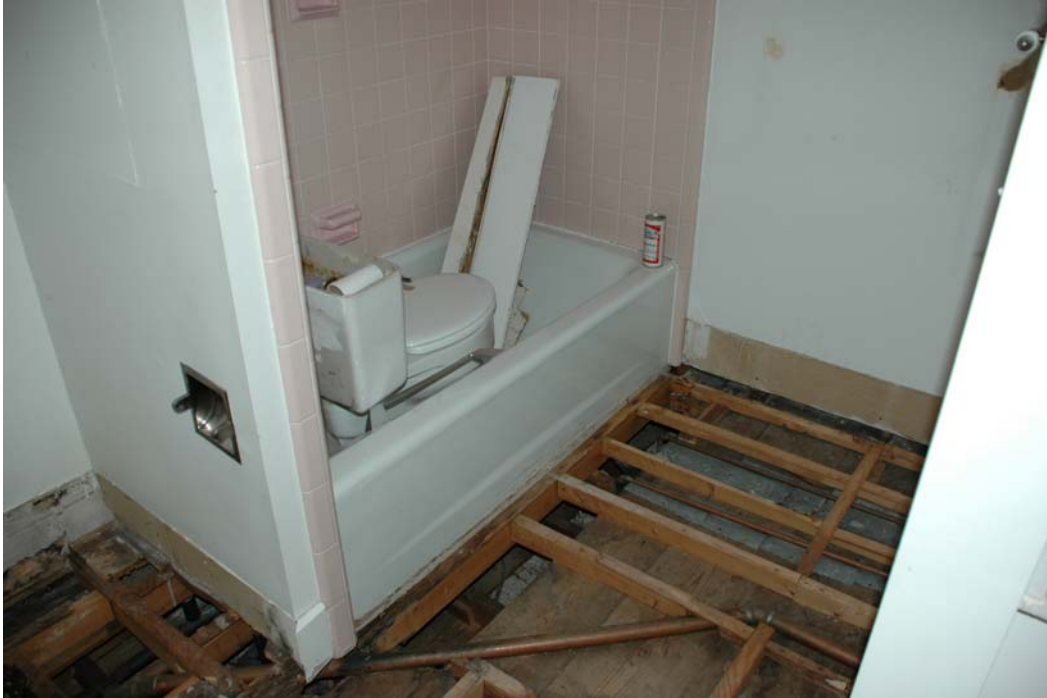
Figure 206-3. Room 206, looking southeast showing removed finish floor and leveling sleepers on top of the original floorboards, which run continuous under the south wall that separates Room 206 from Room 205.

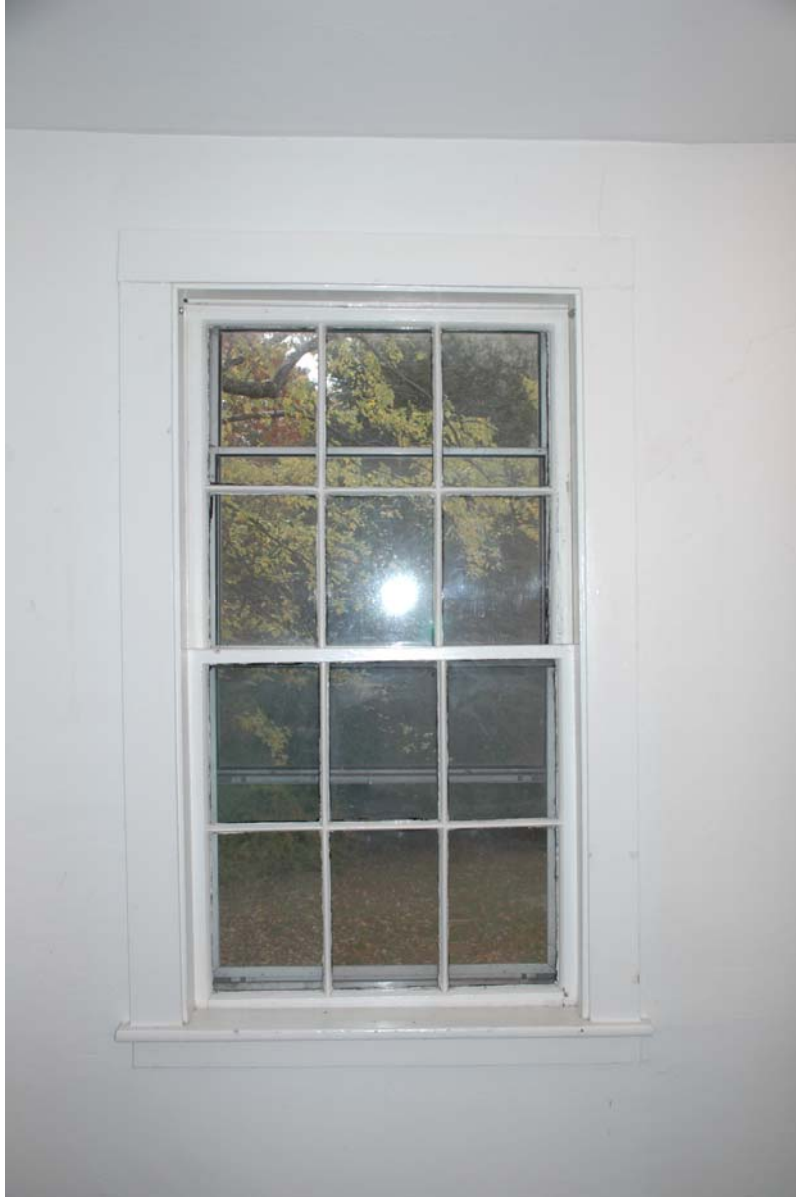
- **Windows 214 & 215:** [fig. 206-4] 6/6 double hung sash with a narrow muntin profile. Windows 214 and 215 are unique to the other windows in the house, indicating that they may have been installed more recently.

Figure 206-4. Room 206, Window 215 (Window 214 is similar). The window casings and sills at windows 214 and 215 are unique to the house.

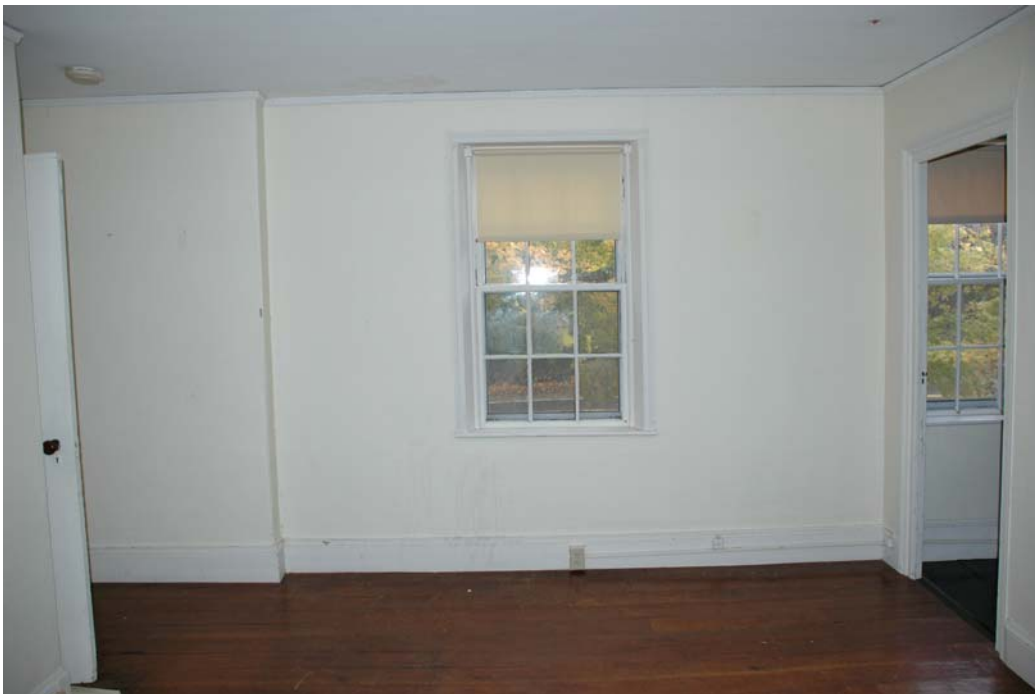
- **Window 203:** [fig. 207-3] 6/6 double hung, $\frac{3}{4}$ " muntin wood sash. The jambs are shallow splayed flat boards. The muntins have multiple layers of paint. Roller shade hardware is installed on the face of the sash stops. There is one cracked sash light.
- **Window 216:** [fig. 207-6] 6/6 double hung, $\frac{3}{4}$ " muntin wood sash, on the north wall. The jambs are square, unlike the splayed jambs of Window 203. The muntins have multiple layers of paint. Roller shade hardware is installed on the face of the sash stops.

Figure 207-3. South elevation of Room 207, with Window 203.

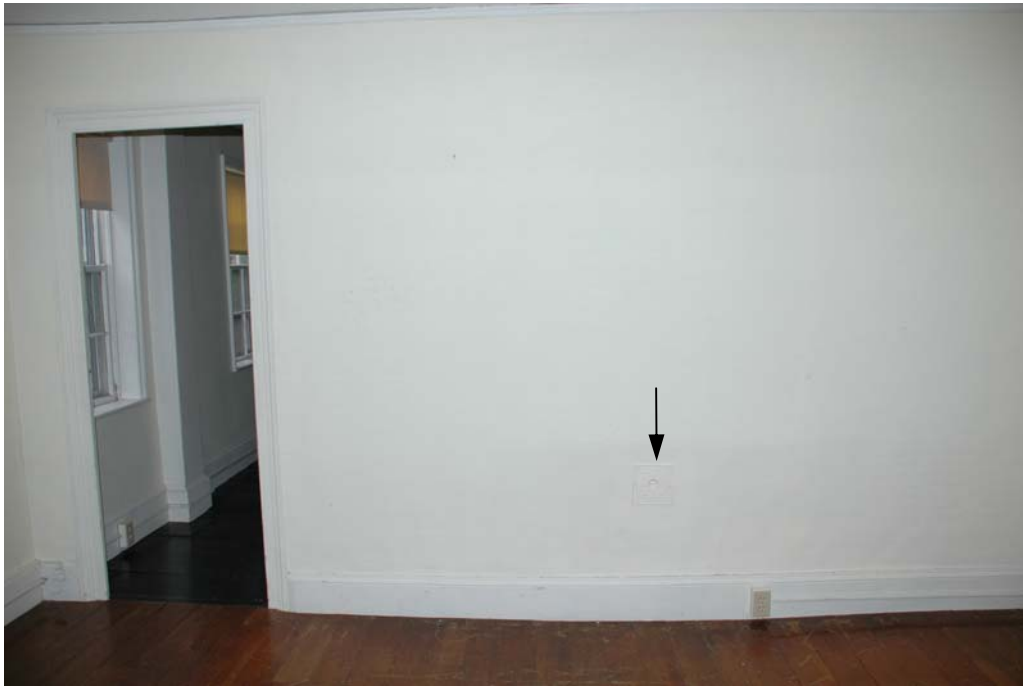
Figure 207-4. West elevation of Room 207 with Door 1/208 that leads to Room 208. The floor sags in the middle, at the possible location of a stove heater. The former stove vent plate is found on the wall above this area, now painted over (see arrow).

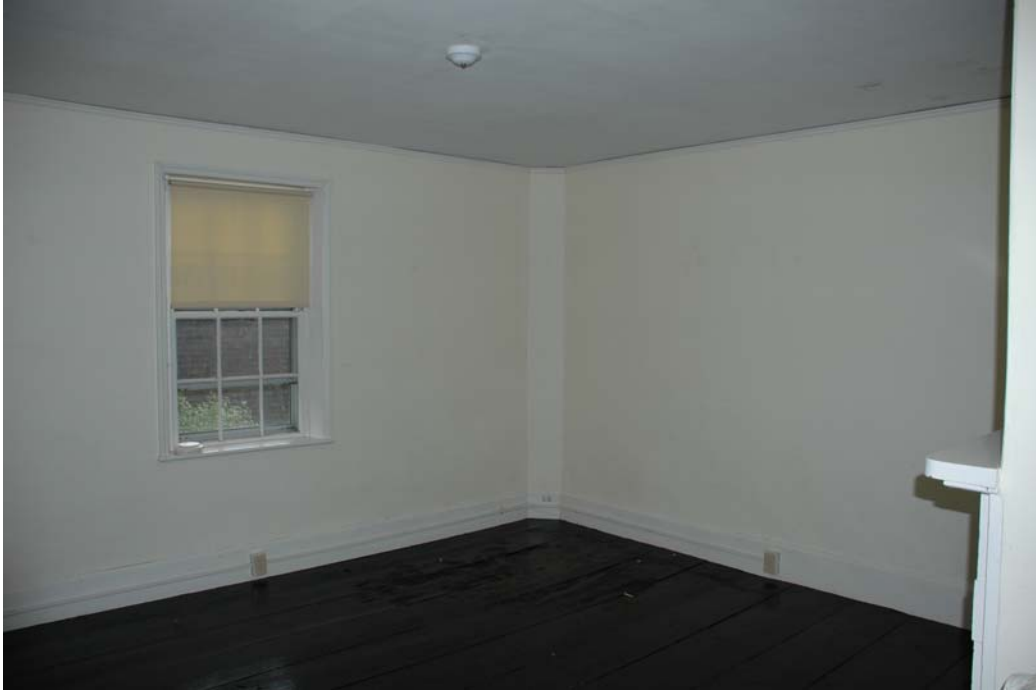
- The northwest and southwest corners are finished with 45 degree walls that most likely conceal corner posts. Room 104 below contains exposed corner posts in the same locations [*fig. 208-3 & 4*].

Figure 208-4. Room 208, looking northwest with an angled corner finish, most likely enclosing a corner post. An area of heavily damaged floor boards is near the corner.

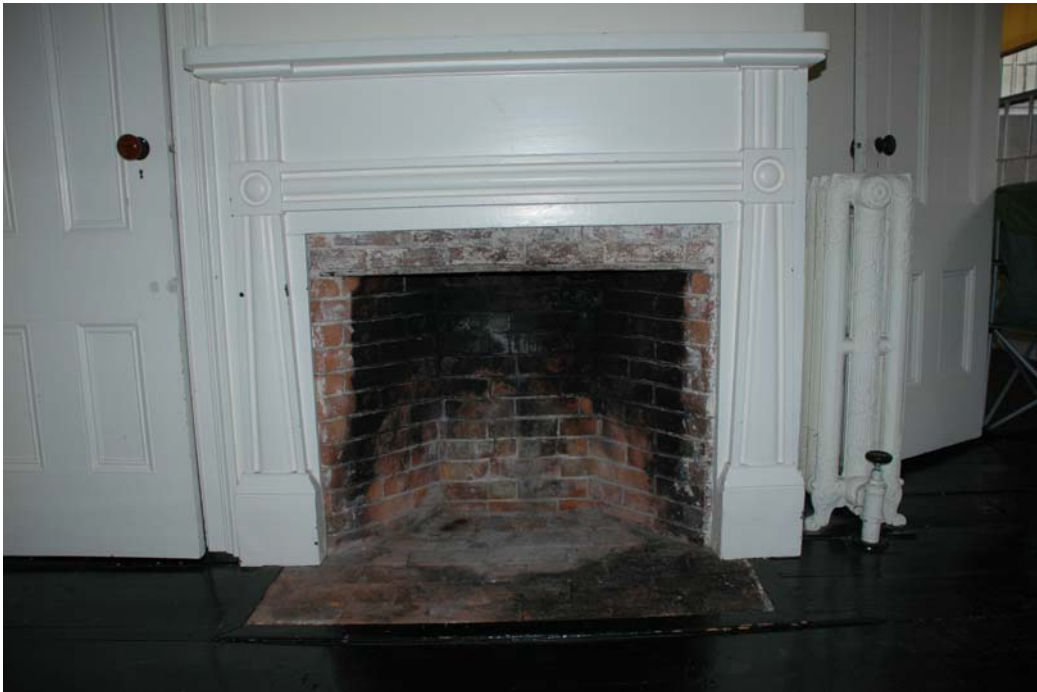
- The firebox and hearth are brick and appear to be original to the northwest wing. The firebox is stained and the brick surface has spalled. The plaster face at the firebox has been removed, as evidenced by the small amount of plaster that remains on the face.
- The decorative painted wood mantel appears to have possibly been added in the late 19th or early 20th century.

Figure 208-5. Room 208, detail of fireplace.

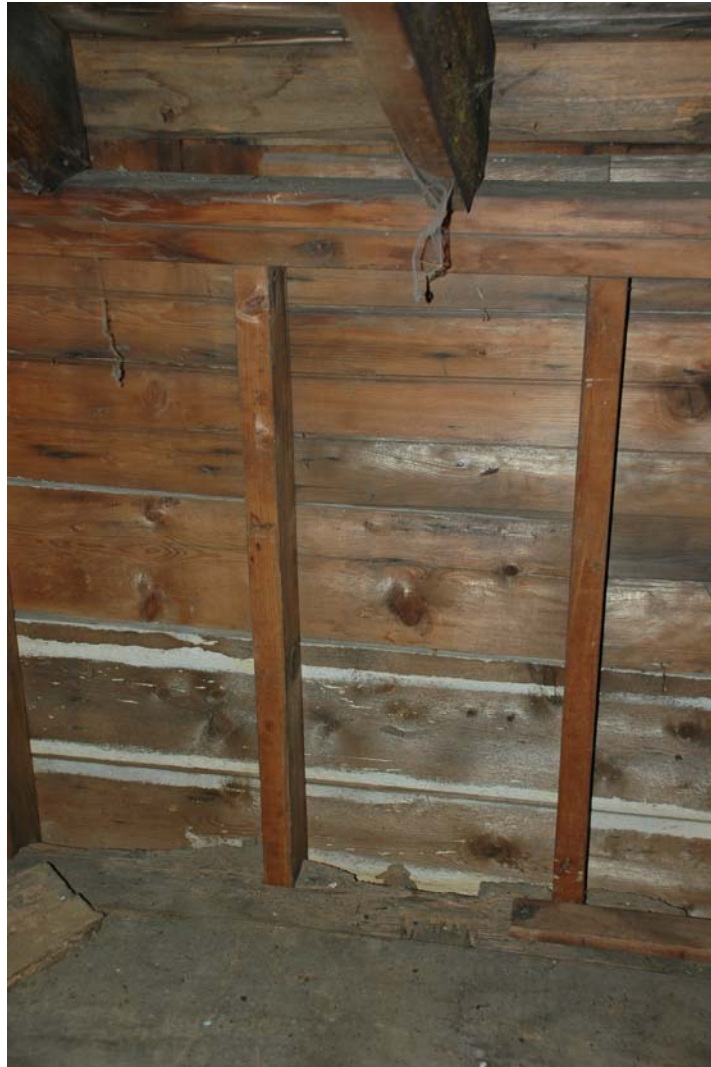
- The unfinished walls are exposed wood framing with the back side of the exterior sheathing boards visible.
- The knee wall framing is not original, as evidenced by the empty stud pockets in the sill plate. The current knee wall framing does not correspond with the pockets. This indicates that the original roof configuration was changed [fig. 209-1].

Figure 209-1. Room 209, knee wall along north wall. The wall stud members appear to have been added, as the original sill plate below has empty pockets that would have contained the original wall studs.
