MINUTE MAN NATIONAL HISTORICAL PARK
JOHN NELSON HOUSE & BARN

HISTORIC STRUCTURE ASSESSMENT REPORT

NOVEMBER 2008

PREPARED BY:
JOHN MILNER ARCHITECTS, INC.
CHADDS FORD, PA

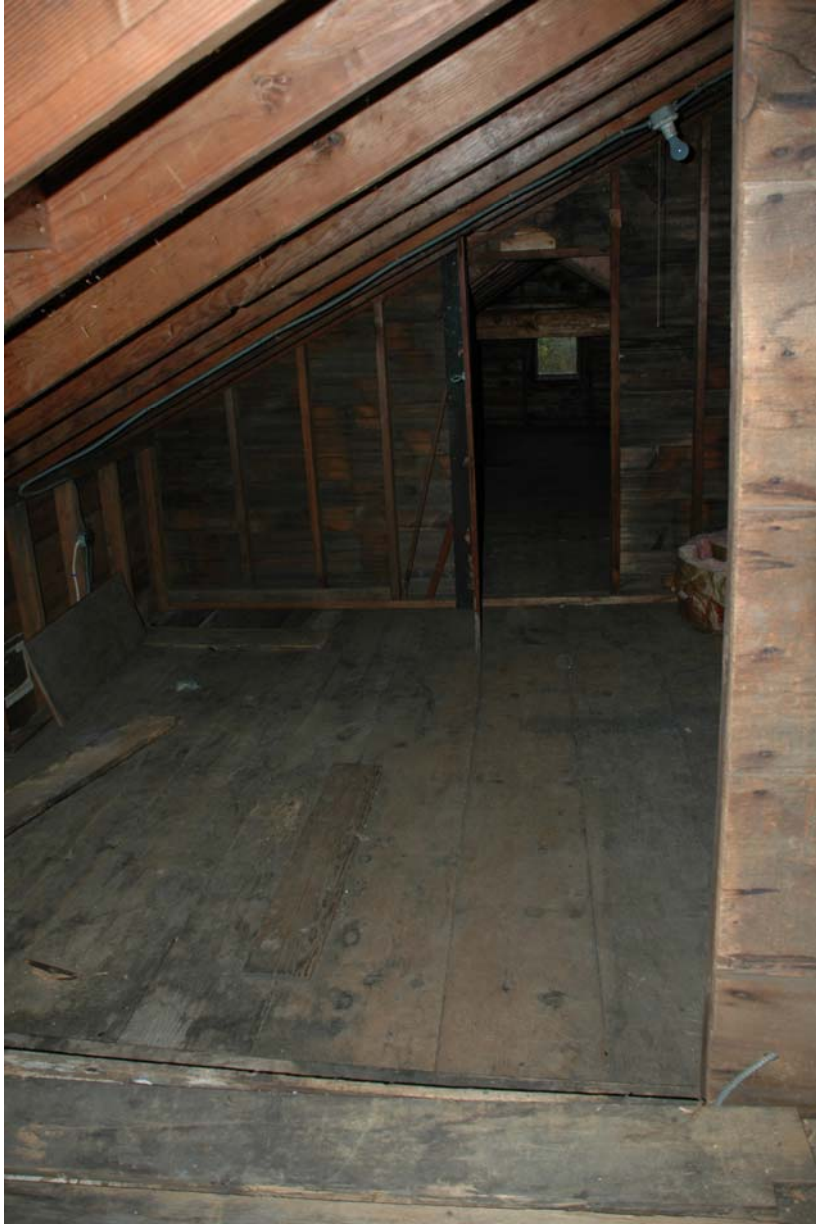
- A small section of the original 18th century west frame wall is intact, with horizontal sheathing boards, installed with wrought nails [fig. 209-4 & 5].

Figure 209-4. Room 209, looking east. The attic space is above the original 18th century block. The partition wall in the right foreground with horizontal sheathing boards and wrought nails is possibly 18th century, however further investigation is needed to determine this. The frame partition wall in the background was added later and divides the original 18th century attic space.

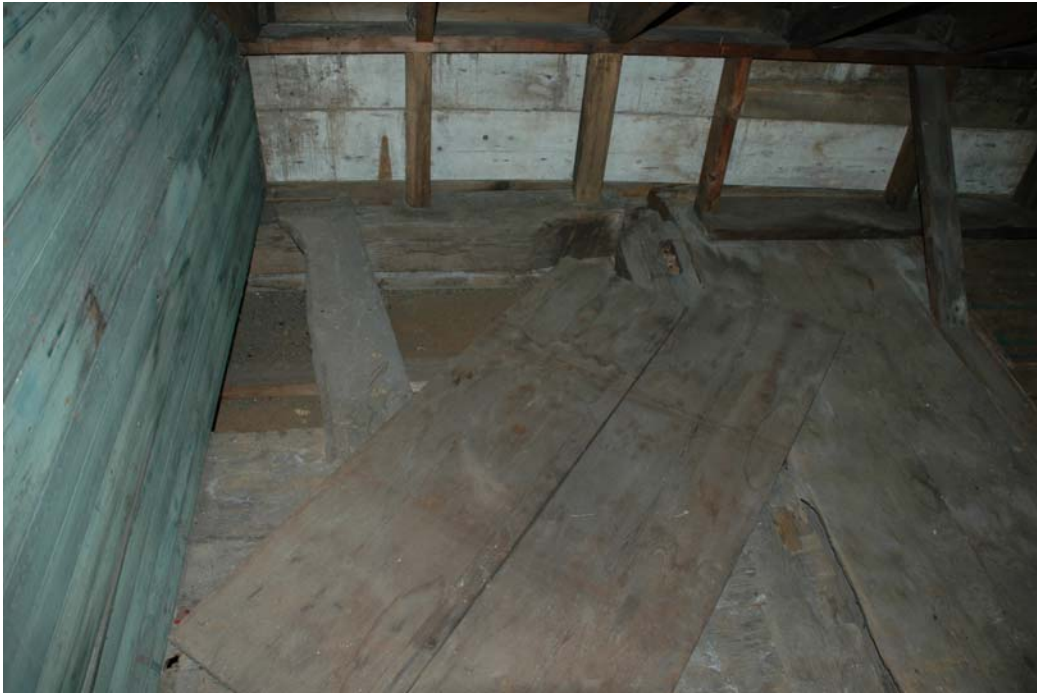
- The floorboards are wide random-width (8" - 13") plank boards, which run north-to-south. The nails in the 18th century block section are wrought while those in the northeast wing section are cut nails. There is an opening in the northwest corner of the room, directly above Room 108 where a scar is seen on the ceiling plaster surface. The opening in the floor may have been for an original staircase [fig. 210-3].

Figure 210-3. Room 210, looking north above the 18th century block. There is a board and batten door over an opening in the floor, shown moved in this image. It is possible that this opening was for a former staircase, as the opening aligns with the scars on the walls and ceilings below in Room 108.

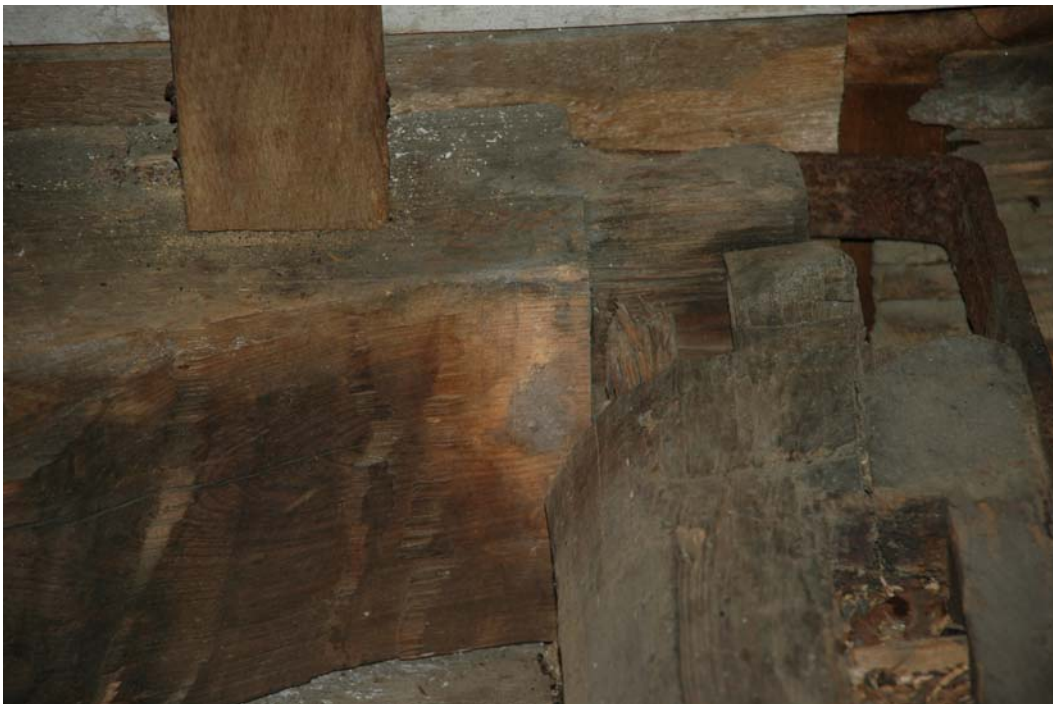
Room 210 is the unfinished attic space that contains part of the original 18th century structure and the entire northeast wing. The footprint of the original 18th century structure continues from Room 209 into the west section of this room. The northeast and southeast corner posts are missing; however, the tenons from the connecting sill plates are intact [fig. 210-4]. The sill plate along the north, east and south walls of the 18th century block contains the original stud pockets.

Figure 210-4. Room 210, showing the original tenon plates at the northeast corner of the 18th century block (the corner post is missing).

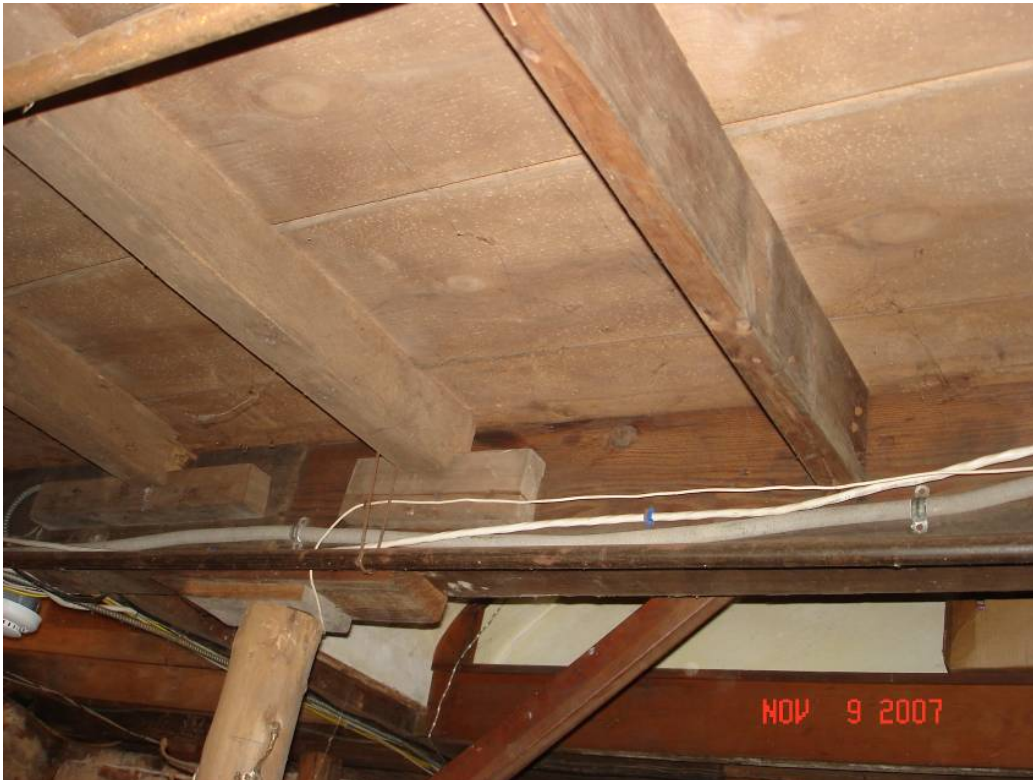
The *first floor* is framed with 3x4 wood joists set at 24" on center in some areas and 3x3 joists set at 24" centers, spanning east-west, and bearing on 8x8 beams [fig. S-1]. Several of the joists have been replaced with 2x6 (nominal) lumber and a beam set along the east side of the basement stairs has been replaced with a 6x8 (nominal) beam.

Figure S-1. Typical first floor framing.

The beams are set at variable spacing from 4'-9.5" to 6'-3" on-center, span north-south, and bear on timber sill beams. The southern ends of the interior beams have been replaced with 6x8 dimensional timbers. These horizontal lap joints are supported by 2x6 (nominal) lumber blocking set on 6-inch diameter cedar posts. The locations of these posts are shown in the sketch. Where original joists connect to the replaced beams, 2x4 (nominal) lumber blocking has been scabbed onto the beam to support the joist tenons. Much of the remaining, original beam material is in poor condition from rot and insect infestation. The poor condition of the beams and unknown extent of the deterioration makes a load rating for the first floor problematic. The engineer estimates that if the members were fully intact and in good condition the original floor structure would have safely support a uniformly distributed live load of approximately 19 PSF. However, if the rotted material is fully removed, repaired, and additional post supports installed as described below, the framing should safely support a uniformly distributed live load of approximately 50 PSF.

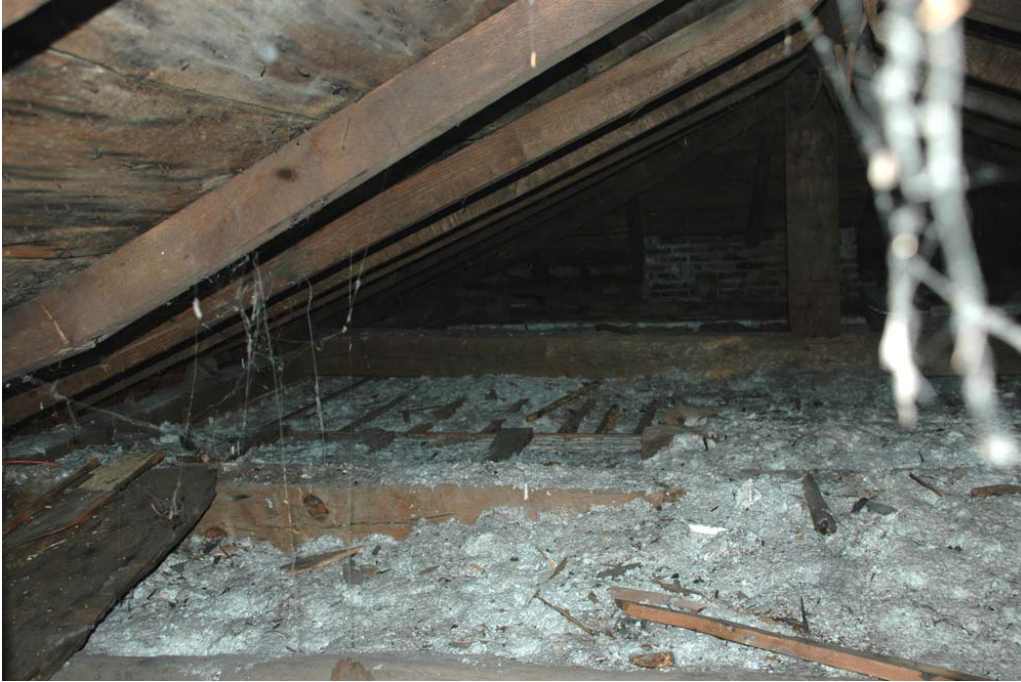
Figure S-2. King post framing in background.

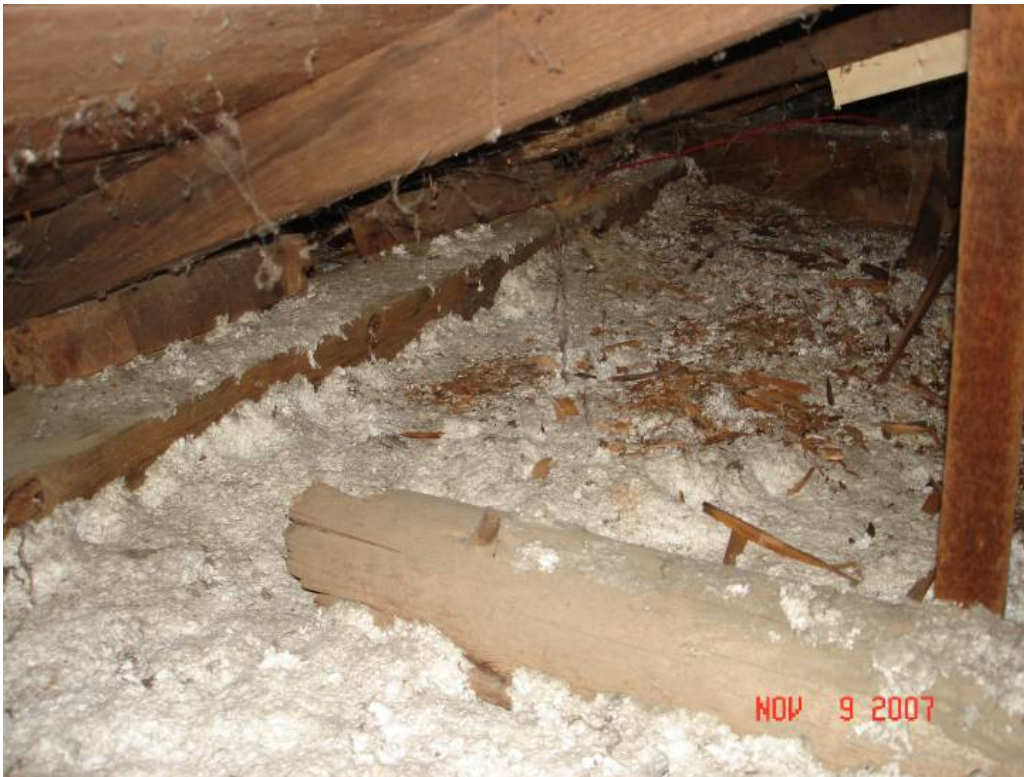
Figure S-3. Half-round joists for ceiling support.

Two half-round joists, also spanning north-south, are spaced 37" on center within each bay to support the second floor plaster ceiling and wooden lath [fig. S-3]. No connections were observed between the ends of the joists and the top plates. The only means of support for the joists appears to be single, 1-inch thick boards of variable width that are attached near each end of the half round joists and suspended from the roof rafters. Although the boards do not appear to be original, no historic connection points for the rafters were observed on the top plate faces.

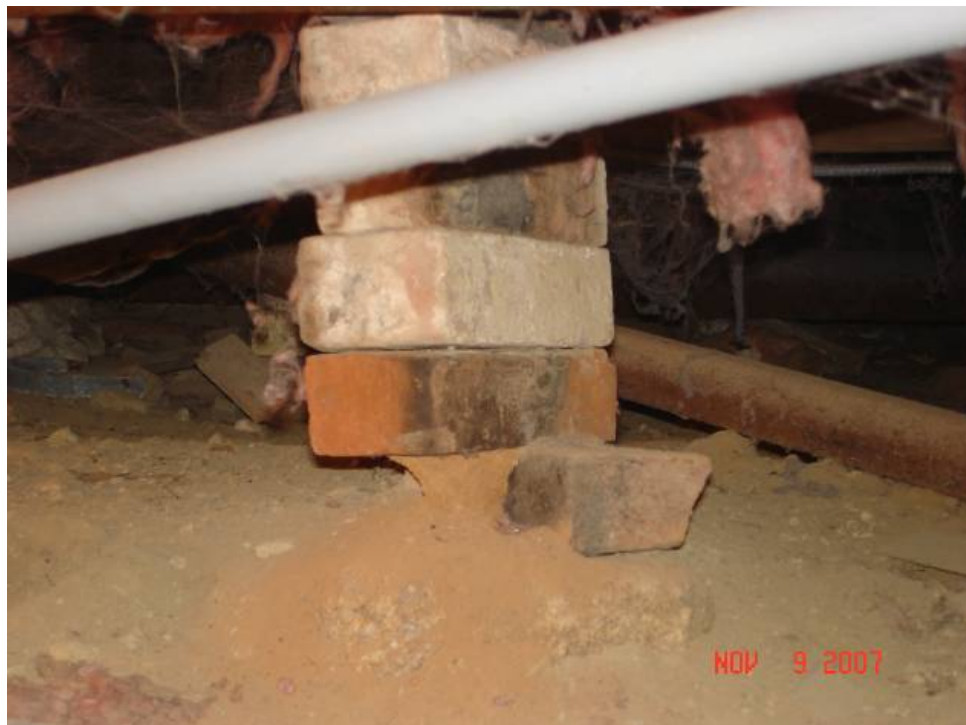
The *first floor* is framed with 3x5 wood joists set at variable centers of 18, 23, and 27 inches. The joists span east-west and bearing on 8x9 beams. The joists are connected to the beams with 3x3, bottom-shouldered tenons. The floor beams are set at 12' centers, span north-south, and bear on timber sill beams. The floor beams have been intermittently shored with various stone and brick piles and wood piers. Some of these intermittent supports have deteriorated beyond their utility [figs. S4 & S5]. The floor beam located west of the back door is in poor condition from rot and insect infestation; this beam has been double-sistered with 2x8 (nominal) lumber that bears on a stone rubble pier. The joists in this area are similarly rotted and have also been sistered with 2x4 (nominal) lumber. Assuming that the rotted material is fully removed and repaired and the existing rubble posts replaced with masonry posts, the repaired framing should support a uniformly distributed live load of approximately 40 PSF.

Figure S-4. Shoring of first floor beam.

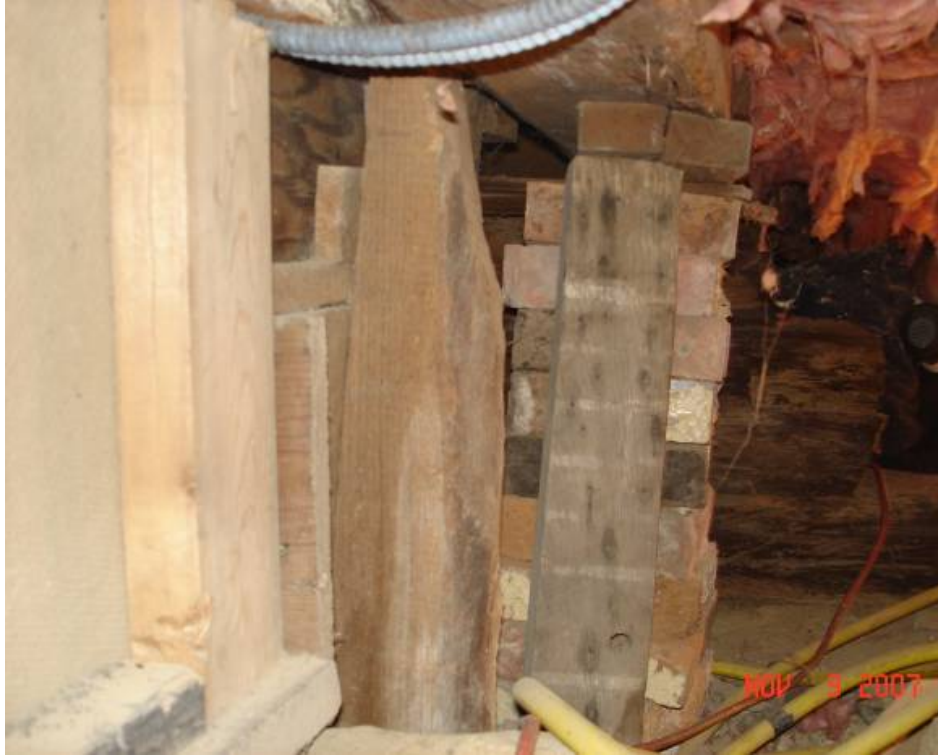
Figure S-5. Shoring of first floor beam.

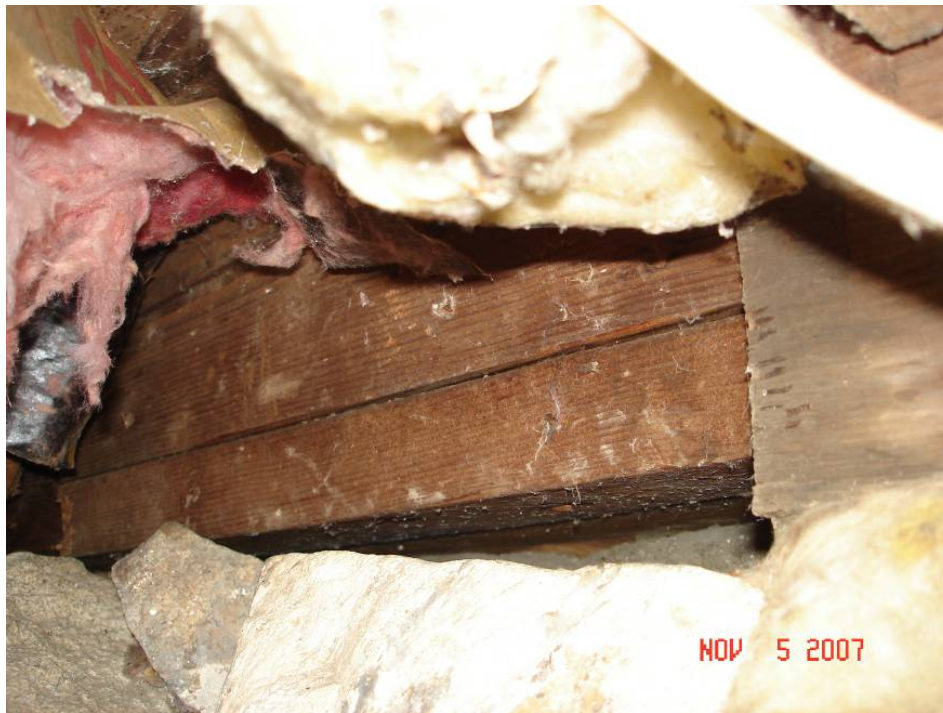
Figure S-6. Replaced section of south sill beam below door.

The sill beams rest along the top of the foundation walls. There are signs of rot at various points along the sill, primarily below the south side door and below the north-side window located east of the chimney. A section of the sill below the south door appears to have been replaced with no visible ties to the original sill [fig. S-6]. The shallow crawl space is crisscrossed with various heating, and plumbing pipes such that access could not be gained to the eastern end of the block. An exterior probing of the sill found it to be intact. However, the locations of the observed rot in the basement side may be indicative of water damage from above; further investigation is recommended.

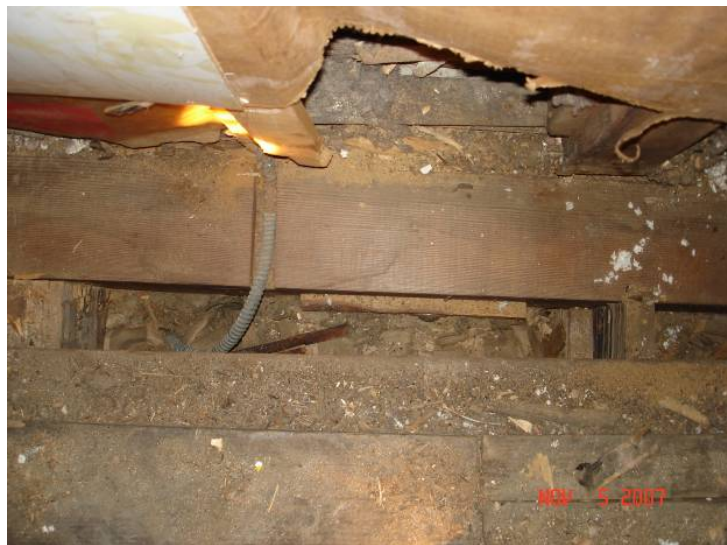
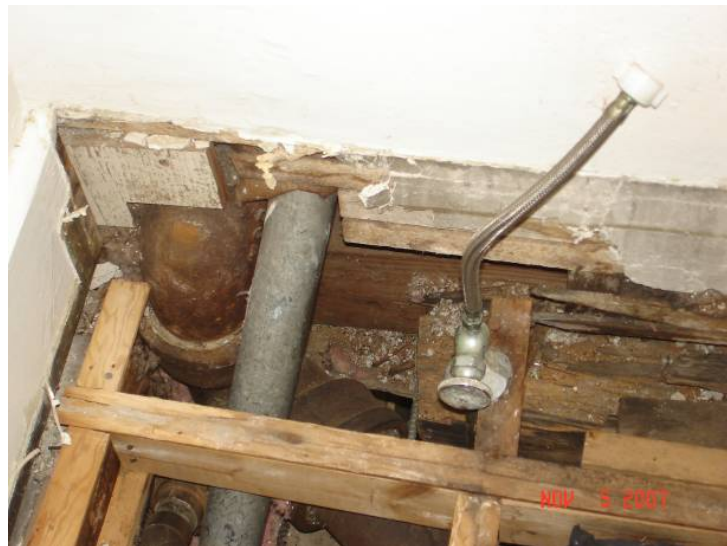
Figure S-7. Sister beam and cut beam at northeast corner.

There is evidence of extensive damage at the northeast corner of this block. The floor of the second-floor bathroom has been extensively shimmed to compensate for significant settlement at the post. The eastern-most, second-floor beam was cut straight through and sistered with a 4x6 (nominal) timber bolted to the east side to make room for a cast iron plumbing vent stack [fig. S-7]. The northern end of the sister beam is enclosed with sheathing and other wall materials, therefore, the engineer could not determine how this sister beam is supported on its northern end. The beam did not exhibit active movement, appeared to be stable, and not in imminent danger of collapse. However, a definitive determination cannot be made without removal of the historic fabric.

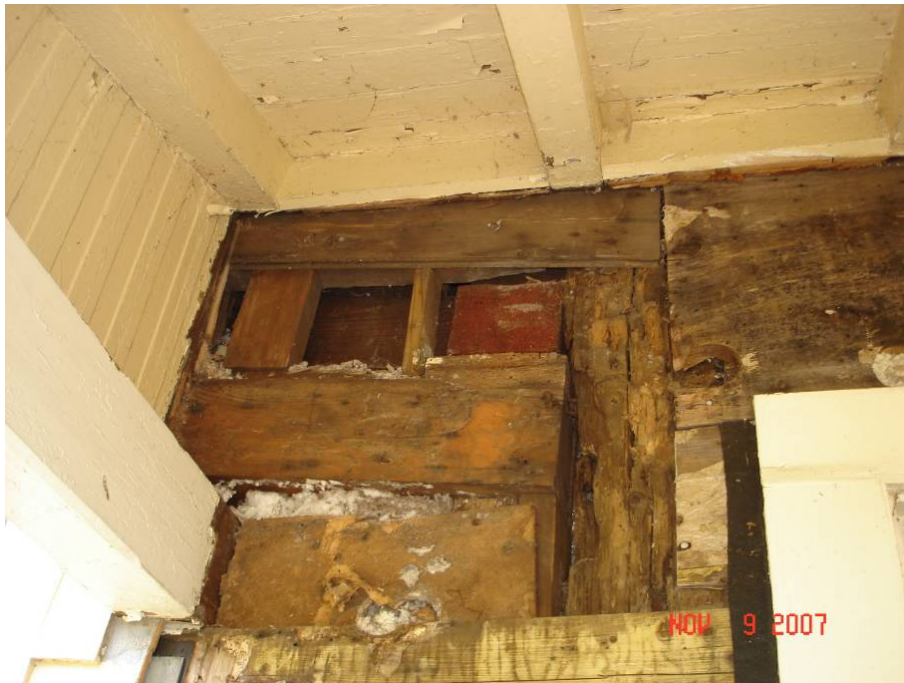
Some of the exterior sheathing had been removed at this post by park staff and the post appears severely deteriorated from water and insect damage [fig. S-8]. Probing under the sheathing at the base of the post did not provide any evidence of either an intact sill or other means of support for the post at this location. Variations in the alignment of the shingle siding and the roof soffit provide circumstantial evidence that there has been significant settlement of the post. Such settlement would appear to explain the significant pitch in the second floor bathroom and hallway. A structural engineering assessment performed by B. B. Diwadkar, P.E. of the National Park Service questions the integrity of the structure and recommends further investigation. The structural engineer for this report agrees with Mr. Diwadkar that the floor in this area should be considered unsafe for any use.

Figure S-8. Deteriorated post with exposed end of sister beam located to the left.

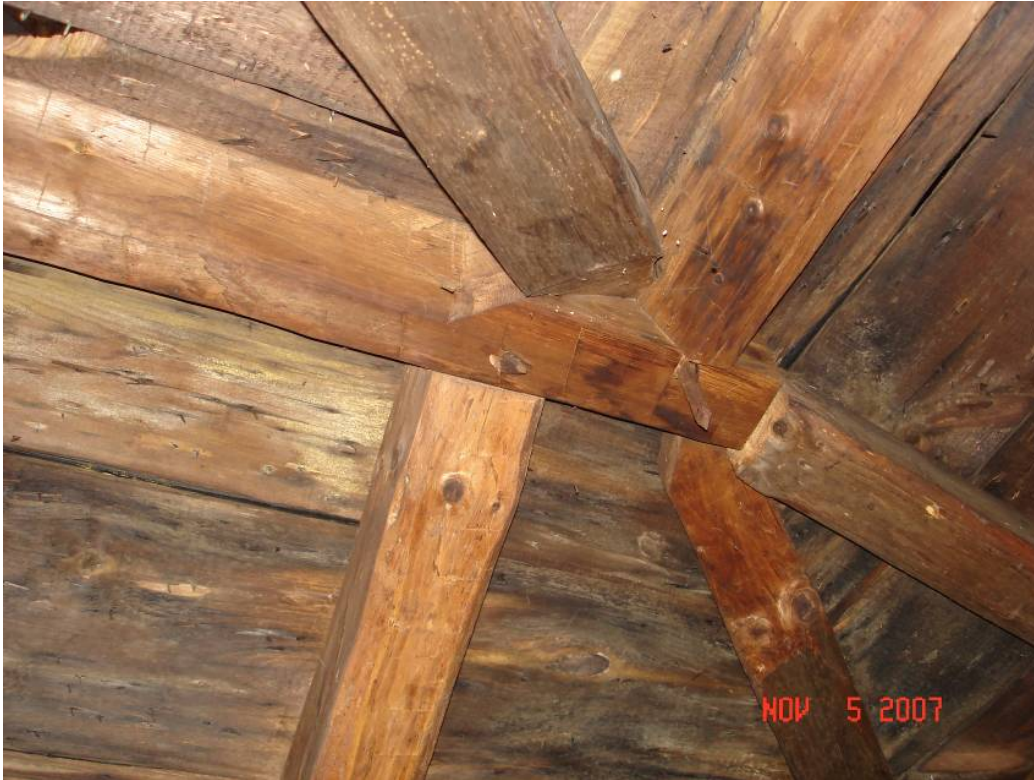
The hipped *roof* framing appears to be in good condition with a five-sided, east-west ridge beam is supported by principal and common rafters that bear on the posts and top plates of both the north and south walls [fig. S-10]. The side faces of the ridge beam have been taper-cut perpendicular to the rafters.

Figure S-10. Hipped roof framing.

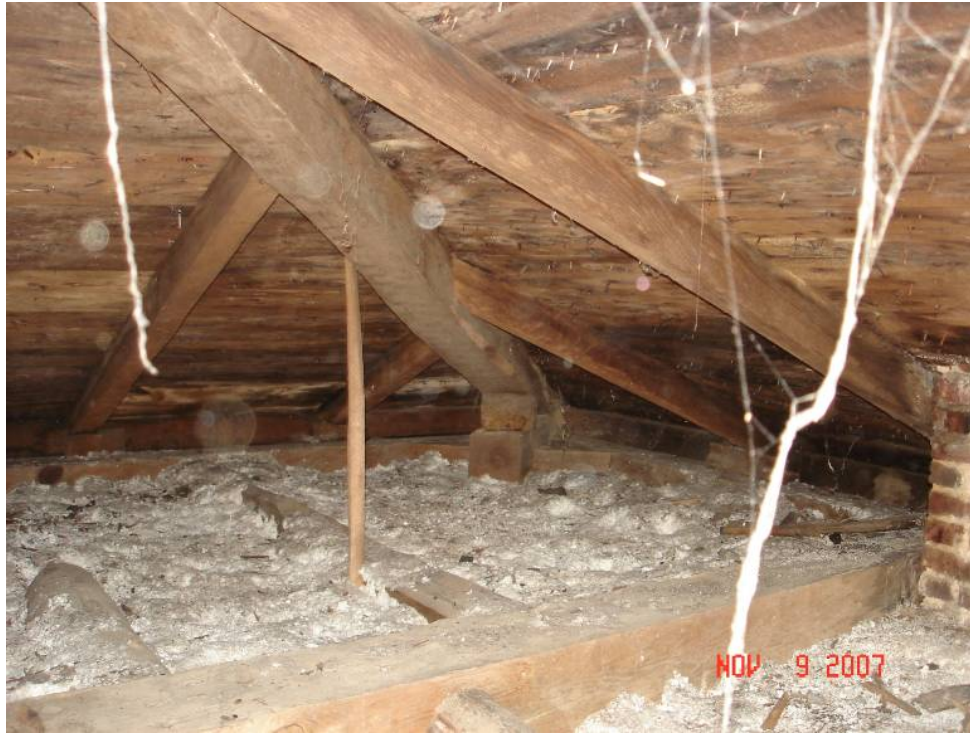
All roof structural members are connected with pegged, mortise and tenon joints. 6x6 principal rafters, spanning north-south, are located at bents two through five. Additional principal rafters, oriented east-west, span from the mid-spans of the tie beams of bents one and six to the ridge beam at bents two and five, respectively. 6x6 hip rafters span diagonally from the ridge beam to the principal posts of bents one and six. The corner end of each hip rafter bears on a 6x4 hammer beam aligned with the hip rafter. The hammer beam is supported by the principal post and a 4x4 horizontal, diagonal brace; this brace bears on the intersecting tie beam and top plate at each corner [fig. S-11].

Figure S-11. Hip rafter connection to hammer beam support.

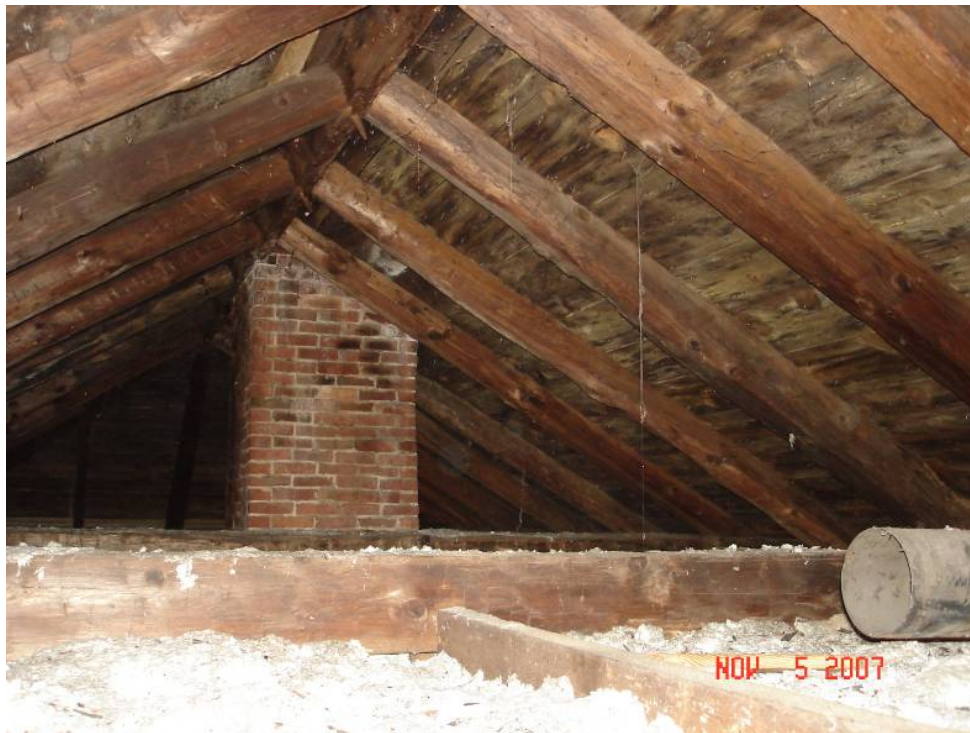
Figure S-12. Typical roof framing.

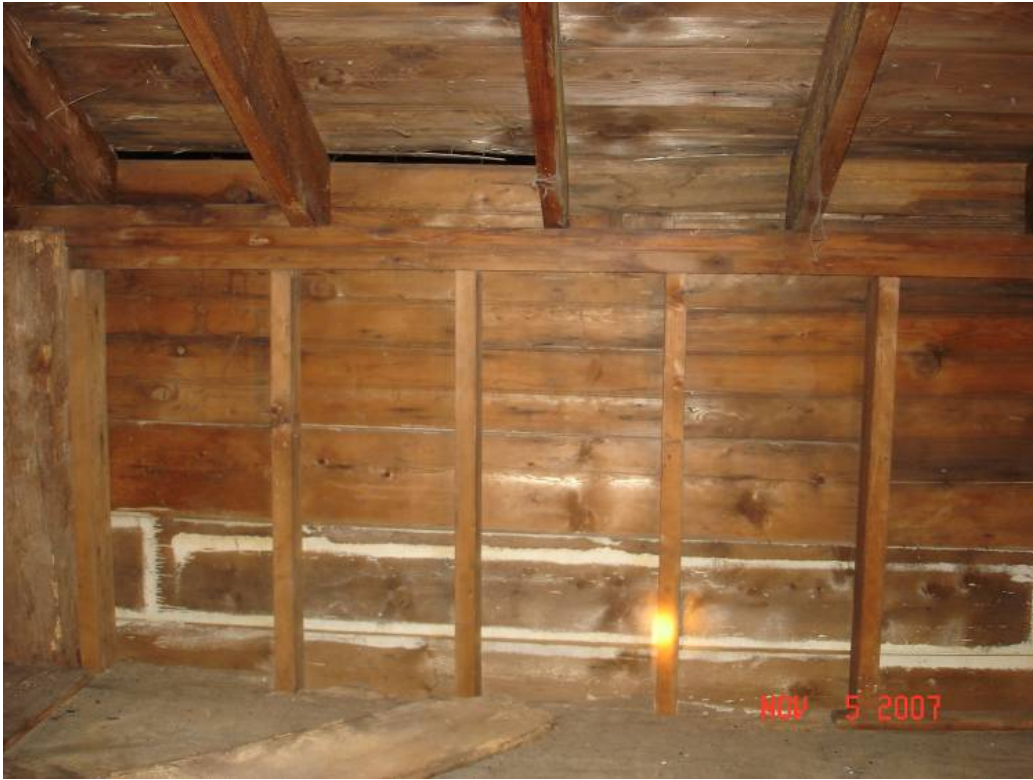
The roof rafters have been replaced with 2x8 (nominal) lumber set 19" and 24" on-center in the eastern and western portions, respectively. The rafters span north-south and bear on a double top plate constructed of 2x4 (nominal) lumber on the north side. The top plate bears on 2x4 (nominal) wall studs set approximately 16" on-center [fig. S-13]. However, additional framing details cannot be confirmed since the wall studs are not accessible at the first floor level. The southern end of the rafters bear on the top plate of the main block southern wall.

Figure S-13. Framing at north wall of the original 18th century block.

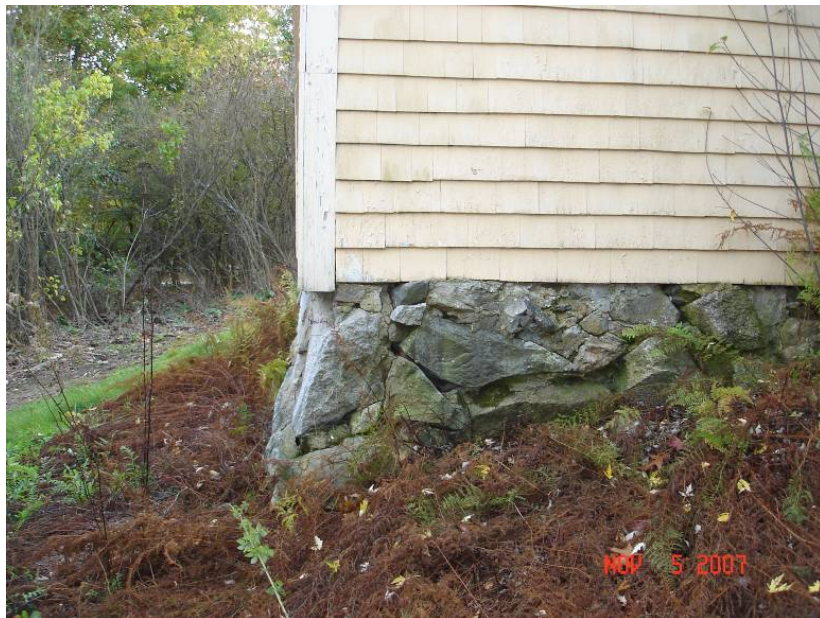
The northeast wing of the house is a braced-frame, post and beam structure that measures 23'-0" east-west by 14'-6" north-south. The first floor consists of a storage room and a garage. The second floor attic may have been used for storage. The crawl space below the storage room was inaccessible. From the exterior, the foundation appears to be dressed granite blocks on the south and east sides with uncoursed, mortared stone on the north side. The granite blocks at the northeast corner appear to have settled inward towards the rubble wall [fig. S-14]. Although this condition causes the sill and structure to project unsupported, a few inches from the foundation, the structure appears to be in good condition and does not appear to be in danger of collapse.

Figure S-14. Foundation at northeast corner.

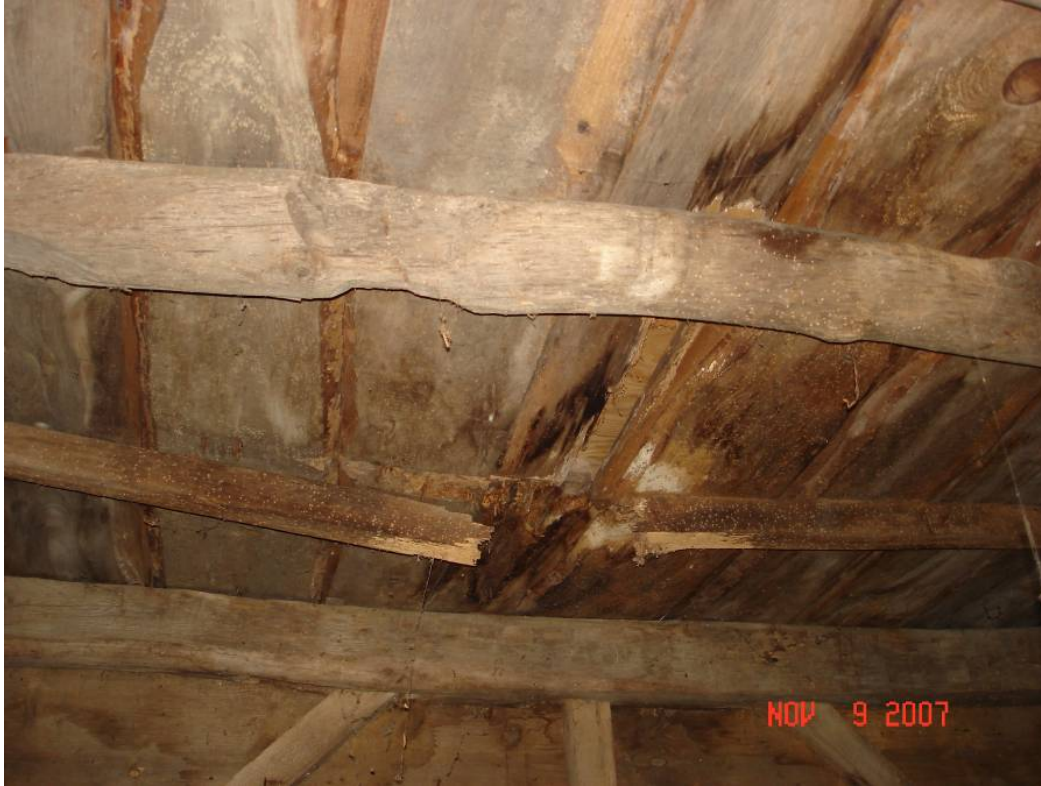
The attic floor joists are unfinished, rounded logs of variable diameter that span north-south. The second floor is supported by round joists of variable diameters set on approximately 30" centers and span 8'-2" and 10'-5" in the western and eastern portions, respectively. A broken joist in the northeast corner should be replaced. The joists tie into the floor beams that span east-west along the southern and northern exterior walls. The south wall shows evidence of movement in the frame with tenon pull-out in the southern, second-floor tie-beam [fig. S-15].

Figure S-16. Second floor joists.

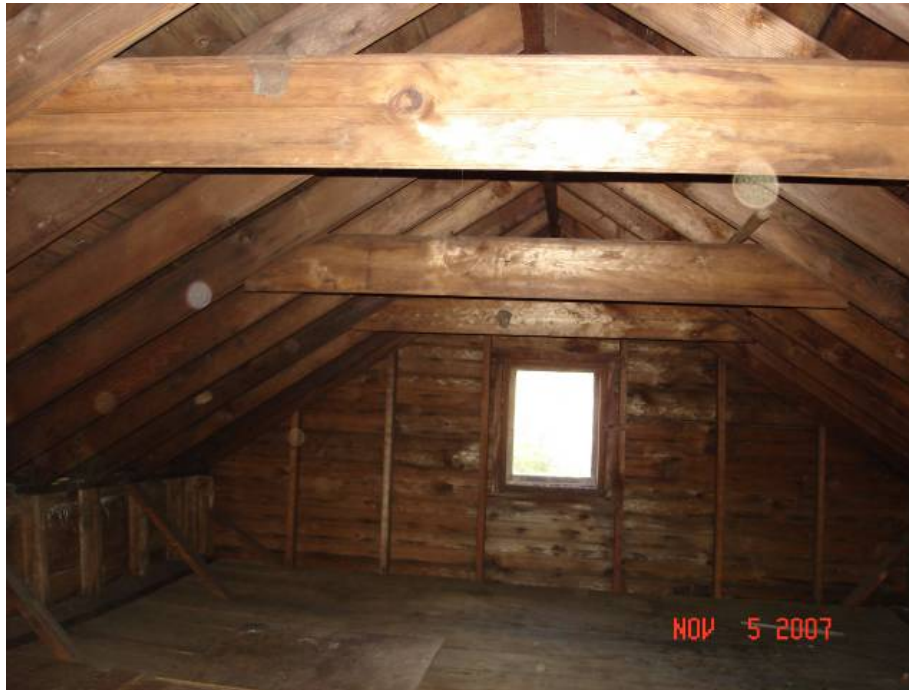
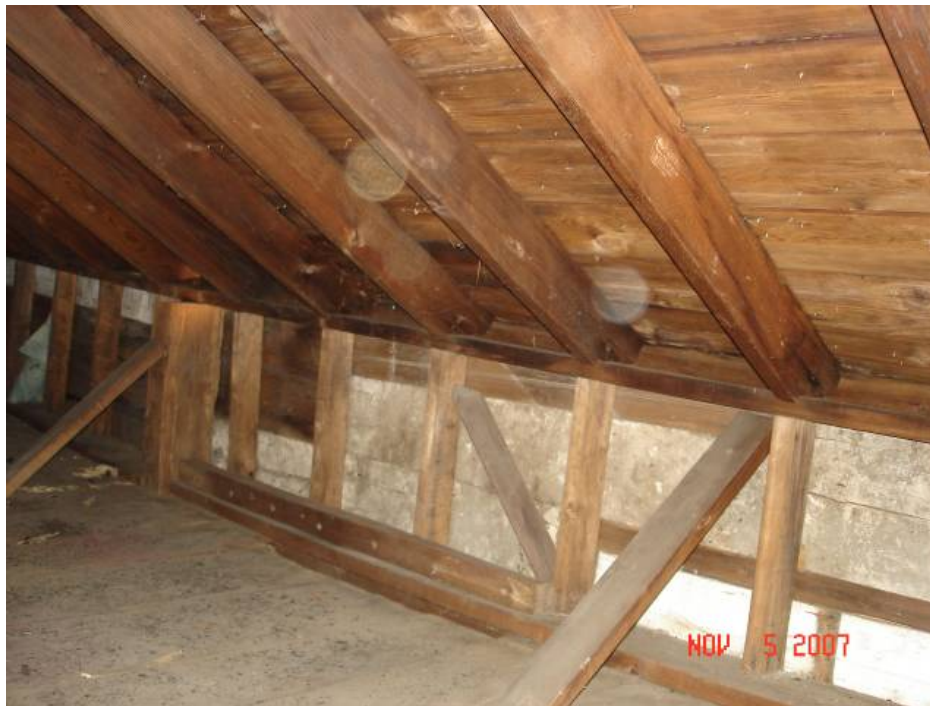
The roof structure was replaced in the 1930's with dimensional 2x6 (nominal) rafters set 20" on-center. There are 1x7 wood collar ties installed at every third rafter. The rafter ends bear on a single 2x4 (nominal) top plate that is supported by 2x4 (nominal) wall studs set 20" on-center. The studs bear on a 2x4 (nominal) base plate that bears on the original timber top plate. Although this connection is unconventional, the structure does not show signs of failure at this point.

Figures S-17 & 18. Roof framing in the northeast wing.

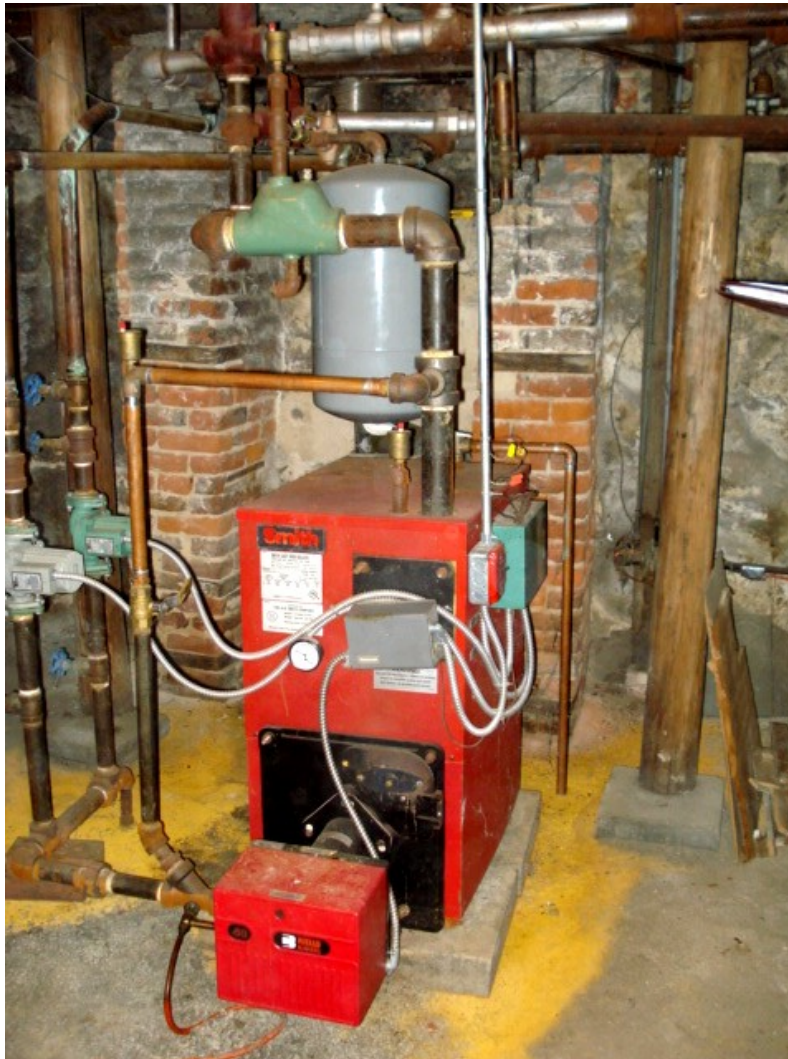
The primary heating boiler supports terminal hot water heating equipment that includes cast iron convectors and fin-tube baseboard mounted radiation. The boiler is an H.B. Smith Company Series 8 model, cast-iron sectional style device rated for 169 MBH. The boiler is fitted with a forced-draft oil burner, fed with 120V, single-phase, electrical service [fig. H-1].

Figure H-1. Hot water boiler.

The heating boiler was installed in the last 10 years and is in good condition. The latest boiler service was conducted on the 19th of February, 2008. During the service, the boiler fuel supply train was cleaned, and burner settings tuned. Preliminary load estimates for the building indicate the boiler has adequate capacity to provide heating hot water for the building.

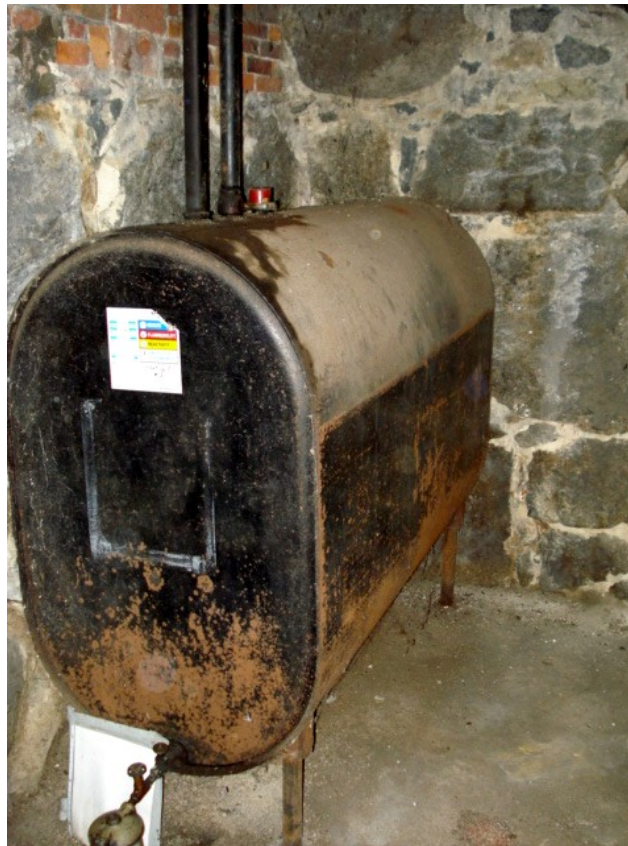
Heating fuel for the boiler is stored in a horizontal steel tank located in the basement. The tank holds approximately 275 gallons and is in marginal condition with signs of corrosion at the seams and connection points [fig. H-2].

Figure H-2. Heating Oil Tank.

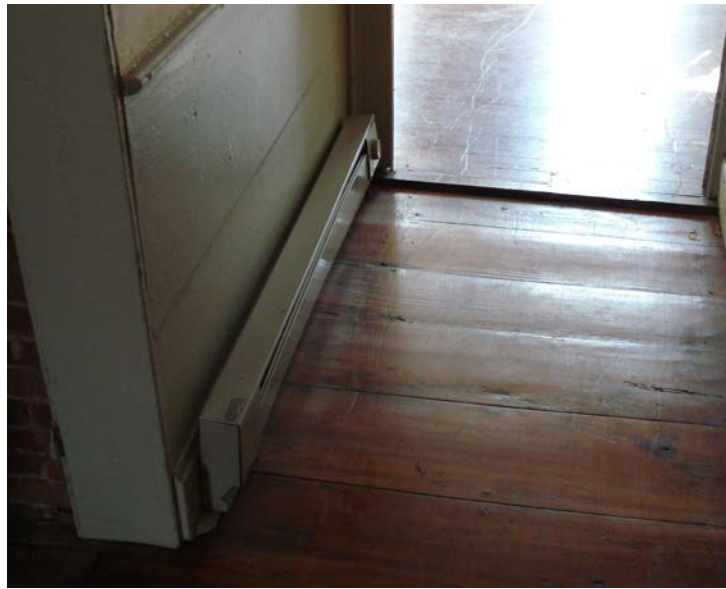
A single piece of electric baseboard heating is also installed in a small corridor area of the room adjacent to the kitchen (on the east side) [fig. H-3]. This baseboard unit is in marginal physical condition (bent enclosure) but is operable.

Figure H-3. Electric Baseboard.

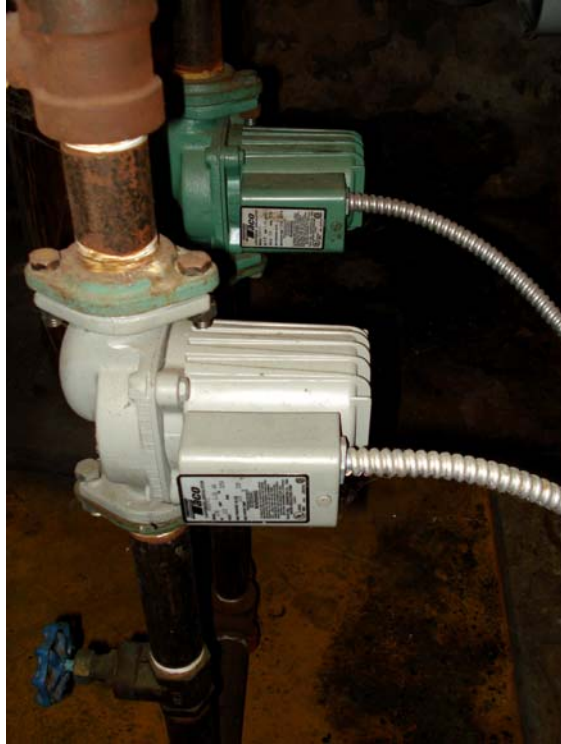
The building hydronic distribution systems consist of two hot water heating loops providing hot water from the boiler and pumped to cast iron radiators [fig. H-4]. The pumps are identical Taco Company in-line centrifugal circulators; both are in good condition. The two hydronic loops are controlled via independent, wall mounted electronic thermostats. Zoning is split between the east and west sides of the building (both floors).

Figure H-4. Hydronic circulator pumps.

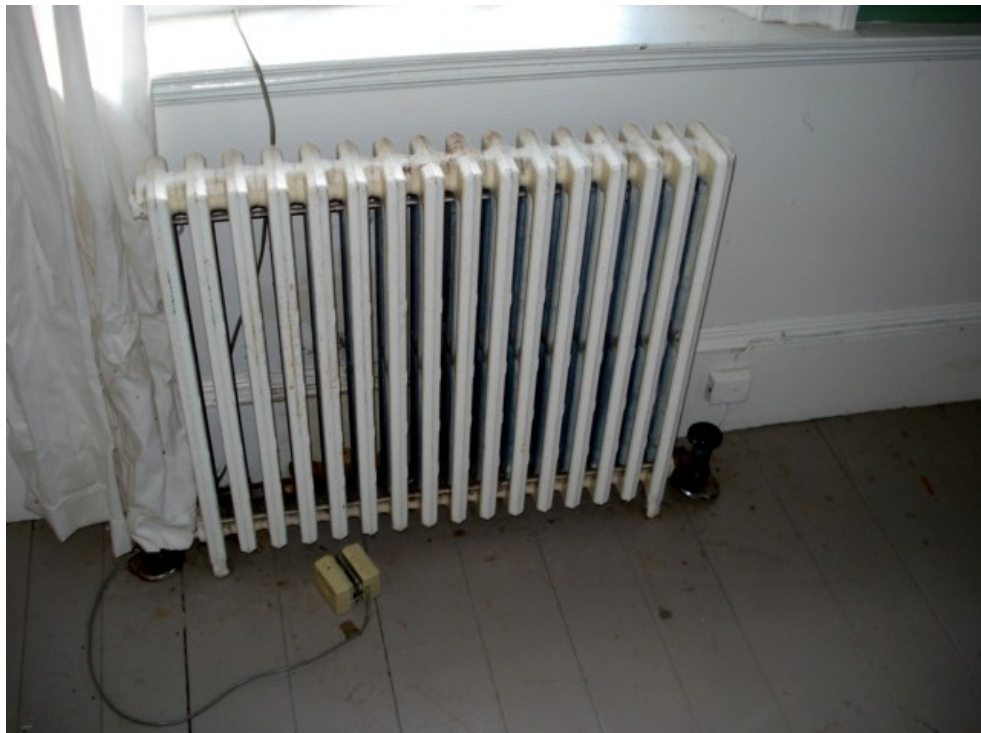
The overall physical condition of the hydronic systems above is fair to poor. The original building heating system appears to have been fireplaces, replaced with a steam system, and subsequently replaced with hydronic heating equipment. When converted to hot water service, several of the existing heating pipes were reused in many places (particularly the risers). The physical condition of the piping, particularly in the basement, is in poor condition. There are multiple areas exhibiting signs of corrosion and deterioration. The terminal heating equipment (radiators) are in marginal condition [fig. H-5]. Isolation valves, air vents, and enclosures are in many cases inoperable, and/or damaged.

Figure H-5. Typical cast iron radiator.

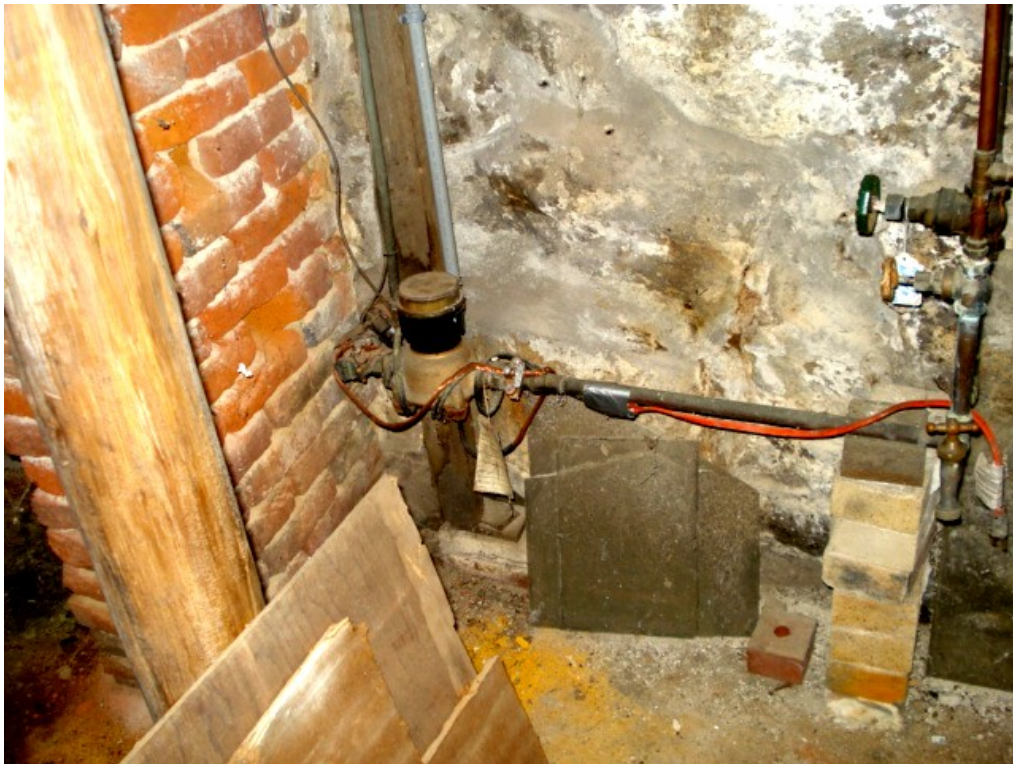
The water service is in fair physical condition with minor corrosion around the basement level fittings. The water supply is adequate for support of the existing plumbing fixtures throughout the facility.

Figure P-1. Domestic water service

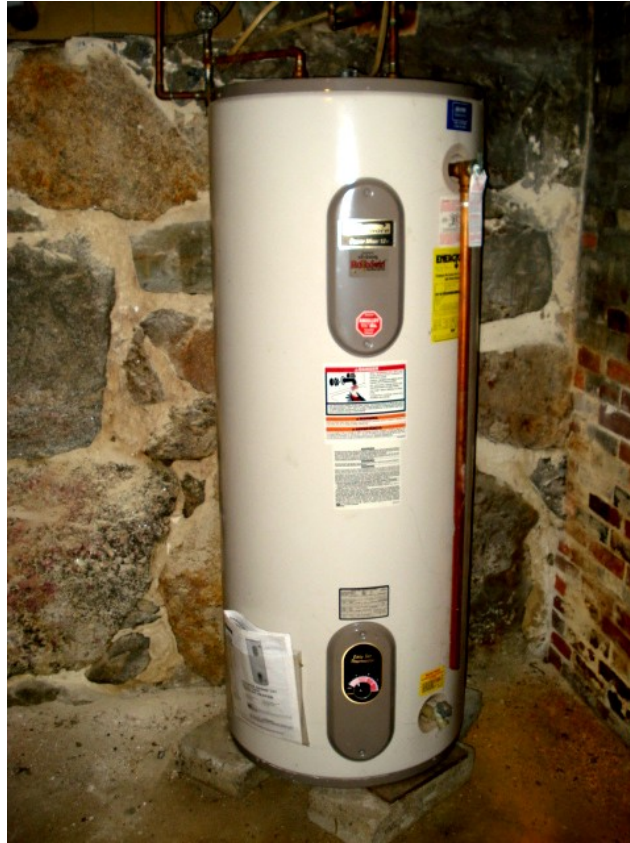
Plumbing systems consist of cold and hot water piped throughout the building. The system serves sinks, lavatories, showers, a washing machine connection, and exterior hose bibbs. Hot water is generated by a 66 gallon electric water heater located in the basement. The heater is in good physical condition [fig. P-2]. Domestic water supply piping is primary copper material, un-insulated, and in fair condition [fig. P-1].

Figure P-2. Domestic Hot Water Heater
