MINUTE MAN NATIONAL HISTORICAL PARK
JOHN NELSON HOUSE & BARN

HISTORIC STRUCTURE ASSESSMENT REPORT

NOVEMBER 2008

PREPARED BY:
JOHN MILNER ARCHITECTS, INC.
CHADDS FORD, PA

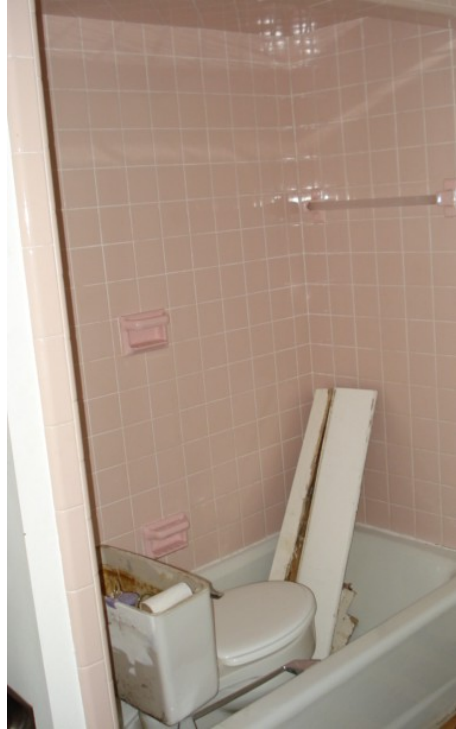
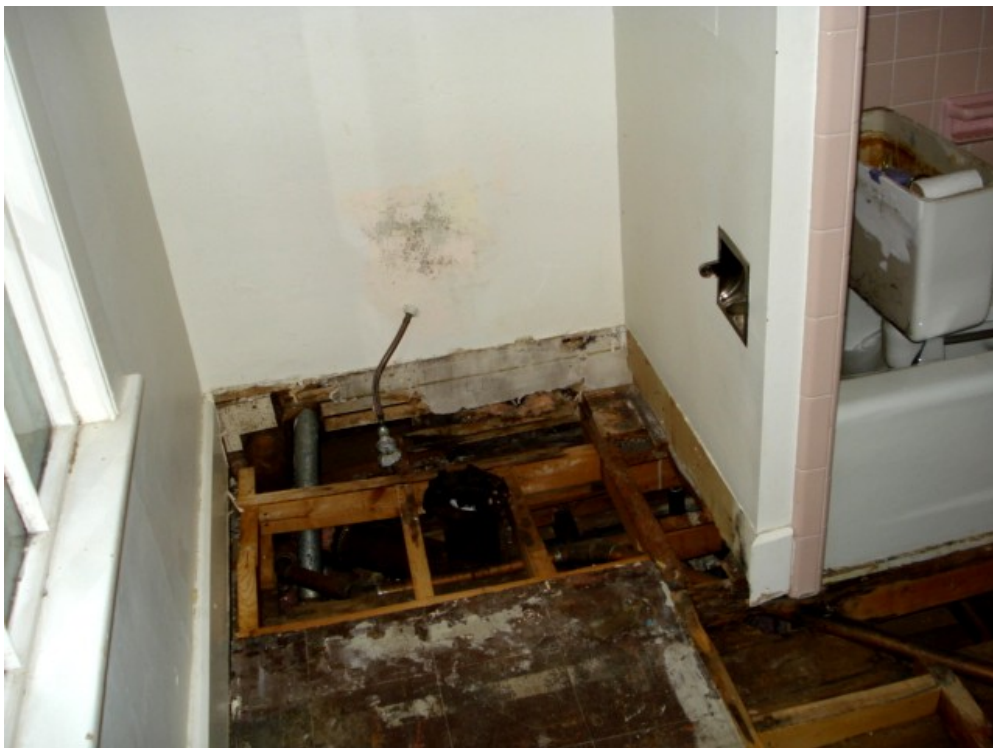
Figure P-3 & 4. Upper Level Plumbing Fixtures.

Floor mounted, tank type water closets, and wall or counter-mounted lavatories are the standard configuration for the bathrooms. There is a single half-bath on the first floor and a single full-bath on the upper level. The upper level tub/shower assembly is a built-up style with tile walls [fig. P-3 & 4]. The kitchen sink is stainless style with single handle faucet. The lower level plumbing fixtures (kitchen and half-bath) are in fair condition; the tailpiece on the lavatory has some corrosion [fig. P-5]. The upper level bathroom fixtures are in poor condition; the water closet is currently not installed due to some plumbing repairs made at the fixture connections.

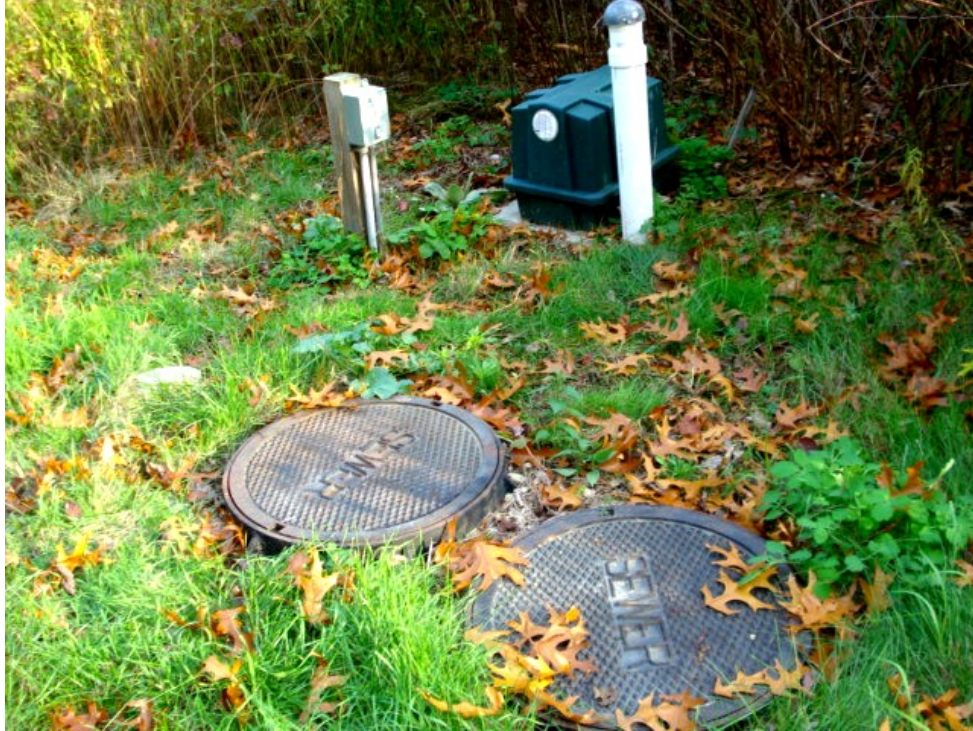
Figure P-6. Sewage Lift Station

The building has gravity sanitary services within that exit the building to a site lift station [fig. P-6]. The lift station is provided with duplex pumping, controlled by an electronic pump control package located in the basement. System venting is connected to all fixture drains and exits the roof at several locations. Sanitary and vent piping is a combination of cast iron with PVC repair in some locations.

At the time of inspection system leak at the upper level water closet was under repair. With respect to physical condition the piping system varies; some sections in the basement exhibit significant corrosion.

Internal piping condition and the physical and operational condition of the sewage lift station were not observable at the time of inspection. It is recommended the piping and lift station be internally evaluated as well.

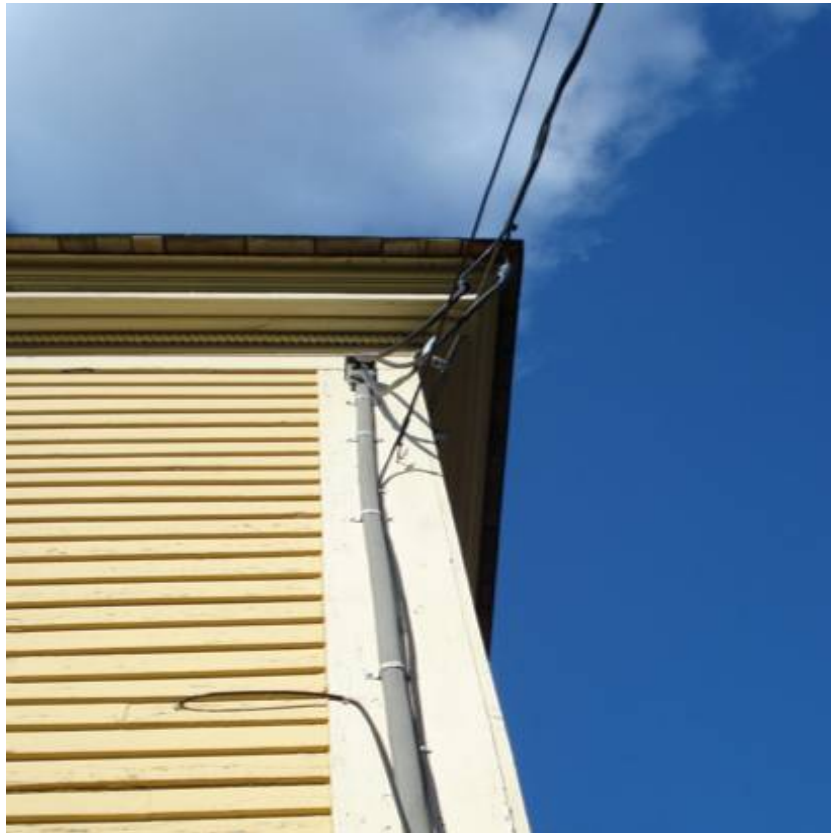
Figure E-1. Main incoming service feeder.

The existing 200Amp service lateral is adequate for the present residential type use. The conductors appear to be in good condition and are sized by the utility company for a 200Amp service. The conductors from the load side of the meter #3/0, which is appropriate for a 200Amp service.

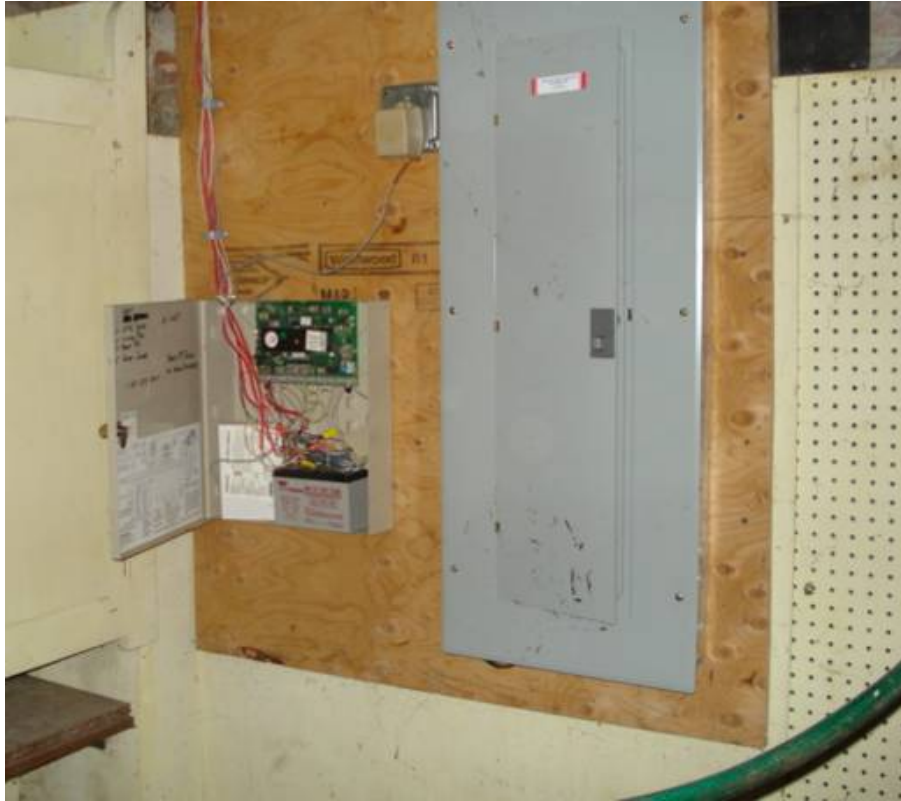
Figure E-3. Main panelboard.

- Main circuit breaker: 200A, 4-pole circuit breaker. The incoming phase conductors land on two poles each. This arrangement effectively creates a condition where each phase leg is connected to two circuit breakers in parallel. There is no technical reason for this type of circuit breaker.
- The panel contains (40) branch circuit breakers with a mix of 15A and 20A single pole breakers in addition to (1) 20A-2P, (2) 30A-2P and (1) 50A-2P.
- The 20A-2P circuit breaker feeds the barn.

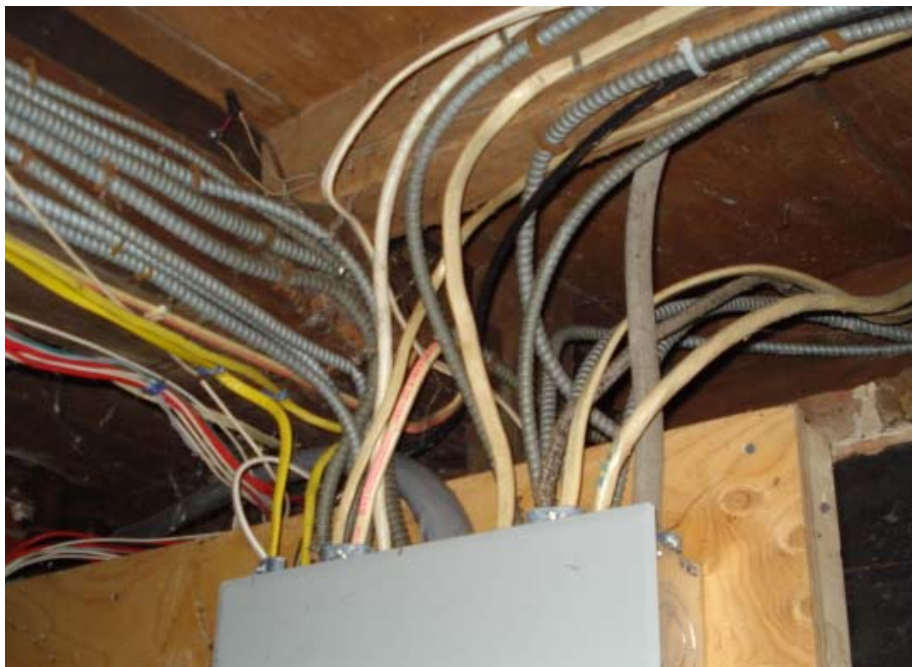
Figure E-4. Typical wiring methods.

Branch circuiting for both structures is distributed throughout the buildings using a multitude of wiring methods, i.e. cloth sheathed, metal sheathed (type AC), and non-metallic sheathed cable (romex) wiring. The wire sizes used for the branch circuits consist of #14, #12, #10 & #8 based on the circuit breaker to which the conductors are attached.

In summary, the existing electrical distribution system is the result of many years of additions, modifications and re-configurations. The level of quality runs the gamut of home-owner level to professional electrician. From a safety perspective, it would be very difficult to trace the wiring in case of a failure. As a whole, the system has reached the end of useful life. The lack of grounding, ground fault protective devices and arc-fault protective devices is a major safety issue. The site personnel were not aware of any problems with the system. The 200Amp, 4-pole main circuit breaker is a serious safety concern and should be replaced whether or not any renovation takes place.

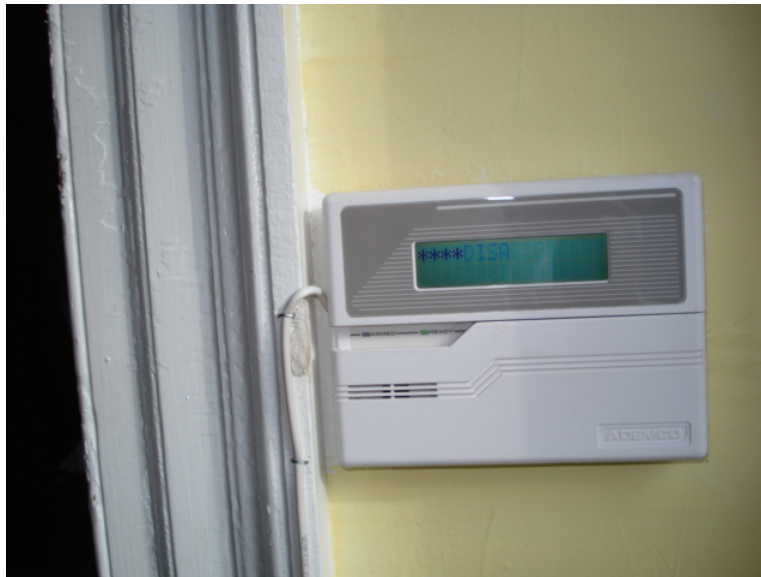
Figure E-5. Security key pad.

The security system appears to be functional and in fair condition.

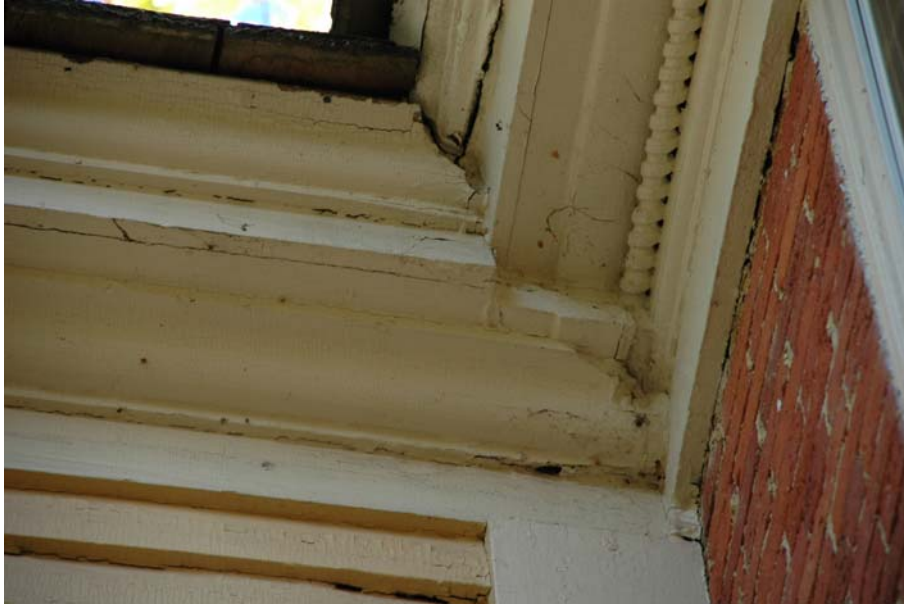
The eave cornice at the northwest wing is a much more simplified profile than the main block, with ogees at the cornice and the bed molding [fig. 1.3A-11]. The ninety-degree intersection between the northwest corner of the main block and the south elevation of the northwest wing is awkward [fig. 1.3A-12]. The two cornices do not align and it appears that the northwest wing cornice was installed around the existing main block cornice.

Figure 1.3A-12. Awkward intersection between roof eave cornices, northwest wing on the left and main block on the right.

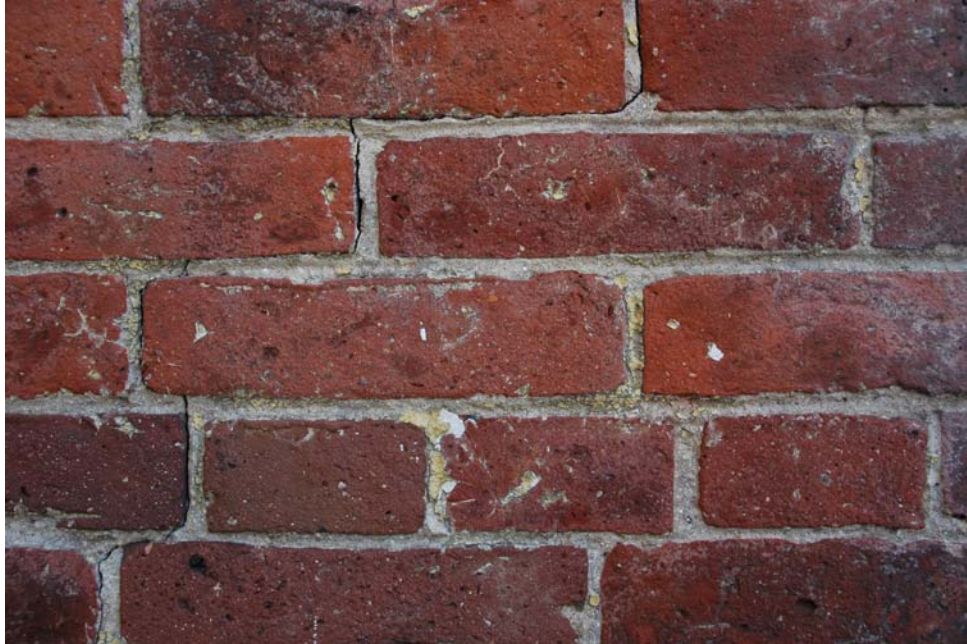
Figure 1.3A-17. Detail of one of the John Nelson House brick end walls, with remains of the painted surface in the mortar and brick crevices.

A close inspection of the end wall surfaces revealed remains of paint in the mortar and brick crevices. Microscopic analysis of the paint samples was performed, and it was revealed that there are approximately nine layers of paint. The time period when the brick surface was painted is unknown. The end walls appear to be painted in an undated photograph that is most likely from the late-nineteenth to early-twentieth century (the estimated age of the photograph is based upon a comparison of the historic and current size of the sugar maple in front of the house.) [fig. 1.0A-1]. All other photographs observed, from the mid-to-late twentieth century mostly, show the end walls as exposed brick. It is also unknown if the brick end walls were originally painted, or if the paint was added later. Further investigation is needed in order to determine the date and composition of the painted layers [fig. 1.3A-8].

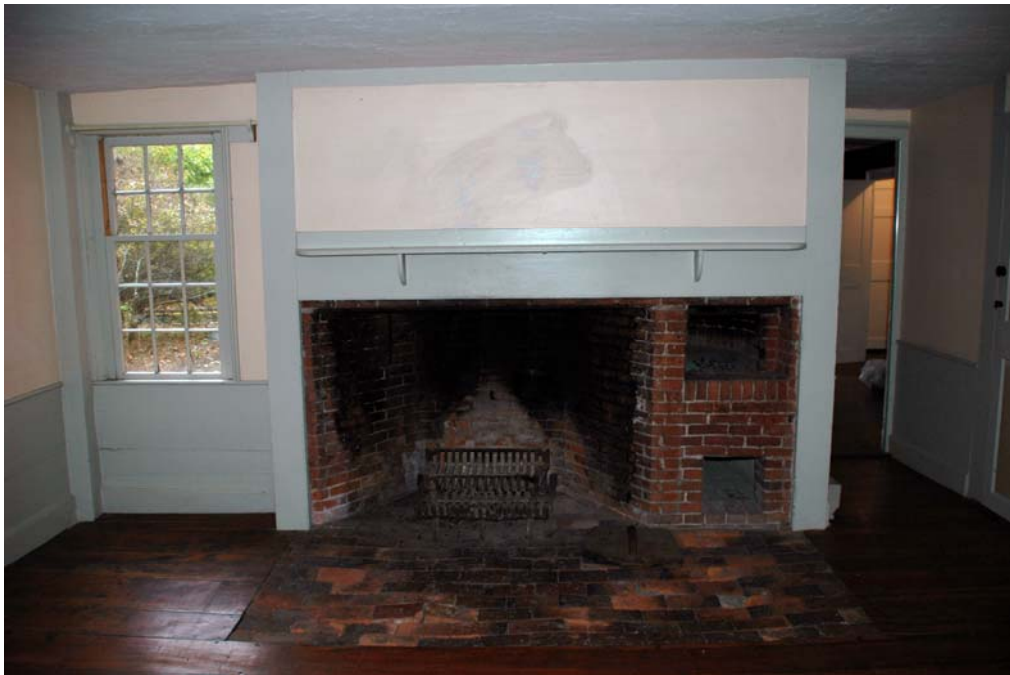
Room 108:

The original 18th century fireplace with bake oven is found intact. The wood and plaster surround appears to be added later, as evidenced by the presence of cut nails in the wood trim installation. The brick hearth and firebox appear to be original and are a fine example of an 18th century cooking fireplace with adjoining bake oven. Prior to the main block construction, the 18th century block was a free-standing structure. The fireplace chimney most likely extended straight up from the fireplace and through the south side of the original roof. When the main block was constructed c. 1808-11, the original chimney was removed and the flues were significantly reworked so that they tied into the new main block chimney for the fireplaces in Rooms 103 and 204.

Figure 1.3A-19. Fireplace in Room 108.

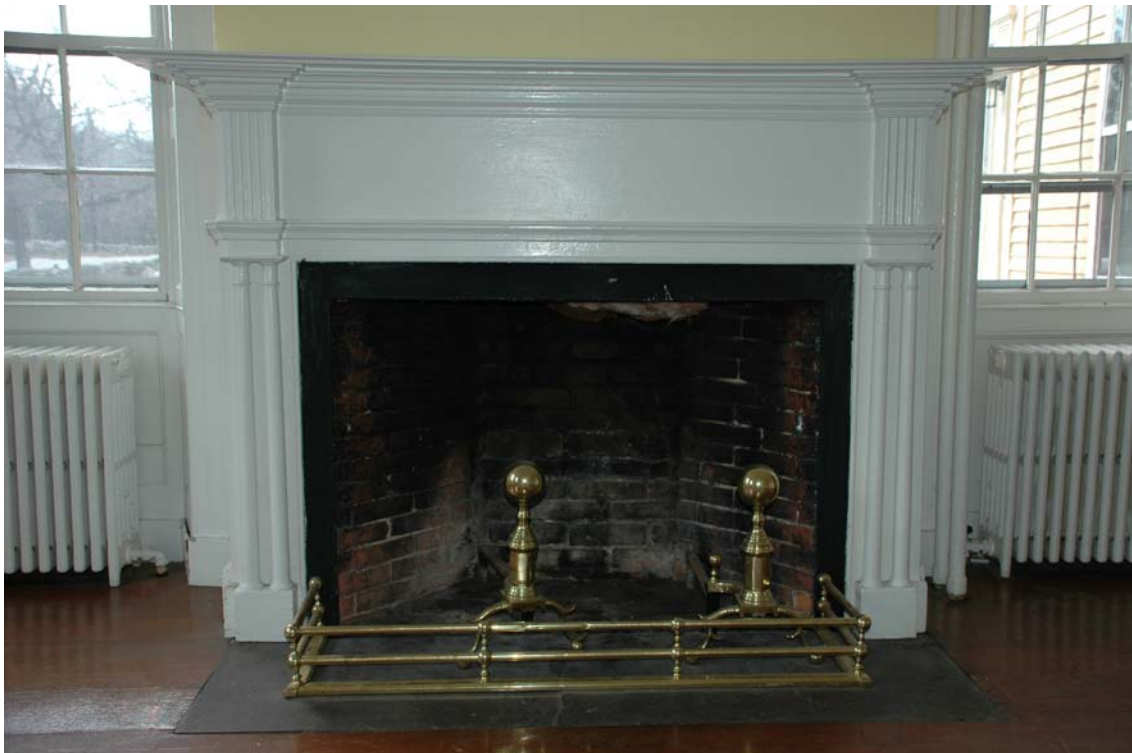
Room 102:

This fireplace mantel appears to be original to the main block construction of c. 1808-11. Microscopic analysis of paint samples suggests that the paint layers on the mantel are consistent with the door and window trim found in the same room, meaning that these architectural elements were installed at the same time. Finish nails were taken from the baseboard area on the left side of the mantel. These nails appear to early machine-cut brads, dating from the early 1800s.

Figure 1.3A-20. Fireplace in Room 102.

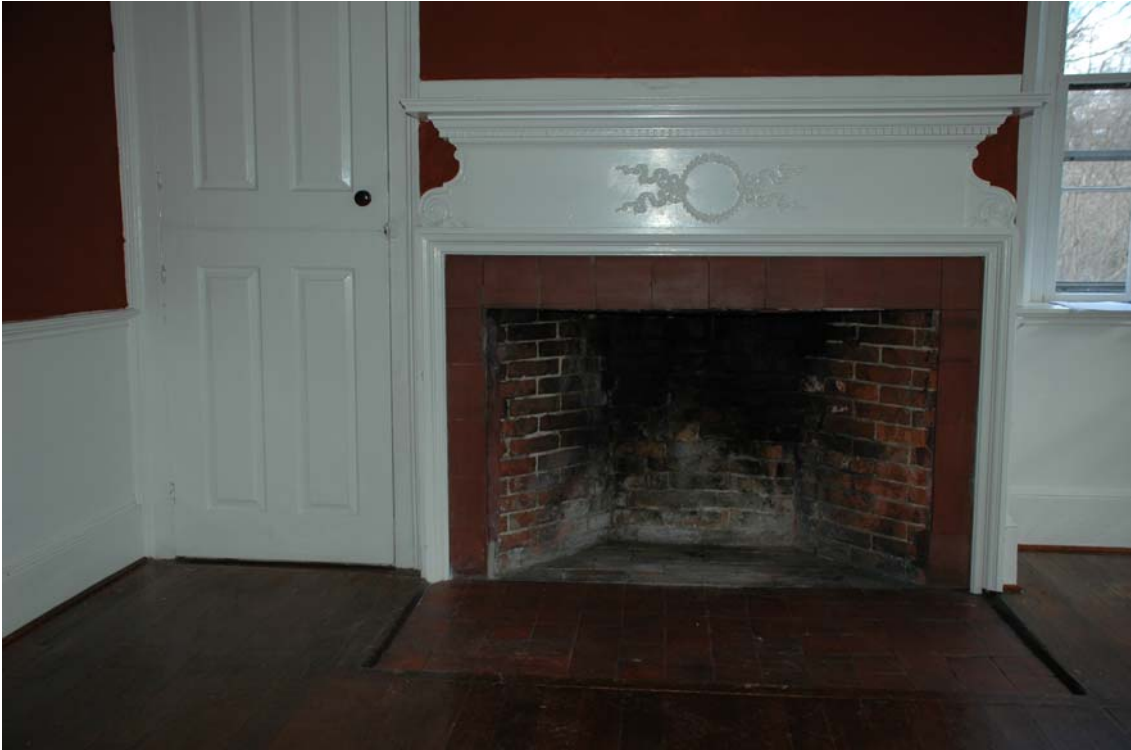
Room 103:

This fireplace mantel appears to have been added in the early 20th century. Microscopic analysis of paint samples suggests that the paint layers on the mantel are not consistent with the door and window trim. There are fewer layers on the mantel, suggesting that it was added later. Added to this evidence is the presence of early 20th century manufactured tiles applied to the firebox face and the hearth. The brick firebox appears consistent with the c. 1808-11 fireboxes found elsewhere in the house. Most likely, the firebox is original to the main block construction while the fireplace surround was refaced sometime in the early 20th century.

Figure 1.3A-22. Fireplace in Room 103.

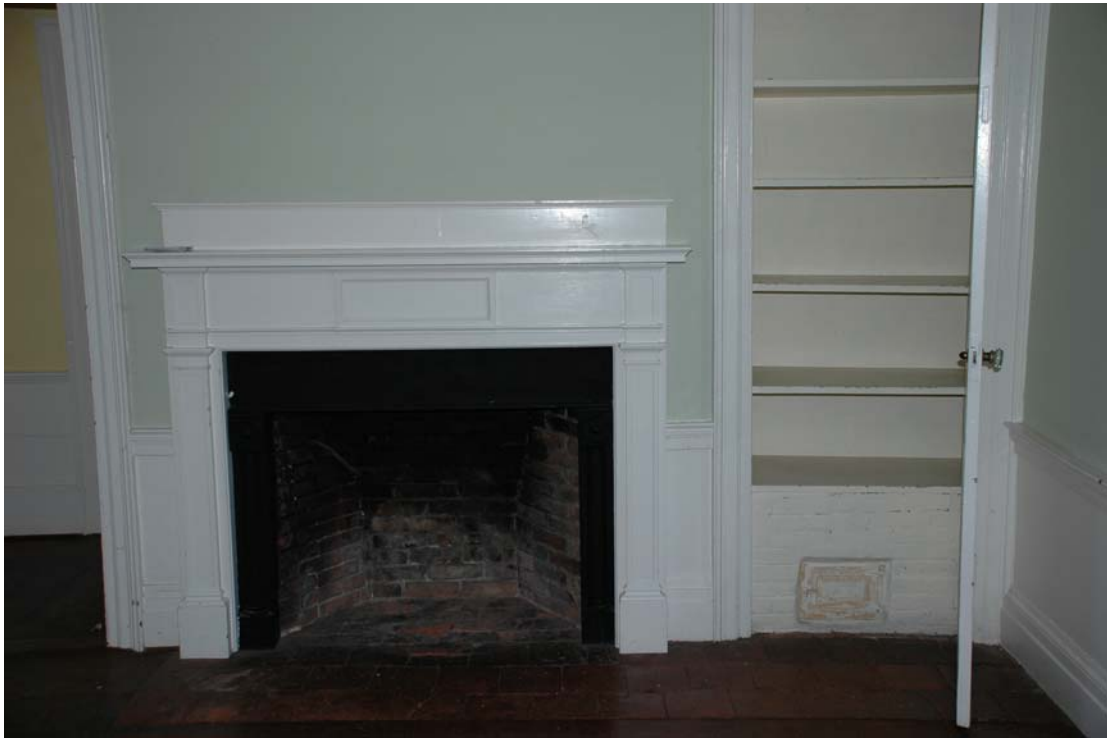
Room 106:

This fireplace mantel, located on the west wall of Room 106, does not appear to be original to the northwest wing construction. Typically a fireplace hearth will extend in front of the general firebox opening only. In this case, the brick hearth extends from the left side of the firebox past the right side until it ends at the north wall. There is a closet to the right of the fireplace that contains a brick base with an ash cleanout. The presence of a brick base in the closet, most likely part of an original bake oven, coupled with the extended hearth suggests that this fireplace was reconfigured. Most likely, the original fireplace (early to mid-19th century) was similar to Room 108 with a large cooking fireplace and a brick bake oven. It appears that at some point the cooking oven was no longer needed and so the fireplace was reworked with a smaller firebox, the bake oven was partially removed, the closet with shelves was added, and a decorative fireplace mantel was installed. Physical evidence that further supports this premise includes the cast iron lintel added to the firebox opening to support the masonry above and the infill wainscot, chair rail, and baseboard between the fireplace and the closet that fail to match the rest of the room. The decorative mantel, although not original to the room, is important to the late 19th century period of significance in its stylistic details including flat paneled pilasters, frieze board, and projecting profile shelf.

Figure 1.3A-23. Fireplace in Room 106.

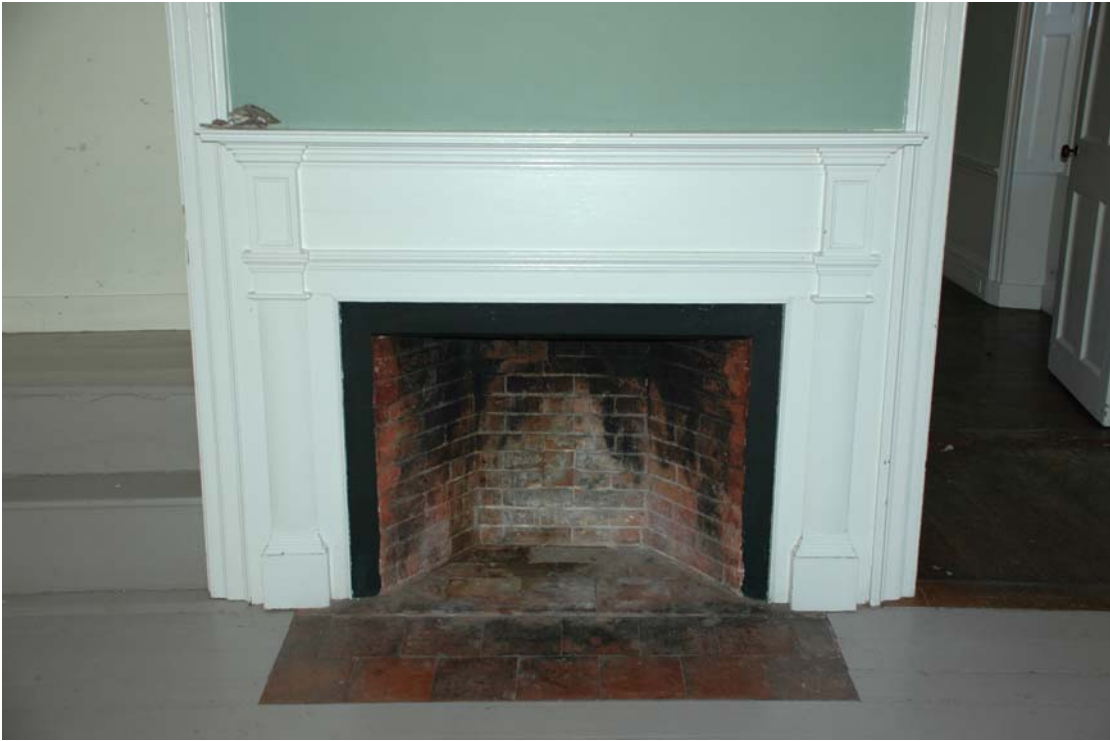
Room 104:

This fireplace and mantel appear to be original to the northwest wing construction (early to mid-19th century). As discussed in Section 1.1-A, it is conjectured that Room 104 is a western addition to the northwest wing. If this is the case, then this fireplace was added to the back end of the existing fireplace in Room 106 and the chimney was reworked. The firebox is brick with a square brick hearth and a painted plaster face. The decorative mantel is significant in its 19th century stylistic details including reeded columns with flat panel capitals, a flat frieze board, and a shallow profile shelf.

Figure 1.3A-24. Fireplace in Room 104.

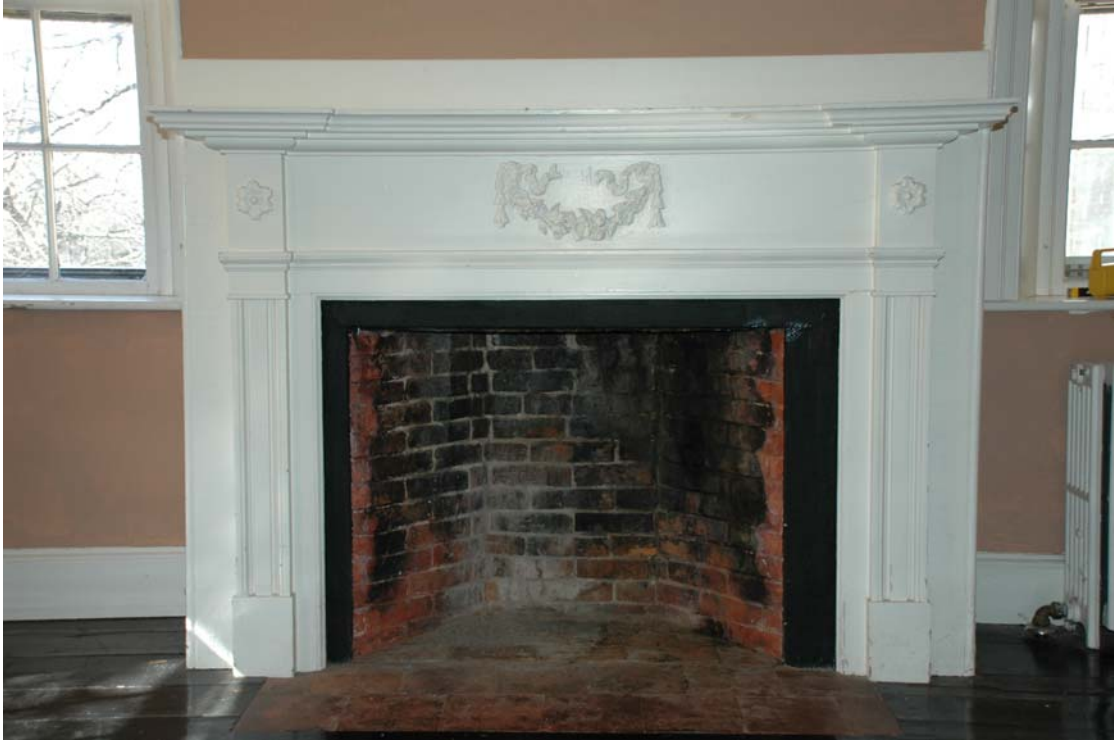
Room 202:

This fireplace and mantel appear to be original to the main block, c. 1808-11. The firebox is brick with a square brick hearth and a painted plaster face. The decorative mantel is significant in its 19th century stylistic details including fluted pilasters, capitals with carved flower, flat frieze board with carved swag motif, and profile shelf with a deep projection.

Figure 1.3A-25. Fireplace in Room 202.

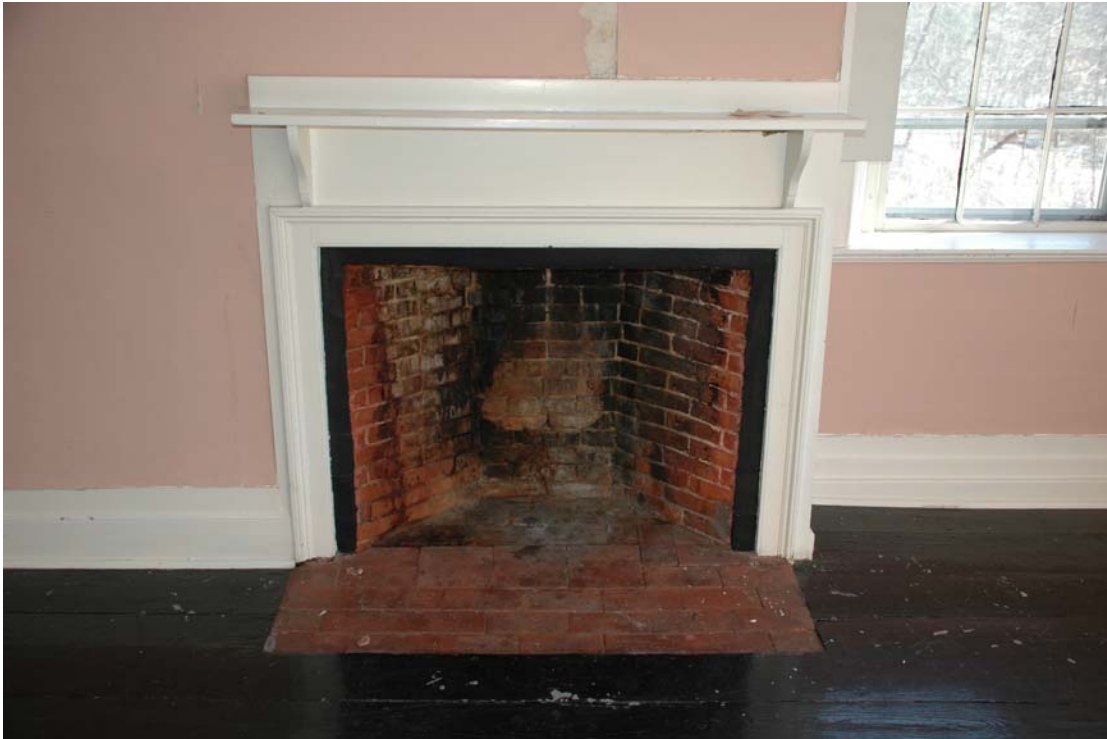
Room 204:

This firebox appears to be original to the main block, c. 1808-11. The firebox is brick with a brick hearth (square and rectangular) and a painted plaster face. The decorative surround consists of a bolection molding and a simple board shelf with ogee brackets. The bolection profile appears to be similar to the window casing backband profile. More investigation is needed to determine if the fireplace surround is contemporary with the main block construction.

Figure 1.3A-26. Fireplace in Room 204.

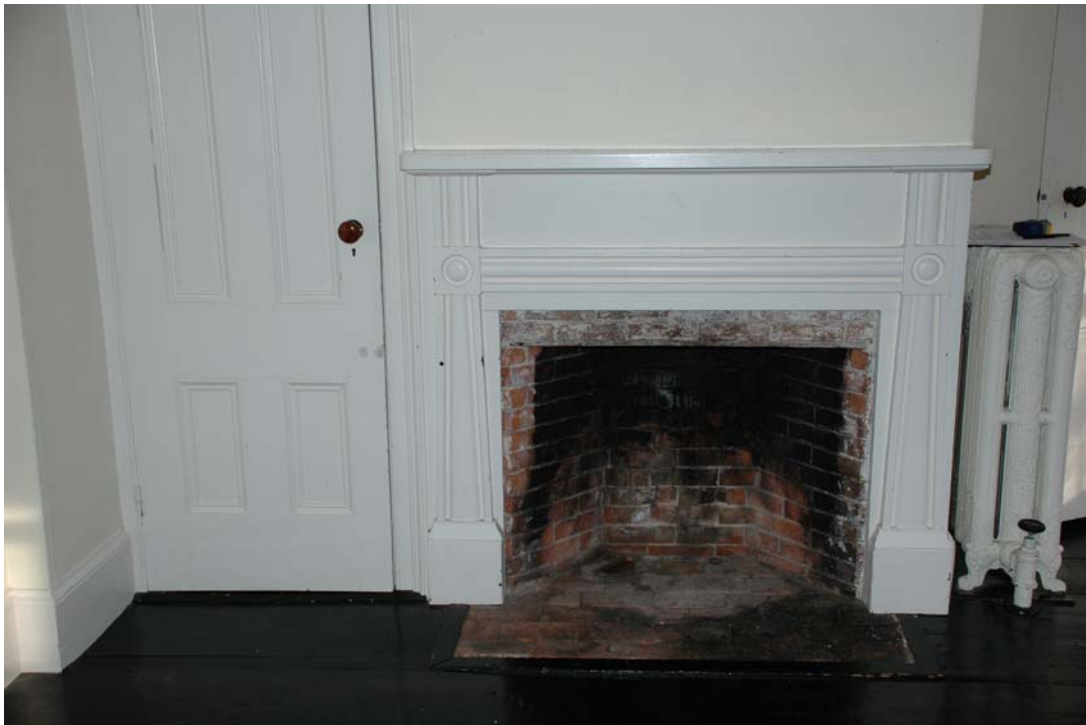
Room 208:

The firebox and hearth are brick and appear to be original to the northwest wing, dating from the early to mid-19th century. Stylistically the decorative wood mantel appears to be later than the others in the house, possibly dating from the late 19th or early 20th century. The mantel may be a salvaged piece that was installed in this existing firebox opening. Reasoning for this conjecture is that the mantel opening does not proportionately fit the brick firebox opening, suggesting that the mantel was not originally designed for this fireplace. On the right side of the fireplace where the finish wall returns along the side of the chimney mass, the mantel extends beyond the wall corner. On the opposite side, the mantel shelf awkwardly projects onto the trim of Door 2/208. Further investigation is necessary to determine the age of the mantel and whether it is original to the room.

Figure 1.3A-27. Fireplace in Room 208.

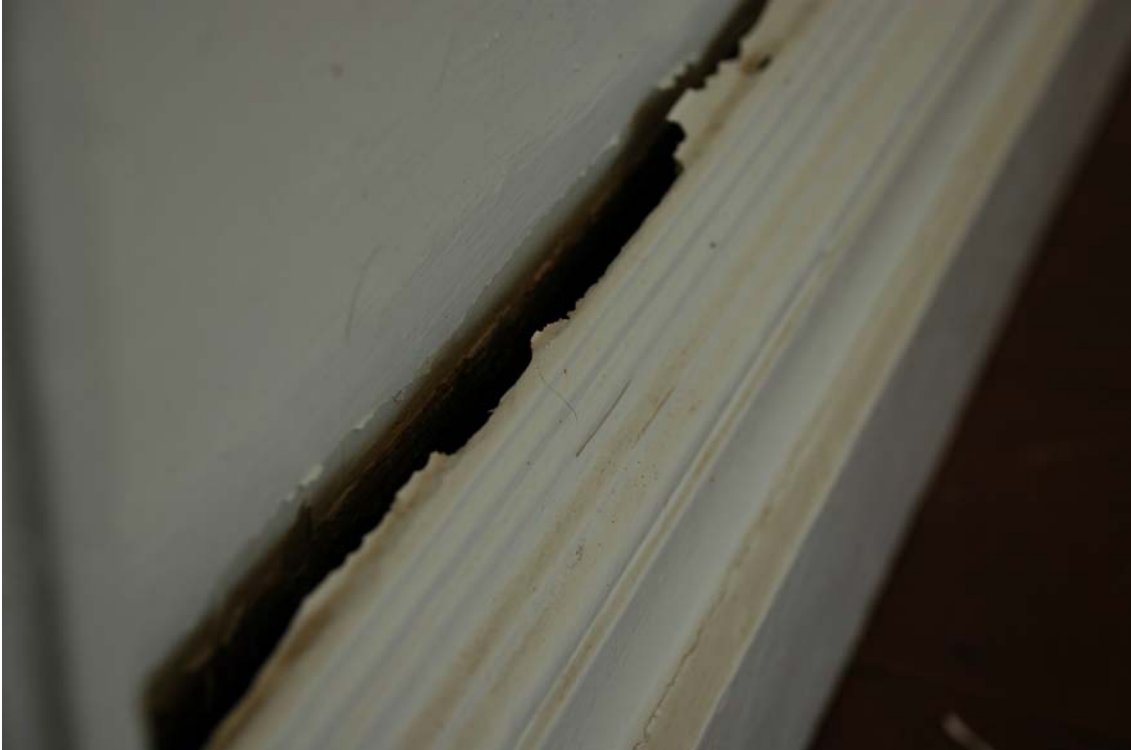
The door and window trim profiles in Rooms 102 and 106 appear to match. Microscopic analysis of paint samples in Room 102 reveals that the paint layers on the door trim, window trim, wood board wainscot, and baseboard are consistent, suggesting that these architectural elements were installed at the same time [fig. 1.3A-28]. Behind the baseboard on the wainscot are paint markings that project lower than the current height of the baseboard [fig. 1.3A-29]. This leads to the conclusion that the baseboard was originally installed slightly lower than its current height. Further investigation should be performed to explore this conjecture.

Figure 1.3A-29. Paint markings on the wainscot behind the baseboard in Room 102, below the height of the current paint markings, suggest that the baseboard was originally installed slightly lower. The baseboard may have been removed for the current floor installation and then reinstalled.

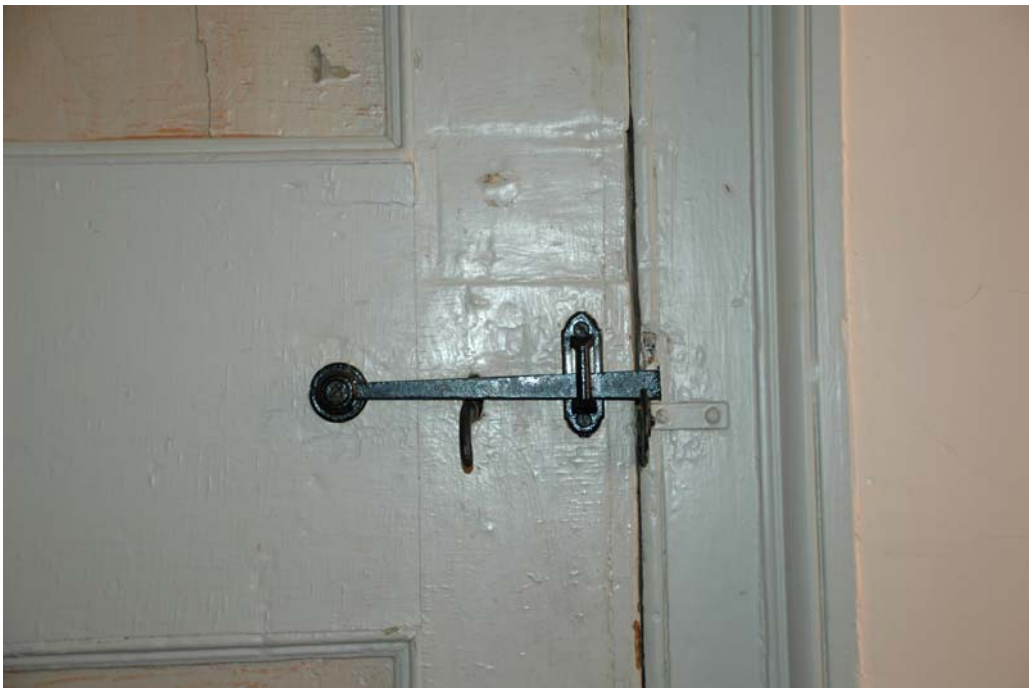
Figure 1.3A-39. Reproduction thumb latch, Room 108. There is a scar on the door from a former rim box lock.

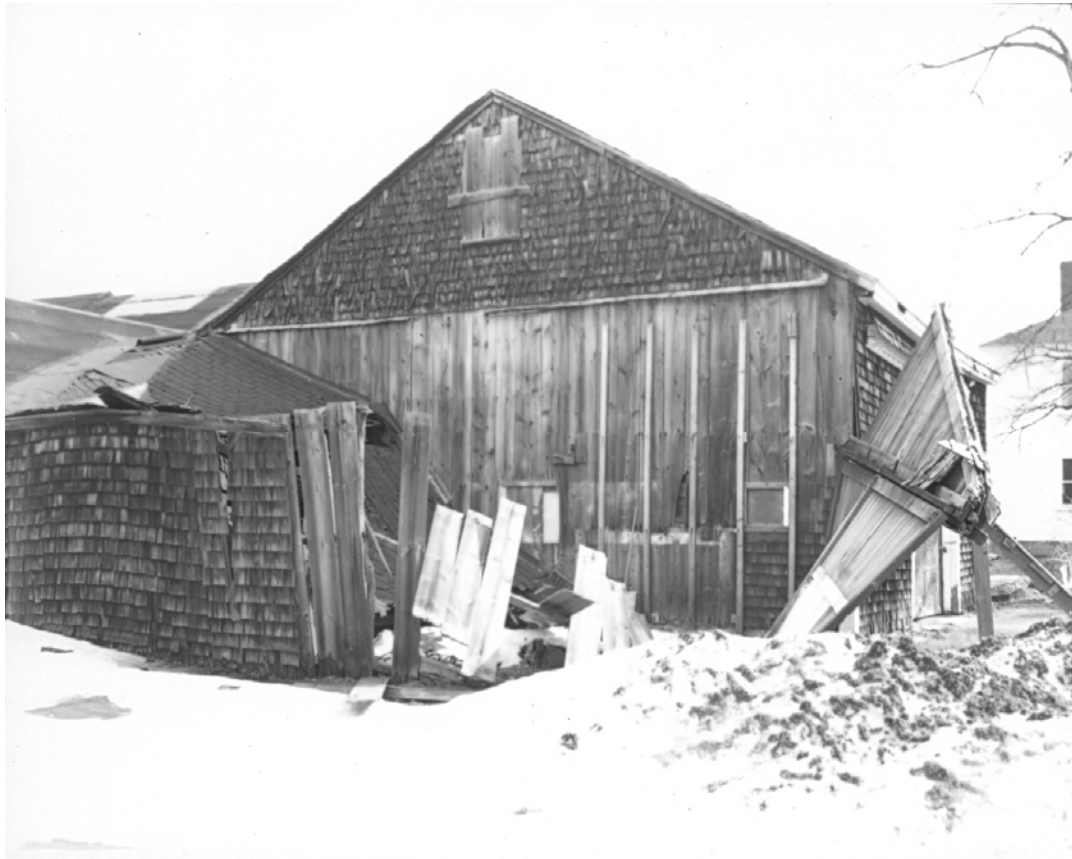
Later improvements to the Barn included a lean-to added to the west elevation, possibly around 1870. A cross-gable wing was added to the west elevation, a small gable wing was added to the east elevation, and the 1830's north barn addition was extended even further to the north around 1900.²³ The barn then remained in essentially the same configuration through the middle of the twentieth century. In 1963, the Historic American Buildings Survey documented the barn with measured drawings of the floor plan, south and east elevations, and an isometric framing diagram.²⁴ The barn was severely damaged in 1978 by a heavy snowfall which, in addition to already present wood rot, caused the collapse of the 1870's lean-to [fig. 1.1B-1]. The lean-to was removed

Figure 1.1B-1. West elevation of the Barn after the ca. 1870's lean-to collapse in 1978. Minute Man National Historical Park Archives, 1979.

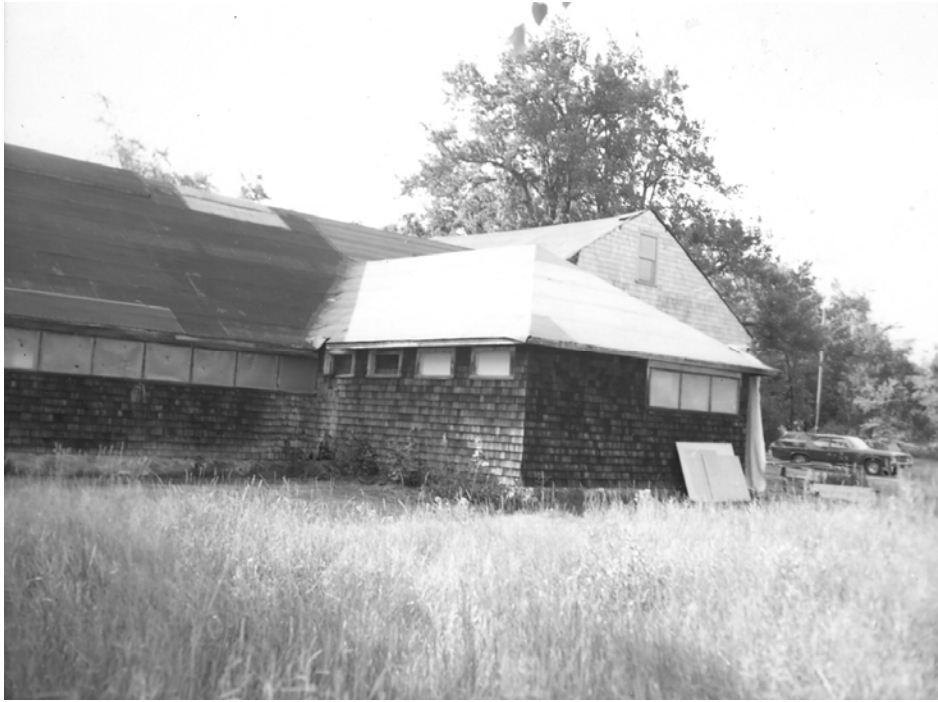
and the NPS started maintenance work to repair the west end wall. It became apparent that extensive repair work would be required on the ca. 1900 west wing due to its deteriorated structural condition. The decision was made to remove this newer wing [fig. 1.1B-2] and expose more of the original barn structure. The west walls of the original barn and 1830's north addition were repaired in 1979 and new wall shingles were installed on top of the original barn boards, in the locations where they still existed [fig. 1B-3].²⁵

Figure 1.1B-2. West elevation of the Barn prior to the 1979 removal of the c.1900 west wing. Minute Man National Historical Park Archives, 1979.

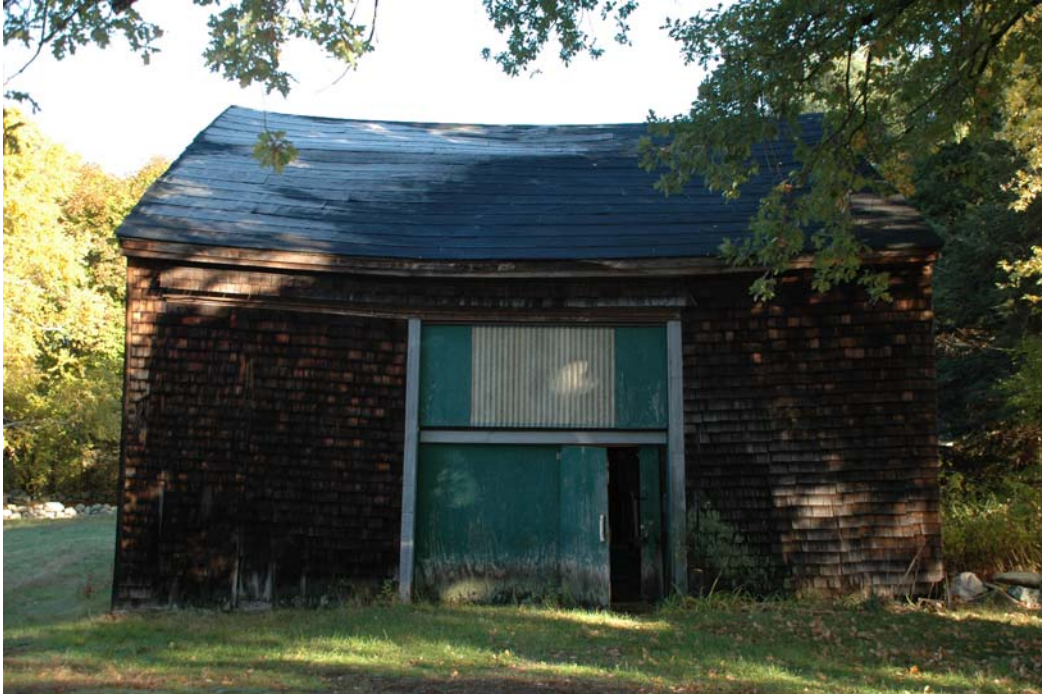
- **Door B-1/101:** [fig. SE-1] Type d-J. Located in the center of the south elevation of the main block, the original door is missing and has been replaced with plywood infill. The door frame is a painted flat board, deteriorated and warped with rot at the base of both jambs.

Figure SE-1. South elevation of Barn at the main block.

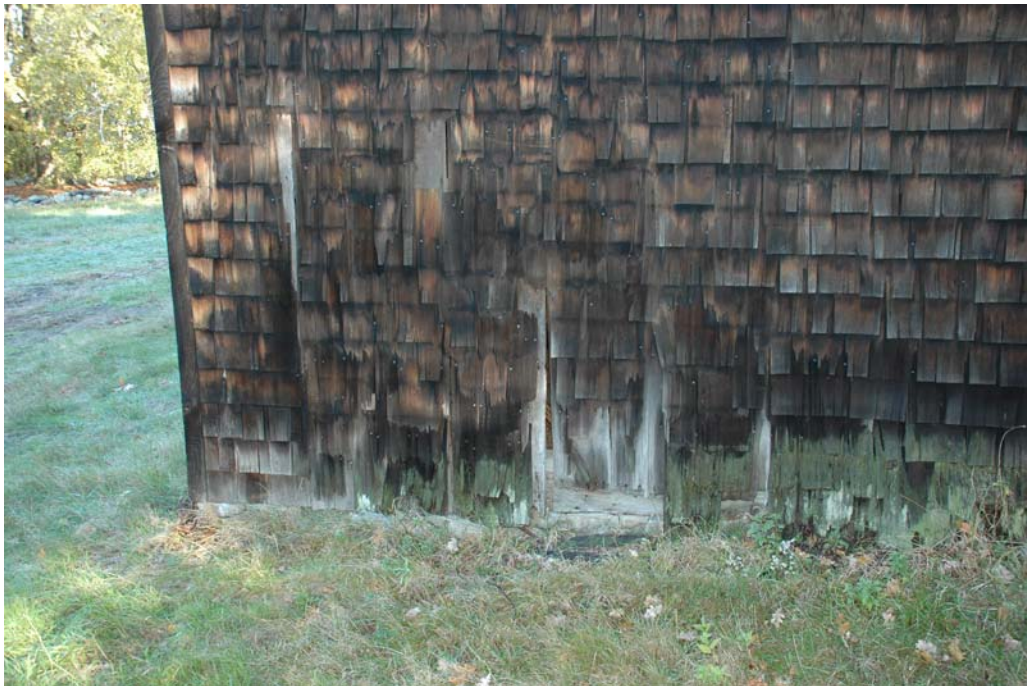
- The entire south elevation is clad with red cedar shingle siding. The wood shingles are in poor condition, with large areas of deterioration and dislodged shingles. The shingles and wall sheathing along the entire foundation wall are rotted and missing, exposing the sill plate which is also rotted [fig. SE-2].
- At the main block, structural deterioration has caused the east side of the wall to project out approximately 2'-0" at the right door jamb [fig. SE-3].

Figure SE-2. Deteriorated shingles, wall sheathing and sill plate at west corner of the south elevation, main block.

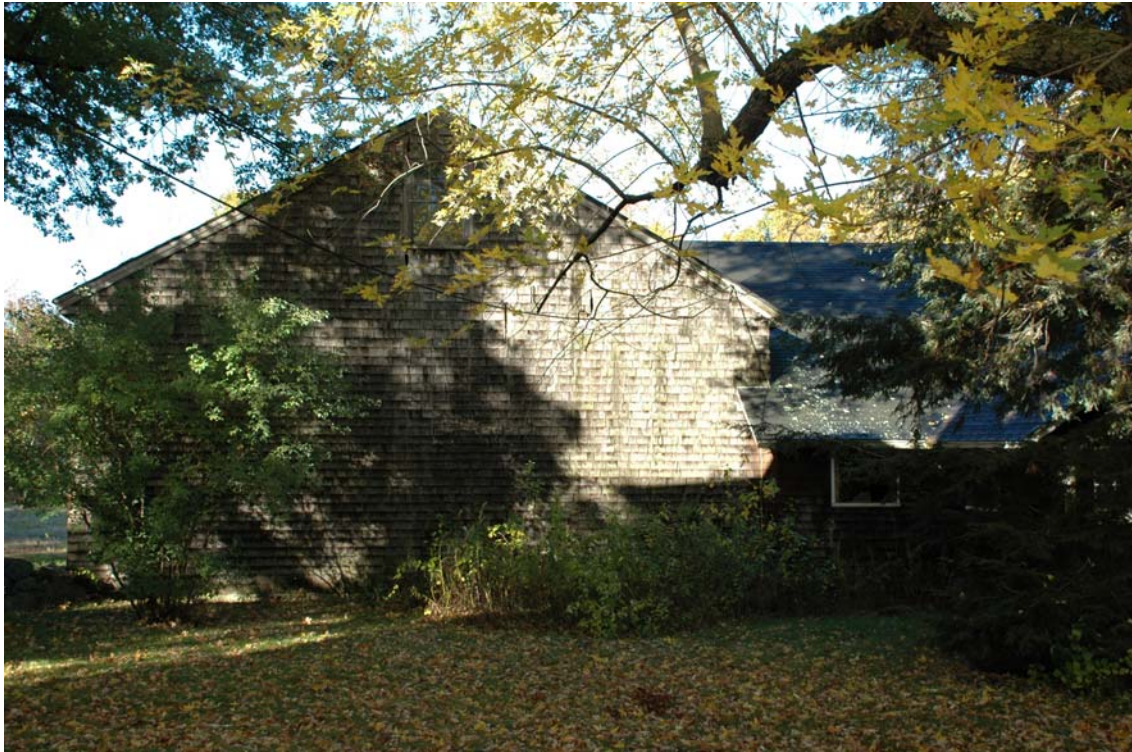
Figure EE-1. East elevation of Barn with the gable end of the main block and the north block on the right.

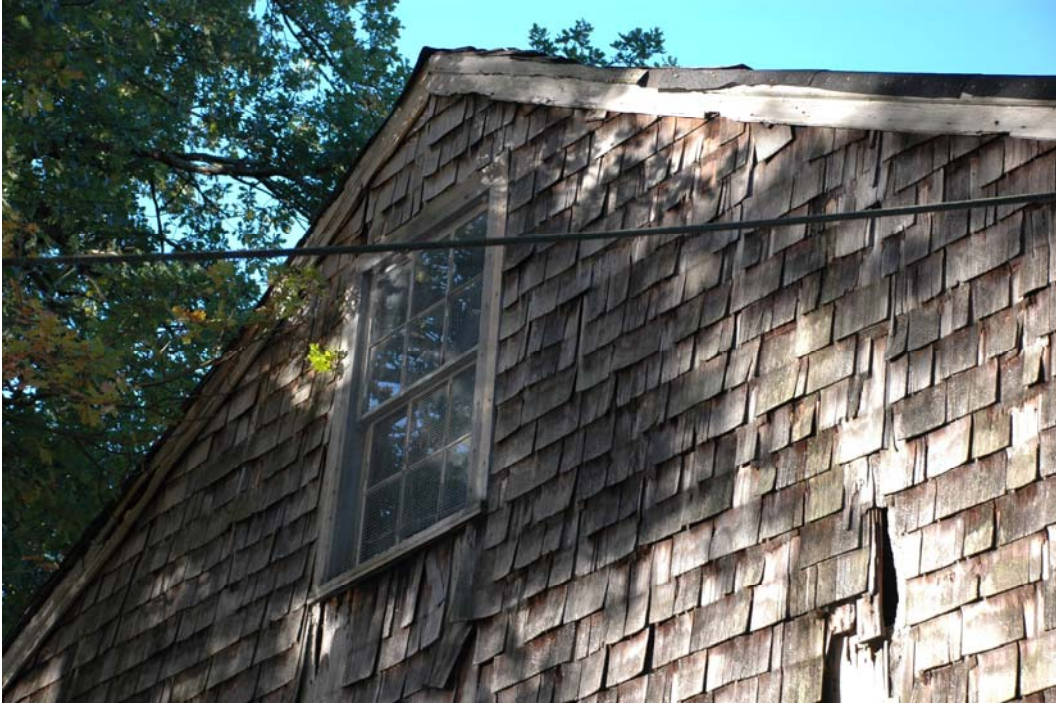
Figure EE-2. Detail of east gable end at main block with window #B-201.
