MINUTE MAN NATIONAL HISTORICAL PARK
JOHN NELSON HOUSE & BARN

HISTORIC STRUCTURE ASSESSMENT REPORT

NOVEMBER 2008

PREPARED BY:
JOHN MILNER ARCHITECTS, INC.
CHADDS FORD, PA

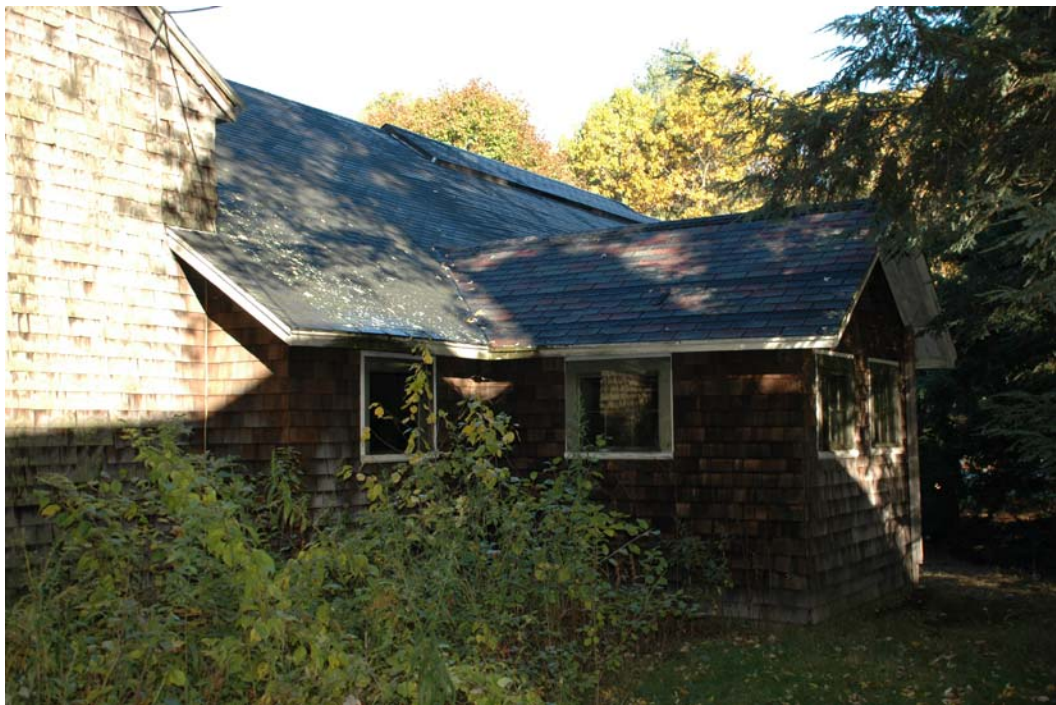
Figure EE-3. East elevation of c. 1830's north block addition on the left and the c. 1900 east wing addition on the right.

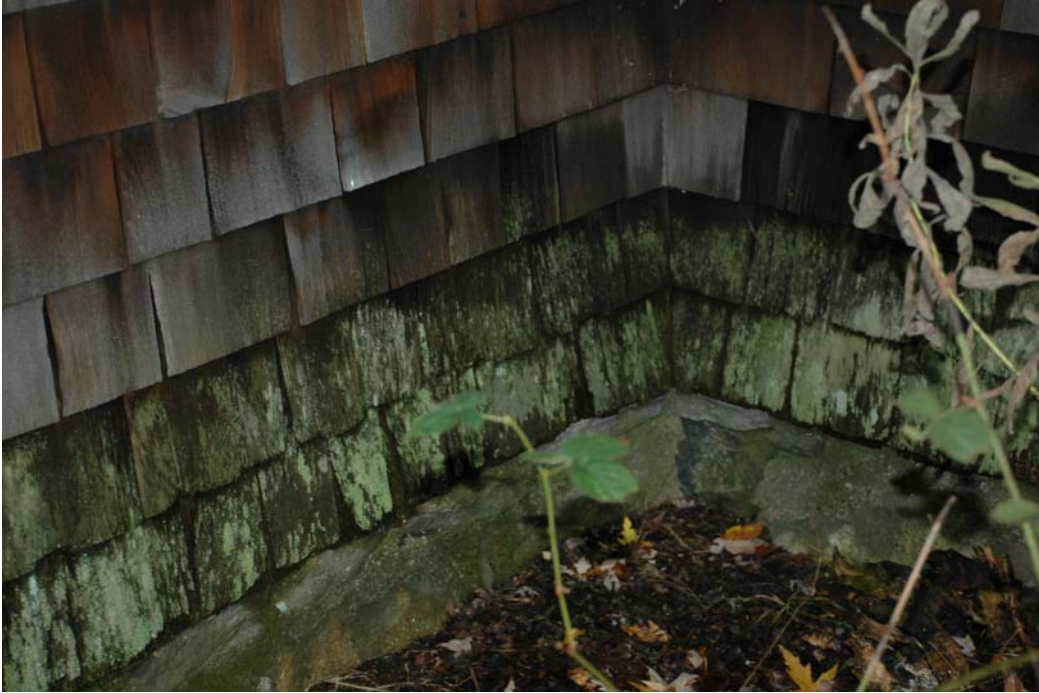
- The exposed portion of the east elevation foundation walls at the main block, the east wing, and the north block is comprised of random rubble fieldstone. The stone is covered with vegetation and mossy growth [fig. SE-4].
- The pointing mortar at the rubble stone joints is hard (cement-based) and is chipped, shrunken and missing in areas.

Figure EE-4. Wall condition at east elevation, with mossy and vegetative growth on the wood shingles and masonry foundation.

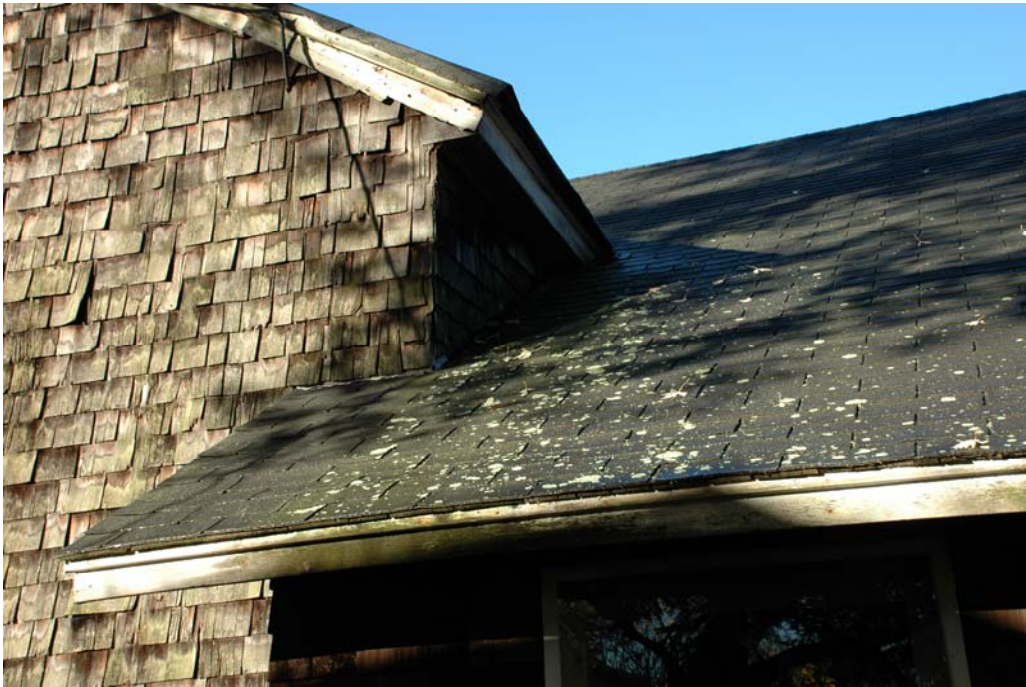
- The east elevation roof at the main block is comprised of rolled asphalt roofing on $\frac{3}{4}$ " plywood sheathing, installed on existing horizontal wood sheathing boards.
- The east elevation roof at the north wing is comprised of asphalt shingles on horizontal wood sheathing boards with a wood shingle drip course. The shingles are deteriorated and missing in areas.
- The area where the north block gable intersects the higher main block roof displays the most deterioration, caused by the water runoff [fig. EE-5]. The intersection between the north block roof and east wing gable is also a problem area.
- There is a raised portion of the north block roof for a roof vent, which appears to be closed off.

Figure EE-5. Roof condition at east elevation where the north block roof, right, intersects with the main block roof, left.

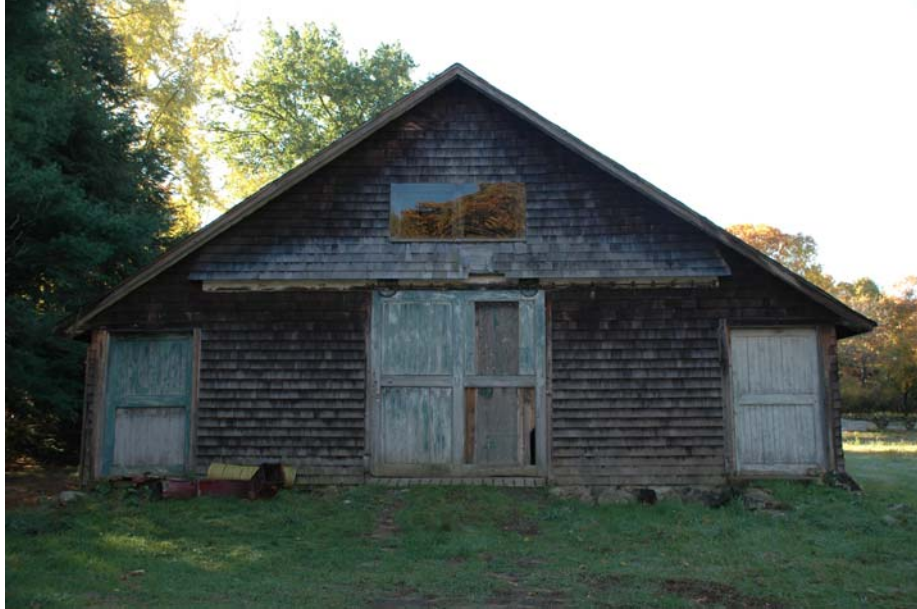
Figure NE-1. North elevation of the barn, north block.

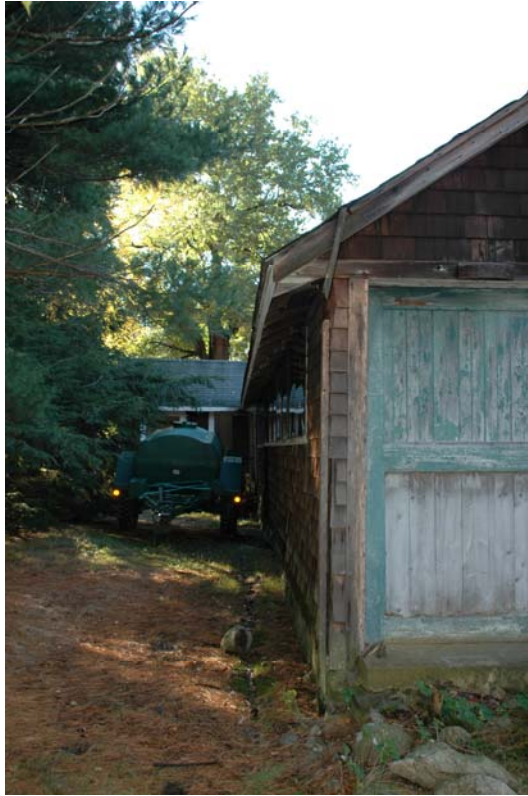
- **Door B-2/102:** Type d-K. Located on the east side of the north elevation, this is an original 2-panel vertical board door. The painted door is weathered.
- **Door B-3/102:** Type d-L. Located in the middle of the north elevation, this is an original large barn door with 4 vertical board panels. Nearly half of the vertical boards have been replaced with modern boards or plywood infill. The painted door is weathered. The original sliding door hardware is intact and door still operates.
- **Door B-4/102:** Type d-K. Located on the west side of the north elevation, this is an original 2-panel vertical board door. The painted door is weathered.

Figure NE-2. East side of north elevation, north block, with Door B-2/102 in the foreground. The north elevation of the east wing is in the background.

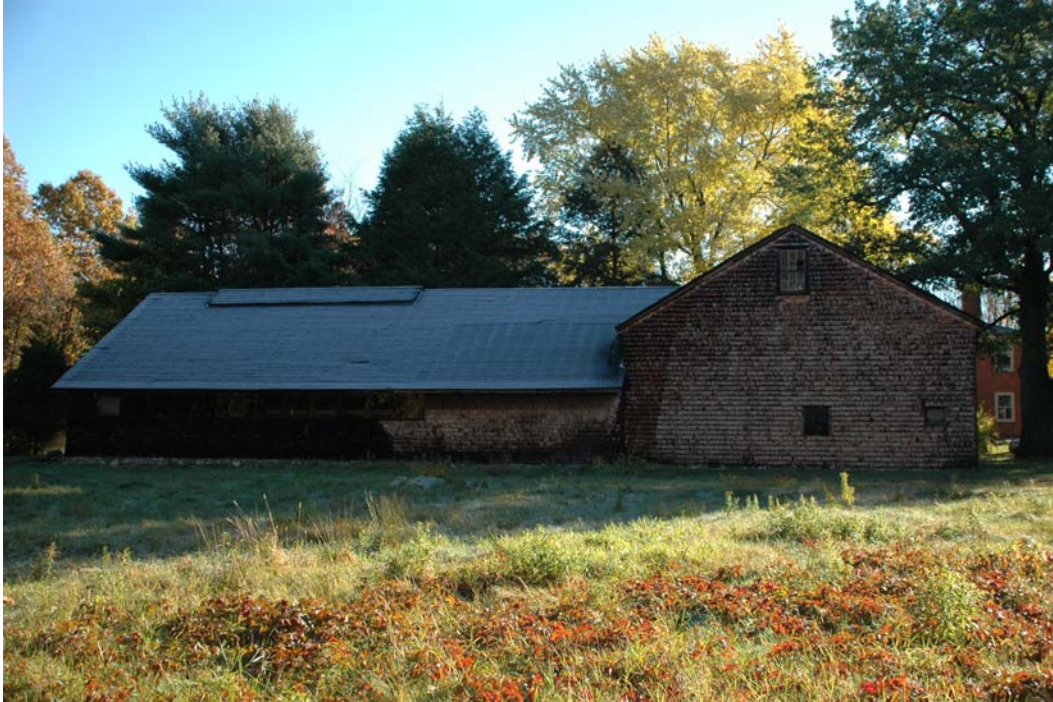
Figure WE-1. West elevation of the barn. The main block is on the right and the north block is on the left.

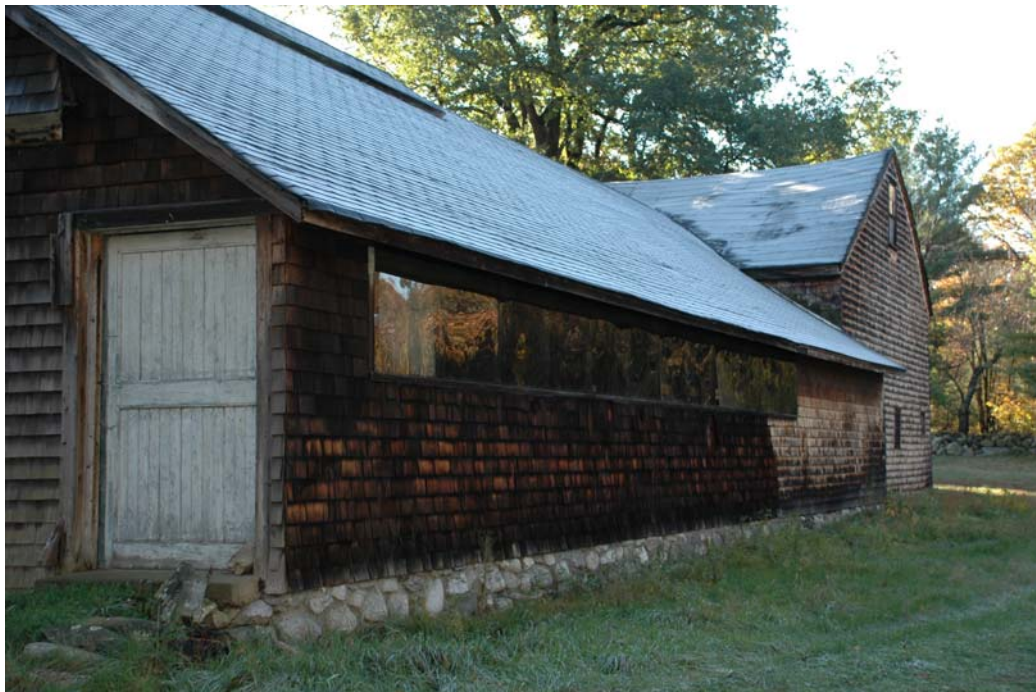
- **Window B-107:** [fig. WE-2] Type w-L. Bank of 12 framed window openings with wood sash missing. Wood trim is unpainted flat boards. The window openings are covered with sheets of Plexiglas that are screwed onto the face of the trim.
- **Window B-108:** Type w-L. Framed window opening with plywood infill.
- **Window B-109:** Type w-L. Framed window opening with plywood infill.
- **Window B-203:** Type w-J. 6/6 wood double hung sash with flat board trim. The painted sash and unpainted trim are extremely weathered. One glass light is missing.

Figure WE-2. West elevation of the north block, looking towards the southeast.

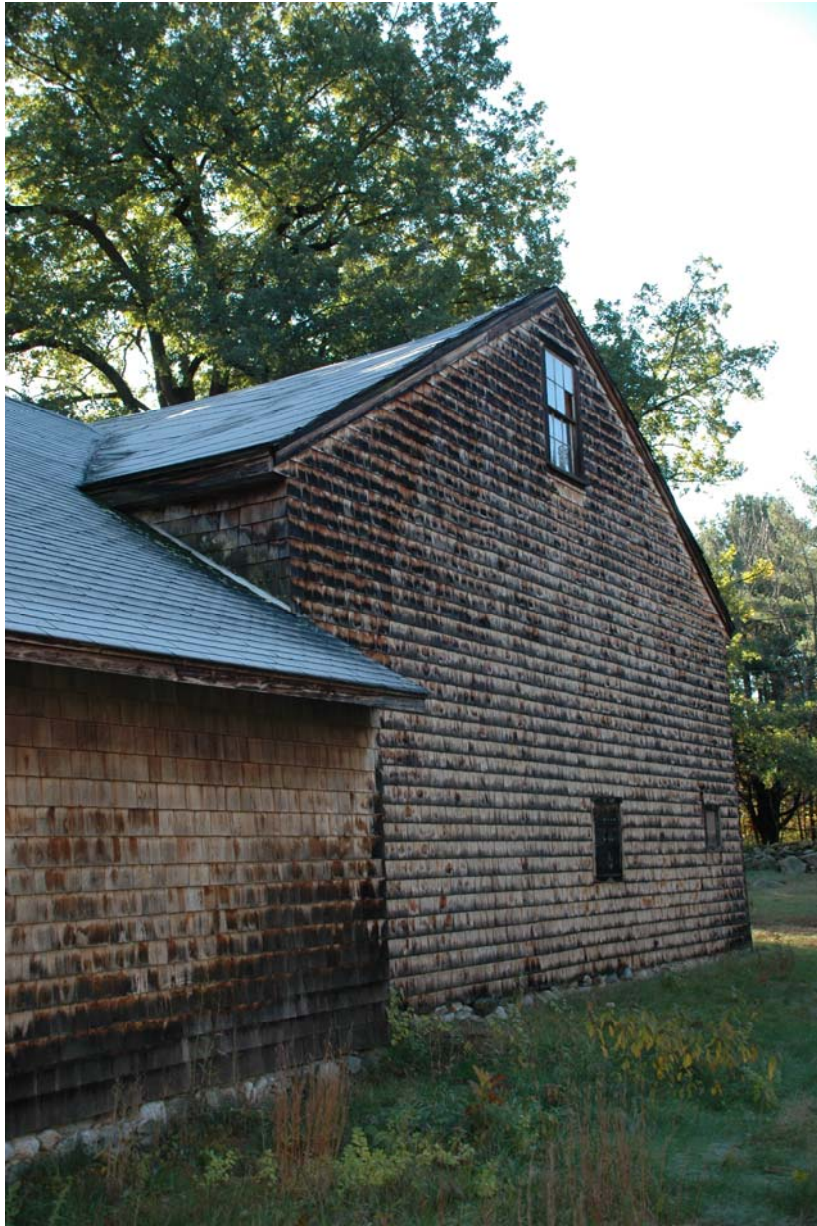
Figure WE-3. West elevation of the main block.

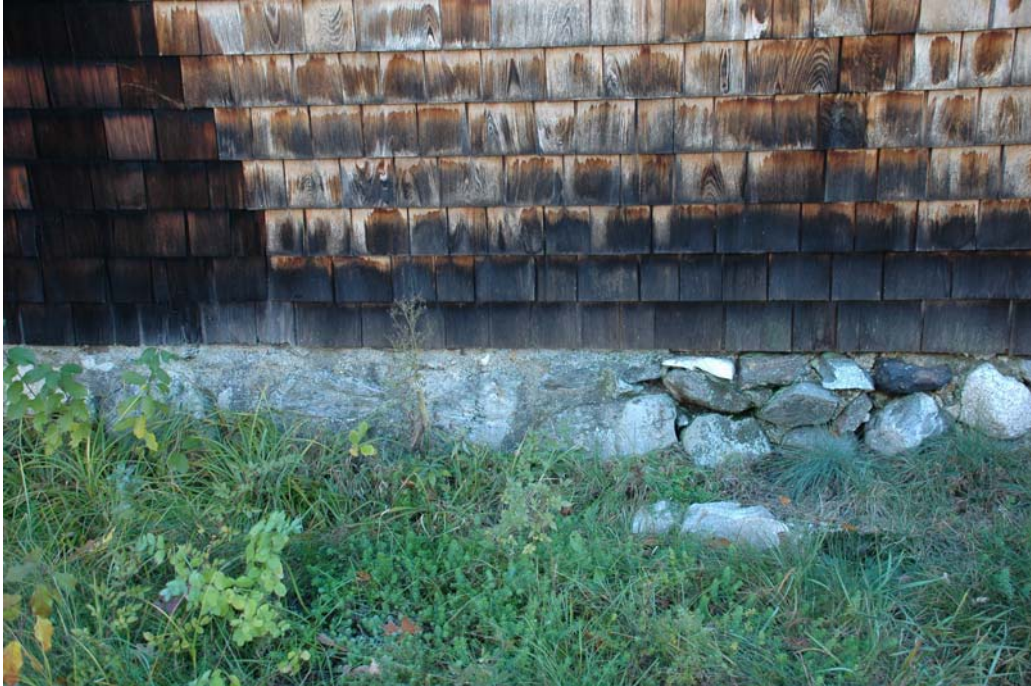
- The exposed portion of the west elevation foundation walls at the north block and the main block is comprised of random rubble fieldstone. The stone is covered with vegetation and mossy growth.
- There is a clear joint in the foundation wall indicating where the now-demolished west wing extended from the west elevation. The foundation wall at this location does not have finished pointing [fig. WE-4].
- The pointing mortar at the rubble stone joints is hard (cement-based) and is chipped, shrunken and missing in areas.

Figure WE-4. Foundation wall at west elevation, where the now-demolished west wing extended from the west wing on the right half of the foundation wall.

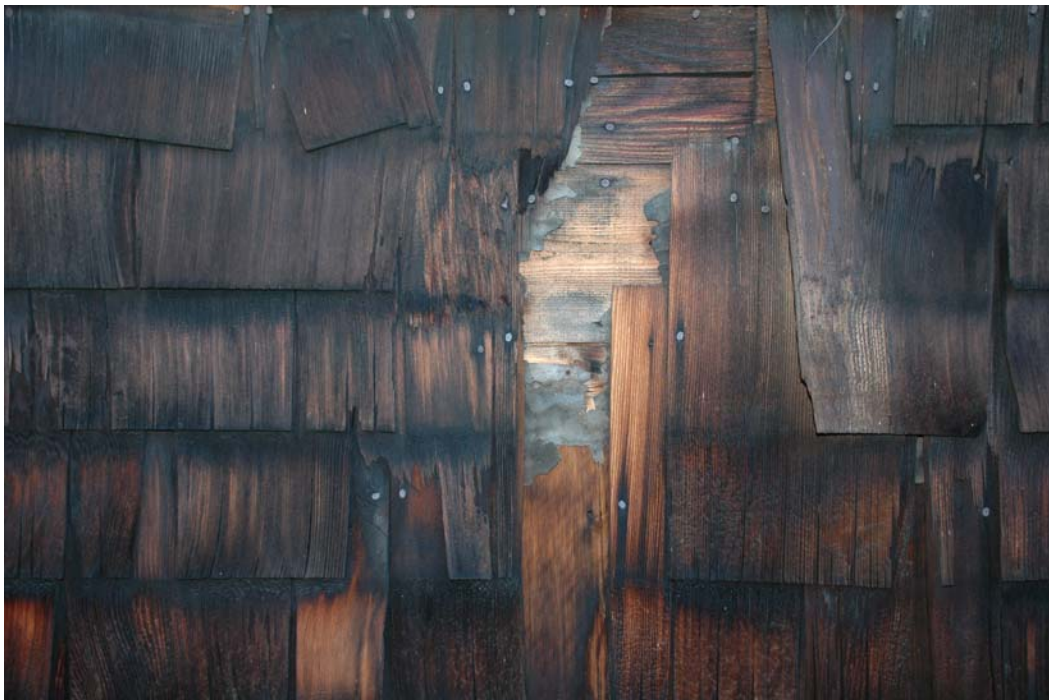
- The west elevation is clad with a mixture of red and white cedar shingle siding. The northern portion of the north block is red cedar. White cedar shingles cover the area where the now-demolished west wing extended from the west elevation. The west elevation of the main block is also white cedar shingles, installed at the same time as the work on the north block took place. The wood shingles are in poor condition with large areas of weathering and rot [fig. WE-5]. The shingles directly above the foundation wall exhibit the largest amount of deterioration.

Figure WE-5. Condition of deteriorated areas of west elevation, main block.

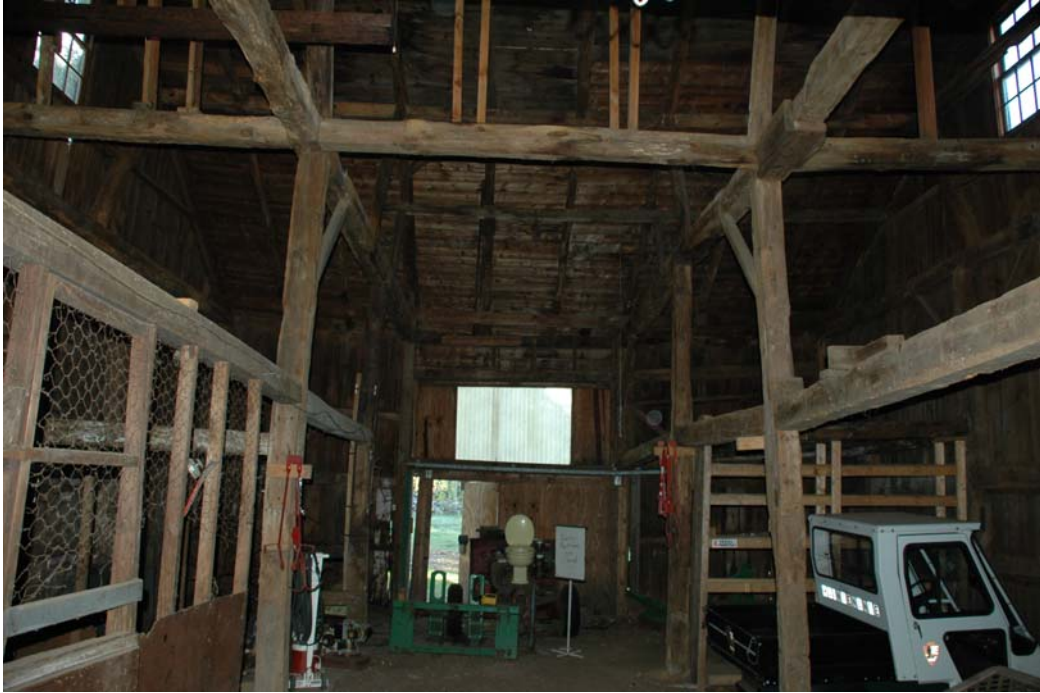
- **Door B-1/101:** [*fig. B101-1*] Type d-J. Located on the south wall, the original sliding barn door is missing. The large framed door opening is infilled with plywood and corrugated fiberglass.
- **Door B-2/101:** Type d-L. Located on the north wall, the original large board-and-batten sliding barn door is intact along with the original sliding door hardware and track.

Figure B101-1. Room B-101, looking south. The original barn door opening is infilled with plywood and a corrugated fiberglass panel.

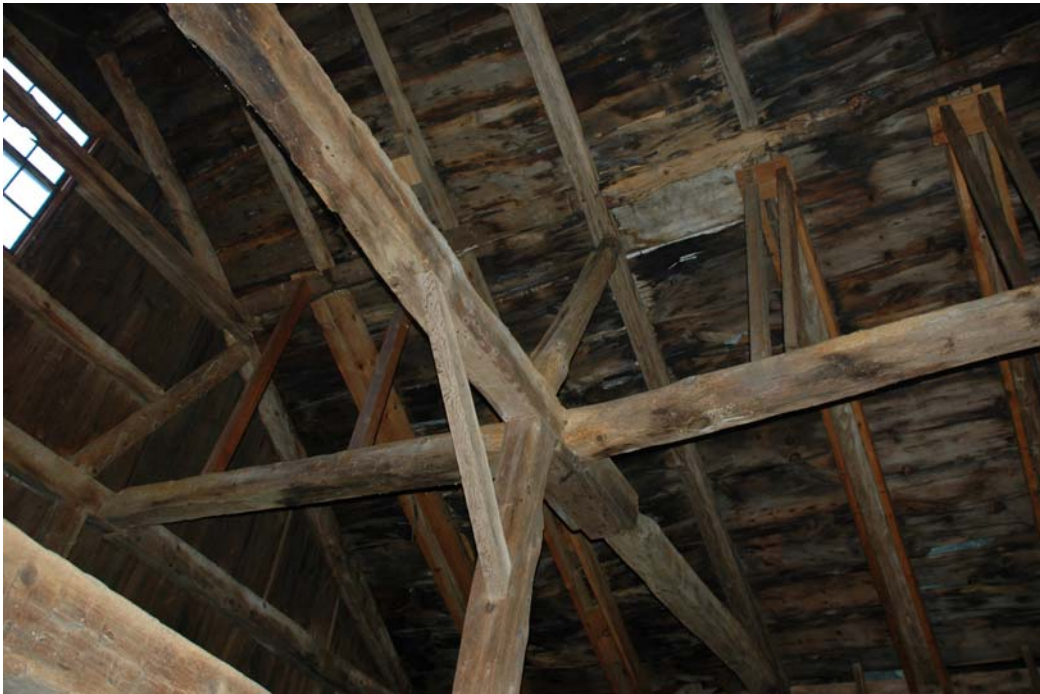
- The ceiling is original rafter framing with the underside of the roof sheathing exposed. Most sheathing boards appear to be original, except for areas with plywood patching, and are deteriorated with rot and water staining. A full layer of modern plywood sheathing is installed on top of the original sheathing boards, which can be seen through the deteriorated sheathing boards [*fig. B101-2*].
- The rafters are deteriorated. The previously failed rafters in the northwest section were repaired and reinforced by the National Park Service in 1979.

Figure B101-2. Room B-101, showing repairs to the rafters and roof sheathing.

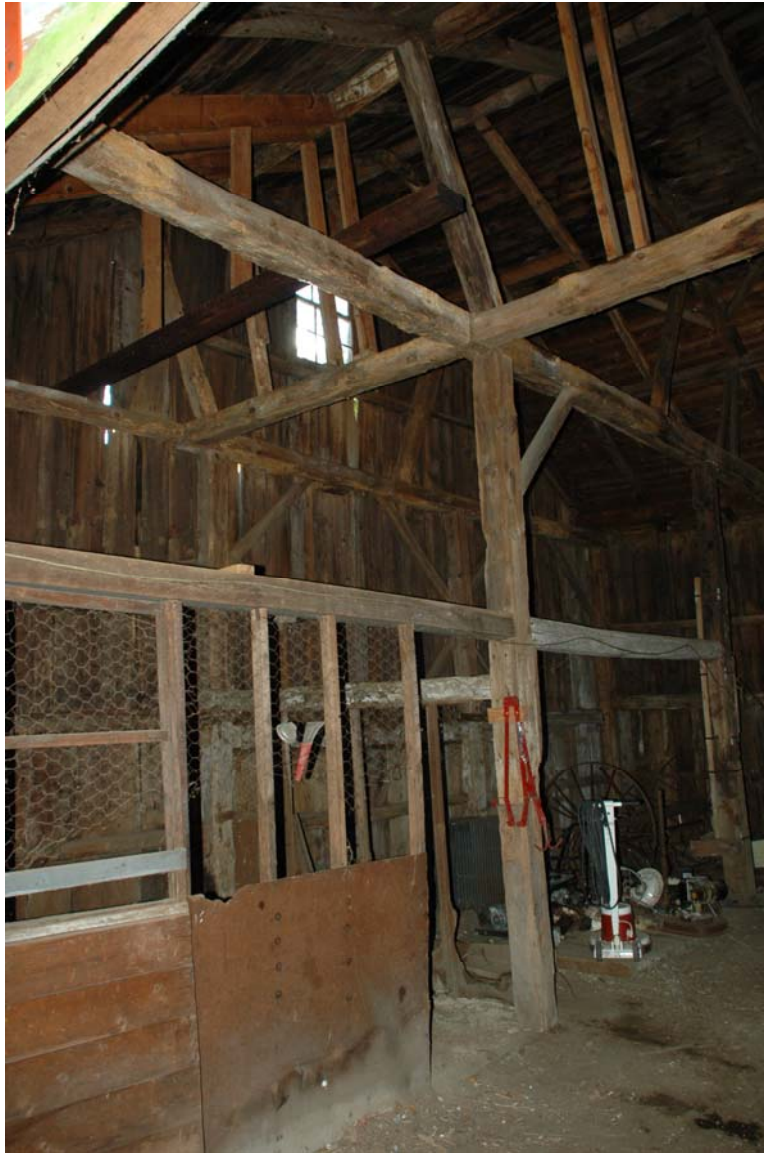
Figure B101-3. Room B-101, looking southeast.

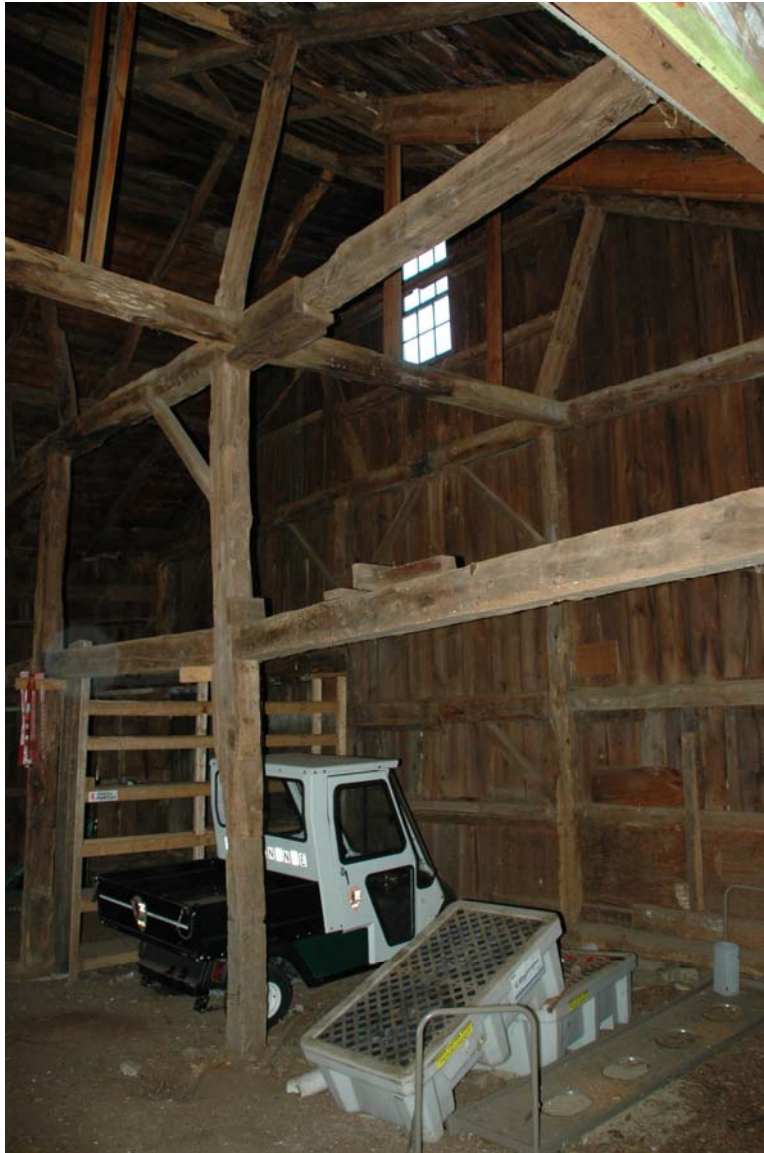
Figure B101-4. Room B-101, looking southwest.

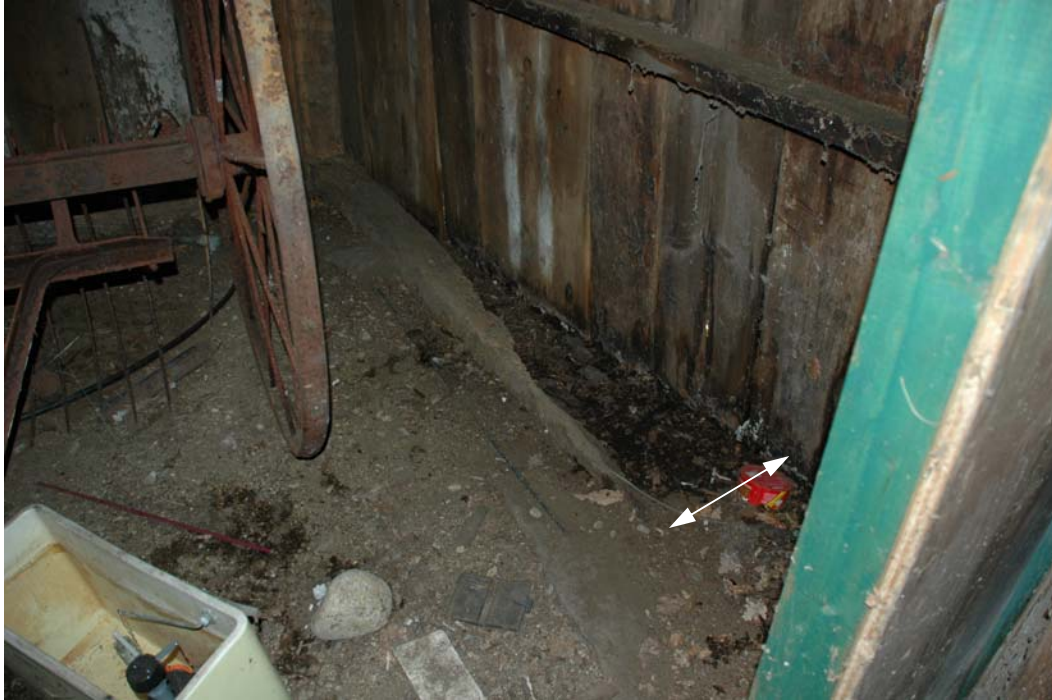
- The walls are wood framing with the backside of the exterior vertical sheathing boards exposed. Areas of the wall sheathing are deteriorated and are open to the exterior. The original posts, joists, plates and other framing members are deteriorated.
- The exposed sill plates are extremely rotted.
- The southeast wall has bowed significantly toward the south with the failure of adjacent structural framing members [*figs. B101-5 & 6*].

Figure B101-5. Room B-101, interior view of south wall that has projected out due to structural deterioration. The rotted sill plate at the left arrow is the original wall line.

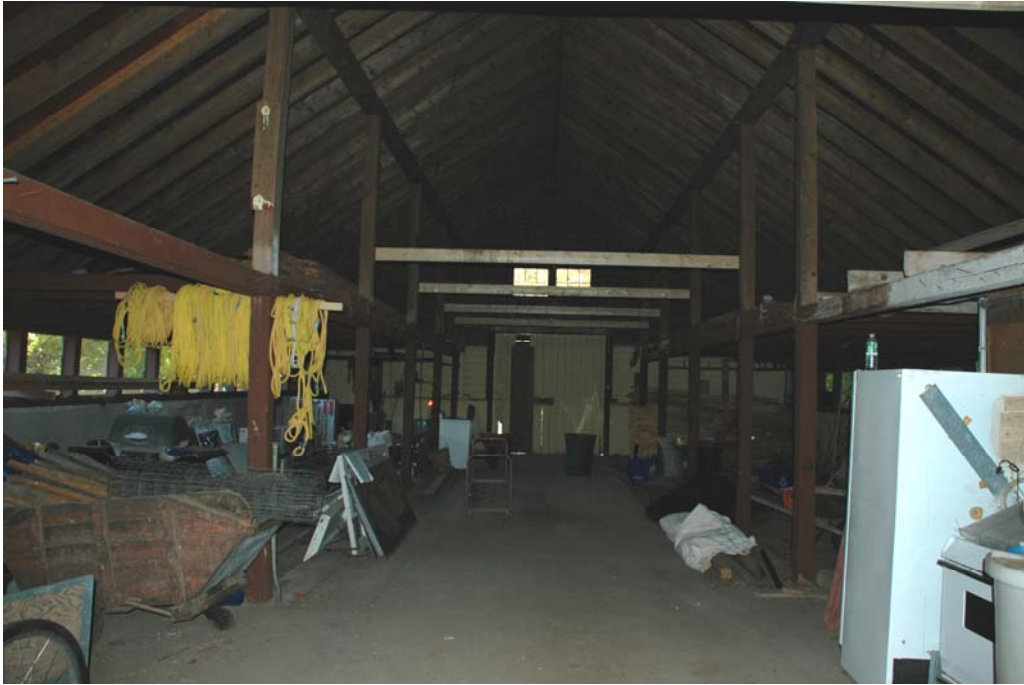
Figure B102-1. Room B-102, looking north toward Door B-3/102 in the center and Doors B-4/102 and B-2/102 on the left and right.

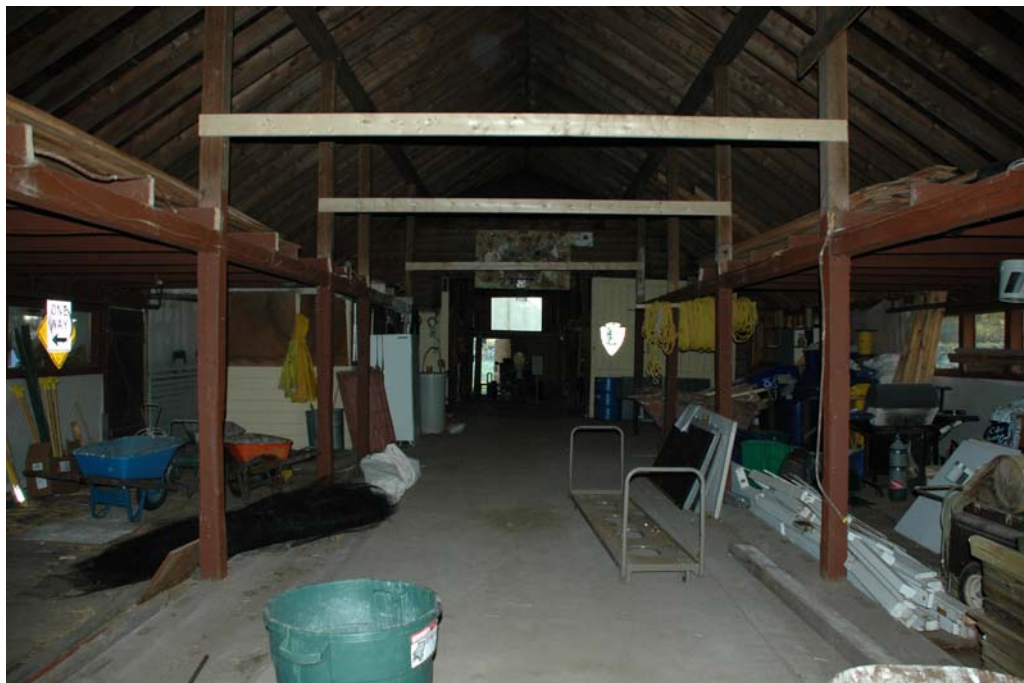
Figure B102-2. Room B-102, looking south toward Door B-2/101 and Room B-101.

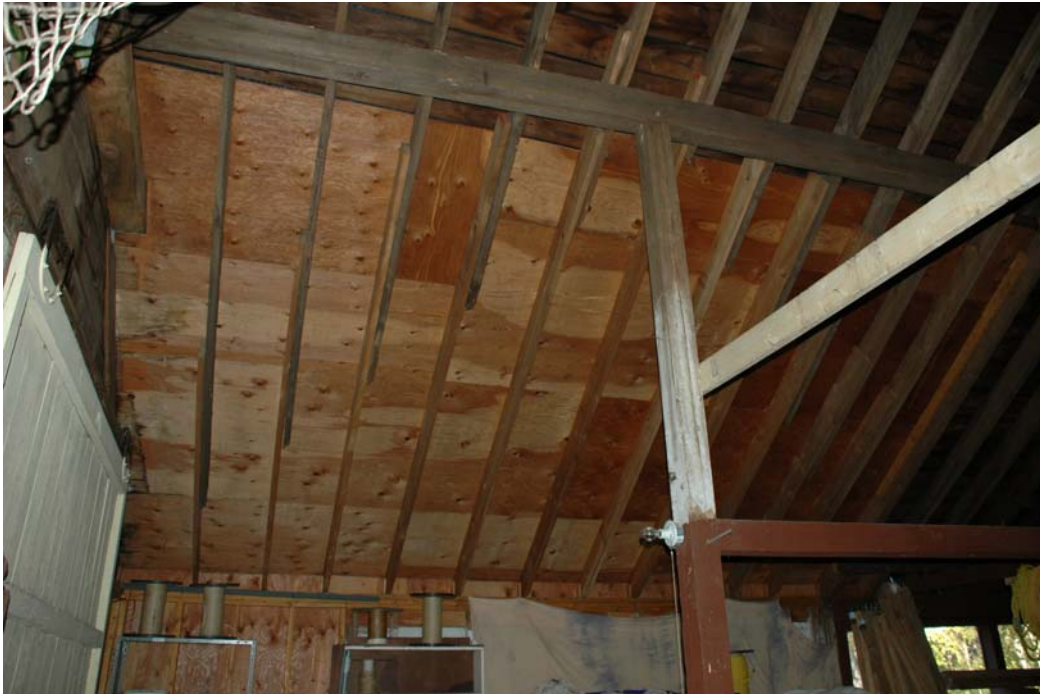
- The ceiling is original rafter framing with the underside of the roof sheathing boards exposed. The southwest roof area was infilled with new rafters and sheathing in 1979 when the deteriorated west cross-gable addition was removed [fig. B102-3].

Figure B102-3. Room B-102, looking west at the ceiling. The plywood roof sheathing and sistered rafters were installed in 1979.

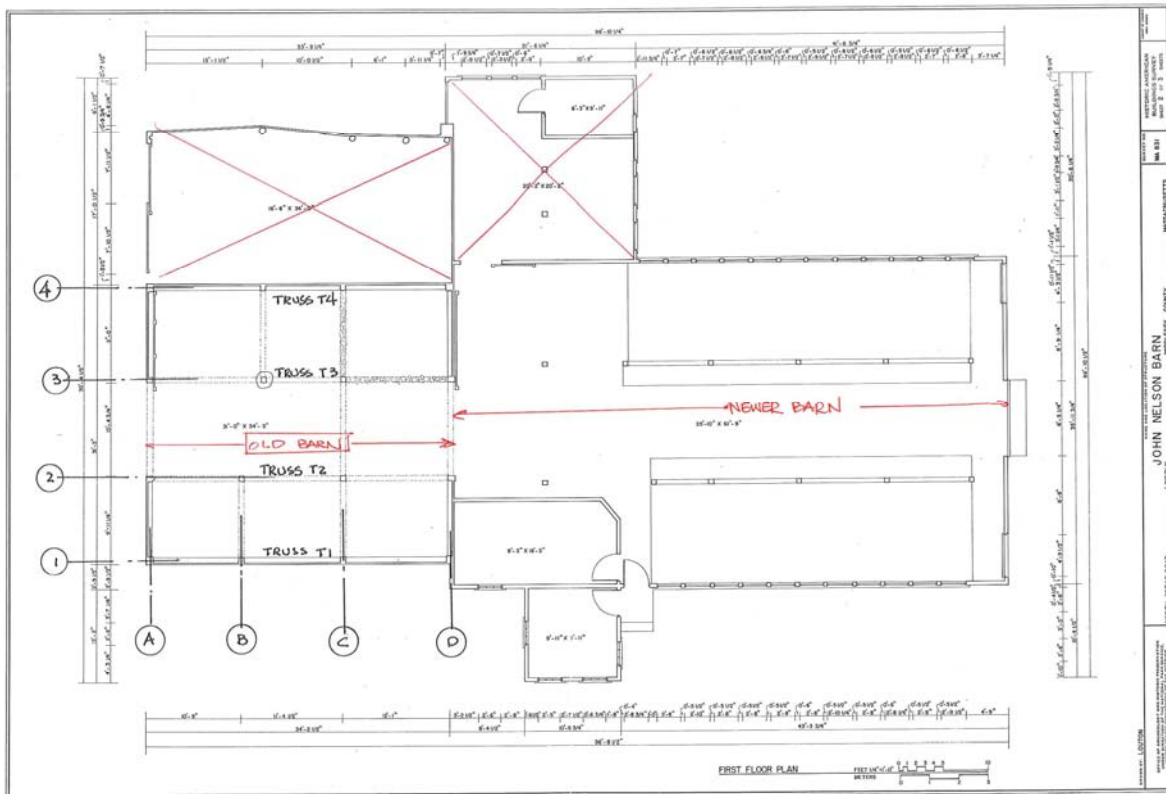
The structure rests on 8x8 timber sills along the exterior walls. The frame consists of four structural bents oriented north-south and spaced approximately 10 ft, 10 ft, and 11 ft on-center, east-west. A sketch of the bents and column lines is included. Each bent consists of two external (principal) posts and two internal posts. The posts are connected by 8x8 timber sills at bents one and four. No sills were found connecting the internal posts of the internal bents.

Figure BS-1. Sketch diagram showing the bents and column lines.

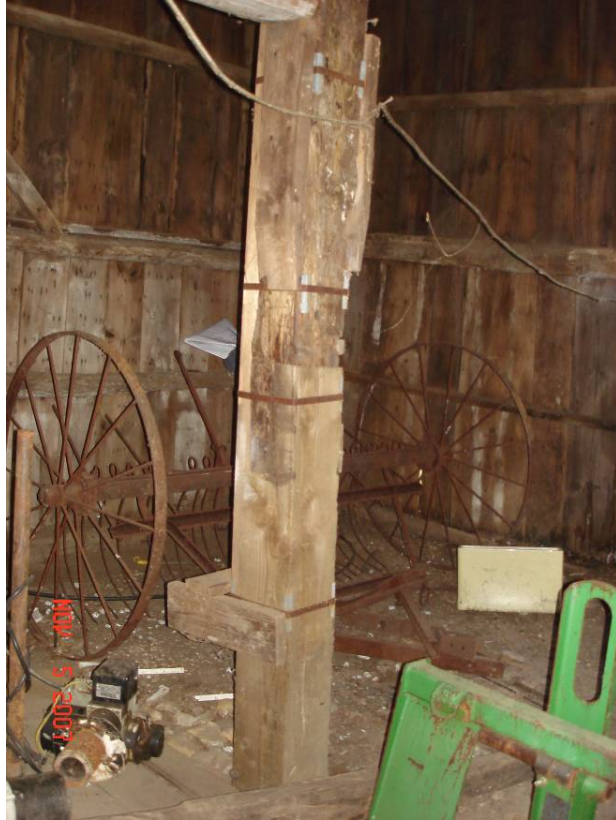
Figure BS-2. Typical barn post.

Each bent post is connected by an 8x8 upper tie-beam at the top and an 8x8 lower tie-beam at about mid-height. Each bent also includes a pair of principal rafters bearing on the principal posts [fig. BS-2], connected to each other at the ridgeline, and braced near the upper one-third points by queen posts. The queen posts bear on the upper tie-beam of each bent, just inside from the internal posts. The bottom of each internal post has been replaced with new timbers spliced with lap joints of variable lengths. In addition to the lack of sill beams at the internal bents, there are no observed mechanical means of connection between the internal posts and their concrete bases. The posts exhibit evidence of significant insect infestation; no active insects were observed.

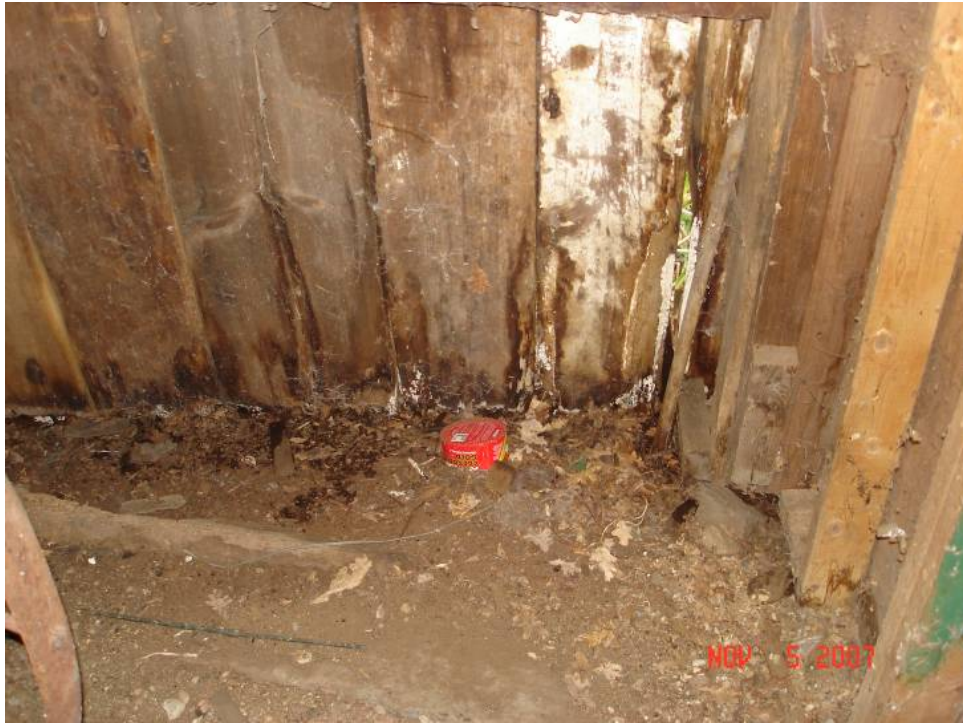
Adjacent bents are connected by sill beams, running east-west, between the first and second bents along the north wall. Although evidence of corresponding sill beams was found along the southern wall, these beams have greatly deteriorated and in some cases are missing altogether [fig. BS-3].

Figure BS-3. Missing sill beams at southeast corner.

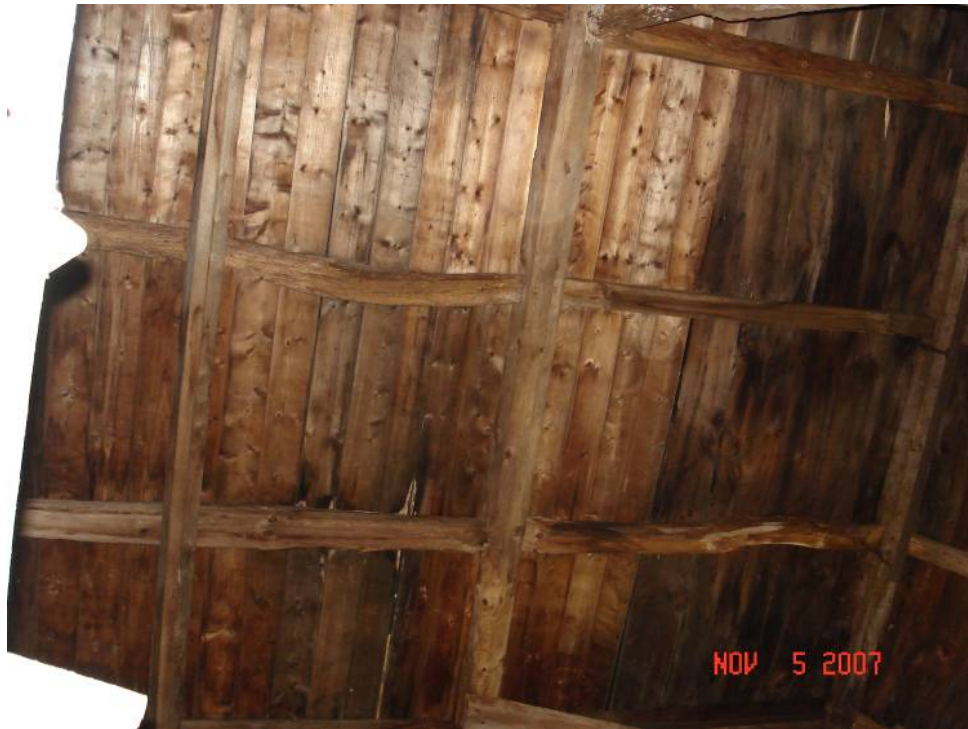
Figure BS-4. Buckled secondary rafters.

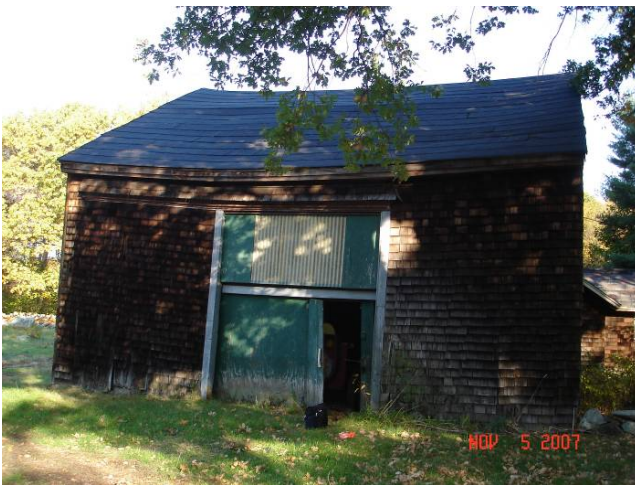
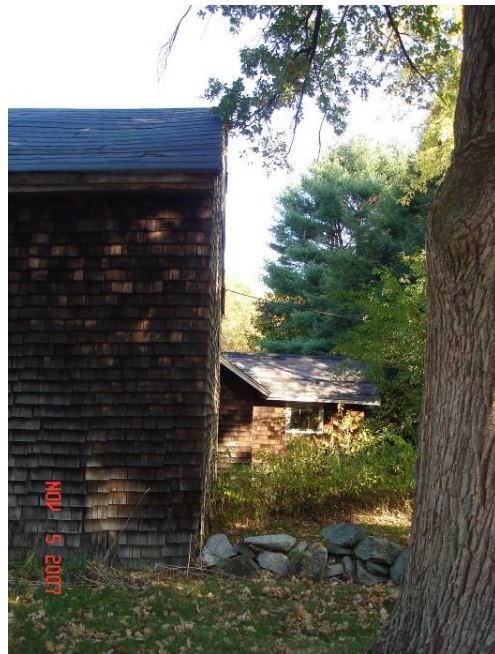
The structure has lost most of its structural integrity and is in need of significant repairs. The roof line has a clearly, discernable sag from east to west; the structure appears to have a slight lean to the east; and the south wall exhibits signs of movement at the base of about 12 to 15 inches [*figs. BS-6 & 7*]. The sill along the south wall has severely deteriorated and in some areas is missing completely.

Figures BS-6 & 7. Roof line and soffit line sag – the structure is out of plumb.

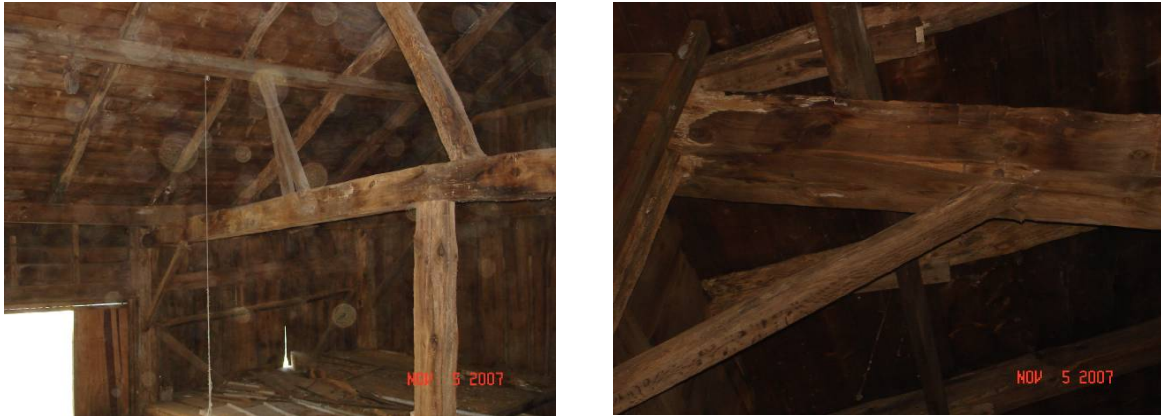
This missing sill appears to have caused much of the damage visible in the roof line in that the southern, principal post of bent three may have settled approximately 8-inches. This settlement appears to have resulted in a severely distressed (possibly broken) tie-beam in bent three and a ruptured mortise on the knee brace between the post and the tie-beam [fig. BS-8]. The lack of a sill beam below the south door appears to have allowed the base of the south wall at bent two to move outward by approximately 12 to 15 inches. Additional trim work has been installed around the south door in an apparent attempt to compensate for this movement.

Figure BS-8. Broken tie-beam and ruptured tenon at knee brace

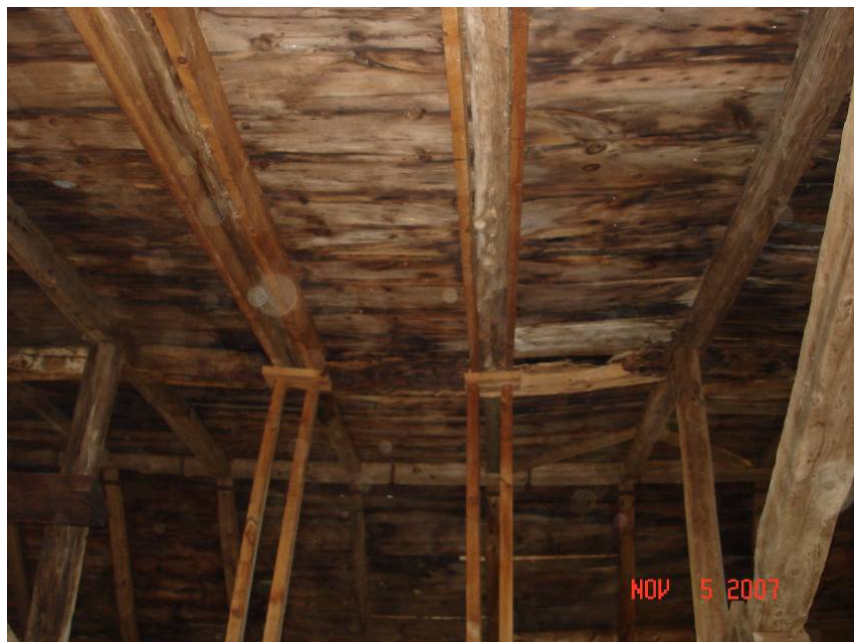
Figure BS-9. Sagging and deteriorated framing under north block roof projection.

The roof the north block, oriented perpendicular to the main block, was constructed directly on top of the main block. As a result, the north roof of the main block carries loads from the north block. This additional load appears to have overstressed the roof of the main block as evidenced by the additional shoring installed under the north roof [fig. BS-9].

The structural capacity of the roof framing should be further investigated to determine if additional and/or larger structural members are required to support the required snow and wind loads. The additional dead load introduced by the north block roof should also be considered in this analysis.

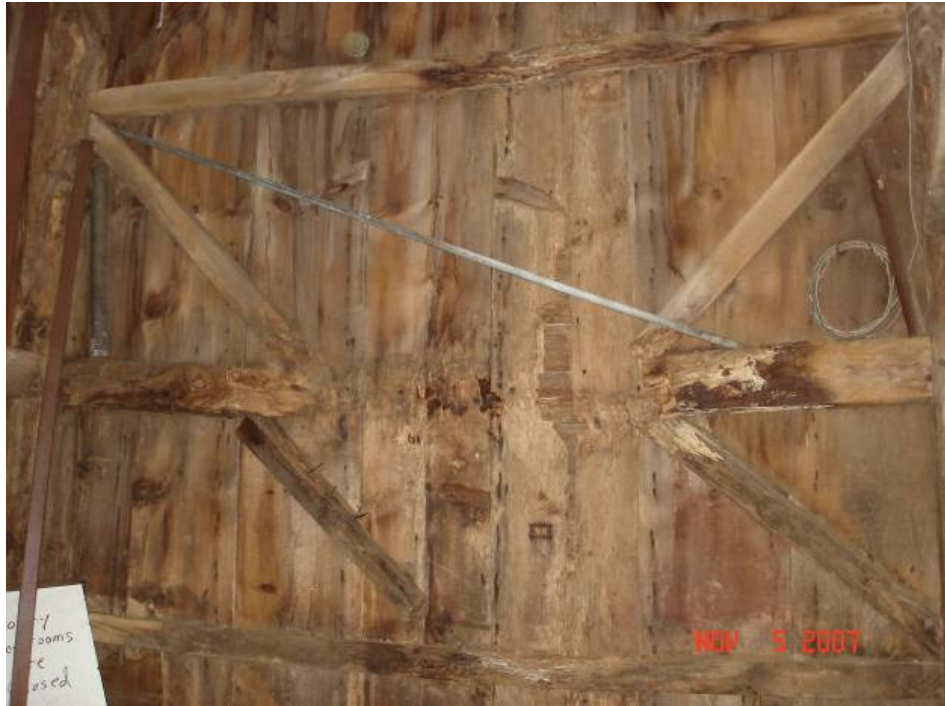
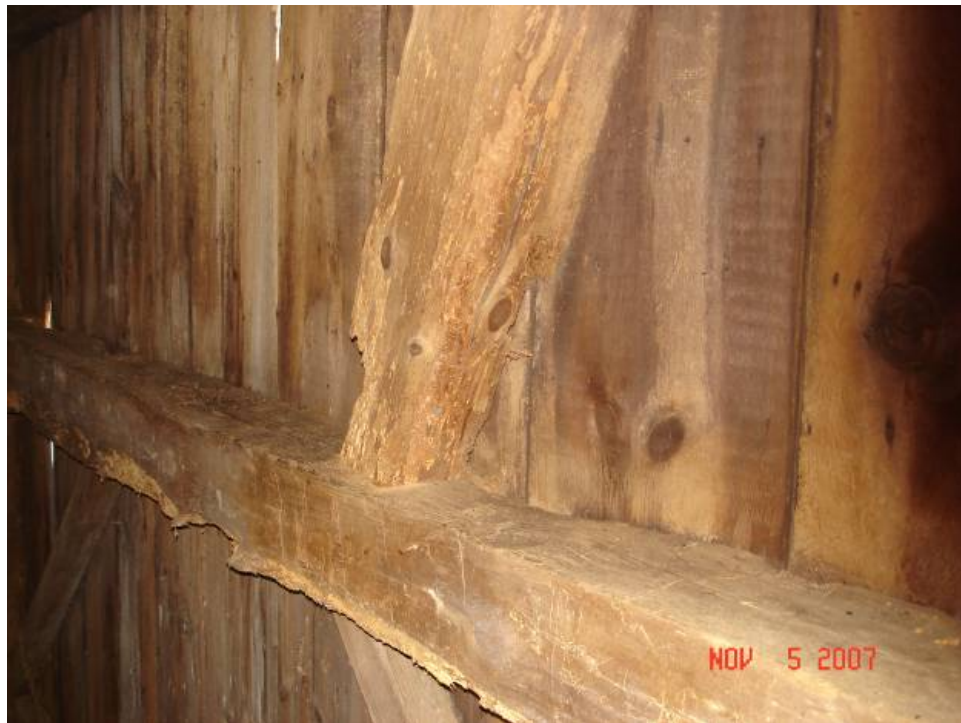
Much of the remaining, original structural material is in poor condition from rot and insect infestation [figs. BS-10 & 11]. Significant differential post settlement has overstressed some of the members to the point of breaking. Some joints display evidence of movement with tenon pull out of up to 1.5 inches and some of the internal columns exhibit signs of movement at their bases [figs. BS-12 & 13]. The poor condition of the beams and unknown extent of the deterioration makes a load rating for the roof problematic. During the site visit, the engineer was informed by park staff that the asphalt shingle roof was overlain with ½" plywood and rolled roofing material.

Figure BS-10 & 11. Deteriorated/missing structural members.
