MINUTE MAN NATIONAL HISTORICAL PARK
JOHN NELSON HOUSE & BARN

HISTORIC STRUCTURE ASSESSMENT REPORT

NOVEMBER 2008

PREPARED BY:
JOHN MILNER ARCHITECTS, INC.
CHADDS FORD, PA

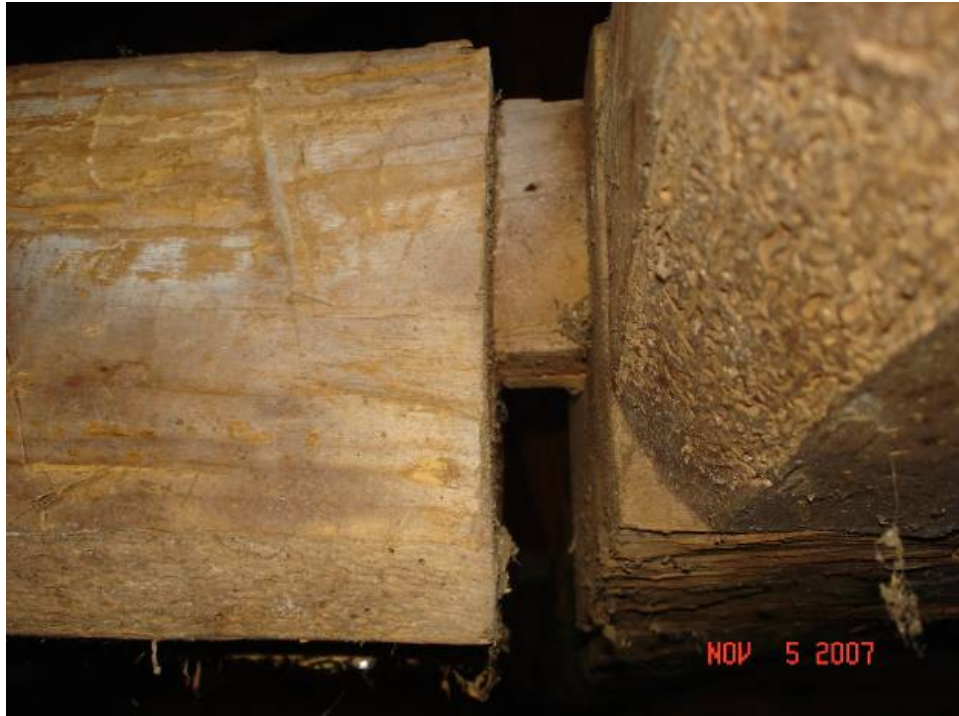
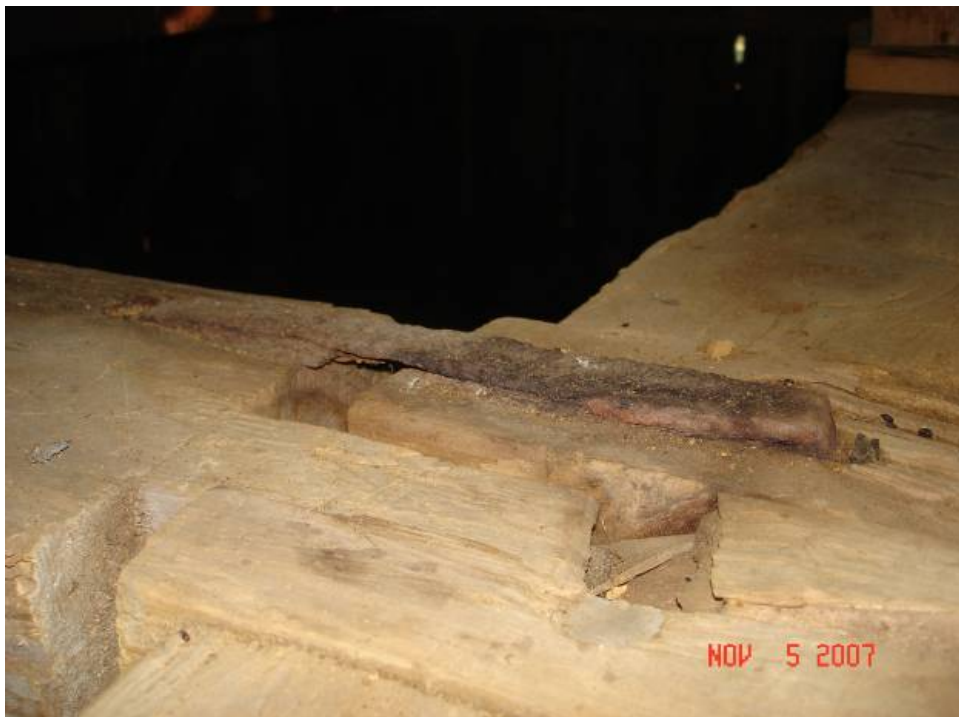
Much of the remaining, original structural material is in poor condition from rot and insect infestation [figs. BS-10 & 11]. Significant differential post settlement has overstressed some of the members to the point of breaking. Some joints display evidence of movement with tenon pull out of up to 1.5 inches and some of the internal columns exhibit signs of movement at their bases [figs. BS-12 & 13]. The poor condition of the beams and unknown extent of the deterioration makes a load rating for the roof problematic. During the site visit, the engineer was informed by park staff that the asphalt shingle roof was overlain with ½" plywood and rolled roofing material.

Figure BS-12 & 13. Tenon pull-out at upper tie-beam.

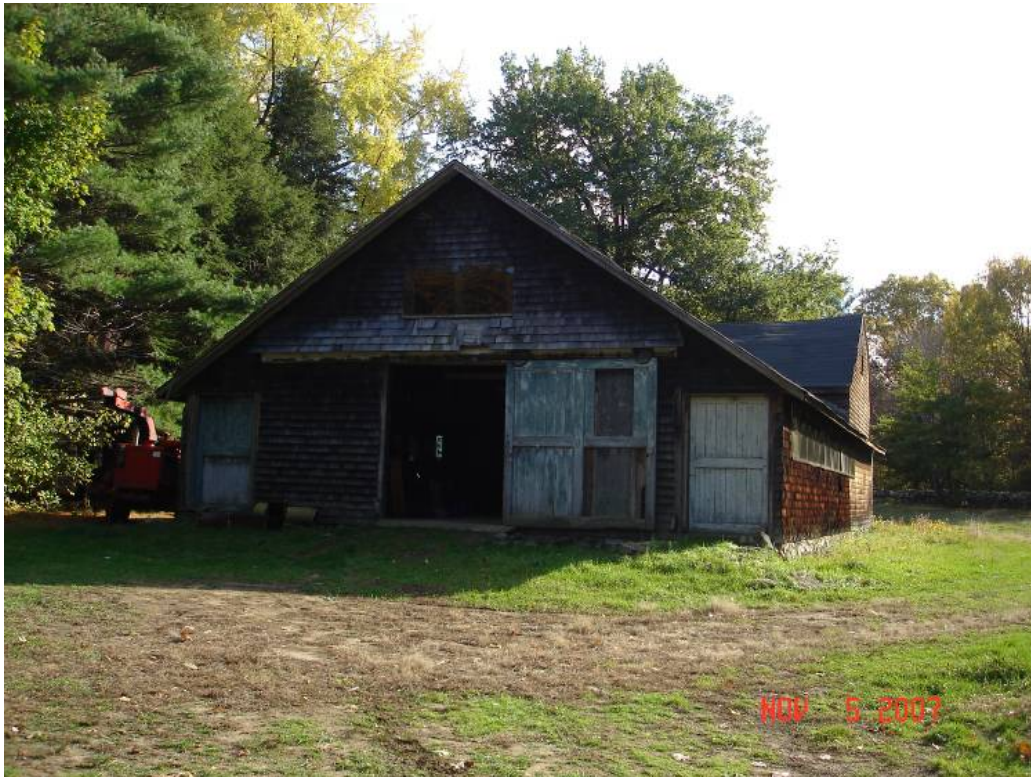
Figure BS-14. North end of north block

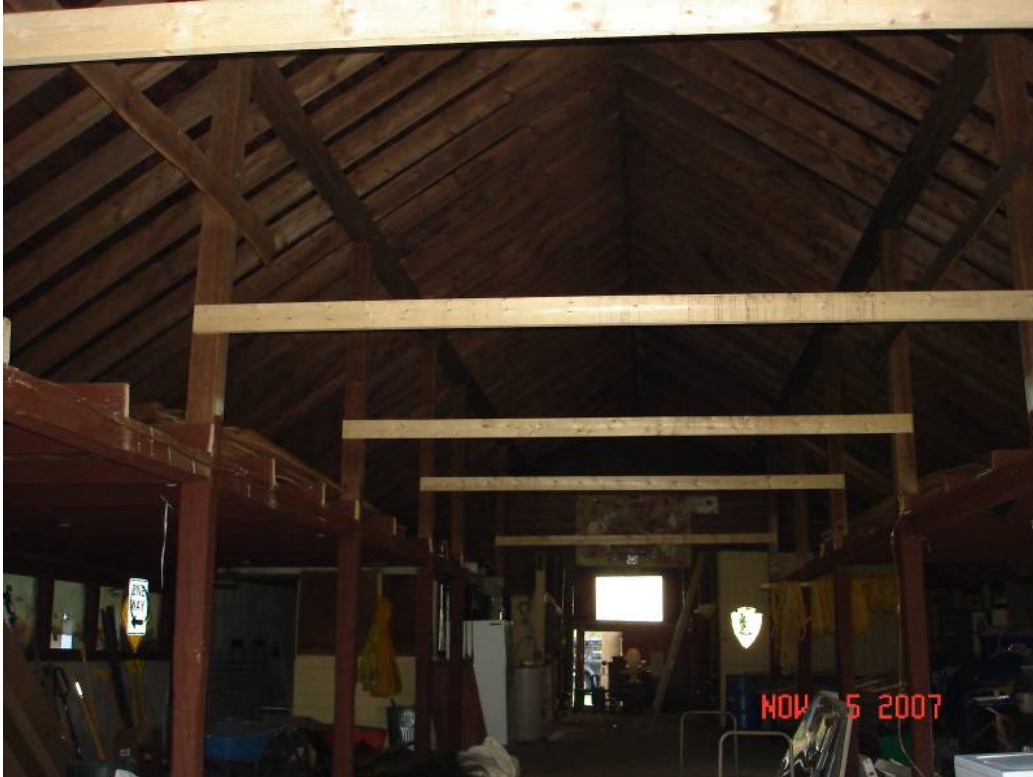
The structural system of the north block consists of two exterior load bearing walls and two interior post and beam bents, oriented north-south. The structure is symmetrical to the roof ridge board. The internal bents consist of 6x6 posts set approximately 9'-7" on-center. The posts are connected by a 6x8 (estimated) tie beam, spanning north-south. The 2x8 rafters span east-west between the ridge board and the exterior walls. The tie beams support the rafters at about the upper one-third point of the rafters.

Figure BS-15. North block framing.

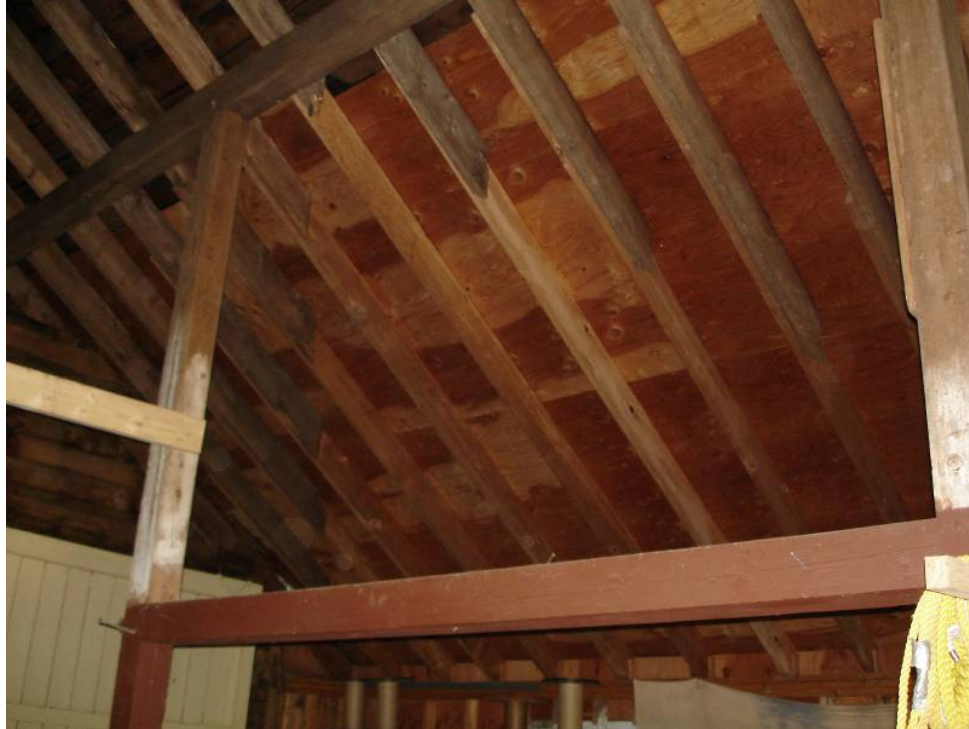
The roof is sheathed in solid wood boards (likely tongue and grooved). A portion of the roofing in the southwest corner was installed in 1979 when the western wing was removed. The replacement roofing is framed with 2x8 rafters that are “fish-plate” spliced to the original rafters. Plywood sheathing was installed in this repaired area [fig. BS-16].

Figure BS-16. Roof framing at southeast corner.

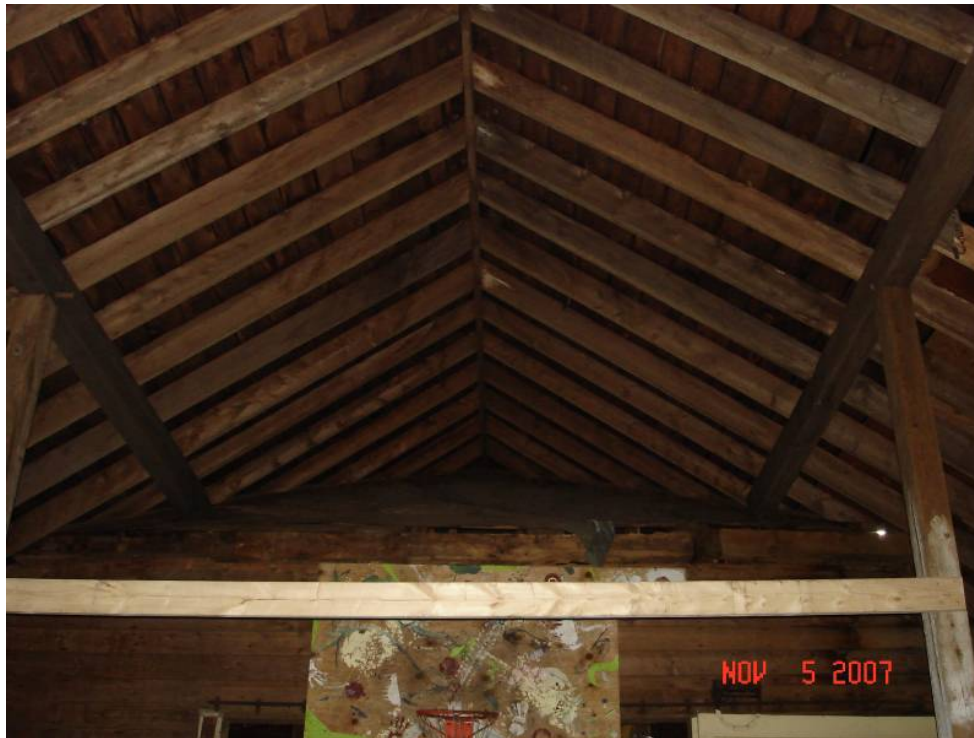
Figure BS-17. North block roof extension over south block roof.

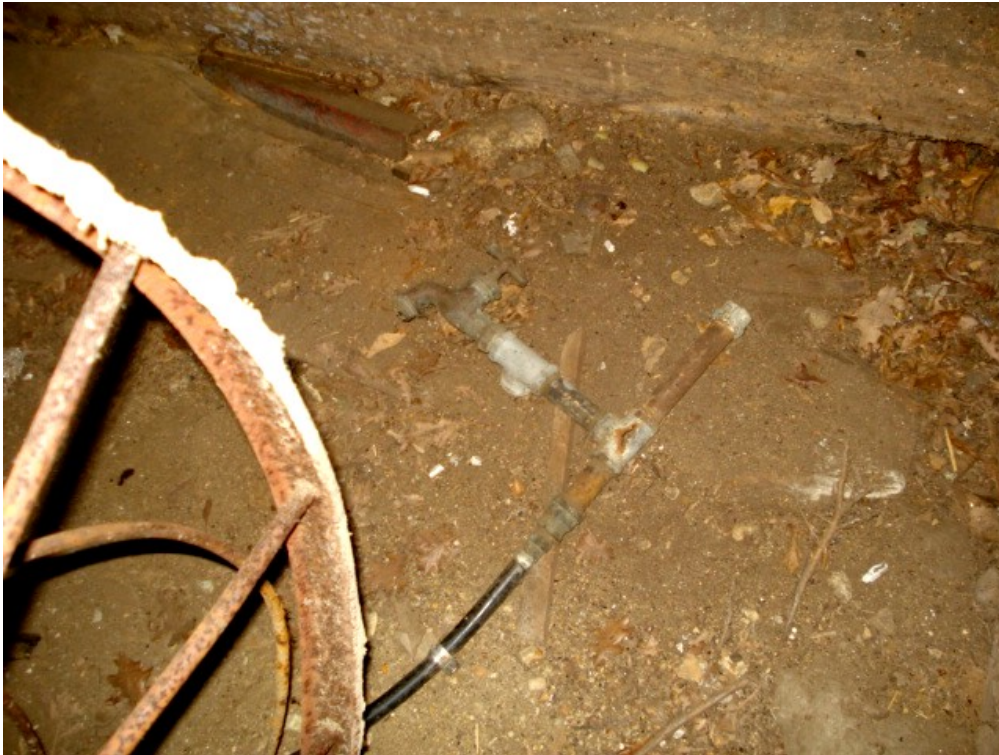
The municipal domestic water service includes a 3/4" connection that is routed to a buried plastic pipe serving a hose bibb located in the ground within the adjacent barn [fig. BP-1].

Figure BP-1. Hose Bibb in Barn

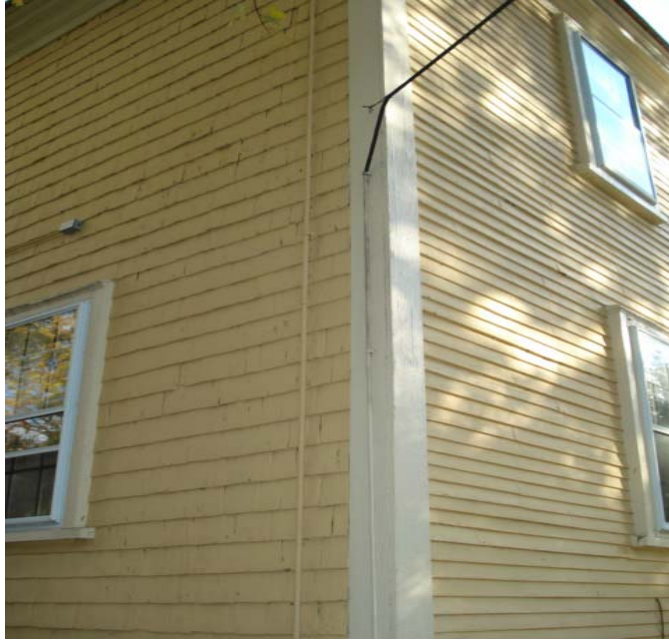
Figure BE-1 . Barn overhead feeder.

The existing 2-circuit electrical service panel, which contains the only disconnecting means, is in poor condition and should be replaced. The condition of the service conductors is poor. The interior distribution and devices are also in poor condition. The existing 2-circuit electrical service panel/disconnect serves lighting and receptacle throughout the barn. The existing service conductor (overhead), service panel, interior wiring, and light fixtures are in poor condition and require replacement for any type of re-use scenario.

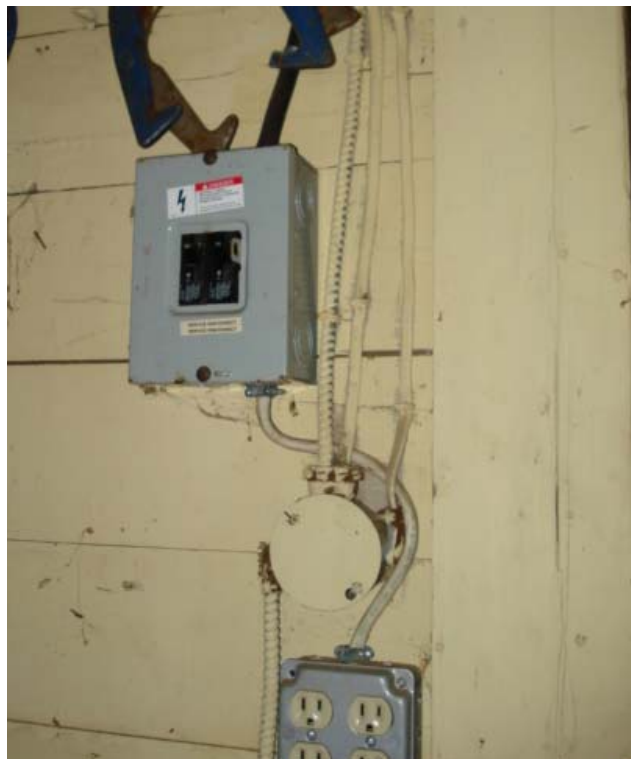
Figure BE-2. Barn service.
