DISTRICT OF COLUMBIA WAR MEMORIAL

Historic Structure Report
& Cultural Landscape Assessment

National Mall & Memorial Parks
PMIS NO. 43699

May 2006

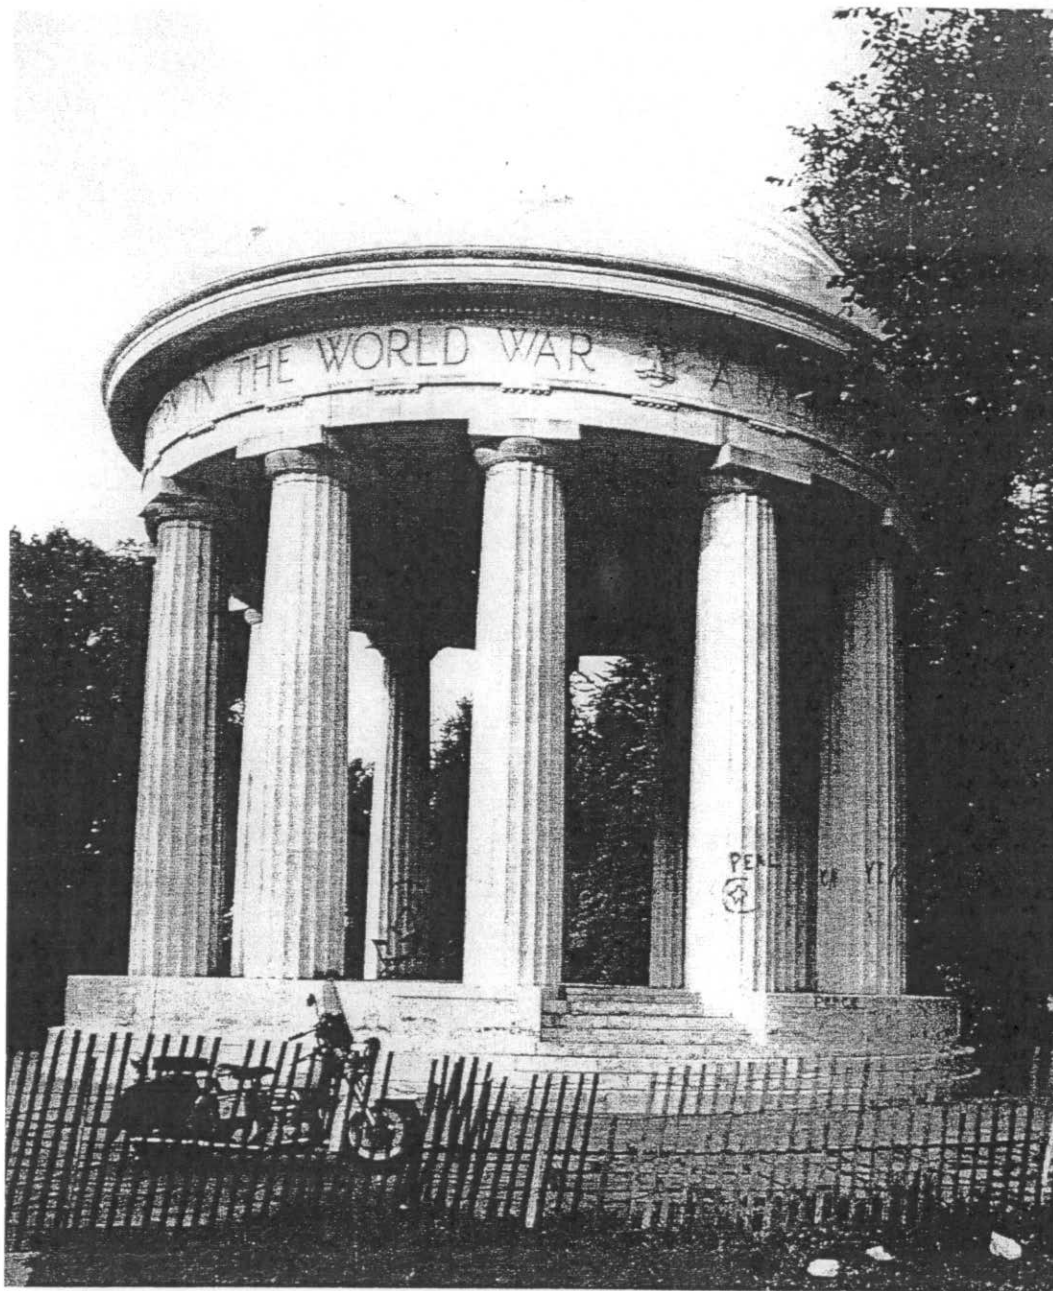
Figure 22. In 1968, vandals defaced the Memorial with graffiti. [Action Line, Evening Star, June 29, 1968]

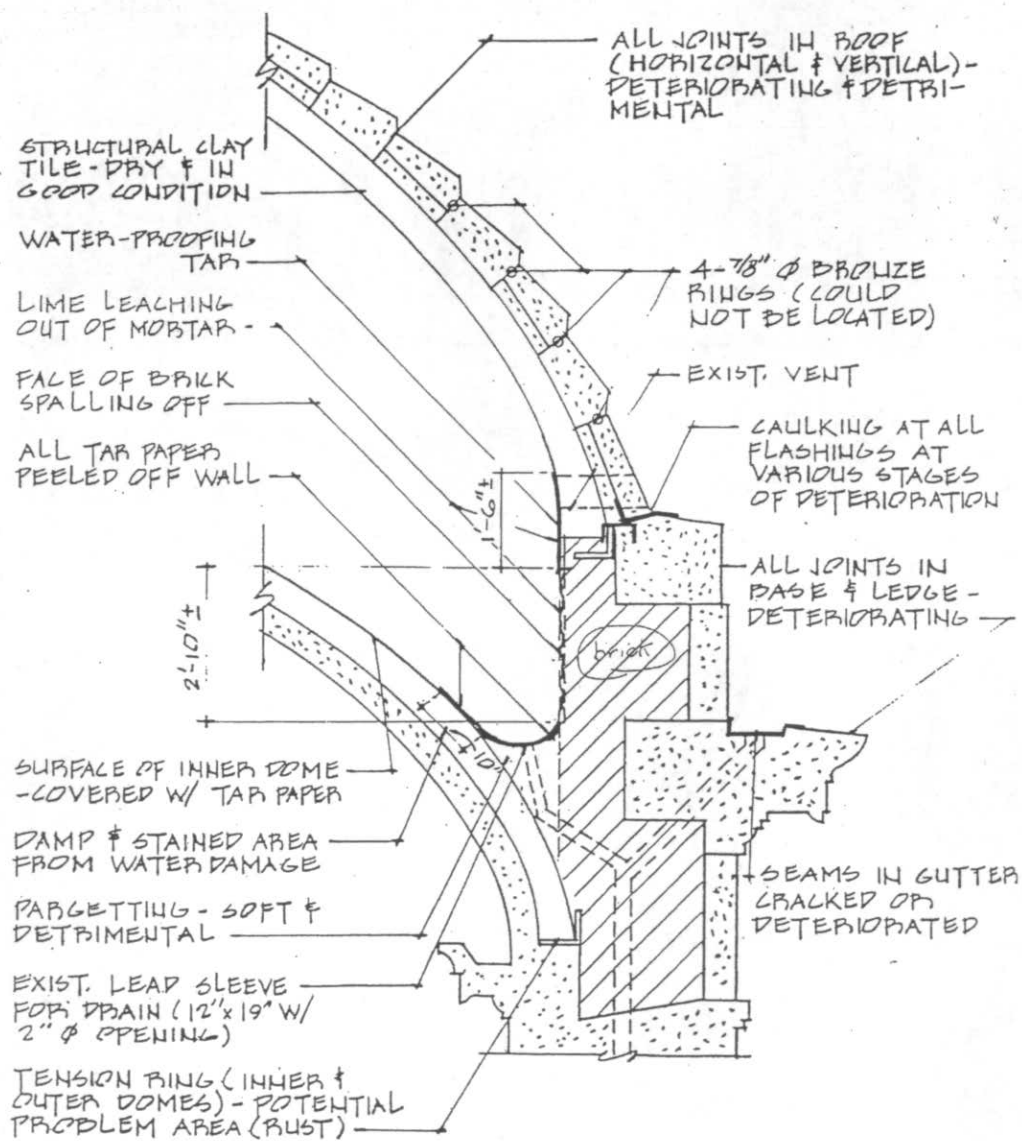
EXISTING CONDITIONS
@ CORNICE

Figure 24. "Existing Conditions @ Cornice," included in September 28, 1984 report by Tom Fields. [District of Columbia War Memorial File, National Capital Parks-Central, courtesy of Tony Donald.]

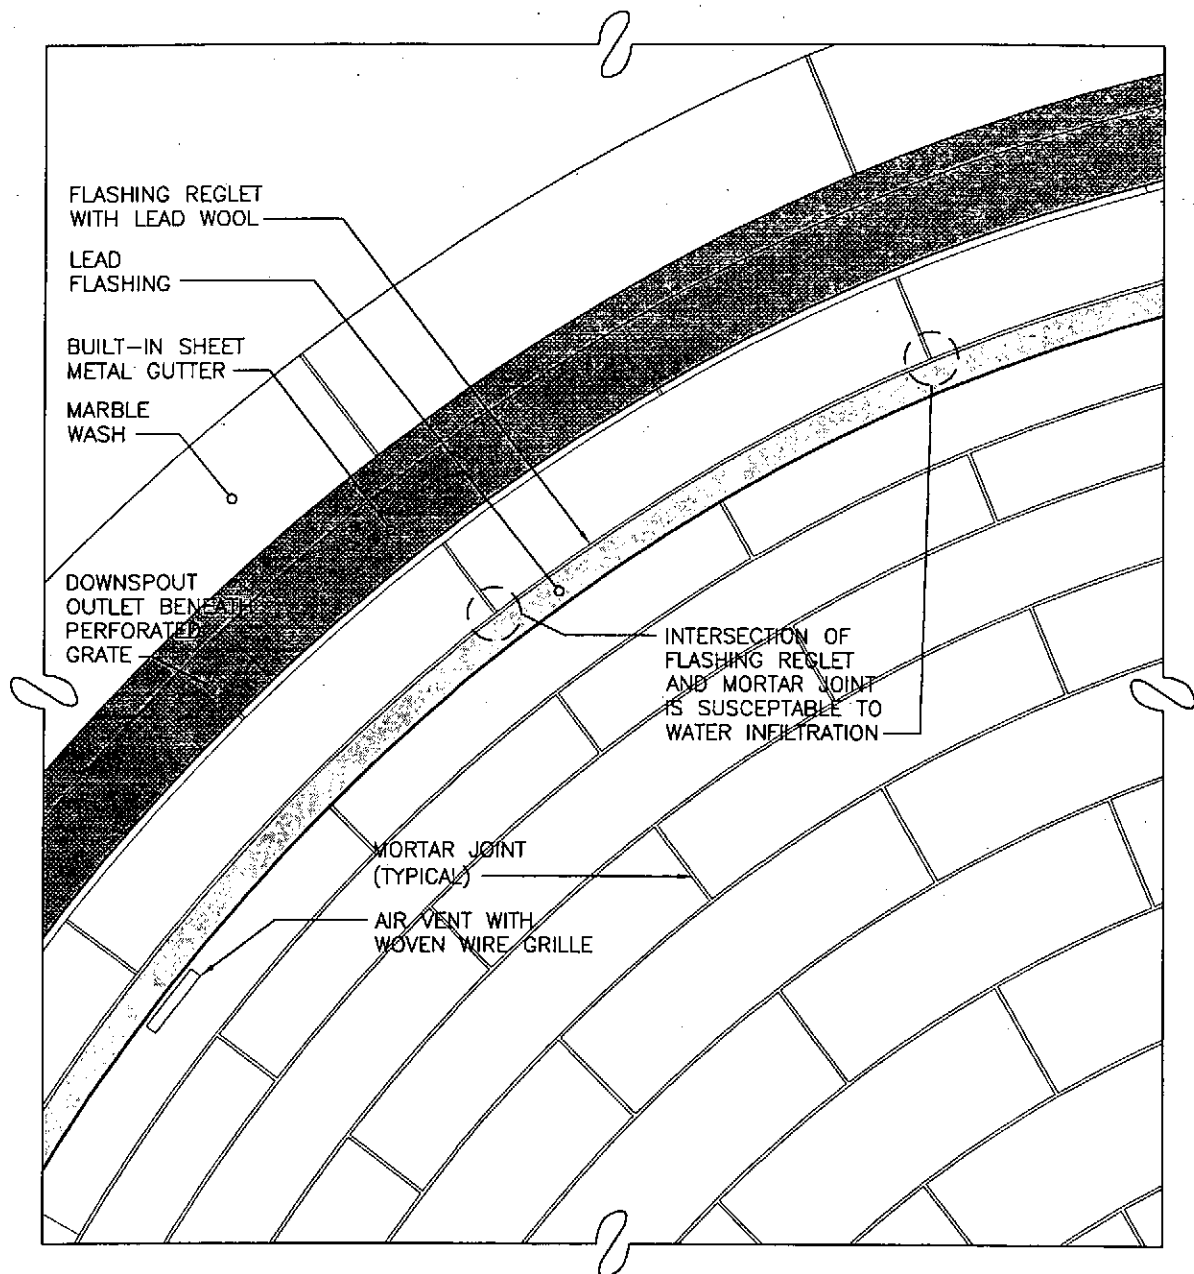
DC WAR MEMORIAL
ROOF PLAN — REGLET LOCATION

- The woven-wire stainless steel vent grilles at the base of the outer dome are loosely fitted in the openings.
- The lead-coated copper of the replacement gutter is beyond its service life span; the lead is eroded, exposing the thin layer of tin between the lead and copper. Many of the joints in the lead-coated copper have been compromised; they have been torn and pulled apart by thermal expansion and contraction of the metal. The solder joints are cracked. The counter flashing at the back of the gutter is generally loose in the horizontal mortar joint of the marble. Moss and algae are growing in the mortar joint; and sealant, which is over-applied onto the flashing and surrounding stone and mortar, has failed.

- The pitch of the gutter is insufficient for proper drainage to the four downspout outlets. Cross seams in the copper gutter are pronounced, preventing proper drainage.

1. Clean the marble construction of the memorial, removing soil, stains, biological growth, and mineral deposits.
2. Conduct building probes to determine the nature and condition of the bronze tension ring reinforcement at the base of the outer dome.
3. Remove and reset individual pieces of displaced marble. Pin broken stones and perform dutchman repairs. Point the marble construction of the memorial.
4. Install new lead gutter and flashings to replicate the original sheet metal construction, and replace the existing internal downspouts in four columns.

Alternate: Install sheet metal flashings and drip edges over the capstones at the base of the outer dome, and over the built-in gutter.
5. Replace the electrical panel box and circuit wiring that services the memorial.
6. Replace the cove lighting beneath the lower dome.

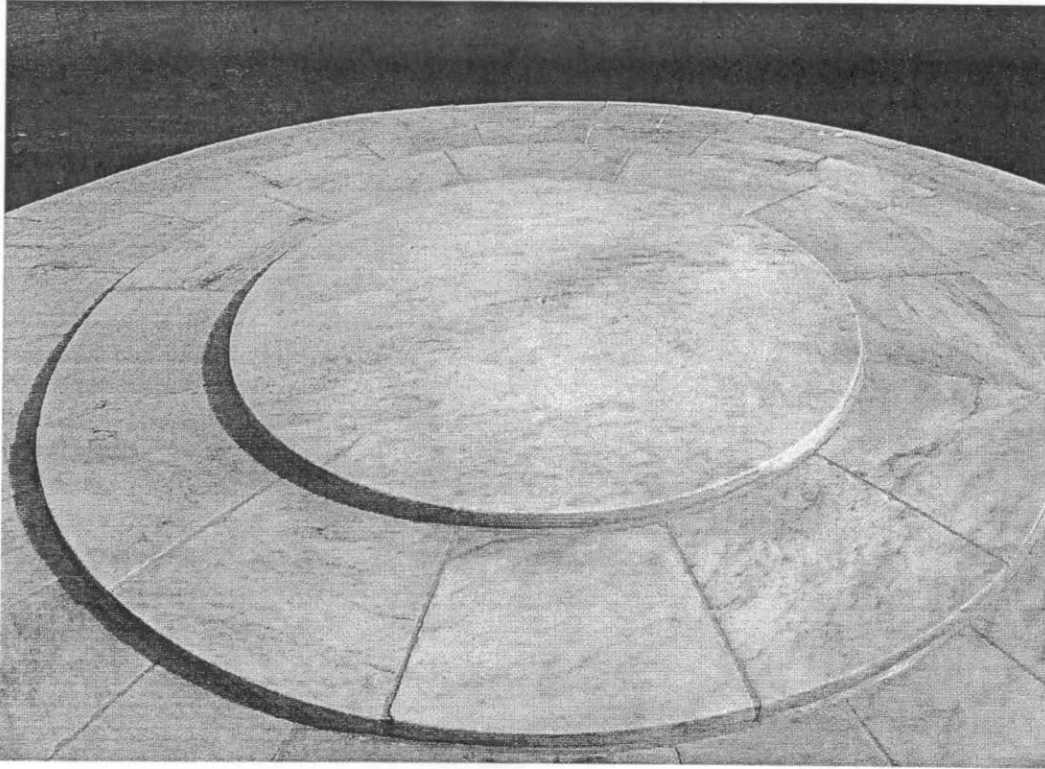
Detail of the capstone of the dome. [JGWA, 2005]

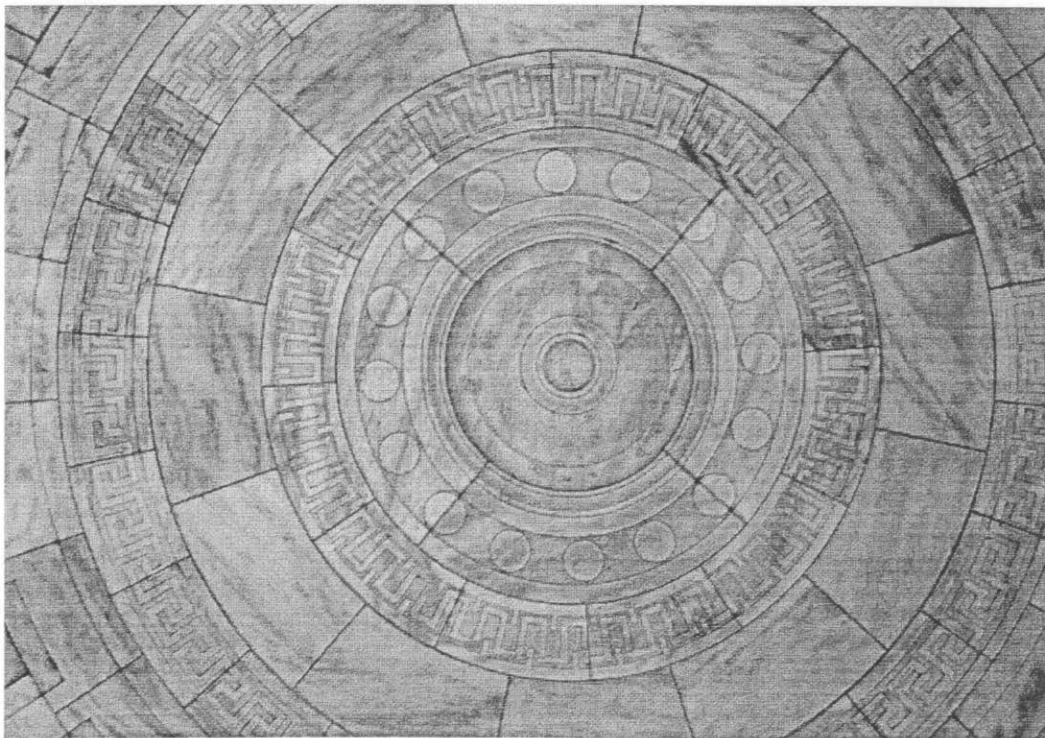
The ceiling of the Memorial. The counterweighted attic access panel is located in the oculus of the lower dome. [JGWA, 2005]

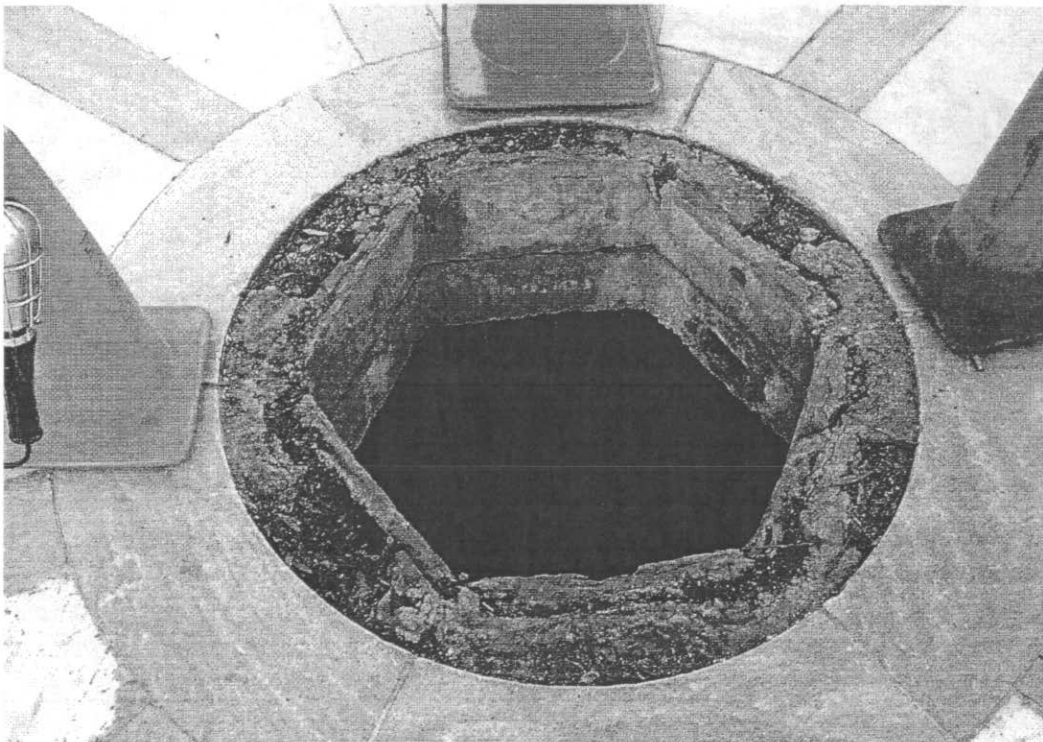
Floor opening providing access to the electrical vault below the Memorial. [JGWA, 2005]

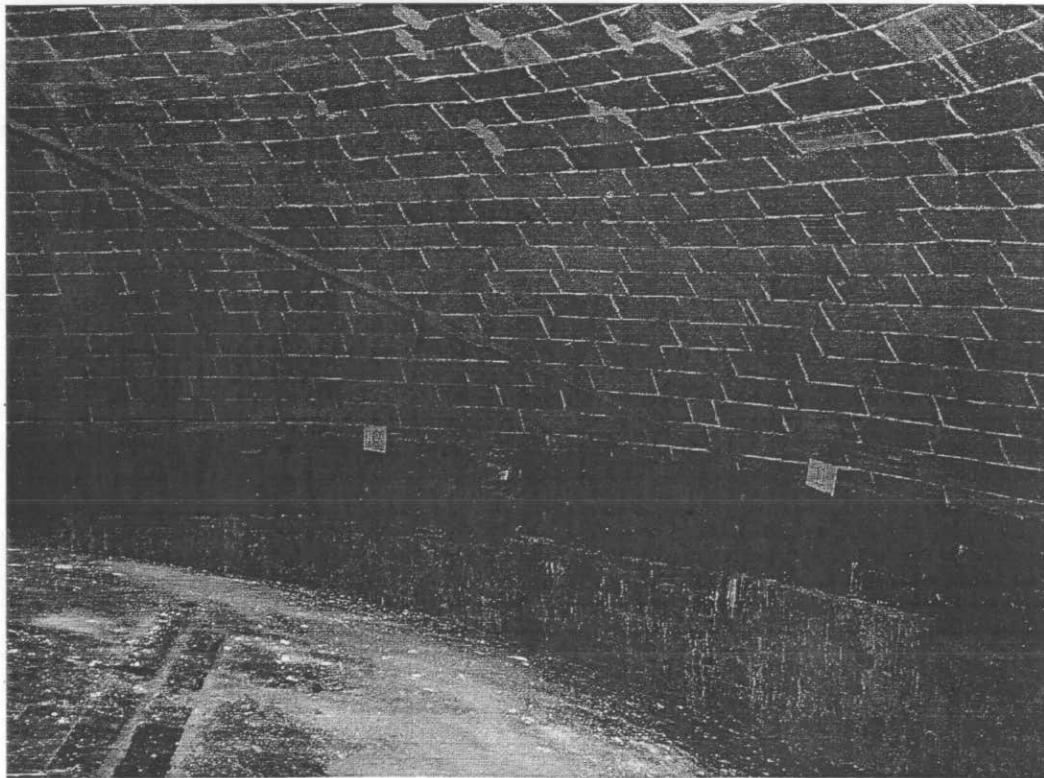
The tile construction of the upper dome bears on the brick drum below. [JGWA, 2005]

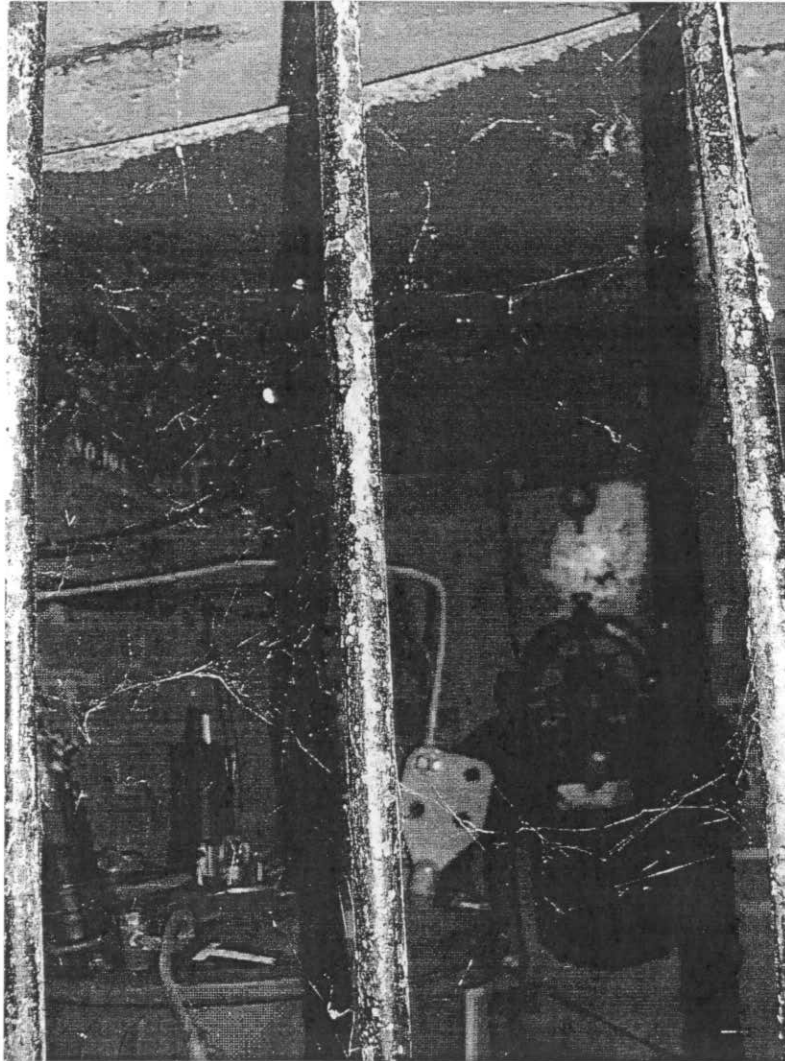
The electrical vault beneath the Memorial, looking south into the transformer room. [JGWA, 2005]

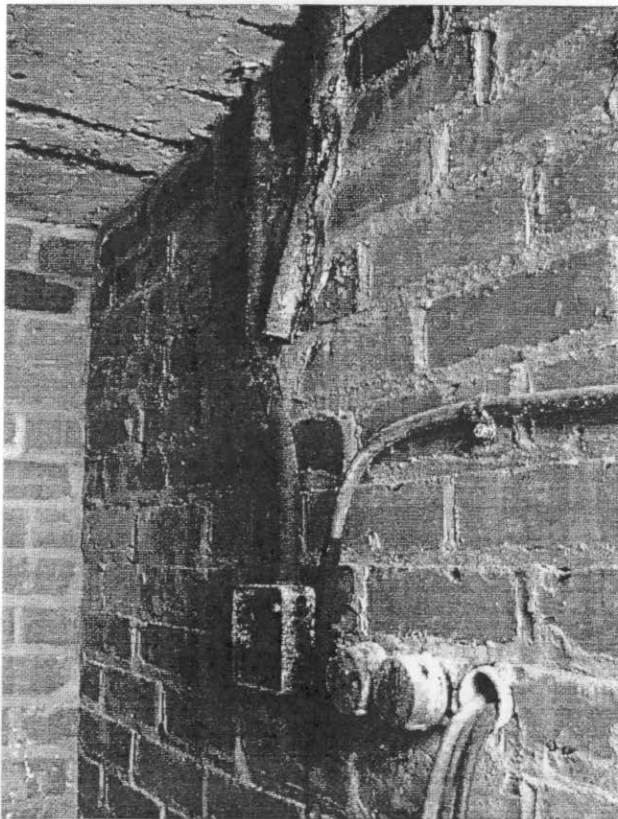
An open electrical junction box and a panel box with exposed conductors are located in the electrical vault beneath the Memorial. These are significant electrical shock hazards. [JGWA, 2005]

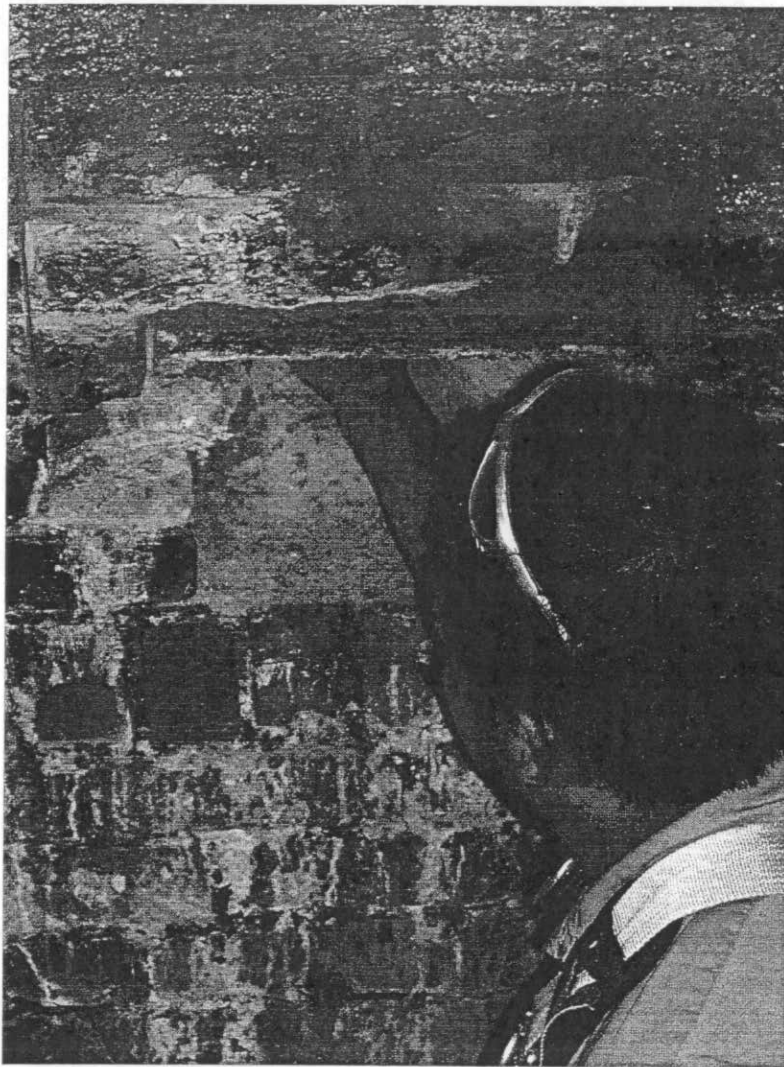
Binh Nguyen of the National Park Service investigating the void between the steel angle tension ring and the marble construction beyond. [JGWA, 2005]

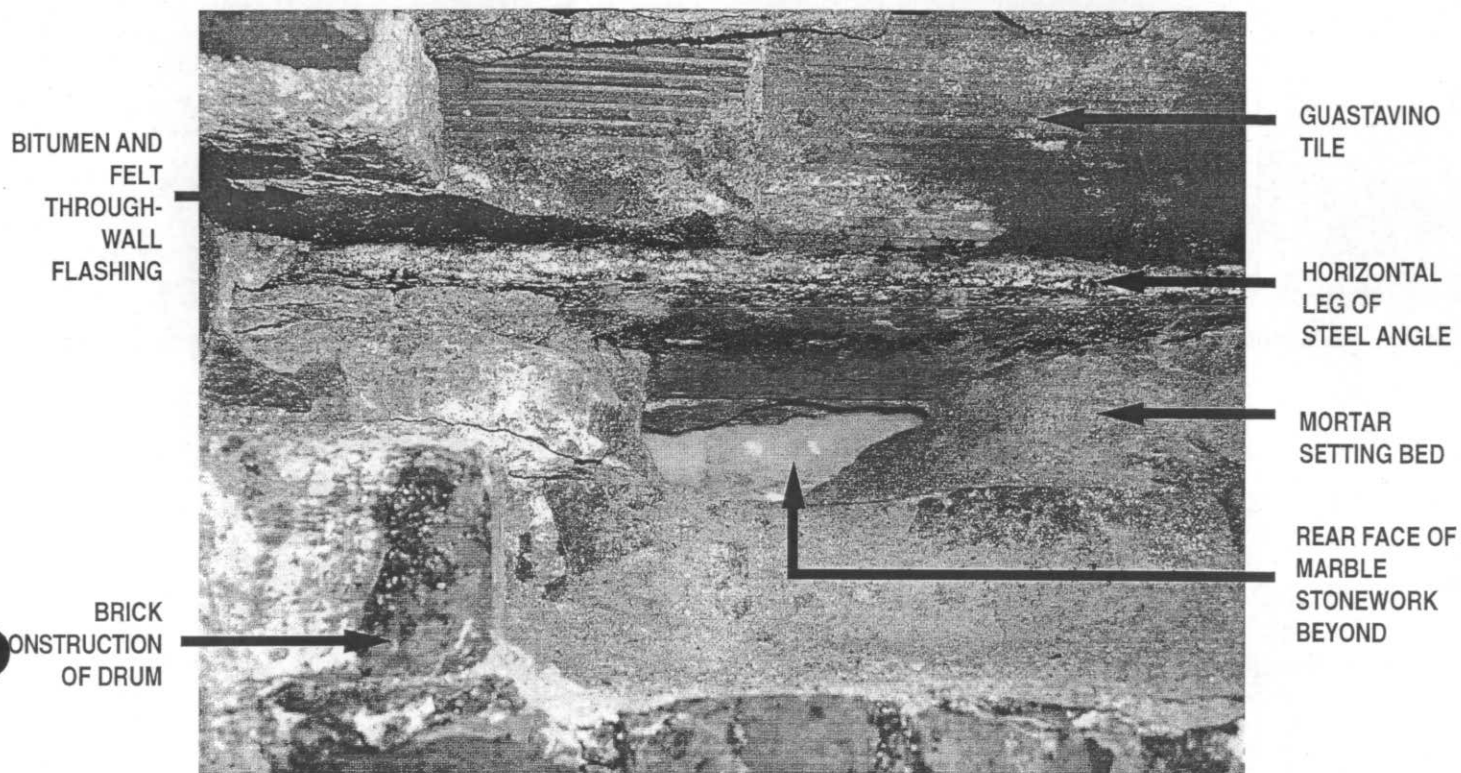
Probe A investigated the condition of the steel angle tension ring at the base of the upper dome. Binh Nguyen and Ray Wooden of the National Park Service removed brick and mortar from the drum construction supporting the dome. The probe was located between columns 10 and 11. [JGWA, 2005]

Detail view of Probe A. [JGWA, 2005]

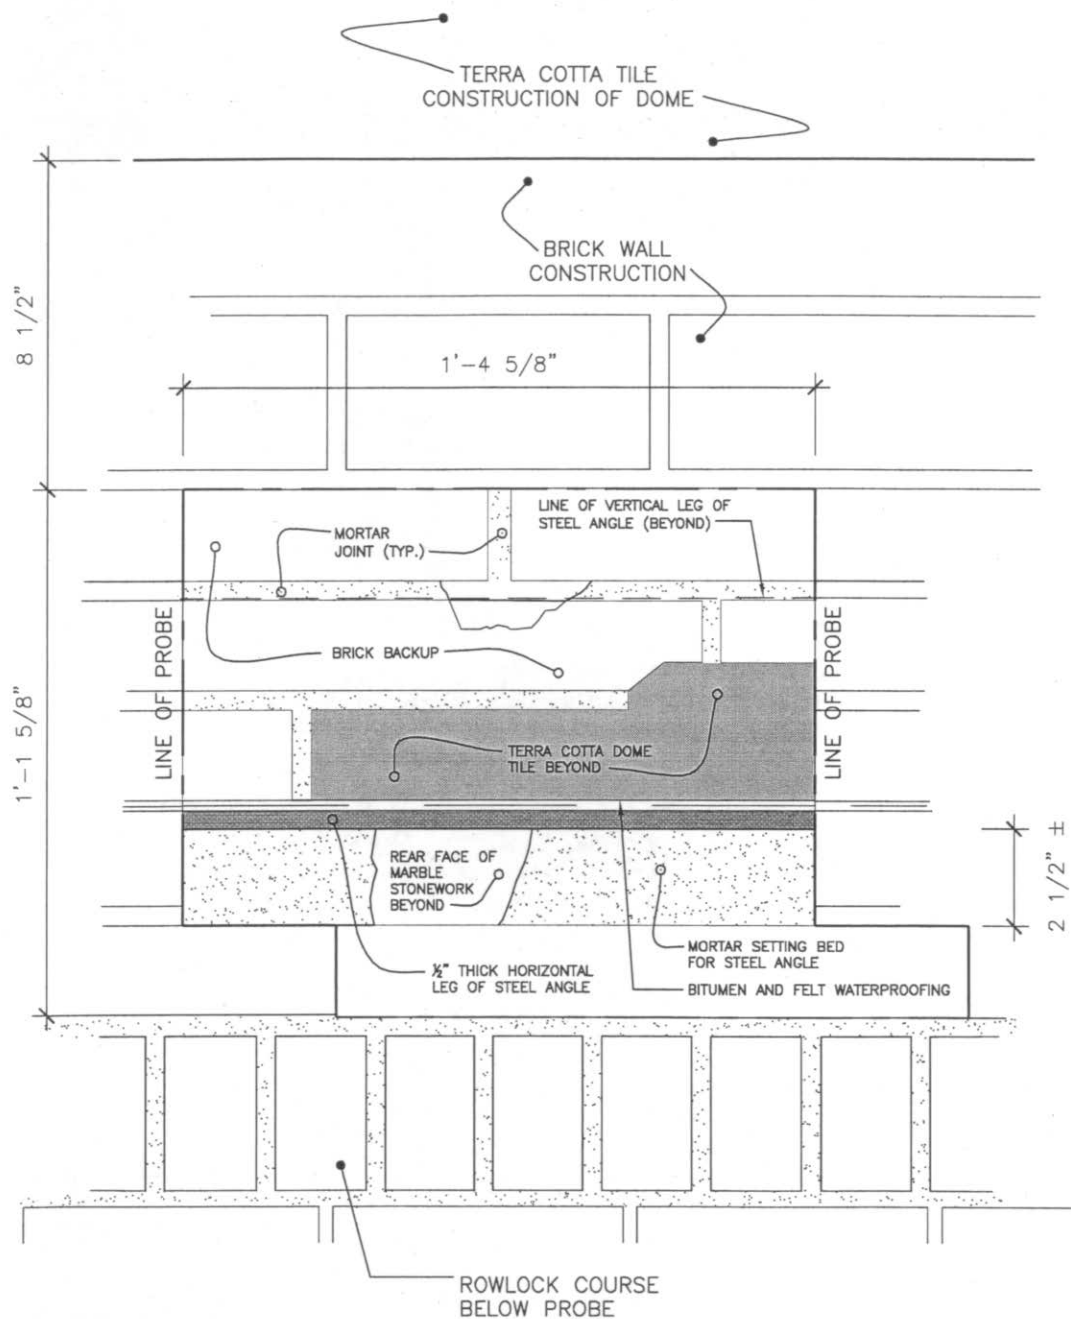
DC WAR MEMORIAL
 PROBE A -ELEVATION
 JUNE 22, 2005

The brick was removed above and below the horizontal leg of the 6"x6"x1/2" steel angle. The terra cotta tile of the outer dome was found to be bearing on the angle, with the vertical leg of the angle restraining the tile. The displaced brickwork was the result of the brick at the upper extent of the drum sliding on a through-wall bitumen-and-felt waterproof flashing that appears to have been installed during the original construction of the memorial. The flashing or membrane appears to have been applied along the vertical surface of the brick drum, within the attic space, and turned into the wall approximately 3'-0" above the condensate drainage valley between the lower dome and the drum of the upper dome. The flashing was laid over the horizontal leg of the steel-angle tension ring, and presumably extended upward at the vertical leg of the steel angle, between the terra

If the through-wall flashing simply continued up the outer surface of the upper tile dome, we would expect the steel-angle tension ring to be seriously corroded as water was shed off the base of the tile dome. This was not the case. The steel was found to be in very good condition, with only a minor degree of surface rust. The membrane on the outer surface of the upper tile dome may have continued out to the lead flashing at the base of the marble dome tiles. In this way the integrity of the steel angle may have been preserved. The 3"± void between the vertical leg of the steel angle and the back face of the marble cap stone of the outer drum may have contributed to the survival of the angle (see drawings).

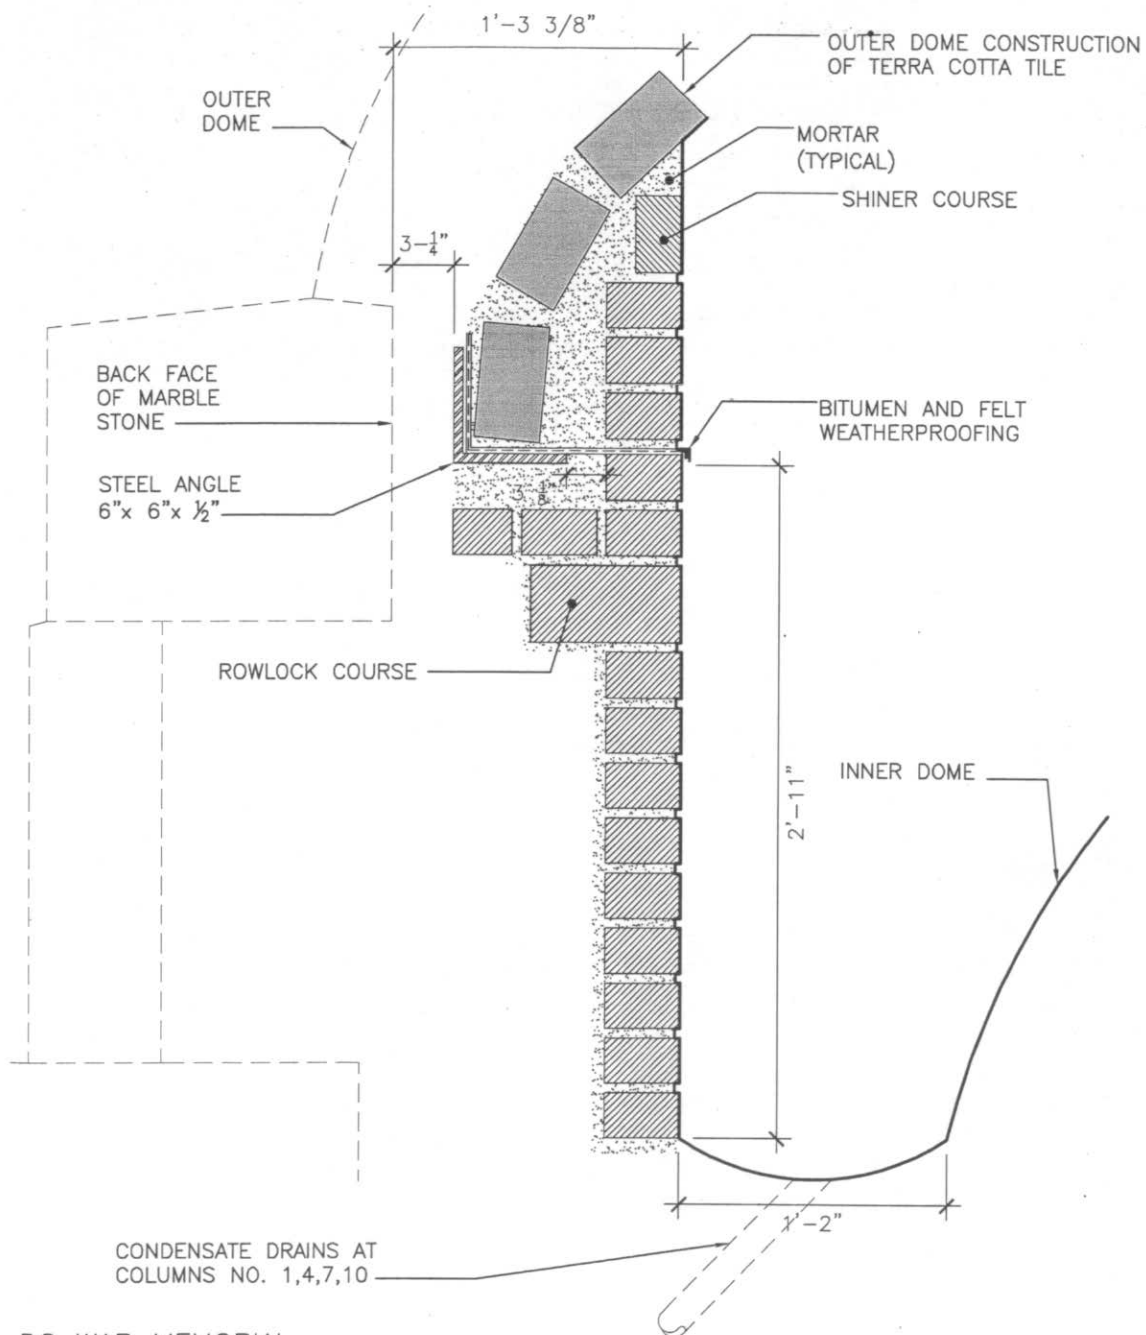
DC WAR MEMORIAL
 PROBE A -SECTION THROUGH OUTER DOME AND DRUM
 JUNE 22, 2005

Within the attic space the terra cotta tile of the upper dome appeared to be in excellent condition, with no staining, nor indications of failure. Therefore, it was assumed that the waterproofing membrane above the terra cotta dome must be in good condition. It was known that the mortar in the joints of the marble roofing tiles or slates was deteriorated or missing for an extended period of time. It appears that water infiltrated the open joints in the marble dome construction and was shed by the waterproof membrane above the tile dome. The water appears to have drained to the base of the outer dome, where it saturated the masonry construction of the drum; the moisture in the drum construction then appears to have undergone freeze-thaw cycling, causing brick spalling and the delamination of the waterproof membrane from the inner wall of the drum. A significant amount of efflorescence has occurred on the surface of the drum brickwork as the moisture in the drum construction has evaporated.

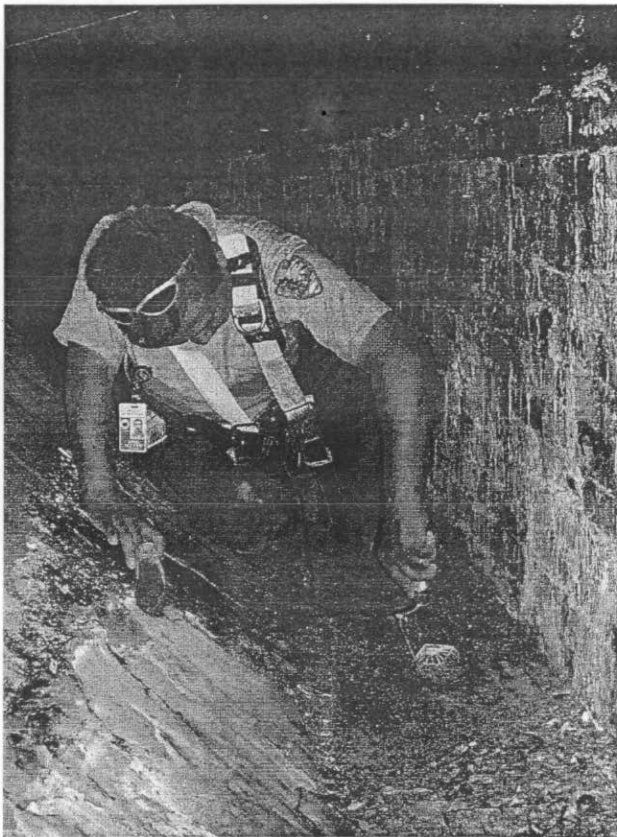
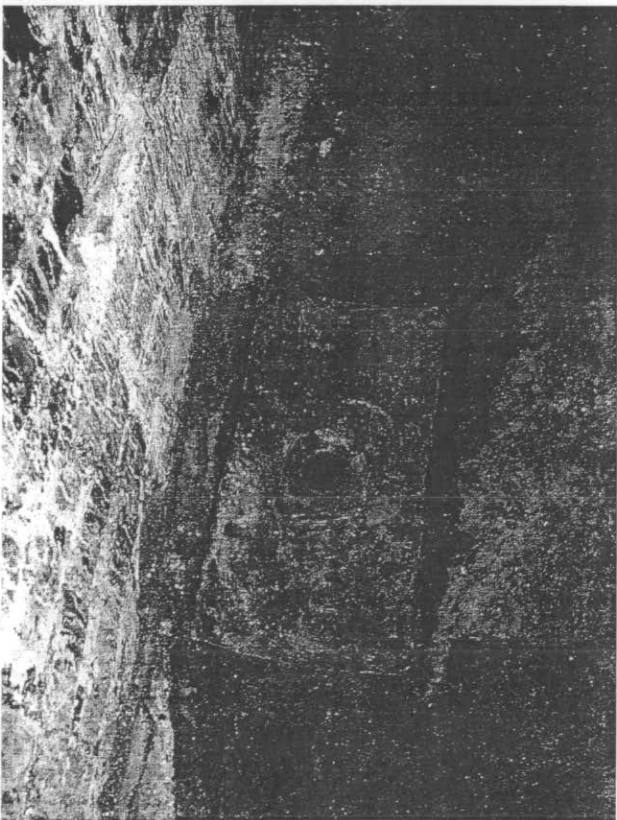
A lead flashing or pan, approximately 9-1/2" wide by 1'-6" long was exposed. There was a 2" diameter outlet located at the center of the pan. The pan was located in the shallow trough or valley at the intersection of the inner dome and the drum construction of the outer dome. The drum construction consisted of brick as a backup material for the marble entablature.

Probe B investigated the condensate drainage outlet above column 10. The outlet and bird's nest strainer were blocked with sand and covered with bitumen-coated roofing felt.

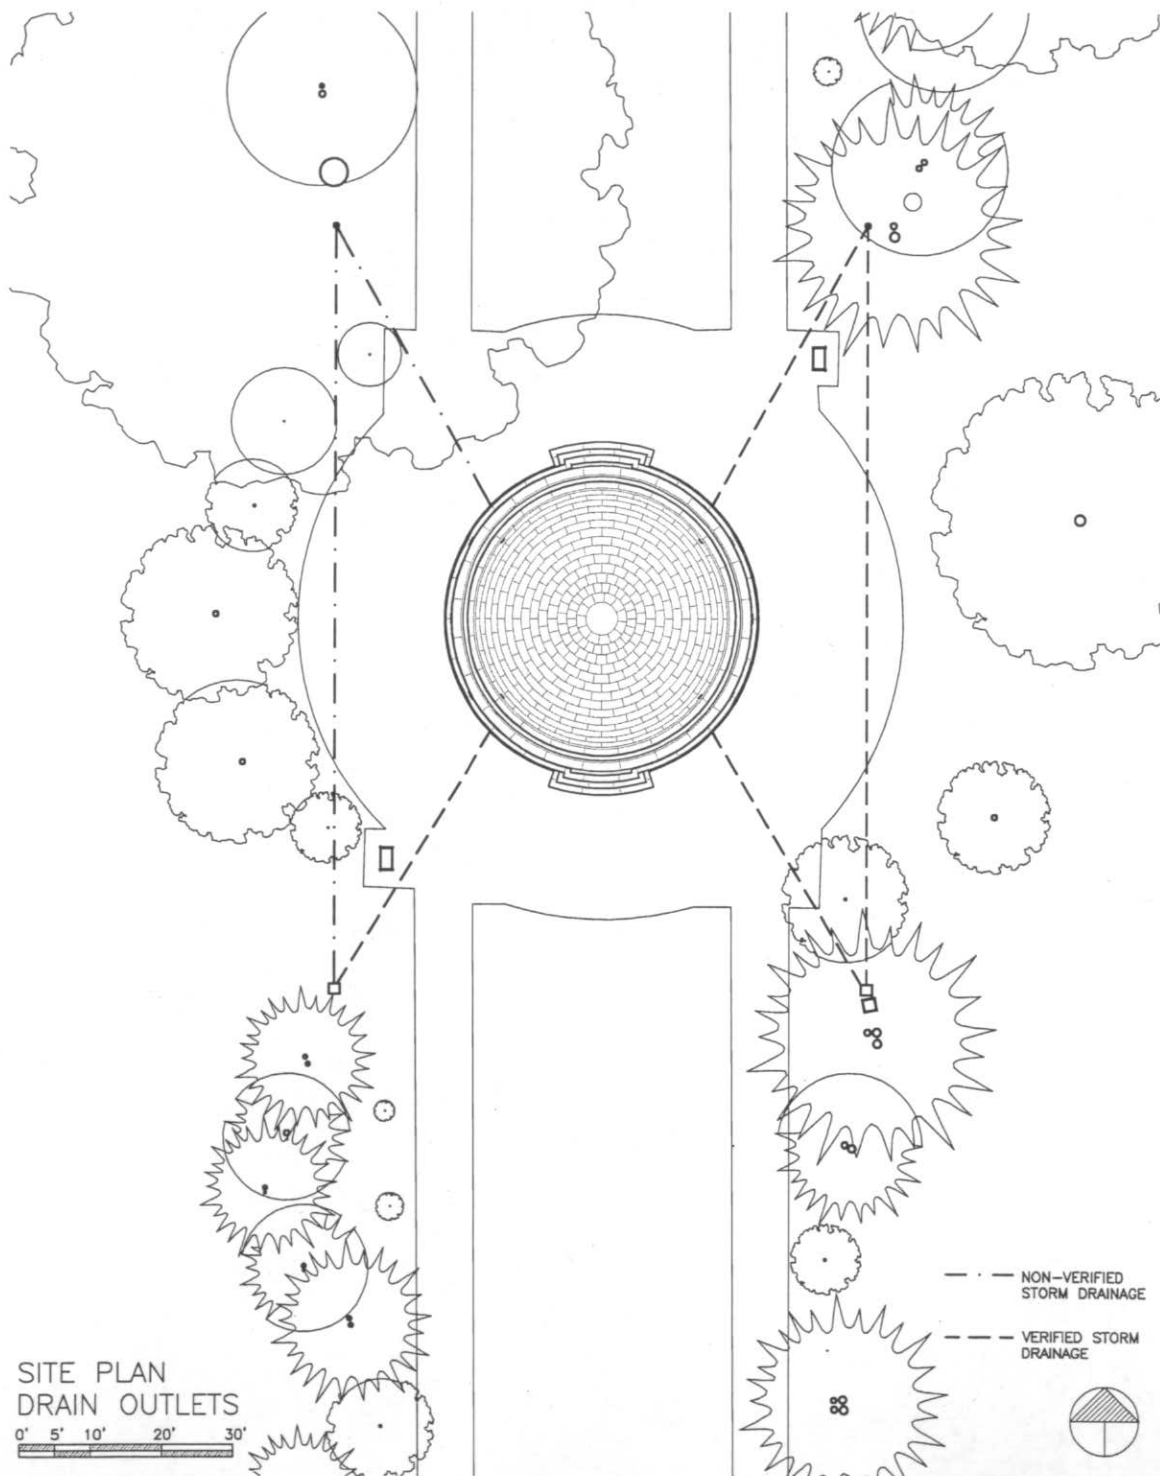
On July 15, at 12:50 p.m., in hot, humid weather (overcast with sun, 80 degrees F), a continuously flowing water hose was inserted in the downspout outlet above Column No.10 (southwest quadrant). After removing six to twelve inches of soil and mulch from the grate of the catch basin located approximately twenty yards to the southwest of the memorial, water was observed to be flowing freely through the catch basin. Water came into the catch basin on the diagonal, directly sighted from Column No.10. No moving water was observed at the catch basin located to the southeast of the memorial.

A continuously flowing water hose was inserted in the downspout outlet above Column No.7 (southeast quadrant). After removing the grate of the catch basin located approximately twenty yards to the southeast of the memorial, water was observed to be flowing freely through the catch basin. Water came into the catch basin on the diagonal, directly sighted from Column No.7. No moving water was observed at the catch basin located to the southwest of the memorial.

A continuously flowing water hose was inserted in the downspout outlet above Column No.4 (northeast quadrant). Water was heard running in the manhole located approximately twenty yards to the northeast of the memorial; and after a ten to fifteen minute delay water was observed to be flowing freely at the catch basin located approximately twenty yards to the southeast of the memorial. Water came into the catch basin from the north, directly sighted from the manhole located to the northeast of the memorial.

A continuously flowing water hose was inserted in the downspout outlet above Column No.1 (northwest quadrant). A capped concrete distribution box was located six to twelve inches below grade, approximately twenty yards to the northwest of the memorial. It was not possible to determine if water was flowing into the distribution box (see drawing).

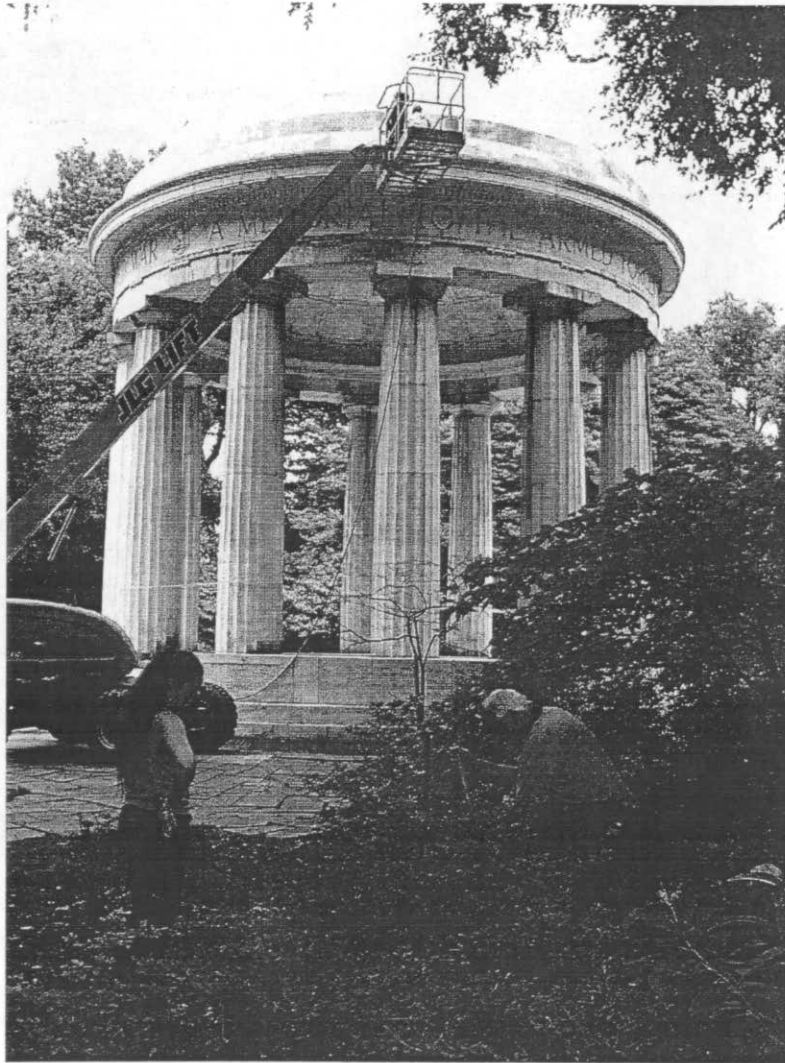
Tony Donald of the National Park Service and Nancy Rankin of John G. Waite Associates, Architects look for a site drainage structure to the northwest of the Memorial, as Binh Nguyen of the National Park Service directs water through the internal downspout at column 1. A series of water tests were conducted to determine how the Memorial's stormwater drainage system operated. [JGWA, 2005]

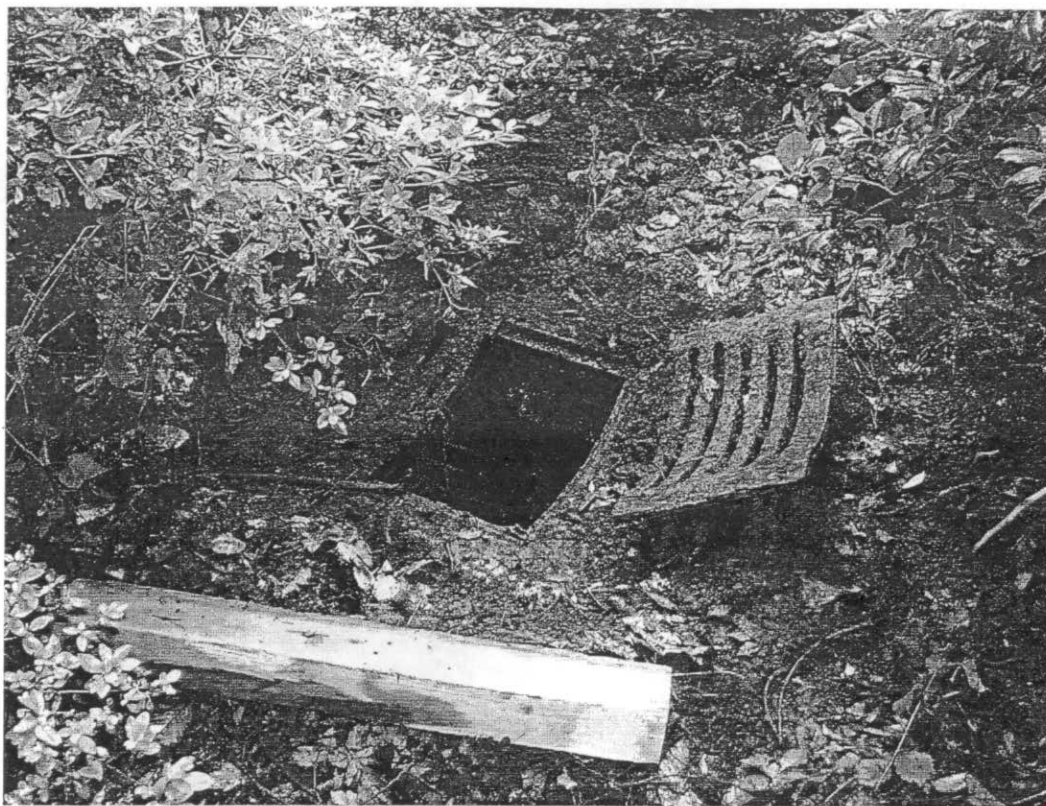
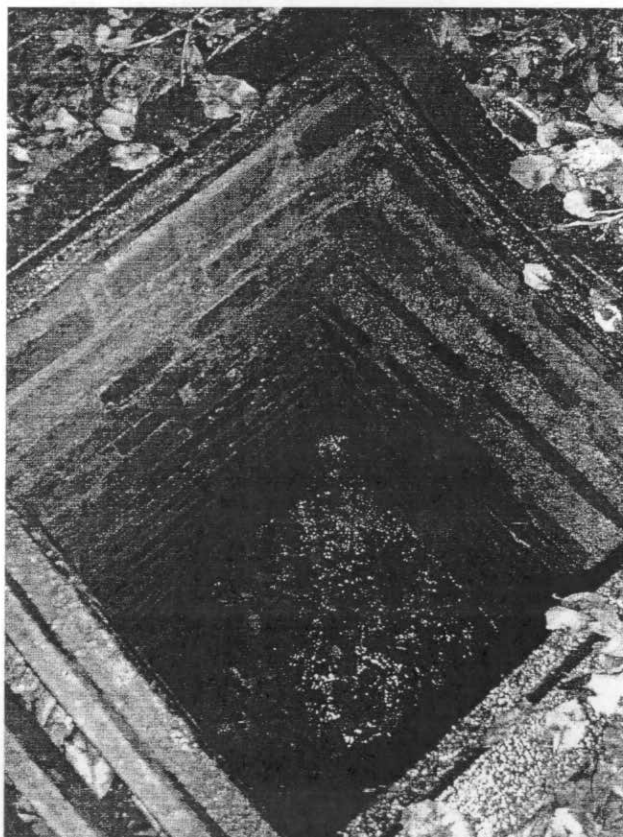
Field observations on July 15, 2005, revealed that the downspouts in Columns 1, 4, 7, and 10 have apparently failed. Original specifications indicate that these downspouts were of cast-iron construction. Water was found leaking from the horizontal base joints at each of these columns. This appears to be a chronic problem because the constant presence of water on the marble paving at the base of these columns is supporting the growth of algae.

Water tests demonstrated that the downspouts in columns 7 and 10 drained directly to these catch basins located to the southeast and southwest of the Memorial, respectively. [JGWA, 2005]

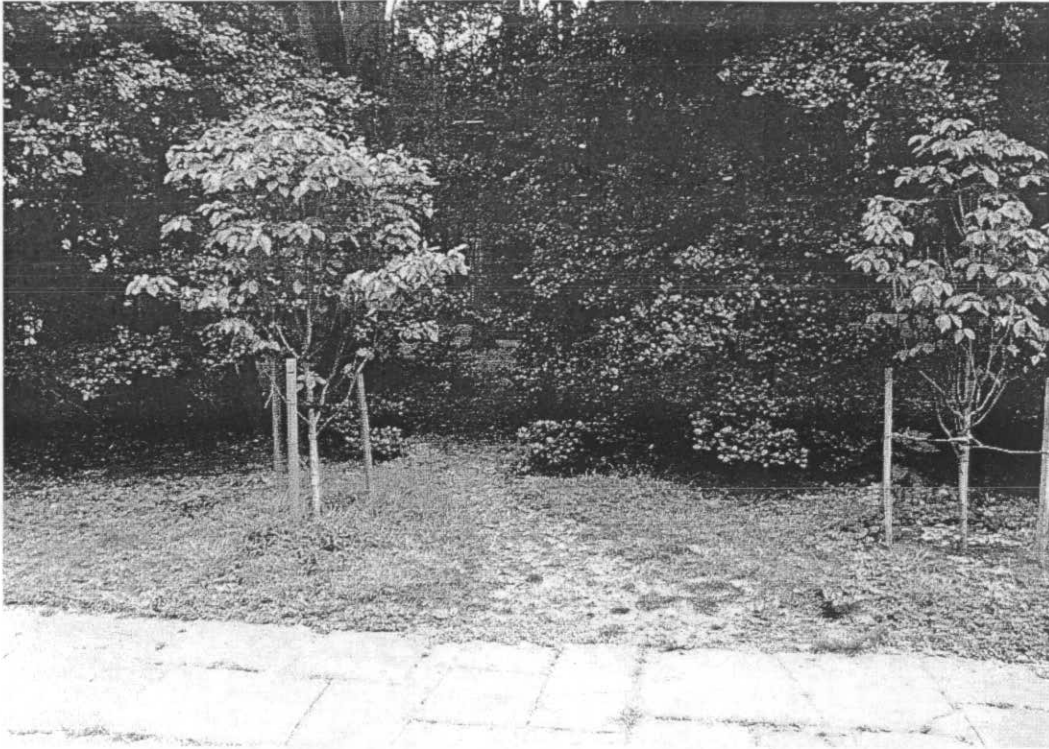
Several wear trails exist that provide access through the plantings to and from the east and west and one major north/south trail west of the Memorial. The latter is a combination trail used by both pedestrians and vehicles. Two trails from the west approach the flagstone walks - one trail on the south approach walk and one on the north walk. The combination trail begins at the crosswalk on Independence Avenue, directly north of West Basin Drive, where a map and several directional signs help direct pedestrians in this area. Another trail provides a sweeping link between the Memorial and the restrooms to the northeast. All of the trails cut through the woods and detract from the Memorial's natural setting.

West trail connecting the flagstone walk with the woods to the west. [EDC, 2005]

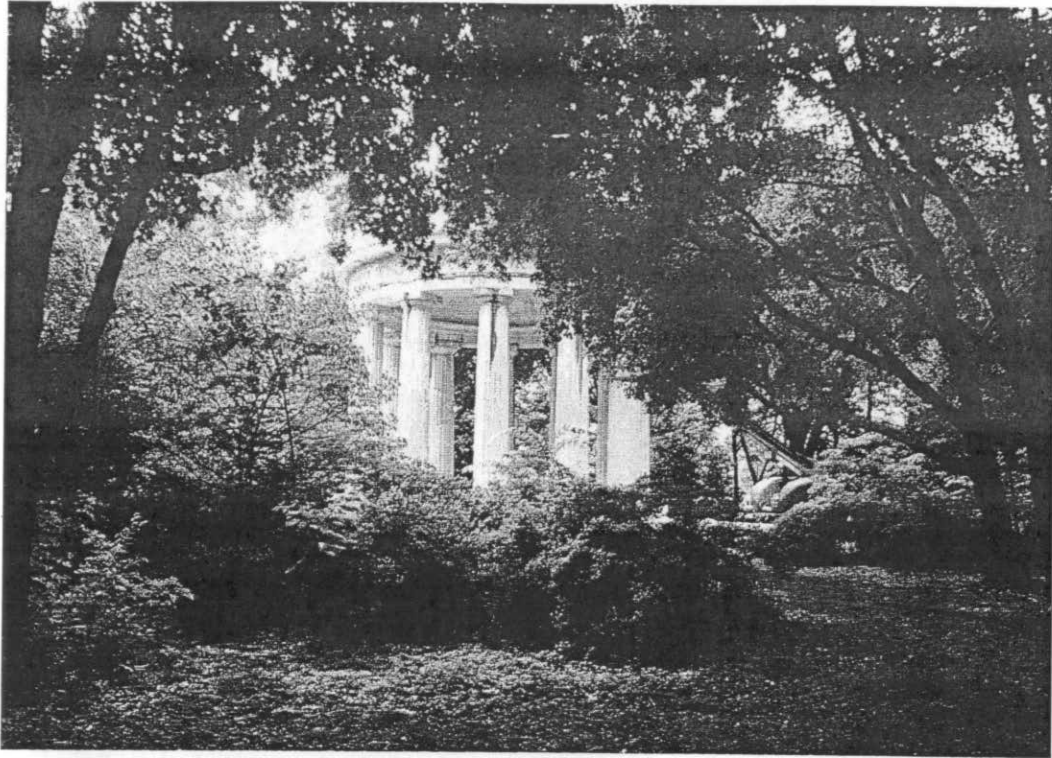
Azaleas and low tree branches restrict views to the Memorial from the woods. [EDC, 2005]
