DISTRICT OF COLUMBIA WAR MEMORIAL

Historic Structure Report
& Cultural Landscape Assessment

National Mall & Memorial Parks
PMIS NO. 43699

May 2006

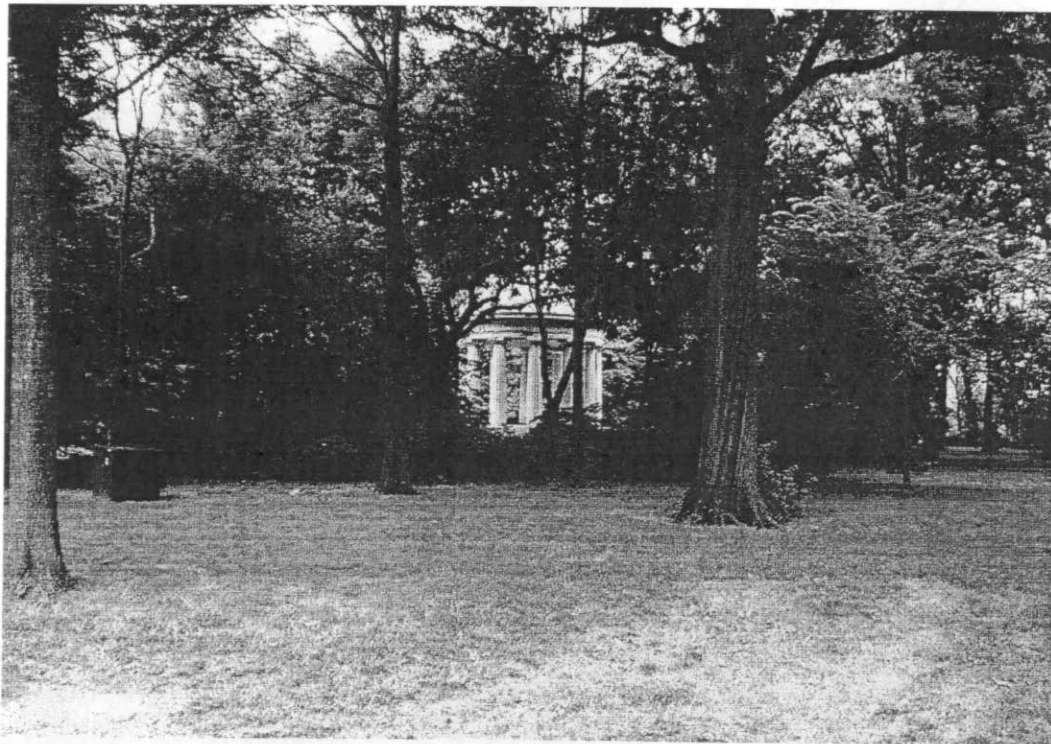
Hollies, azaleas, and low tree branches restrict views to the Memorial from the woods. [EDC, 2005]

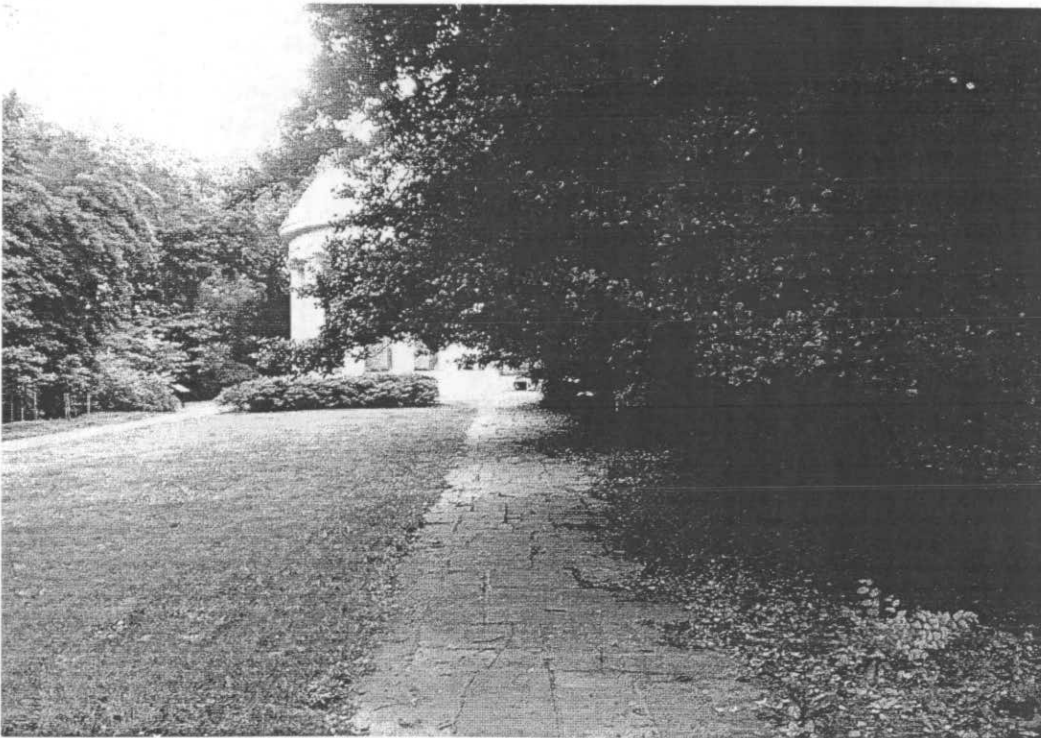
Hollies overhang the flagstone walks south of the Memorial. [EDC, 2005]

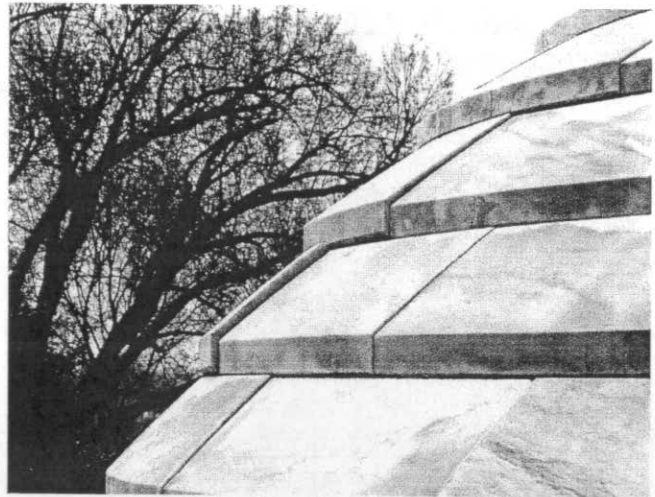
Localized movement was observed in some of the marble roof pieces (Photo 2). The Guastavino tile dome which supports the marble roof was observed from the interior attic space and appeared to be in good condition with little movement or mortar loss. It is unclear what may have caused the shifting of the roof marble, however, the long term entrapment of moisture within the setting bed or collar joint between the marble and Guastavino vault structure could certainly have induced movements in response to freeze-thaw cycling. The shifting could also be in response to minor shifting of the Guastavino dome, however, as noted above, there was no cracking or apparent displacement observed from within the attic. Another possible influence on the marble roof tiles is the presence of 4 – 7/8"

Photo 2. Displaced marble roof pieces.

diameter bronze rings which are shown on historic drawings to be set within the marble joints at the lower levels of the dome (SSK-1). Some localized disturbance related to these rings may be occurring, however no consistent pattern was observed which would indicate this as the likely cause.

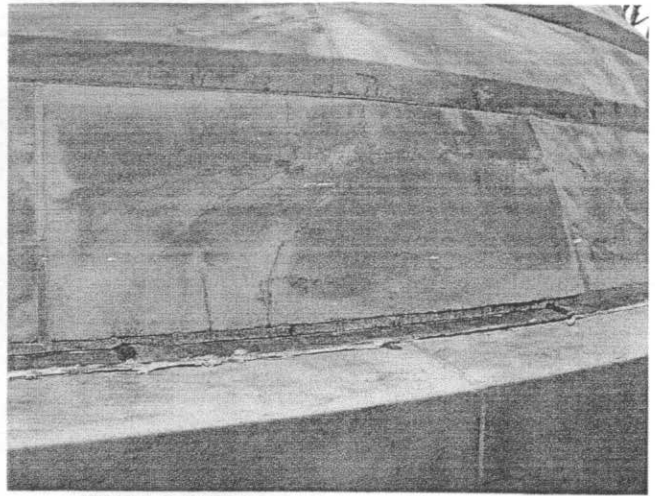
Small hairline cracks were observed in the marble roof pieces (Photo 3.) These cracks are most likely due to age and normal wear, and do not appear to affect the structural integrity of the roof.

Photo 3. Minor cracks in marble roof piece.

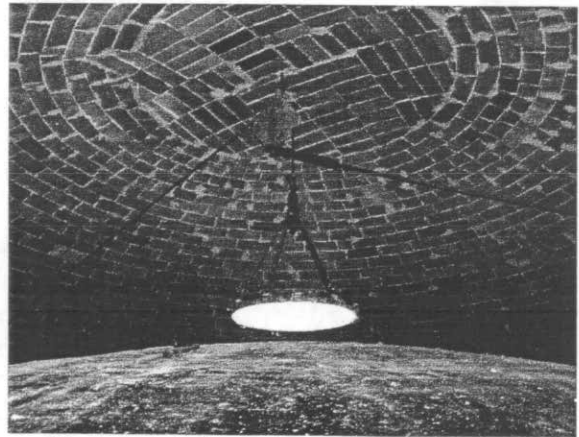
The visible surface of the outer Guastavino tile dome appeared to be in good condition (Photo 4). The inner dome surface was obscured by a bituminous surface coating. From within the attic space we could observe the general arrangement of support for the upper and lower domes on the entablature. Here, the brick backup wall of the entablature presented nearly continuous efflorescence around the perimeter, a strong indication that water has been passing through the base of the roof dome into the entablature substrate (Photo 5). Significant movement in the brick backup masonry was observed in the vicinity of the L-rings from within the attic space. A probe of the masonry (Photo 6), however, revealed the steel L-rings to have only minor surface rust (Photo 7).

Photo 4. Interior surface of outer dome and counterweighted ceiling oculus.

Recommendation: The infiltration and potential entrapment of water should be minimized by

addressing water penetration and general breathability of the masonry at the exterior in the vicinity of the drum. No immediate structural action is required in this area.

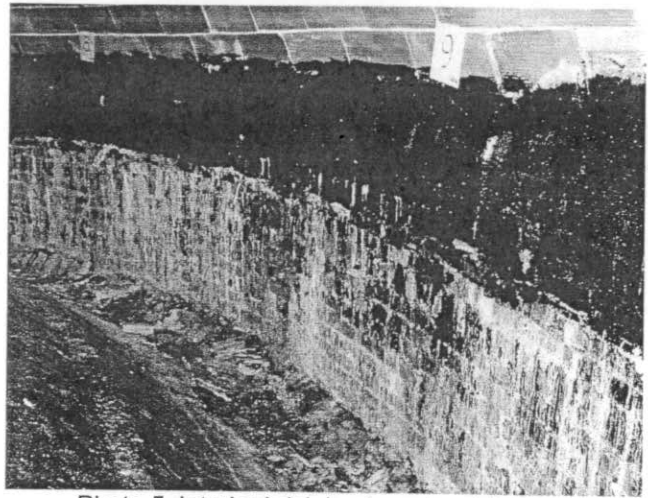
Photo 5. Interior brick backup at entablature

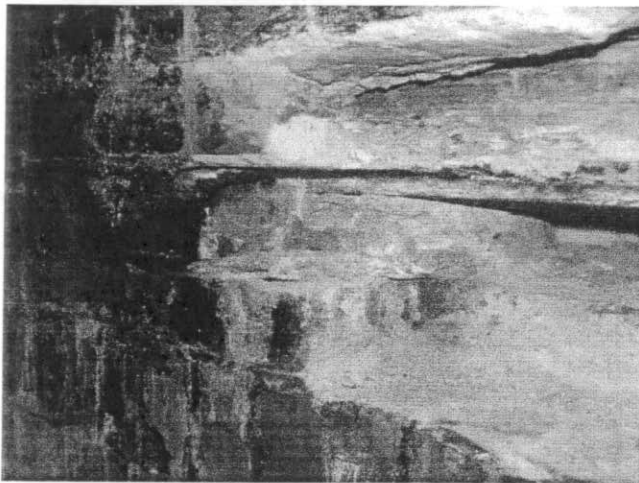
Photo 6. Probe of masonry wall at attic.

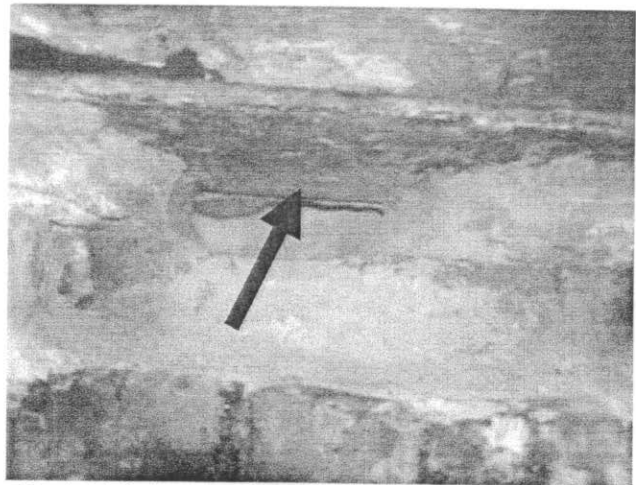
Within the interior attic space, the upper steel L-ring was observed on July 15, 2005 through a probe, and appeared to be in relatively good condition; the steel presented a nearly fully intact section with only some minor surface rust. Significant displacement was observed from within the attic space within the area of brick masonry between the underside of the Guastavino tile dome and the waterproofing layer (approximately where the brick is coated with a bituminous material. See Photo 5). The observed masonry displacement may be the result of a number of possible phenomena, given the generally loose connectivity of this upper, non-structural portion of brick masonry at the interior, backside of the drum. Possibilities may range from simple thermal cycling to the effects of freeze-thaw cycling of saturated masonry. A failure of the drainage and water-shedding systems may have resulted in long term moisture entrapment within the masonry. This extended presence of moisture may be the source of a number of problems, which could range from deteriorating ferrous masonry ties or embedded elements to basic freeze-thaw cycling. No direct evidence of deteriorating ferrous elements within the masonry was uncovered in this investigation.

Photo 7. Bottom surface of steel L-ring seen in probe.

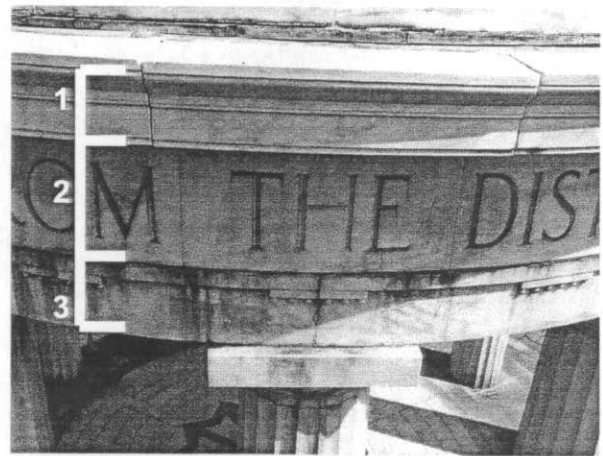
Photos 8-10 show the cracked cornice section located on the west elevation. The crack extends from the right joint to the center of the soffit (Photo 9) to the joint of the dentil unit below (Photo 10). The entire section appears to be sloping downward to the right (Photo 8), and there is significant mortar loss in the joints between adjacent marble pieces (Photo 11). Original drawings indicate that the column below this section is one of four that contain a downspout. It is probable that this downspout is not functioning properly, causing water to become trapped in the gutter and in the masonry assembly itself (Photo 12). In addition, the presence of water in the brick walls adjacent to the steel L-rings could be causing displacement of the masonry due to freeze-thaw cycles or possible ferrous metal deterioration, in turn placing stresses on the exterior marble pieces. As noted previously, no direct evidence of steel rusting was uncovered in this investigation, so our concerns are more focused on general moisture infiltration and entrapment at this time.

Photo 8. Displaced cornice element.

Recommendation: As the previously described probe investigation did not reveal ferrous metal deterioration as the source of masonry cracking and displacements, we recommend focusing on water infiltration and entrapment by implementing repairs of the cracks. Though it doesn't appear that any pieces are near falling from the building, it is prudent to provide a connection between the cracked pieces to assure long term stability. A combination of stainless steel pinning and epoxy injection are the likely means of assuring long term stability and minimizing moisture entrapment at the crack interface.

Recommendation: The entire downspout and drain system of the structure should be examined further to determine its deficiencies. These deficiencies should then be repaired in order to prevent continued water penetration of the entablature. After the drainage system is

repaired, the cracked cornice sections should be patched with an appropriate material and the joints repointed to restore stability. Localized pinning and epoxy injection are appropriate treatments to reconnect pieces where stability of one part is in question.

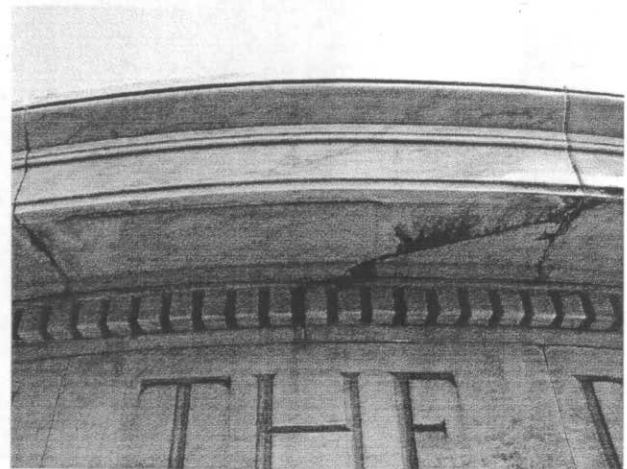
Photo 9. Crack extending from right joint to center of the cornice soffit.

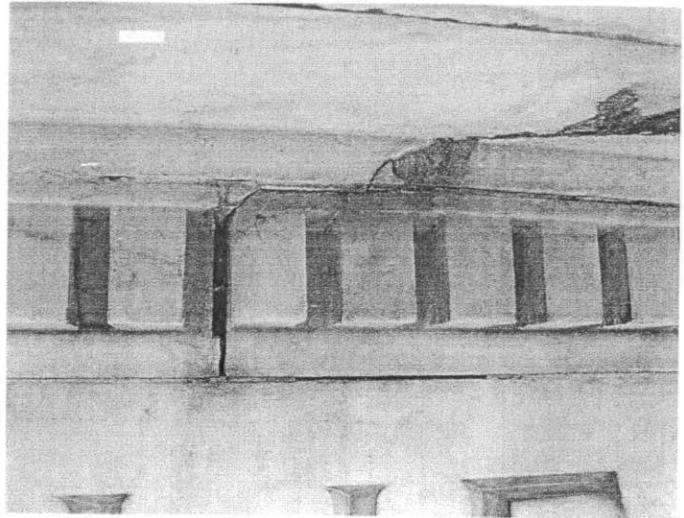
Photo 10. Close-up of crack through joint between dentil units.

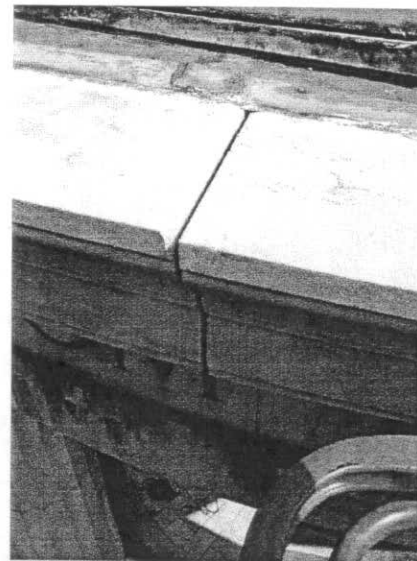
Photo 11. Mortar loss around displaced element.

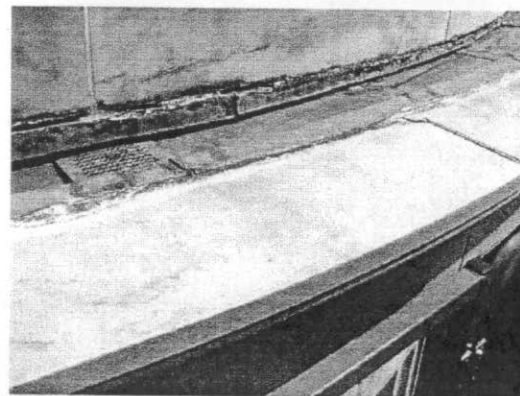
Photo 12. Top of cornice unit showing gutter.

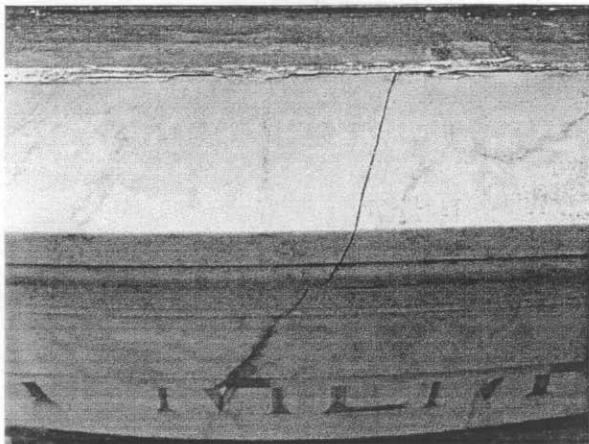
A similar condition occurs in a cornice section on the north elevation (above the word "Memorial" in the frieze.) This crack extends across the top of the section and down its face, terminating where it meets the dentil unit below (Photos 13-14). Original drawings indicate that the column below does not contain a downspout; however, malfunctioning of the drainage system and subsequent water penetration is still the likely cause of this crack.

Photo 13. Cracked cornice unit on north elevation.

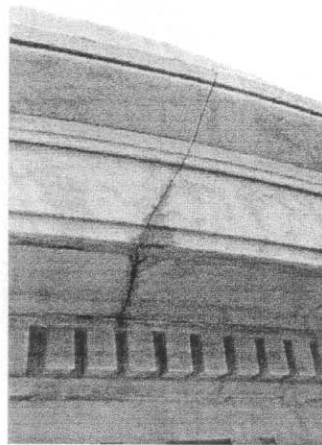
Photo 14. Extent of crack in cornice unit.

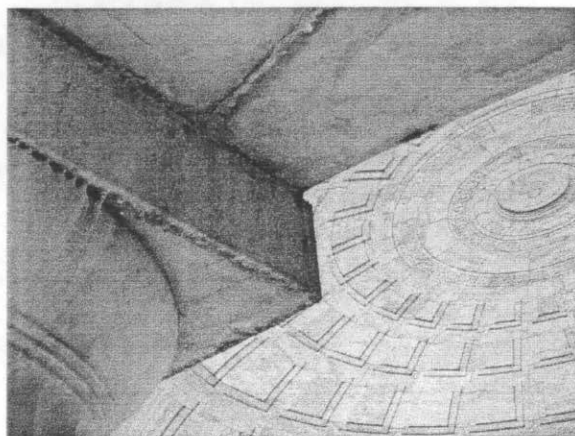
SSK-2 shows the observed locations of cracks in the soffits of the architrave between columns. Three of the architrave pieces exhibited significant cracks, while one had light cracking. Photos 15 and 16 show the cracked soffit at the north side of the structure. The cracks appear to have either a buildup of mineral deposits or a prior repair with some kind of mortar or patching material. As with the cornice, it is most likely that the drainage system is not functioning properly, causing water to soak through the entablature elements and allowing the freeze-thaw cycle to damage the stones. Furthermore, an existing section of the entablature shows a metal strap extending from the interior ceiling cornice through the architrave unit. Corrosion of this metal strap could cause significant cracking in the architrave.

Photo 15. Cracks in architrave soffit.

The outer surfaces of certain columns exhibited signs of mineral deposition and staining, as well as small cracks (Photo 15).

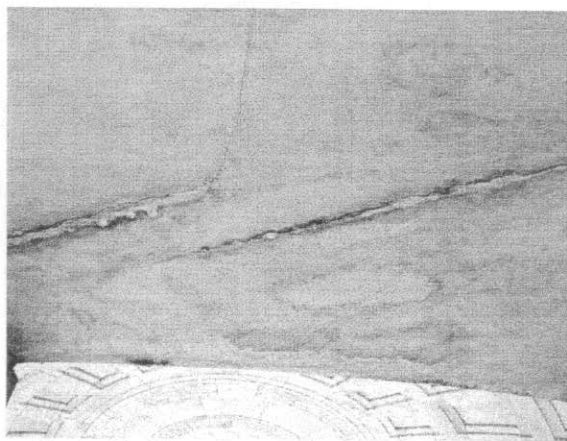
Photo 16. Close-up, cracks in architrave soffit.

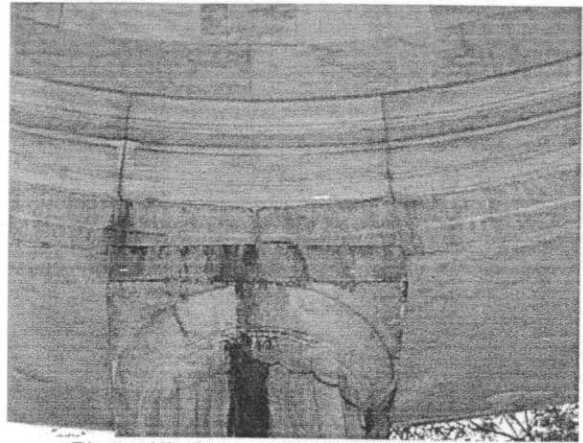
Photo 17. Column Capital with Staining

Recommendation: No immediate action is required structurally, however consideration should be given to possible treatments to best support the longevity of the stone.

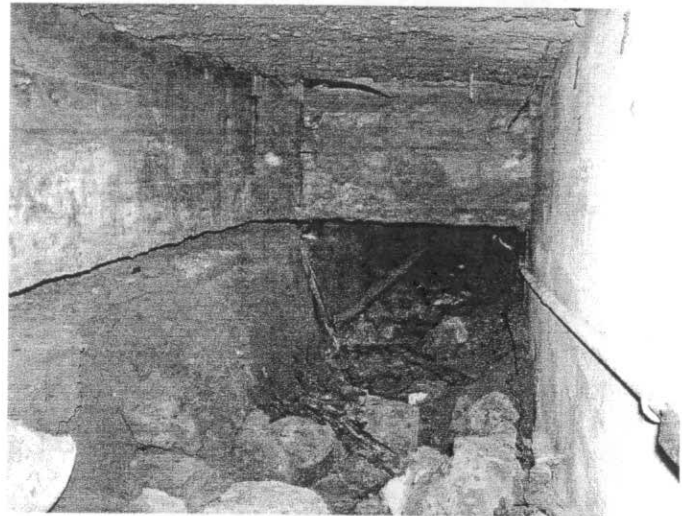
The foundation was observed through a crawlspace accessed through the manhole in the center of the memorial's floor. Based on original drawings and observed conditions, it appears as though the space beneath the foundation beams was originally filled. Removal of the fill material, however, does not affect the structural stability of the foundation, since the beams span to the outer concrete pile caps. The concrete beams appeared to be in good condition (Photo 18). In some locations, the reinforcing bars of the concrete slab were exposed, giving an appearance as if the framed slab was originally cast on earth but subsequently excavated for the vault construction (Photo 19).

Photo 18. Concrete grade beams.

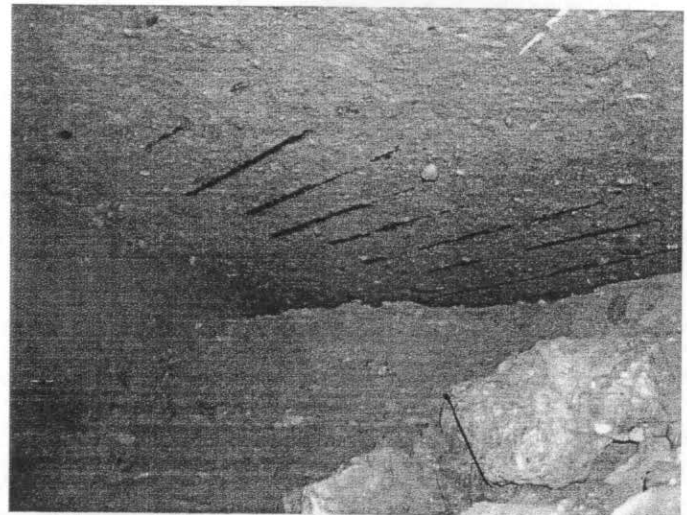
Photo 19. Underside of floor slab showing exposed reinforcing bars.

Recommendation: Areas of exposed reinforcing should be repaired to minimize the possibility of further deterioration of the reinforcing steel. Exposed bars should be further exposed, coated with a corrosion inhibitor and bonding agent, then covered with an overhead repair mortar.

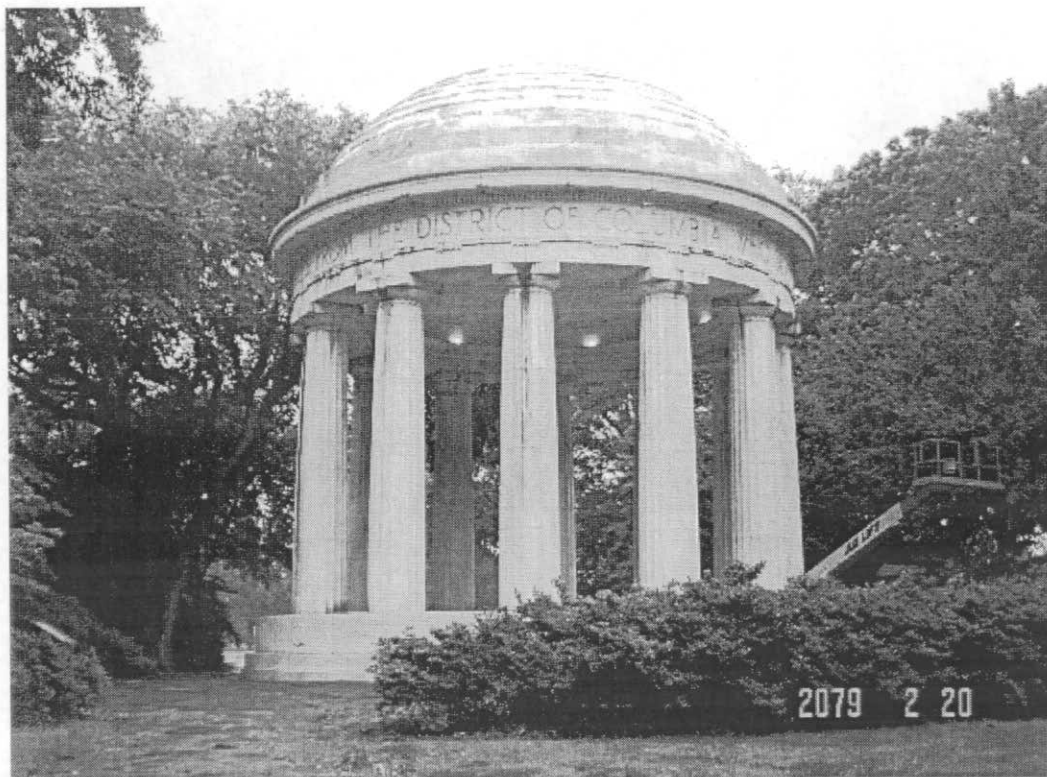
The District of Columbia War Memorial, July 14, 2005. [MSSC., 2005]

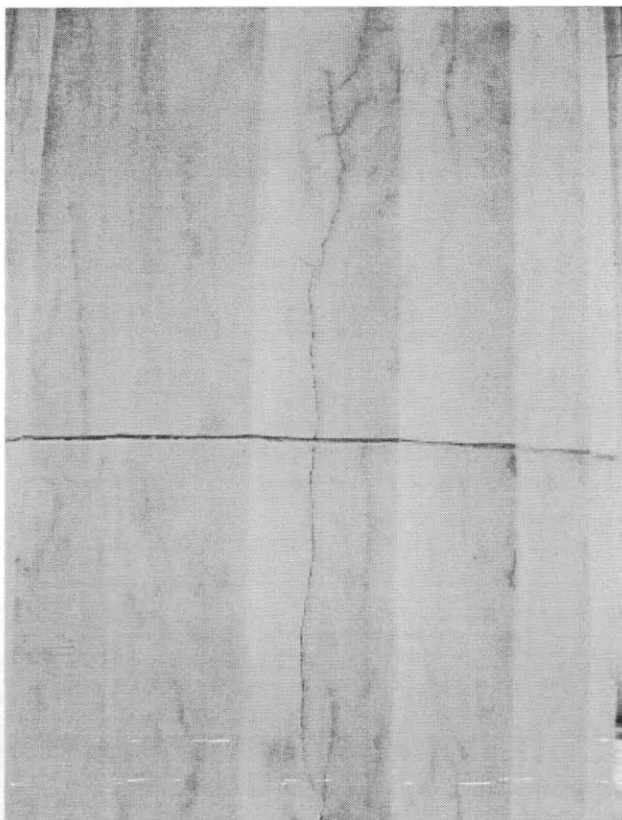
Occasionally, vertical cracks extend through mortar joints. [MSSC, 2005]

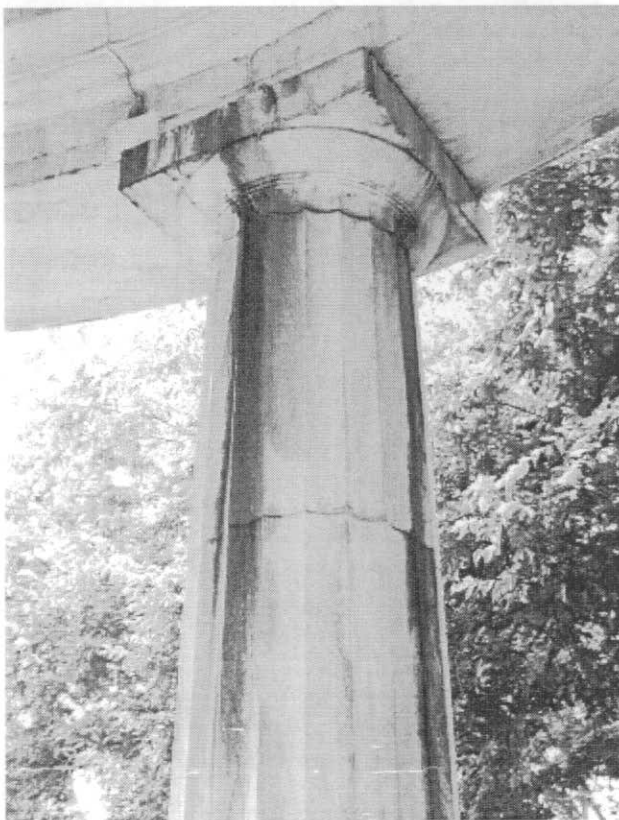
Vertical staining on interior of column. [MSSC, 2005]

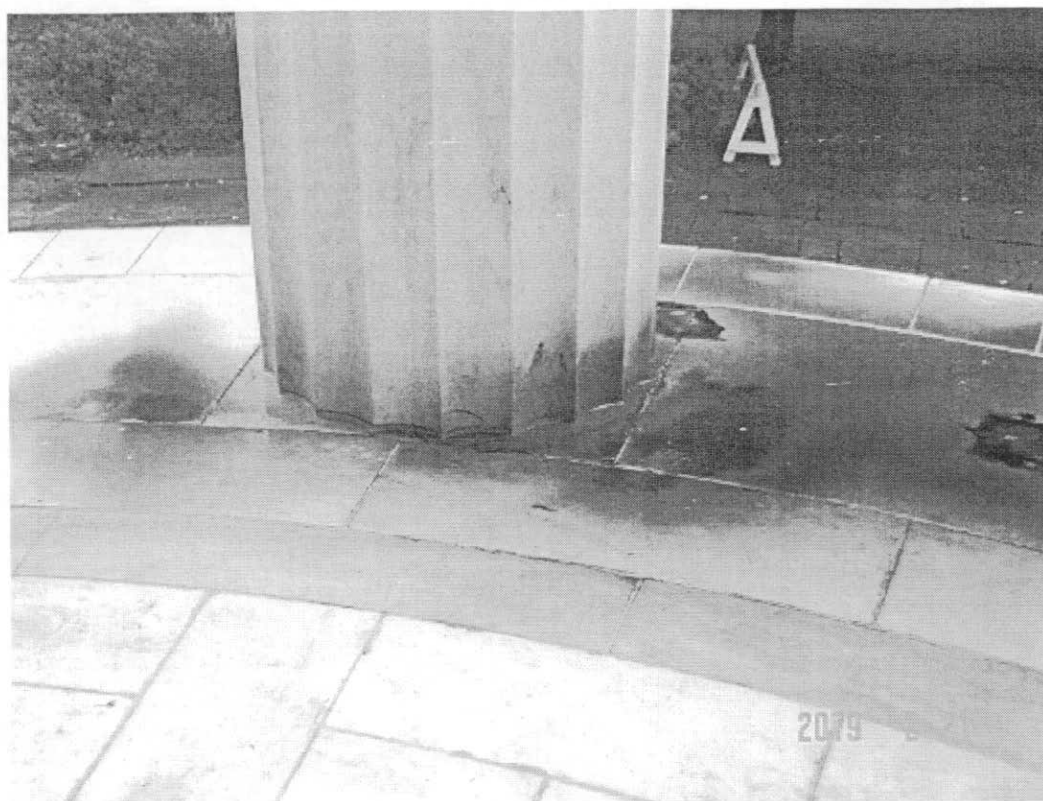
Dark-colored soiling and water pooling on marble floor near base of column. [MSSC, 2005]

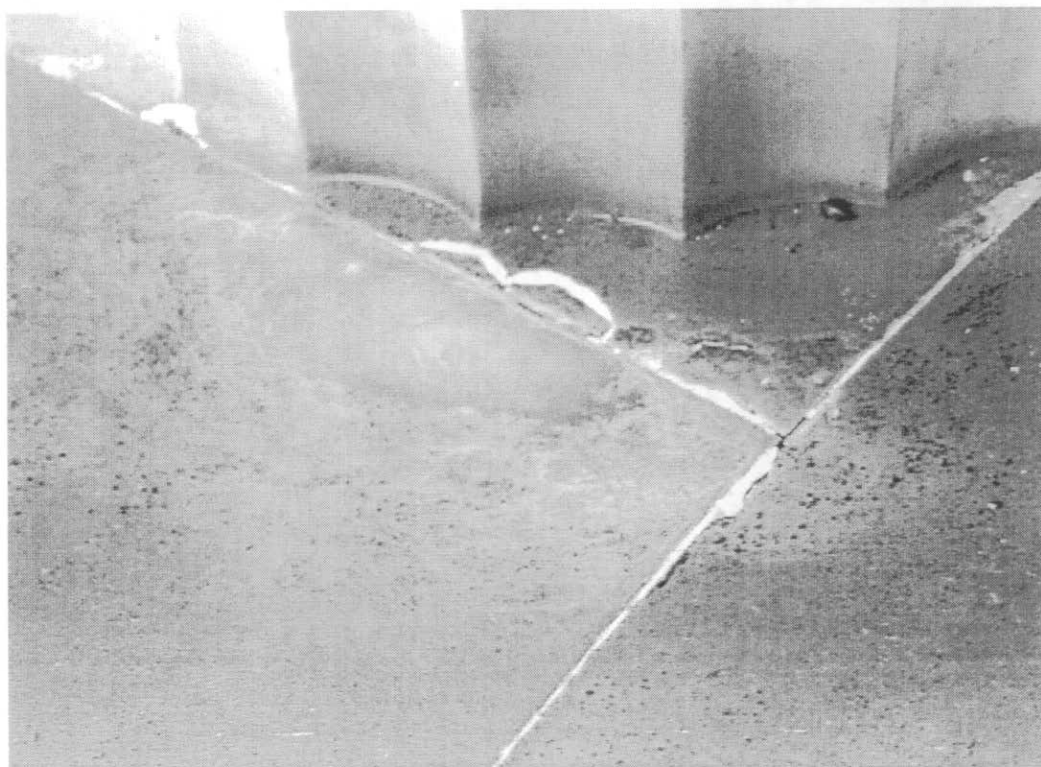
Re-deposited calcium carbonate on marble floor. [MSSC, 2005]

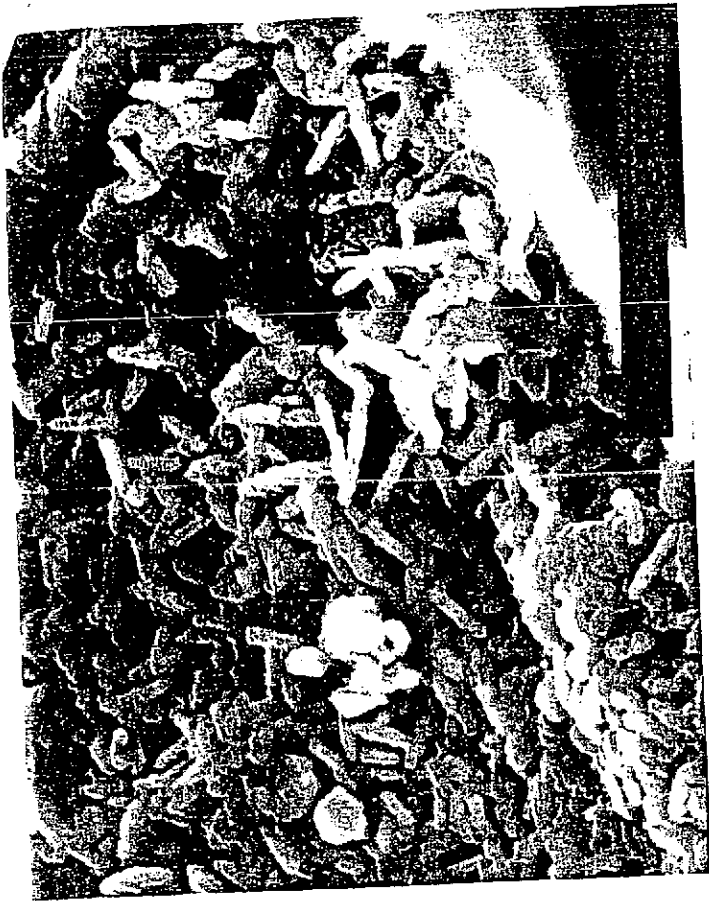
Discoloring of Marble: A discolored piece of marble was analyzed by Dr. Kulpa of the Dept. of Biology. Two types of organisms were recognized, orange algae, *Hematococcus pluvialis*, and a bacteria of unknown species forming a dense black crust. SEM pictures are enclosed for each type of organism. The accurate identification of the bacteria would require the growing of a culture, a lengthy and expensive procedure. Neither organism binds nitrogen or sulfate from the environment, but produces organic acids which corrode the marble surface visibly. Dr. Kulpa, recommends washing the stone with commercial Chlorox. A 1:1 dilution with water prevents possible staining of the sensitive white marble. Painting such a mixture onto the stone surface should be repeated twice, and twice each year, one early in spring and the other one late in summer.

8/6/90 5000X
MARBLE BLACK AREA
