Nicodemus National Historic Site
Nicodemus, Kansas
Historic Structures Report
National Park Service

25 October 2002

Bahr Vermeer Haecker Architects, Ltd.
in association with
Wiss Janney Elstner Associates, Inc.

Historic Structures Report

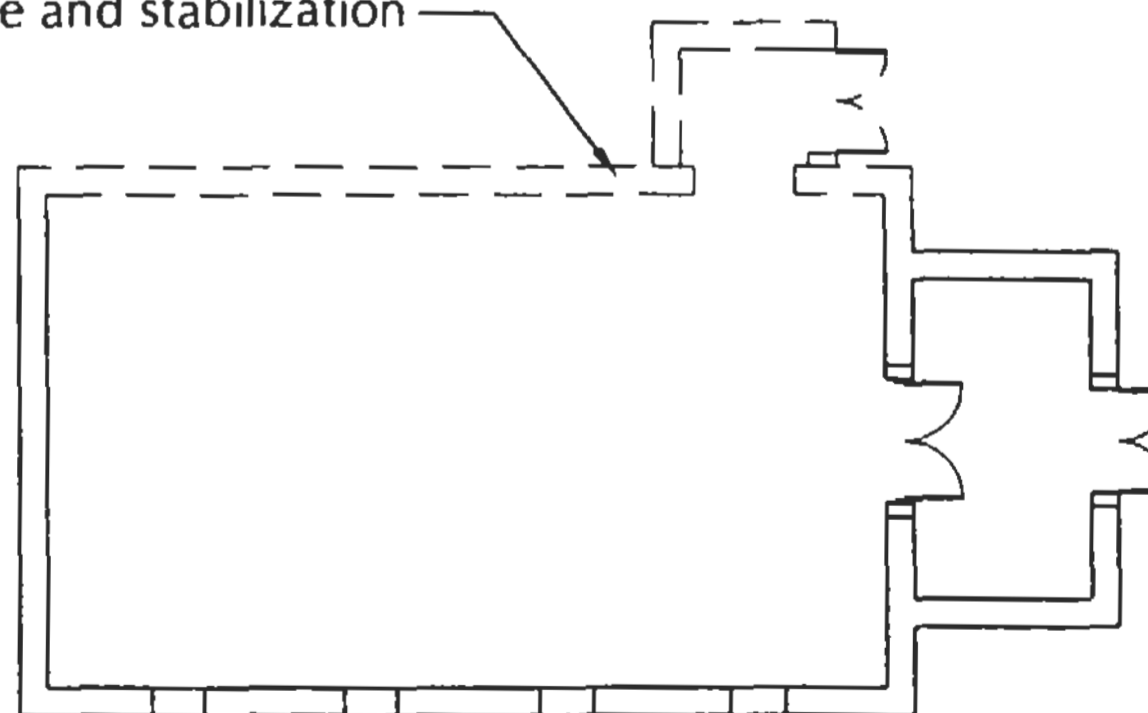
Partial collapse at west end of north wall
circa 1996

Temporary stabilization of north wall
1996 and 2000

Church re-roofed with wood shingles
2001

Area of collapse and stabilization

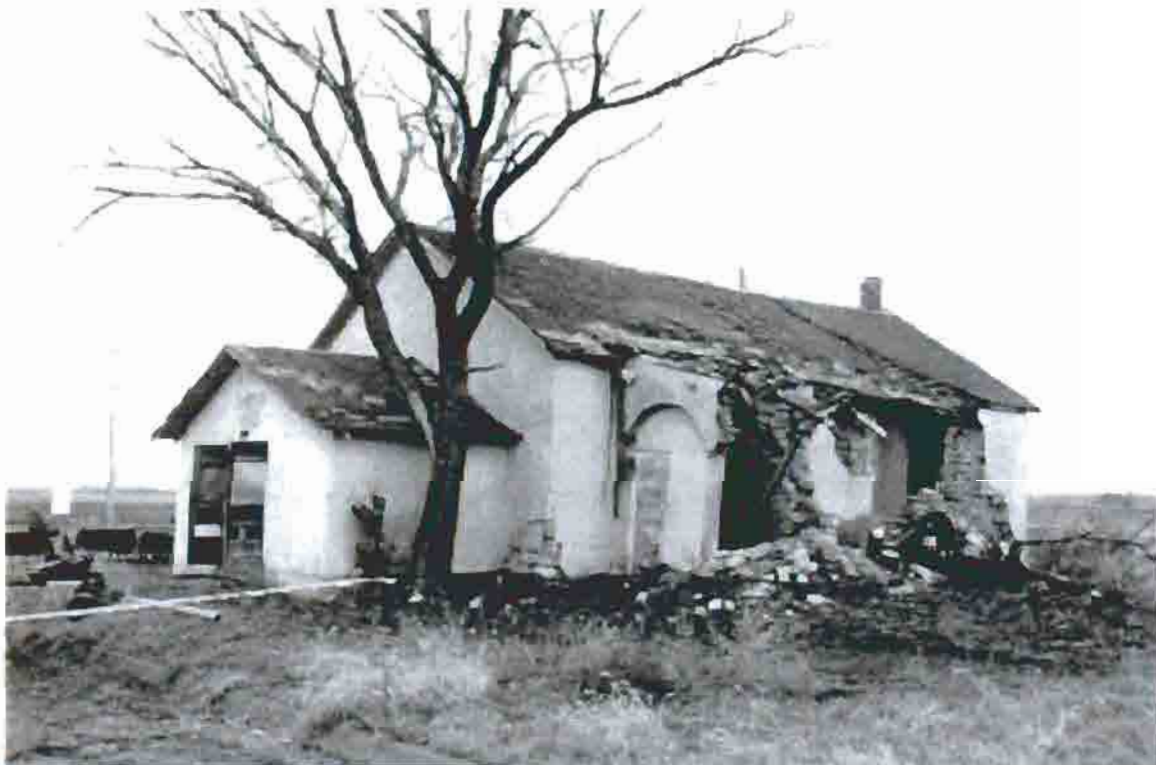
Photo A-10 The A.M.E. Church, view from the northeast, 1990s. The northeast vestibule and much of the north wall had collapsed. Photo from National Historic Landmark files.

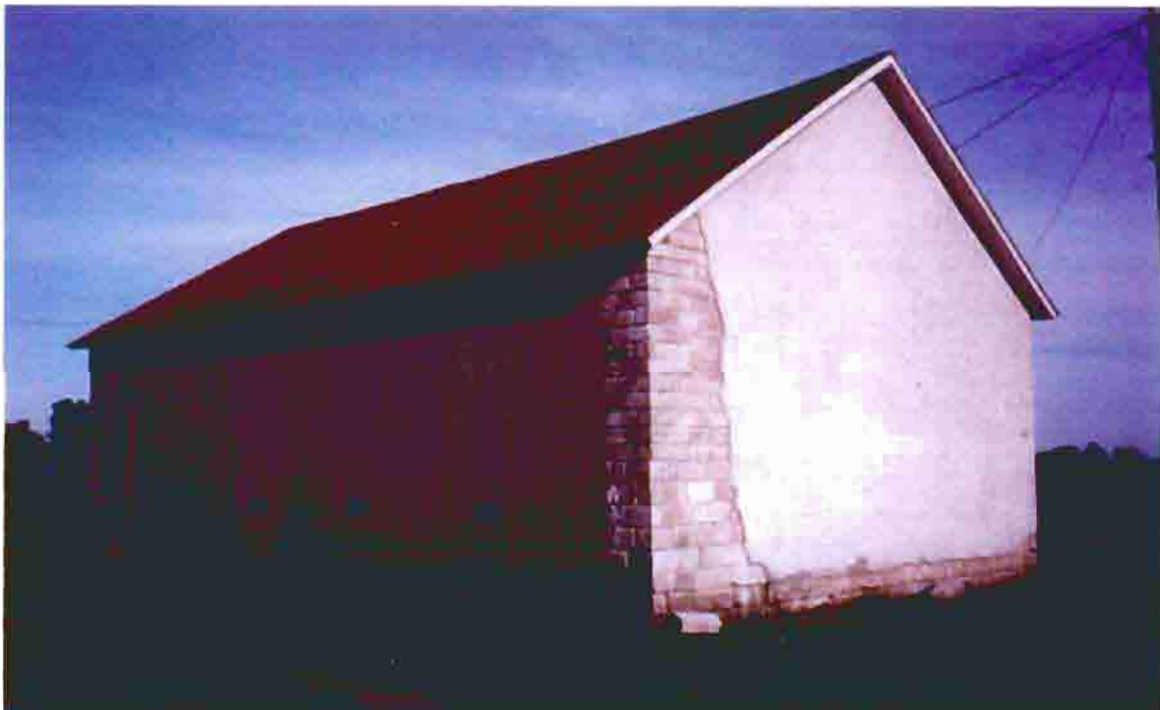
In May 2001, the main roof only was entirely replaced by the National Park Service. (See Photos A-14, A-16, and A-18) All previous roofing materials were removed down to the original decking, and new cedar shingles were installed with a 4½-inch exposure. (The first layer of historic shingles had a 5-inch exposure.) All soffit and fascia boards were replaced, and the brick chimney was dismantled to the roof line.

Photo A-14. The A.M.E. Church, view from the northwest, summer 2001. Photo by Jim Creech, Midwest Regional Office, National Park Service, Omaha, Nebraska.

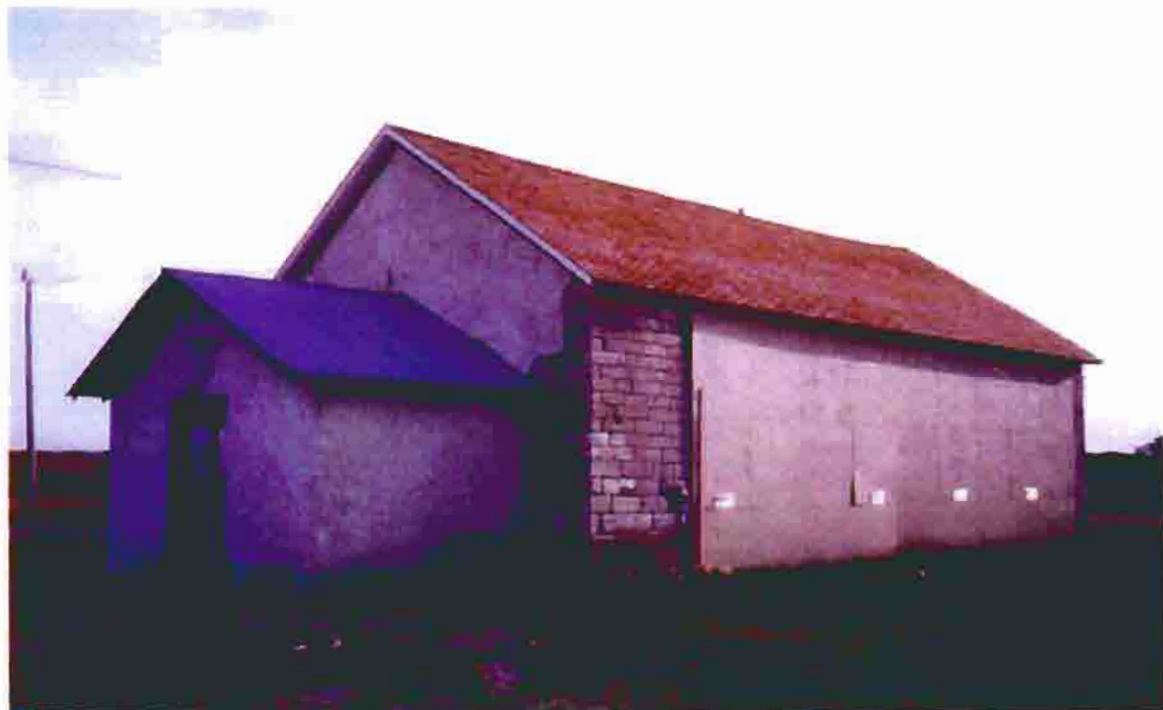
Photo A-16. The A.M.E. Church, view from the northeast, summer 2001. Photo by Jim Creech, Midwest Regional Office, National Park Service, Omaha, Nebraska.

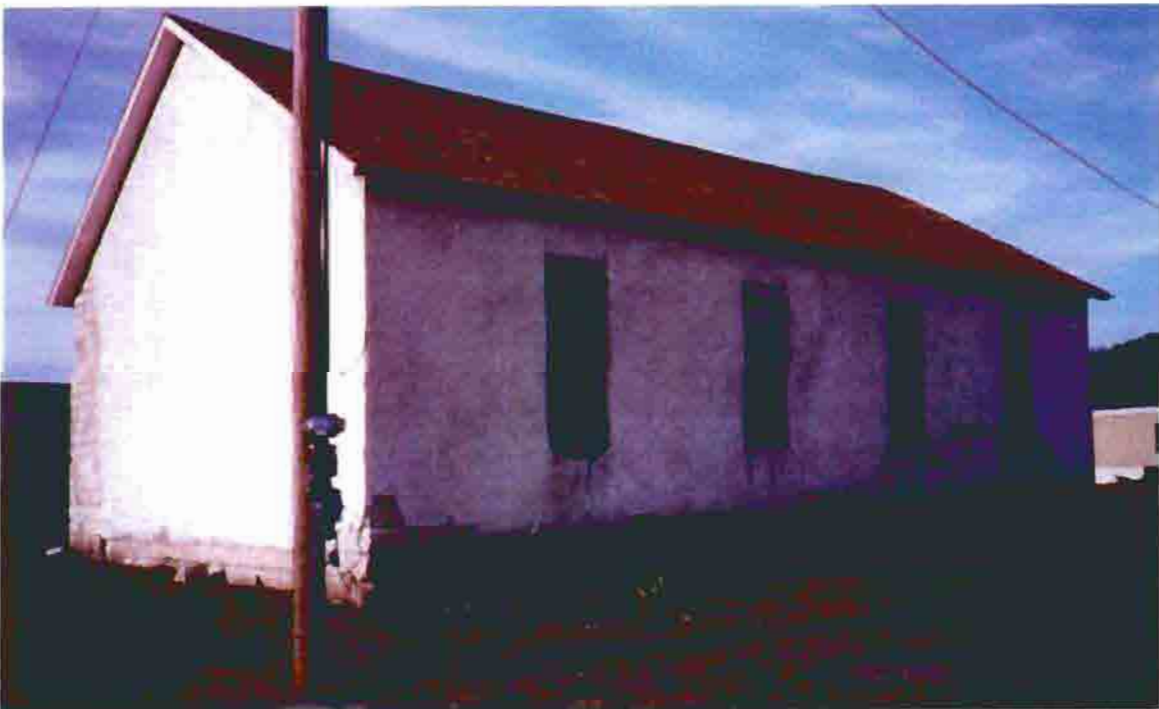
Photo A-18. The A.M.E. Church, view from the southwest, summer 2001. Photo by Jim Creech, Midwest Regional Office, National Park Service, Omaha, Nebraska.

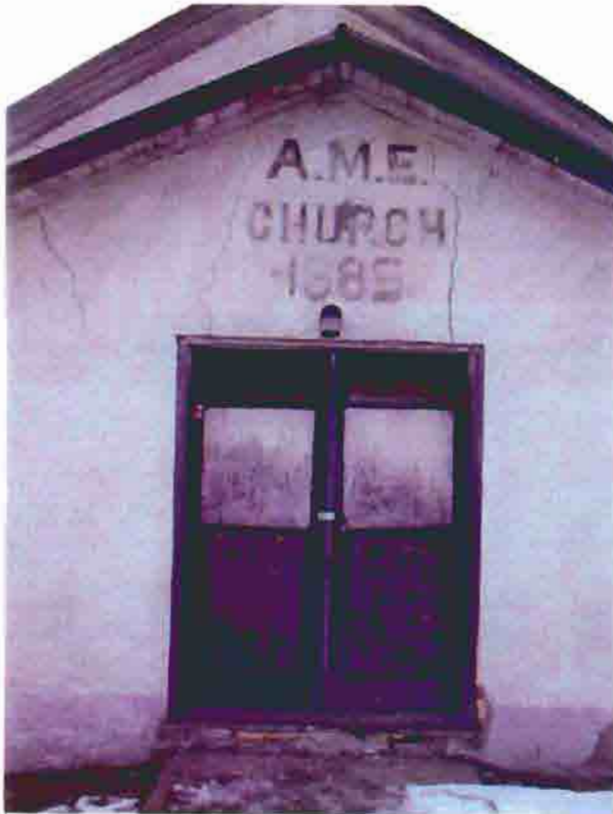
1. There are large vertical and diagonal cracks, up to 1/2 inch wide, extending from the top of the door opening. There are also large diagonal cracks on either side of the main east wall gable. These cracks are shown in Photo A-19.

2. The wood of the double front door is deteriorated, with no paint. The glass in the doors is broken.
3. Eroded stone is visible below the weathered wood sill at the entrance.

Photo A-19. The A.M.E. Church, east entrance, February 2001. Photo by Wiss, Janney, Elstner Associates, Northbrook, Illinois.

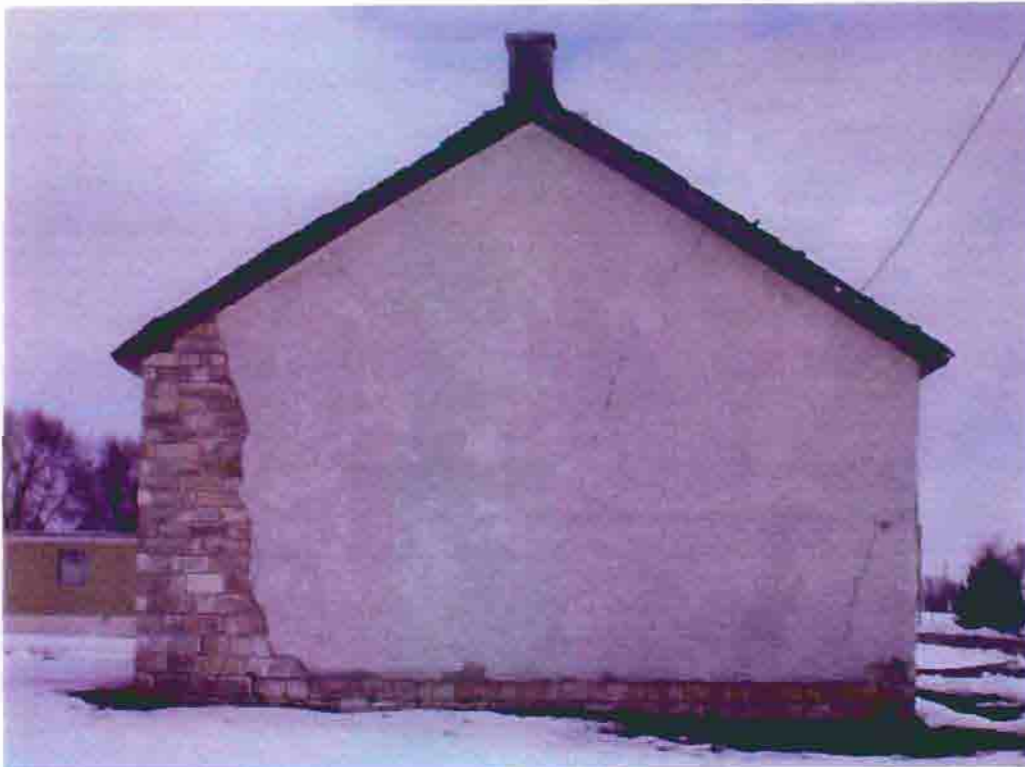
1. Most of the stucco is missing from the two lowest stone courses and at the north end of the west wall. The face of the stucco covering is spalling at the bottom edge of the stucco. This condition is shown in Photo A-22.

Photo A-22. The A.M.E. Church, west elevation, February 2001. Photo by Wiss, Janney, Elstner Associates, Northbrook, Illinois.

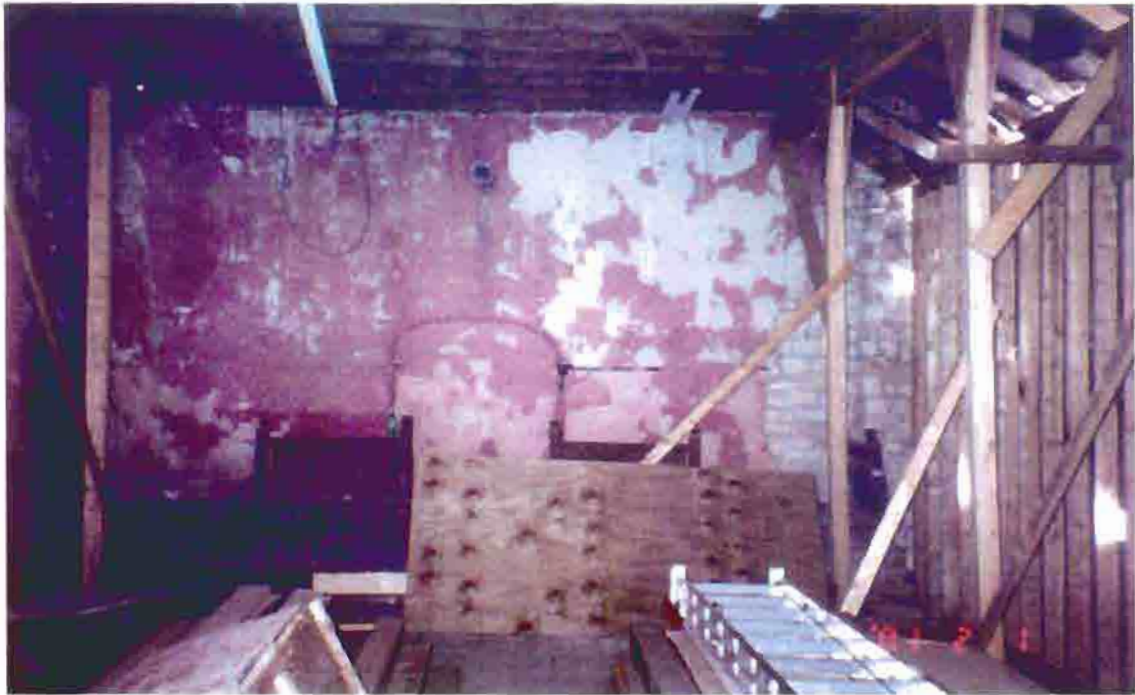
Photo A-23. Interior view of the sanctuary of the A.M.E. church, facing west, February 2001. The posts and beams that were installed to support the roof load are visible at right; beyond is the wood stud wall that replaced the north stone masonry wall. Above the niche in the west wall is a round pipe, where a heating stove was connected to the brick chimney. Photo by Bahr Vermeer Haecker Architects, Lincoln, Nebraska.

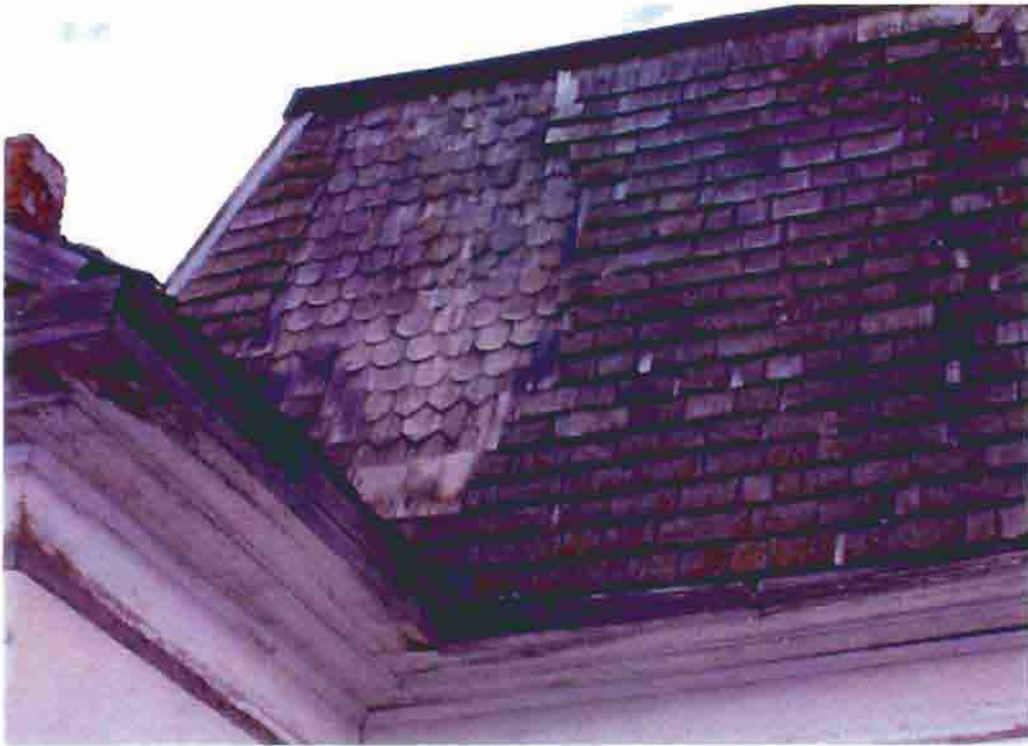
Photo B-15. The Old First Baptist Church, two layers of wood shingles on the vestibule roof, February 2001. Photo by Wiss, Janney, Elstner Associates, Northbrook, Illinois.

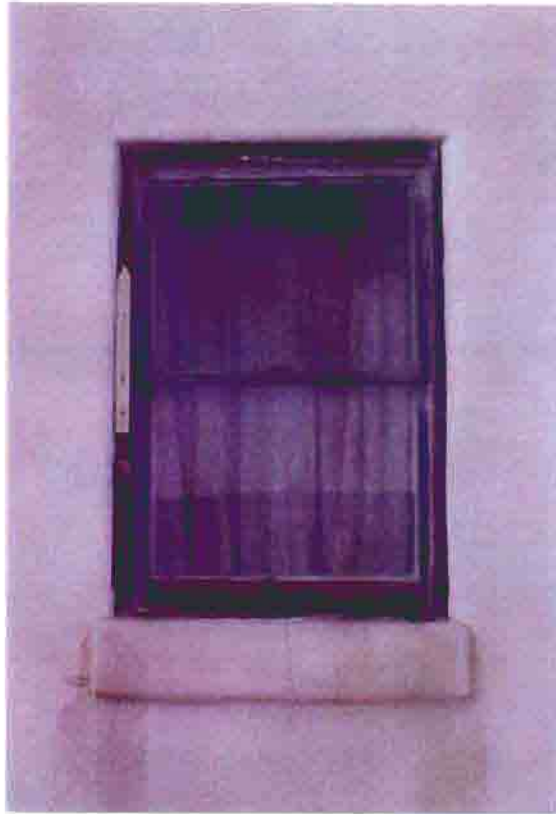
The existing rectangular windows are replacement units with one-over-one double hung wood sash with wood surrounds (see Photo B-17). The original Gothic Revival style windows had triangular lintels with diamond-topped two-over-two wood double hung windows. The triangular shape at the top of the window openings has been filled in with wood framing, reducing the size of the window openings. The window sills are limestone and have been covered with stucco. Typically, the double hung windows include a single light of textured glass in the upper sash and a single light of flat glass in the lower sash. At the northwest addition, the window is partially boarded up with plywood. Some windows also have wire mesh insect screening installed on the exterior. There is a single circular window in the gables on the north, west, and south facades. The south gable circular window is boarded up with plywood.

Photo B-17. The Old First Baptist Church, typical window, February 2001. Photo by Wiss, Janney, Elstner Associates, Northbrook, Illinois.

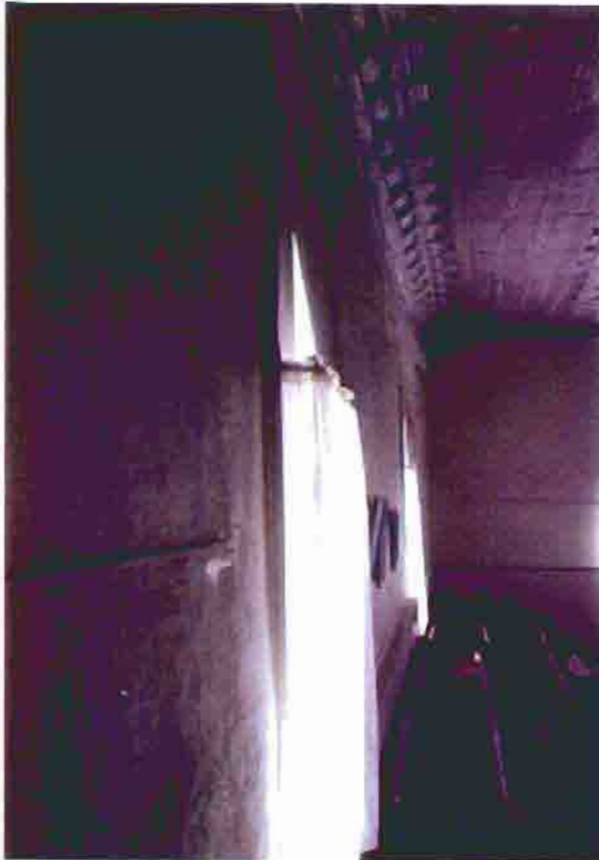
Photo B-21. The First Baptist Church, east wall out of plumb, February 2001. Photo by Wiss, Janney, Elstner Associates, Northbrook, Illinois.

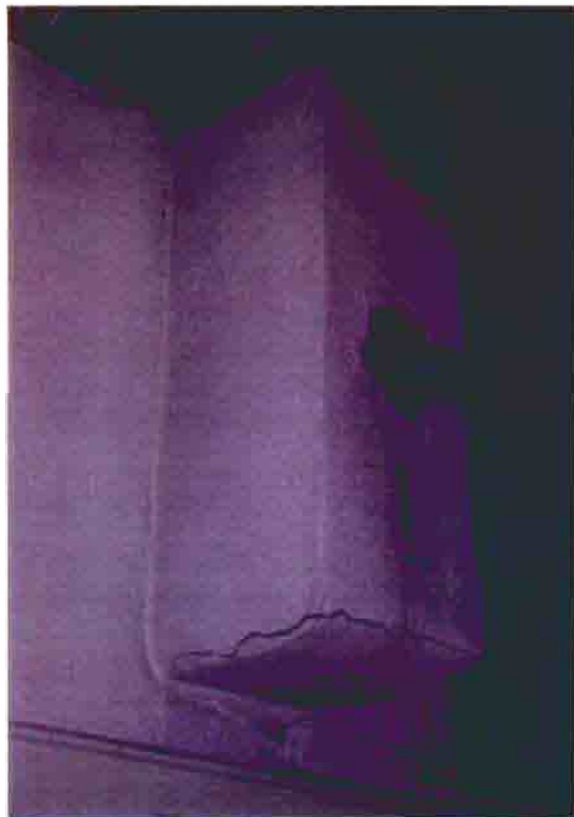
Photo B-24. The First Baptist Church, chimney in kitchen, February 2001. The chimney is suspended above the serving counter between the sanctuary and kitchen. Photo by Wiss, Janney, Elstner Associates, Northbrook, Illinois.

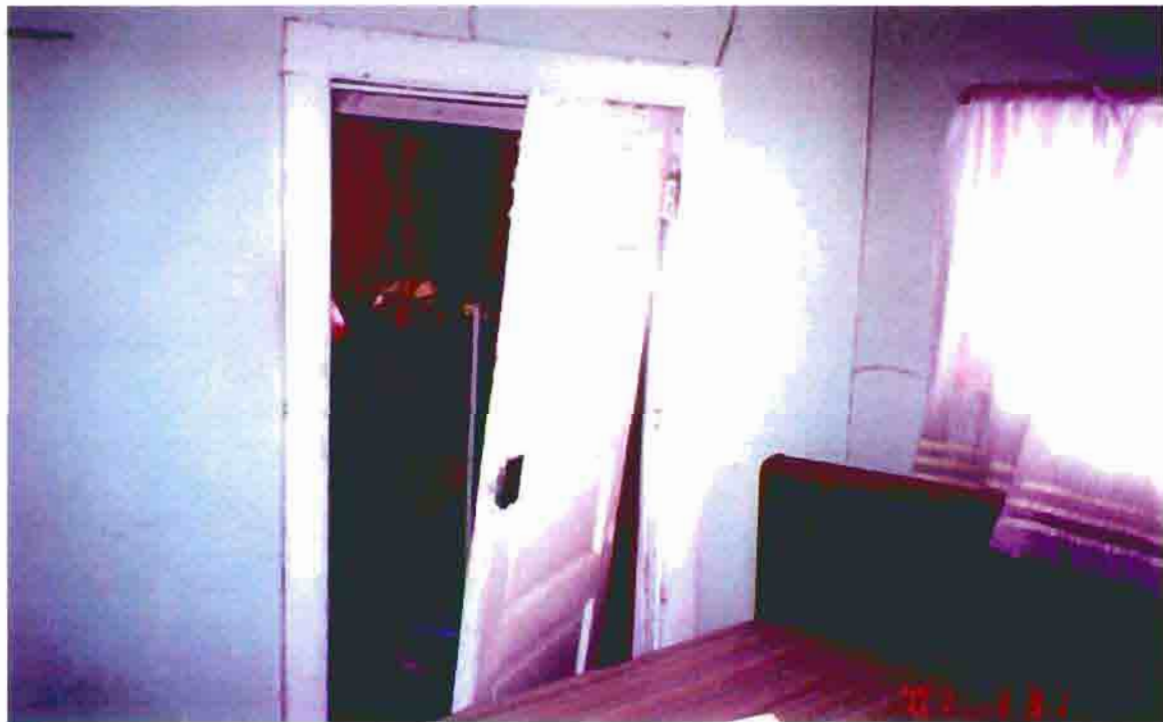
Photo F-26. The Fletcher-Switzer House, first floor Bedroom, February 2001. The door off its hinges leads to the southwest corner Bedroom beyond. Photo by Bahr Vermeer Haecker Architects, Lincoln, Nebraska.

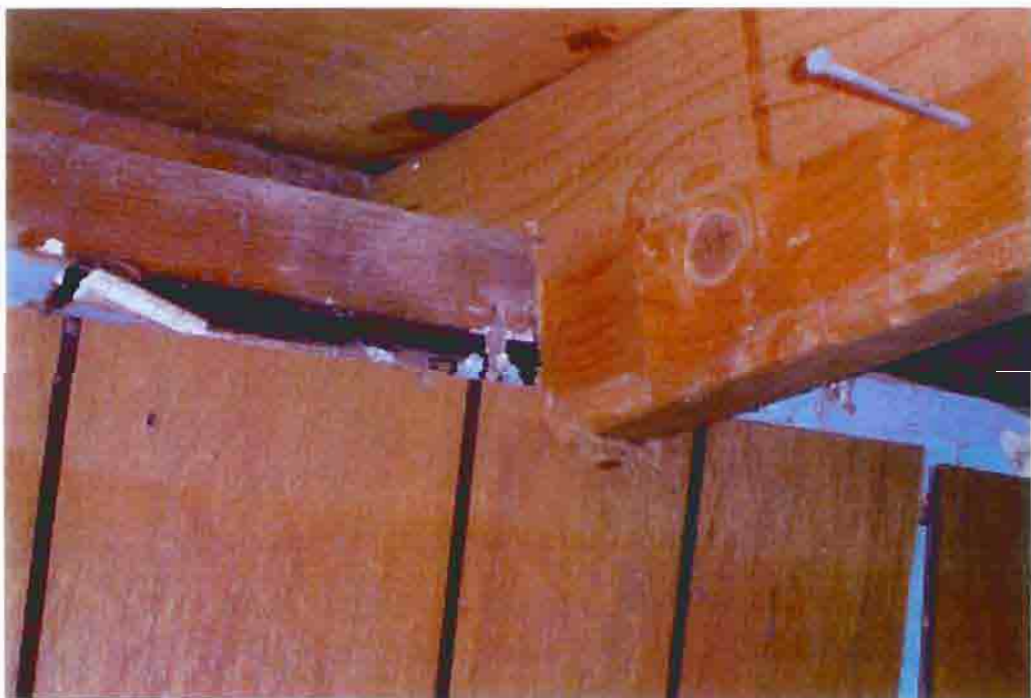
Photo F-28. The Fletcher-Switzer House, new rafters of porch roof, February 2001. Photo by Wiss, Janney, Elstner Associates, Northbrook, Illinois.

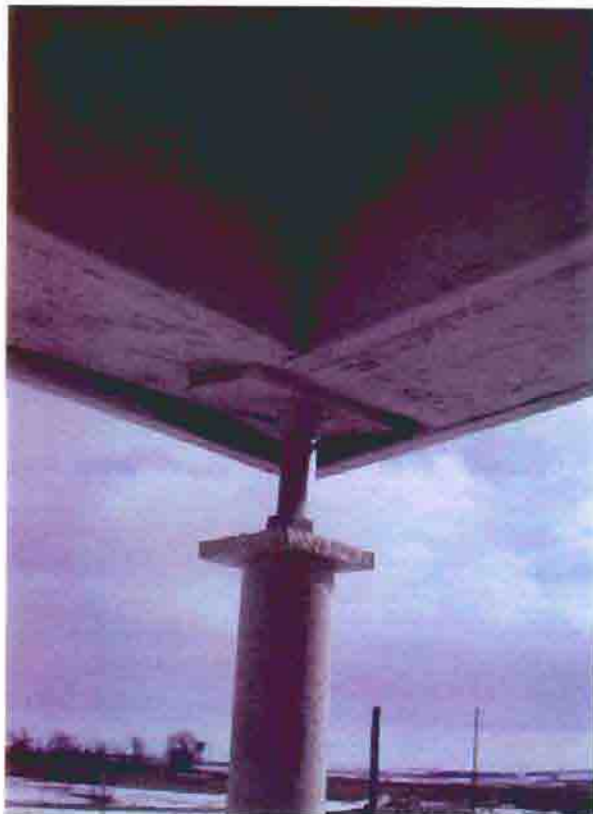
Photo S-14. The District No. 1 School, porch support post, February 2001. Photo by Wiss, Janney, Elstner Associates, Northbrook, Illinois.

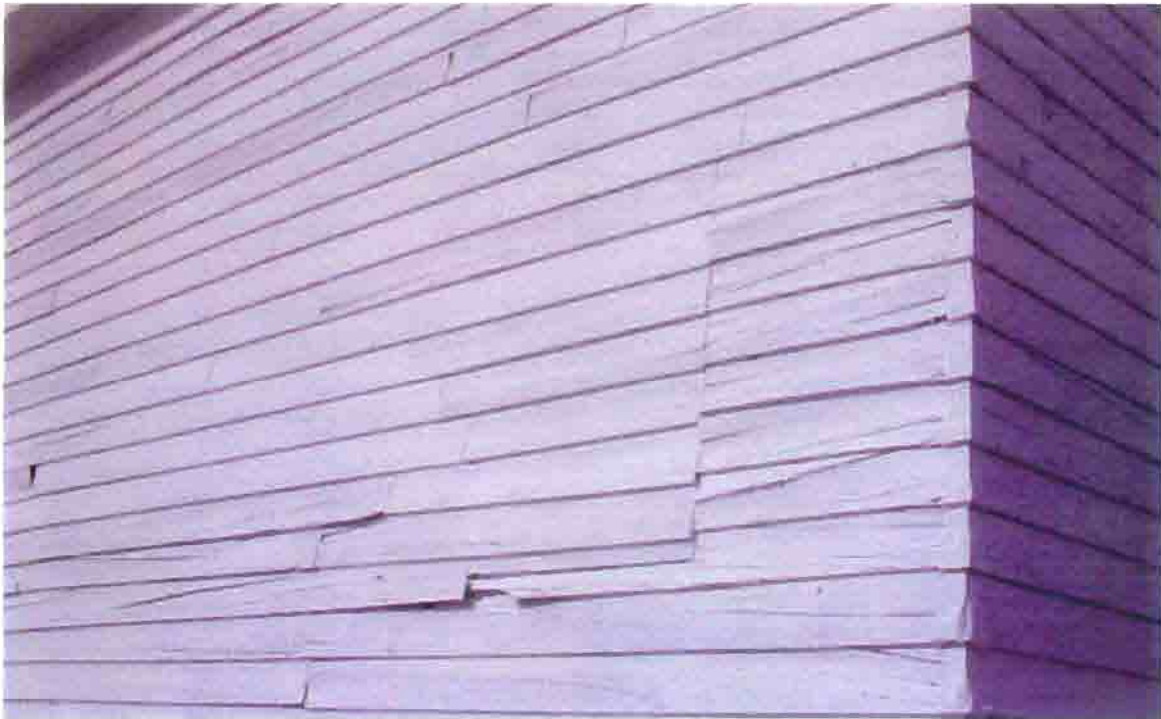
Photo S-16. The District No. 1 School, wood siding detail, February 2001. Photo by Wiss, Janney, Elstner Associates, Northbrook, Illinois.

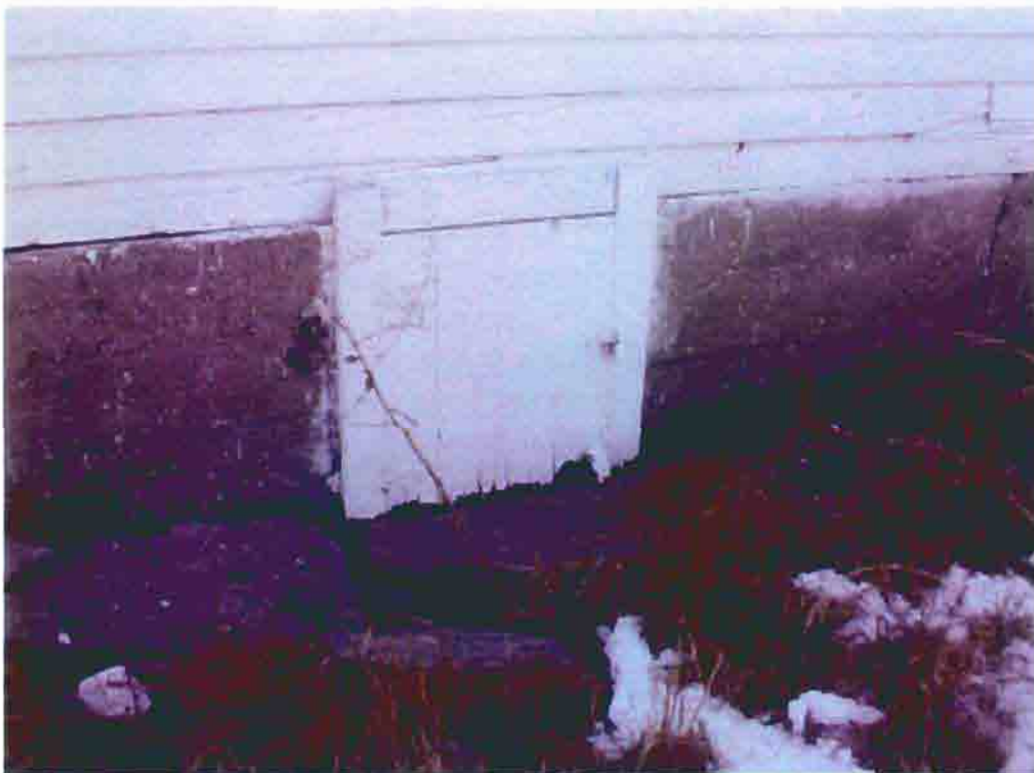
Photo S-20. The District No. 1 School, foundation access door, February 2001. Photo by Wiss, Janney, Elstner Associates, Northbrook, Illinois.

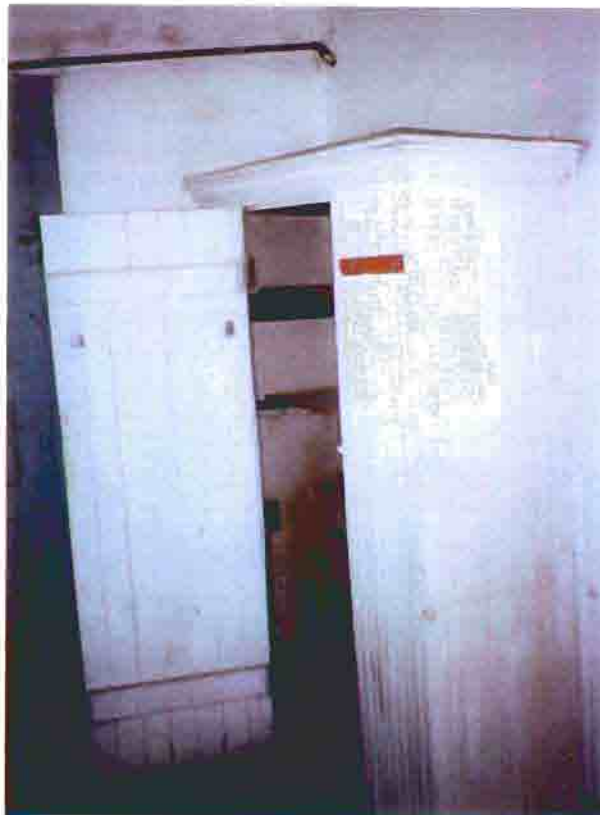
Photo S-26. The District No. 1 School, built-in cupboard in the kitchen, February 2001. Photo by Bahr Vermeer Haecker Architects, Lincoln, Nebraska.

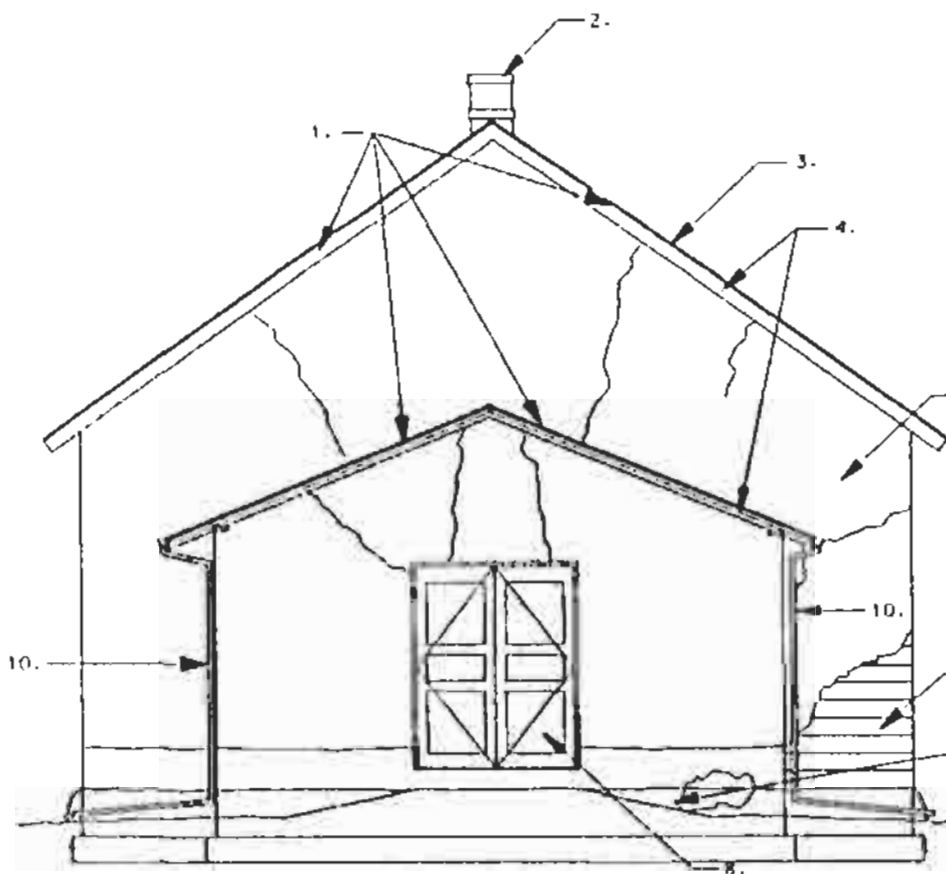
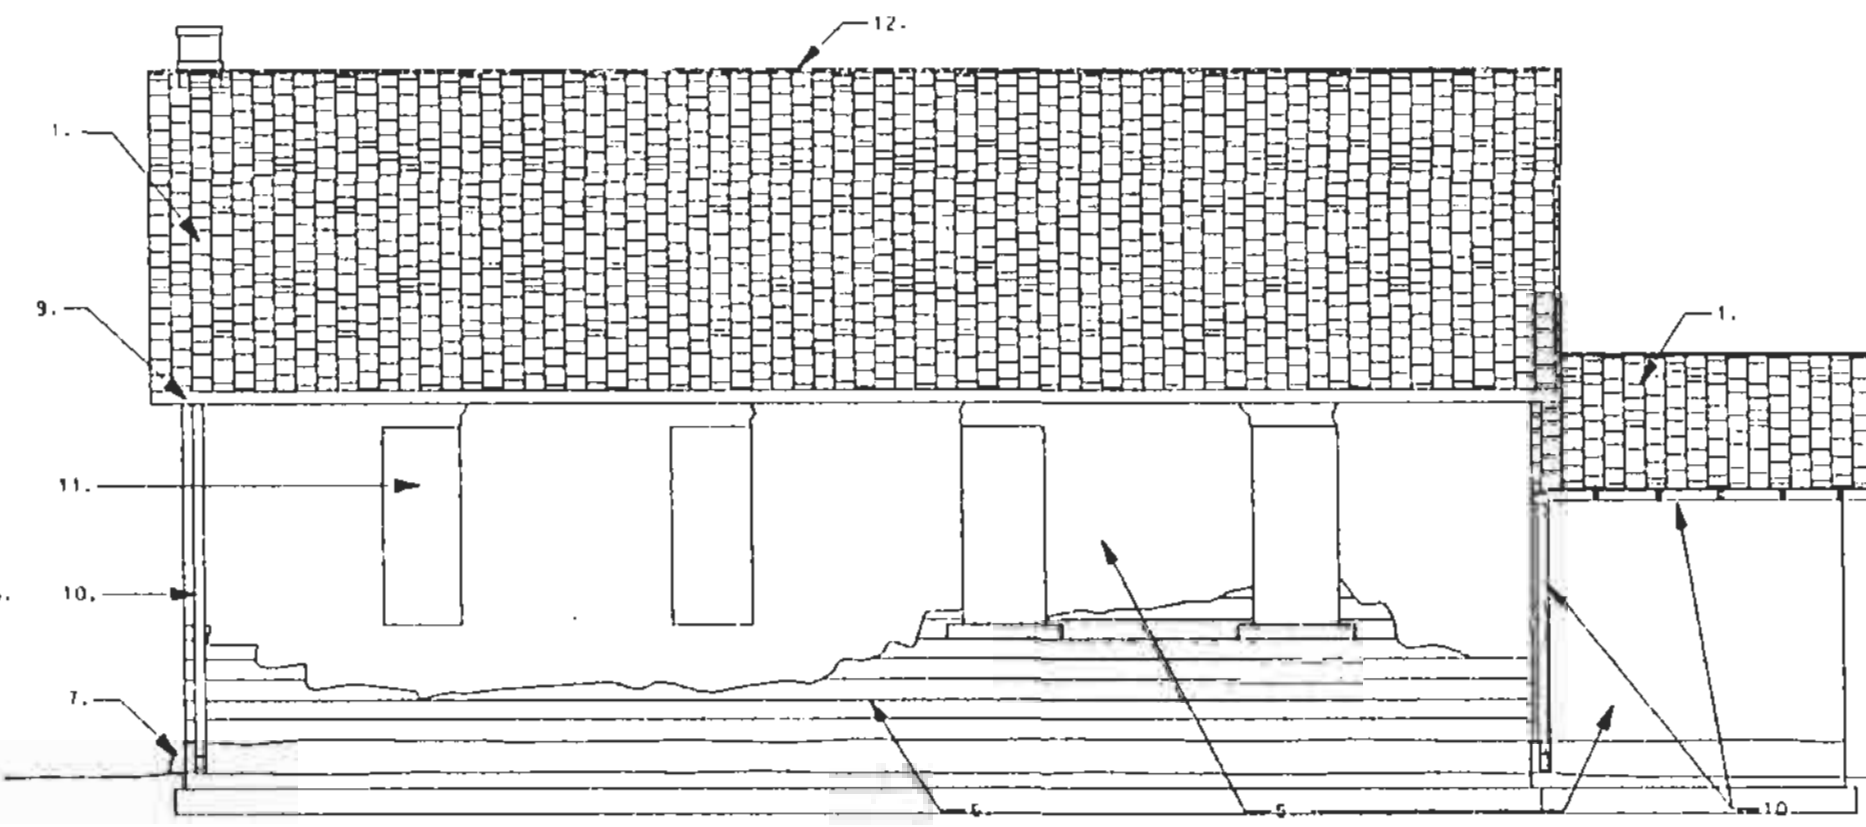
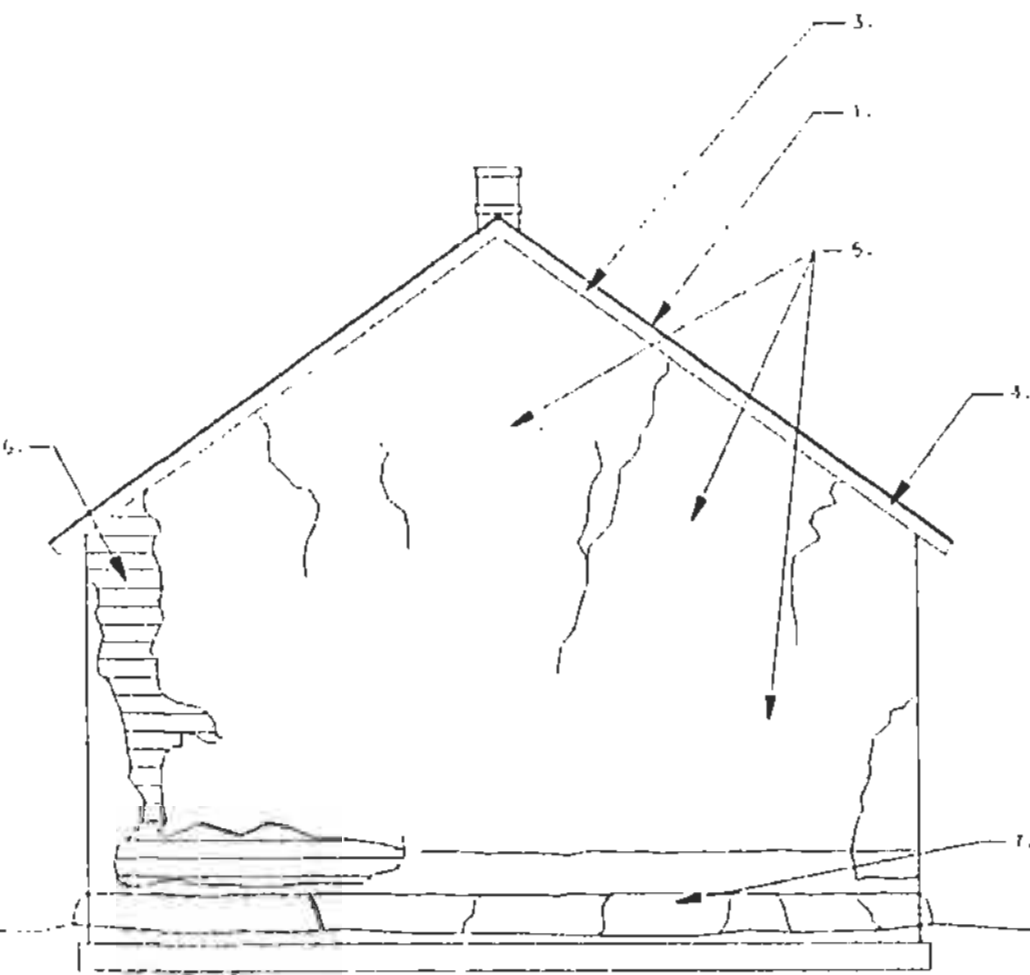
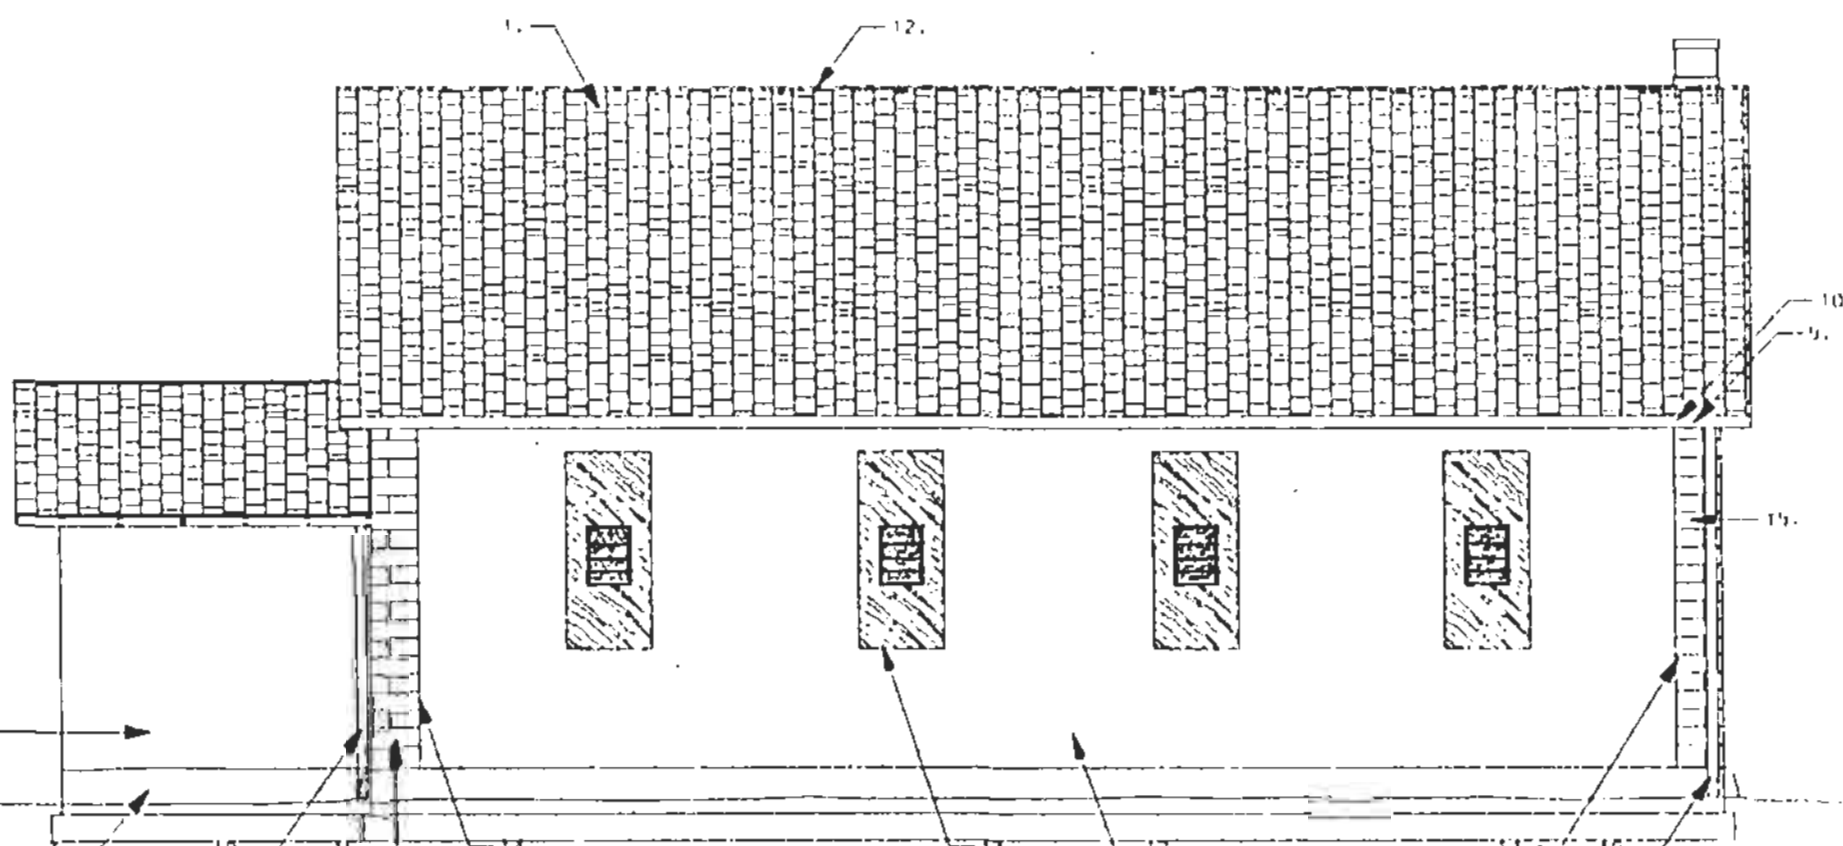
4. REPLACE 1X4 WOOD TRIM. PAINT.
5. COMPLETELY REMOVE EXISTING SIDING. SIDING IS CRAYED IN NUMEROUS LOCATIONS AND IS NOT OPTIMAL.
6. EXPOSED LIMESTONE WALL TO REMAIN. EXISTING WALL FINISHES OF EXTERIOR WITH LOCAL SOFT LIMESTONE FACE BLOCKS OF UNIFORM CREAMY YELLOW COLOR. MOSTLY UNIFORM SIZE OF 12" LONG, 6" HIGH, 8" DEEP. UN-TOOLED JOINTS. LAY UP IN ASHLAR PATTERN. INTERIOR WITH LOCAL LIMESTONE BLOCKS. UNIFORM CREAMY YELLOW COLOR. LAY UP IN RANDOM ASHLAR. SIZES VARY FROM A MAXIMUM OF 20" LONG X 12" HIGH TO A MINIMUM OF 10" LONG X 8" HIGH WITH UN-TOOLED JOINTS. REPOINT WALL WHERE POSSIBLE USING LIME MORTAR. REPLACE EXTREMELY DETEIORATED STONES WITH STONES SALVAGED FROM THE NORTH WALL. DUE TO THE EXISTING EXTERIOR SIDING AND INTERIOR PLASTER, THE EXTENT OF THESE REPAIRS IS UNKNOWN.

1. REMOVE EXISTING ROOF DOWN TO RAFTERS. INSTALL NEW ROOF RES: 3/42.
2. REMOVE EXISTING MASONRY CHIMNEY AND PLYWOOD COVERING.
3. REPLACE 1X12 WOOD SOFFIT AND OUTRIGGERS. PAINT WHITE.

7. REMOVE EXISTING ADHERED CONCRETE BASE ENTIRE PERIMETER OF BUILDING.
8. EXISTING HISTORIC WOOD PANEL DOORS TO REMAIN.
9. REPLACE 1X4 WOOD FASCIA, 1X4 WOOD TRIM AT WALL AND 1X12 WOOD SOFFIT. PAINT.

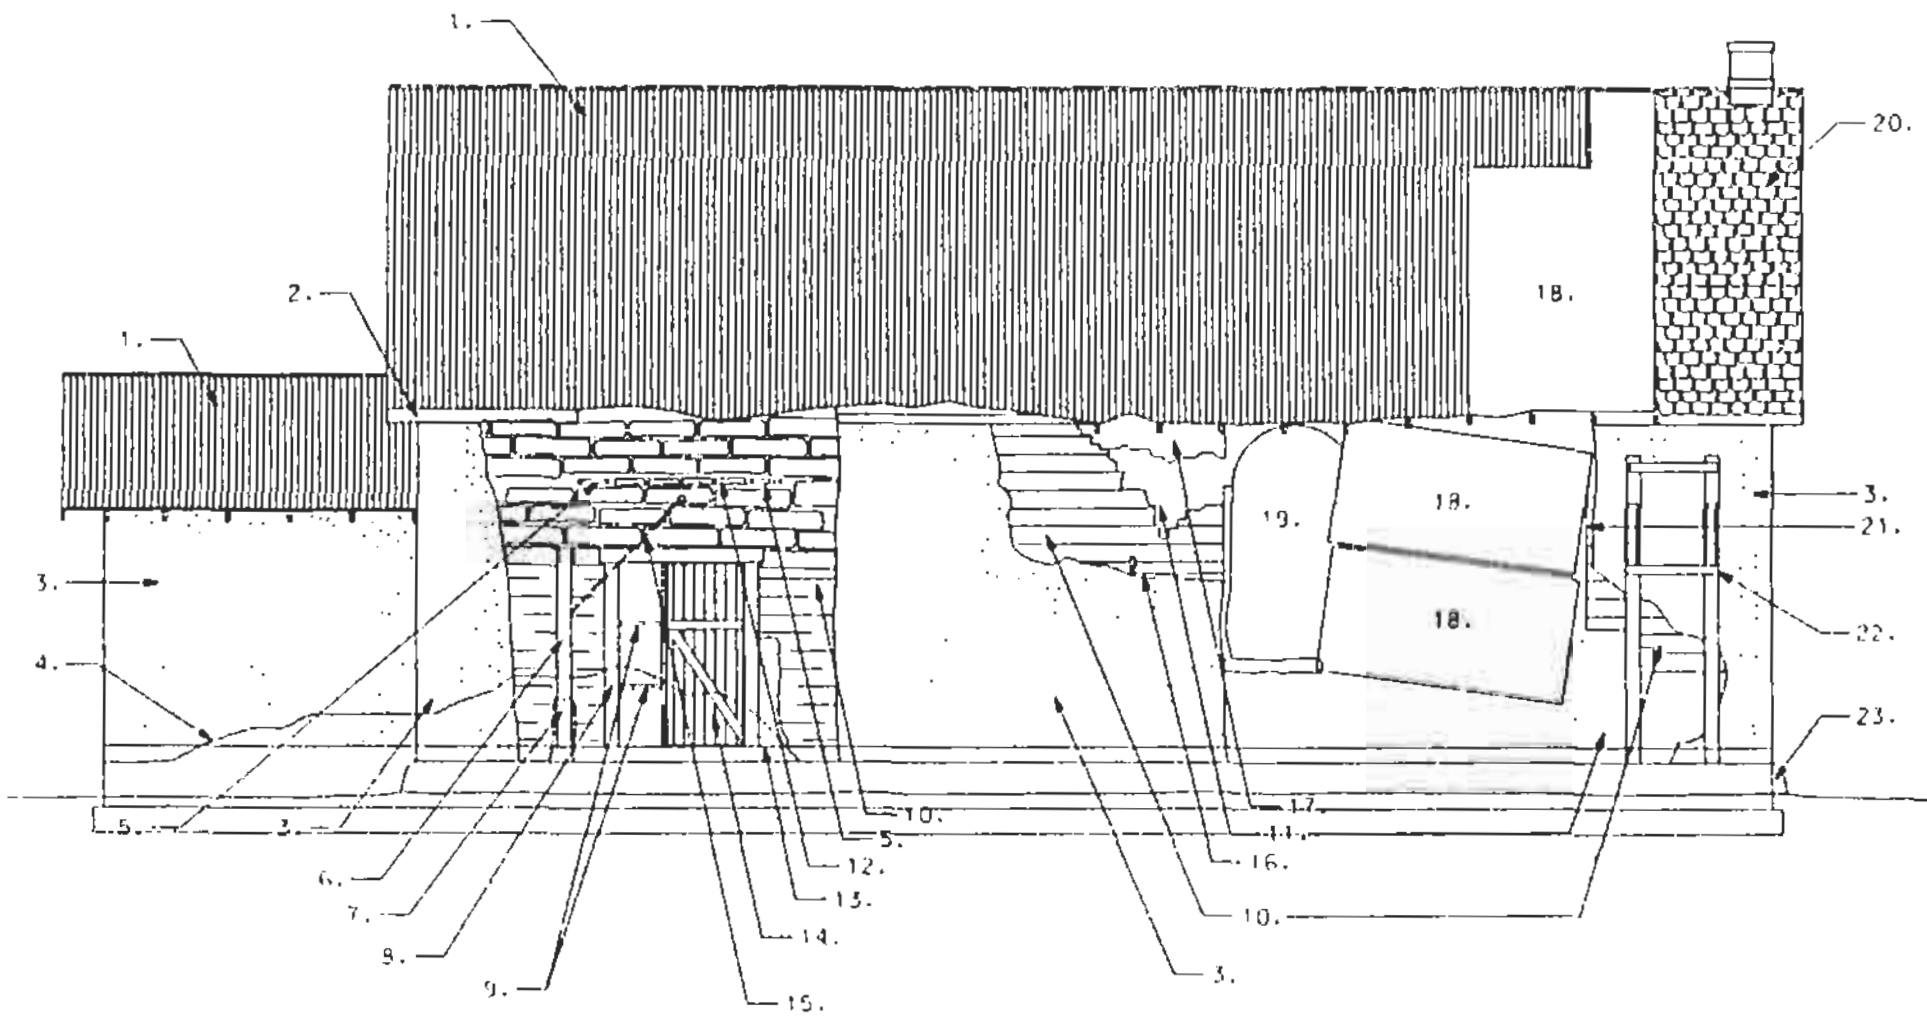
EXISTING NORTH EXTERIOR ELEVATION

17. PLYWOOD INSIDE BUILDING.
18. PLYWOOD COVERING DETERIORATED LIMESTONE OUTER WYTHE.
19. FORMED CONCRETE.
20. HISTORIC SHINGLES: CEDAR, 5" WIDE X 11 1/4" LONG X 5/16" THICK WITH MAXIMUM 4" EXPOSURE.

32. 1X4 T&G WOOD CEILING.
33. DETERIORATED BRICK MASONRY CHIMNEY COVERED WITH PLYWOOD AND 1X4'S.
34. 2X12 WOOD FRAME WITH WOOD LATH ON INTERIOR SIDE.
35. 1&O COATS STUCCO ON METAL LATH.

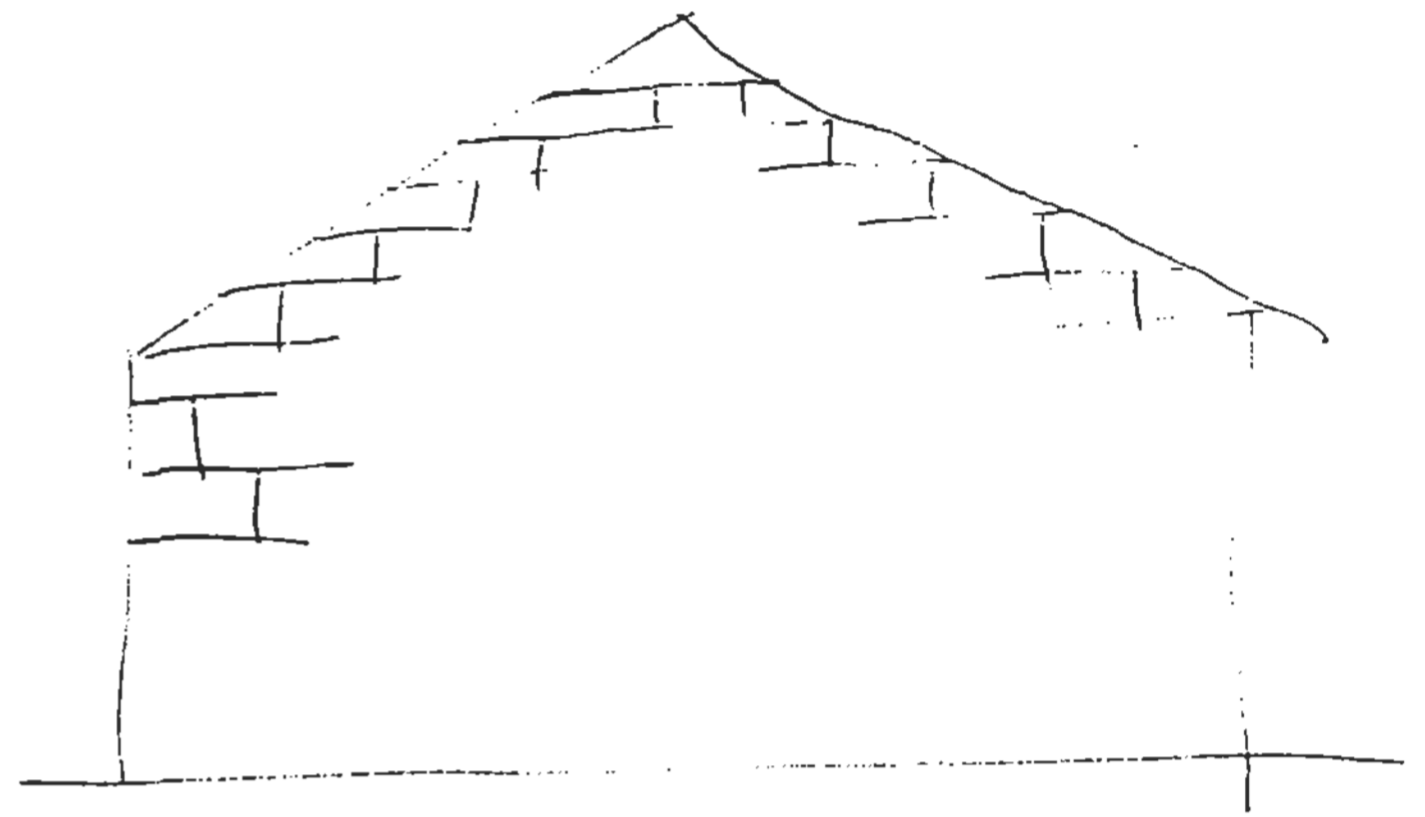
Front Gable

The rear gable may not have been constructed high enough!
