Nicodemus National Historic Site
Nicodemus, Kansas
Historic Structures Report
National Park Service

25 October 2002

Bahr Vermeer Haecker Architects, Ltd.
in association with
Wiss Janney Elstner Associates, Inc.

Historic Structures Report

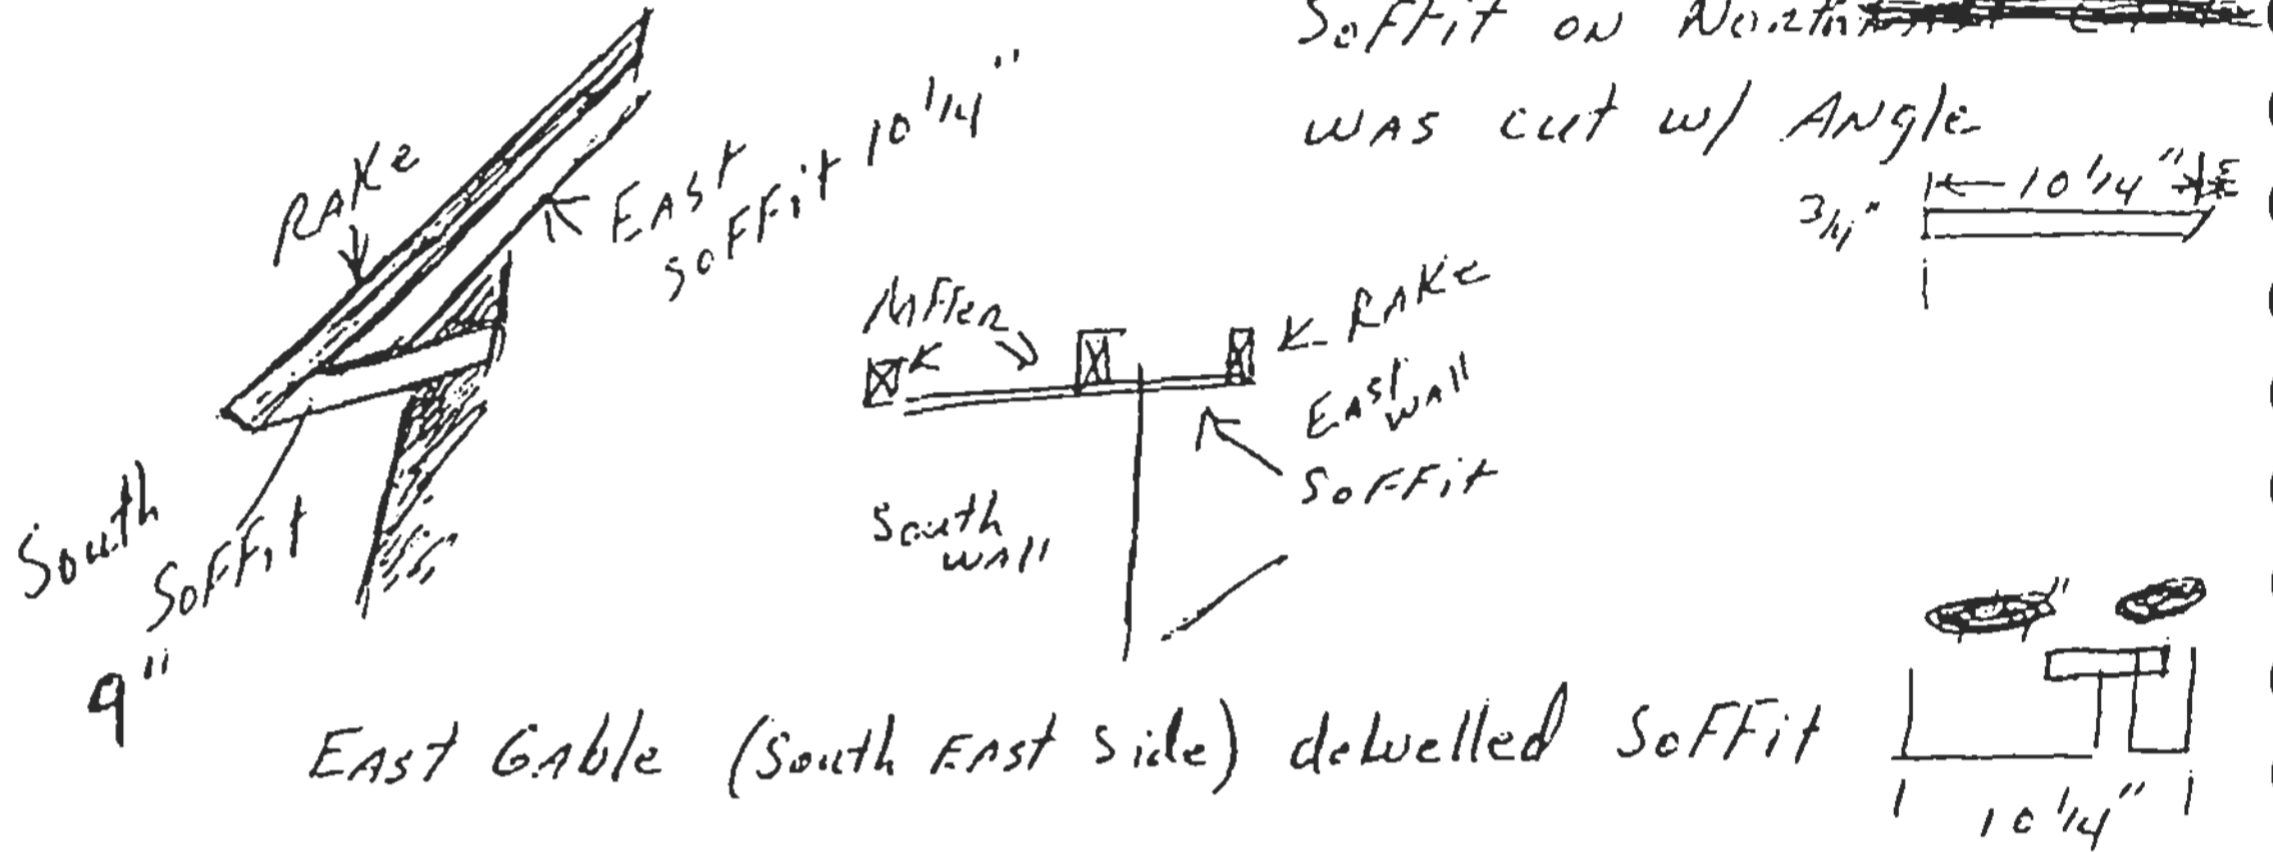
Removal of Roof consisted of Metal Roof Attached to 1" x 4" Pine Sheathing shot in w/ coated #10 (common) Nail gun
 Rolled Roofing - Green (Dark)
 2 wood cedar roofs
 Edges of 1st Roof had been removed and A filler Bd was installed $3\frac{1}{4}''$ x $3\frac{1}{2}''$

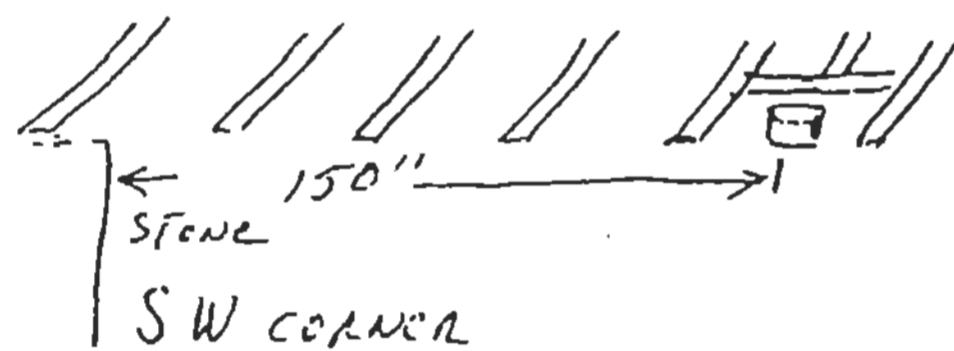
Paint Can Found inside Roof on South Side of Bldg.

(CAN approx 7" diam.)
 TURNED upside down

could be where stove pipe was GREEN paint inside of can very close to color found on shingles & nails

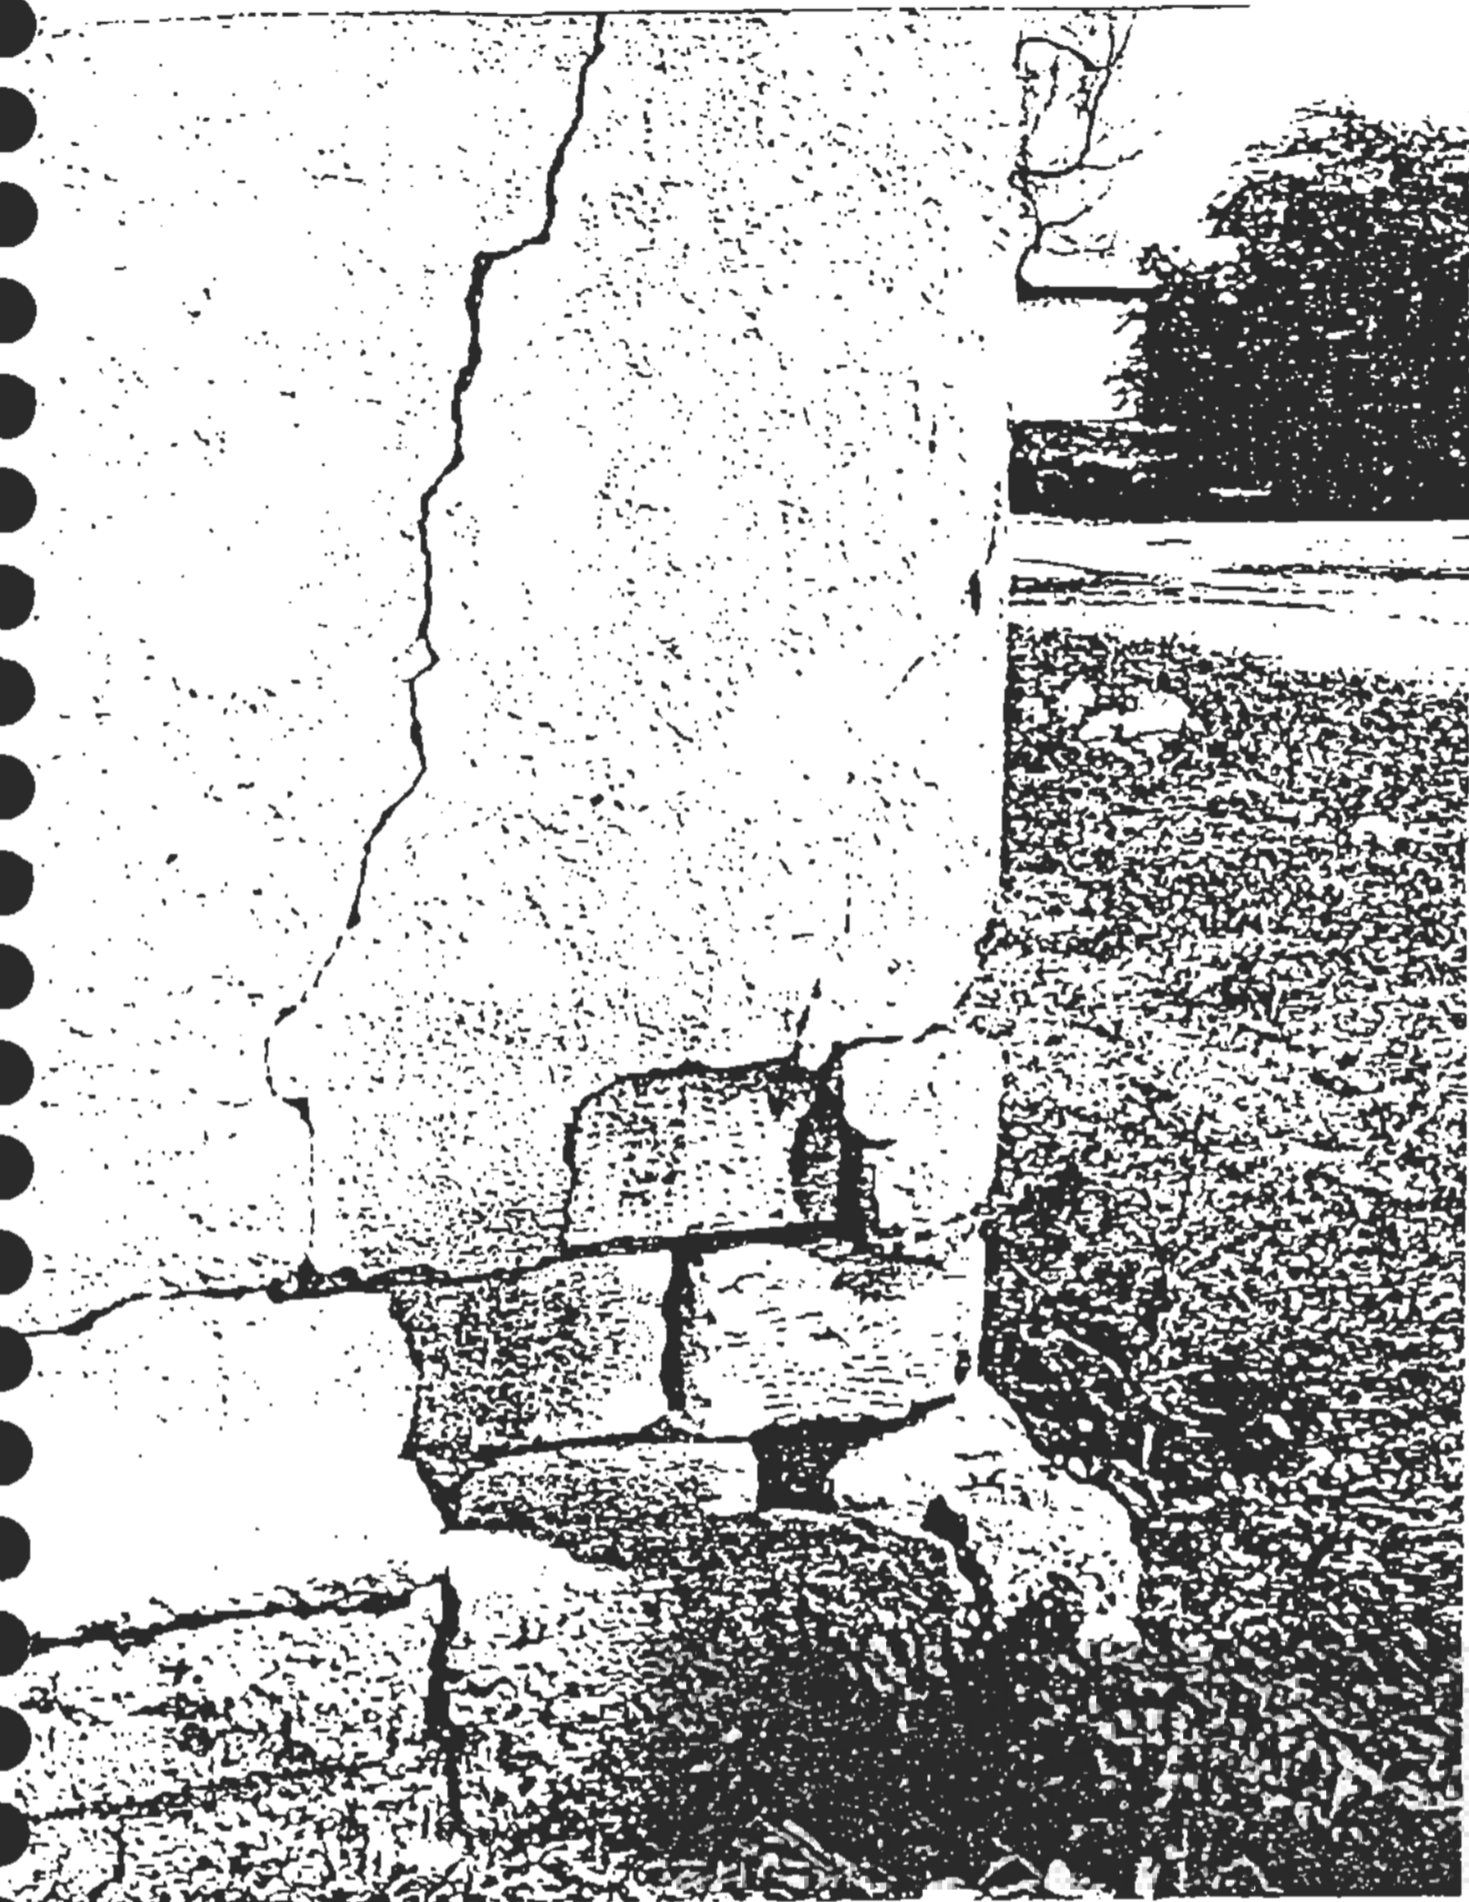
Fig. 1

At some point in the past, possibly in the 1930's, the exterior wythe of limestone blocks was scarified and a cement plaster stucco was placed over the entire exterior (Figs 1, 8). The interior finish on the stone walls is painted plaster which appears to be original. The exterior stucco is fairly intact, except for some vertical cracking, on the vestibule and on the east and west walls of the main church. The stucco on the south wall has fallen off along the entire length of the wall for a height of about twenty-four inches above the foundation (Fig. 3). Stucco has fallen off from the eastern half of the south wall for a height of four to six feet, indicating a more severe problem in this area (Fig. 2). The stone exposed to the exterior appears to be in fairly good condition, except at the base of the wall in the eastern half of the south elevation. In general, not much mortar remains, although the extent of this condition is difficult to determine without removal of the stucco.

The original foundation is a very shallow continuous stone spread footing. At some point in the past, concrete was poured against the outside face of the foundation in an effort to stabilize it (Figs 1, 2). In 1996, the new interior post-and-beam roof structure was installed on a new wood cribbing foundation (Fig. 11).

Southwest Corner, base of wall showing foundation modification. Note scarification marks in stone.

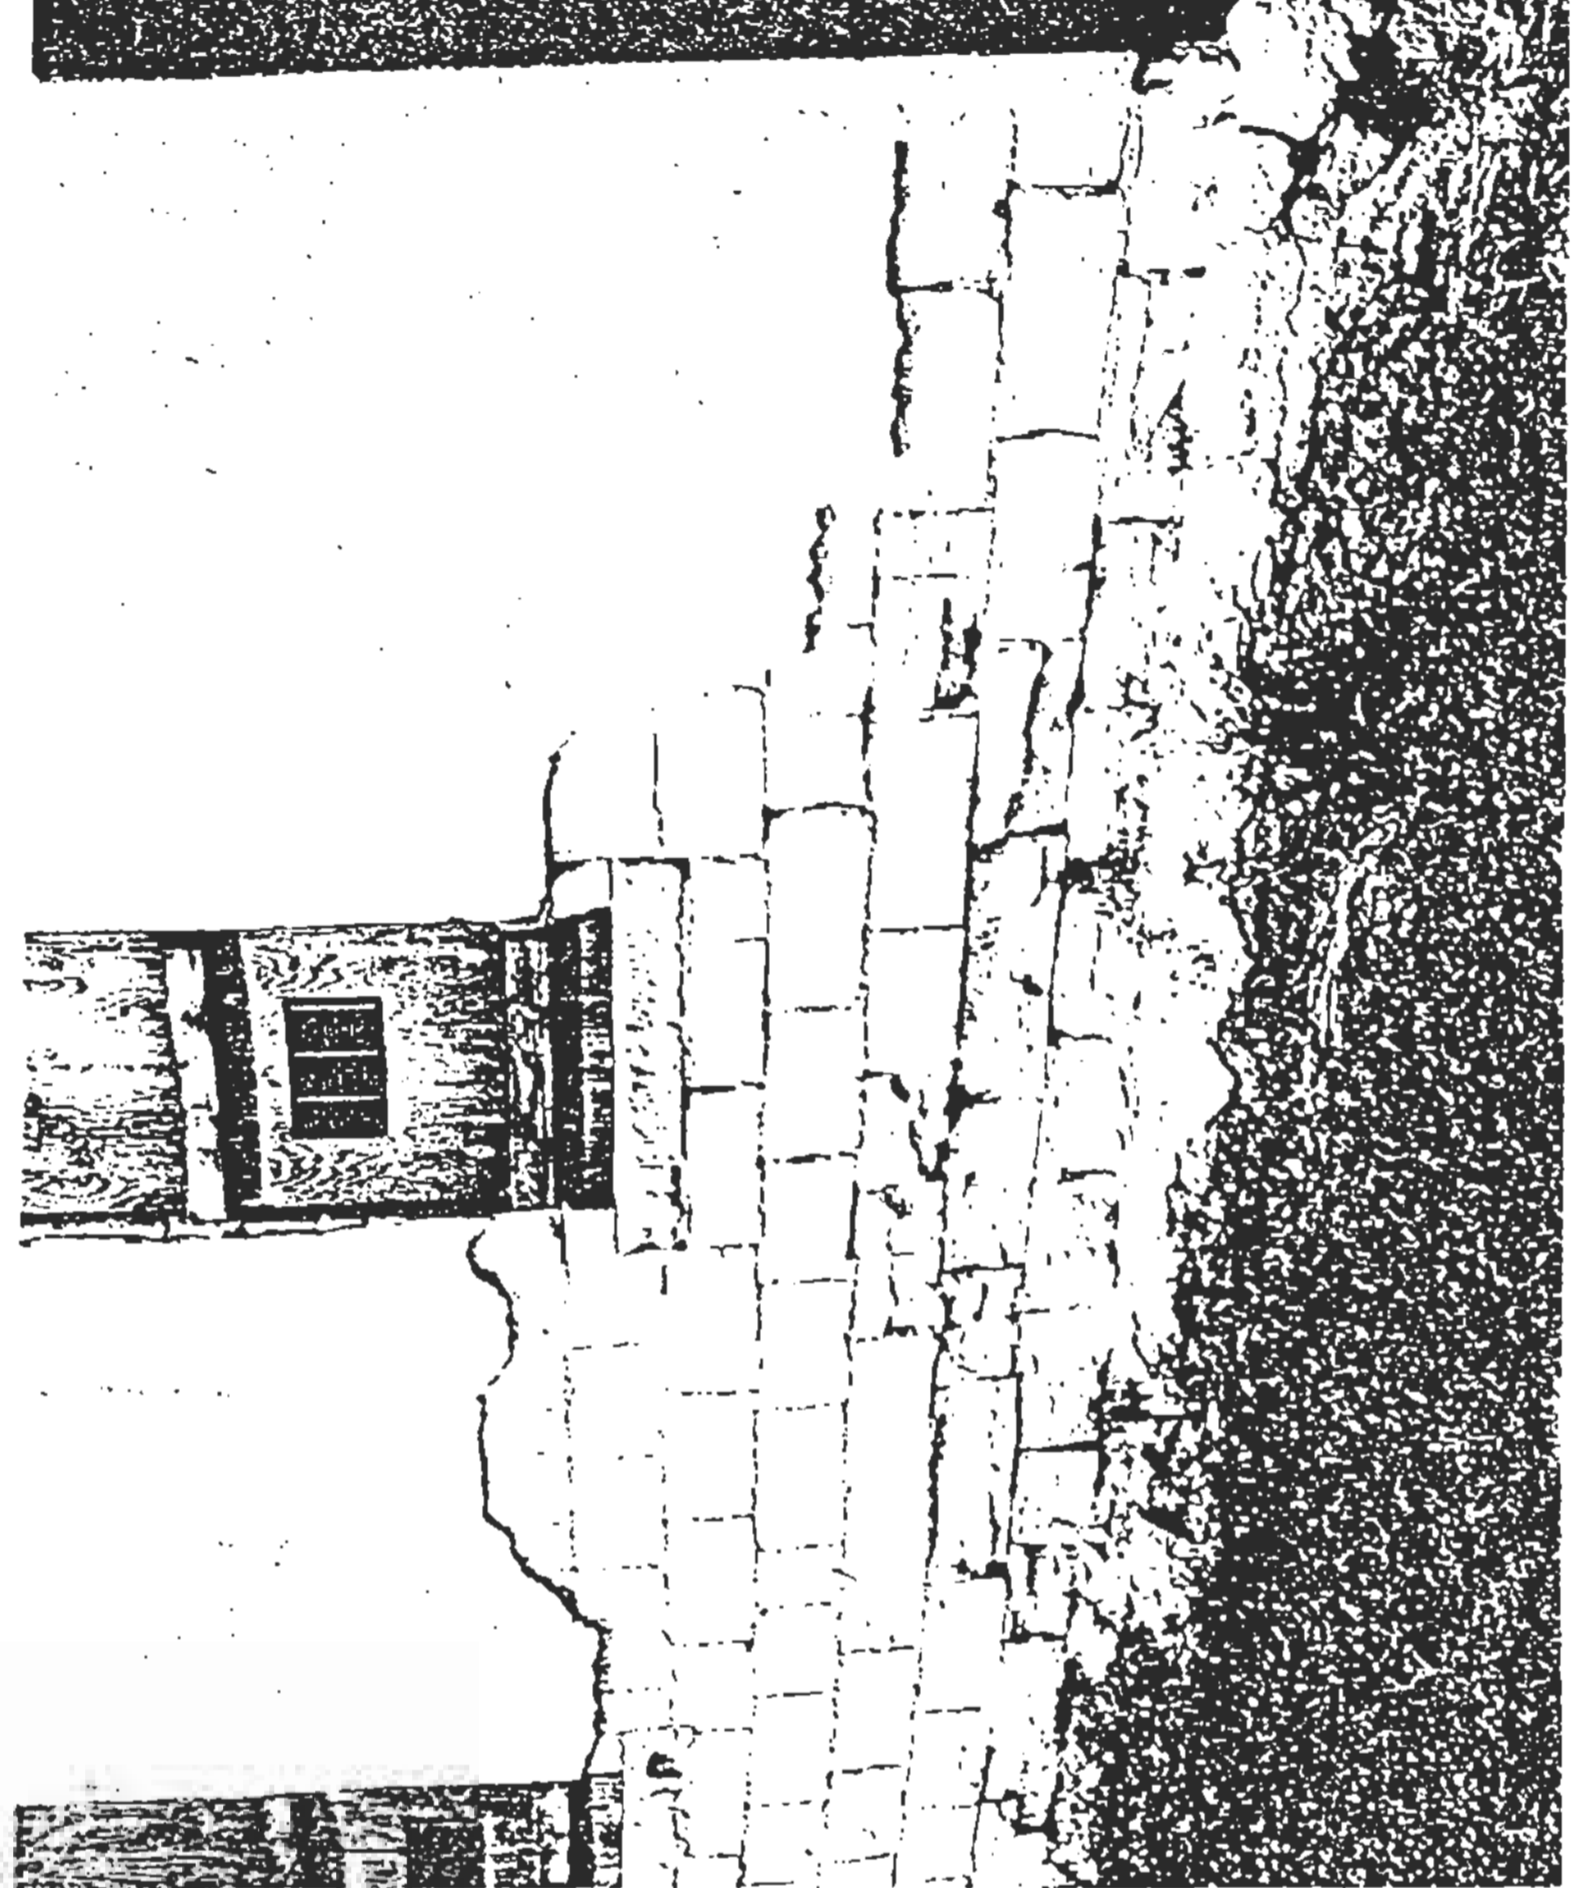
Fig. 2

South Side, closeup of stone deterioration at base of wall

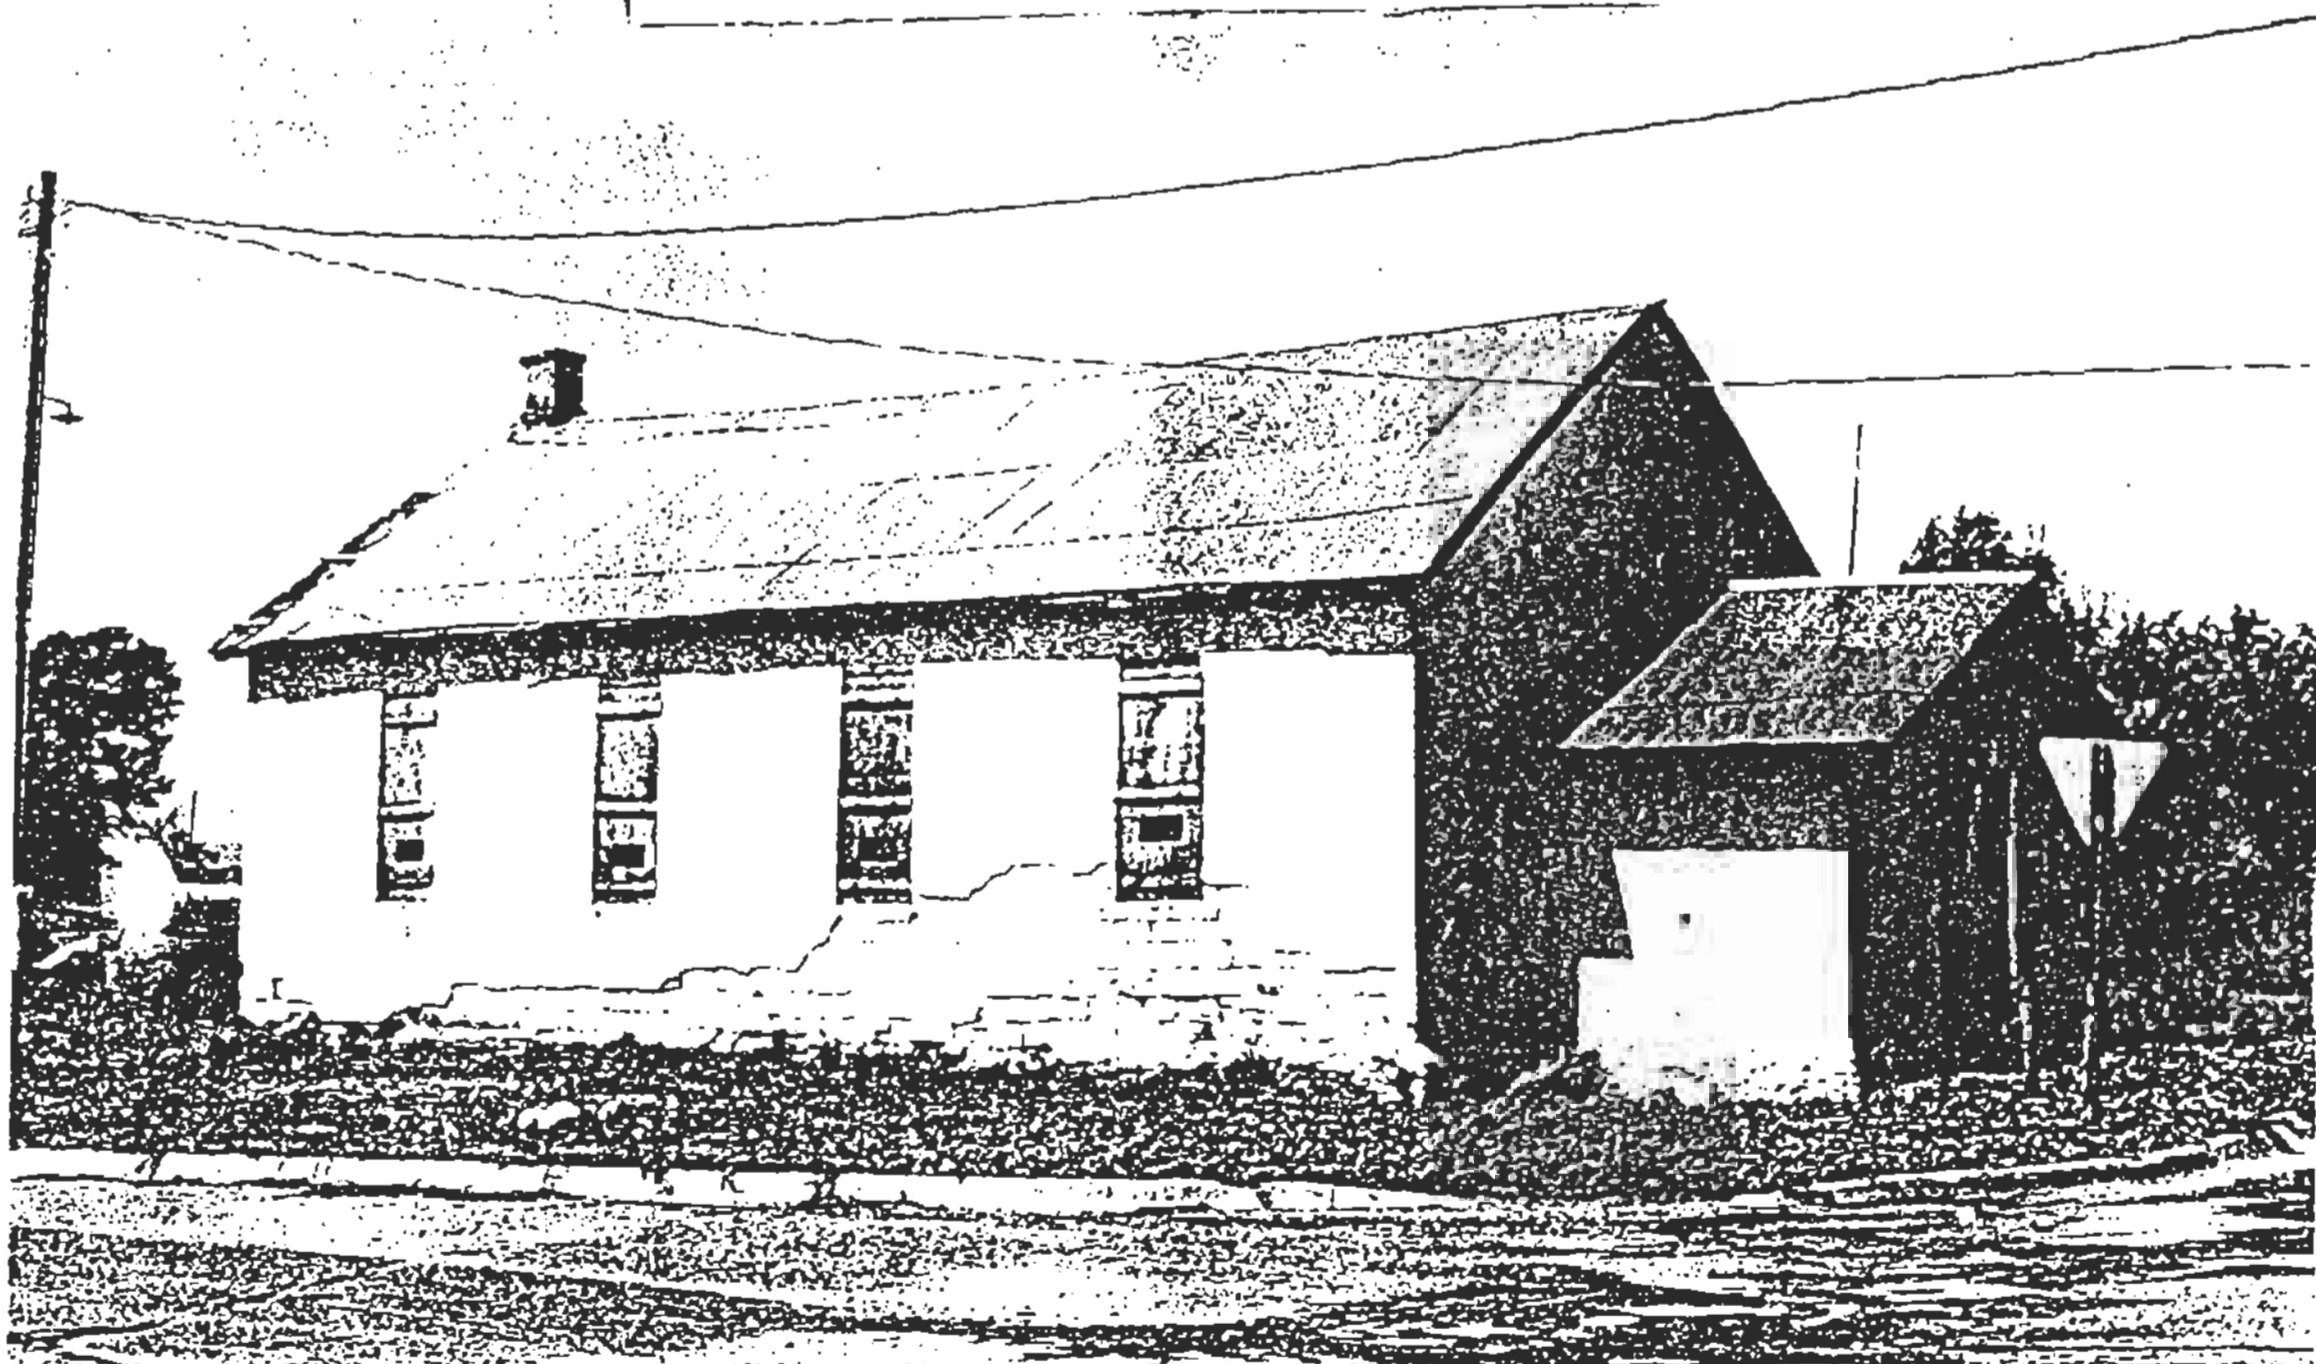
Fig. 3

The AME Church was constructed in 1885. It is a single story structure constructed of limestone masonry walls with a more recent stucco coating, a wood-framed roof, wood-framed floor, and stone foundation (Fig. 3). The overall condition is extremely dilapidated. The floor plan is rectangular and the primary elevation faces east. The building measures approximately forty-three feet six inches from east to west, and approximately twenty-six feet six inches from north to south. A small rectangular vestibule is on the east side. Evidence of an arched opening into the main church was found above the vestibule ceiling, suggesting that the vestibule may have been an addition, although probably a very early one.

The exterior walls are constructed of cut local limestone blocks laid up in ashlar fashion in a double-wythe wall on a shallow limestone foundation. The cut stones vary in size, but they average about 8 inches high, 16 inches long, and 8 inches deep. The entire wall thickness is about 20 inches. The north and south walls were originally bearing walls, but a freestanding interior wood post-and-beam structure was added in 1996 to remove the roof load from the deteriorated stone walls (Fig. 10). There are four boarded-up window openings on the south side, and a pair of partially boarded-up entry doors on the east side (Fig 3).

South and east sides

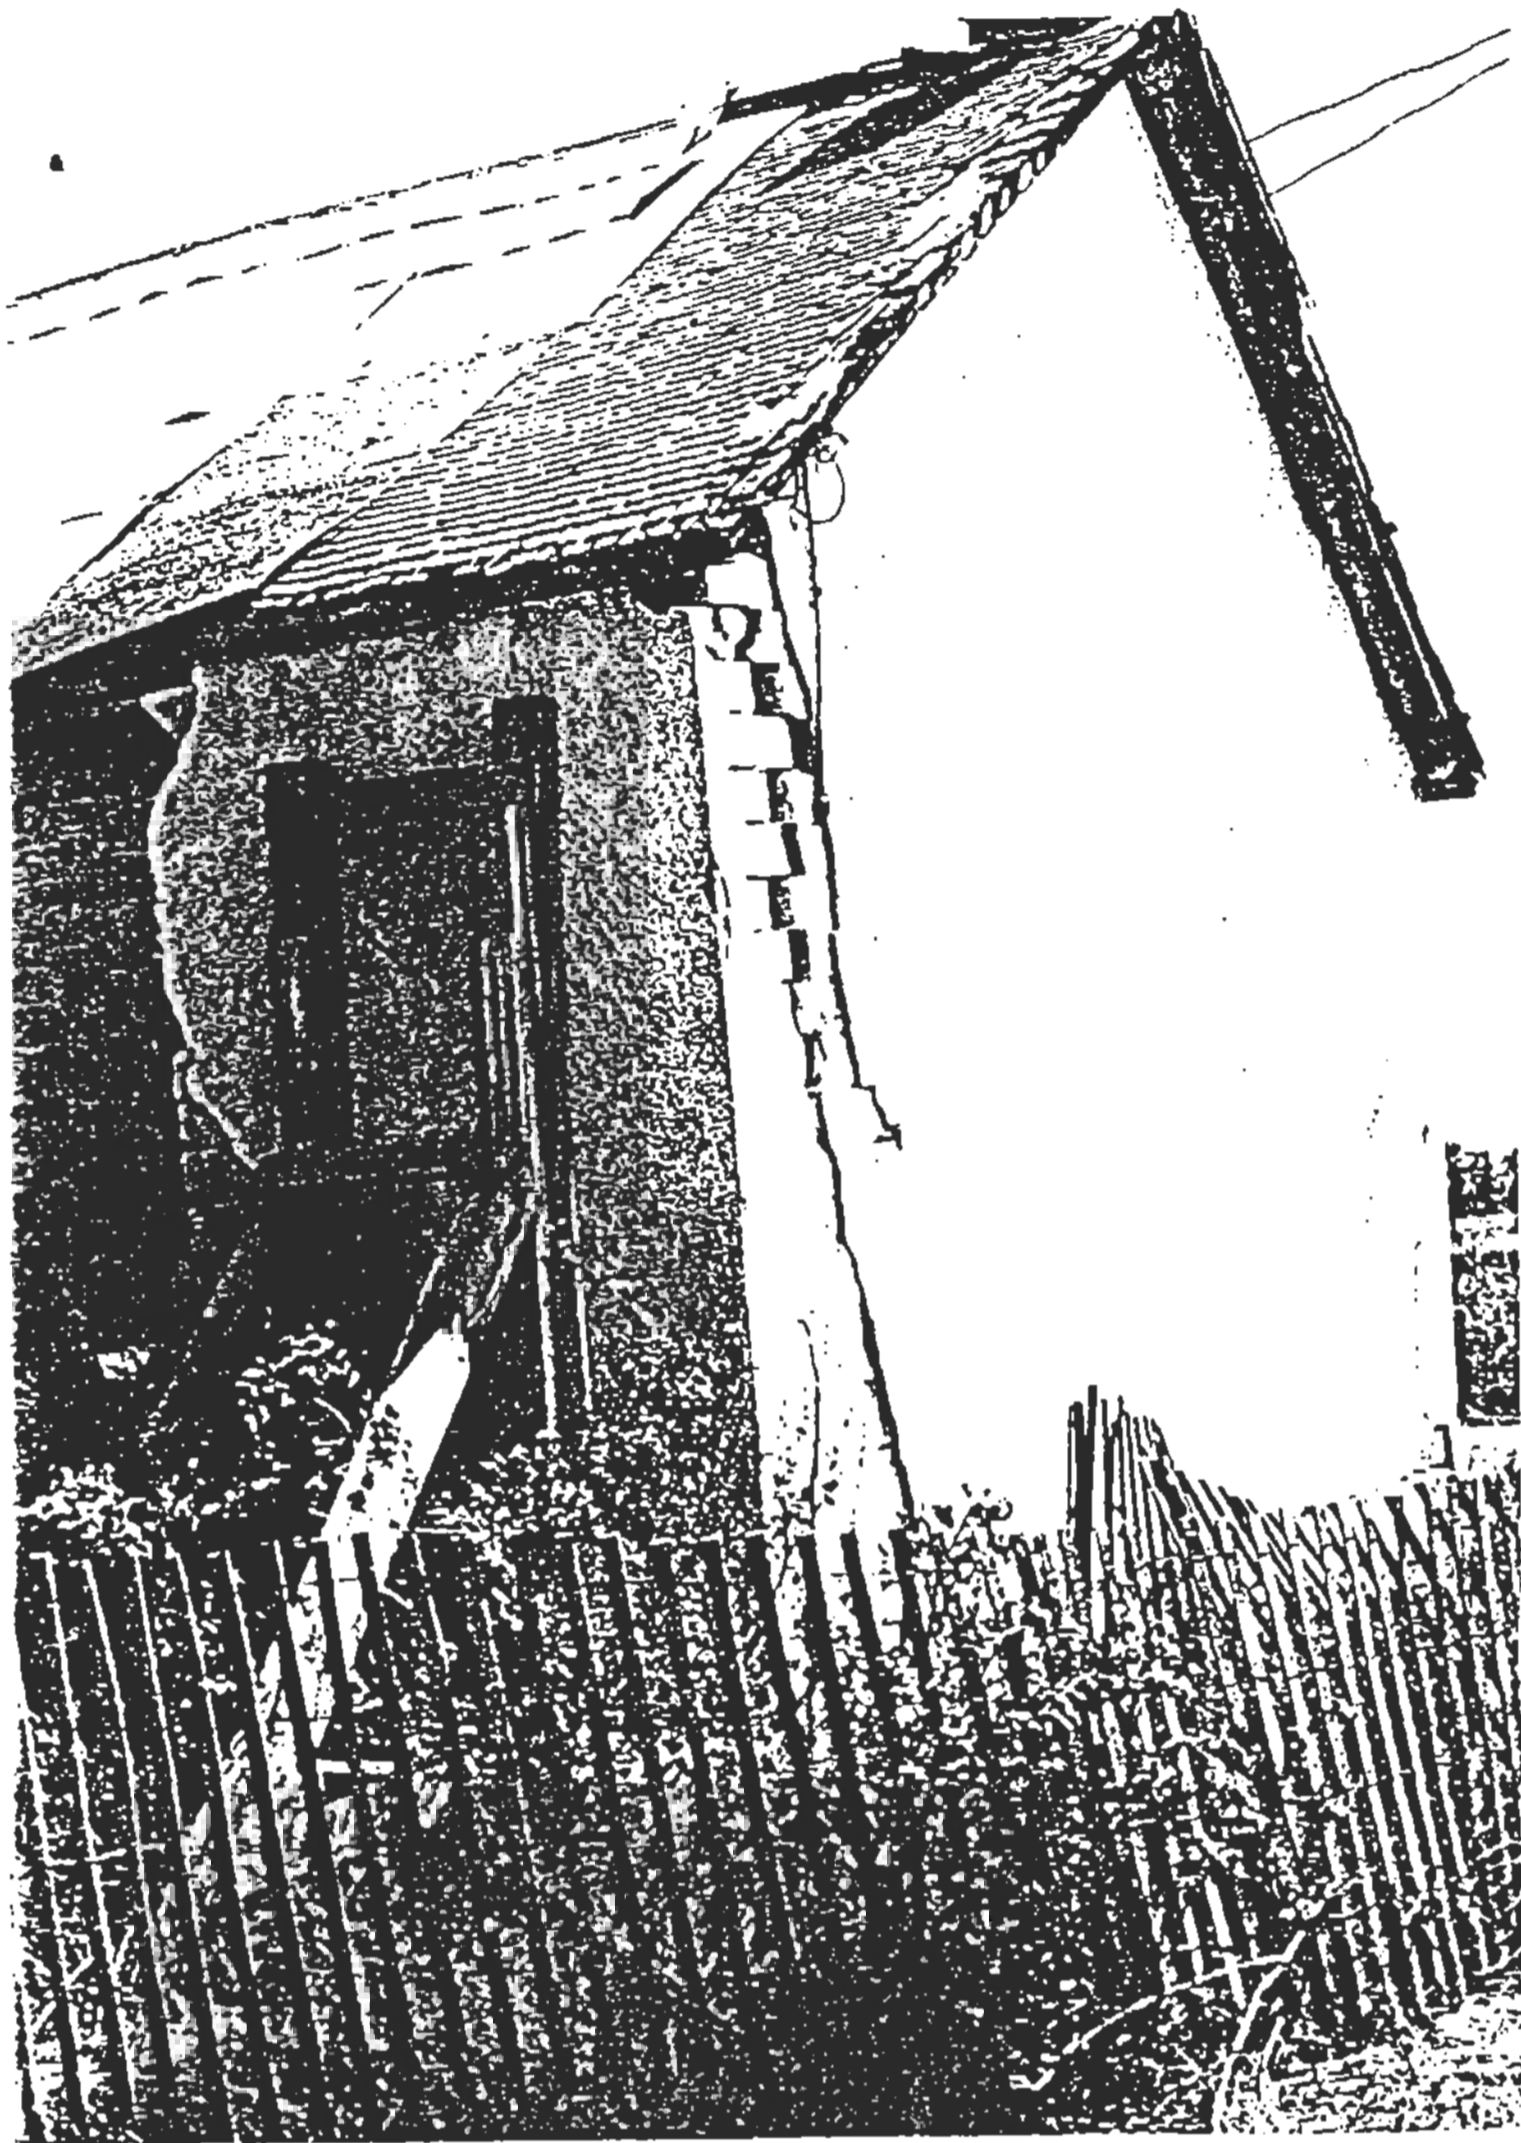
Fig. 4

The building has a front-facing gable roof with an eave height of approximately twelve feet. The original roofing was wood shingles on 1x6 spaced wood sheathing (Fig. 4). The shingles and sheathing are still existing, although very deteriorated. The roof is framed with original 2x6 rafters at 24" on center, with 1x6 horizontal ties and kingposts at 24" on center. There are no gutters or edge flashing, and the decking edge is exposed to the elements. Stabilization efforts in 1996 included the addition of new 2x6 sister rafters in the northwest corner, and corrugated metal roofing over the existing roof.

Northwest corner

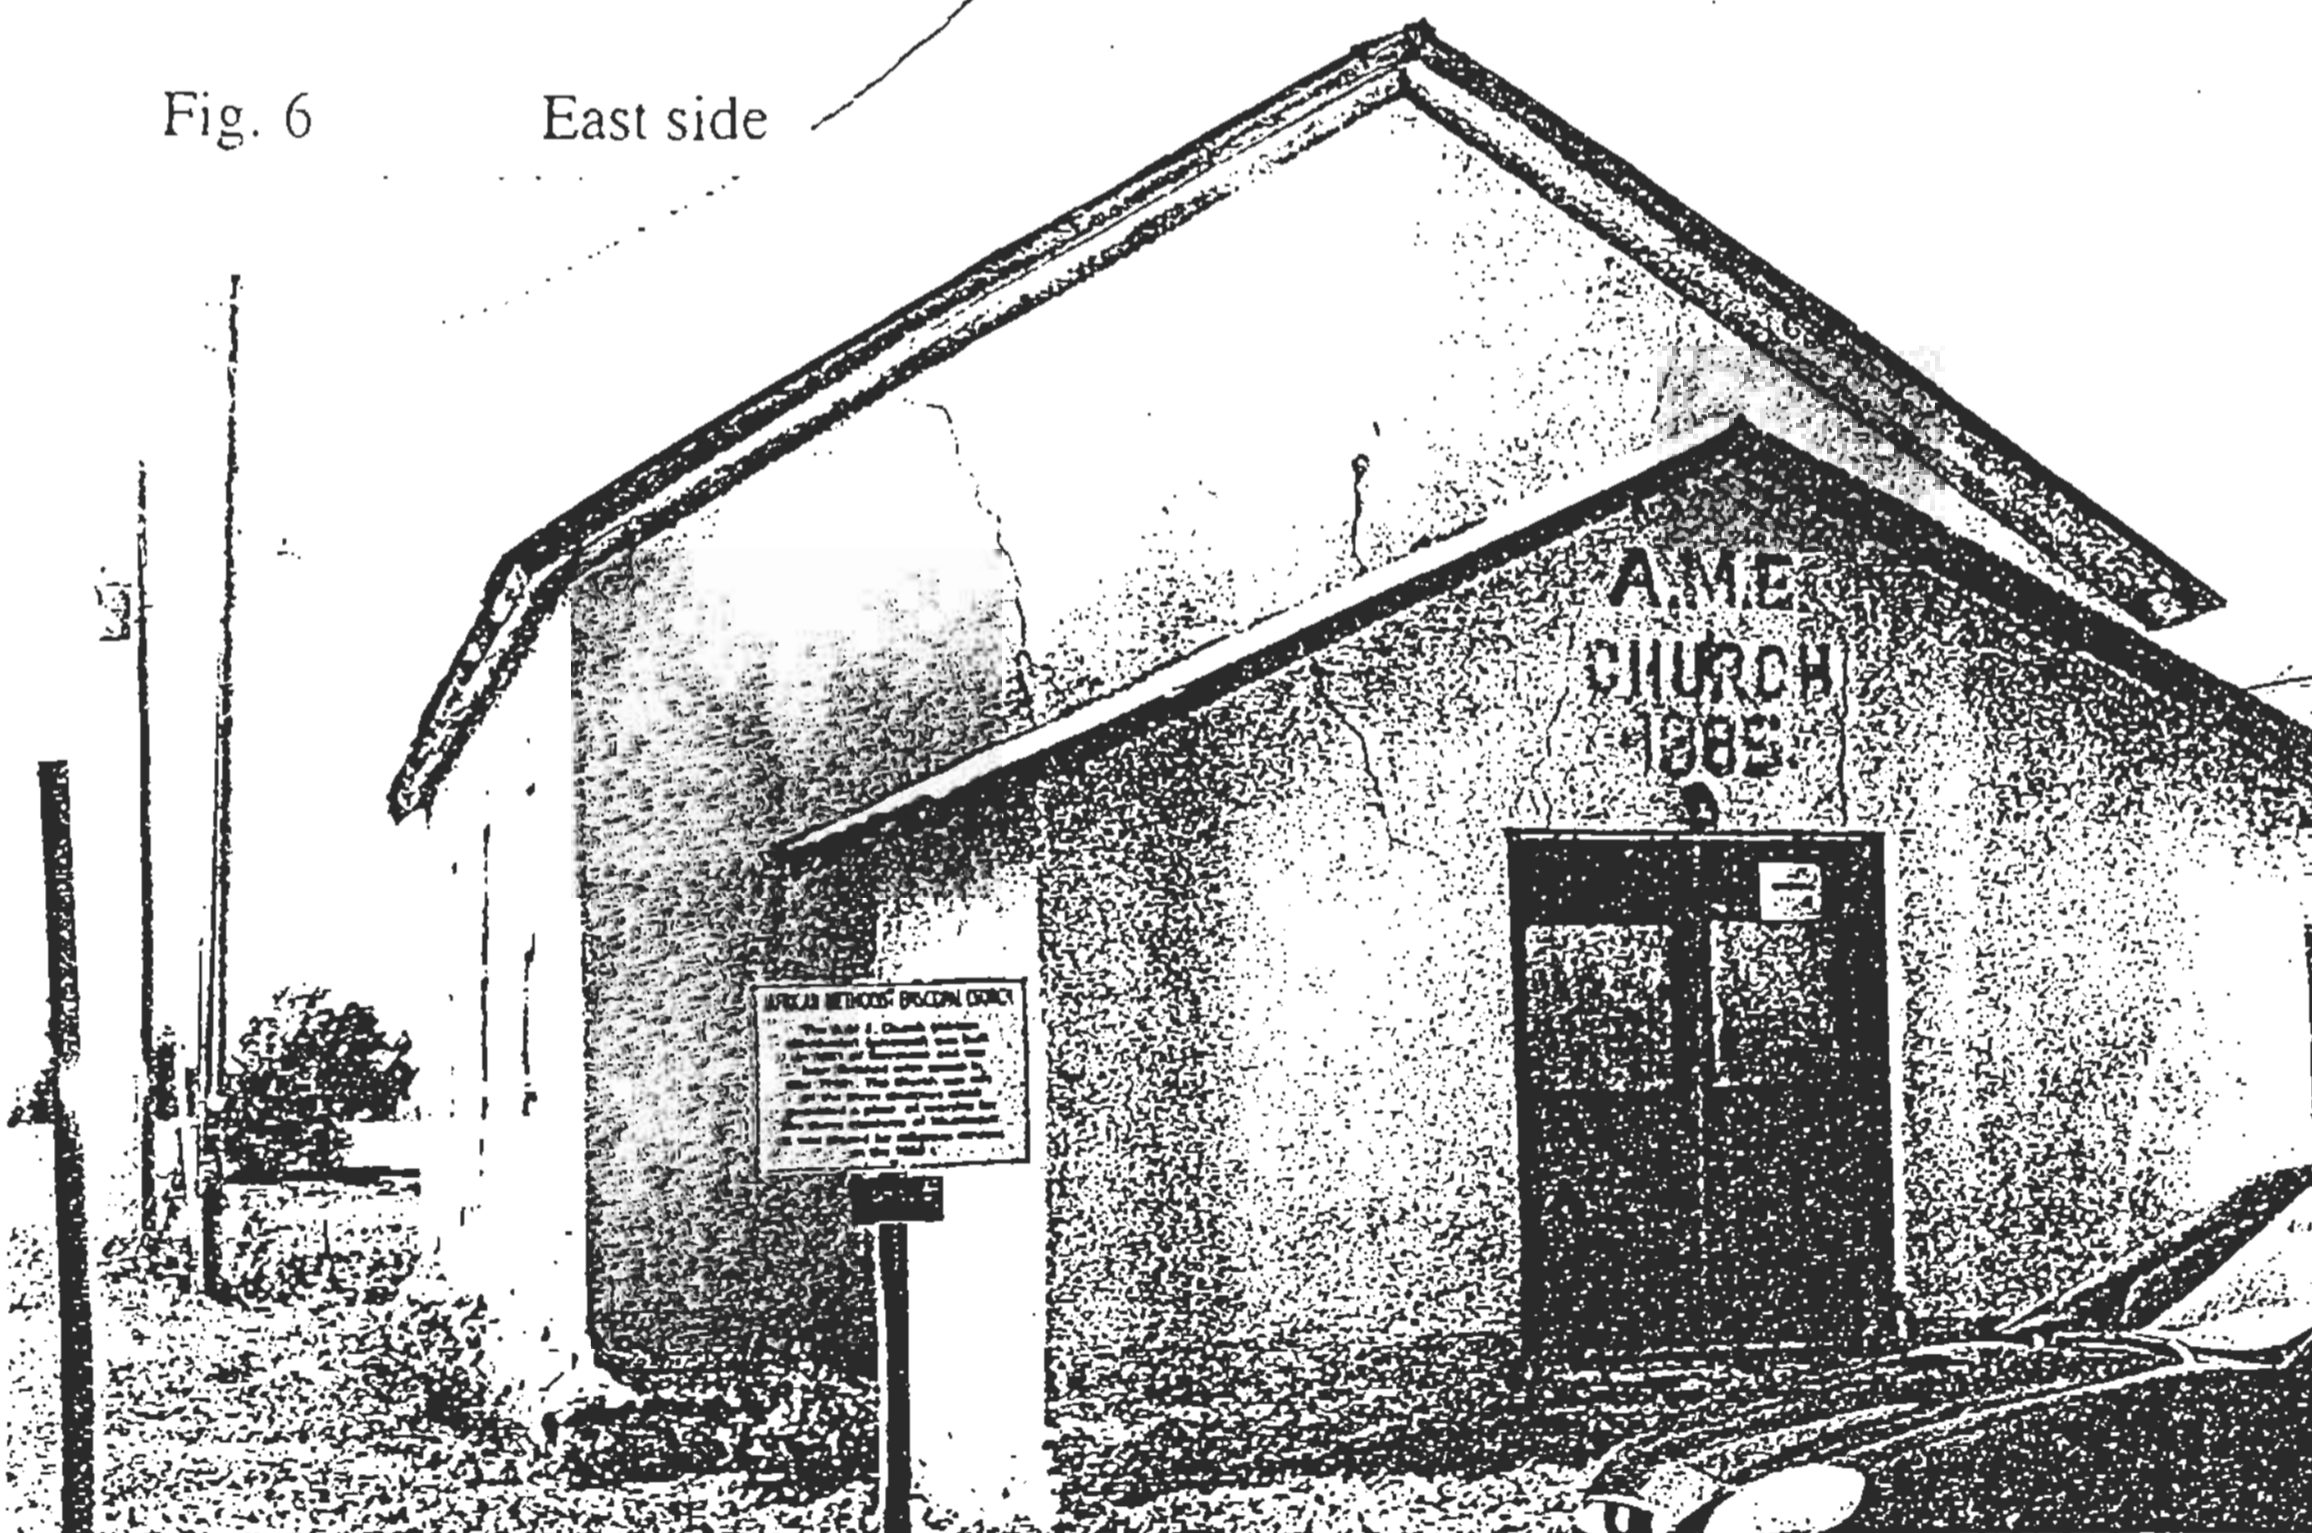
Fig. 6

East side

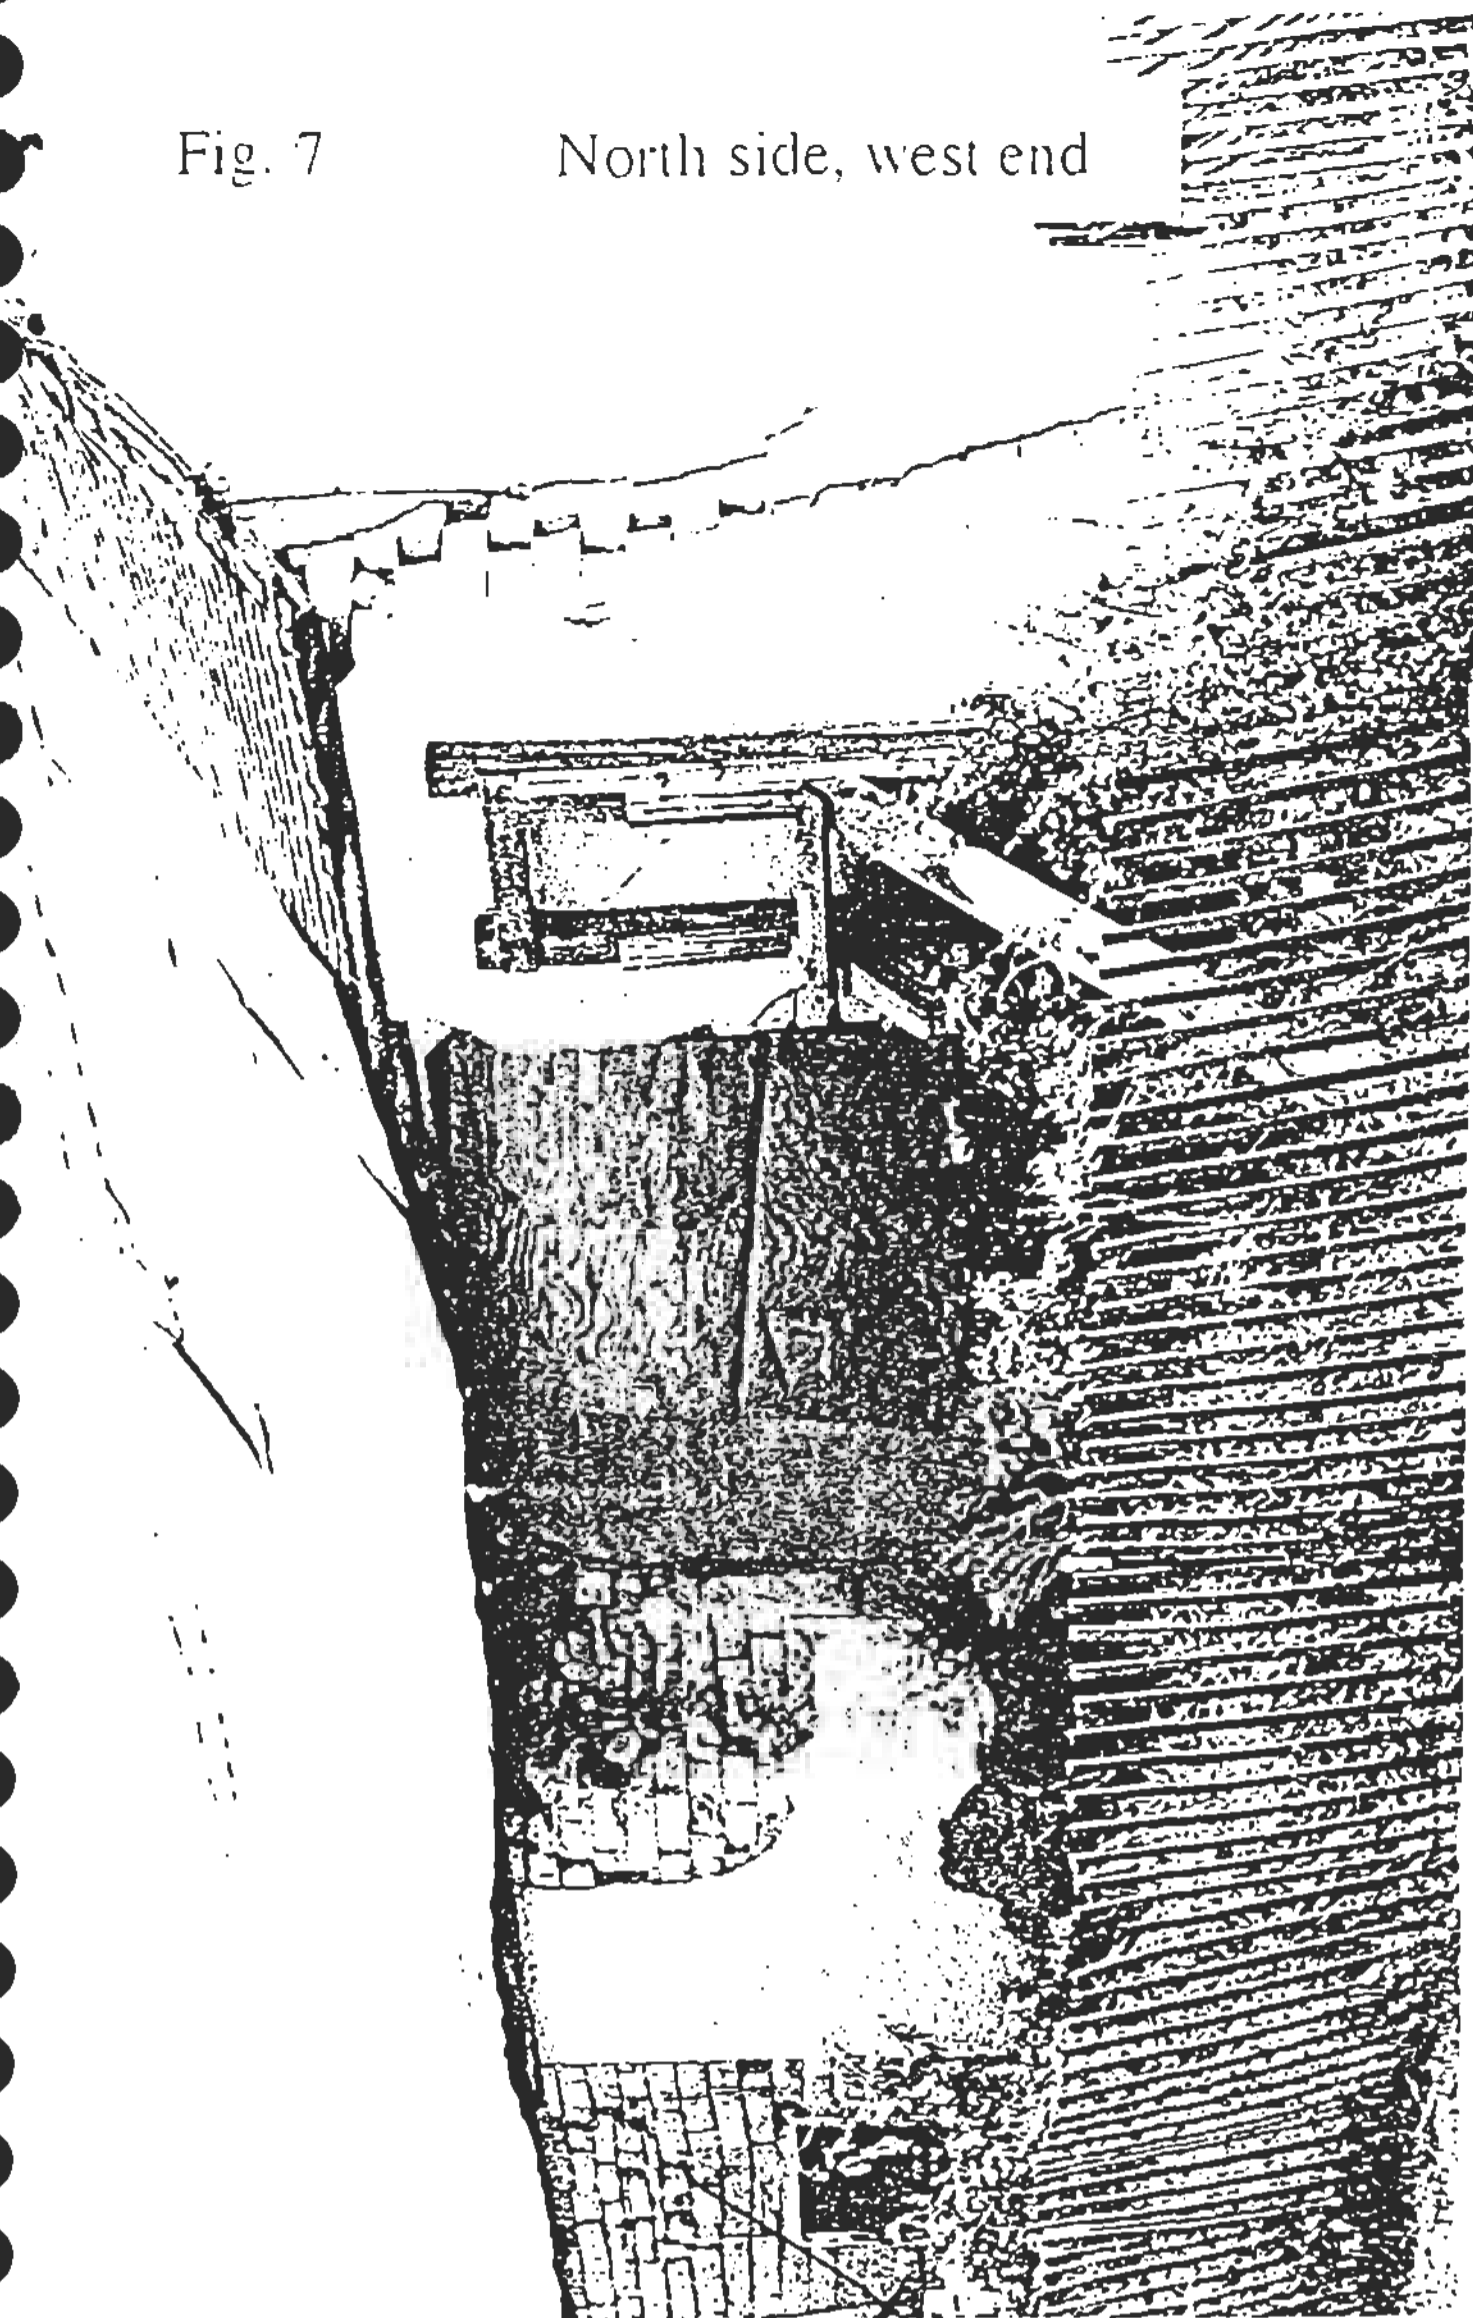
Fig. 7

The north wall of the main church is extremely dilapidated and partially collapsed (Figs 7, 9, 12). At some point in the past, a large opening (about twelve feet high and about twelve feet long) was cut into the western portion of the north wall (Fig. 12). Another opening, about eight feet high and about six feet wide, was cut into the eastern portion of the north wall (Fig. 12). The north wall has

been shored up from the interior and the exterior with wood shoring (Figs 7, 10). Much of the stone has collapsed, leaving the remainder of the wall very unstable. The north wall is about six inches from vertical at the west end (Fig. 8).

North side, west end
